R-05-02

Äspö Pillar Stability Experiment

Final experiment design, monitoring results and observations

December 2005

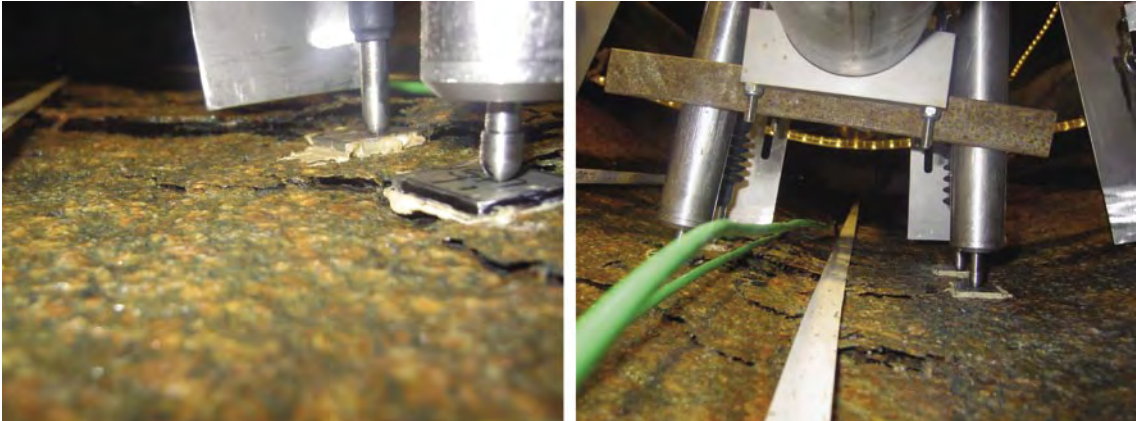
Figure 5-37. May 18. Photographs of the pillar wall. Left: close-up of position #3 (2.5 m level); the short-range LVDT is the right one. Right: photograph from below along the centre of the pillar (pos #3 to the left and pos #4 right of the pipe).

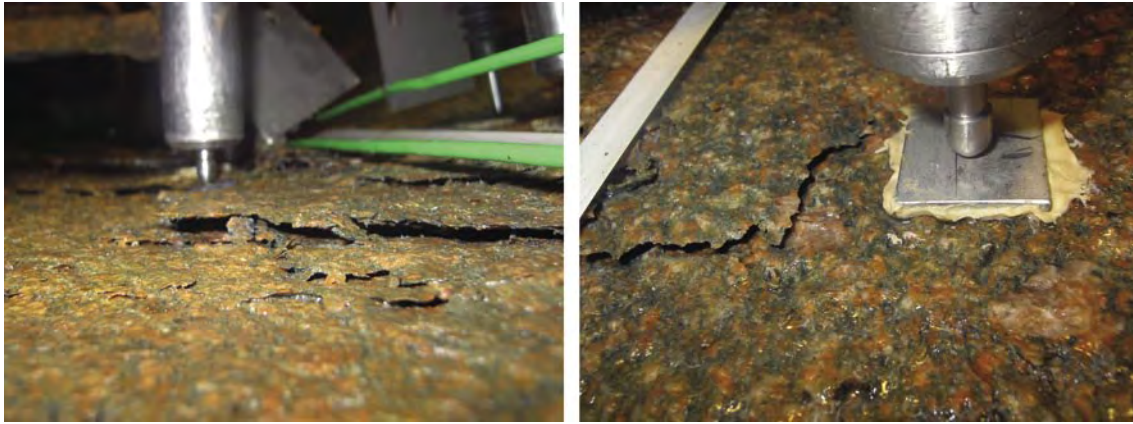
Figure 5-39. May 25. Photograph of the short-range sensors at positions #3 (left) and #4 (right).

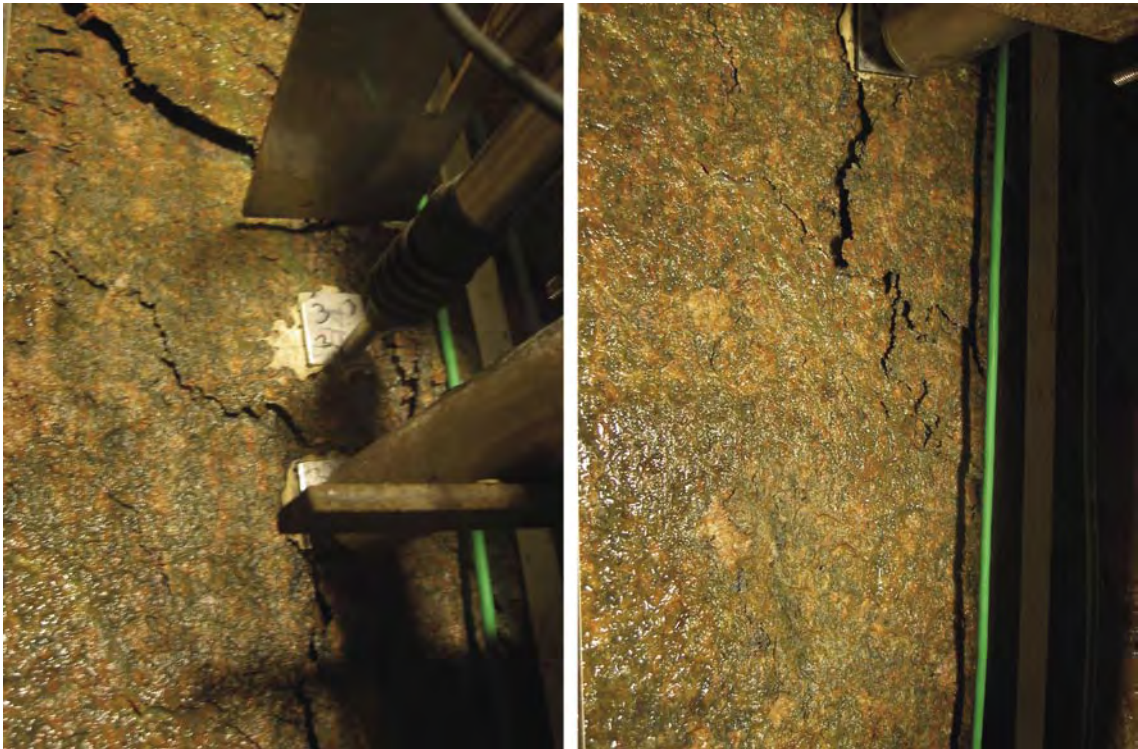
Figure 5-41. May 27. Photograph of position #3, left both sensors and right below the short range sensor.

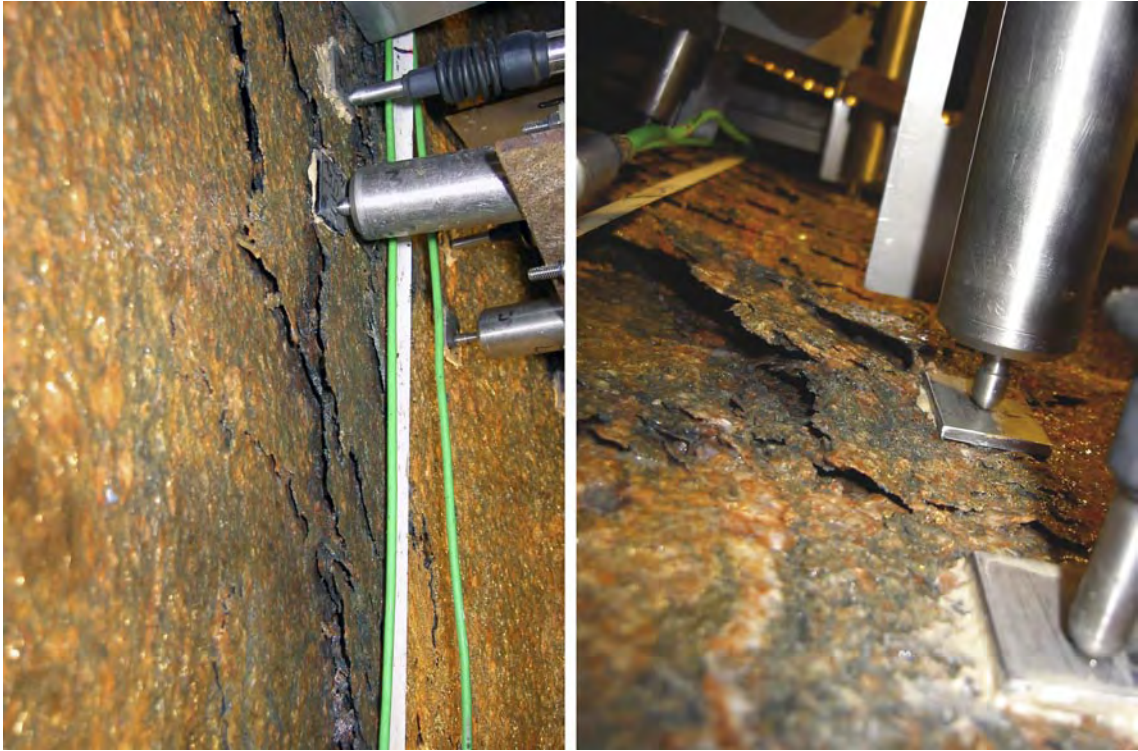
Figure 5-43. June 2. Photograph of spalling/fracturing at positions #3 (left) and #10 (right).

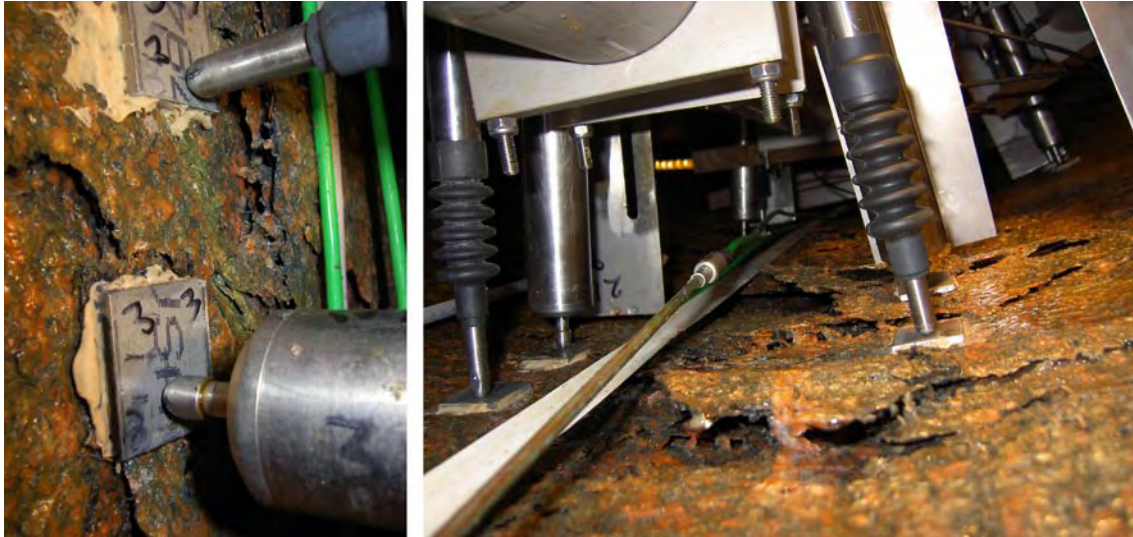
Figure 5-45. June 8. Photographs of spalling/fracturing at position #3 (2.5 m level) and between positions #9 and #10 at the 3 m level. In the right photograph position #9 is to the left.

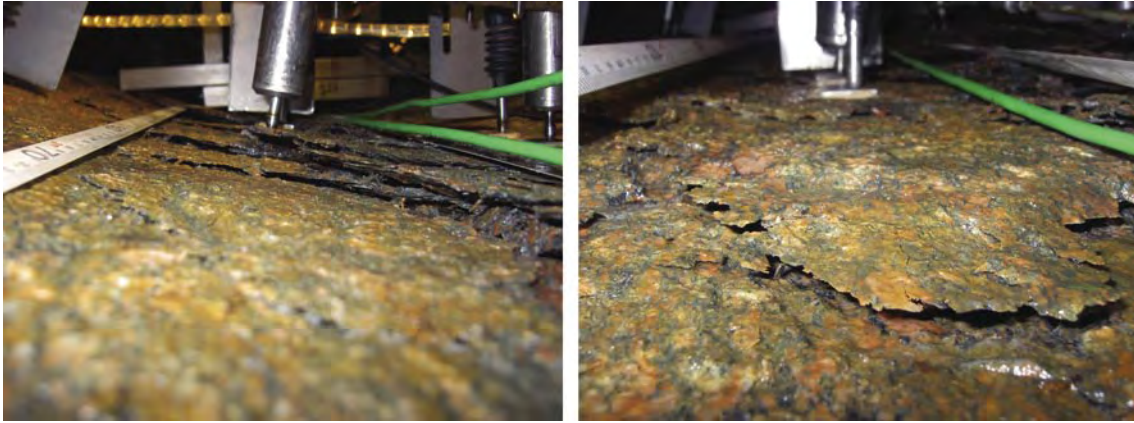
Figure 5-48. June 16. Photographs of spalling/fracturing at position #3 on the 2.5 m level (left) and at position #9 on the 3 m level (right).

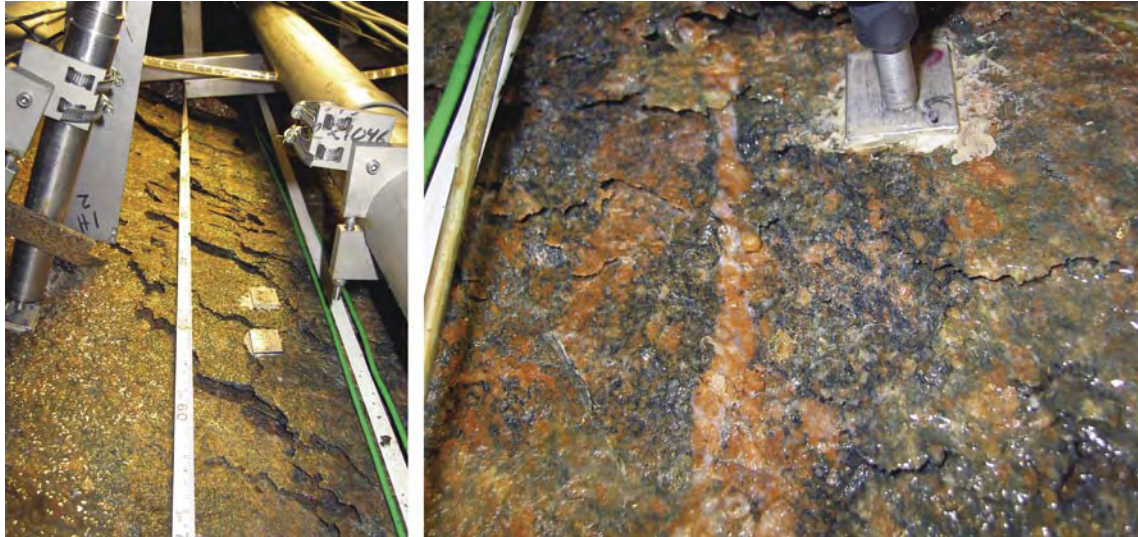
Figure 5-50. June 23. Photographs of spalling/fracturing at position #3 on the 2.5 m level (left) and at position #10 on the 3 m level (right).

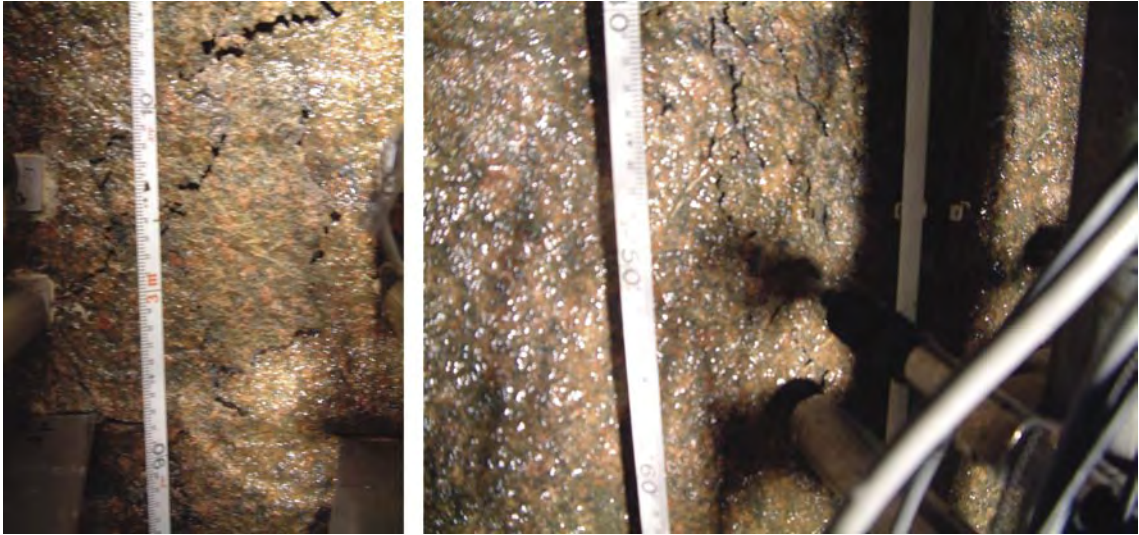
Figure 5-53. June 29. Photographs of spalling/fracturing at position #9 at the 3 m level (left) and at position #15 at the 3.5 m level (right).

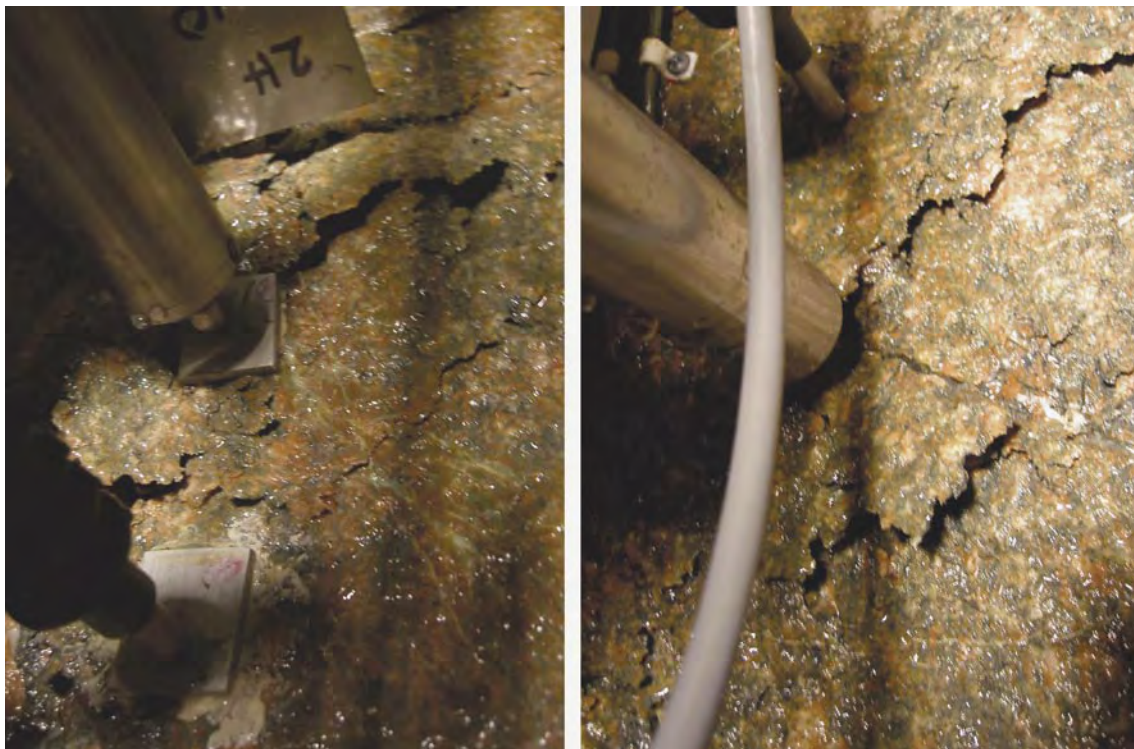
Figure 5-56. July 6. Photographs of position #10 (left) and position #16 (right).

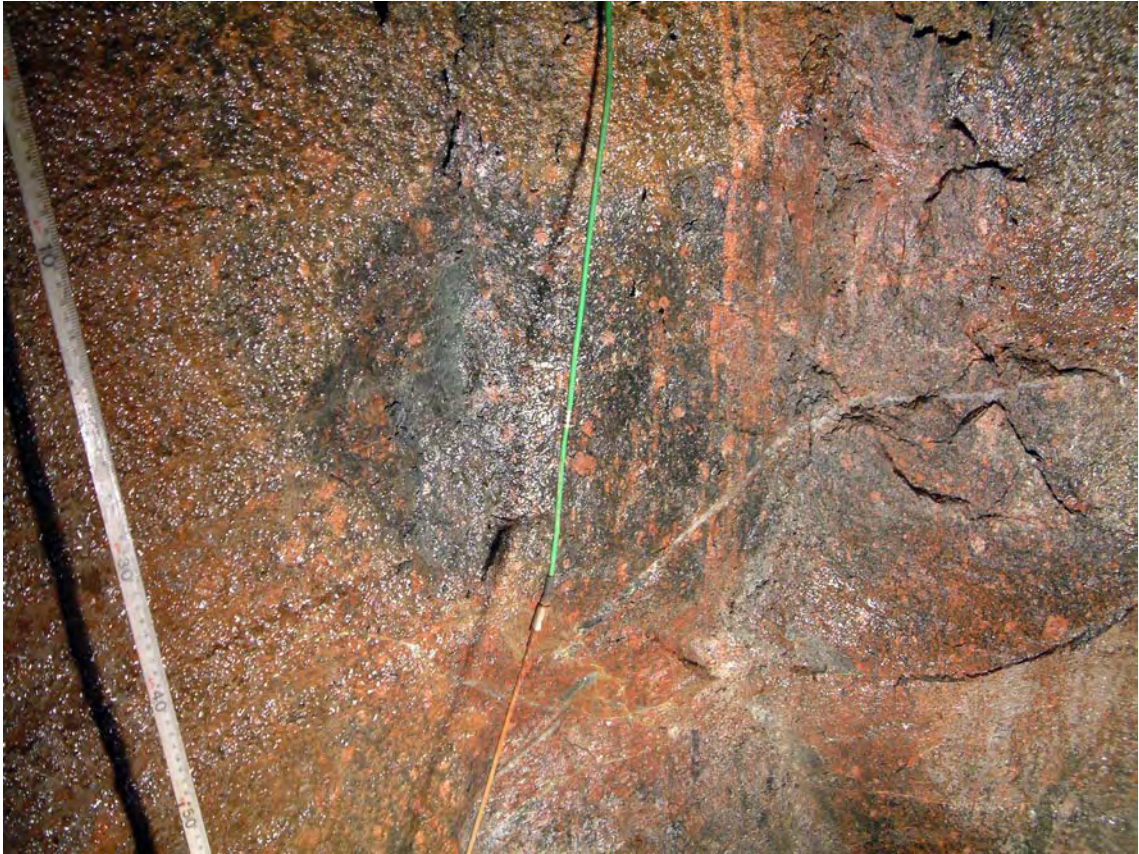
Figure 5-58. The greenstone body that created a small pit in the rock wall.

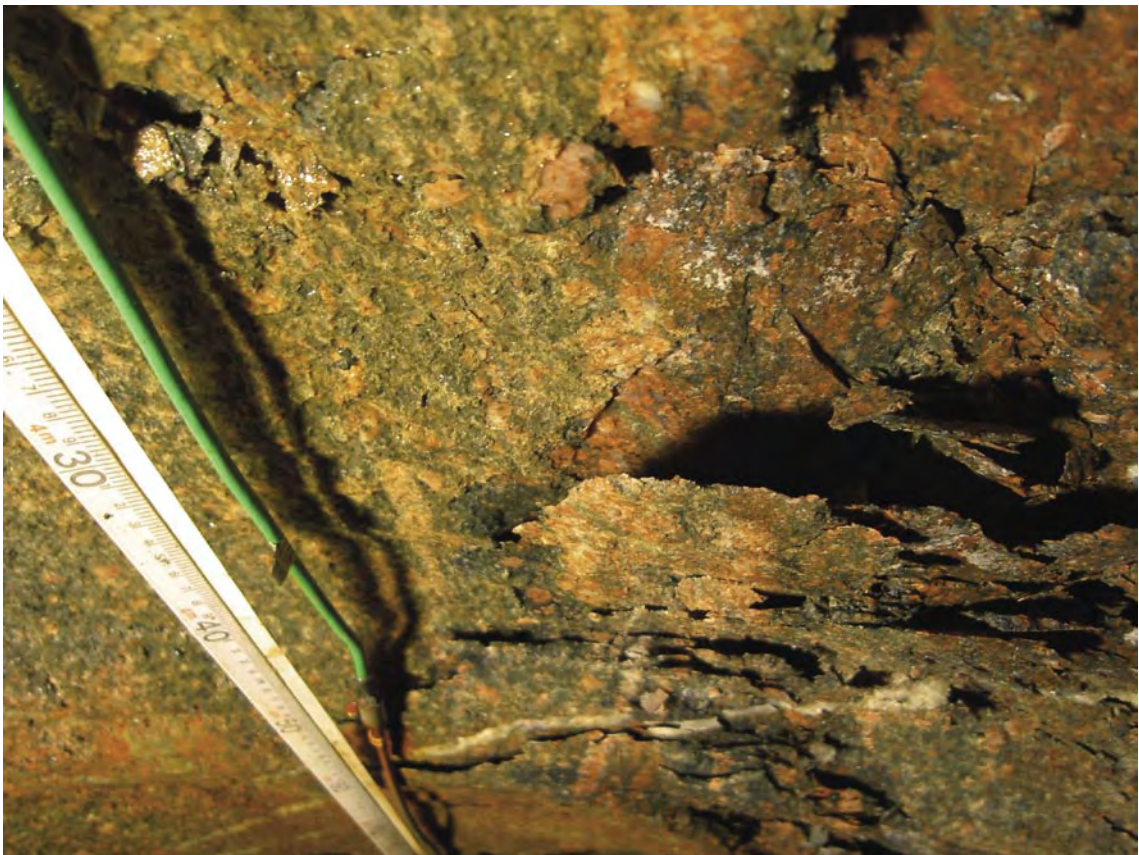
Figure 5-59. Photograph of the upward-pointing chips, looking downwards.

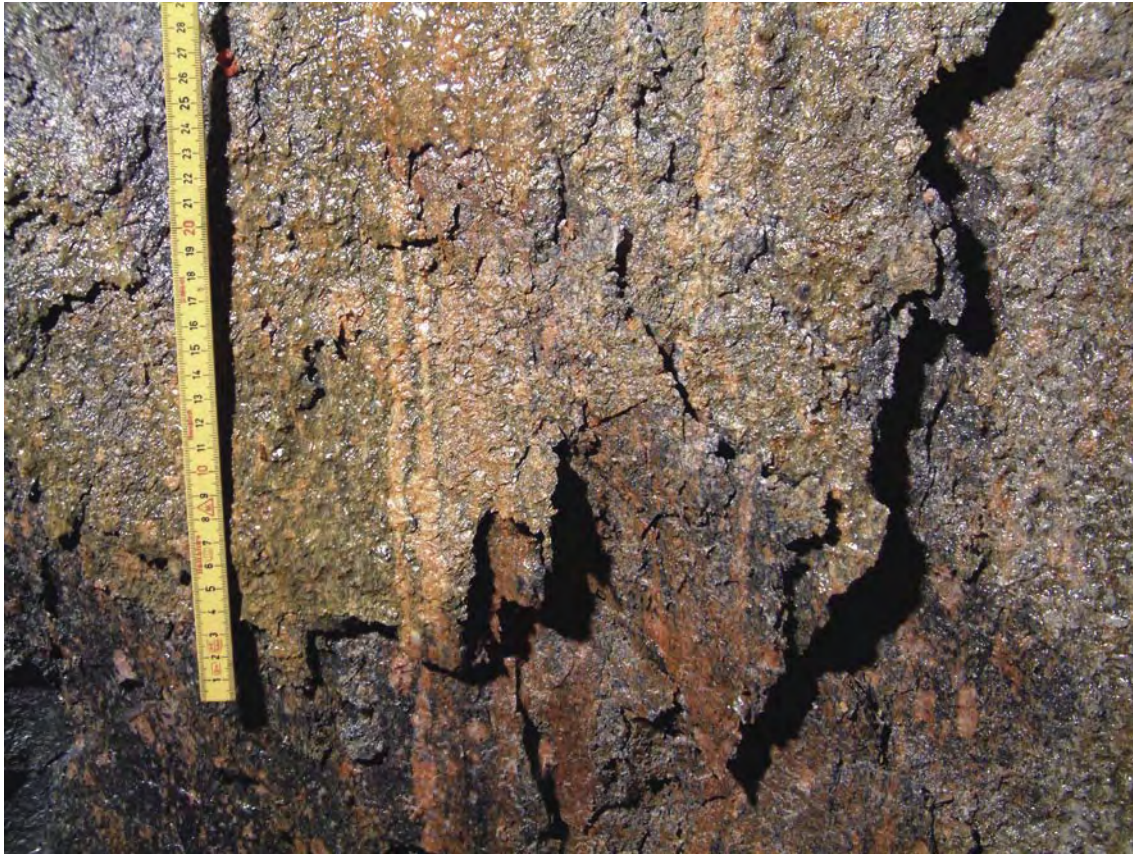
Figure 5-60. Photograph of rock wall at depth of approximately 4 m. The small cm-scale chips on top of the larger chips are clearly visible.

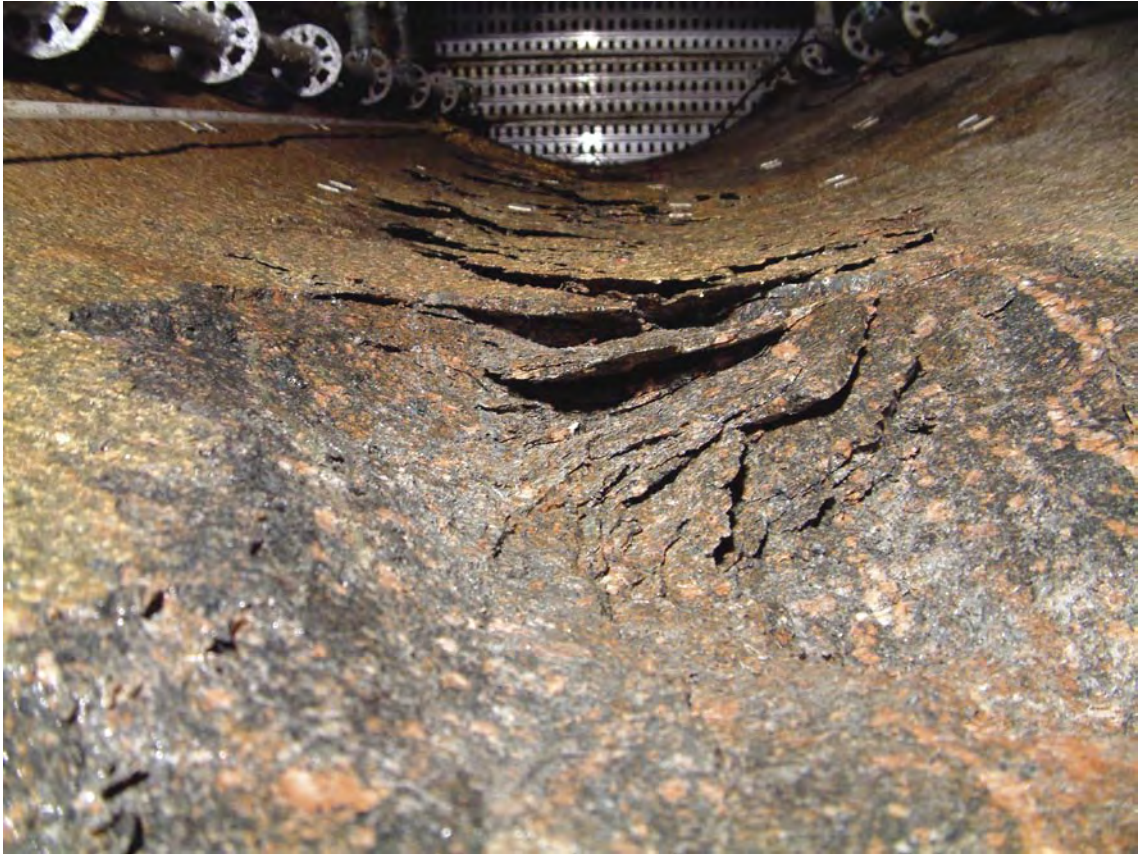
Figure 5-61. Photograph taken from below of chips at 3.7 m and up. The dilatation and curvature of the slabs can be seen.

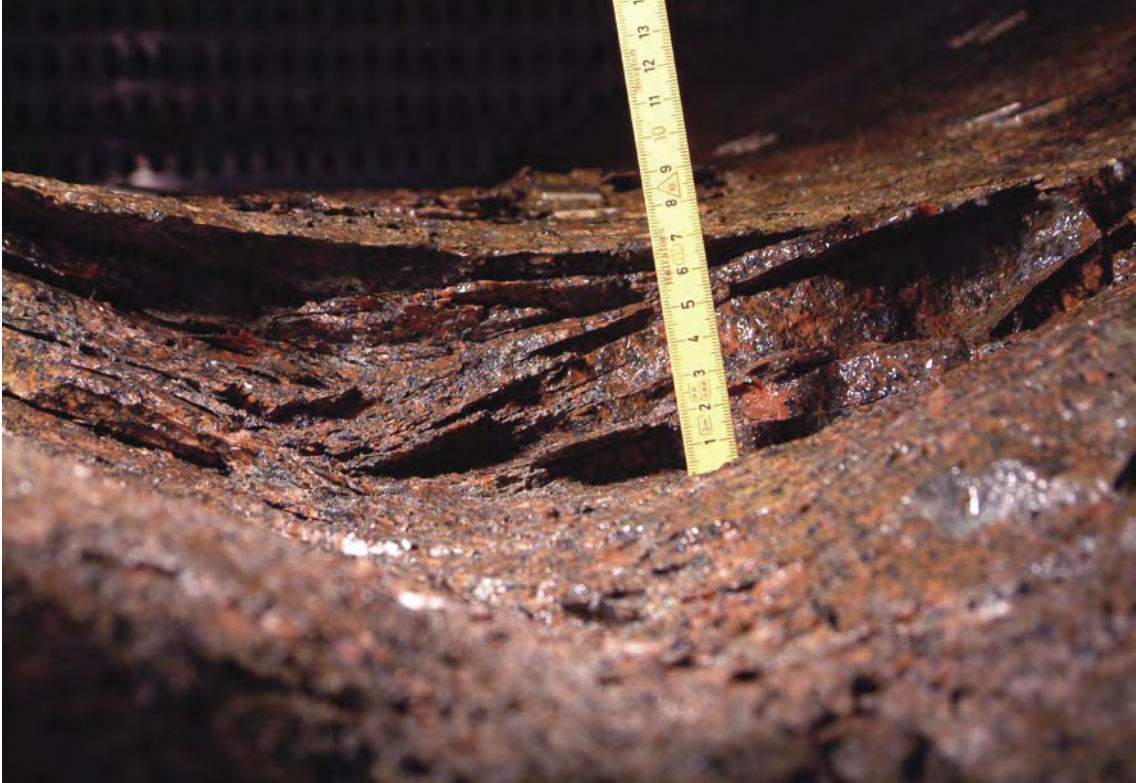
Figure 5-62. Photograph of the smooth arched notch at a depth of 3.7 m.

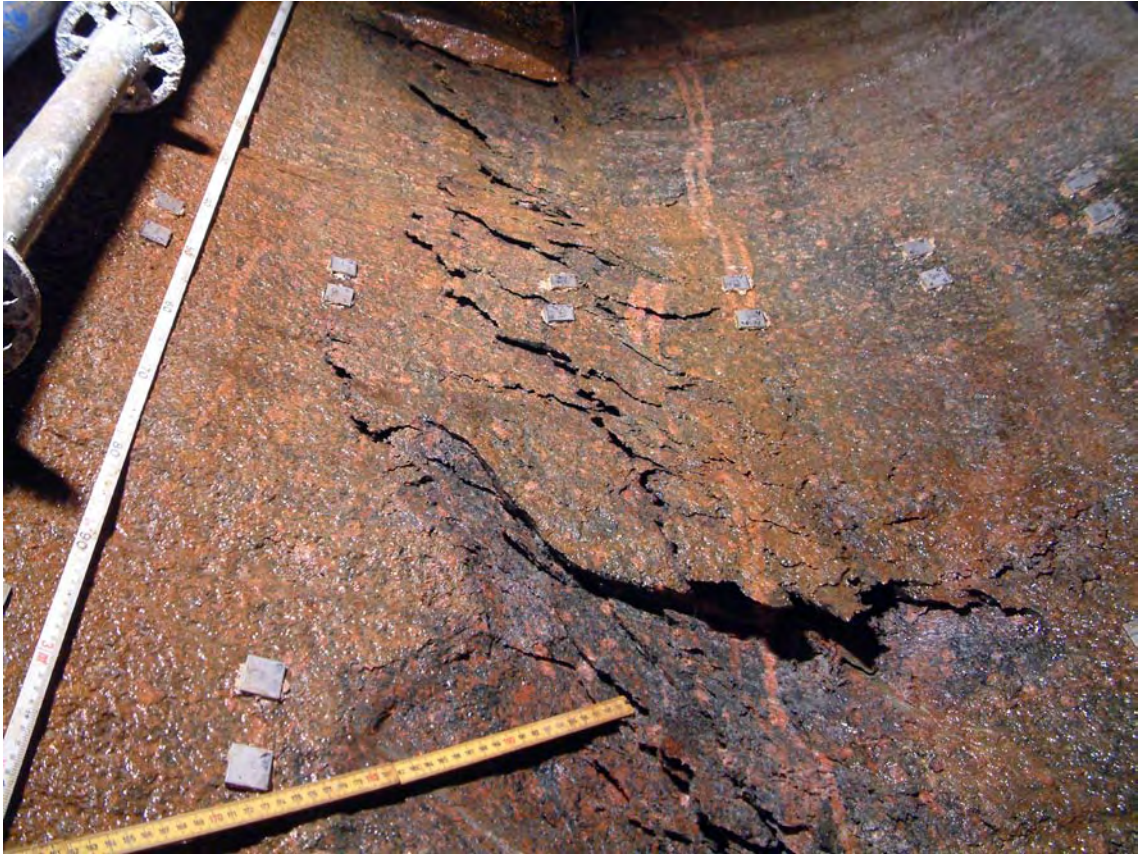
Figure 5-63. Photograph of the slabs with a free left surface and the right side attached to the rock wall. The depth at the bottom of the photograph is 3 m.

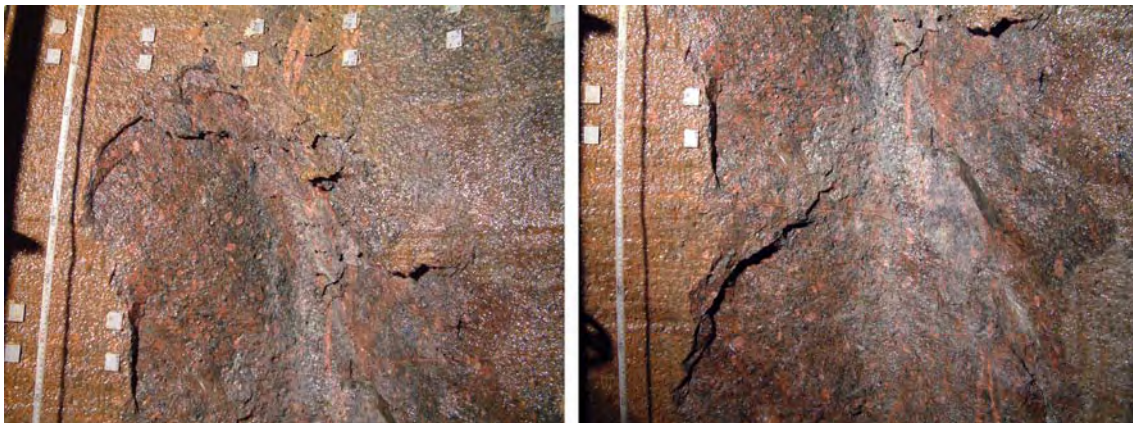
Figure 5-64. Photographs of the smooth notch surface. The upper two rows of steel plates in the left photograph are from the 2.5 m instrument level.

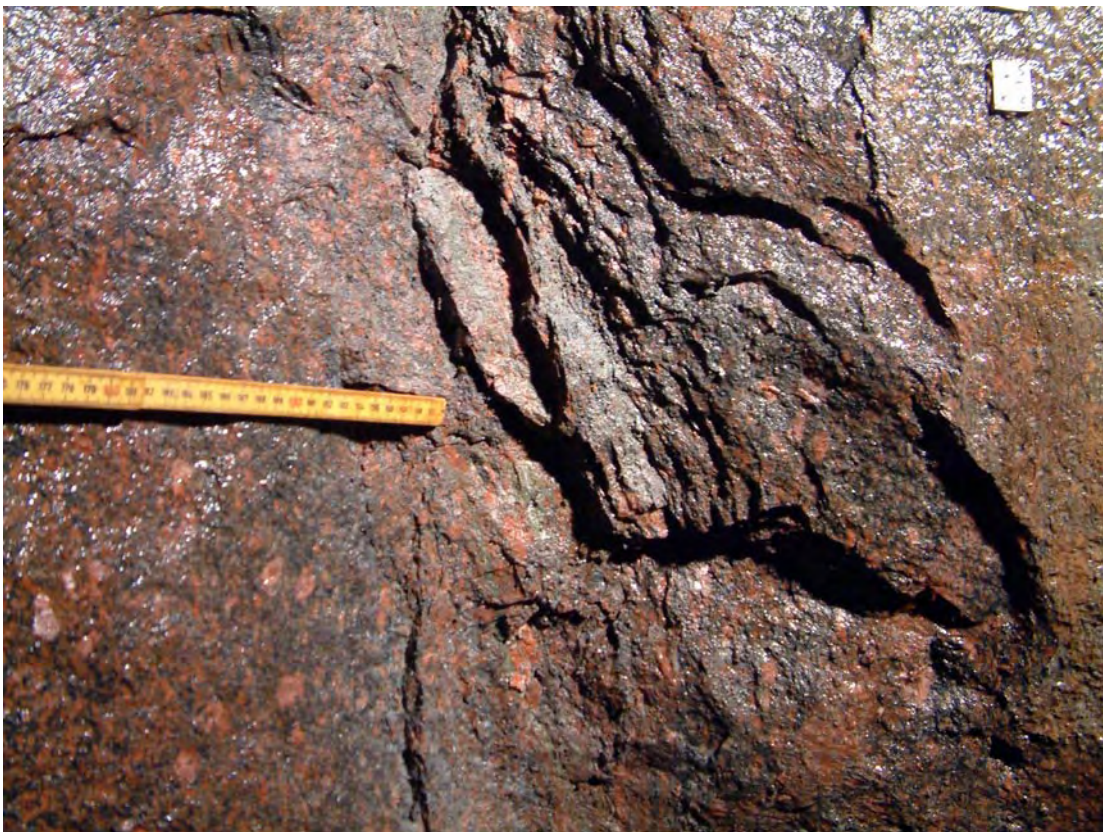
Figure 5-66. Photograph at depth of approximately 2.5 m showing the right side of the pillar, where almost no slabs could be removed.

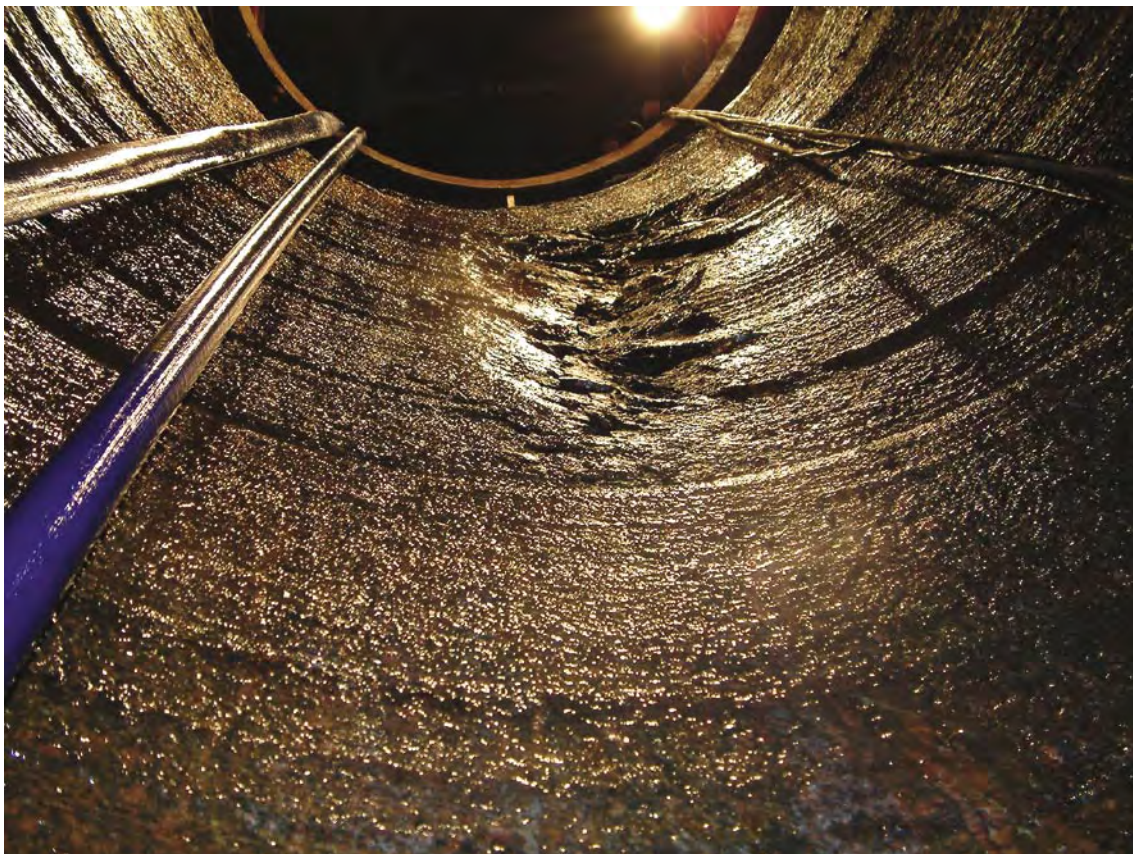
Figure 5-67. Photograph of the initial spalling in DQ0063G01 that occurred during the drilling.

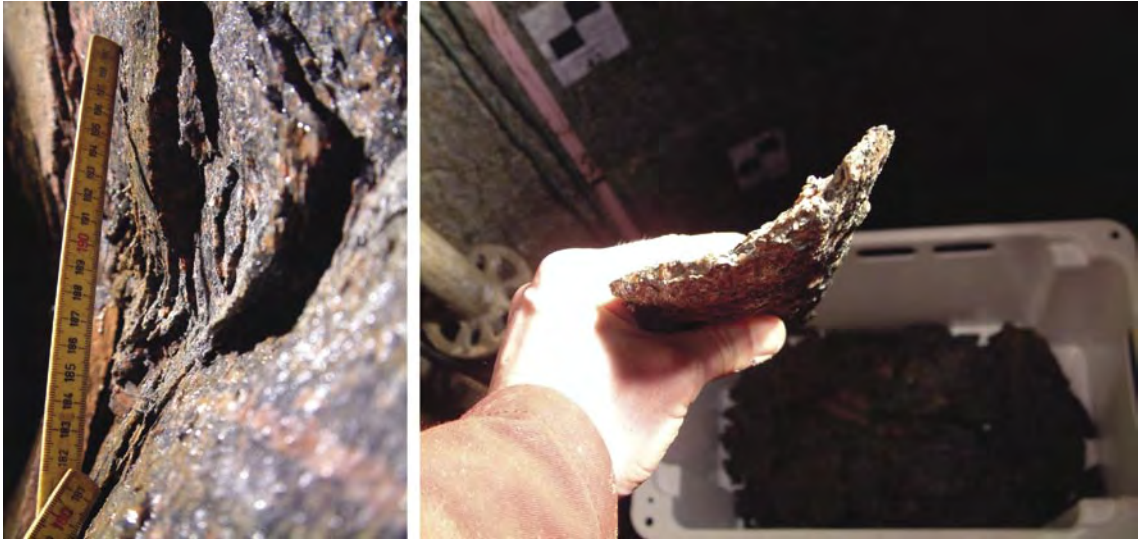
Figure 5-68. Photograph of the location of the arched chip and the chip itself.

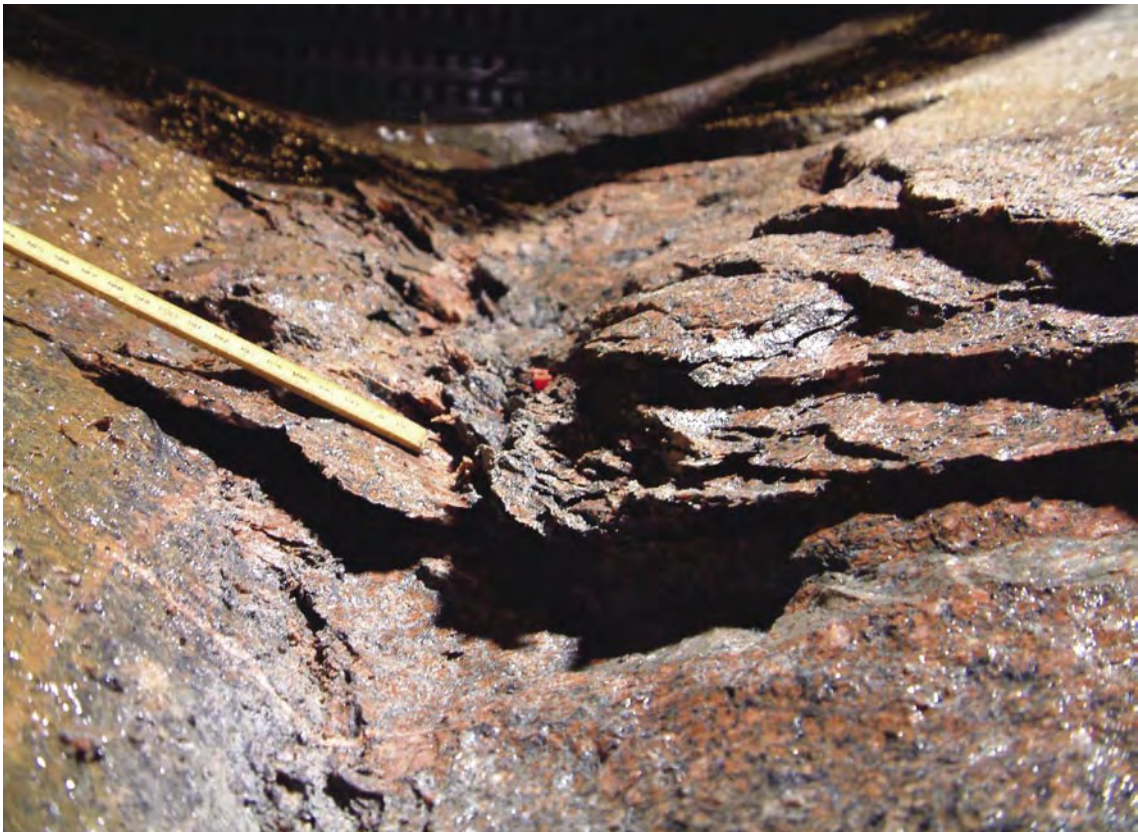
Figure 5-69. Photograph of the fractures and slabs between 1.6 and 1.1 m.

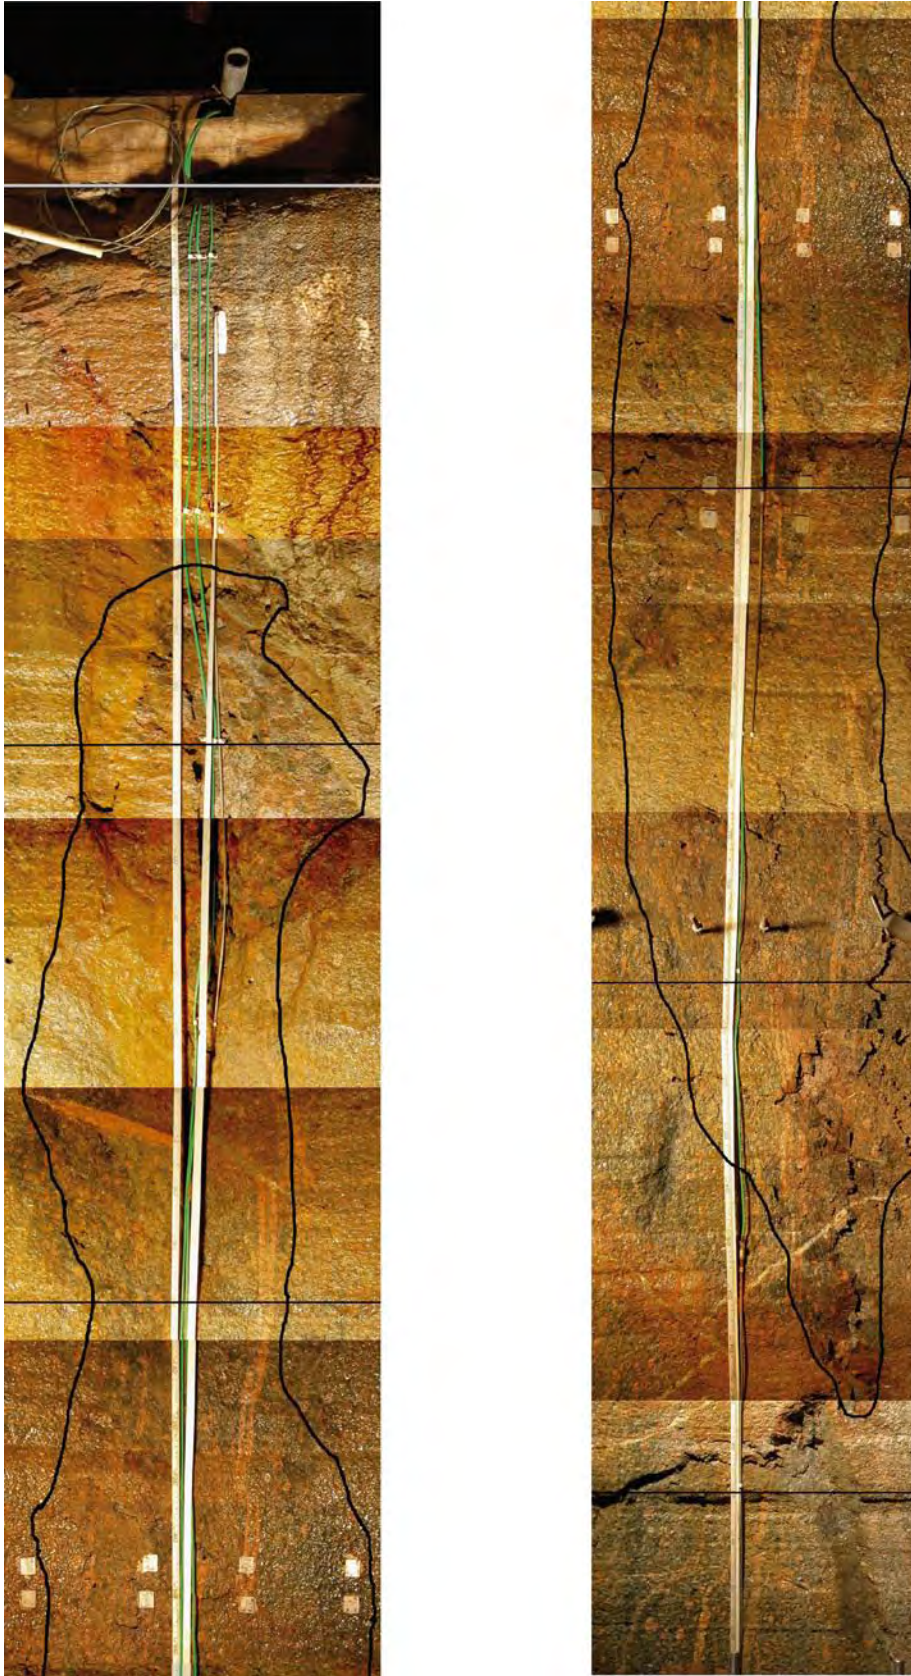
Figure 5-71. The final extent of the notch superimposed on a photograph of the pillar wall. The horizontal lines are metre markers.
