R-09-39

Examination of the Excavation Damaged Zone in the TASS tunnel, Äspö HRL

October 2009

Svensk Kärnbränslehantering AB

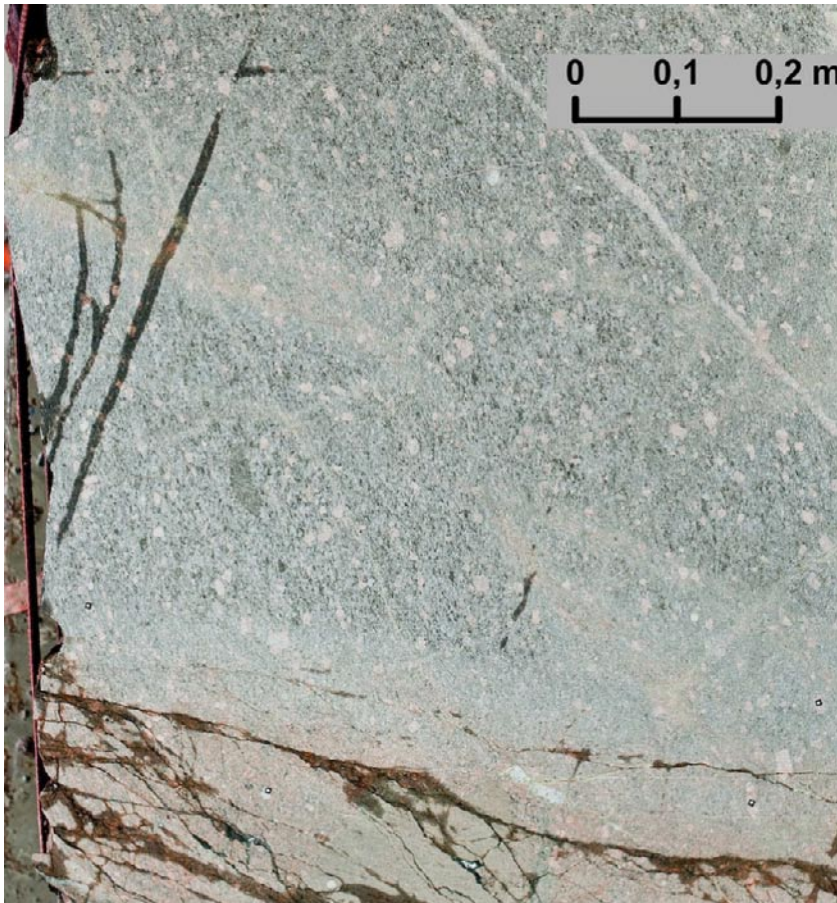
Figure 2-7. 20 cm wide fractured zone in bottom of the block (and photo), which is possible to follow from block no 36B to block no 40B. Note half-casts on left side of slab. This gently dipping fracture is noted all the way to the collar of the tunnel, i.e. it is more than 40 m long.

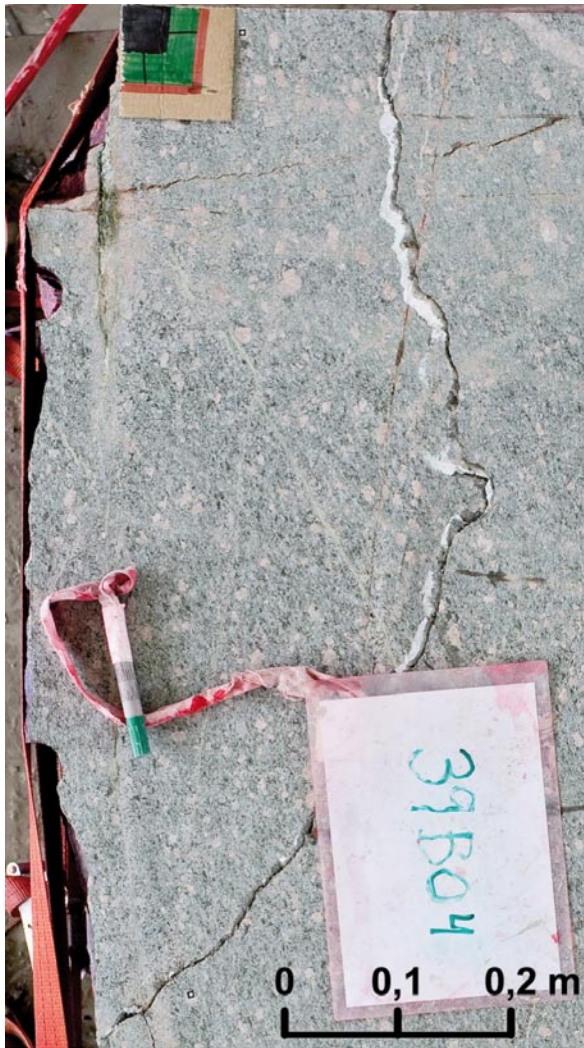
Figure 2-8. An open, 2 cm thick fracture filled with calcite in block 39. Note half-casts on left side of slab.

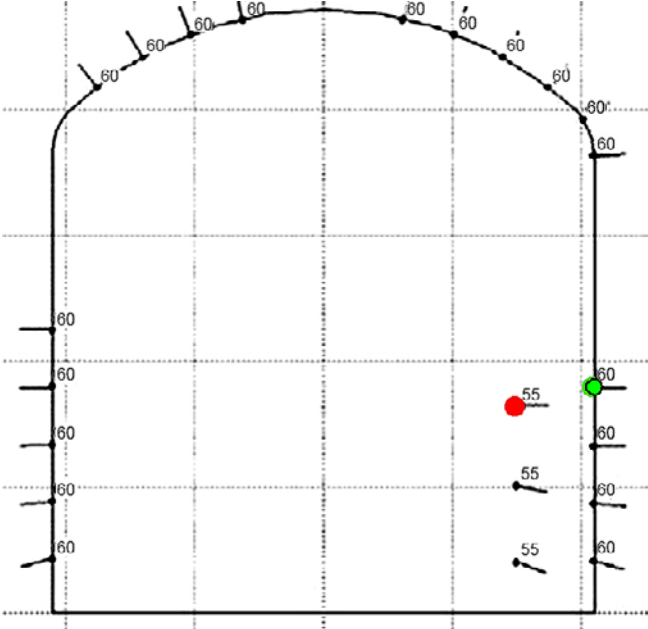
due to remaining rock in the bottom of the holes and also due to one undetonated electronic detonator, see Figure 3-6. The holes were re-charged with one 30×380 mm cartridge of Dynamit each and initiated with Nonel detonators. The hole marked as green corresponds to hole 3 in Figure 2-2 and it is the lowest hole in the test area. Certainly this re-blast has influenced the EDZ in this area but it is not clear how.

Figure 3-6. Re-charged holes. The red marked hole contained the uncharged detonator.

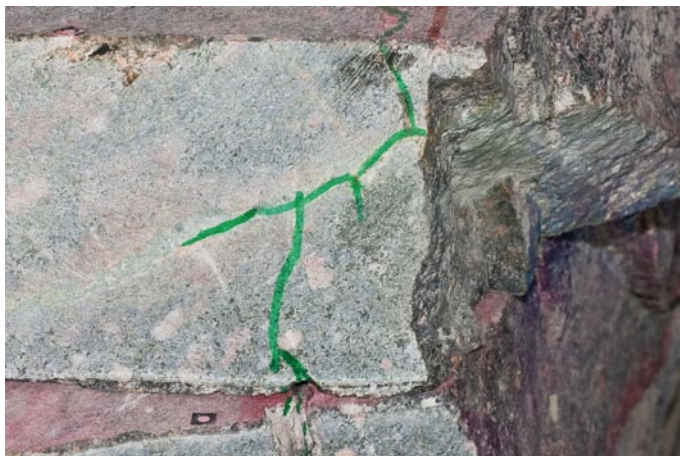
Figure 6-18. Detail of case 1. A blast fracture which comes from above meets an intersecting fracture, jumps to the side and continues.

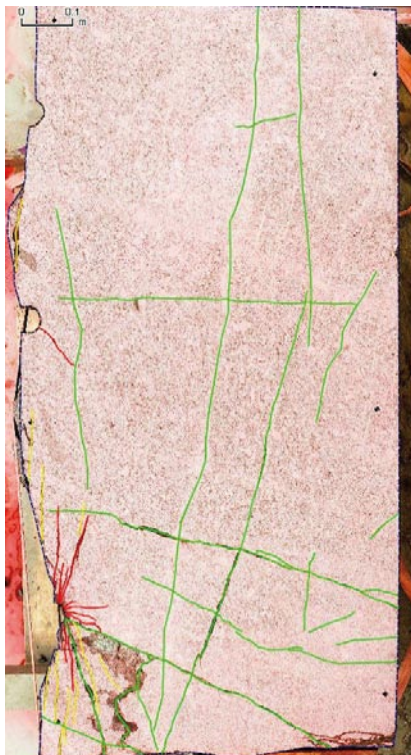
Figure 7-1. Example of a section with a lot of blasting fractures at the lowest hole and hardly any at the two upper holes. Section 40B-03.

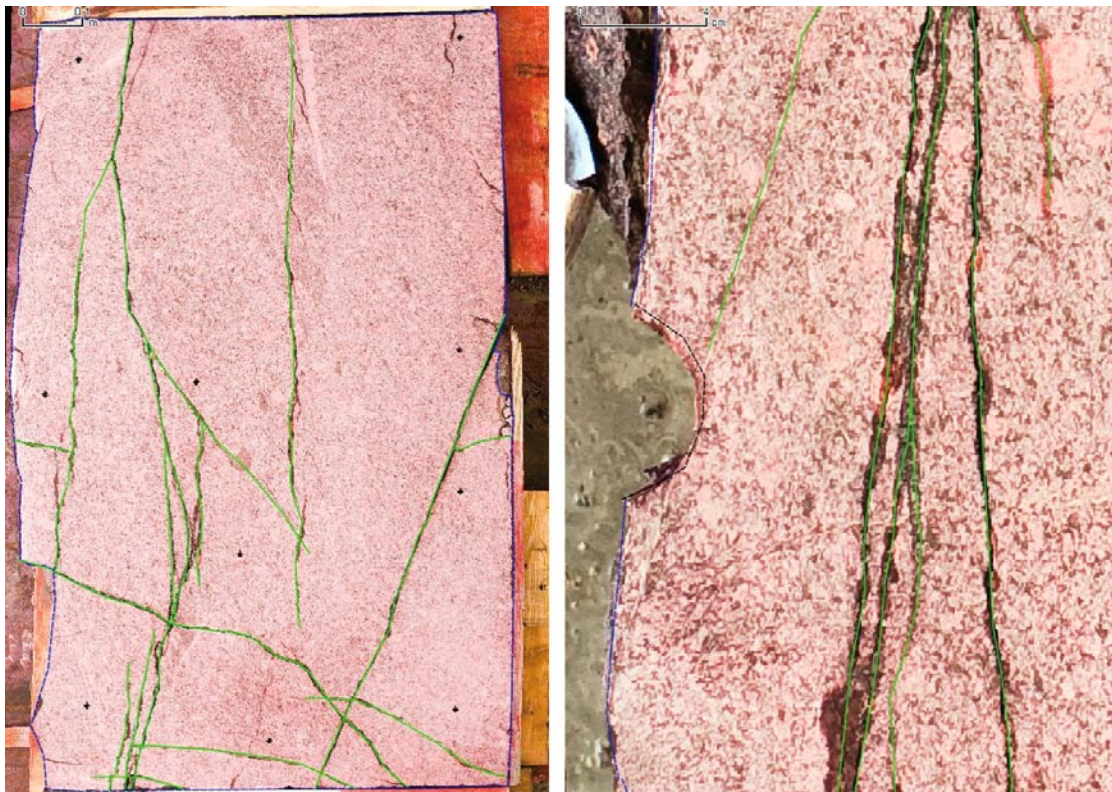
Figure 7-2. Examples from the first section of a round. The fracture originating from contour hole on the right photo has infillings and is hence classified as natural.

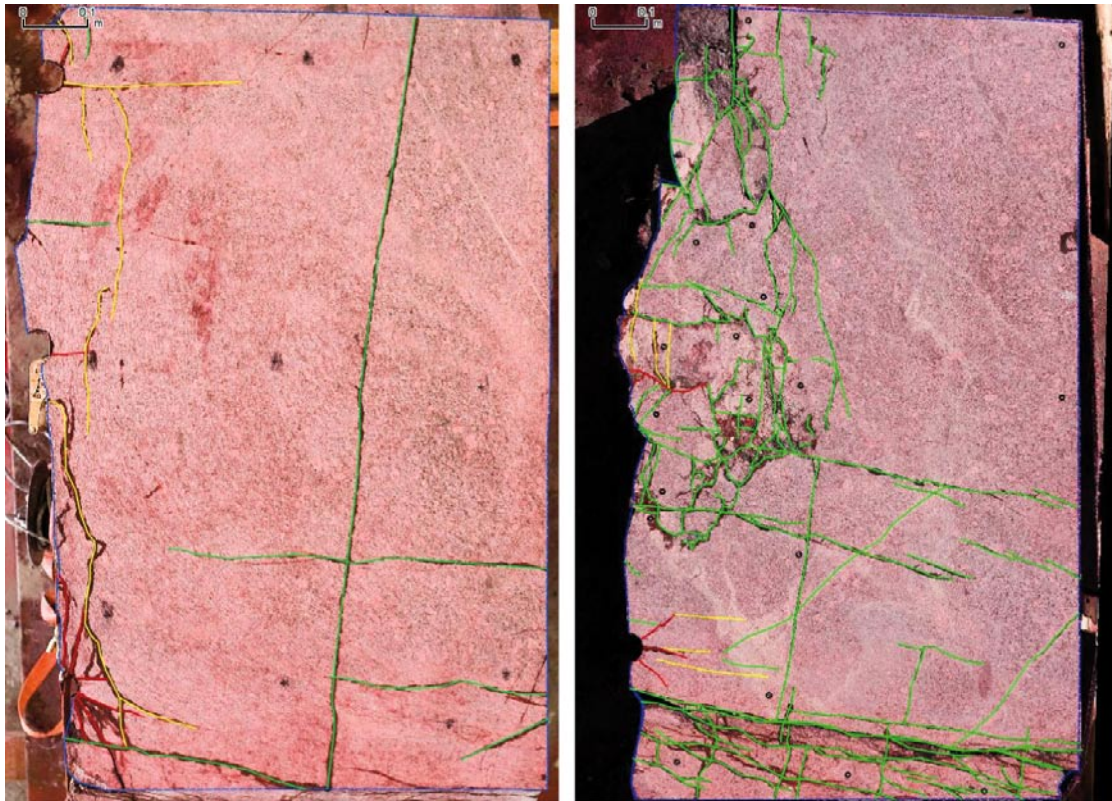
Figure 7-3. Sections in the middle of a round 39B-01 and 37B-07.

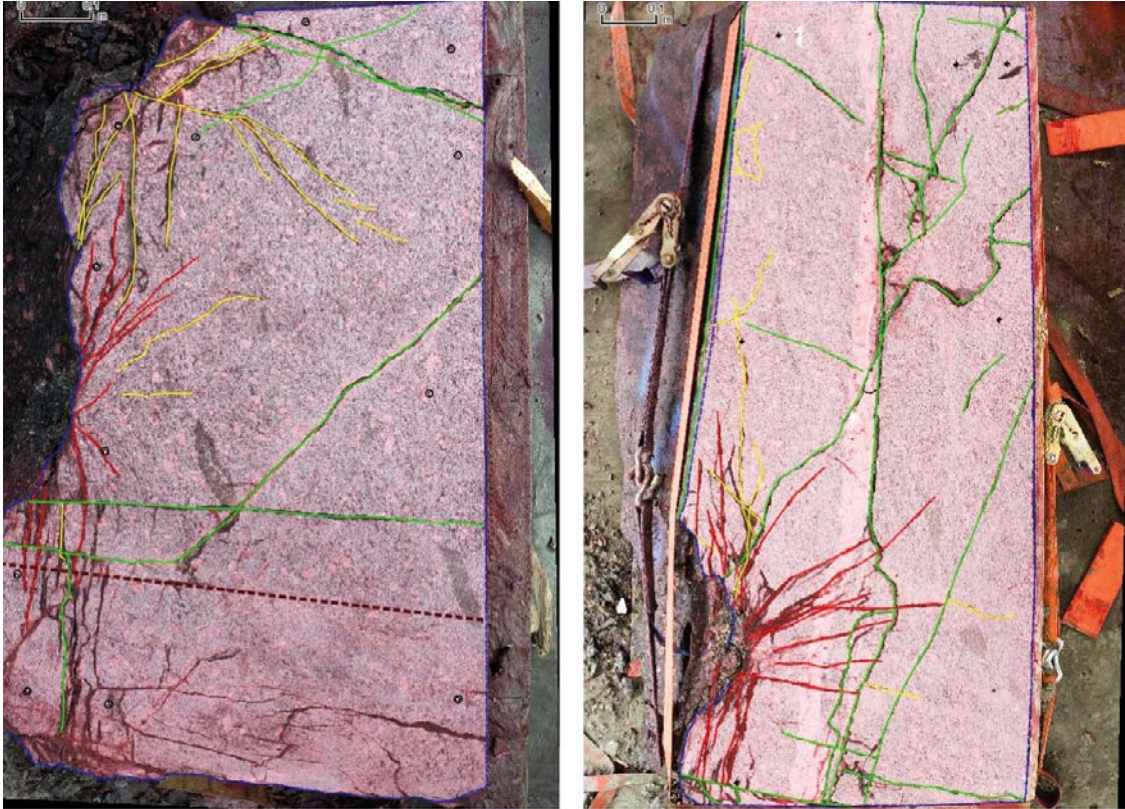
Figure 7-4. Sections at the bottom of a round (36B-09 and 41B-06).

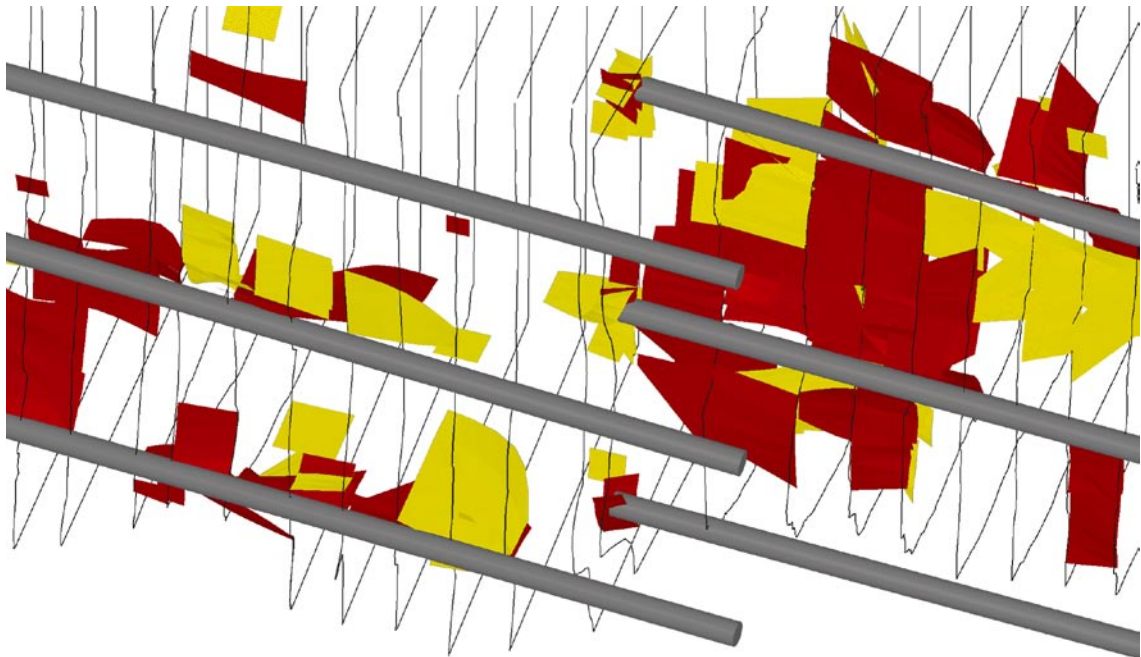
Figure 8-1. Modelled blasting fractures at the transition zone between round 9 and 10.
