# Surface morphology and elemental composition of copper canisters for disposal of spent nuclear fuel

**SKB P-17-11**

August 2017

Carl-Johan Högberg, Oskar Karlsson, Mats Randelius  
Swerea KIMAB

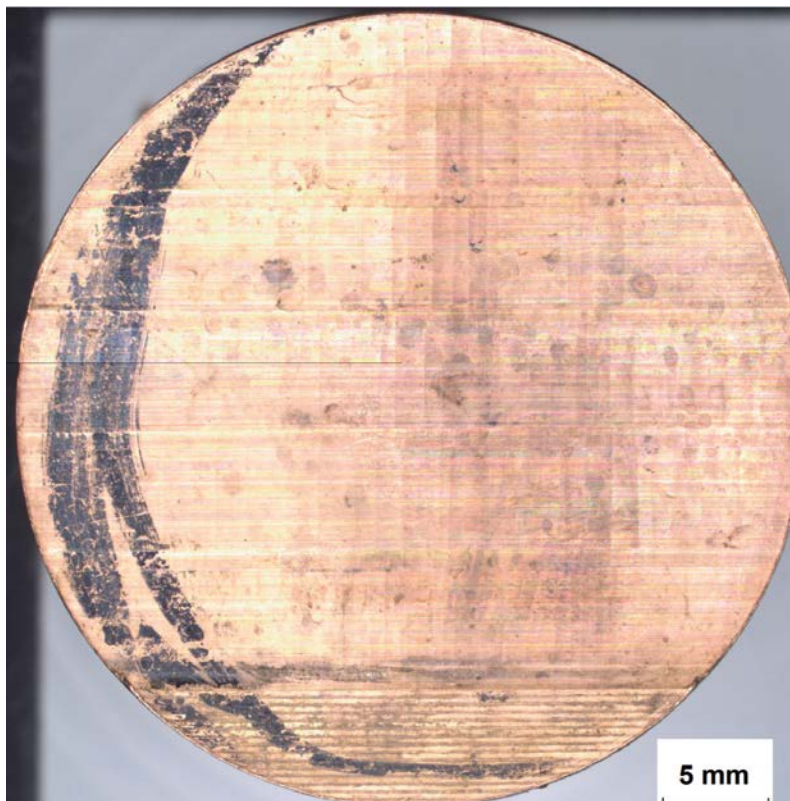
In Figure 3-1 an overview image of the surface of sample A is shown. The main part of the surface has a pattern with vertical lines. The bottom part is however different with more coarse horizontal lines.

**Figure 3-1.** Overview for the surface of the core drilled sample A as received before any sample preparation was made.

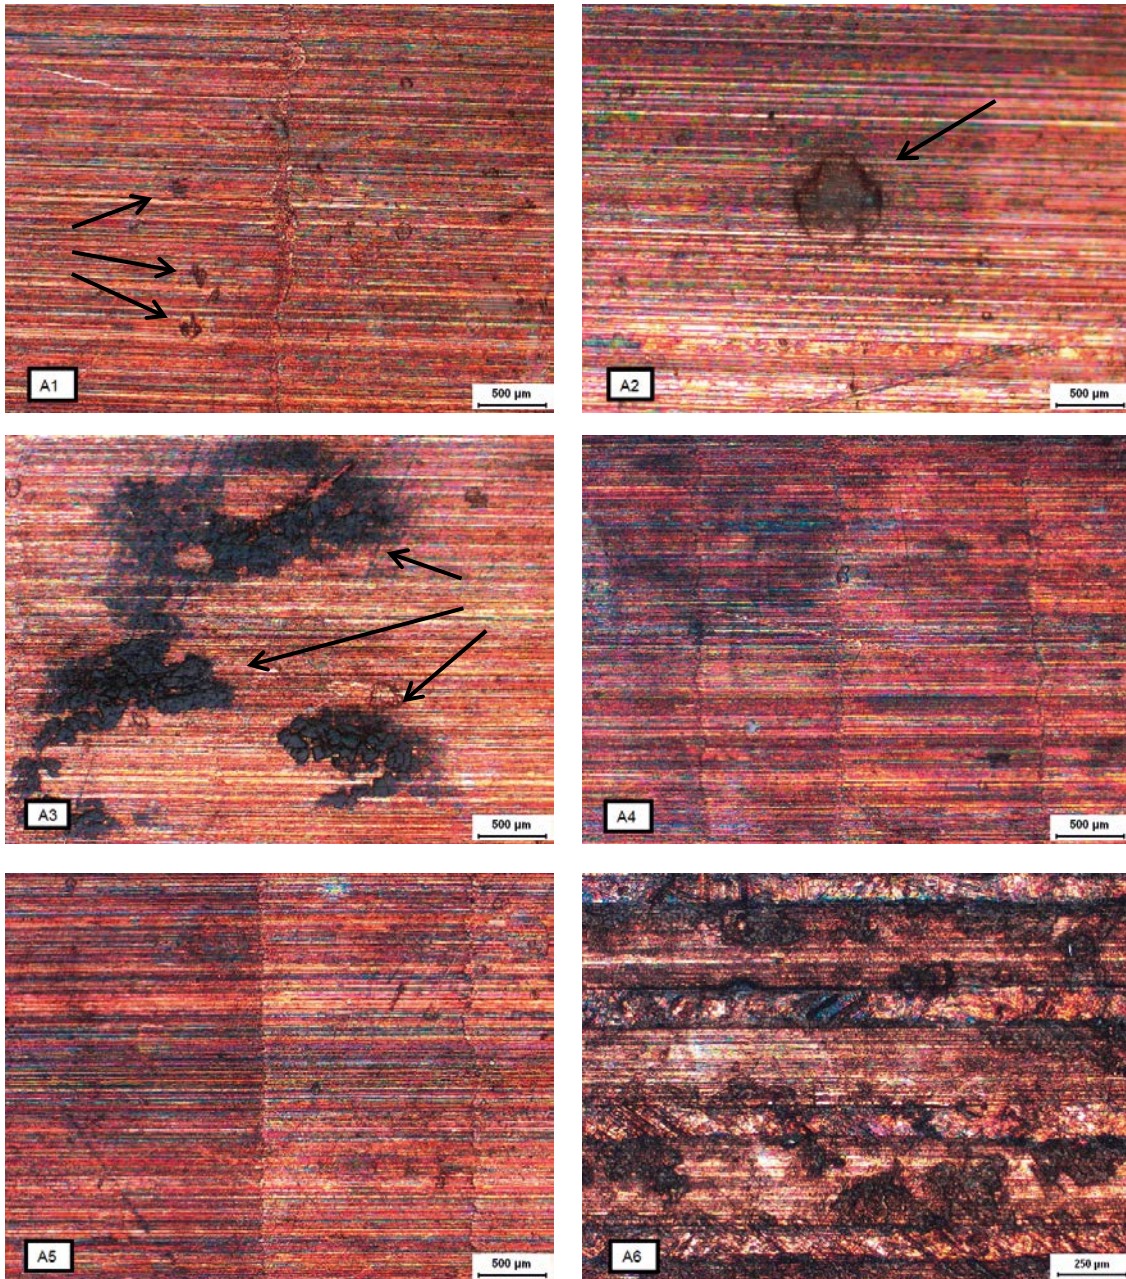
In Figure 3-2 images from different areas on sample A are shown. A1–A3 show deposits on the surface, indicated with arrows. The thickness of the deposits in A1 was too small to be measured in the microscope ( $< 1 \mu\text{m}$ ). In A2, the deposits were about  $1 \mu\text{m}$  thick and in A3  $5 \mu\text{m}$ . A4 and A5 show the vertical lines that can be seen in the overview image in Figure 3-1. The lines are channels, so shallow that they could not be measured. A6 shows a magnification of the horizontal pattern at the bottom of the sample in Figure 3-1. It is about  $0.25 \text{ mm}$  between the traces and they are  $3 \mu\text{m}$  deep.

**Figure 3-2.** Magnifications of the surface of sample A with arrows indicating deposits. The scale bars are 500  $\mu\text{m}$  for A1–A5 and 250  $\mu\text{m}$  for A6.

Traces from the mechanical processing and handling of the material can be seen for both samples examined. Numerous deposits are visible with a thickness up to 13  $\mu\text{m}$ .

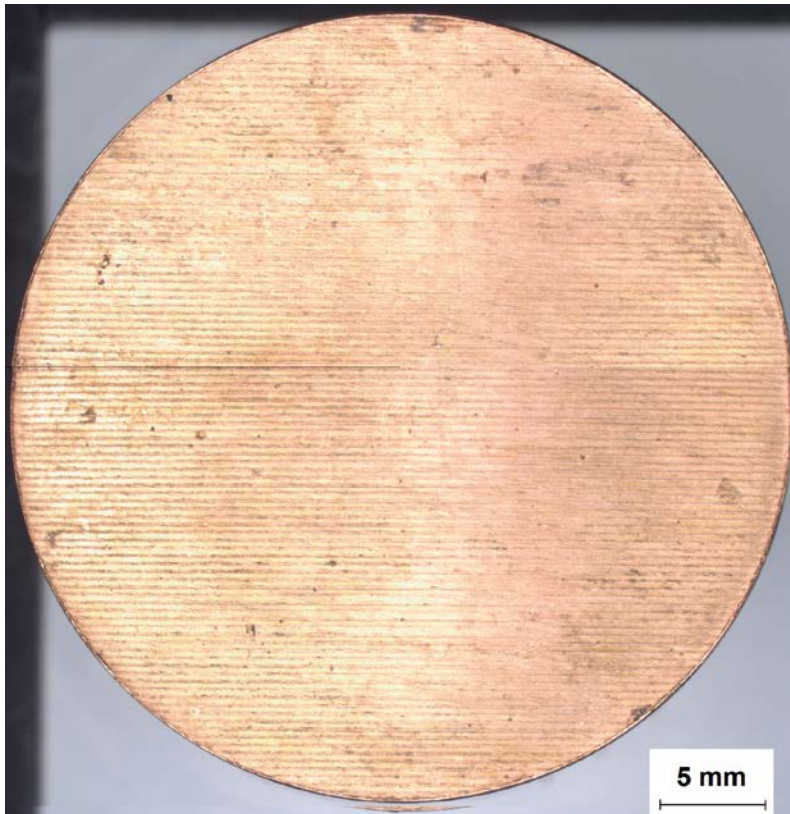
In Figure 3-3 an overview image over the surface of sample B is shown. The appearance with equidistant lines (channels) is the same over the whole surface.

*Figure 3-3. Overview image of the surface of core drilled sample B as received before any sample preparation was made.*

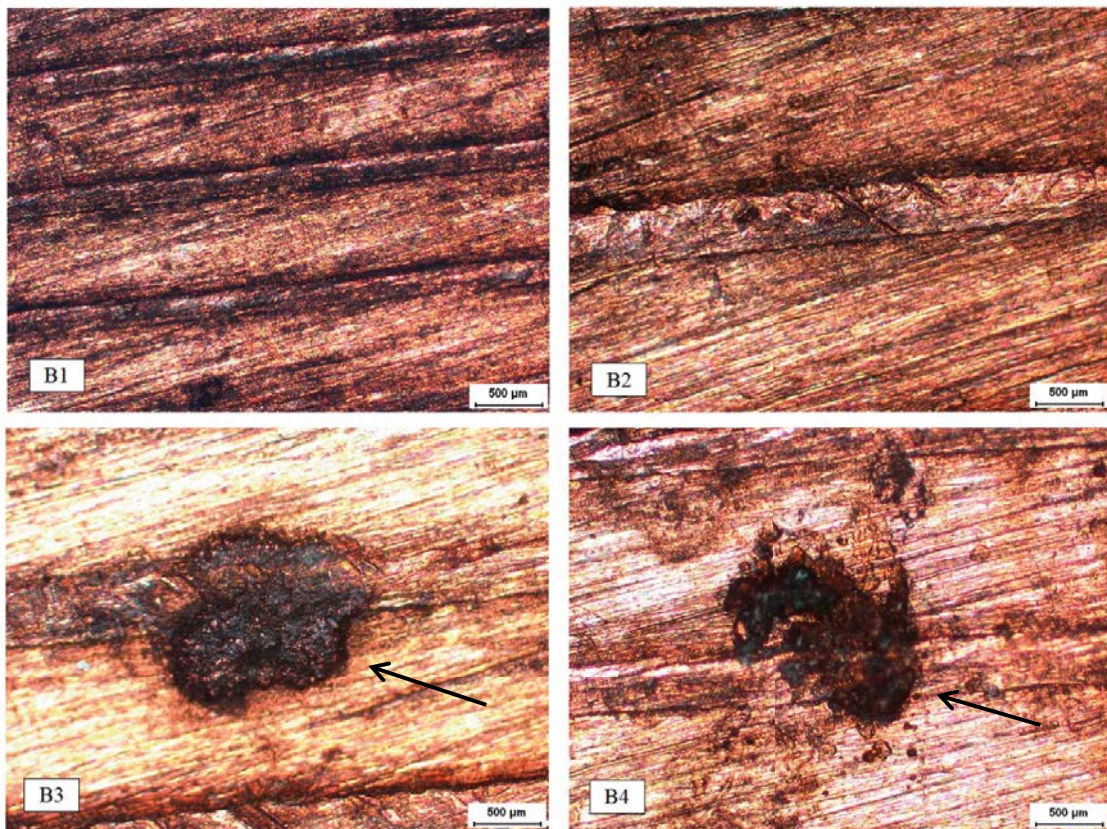
In Figure 3-4, magnifications of the surface for sample B is shown. B1 and B2 are magnifications of the pattern visible in the overview image in Figure 3-3. In B2, the depth of the channels was measured to  $2 \mu\text{m}$ . The thickness of the deposit in B3 is up to  $10 \mu\text{m}$  and up to  $13 \mu\text{m}$  in B4. The deposits are indicated with arrows.

*Figure 3-4. Magnification of the surface of sample B with arrows indicating deposits. The scale bars are 500  $\mu\text{m}$ .*

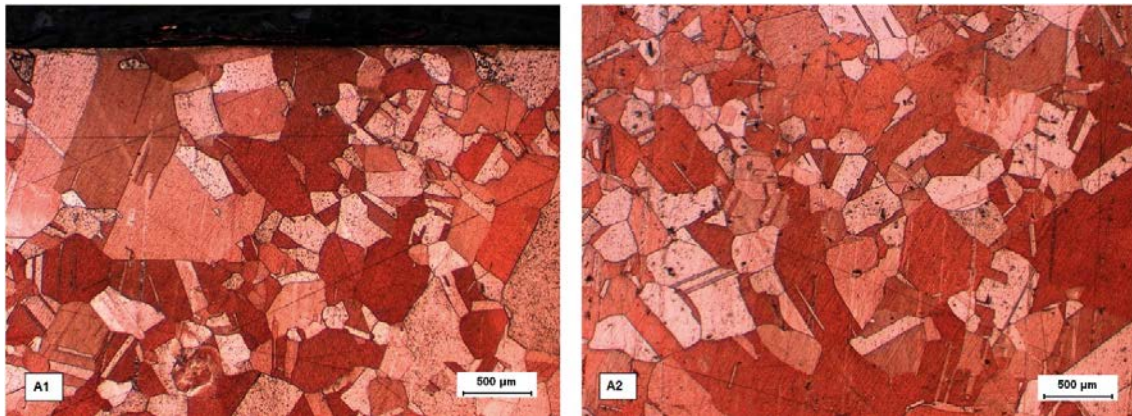
**Figure 3-6.** Metallographic cross section of sample A. A1 shows the area close to the surface and A2 further into the bulk of the sample. The scale bars are 500 μm.

From the metallographic examination of both samples it can be seen that the grains close to the surface do not differ from the bulk. No intercrystalline cracks could be distinguished.

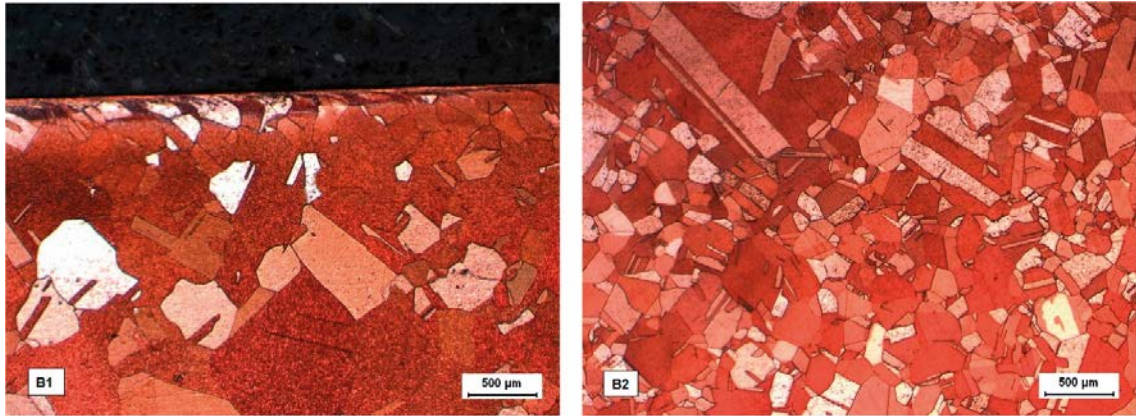
**Figure 3-8.** Metallographic cross section of sample B. B1 shows the area close to the surface and B2 further into the bulk of the sample. The scale bars are 500 µm.

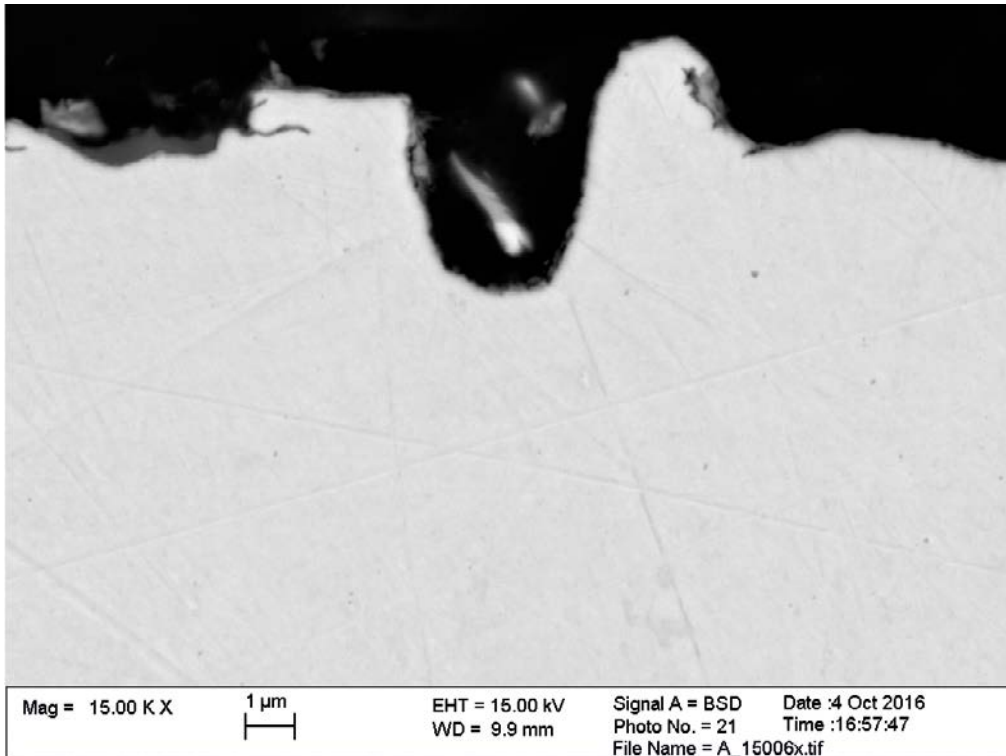
*Figure 3-10. The deepest pit that could be found on sample A, about 3  $\mu$ m deep.*

In cross sections of the samples, pits and defects of around 1  $\mu\text{m}$  occurred frequently. The deepest pit found on sample A was about 3  $\mu\text{m}$  deep. Both samples A and B show cracks that are a few  $\mu\text{m}$  deep and that are present close to the surface, see Figure 3-12 and Figure 3-17. These cracks are believed to have formed during mechanical processing of the surface.

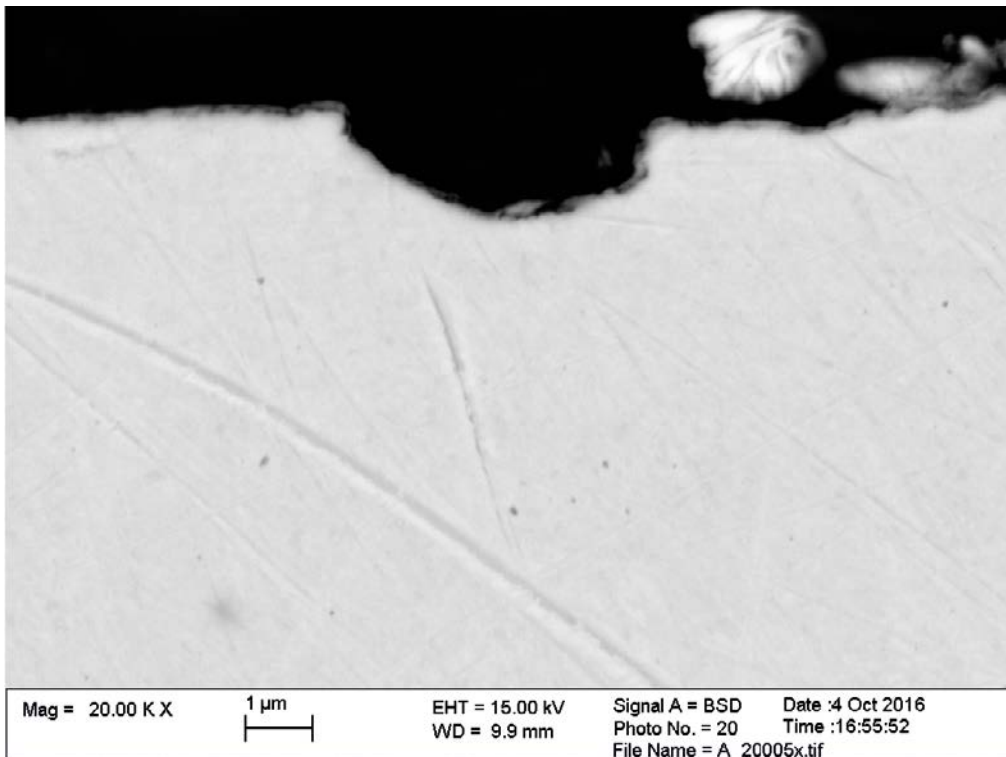
*Figure 3-11. About 1  $\mu$ m deep pit on sample A.*

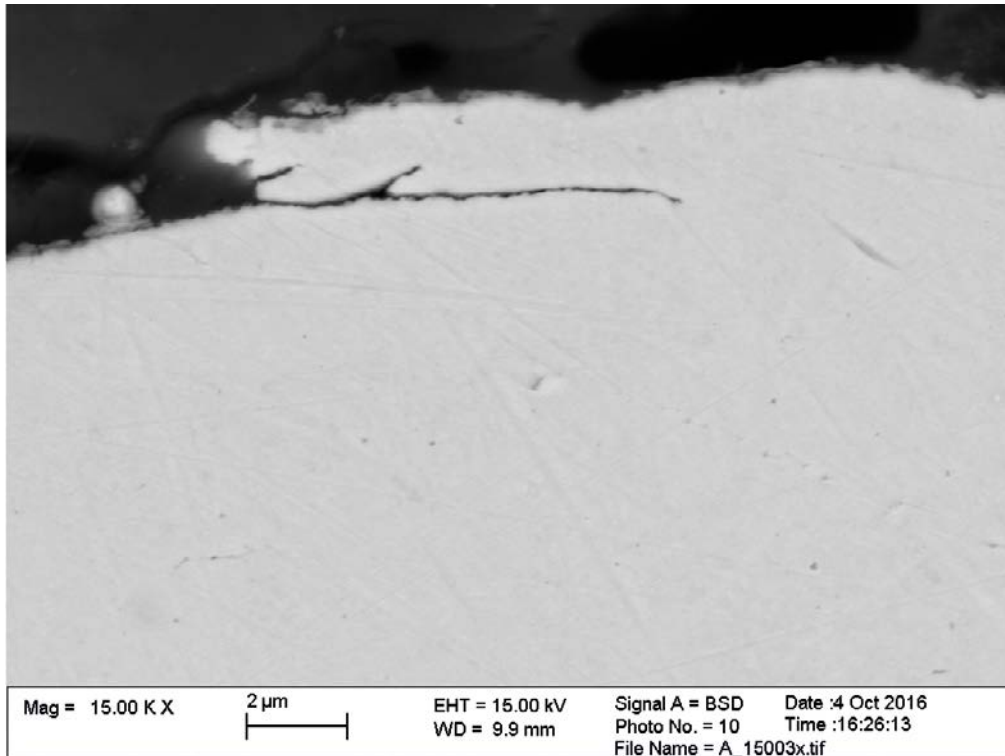
*Figure 3-12. Surface profile showing defects in the surface of sample A.*

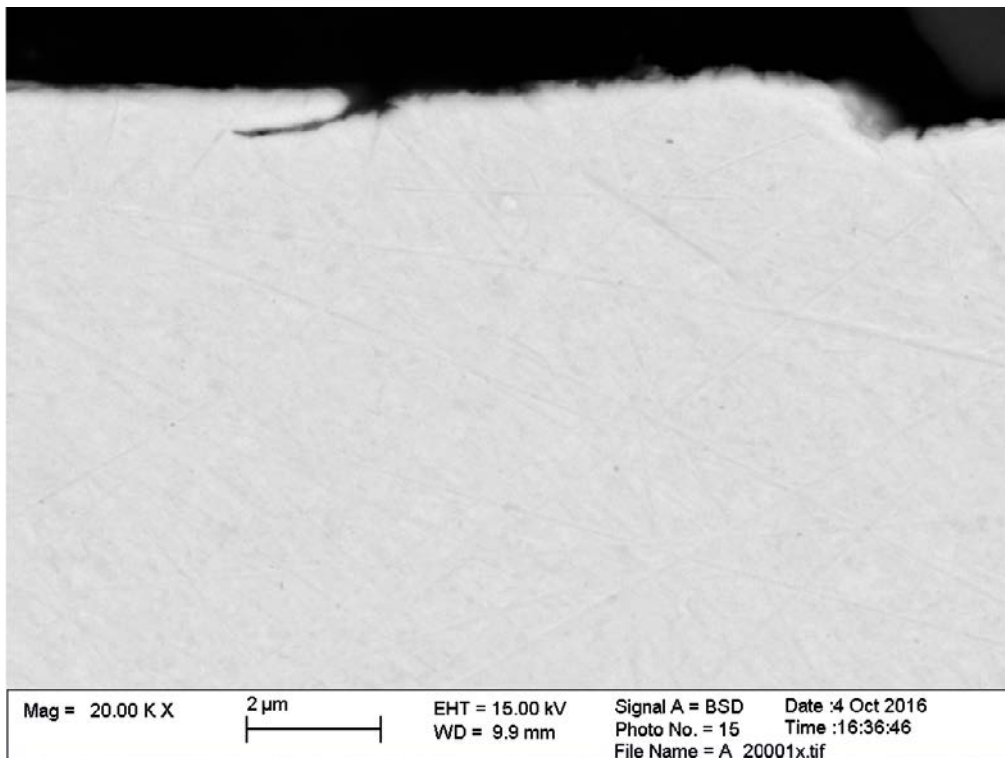
*Figure 3-13. Surface profile showing defects in the surface of sample A.*

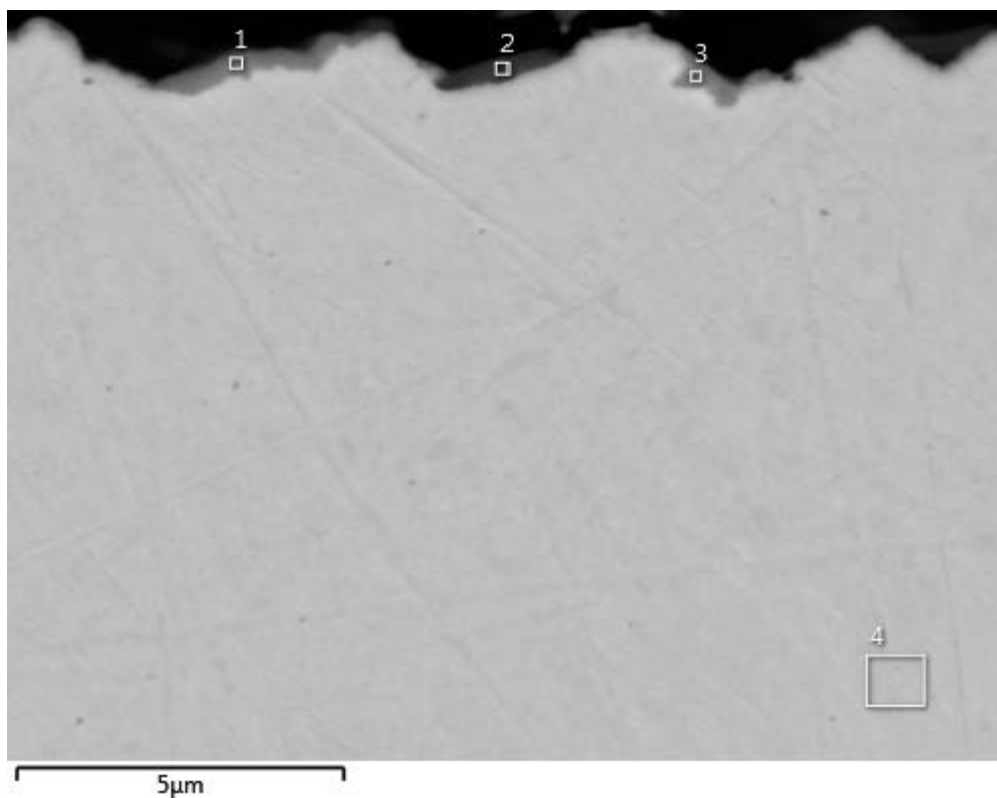
*Figure 3-14. Surface profile with wave like shape on sample A. The areas in the squares in the figure have been analysed with EDS, results are given in Table 3-1.*

Sample A shows an area where the surface profile is wavy, possibly due to the mechanical machining of the copper tubes (see Figure 3-14). EDS analysis in the valleys show levels of oxygen of up to 9.5 wt%, reflecting atmospheric corrosion of the surface. Similar, but slightly lower levels of oxygen were found in areas analyzed on sample B.

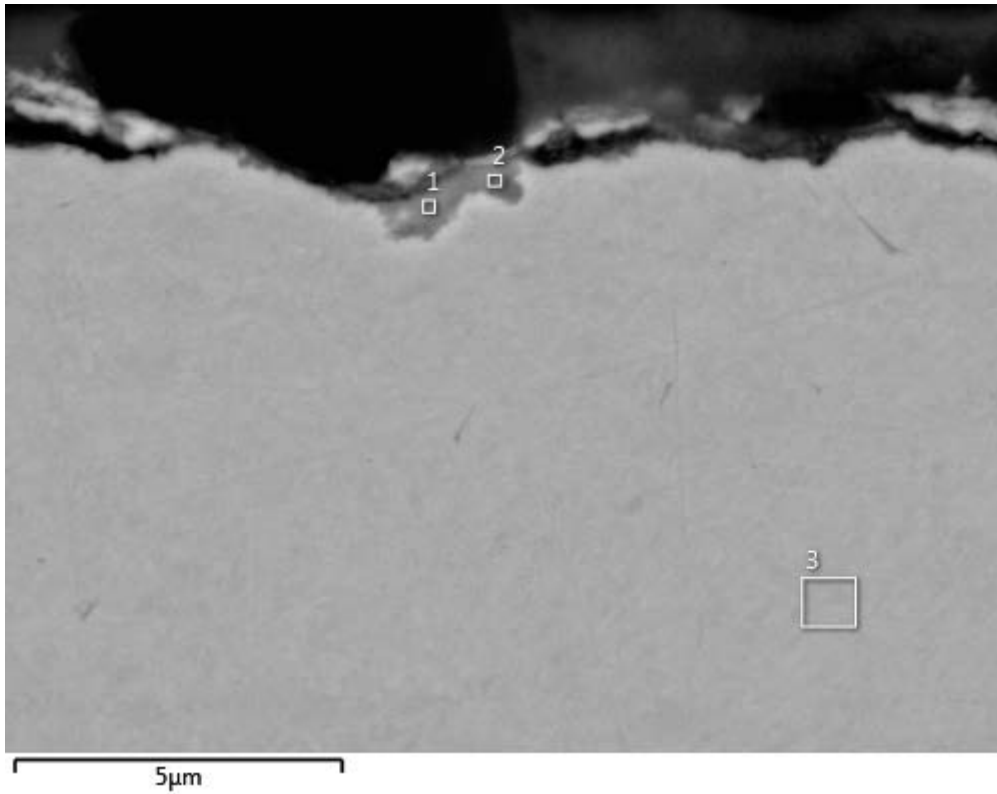
**Figure 3-15.** Surface profile showing corrosion attack with increased oxygen content on sample A. The areas in the squares in the image have been analysed with EDS, results given in Table 3-2.

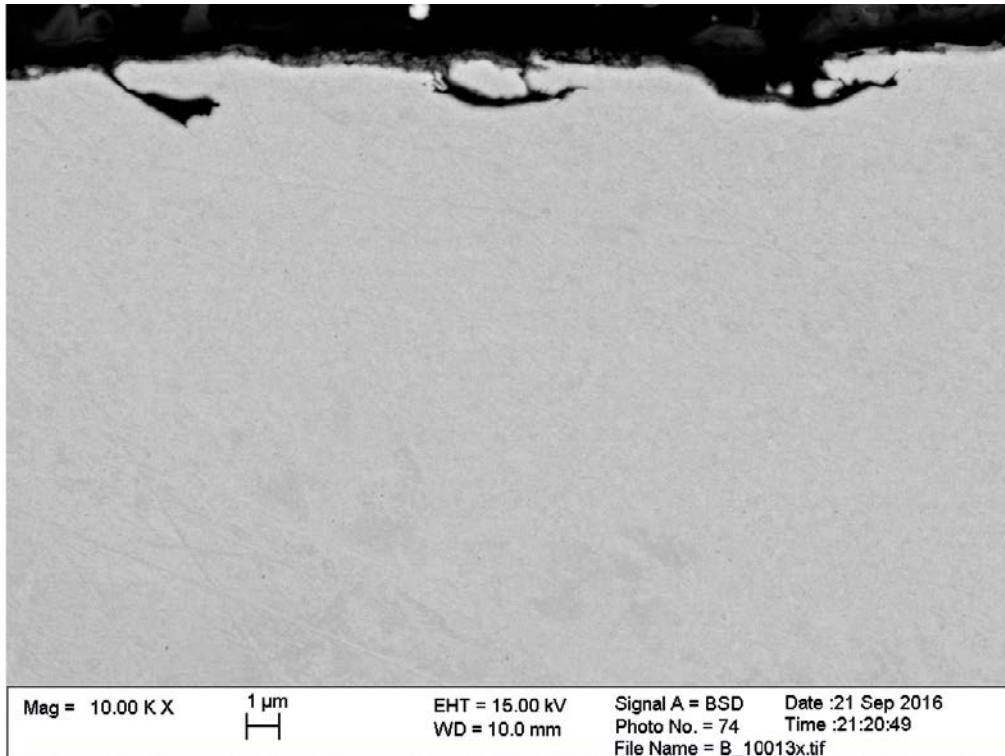
**Figure 3-17.** Surface profile for sample B.

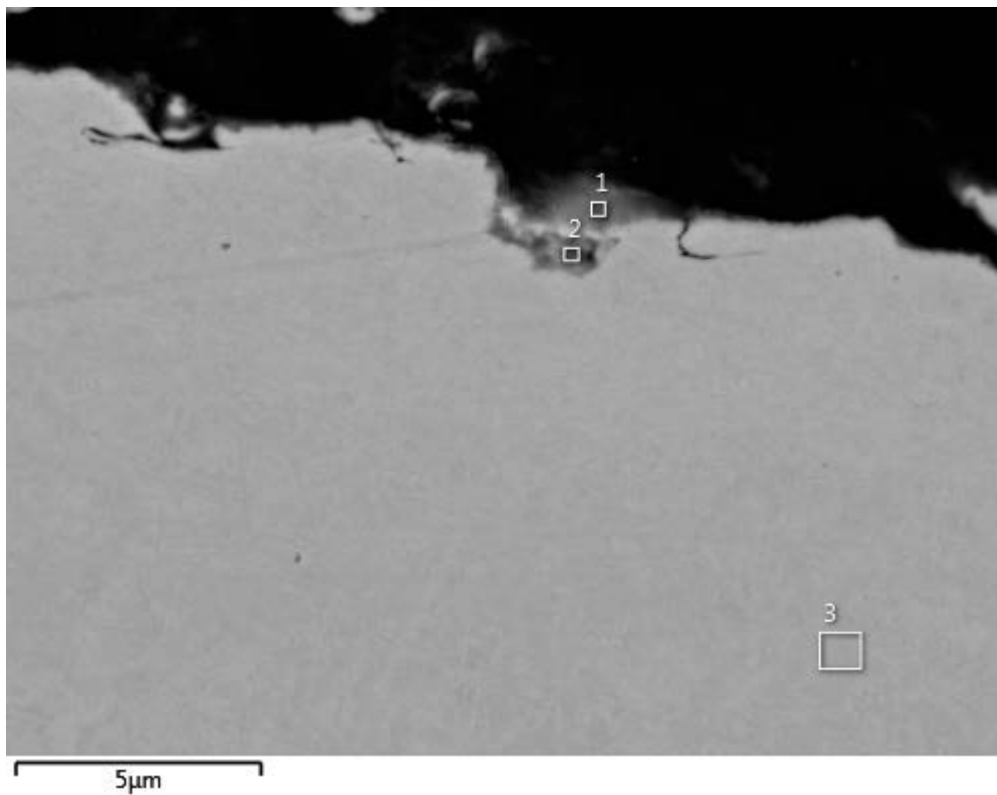
**Figure 3-18.** Surface profile at large magnification for sample B with possible corrosion attack. The areas in the squares in the image have been analysed with EDS and the result is shown in Table 3-3.

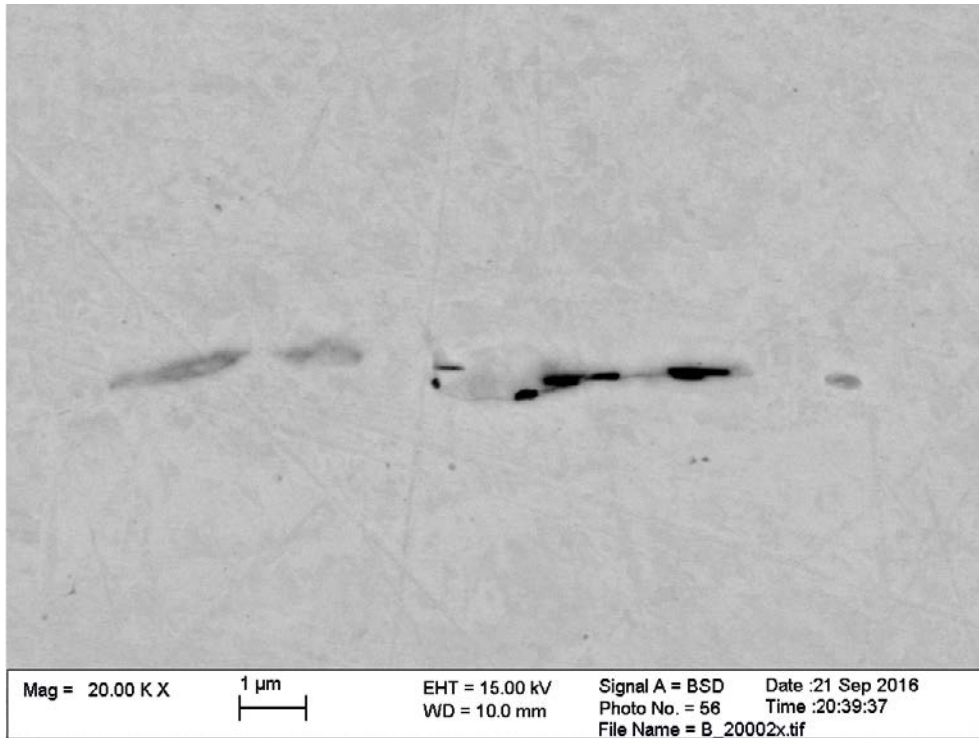
*Figure 3-20. Possible contamination or cavity in the bulk of sample B.*

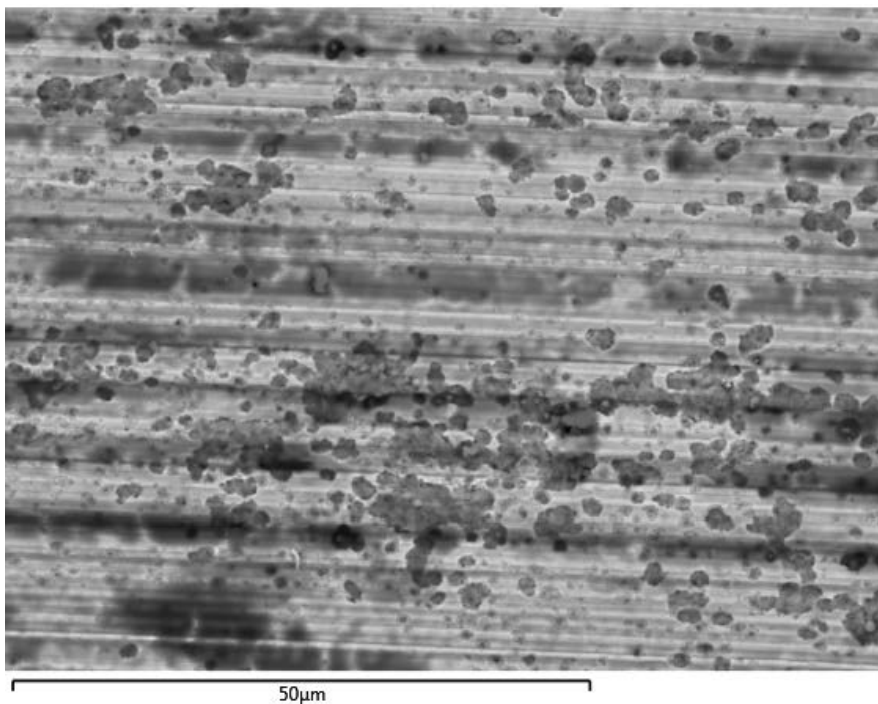
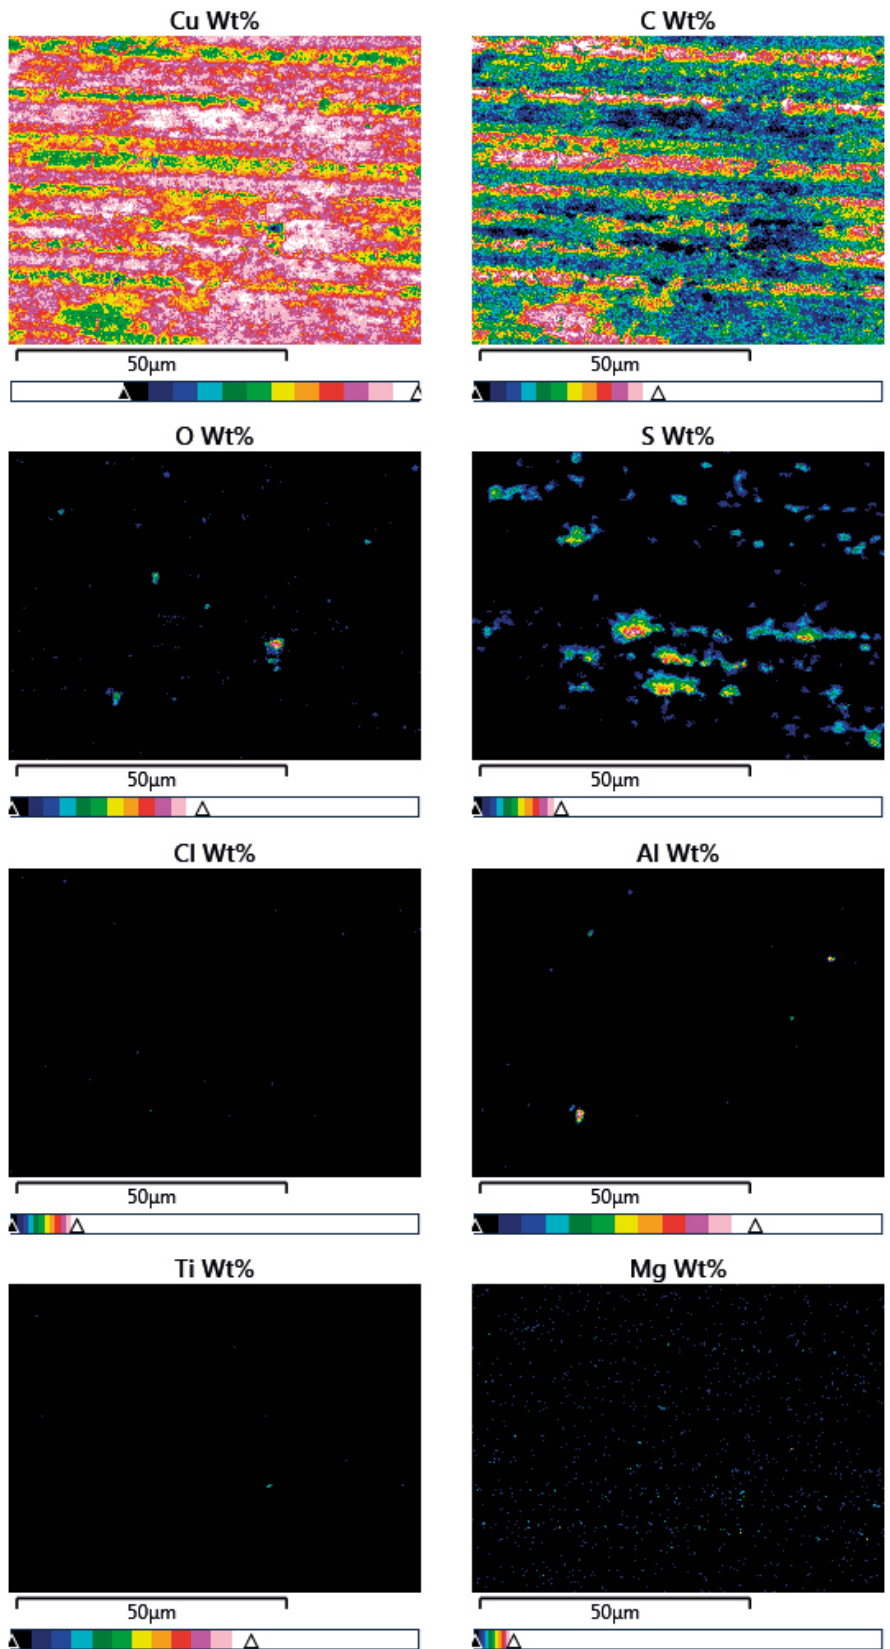
The EDS mapping performed show the presence of various elements on the surface. On sample A, an area with a few shallow pits has been studied, see Figure 3-21. Carbon is present in a striped pattern on the surface, see Figure 3-22. Oxygen is indicated only as spots which indicates that the surface has not generally been oxidized. Sulfur and chlorine are indicated, chlorine only as one spot. Small amounts of aluminum, titanium and magnesium are also identified on the surface.

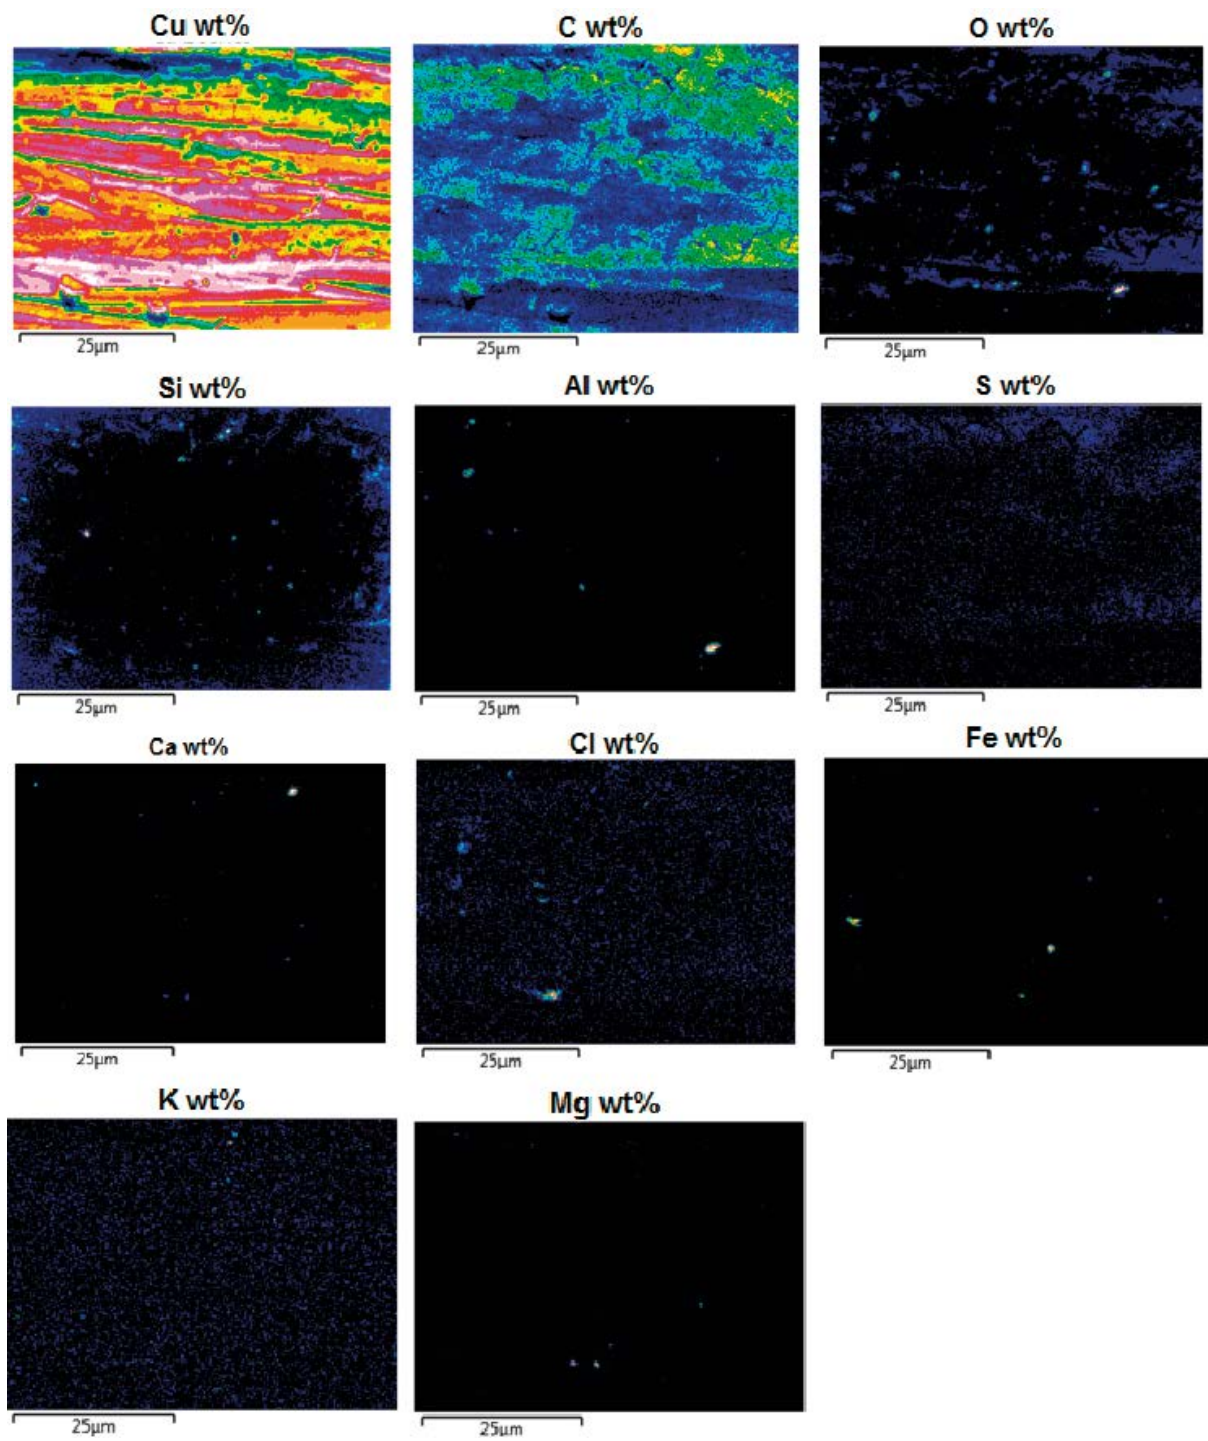
From the EDS mapping on sample B it can be seen that carbon is present in high amounts, see Figure 3-24. Oxygen is present to some extent, with higher intensity in a number of areas. Small amounts of sulfur are present over the examined surface. Chlorine is also present to some extent, with a higher intensity in a number of areas. Potassium, silicon, aluminum, iron and magnesium were also identified on the examined surface.
