Technical Report

TR-18-17

December 2018

Examination of copper corrosion specimens from ABM 45, package 5

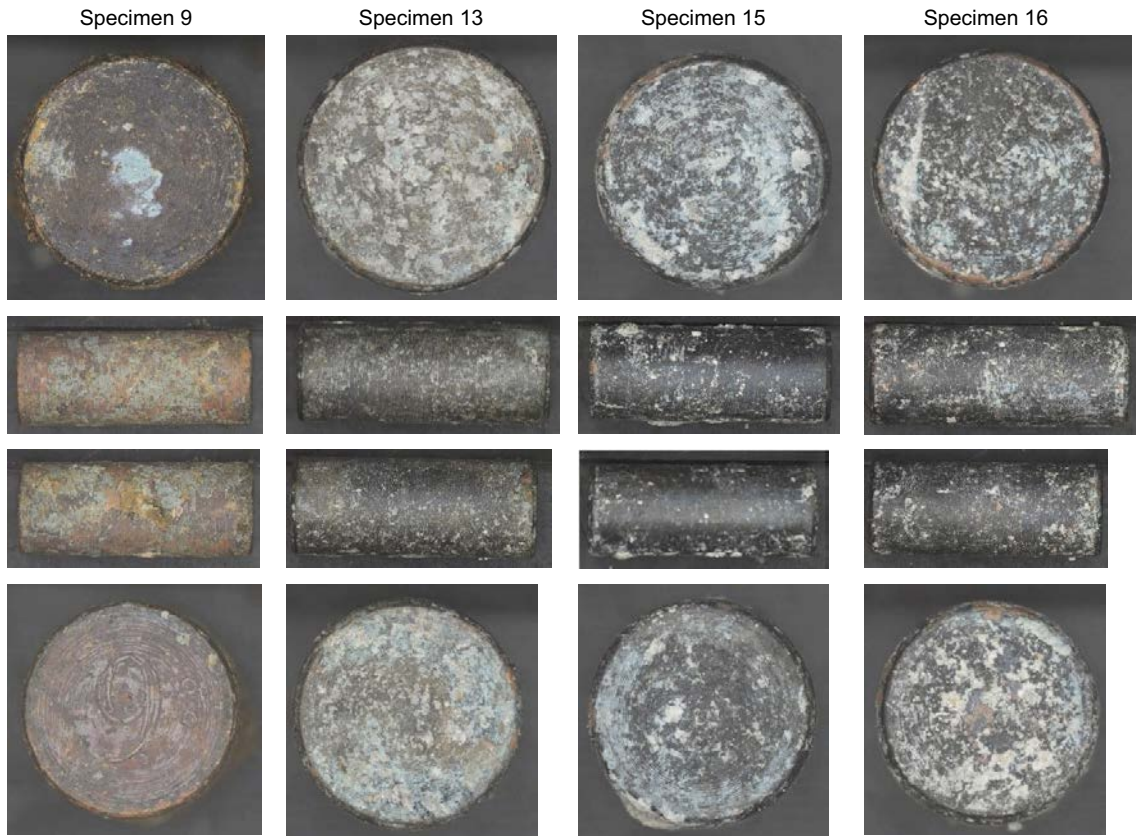
Figure 3-1. The corroded copper specimens from ABM 45 package 5. The images show the appearance of the specimens prior to cleaning. Some bentonite clay is still attached to the surfaces. Top row: end surface of the specimens; Middle two rows: representative images of the side surfaces of the specimens; Bottom row: opposite end surface of the specimens.

From the appearance of the corroded copper specimens (Figure 3-1) a difference may be noted between the specimen mounted in Asha bentonite (Specimen 9) and the specimens in MX-80 (Specimens 13, 15, 16). The reason for this apparent difference in composition and/or morphology of the corrosion film is currently unknown. The corrosion products will be analysed on additional copper specimens found after retrieval, as discussed in the introduction. Although some bentonite clay is visible as light patches at the surfaces in Figure 3-1, it is also possible that some of the light areas were formations of some Cu(II)-hydroxy corrosion product. In the LOT series, which contained only MX-80 bentonite, it was confirmed that molecular oxygen was the major oxidant causing the corrosion observed (Wersin 2013). At the copper surface, mainly Cu_2O and some $\text{Cu}_2(\text{OH})_3\text{Cl}$ were identified with XRD. While particles rich in Cu and S were found at the copper-clay interface, elemental analysis by EDS showed in general very little sulphur (Karnland et al. 2009). Due to similar experimental configurations and dimensions it is reasonable to assume that the corrosion scenarios were similar in ABM and LOT.

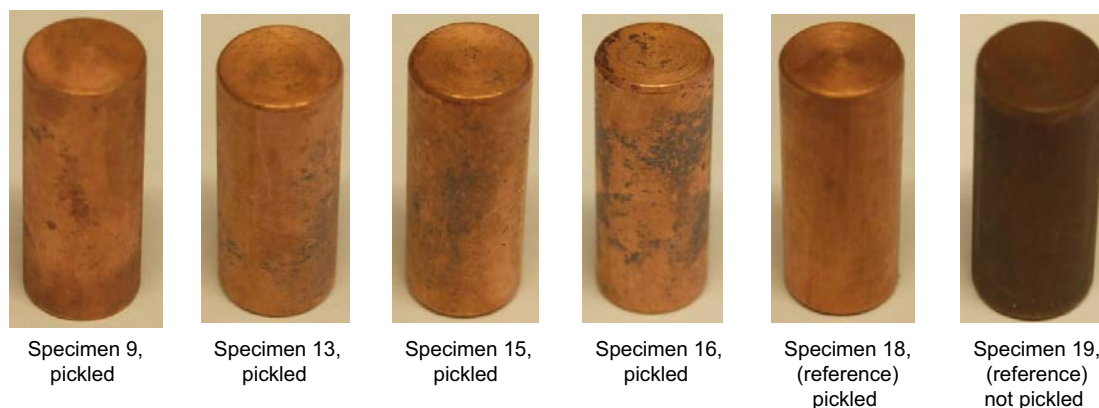
The mass-loss of the corroded specimens corresponds to average corrosion depths of ca 2.3–5 μm , with a mean value of 3.2 μm . Some dark spots (possibly Cu_2S) remained on the surfaces of the corroded copper specimens after cleaning (see Figure 3-2), however, the results of the cleaning procedure indicated that the cleaning was complete (see Appendix).

The mass-loss of the reference Specimen 18 corresponds to an average corrosion depth of 0.6 μm , which is markedly lower than for the exposed specimens. The reference specimens were covered by a dark brown oxide layer that was removed during the cleaning (pickling) treatment (see Figure 3-2), which explains the mass-loss of the reference specimen.

Figure 3-2. Corroded copper specimens after pickling. Reference specimens pickled and not pickled.

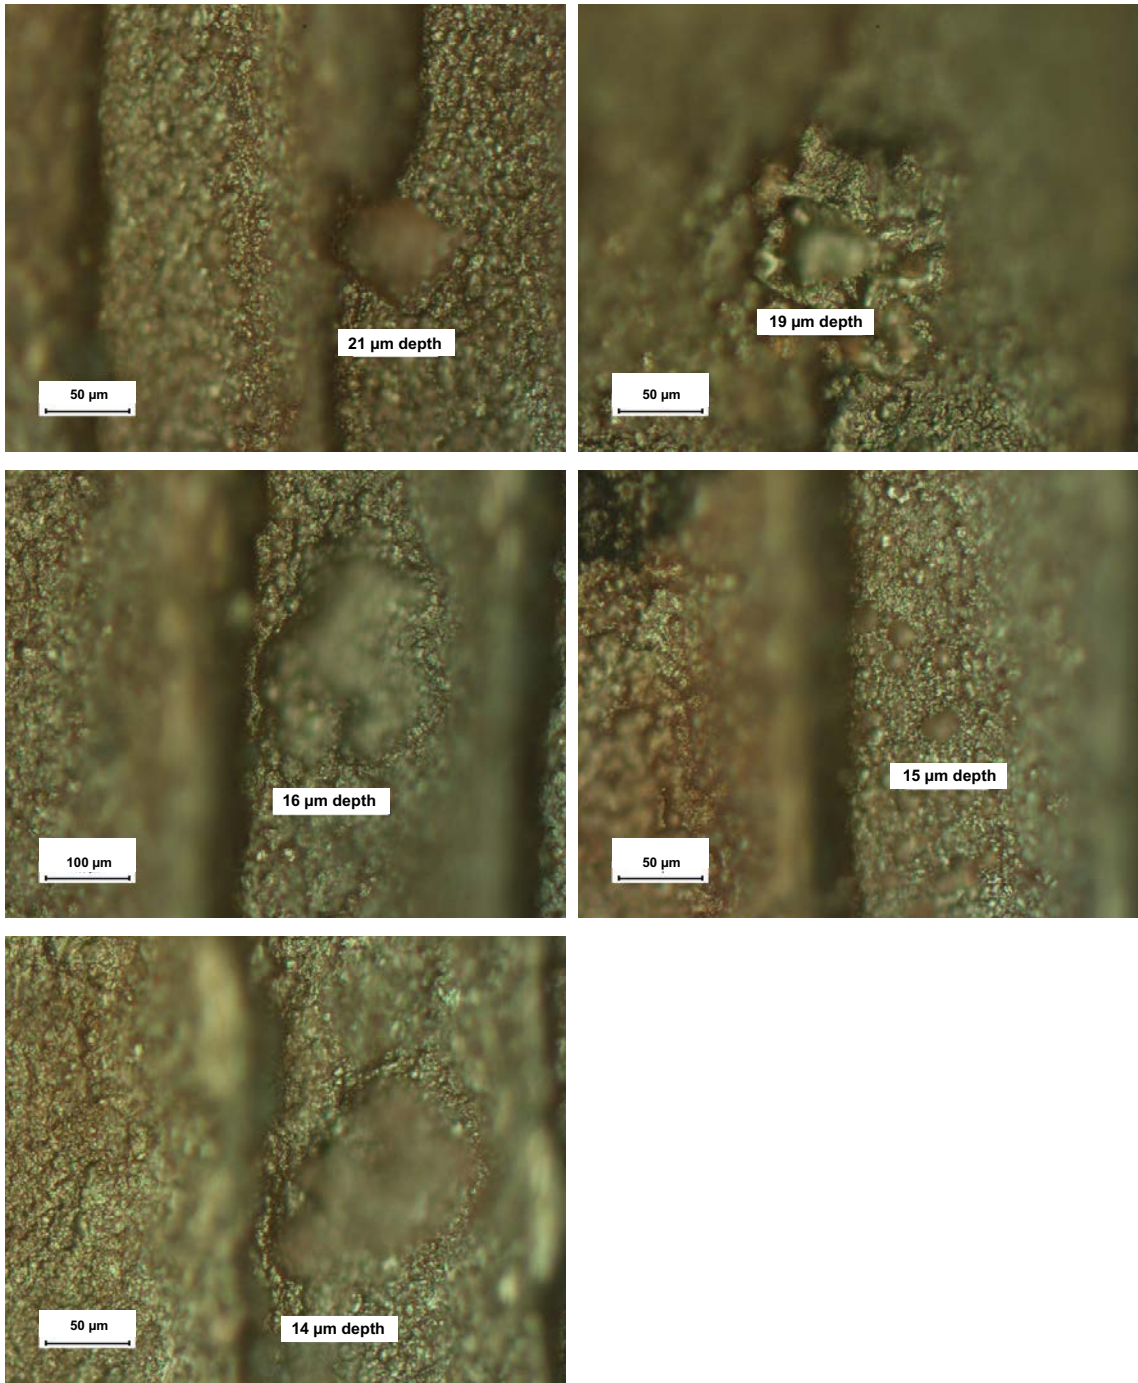
Figure 3-3. Microscope images of the five deepest defects found on Specimen 9.

The deepest defect found on the corroded Specimen 9 was 21 μm , while the deepest defect found on the reference specimen was 25 μm (Table 3-2). The average of the five deepest defects found on the corroded Specimen 9 were 17 μm , while the corresponding average defect depth for the reference specimen was 19.4 μm . A comparison between the deepest defects found on the corroded specimens with the defects found on the references shows that there is a mutual overlap of the confidence intervals (95 %) and the mean values of the deepest defects found on the specimens (Figure 3-7). This means that there is no significant difference between the deepest defects found on the specimen surfaces, which suggests that these are not related to corrosion during the experimental exposure.

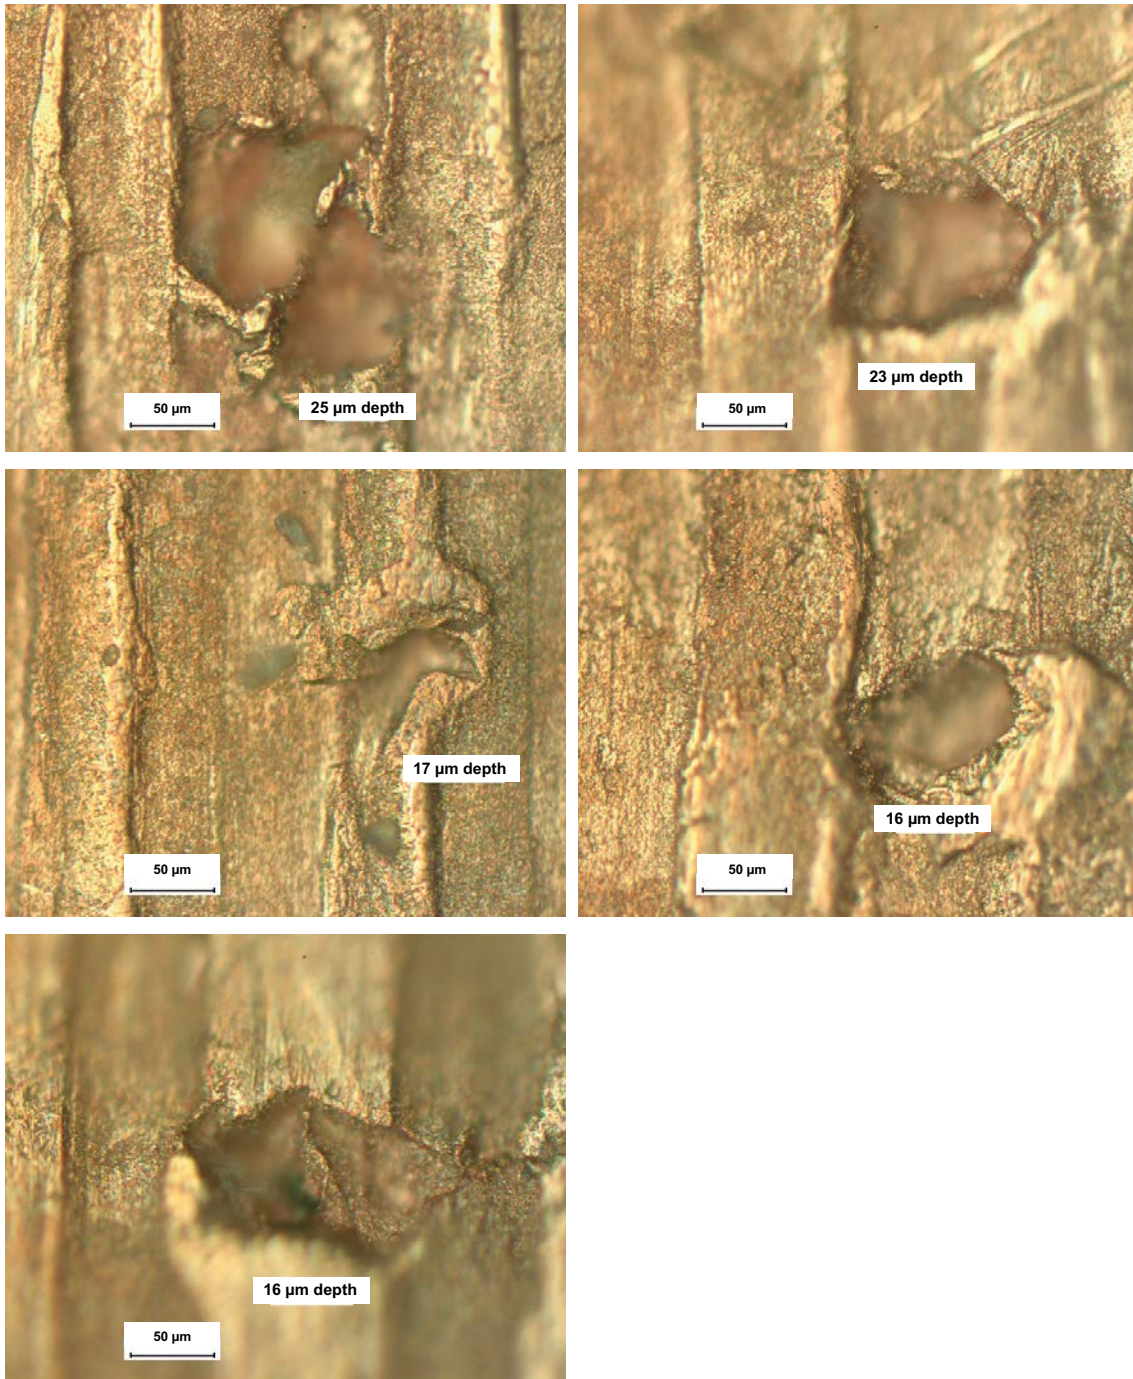
Figure 3-4. Microscope images of the five deepest defects found on Specimen 18.

In principle, since the reference Specimen 18 was slightly corroded, the deepest defects analysed could have been caused by corrosion. However, this would mean that the same pit depths were formed after a mass-loss corresponding to 0.6 μm corrosion (Reference 18) as for 5 μm corrosion (Specimen 9). The conclusion that the deepest defects found are not related to corrosion of the copper surfaces is further supported by the morphology and shape of some of the defects shown in Figure 3-4, suggesting that mechanical damage or wear is the likely origin of the topography observed. For example, the 17 μm deep defect found on Reference 18 shows signs of a directed mechanical damage on the surface. It may further be noted that defects of similar dimensions and shapes have been reported for both machined and polished copper surfaces, and before as well as after corrosion exposure (Högberg et al. 2017, Gordon et al. 2018).

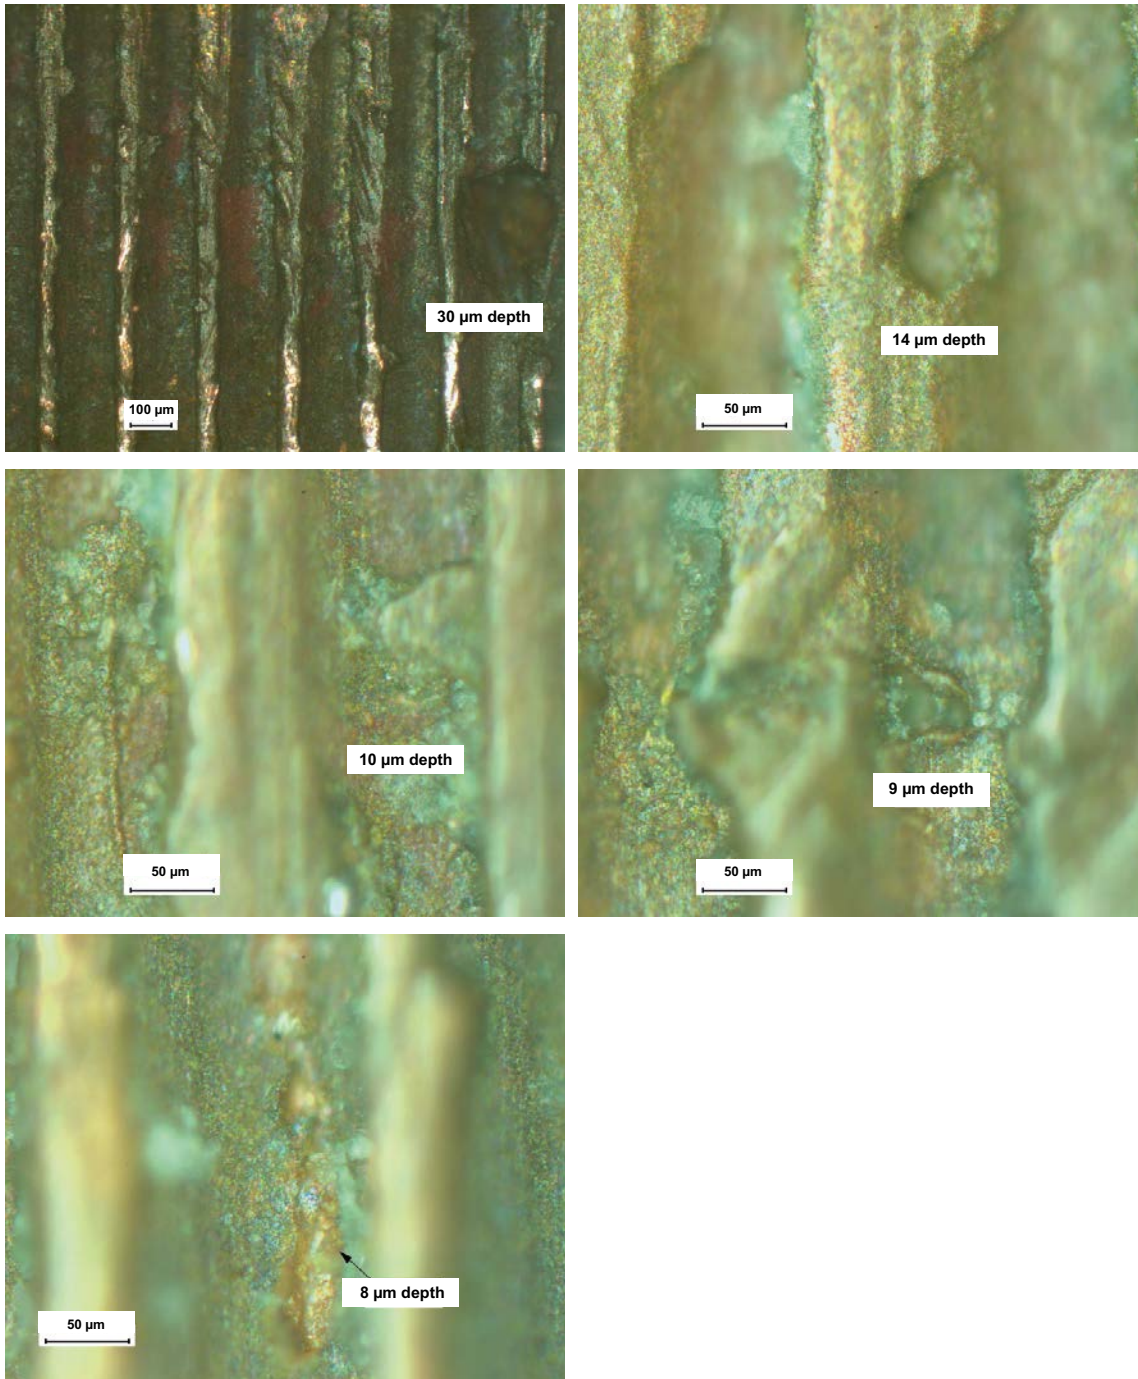
Figure 3-5. Microscope images of the five deepest defects found on Specimen 19.

The occurrence of defects deeper than 6 μm was of the same order of magnitude for both the corroded and reference specimens after film removal, ca 10² defects/cm². This is markedly different to the reference specimen before film removal, which had only five defects/cm². One possible explanation could be that the oxide film was covering shallow defects before its removal. However, it has also recently been reported that aerobic acid cleaning of both corroded copper specimens and reference specimens can cause some localised corrosion (Gordon et al. 2018). In that study it was found that while film removal using cycles of alkaline (20 wt% NH_4OH) and acid (37 wt% HCl) exposure (as used herein) had a pronounced effect on the topography of the copper surface, whilst using only

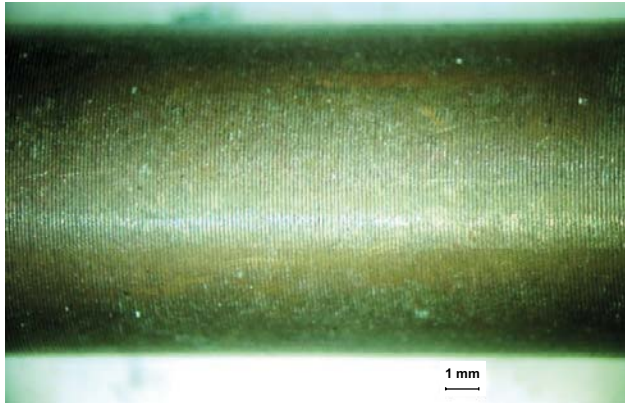
Figure 3-6. Reference Specimen 19. Machining marks on the specimen were found to be ca 10 μm deep.
