**TR-18-02**

June 2019

# Full-scale test of the Dome Plug for KBS-3V deposition tunnels

## Project summary and evaluation of the final results

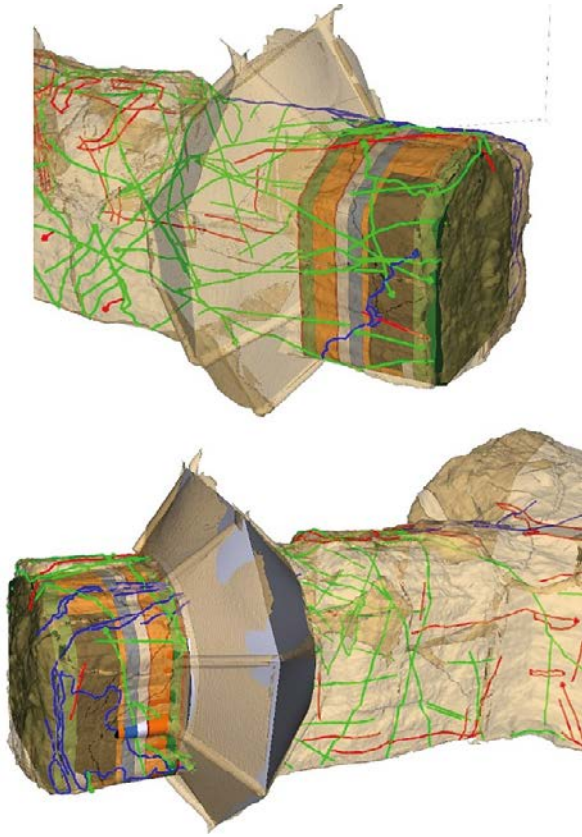
*Figure 4-36. Illustrations of rock fractures at the plug location.*

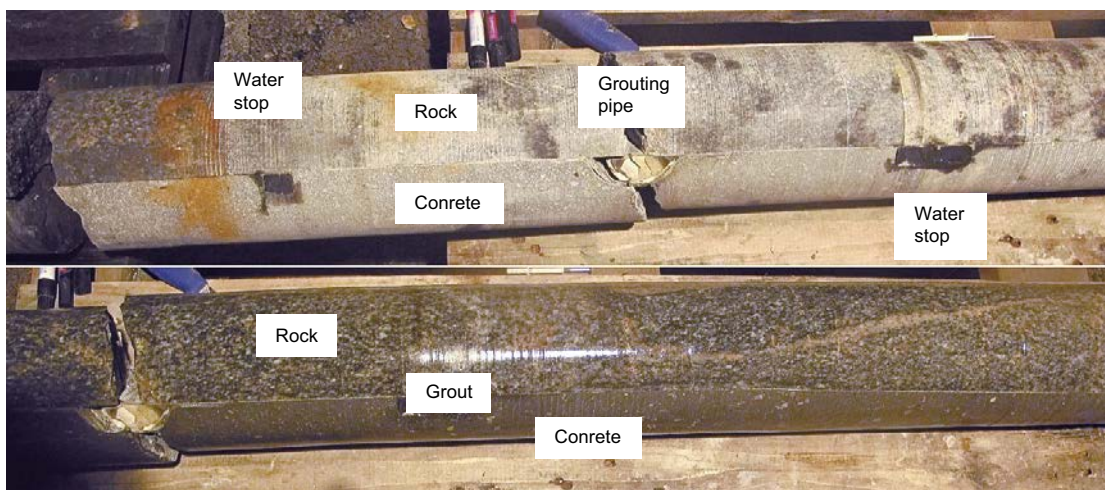
**Figure 6-3.** Examples of drill cores (A03) from the interface between rock and concrete immediately after drilling. The water stops (dark squares) and grouting pipes (light coloured half-circles) are clearly visible. Also, a thin layer of grout (light colour) at the interface. These cores seemed to be attached to each other after drilling, i.e. a certain bond strength existed. From Vogt (2019).

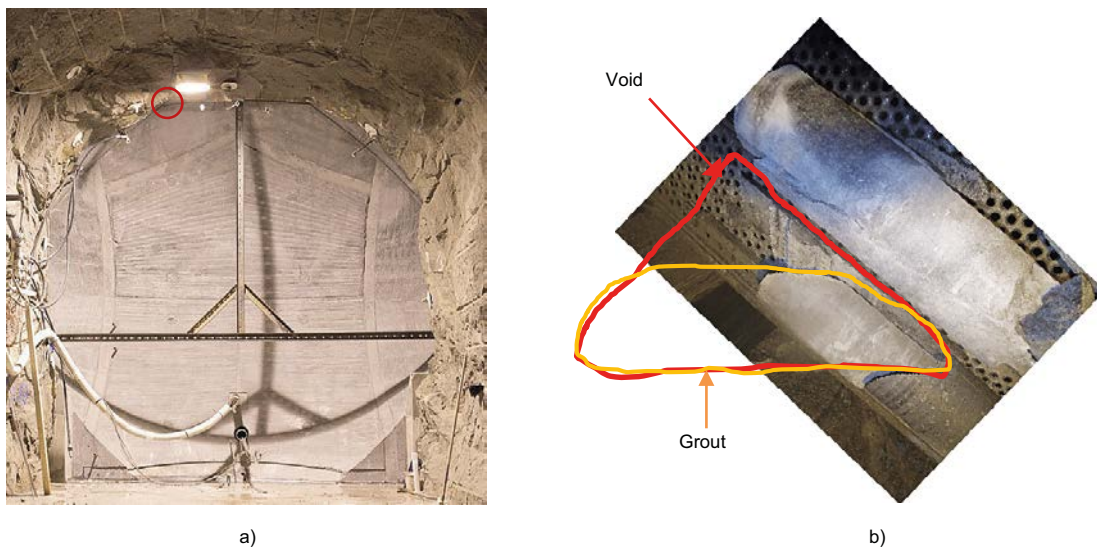
**Figure 6-6.** Detected void in the top of the dome. a) Location of the drill core. b) A drill core showing the amount of grout filling the void, the hand drawn lined represents the size of the void and the outline of the abutment.

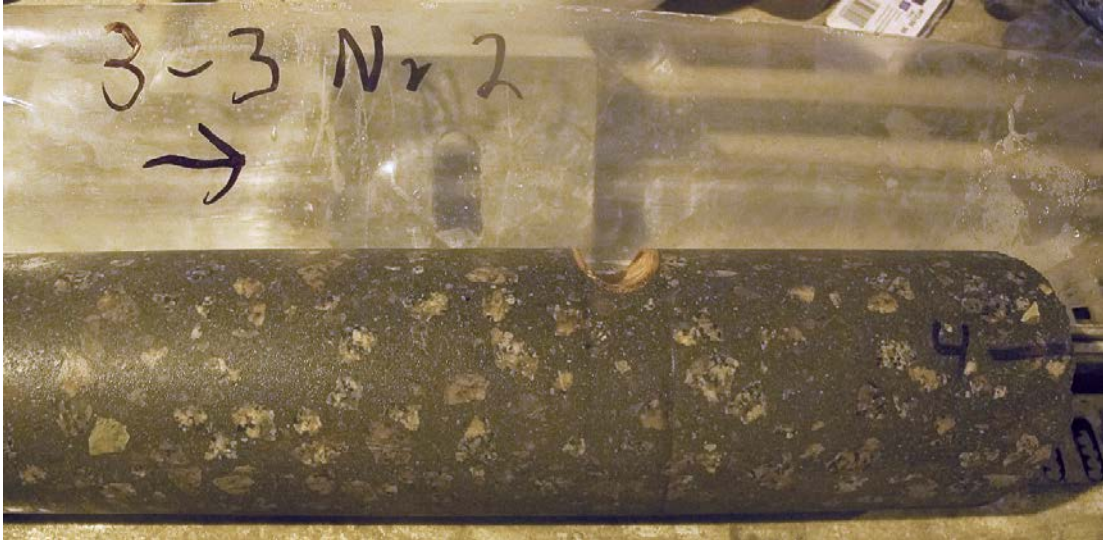
**Figure 6-9.** Core 3-3-1, part 2. The large aggregates seem very well distributed, the cooling pipe is well embedded in concrete.

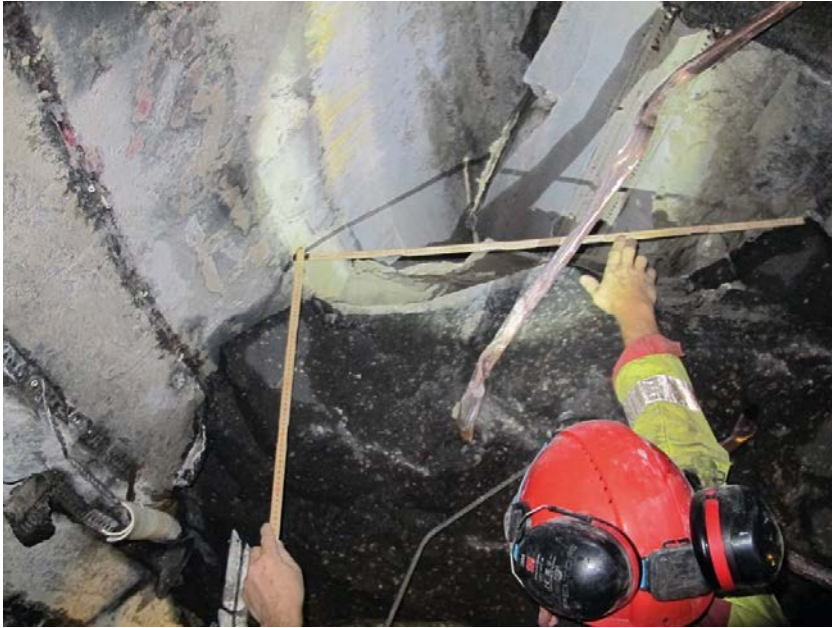
**Figure 7-10.** Measuring the width of the large void, about 1 m.

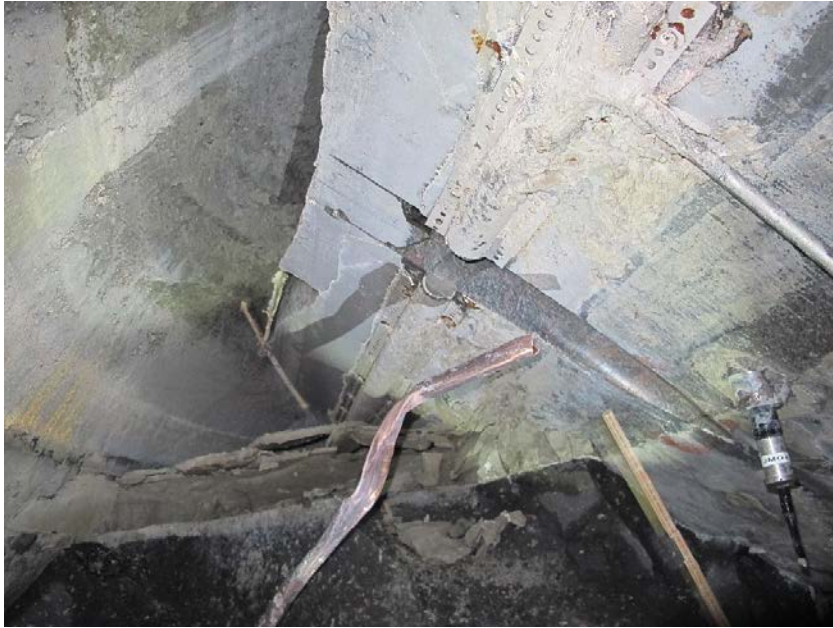
**Figure 7-12.** Photo of the void and the joint-meter JM01 to the right.

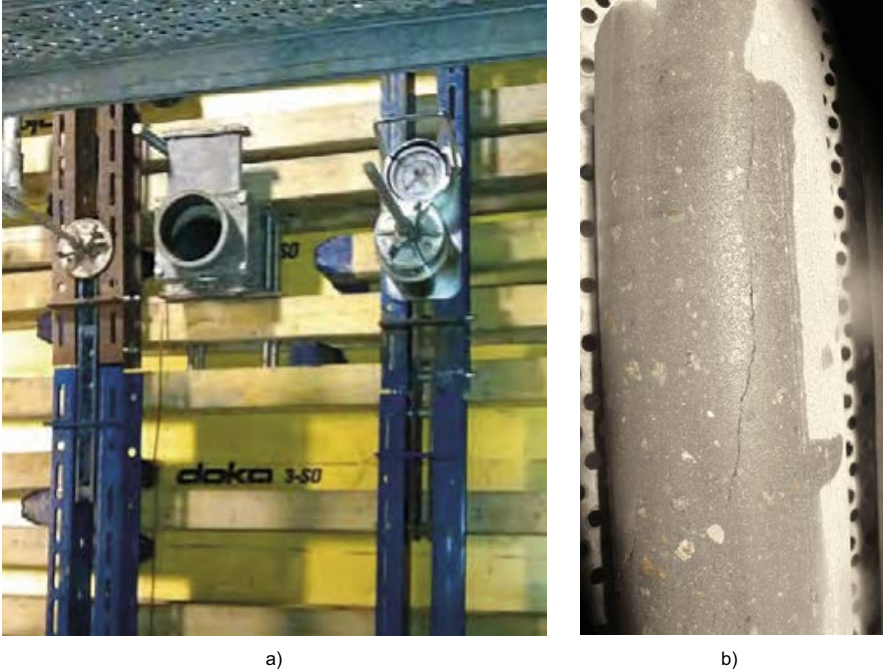
**Figure 9-2.** a) Illustration of the formwork with the connection for pumping hose, b) The observed hardened skin from casting seen in one concrete core.
