**TR-22-01**

# Analysis of corrosion products on filter housings in the Lasgit field experiment

SVENSK KÄRNBRÄNSLEHANTERING AB

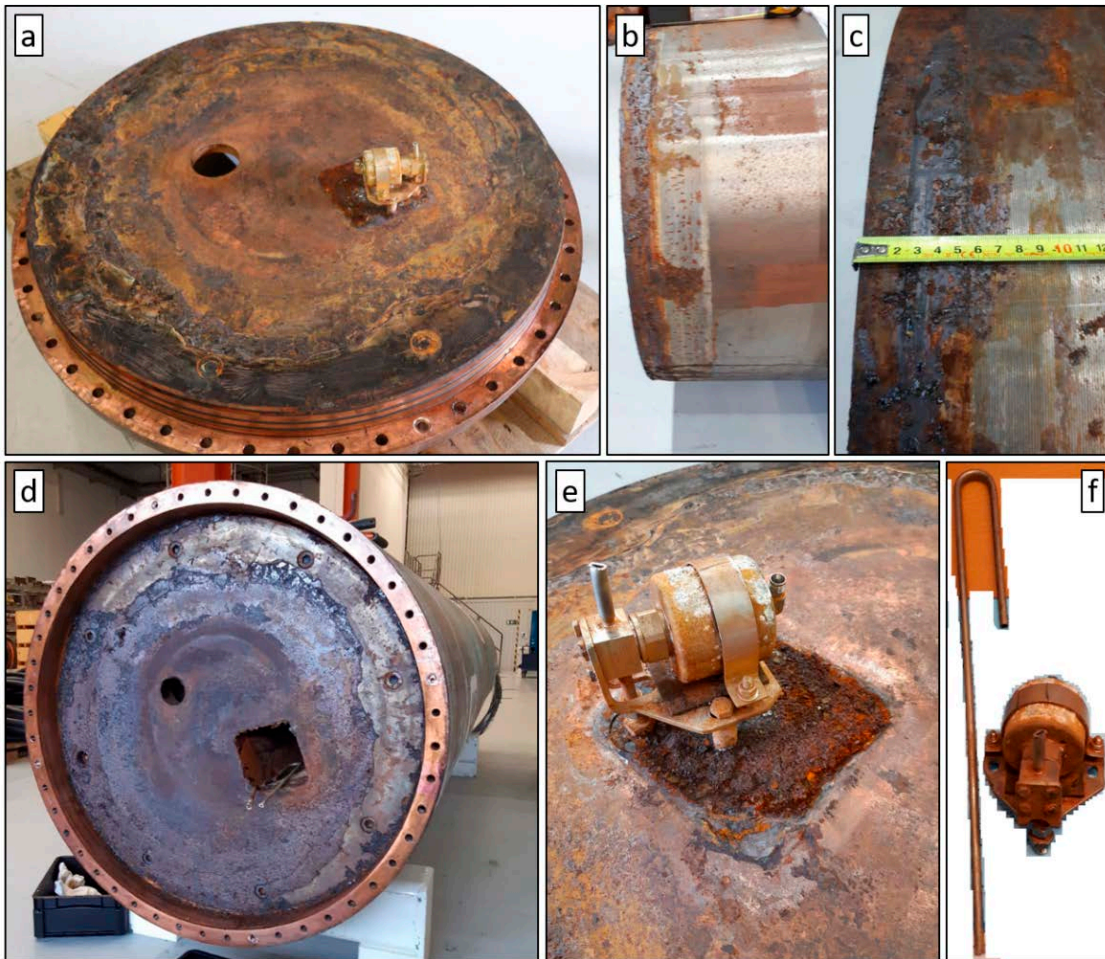
A valve connected to a filter housing at the base of the canister was open for the first approximately 20 days of artificial hydration. As a consequence, stagnant water accumulated in the canister insert. This resulted in extensive corrosion at the base of the insert, as demonstrated in Figure 2-3 a–e. The water entered the canister through a roughly 30 cm long metal tube (Figure 2-3 f), and the rust layer (consistently around 7 cm and a maximum of around 15 cm) in Figure 2-3 b–c indicates that the water level was never that high. It can therefore be assumed that all water which entered the canister through the open filter housing, actually stayed in the canister throughout the field experiment – it did not exit back through the tube. The canister was placed horizontally in the deposition tunnel after retrieval from the deposition hole, during this time, it is possible the remainder of the accumulated water could have seeped out of the canister or evaporated, as the filter assemblies had then been removed. The iron corrosion products were not characterized chemically, however, samples of moist corrosion products and surface deposits were taken to be analysed for the possible presence of microorganisms potentially influencing the corrosion.

**Figure 2-3.** Images showing (a) the inside of the copper canister base, (b) the base of the cast iron insert (from side), (c) close-up of the base of the cast iron insert (from side) with measuring tape showing the extent of cast iron corrosion from the open valve, (d) cast iron insert base (from below), (e) a close-up of the valve which leaked water, (f) and a side-by-side view of the valve and appurtenant metal tube. Images (a) and (d) show the circular hole connected to the filter assembly and the square-shaped hole for the opened valve. Samples for MIC-analysis were collected from the base of the cast iron insert (d), from the inside of the canister base (a), and from a small volume of residual water which was present upon removal of the canister base. In the left-hand side of image (e) is the cut off metal tube through which the water entered the canister; also shown with the filter valve in in image (f). This metal tube extended roughly 30 cm into the canister; thus no water exited the canister this way.

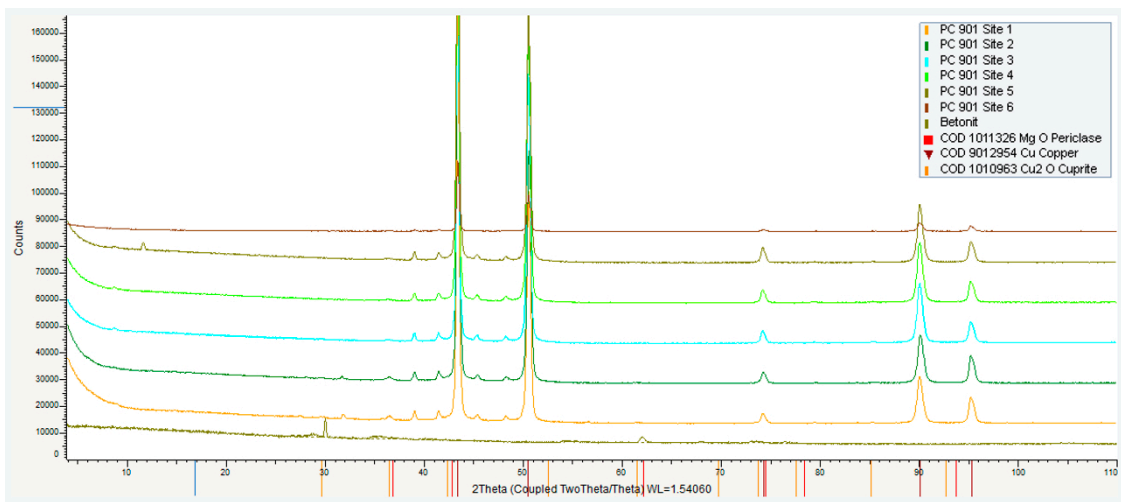
Corrosion products were analyzed by XRD on the sample coupon surfaces. Apart from metallic copper, small peaks of cuprite were observed at  $36.5\ 2\theta$ , which can be seen in Figure 3-16. MgO was detected at angle  $62\ 2\theta$  for bentonite which was added to see the contribution of bentonite on the copper samples. No clear peaks of MgO was observed for PC901 or any of the other filter housing samples. Several “satellite peaks” can be seen around the main copper peaks, similar to the findings in previous studies from field tests (Johansson et al. 2020). The unidentified “satellite peaks” were located at  $39, 41.5, 45.5$  and  $48.5\ 2\theta$  and were observed on all samples. A Ni-filter was used to remove Cu  $K\beta$  X-rays along with other high energy background radiation, see red graph in Figure 3-17. After removing  $K\beta$  X-rays and other background radiation only cuprite and metallic copper peaks could be seen. However, the Cu  $K\beta$  X-rays were only seen at  $39$  and  $45.5\ 2\theta$  leaving the peaks at  $41.5$  and  $48.5\ 2\theta$  unidentified. Aged X-ray tubes with tungsten filaments deposit W on the inside glass envelope. This produces W  $L\alpha$  peaks and it could be found that it coincides with the peaks at  $41.5$  and  $48.5$  which is also filtered out by the Ni-filter.

Figure 3-16. XRD diffractograms obtained from the surface of PC901.

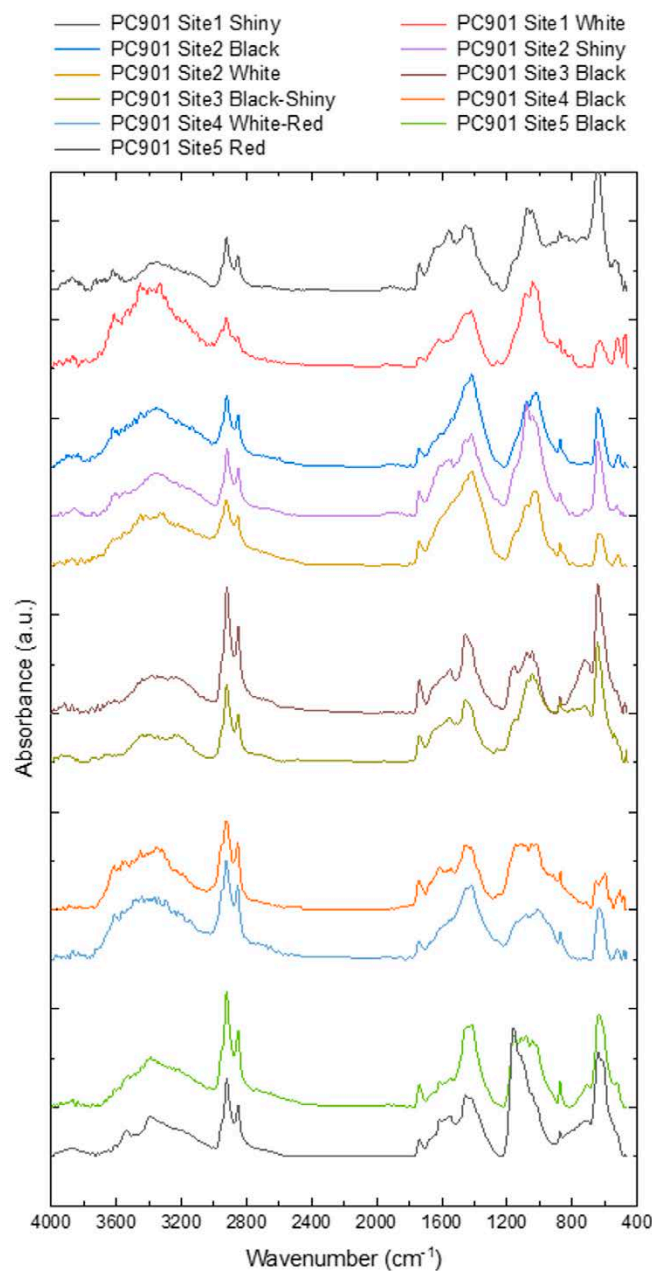
IRRAS measurements were made on the PC901 coupons and their corresponding IR-spectra can be seen in Figure 3-18. A characteristic cuprite peak around  $630\text{ cm}^{-1}$  can be seen for most measured areas, indicating the presence of the corrosion product. The double peak around  $1300\text{--}1600\text{ cm}^{-1}$  are slightly visible and could indicate malachite. The peaks at  $1000\text{ cm}^{-1}$  and  $3600\text{ cm}^{-1}$ , and the double peak at  $500\text{--}600\text{ cm}^{-1}$  indicate bentonite. In addition, site 5 and the area with red appearance, shows a sulfate peak around  $1150\text{ cm}^{-1}$ .

**Figure 3-18.** Infrared spectra from FTIR/IRRAS measurement on surface of sample PC901.

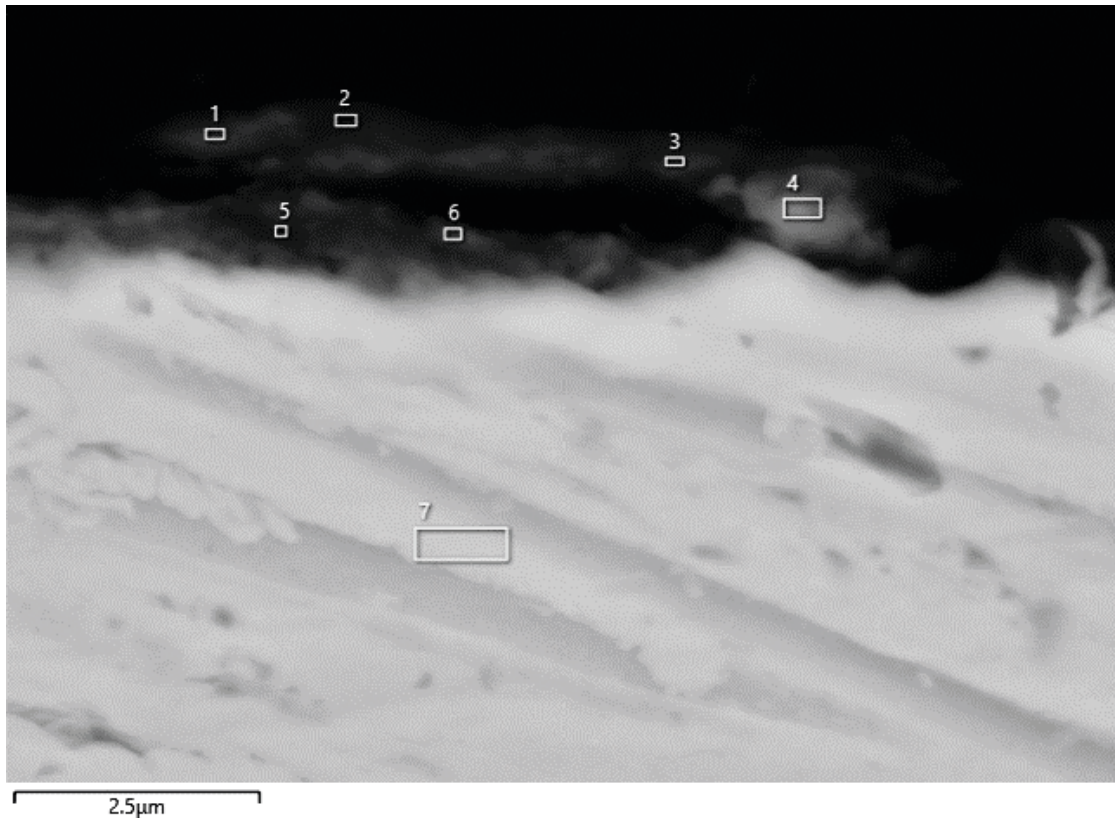
The cross section samples were cut in half, cast into epoxy resin while mounted surface-to-surface (in order to try and protect the surface oxides during sample preparation), grinded or polished, and analysed with SEM/EDS. In Figures 3-19–3-20 and corresponding tables, the cross section of PC901 are presented after dry grinding. Subsequently, in Figures 3-21–3-27 and corresponding tables, the cross section of PC901 are presented after diamond polishing. The cross section images showed that the surfaces were generally observed to be smooth, with some minor features, possibly resulting from the manufacturing process (machining), but no clear sign of localised corrosion. In Figure 3-22 two surfaces can be seen mounted against each other, which is indicated with a red dashed line. The oxide layer was observed to be in the range of 1–2  $\mu\text{m}$  in thickness. The EDS results show signs of sulfur being present (Figure 3-19).

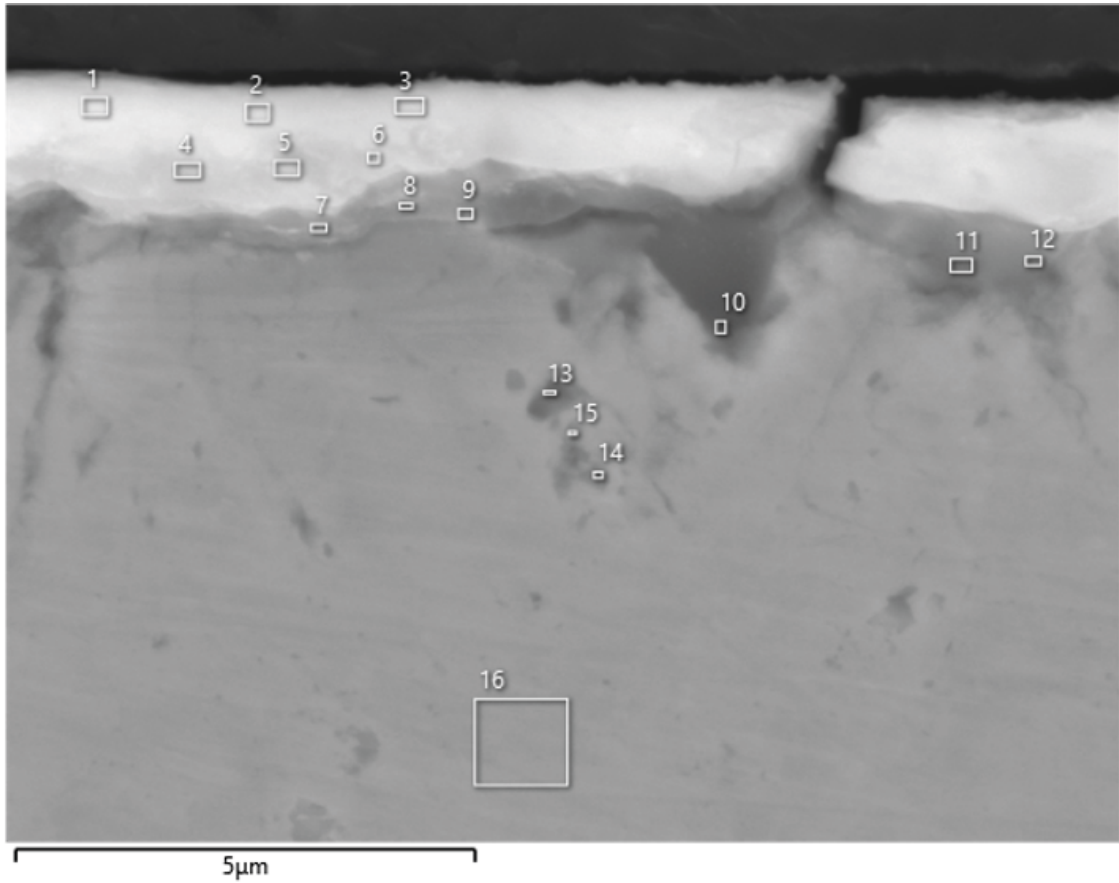
**Figure 3-21.** SEM image of the cross section of PC901, diamond polished. A crack in the thin oxide layer is depicted. The EDS result of the cross section of PC901, diamond polished, is shown in the table.

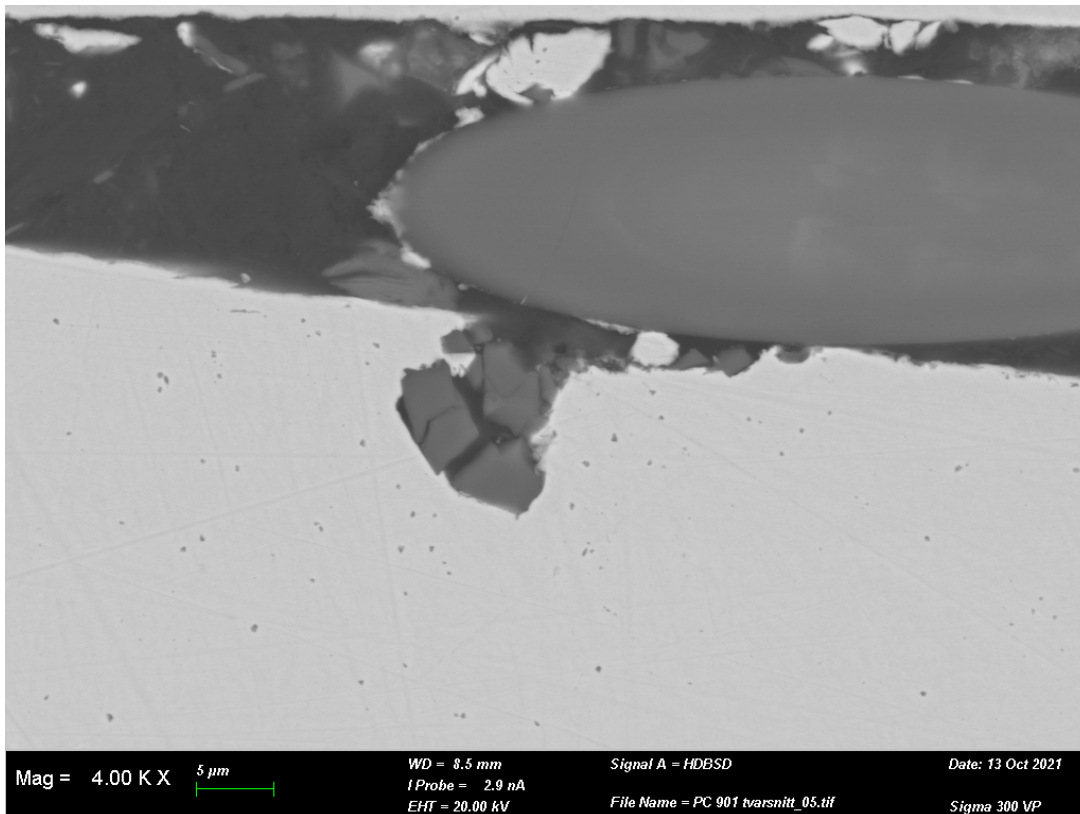
**Figure 3-25.** SEM image overview of cross section mounted in epoxy resin surface to surface at  $\times 4\,000$  magnification, PC901. The cavity formed shape in the image is likely consisting of particles from the sample preparation. It cannot be said for certain if the cavity was formed due to corrosion or sample preparation or if it is a cavity at all.

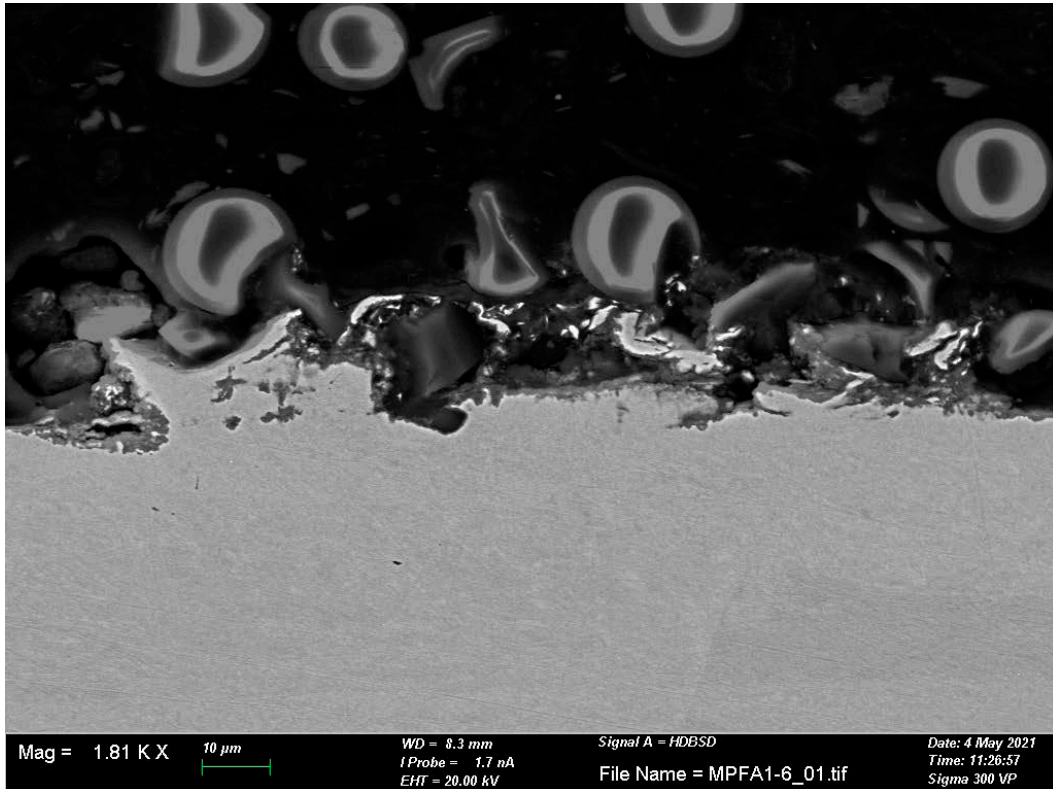
**Figure 3-48.** SEM image of the cross section of MPFA1, at higher magnification ( $\times 1800$ ) than in Figure 3-50, showing the appearance of the surface after dry grinding and subsequent polishing. It appears that the surface is uneven, which may correspond to the machining process prior to exposure (grooves approximately  $10\ \mu\text{m}$  deep into the surface). Some areas of deformation are observed, possibly due mechanical forces applied during polishing of the sample.

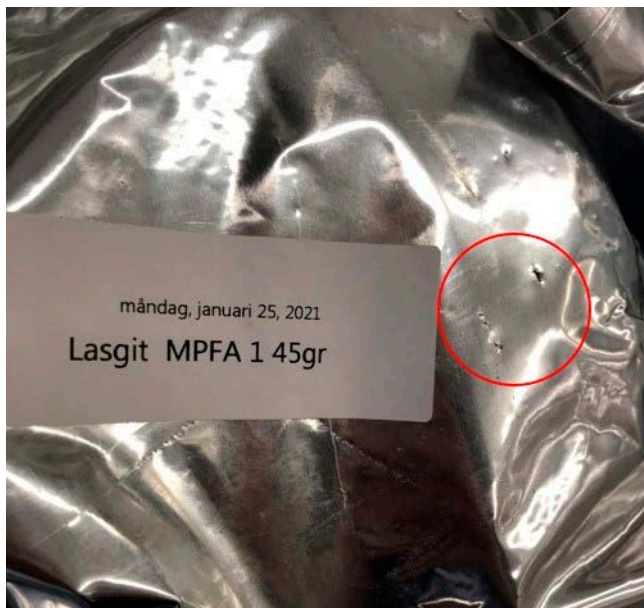
*Figure A-1. The Perforated foil package of filter housing MPFA1.*
