**TECHNICAL
REPORT**

90-07

**Examination of reaction products
on the surface of UO_2 fuel exposed
to reactor coolant water during
power operation**

R S Forsyth, T Jonsson, O Mattson

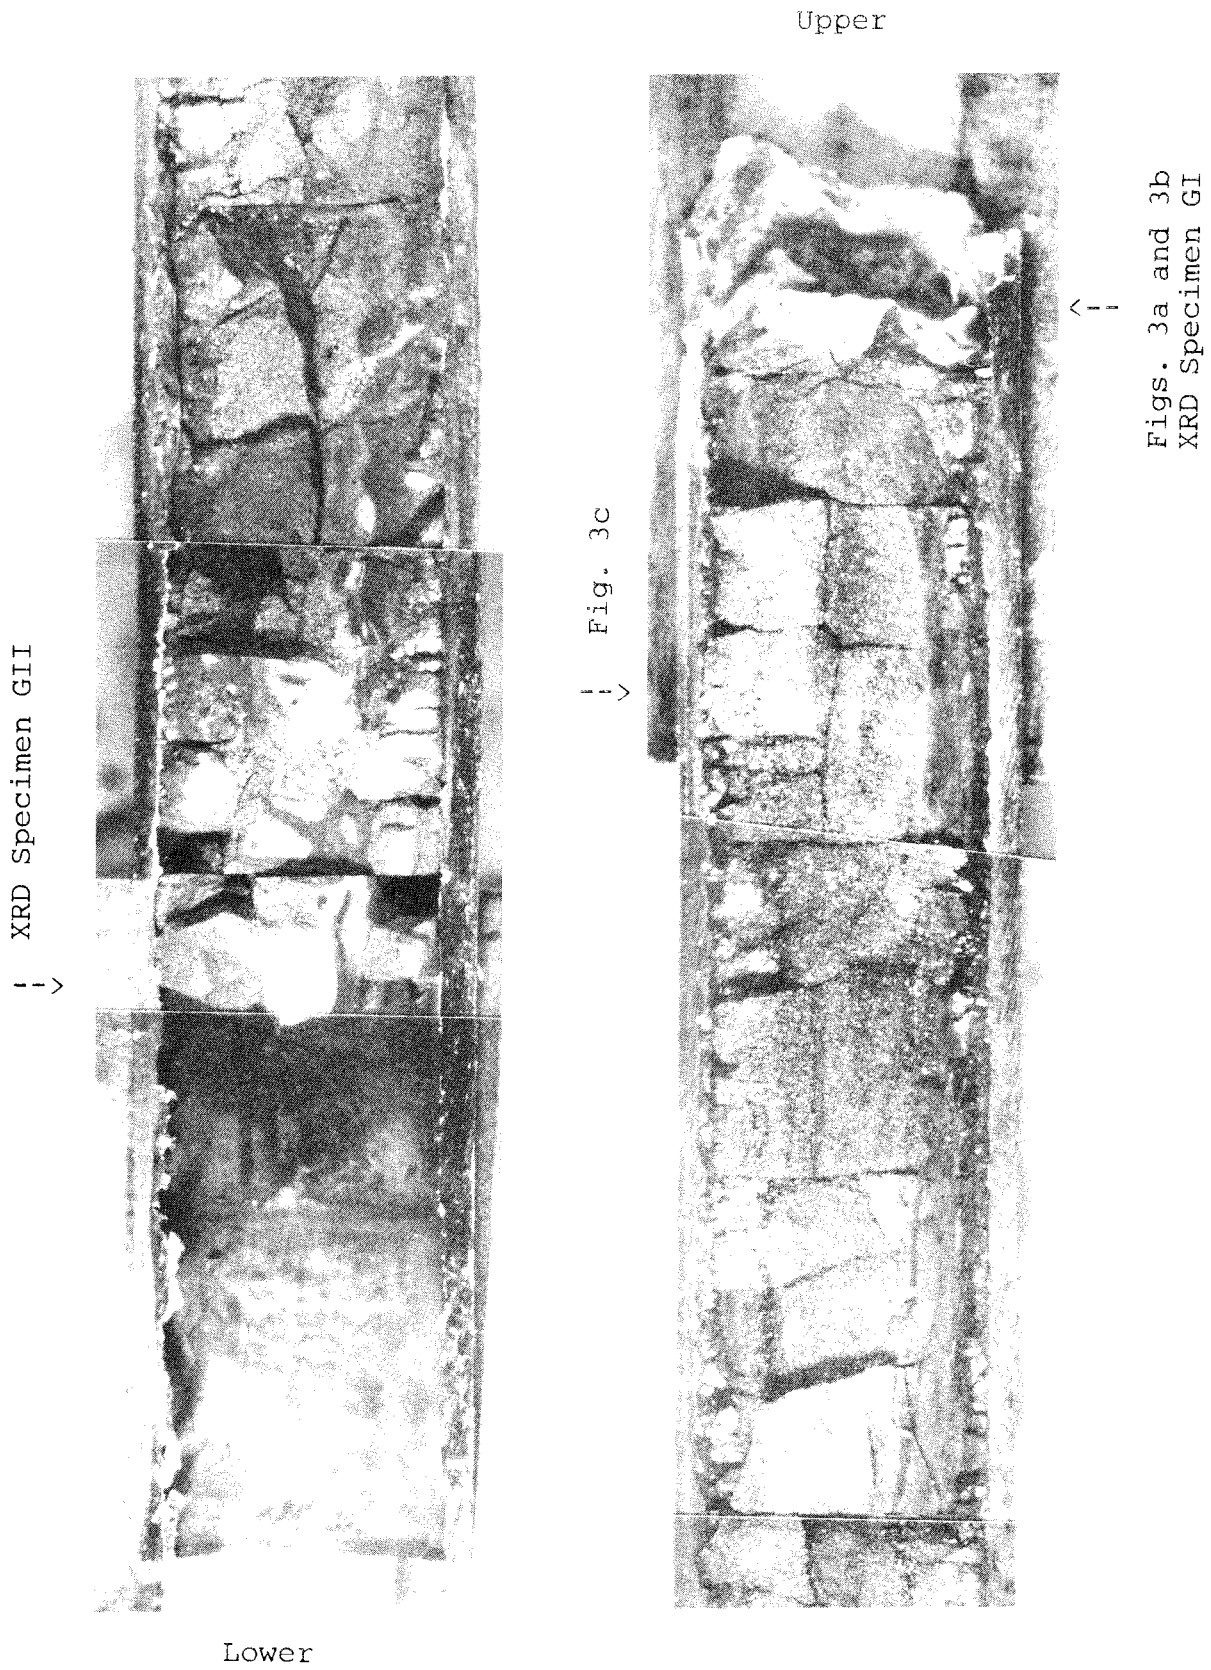
Fig. 1 Fuel/clad half A

A section of this part of the rod, about 100 mm long, from the fracture downwards, was cut off and then sectioned longitudinally through the clad to give two halves, denoted here A and B, which are shown in Figs. 1 and 2 respectively. The fuel in half A remained essentially in its original position, while the fuel in half B had been disturbed in the cutting operation and consisted largely of loose fragments which had been moved from their original positions.

Samples of the deposit for XRD analysis were taken from two positions denoted GI and GII in Fig. 1. This was effected by taking selected fuel fragments with adherent deposit from these positions, and sampling the deposit by pressing warmed plastic tape against the surface. Small specimens of the material thus removed were then mounted in the normal manner and analyzed in a Guinier-Hägg focussing camera. Good quality diffraction patterns were obtained [2] which showed that both specimens consisted of the sub-monohydrate of schoepite as reported by Dawson et al [3] and which had already been identified in earlier corrosion tests on the

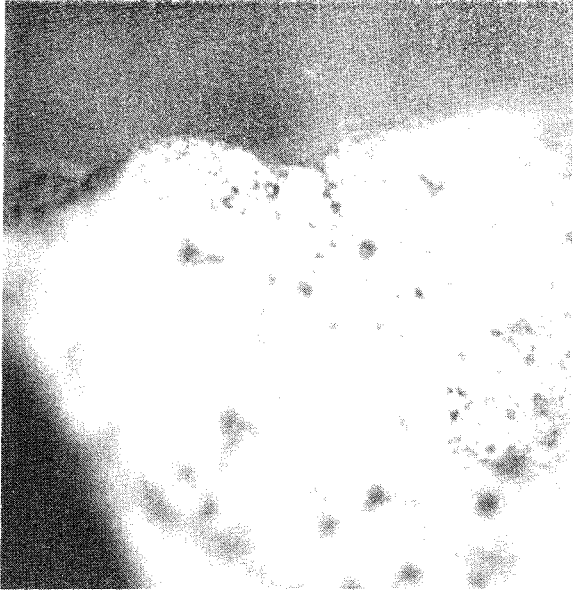
3a) x25

Inspection of the two halves showed that the yellow material was largely restricted to the surface exposed directly to the reactor coolant water during operation at power, although some was also observed at the lower end of half A. At higher magnification, the material displayed a granular appearance. (Figs. 3a, b and d).

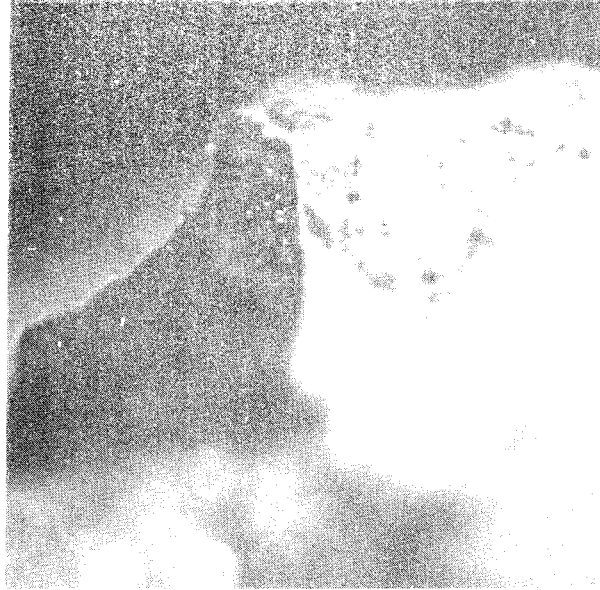
3b) x30

Detail of deposit crust at upper end of clad half A.

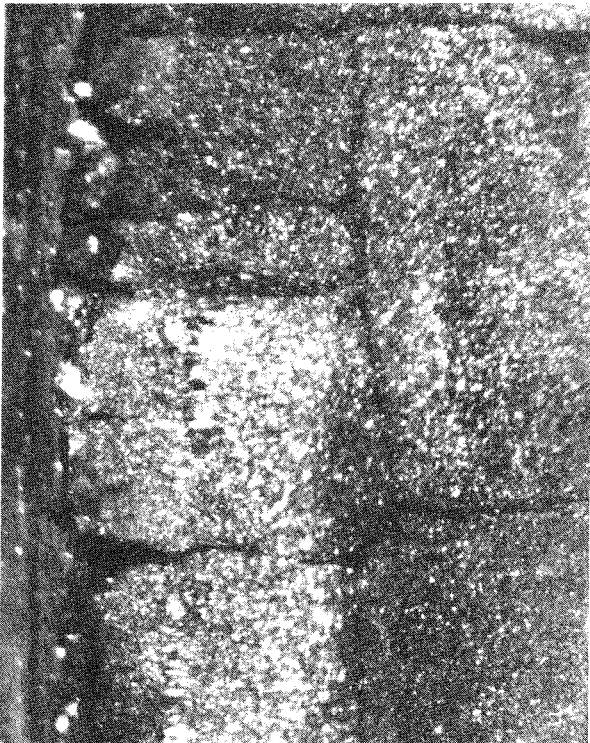
3c) x10

Most of the fuel fragments had a bright lustre and were probably fracture surfaces formed on reactor shut-down. Some surfaces near the clad, however, had a dull appearance and could have been those exposed to the coolant during operation. A narrow band of fuel at about the half-radius position displayed a structure similar to columnar grains (Fig. 3c), formed during operation under oxic conditions.

Detail of fuel:
half A.
(See Fig. 1)

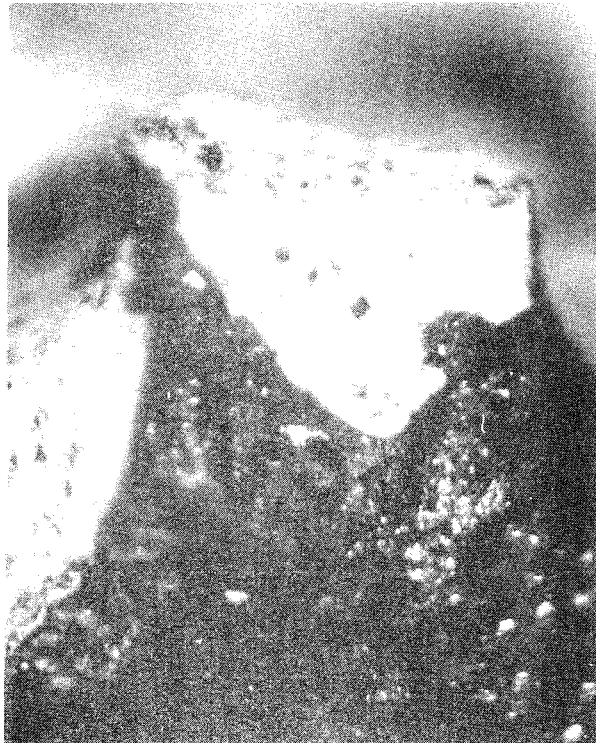
3d) x40

It was mentioned earlier in this report that the occurrence of the yellow material appeared to be restricted mainly to the ends of the fuel column directly exposed to the reactor coolant. The sharp local boundary to the deposit is shown clearly in Fig. 3d.

Detail of deposit Clad
crust at upper end of
clad half B.
(See Fig. 2)

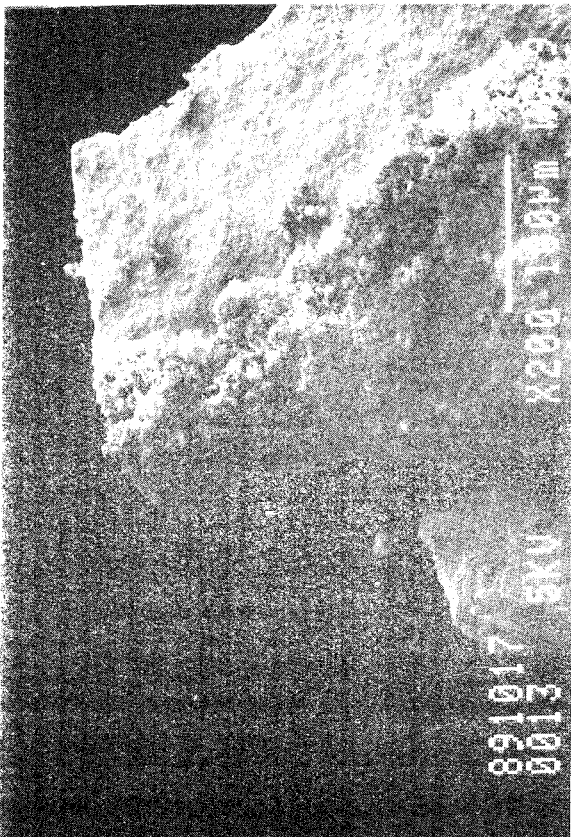
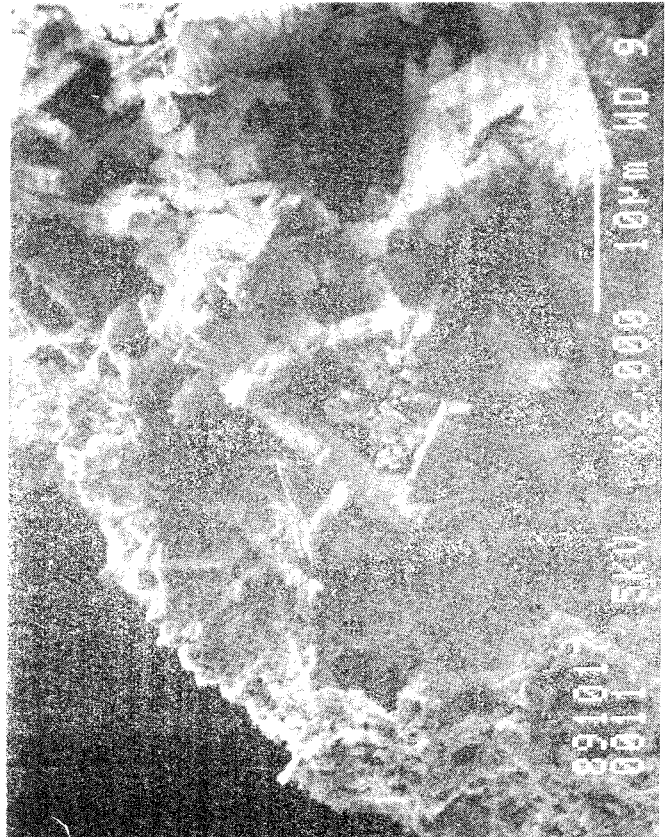
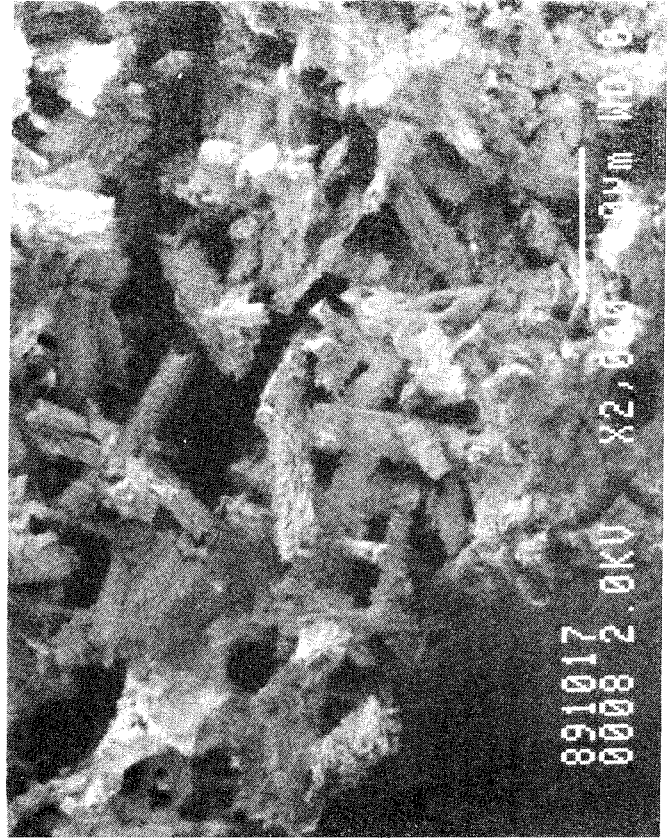
The appearance of the (yellow) deposit crust at about the position sampled for XRD specimen GI is shown in Figs. 4 and 5. Although the morphology of the material is poorly defined, the larger crystals show a resemblance to the material also identified as the sub-monohydrate of schoepite (dehydrated schoepite-DS) by Taylor et al [4] in

A small fragment of the surface crust, from an unknown location on the fuel fragment, showed a completely different appearance, and consisted of sub-micron sized granules and platelets about 2 microns in size. Qualitative EDS examination of both this material and that shown in Figs. 4 and 5 showed only the presence of uranium.

Fig. 4 Detail of deposit crust at upper end of clad half A. (See Fig. 1)

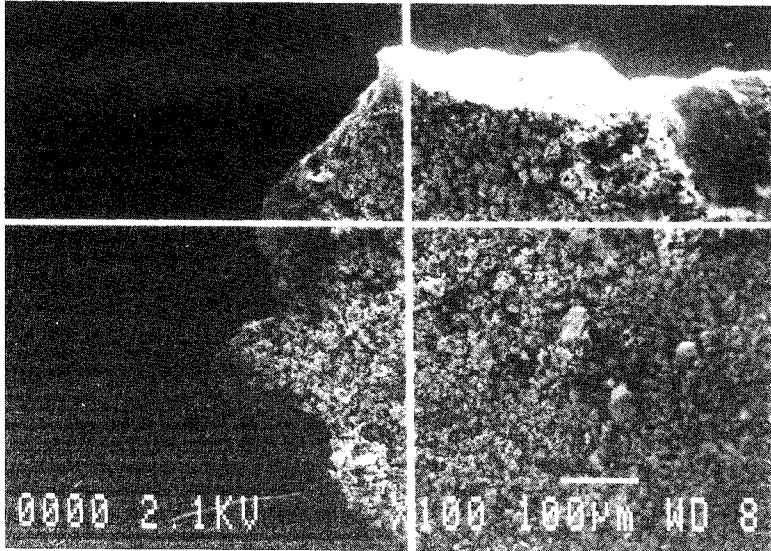
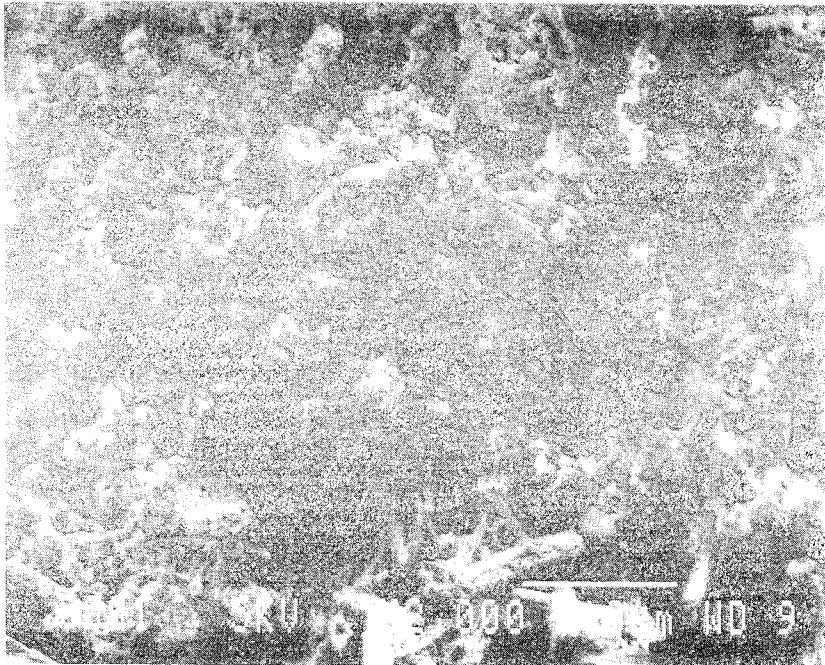
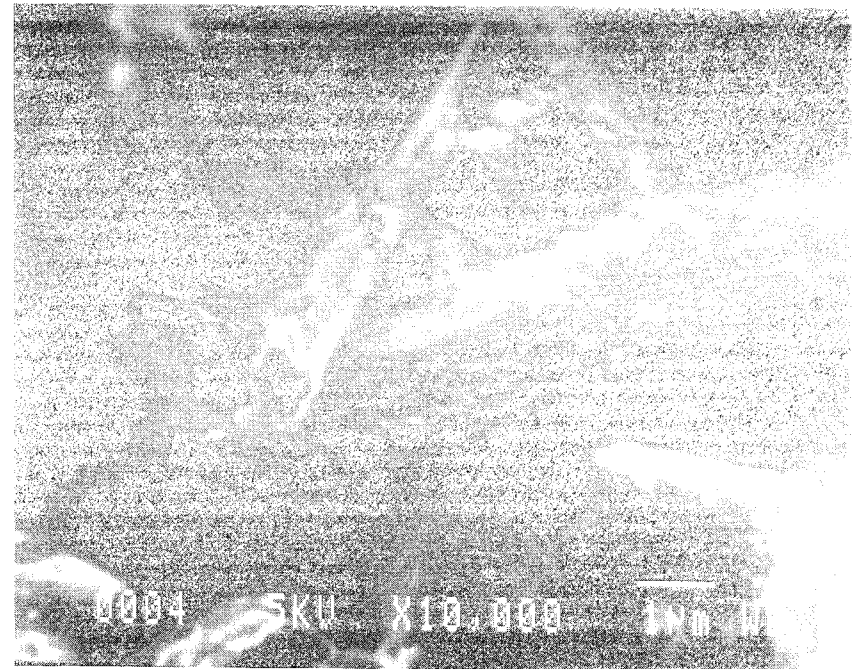
No attempt was made in this limited programme to positively identify the other corrosion products observed on the fuel surfaces, (Figs. 5, 8 and 9), partly because of shortage of time and partly because of some uncertainty with regard to whether they were formed in-reactor or during subsequent storage. A reasonable assumption, however, is that they were UO_3 hydrate(s).

Fig. 5 Detail of deposit crust at upper end of clad half A. (See Fig. 1)

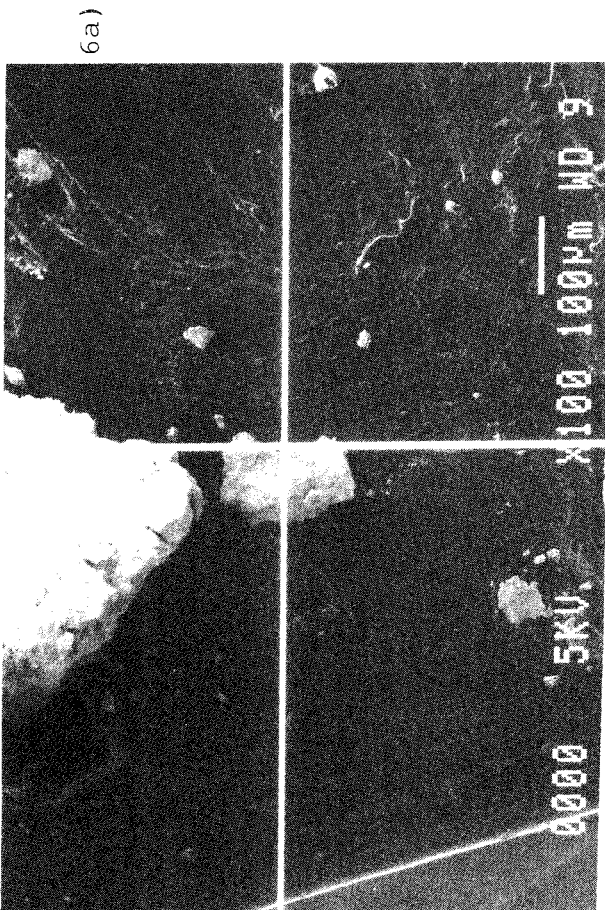
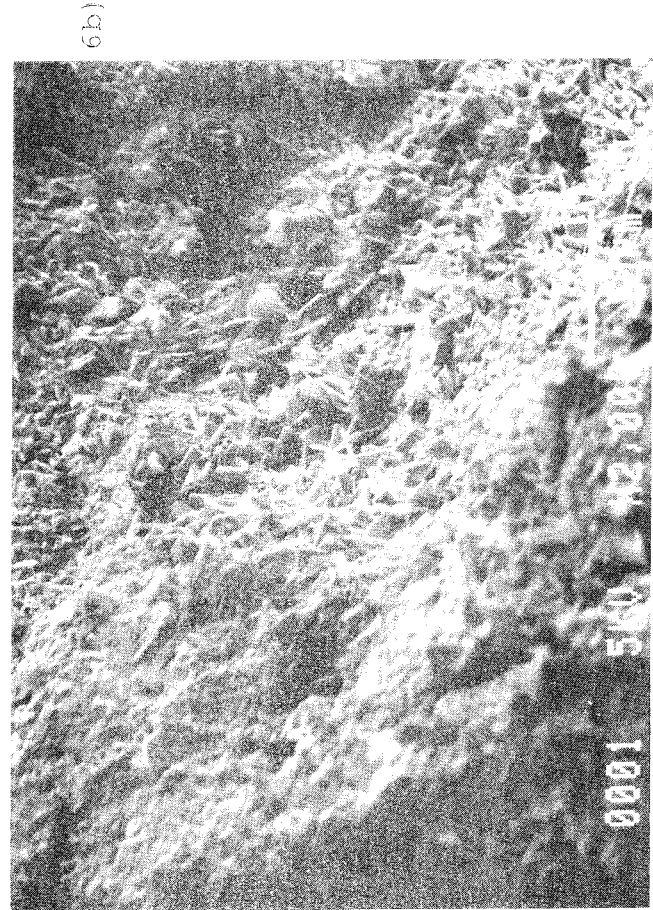
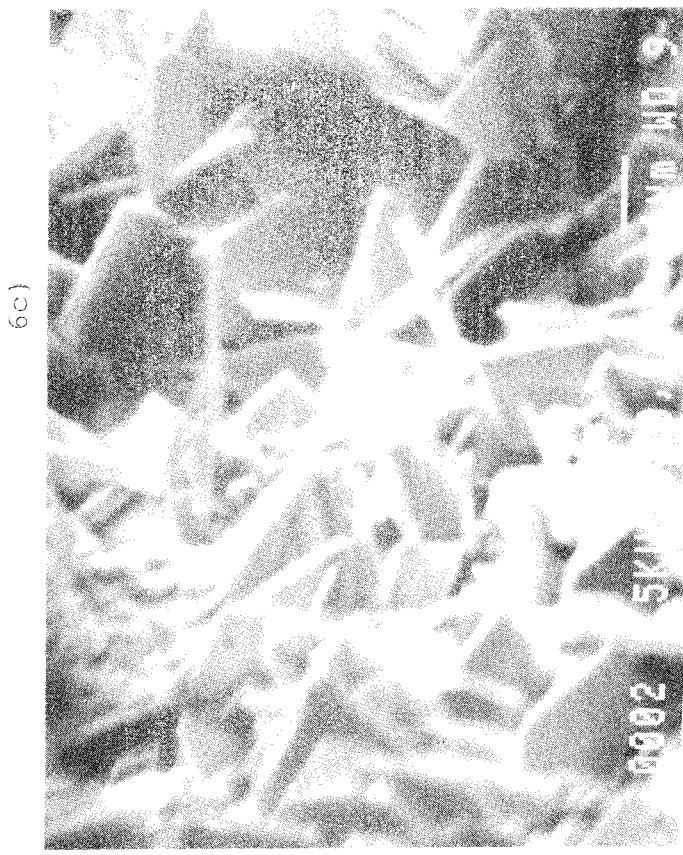
Fig. 6 Detail of small fragment of surface crust.

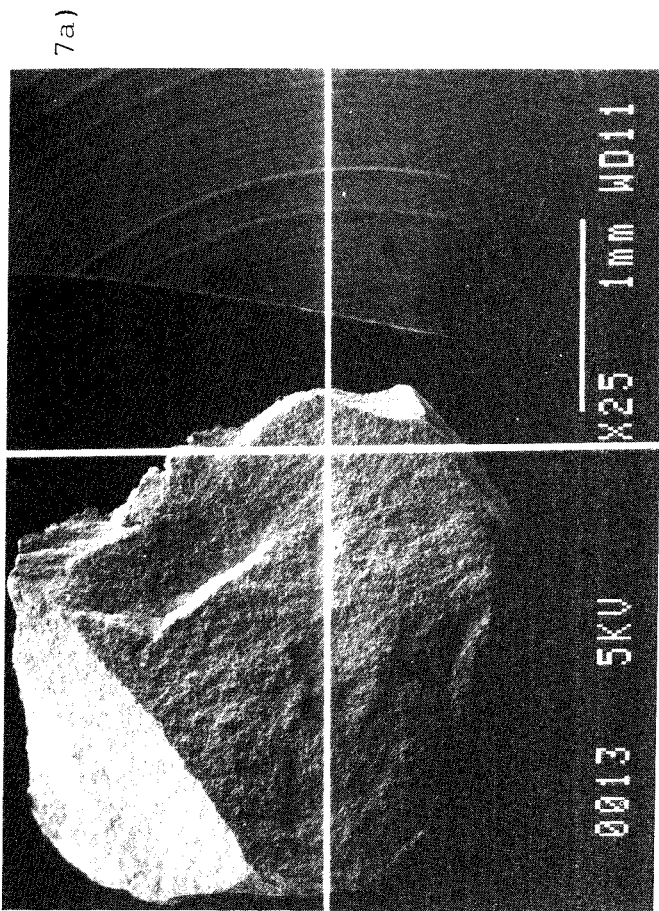
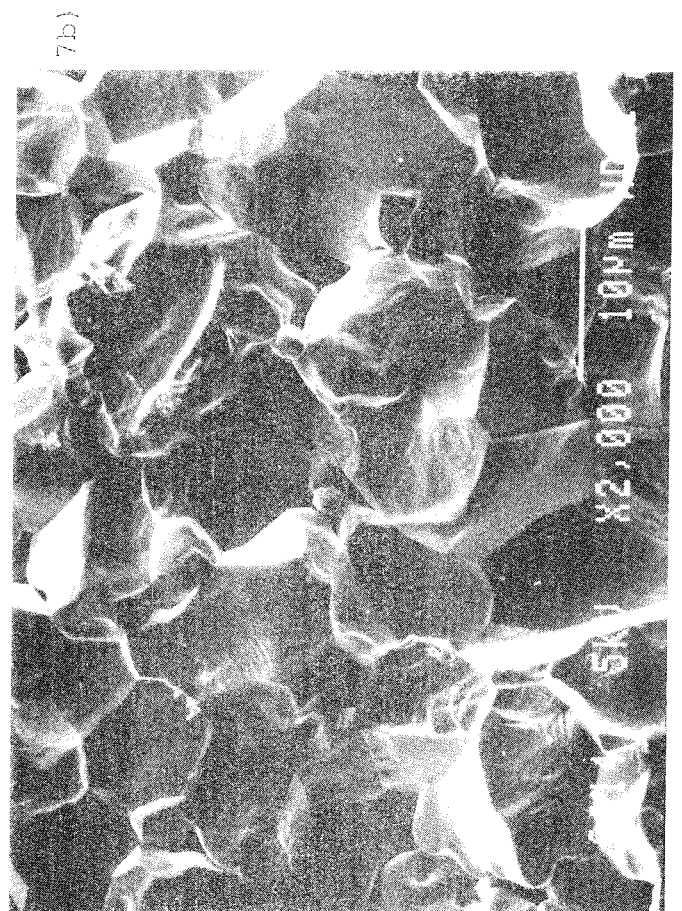
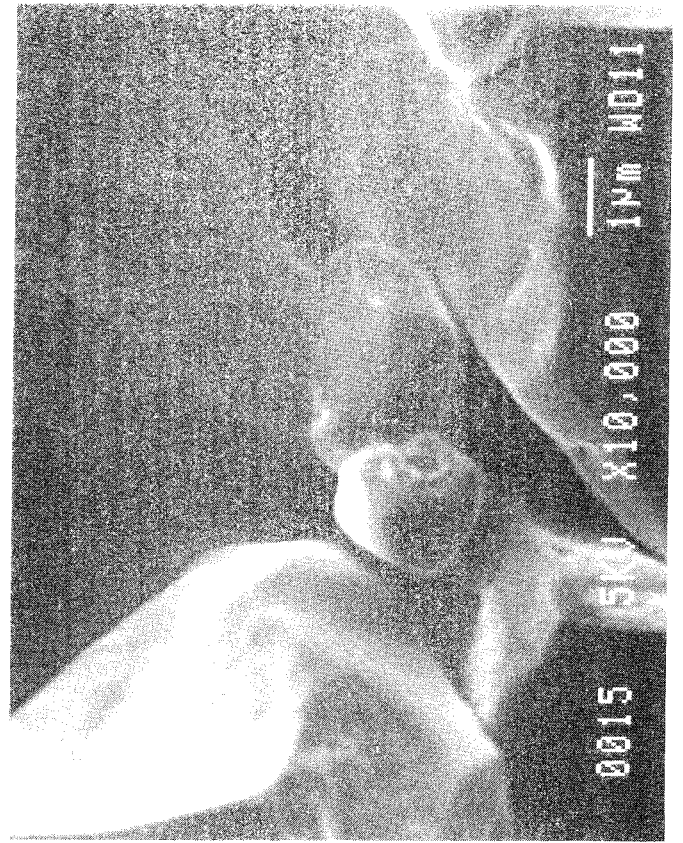
A small fragment from the lower end of the sampled fuel fragment with surface crust was also examined in the scanning electron microscope. At low magnifications it was difficult to distinguish between the surfaces which had been exposed to the reactor coolant and those caused by the specimen size reduction technique. At higher magnifications, however, the inter- and intra-granular fracture typical of the fresh fracture surfaces could be clearly seen. This is shown in Fig. 7 for comparison with the following photographs.

Fig. 7 Detail of fresh fracture surface.

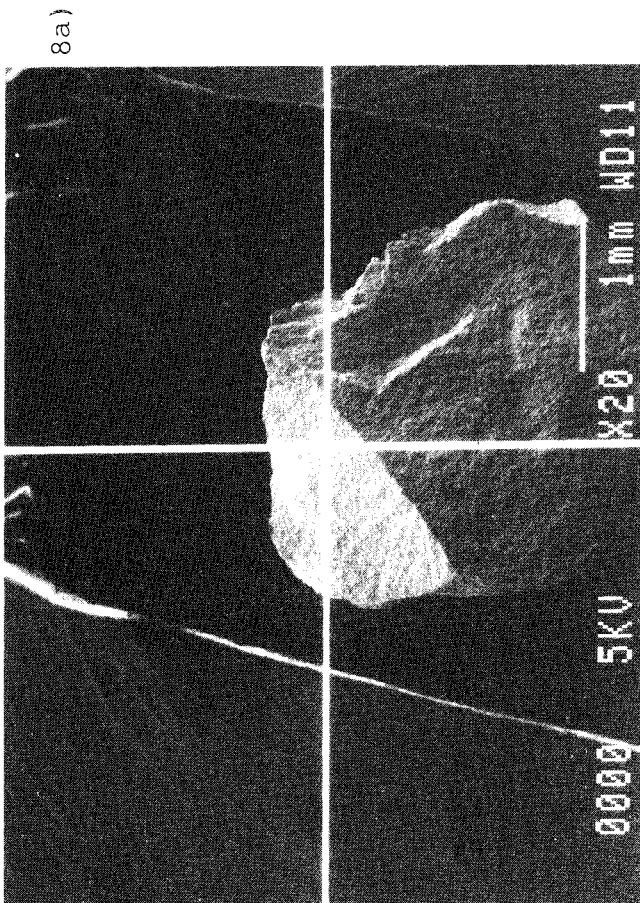
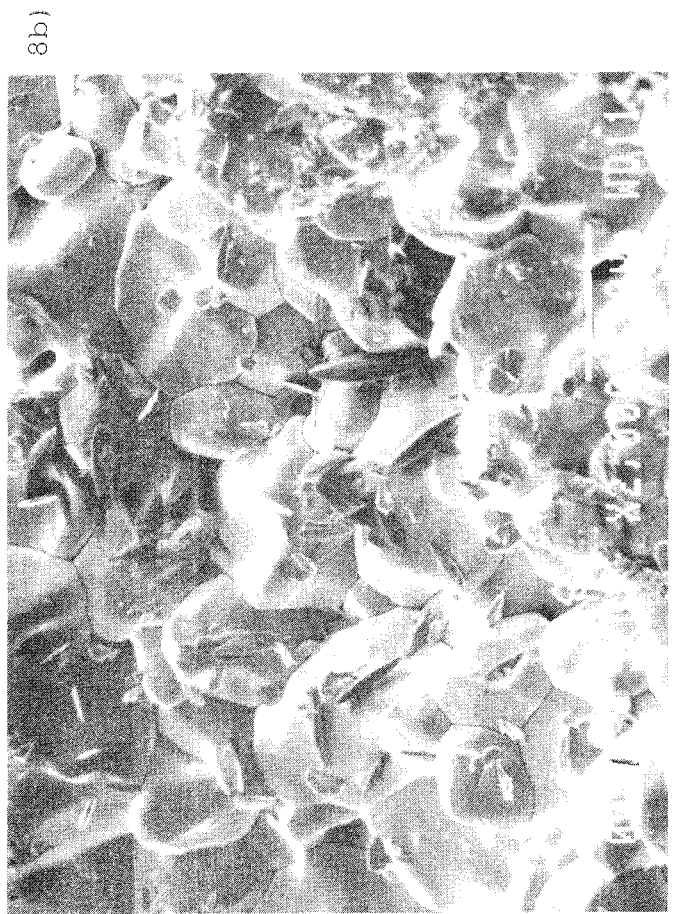
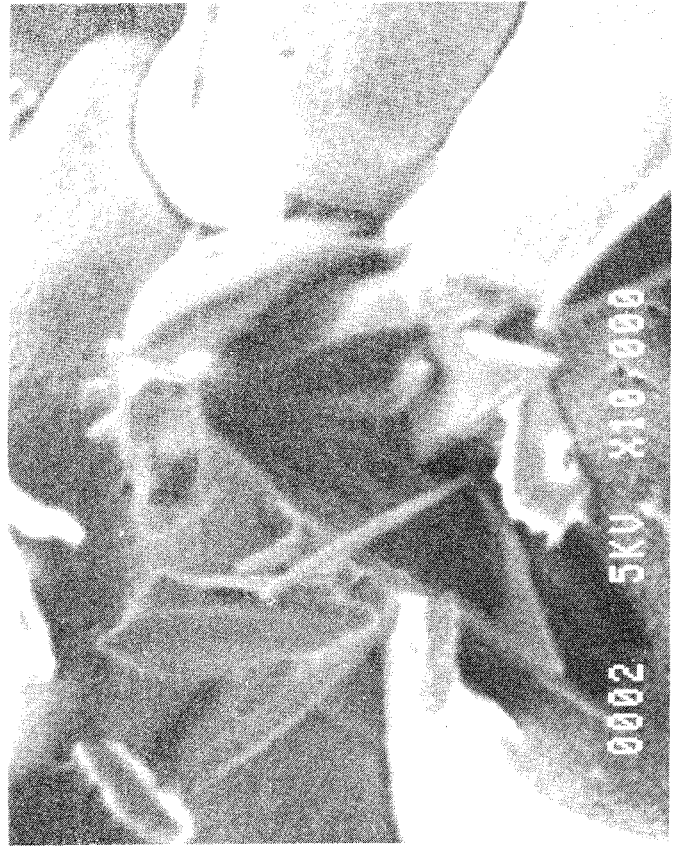
The appearance of a corroded fragment surface is illustrated in Figs. 8 and 9, showing smoothly rounded fuel grain surfaces and an irregular covering of UO_3 hydrates, with varying morphology

and size, located on grain faces and at grain boundaries. The fuel grains themselves appear to be evenly covered by a granular material of the order of 100 nm in size. Two of the fuel pores visible in one of the high magnification photographs in Fig. 9 are seen to contain spherical particles, presumably consisting of the fission product metals Mo, Tc, Ru, Rh and Pd, either as the original metallic inclusions or as oxidized/hydrated reaction products.

Fig. 8 Detail of corroded fragment surface.

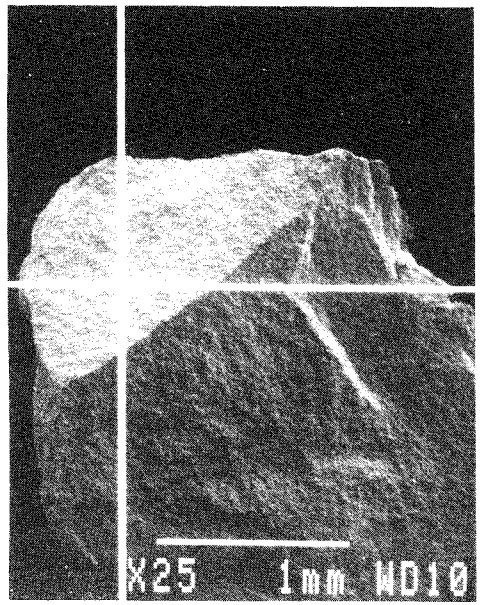
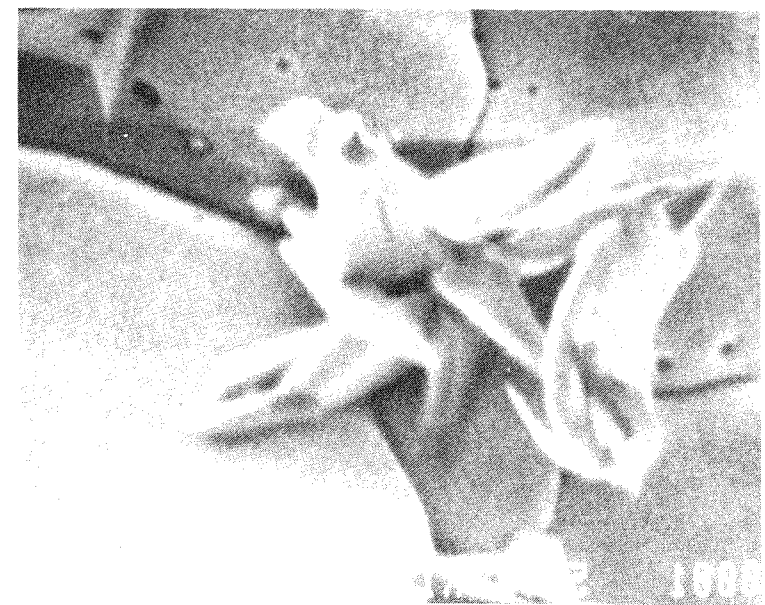
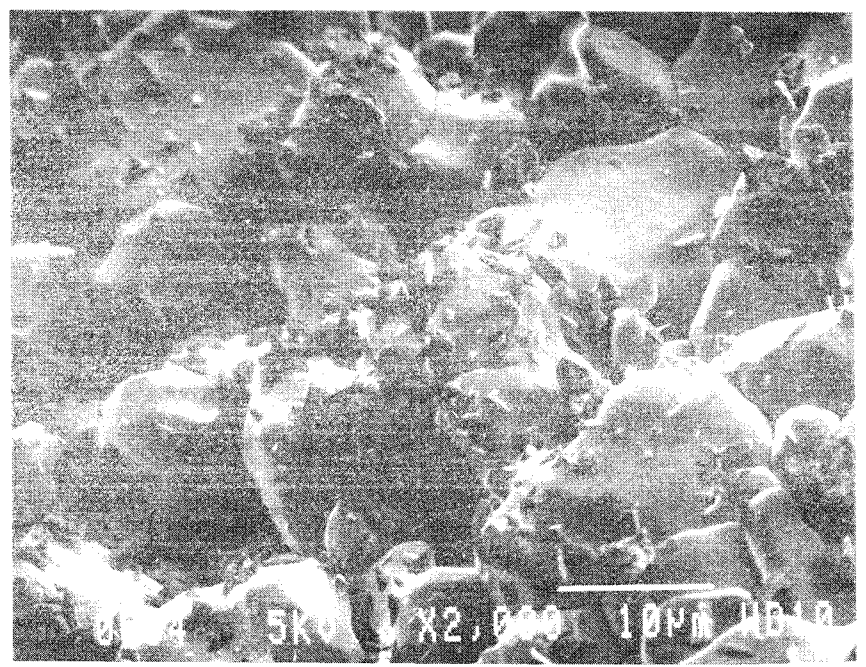
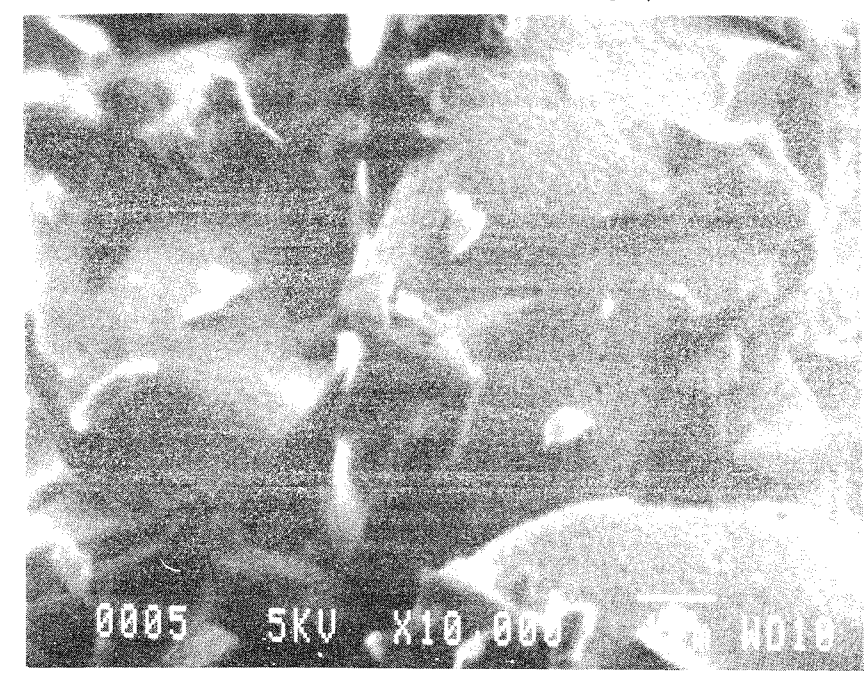
Fig. 9 Detail of corroded fragment surface.
