Äspö HRL

Experiences of blasting of the TASQ tunnel

November 2004

Svensk Kärnbränslehantering AB

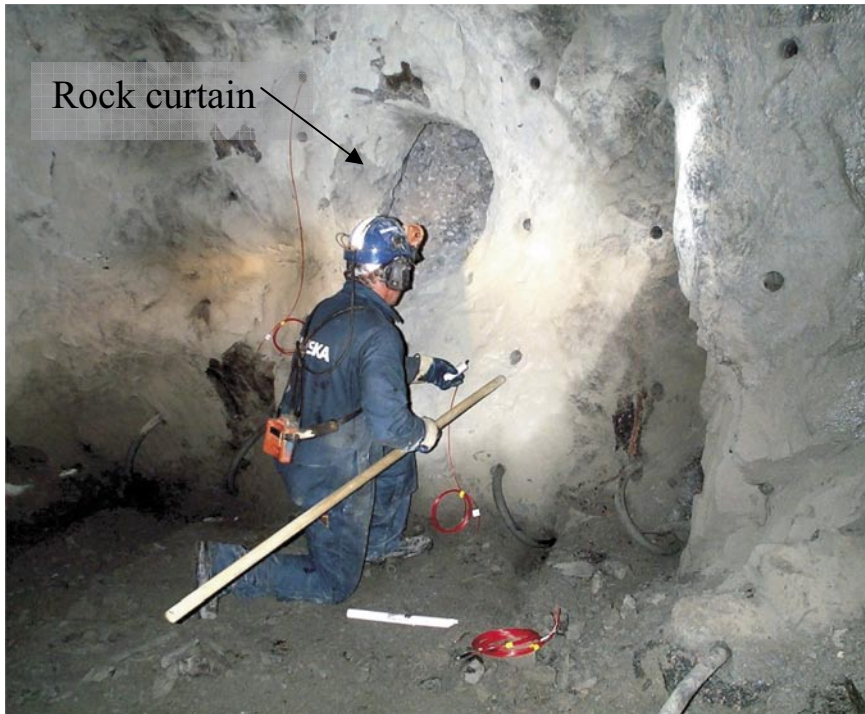
As has been mentioned in Section 6.3.1 on “Misfires”, it may be relevant to expect the clay plug to take an active part not only in the confinement of the charge preventing fly-rock, but also in causing the rock curtain that has been experienced at several occasions. As can be seen in Figure 6-5 the broken rock is clearly visible behind the rock curtain. This picture was taken from one of the first blasts. In this case the rock curtain did not lead to any complications. It was broken when the next section of the face was blasted.

Figure 6-5. An example of a rock curtain.

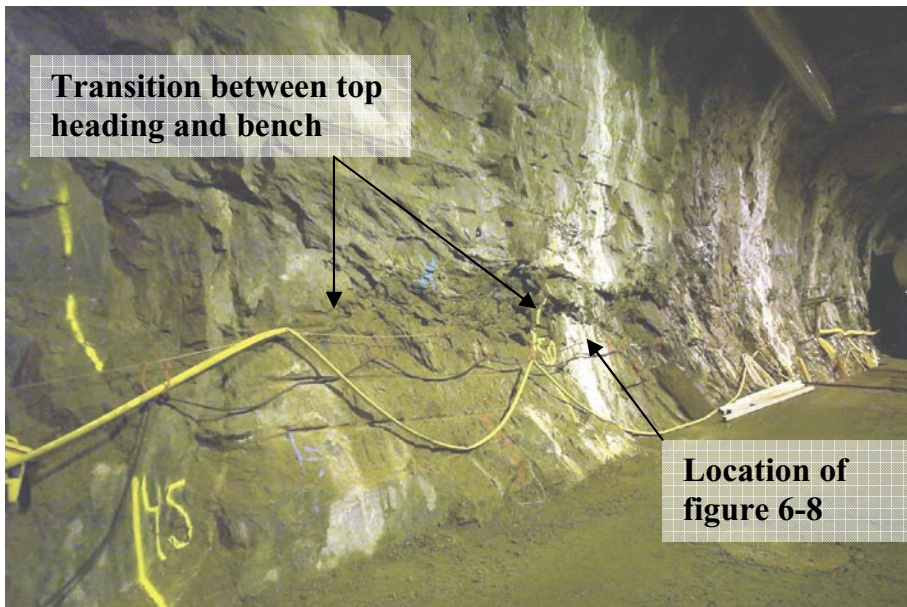
Visible signs on the tunnel walls clearly show that the transition zone between the top heading and the bench is more affected by the blasting than the rest of the wall. Figure 6-7 shows the transition zone. The lower corner holes of the top heading must be charged as contour holes. The bottom corners of the section were chamfered in order to reduce the confinement of the corner holes. Despite these measures the wall seem to have been affected although only a more thorough investigation of the zone would show if blast damage has penetrated further into the wall than the blast damage below and above the zone.

Figure 6-7. The visible signs of the transition zone on the tunnel wall between the top heading and the bench on the left hand side wall.

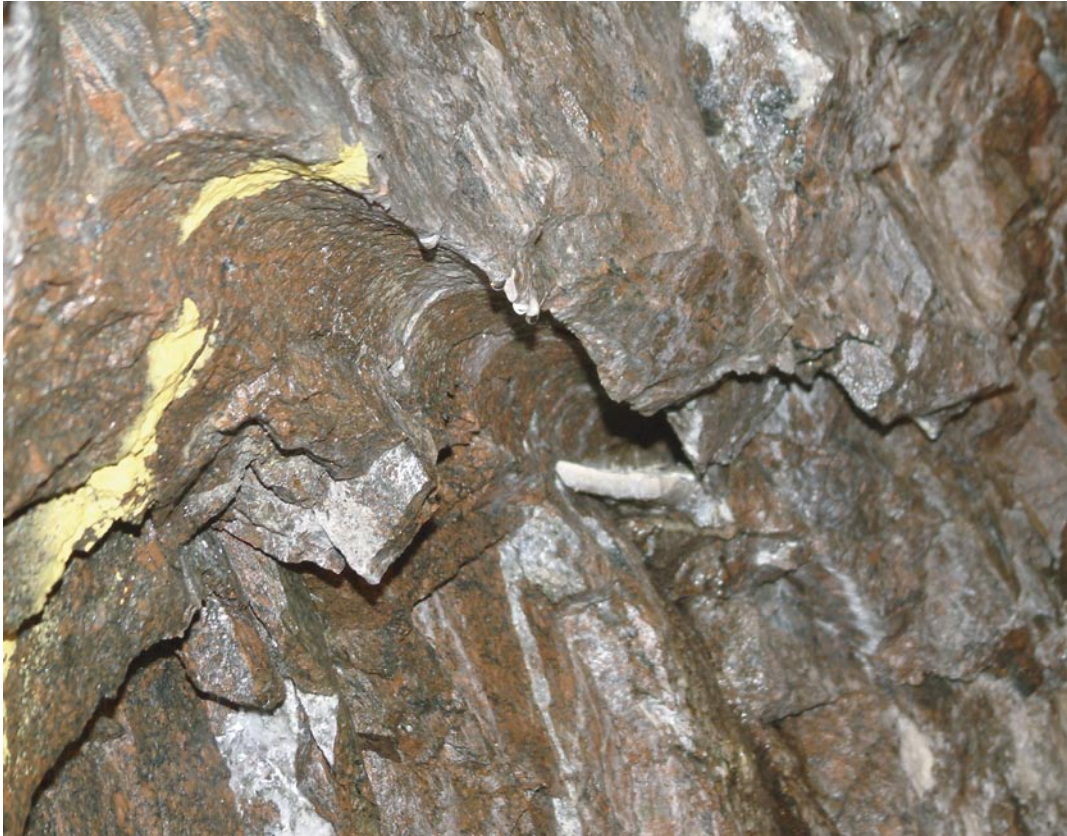
Figure 6-8. A grout hole at section 0/050.7, location is indicated in Figure 6-7. The white slab in the bottom of the borehole is cement from the grouting. The hole was not fully filled with the grout slurry, and the cement has sedimented in the hole. Borehole diameter is 64 mm.

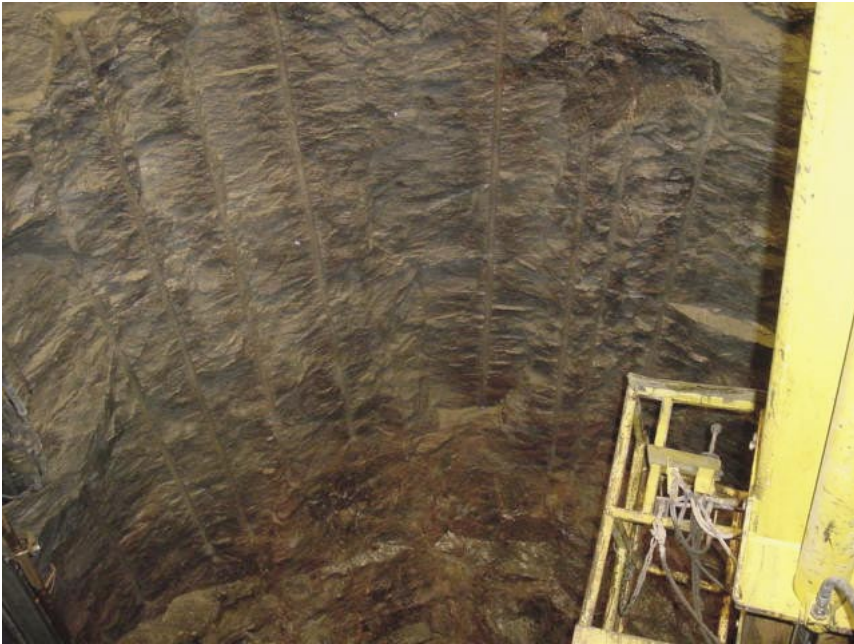
Figure 6-19 shows the half casts in the roof after blasting of this round and Figure 6-20 shows the half casts in the right hand wall. The highest number of half casts was in the roof. The right hand wall with electronic caps had much higher number of half casts than the left hand wall charged with Nonel initiated explosives.

Figure 6-19. Round 2. Half casts in the roof. Notice spacing variation.

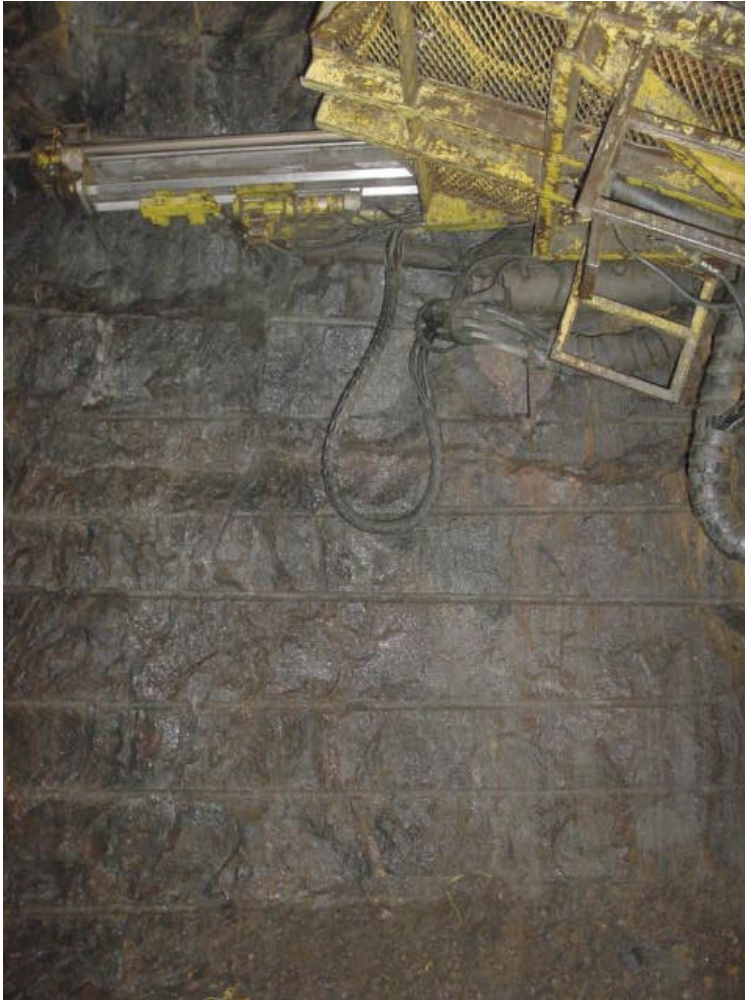
Figure 6-20. Half casts in the right hand wall of round 2.

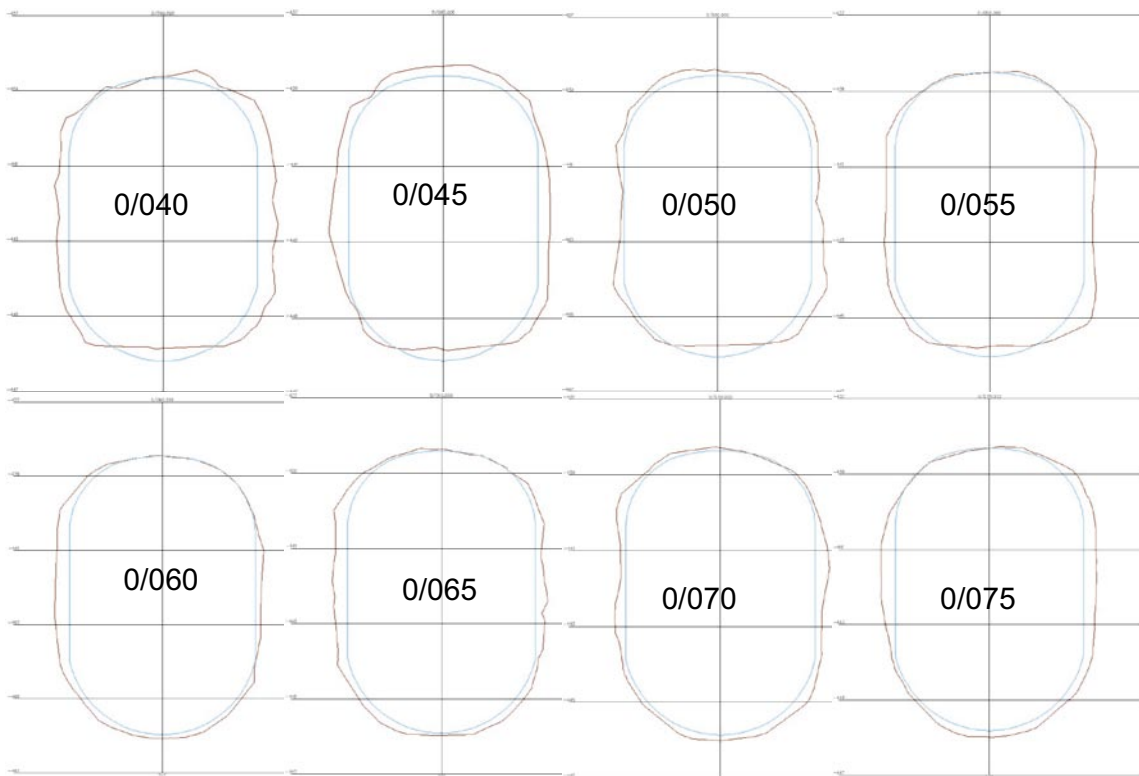
To further study the accuracy in drilling precision all visible half pipes in the walls were surveyed at the starting and end points. The difference between the start- and end point was calculated. The results are presented in Figure 7-2. The absolute over-break in the walls is not possible to see, because the collar position relative the theoretical contour is not considered. Since all half pipes are not visible through the full length of a round the graph in Figure 7-2 under-estimating the true over-break in the walls to some degree. Because the large number of visible half pipes is this error probably small. This study could not include the roof, because it was covered by shotcrete. However, Figure 7-1 indicates that the overbreak in the roof is less than in the walls.

Figure 7-1. Results of profiling of the tunnel contour.

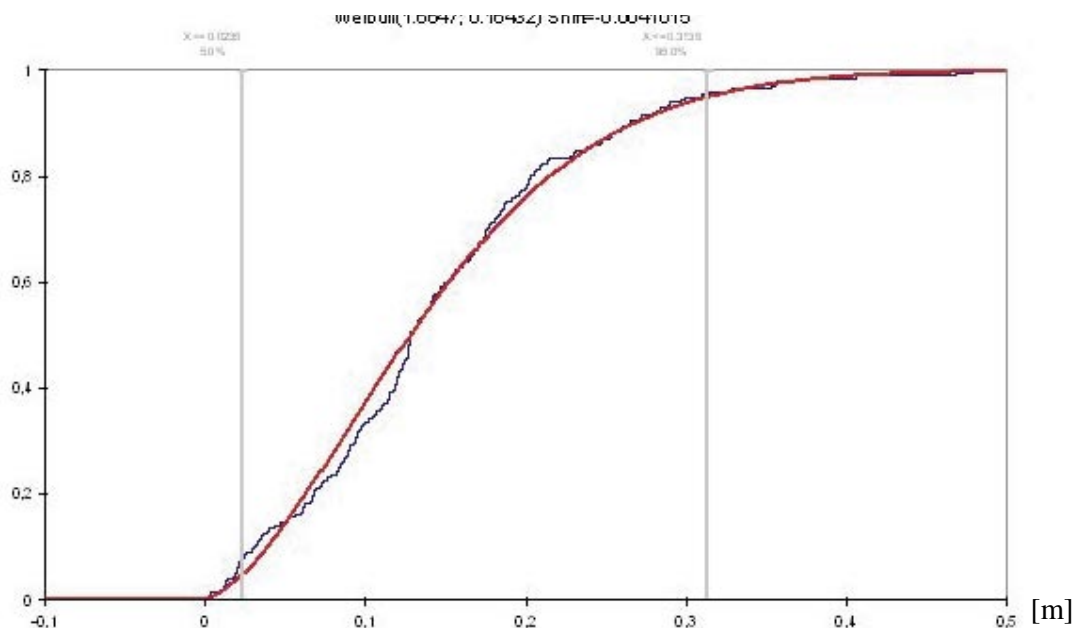
Figure 7-2. Cumulative distribution of look-out angle for visible half pipes in the walls. 0.3 m was the maximum acceptable over-break according to the requirements. 94% of the visible contour holes in the walls stayed within this limit.

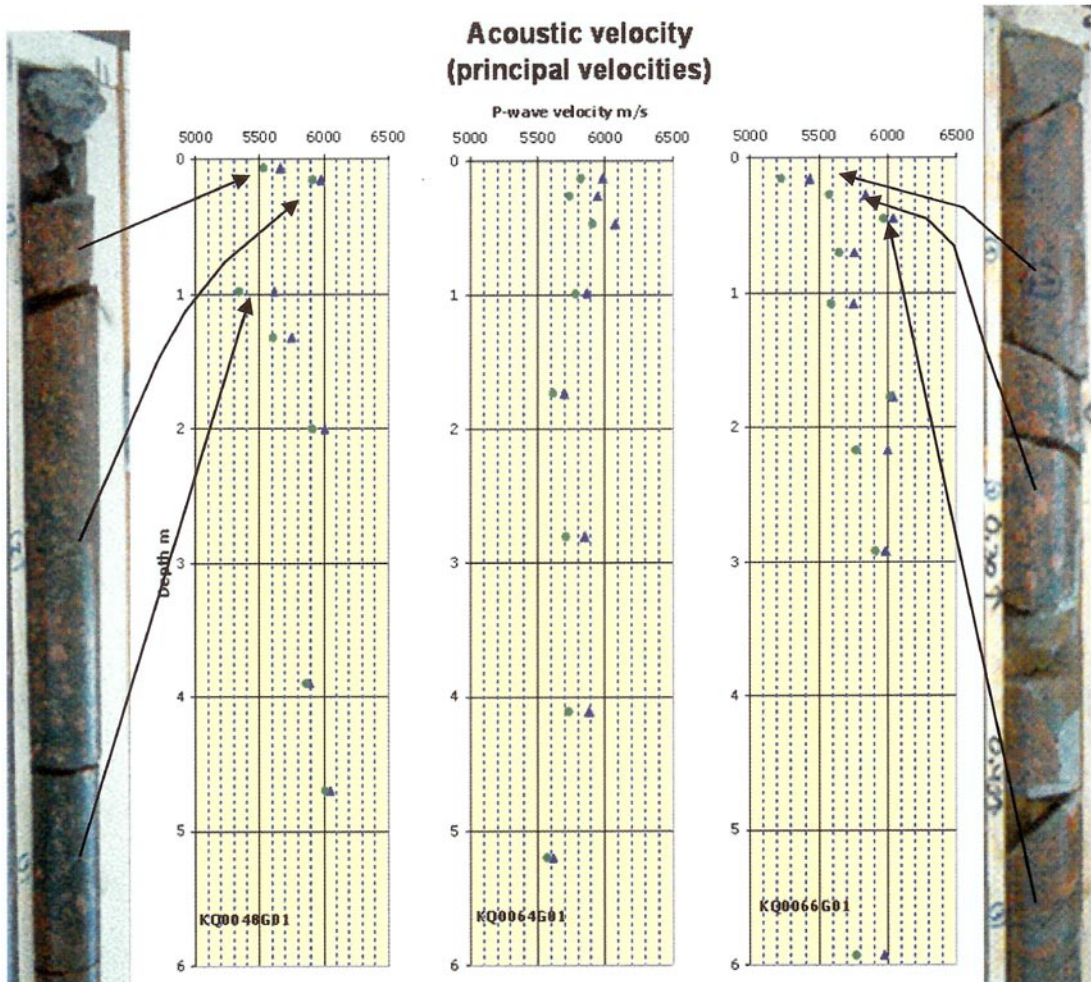
Figure 7-3. Two cores from the floor of the TASQ tunnel with results of measured sonic velocity as well. There are no indications for damage below approximately 0.3 m /Bäckblom et al. 2004/.

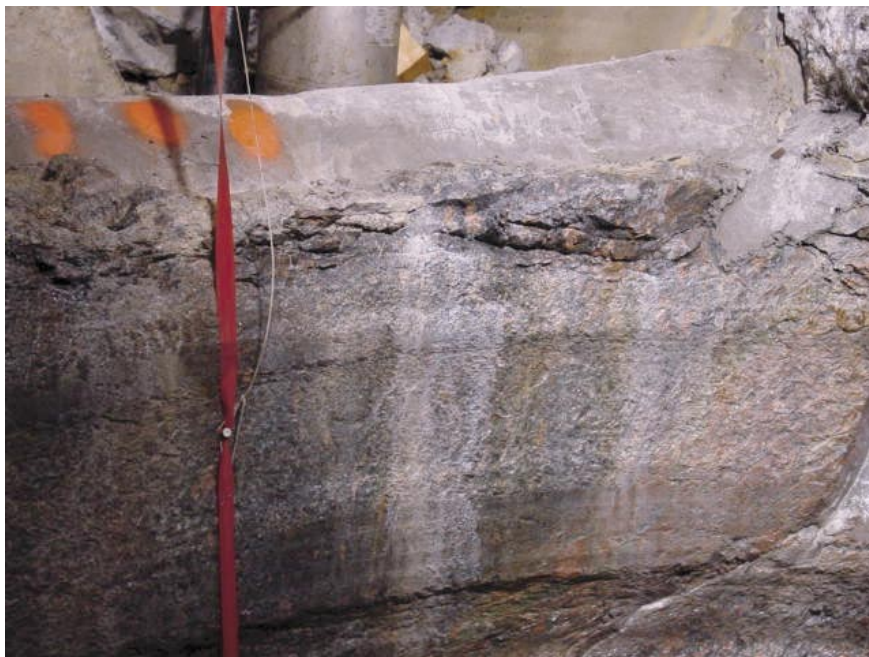
In addition, when drilling the two 1.8 m diameter holes in the floor for the APSE experiment /Andersson, 2003/, the upper part of the floor could be studied. The observations from the large size bore holes supports the observations from the 51 mm cores, Figure 7-4.

Figure 7-4. Observations of the upper part of a 1.8 m diameter bore hole. The upper part is a concrete slab that was casted to provide a smooth surface for collaring of the bore hole. The slab is approximately 0.3 m thick.

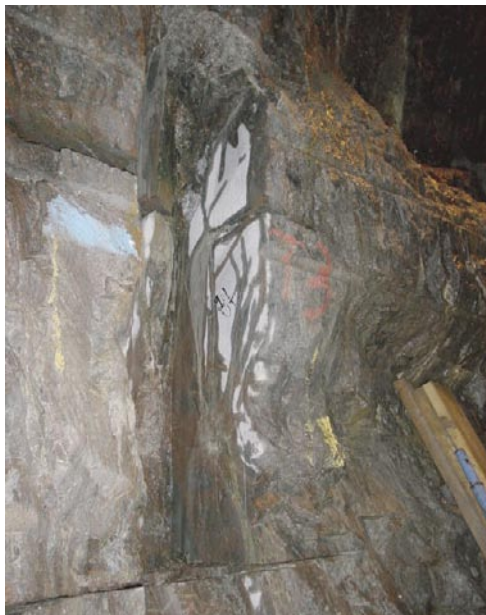
A slot was made in the right hand wall of the tunnel at the end of round 32. The right wall of the slot shows the crack pattern from the column charge and the left wall shows the corresponding picture from the bottom charge, see Figures 7-6 and 7-7. Three half-pipes are crossed by the slot. All of the holes were initiated simultaneously.

Figure 7-6. Right slot wall.

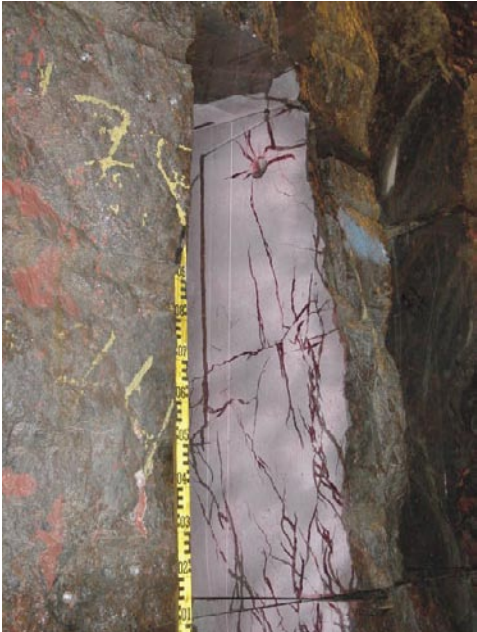
In the upper part of Figure 7-8 cracks from a bottom charge are shown. This is a very typical crack pattern from a confined charge with symmetrical cracks all around the hole. There are also a number of cracks from the half-pipes; the longest is around 20 cm. On the left wall, the cracks from the half-pipes have about the same length. But there are also longer cracks; the longest around 40 cm which seems to originate from the half-pipes. These cracks might also be classified as blast induced cracks. Most of the half-pipes in this section pointed downward which could indicate that the holes were partly filled with water when blasted. There are also many natural cracks in this section. Most of them have a more vertical plunge. One of these cracks was an open crack. More details may be found in Appendix 3 and in Section 7.3.5.

Figure 7-8. Cracks in upper part of right slot wall.

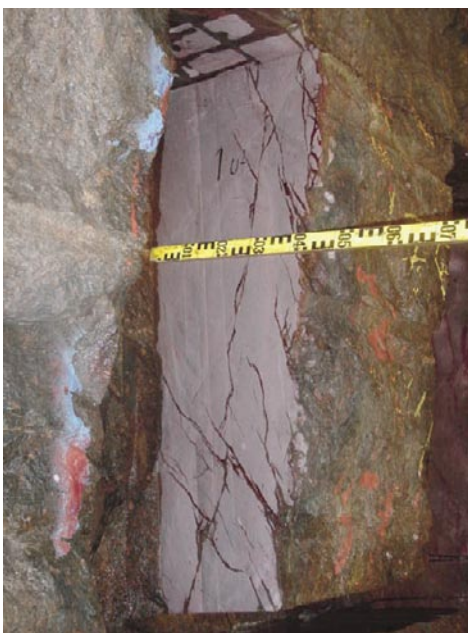
A slot was made on the right hand wall of the tunnel in the first part of round 33. Three half pipes were crossed by the slot and the longest crack from them was some 20 cm. Most of the cracks originating from the half pipes were shorter with crack lengths < 15 cm, see Figure 7-12. Most of the half-pipes in this section also pointed downwards which could indicate that the holes were partly filled with water when blasted. There are also a number of induced cracks as well as some natural vertical cracks but generally there seem to be fewer cracks in this section compared to section 1 and section 2.

Figure 7-12. Cracks from right slot wall.

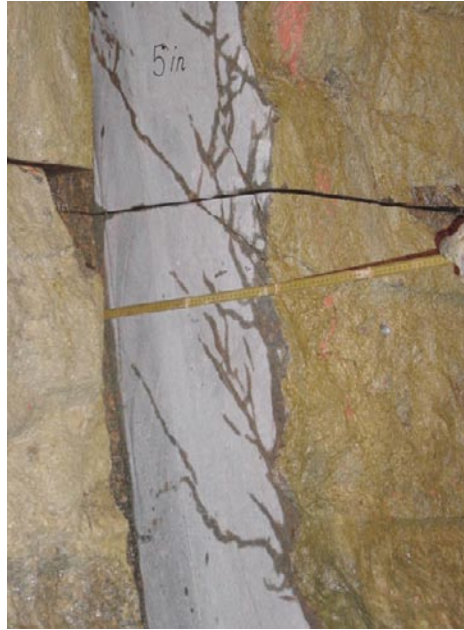
Figure 7-17. Open cracks in the right slot wall.
