International
Progress Report

IPR-03-50

TRUE-1 Continuation project

Preliminary structural-geological
description of target structures based
on borehole data and tunnel mapping

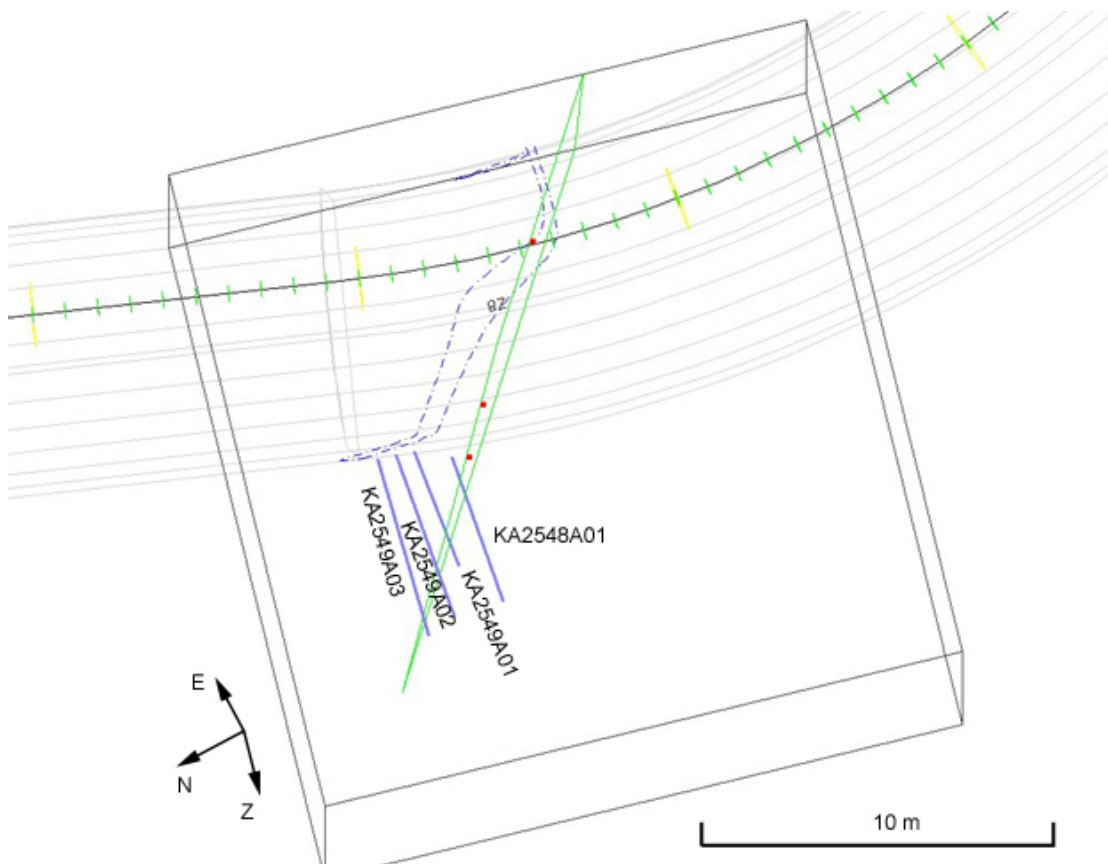
The new survey of the tunnel in conjunction to the drilling campaign highlighted the inaccuracy of the measurements of zone locations on the tunnel wall. Therefore the zone was remodeled prior to drilling based on new survey data. The remodeled structure strikes 303.2° and dips 89.6°, see (Figure 3-1).

Figure 3-1. The model of 'zone 2545' as interpreted before drilling but using data from the new tunnel survey. The red points illustrate the tunnel intercepts of the zone used for the modelling.

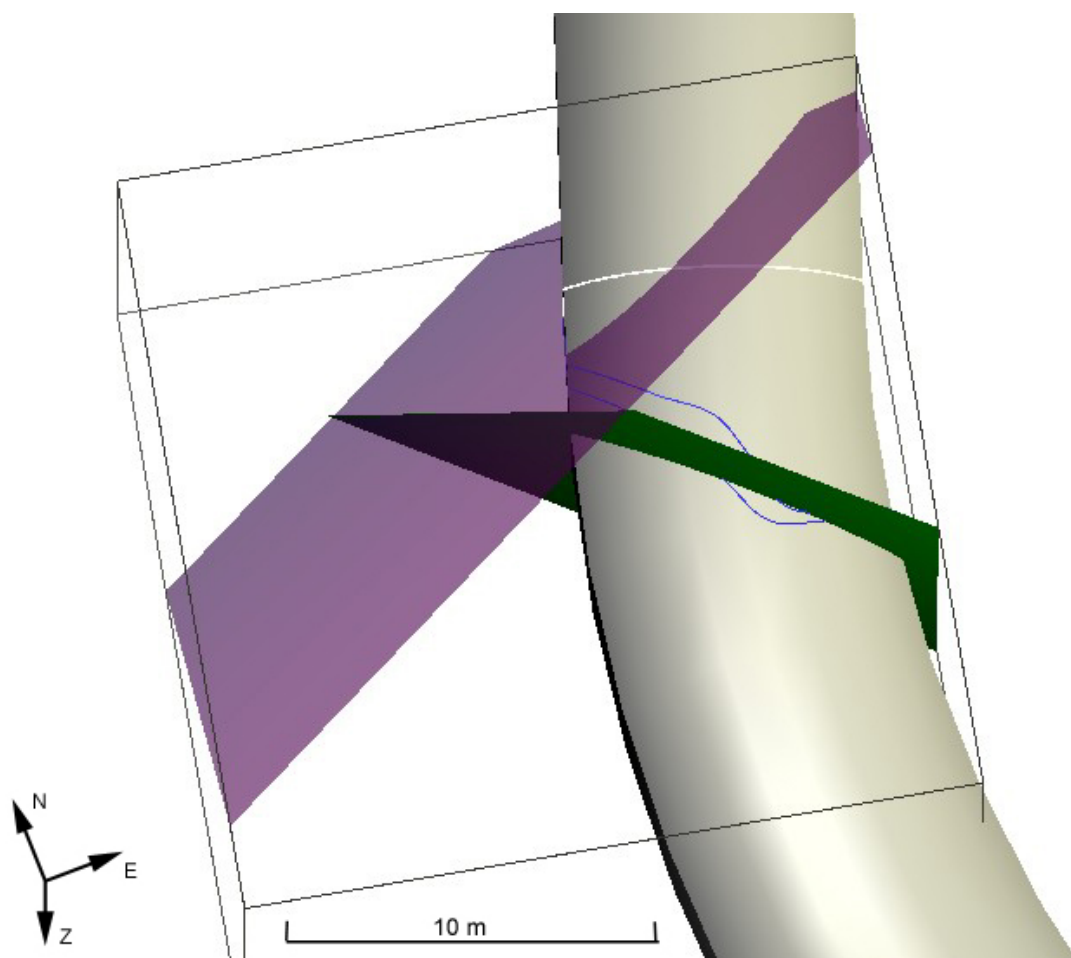
In the tunnel the structure appears to terminate against a steeply dipping fracture striking NNE, which is crossing the tunnel ceiling at 2/550 m, see Figure 3-2. This was confirmed during drilling of KA2549A01 where a shear plane, featuring narrow breccias, striking 235° and dipping 65-70° was identified at a depth of ca 2.1 meters (Figure 3-3). Beyond that shear zone other NW striking fractures are identified by BIPS logging, but none of them at a depth corresponding to the target fracture exposed in the tunnel. Thus, these fractures are not suitable for the experiment as epoxy resin will be administered in different fractures.

Figure 3-2. Overview of the RVS model A. The target zone 'zone 2545' (green) terminates towards a narrow shear plane (transparent purple).

Neither breccia nor fault gouge occur in the selected structure. As ‘zone 2545’ does not contain any loose material, and as the original target fracture does not extend beyond a crossing structure, as shown in Figure 3-2 and Figure 3-3, its character is regarded as not being within the scope of the present project, and is thus not recommended for resin injection experiments. The injection boreholes may be suitable for study of the “porosity” of a fracture zone or of very coarse (10-20 cm blocks) “crushed zone” rather than of what is usually regarded as fault material, such as fault crush, fault breccia or fault gouge.

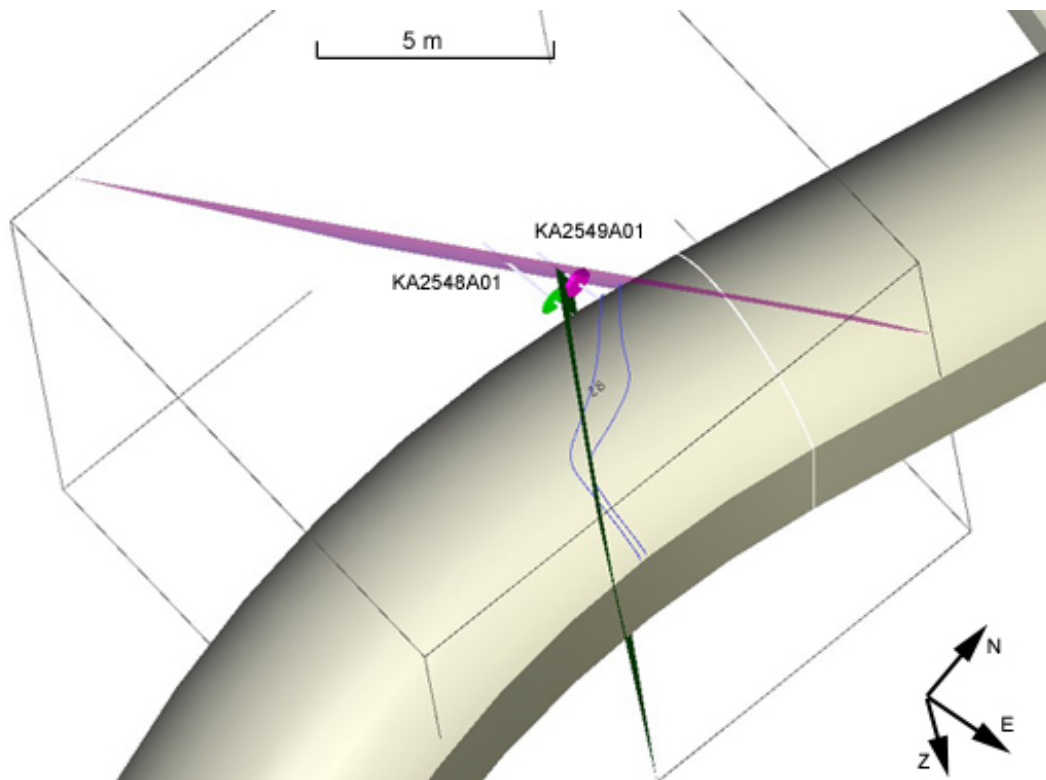
The indication of a zone in KA2548A01 shows the characteristics of the NW structure and is associated to 'zone 2545' (Figure 3-3). Nevertheless, this fracture is located very close to the tunnel and is thus not suitable for the experiment.

Figure 3-3. RVS model A with borehole and fault geometry. View along ‘zone 2545’ intersection axis (crest of the tunnel, chainage 2/545 m). The purple disc shows an indication of the NNE shear zone, the green disc is an indication of a NW-striking feature.

As illustrated in Figure 3-3 indications of the shear zone are not found in KA2548A01 which might indicate that the zone changes direction to the north beyond KA2549A01 or that the zone has a limited extent.

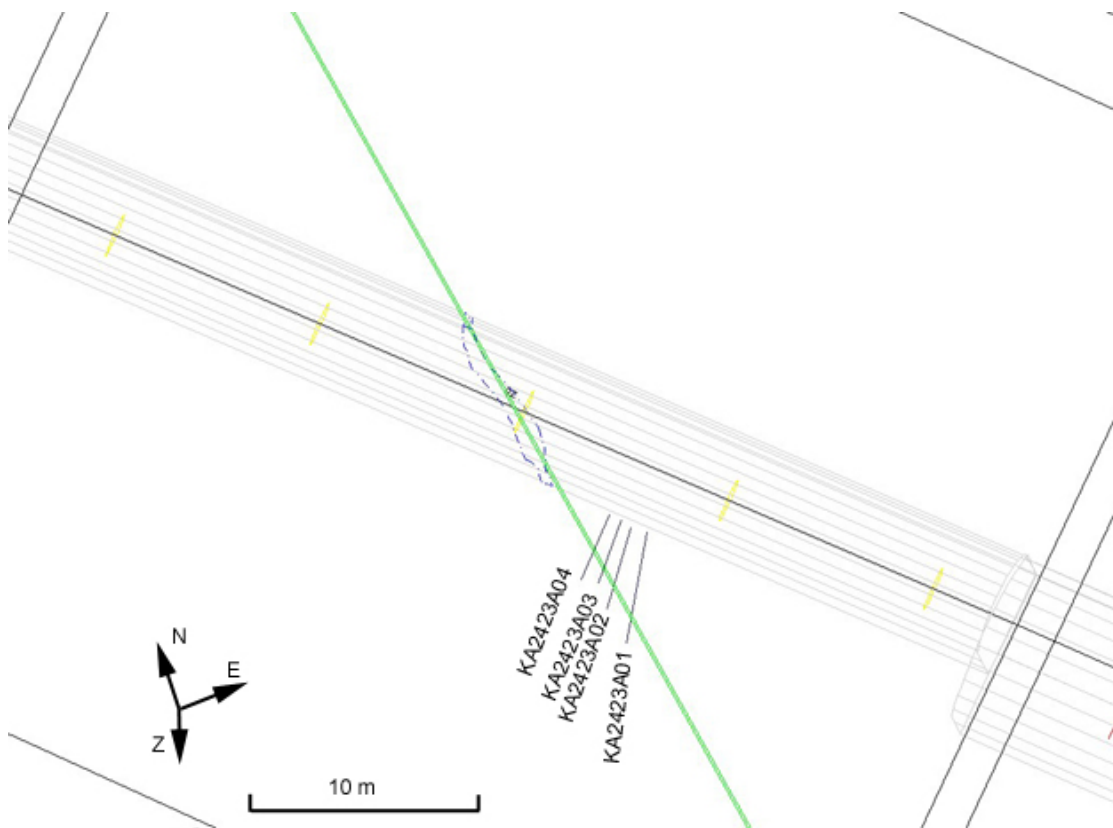
Figure 4-1. Illustration of the zone occurrence in the tunnel and the points used for modelling the 'zone 2430' before drilling, and localisation of the boreholes.

Four holes, KA2423A01, KA2423A02, KA2423A03 and KA2423A04 were drilled from the tunnel in the proximity of the target structure (Figure 4-1). The rock identified in the holes is mainly Småland Granite, and granodiorite (Åspö Diorite), see Appendix 3. RQD varies between 85 and 96 in the four exploration boreholes.

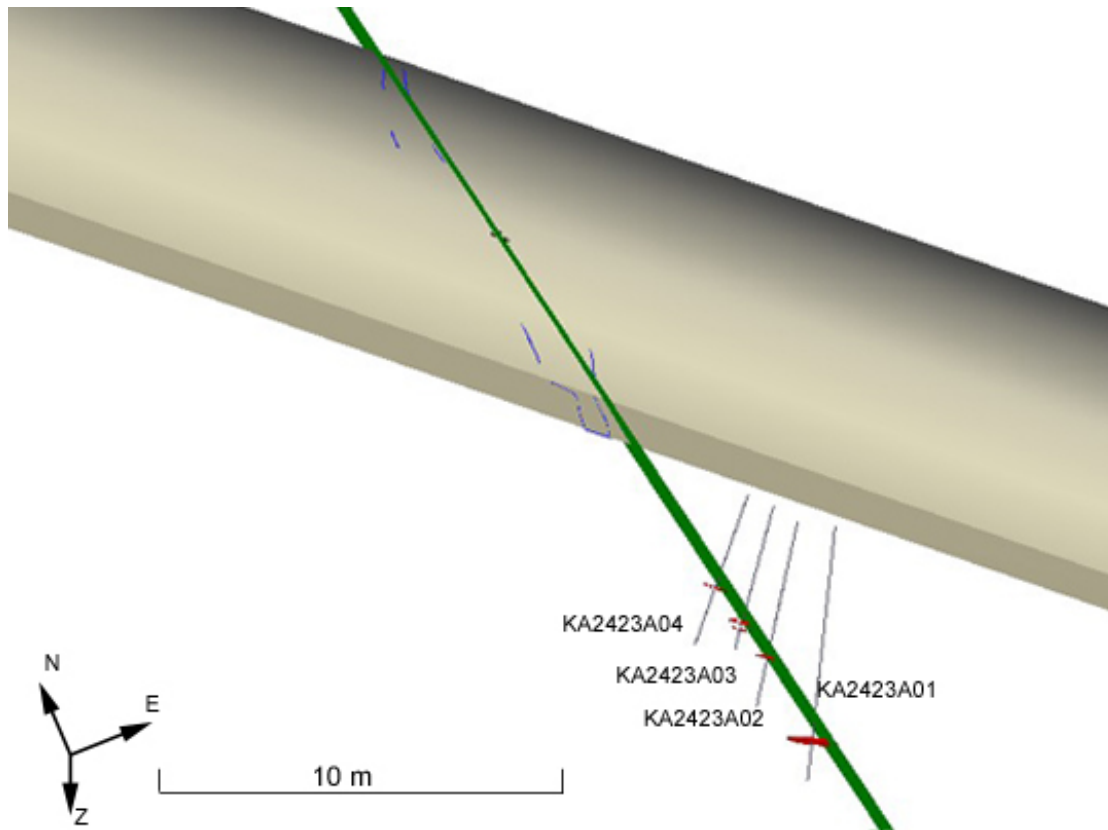
All four holes intercept fault breccia and crushed material in zones about 1-3 cm wide. The zone occurs in borehole KA2423A01 at 4.25 m, in borehole KA2423A02 at 2.75 m, in borehole KA2423A03 at ca 3.3 m, and in borehole KA2423A04 at ca 1.9 m (Figure 4-2).

In the cores the zone is located in protocataclasite and includes thin mylonites. It is characterized by repeated 1-2 cm wide sub-zones of fault breccia and subordinate fault crush. The material is flaky with green, hard, unidentified minerals. There are also a number of sub-horizontal fractures interpreted as splay cracks.

Figure 4-2. RVS model B with visualisation of the zone occurrence in the boreholes and the fault geometry. The zone intersects the tunnel crest at chainage 2/430 m.

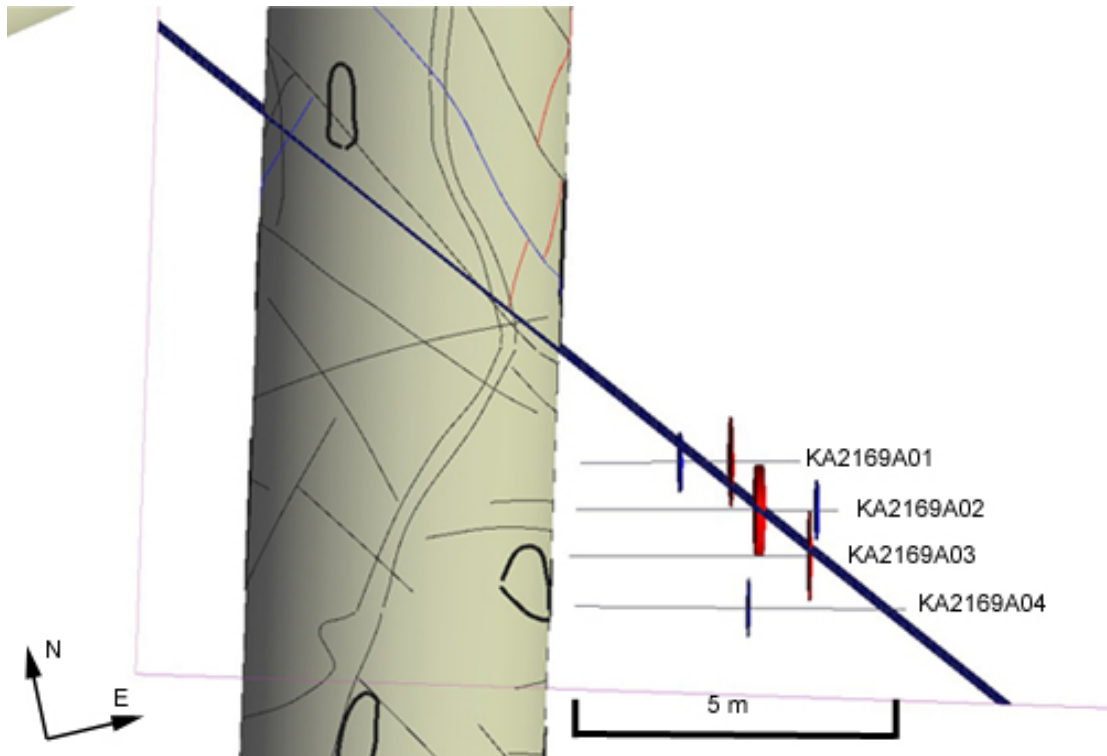
Four holes, KA2169A01, KA2169A02, KA2169A03 and KA2169A04, were drilled from the tunnel in the proximity of the identified structure (Figure 5-1). The rock identified in the boreholes is granodiorite (Äspö Diorite) with occasional aplite and granite, see Appendix 3. The RQD varies between 81 and 99.

Crushed rock and subordinate breccia occur with widths of 1-5 cm in the 4 holes, at L=2.5 m in KA2169A01, at L=3 m in KA2169A02, at L=3.95 m in KA2169A03, and at L=2.87 m in KA2169A04, see Figure 5-1. The material is flaky, sub-zones are less than 1 cm wide. Minerals in the zone appear to be minerals of the wall rock. The sub-zones occur in good quality rock and do not influence on RQD at all. The structures identified in KA2169A01 to KA2169A03 appear aligned and their orientations determined from BIPS logging fit well to the orientation of the zone in the tunnel. Their indications are found somewhat deeper than expected from the previously modeled structure. The intercept identified in KA2169A04 is much closer to the casing than the depth of intersection predicted from the modeled structure. Furthermore the orientation of the intercept identified in KA2169A04 does not fit very well with zone 2163. Hence this structure is considered to be a single fracture. Two other single fractures are identified in KA2169A01 and KA2169A02 (Figure 5-1).

Figure 5-1. RVS model C with borehole and fault geometry. The red discs are indications of 'zone 2163'. The smaller blue discs are indications of zones not associated with the main structure.

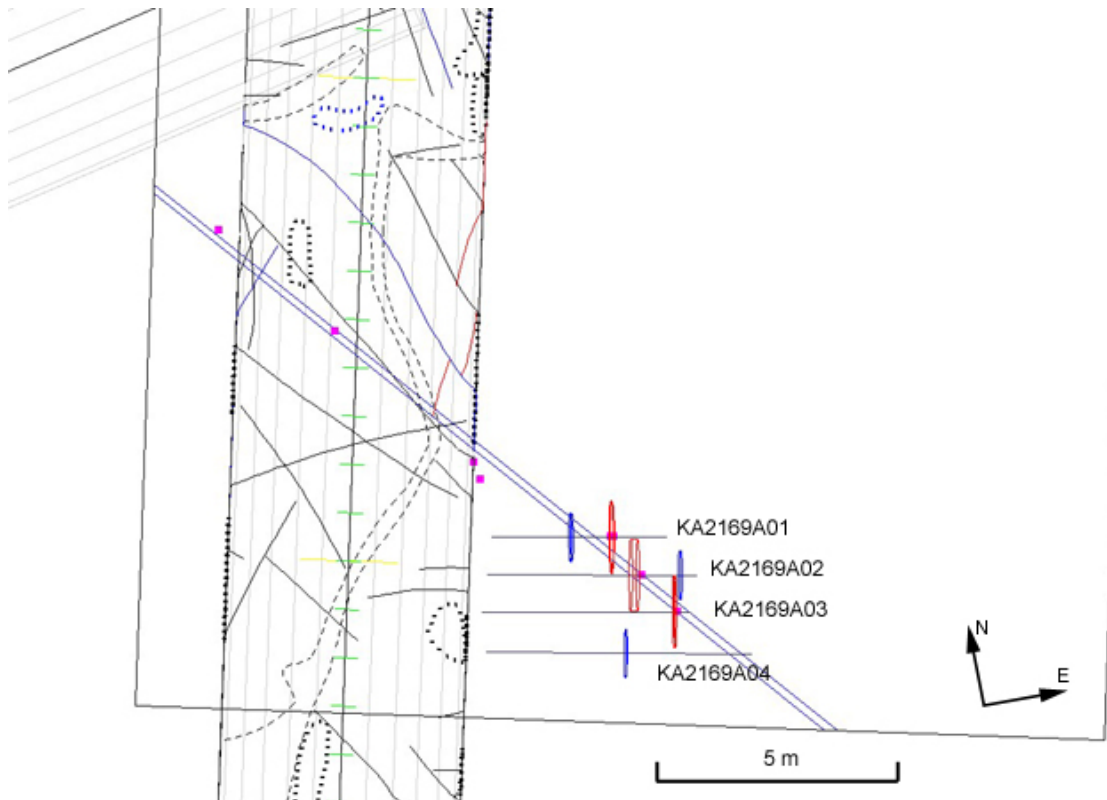
The structure has been remodeled on the basis of tunnel survey and the mapped occurrences in the boreholes (Figure 5-2). The deviation of the geometry of the updated structure compared to the one based on the original model is minor and the updated orientation is $308.7 / 85.5^\circ$.

Figure 5-2. Illustration of the points (purple) in the tunnel and in the boreholes used for remodeling the ‘zone 2163’.

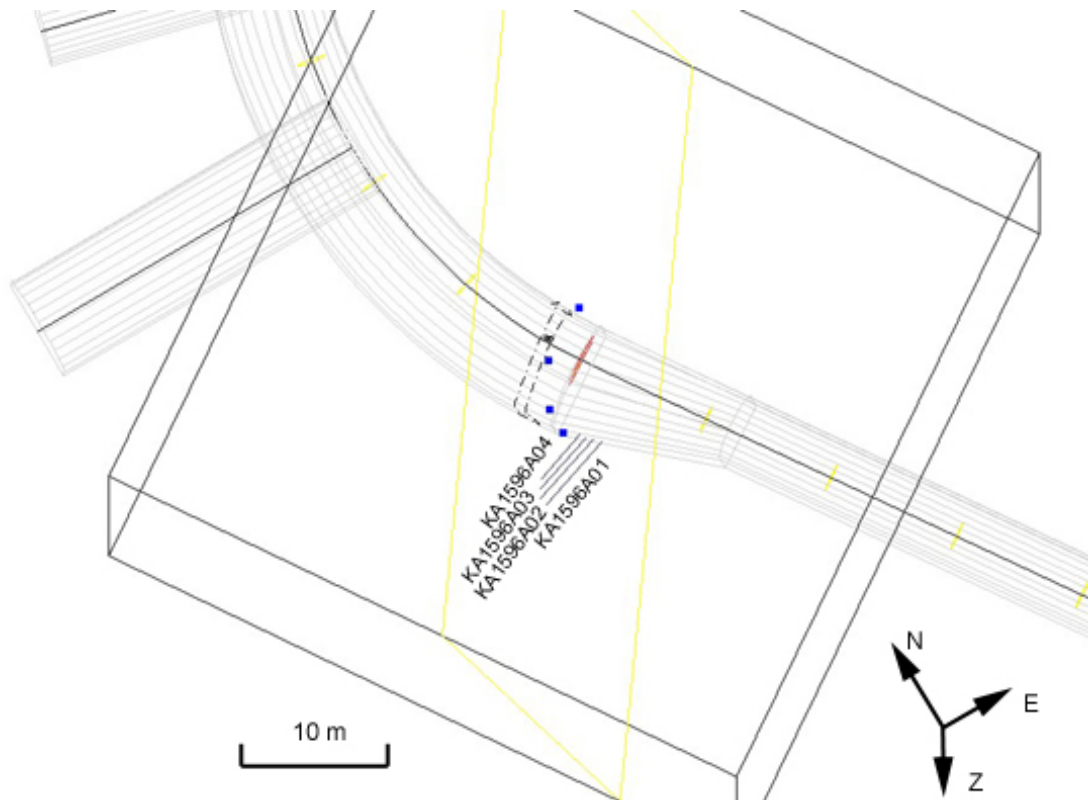
The accurate survey made in conjunction with the experiment show discrepancy in the position of zone occurrences in the tunnel. The 'zone 1600' therefore has been remodeled. The points used for reinterpretation are illustrated in Figure 6-1. The remodeled structure strikes 28° and dips 75°.

Figure 6-1. Visualization of the points (blue) based on tunnel survey and used for the remodeling of 'zone 1600', and positions of the boreholes.

Four boreholes; KA1596A01, KA1596A02, KA1596A03 and KA1596A04 were drilled from the tunnel in the vicinity of the interpreted structure (Figure 6-1). The rock in the boreholes is mainly granodiorite (Äspö Diorite) with subordinate chloritic phyllonite, fine grained, red protocataclastic granite, and minor occurrences of pegmatite, see Appendix 3. RQD varies between 75 (where the zone occurs) and 100.

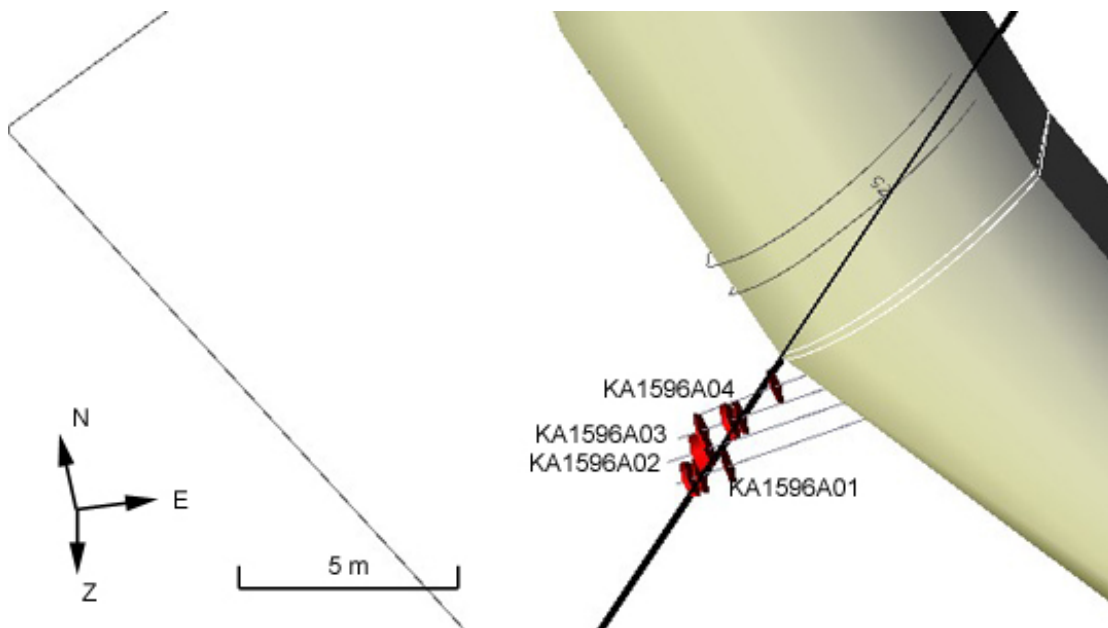
The structure occurs in all four boreholes, at L=5.55 m in KA1596A01, at L=4.7 m in KA1596A02, at L=3.3 m and L=4.2 m in KA1596A03, and at L=2.55 m in KA1596A04 (Figure 6-2). The thickness of the zone varies from 10 cm to 40 cm and the zone is divided into two branches in borehole KA1596A03.

The occurrences of 'zone 1600' in the drill cores fit fairly well with tunnel observations and with orientations indicated by BIPS logging, see Figure 6-2. The fault gouge contains clay minerals, mainly chlorite and rock fragments.

Figure 6-2. Location of zone occurrences in the boreholes associated with 'zone 1600' as modeled from tunnel observations.

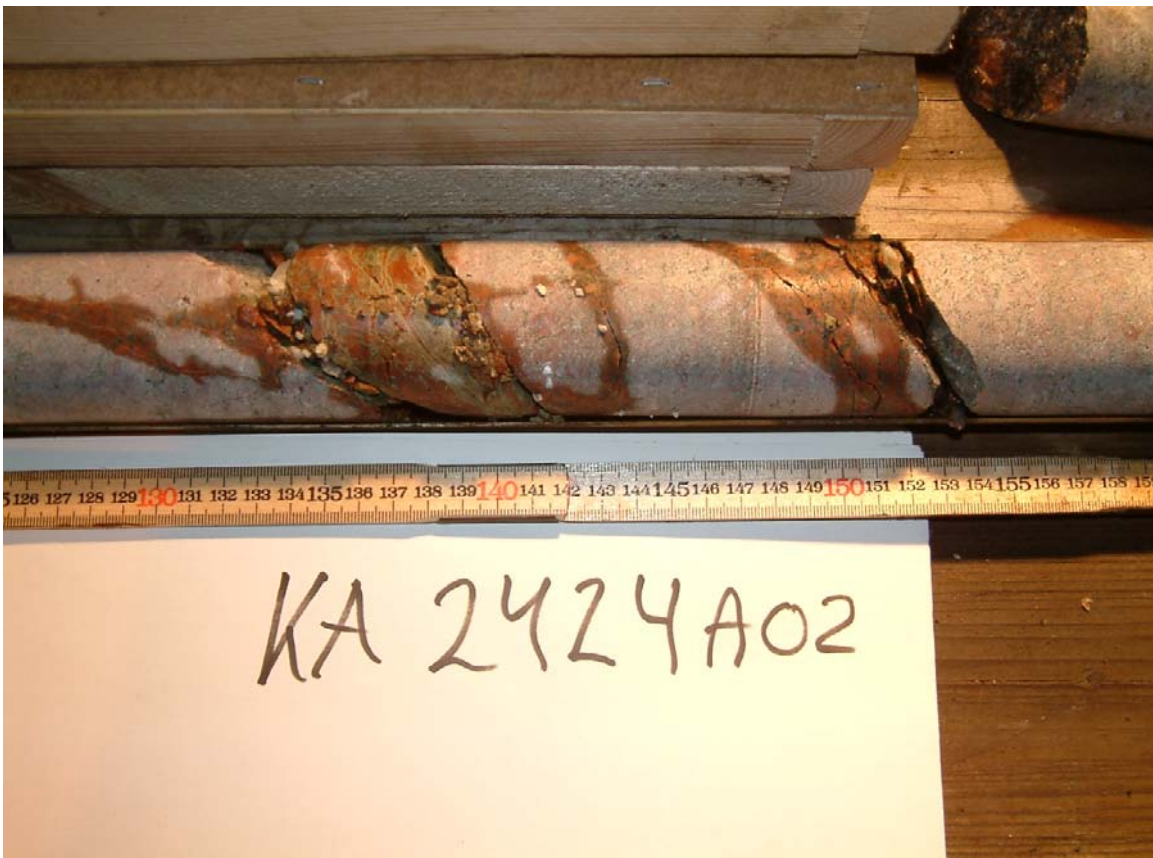
Figure A1-3. Fault at 2.5 m in KA2424A02 drill core.

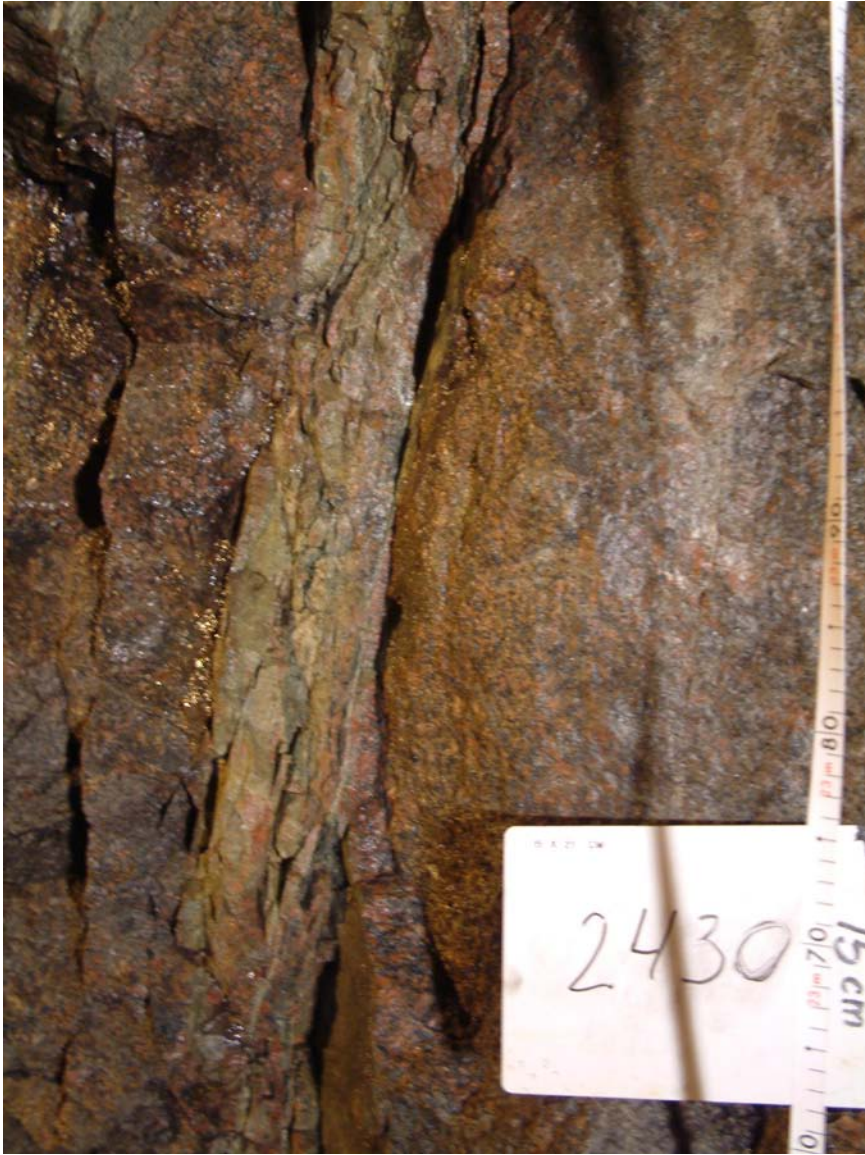
Figure A1-4. Fault visible in tunnel section 2/430 m.

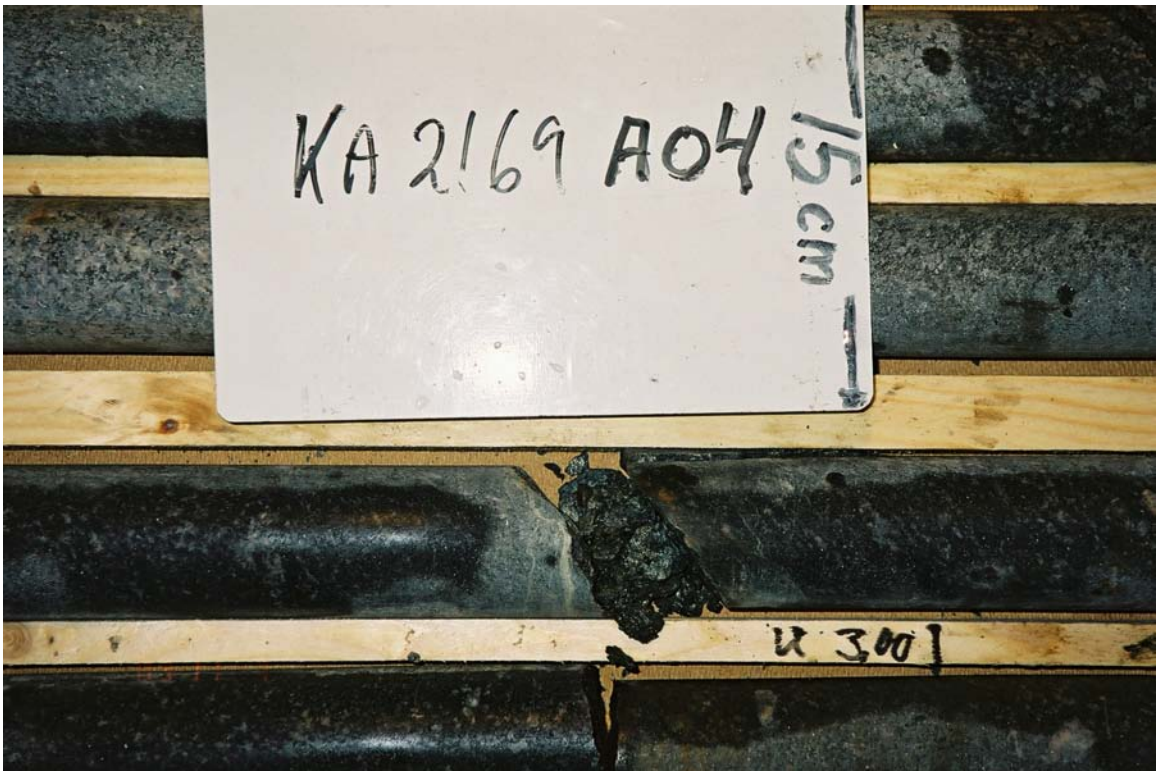
Figure A1-6. Fault in KA2169A04 at 3 m borehole length.

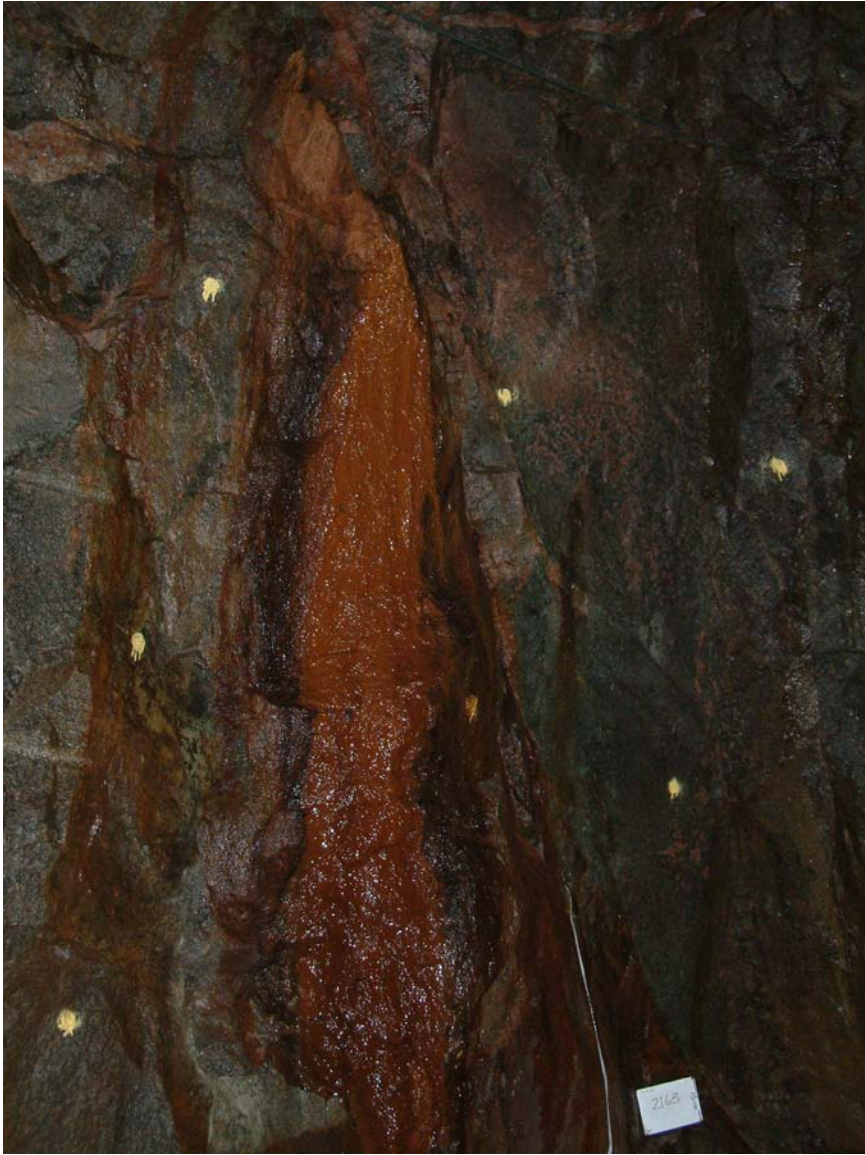
Figure A1-7. Fault in tunnel section 2/163 m.

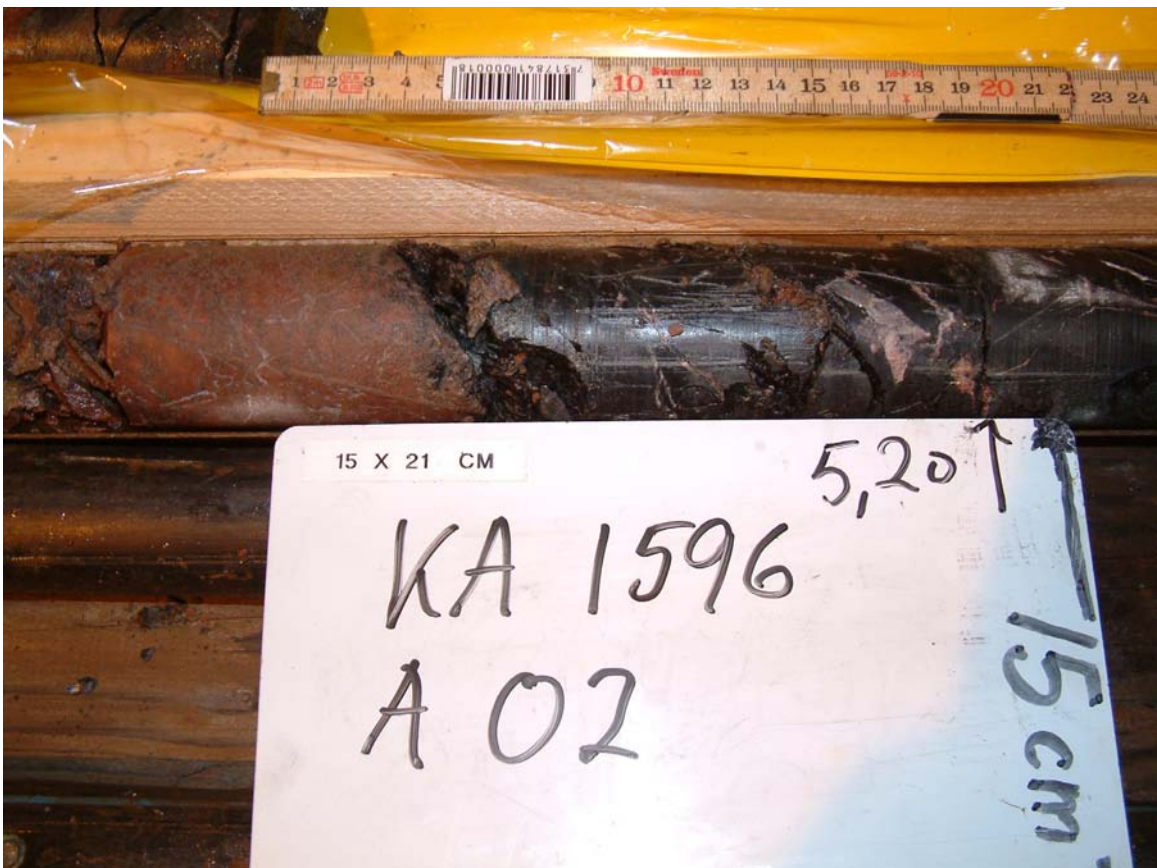
Figure A1-9. Detail of fault at 5.2 m borehole depth in KA1596A02.

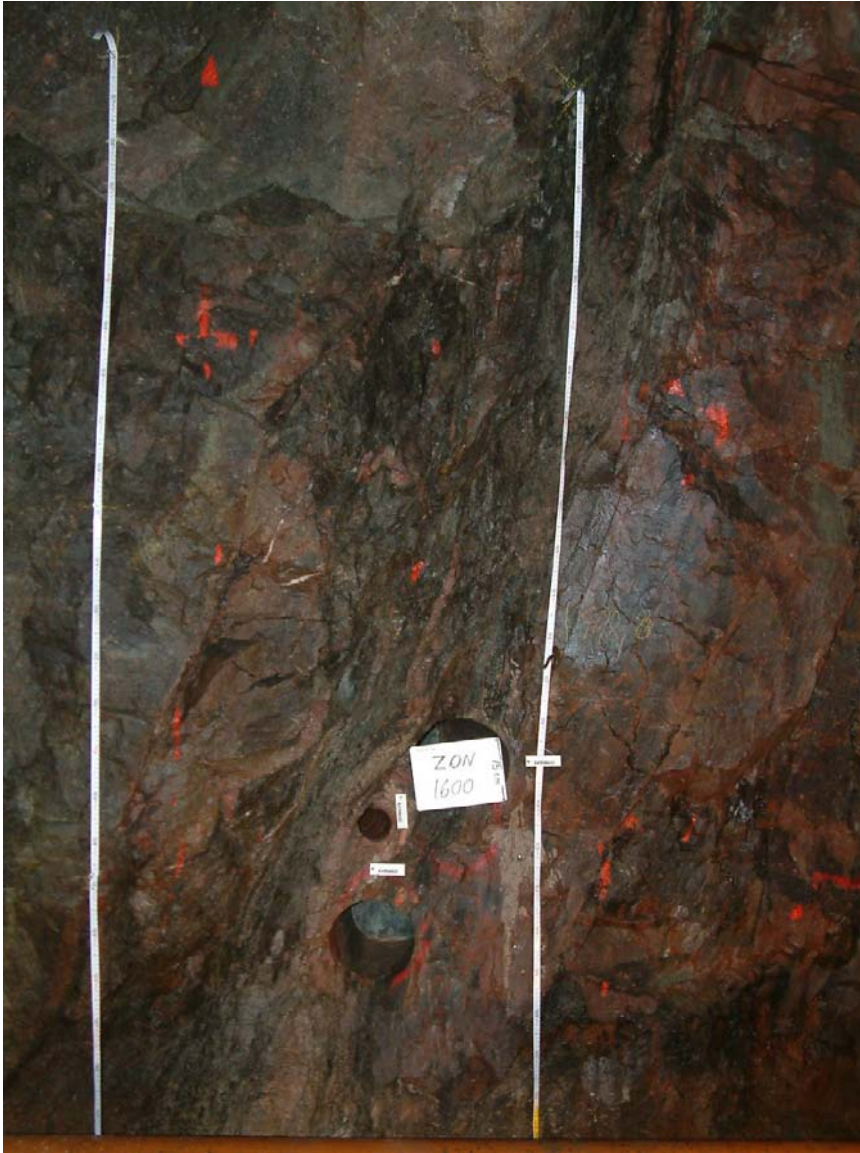
Figure A1-10. Target fault zone at tunnel section 1/600 m.

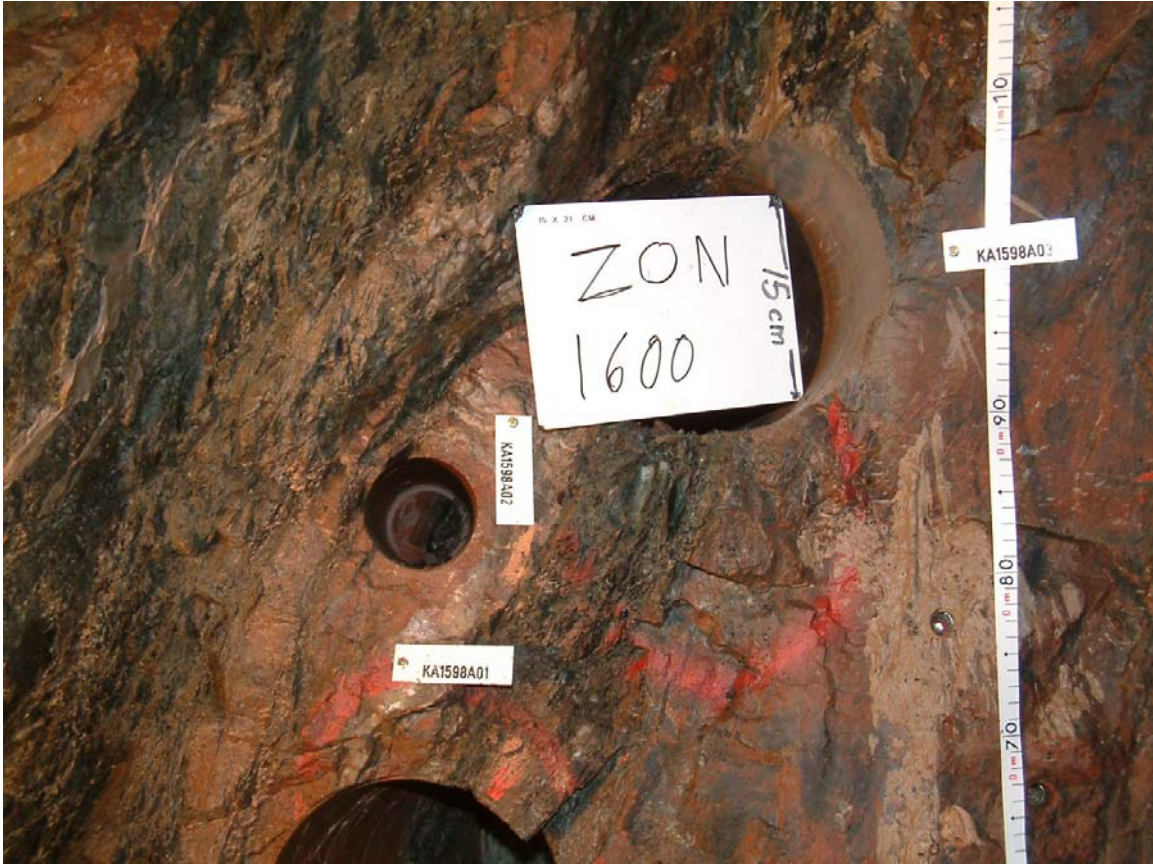
Figure A1-11. Detail of target fault zone at tunnel section 1/600 m.
