Technical Report

TR-18-14

Corrosion morphology of copper in anoxic sulphide environments

SVENSK KÄRNBRÄNSLEHANTERING AB

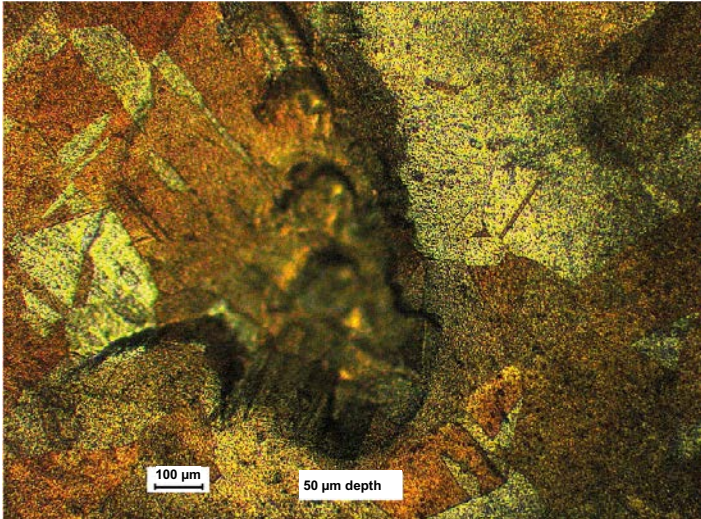
Figure 2-3. Example of a 50 μm defect found on coupon 2-1 after exposure to Gas B conditions (Table 2.1) and pickling with both 20 wt% NH₄OH and 37 wt% HCl.

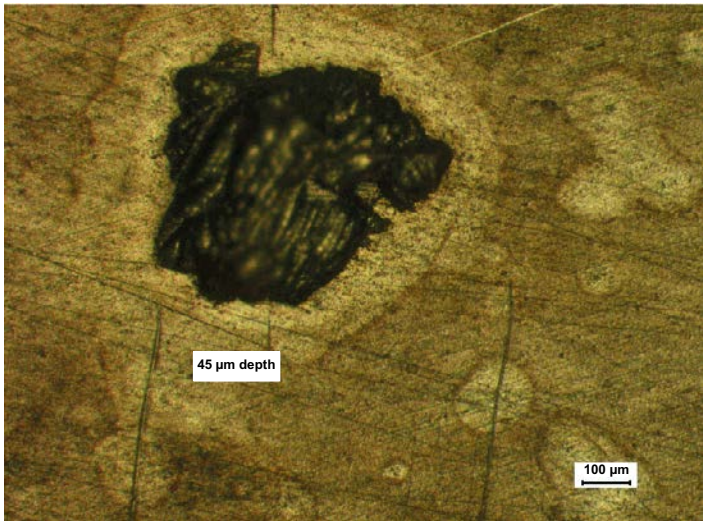
Figure 2-4. Example of 45μm defect found on coupon 3-2 after initial exposure to Bio C conditions and pickling with both 20 wt% NH₄OH and 37 wt% HCl.

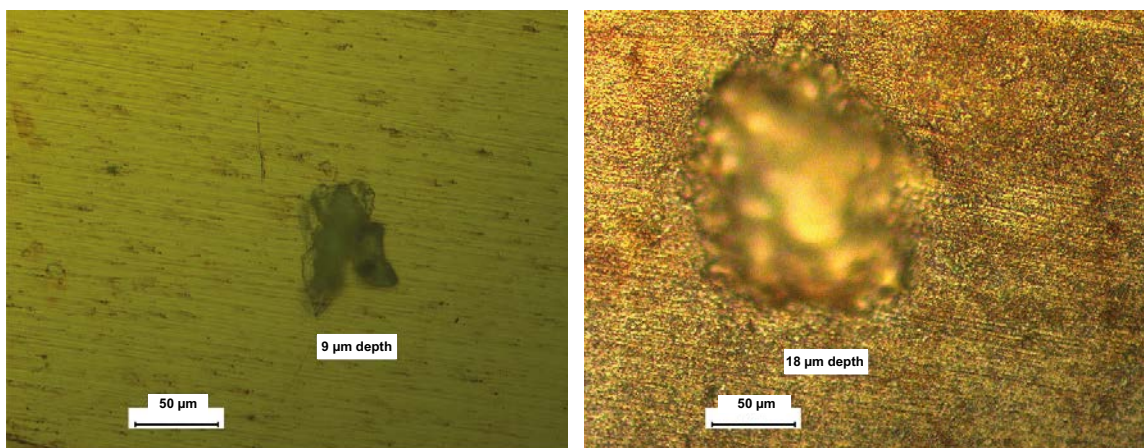
Figure 2-6. Microscope images of the deepest defects found on the surface of the test coupon before (left) and after pickling (right) with both alkaline and acidic solutions.

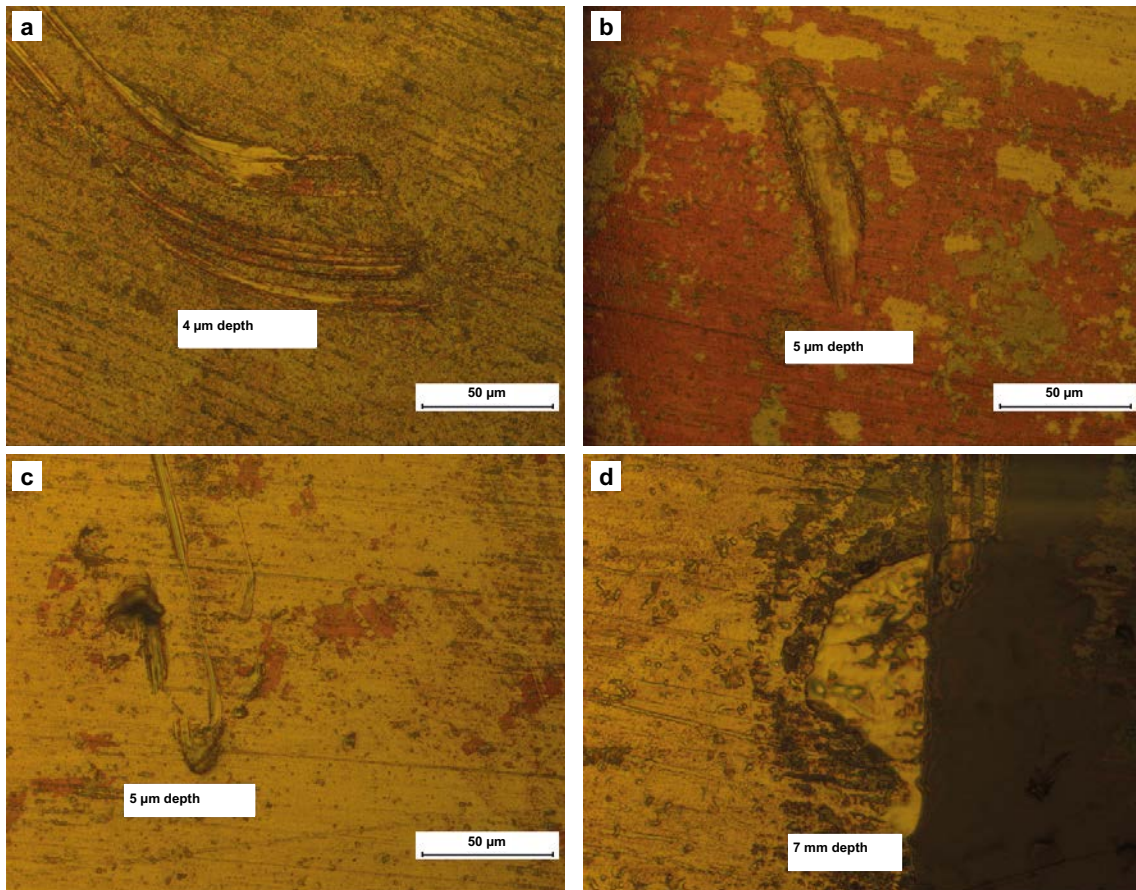
Figure 3-9. Examples of defects due to apparent mechanical damage. a) Bio-A coupon S7-11 side 1; b) Bio-A coupon S10-3 side 2; c) Bio-A coupon S10-3 side 2; d) Bio-D coupon S9-1 side 2.

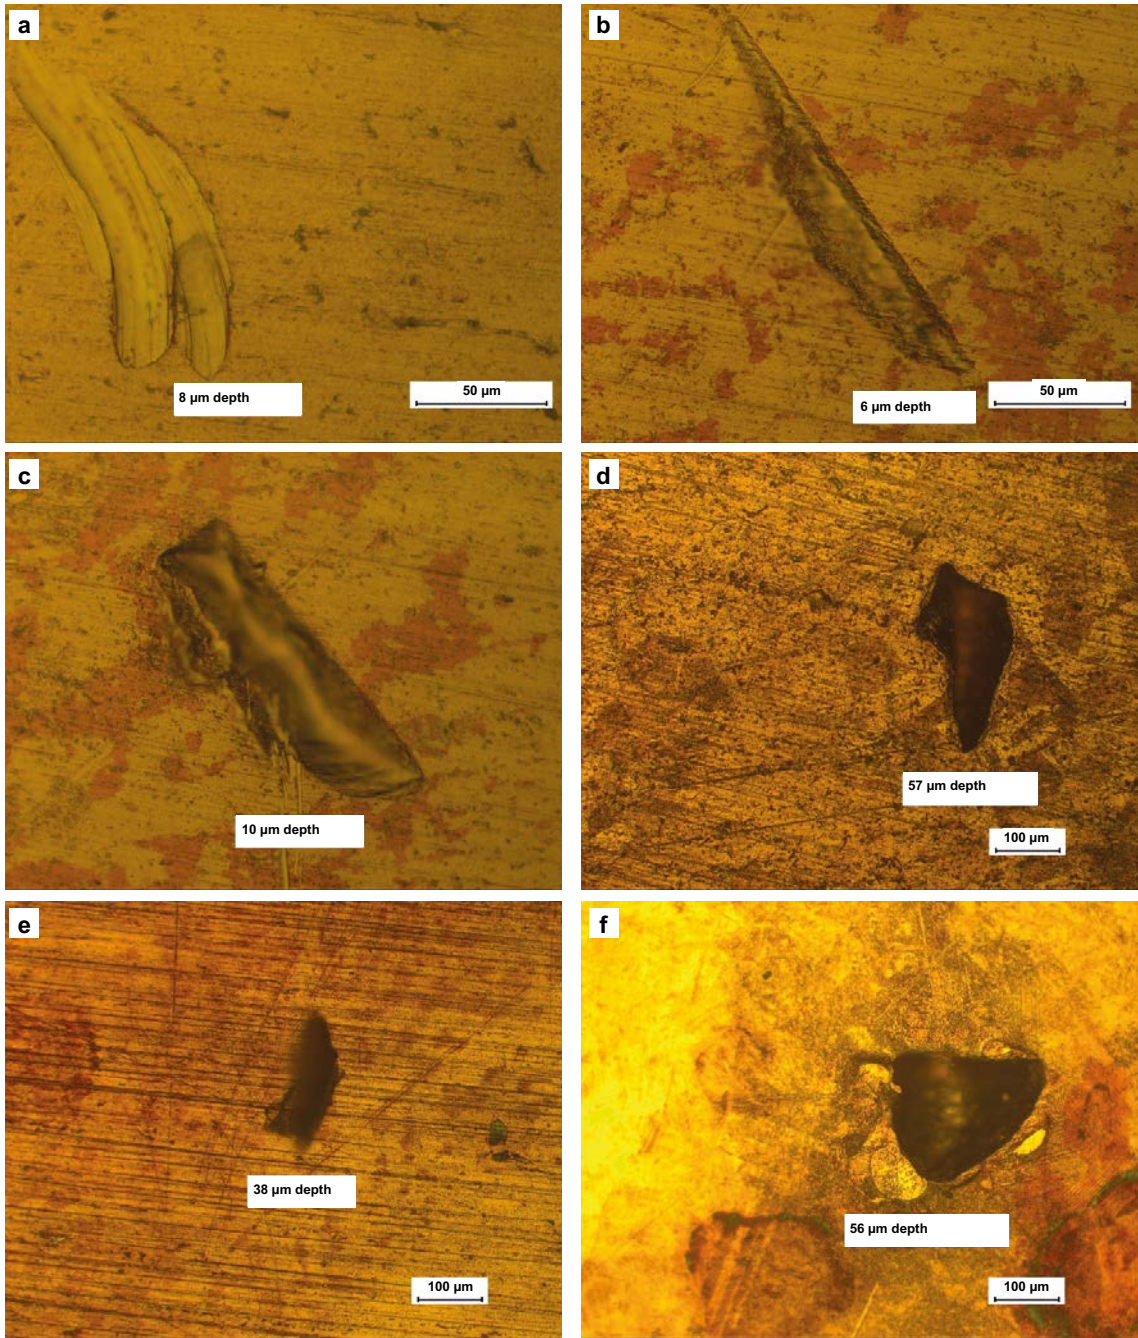
Figure 3-10. Examples of defects due to apparent mechanical damage on reference coupons. a) Reference coupon 1 side 1; b) Bio-B coupon S7-2 side 1; c) Bio-B coupon S7-2 side 1; d) Bio-D coupon S9-3 side 2; e) Reference 2 side 1; f) Reference 2 side 2.

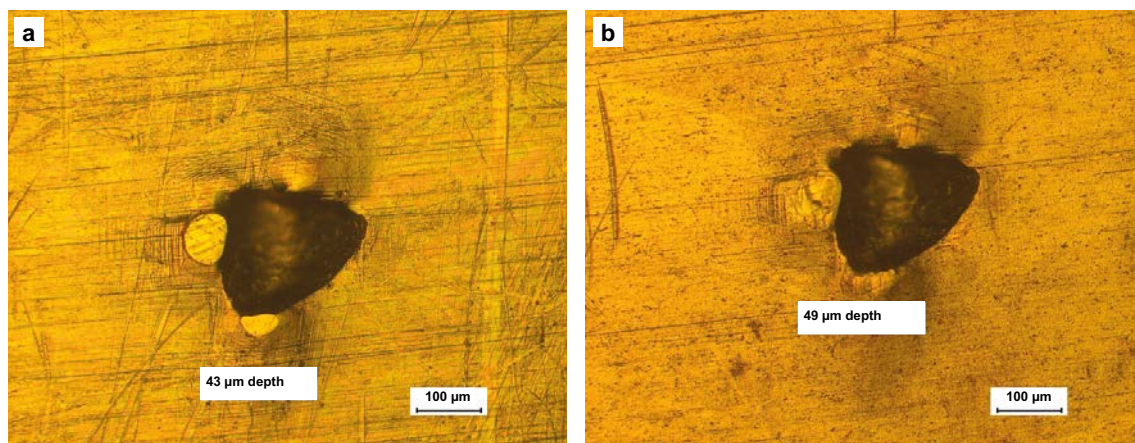
Figure 3-11. Photographs of deepest defect measured on one of the reference coupons before pickling (a) and after pickling (b) with 20 wt% NH_4OH .

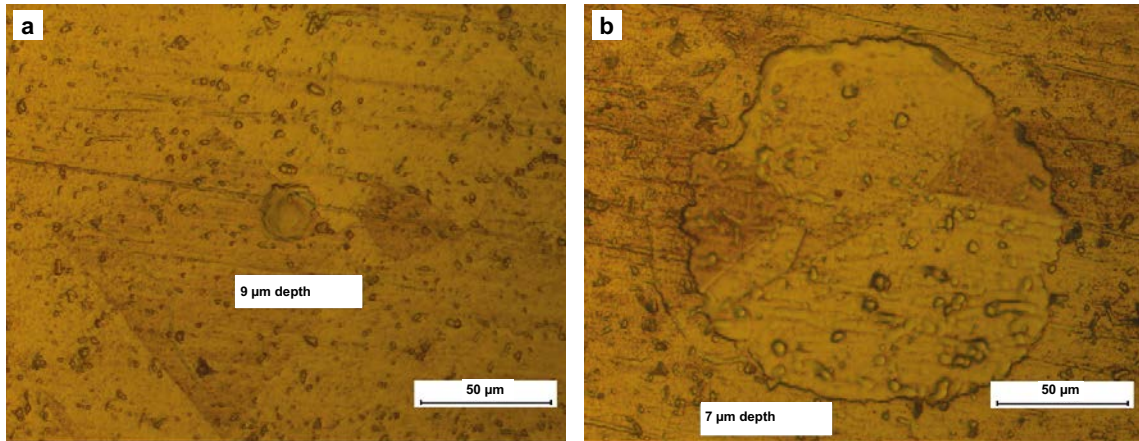
However, there are also defects that seem to be caused by corrosion. Coupons from the Bio-D exposure display a number of defects, see for example Figure 3-12 (a), resembling localized corrosion attacks that have been attributed to SRB in a recent work (Dou et al. 2018). In that study it was shown that at a low degree of corrosion (ca $1 \mu\text{m}$ by mass-loss) the pits attributed to corrosion were deeper than the average corrosion, which might reflect that some defects were present from start also in that experiment. However, with more extensive corrosion (12 , 28 and $45 \mu\text{m}$ average corrosion by mass-loss) the deepest pits found (14 , 20 , and $44 \mu\text{m}$) were of approximately the same depth as the general corrosion. The authors of the paper made the interpretation that general and localized corrosion are equally important processes under the conditions applied (highly nutritious growth media with SRB). Due to the high degree of general corrosion in relation to the localized corrosion attacks, the authors did not describe the localized attacks as due to pitting and a presence of a passive film, but instead suggested that the localized attacks are due to uneven distribution of corrosive metabolites ($\text{H}_2\text{S}/\text{HS}^-$) under the biofilm.

Figure 3-12. a) Example of a defect found on Bio-D S9-7 side 1 which resembles localized corrosion attacks that have been attributed to SRB in other studies (Dou et al. 2018). b) A wide but shallow defect found on Bio-D S9-3 side 2.

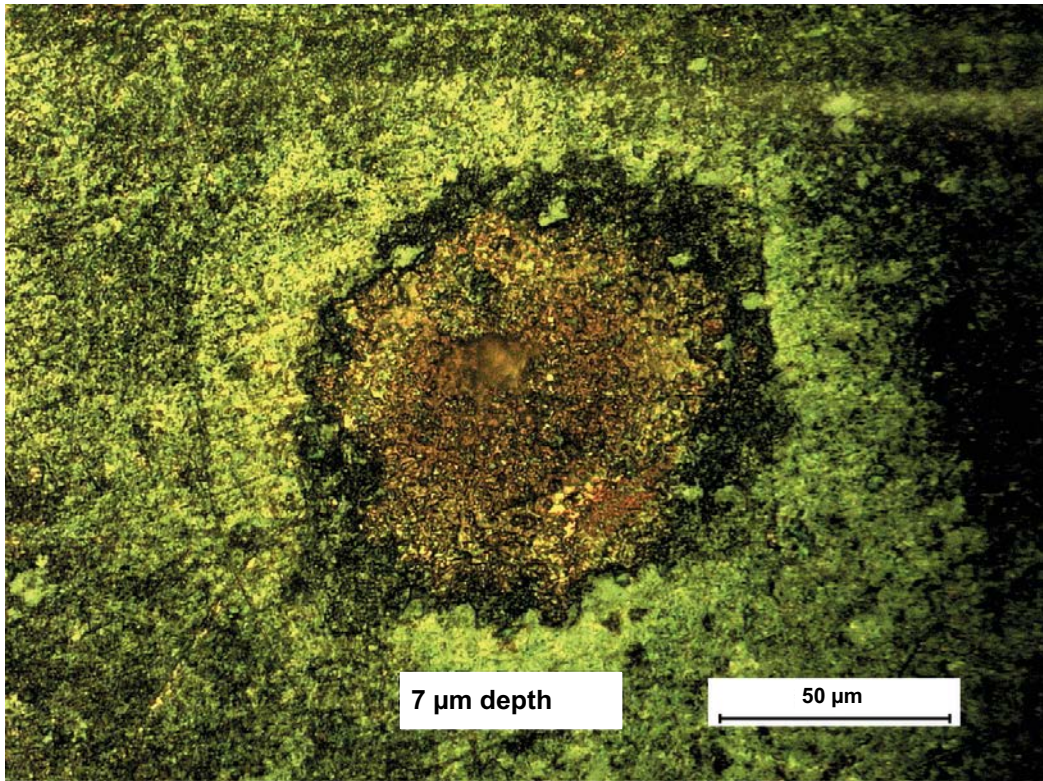
Figure A-2. Example of defect found on coupon SI-4 after exposure before pickling. The surface deposits can be seen around the defected area.

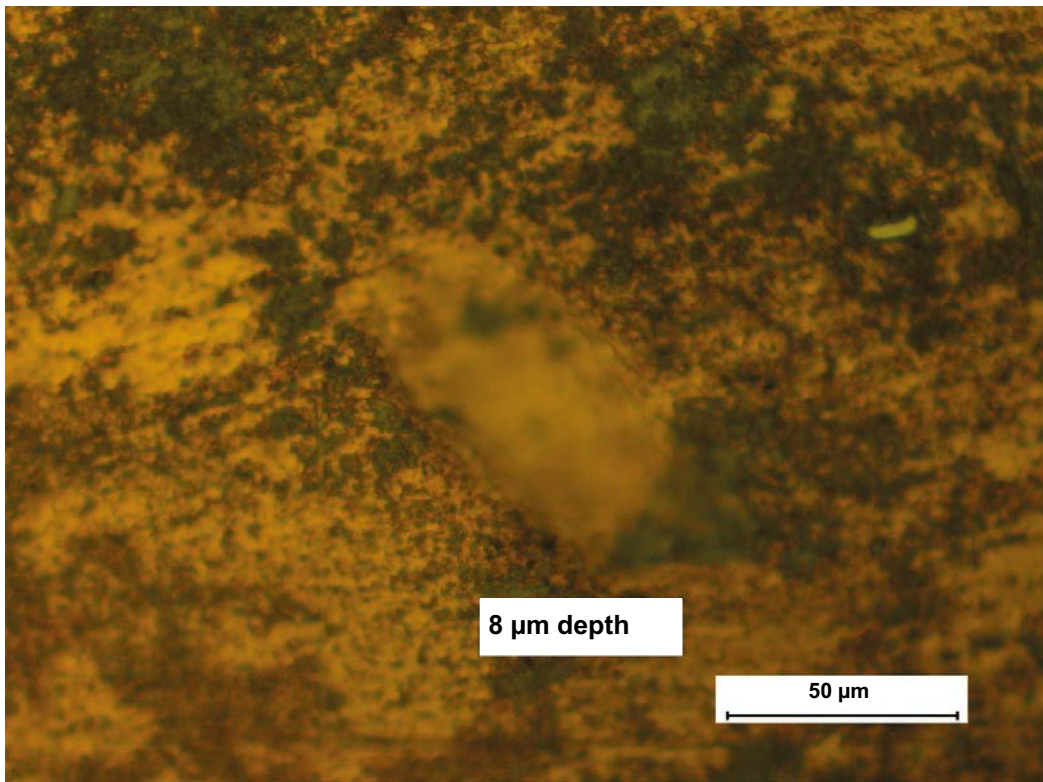
Figure A-3. Defect found on coupon SI-5 after pickling. The darker areas around the defect are corrosion products that have remained after the pickling.

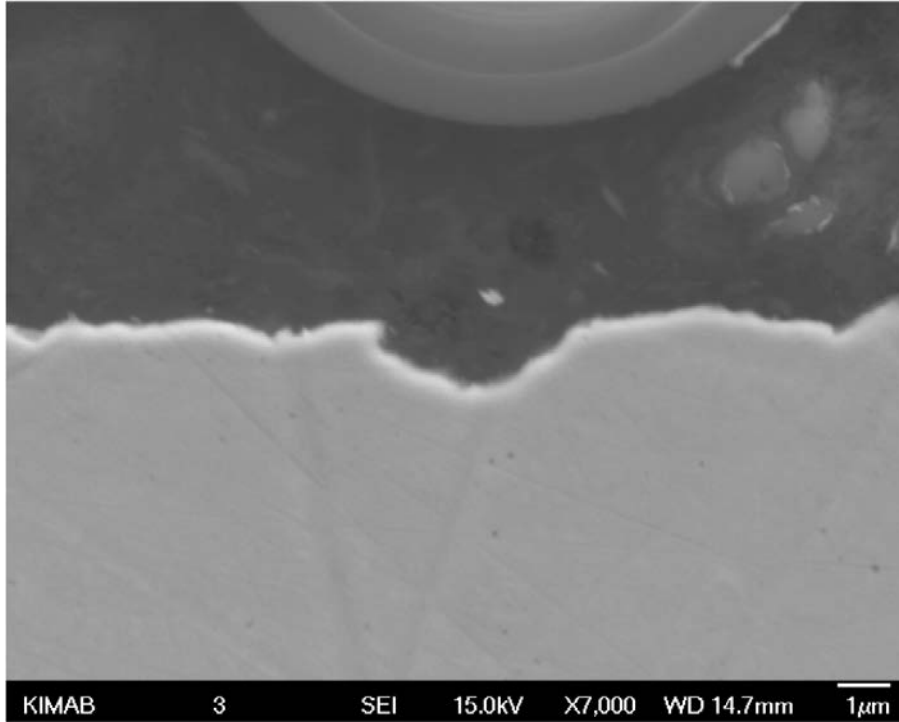
Figure A-8. Cross-section of coupon S1-3 after pickling. No sulphide layer could be seen.

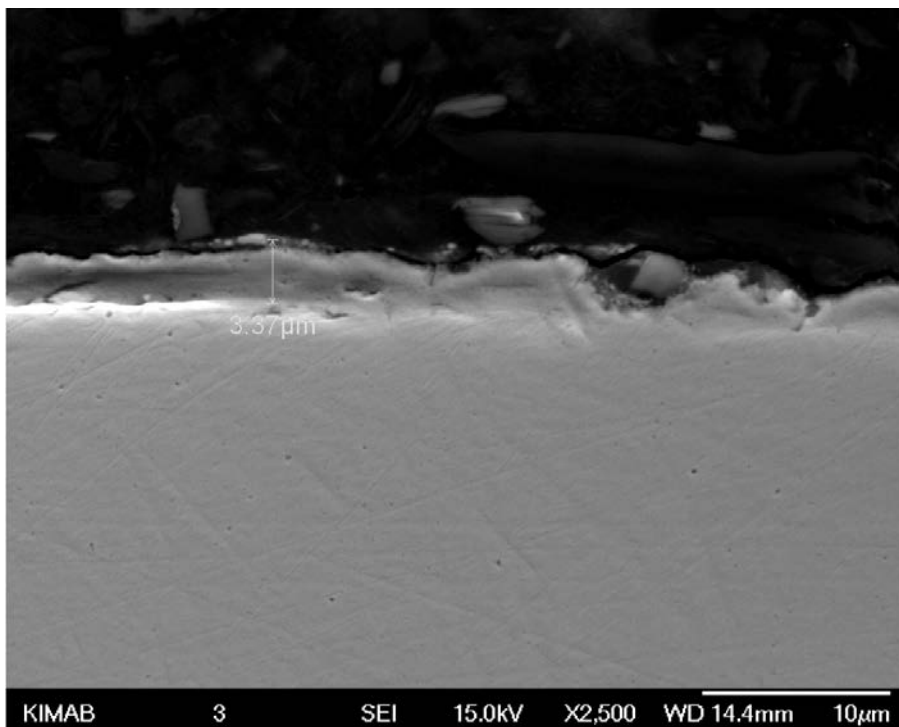
Figure A-9. Cross-section of coupon S1-4 after pickling. A sulphide layer of approximately 3 μm thickness can be seen.

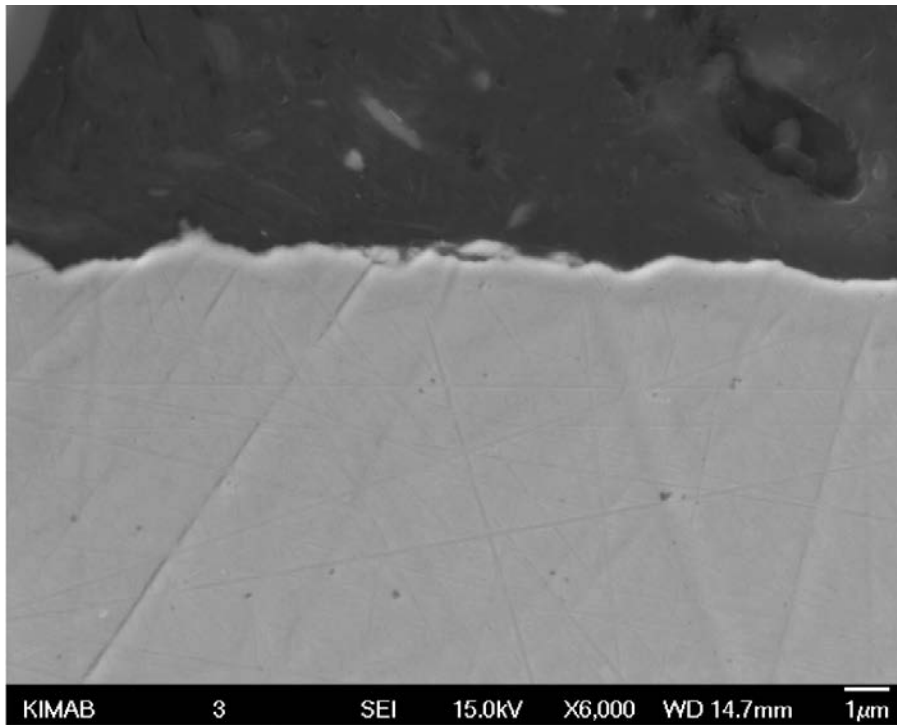
Figure A-10. Cross section of coupon SI-5 after pickling. No sulphide layer could be seen.

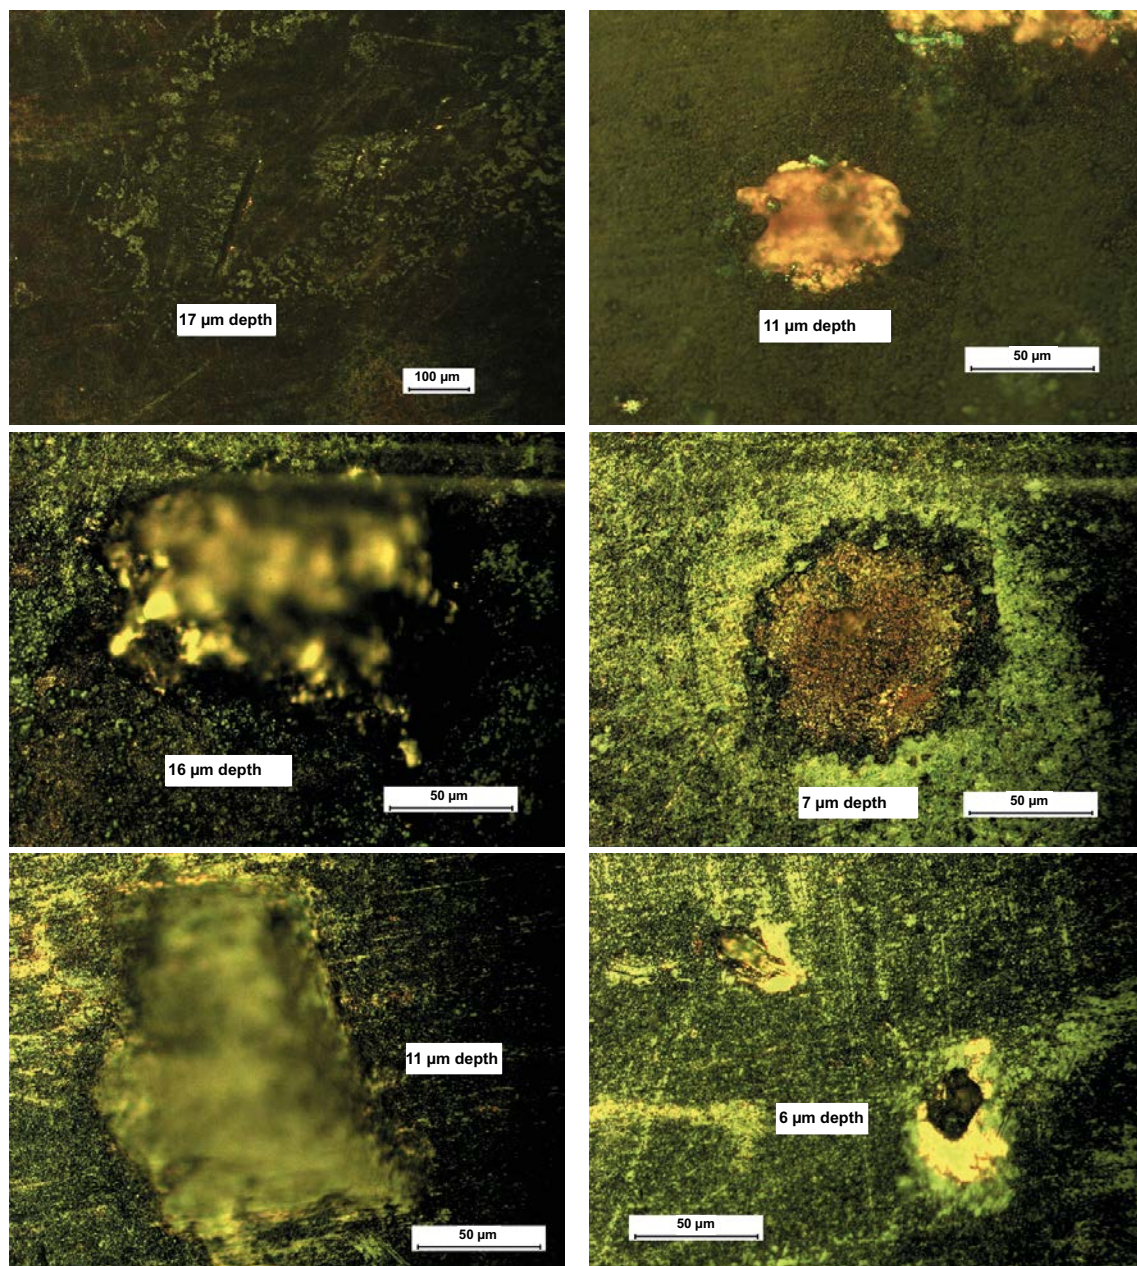
Figure A-14. Examples of defects found on the coupons before pickling. Top row: S1-3; middle row: S1-4; bottom row: S1-5.

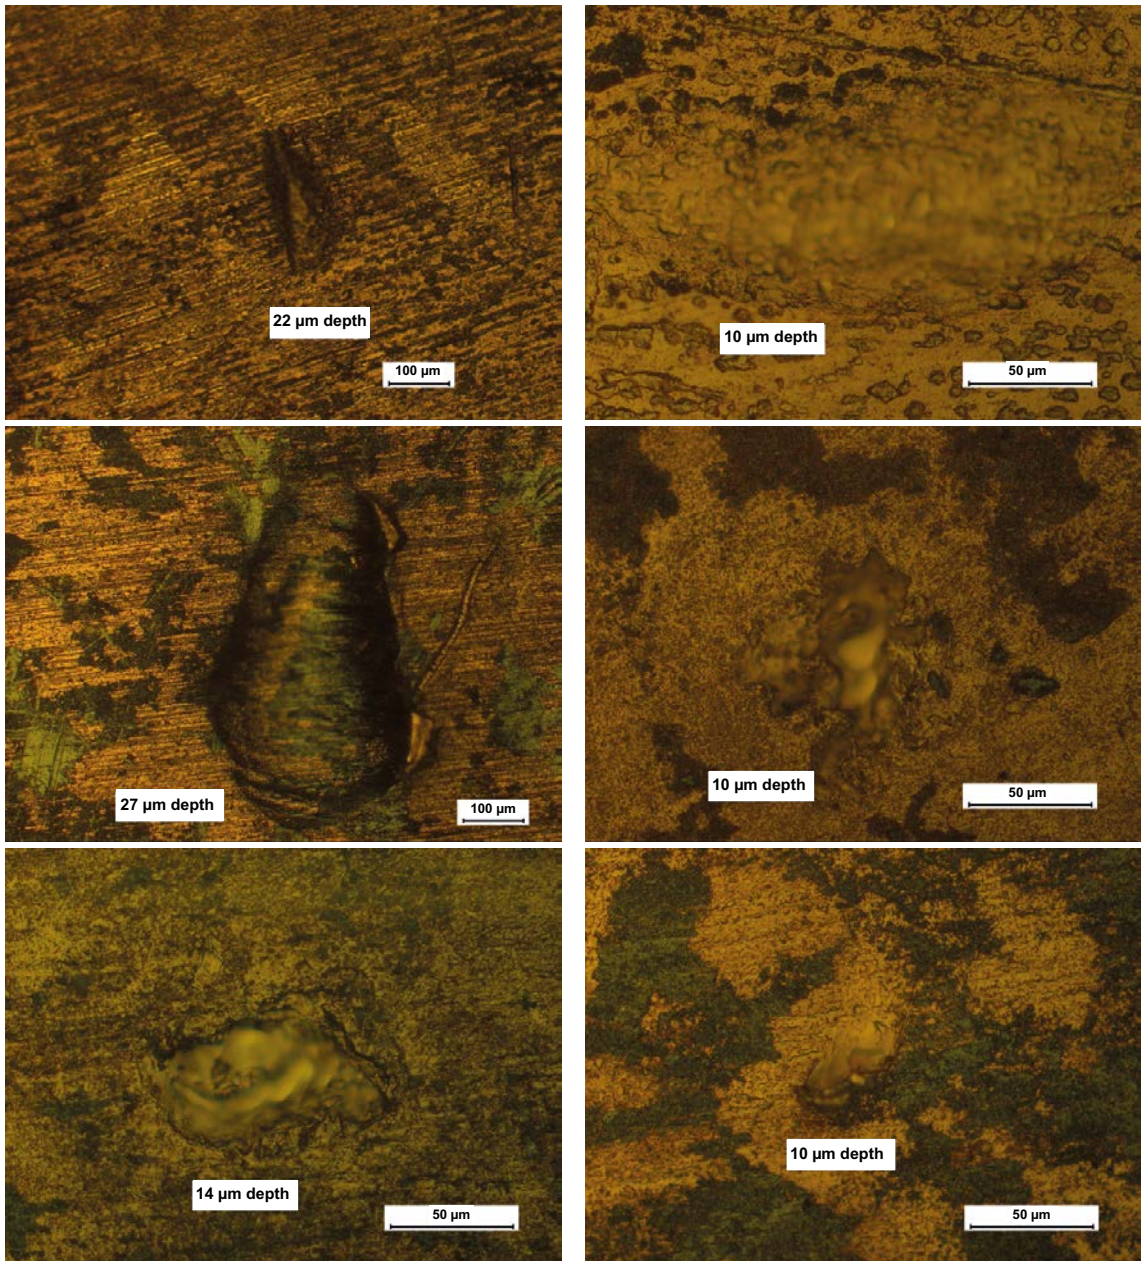
Figure A-15. Examples of defects found on the coupons after picking. Top row: S1-3; middle row: S1-4; bottom row: S1-5.

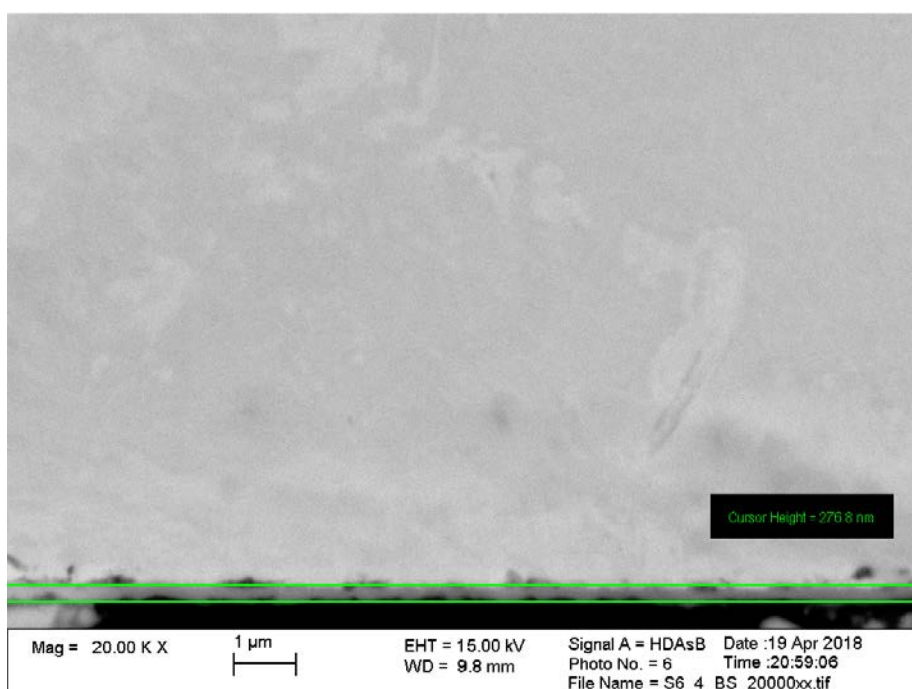
Figure D-3. SEM image on the cross section of coupon S6-4 (Gas A) showing the sulphide layer thickness on the surface of the coupon.

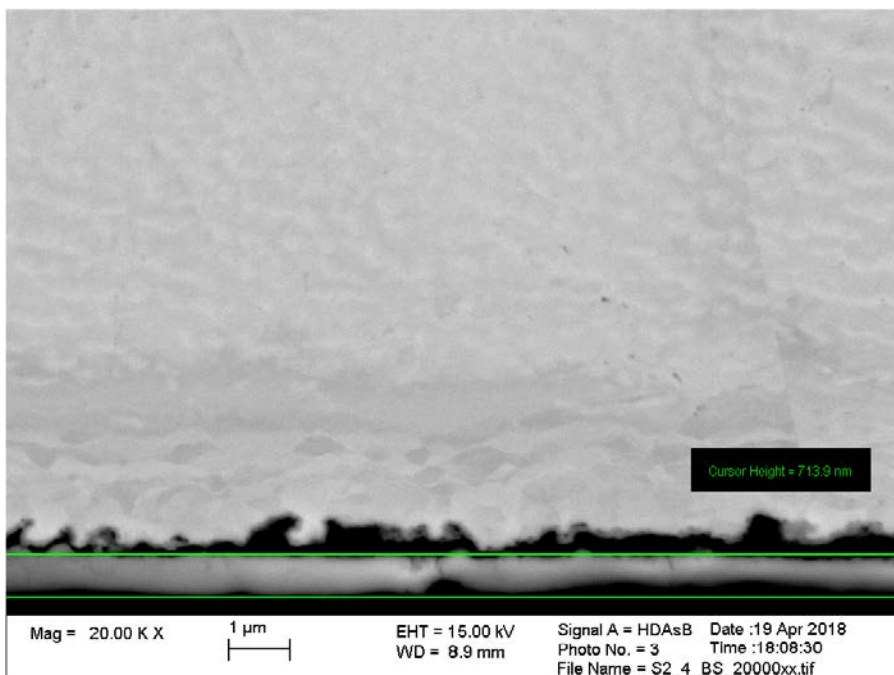
Figure D-7. SEM image on the cross section of coupon S2-4 (Gas B) showing the sulphide layer thickness on the surface of the coupon.

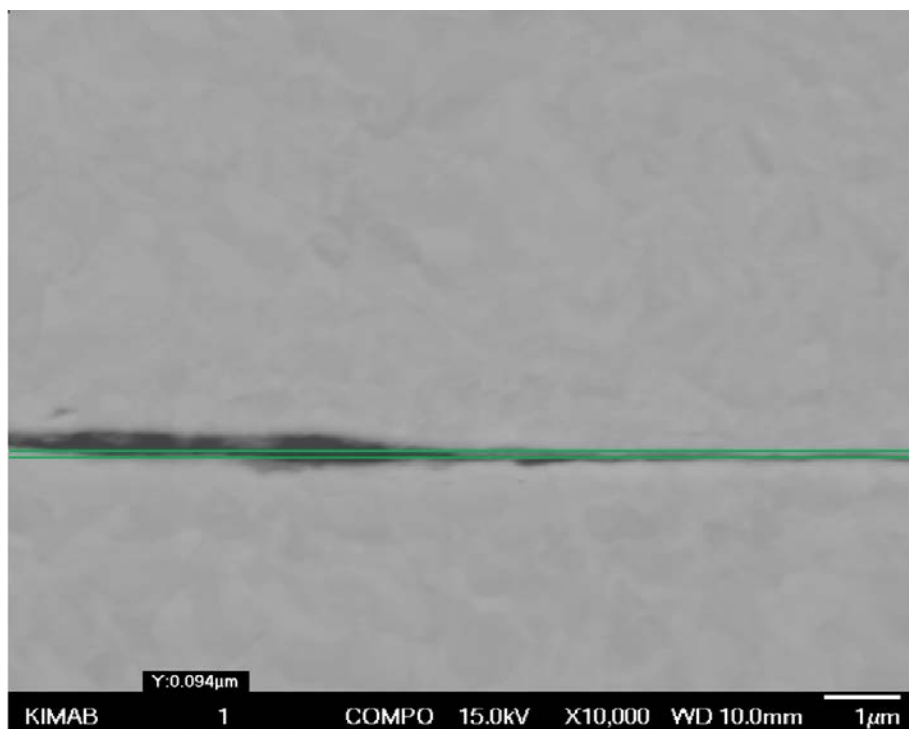
Figure D-25. Coupon Bio-B S7-6 (top) (BEI). The sulphide layer was measured as being 94 nm thick.

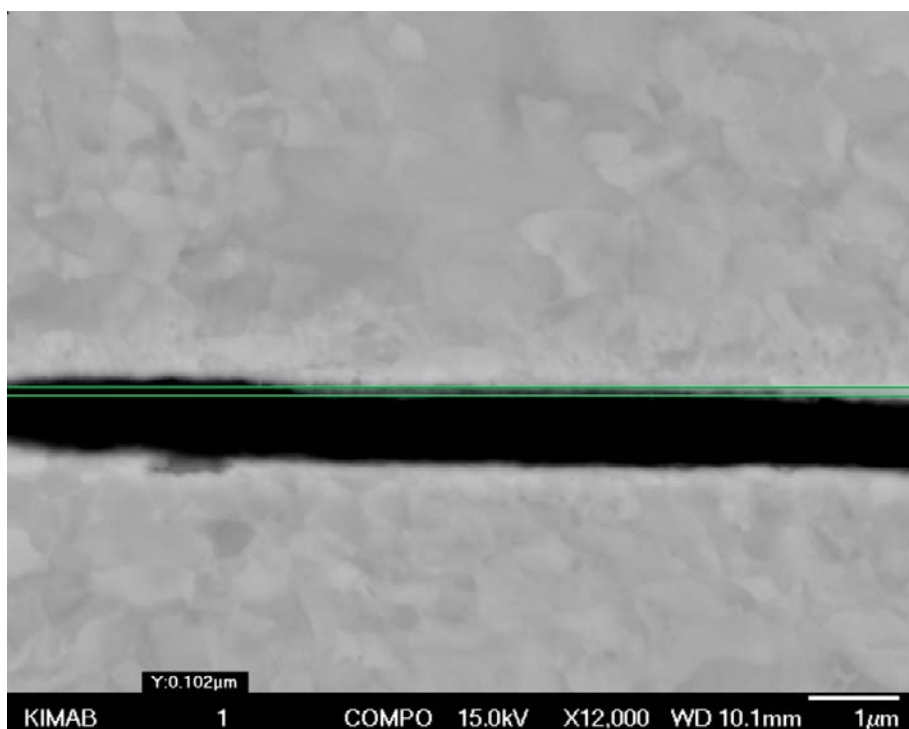
Figure D-26. Coupon Bio-B S7:6 (top) (BEI). The sulphide layer was measured as being 102 nm thick.

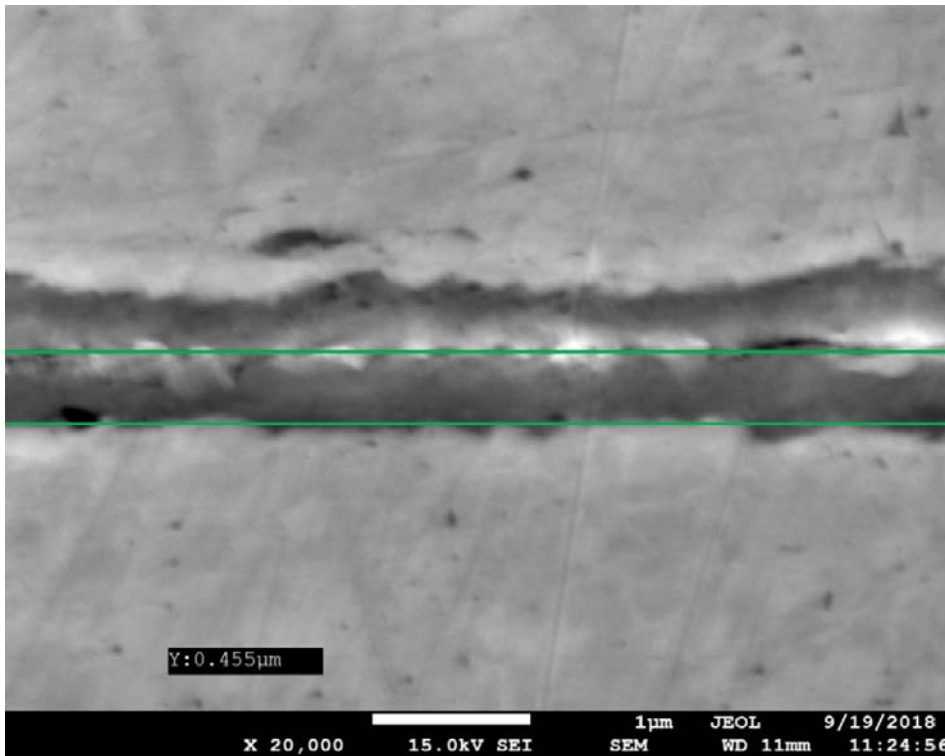
Figure D-32. SEM image on the cross section of coupon S8-6 (Bio C). The sulphide layer was measured as being 0.46 μm thick.

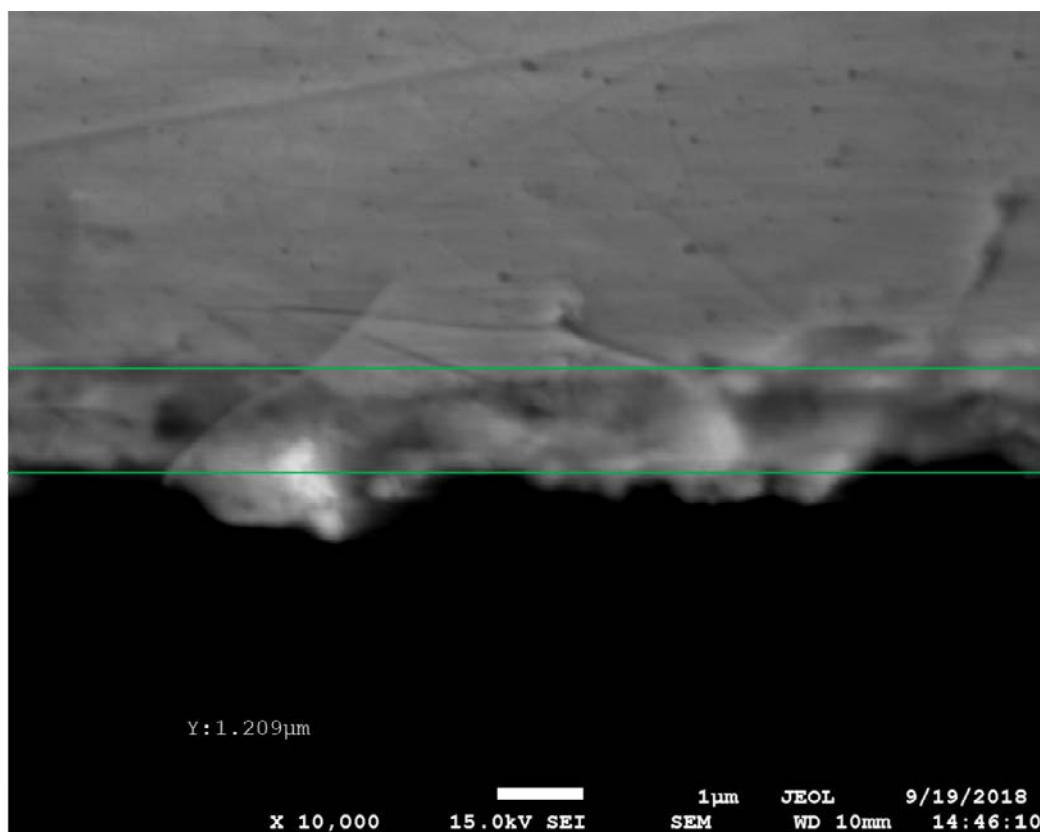
Figure D-39. SEM image on the cross section of coupon S7-8 (Control G). The sulphide layer was measured as being 1.2 µm thick.
