Pressure tests of two KBS-3 canister mock-ups

Karl-Fredrik Nilsson, Frantisek Lofaj
European Commission, DG-JRC, Institute for Energy,
Petten, The Netherlands

Executive summary

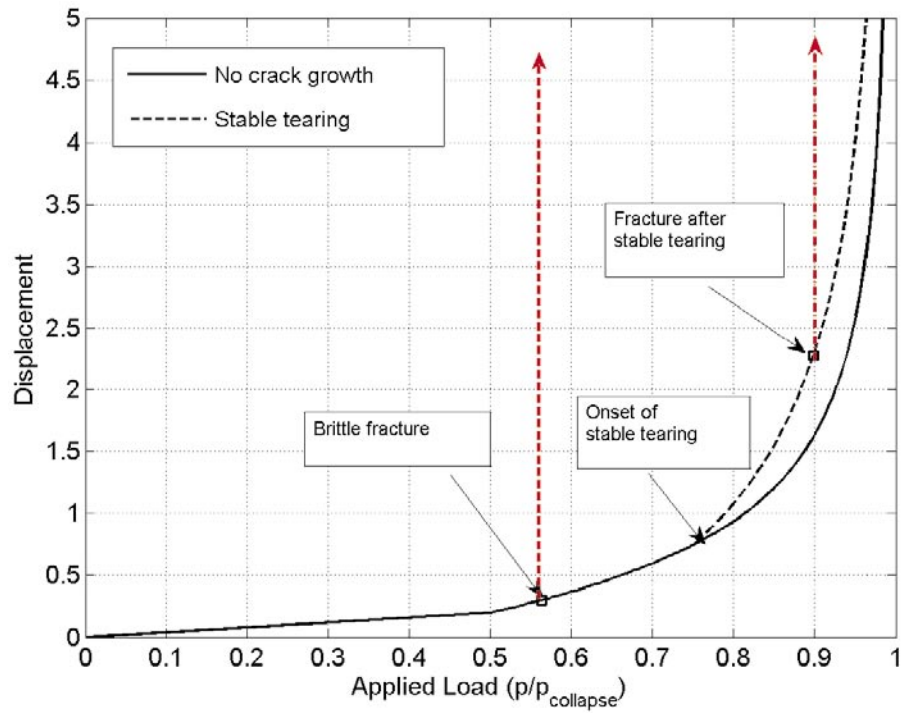
Figure 1-3. Schematic illustration of load-displacement until plastic collapse with brittle fracture and onset of stable tearing. The dashed arrows indicate fracture by brittle fracture and after some stable tearing.

Figure 1-3 is a schematic illustration of the plastic deformation plotted against applied load up to global plastic collapse for different scenarios. The worst case would be brittle and unstable fracture from a large defect. If a cracks starts to propagate when the deformation is plastic then it is likely that further crack growth is by a stable tearing mechanism. Depending on the loading and material properties a stable tearing crack may arrest or become critical.

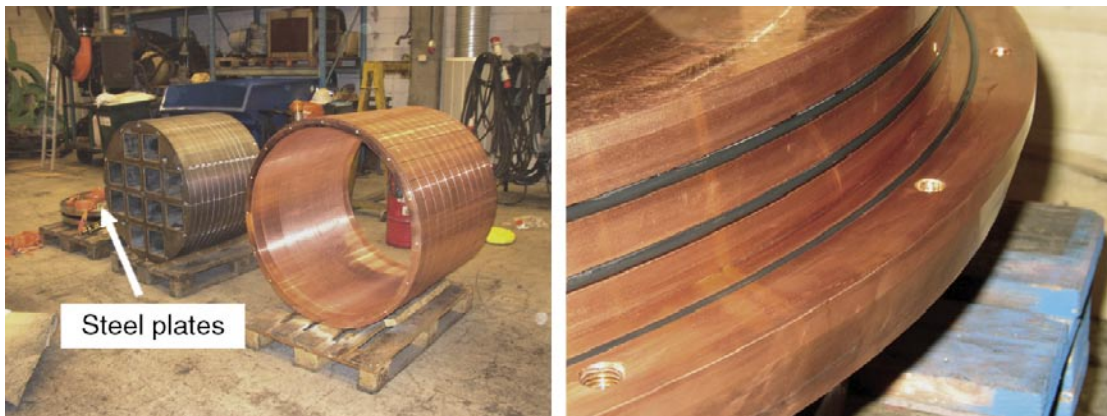
Figure 2-2. a) Cast iron insert and copper tube cut to specified dimensions and machined before assembly b) detail of copper lid with O-rings.

A schematic drawing of the mock-up is shown in Figure 2-1. The machining of the parts and their assembly was done by Saltängens Mekaniska Verkstad in Sweden. Figure 2-2a shows the cast iron insert, copper tube and steel plates and a detail of the copper lid for Mock-up #1. The complete KBS-3 canister has a length of almost five meters, the lids are welded to the copper tube and the bottom part of the insert is homogeneous as indicated in Figure 1-1, which provides a stiffening effect at the ends of the canister. Since the mock-up is substantially shorter than a full size KBS-3 canister, the “end effects” would be larger if the same design were used at the ends. Hence to alleviate the end-effects and allow disassembly of the mock-up after the test, the lids were attached to the both ends of the insert by one large bolt and the lid to the tube by 16 smaller bolts. Three O-rings (seen in Figure 2-2b) were attached to the lid to ensure tightness between lid and tube. The total length and weight of each mock-up were 1,050 mm and 5 tons respectively. Figure 2-3a shows the insert lowered into the copper tube and Figure 2-3b shows the assembled Mock-up #1. A rectangular pattern was machined into the copper tube for Mock-up #1 as seen in Figures 2-3a and 2-3b. The purpose of this was to better assess by visual inspection any large plastic deformations between pressure cycles. For Mock-up #2 this surface machining was not done.

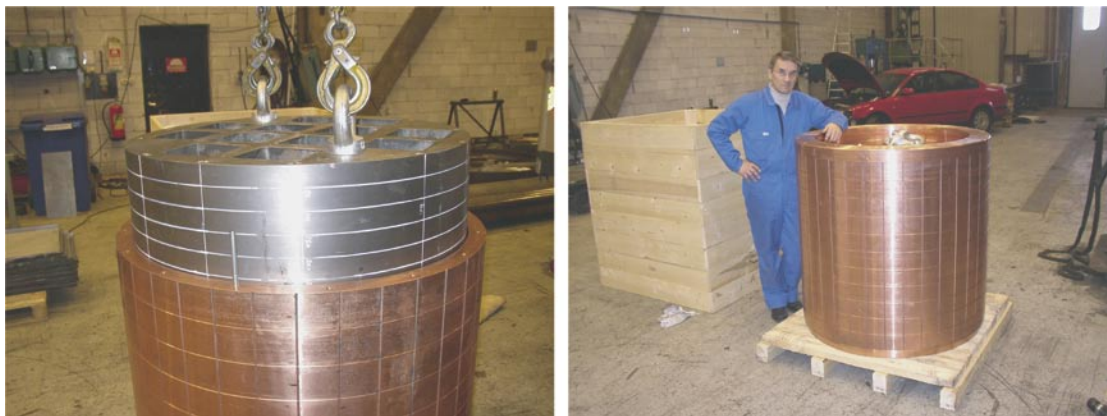
Figure 2-3. a) Cast iron insert being inserted into the copper tube and b) assembled mock-up.

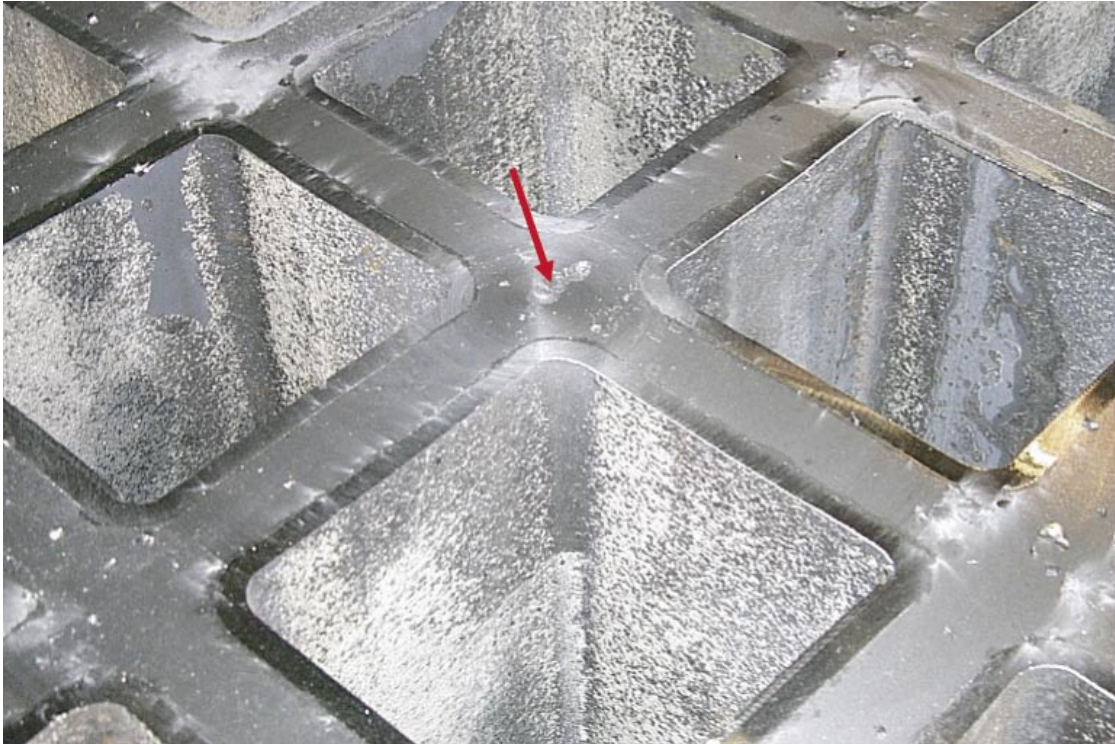
Figure 2-4. Large casting defect observed on insert's cutting surface for Mock-up #1.

The insert Mock-up #1 was cut from the segment with the largest defect indications from ultra-sound¹. The ultra-sound investigation could not size the defects. Casting defects were, however, observed at the end surfaces of the mock-up insert. A typical casting defect with a size of thumbnail can be seen in Figure 2-4. Another important manufacturing deviation was that the fuel bundle channels had an off-set of 12 mm from its assumed symmetric location. As a consequence the wall thickness between the outer surface and the corner of the fuel channel varied from 22 to 44 mm at the locations indicated in Figure 2-5. This off-set will

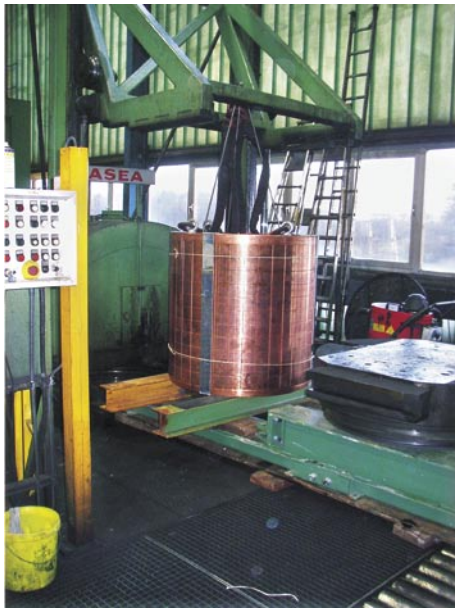
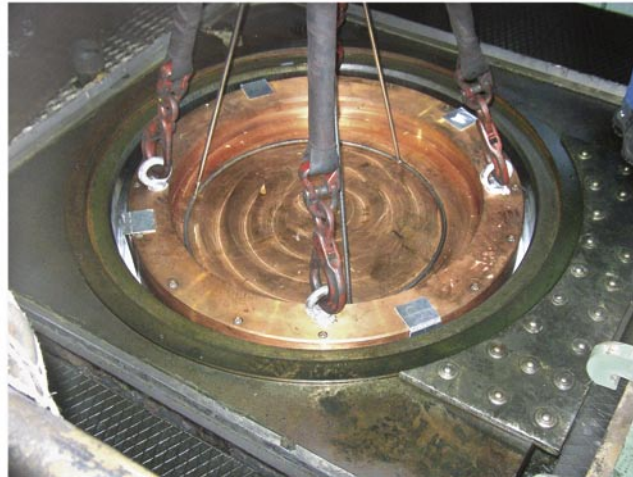
Figure 3-2. a) Mock-up ready for testing b) mock-up inserted into the cold isostatic press.

A cold isostatic press (CIP) of ASEA Quintus type at Schunk Kohlenstofftechnik in Heuchelheim, Germany, with inner diameter of 1,120 mm and height of 2,600 mm and maximum pressure 200 MPa was used in the tests. A cold isostatic press consists of a pressure vessel with a frame for axial support of the pressure vessel end closures and it uses water emulsion as the pressure medium as illustrated schematically in Figure 3-1. The pressure medium is pumped into the press. The hydraulic system of the press is designed to pressurize and decompress the pressure vessel in a controlled manner by means of an intensifier. Other presses were also considered but they did not fulfill the three basic test criteria (size, maximum load and temperature). The applied pressure was recorded on a PC-system with a sampling frequency of 0.5 Hz. It was not possible to directly measure the deformation during the loading, but sudden and local bulge-in, provided the leak-tightness remains intact, would be registered as small drop in the applied pressure. Simple elastic analyses indicate that a 1 MPa pressure drop would correspond to a bulge-in of around 1 litre. A complete failure of the mock-up would lead to complete de-pressurization, which would be registered from the pressure recording. The Mock-up #1 before a test cycle is shown in Figure 3-2a and Figure 3-2b shows the mock-up being placed into the press.

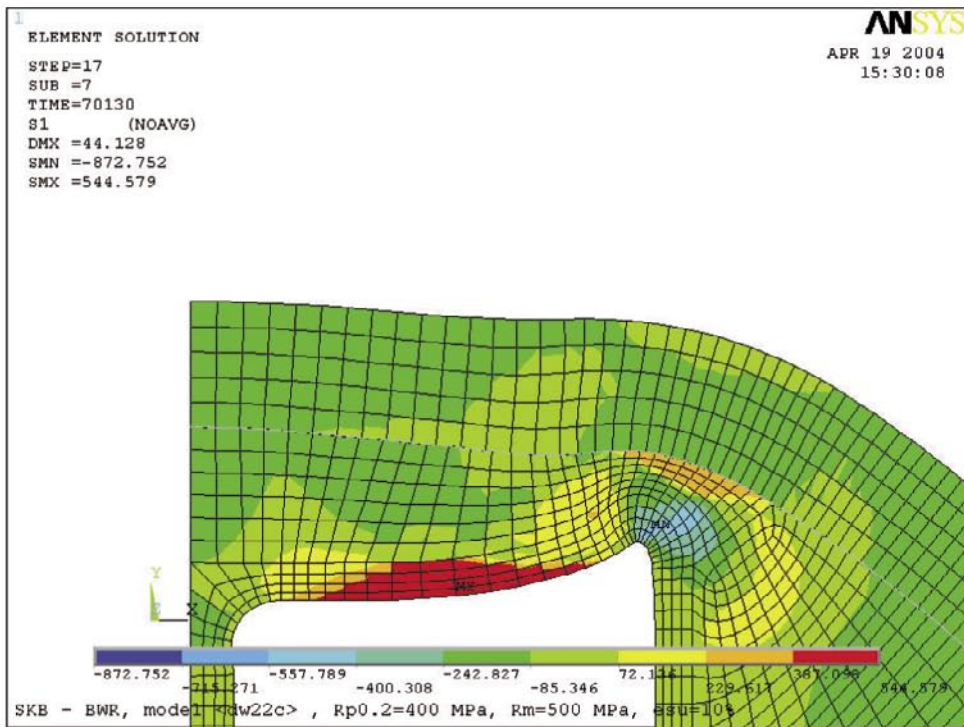
Figure 4-3. The distribution of a) the direction of principal stresses b) iso-stress contours for tangential stress component. The red surface indicates that the stress is above 350 MPa and the material has essentially yielded.

and red areas in Figure 4-3b represents the area with tensile stresses. For the “red” area the tensile stresses are above 387 MPa and that the material has yielded. The arrows in Figure 4-3a show the stress component tangential to the fuel channel surface, which is the one that can propagate cracks in the radial direction. Assuming that defects will only grow in tension loading, it follows that only defects in this region may become critical. Figure 4-4 shows the computed maximum plastic strain at the corner in the cast iron and the steel tube versus the applied pressure. The strains are larger in the steel tube but cracking in the steel tube is less critical than of the insert for the mock-up’s overall integrity. The computed deformation versus the applied pressure is plotted in Figure 4-5 at the two locations indicated in the figure insert. The copper tube yields already below 10 MPa and the 2 mm gap between the tube and insert closes. The deformation then increases linearly until the insert yields at about $p = 110$ MPa, whereafter the plastic deformation increases rapidly. It is interesting to note that in the plastic regime the deformation is much higher in the 90° location than in the 45° location as defined by the figure insert, as the fuel channels introduce a loss of symmetry and the local wall thickness is much larger. It was mentioned above that the probabilistic analysis was based on local failure criteria, which is likely to be very conservative model for failure of the canister. This is illustrated by the von Mises iso-stress contours in Figure 4-6 (taken from /2/) where the red areas represent yielded material. The development of a local yielding can be seen at the corner of the insert already at a pressure of 44 MPa (Figure 4-6a), but it is not until a load of 130 MPa that a global failure mechanism is seen (Figure 4-6b). The results reproduced in Figure 4-6 were based on a two-dimensional model of the insert and without the copper overpack, which gives somewhat lower loads for local and global yielding. In addition, global plastic collapse could be lower for a model without double symmetry. Nevertheless the results give an idea of the margin between local and global plastic collapse. In /2/ the measured compressive stress-strain data from the three inserts was used, which was a bit lower than what was used in the “pre-test” analyses.

(7) was detected in the segments L1 and L2 with maximum length of about 40 mm. However, radiography did not provide information about the crack depth and the crack propagation mode (tearing or cleavage). The segments L1 and L2 were therefore cut into smaller parts (Figure 6-6) to study the largest cracks in more details. The depth of the individual cracks in the “cut” pieces was measured with ultrasonic method in axial and tangential directions. Figure 6-7 shows a C-scan of two cracks in the “II part” of the L1 segment. The depths of these cracks in L1 and L2 were estimated to be about 10 mm, which corresponds roughly to the depth of the tensile region outlined in Figure 4-3b.

only on the surface that was subjected to tensile stresses indicated by FEM analysis (see Figure 4-3). Despite numerous subsurface inclusions observed at the remaining sides of the fuel channels, cracks were absent there.

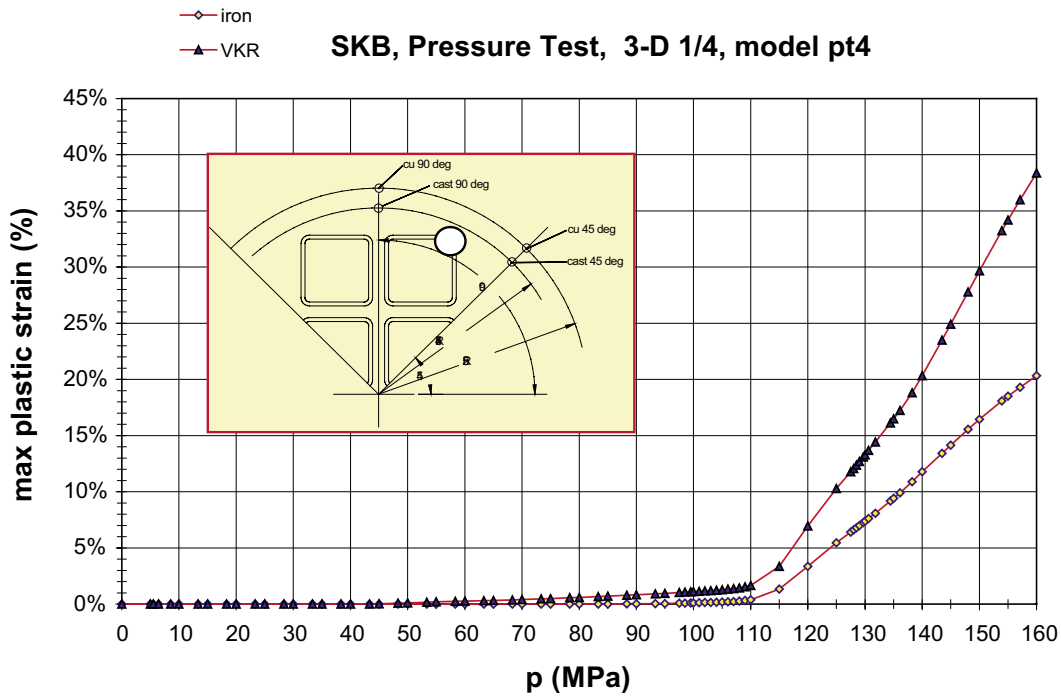
Figure 4-4. Computed plastic strain versus applied pressure at corner of the channel in steel tube and insert respectively. The white circle indicates the location where the largest strains are computed.

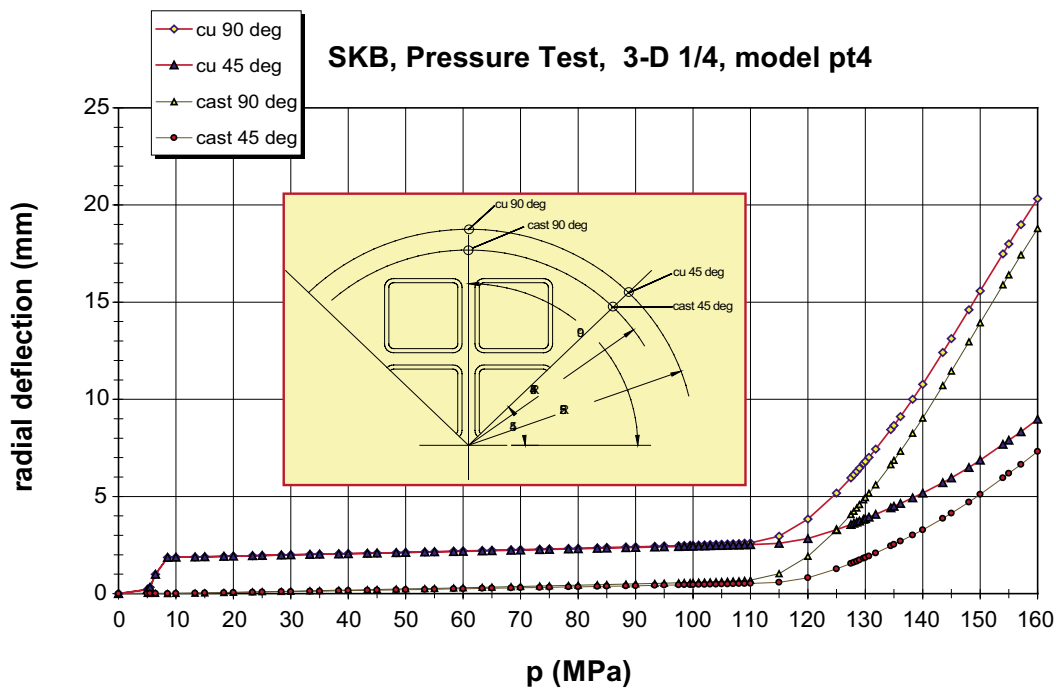
Figure 4-5. Computed radial displacement in copper and insert at the reference points.

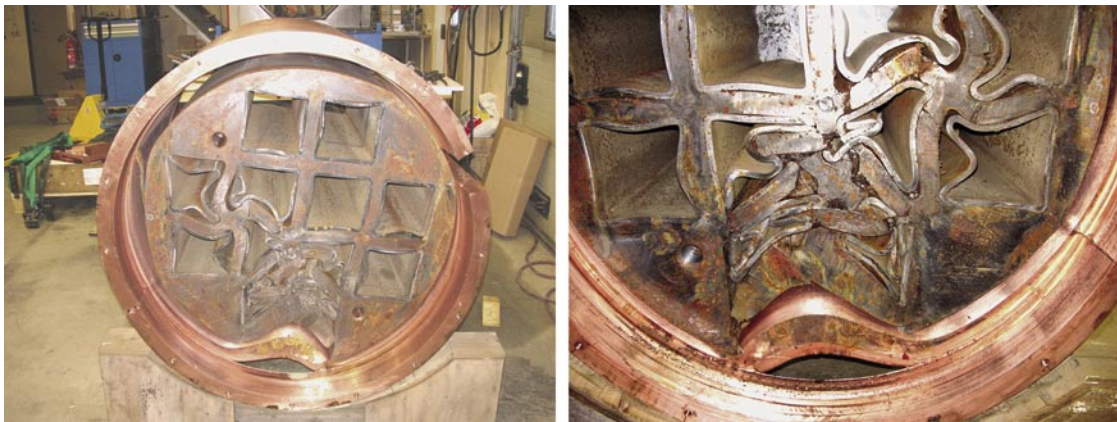
a) b)
Figure 5-4. Mock-up #2 showing large deformation after plastic collapse.

The pressure test of the second mock-up followed the same procedure and the main observations for each pressure cycle are summarized in Table 5-2. The observations up to $p_{\max} = 130$ MPa were similar to those observed for Mock-up #1 but a small additional deformation was registered between 40–70 MPa and the deformation was more symmetric than for Mock-up #1. The purpose of the final load cycle was to load the mock-up until failure. At 139 MPa, a loud bang could be heard, the pressure dropped almost instantaneously and the test was immediately stopped. The deformed mock-up when it is being lifted out of the CIP is shown in Figure 5-3. The deformation after the collapse was quite non-symmetric with a maximum indentation of almost 200 mm. The large deformation also induced large cracks in the upper part of the copper over-pack, as also illustrated in Figure 5-3 and pressure medium could enter the canister, which resulted in the fast pressure drop. The large deformation of the insert and copper shell are also shown in Figure 5-4. The failure mode is clearly global plastic collapse.

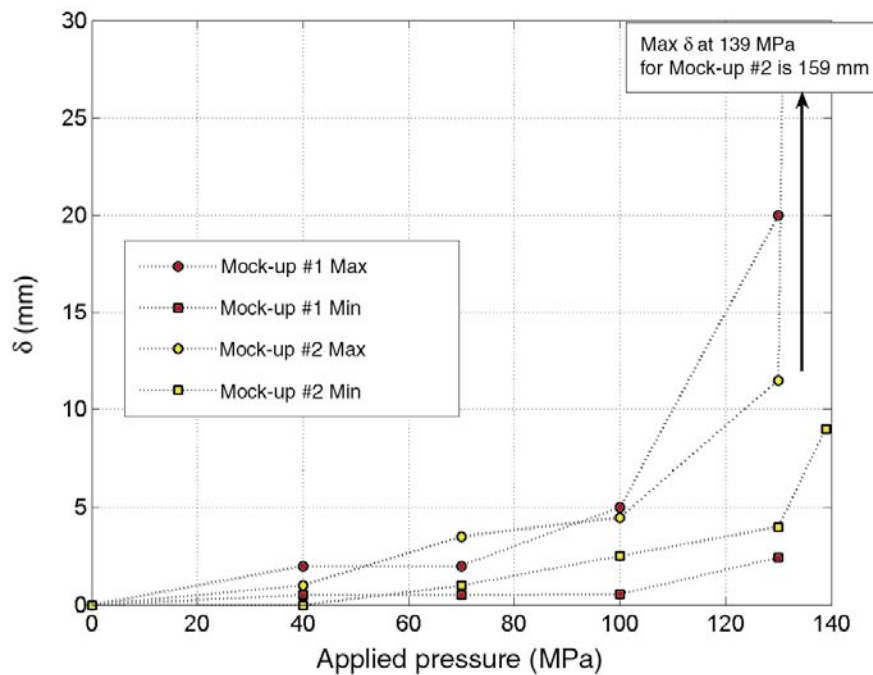
Figure 5-5. Measured maximum and minimum residual radial deflection of Mock-up #1 and #2 versus applied pressure.

Figure 5-5 shows the minimum and maximum residual deformation measured along centre of the two mock-ups. We see that the difference between the minimum and maximum deformation, which is an indication of the asymmetry, is much larger for Mock-up #1 than for Mock-Up #2. The onset of large plastic deformations when the pressure exceeds 100 MPa are also clearly seen. The lower values for onset of plasticity compared to the analyses is probably due to the off-set in Mock-up #1 and lower yield stress and hardening for Mock-up #1 and #2.
