**Grain boundary corrosion of
copper canister weld material**

Rolf Gubner, Urban Andersson, Mats Linder,
Andrej Nazarov, Claes Taxén
Korrosionsinstitutet

January 2006

Svensk Kärnbränslehantering AB

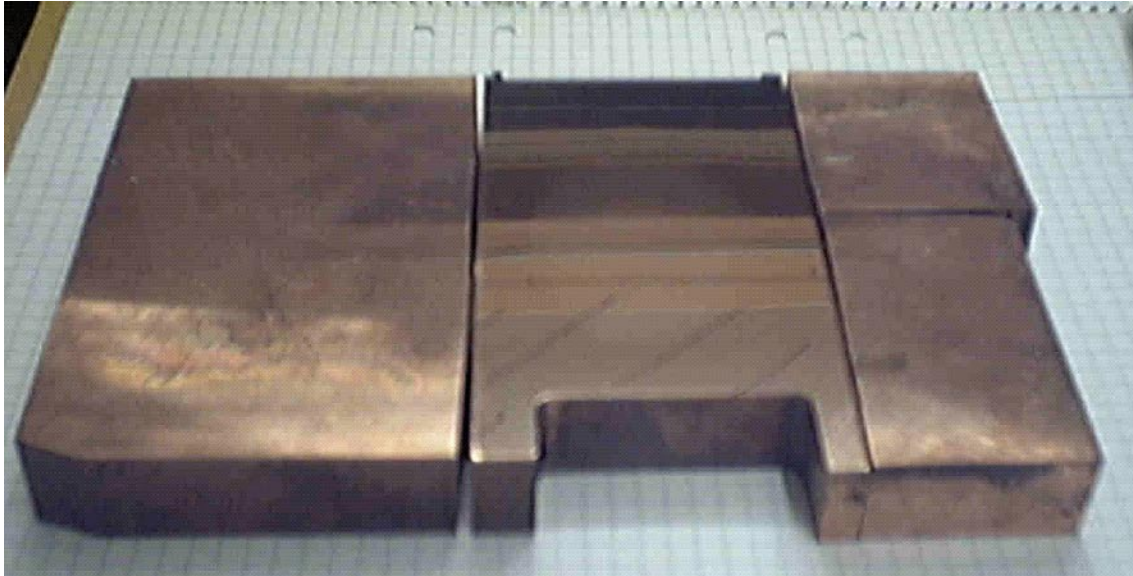
Figure 2-2. Friction stir weld sample. The centerpiece contains the weld in the upper half of the sample.

Two friction stir weld samples were also provided by SKB with the labels “Corrosion KL059-COR1/T” and “KL059-COR2/T”. The samples were cut parallel to the weld on both sides (Figure 2-2).

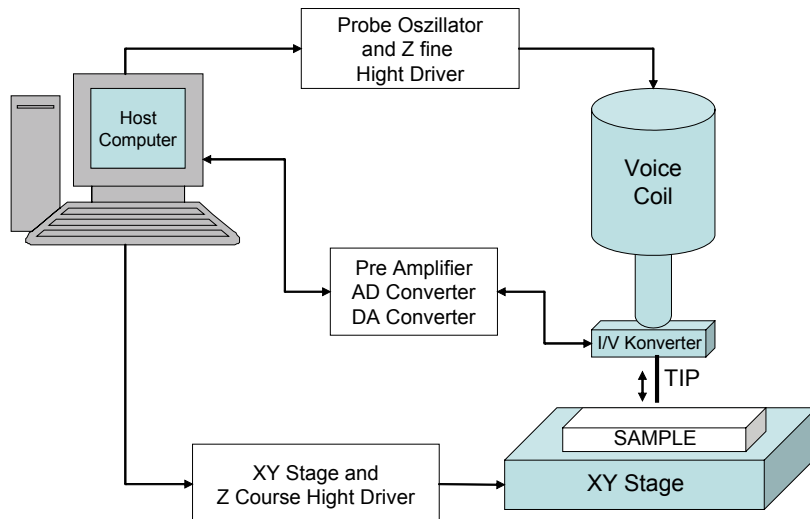
Figure 2-3. Scanning Kelvin probe principle.

The vibrating capacitor or Kelvin technique, which has been used for a long time to measure the work function or contact potential of metals in vacuum or in gases and to study the adsorption of species on the surfaces of metals, has been adapted to the measurement of corrosion potential. Stratmann and his co-workers have applied Kelvin probe method to study the atmospheric corrosion of metals covered with thin electrolyte layers /7, 8, 9/. In 1991, a scanning Kelvin microprobe system was described. Since then, the Scanning Kelvin Probe Microscope (SKPM) has been successfully used in corrosion science, especially for mapping the potential distribution under organic coatings. Figure 2-3 shows an experimental setup of a scanning Kelvin probe. A motorized X-Y stage controlled through a microcomputer is used to scan over the specimen. The KP potential is measured through an electronic feedback system that uses the ac signal from the working electrode as a driving force for the control circuit. The ac signal is first amplified and then sent to the lock-in amplifier. The output of the lock-in amplifier is then used to adjust a battery applied between the probe and the sample. Until the null condition is reached, the data are sent to the computer for display and analysis.

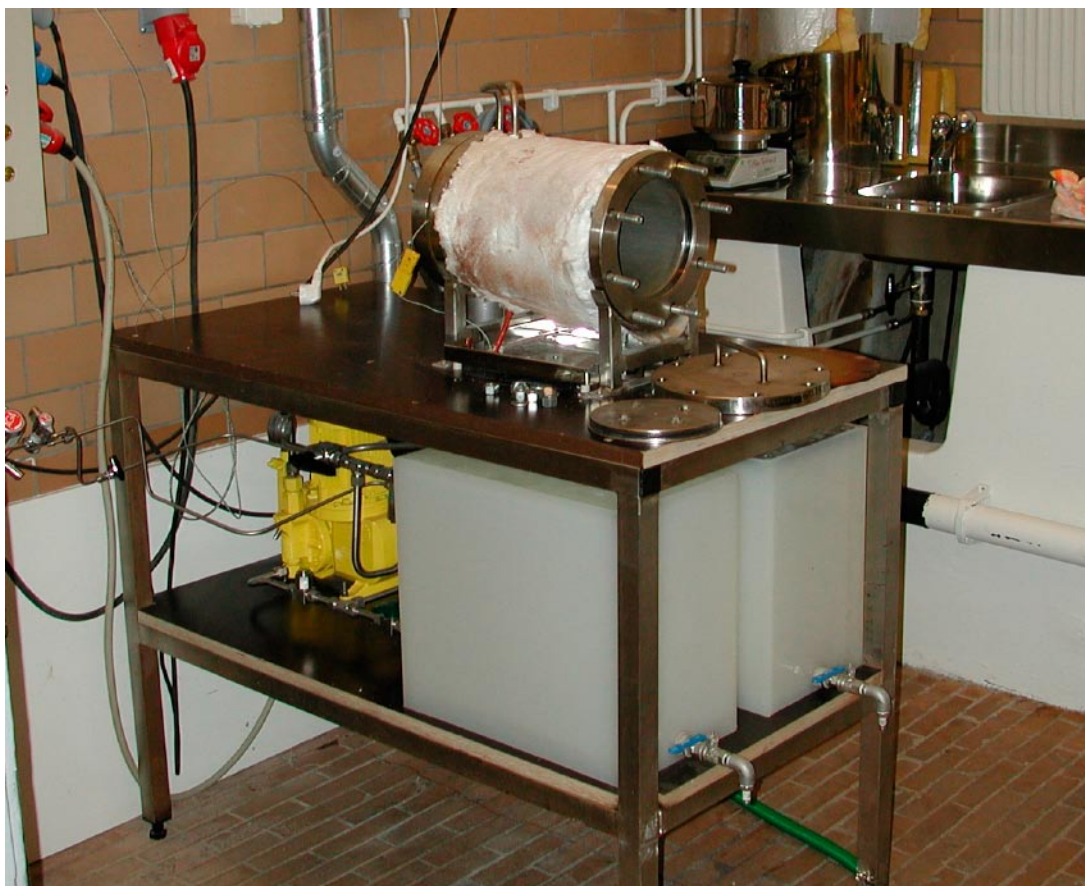
Figure 2-6. Picture of autoclave table with liquid storage tanks and the high pressure pump.

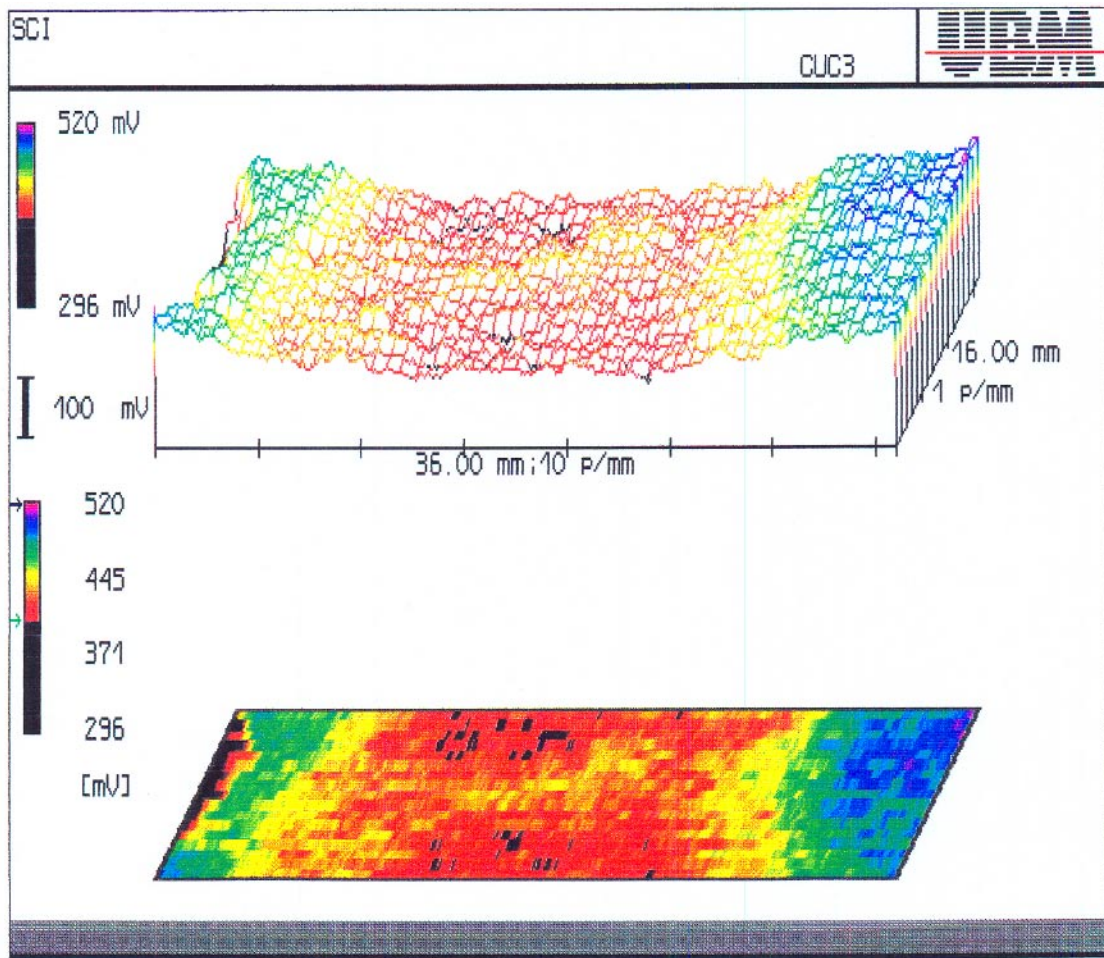
It was observed that the surface potential of the weld and heat affected zone is ca 200 mV more anodic compared to the base material. It can also be noted that the base material has a slightly more noble potential compared to the lid material.

Figure 3-1. Scanning Kelvin Probe image from sample L019. The scanned area was 36 mm wide and 16 mm deep and the offset from the making was 40 mm.

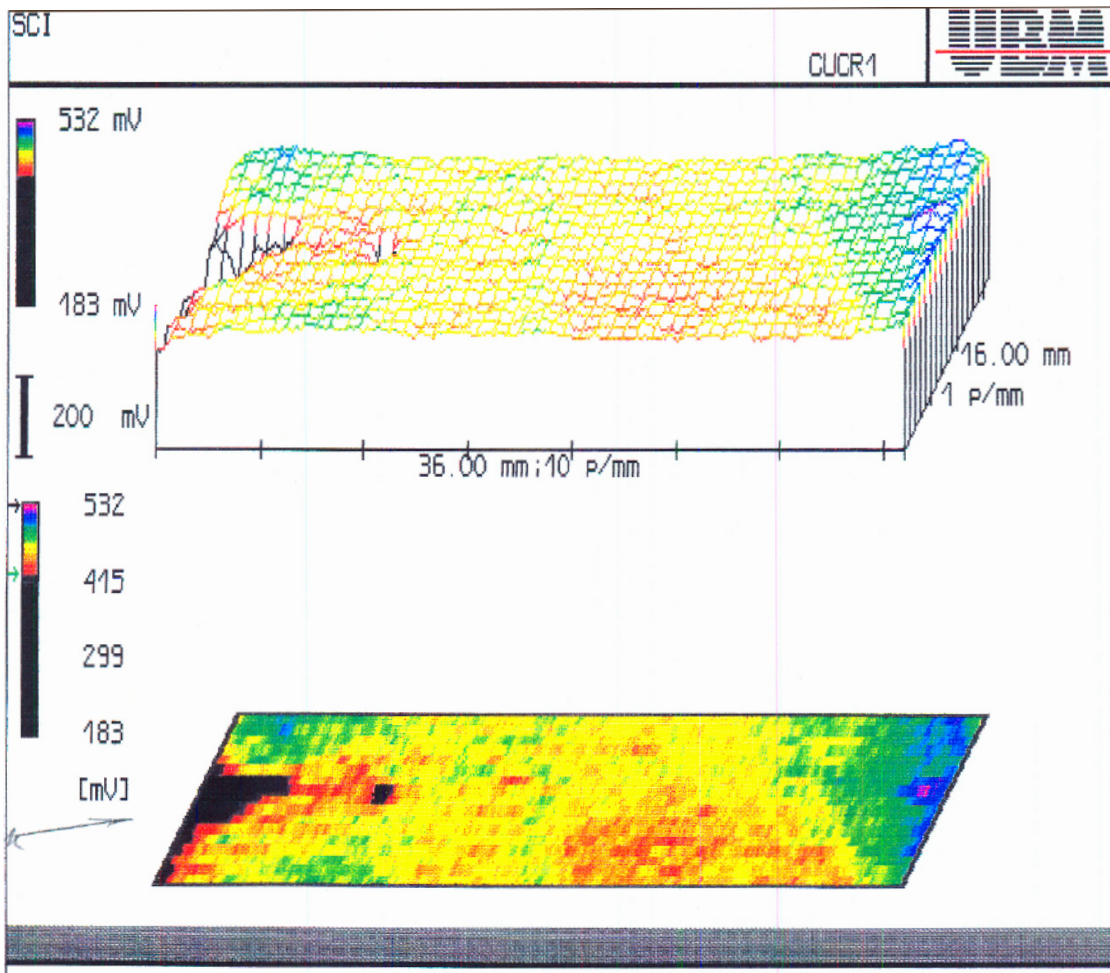
It can be noticed in this figure that where the canister material and the lid material join, a strong anodic potential was measured (ca 200 mV difference). At this area, the material is not welded together.

Figure 3-3. Scanning Kelvin Probe image over the root area of the weld over the joint between the canister and its lid (sample L019).

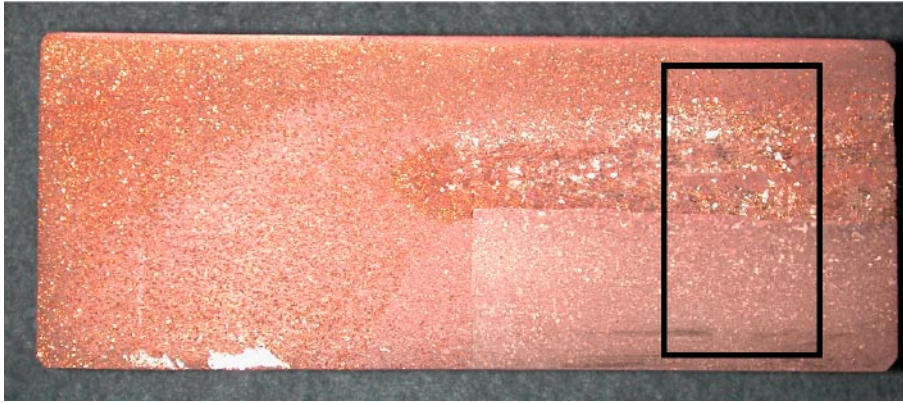
Figure 3-6. Exposed sample revealing canister material and lid material. The marking indicates the scan area of the SKP image above, rotated 90°.

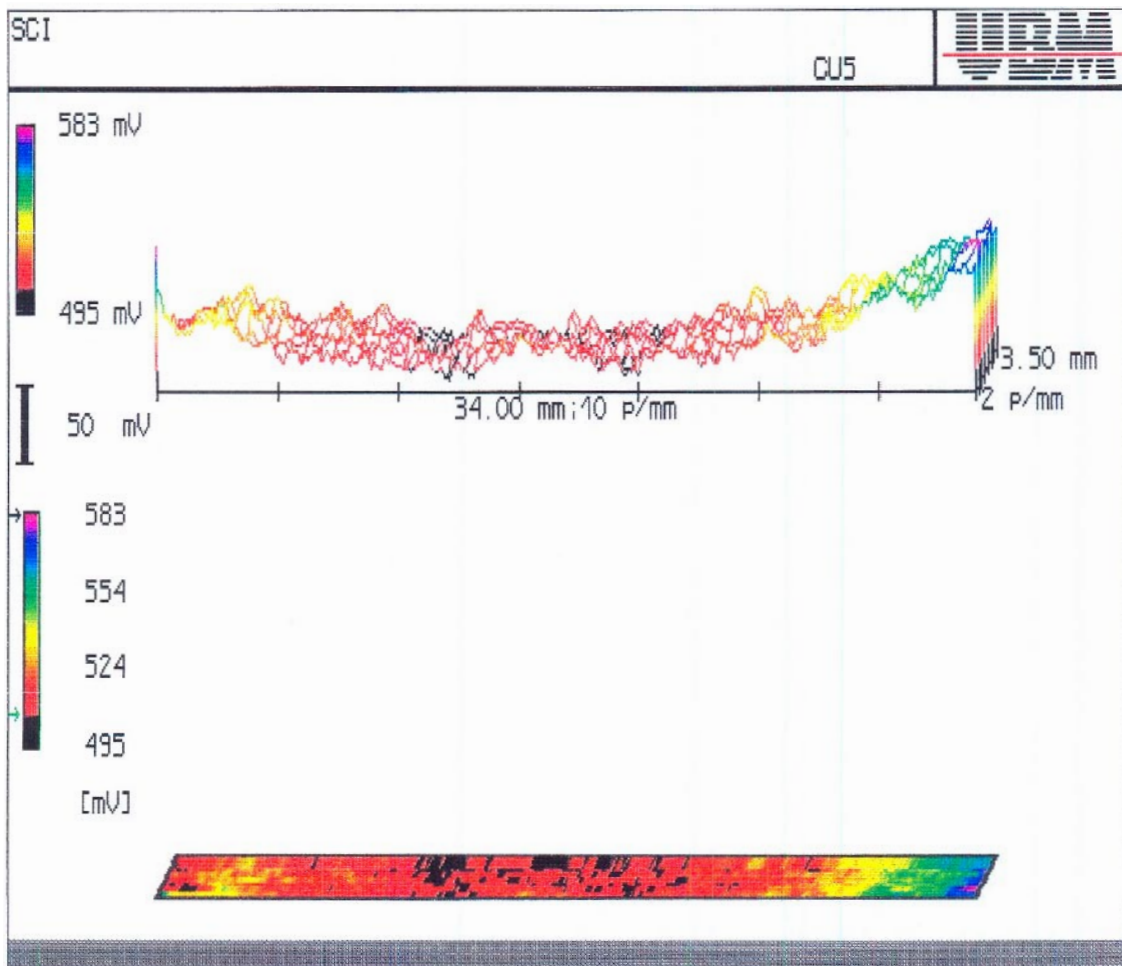
The SKP image shown in Figure 3-7 indicates that the weld area is more anodic (more likely to corrode) compared with the base material from lid and cylinder by ca 100 mV. Since this is the weld surface exposed to the bentonite, such a potential difference could raise concern about galvanic corrosion of the welds.

Figure 3-7. L013 scan over weld.

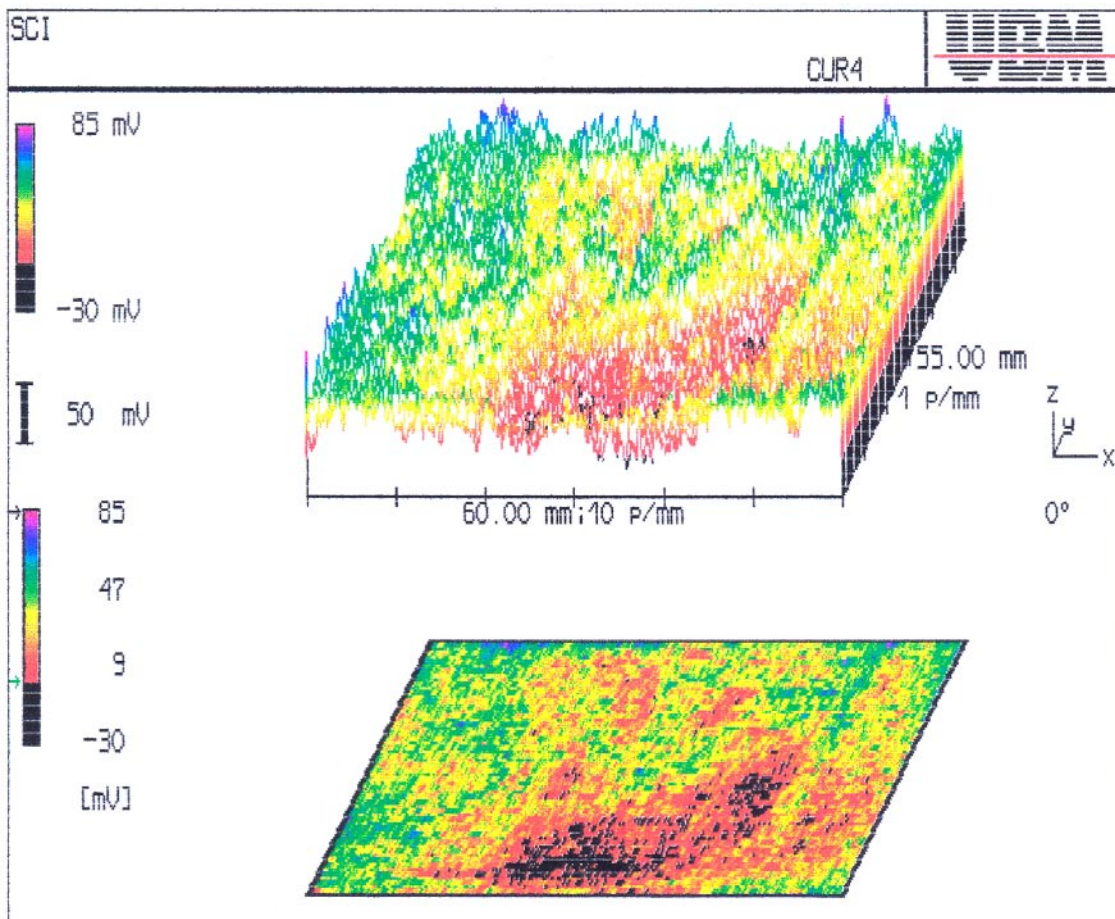
Figure 3-9. SKP image of the friction stir weld sample “Corrosion KL059-COR1/T”.

Friction stir welding seems to reduce the potential difference between the weld and base materials. However, a potential difference of ca 75 mV was observed on the right side (exposed to the environment) between weld and base materials.

Atomic Force Microscopy was applied to measure the depth and width of the grain boundary attack caused by the sodium citrate solution. After exposure for 24 hours, the grain boundaries were attacked to a depth of 0.8 nm and a width of 1.1 μm . An example is given in Figure 3-35. A similar rate of grain boundary corrosion was observed on the electron beam welded samples with the difference that the samples were only exposed for 2 hours, indicating that the friction stirred weld samples have a better corrosion resistance compared to the electron beam welded samples. This observation is in good agreement with the Scanning Kelvin Probe measurements of the surface potentials on the samples. In case of the electron beam welded samples a potential difference between weld and base material of ca 200 mV was obtained (Figure 3-5), while on the friction stirred weld sample the potential difference was ca 90 mV (Figure 3-9).

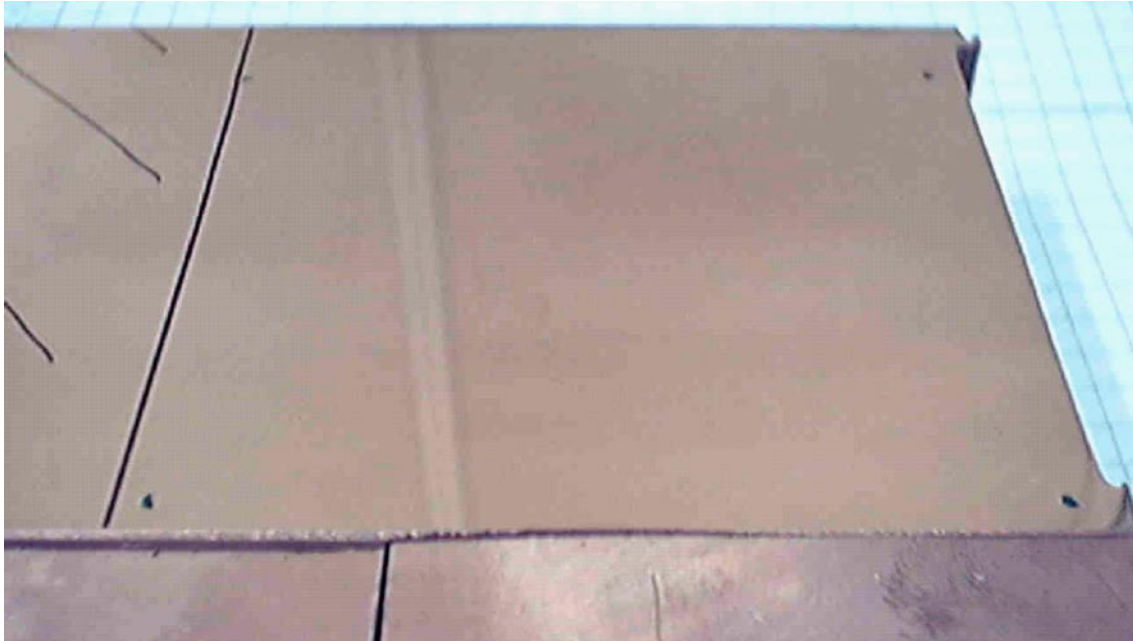
Figure 3-10. Photograph of the sample “Corrosion KL059-COR1/T”. The white lines indicate the SKP scanning area shown in Figure 3-9.

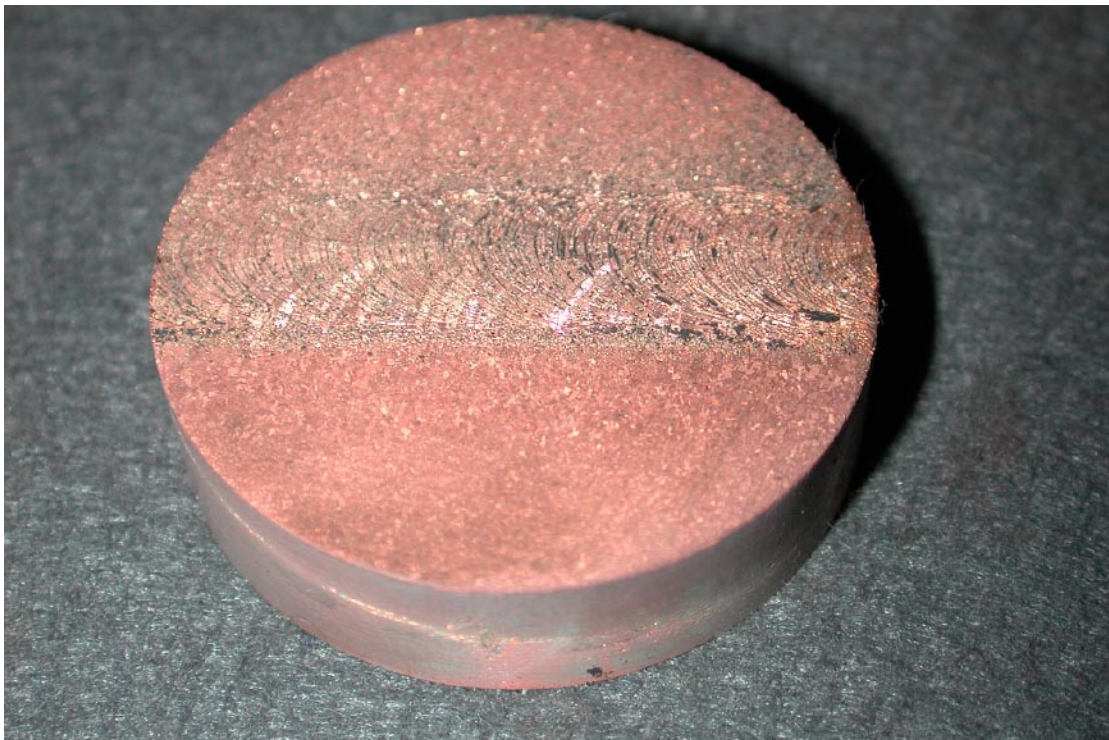
Figure 3-14 to 3-16 show images from sample L013. The main corrosion attack was observed on the weld material following the “flow type pattern” as also observed for the samples cut longitudinal.

Figure 3-14. Photograph sample L013 after exposure. The grain structure is revealed along weld and markings from the welding process have been etched out of the surface.

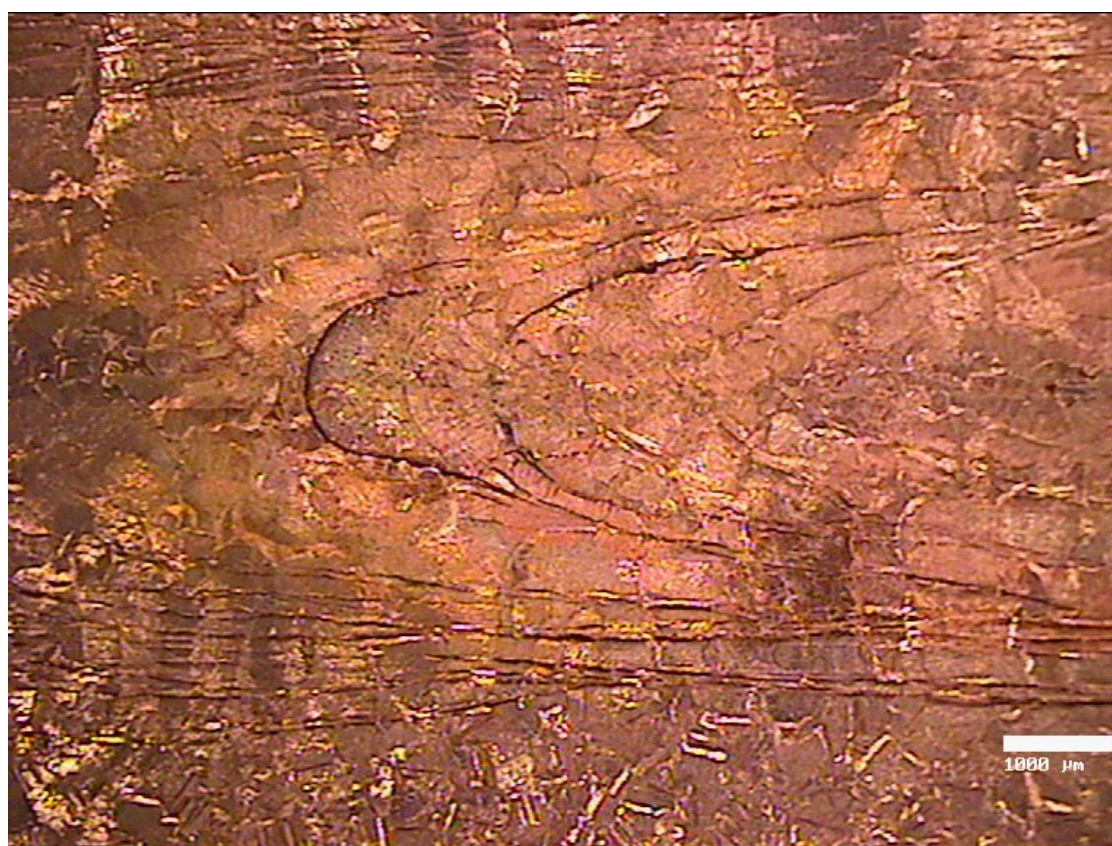
Figure 3-17 shows the weld root area of sample L017 after the exposure inside the autoclave. It can be noted that deep cracks have developed at the root of the weld. This is possibly due to stress corrosion induced by the residual stresses from the welding process. Furthermore, the grains show with a strong contrast in the images and corrosion attack along the grain boundaries cannot be excluded (see Figures 3-18 to 3-21).

Figure 3-17. Micrograph of sample L017 showing a strong corrosion attack at the root the weld. Small indentions along the grain boundaries can also be observed in this sample.

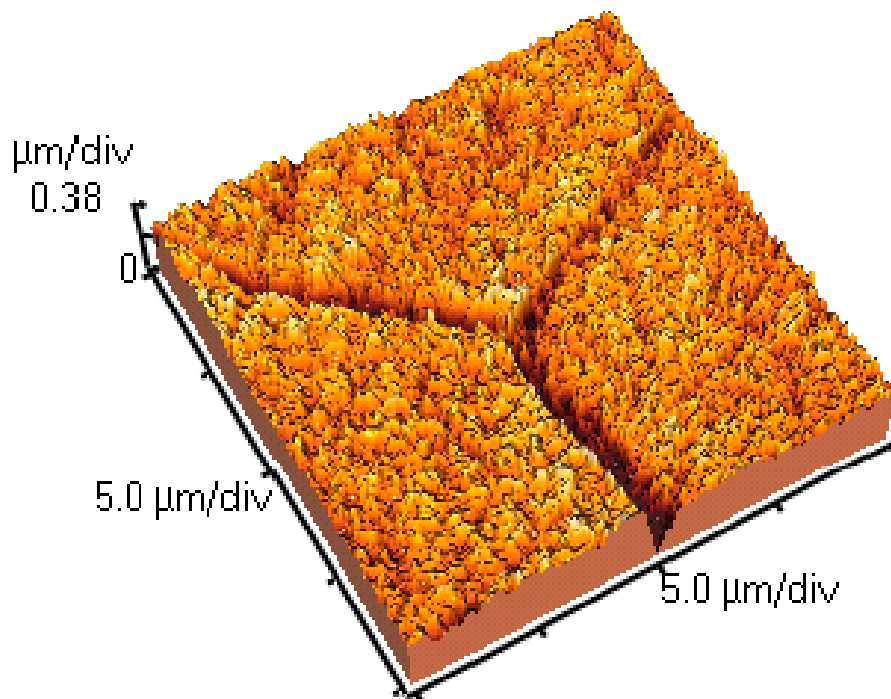
Figures 3-26 and 3-27 show the borders between three grains located in the heat affected zone that have been attacked by the test solution. The attack in the grain boundaries was most predominant in the heat affected zone, but could also be observed on the base material (Figures 3-29 and 3-30). Figure 3-28 shows the analysis of the depth of the grain boundary attack, clearly indicating that the lines seen in the light micrographs at the grain boundaries are indeed induced corrosion of the boundaries, rather than being artifacts.

Figure 3-27. 3D image of the Atomic Force Micrograph presented in Figure 3-23.

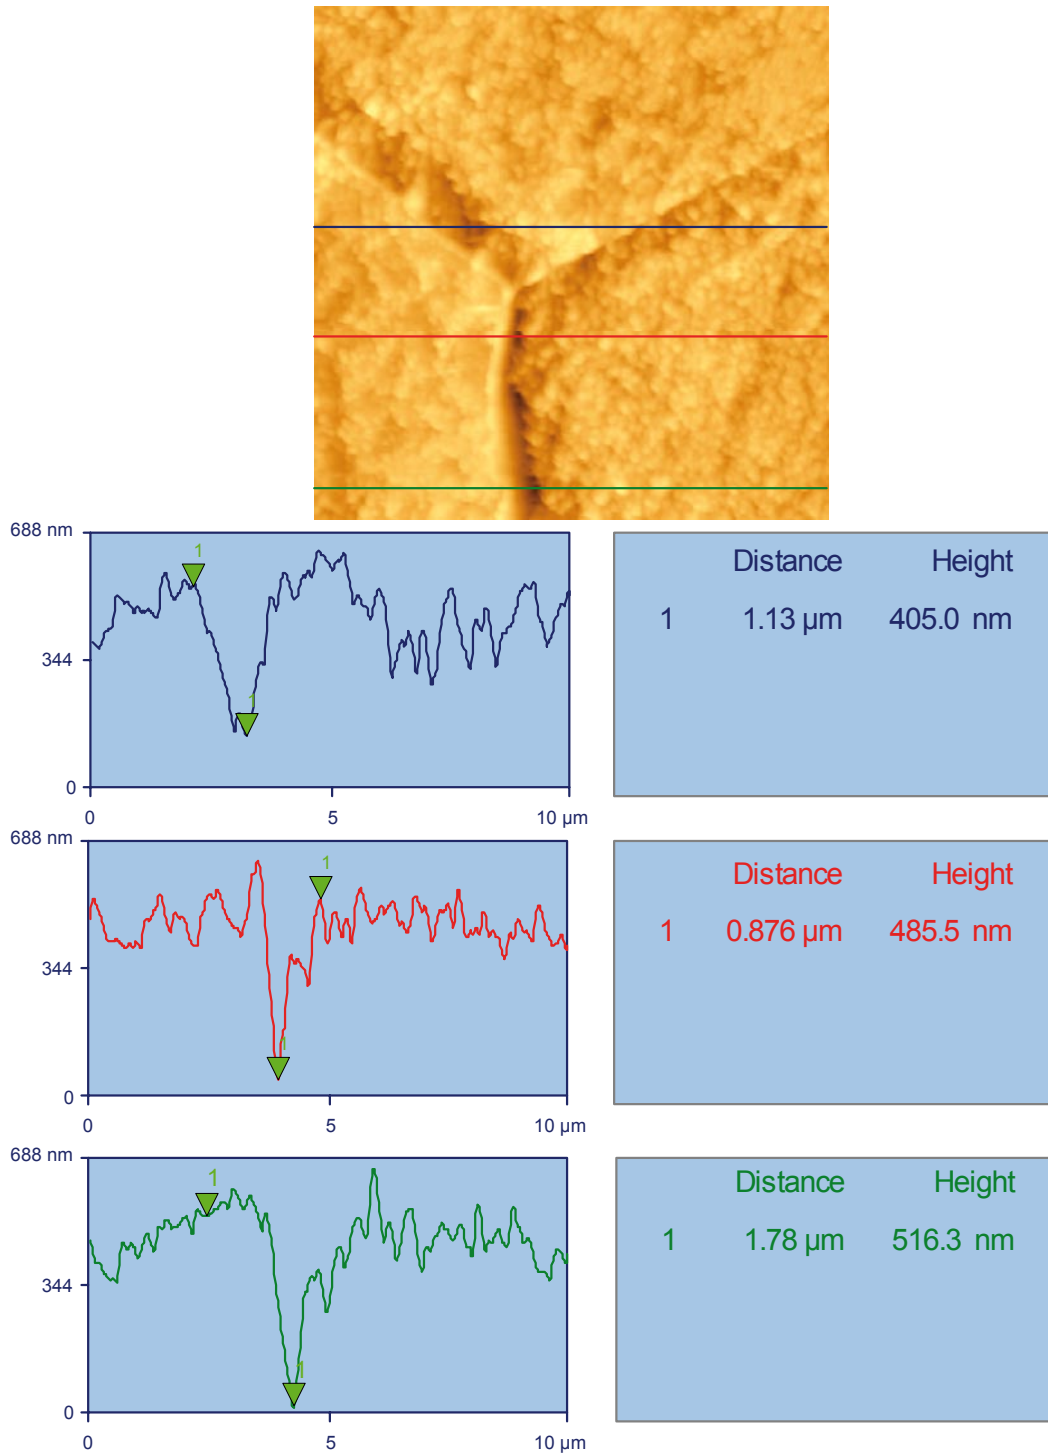
Figure 3-28. Measurement of grain boundary corrosion depth of the Atomic Force Micrograph show in Figures 3-23 and 3-24.

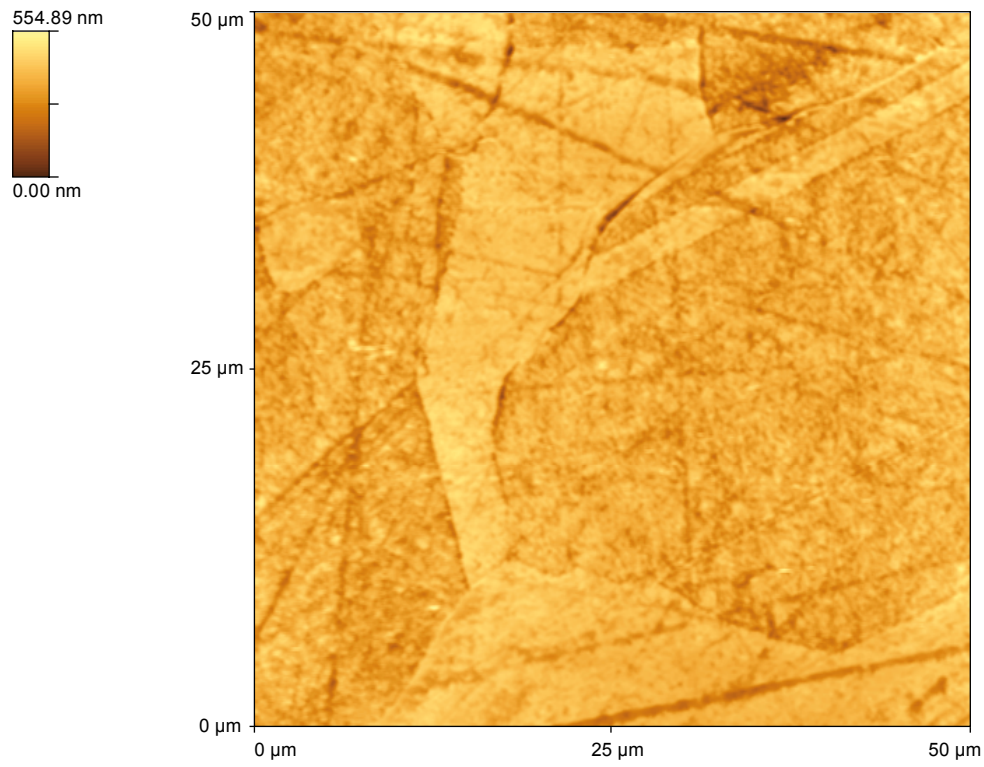
Figure 3-29. Atomic Force Micrograph of sample L013 taken on the base material.

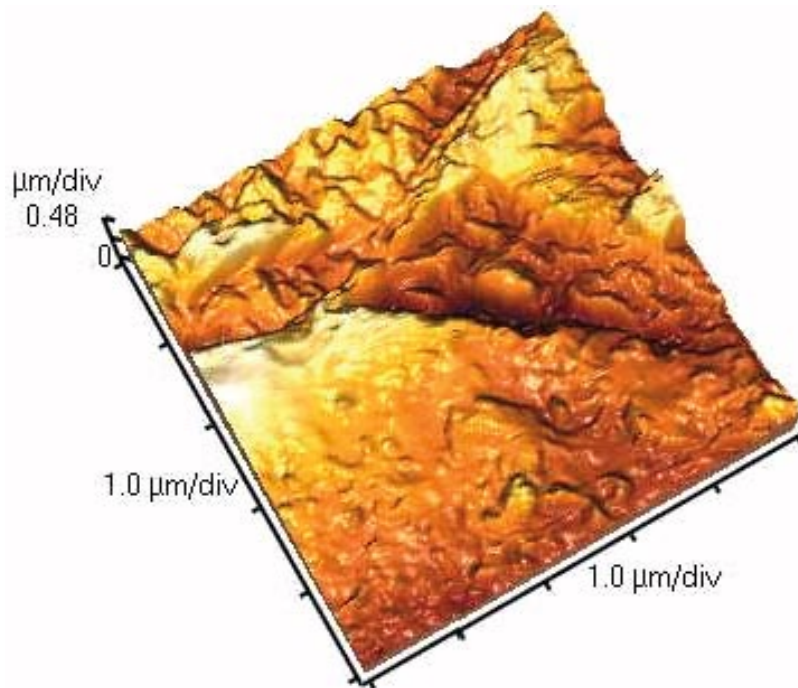
Figure 3-35. 3 dimensional Atomic Force Micrograph taken at the junction of three grains.

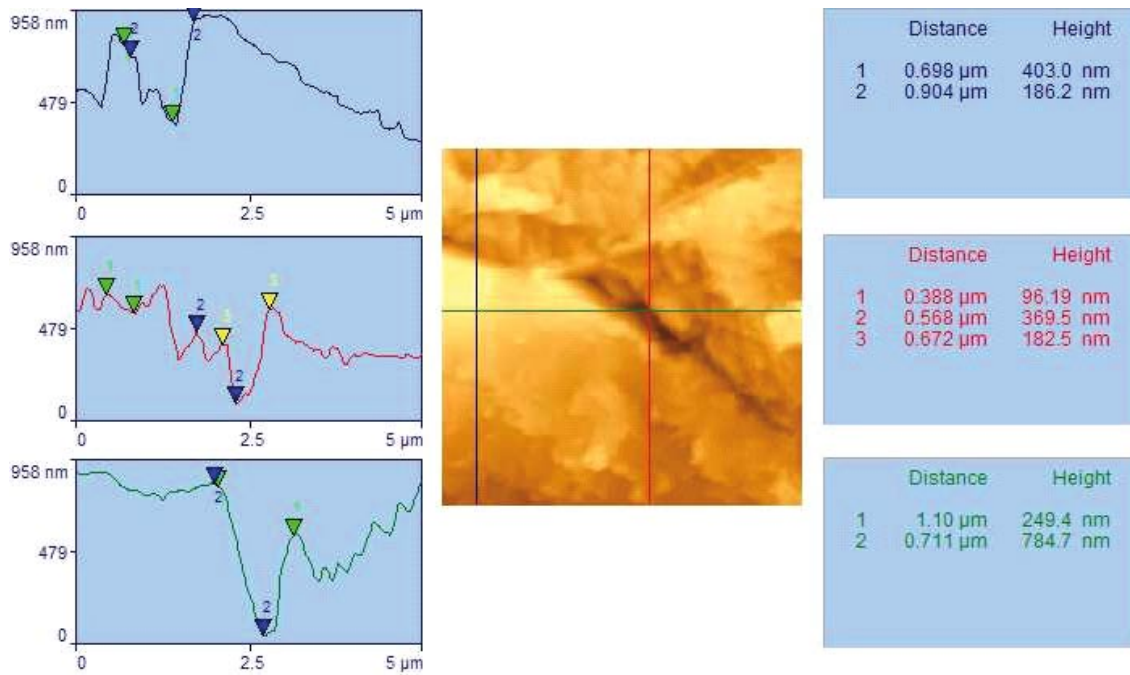
Figure 3-36. Line analysis of the image shown in Figure 3-35. The grain boundaries have been corroded to a depth between 100 to 500 nm and a width between 0.4 to 1.1 μm .
