R-00-23

Geophysical and geological investigations of the Boda area

Stefan Wänstedt
GEOSIGMA AB

Svensk Kärnbränslehantering AB

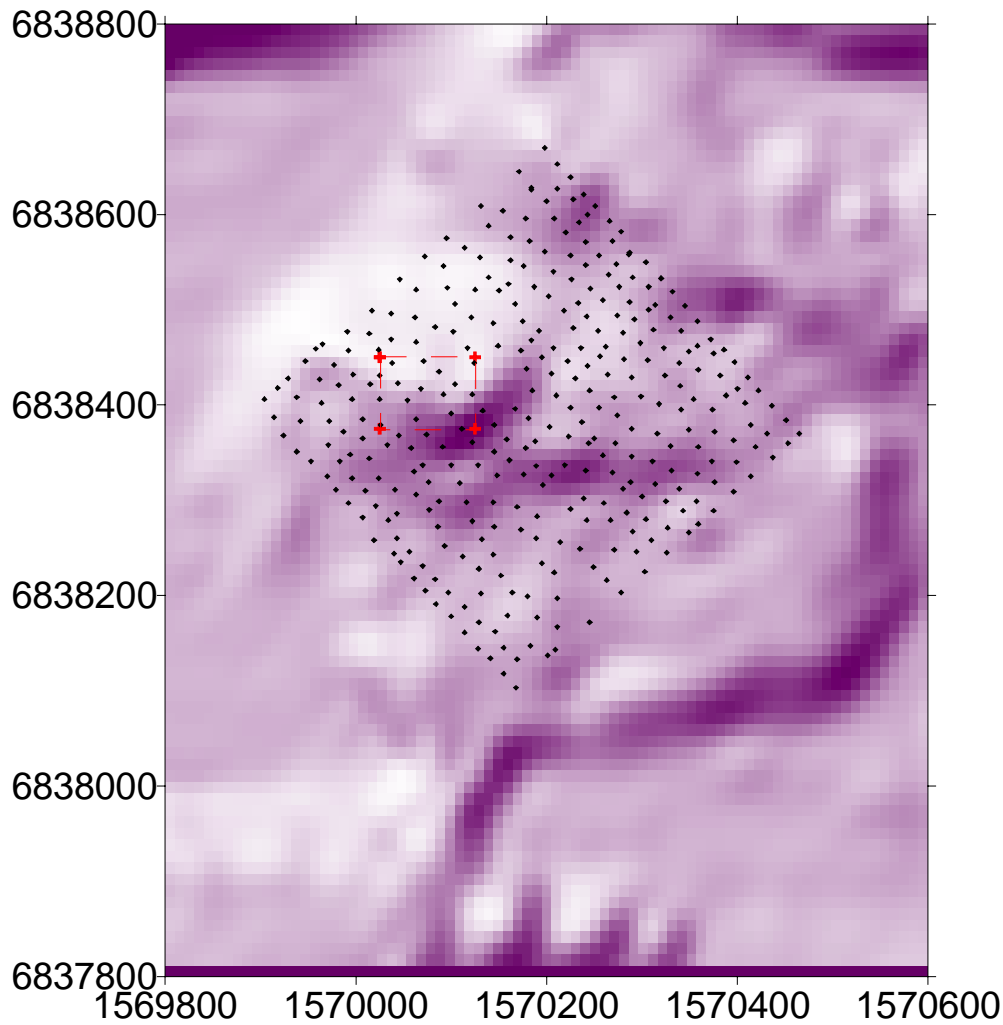
Figure 1-2 Relief map based on the digital elevation database of the area. Dots on map refer to grid points described in section 3. The dashed rectangle outlines the cave area.

Figure 1-2 is a close-up of the area showing the topography, the coordinates of the area surrounding the cave, the investigated area and, finally, a rectangle approximately outlining the cave area. The investigated area covers 400 x 400 m. The actual cave area is somewhat smaller, about 150 x 150 m.

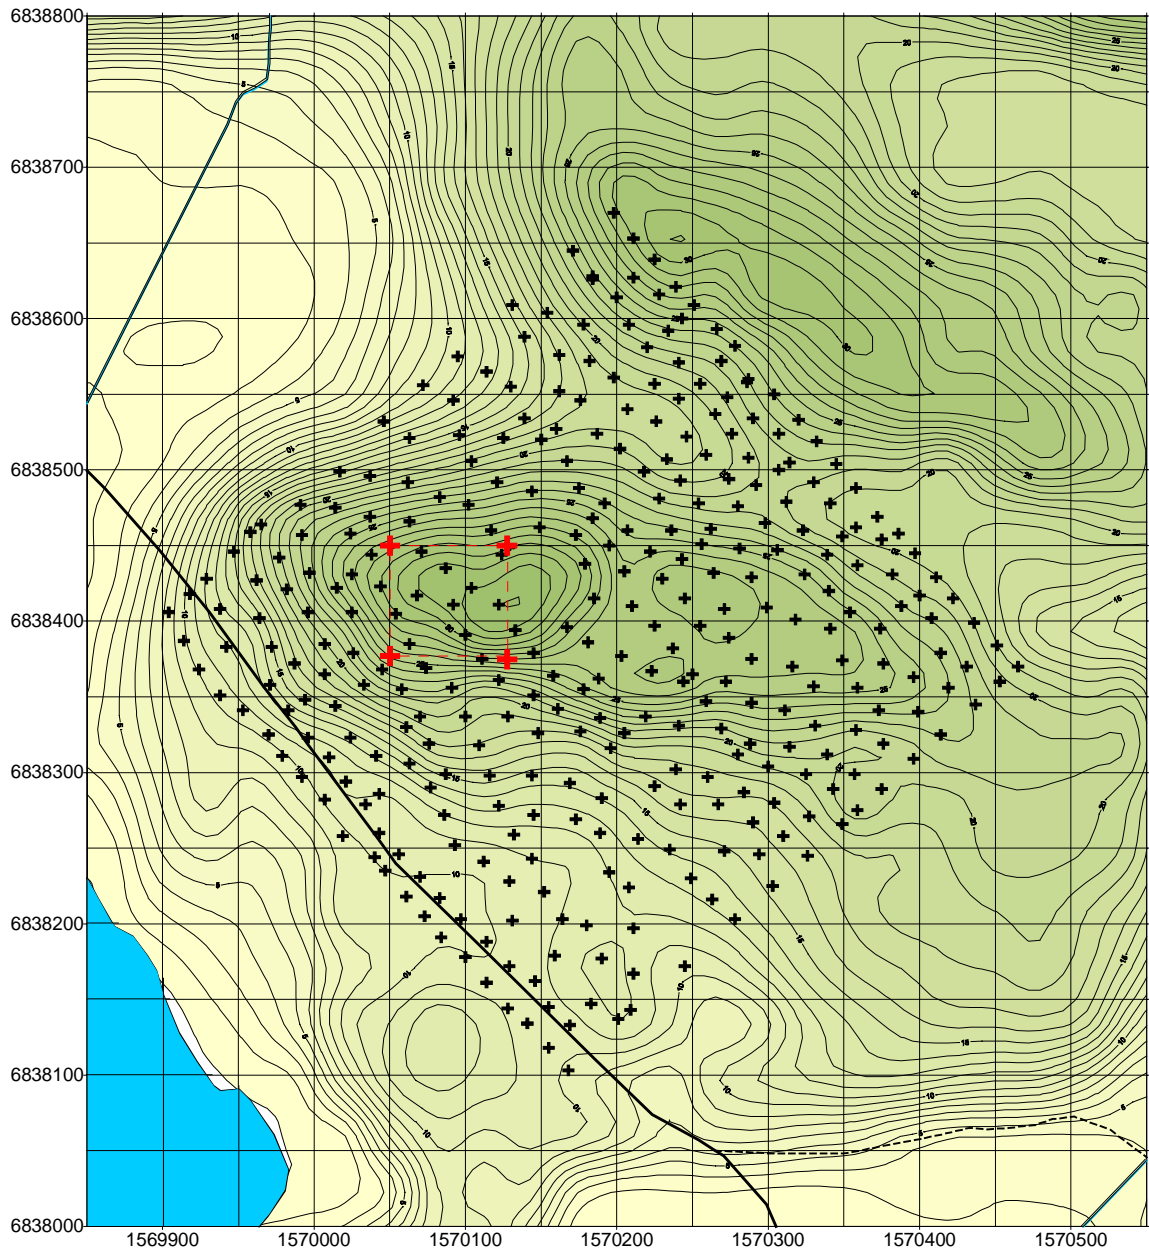
Figure 3-1 Map of area with locations of grid points recorded with GPS. Pluses represent GPS positions. The two linear features are roads where positioning was done with GPS. The dashed square outlines the cave area.

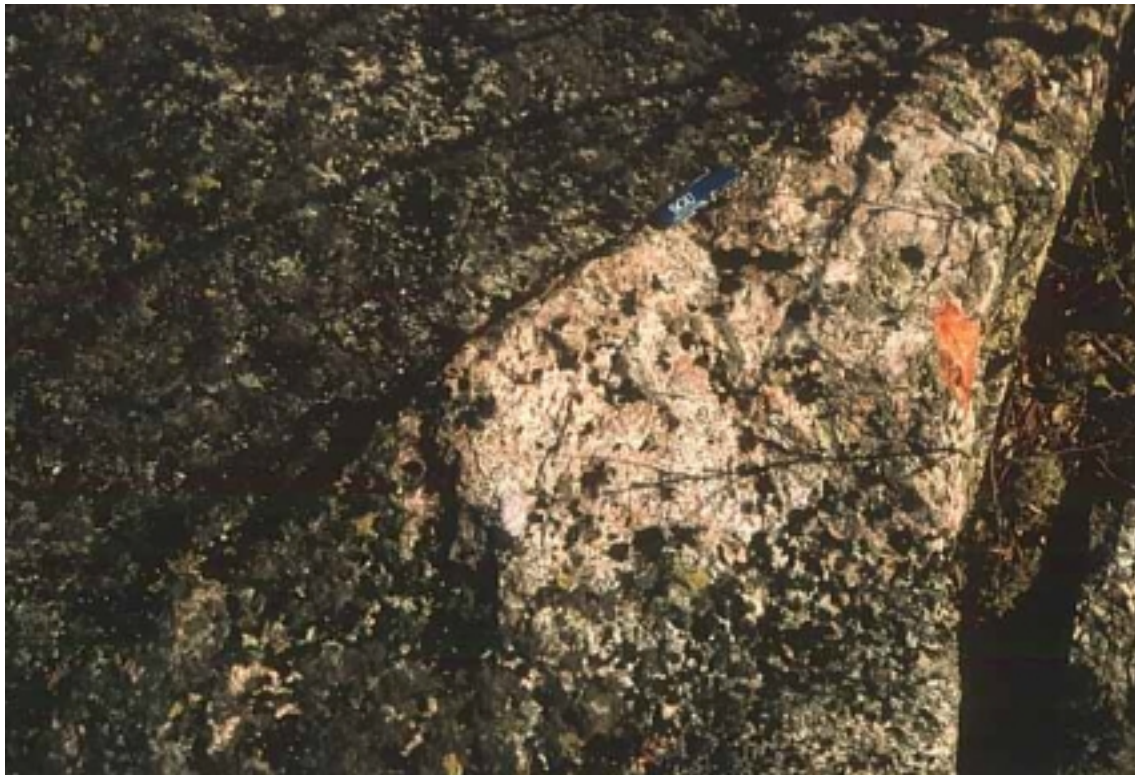
Figure 4-2 Example of a pegmatite vein.

In the exposed parts of the investigation area veins of pegmatite are rather common, figure 4-2. A few veins of granite/aplite were also observed. The thickness of the veins varies from 1 cm to 2-3 dm, and the color is red. Most veins dip steeply. The strike, on the other hand, is highly variable.

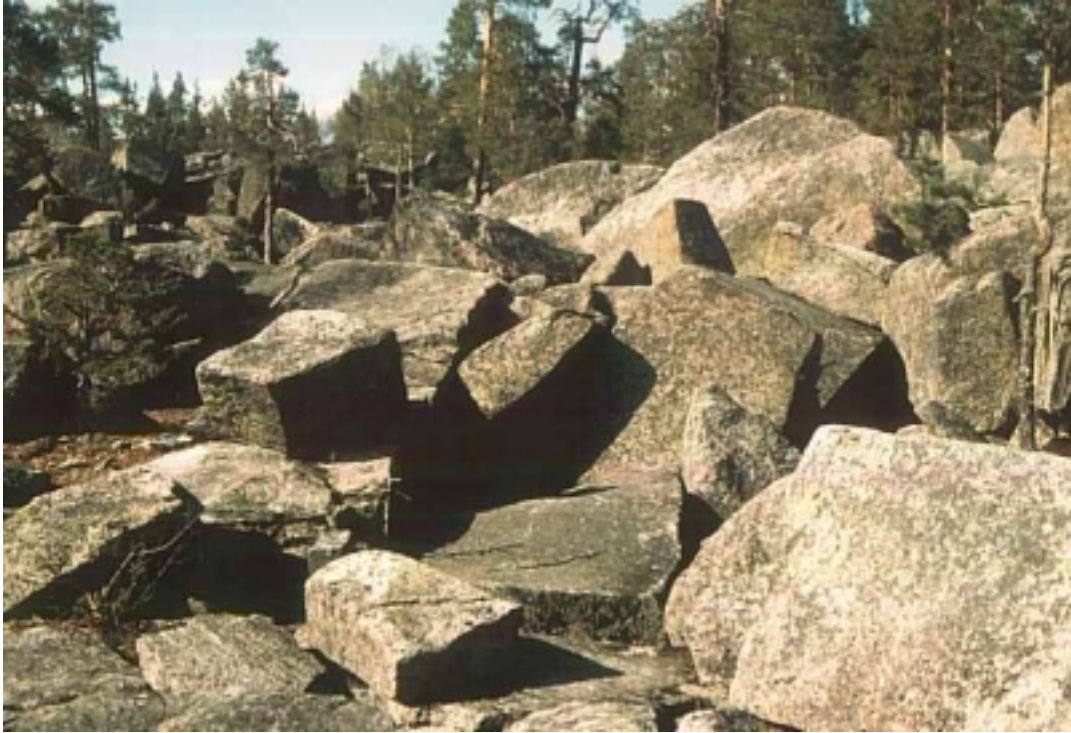
Figure 4-3 Overview of blocks in the central part of the cave area.

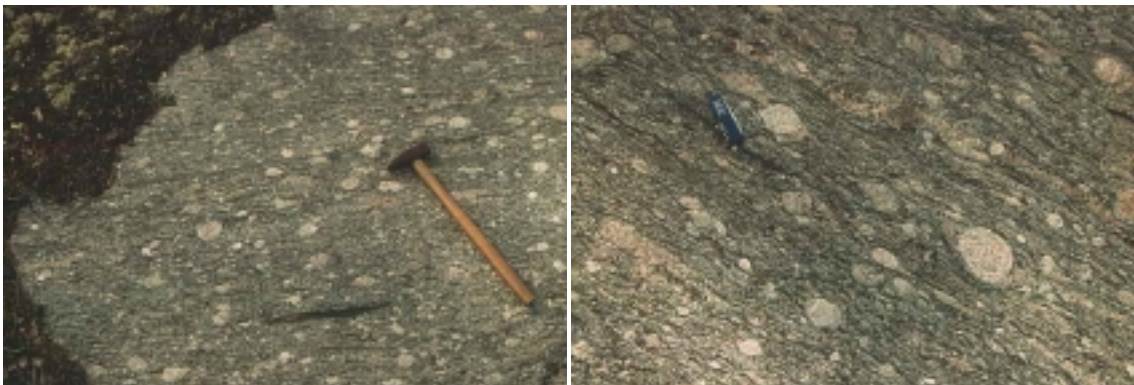
Figure A1-1 Outcrop of augenbearing granodiorite at Observation no. BOD980001. Right picture shows detail.

Observation no. **BOD980001** (6838935; 1570075) GRANODIORITE, gneissic, redgrey, augen texture, Figure A1-1.

The rock is intruded by numerous microcline augen, both long and rounded (≤ 10 cm), and a rather dark, biotite-rich matrix. Some drawn-out fragments of meta-argillite containing skarn lenses exist. There are plentiful of garnets, generally in the form of aggregates (≤ 5 cm), and cordierite. Concordant sills of granite/aplite occur occasionally. The granodiorite is strongly deformed, and in part mylonitic.

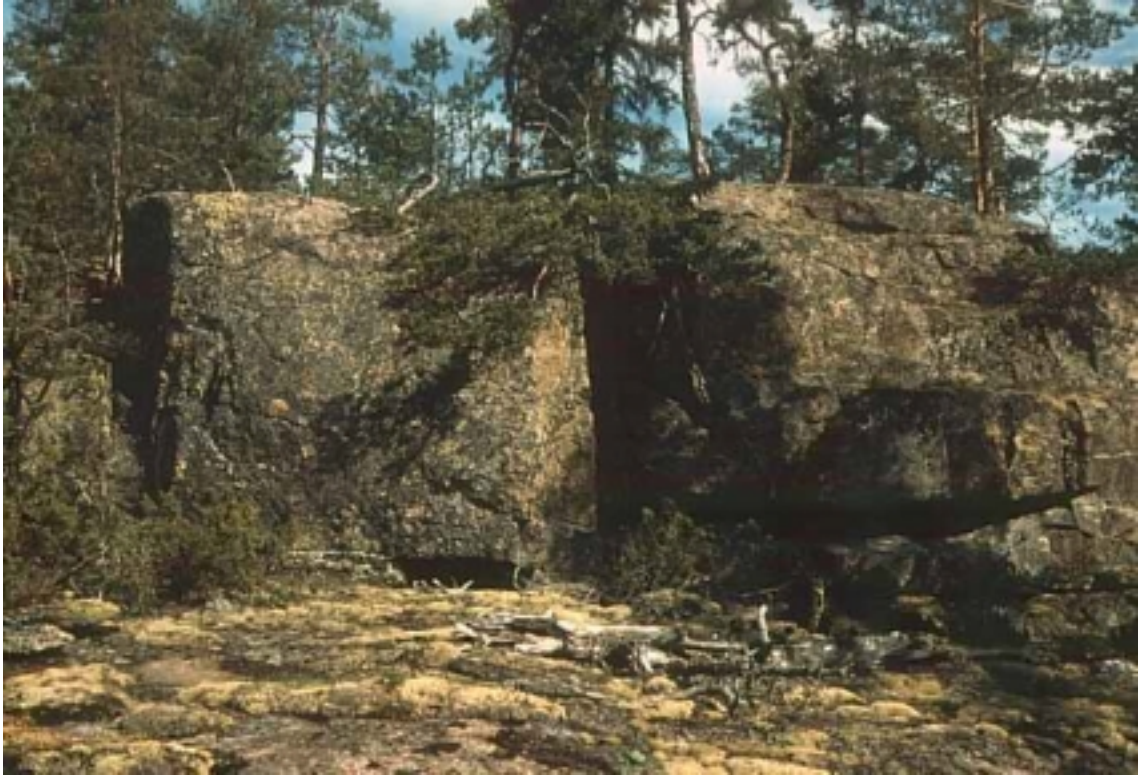
Figure A1-2 Perpendicular fracture system illustrating the formation of blocks at observation no. **BOD980006**.

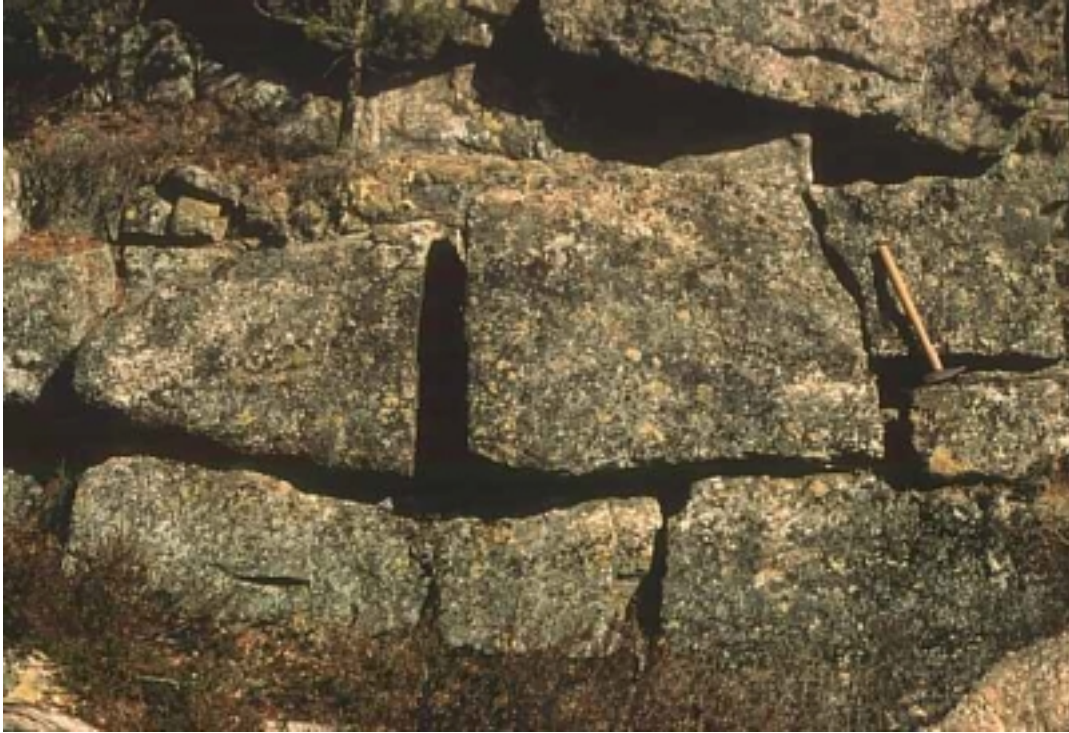
Figure A1-3 Perpendicular fracture system shows the formation of blocks at observation no. BOD980007.

Observation no. **BOD980007** (6838955; 1570400), Figures A1-3 and A1-4.

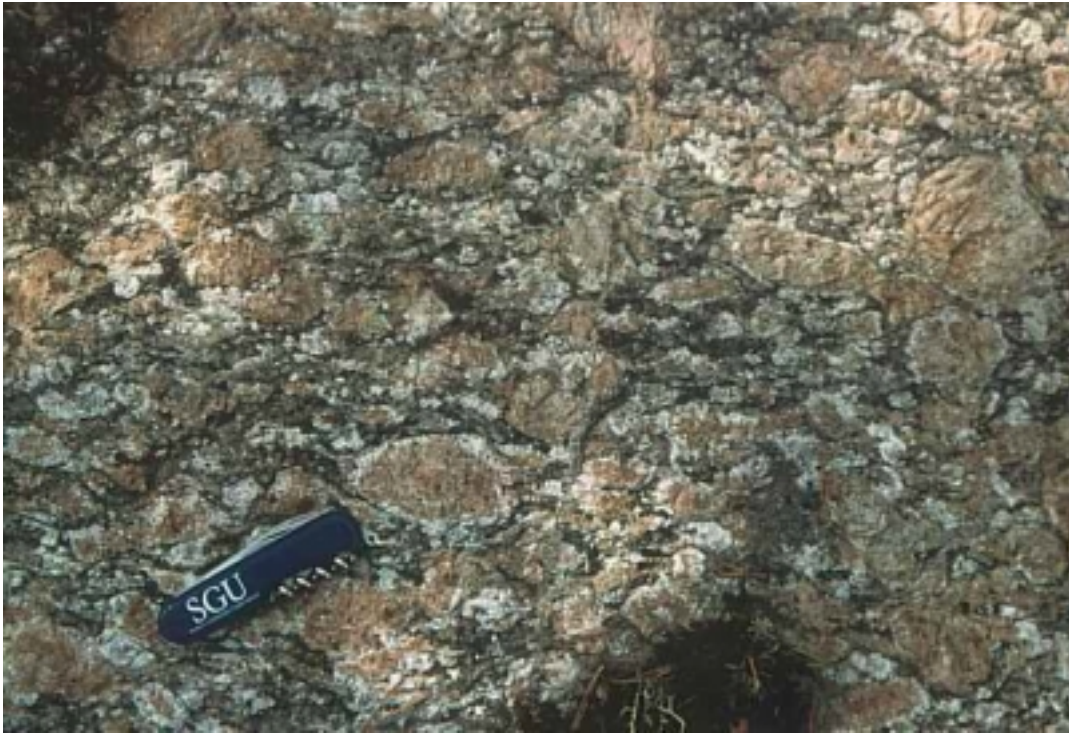
Figure A1-4 Outcrop with augenbearing granite/granodiorite at observation no. BOD980007.

Rock A is stuffed with red, microcline augen. It is sparsely veined with relatively thick veins of red granite/aplite. A few minor streaks of equigranular granite is observed, and garnet generally occurs. Rock B occurs as numerous, large, either angular or strongly drawn-out, fragments in rock A. The meta-argillite, partly well preserved, contains some skarn lenses, and plenty of garnets and cordierite. The area is gneissic and almost mylonitic in some parts. A few veins of coarse pegmatite cut the schistosity at a low angle.

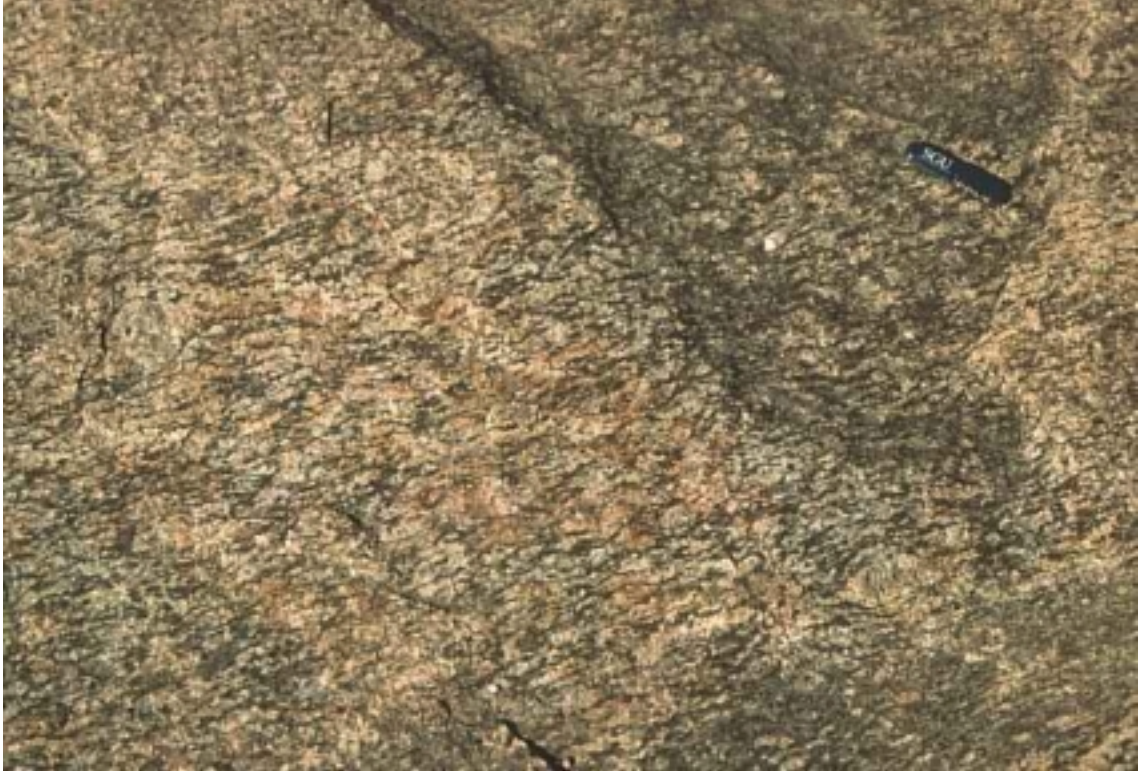
Figure A1-6 Outcrop with porphyric granodiorite in the cave area, observation no. BOD980013.
