Äspö Hard Rock Laboratory

Canister Retrieval Test

Retrieval phase

Project report

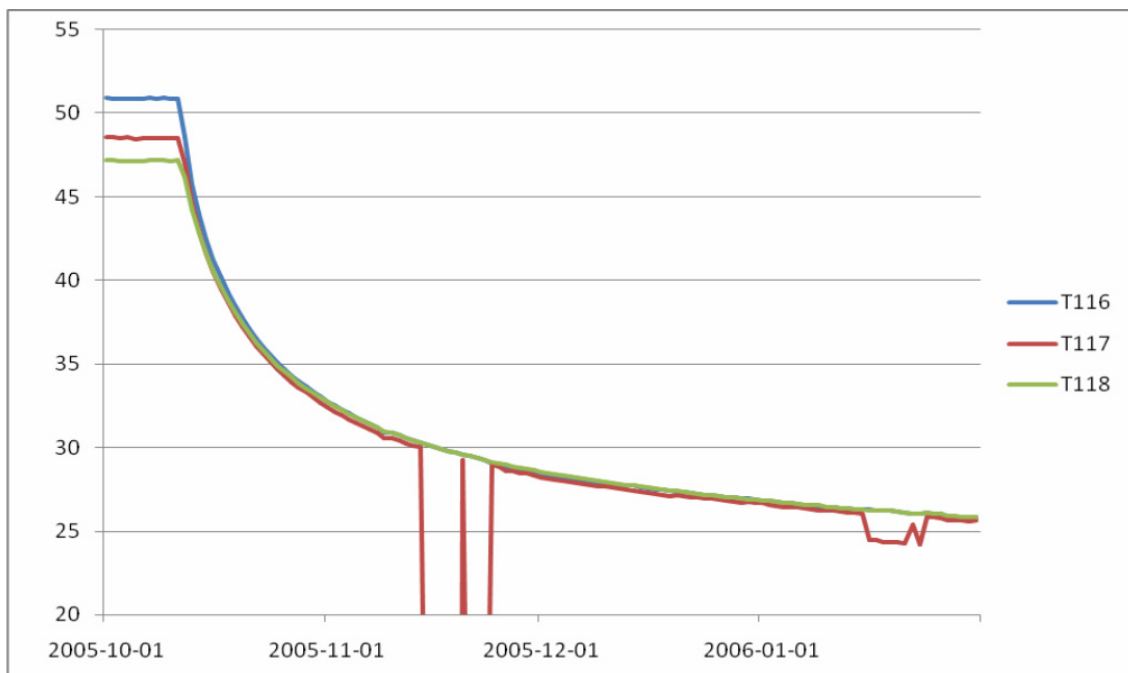
Figure 3. Buffer temperature between October 1st and 2005 and January 31st 2006. During this time the buffer temperature dropped 24 °C and was approximately 26 °C degrees when the buffer excavation was initiated. T116, T117 and T118 refers to temperature sensors. They are located at mid height of the canister, in buffer block R5. T116 is located closest to the canister of the three sensors.

To prepare for the canister retrieval process some measures had to be taken. The first of them was to turn off the power to the heaters in enough time to allow for the buffer to cool and allow manual work with the buffer. The goal was to have a buffer temperature of 25 °C at the time of buffer sampling and excavation. Power to the heaters was turned off 11th October 2005. The buffer temperature at the time of heater shutdown was approximately 50°C, three months later at the start of the buffer excavation the temperature had dropped to 26°C, Figure 3. The heater power was 1380 W at the time of shut down.

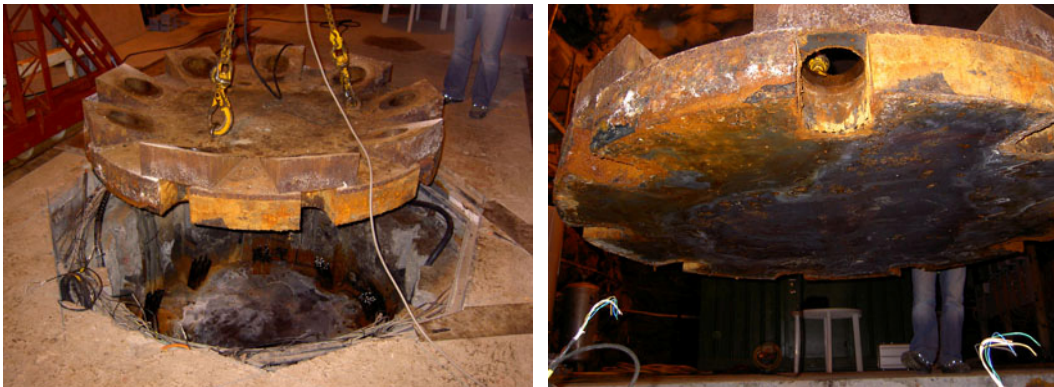
When all cables were loosened the lid was lifted without problems. Underneath the lid some expected corrosion products were found, Figure 5.

Figure 5. The steel lid is lifted from the deposit hole. Some corrosion is visible on the side and underneath the lid.

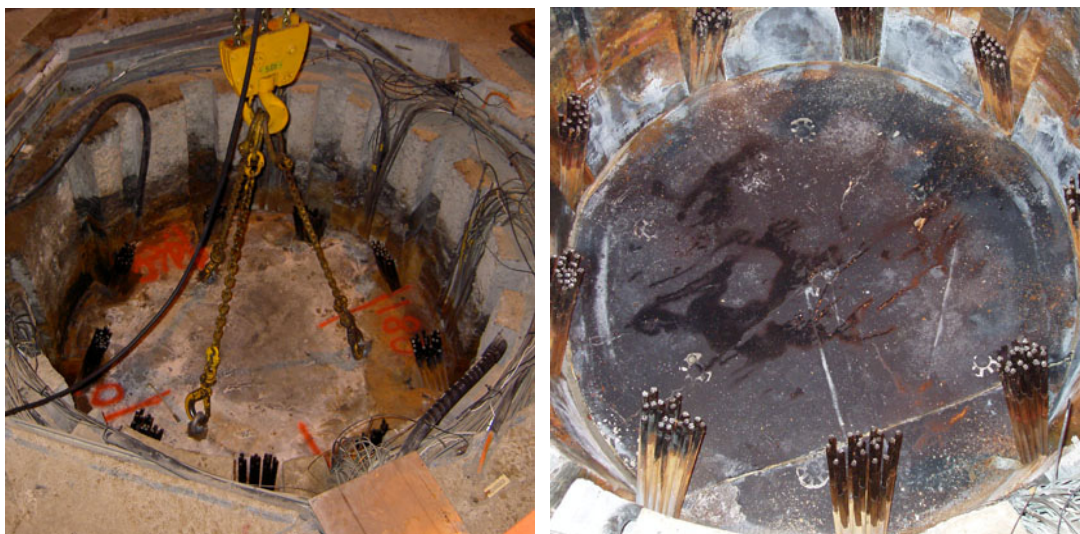
Removal of the plug was straightforward. The threaded lifting nuts casted into the block was cleaned and inspected. Since no issues with corrosion or damaged concrete were found steel loops were screwed into the nuts and lifting chains attached. Figure 6 shows the block just prior lifting and the status of the rubber mat underneath.

Figure 6. Lifting the concrete block. The lifting was straightforward and no issues encountered. To the right the rubber mat under the concrete plug is shown.

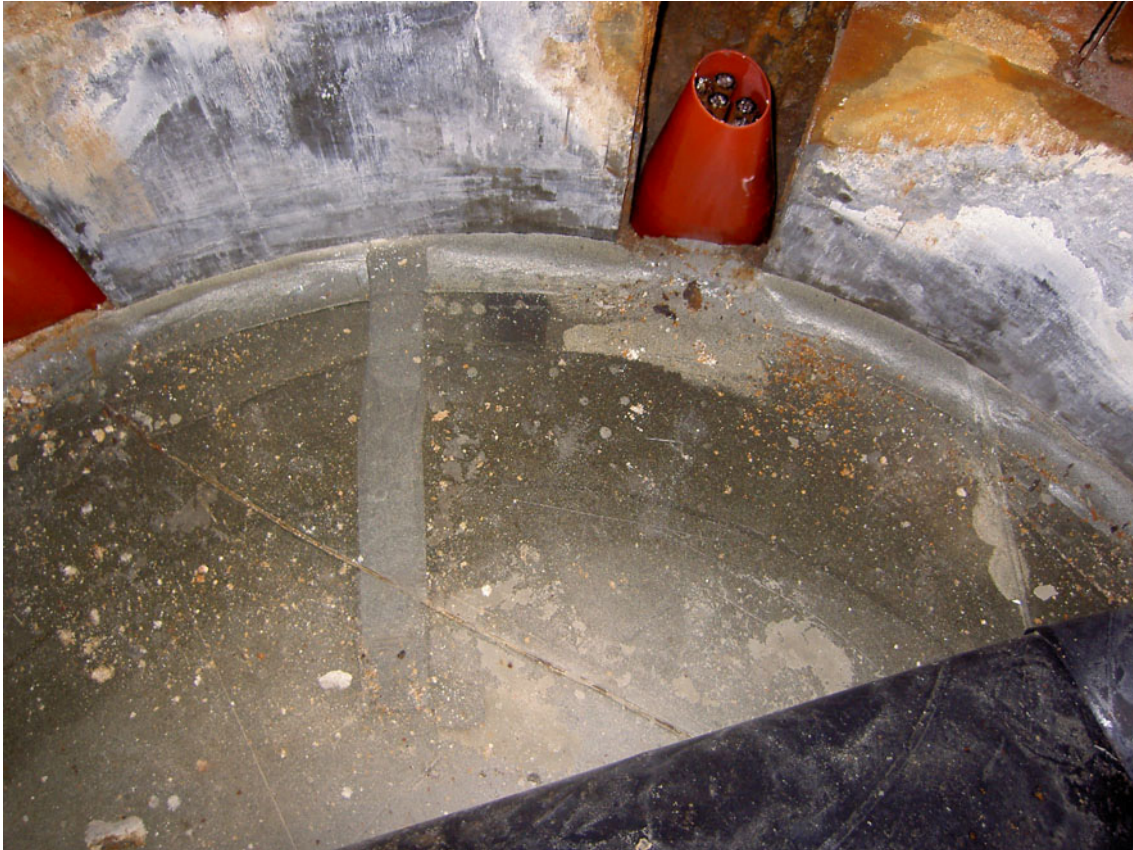
Removal of the rubber mat was also no problem. The buffer hadn't stuck to the mat and no damage on the buffer upper surface was found. Figure 7 shows the buffer surface underneath the rubber mat.

Figure 7. The upper buffer surface as it looked when the rubber mat was first lifted. No damage on the buffer could be found.

To avoid buffer drying and dirt falling onto the buffer a plastic sheet was always covering the buffer when no work was being carried out in the deposit hole.

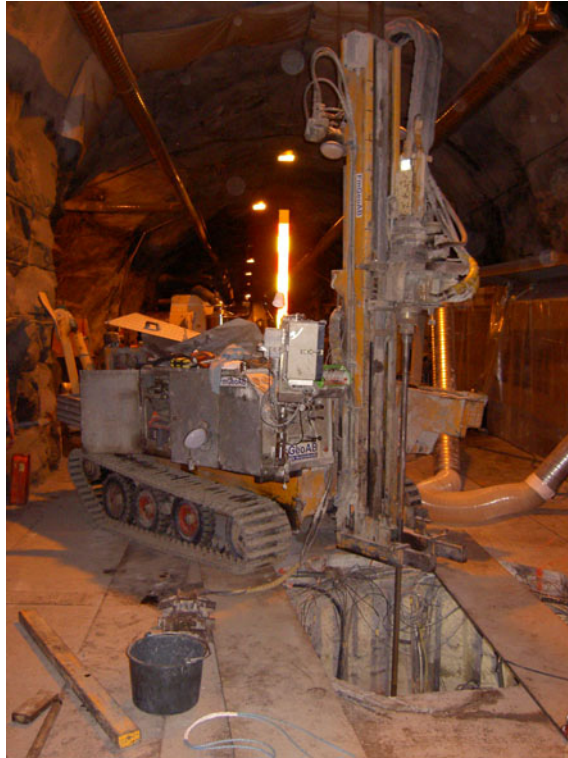
Most of the samples were taken from the buffer by core drilling from the upper surface of each installed bentonite block. The cores had a diameter of about 50 mm and a maximum length equal to the original height of the bentonite blocks of about 500 mm. The drilling was made from the tunnel floor with a rig designed for taking geotechnical soil samples, Figure 8. In addition samples close to the canister and the rock wall were taken by picking pieces from the blocks by hand. Furthermore, samples were taken close to the installed sensors. Larger pieces (up to $\frac{1}{4}$ of a block) were also sawn out from the blocks and stored. The rest of the buffer material was removed and thrown away.

Figure 8. Rig for performing the buffer core drilling. The machine is designed for geotechnical soil sampling.

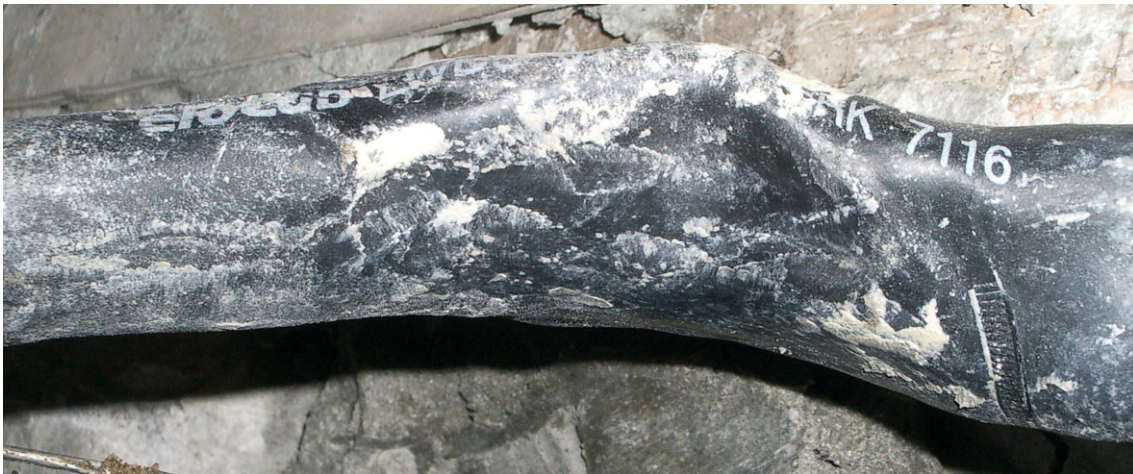
During excavation of the buffer the power cables to the heaters was gradually freed. The cables show wear and tear, both pressure and twist type damages, from the buffer swelling pressure, Figure 11. The damages are found at several positions along the cables. These damages have been looked at by the cable manufacturer and it has been established that the damages are only of cosmetic type, no degradation of cable functionality can be connected to these damages.

Figure 11. The power cables show damages from the bentonite swelling pressure at several positions.

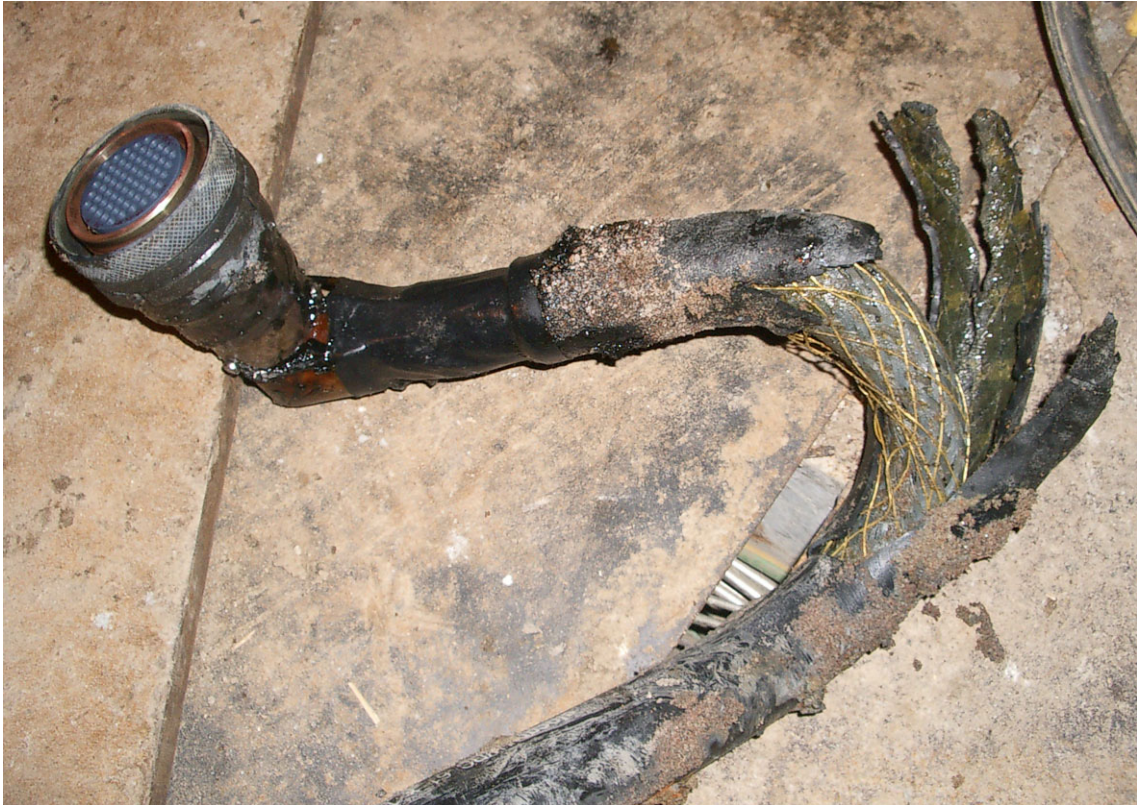
When the upper lid was removed and the cable underneath became visible more damaged was revealed. The cable shield close to the connector was at both cables severely damaged. As seen in Figure 12 the shield has almost completely loosened from the cable exposing the ground wiring.

The damage itself is not reason for the failure of the cable, but the moist conditions have lead to water entering the inner parts of the cable and causing short circuits. These damages have been found to be the main reason for the failures of the heaters.

The cables was analysed by the manufacturer. Comparative tests have been carried out with a unused cable as reference. The analyses have only been able to prove some crystallization of the cable shield material. It is very likely that this process have made the cable shield brittle which eventually have lead to fracturing. The fractures have been penetrated by water with short circuits as result.

Figure 12. Damage on the heater power cable shield. The damage is located between the canister lids and close to the gisma connector.

The cable was specified to be able to withstand the high temperatures that they were exposed to. However the heat together with the moist conditions has evidently been too much.

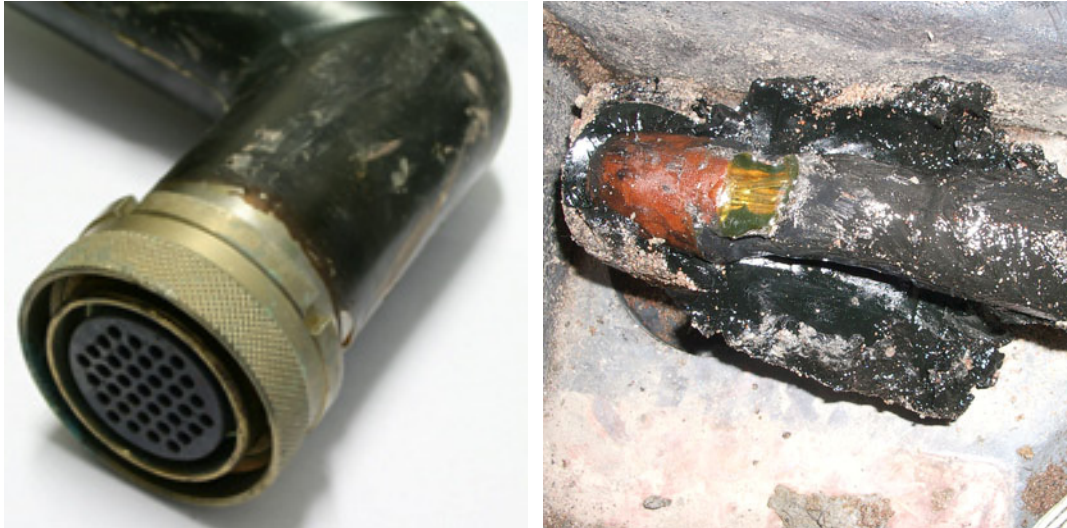
A polyurethane cast was used to seal the connection between the Gisma connector and the cable, Figure 13 left. Also the polyurethane cast shows significant damages, the material has been completely dissolved during the experiment. Using only the thumb pressing gently on the remaining sticky material was enough to remove it, Figure 13 right.

Figure 13. *The polyurethane cast sealing the connection between the Gisma connector and the cable. The left image shows a new cast and the right image the state of the used.*

Also this part of the cable has been analyzed. The results show that the function of the cast is still intact even if the polyurethane has completely been broken down to its chemical components. The power loss can therefore not be caused by this part of the power cable.

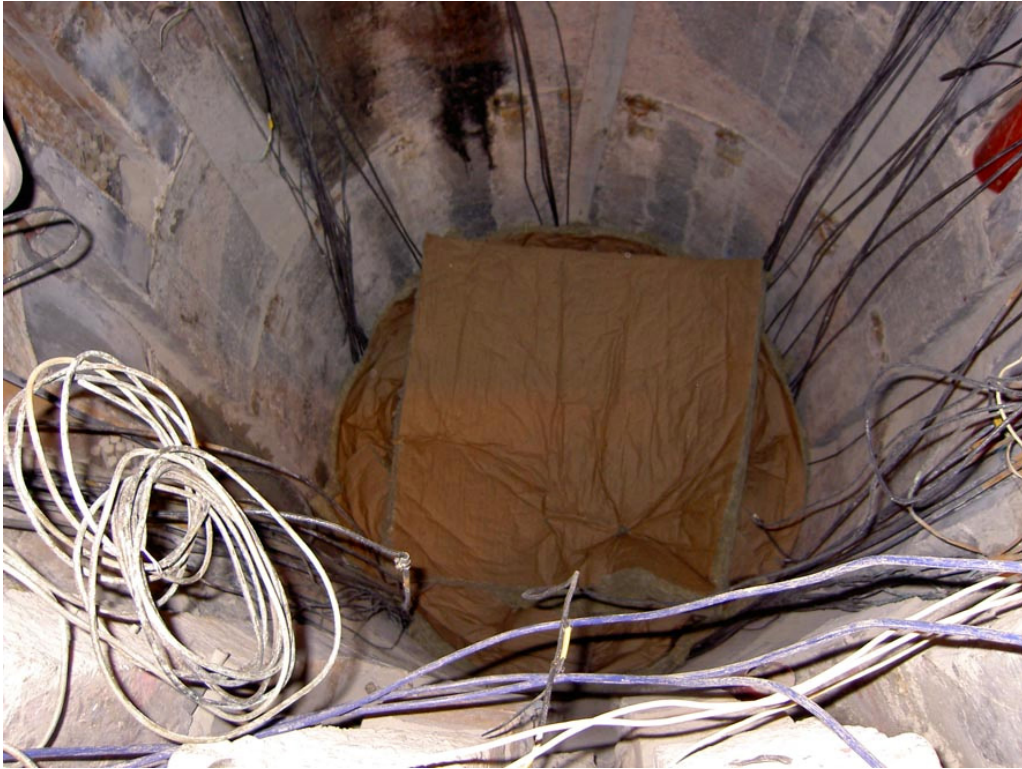
During the short period of time the system was running no errors were found and the system worked as designed. The deposit hole was insulated to prevent too much ventilation and temperature loss during the test. Figure 14 shows the deposit hole with insulation. Figure 15 shows the temperature increase of the buffer during this test. The power to the heaters was set at 1 kW initially and increased to 2 kW after one week. During the test the temperature of the buffer closest to the canister was raised from 23 to 32°C.

Figure 14. New cables were fitted and the heaters restarted. No issues were encountered during this test. The deposit hole was insulated to prevent too much ventilation and temperature loss.

A simple and quick way to find out the condition of the heaters inside the canister without open the canister was to replace the power cables and run the system for a period. This was done when the buffer sampling was completed and the buffer disintegration process was being prepared.

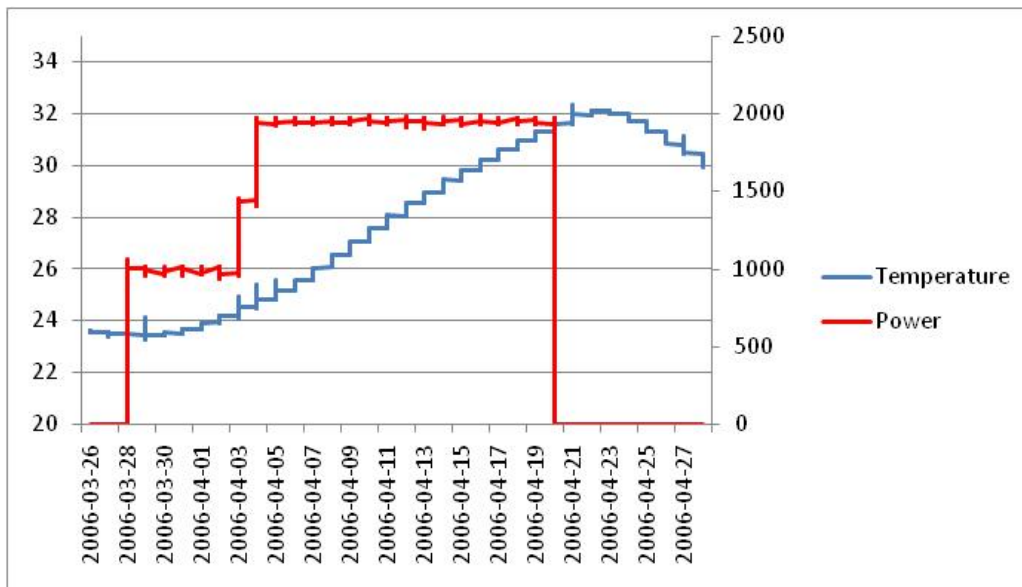
Figure 15. Buffer temperature development during the short test of the heaters with new power cables.

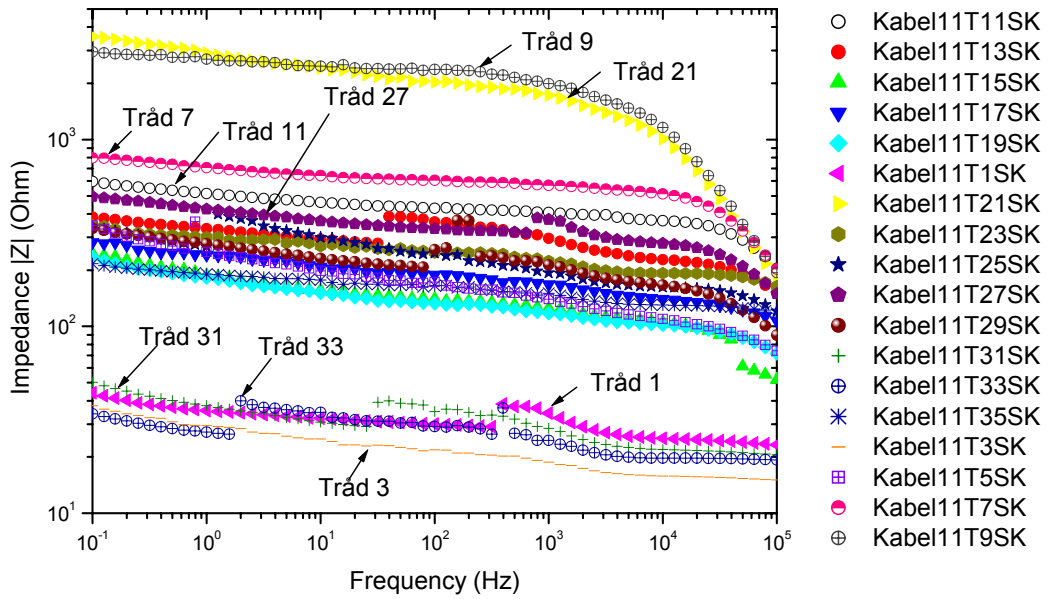
The first test was carried out when the canister was still in the deposit hole and the buffer sampling and excavation had just reached the canister. At this point the power cables had never been removed from the canister. Measurements concluded isolation issues in the system. Electrical resistance between the power wires and ground was low, implying short circuit issues. The measurements cannot pin point the origin of the failure, merely conclude the failure. Figure 16 shows a sample of the results from the test.

Figure 16. Results from the EIS measurements. The low resistances in the system is clearly visible. Values as low as 10^1 to 10^2 are measured. (“Tråd” and “kabel” are Swedish words for wire and cable.)

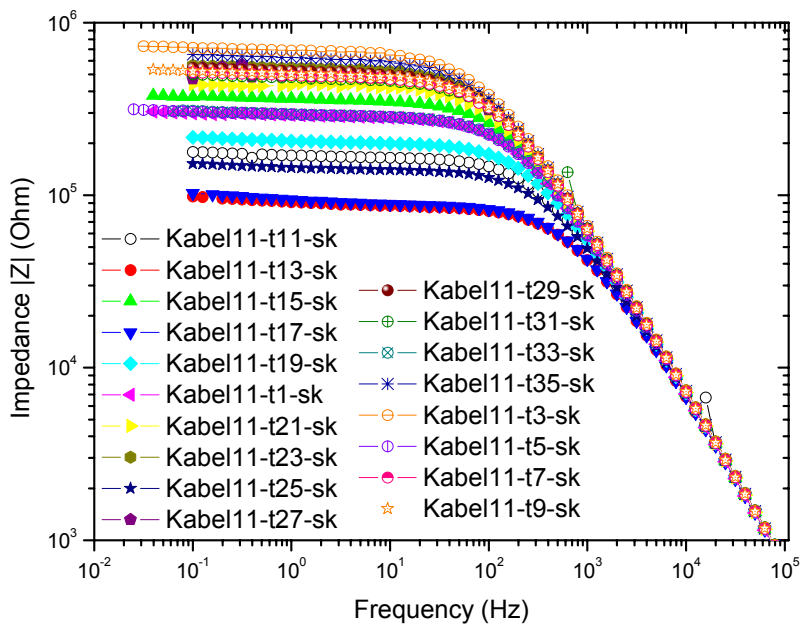
The second EIS measurement was done just prior opening the canister at the canister laboratory in Oskarshamn. At this test the power cables were removed and excluded from the test. The measurement equipment was connected to the GISMA connectors on top of the canister – the same connectors that the power cables were connected to. Results from the second test imply that the heater system inside the canister is fully operational. Isolation values are good and no other problems can be found. This verifies the earlier findings that the main problem is outside the canister (brief test of the heaters with new power cables that was conducted in the deposit hole, chapter 5.4). Figure 17 shows the isolation values from the second EIS test. Values in the right graph are significantly better than in the left.

Figure 17. The right graph are from the second measurement, without the power cables. In the right graph the isolation values are greatly improved over the earlier measurement. This indicates that the problem is within the power cables. (“Kabel” is a Swedish word cable.)

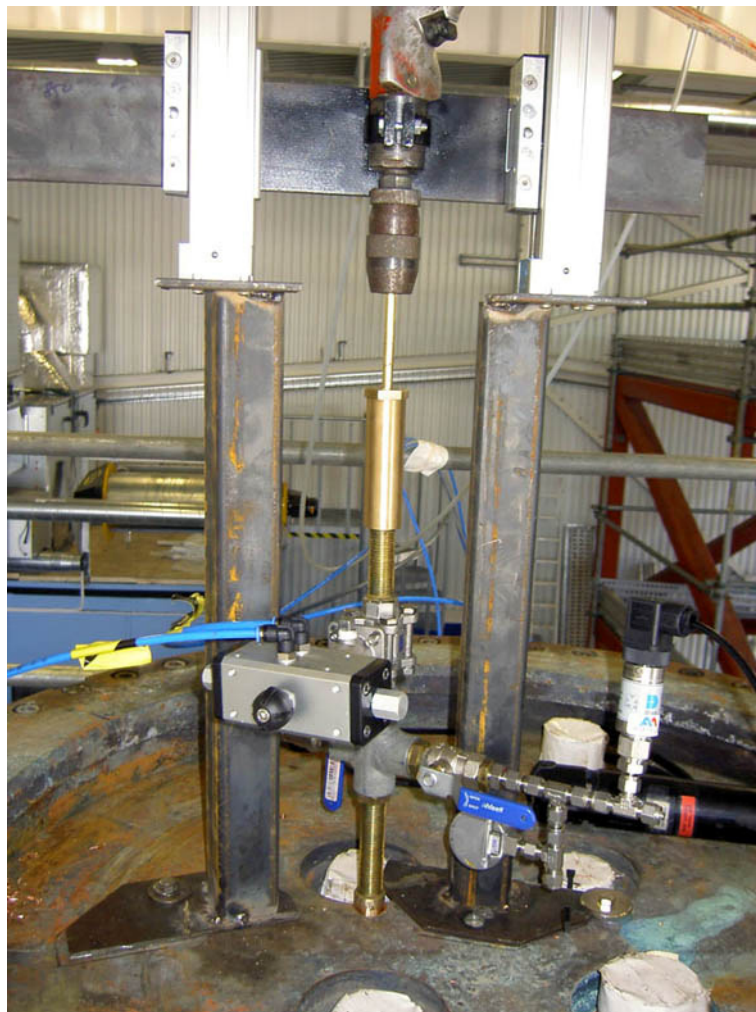
When the valve was finally mounted the gas sampling could be performed. The additional equipment on the hot tap is pressure sensors and additional valves for adding additional sensors or equipment. Figure 19 shows the set up just prior puncturing the canister. In the picture the air-driven drill is visible as well as the remote controlled drill height adjusters (the two vertical steel bars).

Figure 19. Mounting of the valve with the hot tap equipment. The picture is taken just prior the process of puncturing the canister.

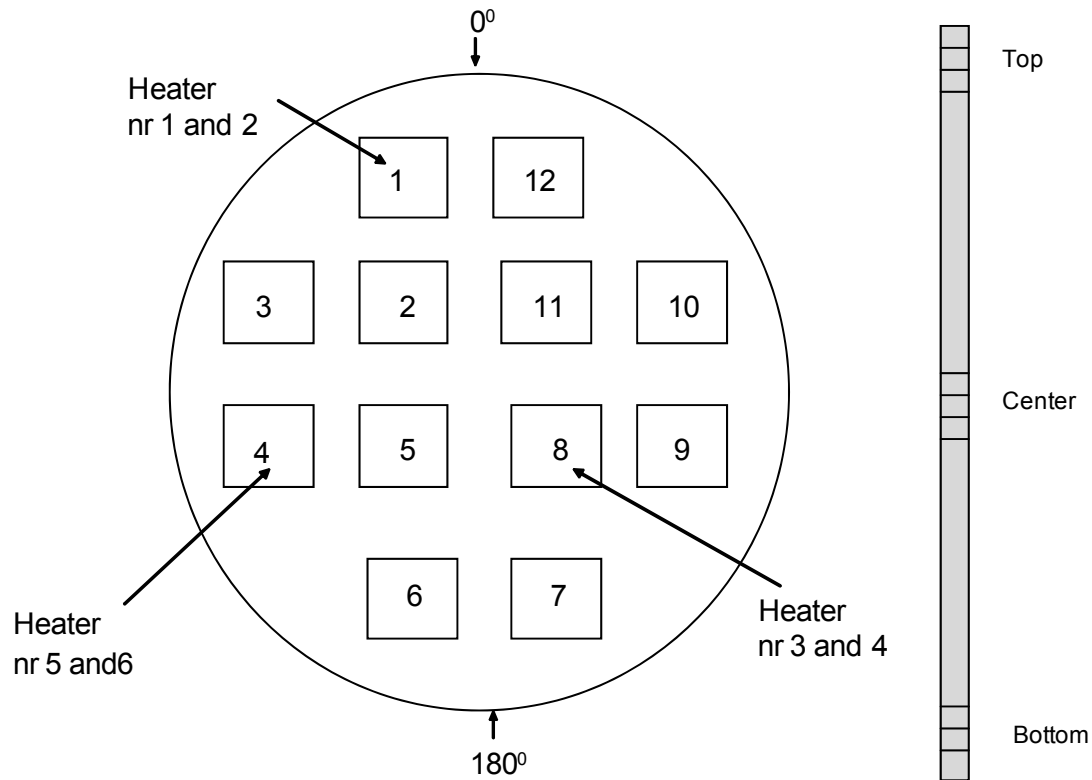
Moisture content, distribution and possible gas release from the magnesium oxide in the heaters have been discussed quite extensively. These have been tested by sampling the heaters. Six heaters were sampled at different positions and analyzed. Figure 20 shows the position of the sampled heaters and a schematic image of the sample positions within each heater.

Figure 20. Sampled heaters. Six heaters were tested from the canister, two from each marked position. To the right a schematic image of the sample positions within each heater is shown.

The analyses conclude that the difference in moisture levels inside the heaters were significant, four of the heaters had the highest levels in the upper part and the remaining two in the middle. In the most extreme case one heater element had 0.29% moisture in the bottom and 0.91% in the top. Earlier studies have shown that the average value for a used heater of this type (Backer) has a moisture content of 0.58%, Studsvik/N(K)-03-026 [4]. The study further concludes that chemical substances, mainly acetic acid that are originating from the heaters can have a negative effect on the leader-ground isolation in the electrical system. These issues will most likely improve over time, and eventually be nonexistent. Early problems with the heaters might have been caused by this issue, the main reason for the total heater failure is however still considered to be the damages of the external power cables.

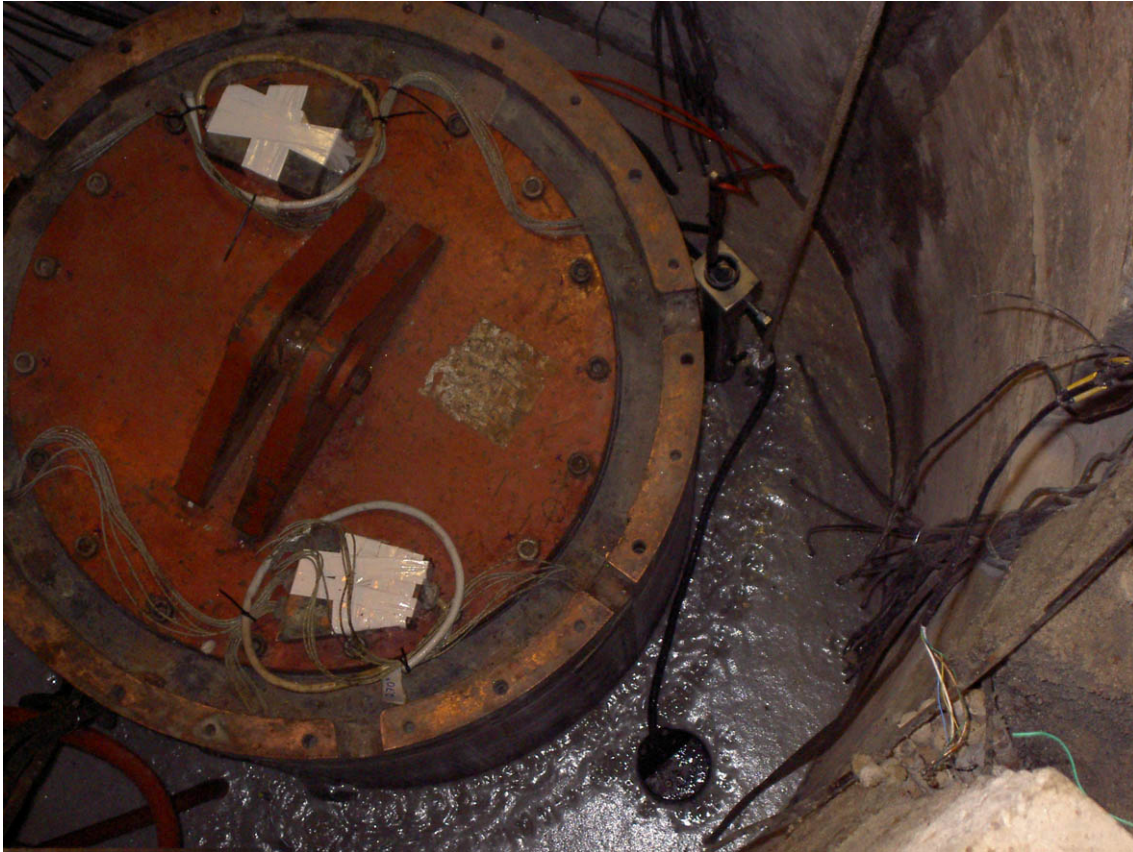
After installation and fine adjustment of the freeing equipment in the Äspö HRL’s retrieval tunnel, remaining buffer around the deposited copper canister was to be removed using the hydrodynamic technique. In trouble-free operation, the hydrodynamic technique worked very well for dissolution and removal of bentonite. Figure 22 shows the system in the deposit hole as it is seen from above during operation.

Figure 22. *The buffer disintegration system in operation. The canister is visible in the center.*

Unfortunately a number of disturbances occurred during the operation of the disintegration process. Pumps were clogged and damaged by sensor wiring and garbage, valves malfunctioned and the controlling computer system didn't always function according to specifications. Due to this a correct assessment of the efficiency of the process is not possible. Some idea of its efficiency in one day of trouble-free operation can be deduced, however. Within a data collection time of 7 hours and 2 minutes some 656 kg of bentonite was slurried and dewatered. This gives a slurring efficiency of about 93.3 kg of bentonite/hour. With this efficiency, it should be possible to free a copper canister embedded in a bentonite buffer (2 blocks above the canister and 10 rings covering the entire canister height) of about 16.5 tonnes in just under 180 hours.

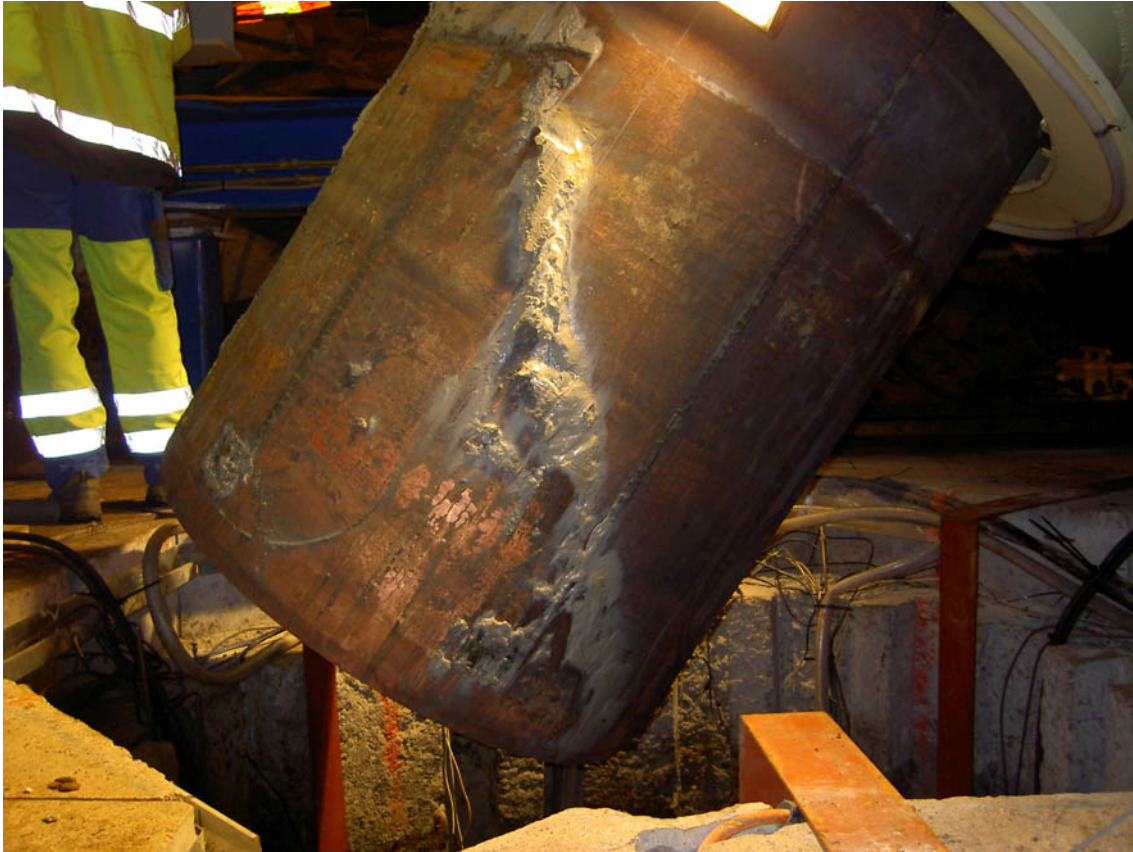
Since the disintegration of the buffer was somewhat uneven around the sides of the canister the process was discontinued when the canister bottom was visible at a section of the canister. Even though the canister was secured with jacks at the top the removal of the bentonite at sections underneath it could make it unstable and fall against the rock wall. This resulted in the fact that there was still bentonite about 100 cm up on sections of the side of the canister at the time of retrieval, Figure 24.

Figure 24. Some remaining bentonite on the canister. The uneven levels of buffer around the canister after the disintegration forced the disintegration to be stopped before the entire canister was freed from the buffer. Despite this it was no problem to lift the canister from the deposit hole.

The fact that there was some buffer left around the canister was not an issue, it loosened easily from the remaining buffer and could be retrieved from the deposit hole.
