R-08-134

Tests to determine water uptake behaviour of tunnel backfill

D Dixon, Atomic Energy of Canada Limited

December 2008

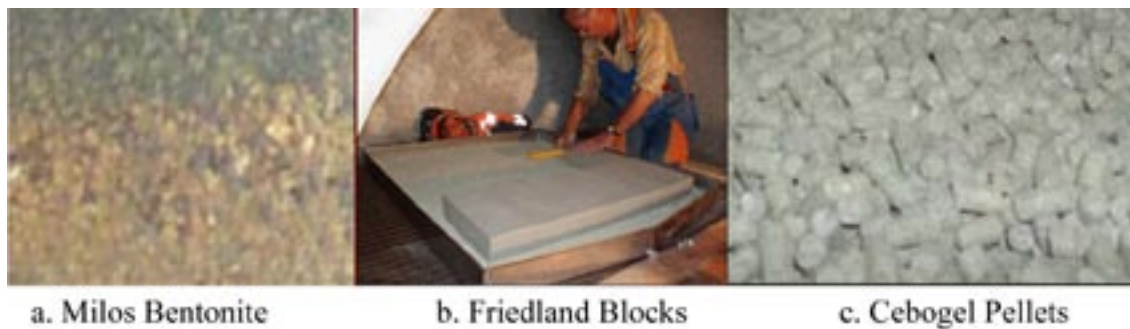
Figure 4-1. *Materials used in testing.*

The crushed bentonite used in this study is known commercially as “Minelco” bentonite and was sourced in Greece. This material was used in Tests 1, 21, 22, 27, 28 and 29 and is shown in its “raw” form in Figure 4-1a. It should be noted that tests 27–29 had Minelco used as flooring and Cebogel was used to fill the remaining unfilled test volume. Information regarding its composition and basic characteristics can be found in Section 4.2.

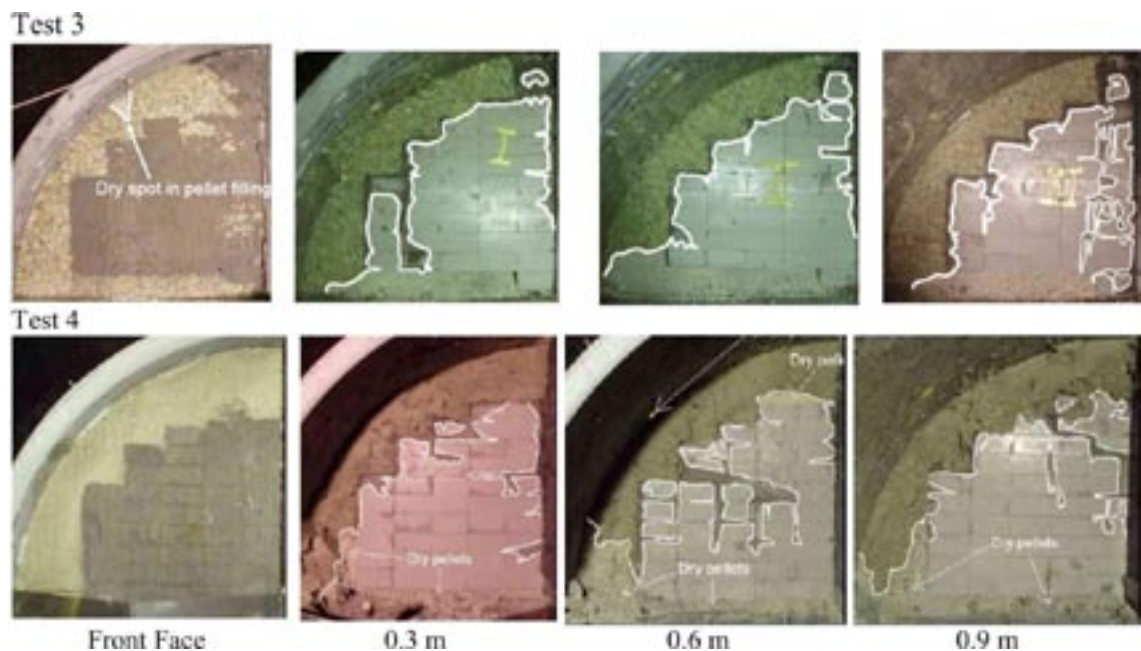
Figure 6-3. Wetting of Tests 3 and 4 (0.1 l/min inflow for 2 days).

Tests 3 and 4 operated for 46.5 hours with water being supplied at the pellet-concrete interface at the mid-height of these assemblies, at 0.6 m distance from the front face. Figure 6-3 shows the front face of these tests at the time of dismantling. Water exited these assemblies at approximately the same time, beginning about 130 minutes after the start of water inflow, but outflow was not measurable until about 24 hours into the test. Water was observed to exit along the horizontal contacts between the pellets and the blocks, the elevation rising with increasing time. By the end of testing, the pellet-fill, excepting the lowermost regions underneath the blocks was largely saturated. At that time almost all the water entering these tests was rapidly transiting the system although very little water had entered the block-filled regions and there was little evidence of substantial ongoing wetting at the end of the test, as can be seen in Figure 6-3

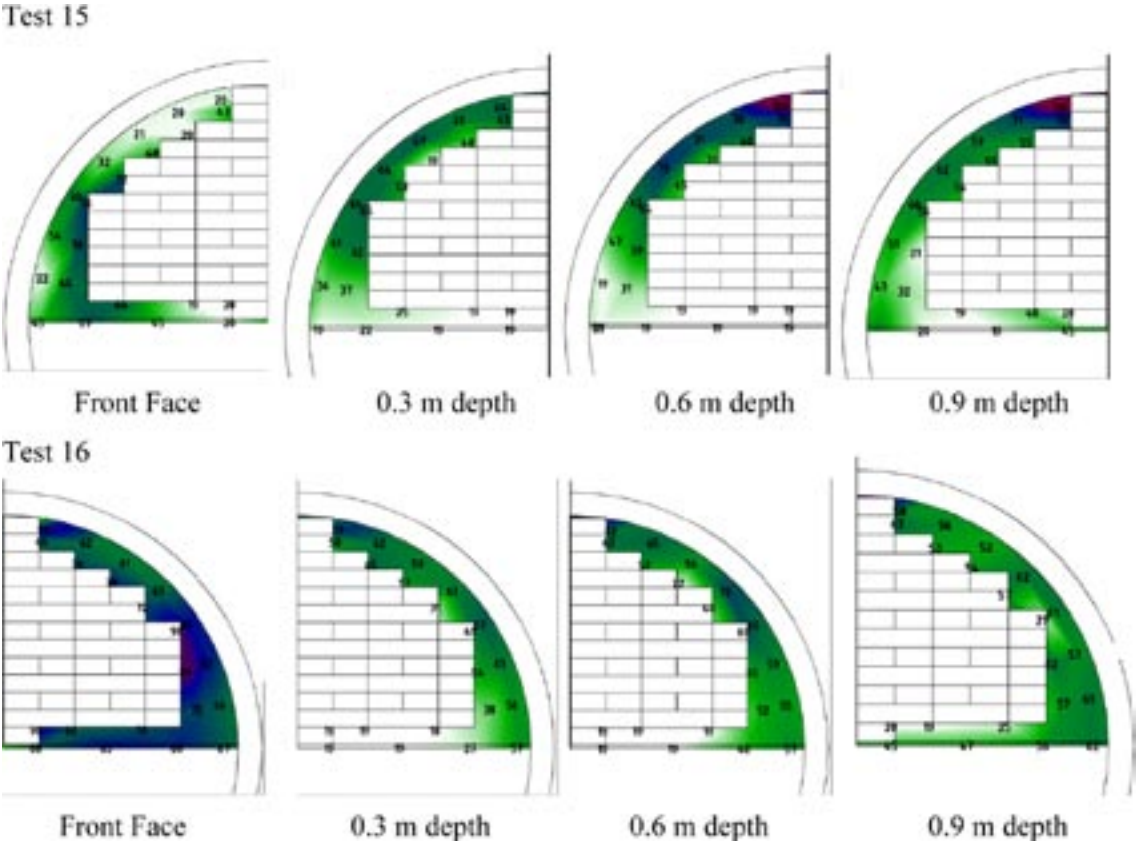
Figure 6-15. Water distribution at end of testing: Tests 15 and 16.

Test 16 had 0.25 l/min supplied to it and experienced water outflow 6 hours and 20 minutes (95 litres inflow) into the test. Initial outflow occurred along the 3 horizontal surfaces where the blocks and pellets are in contact. Within 5 minutes of outflow starting, flow was observed to be exiting the joint near the crown of the assembly and this rapidly established itself as the primary flow path for exiting water. This location was associated with the Friedland clay blocks and considerable erosion was observed in the remaining 18 hours of testing. Inflow resistance gradually increased during operation of the test although the magnitude was not different that other tests done as part of this study. A detailed assessment of the observations made during test observation is provided in Appendix A and is discussed with regards to overall system operation in Chapter 7.

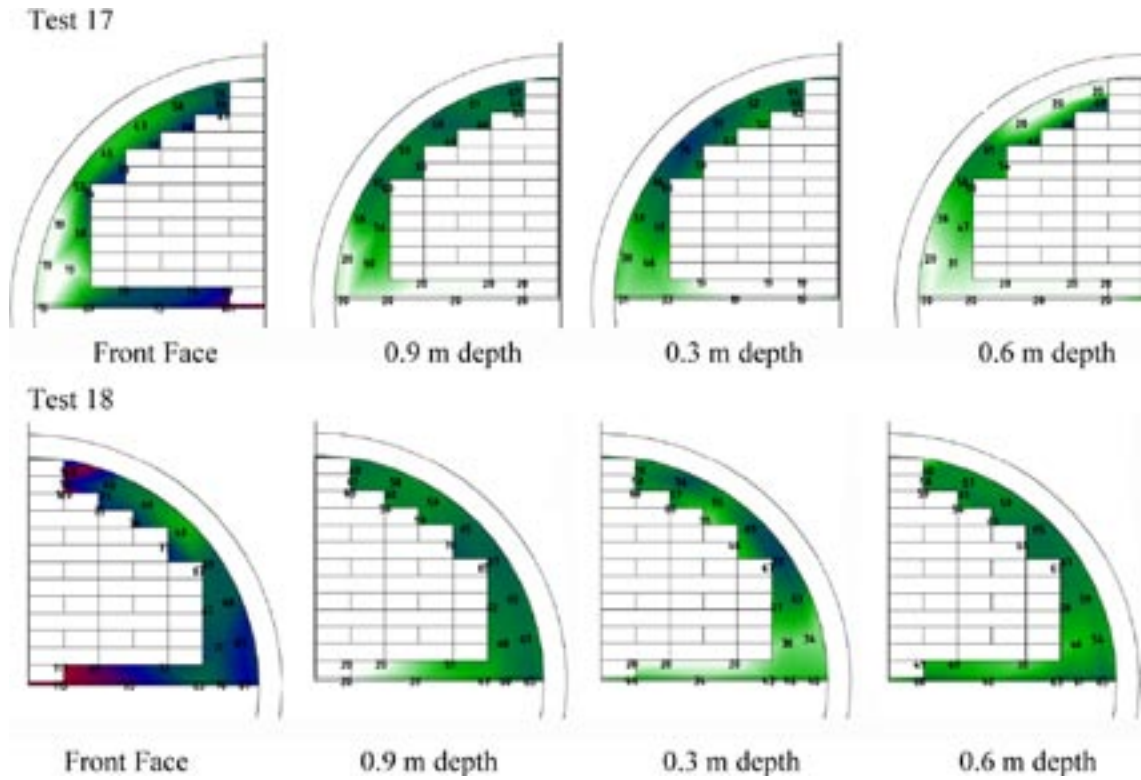
Figure 6-17. Water distribution at end of testing: Tests 17 and 18.

Test 17 was supplied with 0.08 l/min for a period of 48 hours. Water began to exit the front face of Test 17 after approximately 2 hours and 50 minutes of test operation via a vertical joint between the outermost blocks. This was likely the result of water moving along the horizontal pellet-block contact until it found a small vertical passage. This pathway through the blocks persisted and resulted in substantial erosion. Water movement was dominated by the internal flowpath but movement along the other horizontal contacts between the pellets and blocks was also evident, as can be seen in Figure 6-17. Test 17 exhibited a relatively smooth and rapid development of its inflow resistance; the peak resistance was achieved after about 24 hours after which it stabilized. The magnitude of inflow resistance was not however discernibly different than other tests done at this inflow rate. A schematic showing the manner in which water entered and moved through this test is provided in Figure 6-18. Detailed presentation and discussion of the test results is provided in Appendix A and its significance is assessed in Chapter 7.

Test 18 was supplied with 0.25 l/min for 48 hours. Water began to exit the front of the assembly after only 70 minutes of operation, exiting the test from the lower corner where the floor, concrete tube and pellets intersect (Figure 6-17). This location continued to produce a limited amount of outflow for most of the test's duration but had very little eroded material associated with it. After 7 hours into the test water was exiting the system at the lowermost horizontal contact between the clay blocks and the pellet materials. After 24 hours outflow was dominated by a single point located near the top of the test, just above the last horizontal layer of blocks (see Figure 6-17). This was nearly the identical location where channelling flow was observed in Test 16 (0.25 l/min for 24 hours) and considerable erosion of block materials was observed. Figure 6-18 provides a schematic showing the movement of water into this test. The resistance measured is essentially identical to that observed for Test 16 during its 24 hours of operation, gradually increasing towards an equilibrium value of approximately 80 kPa until approximately 40 hours into the test when a very marked drop in inflow resistance occurred (from 80 kPa to 50 kPa). This is likely associated with further development of the main flow channel. Details of the test are provided in Appendix A and the overall system behaviour is discussed in Chapter 7.

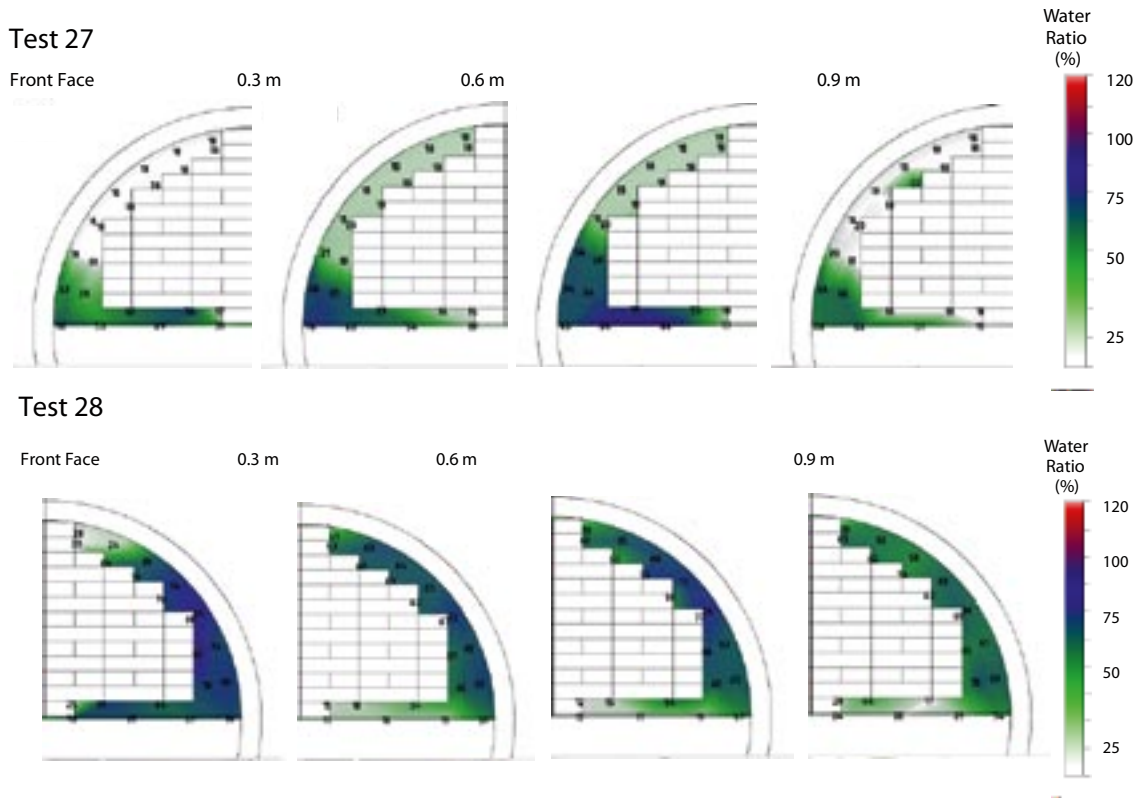
Figure 6-25. Water distribution at end of test: Tests 27 and 28.

Test 27 examined inflow of water to a volume of Minelco granulated bentonite. This assembly had Minelco bentonite installed on the floor with Cebogel pellet materials in the remaining annular space. Water was supplied at floor level 0.6 m from the front face of the assembly for a period of 48 hours. Water began exiting the face after 2 hours and 3 minutes of operation along the pellet-floor interface at the centre-left of the cell. This can be seen in Figure 6-25 and Figure 6-26 and is described in detail in Appendix A. Flow rapidly evolved to a single region of outflow close to the original location with considerable material erosion and pulsating flow as water dammed and broke free near the front face of the cell. All flow was moving through a single channel along the crushed bentonite-block interface region below the block assembly. By the time that 5 hours of testing had elapsed the outflow rate from this test averaged 0.245 l min for a system having a nominal inflow rate of 0.250 l/min. This flow rate persisted for the remainder of the test and the flow path through the pellet materials. The water distribution at the end of testing can be seen in Figure 6-25 and shows a system that has undergone very limited wetting in the course of its operation. Resistance to water inflow was monitored for the entire test duration and the data also shows a system that very rapidly established a preferential flow path, shown schematically in Figure 6-26. Details of the test, its operation and observations made are provided in Appendix A.

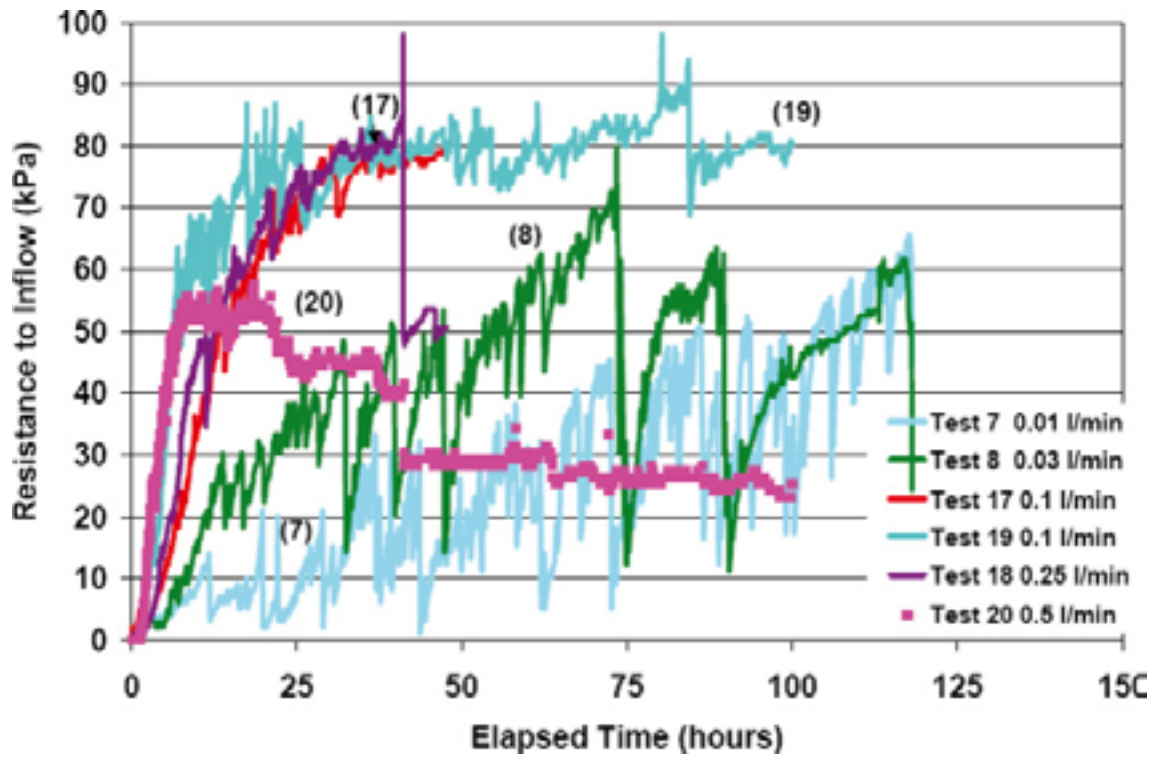
Figure 7-2. Inflow resistance in longer-duration tests.

The stability of assemblies exposed to very low rates of water influx was not anticipated to be problematic and the two long-duration (120 h) tests (Tests 7 and 8), conducted at 0.01 and 0.03 l/min confirmed this prediction. These tests typically showed patterns of incomplete wetting of the pellet fill, limited wetting in crown and base regions, essentially no outflow from the tests, very little wetting of blocks. Where outflow was observed, it typically occurred along the pellet-block horizontal contacts. Figure 6-7 shows the pattern of water distribution after 120 hours of water inflow and illustrates how limited the volume of water supplied was and the uniformity of the wetting that occurred. The inflow resistance for such low water input systems

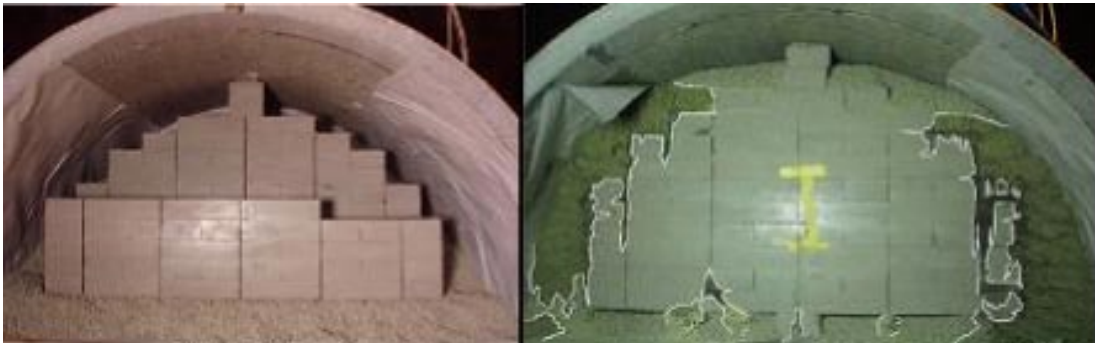
Figure 7-13. Closure of vertical construction gaps in Tests 9, 10.

These tests show the importance of providing lateral (through pellets/granular) and vertical support to the backfill. The vertical support can be provided by ongoing placement of backfill such that the newer materials effectively restrain the previously placed materials or else if operations are to be interrupted then some form of temporary vertical support needs to be provided. In addition, it should be considered what type of block installation pattern (layout) provides the best mechanical stability for the block assembly.

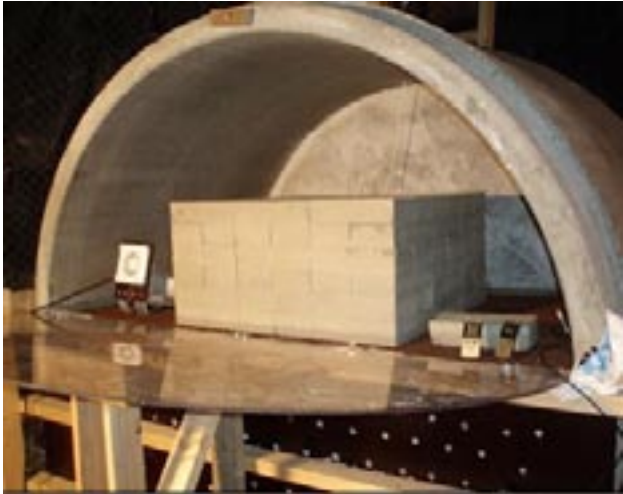
Figure A-1. As-Built Test #1.

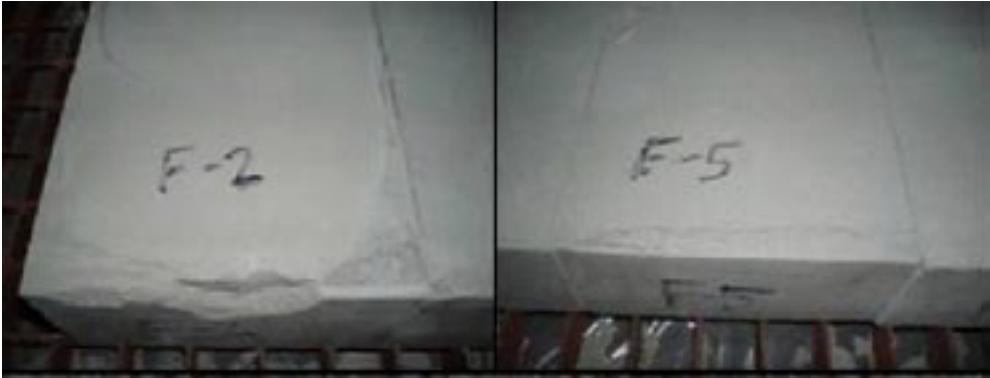
Figure A-3. Cracks in surface of lowermost blocks.

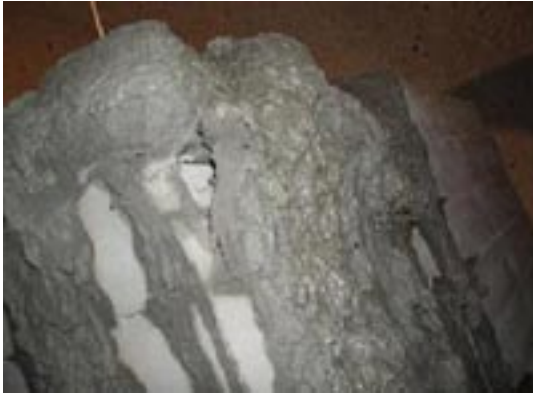
Figure A-6. Erosion of block assembly (24 hours after start) (extensive swelling of clay and slumping from top of assembly).

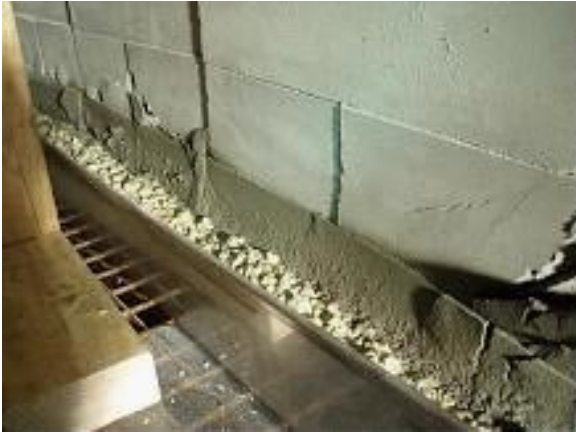
Figure A-8. Wetting of the granules and base of blocks (144 hours) (note lower layer of wet blocks and their deformation due to mass of overlying material).

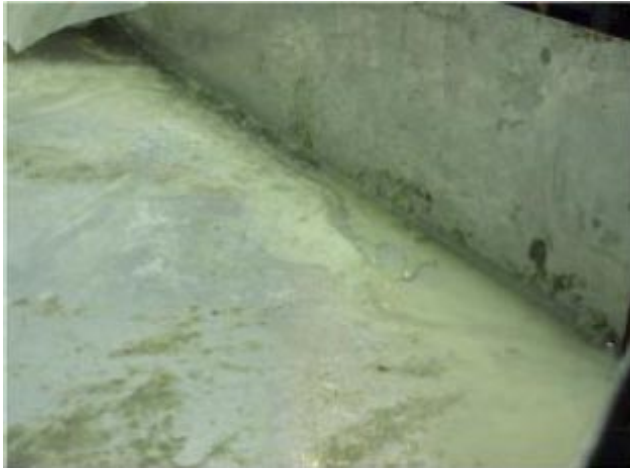
Figure A-14. Eroded bentonite pellet material in Test 8.

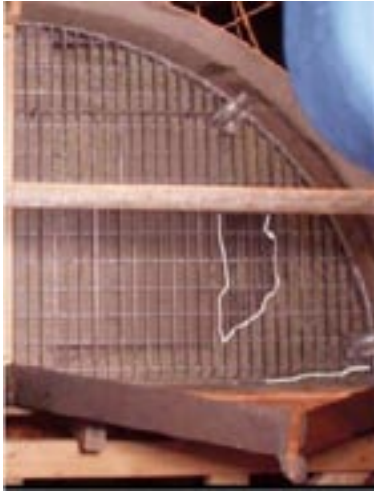
Figure A-43. Test 14 at 5 hours, showing where water outflow was observed.

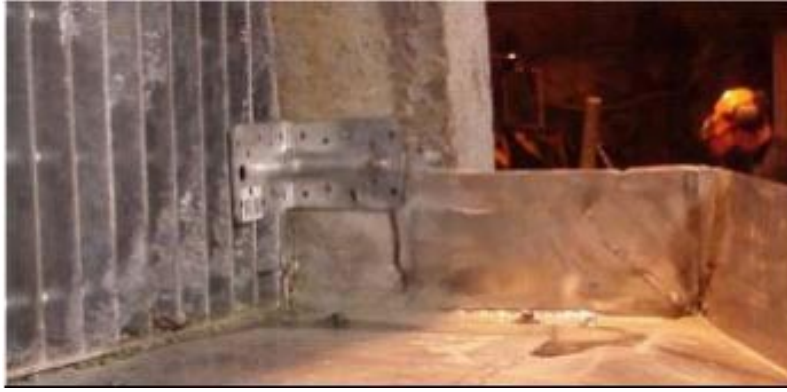
Figure A-48. Water exiting lower corner of Test 12 at 2.5 hours

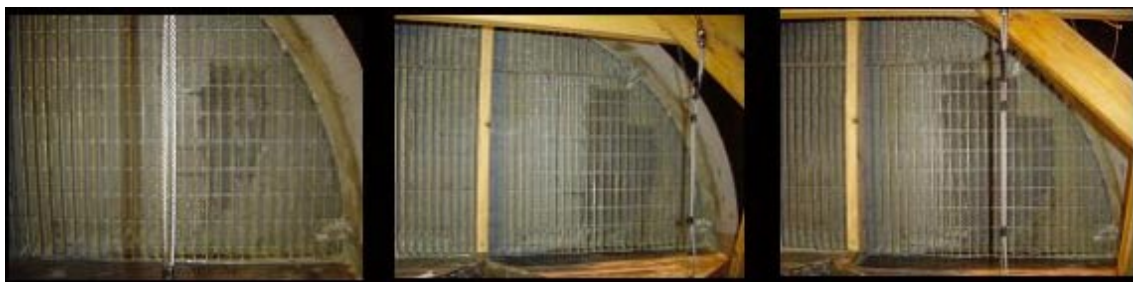
Figure A-65. Wetting patterns at face of Test 29 during testing.
