KBS-3H post-grouting

Mega-Packer test at -220 m level at Äspö HRL

December 2008

Svensk Kärnbränslehantering AB

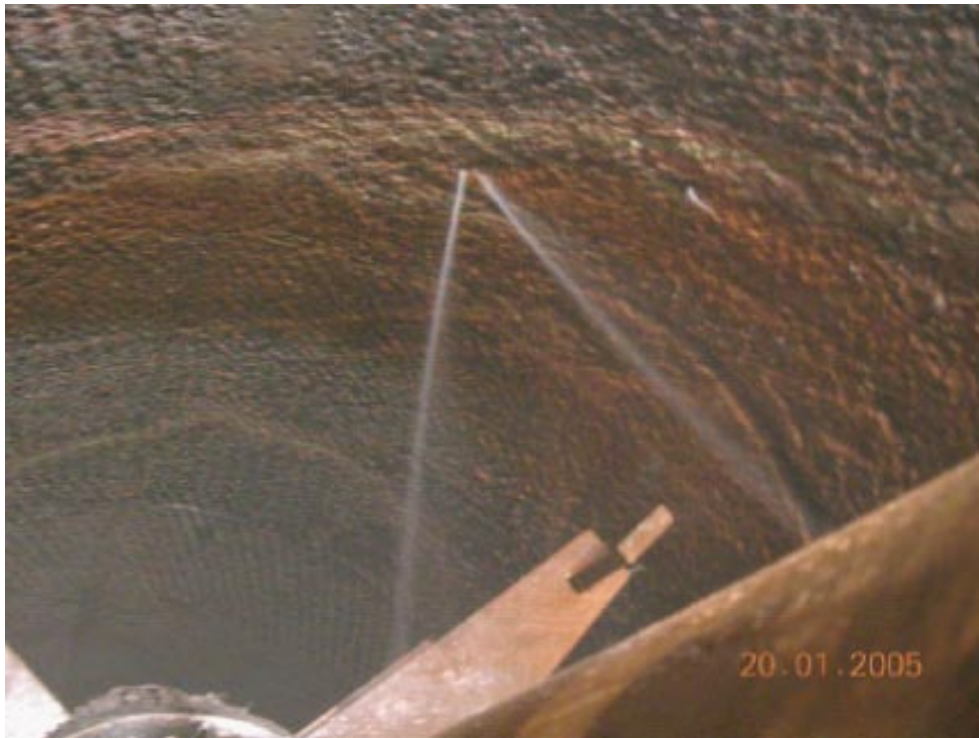
Figure 2-4. Picture from the initial situation with a sprinkling flow due to high pressure gradient / Bäckblom and Lindgren 2005/.

In June 2005 the total inflow to the drift was measured to around 12 litres/minute. According to /Bäckblom and Lindgren 2005/ the inflows was characterised by a high pressure gradient and a channelled flow, resulting in a sprinkling or dripping flow, see Figure 2-4.

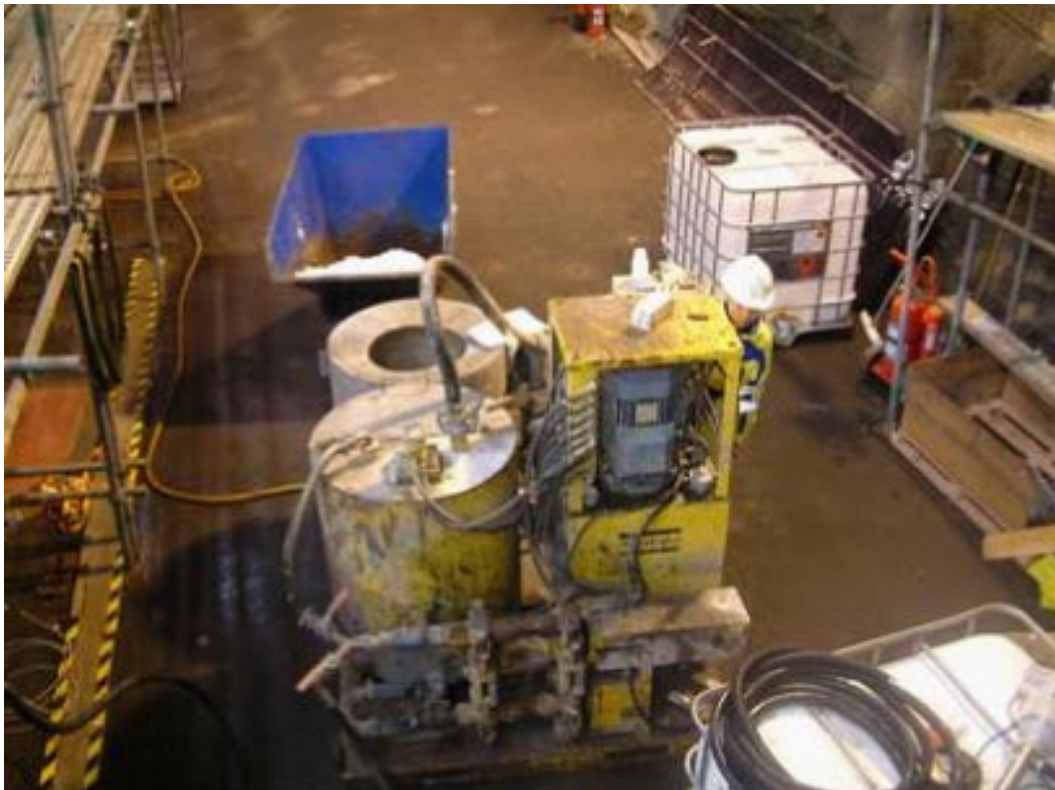
Figure 2-7. The Unigrout equipment used in November 2007.

The Unigrout E22H is constructed for cement grouting originally.

This equipment is quite simple in its construction. It consists of a mixer to store and mix the grouting material, a pump to pump the grouting material in to the gap, hoses to lead the grouting material from the Unigrout equipment to the Mega-Packer, a logging equipment (Logac) to store grouting data such as pressure, time, flow and the volume pumped. There is a control panel to adjust the grouting pressure from the pump. The volume capacity of the pump is 0–120 litres per minute and the pressure capacity ranges from 2–100 bar. The amounts of accelerator and silica sol were dosed by hand by volume.

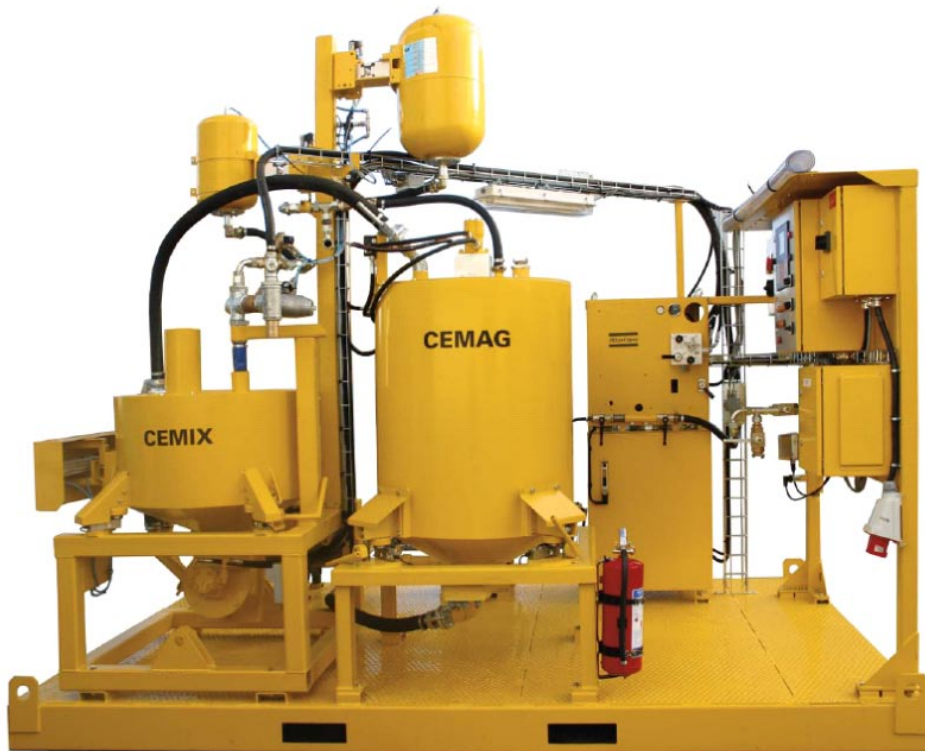
Figure 2-8. The new Unigrout Equipment (EH22 200-140 AWB-SS) used in Mars 2008 /Atlas Copco 2007/.

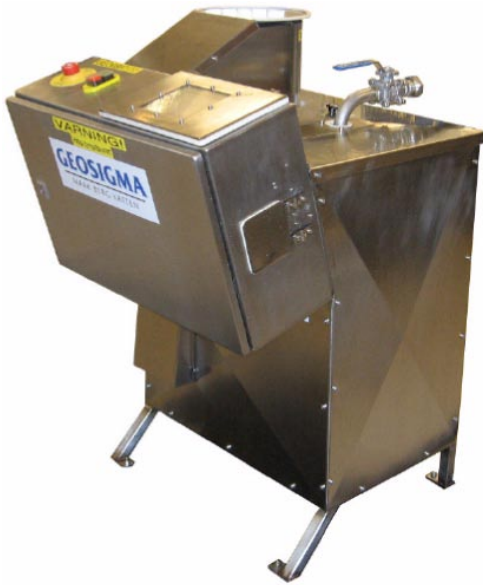
Figure 2-9. The Water Injection Controller /Geosigma/.

The equipment consists of a pump and a logging computer. The computer logs pressure and flow every other second. The pump is adjustable and the accuracy of the water flow is < 20 ml/minute. The logging data is stored in the equipment and can be transferred to MS Excel to be further analysed.

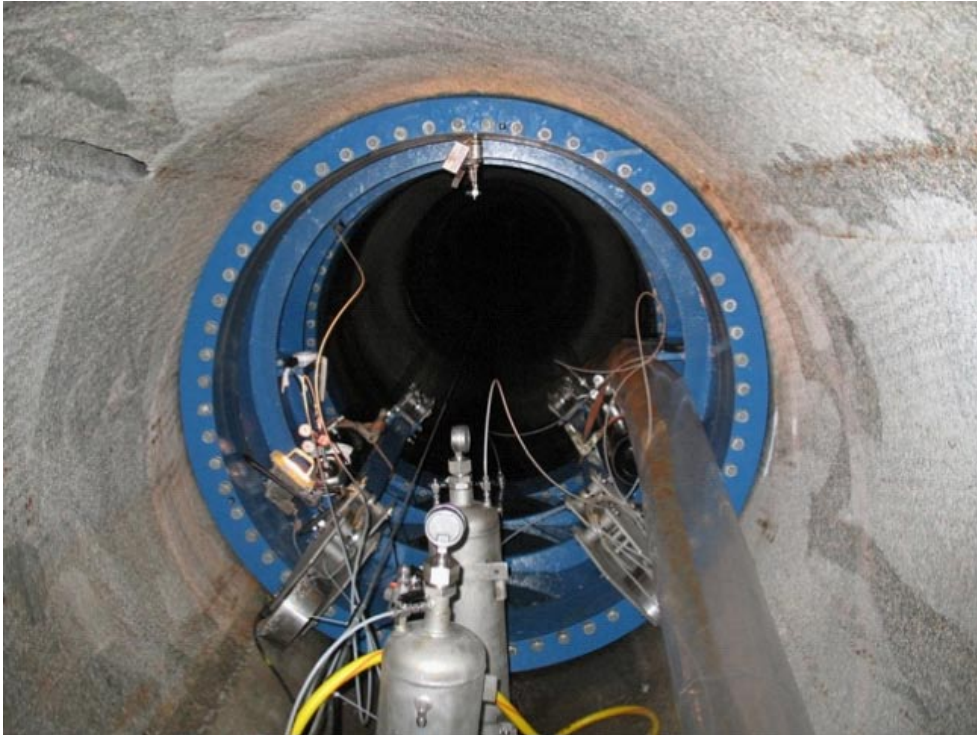
Figure 2-10. Pressure tanks (in the front) connected to the packers.

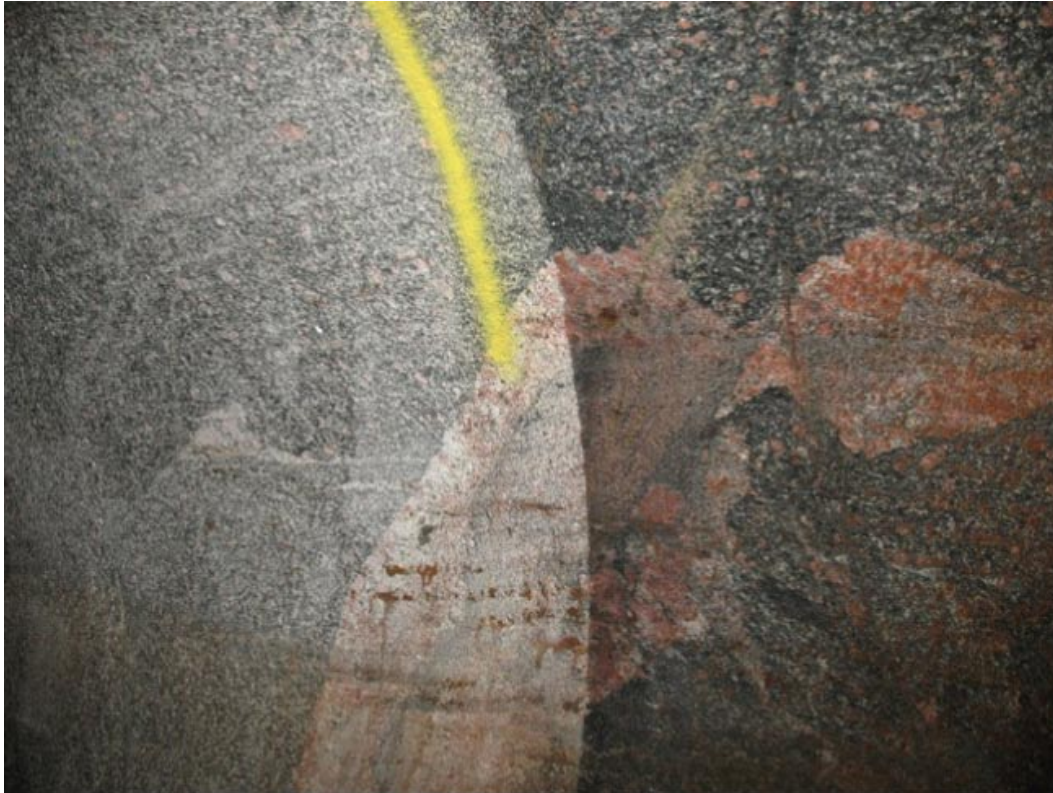
Figure 3-1. Picture showing a wet rock wall and a dry rock wall. This photo is showing that the performance test of the packers was performed perfectly and that the packers had an excellent sealing off effect.

During the session where the water was pressurized in the gap, water leaking out from the gap between the packers and the rock wall was not observed. In Figure 3-1 it is seen that a complete sealing off effect was achieved.

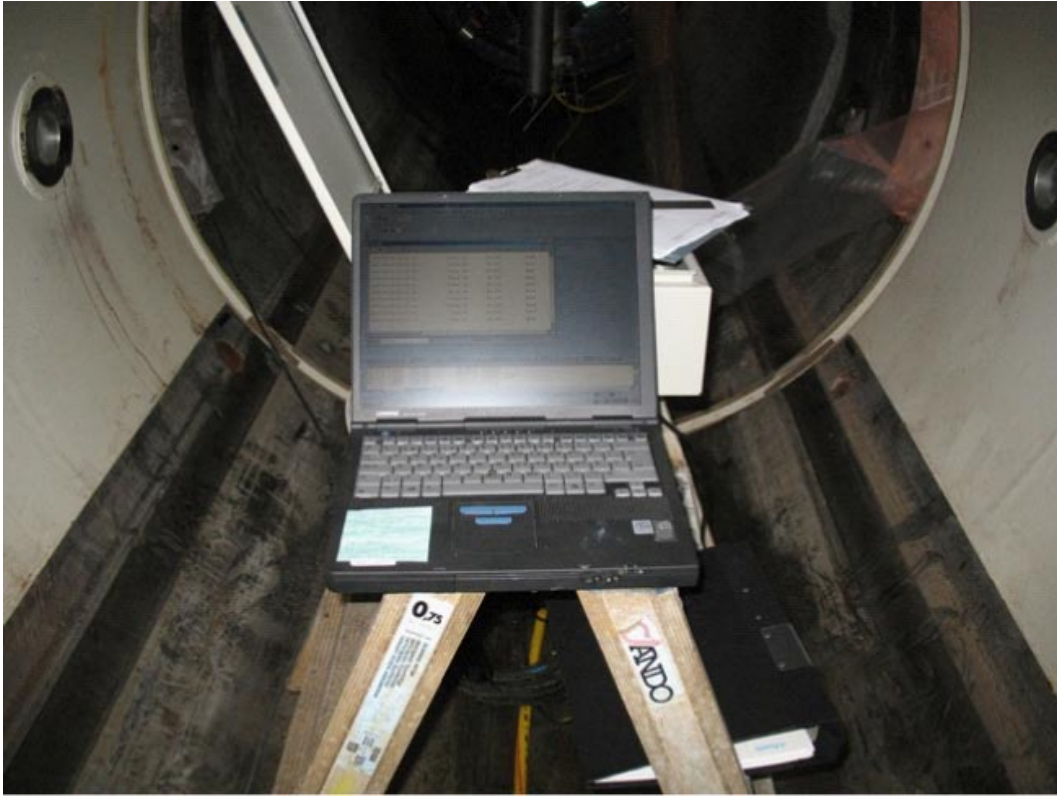
Figure 3-2. Logging during the ground water pressure build up test.

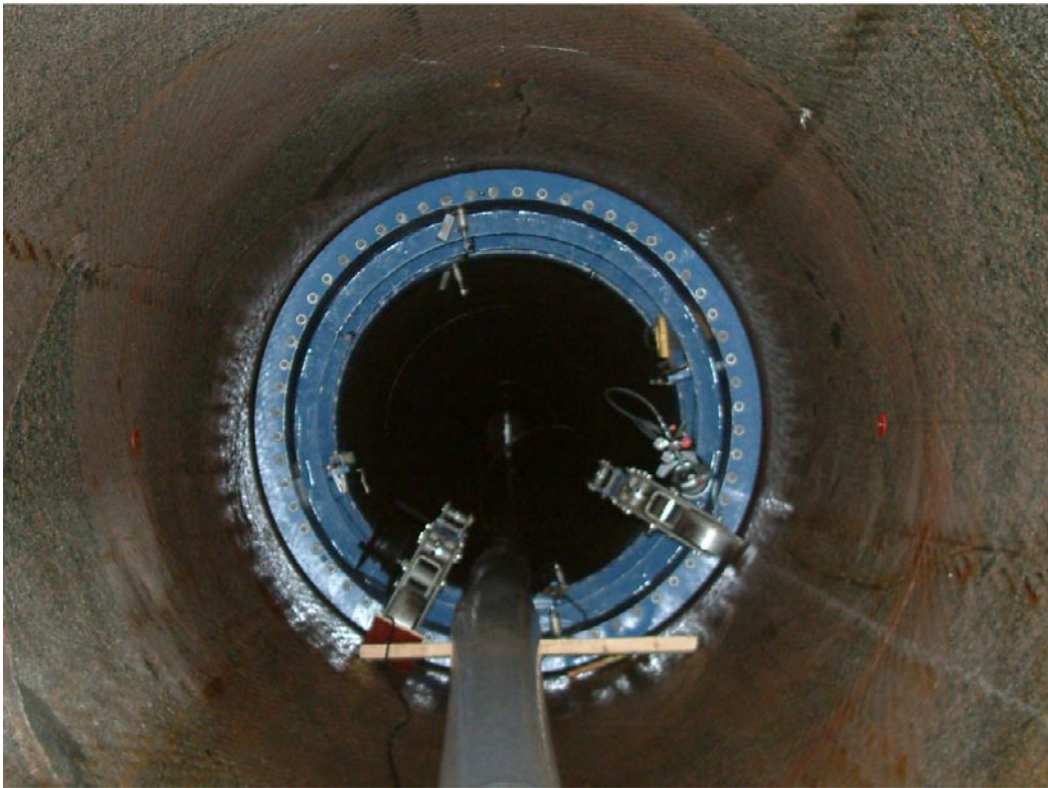
Figure 3-3. The Mega-Packer in the drift. The position of the wheels tells that there has been a rotation of about 15 degrees.

Moving of the Mega-Packer was the most complicated step in the tests since the wheels were not functioning as predicted. This led to problems in moving the device as the wheels made the Mega-Packer rotating while moving it. See Figure 3-3. There was a risk of a great rotation might had caused an overturn of the Mega-Packer in the drift.

In the first set of experiments in the autumn of 2007 the problem was counteracted with lead weights, loaded at the side of the Mega-Packer moving upwards during the movement of the device. The load was about 400 kilos and was required to manage to move the Mega-Packer in the drift without overturning. However, some times the lead weights had to be moved to the other side as the Mega-Packer started to rotate in the opposite direction.

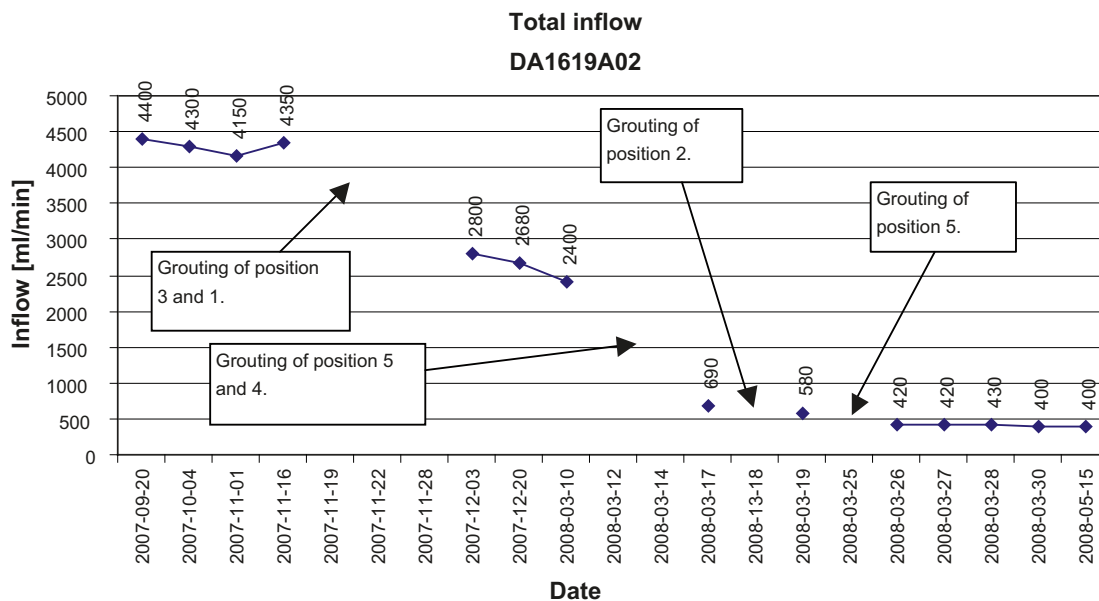
Figure 3-10. Diagram showing the measured total inflow in the drift DA1619A02 (the main drift).

However, after grouting of position 4 (considering that the first grouting of position 5 was not valid) the water inflow into the drift decreased with 1,7 litres per minute.

Totally the leakage from the drift decreased with 90,8%.

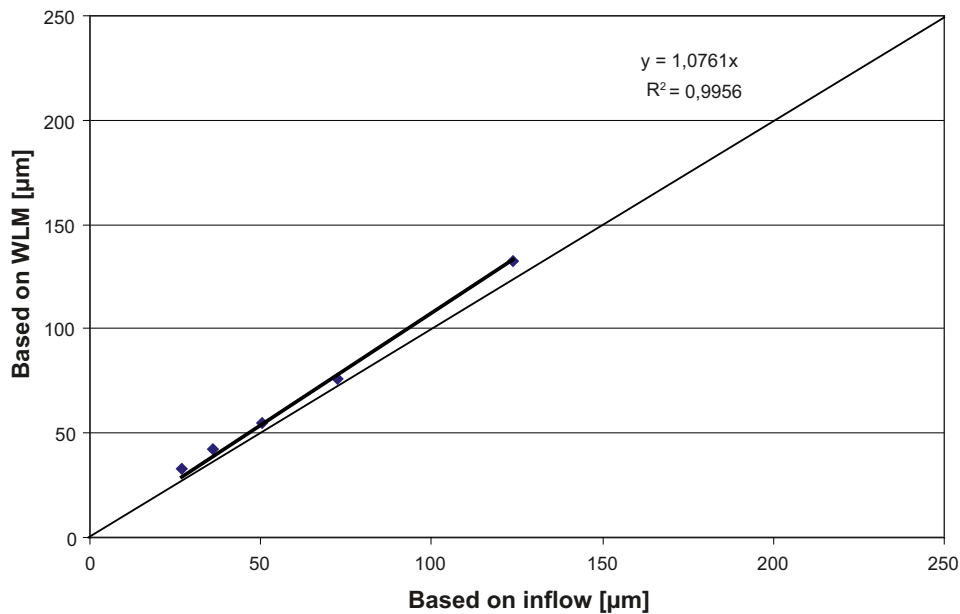
Figure 4-1. Comparison of the hydraulic aperture evaluated from the inflow and from the water loss measurement test.

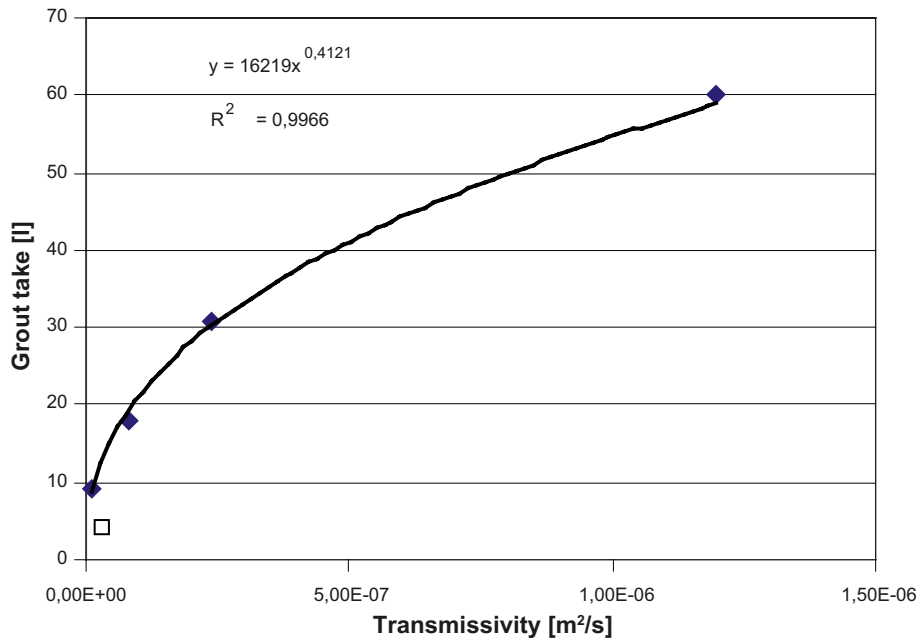
Figure 4-4. Grout take plotted versus transmissivity from the water inflow measurement (measured in the pre-characterisation) The value for position 5 is not included in the trend line.

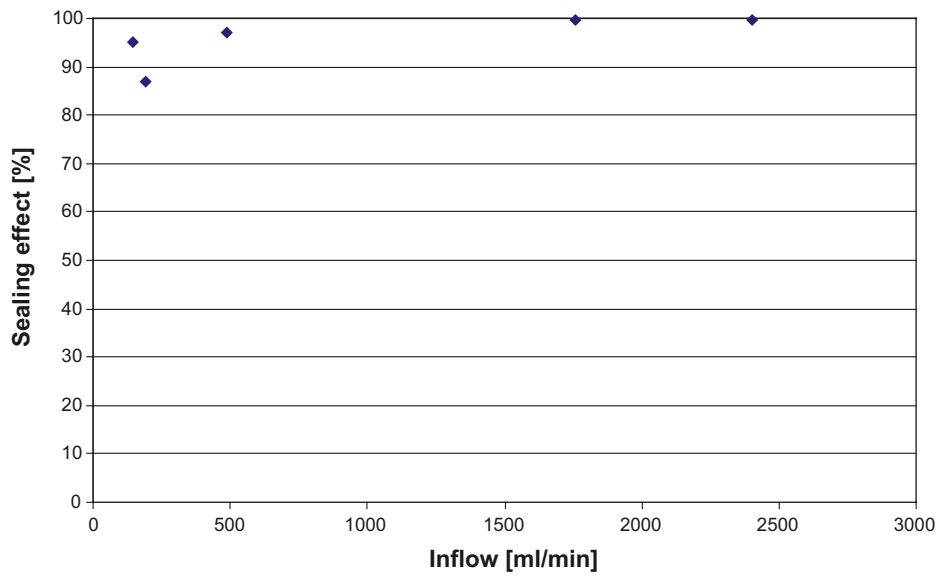
Figure 4-5. Diagram showing the obtained sealing effect as function of inflow.

The inflow in each position is small and the uncertainties in the measurements are difficult to estimate. If these values are in detail accurate it is found that the inflow have in percent and in absolute values been mostly reduced in the positions where the highest inflow and the largest transmissivities were found. Comparing this to theoretical results in /Eriksson 2002/, the results can be explained. The grouting material have the potential to fill the fracture void more completely if the aperture is somewhat larger. The countermeasure, recommended in /Eriksson 2002/ would be to increase the pressure and/or grout longer in finer fractures.

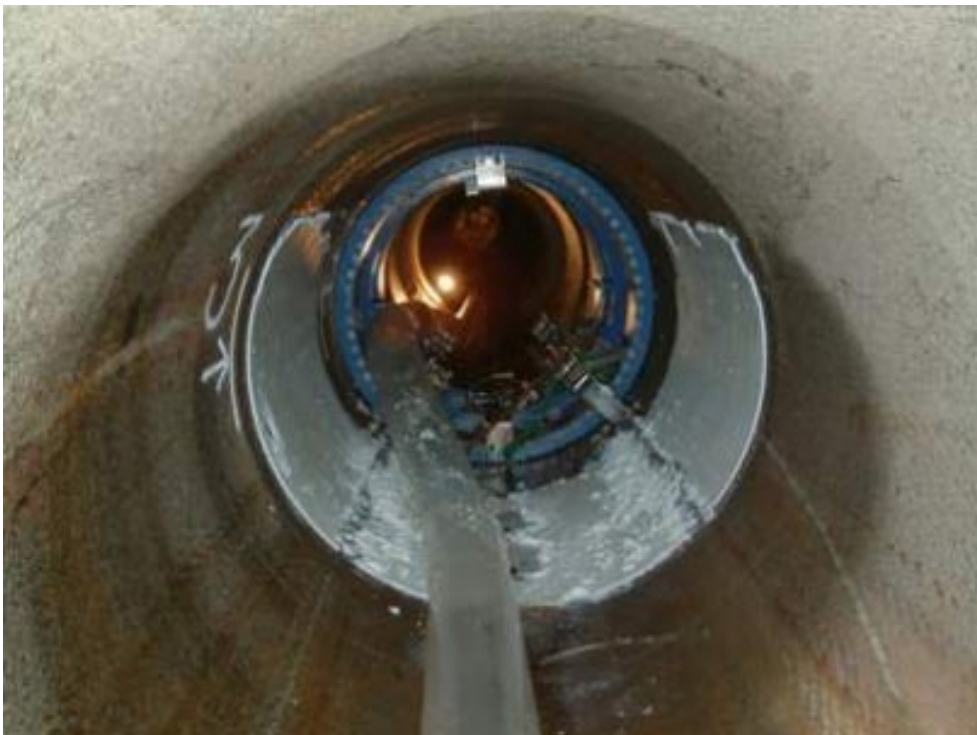
Figure 5-1. The unsuccessful filling of the gap in the Mega-Packer at position 3.

It is clearly seen that the silica sol has not filled the gap as expected. The top of the silica sol had a smooth and wavy look, indicating the surface of it.

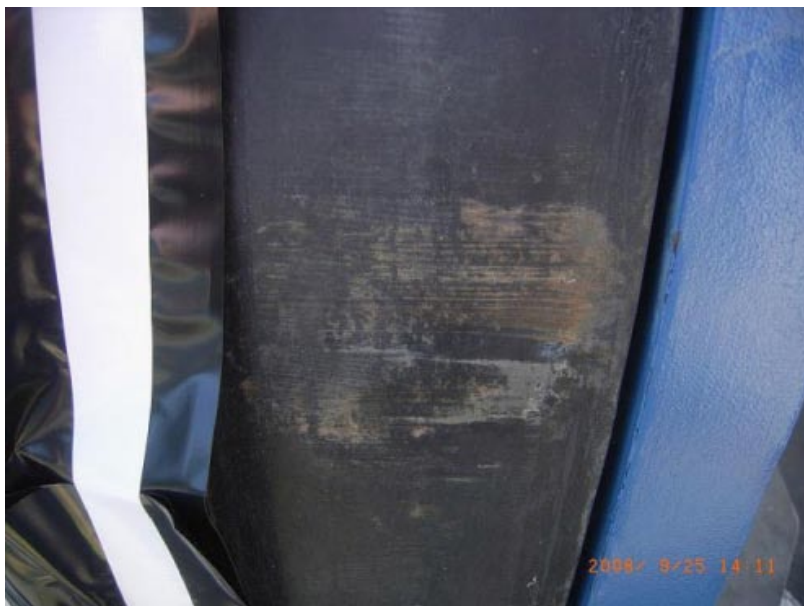
Figure 5-2. Minor scratches in one of the packers.

In further use of the Mega-Packer it is preferred that the packers should be checked and controlled regarding to scratches in them.

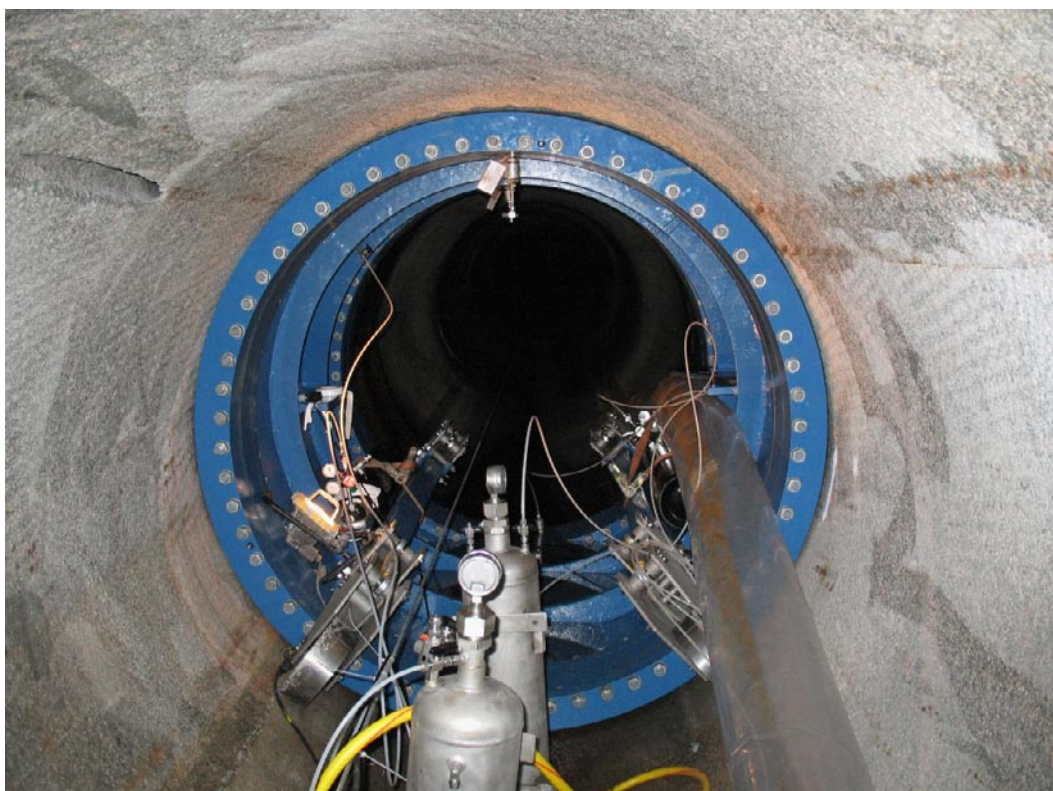
The Mega-Packer connected to the pressure tanks.

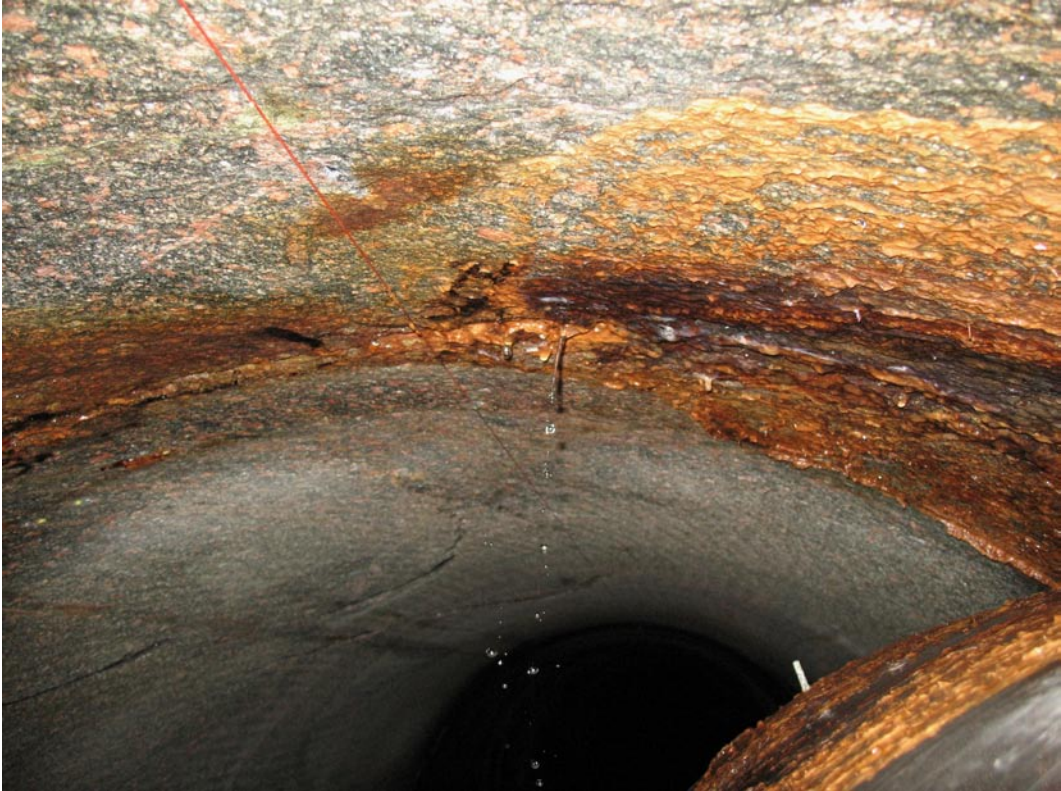
Water leakage at position 1.

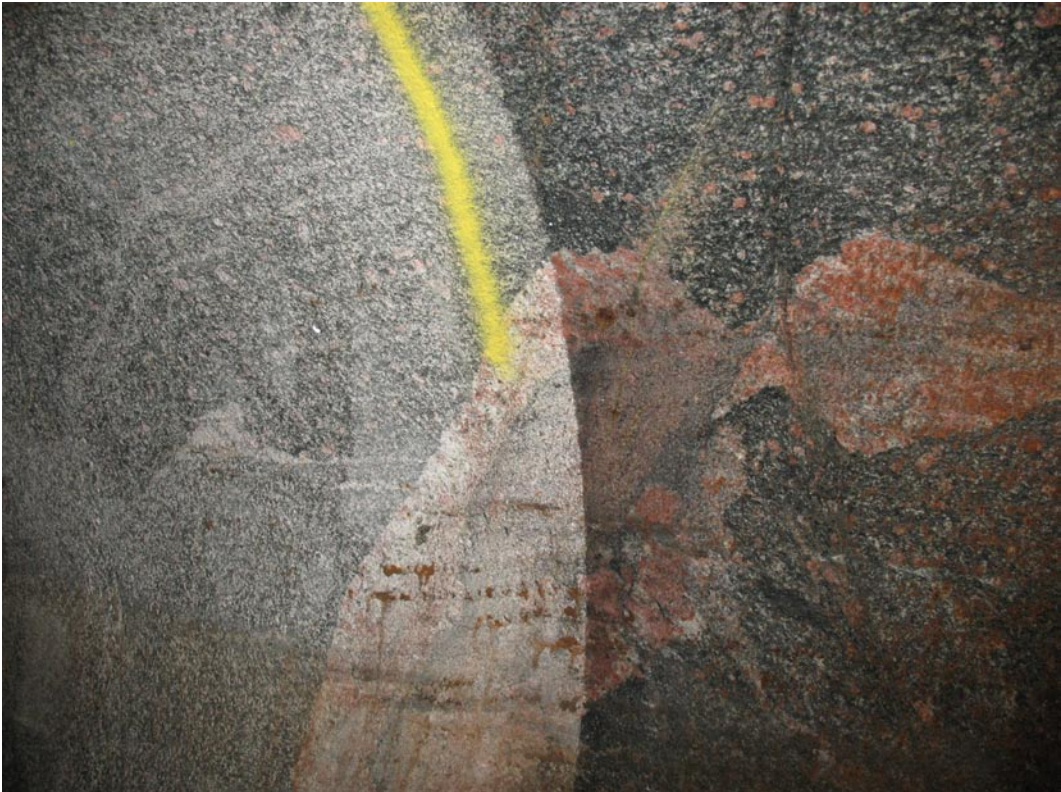
The rock wall after removing of the Mega-Packer showing the sealing effect.

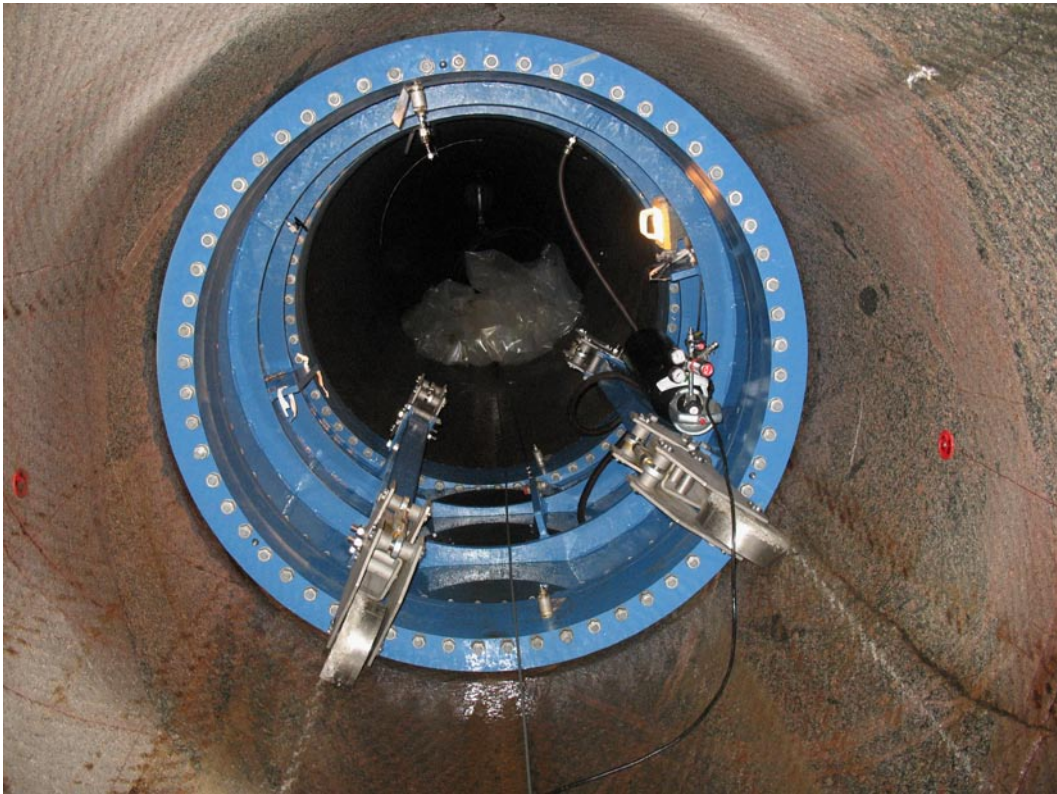
The rotation of the Mega-Packer in the drift before the wheels were adjusted.

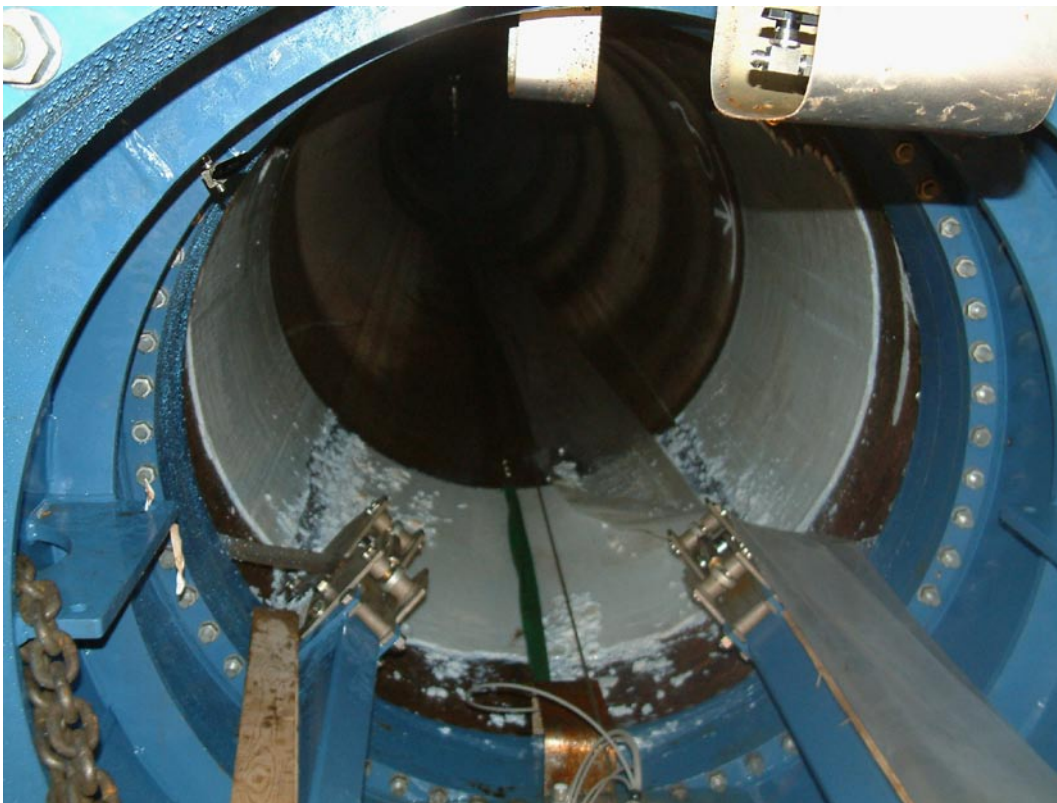
Removing of the Mega-Packer after the first grouting session. The silica sol is left at the rock wall.
