R-03-25

Electron beam welding of copper lids

Status report up to 2001-12-31

Sören Claesson, Ulf Ronneteg
Svensk Kärnbränslehantering AB

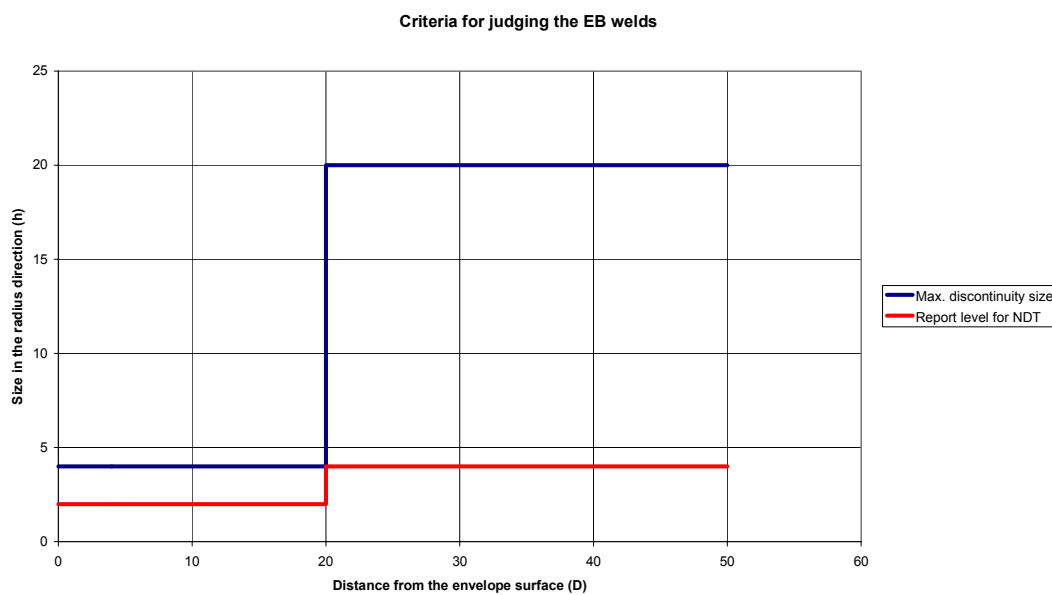
Figure 2: Criteria for the development process regarding welding and NDT at the Canister Laboratory

The main principles of the criteria's for the work at the Canister Laboratory are shown in figure 2 below, where the red line represents the report level for the NDT and the blue line represents the maximum allowable discontinuity size in the weld.

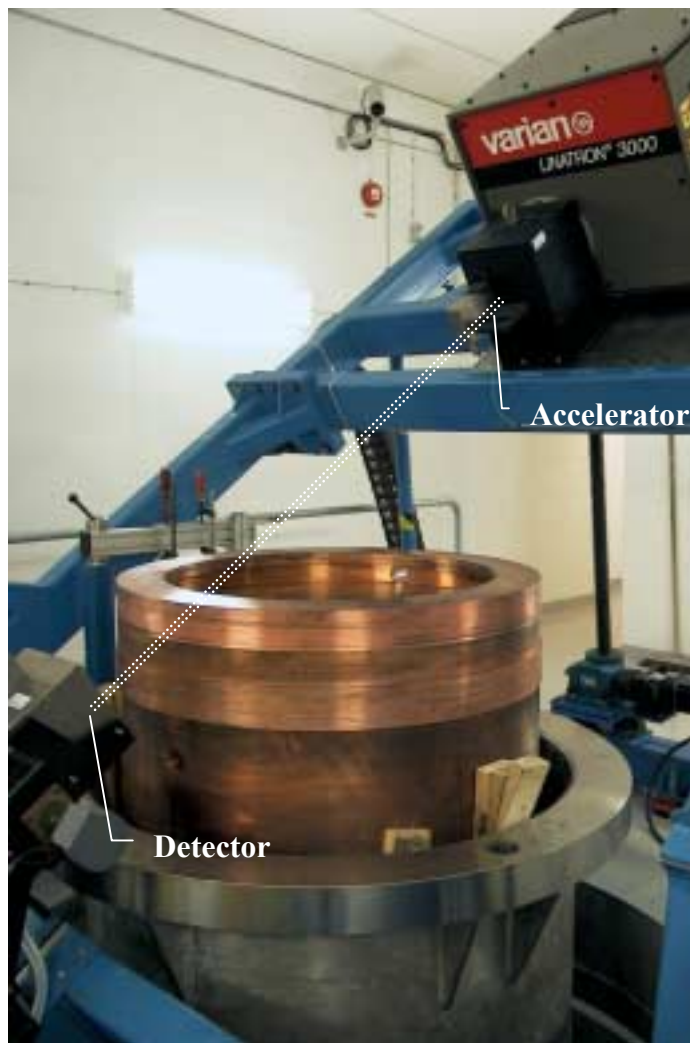
Figure 3: X-ray equipment for inspection of the electron beam welded lid.

The RT is mainly performed according to SKB routine SDKL-009 [47], Radiographic Inspection. The main principles of this are that the object rotates while the 9 MeV Linear Accelerator pulses X-rays through the weld at an incident angle of 35° (see figure 3). The transmitted X-rays are detected by a linear array detector with 0,4 x 0,4 mm resolution. The linear detector is placed perpendicular to the beam angle and the X-ray images are built up of several of these collected lines (see figure 4). These digital X-ray images have been evaluated according to SKB preliminary acceptance criteria.

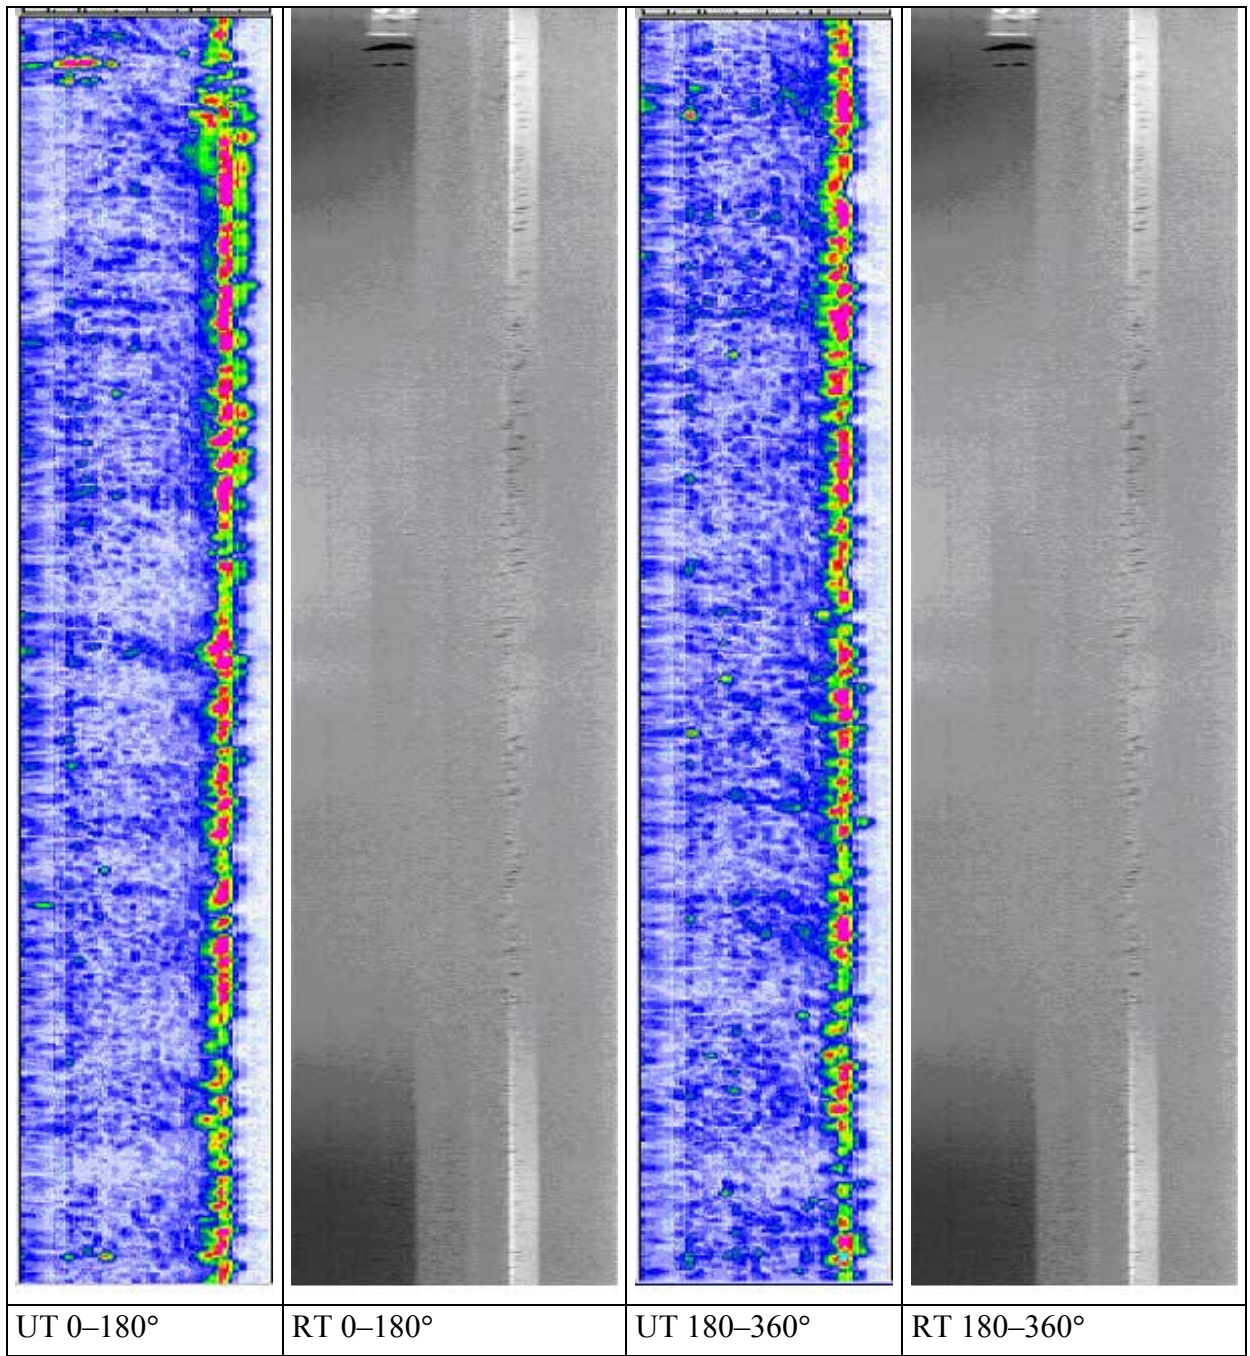
Figure 13: NDT of Lid weld 03.

Large root cavities were indicated around the whole circumference and as in weld no 2 large defects in the overlap area. Surface improved after the re-melting pass. This lid has a typical result for weld no 1, 2, 3 and 5 from NDT point of view, see figure 13 below.

Beam stability was a problem. The beam was pulsing and the weld quality was really bad both internal and at surface. In a way to try to improve the quality, the weld was re-melted (1999-10-28) without any improvement.

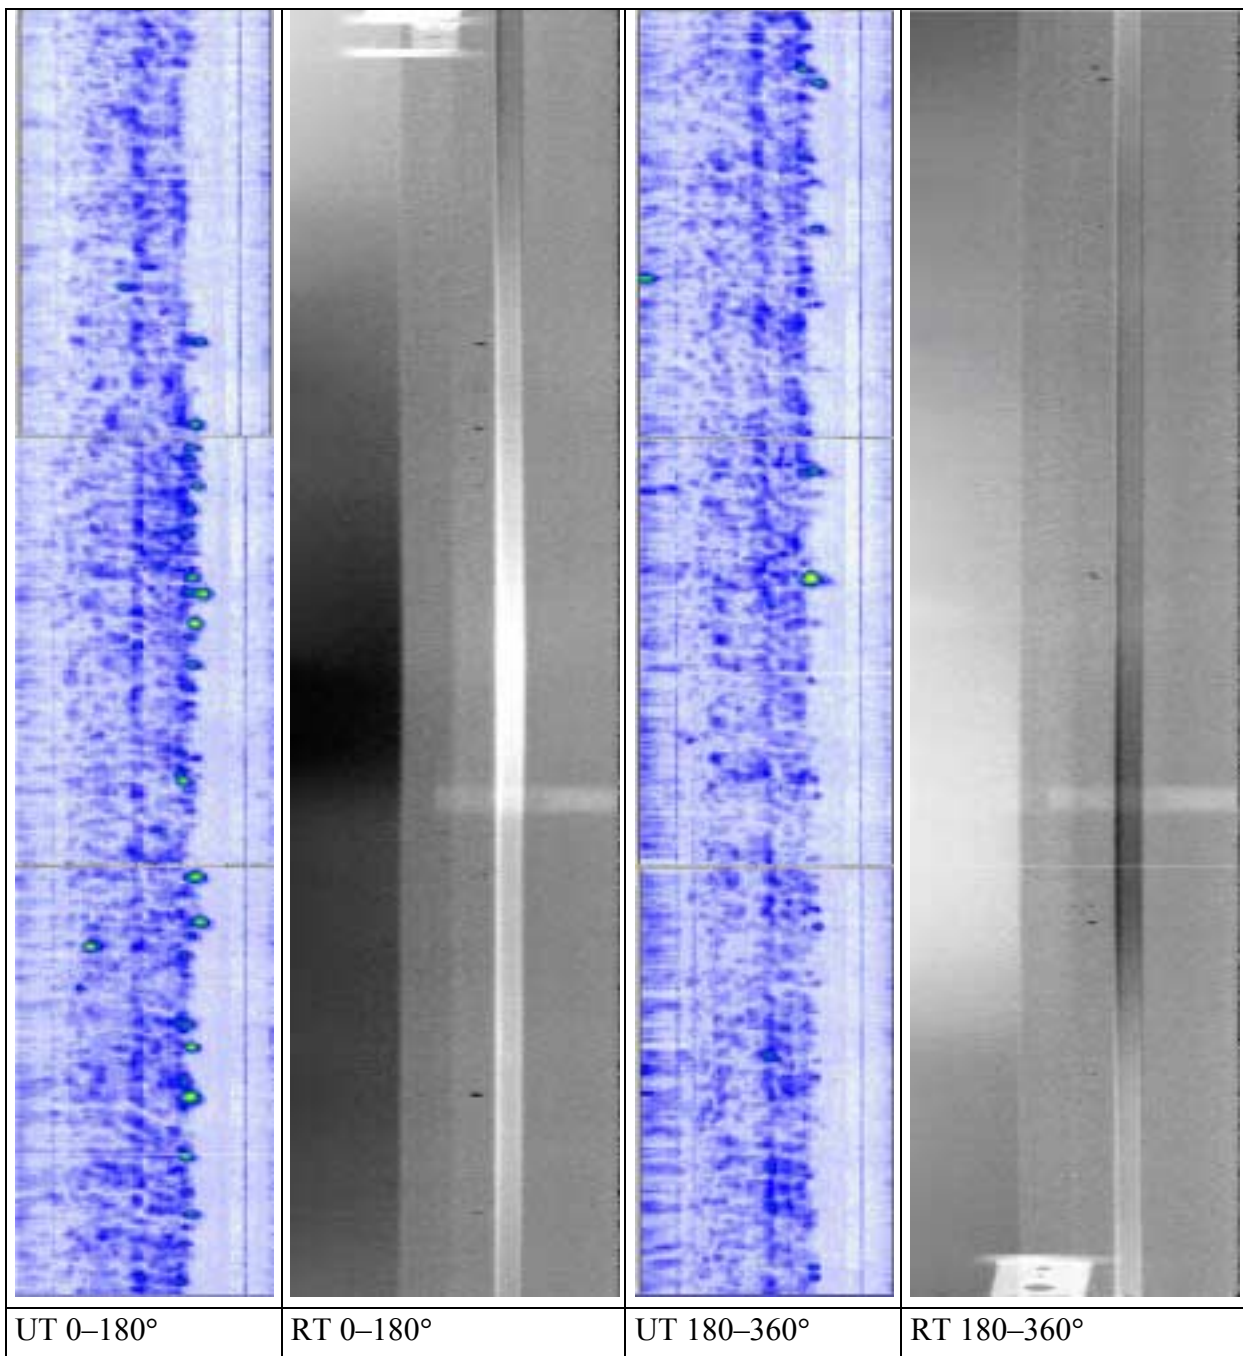
Figure 15: NDT of Lid weld 11 (weld 13 and 15 had a similar look).

The weld internal was very good and there was only some sporadically defects in the root. The weld surface was rather rough with three eruptions, two at the passage of slope in and one just before start of slope out. The eruptions caused local roughness at the surface but no internal cavities. After machining the surface was free from defects and the lid weld fulfilled the preliminary acceptance criteria, see the NDT in figure 15. Tip radius was 1,8 mm at main pass and 1,7 mm at re-melt pass.

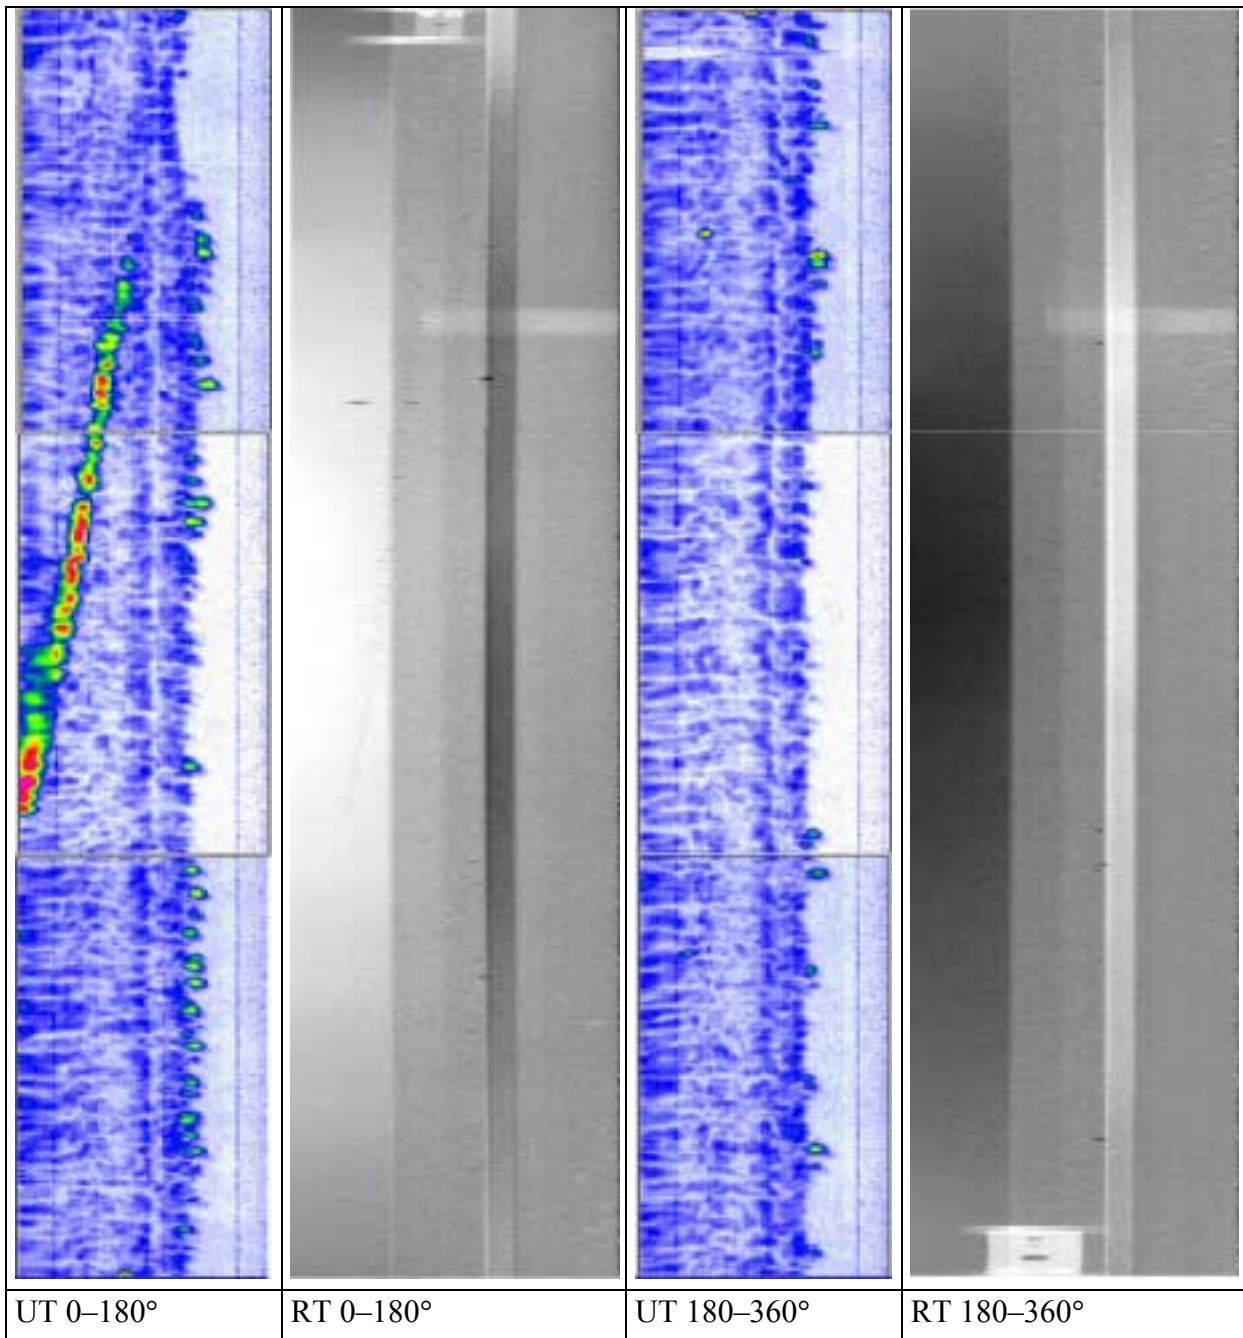
Figure 16: NDT of Lid weld 14.

Slope out distance 130° with Q2 varying from 1,410 to 1,200 A. The weld internal and the weld root area were good. The weld surface was rather good. One eruption arose at the slope out. The eruption caused a locally internal cavity with the size of 8 x 3 mm at 15 mm beneath the surface. There was also a continuous root defect at the slope out area when Q2 was less than 1,361 A, see figure 16. Tip radius 2,0 mm at main pass and 1,2 mm at re-melt pass.

After machining the surface was free from defects.

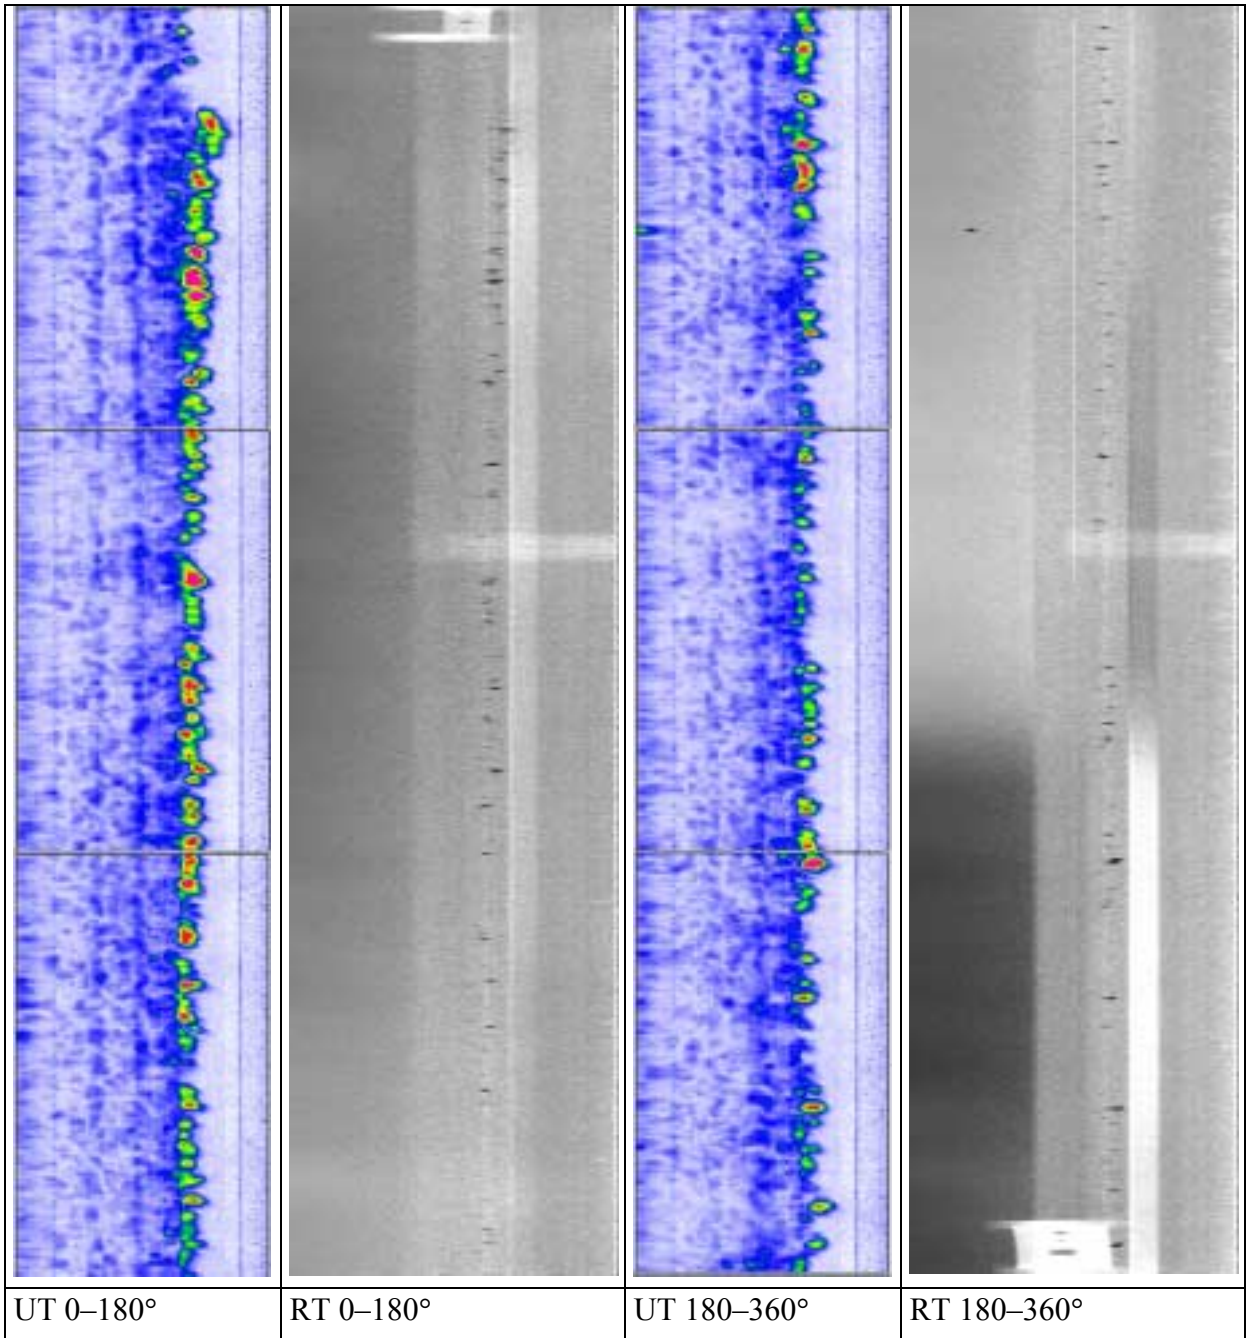
Figure 19: NDT of Lid weld 19.

Test weld to reduce the risk for surface eruptions and to improve the root quality. One additional weld pass was added to reduce the weld depth from full depth to zero very slowly.

Pass	Acceleration voltage	Beam current	Focus Q1	Focus Q2	Travel speed	Working distance
1	190 kV	345 mA	1,195 A	1,470 A	250 mm/min	125 mm
2	190 kV	270 mA	1,195 A	1,470 A	250 mm/min	125 mm
3	190 kV	210 mA	1,185 A	1,470 A	250 mm/min	125 mm
4	190 kV	170 mA	1,180 A	1,470 A	250 mm/min	125 mm
5	190 kV	125 mA	1,180 A	1,470 A	250 mm/min	125 mm

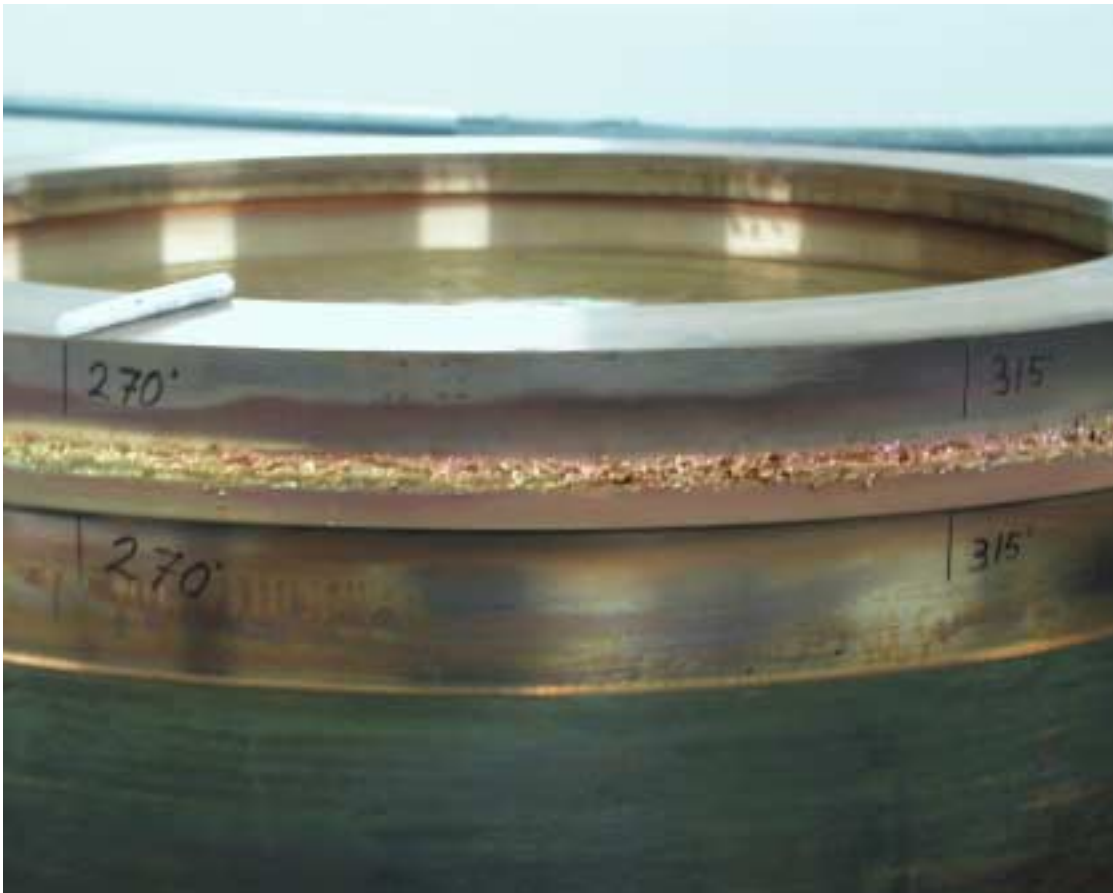
Figure 21: Lid weld no 21, view of the weld surface.

During welding of the third pass 4 eruptions in the weld melt were observed. The weld internal was a little worse than lid weld no 20 with severe root defects in the first run. The weld surface was rather good apart from four cavities, see figure 21. Two of these surface-breaking defects did remain after the machining. The weld profile was very pointed at the weld root.

Pass 1≈0,7 mm Pass 2≈1,7 mm Pass 3≈2,1 mm

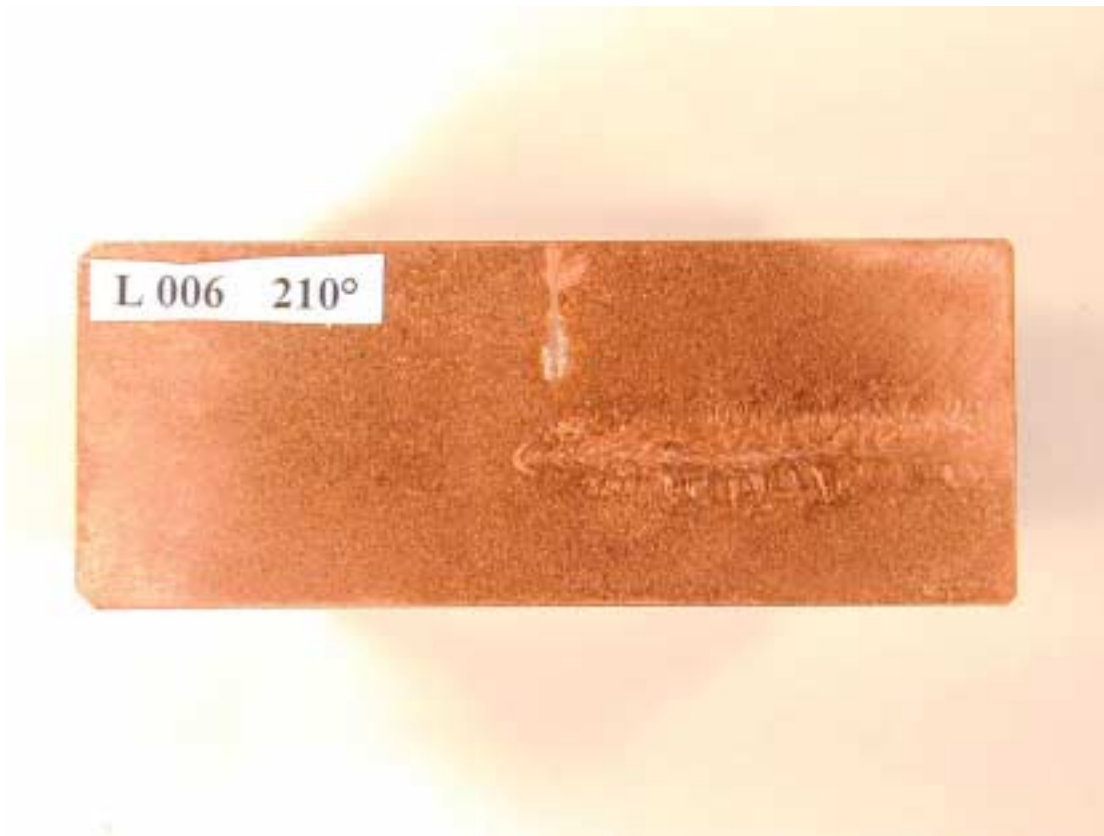
Lid weld no 6: Tip radius 1,5 mm
Cathode: HCC1 Q1=1,200A/ Q2=1,450A

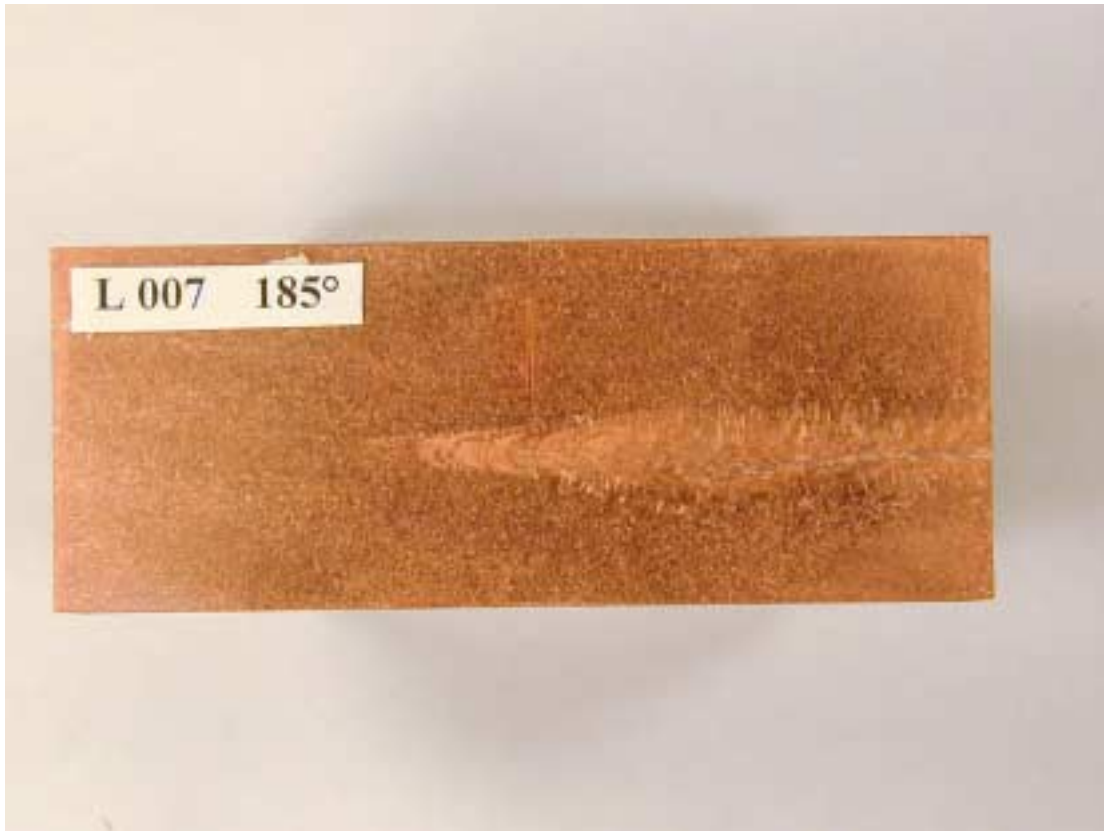
Lid weld no 7: Tip radius 1,6 mm
Cathode: HCC1 Q1=1,200A/ Q2=1,500A

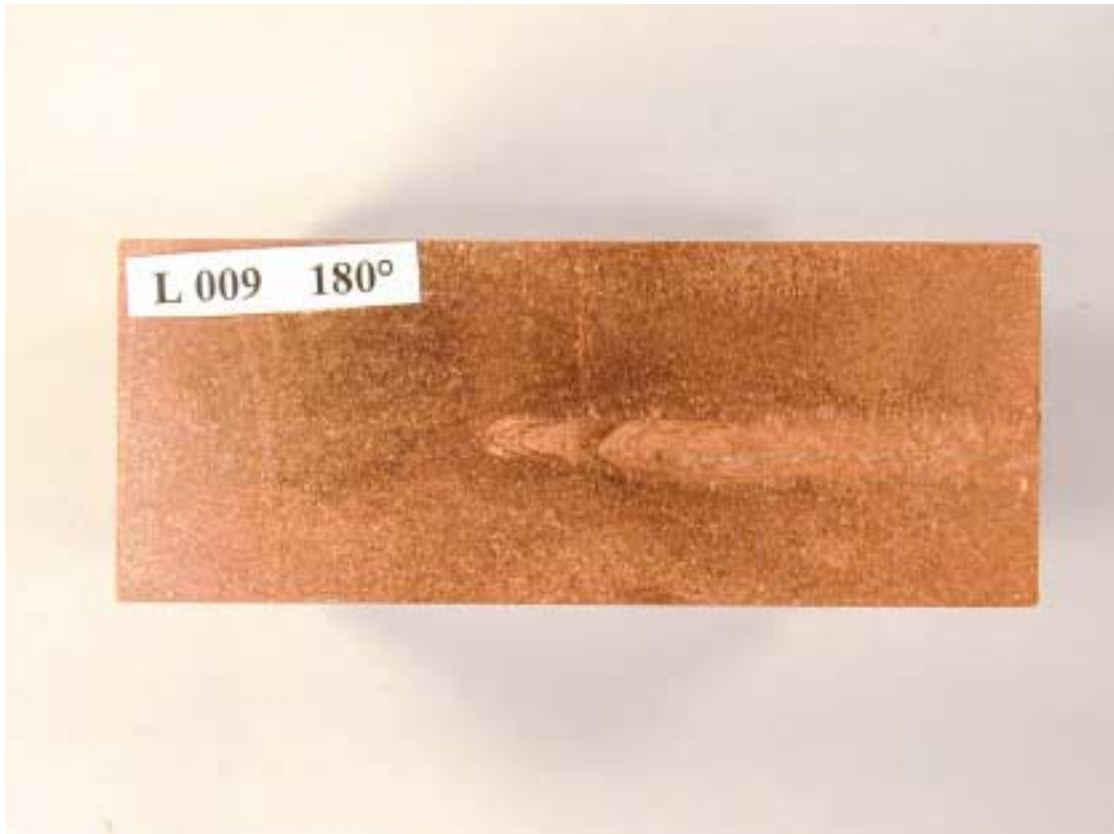
Lid weld no 9: Tip radius 1,8 mm
Cathode: HCC1 Q1=1,200A/ Q2=1,450A

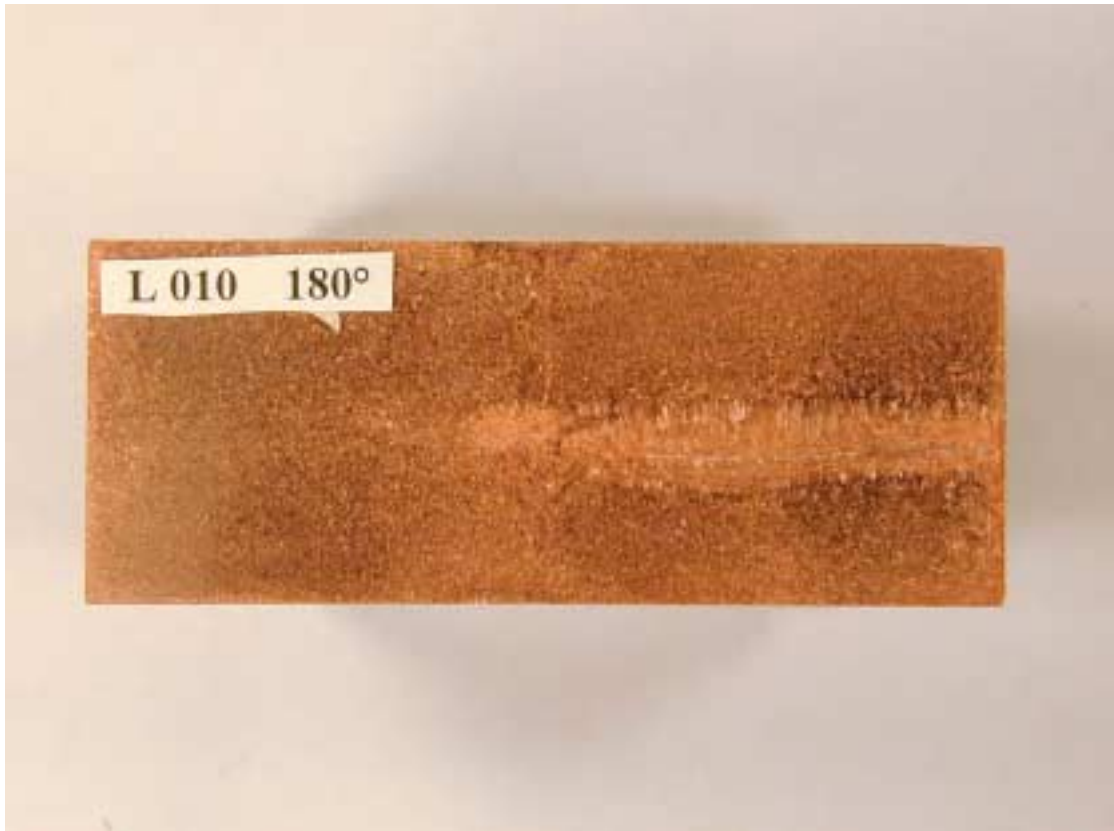
Lid weld no 10: Tip radius 1,8 mm
Cathode: HCC1 Q1=1,200A/ Q2=1,450A

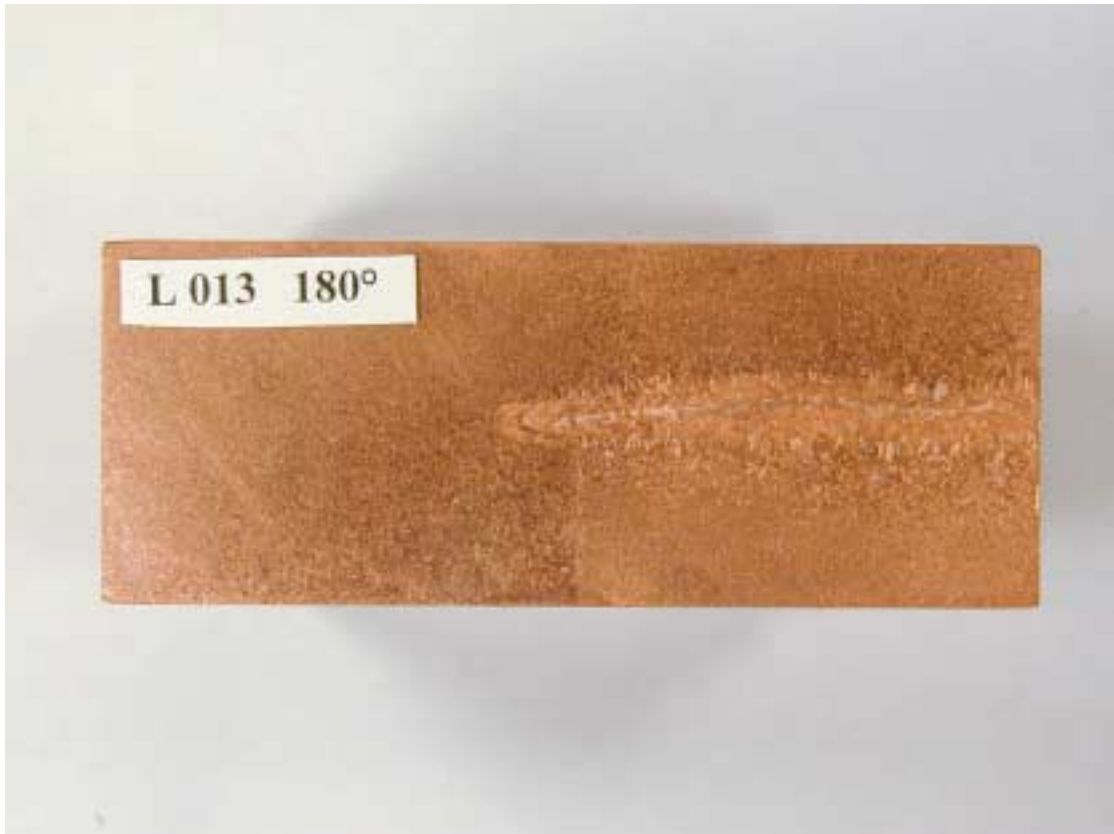
Lid weld no 13: Tip radius 1,8 mm
Cathode: HCC1 Q1=1,195A/ Q2=1,415A

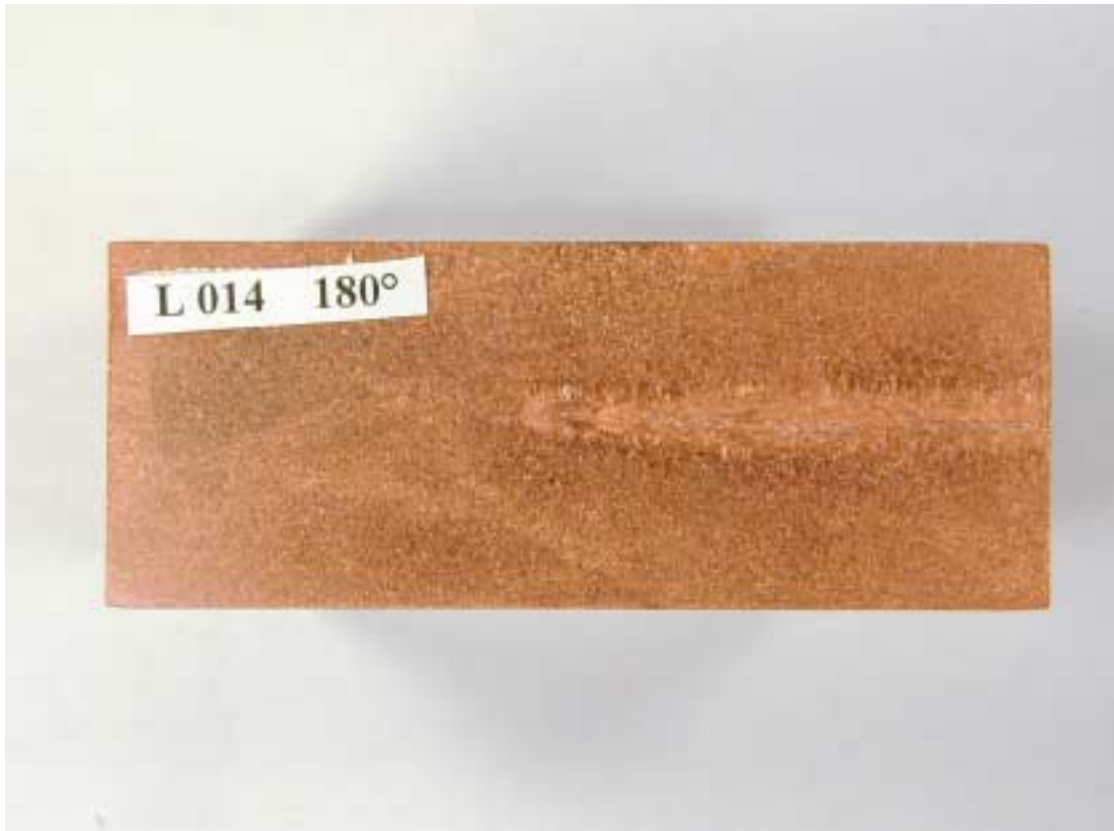
Lid weld no 14: Tip radius 2,0 mm
Cathode: HCC1 Q1=1,195A/ Q2=1,410A

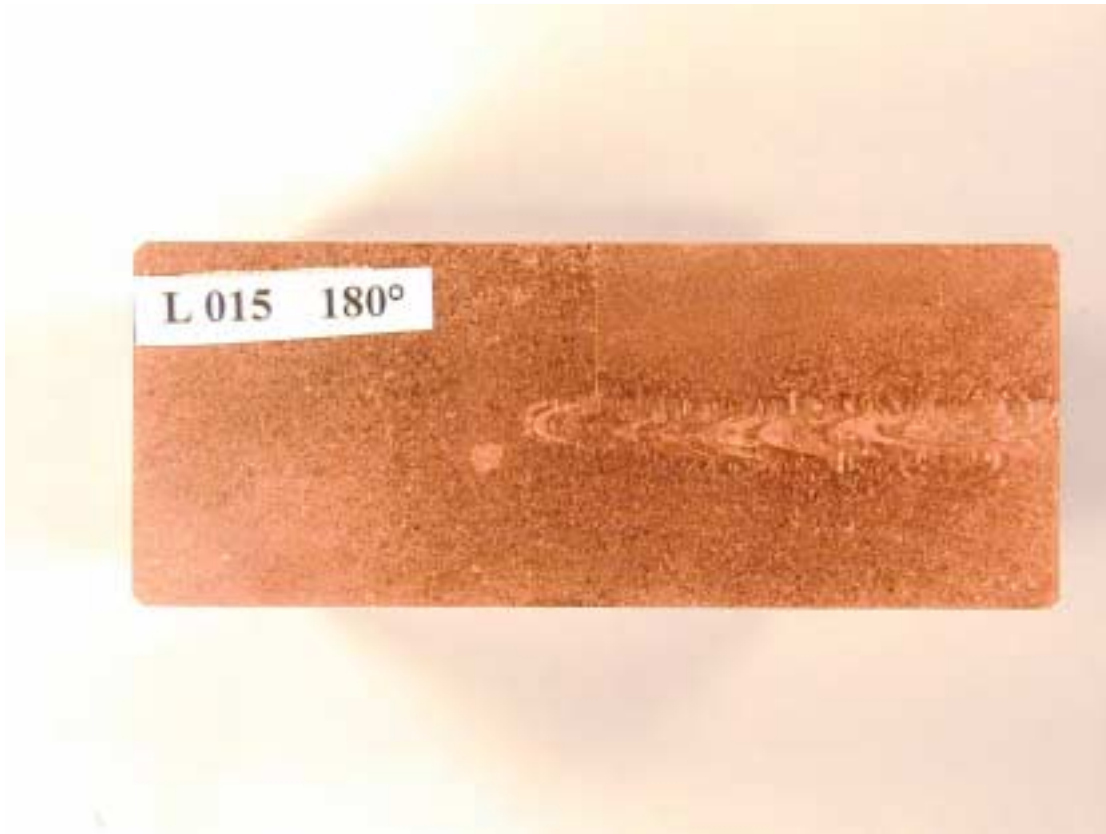
Lid weld no 15: Tip radius 1,8 mm
Cathode: HCC1 Q1=1,195A/ Q2=1,410A

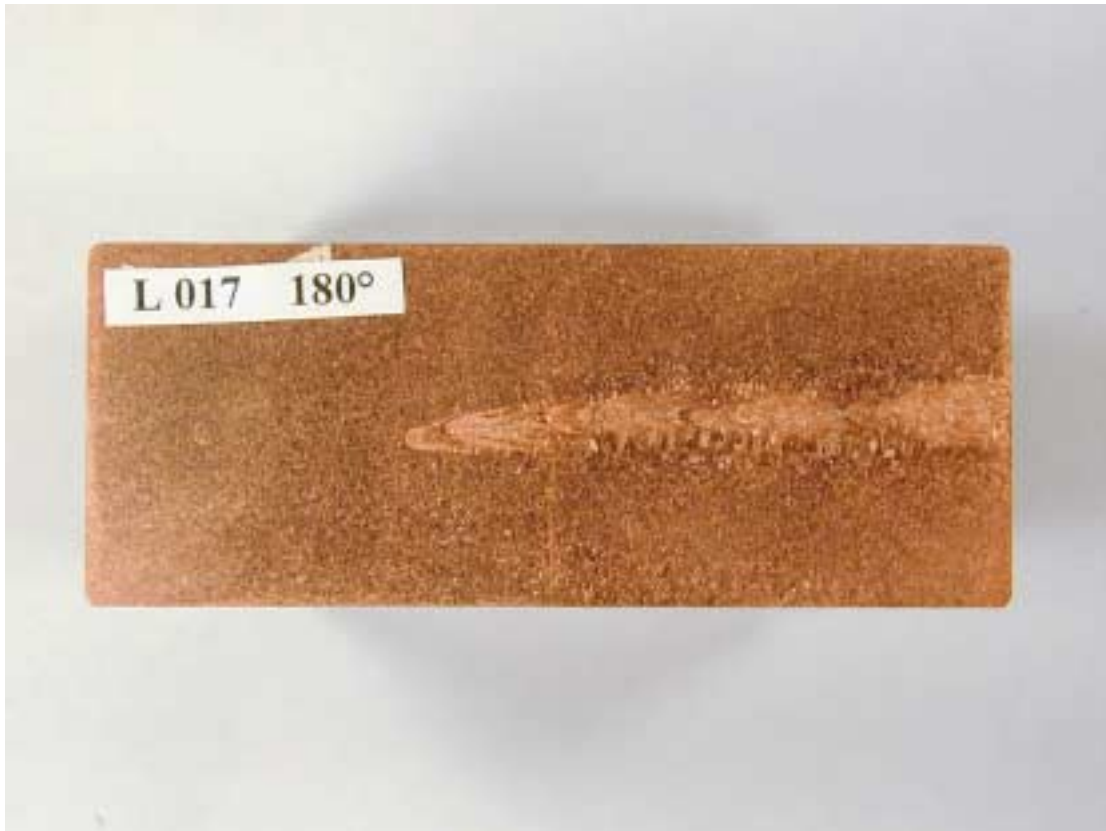
Lid weld no 17: Tip radius 1,2 mm
Cathode: HCC1 Q1=1,195A/ Q2=1,410A

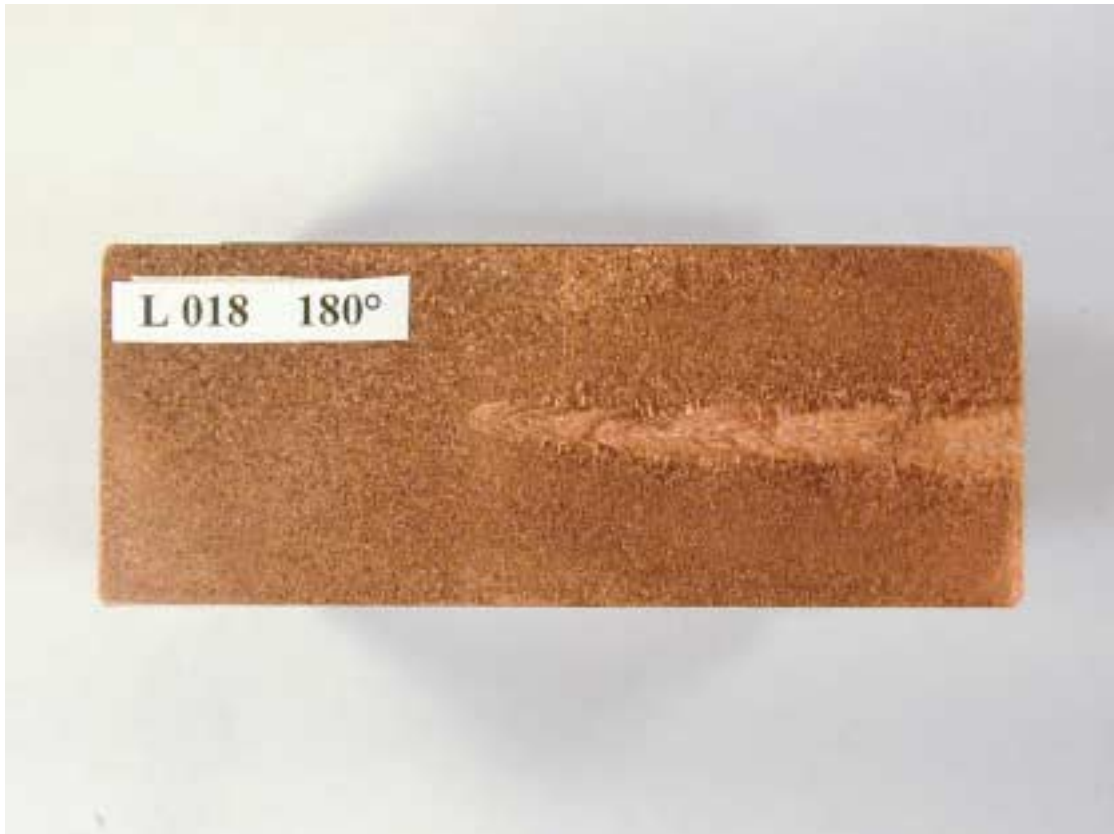
Lid weld no 18: Tip radius 1,4 mm
Cathode: HCC1 Q1=1,195A/ Q2=1,410A

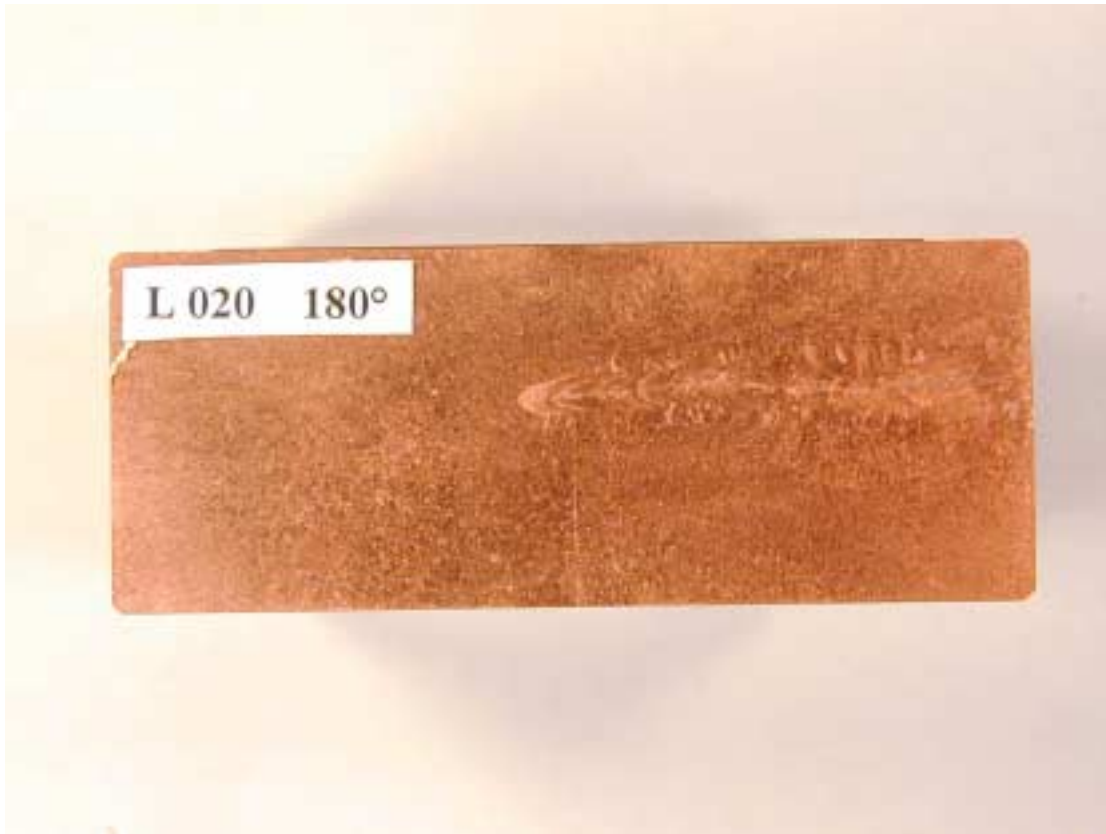
Lid weld no 20: Tip radius 1,0 mm
Cathode: HCC1 Q1=1,195A/ Q2=1,470A

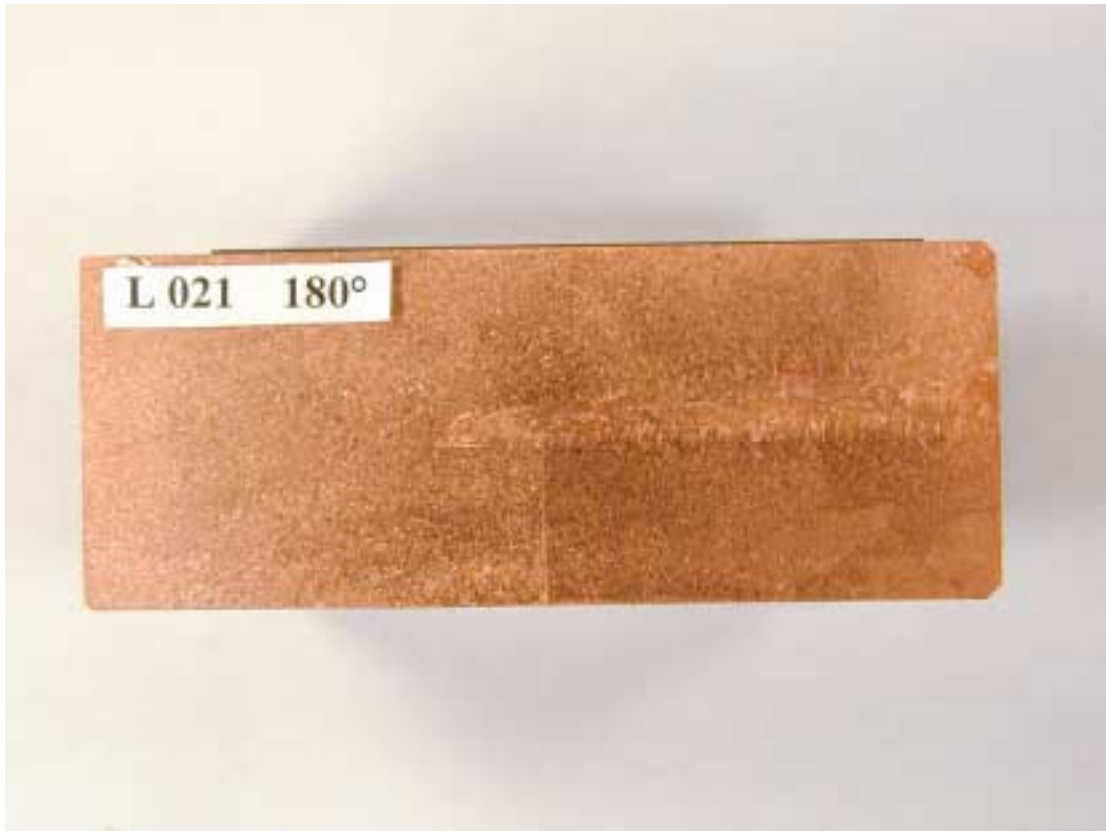
Lid weld no 21: Tip radius 1,2 mm
Cathode: HCC1 Q1=1,165A/ Q2=1,470A
