**P-04-62**

## **Oskarshamn site investigation**

### **Drill hole KSH01A**

#### **Indirect tensile strength test**

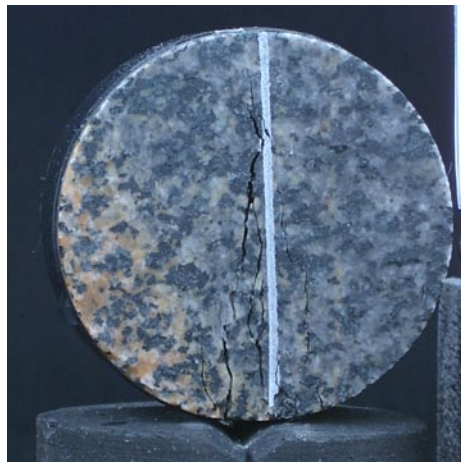
After mechanical test

Diameter [mm]	Height [mm]	Density [kg/m <sup>3</sup> ]	Tensile strength [MPa]	Loading direction
50.1	26.3	2777	15.1	
<b>Comments:</b> None

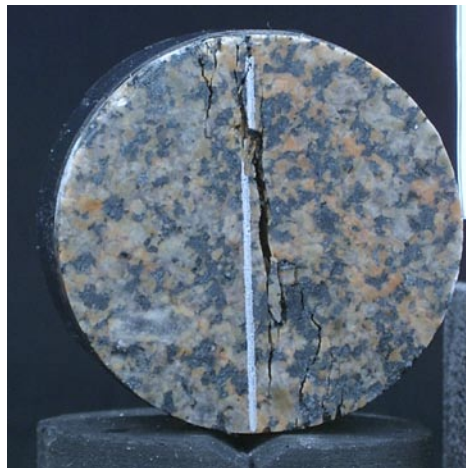
After mechanical test

Diameter [mm]	Height [mm]	Density [kg/m <sup>3</sup> ]	Tensile strength [MPa]	Loading direction
50.1	26.2	2775	15.9	
<b>Comments:</b> None

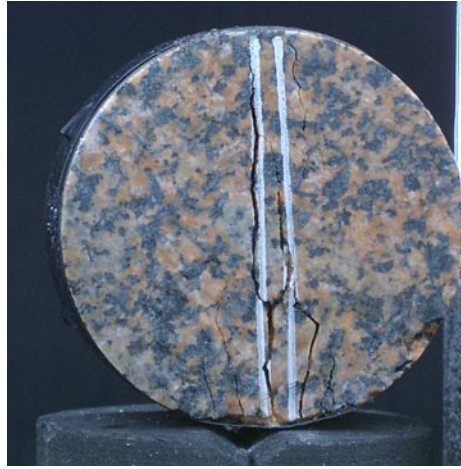
**Specimen ID: KSH01A-110-11**

**Comments:** A small piece on the edge of the specimen close to the loading place is missing

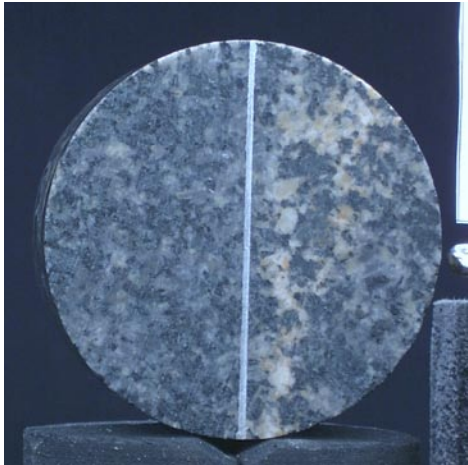
Before mechanical test

**Specimen ID: KSH01A-110-13**

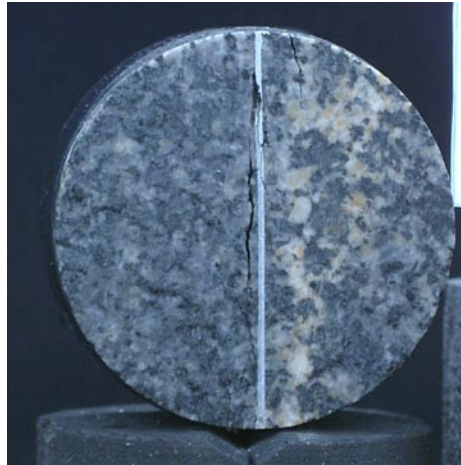
After mechanical test

Diameter [mm]	Height [mm]	Density [kg/m <sup>3</sup> ]	Tensile strength [MPa]	Loading direction
50.0	26.3	2800	15.9

**Comments:** None

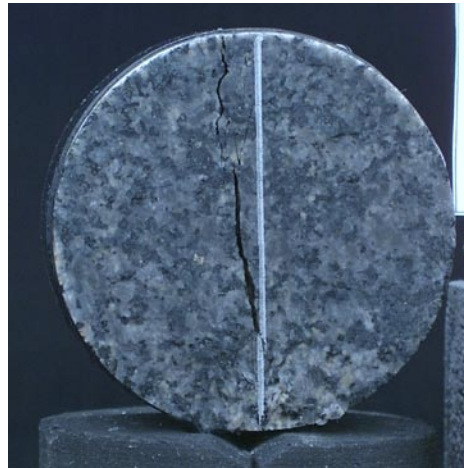
After mechanical test

Diameter [mm]	Height [mm]	Density [kg/m <sup>3</sup> ]	Tensile strength [MPa]	Loading direction
50.0	26.2	2803	15.2	
<b>Comments:</b> None

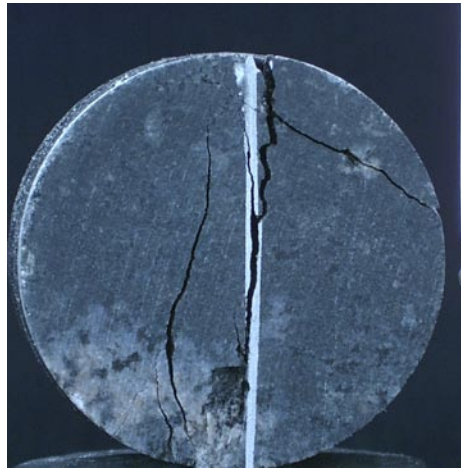
**Specimen ID: KSH01A-110-29**

**Comments:** A secondary crack was developed

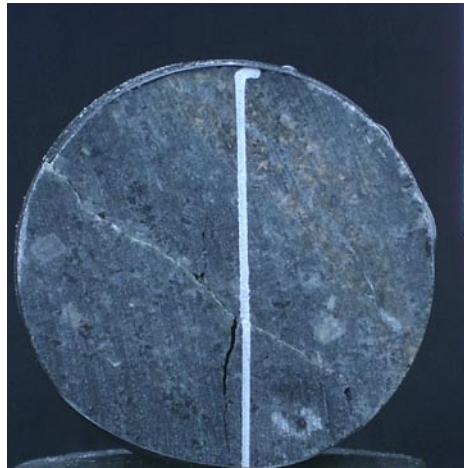
**Specimen ID: KSH01A-110-33**

**Comments:** A crack was developed in a pre-existent weakness. The crack has a kink. A drop of load force was observed at 8 and 10 MPa

A summary of the test results is shown in Tables 5-1 to 5-3. It is seen that specimen number 24, 25, 31, 33, 38, 41, 49 and 52 had pre-existing failure planes and displayed lower values on the tensile strength. The densities and tensile strength versus the depth, at which the samples are taken, are shown in Figures 5-1 and 5-2.

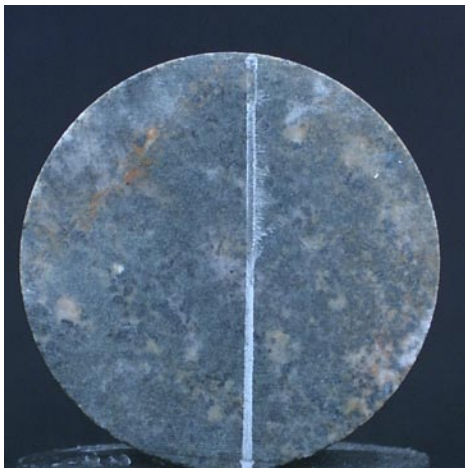
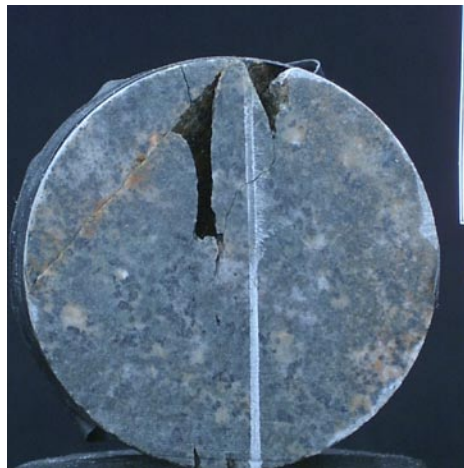
**Specimen ID: KSH01A-110-36**

**Comments:** A crack was developed in a pre-existent weakness plane

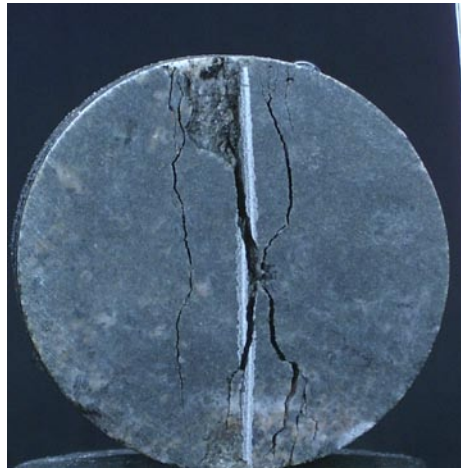
After mechanical test

Diameter [mm]	Height [mm]	Density [kg/m <sup>3</sup> ]	Tensile strength [MPa]	Loading direction
50.1	26.6	2797	21.5	
<b>Comments:</b> None

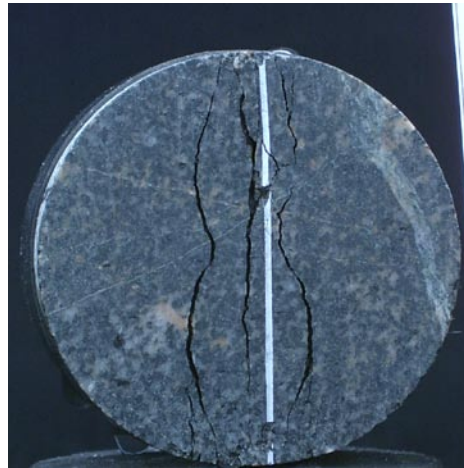
After mechanical test

Diameter [mm]	Height [mm]	Density [kg/m <sup>3</sup> ]	Tensile strength [MPa]	Loading direction
50.0	26.3	2825	21.3	
<b>Comments:</b> None

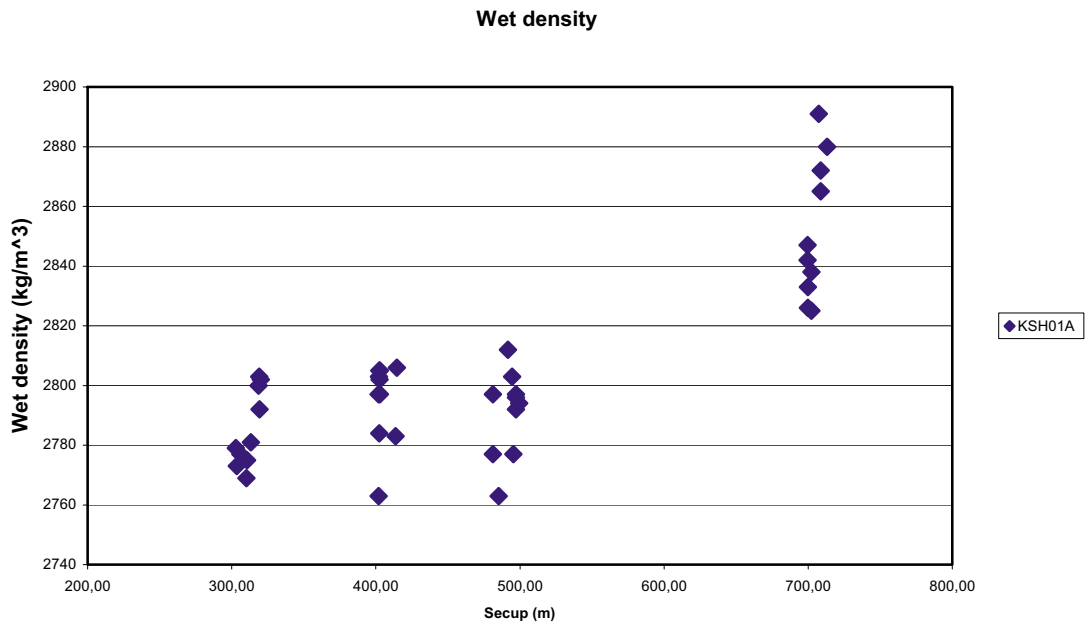
Figure 5-1. Density versus depth at which the samples are taken in the borehole.

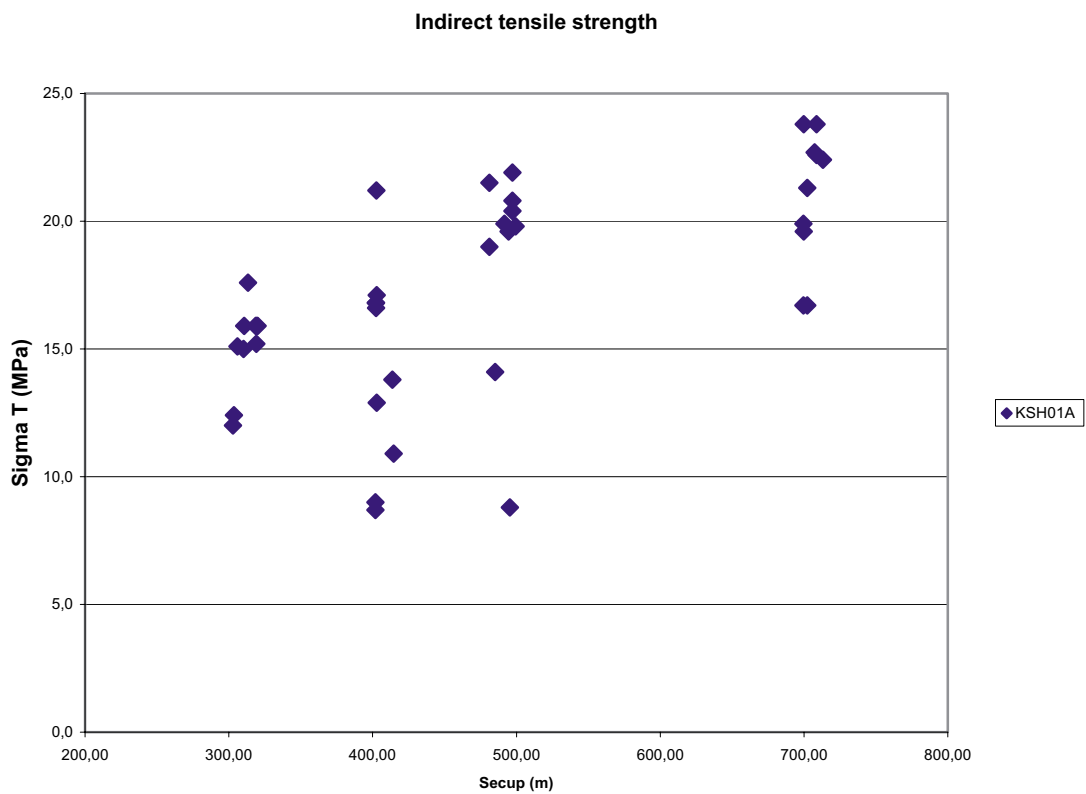
Figure 5-2. Tensile strength versus depth at which the samples are taken in the borehole.
