TR-16-12

Retrieval and post-test examination of packages 4 and 5 of the MiniCan field experiment

SVENSK KÄRNBRÄNSLEHANTERING AB

Abstract

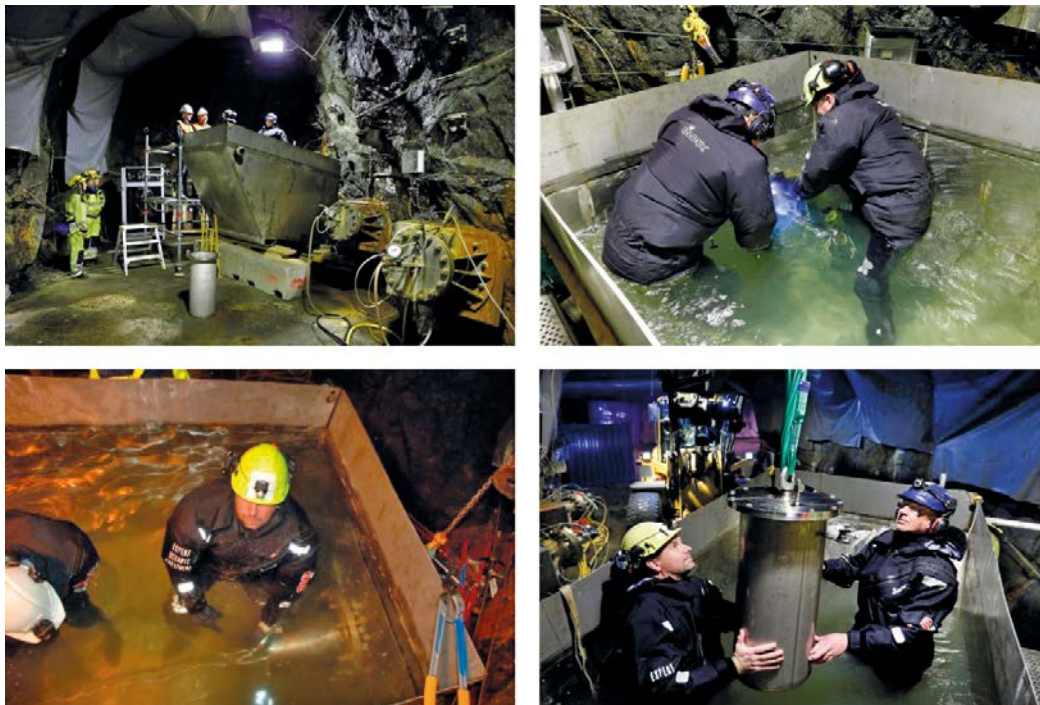
Figure 2-1. a) top-left: water-filler container connected to borehole; b) top-right: SKB personnel removing the MiniCan assembly; c) bottom-left: the MiniCan assembly remained under water at all times during removal; d) bottom-right: a sealed transfer flask was used to keep the MiniCan assembly oxygen-free until it was placed inside the glovebox.

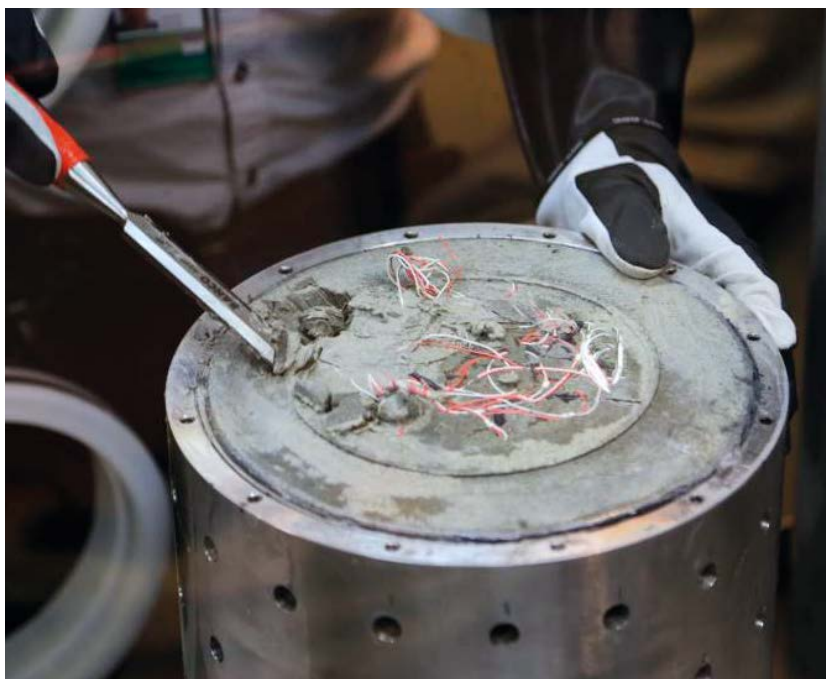
Figure 2-4. The high-density bentonite as seen upon opening the MiniCan 4 assembly.

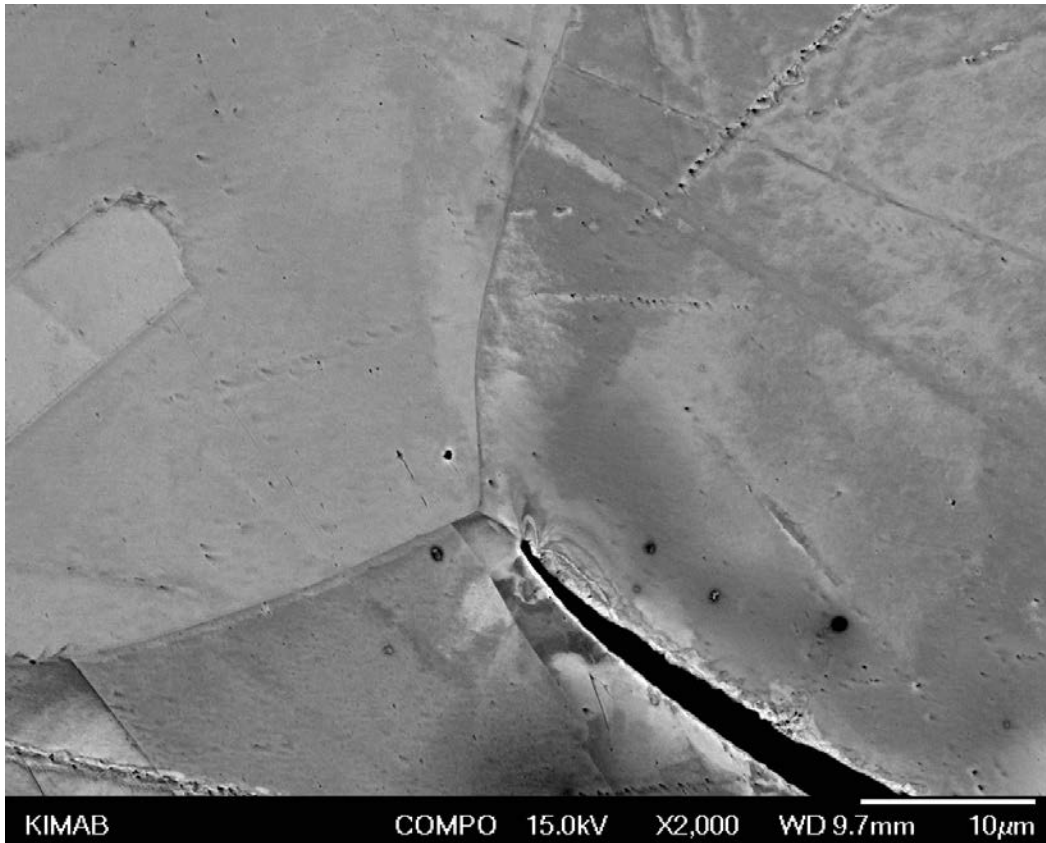
Figure A3-46. Detail of the crack tip of WOL sample M4 3:1.

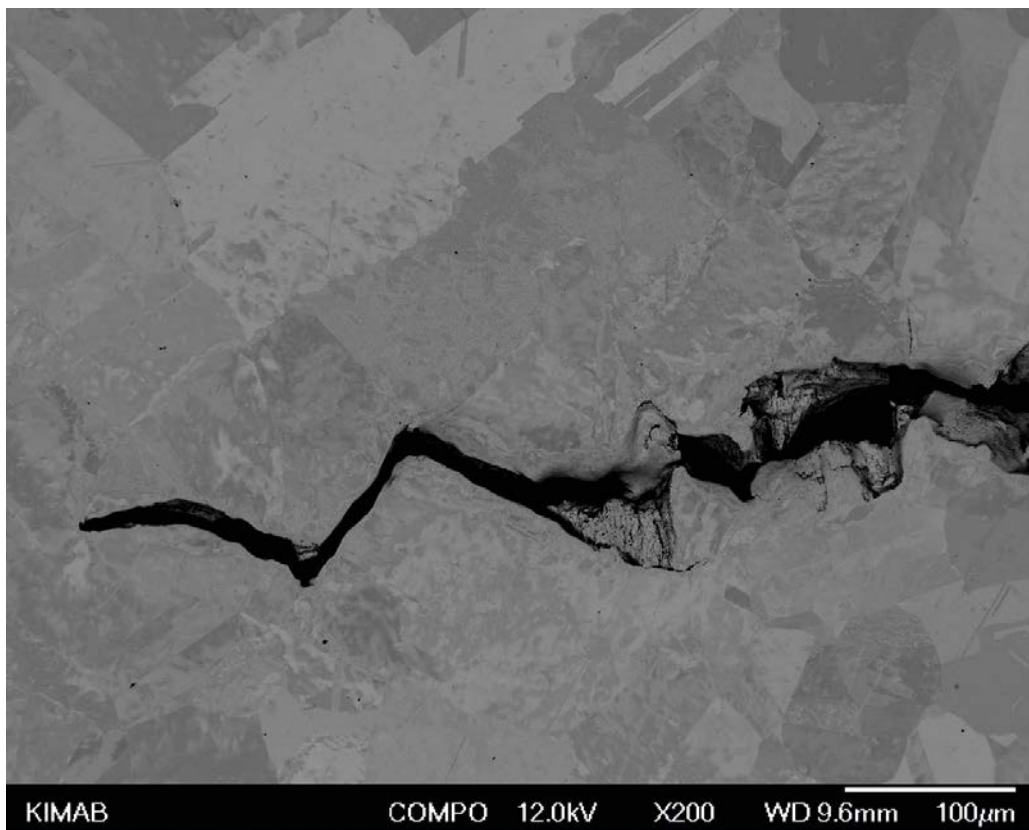
Figure A3-61. Forward part of the pre-crack of WOL sample M4 4:1.

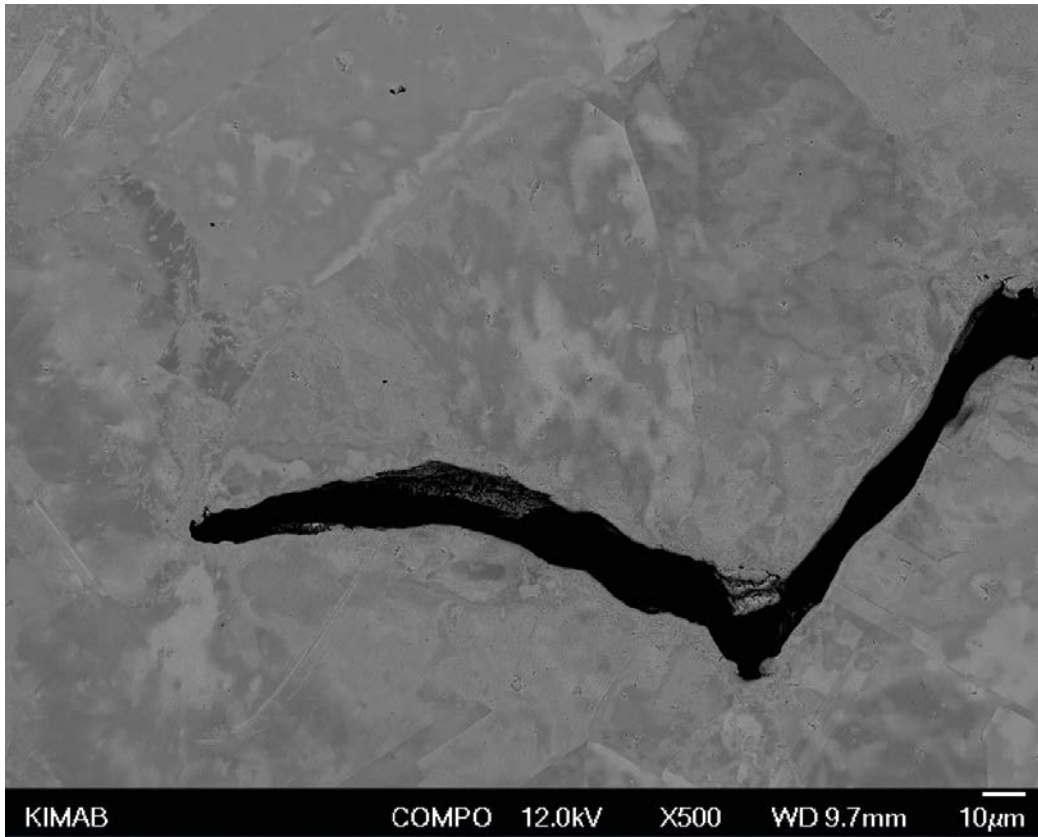
Figure A3-62. Crack tip of WOL sample M4 4:1.

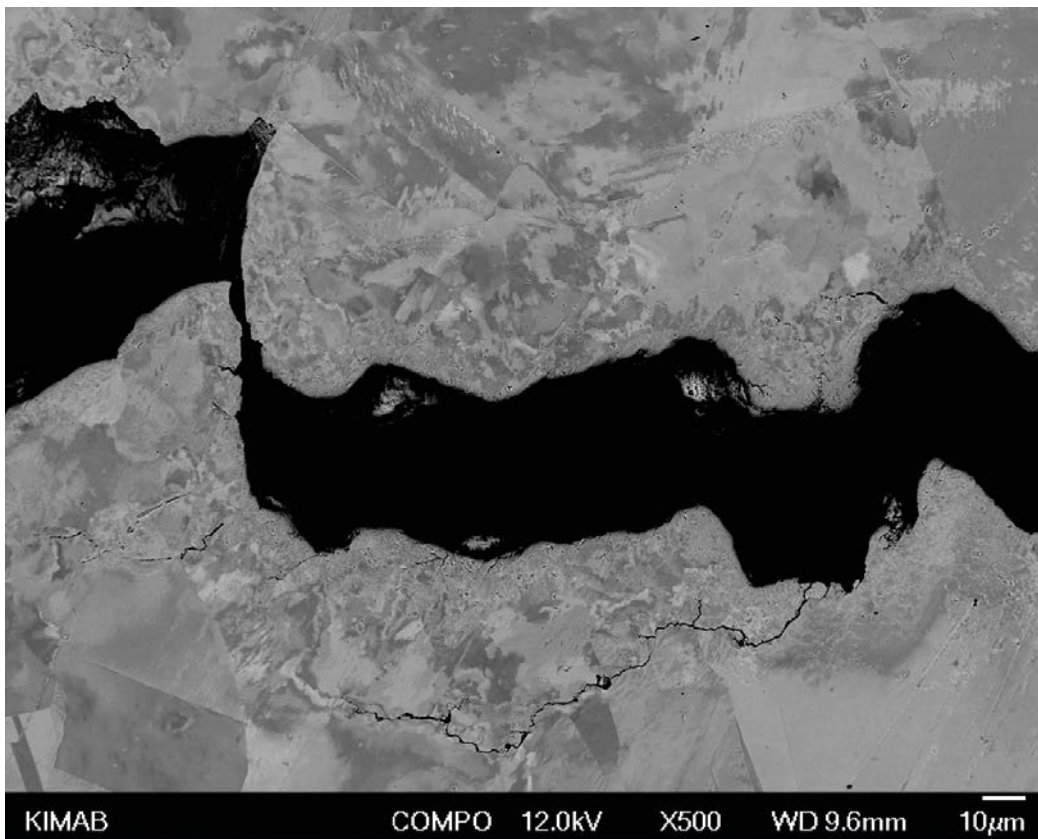
Figure A3-63. Detail of middle section of pre-crack of WOL sample M4 4:1, with smaller cracks emanating from the pre-crack into the cold deformed zone.

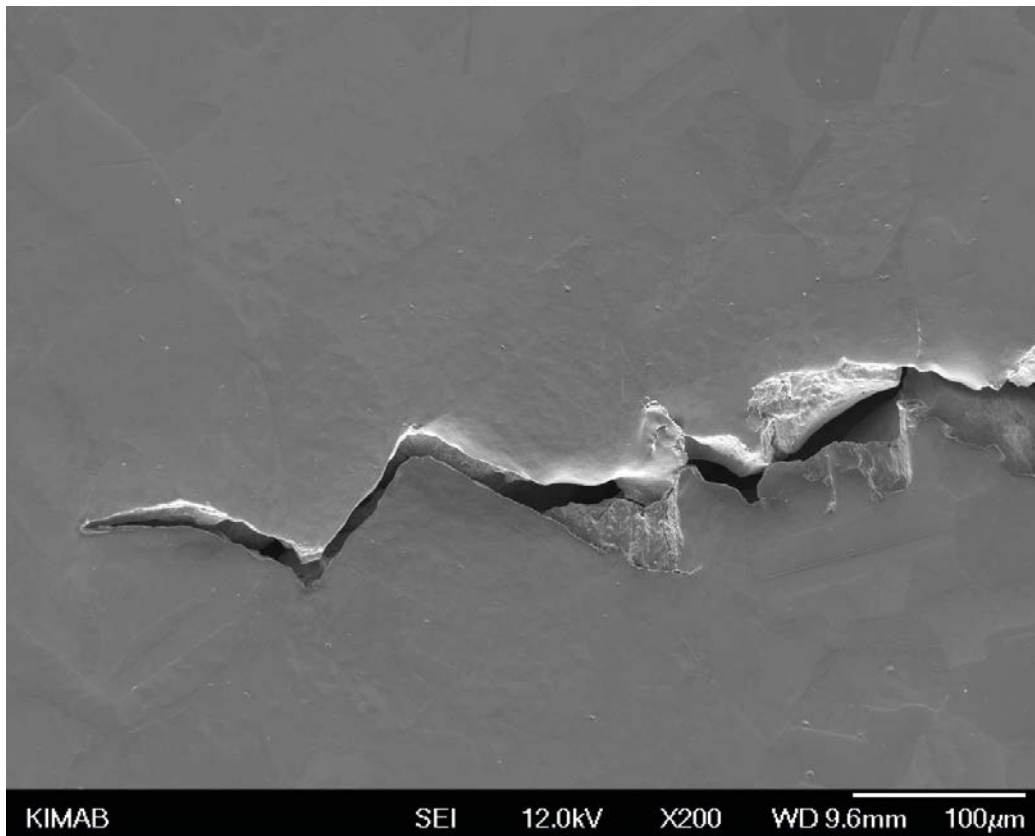
Figure A3-65. Secondary electron image (SEI) of forward part of pre-crack of WOL sample M4 4:1.
