# **Äspö Hard Rock Laboratory**

## **Äspö Pillar Stability Experiment**

### **Coupled Stress-flow tests on large fracture samples from the APSE site**

**SKB R-13-29**

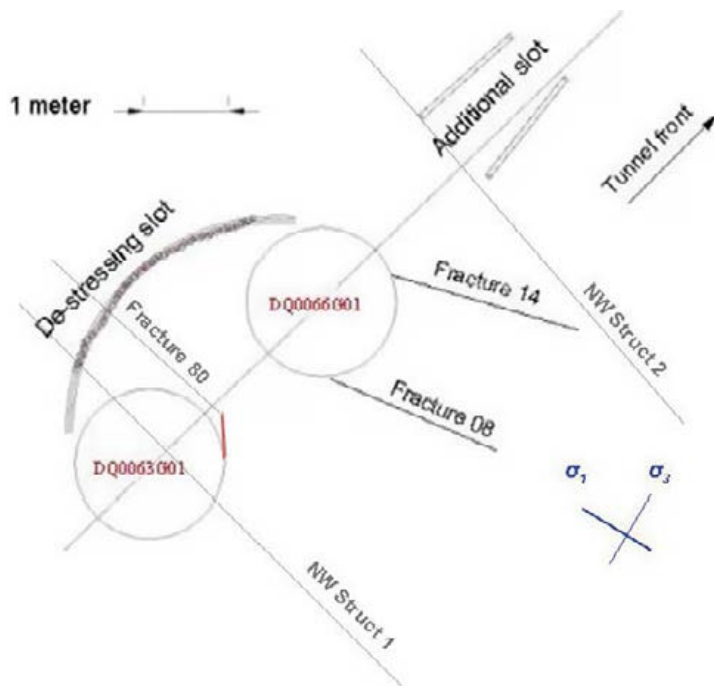
**Figure 1-2.** Layout of the HM data acquisition experiment (Mas Ivars 2005) (not to scale). Fracture 08 is the fracture from which the samples were taken from.

For the planning of the stress-flow tests it was necessary to have an idea about the magnitude of the stresses acting on the fracture plane from where the drill cores had been obtained, during the drilling of the de-stressing slot. There were no stress measurements while drilling the de-stressing slot. For this reason, and to better understand the previous field studies conducted at the APSE site, a three-dimensional mechanical numerical analysis of the redistribution of the stress during the drilling of the de-stressing slot was carried out (Mas Ivars 2006) with the distinct element code 3DEC (Itasca 2003). This simulation included the effect of the main fractures in the study volume, one of which was fracture 08 (see Figure 1-2).

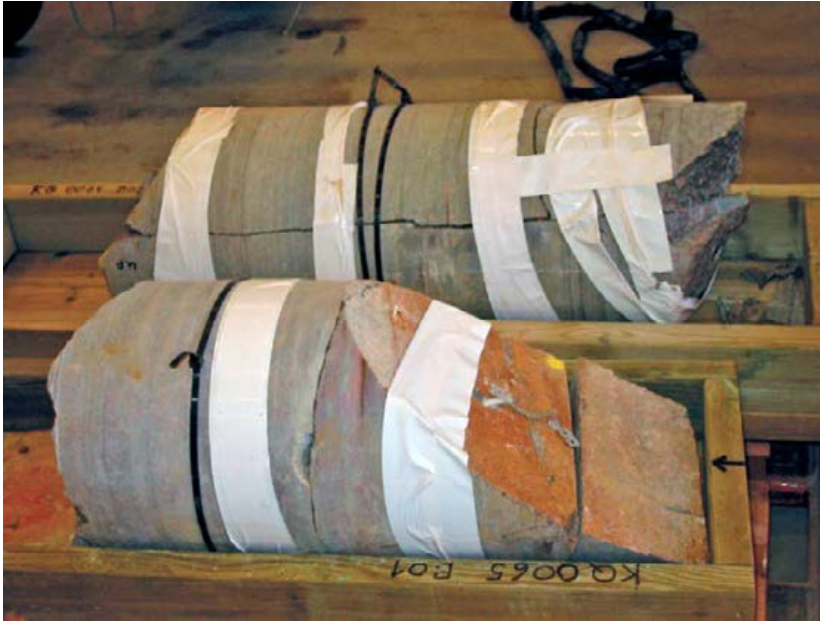
*Figure 1-3. Borehole cores from which the fracture samples were cut.*

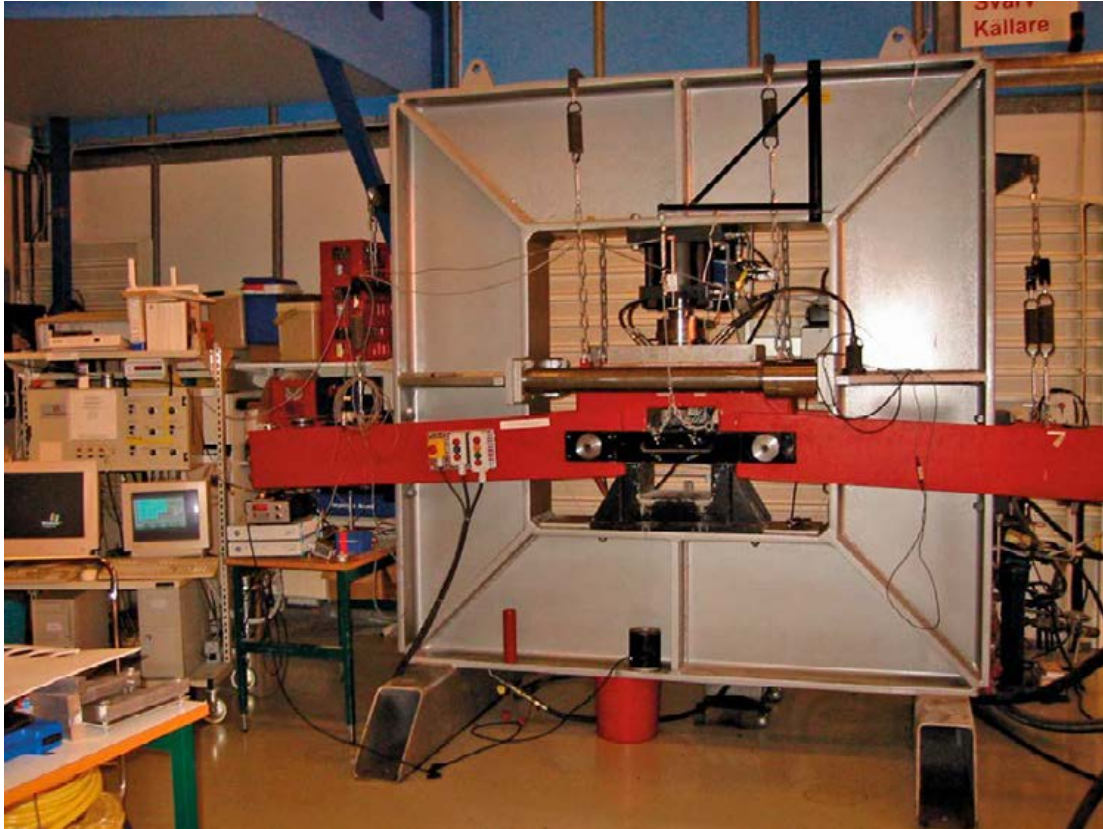
**Figure 2-2.** Shearing frame in grey with shearing system in red. Log system in the right of the picture.

The shearing unit consists of a highly reinforced steel frame (Figure 2-2) in which the lower part of the sample is firmly attached.

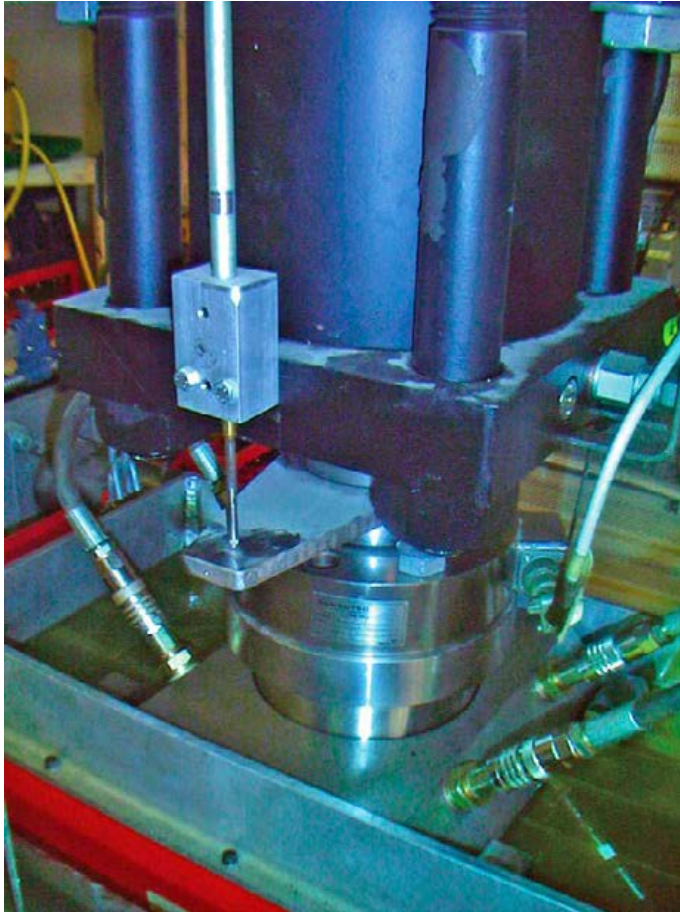
*Figure 2-5. Normal force actuator and the system for distributing the force down on top of the sample.*

Normal force is applied by a 500 kN hydraulic actuator situated on top of the sample, inside the steel frame. It has a stroke capacity of  $\pm 20$  mm. The actuator is equipped with a digital servo valve that is controlled by a program supplied by MOOG. The force that compresses the sample is transferred down to the sample through a spherical bearing and further down through an oil lubricated flat slide bearing down to the upper joint for the samples. The force is measured by a load cell and the stroke determined by a LVDT (Figure 2-5).

As shown in Figure 2-5, the shearing unit has a central transducer (LVDT), located over the normal force actuator, which records the vertical displacement.

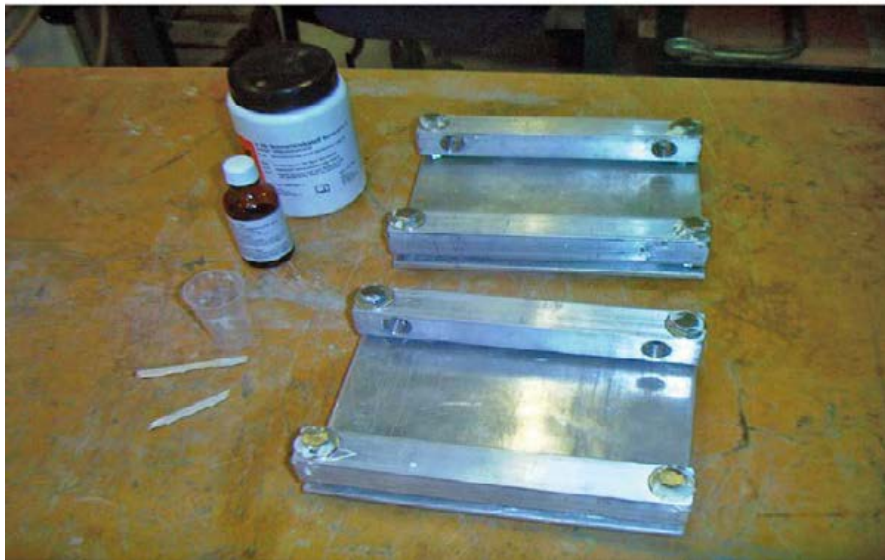
**Figure 2-7.** The fixation tools for mounting the LVDTs along the side of the samples.

The set of LVDT holders and sliding bar (Figure 2-7) are glued on to the side of the concrete with X60-glye. The glye is applied on the heads of the bolts and compressed against the concrete with wing screws that are mounted on to the stretchers (Figure 2-8).

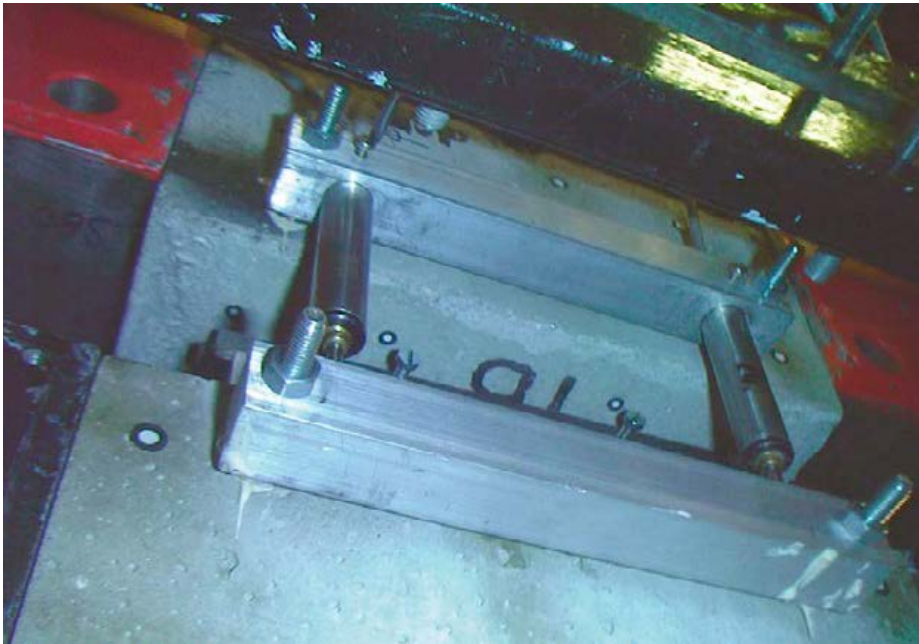
*Figure 2-9. LVDTs mounted into the holders after the guide aluminium plate has been removed.*

After the glue has hardened, the mounting plates are removed leaving the holders glued on to the side of the concrete. Then, when the LVDTs are mounted in the holders, any opening/closure of the fracture could be recorded and evaluated (Figure 2-9).

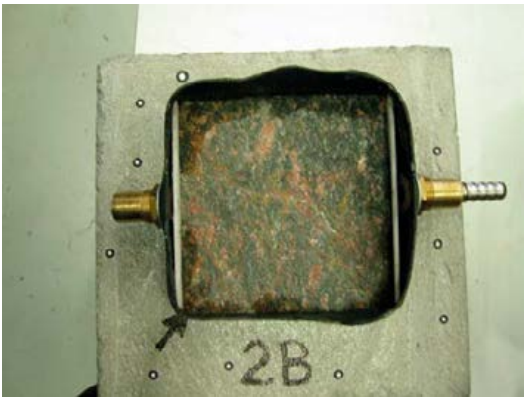
Figure 2-12. Sample, rubber tube, filters and quick joints for water inlet and outlet.

The sealing system consists of rubber tube, with inlet and outlet through a quick joint for the hoses. A white filter is attached on the inside of the rubber seal, on the inlet and outlet sides, so that water is distributed over the entire crack length (Figure 2-12).

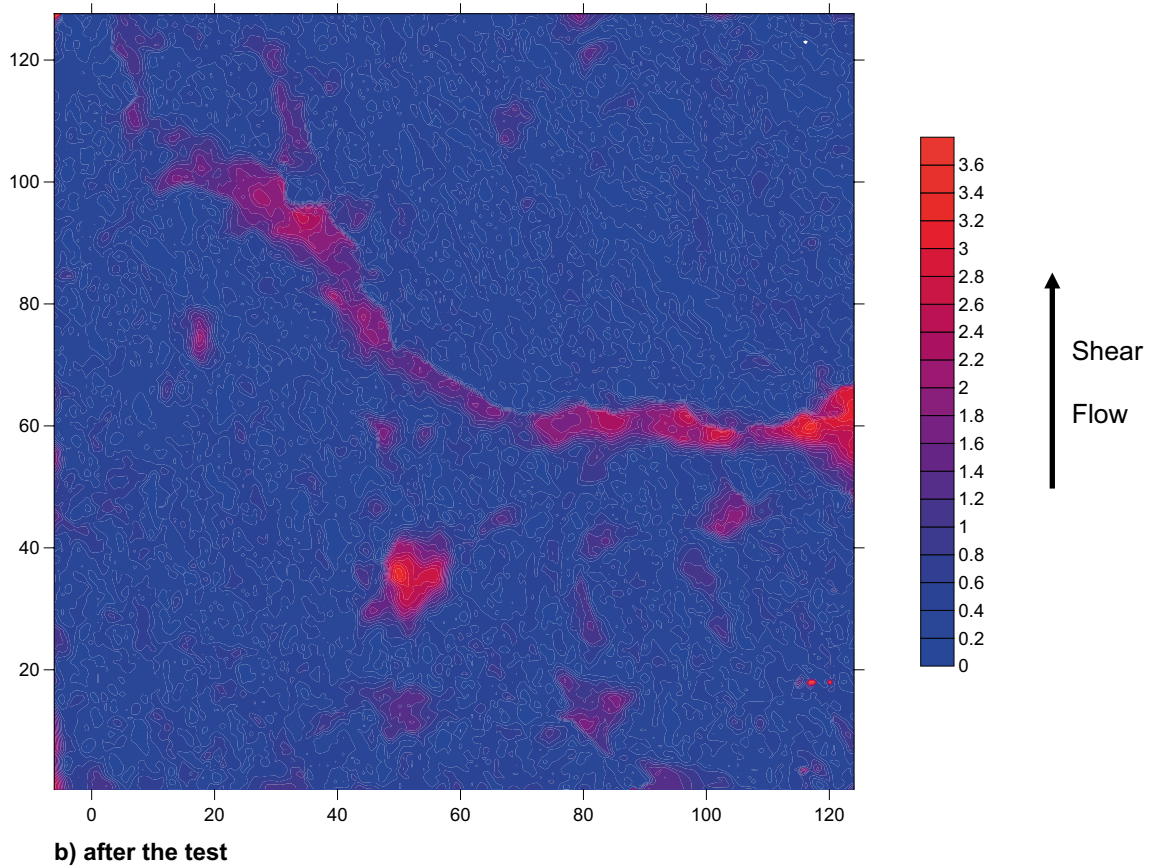
*Figure 3-1. Aperture contours in mm for Sample 1 (whole aperture range).*

From the contour plots we can see that even if the three fracture samples come from the same fracture in the APSE area, they have quite different aperture maps. Sample 1 is marked by the large open channel crossing all the way through the fracture plane (Figure 3-1). However, the channel is assumed to have a relatively small influence on the flow in our test due to the fact that it does not connect the inlet to the outlet of water and it mainly runs in the perpendicular direction to the flow. Besides the channel, it is important to notice that in the lower aperture ranges (Figure 3-2 and Figure 3-3) the low aperture areas (blue) are quite scarce compared to those on Sample 2 and Sample 3. The low aperture areas in Sample 1 seem to have a NW-SE orientation (referred to the plots) that is not clear in Samples 2 and 3. Sample 2 and Sample 3 are more similar to each other in the sense that the larger aperture areas (red) are located mainly in the boundaries of the samples and they both have abundant low aperture areas (blue) if we look at the small aperture range figures (Figure 3-6 and Figure 3-9).

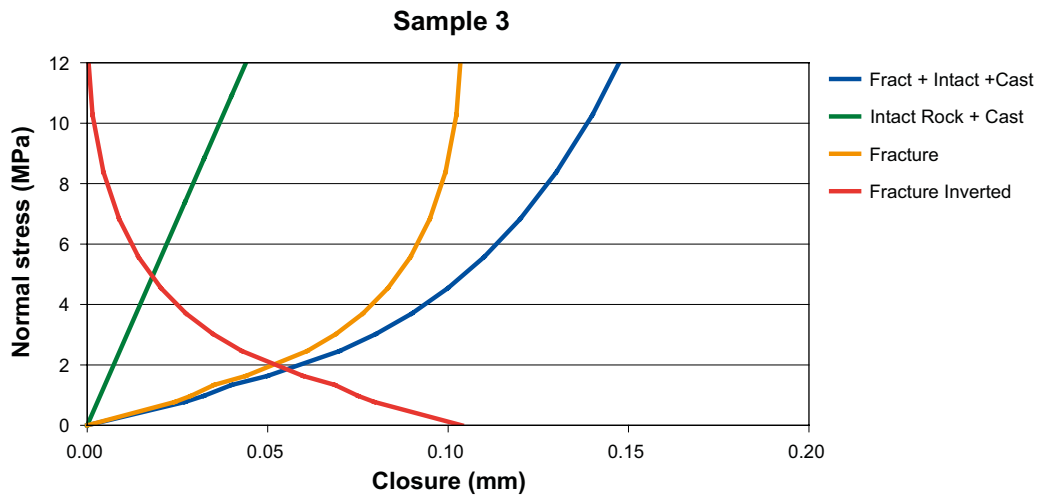
Figure 3-28. Fracture normal stress vs. closure for Sample 3 during the uploading cycle 3.

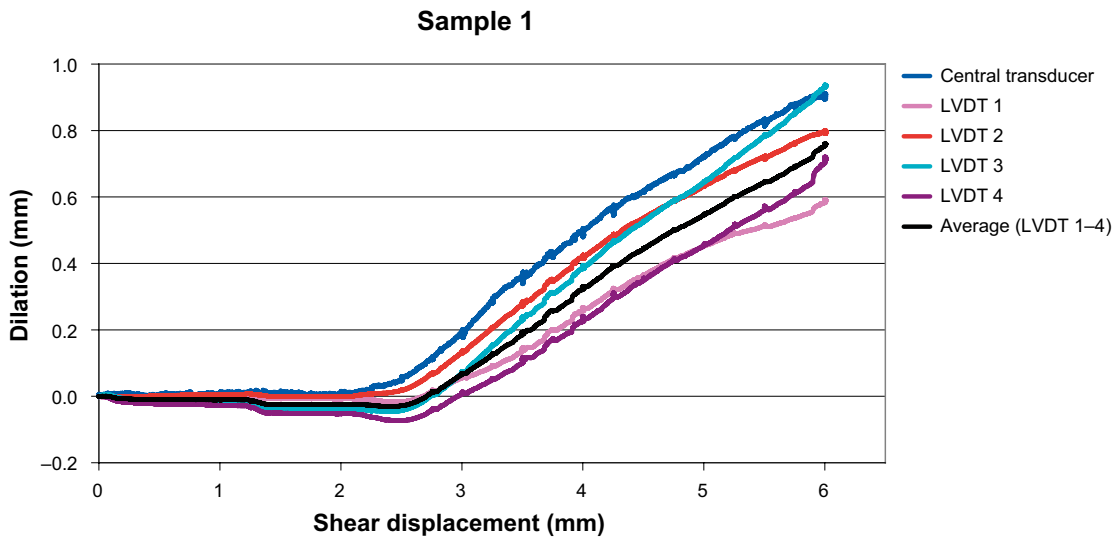
Figure 3-43. Fracture dilation vs. shear displacement during the coupled shear displacement-flow test for Sample 1.

Looking at Figure 3-43, Figure 3-44 and Figure 3-45 one can see that the dilation becomes noticeable at approximately 2.25 mm of shear displacement for Sample 1, while for Sample 2 and Sample 3 it becomes noticeable at a much shorter shear displacement (less than 1 mm). However, the maximum dilation after 6mm of shear displacement is around 0.8–1 mm for the three fracture samples.
