## Spalling initiation experiments on large hard rock cores

Lars Jacobsson, Karin Appelquist, Jan-Erik Lindqvist  
RISE Research Institutes of Sweden

February 2018

**SKB R-14-12**

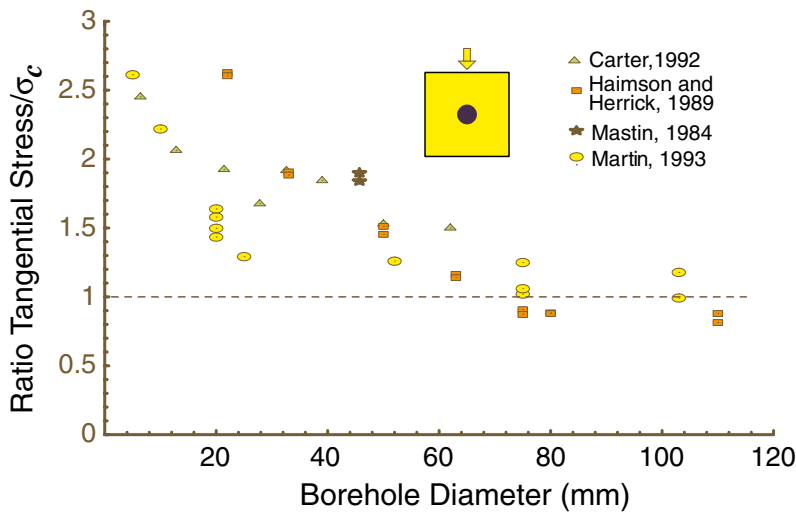
Figure 1-1. Results from different hole in a plate test showing the ratio between the tangential stress when fracturing starts and UCS for various borehole diameters. From Martin et al. (1994).

The “hole in a plate” test is a test where a rock block or plate is compressed in one direction in order to accomplish a tangential stress in the hole which causes spalling. Martin (1993) and Martin et al. (1994) summarize the results from a number of tests, see Figure 1-1. It is seen that the ratio between the tangential stress and UCS is decreasing with increasing borehole diameter. The ratio is approaching 0.8–1 for diameters of 75–115 mm. Diederichs et al. (2004) discuss the effect of feedback confinement which suppress the spalling both in the case of uniaxial compression and in the hole in the plate test. This is illustrated in Figure 1-2.

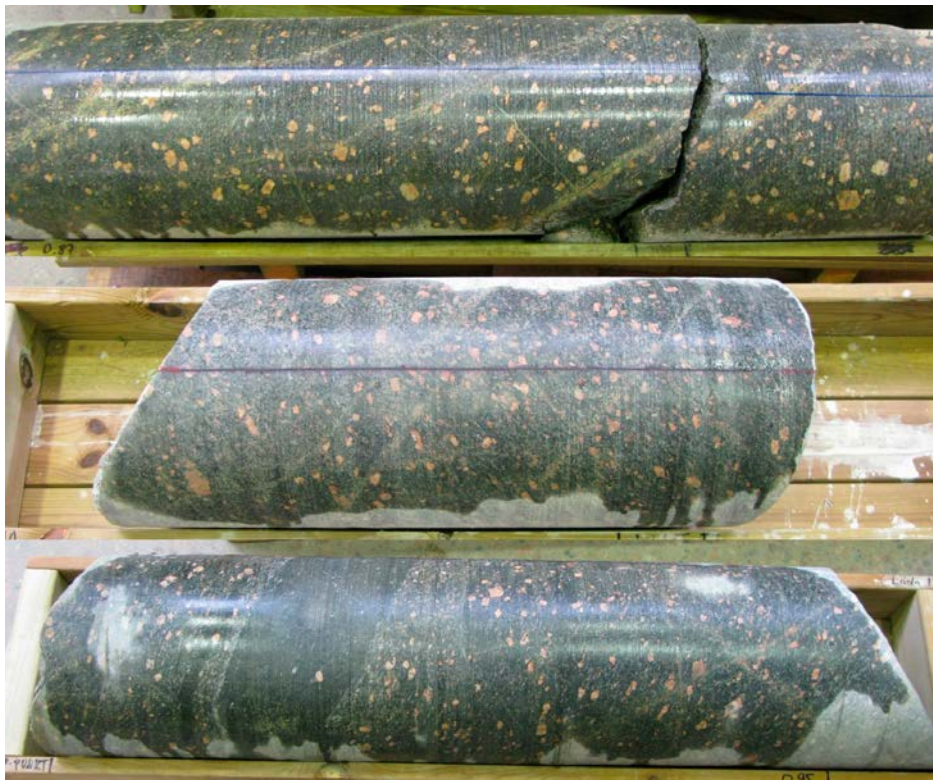
**Figure 2-1.** Specimens after they arrived to SP. Upper picture: KS0037B02; Middle picture: KS0041B02; Lower picture: KS0044B02. The surfaces of the cores were moistured in order to better reveal the rock texture.

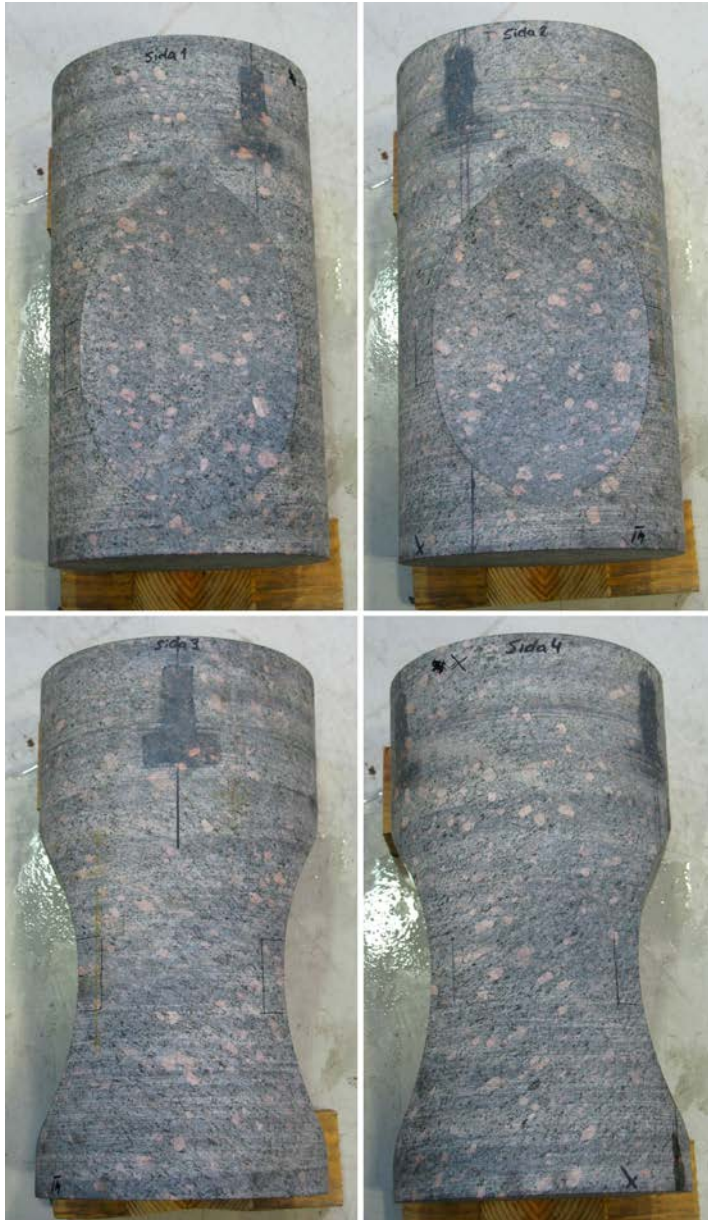
**Figure 2-4.** Specimen KS0041B02. Sides 1–4. The surface has been slightly grinded in the darker areas on the top of the specimen for subsequent strain gauge installation.

Two cylindrical specimens were manufactured from the cores, KS0041B02 and KS0044B02. The end surfaces were grinded and two plane single curved notches with smooth surfaces were manufactured opposite to each other. The notch is shifted 50 mm in the specimen axial direction. Pictures of the specimens after manufacturing are shown in Figures 2-4 and 2-5. It is seen that specimen KS0044B02 has a large xenolith of fine grained mafic rock material in the centre of the notch on side one.

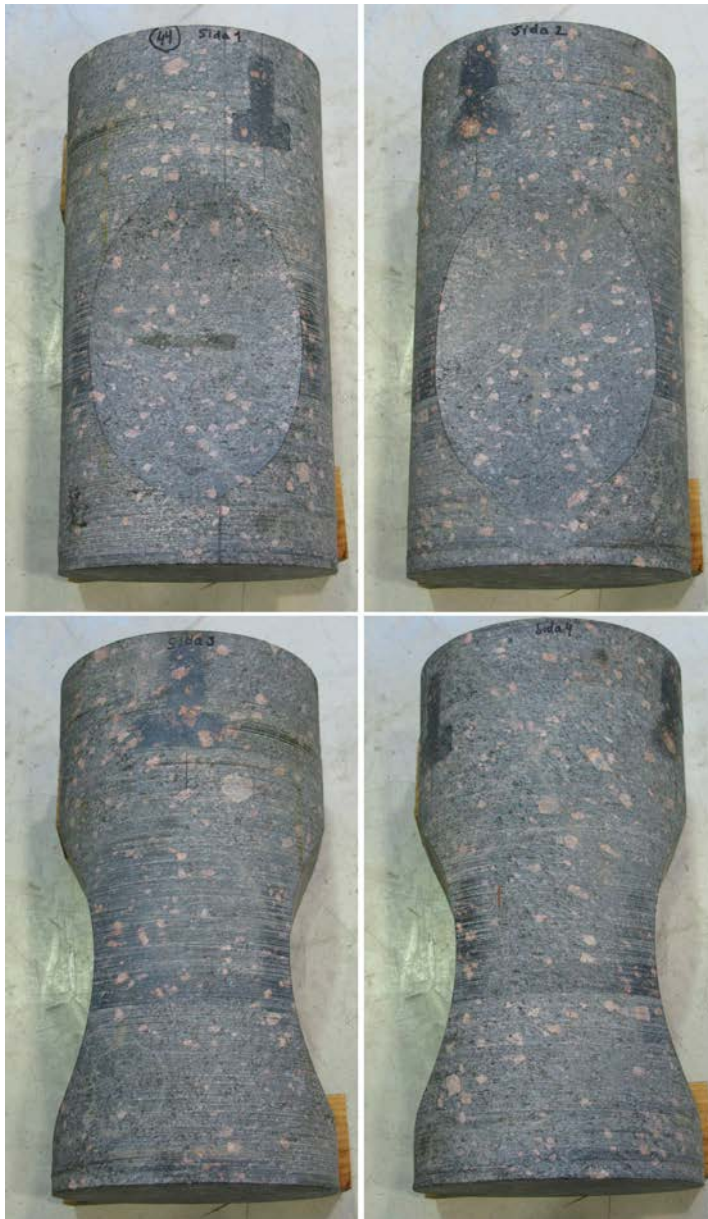
**Figure 2-5.** Specimen KS0044B02. Sides 1–4. The surface has been slightly grinded in the darker areas on the top of the specimen for subsequent strain gauge installation. A long mafitic xenoliths in the horizontal direction is seen at the centre on the notch on side 1 (upper left figure).

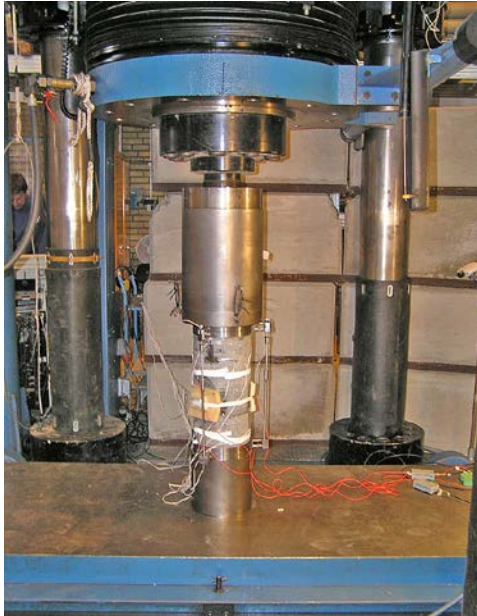
*Figure 2-6. Specimen KS0044B02 placed in the load frame right before testing. The concrete blocks sealing off towards the control area are seen in the background.*

A four column load frame with a maximum compressive load of 20 MN was used for the tests, see Figure 2-6. A safety assessment was carried out prior to the test start. As a result of this, the area where the supervision of the test was carried out was sealed off by a wall of concrete blocks in the case of a specimen failure, see Figure 2-7. The specimen was loaded between flat loading platens of hardened steel. A spherical seat was placed over the upper loading platen. The load was initially measured using an electrical load cell rated up to 5 MN. This would yield a maximum tangential stress of 186 MPa in the notch according to FE-simulations which was estimated to be enough force to achieve spalling. The electrical load cell was subsequently removed as it turned out that fully developed spalling did not take place at a load of 5.0 MN during the first test (KS0041B02). After that, the load was measured only by means of the hydraulic pressure.

The specimen was kept moisture during the test by wetting a sponge cloth and lightly applying it against the notch surface. A piece of soft cell plastic was put outside the cloth to hold it in place. The arrangement is seen in Figure 2-6.

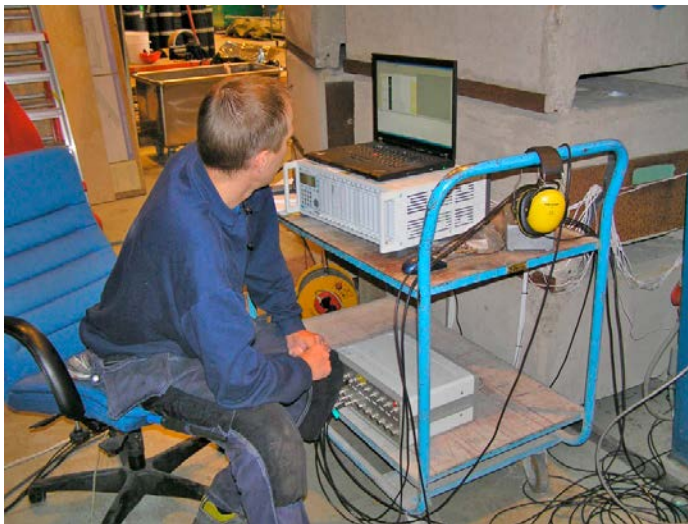
*Figure 2-7. Control and monitoring area during the tests behind the protection shield.*

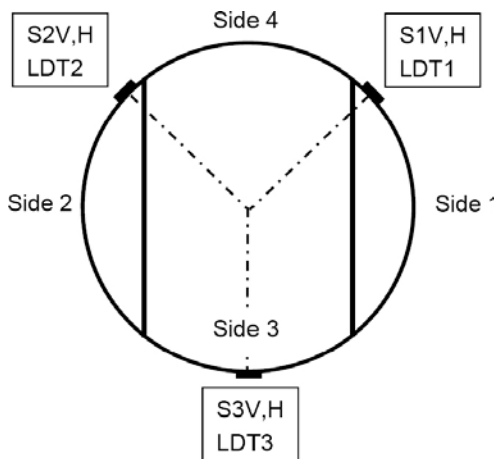
**Figure 2-9.** Specimen seen from the top with the placement of the strain gauges (S) and total axial deformation measurement (LDT).

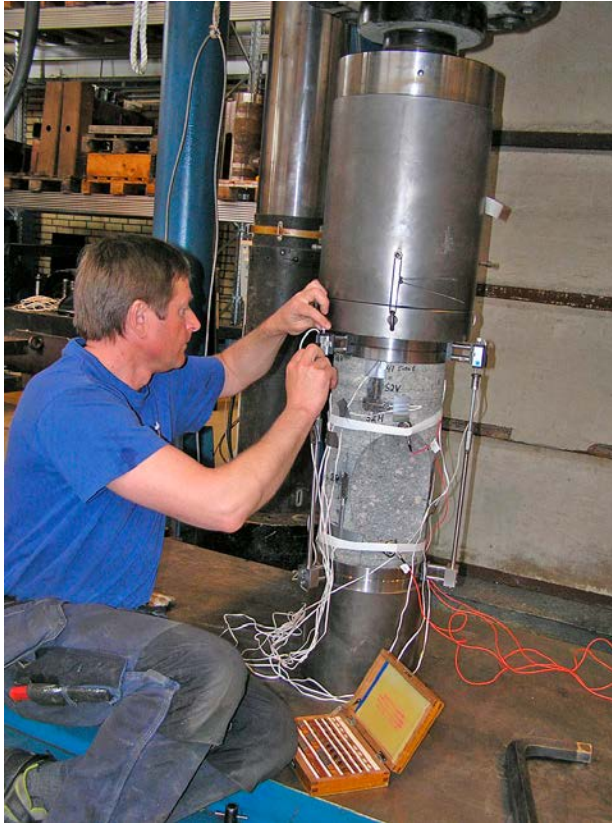
*Figure 2-10. Calibration check of the LVDTs by means of gauge blocks (Johansson gauge) prior to the test of KS0041B02.*

The strain gauges were checked using a shunt resistance prior to the tests. The linear displacement transducers were calibrated using gauge blocks, see Figure 2-10. The signals from the load cell, strain gauges and linear displacement gauges were sampled using a HBM MGCplus device.

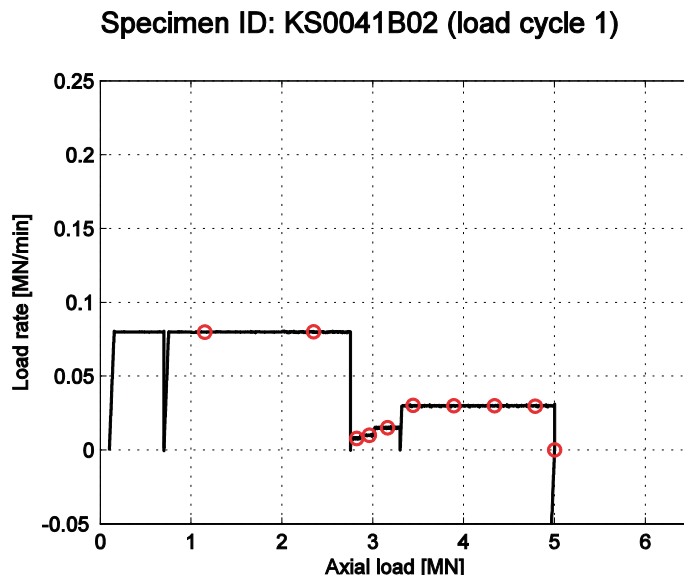
*Figure 3-1. The load history during the first load cycle on specimen KS0041B02. The red circles mark every 15 minutes test time.*

The specimen was manually pre-loaded up to 0.1 MN in order to settle all contacts. The initial loading rate from 0.1 MN was 0.08 MN/min up to 2.8 MN. The load rate was then significantly decreased as spalling was expected to occur close to this load level. The load level was then increased stepwise up to 0.03 MN/min which was kept until 5.0 MN which was the maximum load for the electrical load cell. No significant spalling did occur so far. The specimen was then unloaded and put back into water. The actual load rates for the test are shown in Figure 3-1.

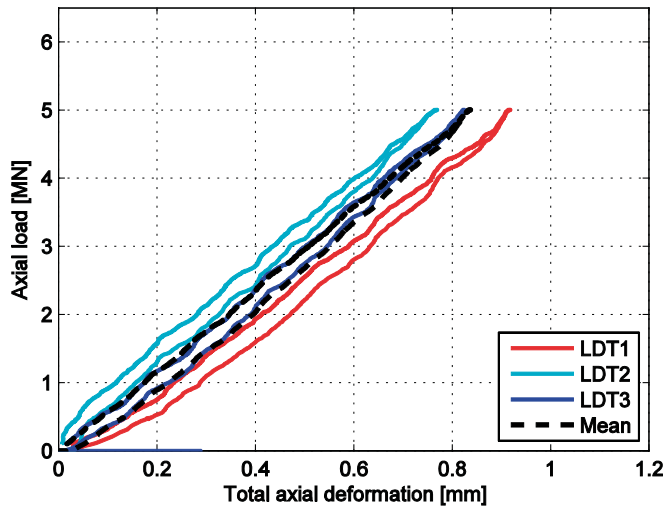
Figure 3-2. Total axial deformation during the first load cycle on specimen KS0041B02 recorded by the three linear displacement transducers (LDT) and their mean value.

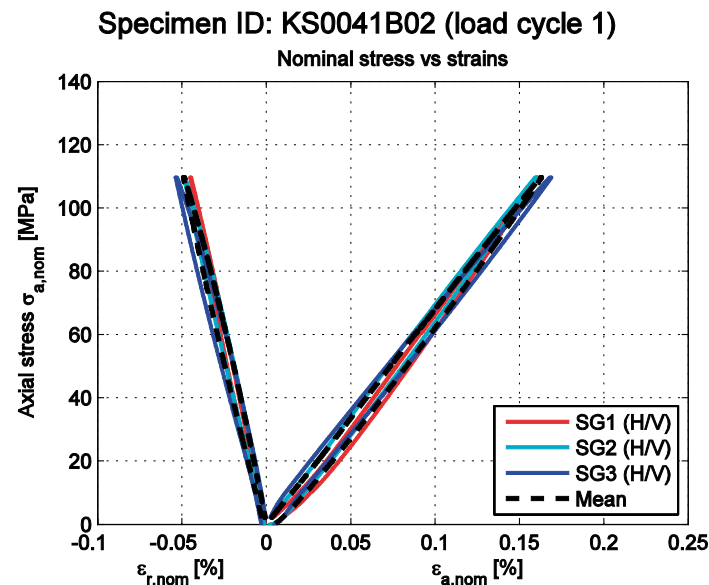
Figure 3-3. Measured strains in the cylindrical part during the first load cycle on specimen KS0041B02 recorded by the three circumferentially (H) and the three axially (V) oriented strain gauges. The thick dashed lines display the mean values of the three gauges in respective orientation.

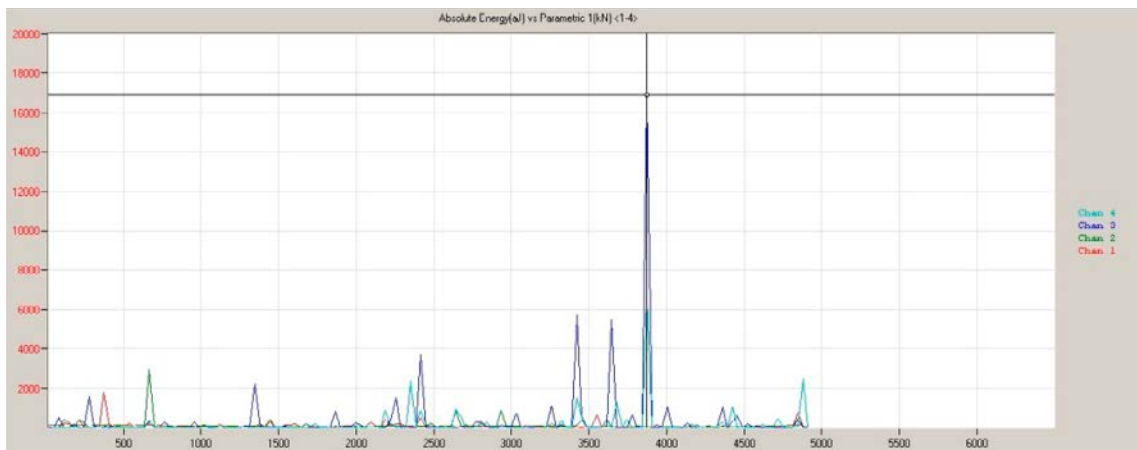
**Figure 3-5.** Absolute energy for all four AE-sensors. A peak is shown at approximately 3.9 MN indicating crack initiation.

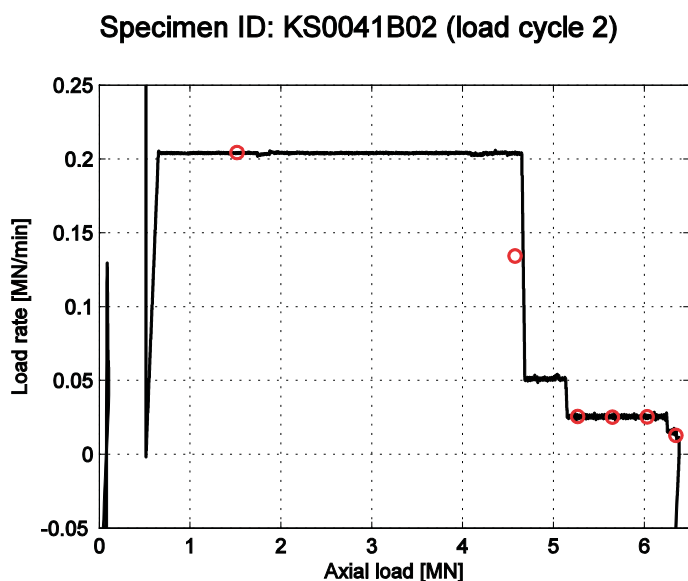
*Figure 4-1.* The load history during the second load cycle on specimen KS0041B02. The red circles mark every 15 minutes test time. The oscillating behaviour is artificial and caused by the numerical computation of the load rate.

The specimen KS0041B01 was reloaded the next day after removing the electrical load cell. The force was from now on measured by means of recording the hydraulic pressure. The two notch areas of the specimen were covered over the night with a wet sponge cloth and sealed with plastics. It is not known how the moisture was preserved with this action. The sponge cloth was removed and water was sprayed on the notch areas prior to testing. The specimen was manually pre-loaded up to 0.5 MN. The initial loading rate was 0.20 MN/min up to 4.5 MN which was close to the previous maximum load that the specimen had experienced. The load rate was successively decreased in stages in order to be ready to act if large fracturing would occur. Moreover, it was of interest to notice at which load level the spalling would take place. Significant AE-activities were recorded at 6.38 MN whereby the test was aborted and the specimen was manually unloaded. The actual load rates for the test are shown in Figure 4-1.

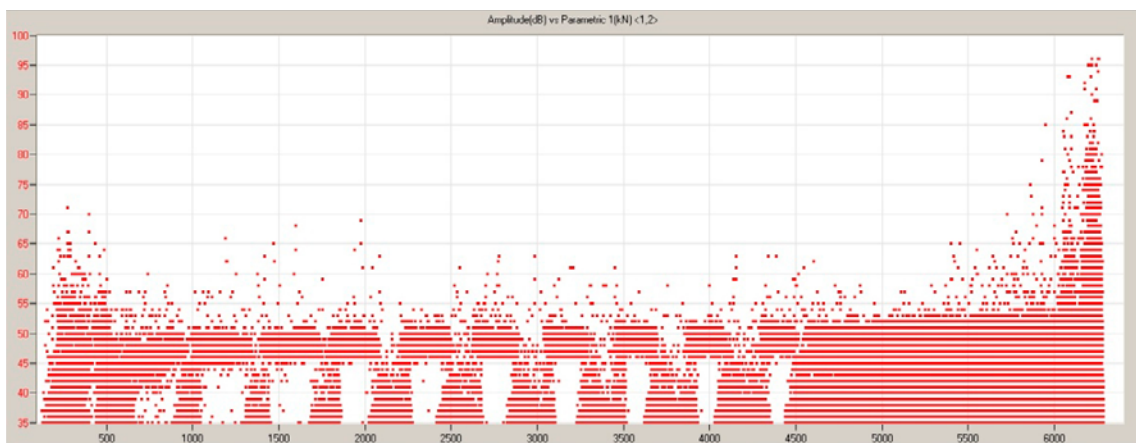
**Figure 4-5.** Amplitudes for hits versus load for the complete test. Pump noise (periodical) on around 45–50 dB is shown. The successive increase of amplitudes and intensity starts at 5.3 MN which continues to increase until the test is stopped.

The amplitudes of the AE-signals increased with higher load starting from about 5.3 MN (197 MPa), which is an indication of accelerated material degradation. First increase in AE intensity happened at around 5.7 MN (212 MPa) which caused a peak in the absolute energy measurements, see Figure 4-5 and 4-6. The first event exceeding 70 dB was exactly between sensor 1 and 2 on side 1 at 5.85 MN, see Figure 4-7. The first event exceeding 70 dB on side 2 (in the centre of the notch) occurred at 5.92 MN (220 MPa). The intensity in the energy accelerated until test was stopped at around 6.4 MN.

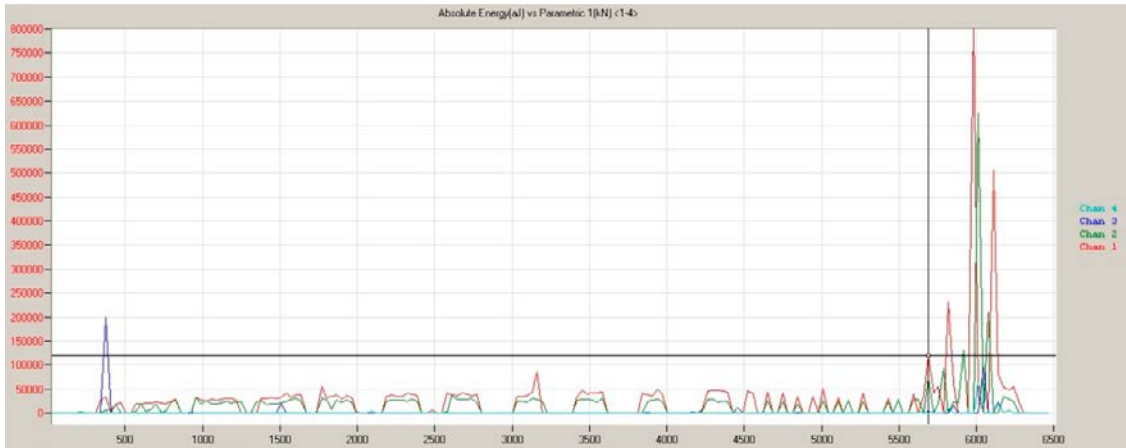
**Figure 4-6.** Absolute energy for all four AE-sensors. A first significant peak is observed at 5.7 MN.

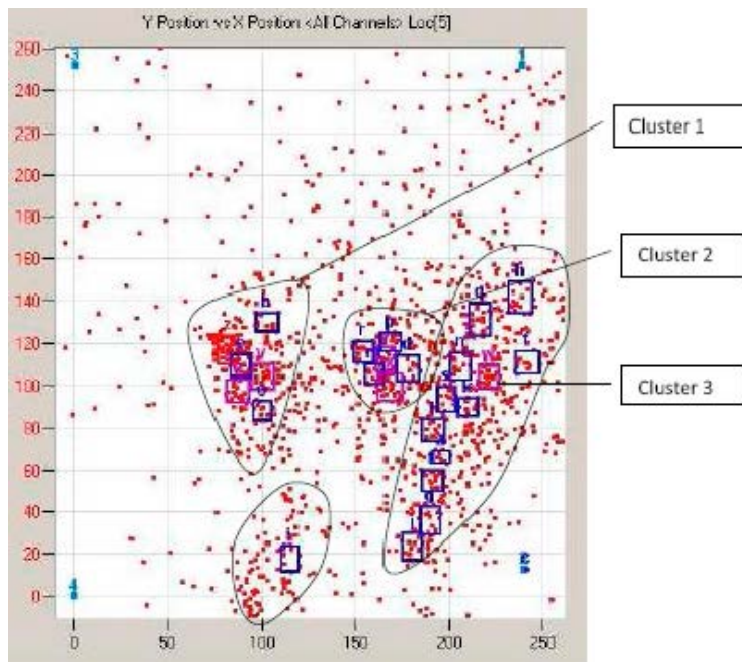
**Figure 4-8.** 2D-graph showing the area spanned by the four sensors (1 upper right, 2 lower right, 3 upper left, 4 lower left). The clusters show the locations of the events.

A localization analysis of the events in the plane between sensor 1 and 2 on one side and sensor 3 and 4 on the other side was done, see Figure 4-8. Three areas with clusters of signals were observed. Cluster 1 was inside the specimen but located closer to sensor 3 and 4 on side 2. Cluster 2 was also located inside the specimen, but closer to the surface but on the other side (side 1 between sensor 1 and 2). The third cluster was located on the surface on side 1 between sensor 1 and 2.

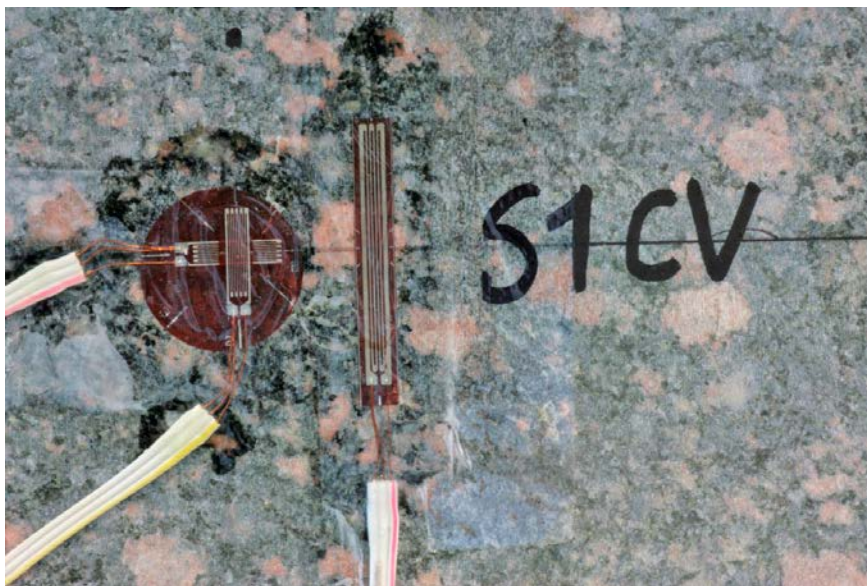
**Figure 4-9.** Centre of the notch at side 1 of specimen KS0041B02 after testing. Some cracks are visible.

Some surface cracks are seen in the centre of the notch on side 1, cf. Figure 4-9. The rock surface is partly covered by the adhesive used for the strain gauges, which may have prevented some fracture propagation. No clear cracks were visible on side 2.

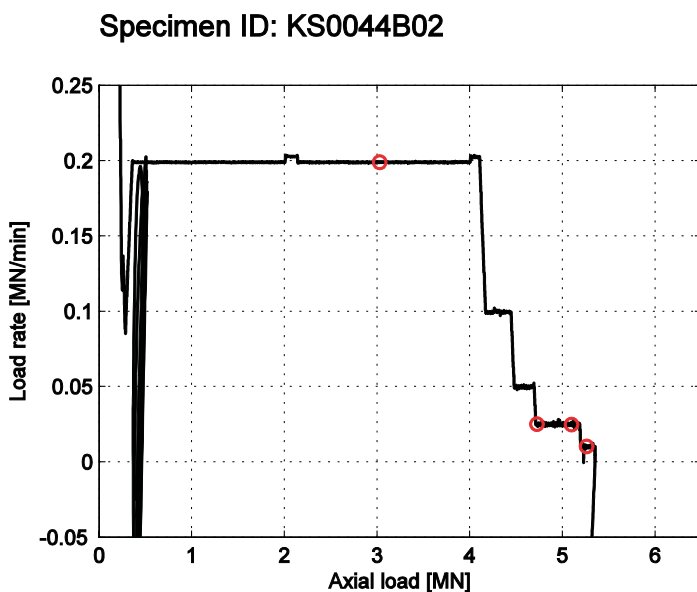
**Figure 5-1.** The load history during the first load cycle on specimen KS0044B02. The red circles mark every 15 minutes test time.

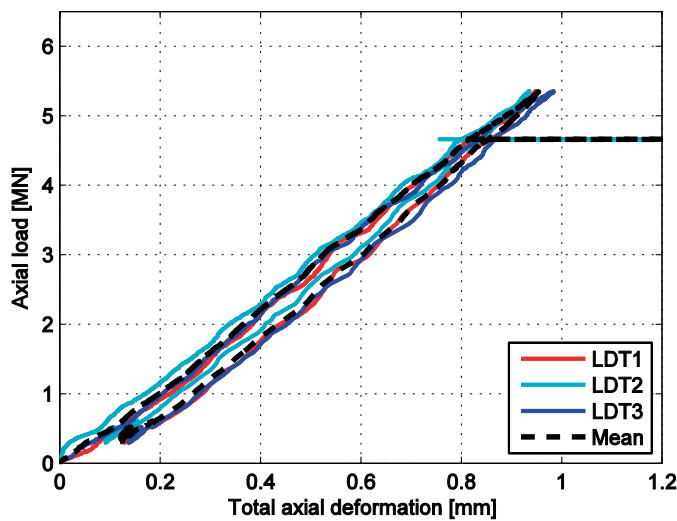
Figure 5-2. Total axial deformation during the test on specimen KS0044B02 recorded by the three linear displacement transducers (LDT) and their mean value.

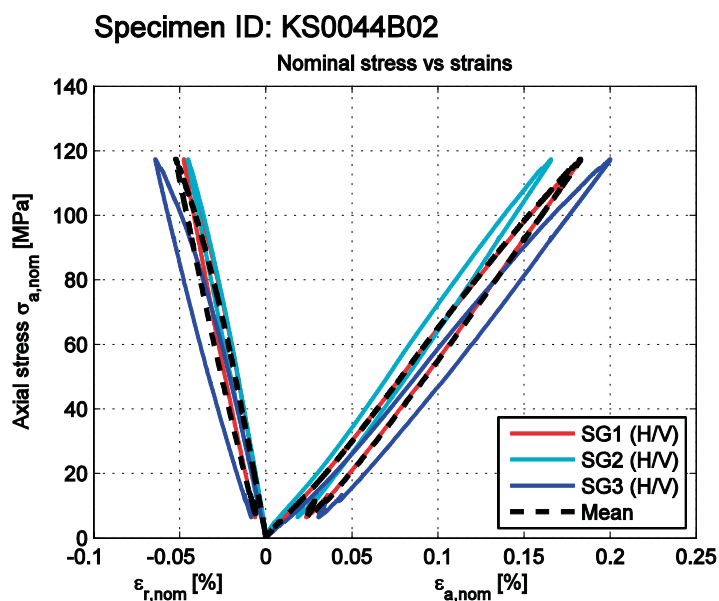
Figure 5-3. Measured strains in the cylindrical part during the test on specimen KS0044B02 recorded by the three circumferentially (H) and the three axially (V) oriented strain gauges. The thick dashed line display the mean values of the three gauges in respective orientation.

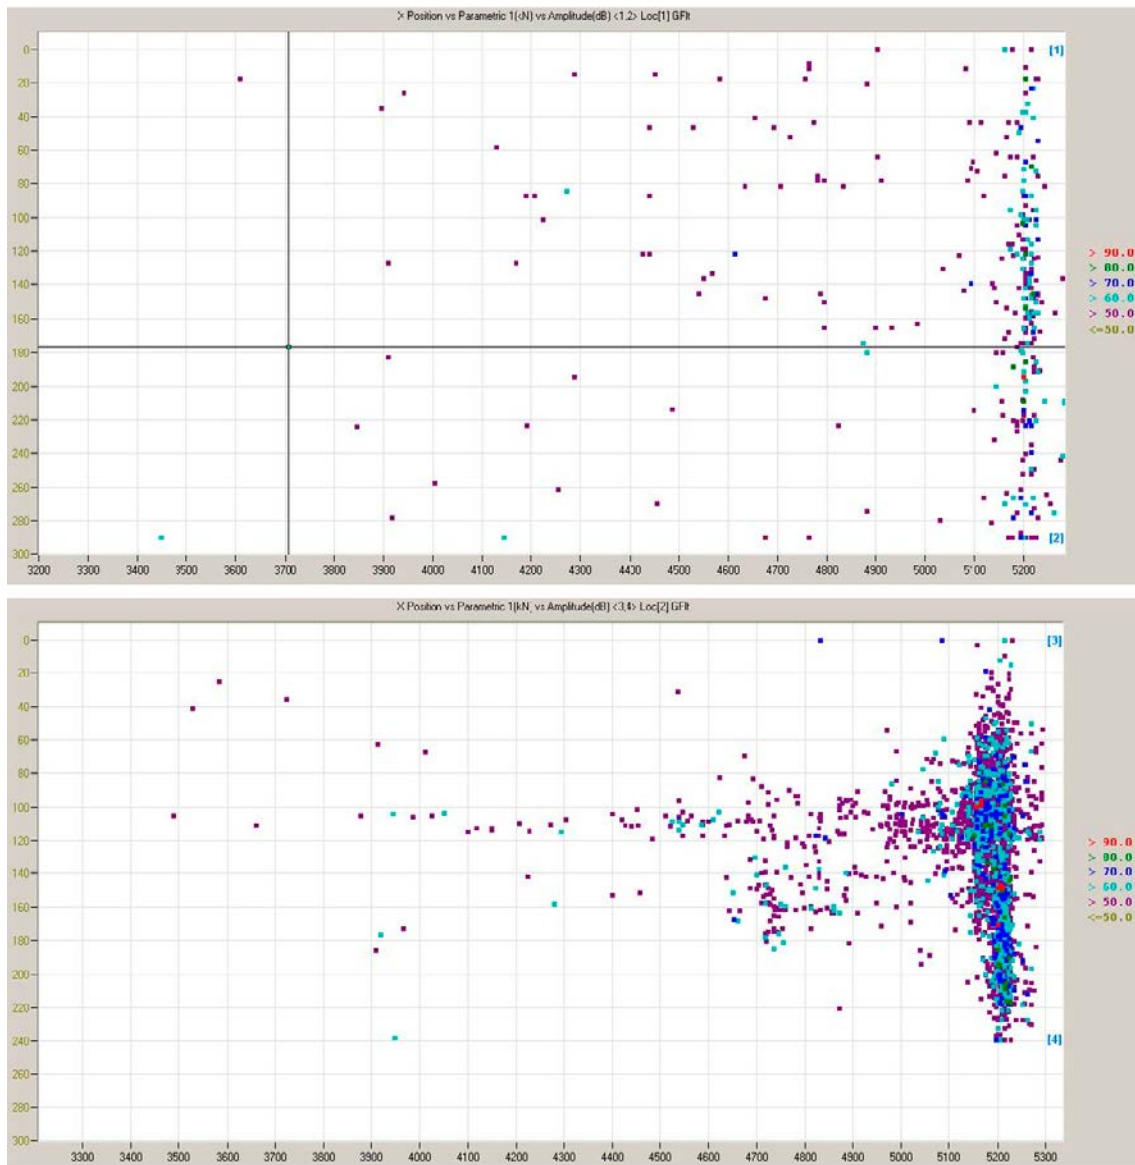
**Figure 5-5.** Localization of events between sensors and their amplitudes versus force. Upper figure localization between 1 and 2 (side 2); Lower figure: localization between sensor 3 and 4 (side 1).

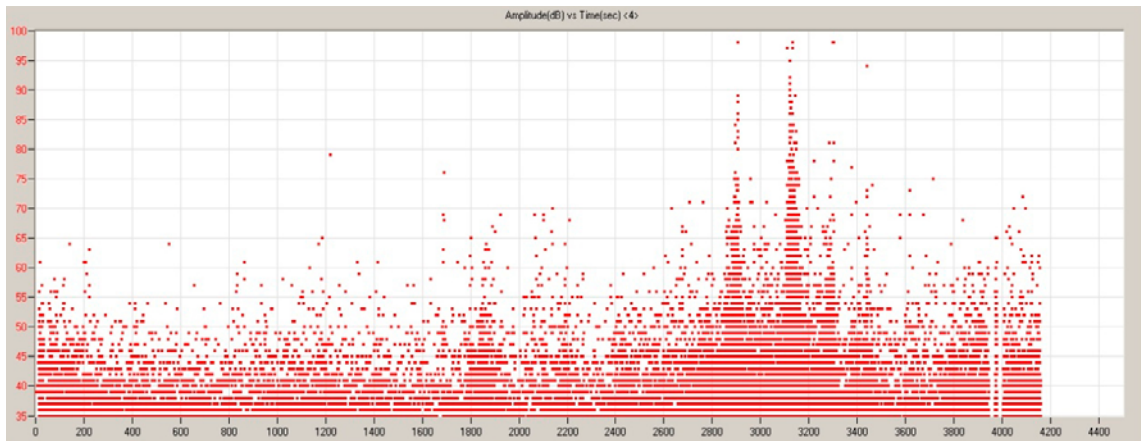
*Figure 5-6. Events recorded by sensor 4 and their amplitudes versus time.*

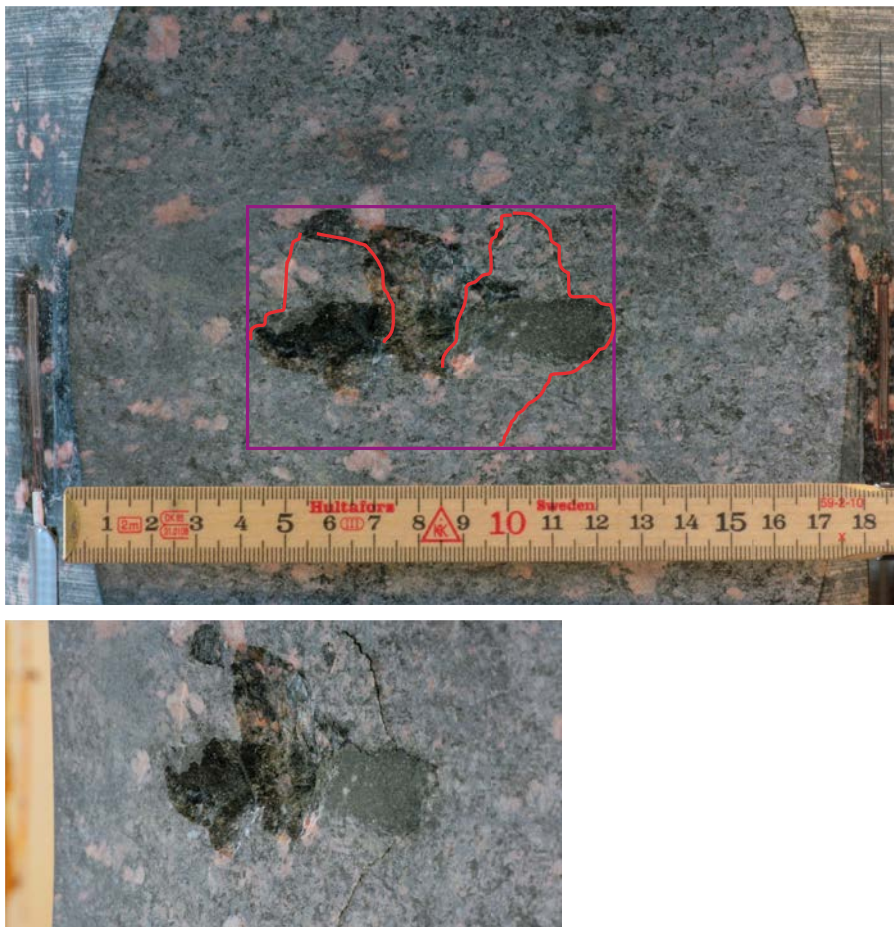
*Figure 5-7. Specimen KS0044B02 side 1. Spalling in the centre of the notch ( $85 \times 45$  mm) Upper picture: The red lines show the crack pattern of fully developed cracks; Lower picture: As above, but seen from the side. Chips of the rock material have fallen off the surface. Fractures around the long mafitic xenolith are visible.*

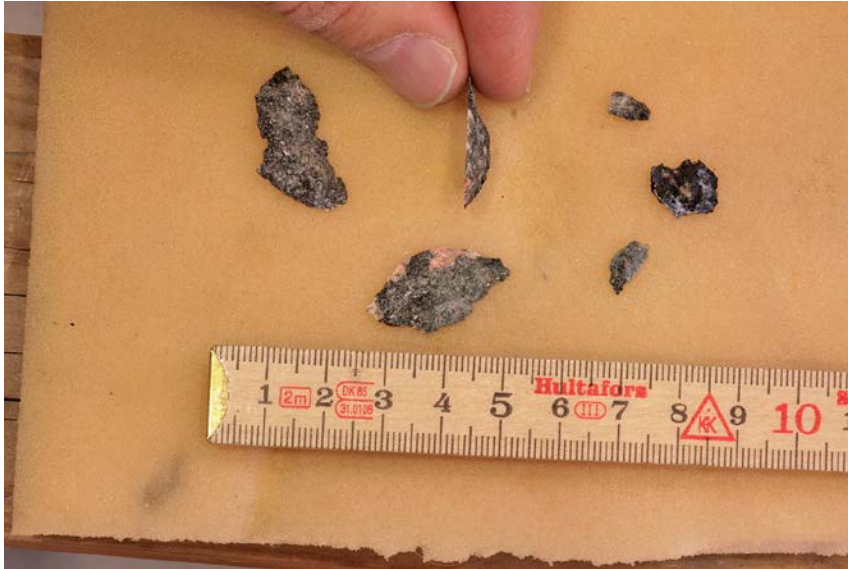
**Figure 5-8.** Chips that has fallen off specimen KS0044B02. The pieces are up to 25–28 mm, thickness/depth about 5 mm.

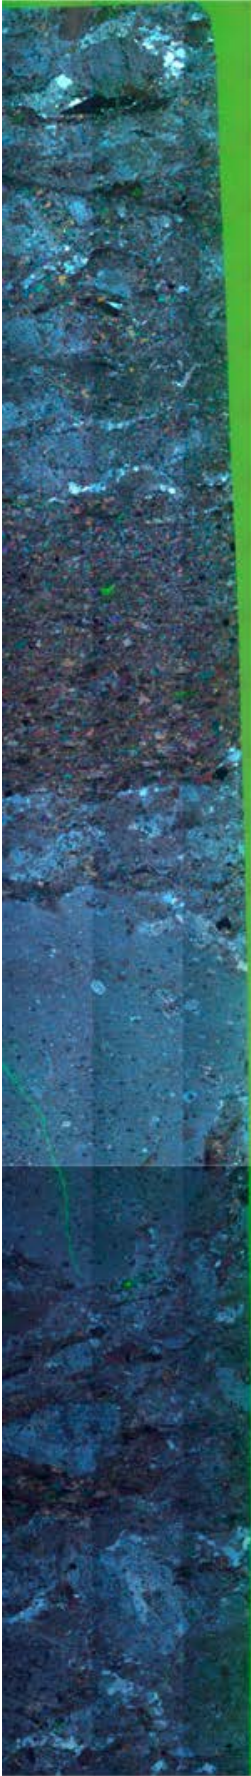
*Figure 6-7. Combined polarized and fluorescent microscopic image of specimen KS0044B02 – Thin-section 1 – Image D. Image size is 7.7 × 54.3 mm.*

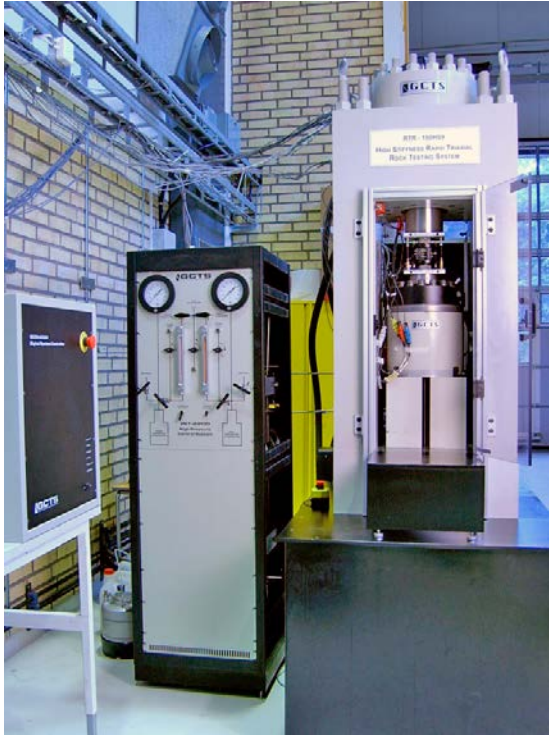
**Figure A-1.** Rock testing system. From left: Digital controller unit, pressure cabinet (used for triaxial tests) and load frame. The PC with the test software (not shown in the picture) is placed on the left hand side of the controller unit.

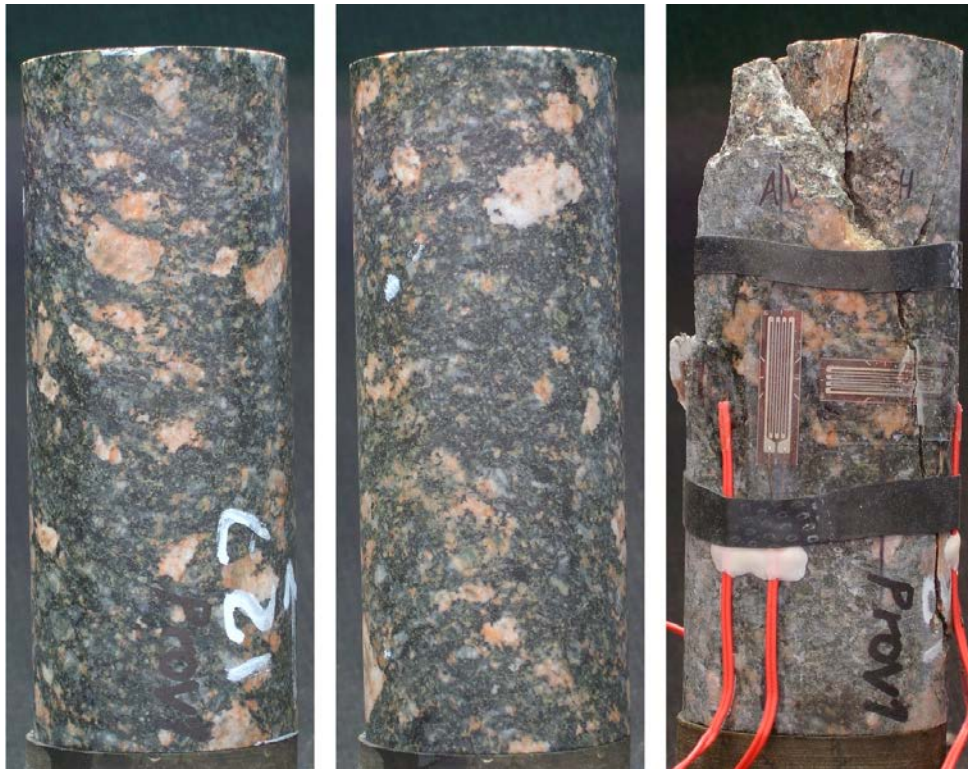
Before mechanical test

After mechanical test

Diameter (mm)	Height (mm)	Density (kg/m <sup>3</sup> )
50.8	127.4	2770
Comments:	–

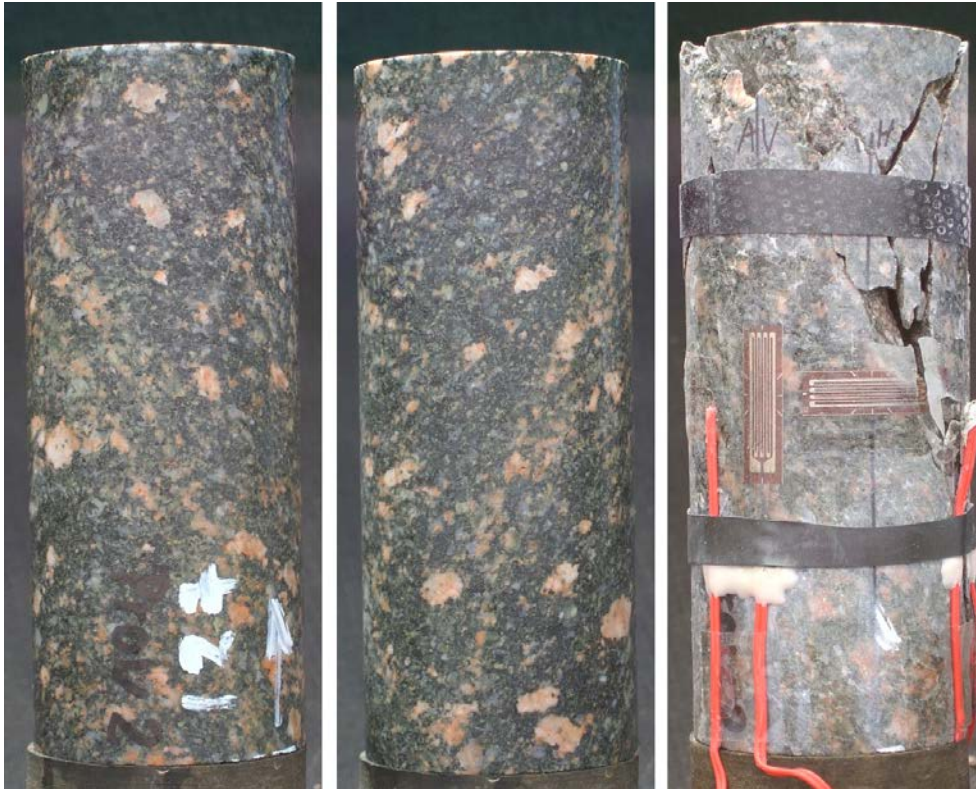
Before mechanical test

After mechanical test

Diameter (mm)	Height (mm)	Density (kg/m <sup>3</sup> )
50.8	127.3	2780
Comments:	—

*Figure A-5. Specimen KS0037B02-113-2: Photographs before and after testing, dimensions and measured wet density.*

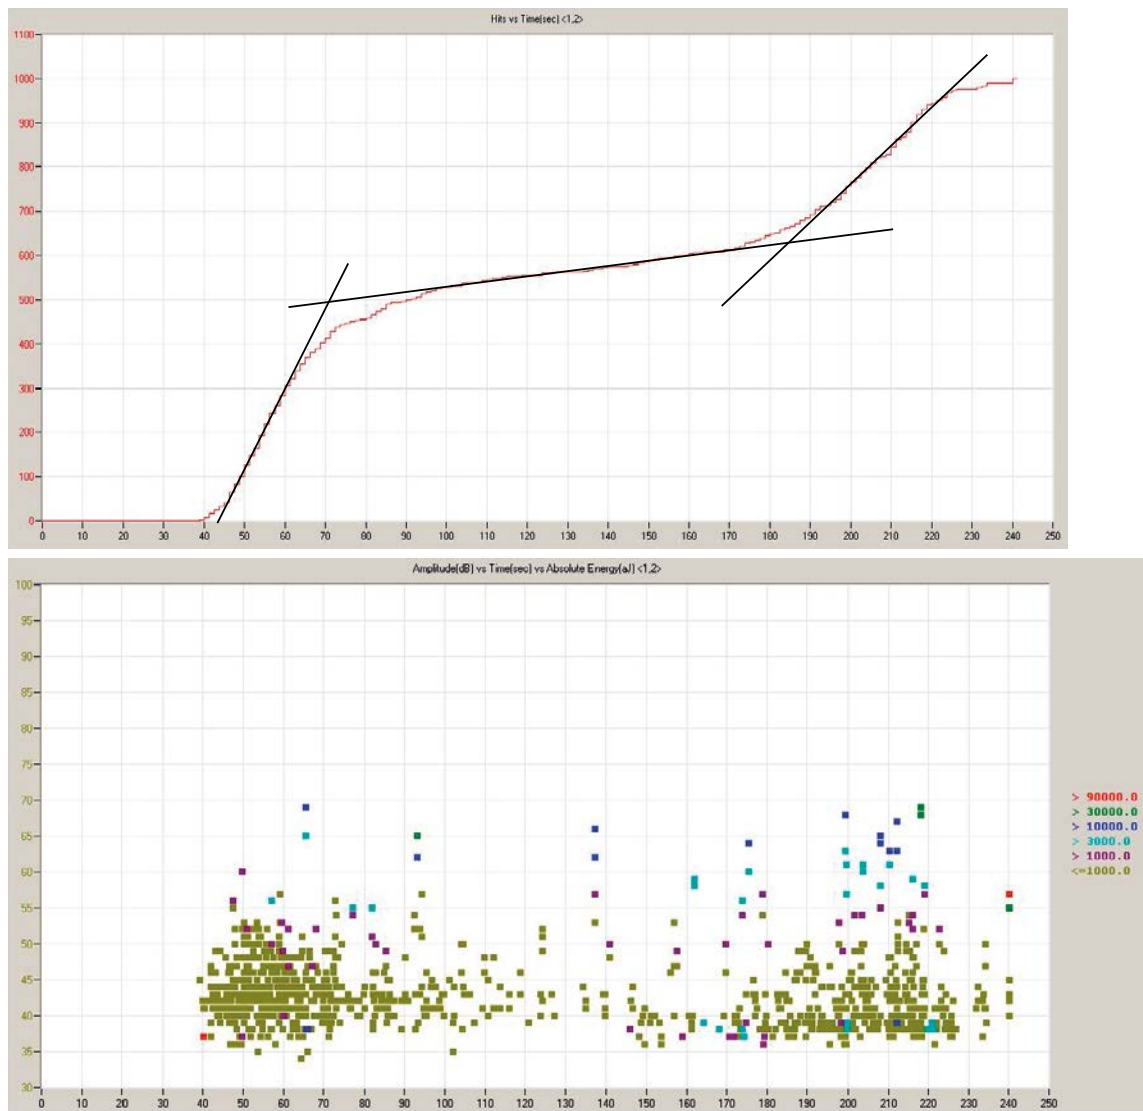
**Figure A-10.** Upper graph: Cumulative of the number of hits versus the test time. Lower graph: Amplitude and absolute energy of the events versus the test time.
