Report

R-17-17

In situ hydrogen charging of OFP copper during creep

SKB R-17-17

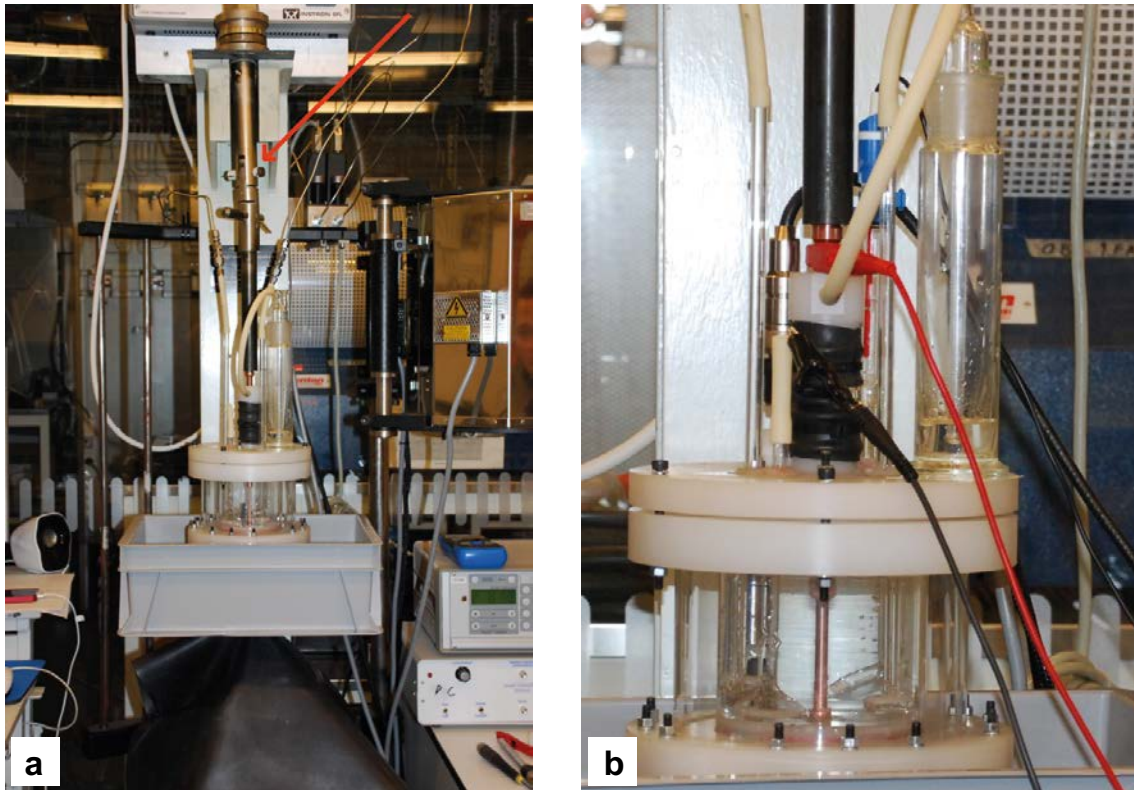
Figure 2-1. The test setup. In a) an overview of the setup the red arrow pointing at the electrically insulated pin, b) a close-up of the reaction chamber.

Figure 2-1a shows an overview of most of the equipment constituting the experimental set up. The SSRT/creep machine consists of a grey Bofors Frame and a Vetek Load cell, which is hidden by a black rubber cloth protecting the load cell from possible leakage of electrolyte. The double-wall glass compartment can be seen just above a grey polymer box for further leakage protection. An OFP copper specimen is mounted in the compartment and further attached to the creep machine through the load rod up to the Bofors load frame.

Figure 2-1b shows a close up on the double-wall glass compartment in the beginning of hydrogen charging. The hydrogen charging was performed in an electrolyte of 1 N H₂SO₄ solution with 10 mg NaAsO₂ (or 5 mg As₂O₃) per litre at a controlled potential of $-1.1 \text{ V}_{\text{Hg}/\text{Hg}_2\text{SO}_4}$. The addition of arsenic to the electrolyte will impede the reaction of 2 adhered hydrogen atoms to recombine to H₂ and it will hence facilitate the hydrogen charging.

The electrode can be seen with a blue cap immersed into Luggin-probe of Hg/Hg₂SO₄. The bubble bottle standing on the double-wall glass compartment receives the hydrogen overpressure arising from the hydrogen bubbling in the compartment. The white tubing was Norprene from Watson Marlow with very low diffusivity of hydrogen. A black bellow of butyl rubber is placed on top of the double-wall glass compartment but below the outlet of the hydrogen overpressure. A black electric cable can be seen in Figure 2-1b and it is connected to the Pt reference electrode. The red electric cable is connected to the OFP copper specimen through a specimen holder constructed of the same OFP copper as the specimen. The specimen is electrically insulated from the creep testing machine further up the load rod with a layer of ceramic as well as a layer of Bakelite. The ceramic layer is applied on a steel pin going through the load rod and it is indicated with a red arrow in Figure 2-1a. The same electric insulation is to be found below the specimen, but it is hidden by the rubber cloth for leakage protection.

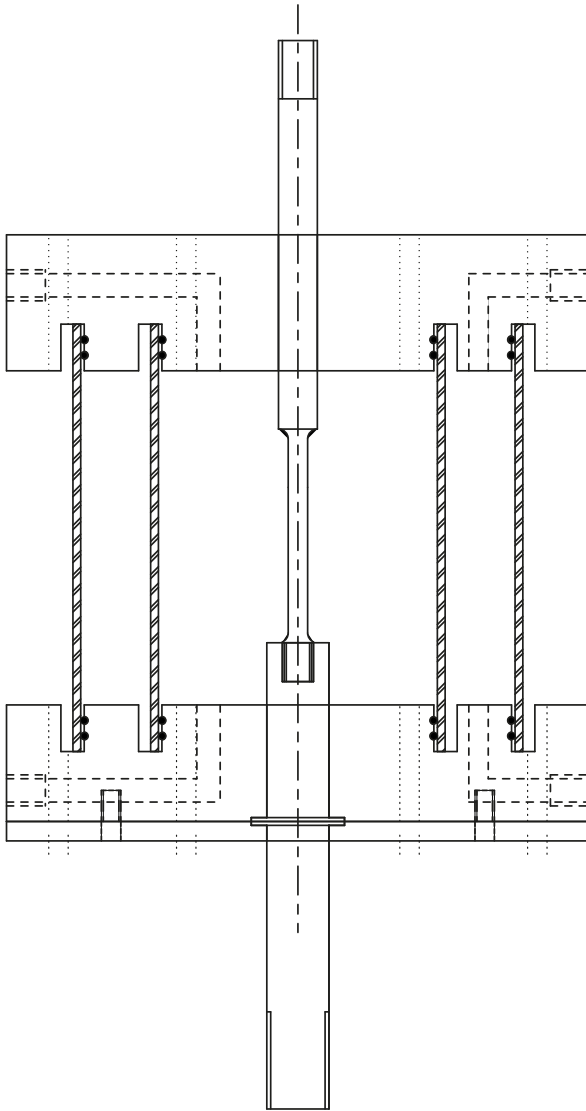
Figure 2-2. The chamber design.

Figure 2-2 shows the drawing of the test chamber. The operator is supervising the initial phase of hydrogen charging where the potential is lowered stepwise in a controlled way to the correct level during 20 minutes. When the correct level had been attained followed the three hours of hydrogen charging and thereafter the controlled increment of tensile load to the specified creep stress. The controlled increment of load to specified creep stress lasted 7 minutes and the stress only showed a small overshoot of stress close to 5 MPa and it thereafter stayed at the stipulated level.

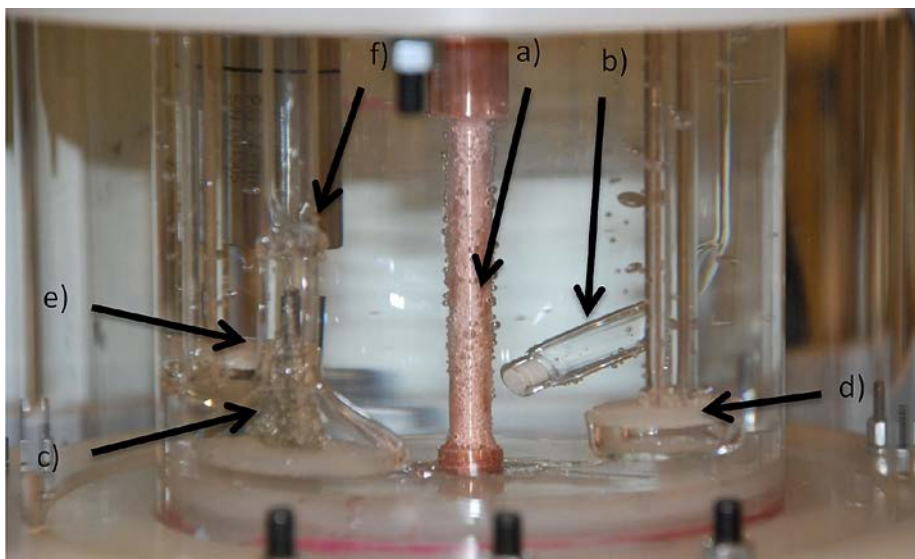
Figure 2-3. The different parts of the reaction chamber where a) specimen, b) Luggin-probe, c) Pt reference electrode, d) e) filter tubes, f) oxygen sensor.

Figure 2-3 shows a close up of the double-wall compartment under hydrogen charging. The specimen (a) in the middle is covered with bubbles over the gauge length where the hydrogen is entering the OFP copper. This is a typical sign of successful hydrogen charging since the only gas that can be released here is hydrogen. The part of the specimen outside the gauge length is protected by a layer of epoxy in order to really concentrate the hydrogen charging to the desired part of the specimen. The Luggin-probe of Hg/Hg₂SO₄ electrode (b) is directed close to the specimen gauge length. The Pt reference electrode (c) is immersed into the electrolyte through a filter tube for reversed filtration where the filter act as an obstacle for the oxygen gas arising at the Pt electrode to enter the compartment. Two filter tubes (d,e) bubbles nitrogen directly into the compartment in order to keep the dissolved oxygen level low. The dissolved oxygen level is measured with the oxygen sensor (f) Hamilton Visiform DO 120.

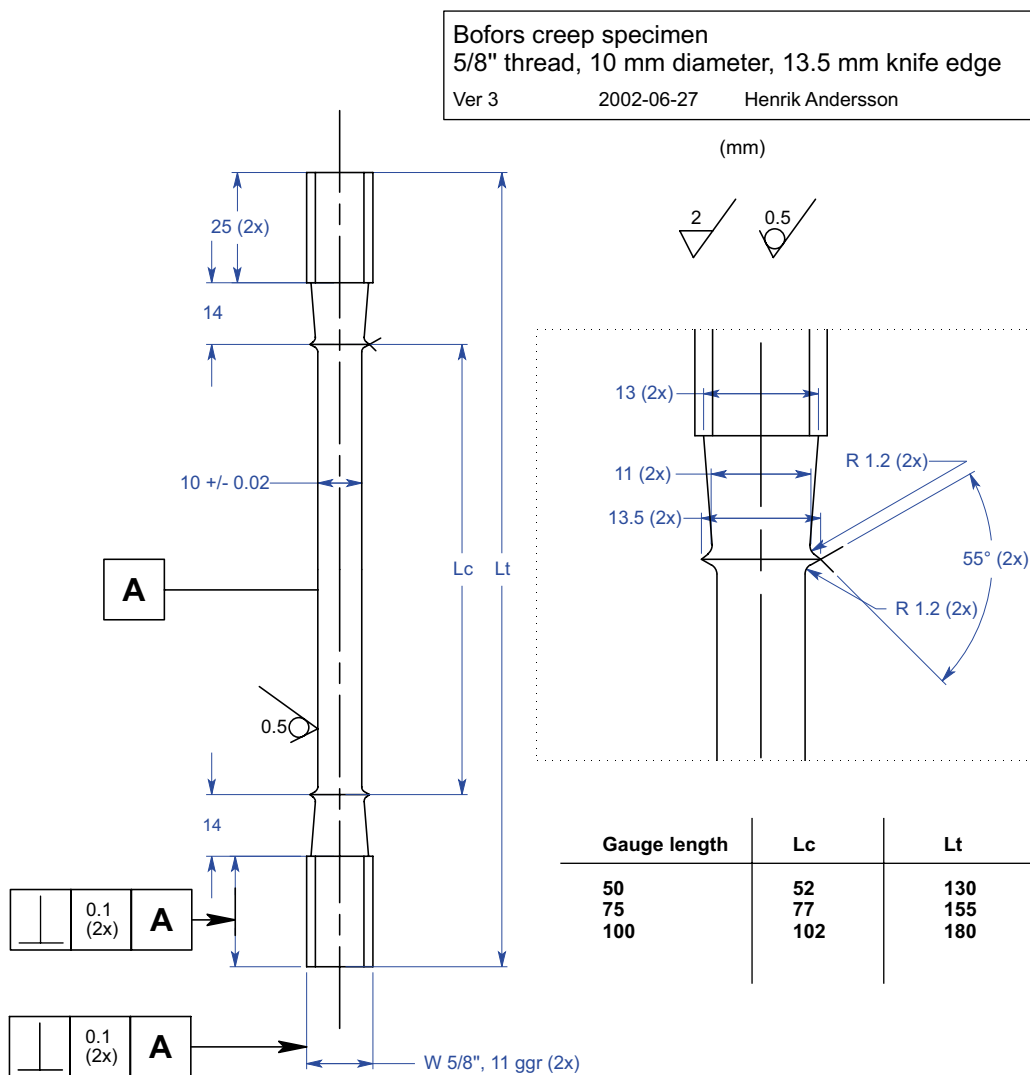
Figure 2-4. The Bofors Creep Specimen with Lc = 100 mm and Lt = 180 mm.

1. The copper was cut and machined into specimen according to Figure 2-4.
2. All “Bofors creep specimens” were soft annealed for 10 minutes at 600 °C in a salt bath as shown in Figure 2-5. The salt was 50 % Na₂CO₃ and 50 % KCl, which melts at approximately 450 °C and has a working temperature range between 500 to 800 °C.
3. One third of the specimens were pre-strained to 10 % strain and one third of the specimens were pre-strained to 20 % strain in tensile test machine (room temperature and laboratory air, 10⁻³ s⁻¹). One third of the specimens were left without any pre-straining.
4. From the “Bofors creep specimens” with various pre-strain the actual specimens utilized in the tests were manufactured according to Figure 2-6. The specimen is a standard 5K50 creep specimen.

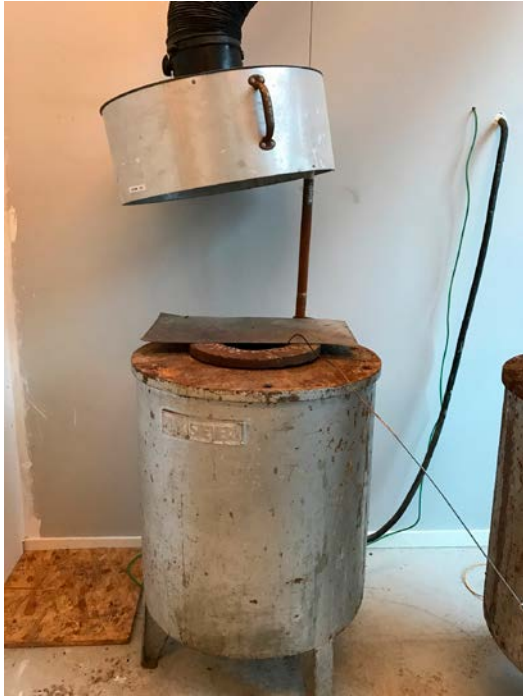
Figure 2-5. The salt bath used for soft annealing of the Bofors creep specimens at 600 °C for 10 minutes.

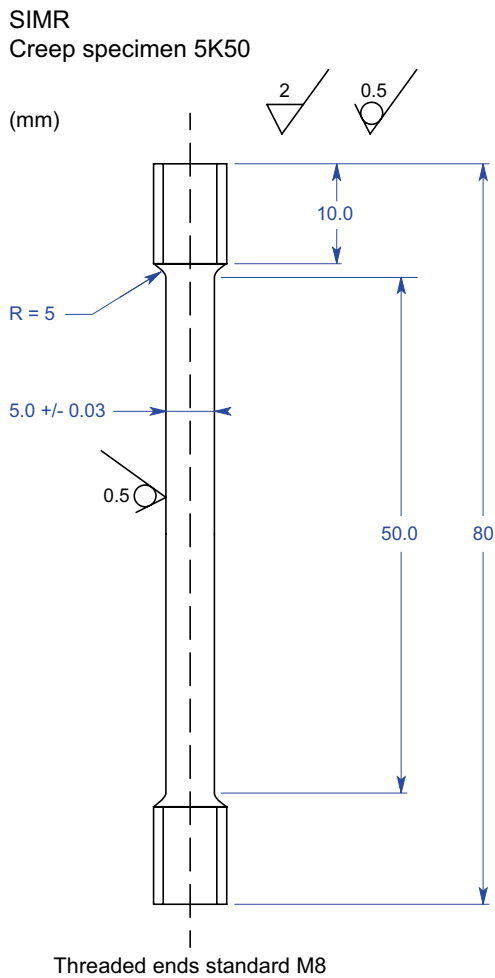
Figure 2-6. The standard 5K50 specimen used in the testing of hydrogen charging under simultaneous creep load.

1. The material was cut in small parts with the approximate dimensions of 120 × 10 × 10 mm.
2. The parts were soft annealed for 10 minutes at 600 °C in an ordinary resistance oven.
3. The specimens were machined out of the soft annealed parts according to Figure 2-6.

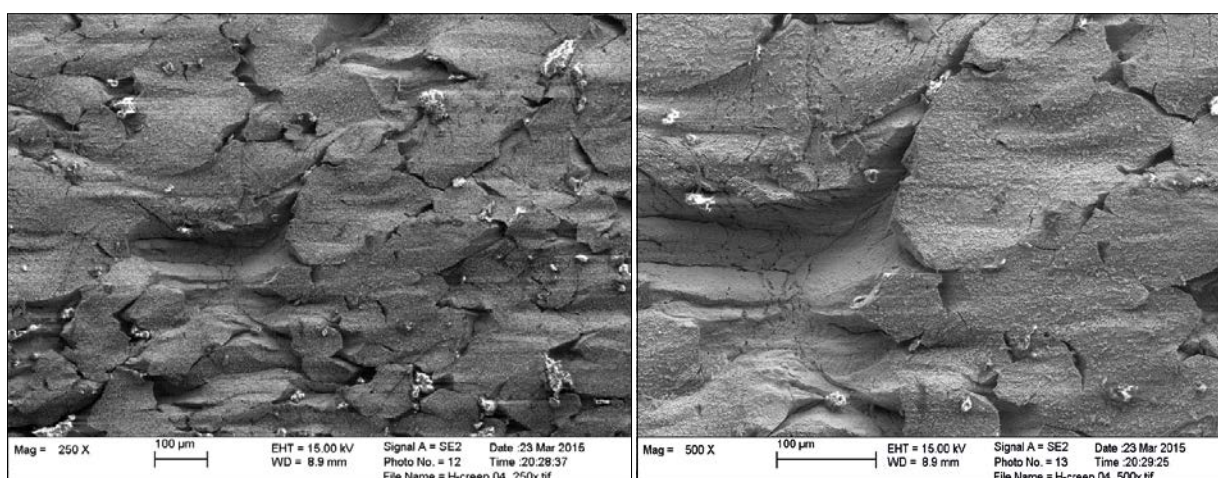
Figure 3-1. The surface of specimen H-creep-04 at the necking section of the specimen that experienced large transverse contraction. The specimen contained 1.6 ppm of hydrogen and was creep tested at 200 minutes before the test was finished due to necking and trigger of load drop criteria.

Parts of the specimens gauge length were cut out for SEM inspection. Figure 3-1 shows two pictures of the surface of specimen H-creep-04 from close to the necking portion of the gauge length where the material had undergone a large deformation. This creep test was finished after only 200 minutes (3.3 hours) of creep testing when the necking was so large that the load drop limit triggered. The load drop trigger was set at 30 kg, which corresponds to approximately 8 % decrease in load from the initial 367 kg. The amount of charged hydrogen was very low compared to all other specimens, most probably due to the short total hydrogen charge time of 16.7 hours.

The micrographs shown in Figure 3-1 and Figure 3-2 present cracking of the surface at the necking section of specimen that experienced large transverse contraction, but not at the fracture surface (cross section). The resemblance of the surface shown in Figure 3-2 with the SEM image shown by Yagodzinsky et al. (2012, p 933, Figure 3) is striking. One difference in appearance is that the surface shown by Yagodzinsky et al. seems glossier than the surfaces in Figure 3-1 and Figure 3-2. The lustreless appearance in Figure 3-1 and Figure 3-2 is due to the grey CuAs layer on the specimen surface from the testing. This layer is easily detached from the surface and does not need extensive polishing to wear off. Another difference is that the many small dimples shown by Yagodzinsky et al. at higher magnification could not be found in the surface cracks on specimen H-creep-04 or H-creep-13 at the corresponding magnifications.

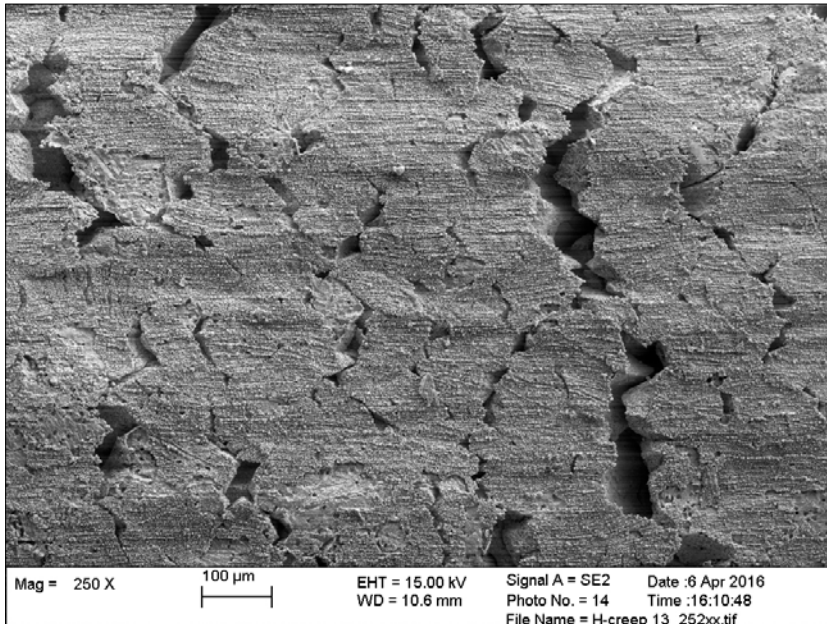
Figure 3-2. At the neck of the specimen H-creep-13.

Figure 3-2 shows the surface of specimen H-creep-13 taken on the necking section of the specimen that experienced large transverse contraction, but not at the actual fracture surface. The section shown in the picture is hence from the same part as for the section of specimen H-creep-4 shown in Figure 3-1 and may be compared.

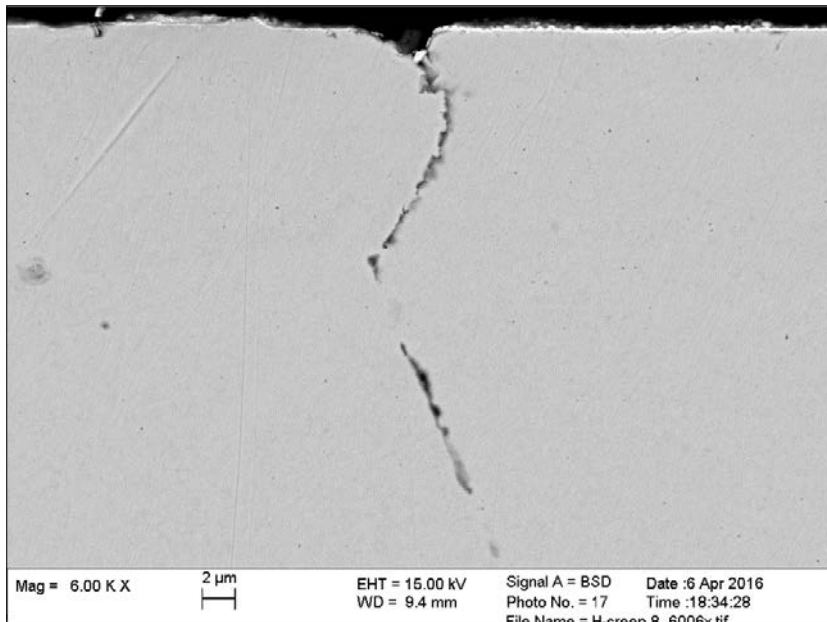
Figure 3-3. Specimen H-creep-08 tested at 50 °C for 117.5 hours of hydrogen charging time and at 172 MPa creep stress. The picture is a cut out cross section of the specimen showing a crack extending from the surface of the specimen.

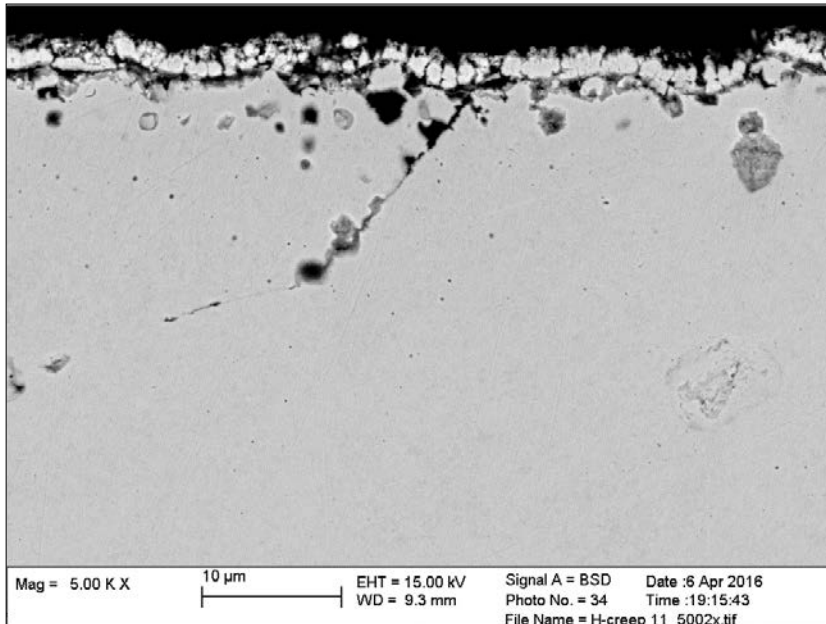
Figure 3-4. Specimen H-creep-11 tested at 75 °C for 100.9 hours hydrogen charging time. The picture is a cut out cross section of the specimen showing a crack extending from the surface of the specimen.

Figure 3-4 shows a cross section of specimen H-creep-11 creep tested at 75 °C. Note the change in direction of the crack as the crack follows the grain boundary.

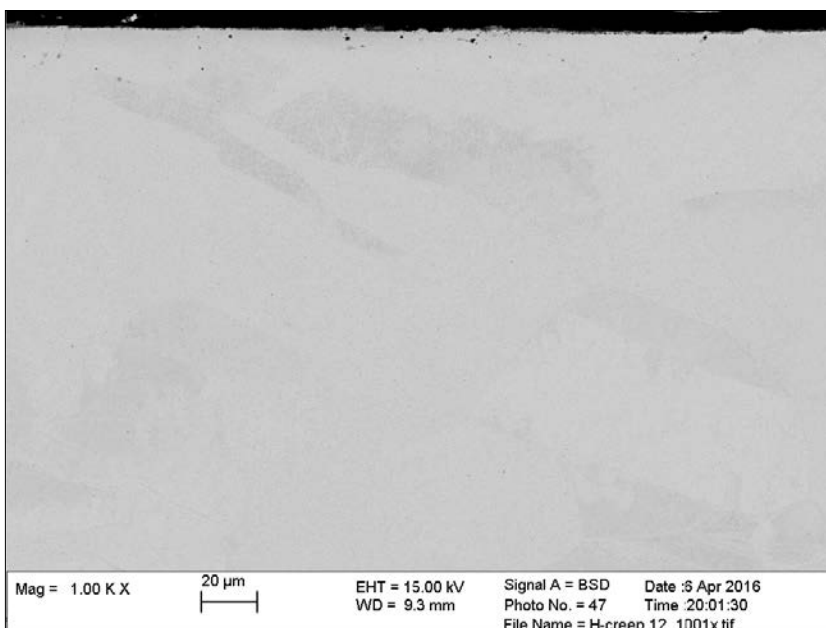
Figure 3-5. Specimen H-creep-12 tested at RT for 260.3 hours hydrogen charging time and creep stress of 176 MPa. No cracks are seen. The specimen was pre-strained to 20 %.

Figure 3-5 shows a cross section of specimen H-creep-12 where no cracks could be found. The specimen was tested at RT with a creep stress of 176 MPa and 260.3 hours of hydrogen charging. The total amount of hydrogen was 6.0 ppm for specimen H-creep-12 which is intermediate in comparison with the amount of hydrogen obtained for other specimens.

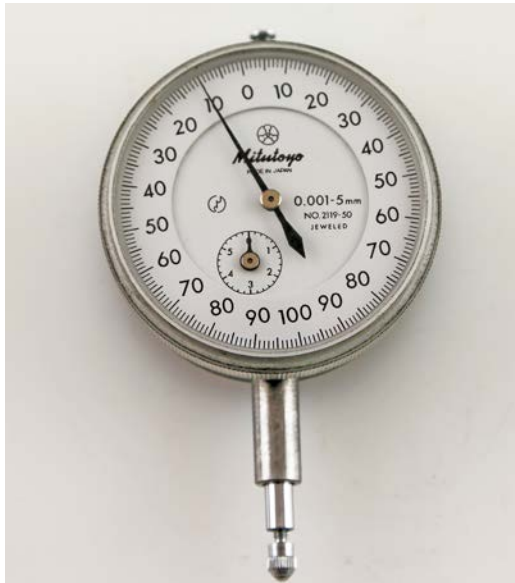
Figure 3-6. The analogue dial indicator with 1 μm in resolution used for measurement of elongation.

The displacement during creep testing with simultaneous hydrogen charging was measured successfully for some of the specimen with an analogue dial indicator with 1 μm in resolution (Figure 3-6). Figure 3-7 shows the specimen elongation for the two specimens H-creep-08 and H-creep-11.

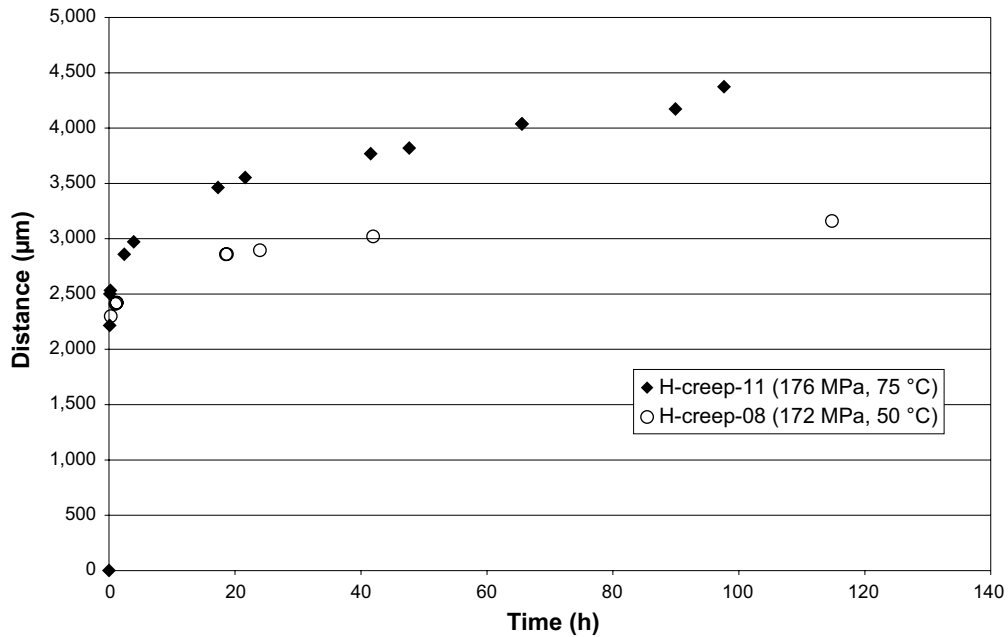
Figure 3-7. Displacement during creep testing with simultaneous hydrogen charging for specimen H-creep-08 and H-creep-11 measured with an analogue dial indicator with 1 μm in resolution.

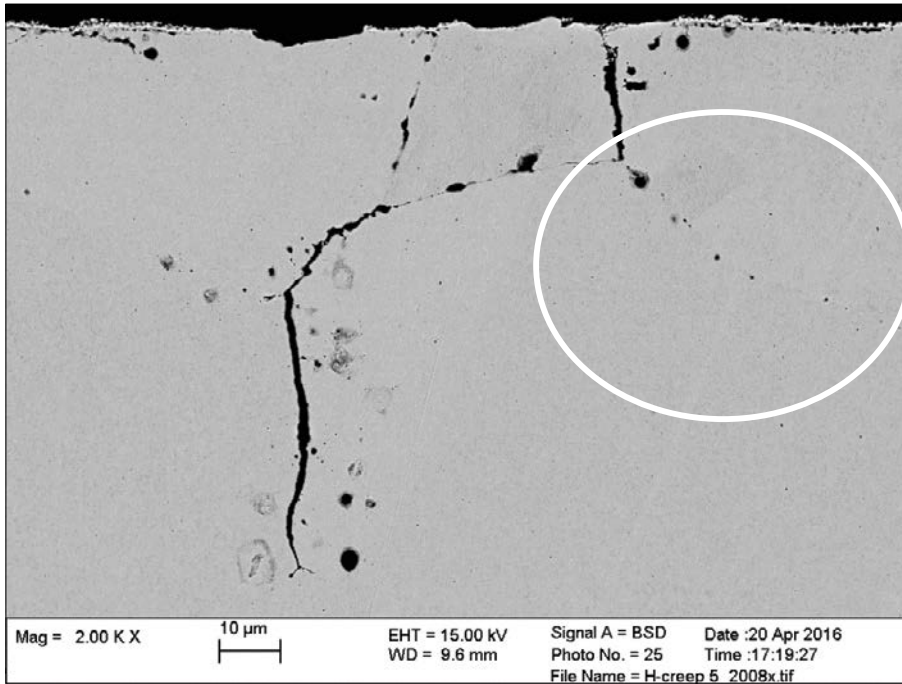
Figure 3-8. Specimen H-creep-05 tested at RT for 1 005.7 hours hydrogen charging time and creep stress of 170 MPa. Larger cracks were discovered. The specimen was tested in soft annealed condition without any pre-strain.

Figure 3-8 shows one of the largest intergranular cracks found in this study. It was found at a cross section of specimen H-creep-05, which had been subjected to 1 005.7 hours of hydrogen charging under 170 MPa nominal creep stress. The specimen was of 0 % pre-strain, i.e. it was manufactured from soft annealed copper. Note the encircled formation of cavities following the grain boundaries where no crack has yet been established.

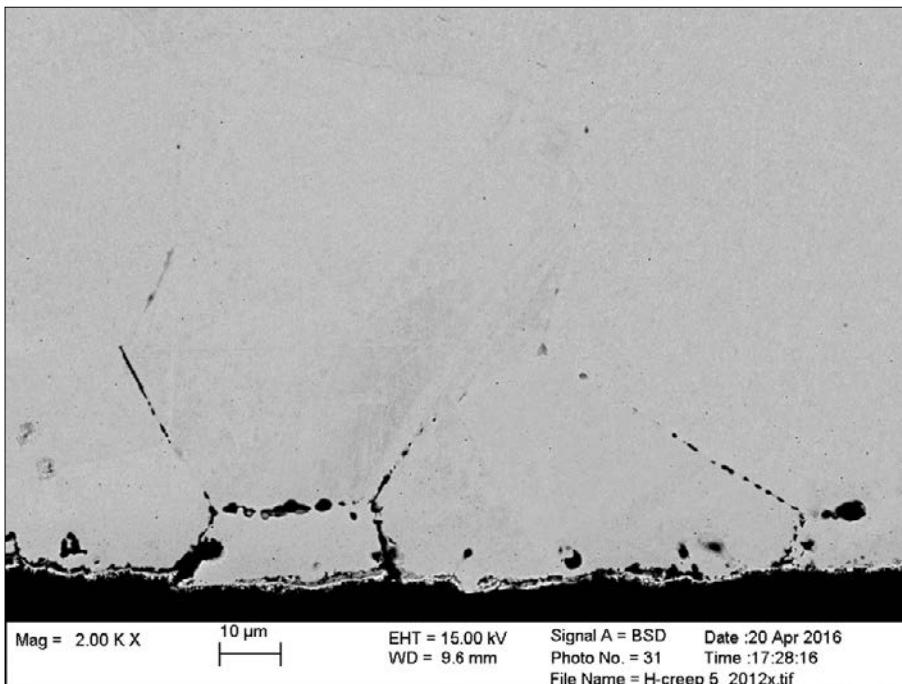
Figure 3-9. Specimen H-creep-05 tested at RT for 1 005.7 hours hydrogen charging time and creep stress of 170 MPa. Larger cracks were discovered. The specimen was manufactured in the soft annealed condition without any pre-strain.

Figure 3-9 shows another example of cracks discovered on a cross section of specimen H-creep-05.

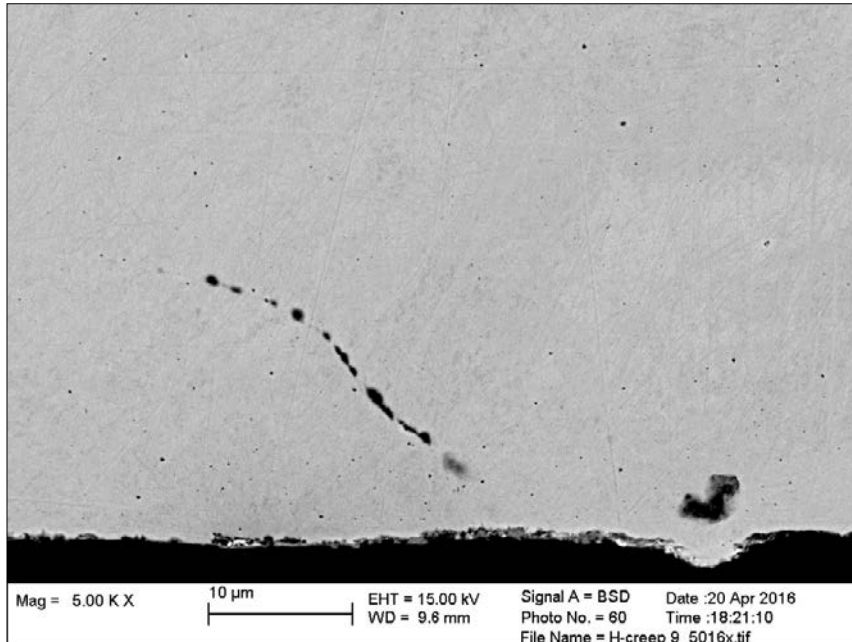
Figure 3-10. Specimen H-creep-09 tested at 50 °C for 168.5 hours hydrogen charging time and creep stress of 172 MPa. Cracks were discovered. The specimen was manufactured with 20 % pre-strain.

Figure 3-10 shows a cross section of specimen H-creep-09 which had been hydrogen charged for 168.5 hours at 172 MPa nominal creep stress and 50 °C. Specimen H-creep-09 was pre-strained to 20 %. The crack is much smaller than the cracks found in specimen H-creep-05.

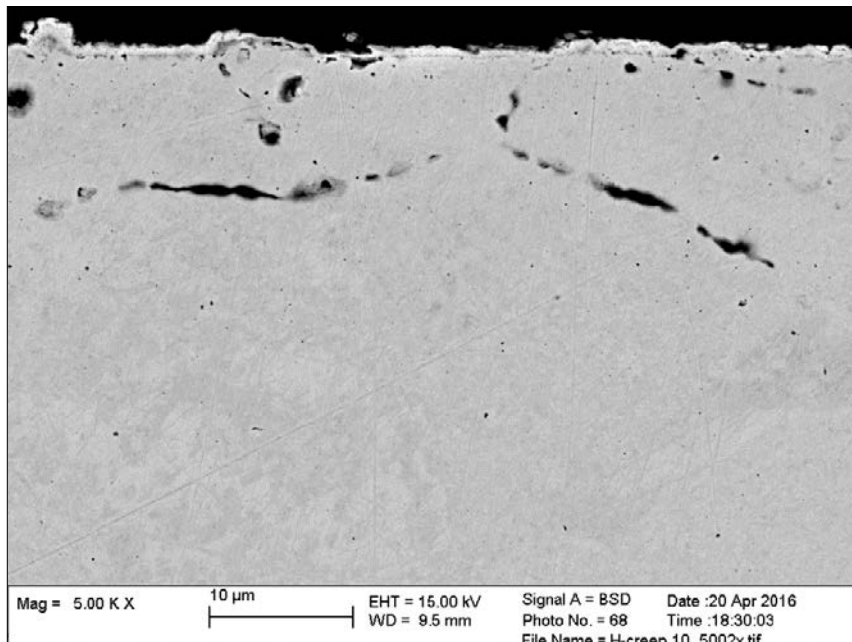
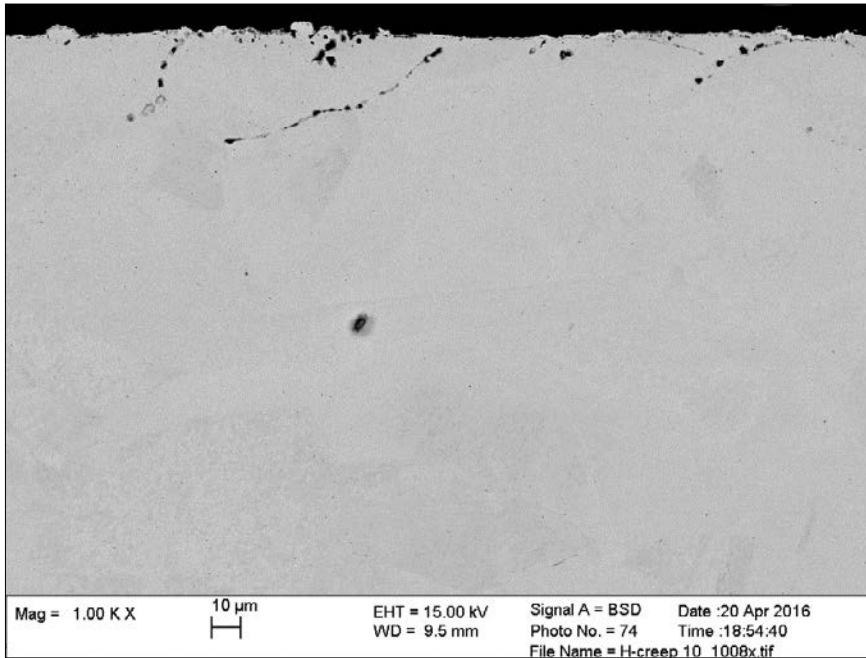
Figure 3-11. Specimen H-creep-09 tested at 50 °C for 168.5 hours hydrogen charging time and creep stress of 172 MPa. Cracks were discovered. The specimen was manufactured with 20 % pre-strain.

Figure 3-12. Specimen H-creep-09 tested at 50 °C for 168.5 hours hydrogen charging time and creep stress of 172 MPa. Cracks were discovered. The specimen was manufactured with 20 % pre-strain.

Figure 3-11 and Figure 3-12 shows another example of intergranular cracks of specimen H-creep-09. The magnification is different in Figure 3-11 and Figure 3-12.

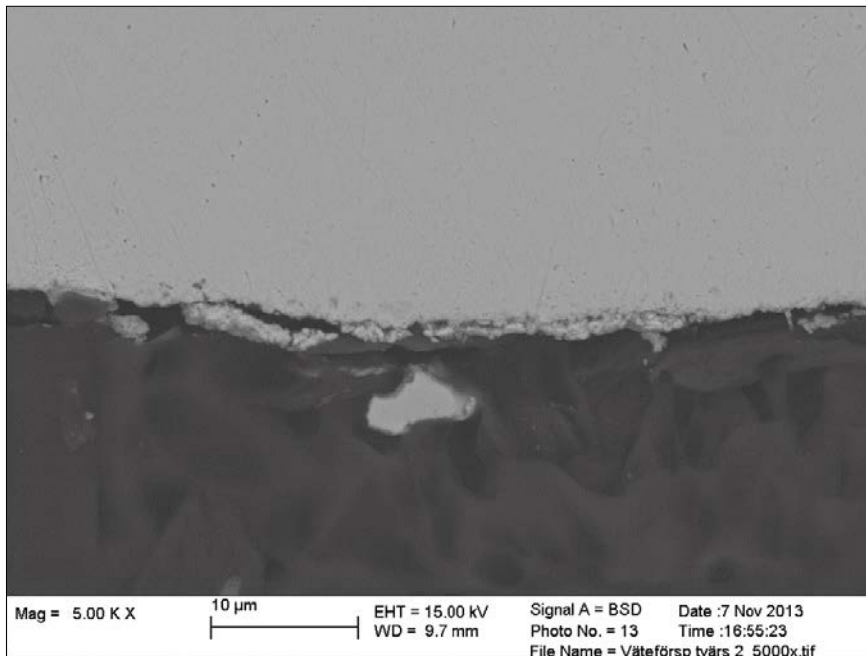
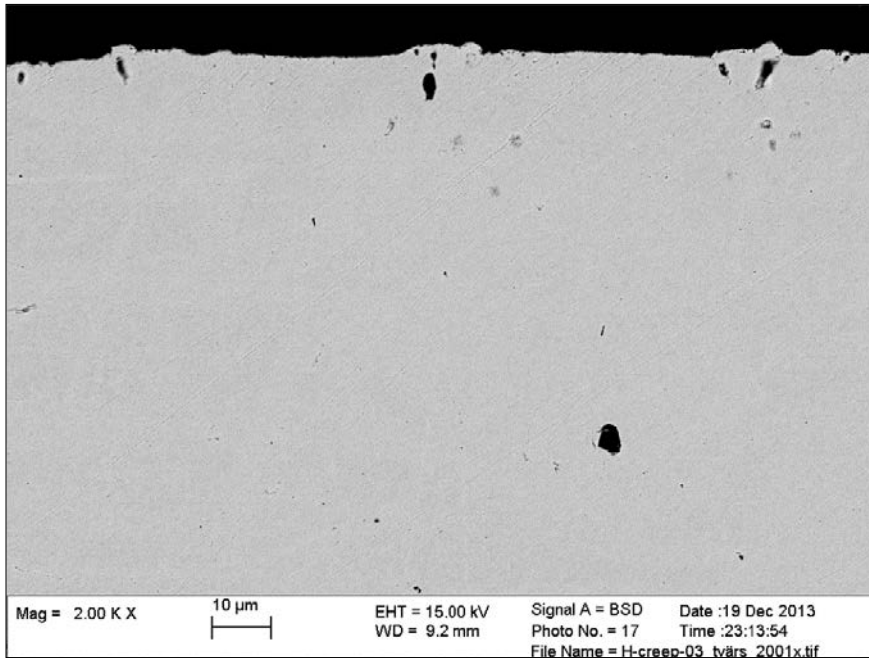
Figure 3-13. Specimen H-creep-01 tested at room temperature for 95.5 hours hydrogen charging time and creep stress of 140 MPa. No cracks were discovered.

Figure 3-14. Specimen H-creep-03 tested at room temperature for 103 hours hydrogen charging time and creep stress of 140 MPa. No cracks were discovered.

Figure 3-13 and Figure 3-14 shows two examples of the specimens tested at the lower creep stress of 140 MPa , where no cracks were found.

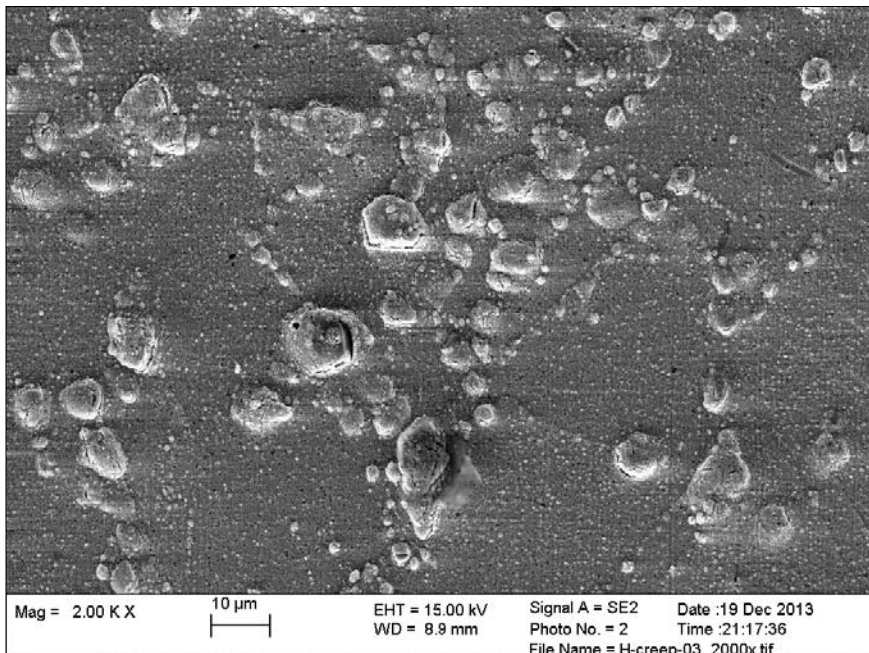
Figure 3-15. Surface of specimen H-creep-03 tested at room temperature for 103 hours hydrogen charging time and creep stress of 140MPa. No cracks were discovered. The round objects on the surface are residue from the electrolyte. For subsequent specimens in stage 2 the electrolyte composition was changed to eliminate the residues.

In Figure 3-15 the surface of the specimen H-creep-03 is shown. This specimen has been tested at room temperature for 103 hours hydrogen charging time at a creep stress of 140 MPa. In this specimen no cracks were found. In the images round objects can be observed on the surface. This is a residue from the electrolyte. For subsequent specimens in stage 2 the electrolyte composition was changed to eliminate these residues.

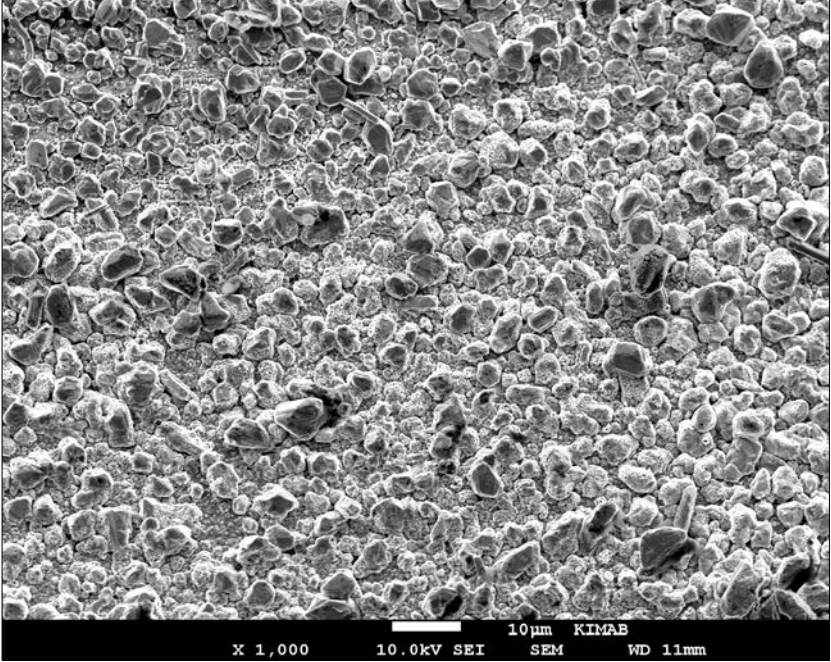
Figure 3-16. Surface of H-creep-14 with lots of residues but no visible cracks.

The reference specimens H-creep-14 to H-creep-16 did not show any cracks on the surface of the specimens, Figure 3-16 and Figure 3-17. The hydrogen content when studied was low and in the region of the base content in the material before testing. Hence, the conclusion is that the cracks seen in previous testing is due to the hydrogen content, not the effect of the electrolyte.

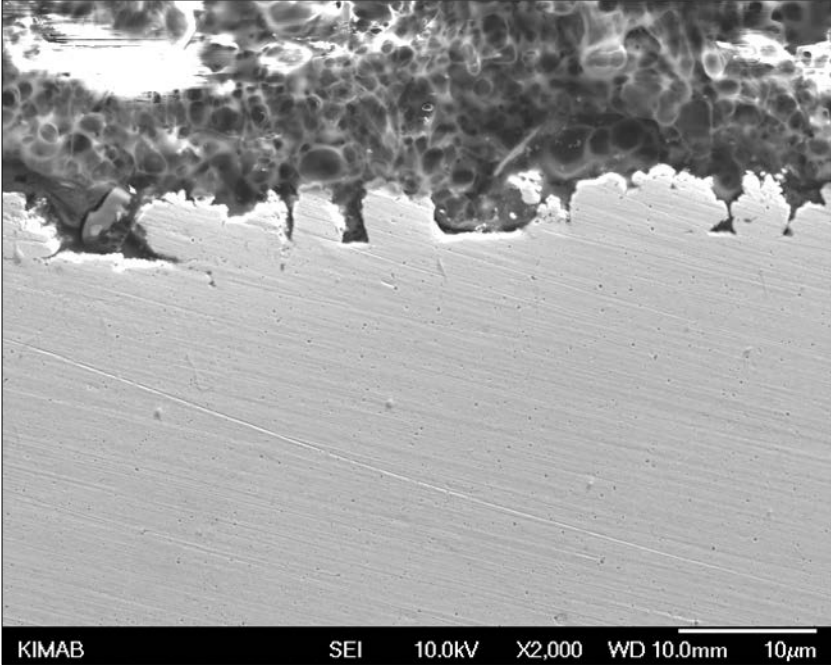
Figure 3-17. Cross section of H-creep-15. No cracks are visible.

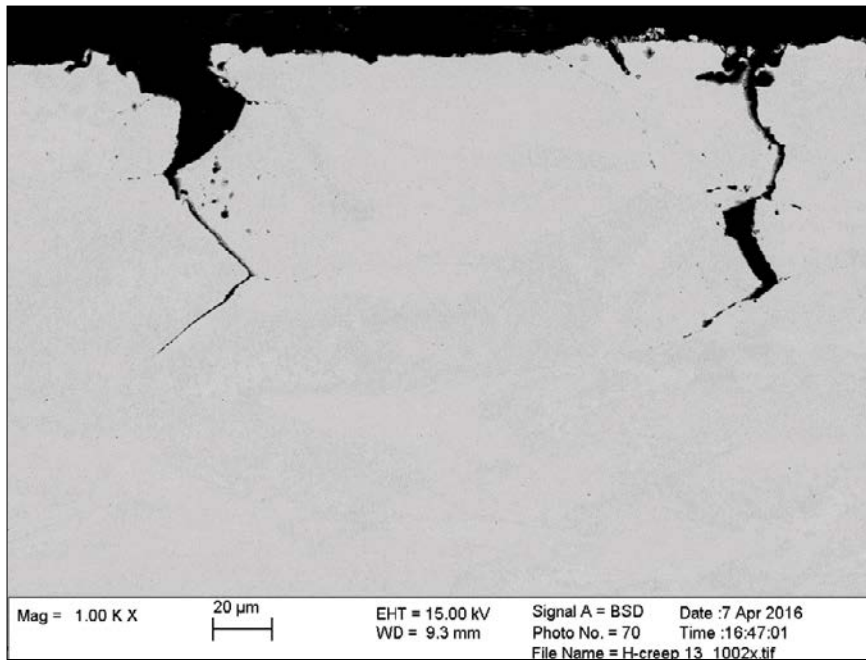
Figure 4-1. Specimen H-creep-13 tested at 75 °C for 13 hours of simultaneous hydrogen charging and at creep stress 172 MPa. Large cracks were discovered, but no or very small amount of cavities in front of the crack. The specimen was manufactured from soft annealed condition without pre-strain.

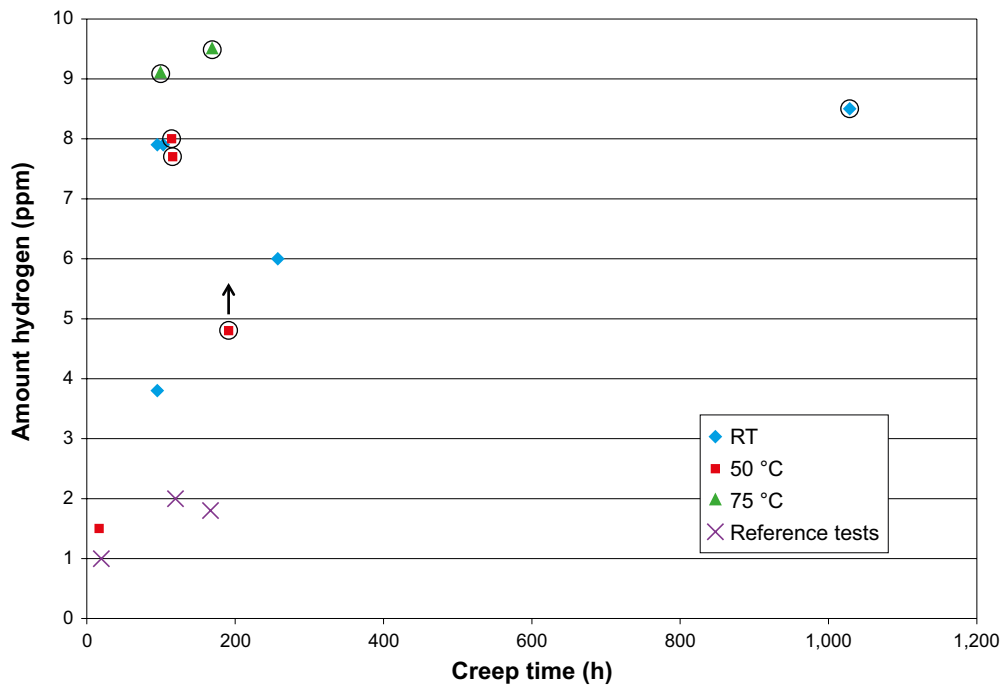
Figure 4-2. The amount of charged hydrogen versus creep testing time. The specimens which presented cracks are encircled. Specimen H-creep-09 presented 4.8 ppm hydrogen, but there was a delay in the analysis of the hydrogen content and an arrow is therefore pointing towards the assumed higher hydrogen amounts for this specimen.

Figure 4-2 shows the amount of charged hydrogen as a function of creep testing time. The specimens which presented cracks are encircled.

The amount of hydrogen was measured with Leco Rhen 602 hydrogen determinator on sections cut out of the gauge section of the specimens with approximately a weight of 1 g. For each specimen, two such sections were cut out and the amount of hydrogen was determined. It should be noted that the amount of hydrogen could vary significantly on the two parts cut out from the same specimen.

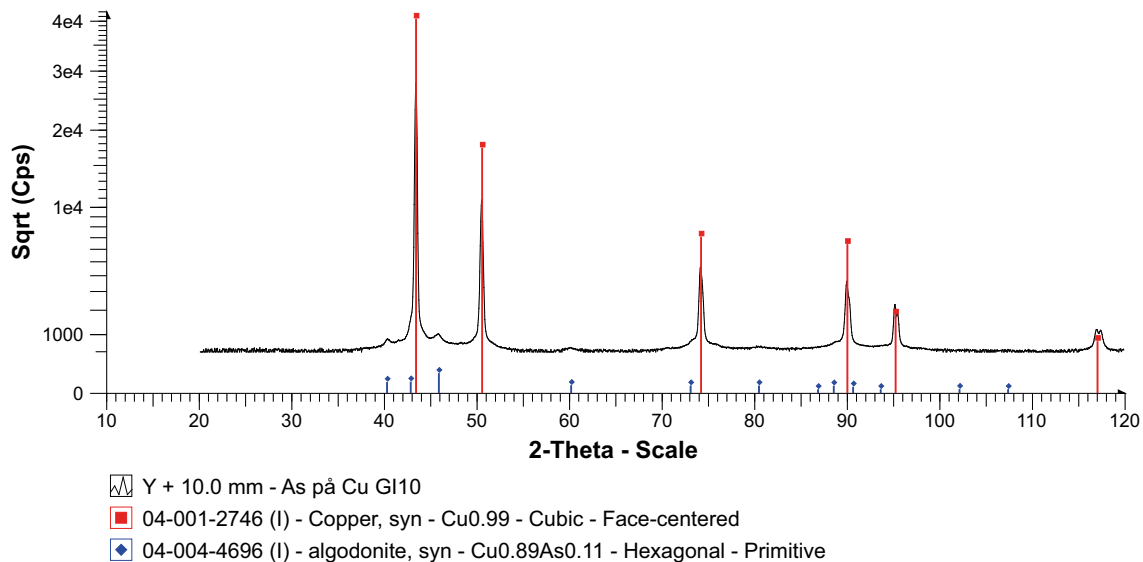
Figure 4-3. The diffraction spectrum of low angle X-ray photoelectron spectroscopy of the surface of specimen H-creep-03.

The reason for this is most likely that the hydrogen concentration is high at the surface and that a significant amount of hydrogen is to be found just below the CuAs layer or even perhaps in the layer of CuAs itself. If some of the CuAs layer is unintentionally removed in the actual handling of the specimen which contains a significant amount of hydrogen it could explain the variation in measured hydrogen content obtained on the same specimen. The CuAs layer that has a dark grey and black colour is easily removed just by pulling a finger along the surface with a small pressure. Some of the layer will come off and the CuAs layer will be discernible on the finger instead. Figure 4-3 shows the diffraction spectrum of low angle X-ray photoelectron spectroscopy performed on the surface of specimen H-creep-03. The spectrum presented the presence of two phases namely FCC-copper and the intermetallic hexagonal Cu-As phase. The identification of the two phases was performed with matching with “EVA” from Bruker AXS. Note that no sulphides, oxides or hydroxides can be found in the diffraction spectrum.

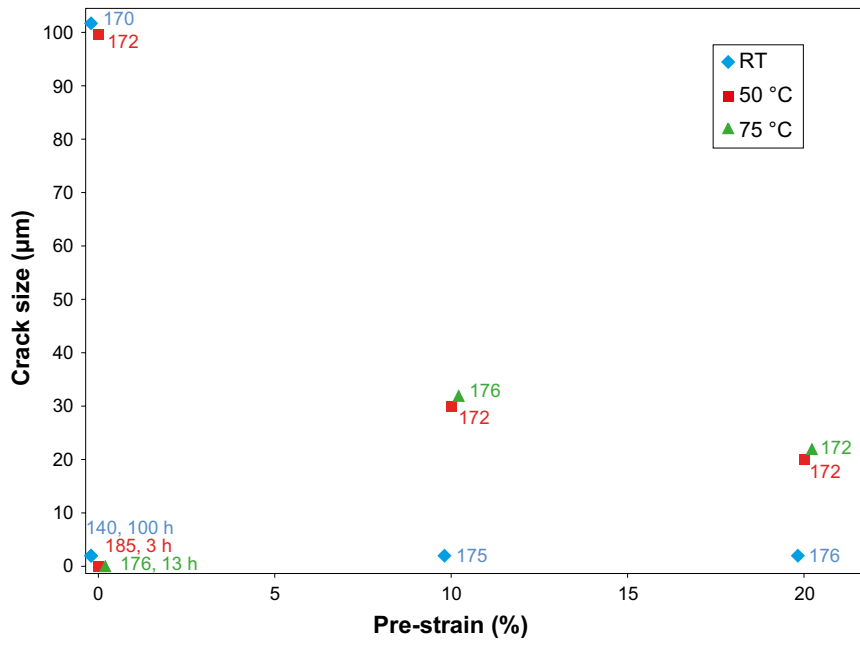
Figure 4-4. Crack size versus pre-strain is plotted with the creep stress values and creep testing times values presented beside the symbols.

Figure 4-4 shows crack size versus pre-strain with the stress values and creep testing time shown near the symbols. Low stress or short creep testing time seem to reduce cracking. The amount of pre-straining also seem to influence cracking in the way that larger pre-straining gives less cracking. It can further be seen that higher temperature seem to give more cracking compared to room temperature.
