TR-17-16

Stress corrosion testing of copper in sulfide solutions

SVENSK KÄRNBRÄNSLEHANTERING AB

Claes Taxén, Jesper Flyg, Hans Bergqvist
Swerea KIMAB AB

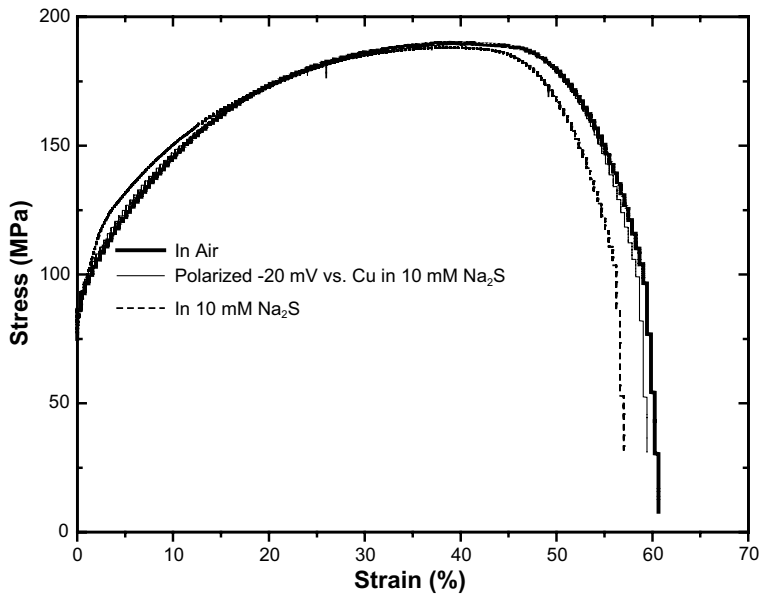
Figure 1-6. Stress-strain curves obtained at room temperature. One reference curve in air, one curve for a test in synthetic seawater with addition of 10 mM Na₂S and one curve for a test in the same solution where cathodic polarisation was applied. (Bhaskaran et al. 2013.)

Figure 1-6 shows stress-strain curves for room temperature. The elongation at failure is about 61.5 % in air and about 56.8 % in synthetic seawater with 10 mM Na₂S. Cathodic polarisation (-20 mV) gives an elongation of about 59.4 %.

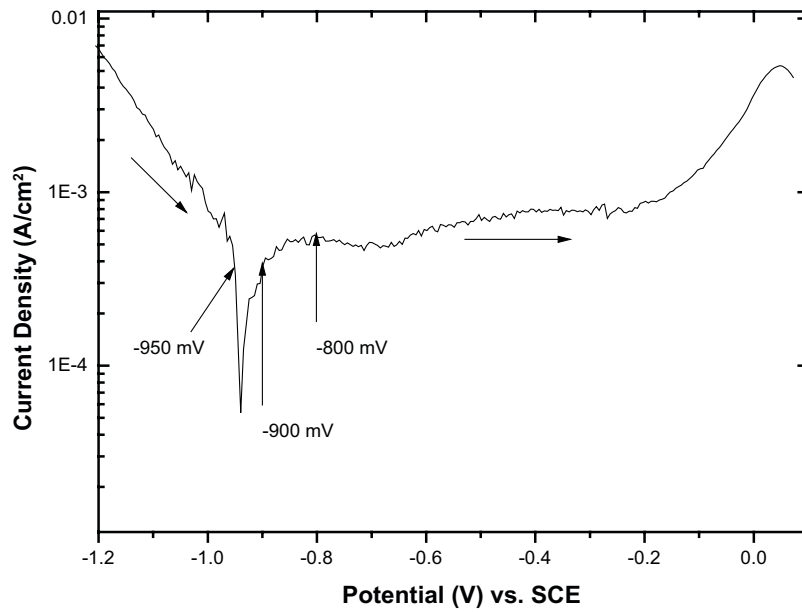
Figure 1-8. Potentiodynamic scan of copper in synthetic sea water with addition of 10 mM Na₂S at 80 °C. Scan rate was 1 mV/s. (Bhaskaran et al. 2013.)

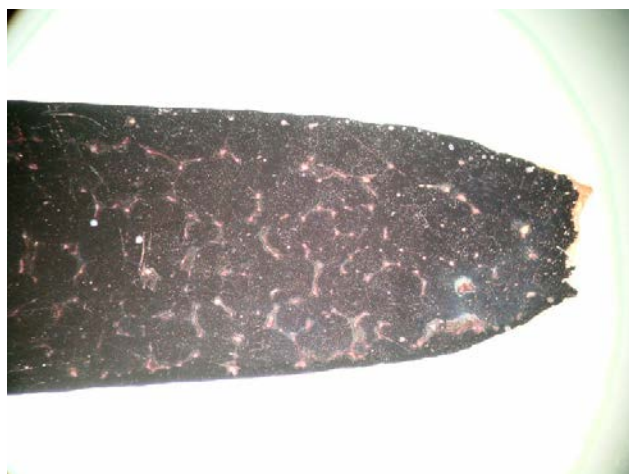
Figure 1-11. Apparent granular network on a polished, unetched surface of sample exposed in 0.414 M NaCl+1.56 mM Na₂S+0.78 mM Na₂S₂O₃ at room temperature. The gauge diameter was 3 mm. (Bhaskaran et al. 2013.)

One SSRT specimen showed aberrant surface features after test at room temperature in 0.414 M NaCl+1.56 mM Na₂S+0.78 mM Na₂S₂O₃ (Total of 100 ppm “S”). Figure 1-11 shows what appears to be a granular network on the polished (unetched) cross-sectional surface of this sample. However further examination did not support the notion that this was some kind of deep, penetrating corrosion that had occurred during exposure to the sulfide-thiosulfate solution. Not least, this was because the grain size of the material was much smaller than that of the apparent granular network (Bhaskaran et al. 2013).

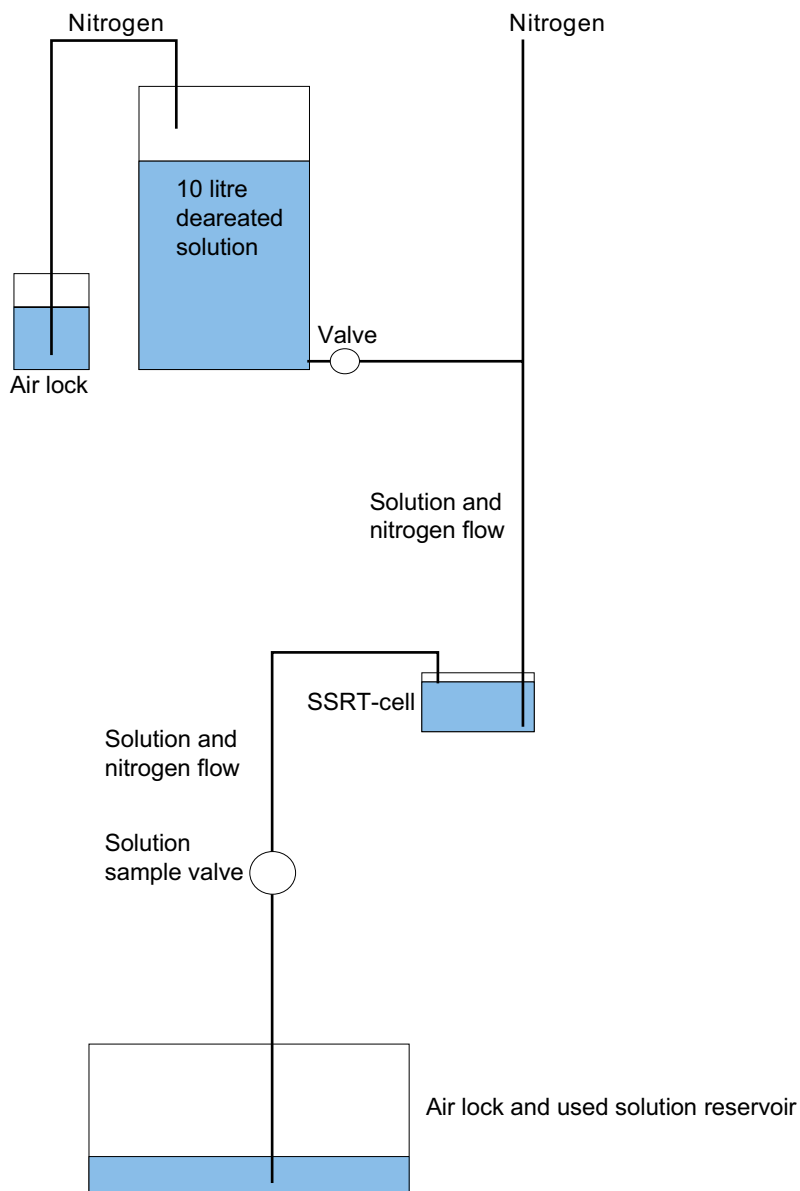
Figure 2-2. Schematic sketch of the solution flow system during SSRT-test on copper.

To ensure that the concentration of Na_2S stays at 0.01 M during the experiments a special setup with continuous flow of solution was used. Figure 2-2 shows a schematic sketch of this setup. The setup consists of a 10 litres reservoir filled with test solution. The outlet valve is adjusted so that gravitation feeds a slow flow through the SSRT-cell ending up in a reservoir for used test solution. A small overpressure of nitrogen gas is maintained.

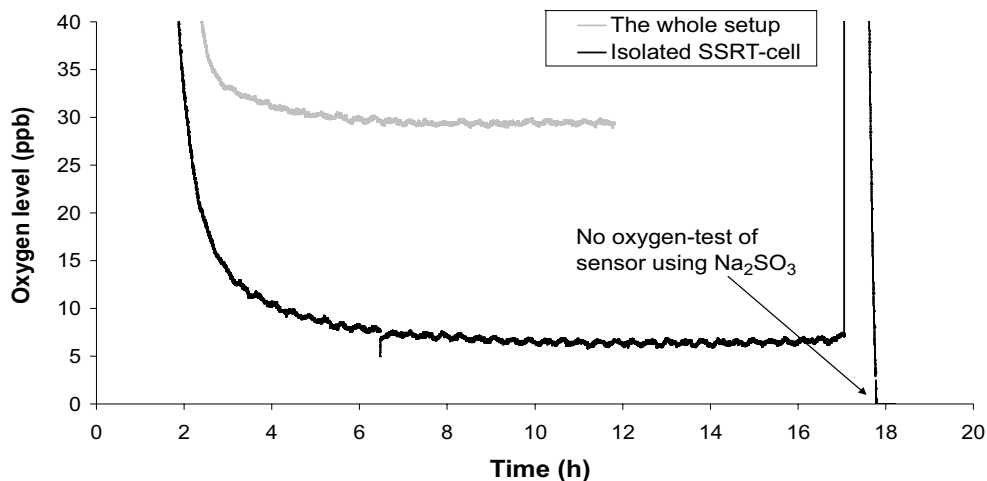
Figure 2-4. In an isolated SSRT-cell the oxygen level leveled out at 7 ppb. On the whole setup the level leveled out at 30 ppb. In the end of the “Isolated SSRT-cell”-test the sensor was placed in an environment where Na_2SO_3 was used as an oxygen scavenger.

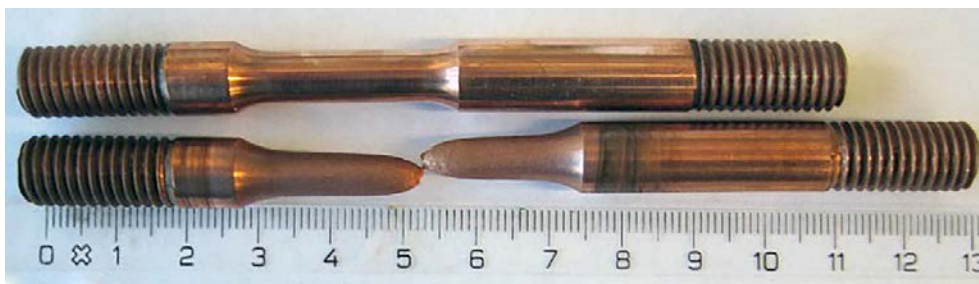
Figure 2-7. A photo of a new test rod and a test rod drawn to fracture in artificial seawater, for a reference curve.

Figure 2-7 shows a photo of a new round test rod and a test rod drawn to fracture in artificial seawater, for a reference curve.

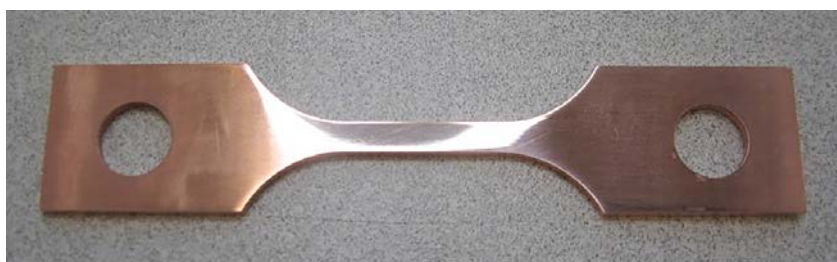
Figure 2-8. A photo of a rectangular test rod rectangular test rod before testing.

Rectangular test rods were cut to the dimensions in Figure 1-1. Figure 2-8 shows a photo of a rectangular test rod before testing. The material was cold rolled to the desired thickness, heat treated to reduce the hardness (not for all tests) and cut to form by milling. The final polish was made using diamond paste 3 μm just as in the work of Taniguchi and Kawasaki.

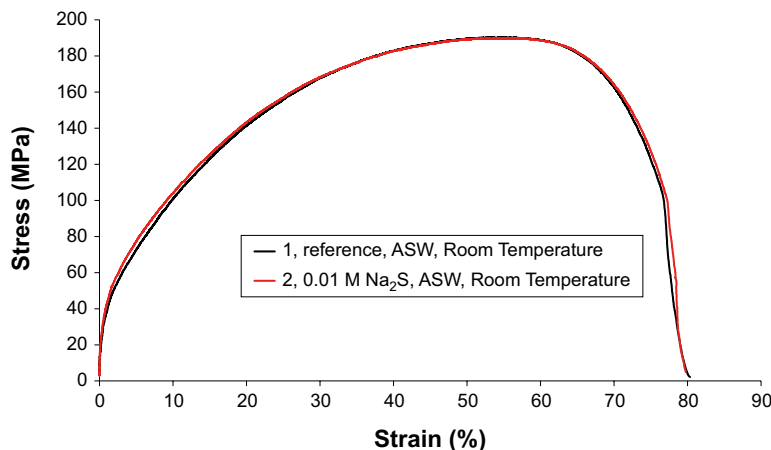
Figure 3-1. Stress-strain curves for copper in artificial sea water (ASW) at room temperature, with and without 0.01 M Na_2S .

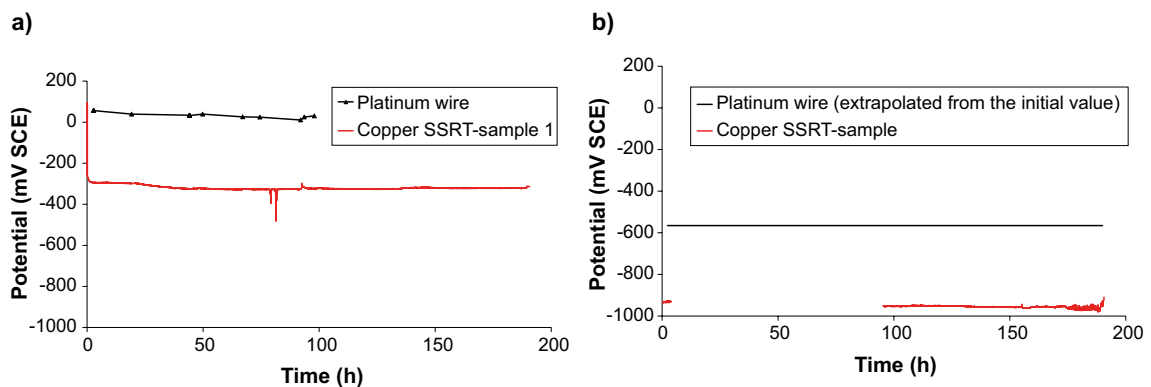
Figure 3-2. Corrosion potentials and Pt potentials measured during SSRT-test at room temperature, a) without Na_2S , b) with 0.01 M Na_2S .

Figure 3-2 shows the corrosion potential for the copper test rod and the potential for a platinum wire in the same solution, a) without Na_2S , b) with 0.01 M Na_2S .

Figure 3-2 shows that the potential of Pt in experiment 1 is close to 0 mV vs. SCE in artificial sea water without sulfide. The potential of the copper test rod is approximately -300 mV vs. SCE. The addition of 10 mM sulfide to artificial sea water, experiment 2, shifts the potentials to between -1 000 and -900 mV for the copper test rod and to about -600 mV for Pt.

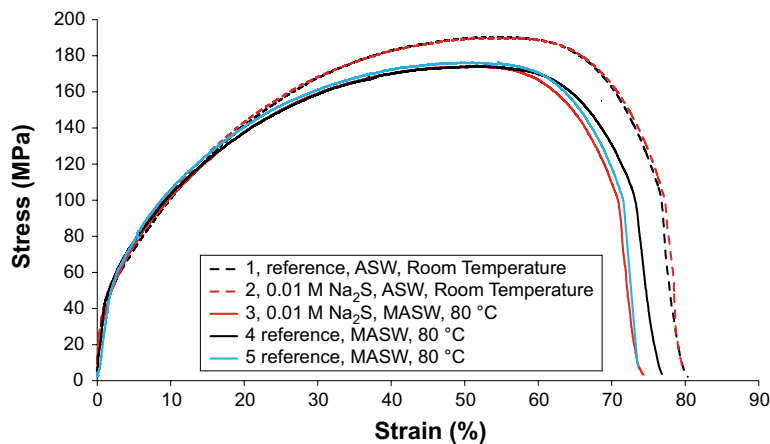
Figure 3-4. Stress-strain curves for copper in modified artificial sea water (MASW) at 80 °C, with (red curve) and without (black curve and blue curve) 10 mM Na₂S. The corresponding curves for room temperature are included as dashed lines, for comparison.

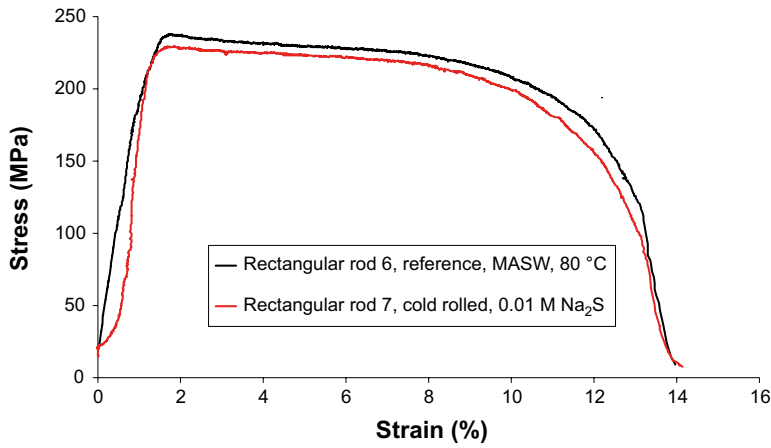
Figure 3-6. Stress-strain curves for copper in modified artificial sea water (MASW) at 80 °C, with (red curve) and without (black curve) 10 mM Na₂S.

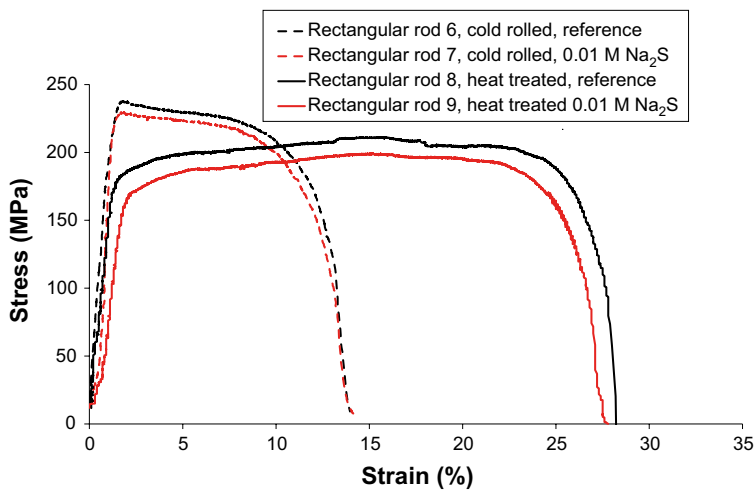
Figure 3-8. Stress-strain curves for copper in modified artificial sea water (MASW) at 80 °C, with (red curve) and without (black curve) 10 mM Na₂S. The curves for the material obtained before heat treatment are included as dashed lines, for comparison.

Figure 3-15 shows an assembly of images for the test rod with rectangular cross section tested in 10 mM sulfide at 80 °C in test 7. The material was not annealed after cold rolling and fractured at about 14 % strain (Figure 3-8).
