Technical Report

TR-18-11

Investigations of gas evolution in an unsaturated KBS-3 repository

Martin Birgersson, Reza Goudarzi

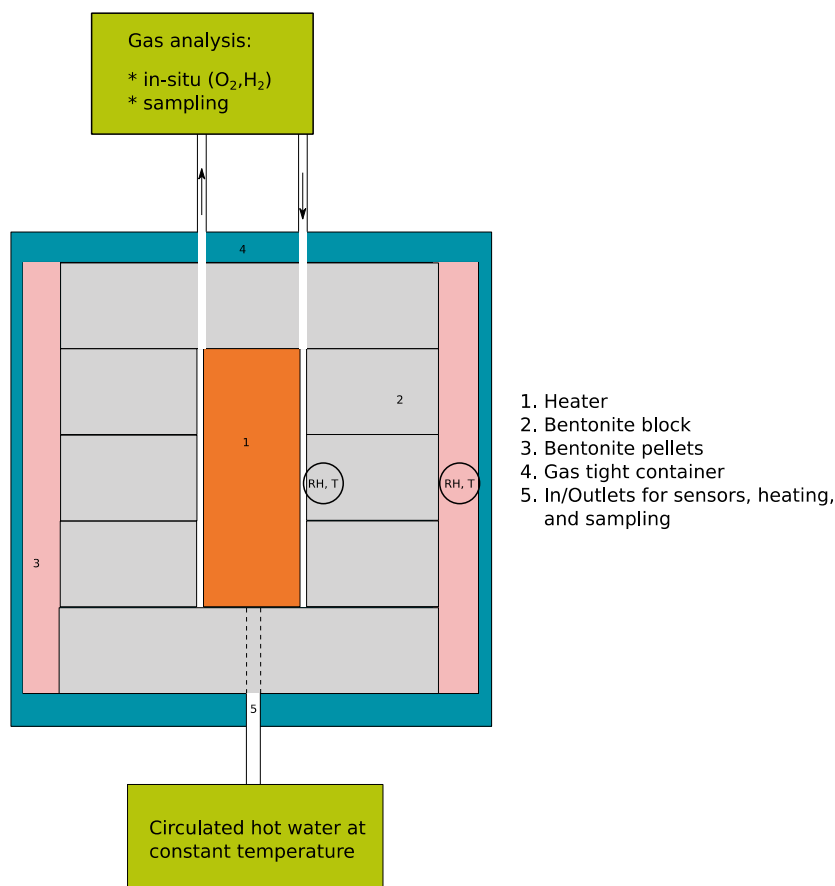
One of the tests includes a heater made of copper, and its schematic design is shown in Figure 2-1. With a copper heater at the center, while the set-up is placed in room temperature, this test is expected to develop gradients in moisture and temperature. It is therefore referred to as the *thermal gradient test*.

Figure 2-1. Schematics of the set-up for the thermal gradient test.

Figure 3-1 shows the evolution of the measured RH and temperature in the thermal gradient test (approximate location of the sensors are indicated in Figure 2-1). It can be noted that although the temperature of the heater is 80 °C, the temperature in the bentonite block near the heater is only approximately 50 °C. There is apparently a huge drop in temperature over inner slot region. In the outer pellets slot, the temperature was about 40 °C throughout the test. Thus, at this position in the set-up, the temperature drops approximately 10 degrees over the bentonite (block and pellets). Note that these measurements only give a rough estimate of the temperature distribution in the full test – there is certainly heat transport also in the axial direction.

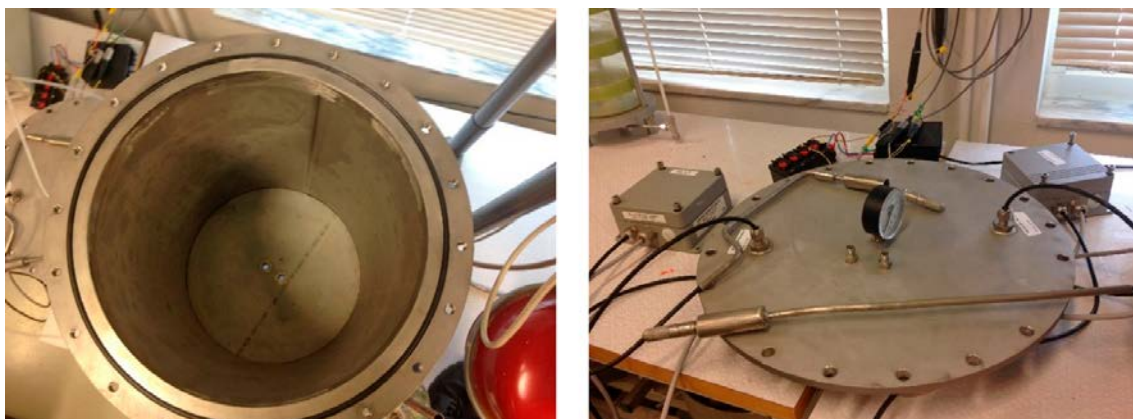
The container is made of stainless steel and consists of a “barrel” and a lid, shown in Figure 2-2. The container has inlet and outlet holes for supporting a water based heating system, as also used in lab tests for investigating the “sauna” effect (Birgersson and Goudarzi 2016). The lid has openings for in situ gas analysis (oxygen) and gas sampling, RH-sensor cables, and a total pressure gauge. The lid is attached to the “barrel” by 20 screws and is sealed with a large o-ring (Figure 2-2).

Figure 2-2. The container of the thermal gradient test. Left: the “barrel” seen from the top. The holes for inlet and outlet of heating water are visible. Right: The lid with the RH sensors and the total pressure gauge attached.

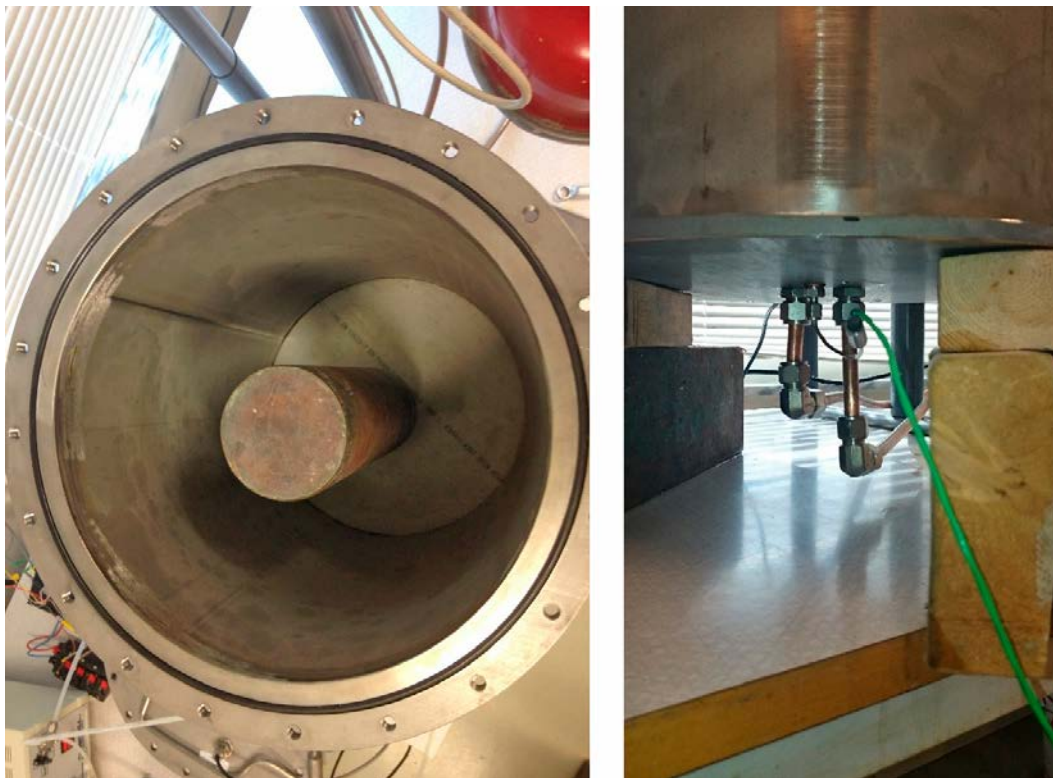
The copper tube was connected to the system for circulating and heating water (Figure 2-3). The heater was regulated as to keep the temperature in the copper tube at 80 °C.

Figure 2-3. The copper heater assembled in the thermal gradient test. The photograph to the right shows the connection at the bottom of the “barrel” for flowing heated water. The water heater is seen in Figure 2-6. The green cable seen in the right picture is for the thermocouple controlling the heat regulation.

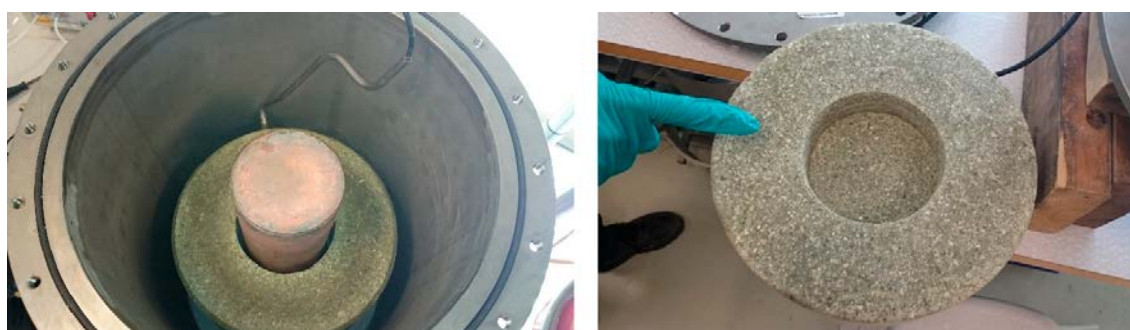
Figure 2-4 shows pictures from the assembly of the bentonite blocks in the experimental set-up.

Figure 2-4. Left: Assembly of the blocks and rings. In this picture is also seen the titanium tubing for the RH-sensor located close to the heater. Right: Bottom side of the top block in the thermal gradient test. This block has a milled hole for fitting the top of the heater.

On the top side of the heater was also noted a red spot, which definitely had appeared during the course of the test (compare Figure 2-4 and Figure 3-5). This is most probably copper (I) oxide. A picture of the top of the heater after termination is shown in Figure 3-9.

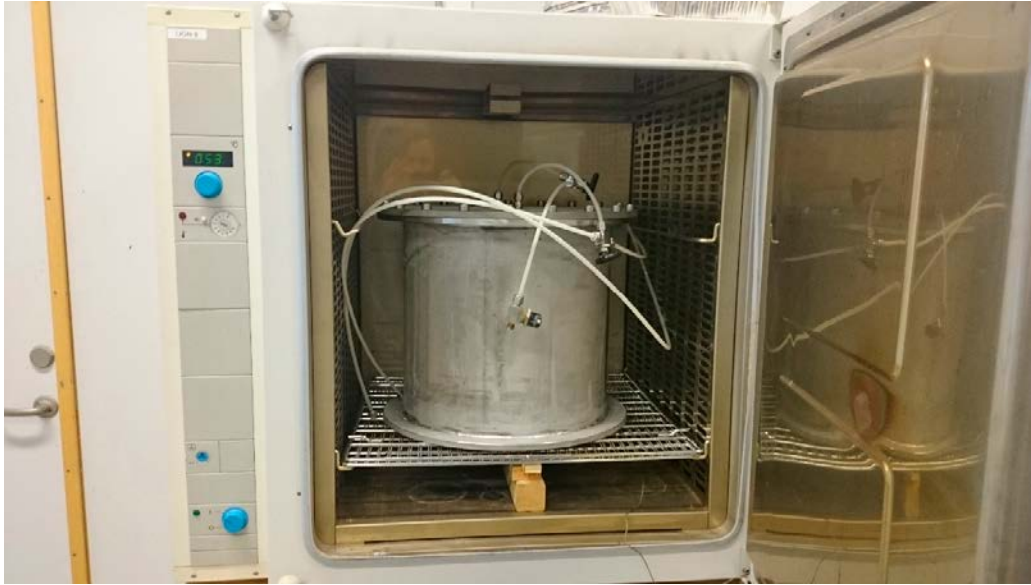
The isothermal test was not instrumented. The test is exposed to isothermal conditions, either room temperature, or placed in an oven at 50 °C. Figure 2-5 shows a photograph of the test placed in the oven.

Figure 2-5. The isothermal test placed in the oven.

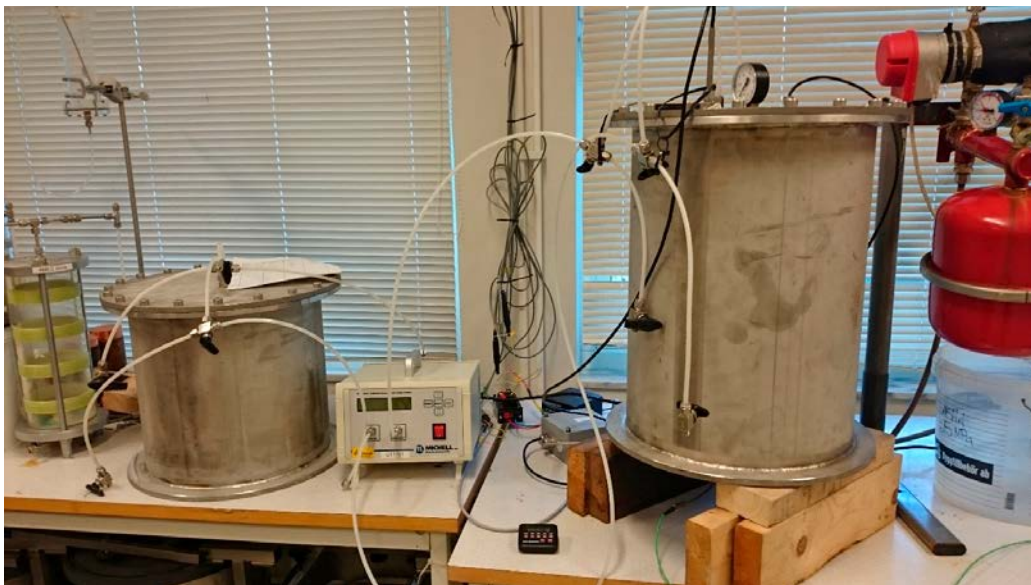
The container is made of stainless steel in the same manner as for the thermal gradient test. Similarly it consists of a “barrel” and a lid, sealed with an o-ring. The lid have openings for in-situ oxygen measurements and gas sampling. The isothermal test was designed to contain approximately 20 L gas and 20 kg of solid bentonite mass. A photograph of the test under operation is shown in Figure 2-6.

Figure 2-6. The isothermal (left) and thermal gradient (right) tests under operation in the lab. In the middle of the picture is seen the oxygen analyser (at the time of the photograph, connected to the thermal gradient test). To the far right is also seen the water heating system.

The test was also equipped with a pressure gauge in order to give an indication of overpressure in the vessel due to temperature elevation (see Figure 2-6).

Gas was sampled for external analysis with the following procedure. One of the tubes used for the in-situ oxygen measurements (see e.g. Figure 2-6) was connected to a vacuum pump, which in turn was connected to the sample bag, as shown in Figure 3-4. In order to minimize contamination from atmospheric oxygen, all external tubing was flushed with nitrogen before conducting the sampling.

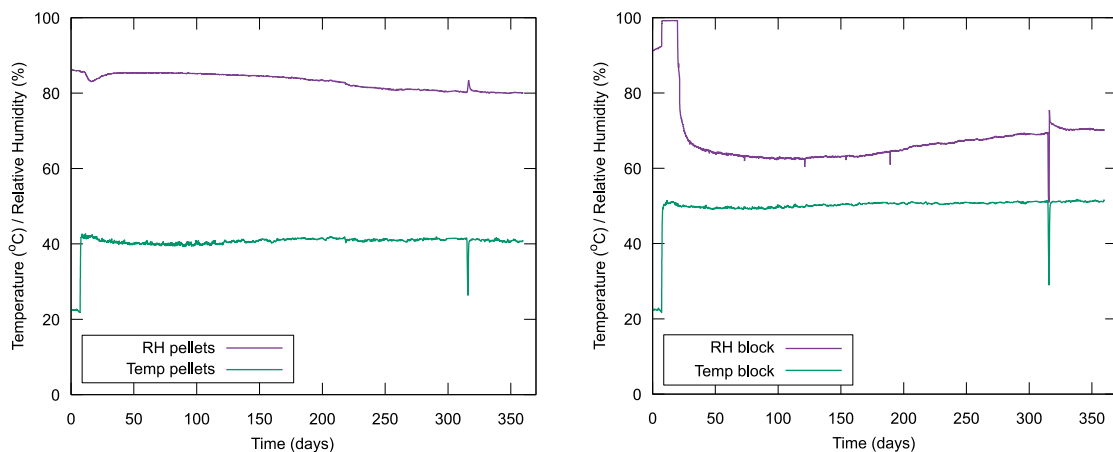
The RH close to the heater reached 100 % as the heater was switched on, only to drop to approximately 63 % as the system evolved. The RH in the pellets stayed approximately constant at 85 %–80 %. This evolution in relative humidity indicates that water has been transported away from the bentonite closest to the heater, while the water content in the pellets slot has basically remained constant. However, the measurements of water content at the termination of the tests confirmed that the bentonite had dried quite extensively in regions near the heater, while water had accumulated near the walls of the container, as further discussed in Section 3.5.

Figure 3-1. Evolution of temperature and relative humidity in the thermal gradient test. Approximate positions of the sensors are indicated in Figure 2-1. The spikes seen in all the curves at day 315 are due to an unintentional shut-off of the heating system for a few hours in connection with gas sampling.

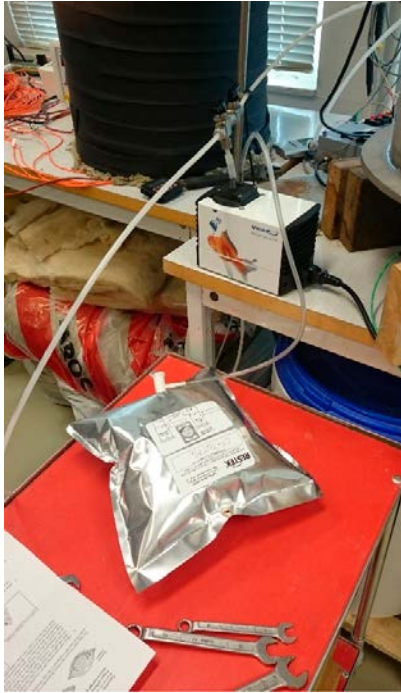
Figure 3-4. Gas sampling of the temperature gradient test. A vacuum pump was connected to one of the outlets of the tests and to the sample bag.

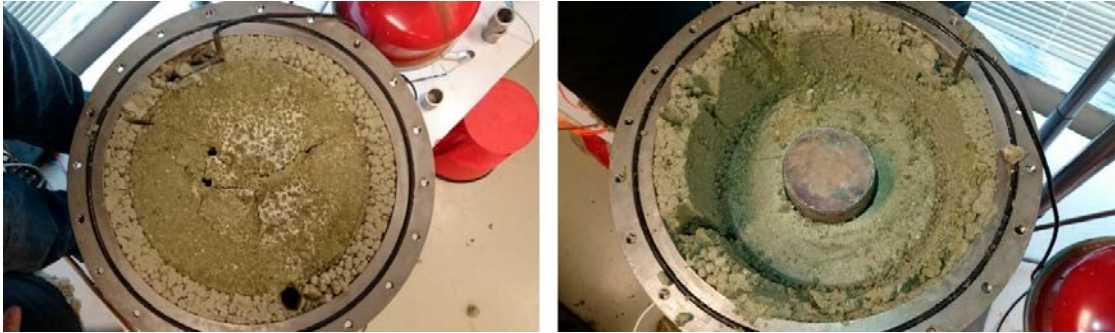
In the temperature gradient test, after a short period (hours) of cooling after shutting of the heater, the bentonite was removed from the top down. Figure 3-5 shows the bentonite directly after the top lid had been removed. The darker colour of the bentonite reveals that the bentonite is rather moist. Evidently, water had accumulated in the top of test. In particular it can be noted that the pellets filling had swelled and homogenized quite extensively.

Figure 3-5. Left: Temperature gradient test after removing the lid at termination. In the top is seen the cable and tubing for one of the RH-sensors, in the middle is seen the two holes where tubes were inserted for gas sampling in the slot region between heater and bentonite. At the bottom is seen a hole where the other RH sensor were located (it was pulled out during opening). Right: After removing the top block. The top of the copper heater is exposed, the homogenization of the top of the pellets slot is clearly seen.

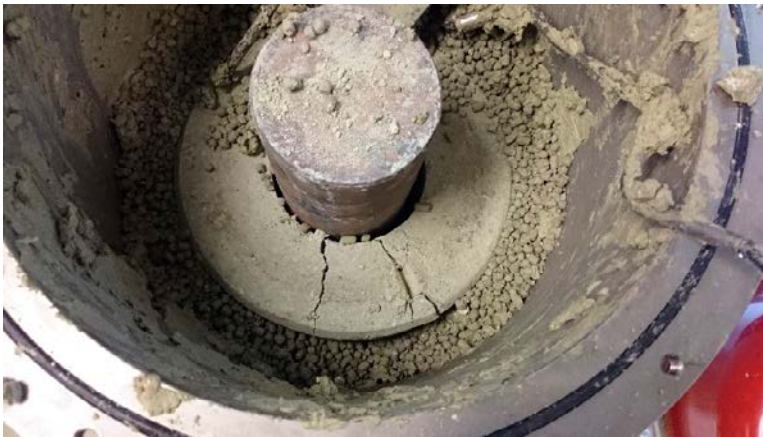
Figure 3-6. Sampling at the level of the mid-ring. The pellets slot was considerably dryer and less homogenized at this level in comparison with the top part. In the top right of the photograph is seen the RH-sensor which was located in this particular bentonite block during operation.

The recorded water-to-solid mass ratios and the approximate positions where sampling was made is shown in Figure 3-7. The measured water distribution confirms that the system dried significantly next to the heater during the course of the tests, while water accumulated in the pellets slot, particular in the upper part. Note that the initial water-to-solid mass ratio for blocks and rings was 0.28 and 0.24 respectively, and the initial water-to-solid mass ratio was 0.23 for the pellets. It should be noted that some of the bentonite samples taken for analysis of water content were quite heterogeneous (with respect to water content). The values here reported thus represent mean values of the particular samples taken, and the water distribution presented in Figure 3-7 only broadly represent the water distribution in the test (this is particularly significant for the pellets, which were very moist at the interface to the sample container, while they could be fairly dry at the interface to the blocks, see e.g. Figure 3-6).

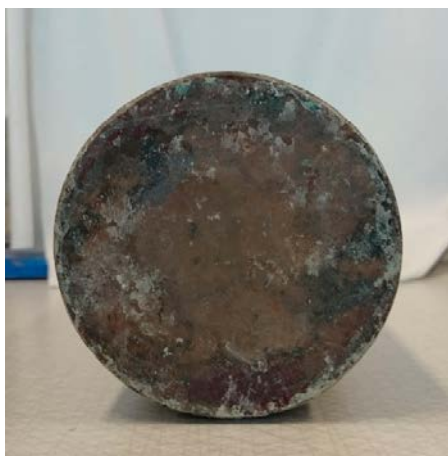
Figure 3-9. Top of the heater in the thermal gradient test after termination. A black corrosion product (CuO) is seen in the upper part, a red corrosion product (Cu_2O) is visible in the lower part.
