**P-18-16**

# Full-scale test of the Dome Plug for KBS-3V deposition tunnels – concrete properties

## Sampling, testing and properties of low-pH concrete in the KBP1016 dome plug

Carsten Vogt, Betong & Stålteknik

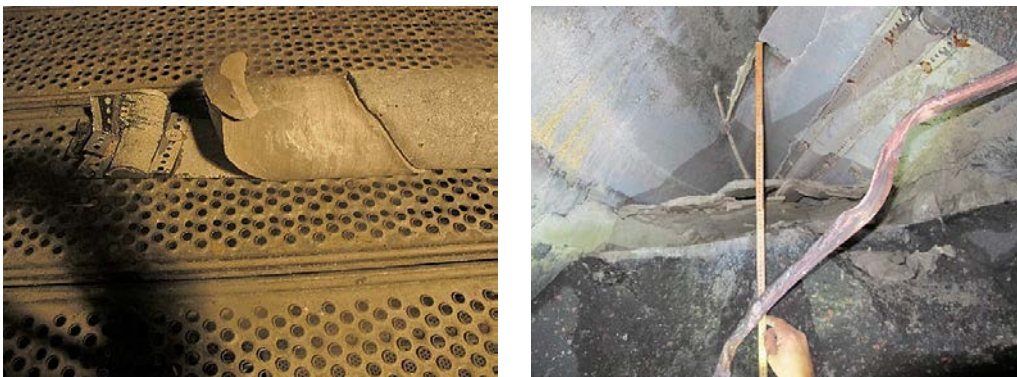
Therefore, an additional core was taken in the center of the upper part of the plug (denoted center in Figure 2-6). This core showed the same situation, a layer of grout on top of the low-pH concrete. After dismantling the plug, it was confirmed that the top part is empty and the concrete has an almost horizontal top under a layer of grout, see Figure 2-6. A triangular shape of the slot with a height of about 50 cm was never filled with concrete. It would have required almost one m<sup>3</sup> of grout to fill this void.

**Figure 2-6.** Drill core “center” (left) and void on top of the concrete (right).

- Install cameras, sensors or similar on top of the slot in order to ensure that pumping is not terminated before the slot is completely filled.
- Increase the number and diameter of venting pipes at the top of the slot. Observe that these pipes have to be removed when casting is finished since they may provide possible leakage passageways.

- Place one or more extra pumping pipe(s) at the top of the slot. Observe that these pipes need to be removed when casting is finished since they may provide possible leakage passageways. Venting pipes are required.

- Allow for increased grouting in order to fill voids. This should be seen as a last resort instead of having to replace a faulty plug. Dismantling a faulty plug and constructing a new plug possibly also includes having to remove and replace the bentonite in the barrier.

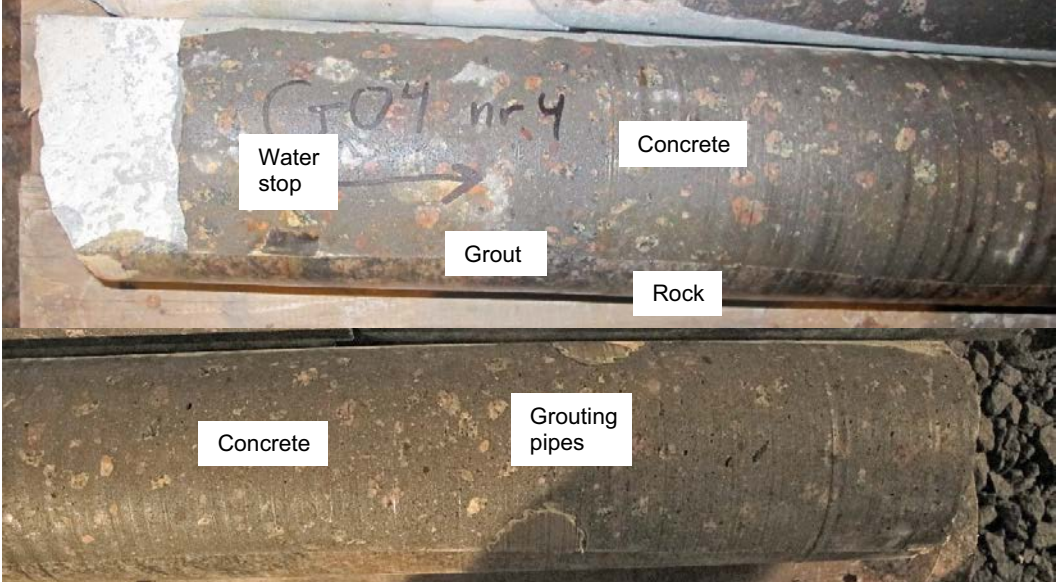
Downstream of the water stops, no grout was observed. The water stops efficiently stopped the grout from penetrating to the downstream surface. The initial placement of grouting pipes and water stops is explained in Grahm et al. (2015). In certain cores, smaller amounts of grout had penetrated the interface, see Figure 2-8. These cores are located in the lower part of the plug. More grout appears to have penetrated between rock and concrete at the upper part of the plug and at the sides.

**Figure 2-8.** Examples of drill cores (G04) from the interface between rock and concrete immediately after drilling. The water stops (dark squares) and grouting pipes (light colored halve-circles) are clearly visible. Very little or almost no grout seems to have penetrated at the interface. These cores seemed to be attached to each other after drilling, i.e. a certain bond strength existed.

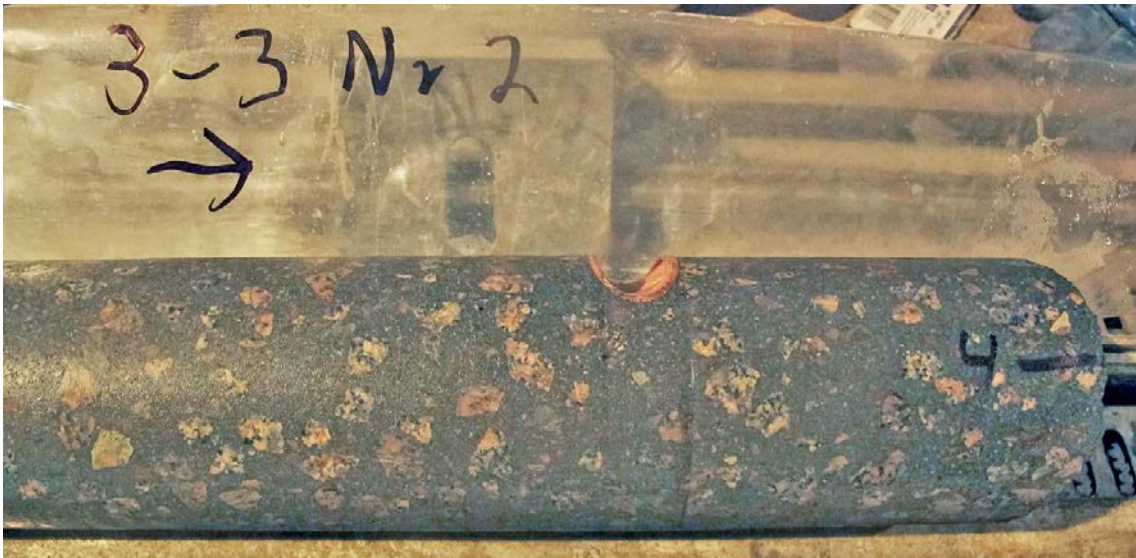
Below, some of the drill cores are documented in photographs. All photographs can be found in Appendix. In general, the cores show very homogenous concrete with evenly distributed coarse aggregates, see Figure 2-10. Cooling pipes and cables from the instrumentation are very well embedded. No visible cracks or any form of honeycombing are observed. However, in certain parts of the cores, locally there are reduced amounts of coarse aggregate, see Figure 2-11 in comparison with Figure 2-10. This observation may be a result of “sieving out” the coarse aggregate by cooling pipes and other installations and thus, a certain segregation of concrete. Another kind of segregation also occurs sometimes in the concrete trucks itself, especially when delivering self-compacting concrete. The very last concrete in the drum tends to lack coarse aggregate, especially if unloading took a long time. It seems to be a localized phenomenon, since it was not observed on cores 3-3 and 3-4, situated right next to core 3-3-1.

*Figure 2-10. Core 3-3-1, part 2. The large aggregates seem very well distributed, the cooling pipe is well embedded in concrete.*

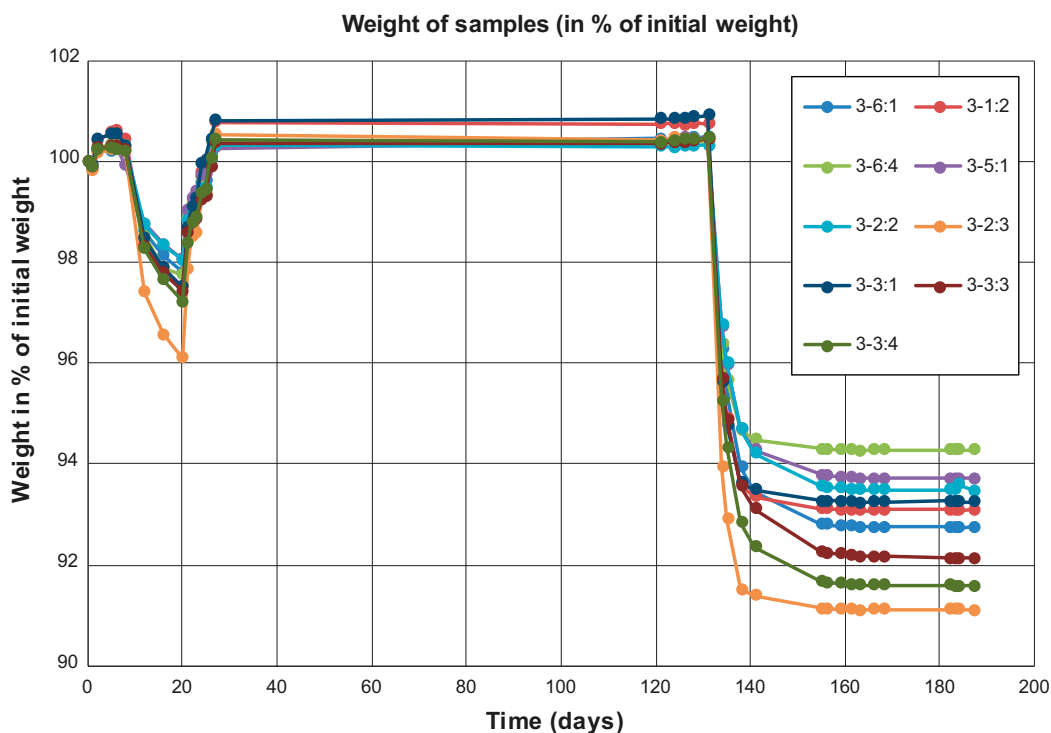
**Figure 4-5.** Weight of samples vs time. The first drying cycle after 10 days is not normal procedure. It was performed since the absorption of moisture was extremely slow and thus, mistakes in method were assumed. This is deemed to have no influence on the final result.

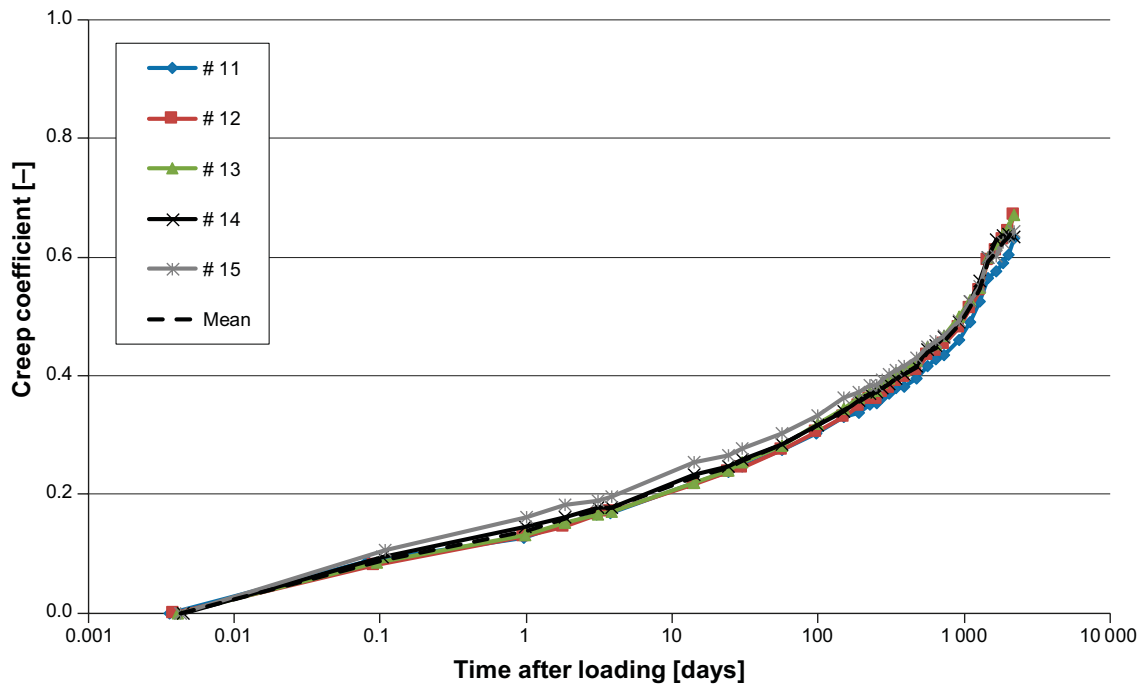
Figure 5-6. Creep coefficient versus time after loading for the creep specimens of test run (TR) 2; applied stress  $\sigma_{cm}(t_0) = 49.4 \text{ MPa}$  ( $75 \% f_{cc}$ ).

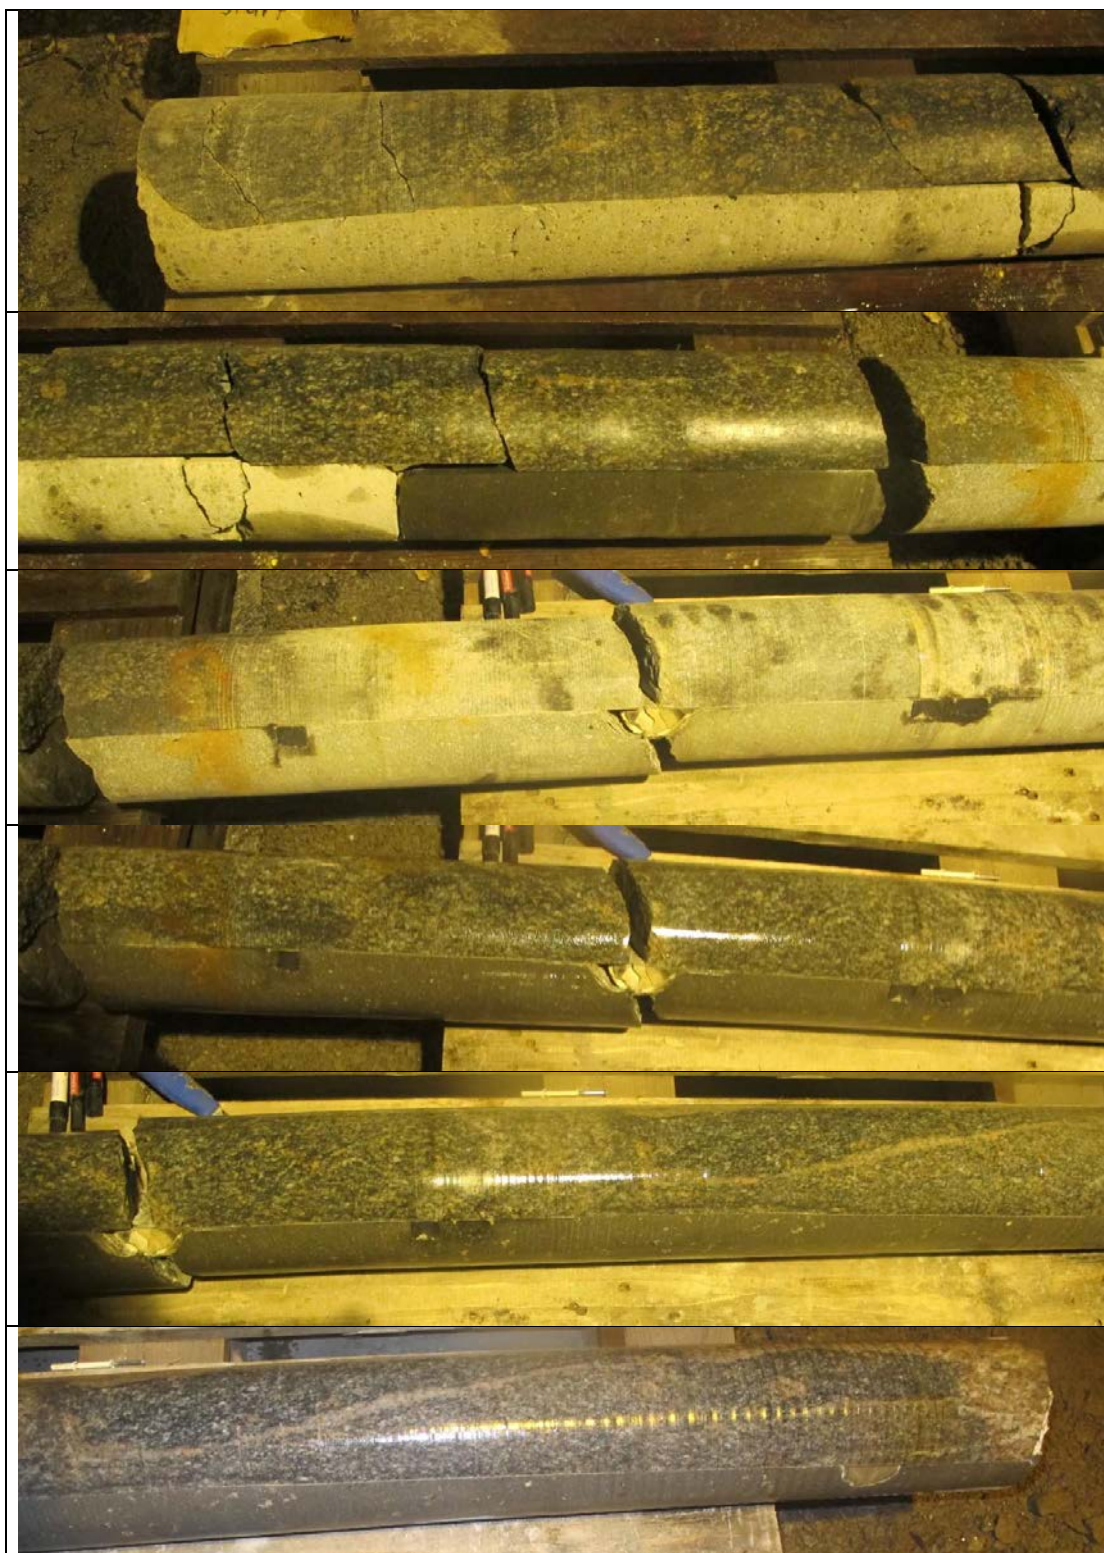
A03

All drill cores are shown in the order they are removed during drilling, i.e. the first picture shows the part of the core that was removed first. The left side of the first picture shows the downstream surface of the drill core.
