TR-20-11

Installation, monitoring, dismantling and initial analyses of material from LOT test parcel S2 and A3

Results from field test

Torbjörn Sandén, Ulf Nilsson
Clay Technology AB

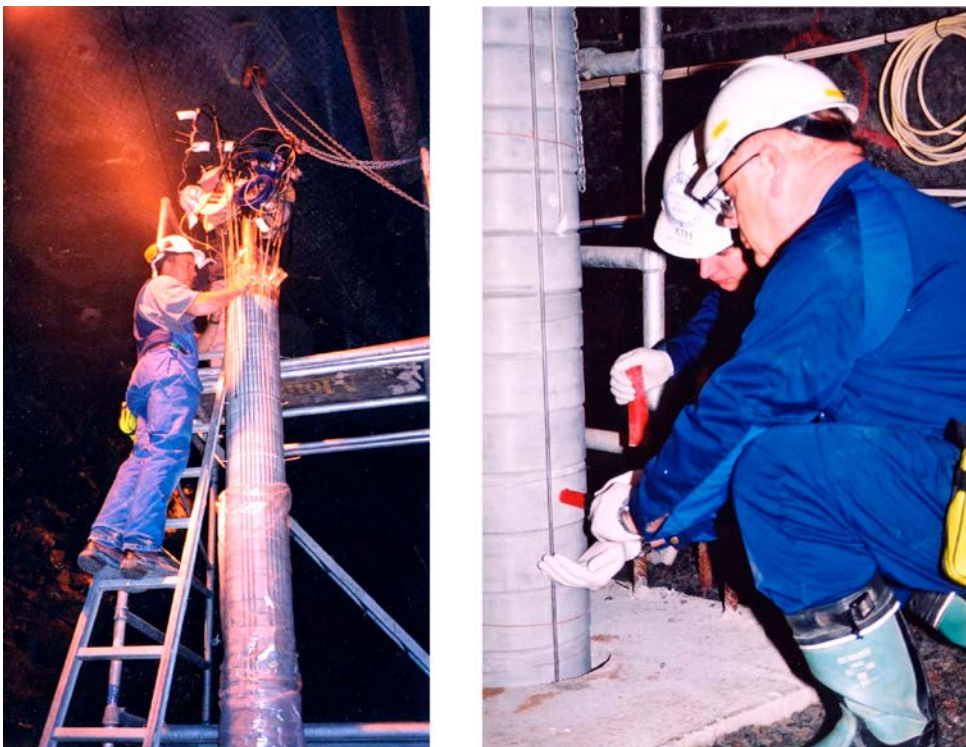
Figure 3-1. Left: Finalising the construction of a LOT test parcel at test site, note the large number of tubes from sensors. Right: Insertion of the plug containing ^{60}Co during lowering the parcel into the test hole. Note the lack of disturbing sensor tubing in the lower hot section.

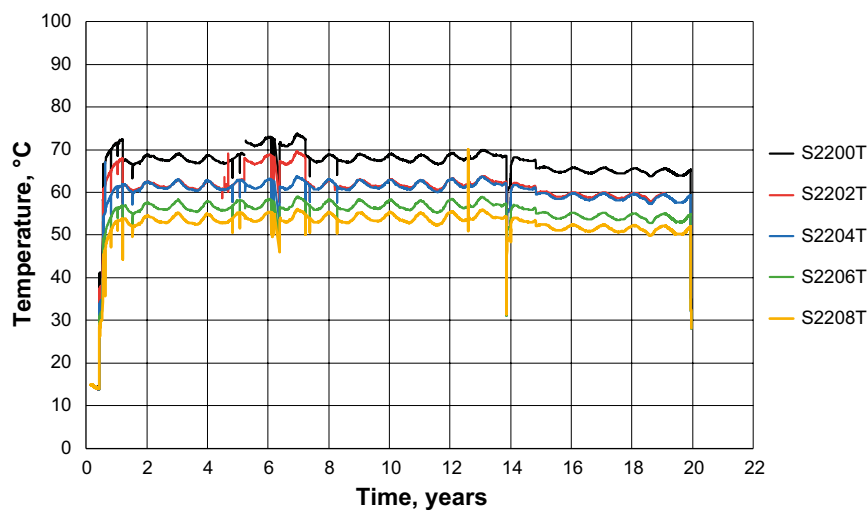
Figure 4-4. Registered temperature plotted versus time for five sensors positioned in test parcel S2, block 20.

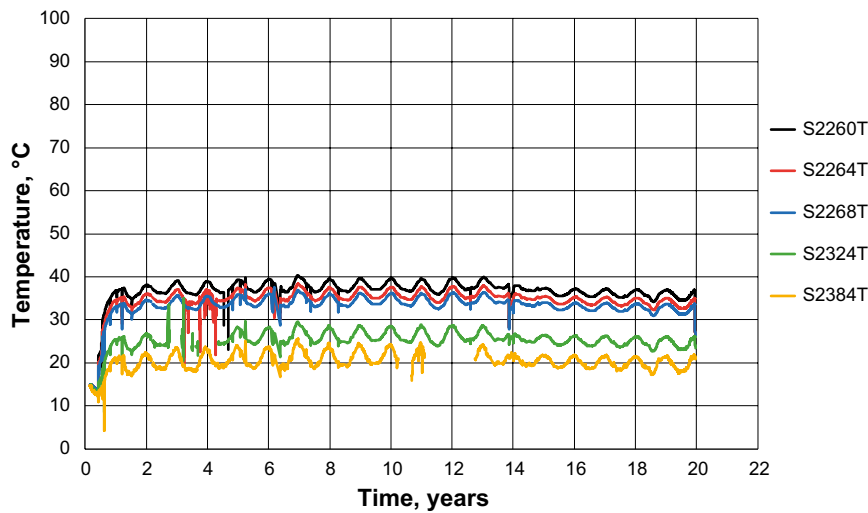
Figure 4-5. Registered temperature plotted versus time for five sensors positioned in test parcel S2, block 26, 32 and 38.

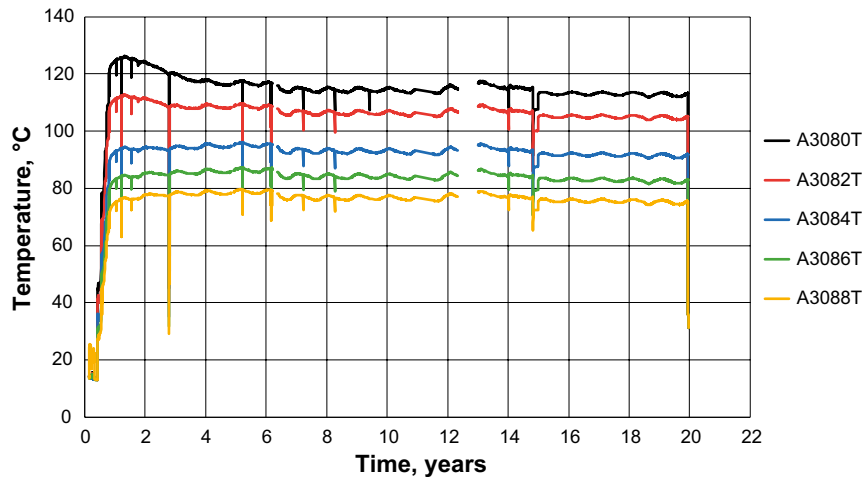
Figure 4-16. Registered temperature plotted versus time for five sensors positioned in test parcel A3, block 08.

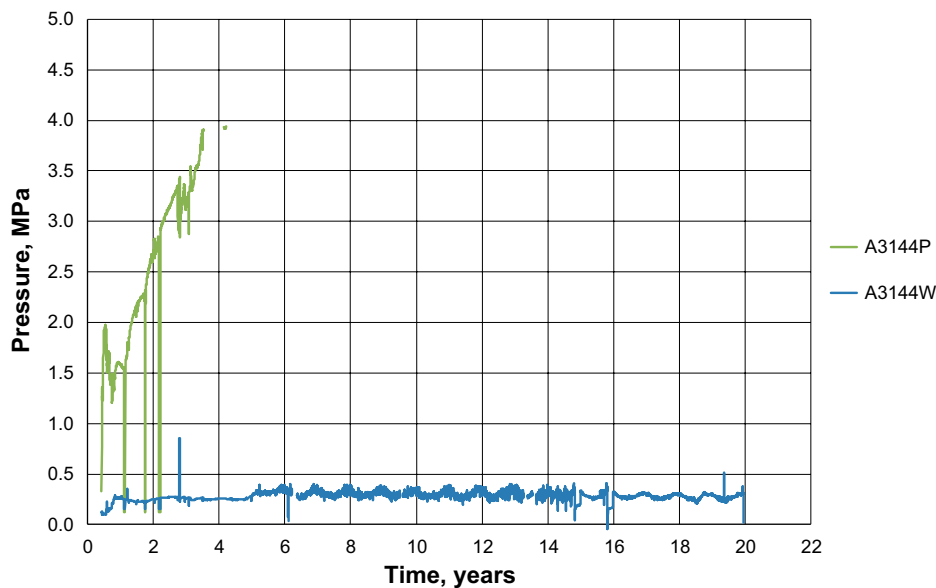
Figure 4-20. Registered total pressure (A3144P) and water pressure (A3144W) by the vibrating wire sensors and plotted versus time for the sensor positioned in test parcel A32, block 14.

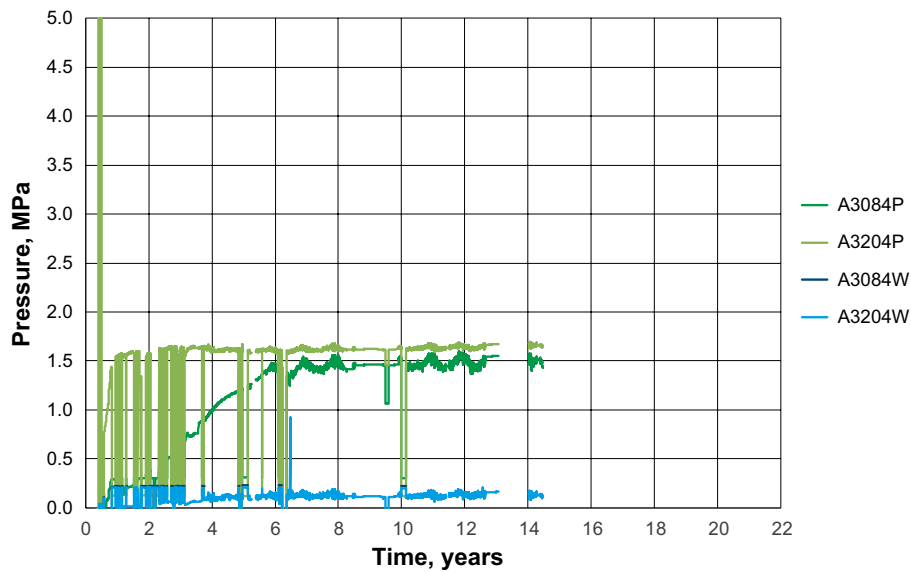
Figure 4-21. Registered total pressure (A3084P and A3204P) and water pressure (A3084W and A3204W) by the optical sensors and plotted versus time for the sensors positioned in test parcel A3, block 8 and 20.

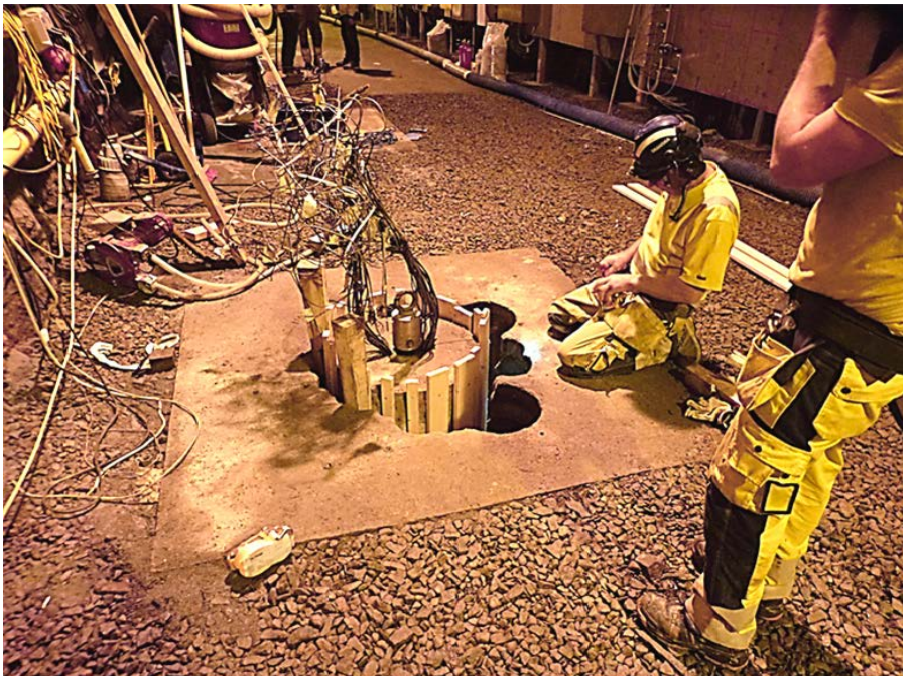
Figure 5-1. The released test parcel ready to lift (A3). Note the surrounding slot made by overlapping percussion drilled holes and the larger core drilled holes.

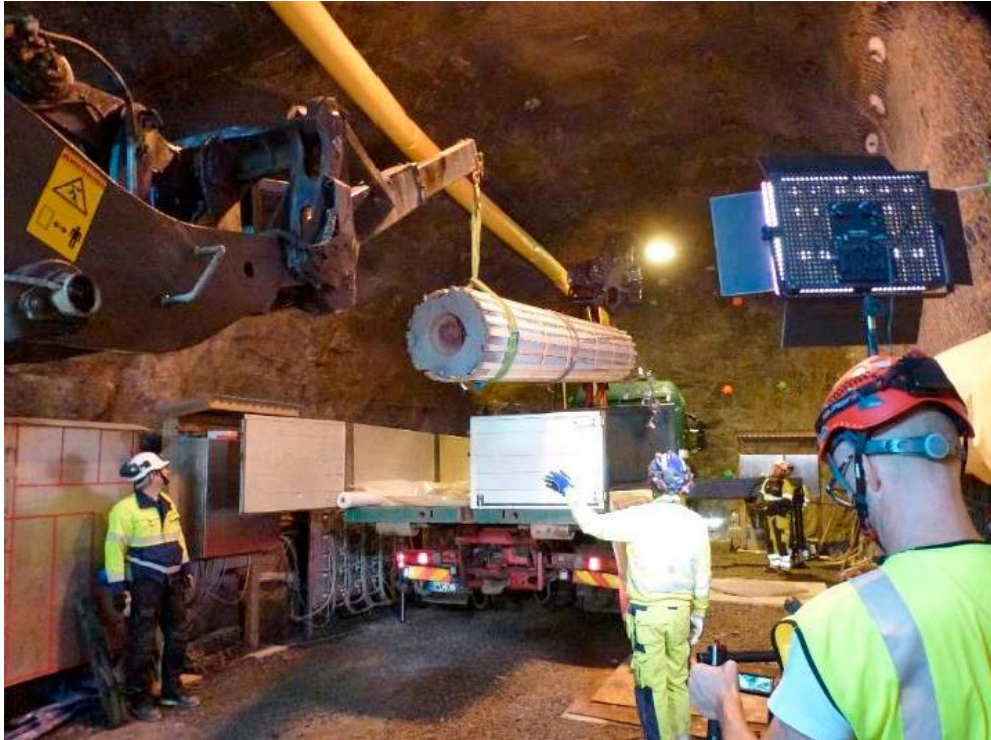
Figure 5-2. The entire test parcels, including rock-cover, were being placed on a lorry for transport to the ground surface.

The released test parcel including rock-cover was lifted by a crane lorry and transported to the ground surface and then further to the laboratory at Äspö, Figure 5-2. The total weight of the rock/bentonite parcel was about 4 500 kg, and the diameter was 650 to 700 mm. i.e. the rock cover of the test parcel was 150 to 200 mm.

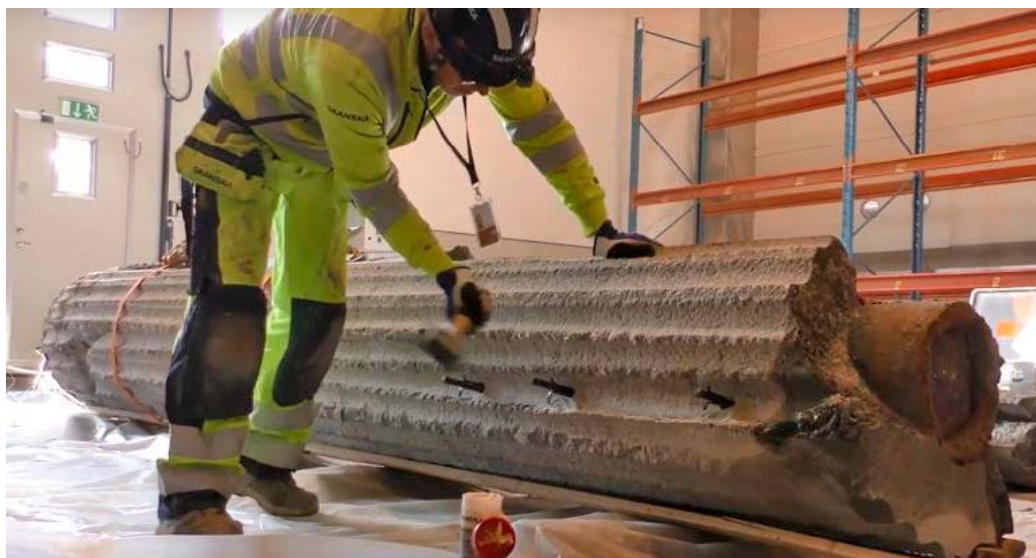
Figure 5-3. Photo showing the removal of the rock cover from the test parcels. Wedges were used to create fractures in the rock.

The covering rock was successively removed from the test parcels. Natural occurring fractures and weaknesses in the rock were used together with drilling and wedges to loosen rock pieces from the test parcels, Figure 5-3 and Figure 5-4. The approximate position of the original block interfaces was identified in the exposed bentonite by measuring the distance from the bottom plate but also by use of different tubes going in to defined positions. The north direction of the test parcel was checked and marked on the bentonite. The bentonite blocks were cut by using a saber saw, Figure 5-5 and Figure 5-6. To facilitate removal of the blocks from the central copper tube it was often necessary to also do a cut in the blocks along the test parcel. The removed blocks, often two or three together, were marked and temporarily placed in plastic bags to minimise the risk of drying.

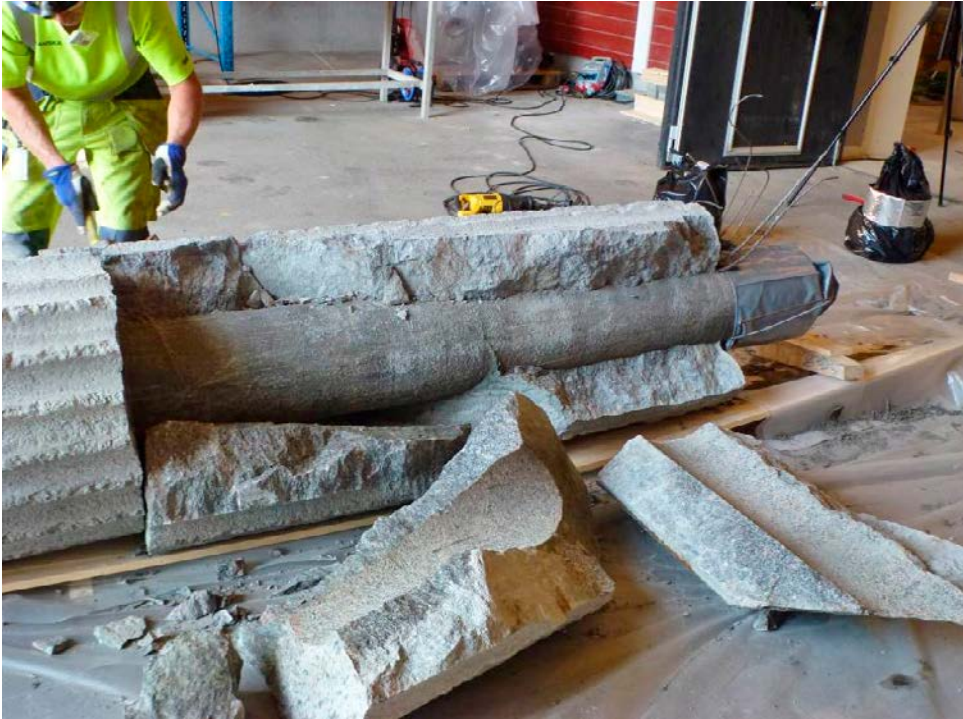
Figure 5-4. Large pieces of rock were removed from the test parcels.

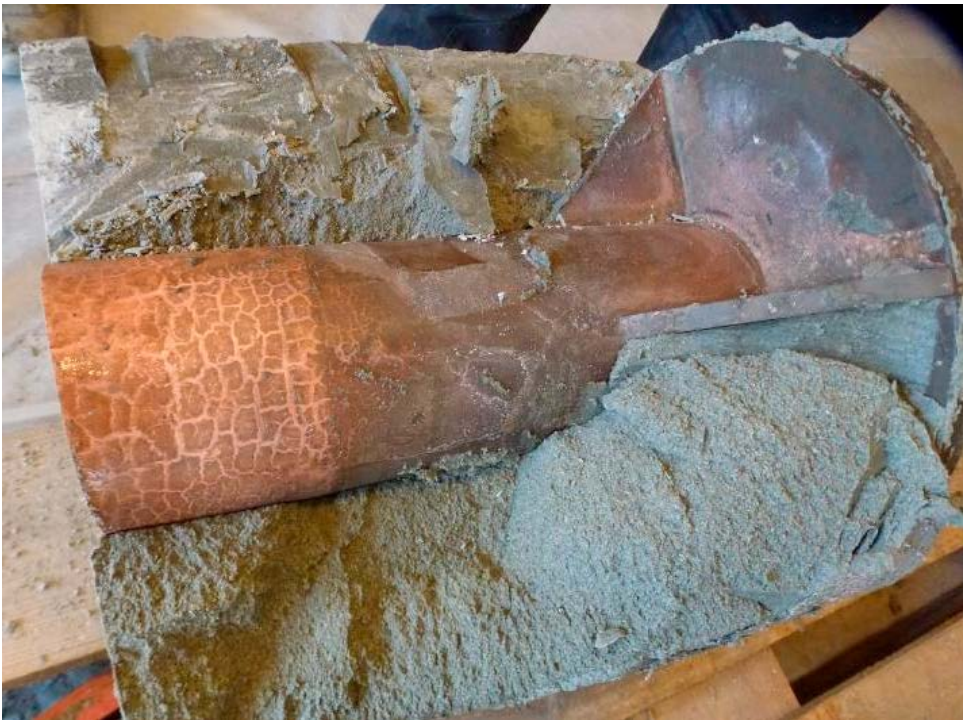
Figure 5-5. The bottom part of the central copper tube, including the bottom plate, was cut off together with three bentonite blocks (photo from test parcel S2).

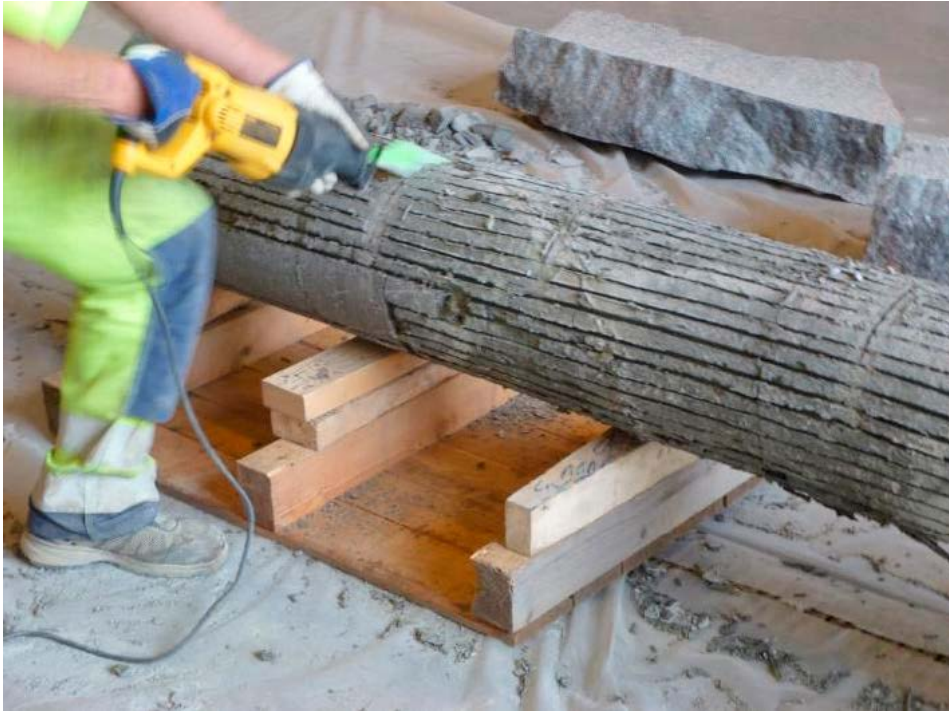
Figure 5-6. A saber saw was used to cut of blocks from the test parcel. The cuts were made approximately at the original block interfaces. The lines along the parcel that can be seen on the bentonite surface originate from thermocouples and other tubes that had been placed on the test parcel periphery (photo from test parcel A3).
