Technical Report

TR-22-05

Creep rate in Cu-OFP under applied electrochemical potential and presence of sulphide

Tiina Ikaläinen, Timo Saario, Zaiqing Que
VTT Technical Research Centre of Finland Ltd.

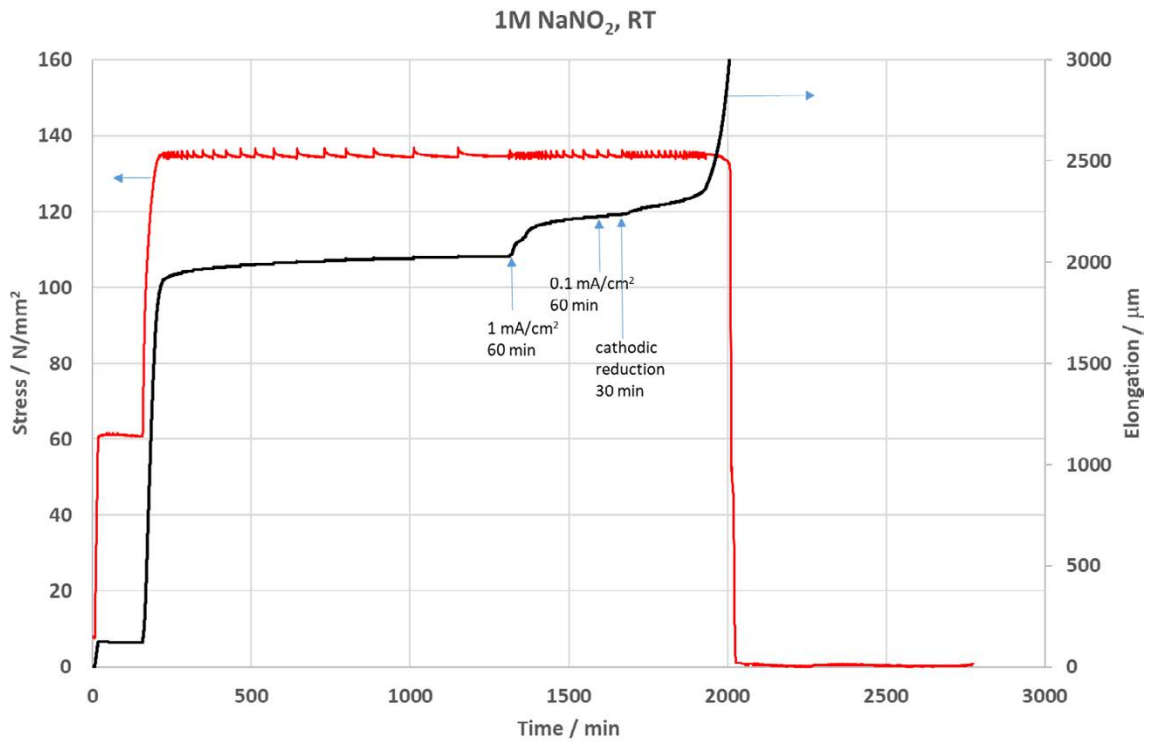
Figure 5-1. Stress (N/mm^2) and elongation (μm) as a function of time.

From the elongation vs. time curve it is clear that the first anodic polarization (to +1 mA/cm² for 60 minutes) produced a dramatic (transient) increase in the elongation rate. The second anodic polarization (to +0.1 mA/cm² for 60 minutes) had almost no effect, while the cathodic reduction (to -0.447 V_{SHE} for 30 minutes) resulted again in a clearly higher (transient) elongation rate. It is noteworthy that the total elongation when the polarisations were performed, about 2000 μ m, corresponds to a total strain of about 7 %, and the elongation at the end, where the specimen failed and the load dropped to zero, corresponds to a strain of less than 10 %. This is very low in comparison to the normal room temperature fracture strain of Cu-OFP, i.e. 40 to 50 % (Kinnunen and Varis 2011).

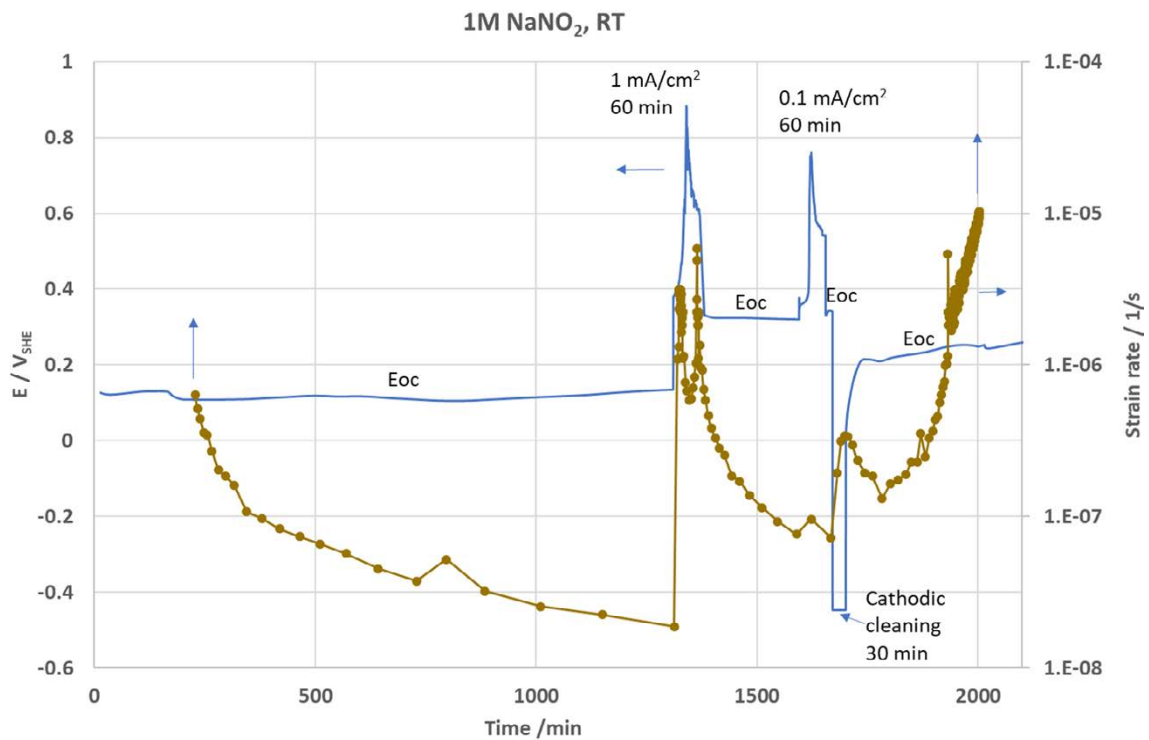
Figure 5-2. Potential (E vs. SHE) and strain rate ($1/s$) as a function of time.

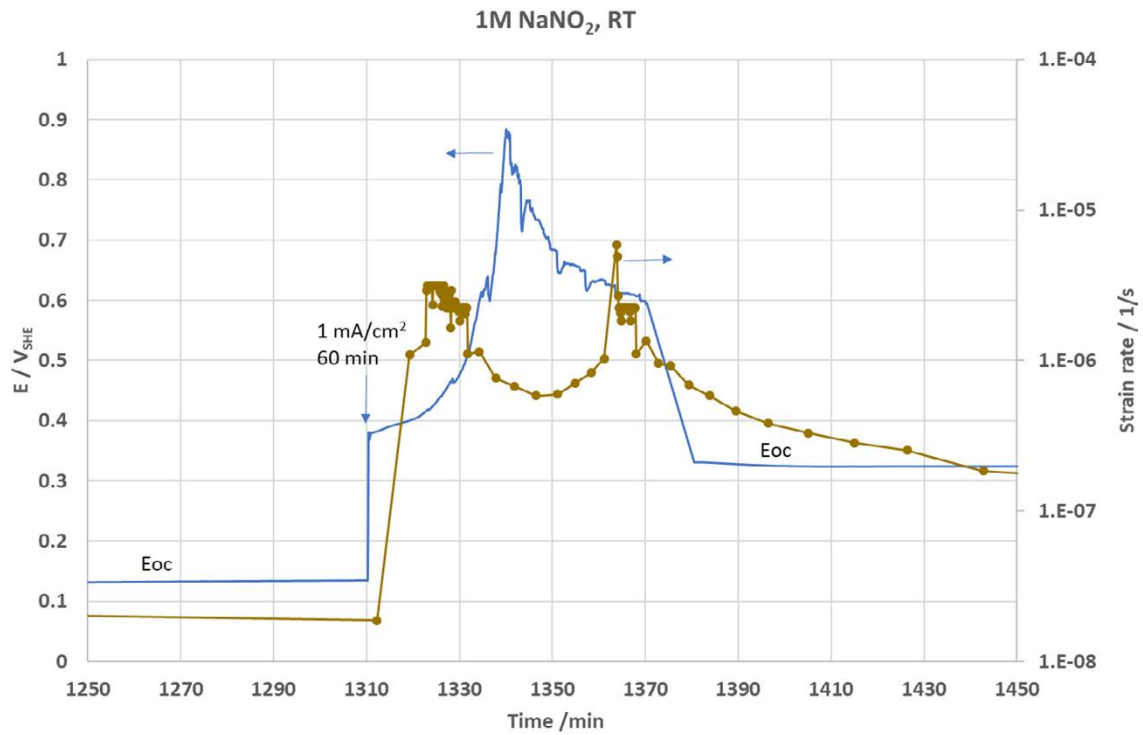
Figure 5-3. Potential (E vs. SHE) and strain rate ($1/s$) as a function of time during the anodic polarization to $i = +1 \text{ mA/cm}^2$ (detail of Figure 5-2).

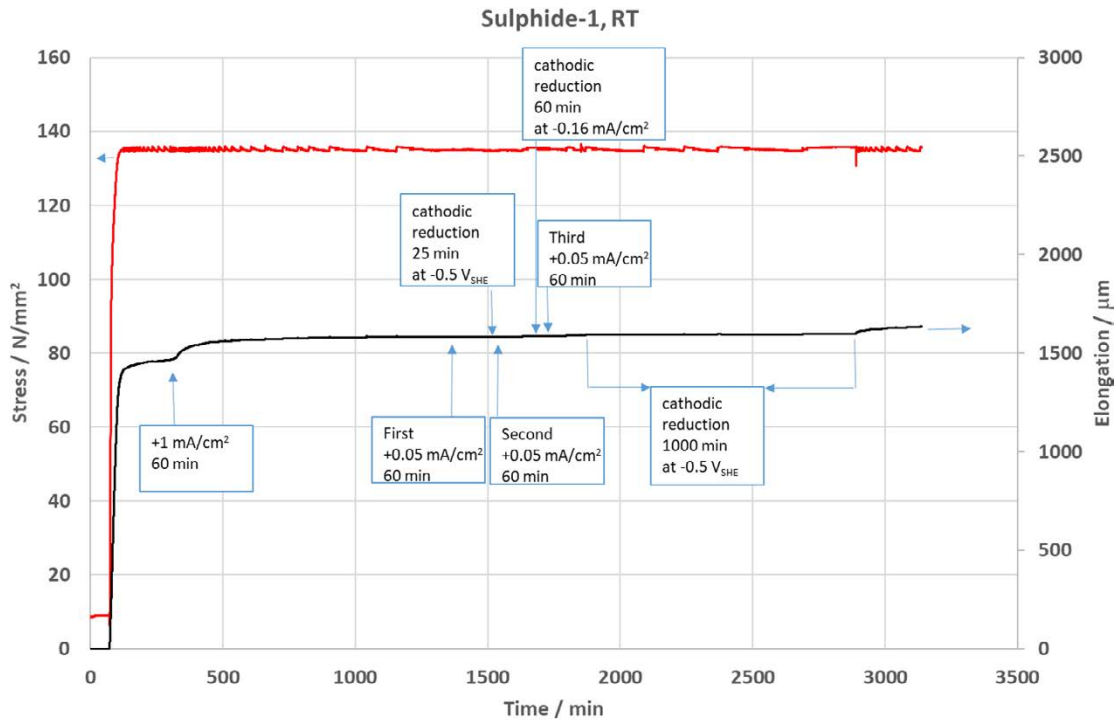
Figure 5-7. Stress (N/mm^2) and elongation (μm) as a function of time, Phase 1.

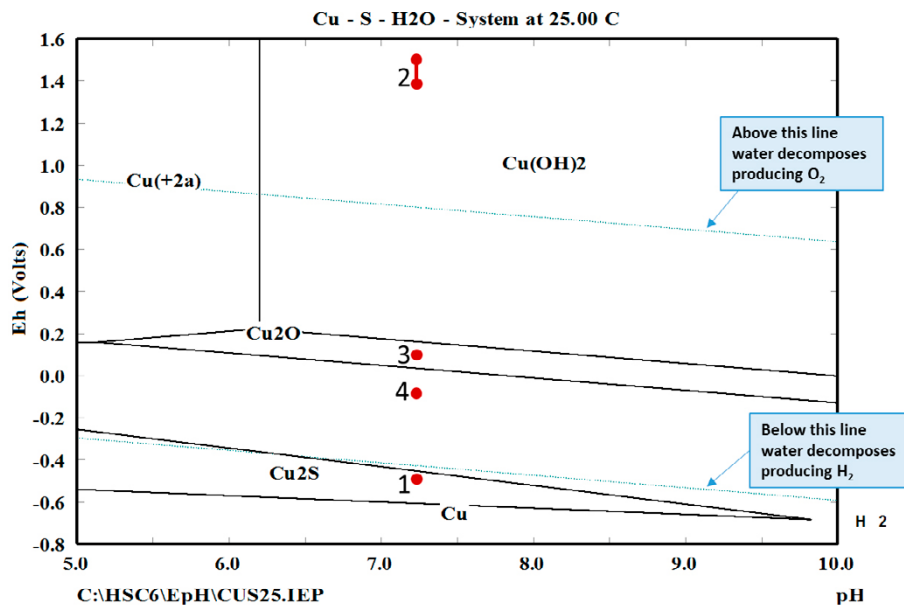
Figure 5-9. Pourbaix-diagram of the Cu-S-H₂O -system at $T = 25\text{ }^{\circ}\text{C}$ ($[\text{HS}^-] = 10^{-4}\text{ M}$, $[\text{Cu}] = 10^{-6}\text{ M}$). The red dots depict the following stages: 1) corrosion potential at the beginning, 2) potential during the anodic polarization to $+1\text{ mA/cm}^2$ for 60 minutes, 3) potential during polarization to $+0.05\text{ mA/cm}^2$ for 60 minutes and 4) corrosion potential at the end (after a cathodic polarization for 1 000 min to $-0.5\text{ V}_{\text{SHE}}$).

polarizations, it could be that the increase in the strain rate observed during the anodic polarization to 1 mA/cm^2 for 60 minutes is in fact related to the potential residing within the stability area of $\text{Cu}(\text{OH})_2$, in line with the hypothesis by Aaltonen et al. that anodic dissolution results in vacancies being injected into the material, thus causing increase in strain rate.

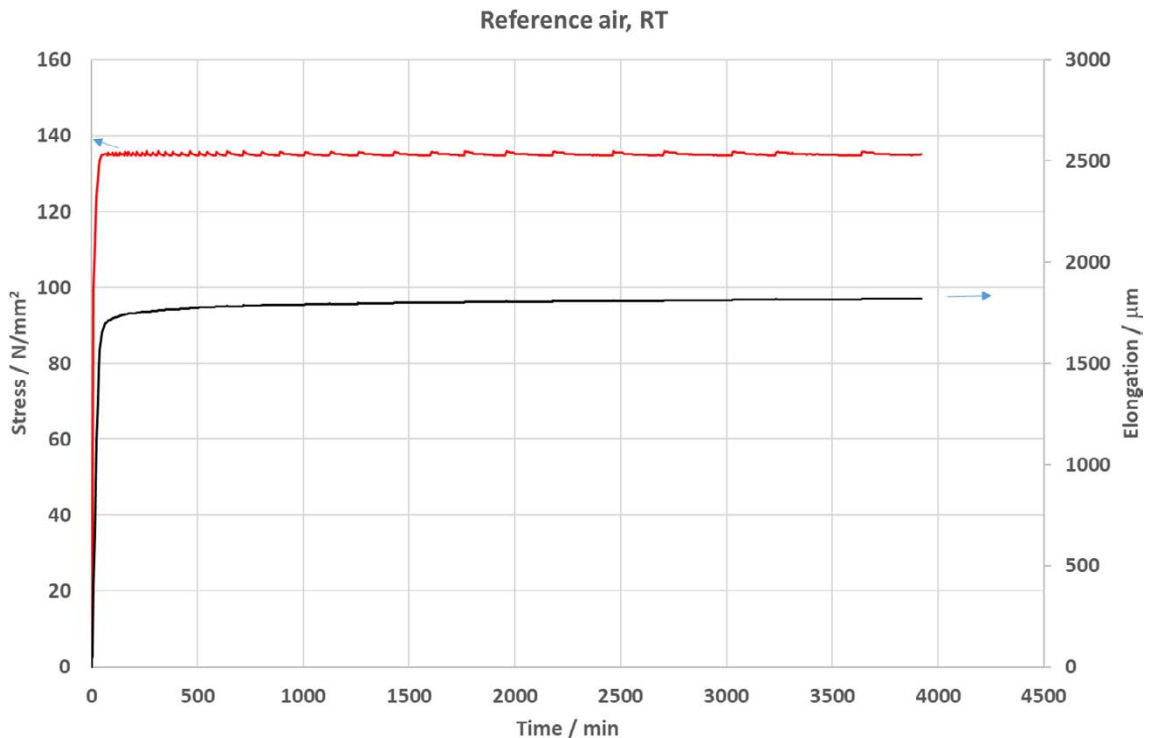
Figure 5-19. Stress (N/mm²) and elongation (µm) as a function of time, reference test in air with the specimen geometry shown in Figure 1.

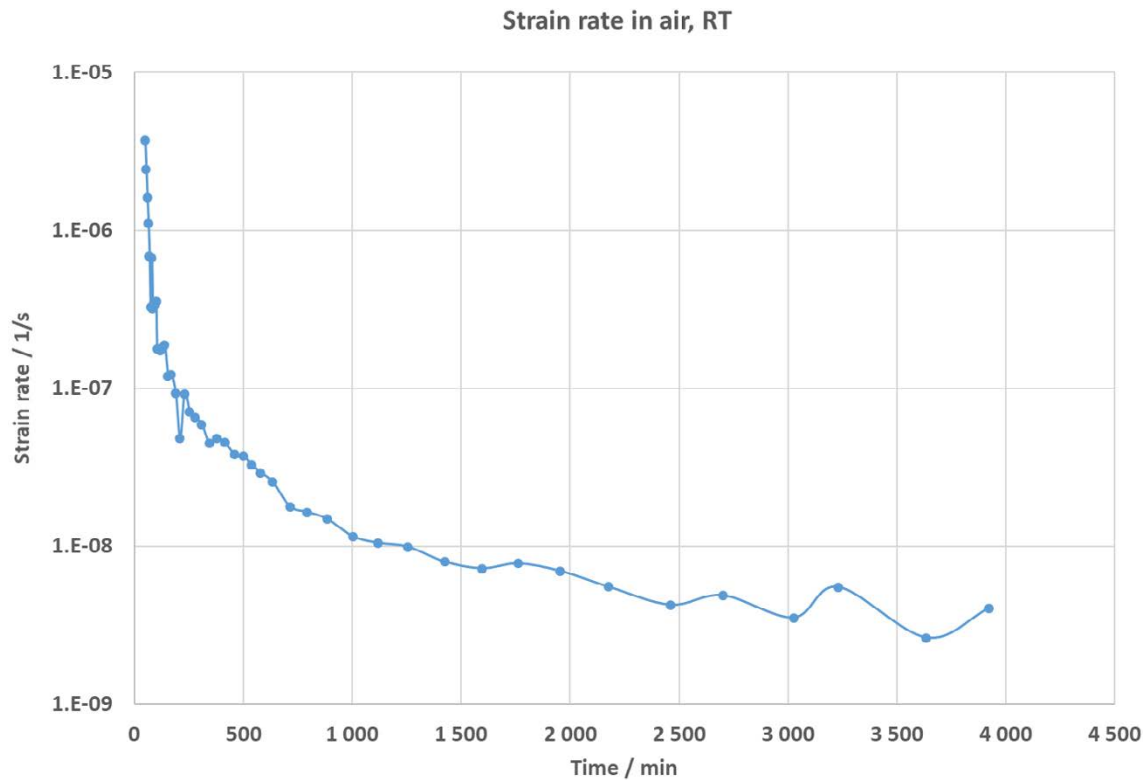
Figure 5-20. Strain rate (1/s) as a function of time, reference test in air with the specimen geometry shown in Figure 1.

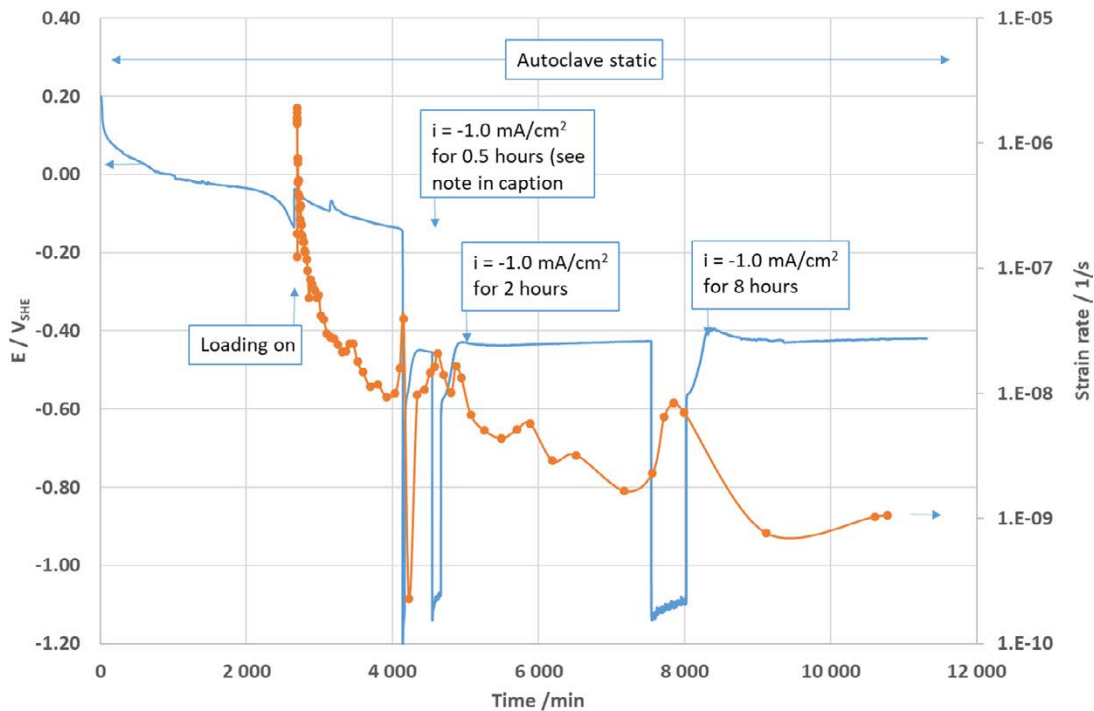
Figure 5-25. Strain rate (1/s, right axis, orange circles) and potential (V_{SHE} , left axis, blue line) as a function of time, Phase I. Note: anodic polarization to $+1.0 mA/cm^2$ was switched on for about one minute (by human error) just before starting the cathodic polarization.

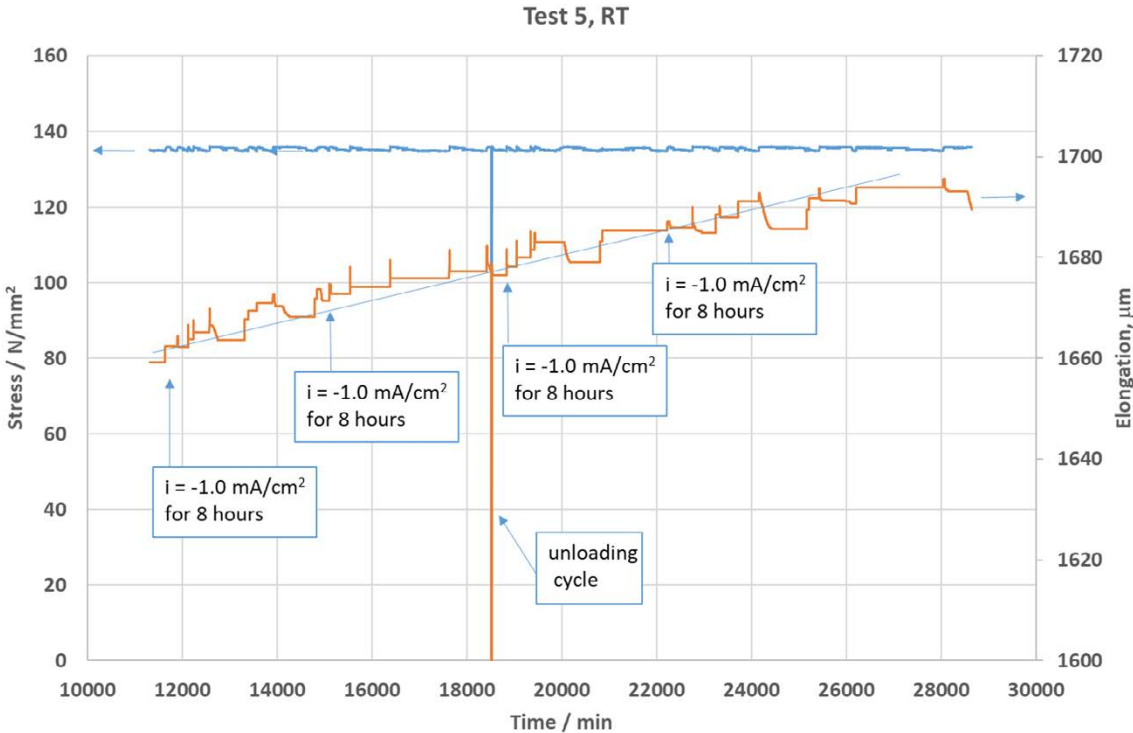
Figure 5-26. Stress (N/mm^2 , blue line) and elongation (μm , orange line) as a function of time, Phase 2.

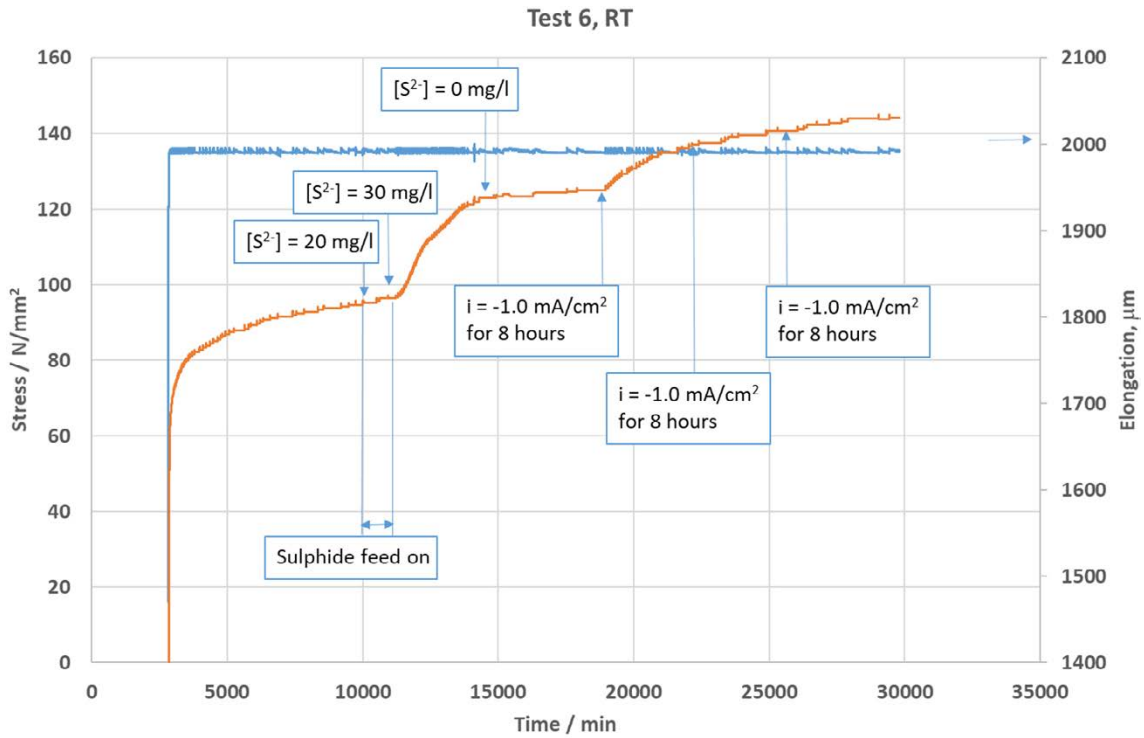
Figure 5-28. Stress (N/mm^2 , blue line, left axis) and elongation (μm , orange line, right axis) as a function of time.

In this test, the effect of sulphide feed and following three consecutive cathodic polarisations was studied, with a stabilisation period of about two days in between changes. Figure 5-28 shows the stress and elongation as a function of time and Figure 5-29 the potential and strain rate as a function of time. During the sulphide feed (about 25 mg/l, lasting for about 22 hours) the elongation rate followed the trend set previously, i.e. no change caused by the sulphide feed, Figure 5-28. However, about two hours after stopping the sulphide feed the elongation rate shows a marked (transient) increase, lasting for about 40 hours. The first cathodic polarisation (to a current density of -1 mA/cm^2 for 8 hours) at about $t = 19\,000 \text{ min}$ also resulted in a marked increase in the elongation rate, whereas the two following similar cathodic polarisation caused no appreciable change in the elongation rate, Figure 5-28.

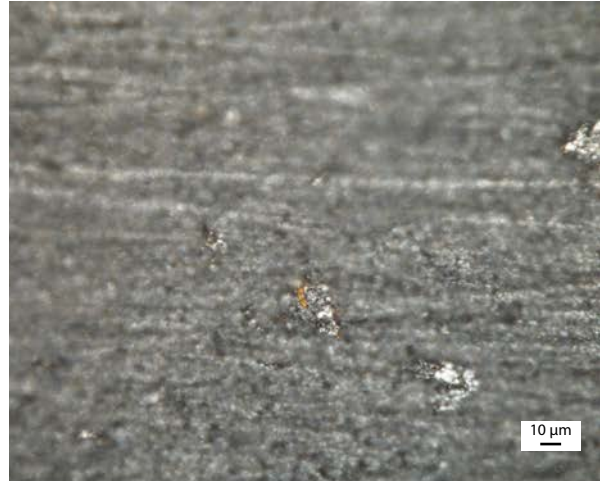
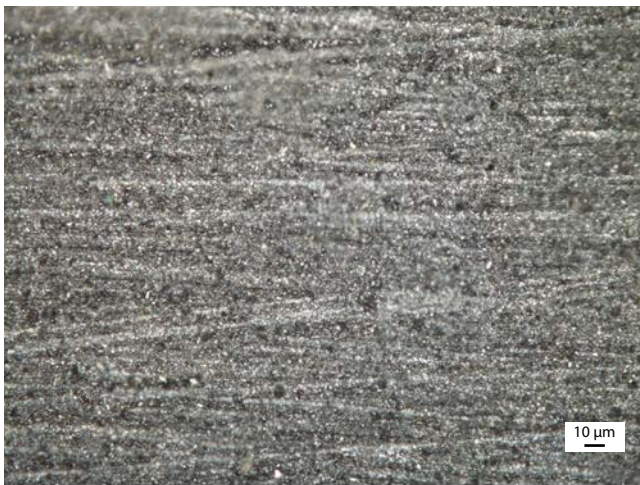
Figure 5-43. Stereo microscope images of the sample surface after testing in environment. In addition to grinding and polishing markings (1200 grit SiC), some crater/pit-like features can be observed.

After testing in a sulphide-containing environment, the specimen was covered in a grey deposit/scale, see Figure 5-43. Nonetheless, there seems to be possibly some indication of craters/pit-like features on the sample surface (see Figure 5-43(b)). In addition, the grinding and polishing markings are still somewhat visible. Grinding/polishing markings are present primarily lengthwise in the gauge length (i.e. parallel to the loading direction). This sample surface was also observed by scanning electron microscopy, Figure 5-44 and Figure 5-45. The surface is covered in a homogeneous layer of crystallites ranging from approximately several hundreds of nanometres to 1–2 μm , Figure 5-45. These crystallites were identified by semi-quantitative SEM energy-dispersive X-ray spectroscopy (SEM-EDS) as likely Cu_2S crystallites, see Figure 5-46. Moreover, the morphology of these crystallites is in agreement with what is reported in the literature for Cu_2S (see Chen et al. 2017).

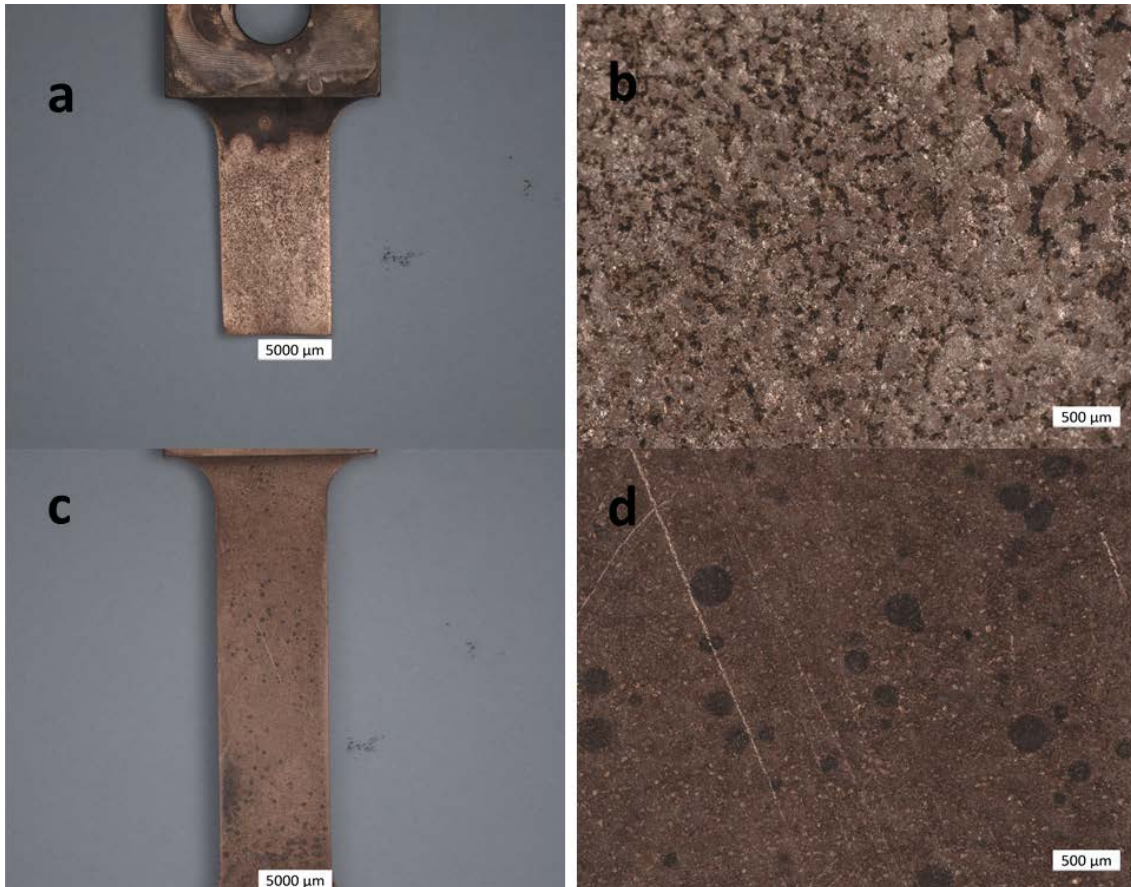
Figure 5-72. Stereo pictures of samples from experiment 3 (a and b) and experiment 6 (c and d) after the sulphide film removal.
