The corrosion rate of copper in a bentonite test package measured with electric resistance sensors

December 2012

Svensk Kärnbränslehantering AB

SKB R-13-15

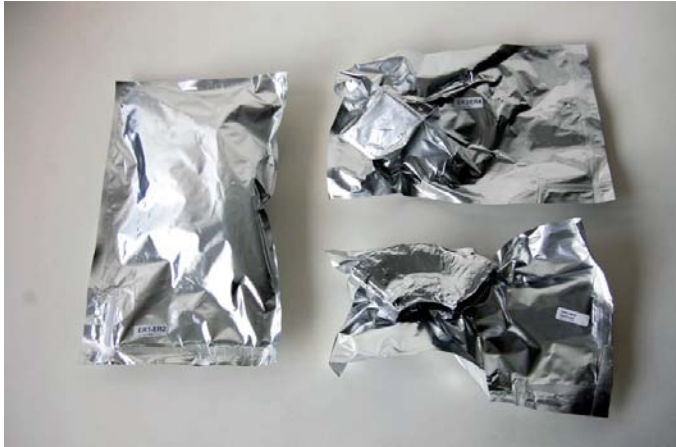
Figure 3-8. Evacuated tri-laminate bags with the two sensor pairs (and another bentonite piece).

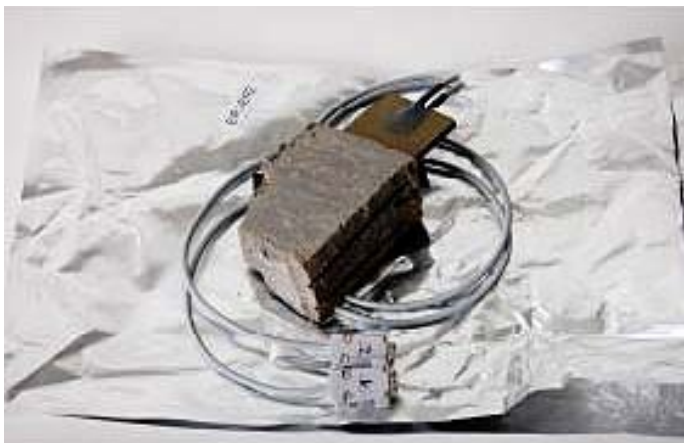
Figure 3-9. Photo of sensor pair ER1/ER2 on top of its tri-laminate bag.

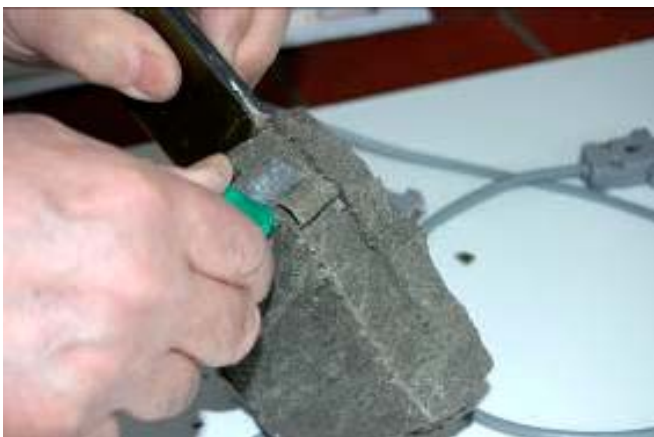
Figure 3-11. Removing bentonite by knife to make one side of the resin plate visible (cut 1).

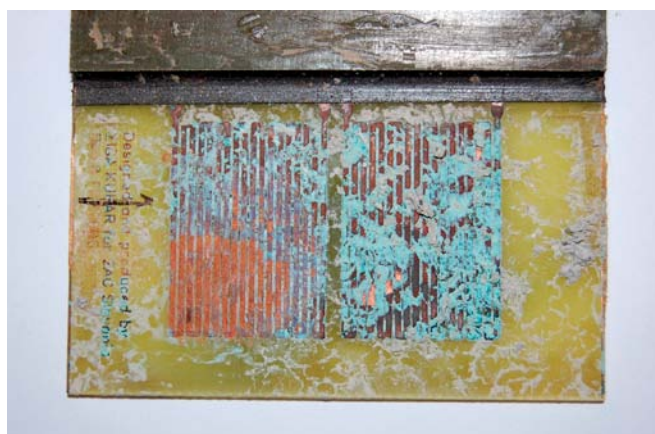
Figure 4-2. The appearance of sensor ER1 after removal of corrosion products from part of the left sensor element (the brownish area).

On removing the bentonite from the sensor pair ER1/ER2, it was obvious from the colours of the corrosion products on the sensors that both Cu(I) and Cu(II) corrosion products had been formed during the exposure, Figure 4-2. The XRD measurements verified the presence of cuprite, Cu_2O , and paratacamite, $\text{Cu}_2(\text{OH})_3\text{Cl}$, as shown for a sample analysis in Figure 4-3. This finding is consistent with analyses on copper coupons in the LOT test parcel A2 (Karnland et al. 2009). As observed on the coupons the blue-green corrosion products were loosely attached to the copper surface on the ER sensors.

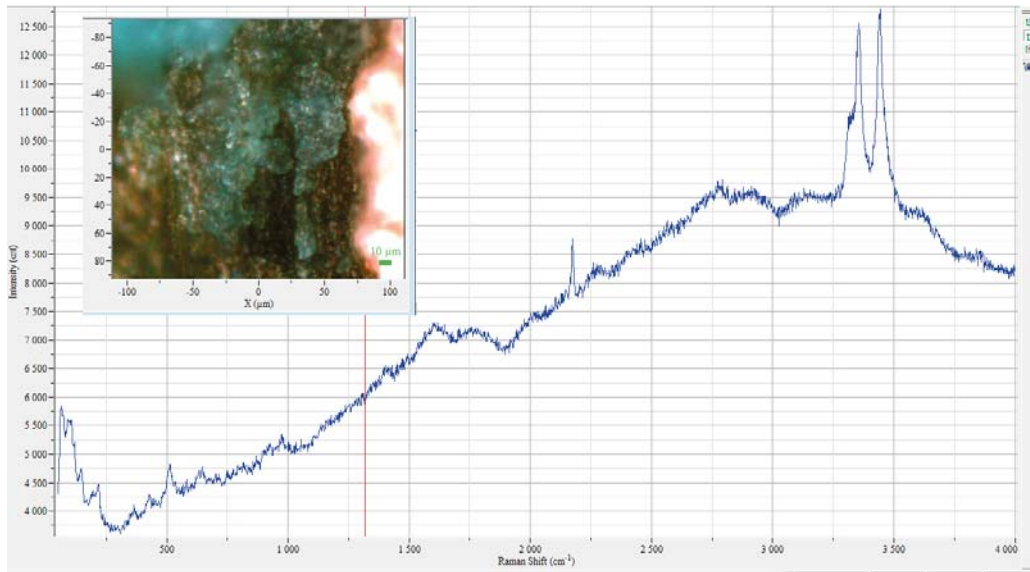
Figure 4-4. A representative Raman spectrum recorded on the blue-green corrosion products on sensor ER2 seen in the inset.

Raman spectroscopy on corrosion products still in place on sensor ER2 confirmed these findings, as exemplified by the spectrum shown in Figure 4-4. The band positioned at 508 cm^{-1} , the broad band at $897\text{--}971\text{ cm}^{-1}$, and the bands at $3,358$ and $3,437\text{ cm}^{-1}$ indicate the presence of paratacamite. (The high intensity of the Raman spectrum in the measured region is due to fluorescence from bentonite.)

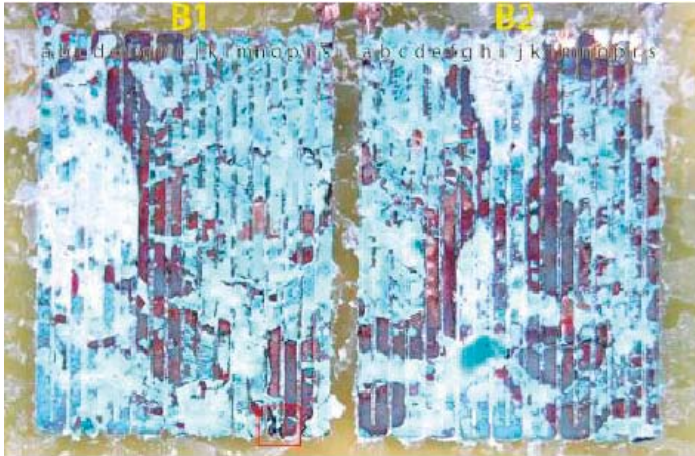
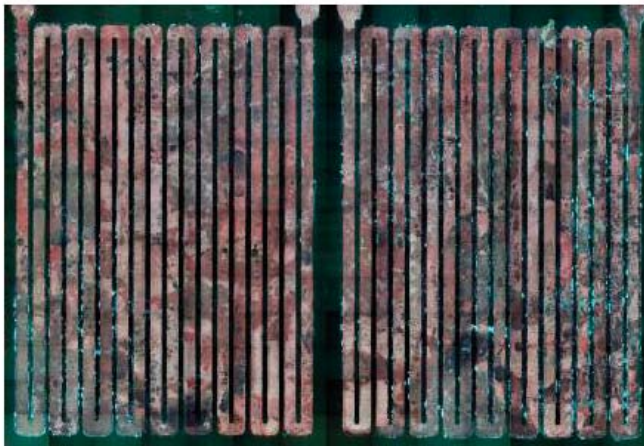
Figure 4-5. Appearance of sensor ER2 (top) after removal of the adjacent bentonite piece and (bottom) after the first ultrasonic cleaning in 10% sulphuric acid solution.

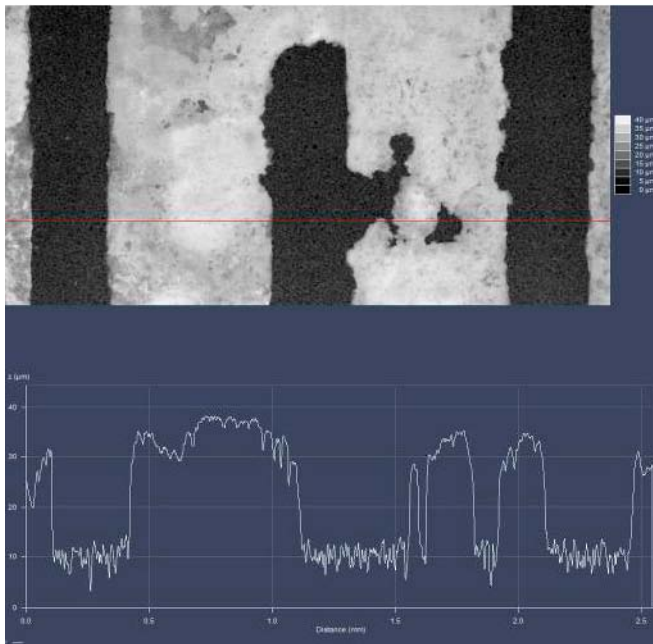
Figure 4-8. Example of a local penetration of the electric lead in sensor ER2. The bottom picture shows the profile of the sensor lead in the top picture along the red line.
