Detailed description of TRUE Block Scale Structure #20 based on intercepts in boreholes and intercepts in the TASS tunnel

September 2013

Svensk Kärnbränslehantering AB
Swedish Nuclear Fuel
and Waste Management Co
Box 250, SE-101 24 Stockholm
Phone +46 8 459 84 00

SKB R-12-09

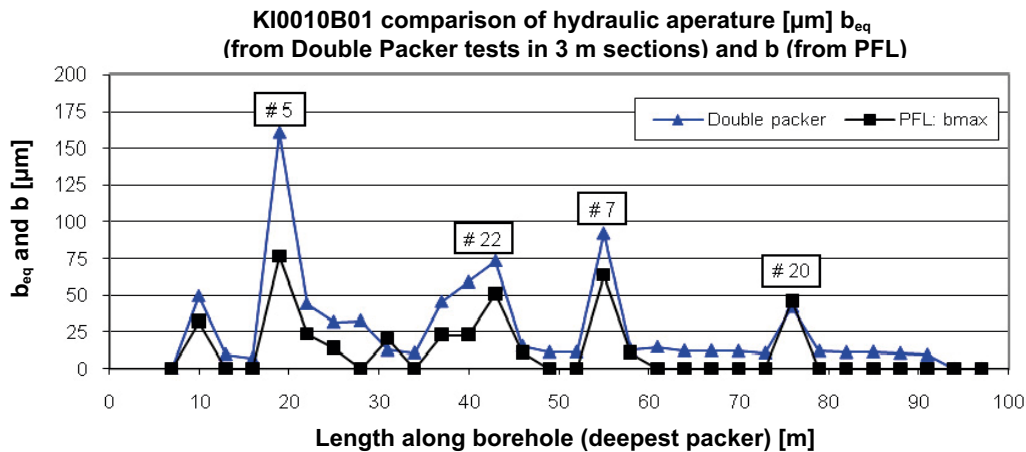
Figure 3-1. Comparison for KI0010B01 between the largest aperture (b) from the PFL within each 3m section and the equivalent aperture b_{eq} obtained from double packer flow logging, from Hardenby et al. (2008).

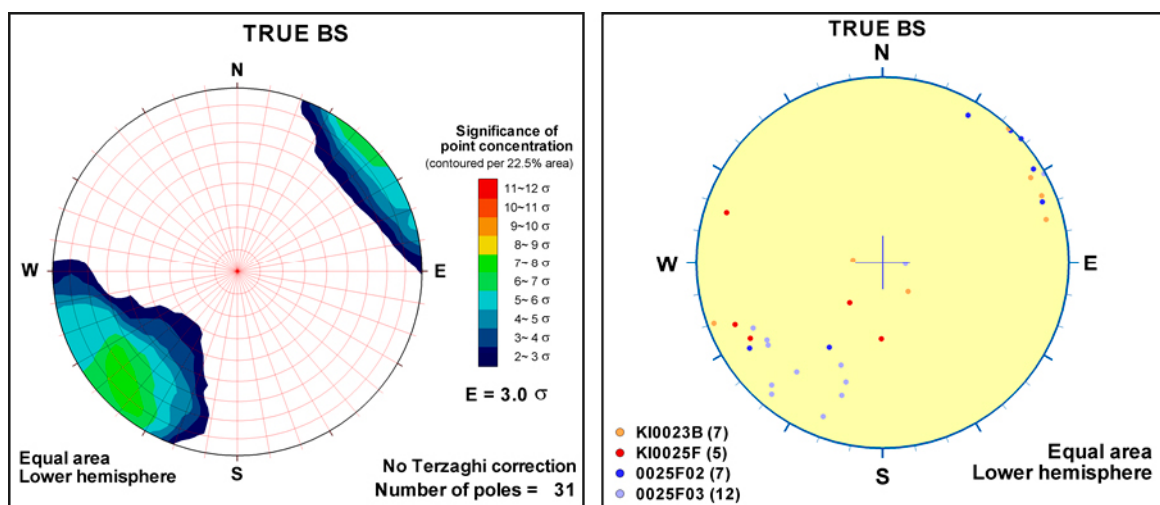
Figure 4-3. Orientations of fractures inside of or near ($\sim \pm 2 m$) the interpreted intercepts of Structure #20 with TRUE Block Scale boreholes. All fracture orientations are in Åspö96 coordinates.

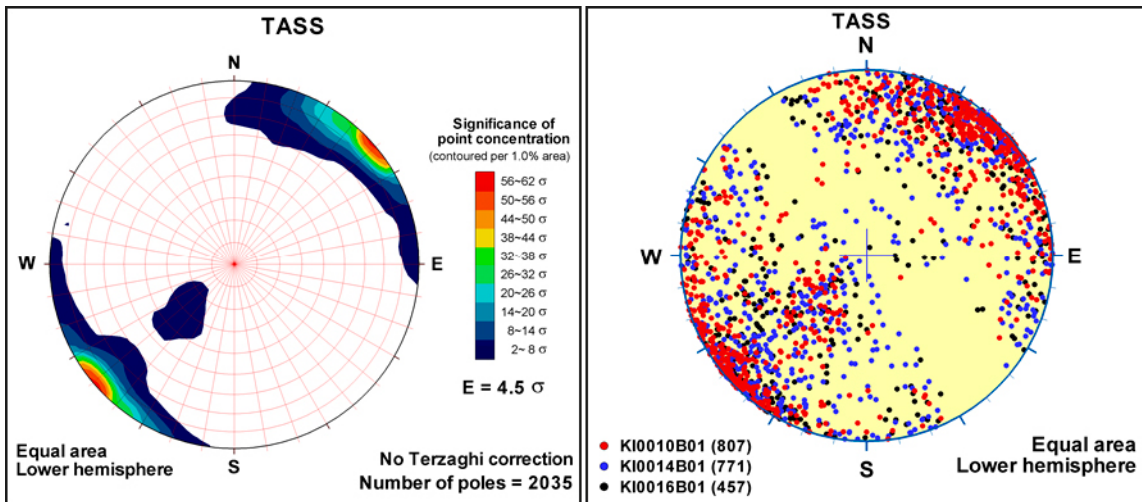
Figure 4-5. Orientations of all fractures recorded in TASS pilot boreholes, presented as a Kamb-contoured stereonet (left) and a pole plot coloured by borehole name. All fracture orientations are in \ddot{A} sp \ddot{o} 96 coordinates.

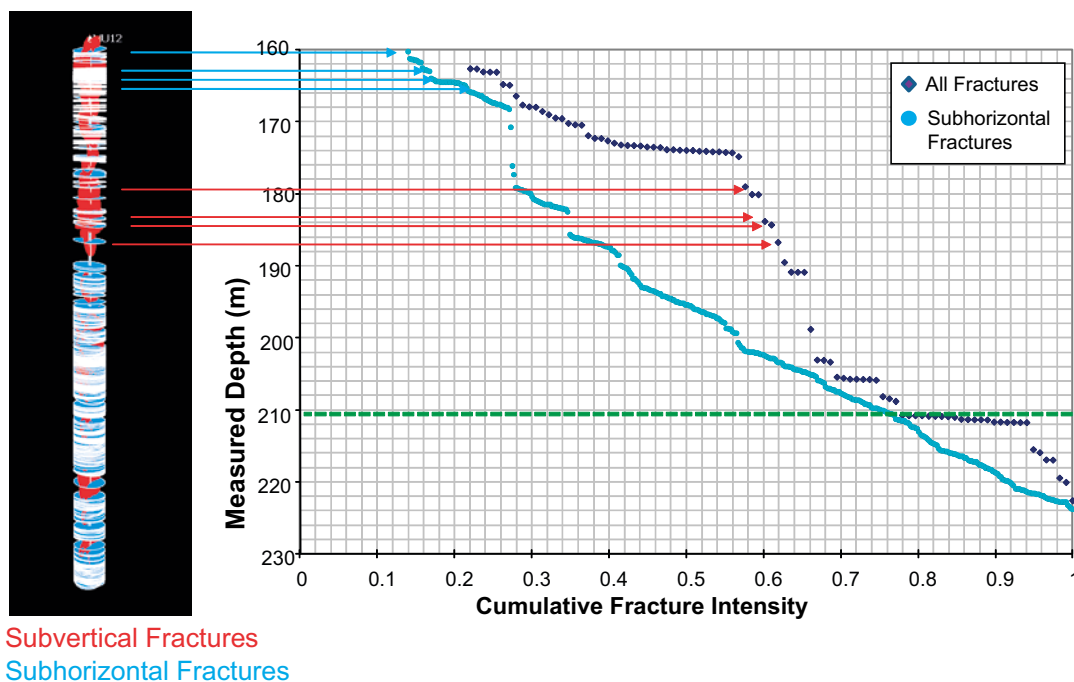
Figure 4-8. Example of cumulative fracture intensity (CFI) plot.

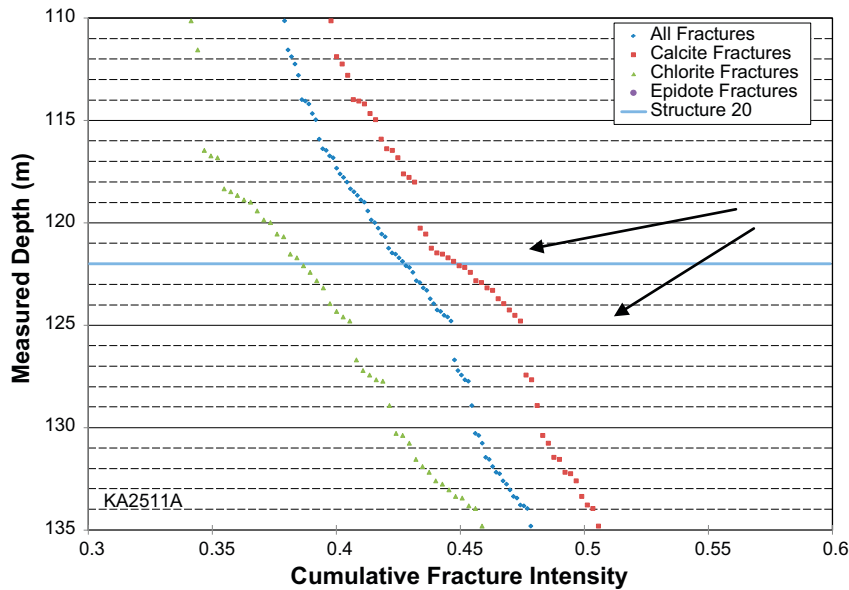
Figure 4-9. CFI plot of fracture intensity in TRUE Block Scale borehole KA2511A, classified by fracture mineralogy. The horizontal line represents the approximate midpoint of Structure #20 in the borehole, as interpreted during the TRUE Block Scale project (Andersson et al. 2002a).

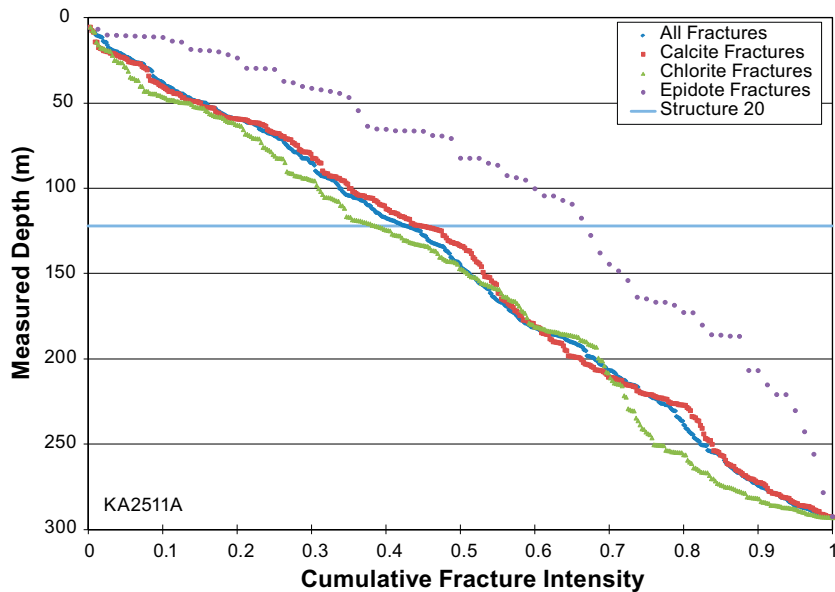
Figure 4-10. Close up of the Structure #20 intercept with KA2511A. Note the spike (black arrows) in the All Fractures cumulative intensity, and in the intensity of calcite-mineralized fractures. No change in the intensity of chlorite-mineralized fractures is noted, suggesting a lack of association at this particular hole. There is also no association with epidote.

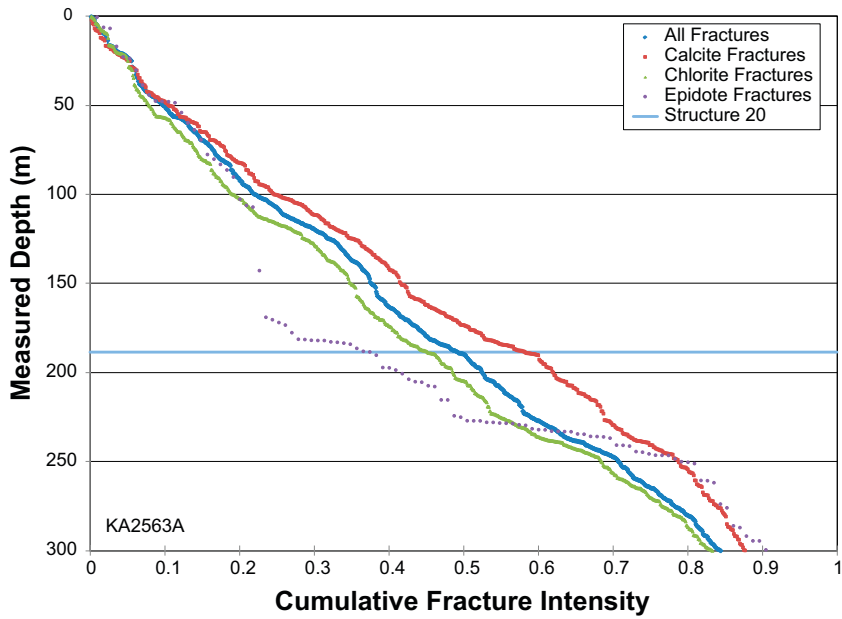
Figure 4-11. CFI plot of fracture intensity in borehole KA2563A. The horizontal line represents the approximate midpoint of Structure #20 in the borehole, as interpreted during the TRUE Block Scale project (Andersson et al. 2002a). Note the strong association of an increase in fractures containing epidote with Structure #20.

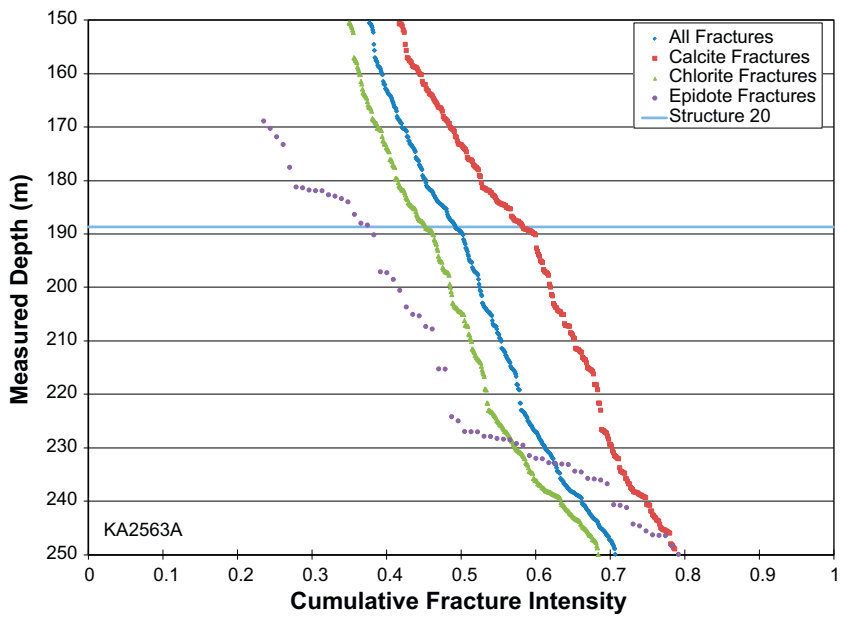
Figure 4-12. Close up of the KA2563A intercept with Structure #20. The increase in epidote-filled fractures occur several metres away from the start of Structure #20. The same relationship (several subparallel epidote-filled fractures) is seen in the TASS tunnel (Chapter 5). Structure #20 sits near the 'base' of a wider interval (~ 10m thick in measure distance along the borehole) of more intense fracturing; whether this represents distal deformation effects from Structure #20, or the activity of some other process in the host rock is not known.

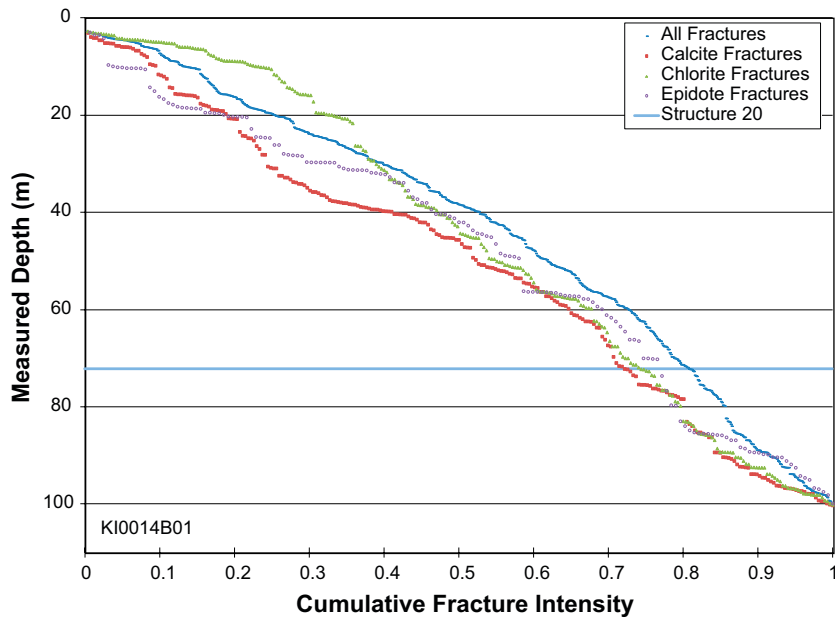
Figure 4-13. CFI plot of fracture intensity in TASS pilot borehole KI0014B01. Any increase in total fracture intensity is undetectable in terms of total fracture intensity, but can be seen in terms of the intensity of calcite- and chlorite-filled fractures.

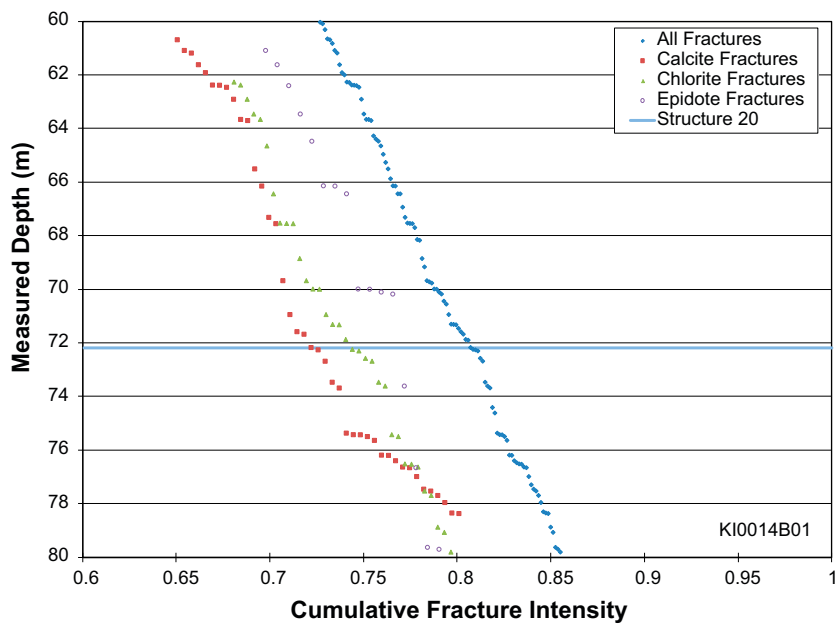
Figure 4-14. Close up of the Structure #20 intersect with KI0014B01. There is a small spike in the intensity of both calcite- and chlorite-filled fractures near Structure #20, but neither is significant enough to be diagnostic. Note again the presence of the epidote-filled cluster of fractures close to Structure #20.

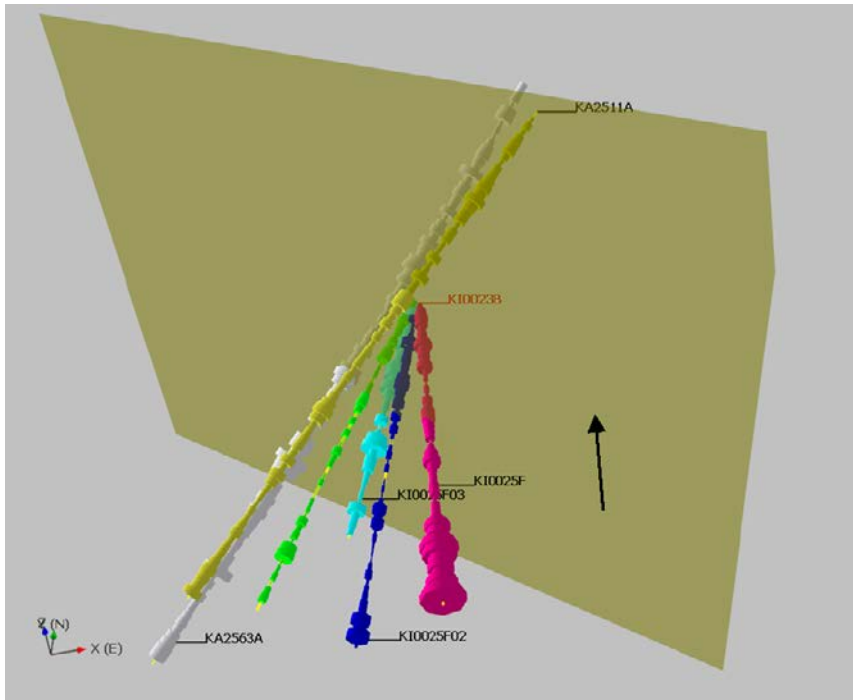
Figure 4-15. Visualization of existing Structure #20 intercepts within TRUE Block Scale boreholes. Borehole radius is sized by total fracture linear intensity P_{10} (open and sealed combined). Transparent polygon (black arrow) is the interpreted Structure #20 from the TRUE Block Scale project (Andersson et al. 2002a). Note that though Structure #20 generally intersects zones of higher fracture intensity, they are not the highest recorded intensities in the hole.

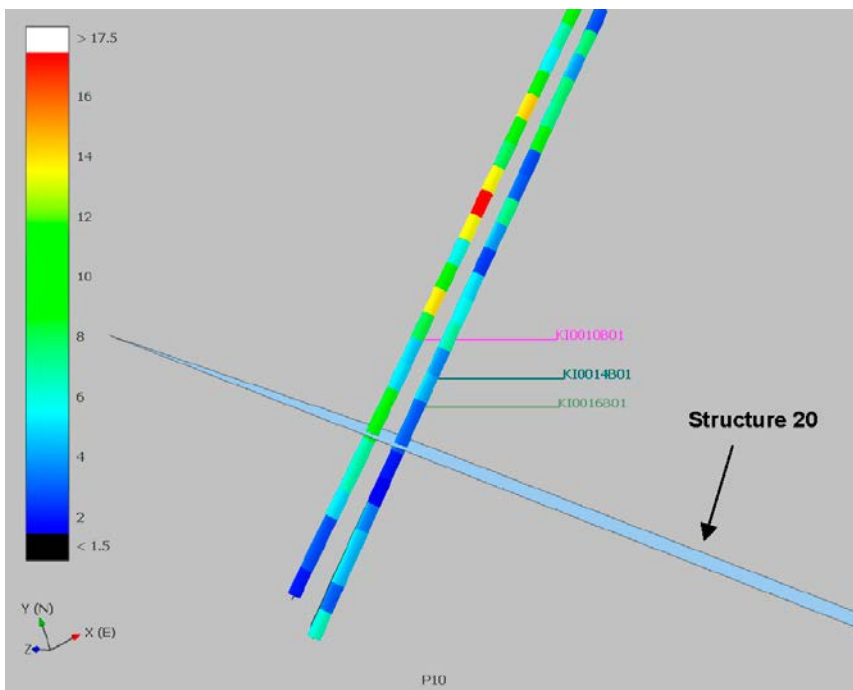
Figure 4-16. Visualization of existing Structure #20 intercepts within the TASS pilot boreholes. Borehole radius is coloured by total fracture linear intensity P_{10} (open and sealed combined).

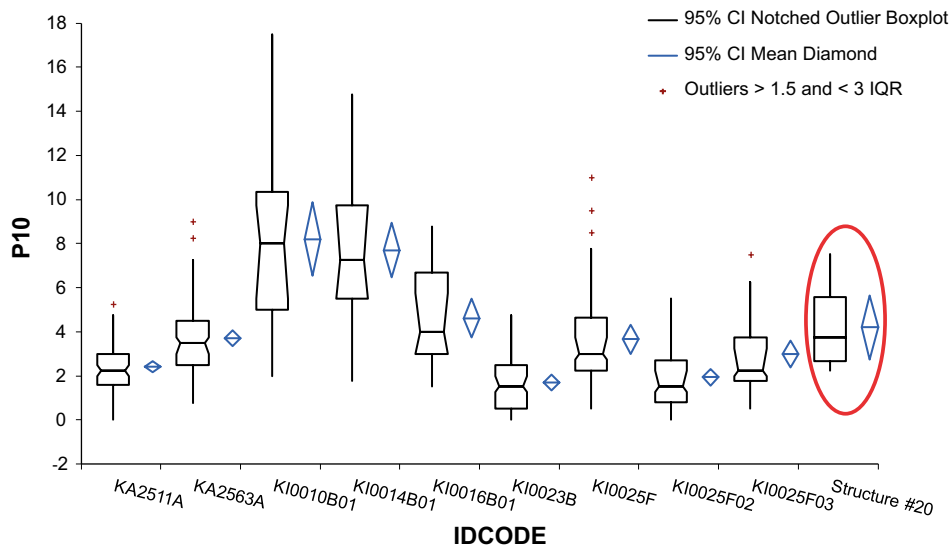
Figure 4-17. Box and whisker plot of total linear fracture intensity P_{10} (m^{-1}) as a function of borehole. Note that, on average, the Structure #20 intercept (red circle) has higher fracture intensity than the mean fracture intensity in the TRUE Block Scale boreholes, but is below the average fracture intensity of the TASS pilot boreholes.

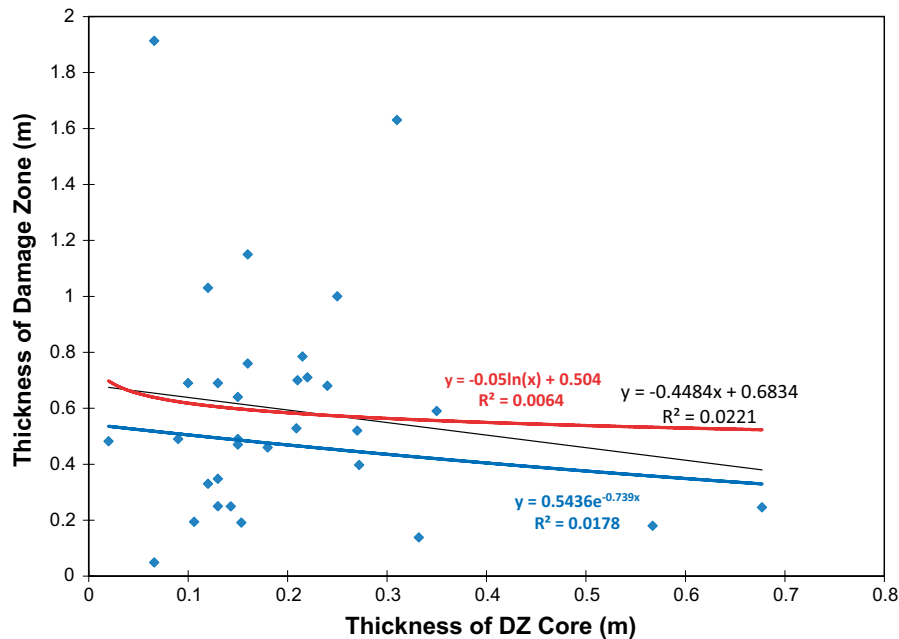
Figure 4-42. Scatterplot of zone core thickness versus damage zone thickness with correlation functions (exponential, logarithmic, and linear) fit to the data. Notice that the correlation coefficient (R^2) is poor for all fits.

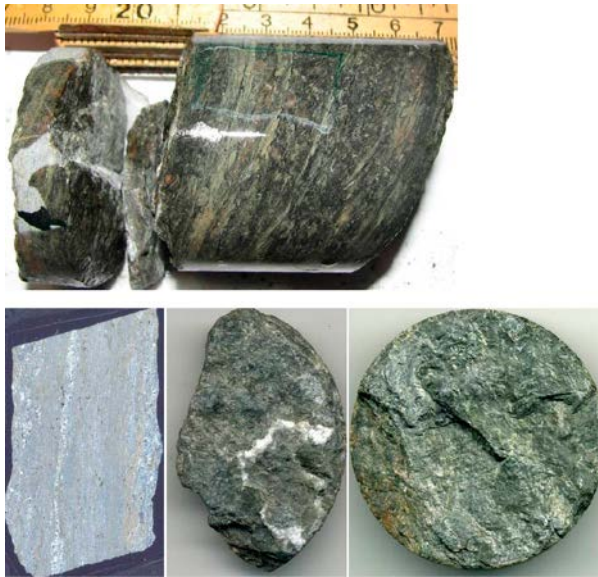
Figure 4-43. Top: Photograph showing the sample KI0010B01: 75.35–75.42 m. Bottom left: Scanned thin section, with crossed polars. Bottom right: Photographs of the fracture surface samples from KI0010B01 (1, left; 2, right).

From this sample one thin section and two fracture surface samples were analysed (Figure 4-43). Detailed images of these samples are shown in Figure 4-47 through Figure 4-50.

General feature: Mylonite exists in the core of the deformation zone; this very fine-grained mylonite consists of numerous parallel shear bands. The main kinematic indicator suggests sinistral motion, shown by C-S fabric with more epidote-rich S-bands in the quartz-rich matrix and by σ -type porphyroblasts/mantled porphyroclasts of K-feldspar and quartz, also with stair-stepping. C-S fabric is a micro-fabric developed in shear zones: S surfaces are generally defined by a planar fabric caused by the alignment of micas or platy minerals, C surfaces are formed parallel to the shear zone boundary: the orientation of the S surfaces in relation to the C surfaces indicates the shear sense [the C-S fabric]). The mylonite is totally dominated by epidote and quartz. Minor minerals are muscovite, biotite, plagioclase, K-feldspar, pyrite, magnetite, titanite. Especially quartz and feldspar show signs of dynamic re-crystallisation, such as sub-grain formation and sub-grain rotation re-crystallisation.

Calcite is present in one part as a layer, which is a remnant of a sealed fracture filling, also including abundant cubic fluorite. Chlorite/clay minerals cover the outermost part of this layer. The clay mineral content is indicated by Ca and K contents in the EDS-analyses (indicating e.g. in-mixed smectite [e.g. saponite which holds Ca], or corrensite which holds both Ca and K). When calcite is the uppermost surface, it shows highly dissolved texture. Pyrite and quartz are also observed (as well as some Fe-oxides). The layer underneath the calcite-fluorite-layer is mainly dominated by chlorite (possibly including clay minerals), and shows striations and abundant pyrite crystals.

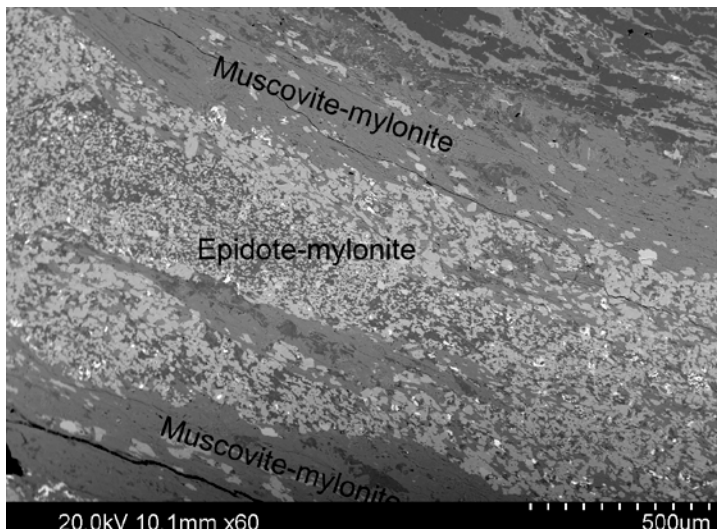
Figure 4-52. Back-scattered SEM-image showing parallel mylonite-bands either dominated by epidote or by muscovite. Uppermost part is quartz-dominated (darker mineral). Sample KI0014B01: 72.16–72.28 m.

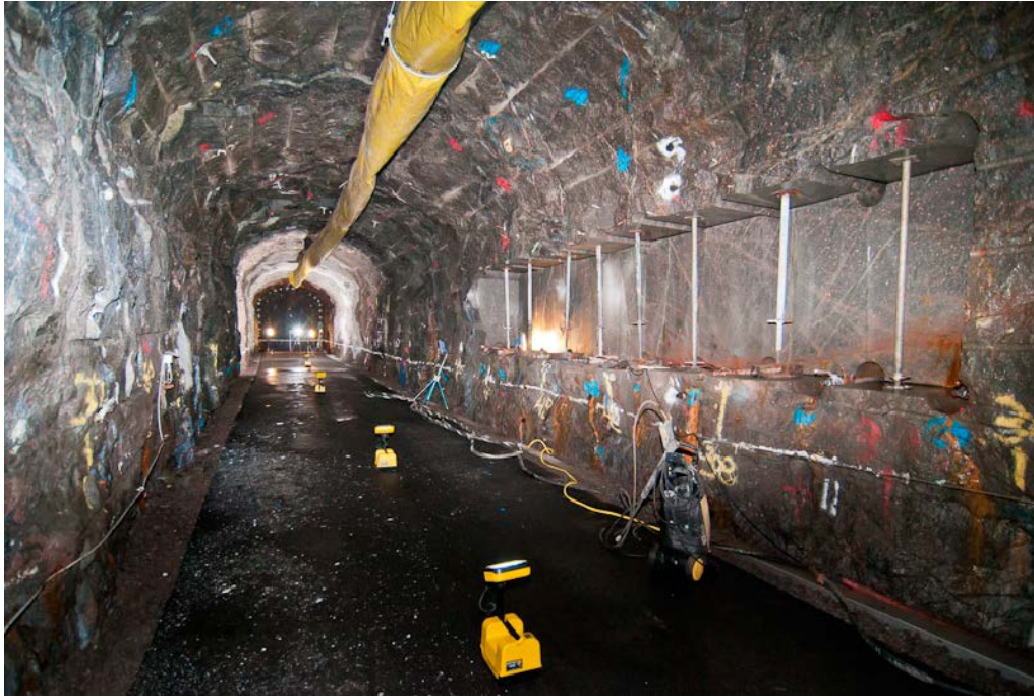
Figure 5-1. Wide-angle photograph of the TASS tunnel, illustrating portable construction lights used for site illumination. Note the lighted section near the end of the tunnel; this is the location of the Structure #20 intersection with the TASS tunnel. The elongated rectangular slot along right side of the tunnel wall is the excavation from the Excavation Damage Zone project (Olsson et al. 2009).

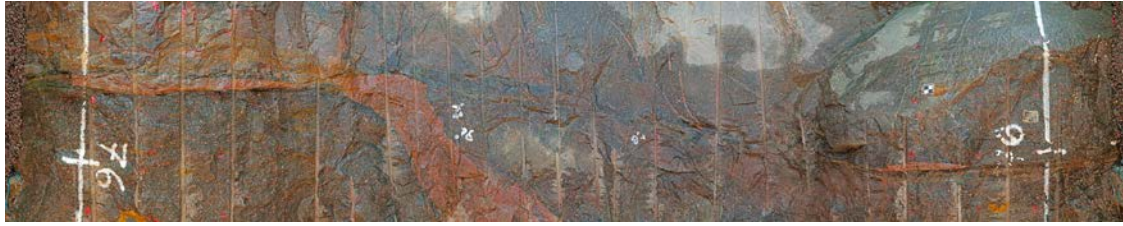
Figure 5-4. HDR image, after of a portion of the Structure #20 intercept within the TASS tunnel. This image has been extensively re-sized using Photoshop so as to fit into the report.

An example of the resulting tone-mapped image of Structure #20 in the TASS tunnel is presented as Figure 5-4. It is difficult to see a difference in the printed photograph, but the HDR image is overall lighter, with fracture traces standing out better, as if a sharpen filter had been run on the image. A comparison of a single-exposure to an HDR exposure is presented below as Figure 5-5. The best use of the HDR imagery is as an overlay in the GIS interpretation process (Section 5.4.2), or in collaborative interpretations of images where extracting detail from shadows is important.

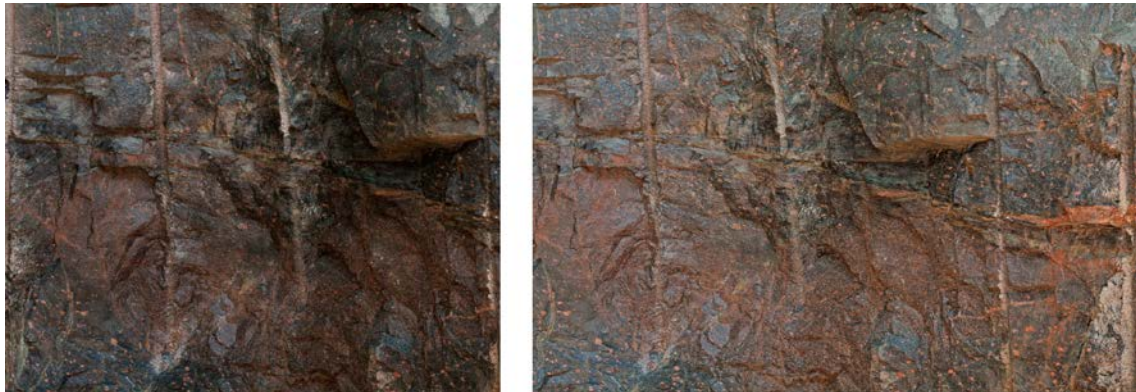
Figure 5-5. Side-by-side comparison of a close-up section of the visible light (left) and HDR (right) image. Notice the significant enhancement of detail in the shadowed areas.

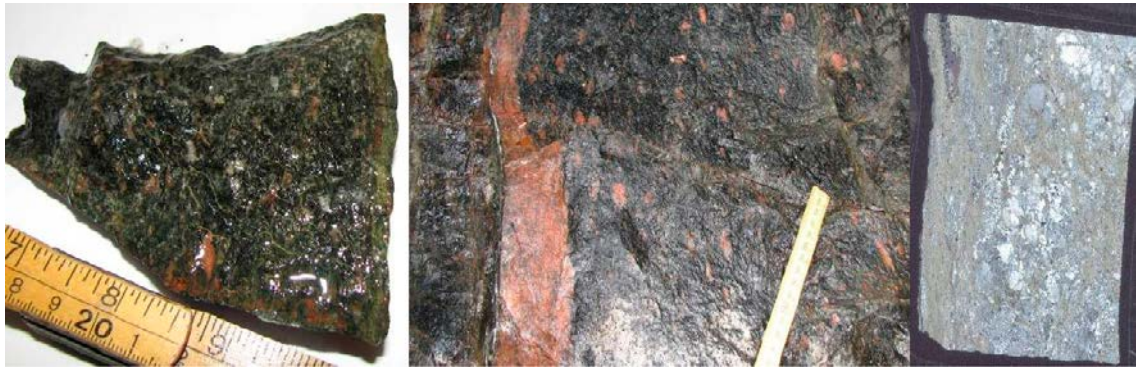
Figure 5-17. Photograph of sample (left), photograph of sample location (middle) and scanned thin section, with crossed polars (right). Tunnel sample #3.

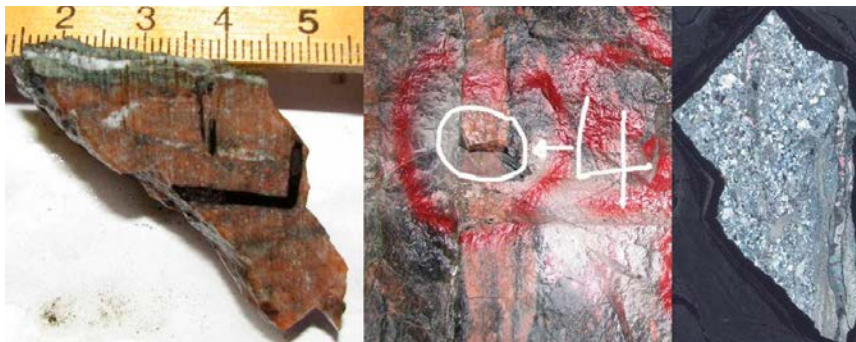
Figure 5-20. Photograph of sample (left), photograph of sample location (middle) and scanned thin section, with crossed polars (right). Tunnel sample #4.

Tunnel sample #4 is aligned with Structure #20, looking into the B-wall at a vertical angle (WNW). Images of the sample are shown in Figure 5-20 through Figure 5-22. This sample consists of a sealed fracture with at least two generations of mineralization; the oldest is a epidote-muscovite-quartz-plagioclase cataclasite/mylonite mixture, and the younger is a brittle fracture coated by euhedral (cubic) fluorite and filled with calcite and a mixture of very fine-grained K-feldspar, quartz and chlorite, which indicates that it is Palaeozoic (Drake and Tullborg 2004, Drake et al. 2009).

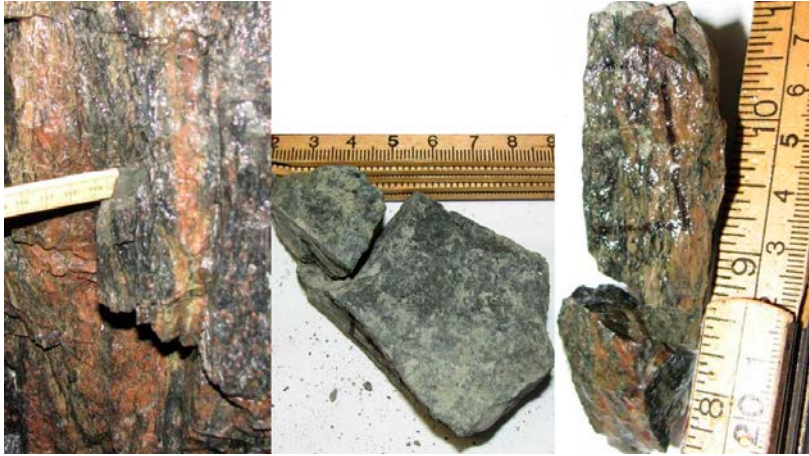
Figure 5-23. Photograph of sample location (left) photograph of fracture surface (middle), sample from the side (right). Tunnel sample #7.

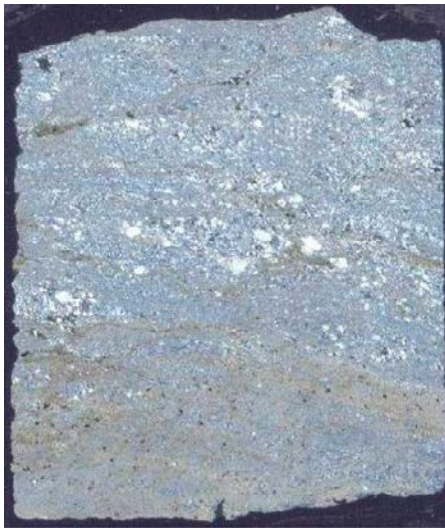
Figure 5-24. Scanned thin section. Crossed polars. Tunnel sample #7.

The orientation of the thin section take from Sample #7 is vertical and aligned along strike with Structure #20, looking from the B-wall towards the A-wall (mirrored in the thin section). The shear sense observed in the thin section indicates dip-slip with inner part of the tunnel (SE part) moved downwards.

General features of the thin section: Mylonite with several parallel very fine-grained bands. Mylonite bands are either quartz-and feldspar-dominated (very fine-grained and completely re-crystallised through dynamic re-crystallisation, e.g. sub-grain rotation and grain boundary migration), with epidote or are (in lower part of thin section) dominated by epidote-and mica (mostly biotite, +chlorite). Primary rock fragments exist but are highly altered, e.g. K-feldspar, plagioclase and magnetite. The feldspars show undulose extinction and limited sub-grain formation as well as deformation twinning. Secondary calcite has formed from altered plagioclase. Very diffuse C-S fabric and mantled porphyroclasts (of re-crystallised quartz surrounded by mica) indicate dip-slip with SE wall moved downwards. Thin layers and lenses of epidote-cataclasite are present and have been reactivated by brittle fractures filled with euhedral quartz, K-feldspar, epidote, fluorite, chlorite and mica.

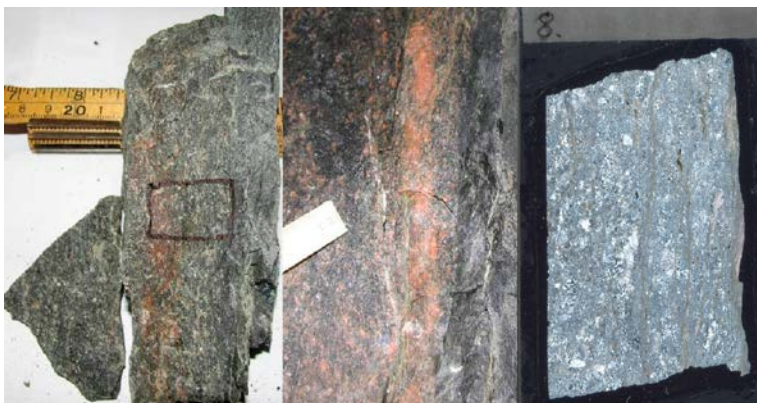
Figure 5-30. Photograph of sample (left), photograph of sample location (middle) and scanned thin section, with crossed polars (right). Tunnel sample #7.

The orientation of the thin section is horizontal, looking from the floor to the roof of the tunnel, and aligned along strike with Structure #20. A sinistral sense of shear suggests strike-slip to oblique-slip movement of Structure #20 with the SW wall moving towards the NW. However, younger brittle dextral indicators indicate reverse-slip movements. Images are shown in Figure 5-30 through Figure 5-32.

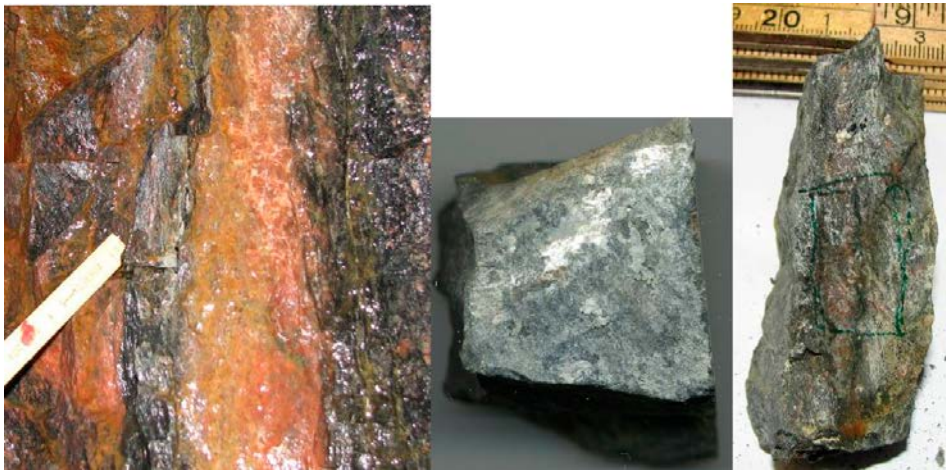
Figure 5-33. Photograph of sample location (left) photograph of fracture surface (middle), sample from the side (right). Tunnel sample #9.

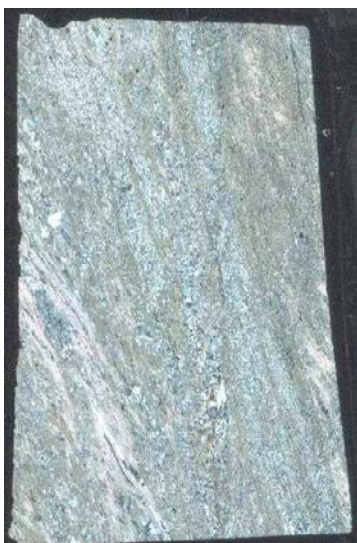
Figure 5-34. Scanned thin section: Crossed polars. Tunnel sample #9.

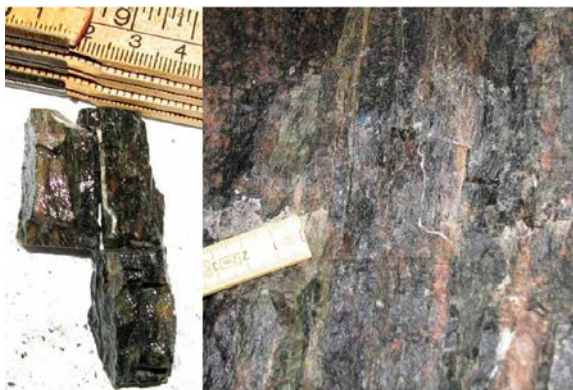
Figure 5-37. Photograph of sample (left) and sample location (right). Tunnel sample #10.

This sample was only analysed for stable isotopes in calcite.

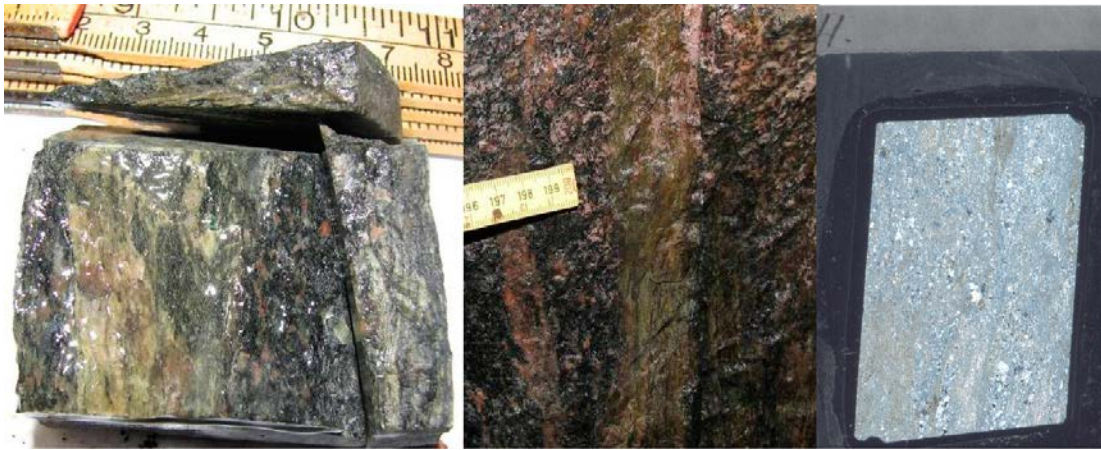
Figure 5-38. Photograph of sample (left), photograph of sample location (middle) and scanned thin section, with crossed polars (right). Tunnel sample #11.

The orientation of the thin section taken from Tunnel Sample #11 is vertical, looking from the B-wall towards the A wall, and aligned along strike with Structure #20. Shear sense indicates dip-slip, where SW wall has moved up relative to the NE wall. Images of this sample are shown in Figure 5-38 through Figure 5-39.

General characteristics of Tunnel sample #11: Mylonite with several parallel bands, which are generally very fine-grained, except for some quartz-bands which have slightly larger grain-size. Bands are either quartz-dominated (with abundant re-crystallised feldspars) or dominated by epidote-mica (+chlorite) and calcite (with minor pyrite). The quartz bands show abundant signs of dynamic re-crystallisation, including sub-grain formation, sub-grain rotation re-crystallisation and grain-boundary migration re-crystallisation. Occasional porphyroclasts of K-feldspar and plagioclase show deformation twinning. Very diffuse C-S fabric indicates dip-slip (SW-wall moved upwards) movement but apart from that there are no shear-sense indicators. Two generations of calcite-filled fractures exist. One is parallel to the mylonite foliation and one cuts the mylonite at approximately 45°; both sets have minor amounts of pyrite.

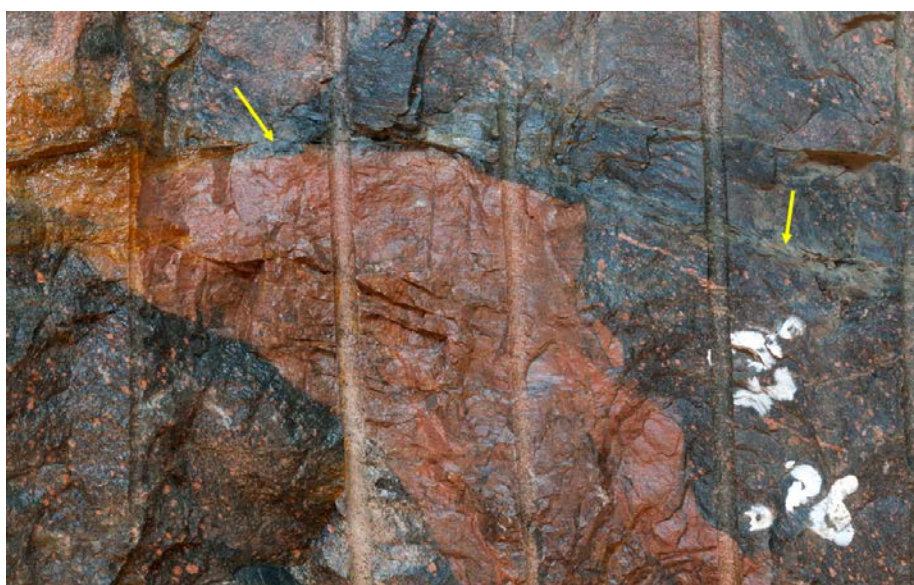
Figure 6-1. Localization of Structure #20 (yellow arrows) in relation to a dike of fine-grained granite exposed at chainage 76+00 in the TASS tunnel.

Structure #20 shows at least a weak association with fine-grained granite intrusions. During the initial tunnel mapping process (Hardenby and Sigurdsson 2010), the rock around the Structure #20 intercept was classified as “hybrid rock”, representing a significant degree of intermingling and partial re-crystallization of Äspö diorite and fine-grained granite. Termination relationships (Figure 6-1) indicate that, while brittle fracturing has localized along the shear zone/dike contact, the lateral spread of the initial intrusion was limited by the presence of the Structure #20 ductile precursor. This provides constraints on the age of the ductile precursor. It also suggests that paying attention to igneous intrusions is necessary, as they may follow pre-existing ductile shear zones or may be coincident with ongoing ductile shearing.

- The description of geological, structural and mineralogical heterogeneity and variability on a metre to decametre scale is significantly enhanced through the detailed mapping results, see Figures 6-1 and 6-2 and associated text.

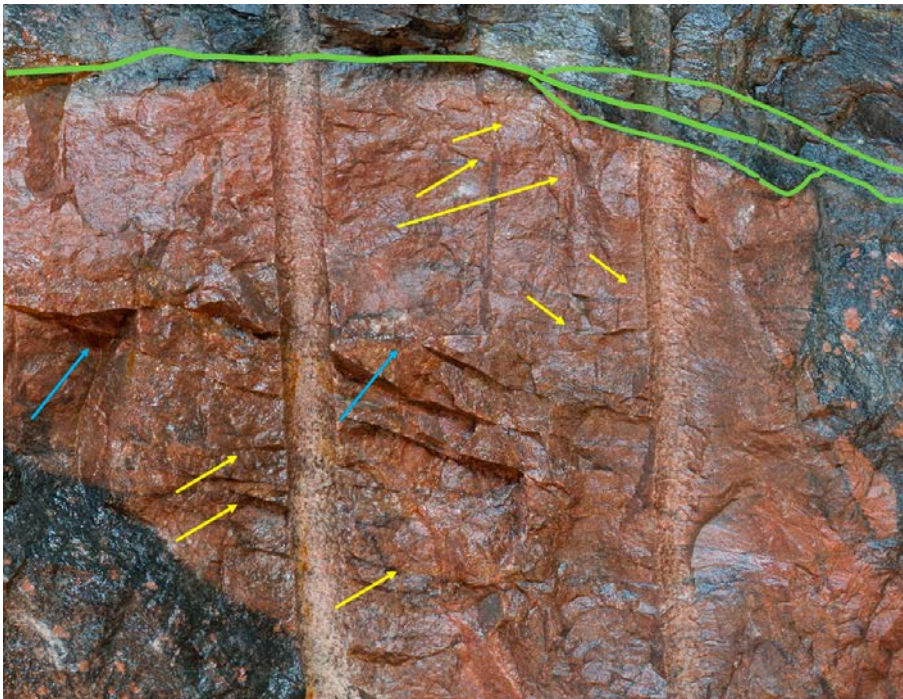
Figure 6-3. Close up of contact between fine-grained granite and Structure #20. Note the abundance of sealed fractures (yellow arrows) and partially open fractures (blue arrows) inside the fine grained granite. These fractures all have similar orientations to Structure #20, and are likely related to at least one phase of brittle deformation along the deformation zone. The green lines represent the open fractures inside the brittle core of Structure #20.
