**TECHNICAL
REPORT**

87-02

**Fuel rod D07/B15 from Ringhals 2 PWR:
Source material for corrosion/leach
tests in groundwater
Fuel rod/pellet characterization program
part one**

Roy Forsyth
Studsvik Energiteknik AB, Nyköping

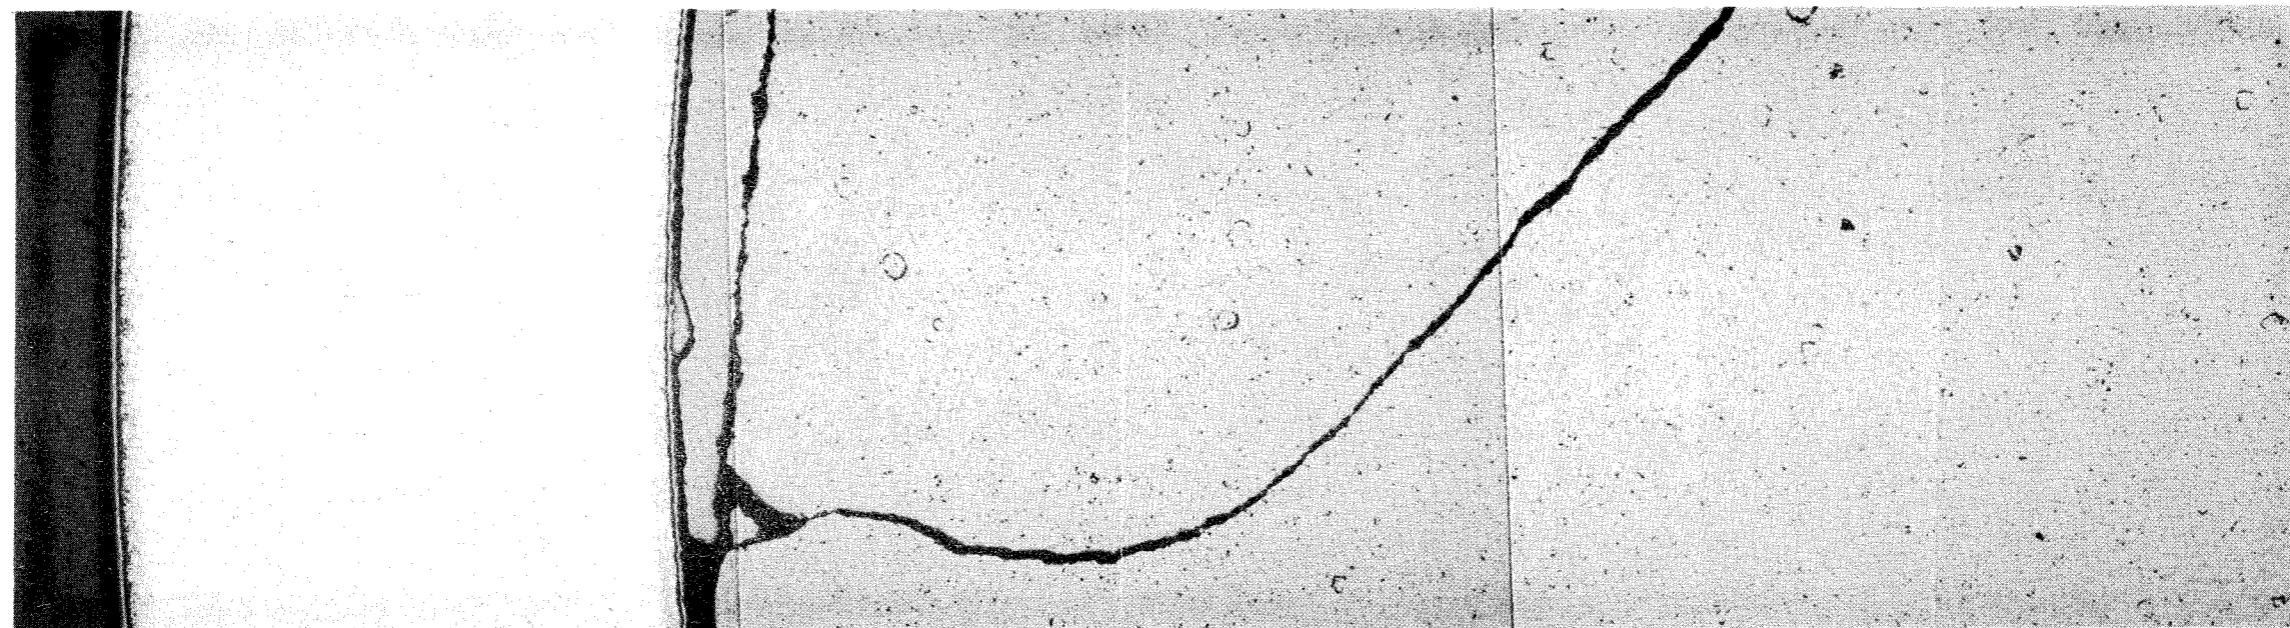
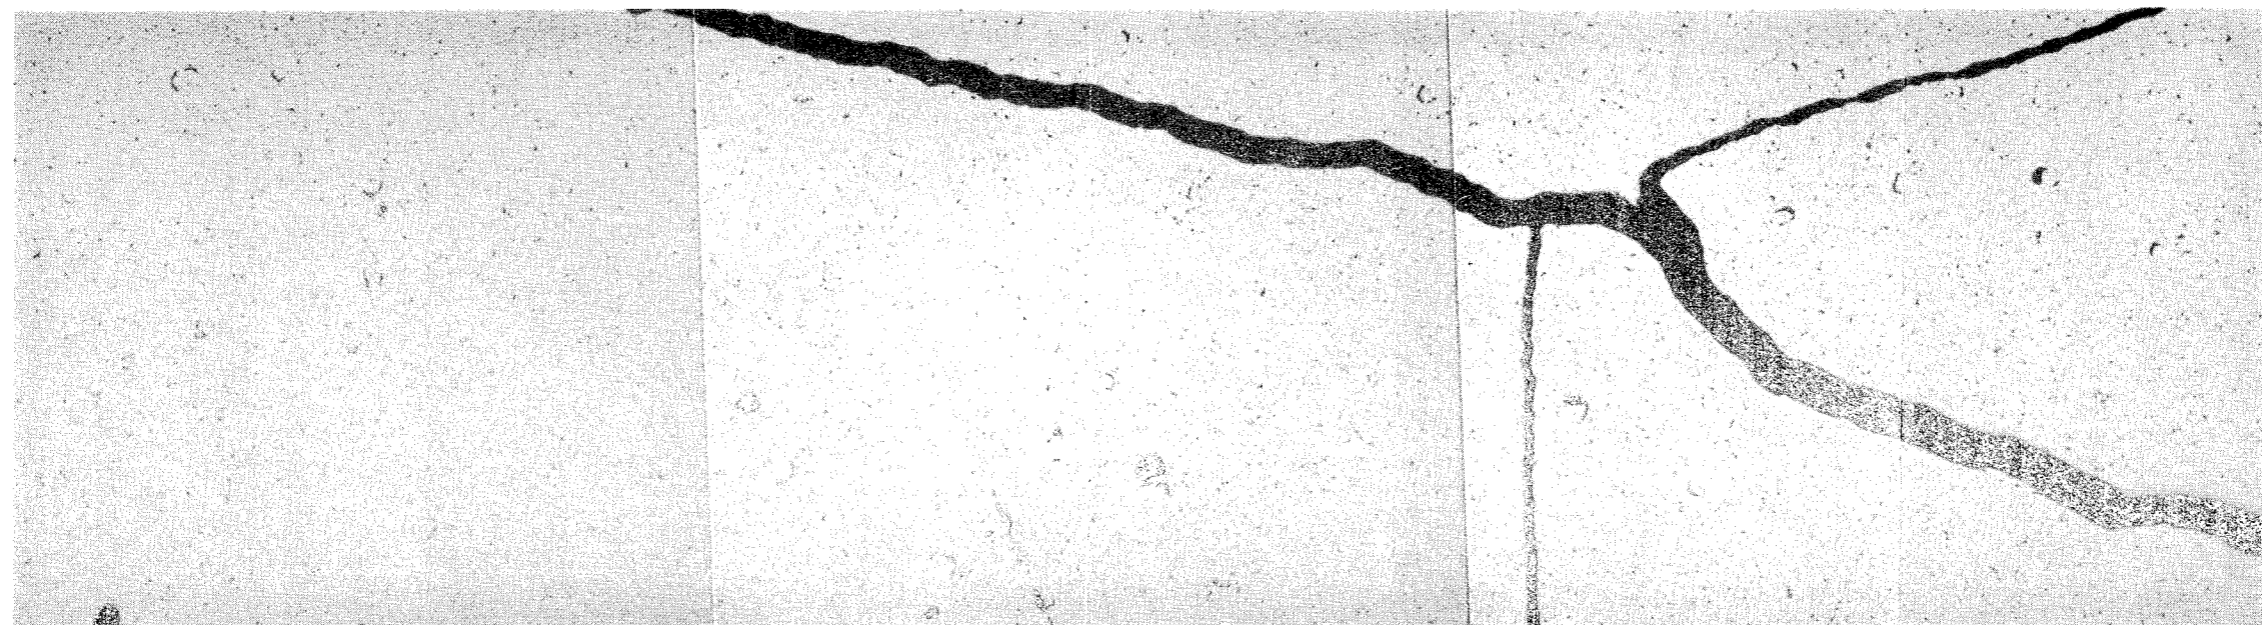
Sample 1265
Radial fuel section.
As polished.

The fuel microstructure along a radial section is shown in Figure 2. The fuel macrocracks do not show any unusual features, apart from the extensive circumferential crack very close to the pellet periphery. This may have been caused during cooling, as a result of the fuel-clad bonding in this region (Figure 3).

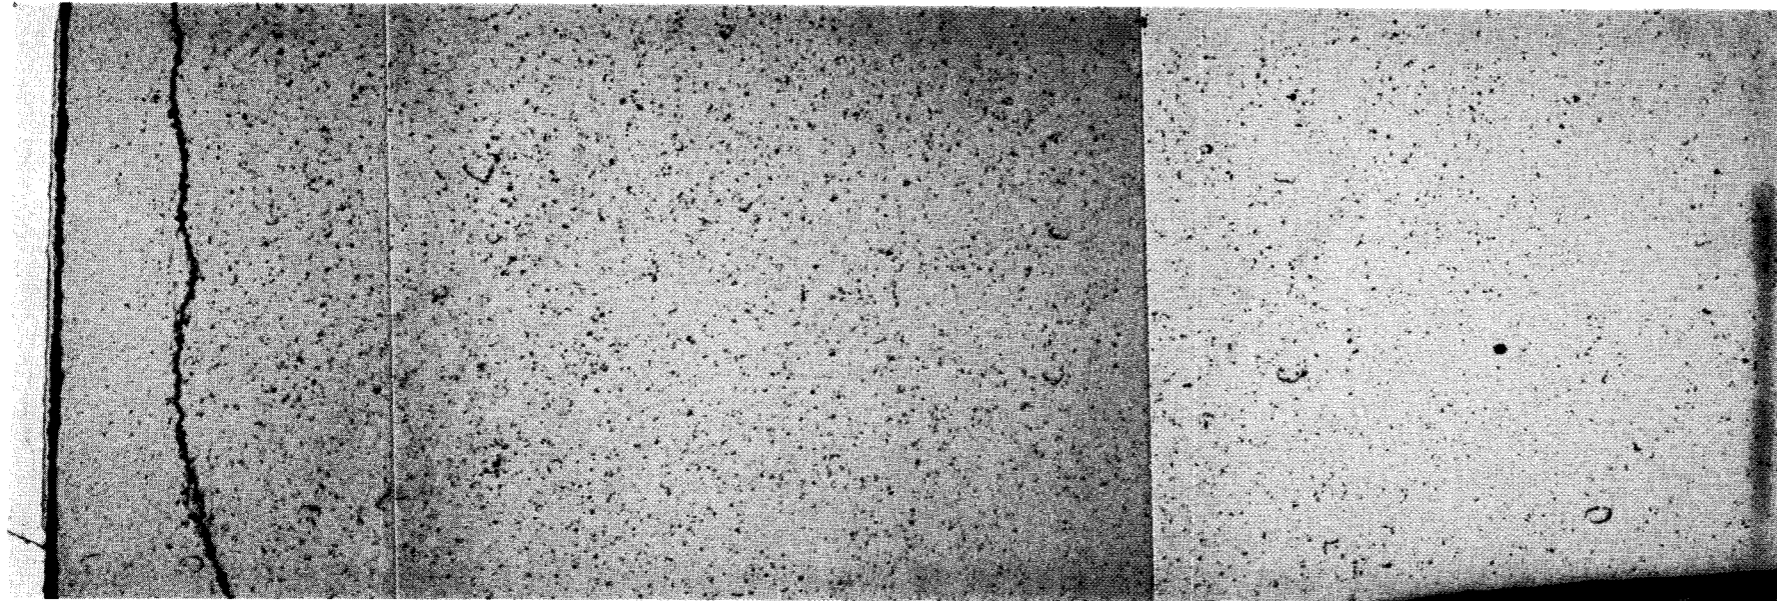
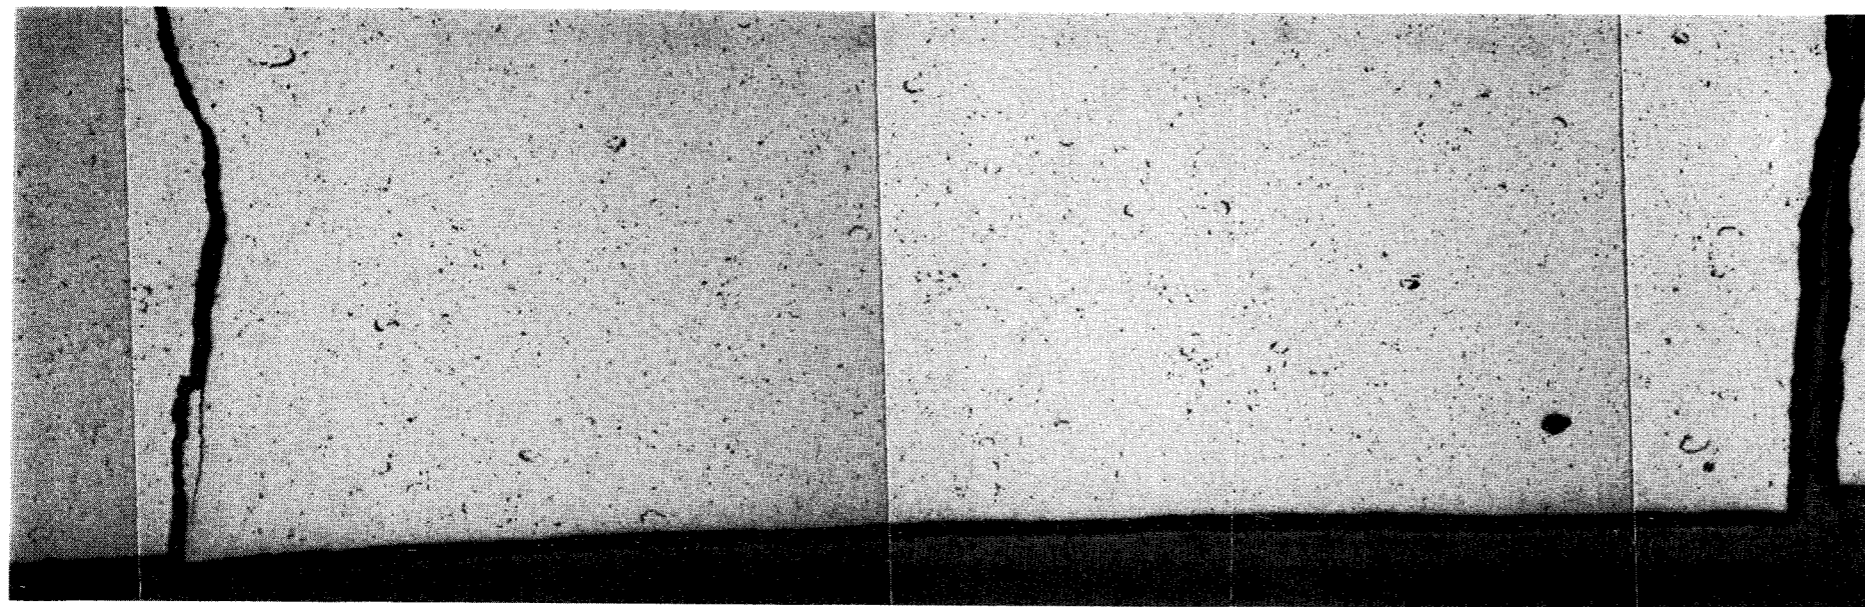
Pellet-end radial fuel section.
As polished.

The fuel microstructure along a radial section at a pellet end is shown in Figure 5, and at a mid-pellet position in Figure 6. The mid-pellet section is dominated by a large radial crack, but otherwise the macrocracking is similar in both sections.

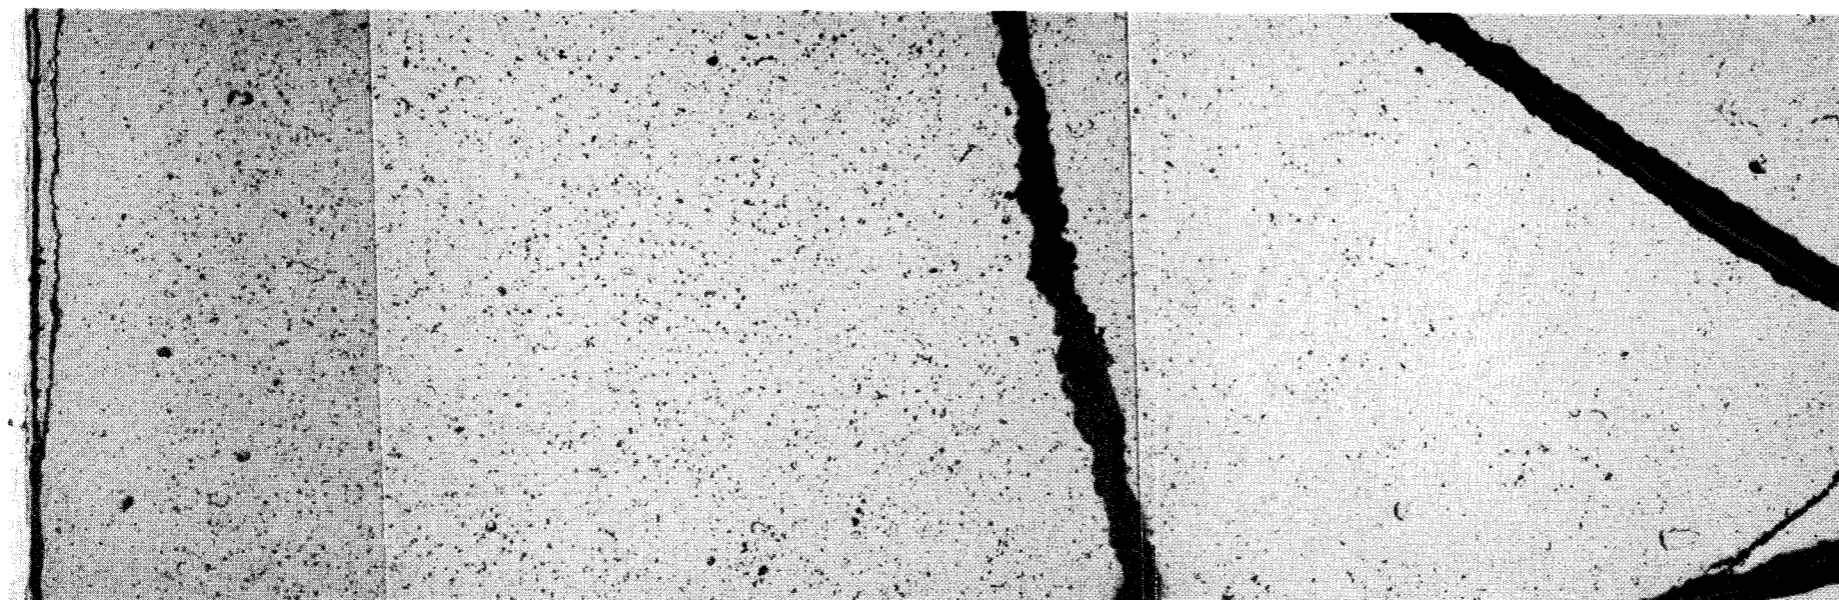
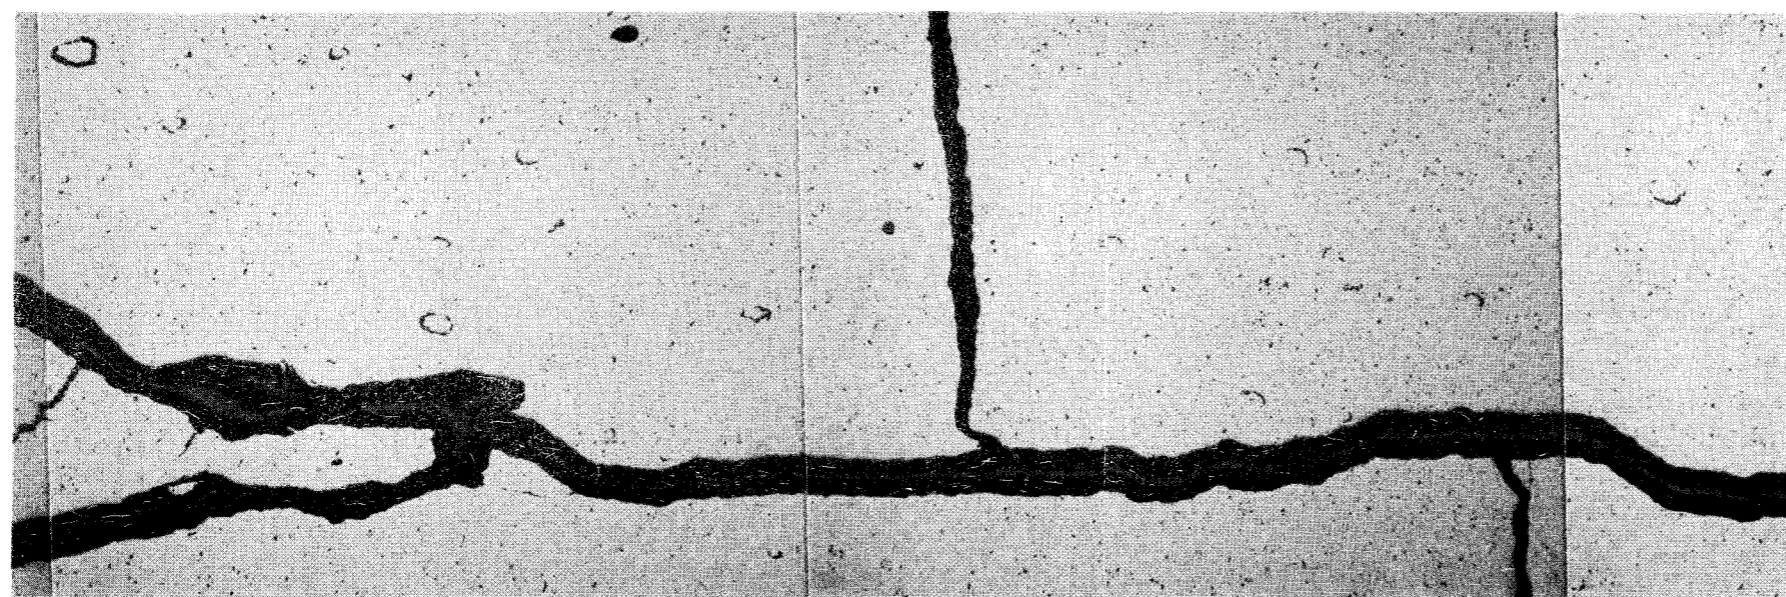
Mid-pellet radial fuel section.
As polished.

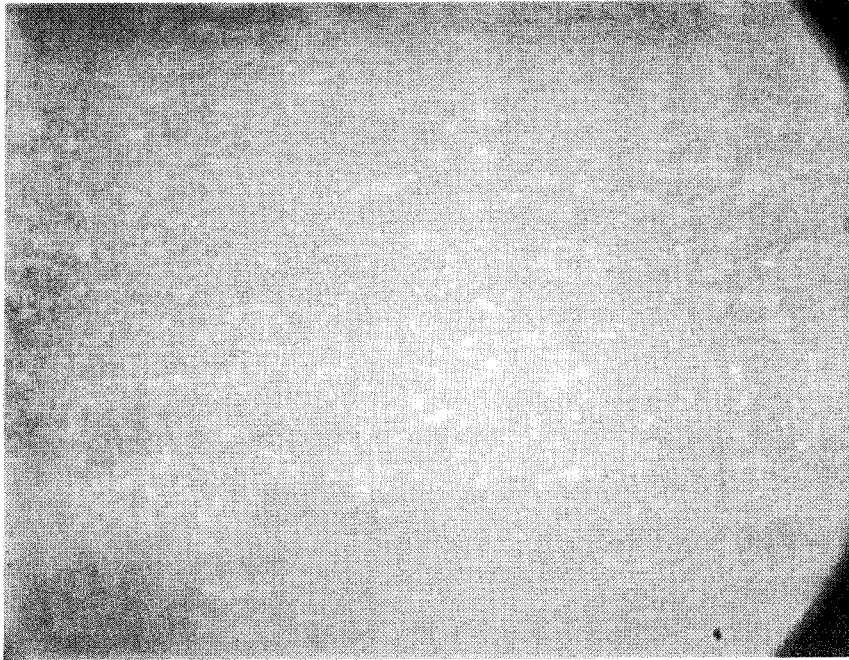
Fig. 1 Small unevennesses in the oxide layer 150 mm from bottom. 15X
All pictures are oriented with the bottom end of the fuel rod to the left.

At the lower end of the rod the oxide was even and grey black. About 150 mm from the bottom small irregularities in the oxide layer start as shown in Fig 1. These then increase in size but hardly in density and the oxide surface then has the mottled appearance which is illustrated in Fig 2. At a quick glance, the appearance is reminiscent of BWR-rods with nodular corrosion. However, from what can be seen in the periscope, these patches are not very thick as no level difference can be seen between the white paths and the surrounding dark oxide. Already 525 mm from the bottom (Fig 2) the white oxide has formed a continuous layer of white oxide around the major part of the rod. The rod has the mottled appearance of Fig 2 only in a sector of about 90° .

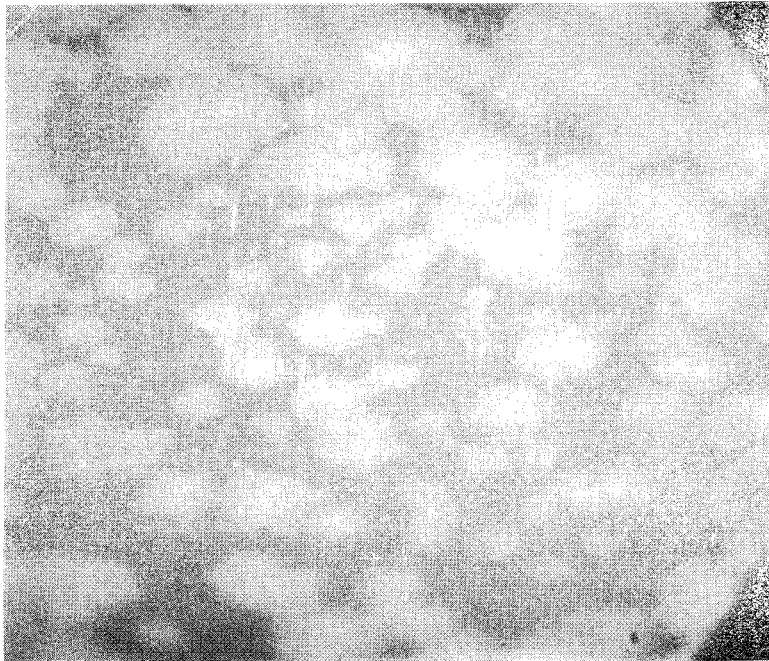
Fig. 2 Mottled oxide. 525 mm from bottom. 15X

When the change from grey black to white oxide is observed, (Figs 2-4), the impression is obtained that the white patches are zirconium oxide. In areas where the rod is completely white, the surface has however such a dull, powderish character that the impression is given that the rods have a coating. Fig 5 is an attempt to show what in the periscope appears to be a mottled oxide under a light-coloured coating, giving the surface a somewhat uneven appearance. With this background, it is interesting to note that the white surface layer has fallen off where the rod was in contact with the rod-feed rollers. on which the rod rests when rotated during the examination (Fig 6).

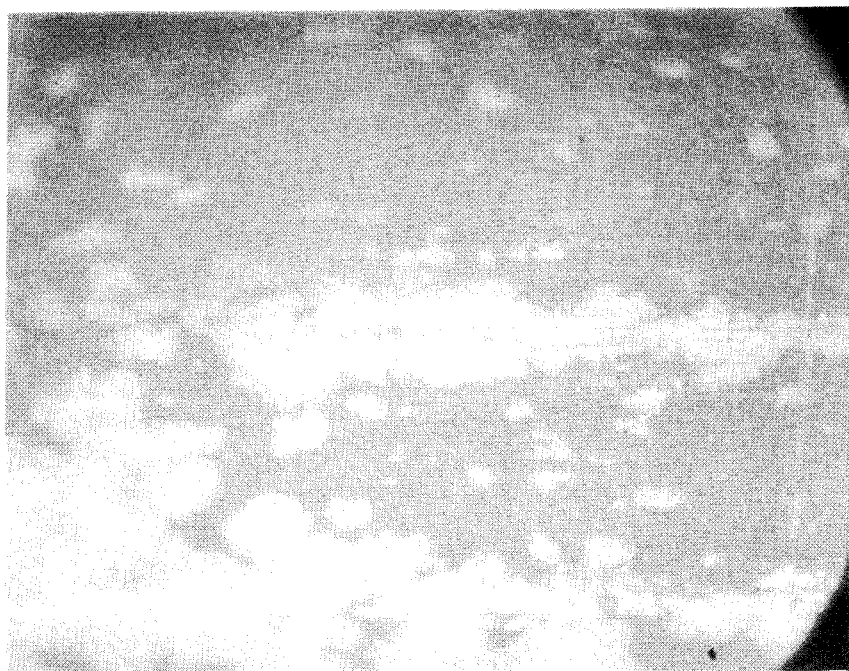
Fig. 3 Oxide patch at spacer's con- 15X
tact point. 700 mm from bottom.

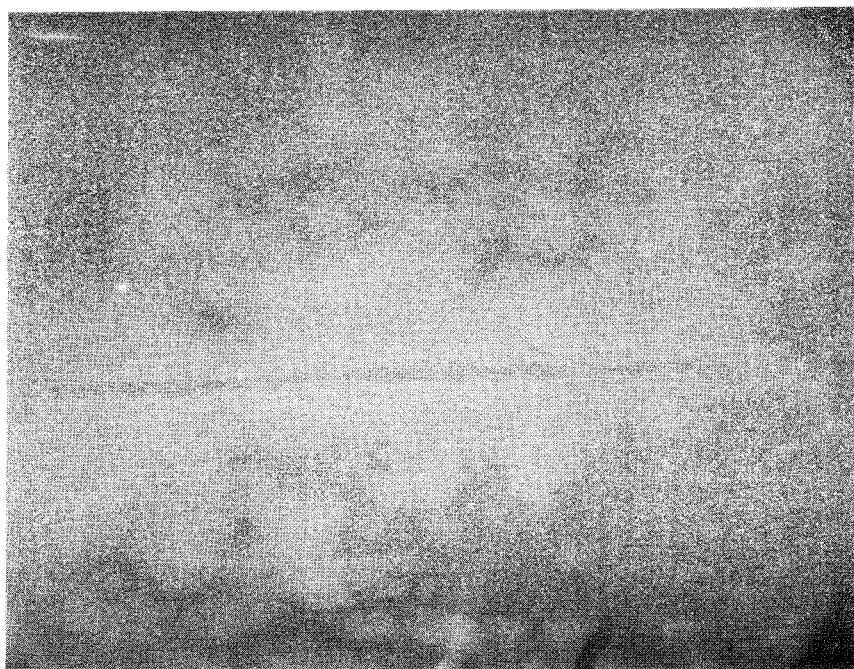
Fig. 4 Oxide at third spacer from 15X
bottom. 1350 mm from bottom.
The white oxide covers more
of the surface here than at
the preceding spacer.

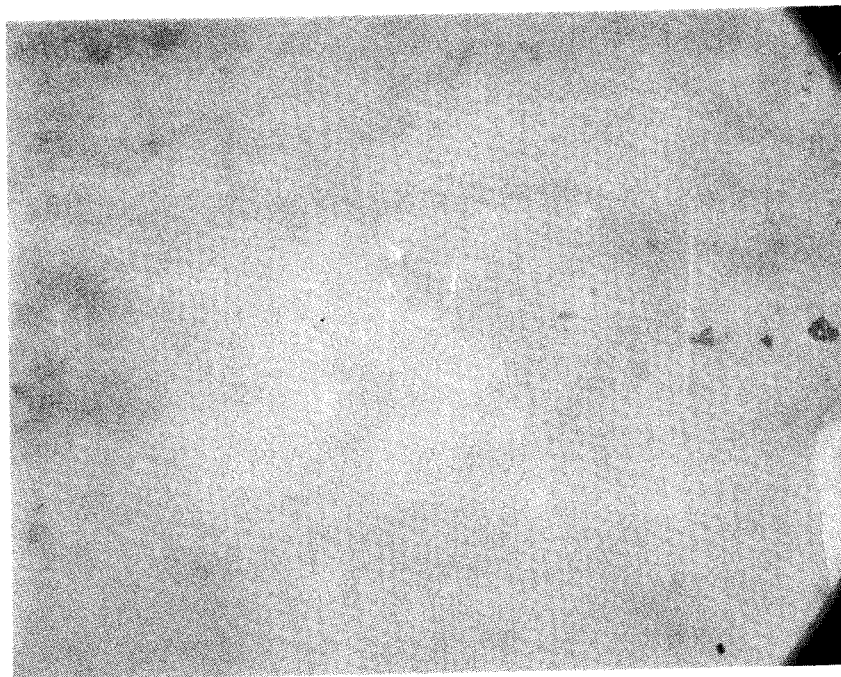
Fig. 5 Uneven oxide, which in the 15X periscope gives the impression of a mottled oxide layer under a light-coloured layer. 1070 mm from bottom.

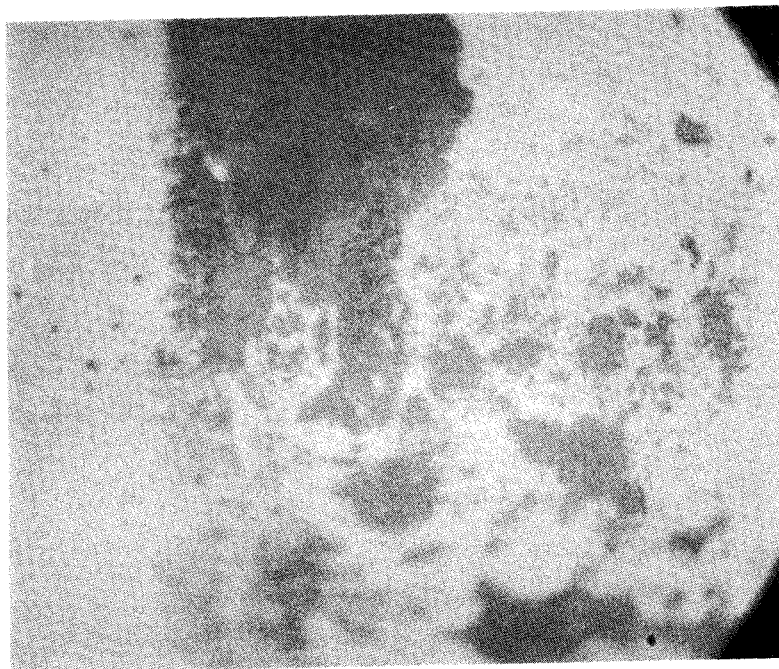
Fig. 6 Coating or white oxide removed by contact with the rod-feed roller during inspection. 15X 2190 mm from bottom.

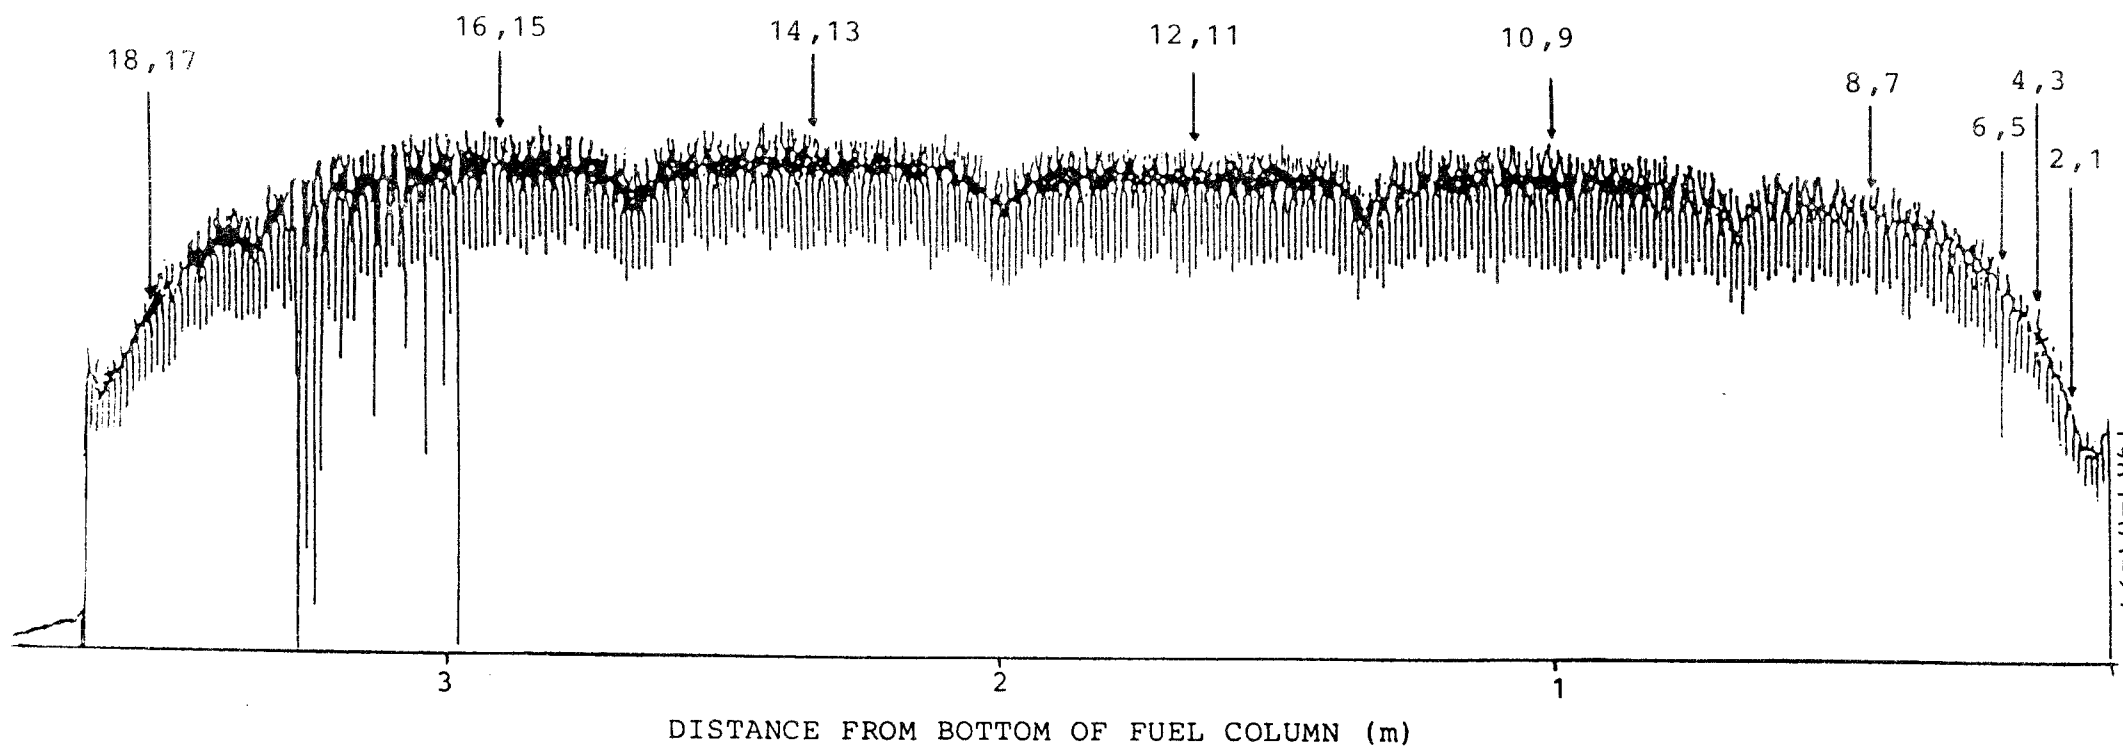
Fig 1. Axial gamma scan (Cs-137) of PWR rod number 03688 from Ringhals 2 assembly D07.

The two axial gamma scanning curves (with 180° rotation between scans) were extremely similar so only the second scan is presented in this report as Fig 1. Although there has been some loss of detail and clarity in the size reduction process, it can be clearly seen from the figure that over the whole fuel column, the interpellet gaps are clearly marked. The flux depressions caused by the spacer grids are also evident. It is also clear that the burnup is very even over more than 2 meters of the fuel pellet stack.

The locations of the 18 point measurements are also shown in Fig 1. Because of the long irradiation history of the rod (Fig 2) and the decay time of almost two years, the gamma spectrum was dominated by the photopeaks of Cs-134 and Cs-137, but the spectrum also contained peaks from Ru-106, Ce-144 and Eu-154. These are the main gamma-emitting fission products which will be studied during the leaching experiments, and it is, therefore, essential to determine their inventories as a function of location along the

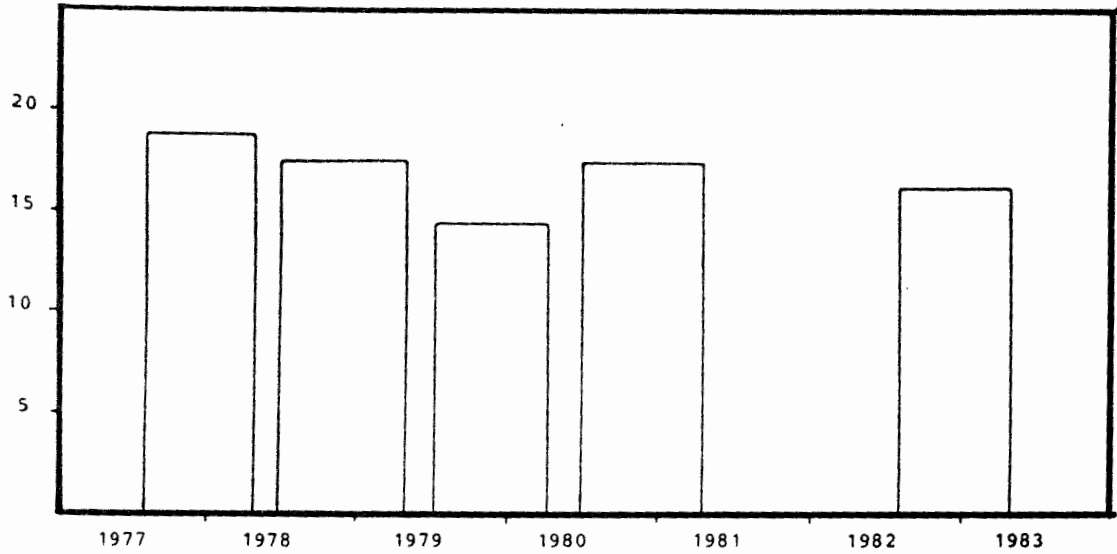
Fig 2. Schematic rod irradiation history

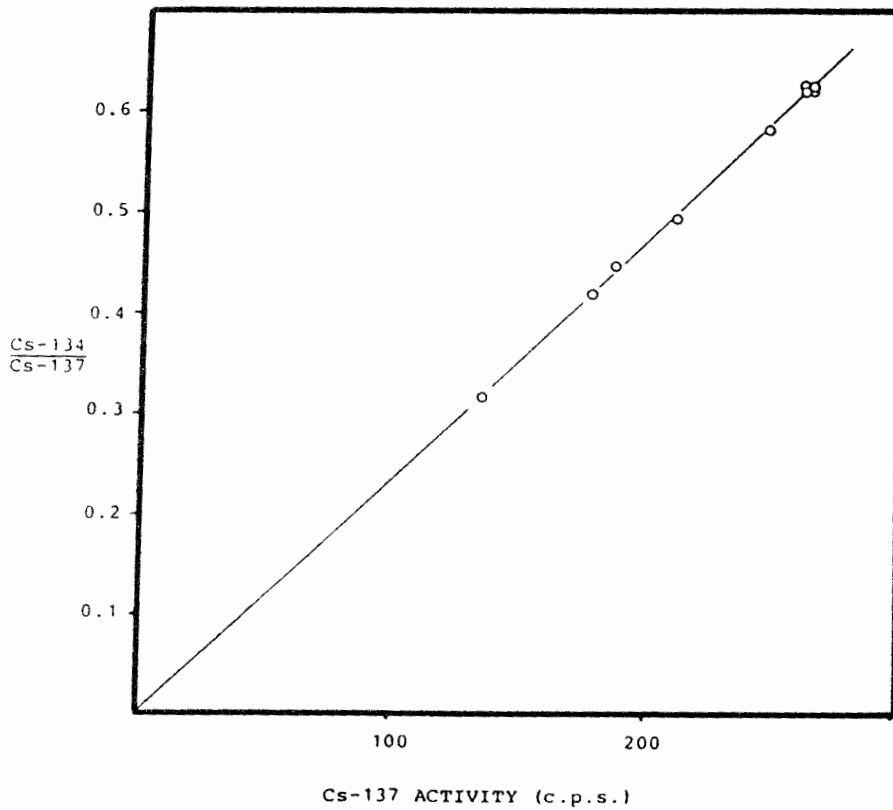
Fig 3. Results of point measurements demonstrating validity of Cs-134/Cs-137 ratio as burnup monitor.

fission, is a measure of the fluence, and hence the burnup. This is illustrated in Fig 3, where ratios of the Cs-134 796 keV peak to the Cs-137 662 keV peak for the measured points is plotted against the Cs-137 activity. The linearity obtained confirms the effect, and also suggests that the axial form factor has not changed appreciably during irradiation.

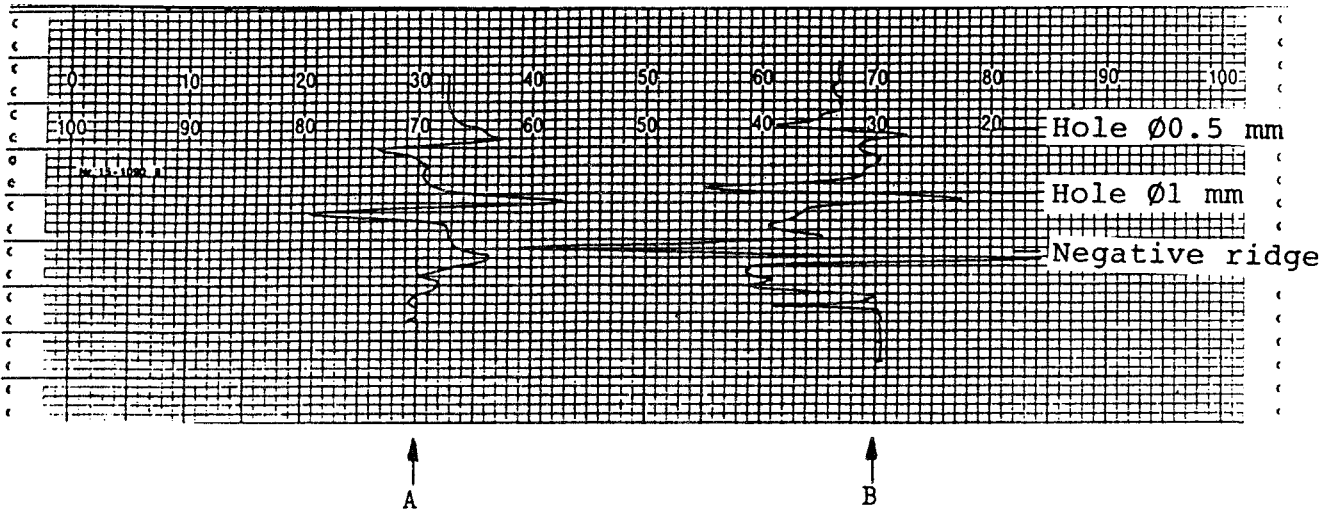
Tube reference defects. Diameter 10.25 mm.
Frequency 200 kHz. Double coil diameter 11.5 mm
Sensitivity index 0.10
Oscilloscope 1 V/channel
Plotter 10 V/channel

Curve A. High sensitivity for defects.

Curve B. High sensitivity for defects and
dimensional changes.

The results are shown in Figure 3. The length scale is 6 mm/scale division. The left curve (A) is sensitive to defects and the right curve (B) to dimensional changes.

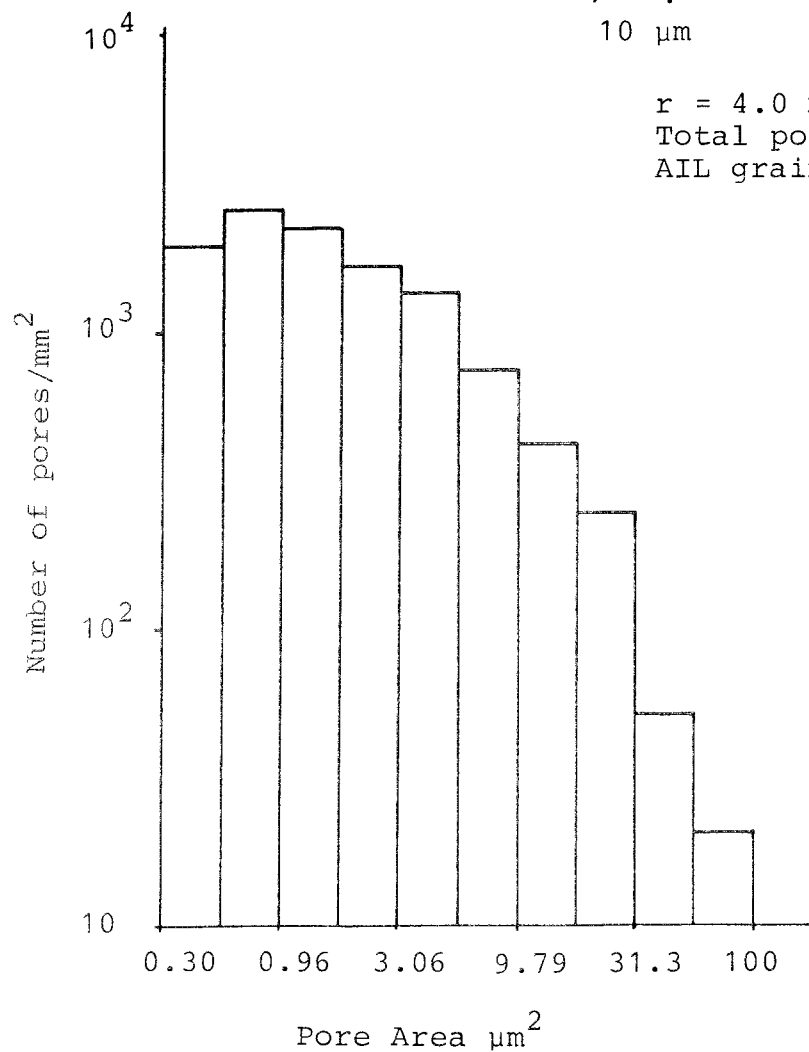
$r = 4.0$ mm (0.5 mm from periphery)
Total porosity = 3.4 %
AIL grain size = 4.3 ± 0.1 μ m

At a radius of 4 mm (0.5 mm from the pellet periphery) the fuel microstructure is fairly similar to the as-fabricated fuel as regards the pore size distribution and grain size (Figure 8). There is, however, some reduction in the overall porosity, as well as solid fission product swelling in the fuel matrix. The as-fabricated density (design data) was 10.36 g/cm^3 , corresponding to 5.5 % porosity.

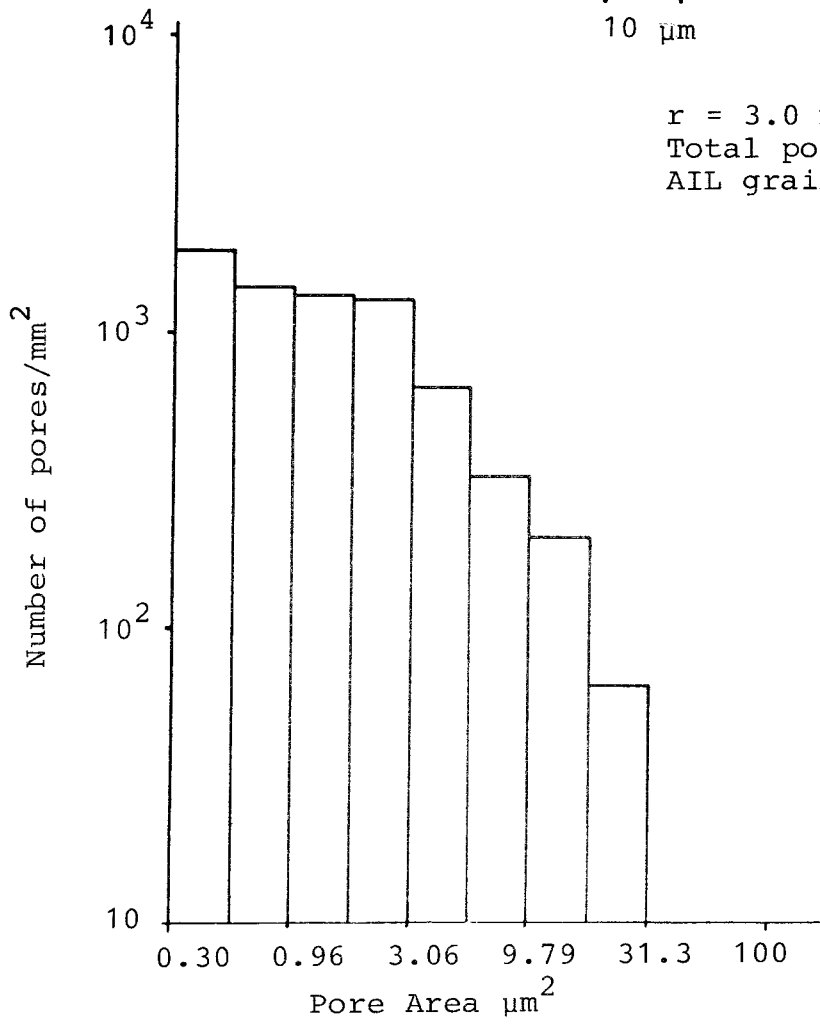
$r = 3.0 \text{ mm}$
Total porosity = 1.6 %
AIL grain size = $4.5 \pm 0.1 \text{ μm}$

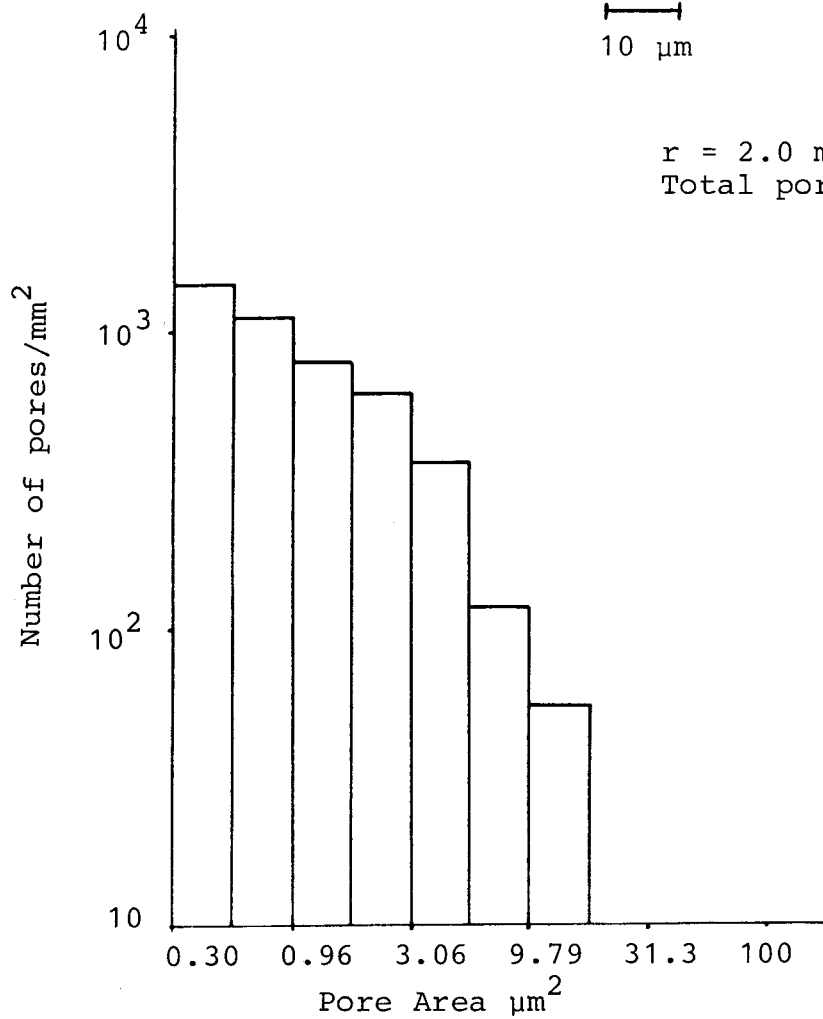
$r = 2.0 \text{ mm}$
Total porosity = 0.75 %

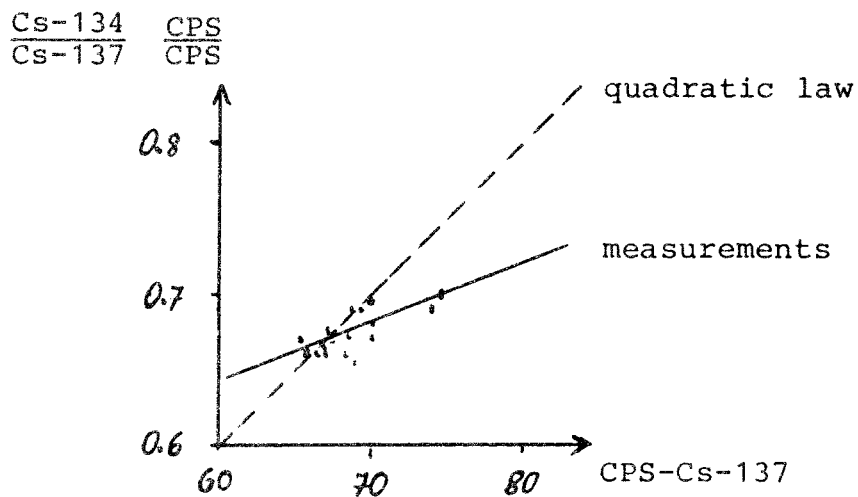
The Cs-137 curves represent the local burnup distribution across the pellet. The Cs-134 curves are more representative of the square of the burnup since the Cs-134 is formed by neutron capture in the stable fission product Cs-133. However, at this high burnup (50 MWd/kg U) when the depletion of the U-235 is almost complete, a higher neutron fluence is needed for each unit of burnup increase and therefore the amount of Cs-134 formed will be higher than that given by the quadratic law. This is especially true in the pellet centre where the Pu buildup does not counteract the U-235 depletion as much as at the periphery. The phenomenon is illustrated in the figure below where the quotient of the Cs-134

604 keV peak and the Cs-137 662 keV peak at different radii is plotted versus the Cs-137 counts.

Taking an average of the Cs-134/Cs-137 cps ratio over the diameter gives a figure of 0.675. If this figure is transformed to a Bq ratio per 1st April 1985 one arrives at a value of 0.733 Bq Cs-134/Bq Cs-137 which is very close to the value 0.720 calculated from the figures for points 11 and 12 in Table 4 of ref 1 which deals with the point measurements on the rod.

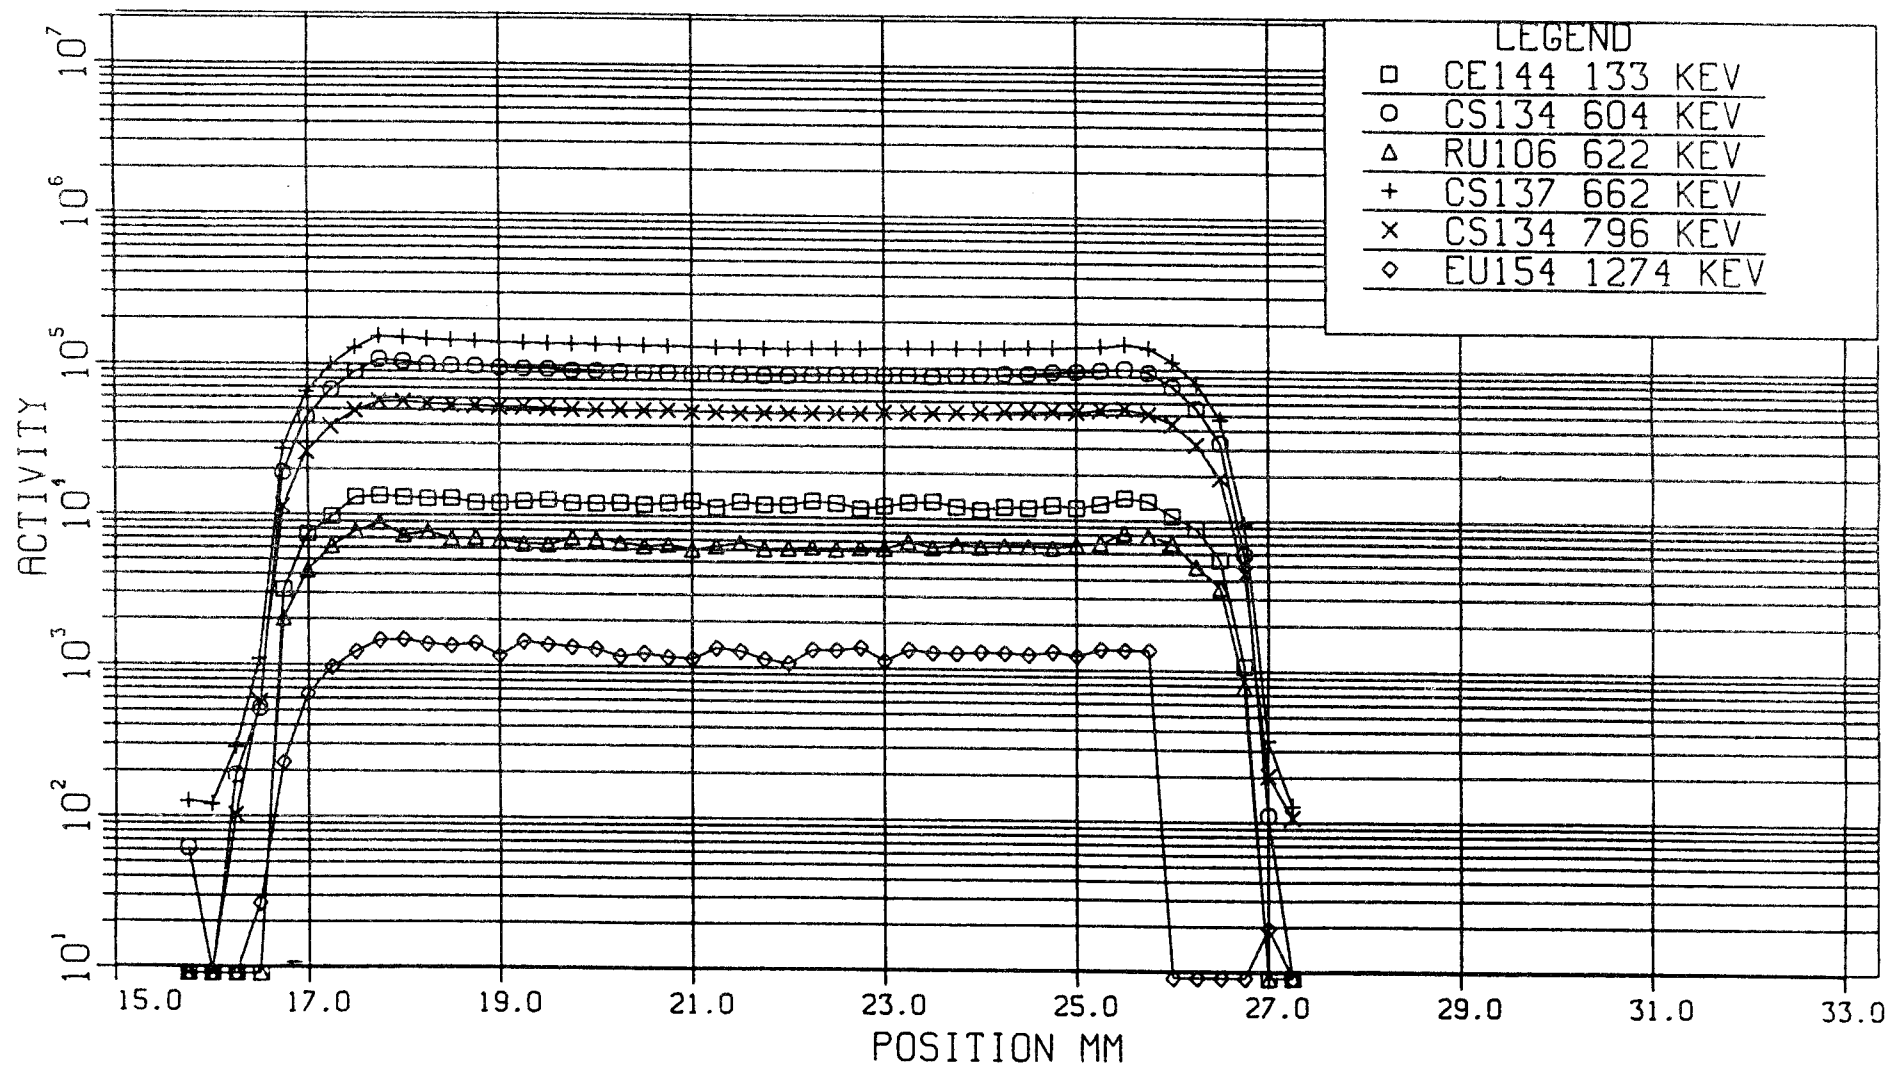
Figure 1

ROD 3688 SPECIMEN 1265 RADIAL MEASUREMENT PWR1 8605
