## **Oskarshamn site investigation**

### **Searching for evidence of late- or postglacial faulting in the Oskarshamn region**

#### **Results from 2003**

*Keywords:* P-04-192, Late- or postglacial faulting, Earthquake, Quaternary deposits, Seismically induced deformations, Unstable boulders.

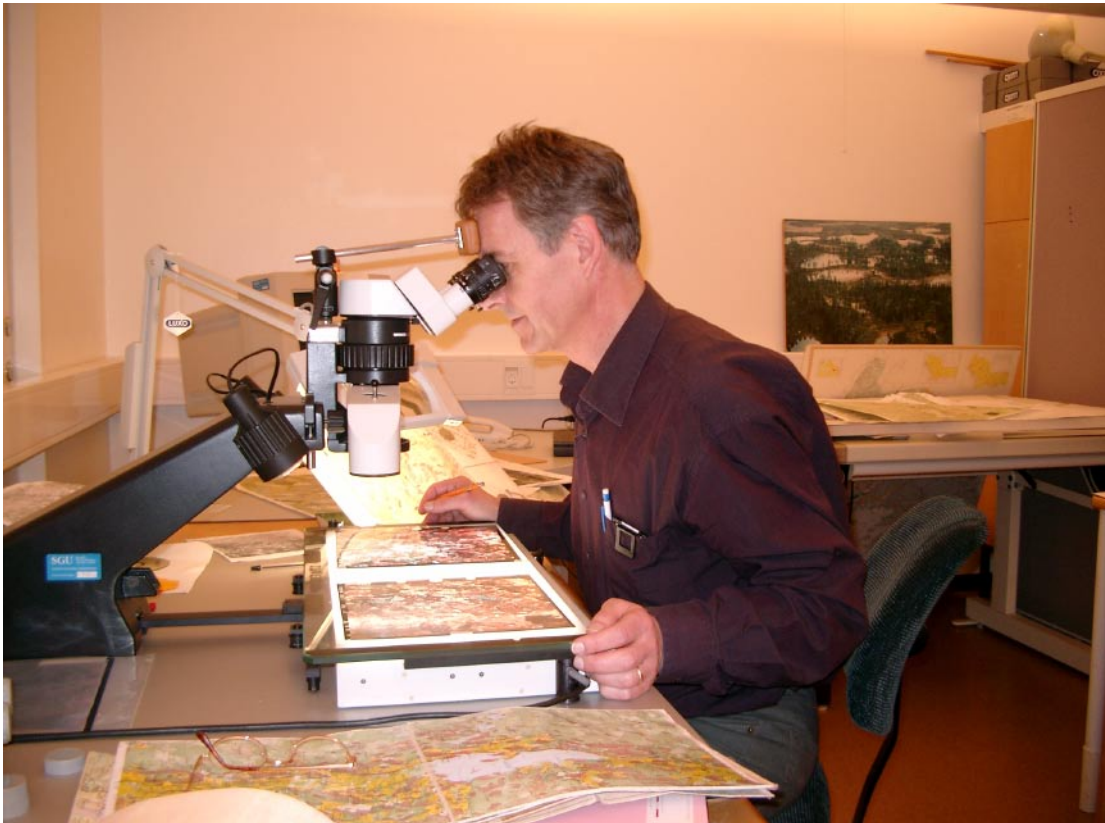
*Figure 3-1. Air-photo interpretation was the most important step in the study during 2003.*

Air-photo interpretation was performed in a Wild Aviopret stereoscope (Figure 3-1) using IR-images at the scale of 1:30,000 (1:15,000 within the site-investigation area).

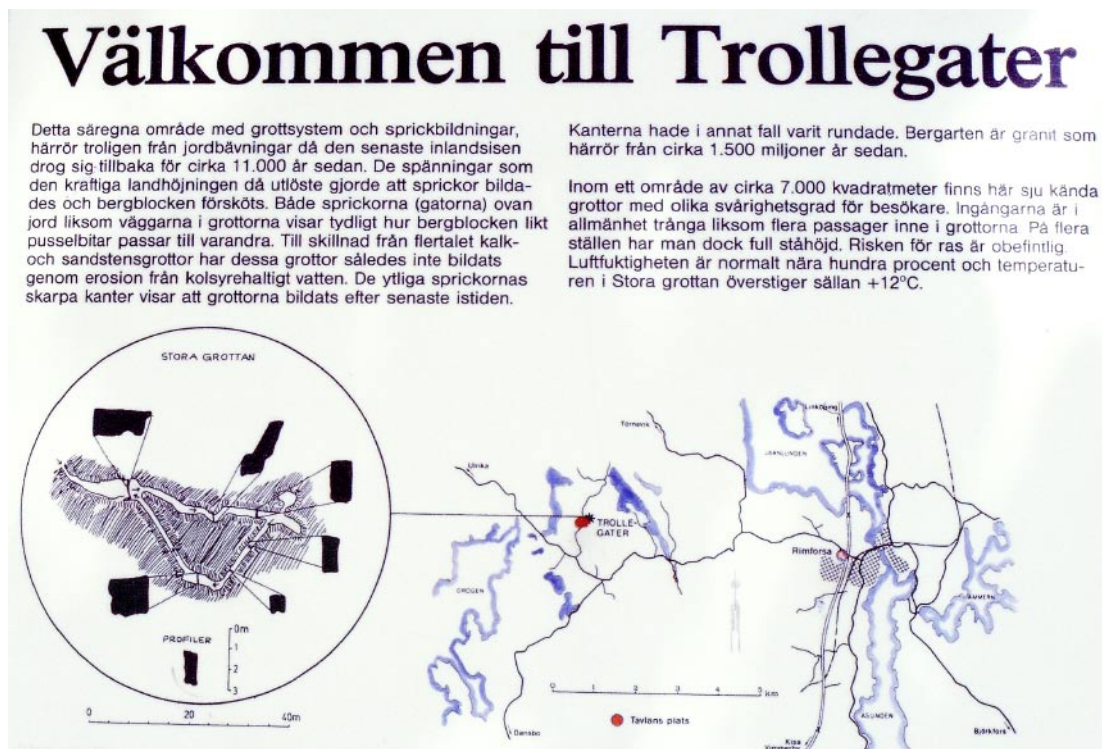
**Figure 5-1.** Tourist information sign at Trollegater, a “fissure cave” near Rimforsa in the northernmost part of the investigation area. According to the sign, the fracturing probably originates from earthquakes following the deglaciation some 11,000 years ago.

Trollegater is a well-known fissure cave some 7 km to the west of Rimforsa in the northernmost part of the investigation area. According to an information sign at the site, the intense fracturing of the bedrock was caused by earthquakes following the last deglaciation (Figure 5-1). Features like this are often routinely claimed as results of earthquakes, but credible evidence for this is commonly missing. It appears that the old problem of “the hen and the egg” is applicable. Generally, fracturing and displacement of bedrock generate earthquakes, but not the reverse.

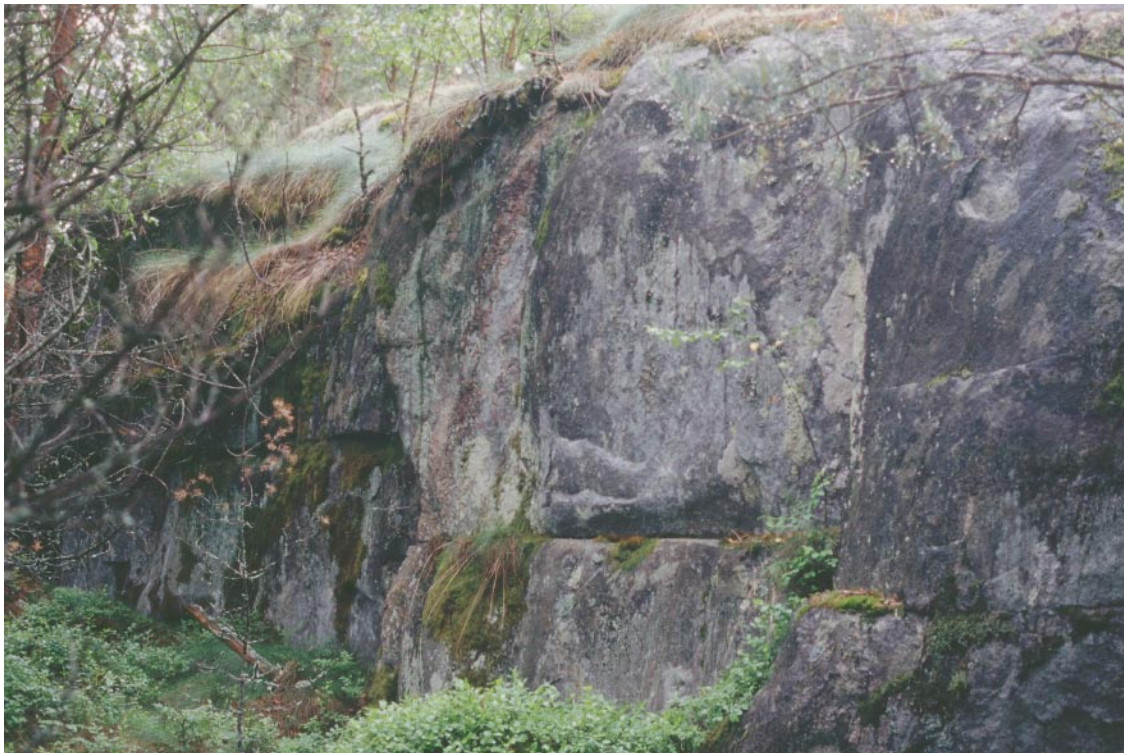
*Figure 5-4. Glacially abraded escarpment at Stora Vadsbro some 35 km N of Västervik*

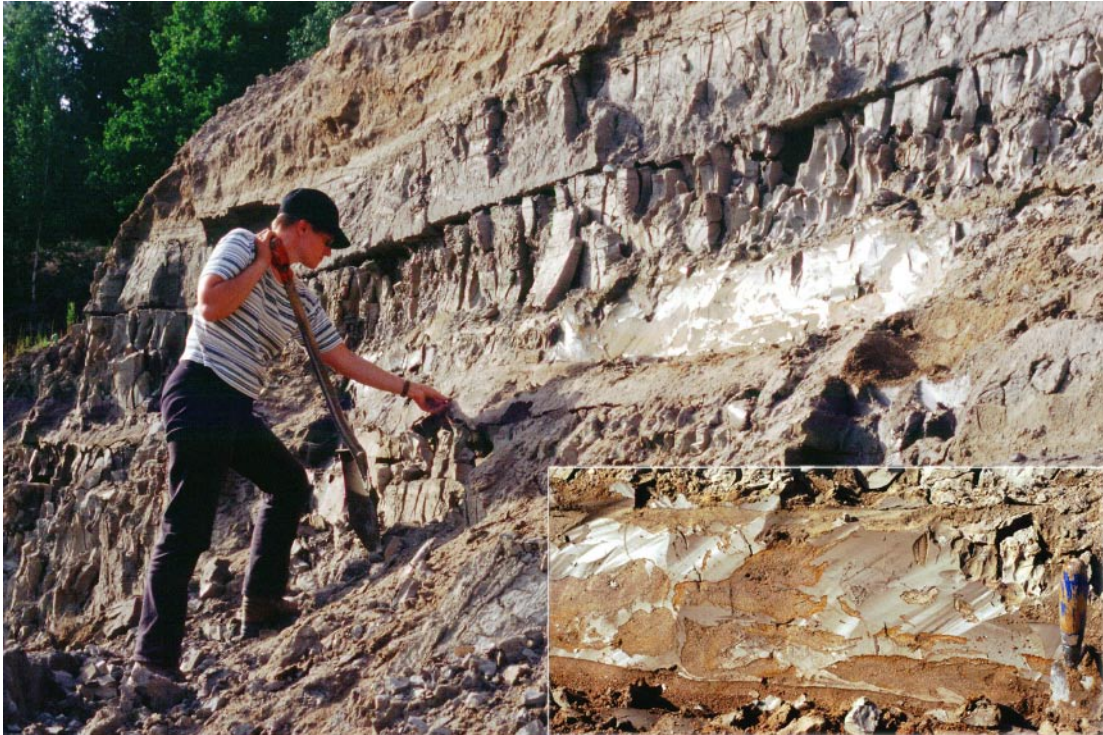
**Figure 5-5.** Complex sediment stratigraphy of alternating sandy and clayey layers in a gravel pit at Helgenäs some 25 km NNW of Västervik. Extensive deformations of unknown origin occurred in two horizons, of which one is shown in the close-up photo in the lower right-hand corner. Due to a long period of drought the clayey beds were extremely tight and difficult to clean, and therefore a more thorough examination had to be postponed.

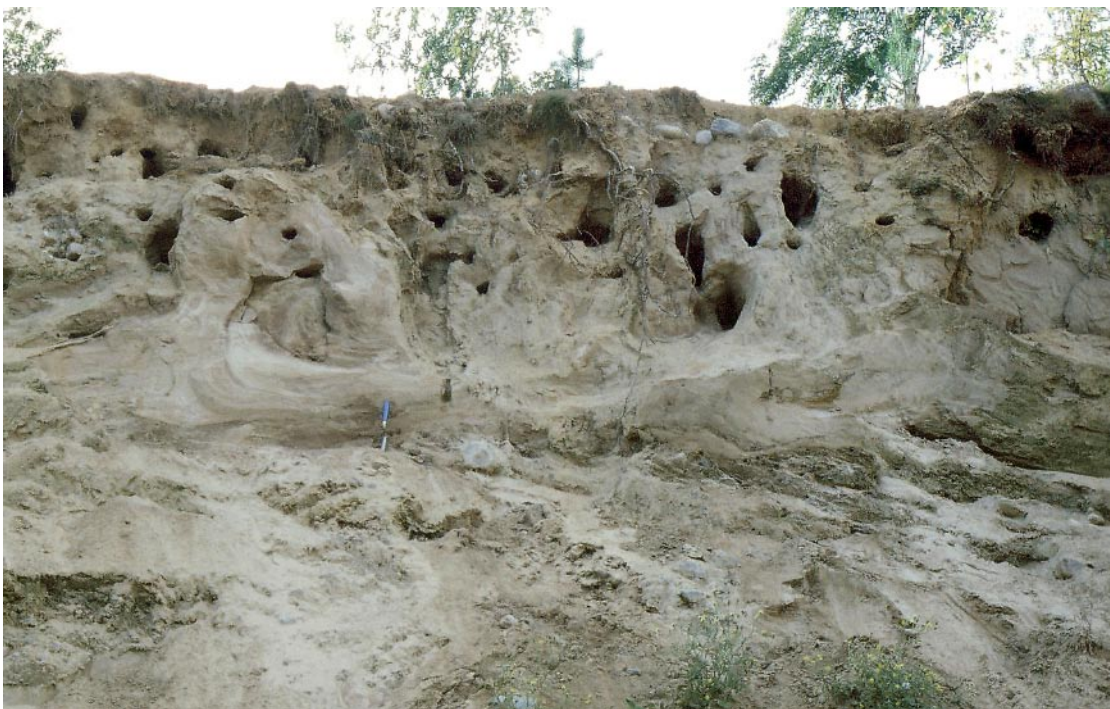
**Figure 5-6.** Strongly deformed bedding in sandy-silty deposits at Finede c 20 km to the north of Vimmerby. The water-lain sediments are partially covered by a thin bed of diamicton, probably glacial till, but to judge by appearances, glaciotectonics can probably be excluded as a cause of deformation. The features resemble seismically induced liquefaction features but the alternative, periglacial involutions developed during the Younger Dryas period, perhaps cannot be ruled out.

No matter if these stratigraphies are the result of oscillations during the last deglaciation or represent deposits from two separate glaciations, glaciotectionics has to be considered a cause for deformational features in the water-lain sediments. Likewise, in areas that are situated above the highest coastline or were raised above the sea during the Younger Dryas period, periglacial processes may have contributed to the deformation of sediments (Figures 5-6 and 5-8)

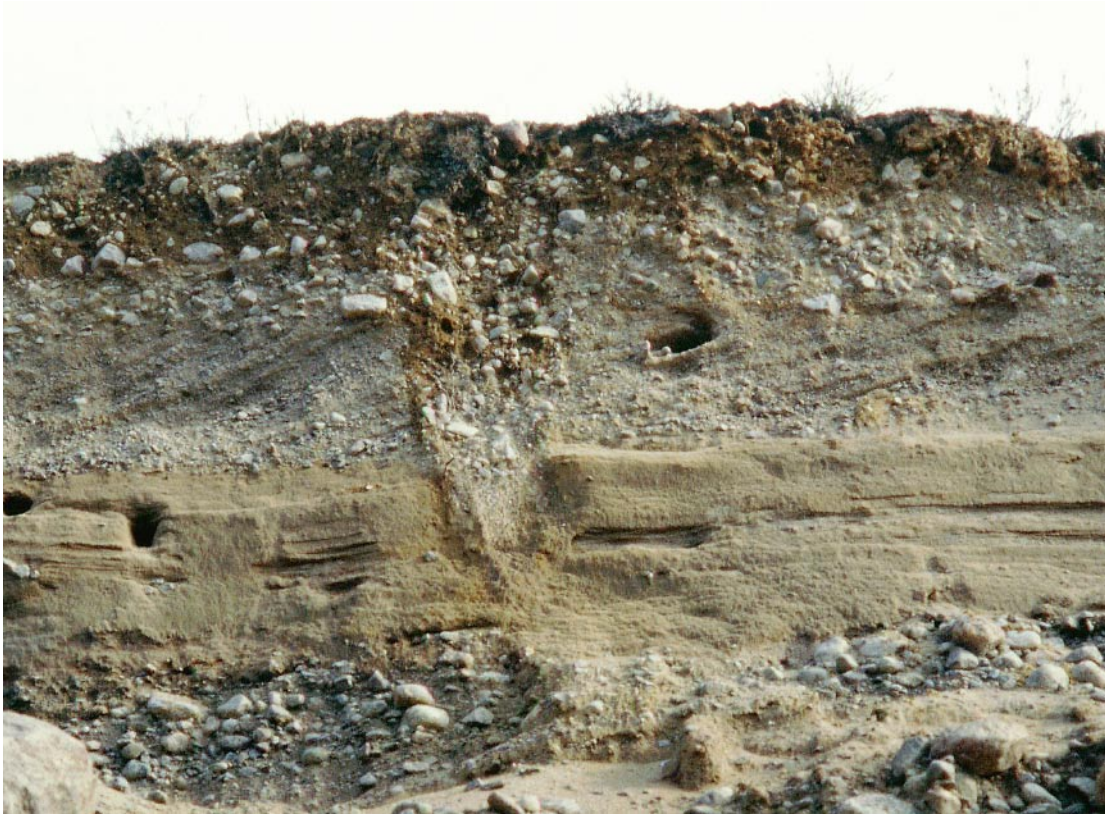
*Figure 5-8. Ice-wedge cast in a gravel pit 1.5 km to the northwest of Södra Vi. Together with numerous ventifacts in the region the feature provides evidence of the periglacial environment prevailing during the Younger Dryas period shortly after deglaciation. Periglacial processes have to be considered when evaluating the origin of deformational features in areas that were raised above the sea during the Younger Dryas.*

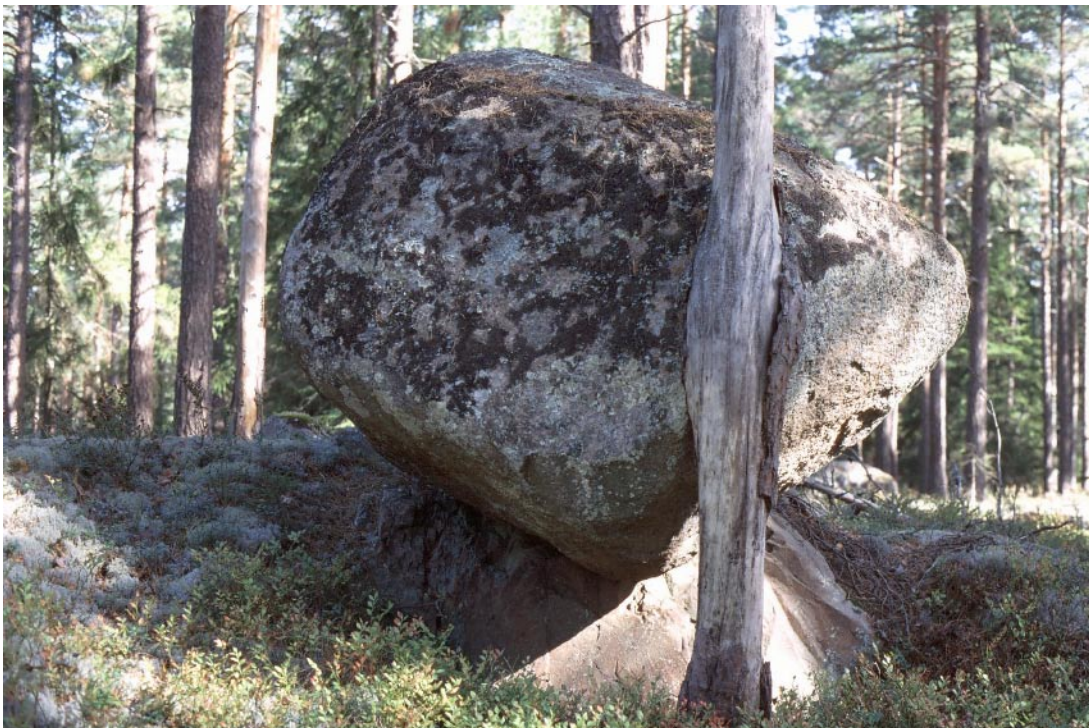
*Figure 5-10. To avoid falling over, this boulder seemingly appears to be supported by the tree. However, as situated above the highest coastline the boulder has probably, without any support, remained in the same position for thousands of years. Boulders in unstable positions occur rather frequently in parts of the investigation area and preferably above the highest coastline, where they have escaped the impact of waves and sea ice.*

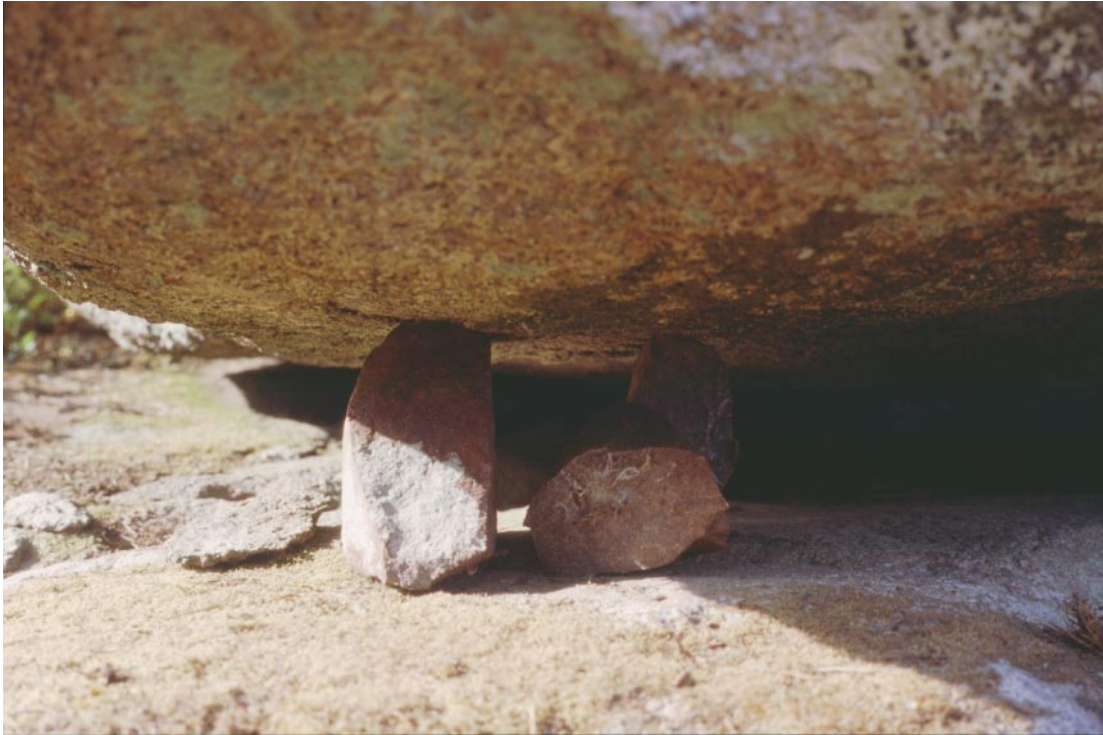
**Figure 5-12.** *Bottom of a big boulder, in the foreground resting on the fragments of a shattered stone but on bedrock at the very back. The primary, pre-shattering surfaces of the fragments as well as the bedrock surface displayed wind-polish, whereas the secondary, cracked surfaces were quite rough. As the wind-polishing probably dates back to the harsh climate prevailing during the Younger Dryas event, the stone obviously resisted the load of the boulder for at least several hundreds of years, but for some reason it cracked sometimes during the Holocene. If more examples of this phenomenon prove to be frequent in the area it might be indicative of a post-Younger Dryas earthquake, but so far this fragile fellow stays without known friends.*

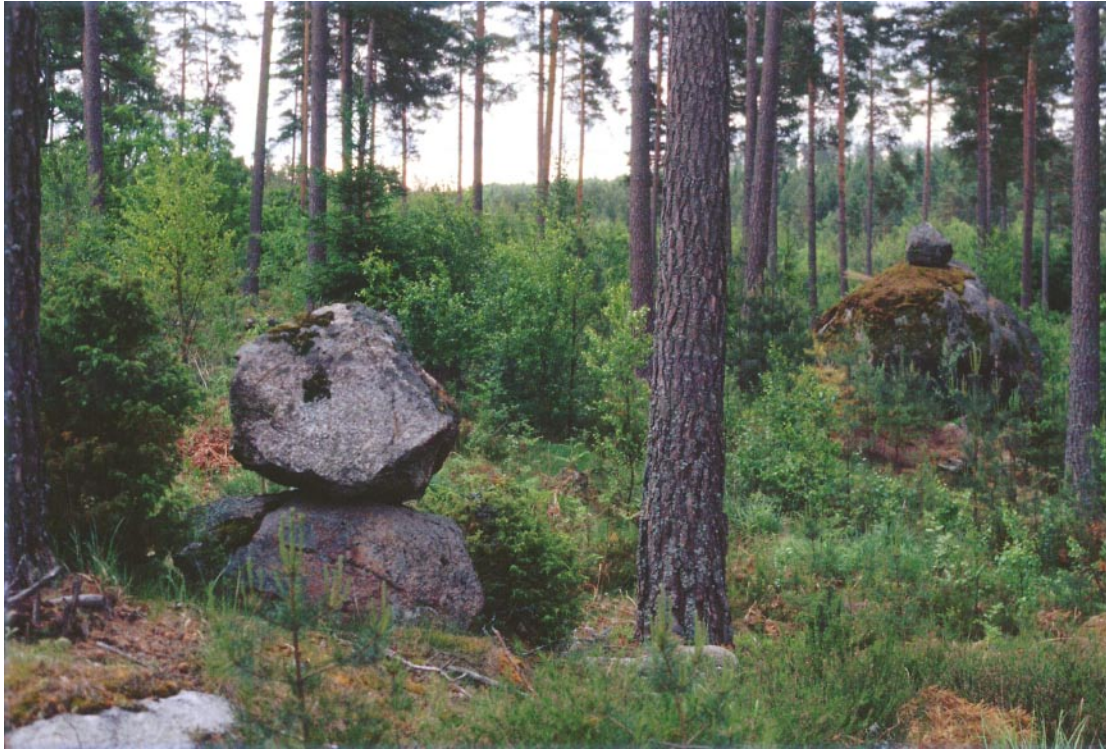
*Figure 5-13. These two perched boulders may serve as low-resolution seismoscopes for the time being, but cannot be used for the refuting of earthquakes in the distant past. The boulders proved to be quite recently piled up by human beings, probably the native people (so-called “smålännigar”) who appears to be genetically predestined to collect and pile stones and, thus, cannot give up this habit despite it no longer being of vital importance for their survival.*

Most of the boulders encountered and considered “unstable” within the investigation area can principally be divided into two categories; a) boulders located on sloping bedrock surfaces (Figure 5-10) and b) large boulders wedged up on small stones (Figure 5-11). Intermediate forms, at one end resting on bedrock and in the other end on one or more minor stones, occur as well (Figure 5-12). A third category, c) boulders perched on top of another boulder, should also be considered. A few boulders belonging to this category were also encountered but not considered very useful as paleoearthquake indicators (Figure 5-13).
