P-05-06

Oskarshamn site investigation

Drill hole KSH01A

Normal loading and shear tests on joints

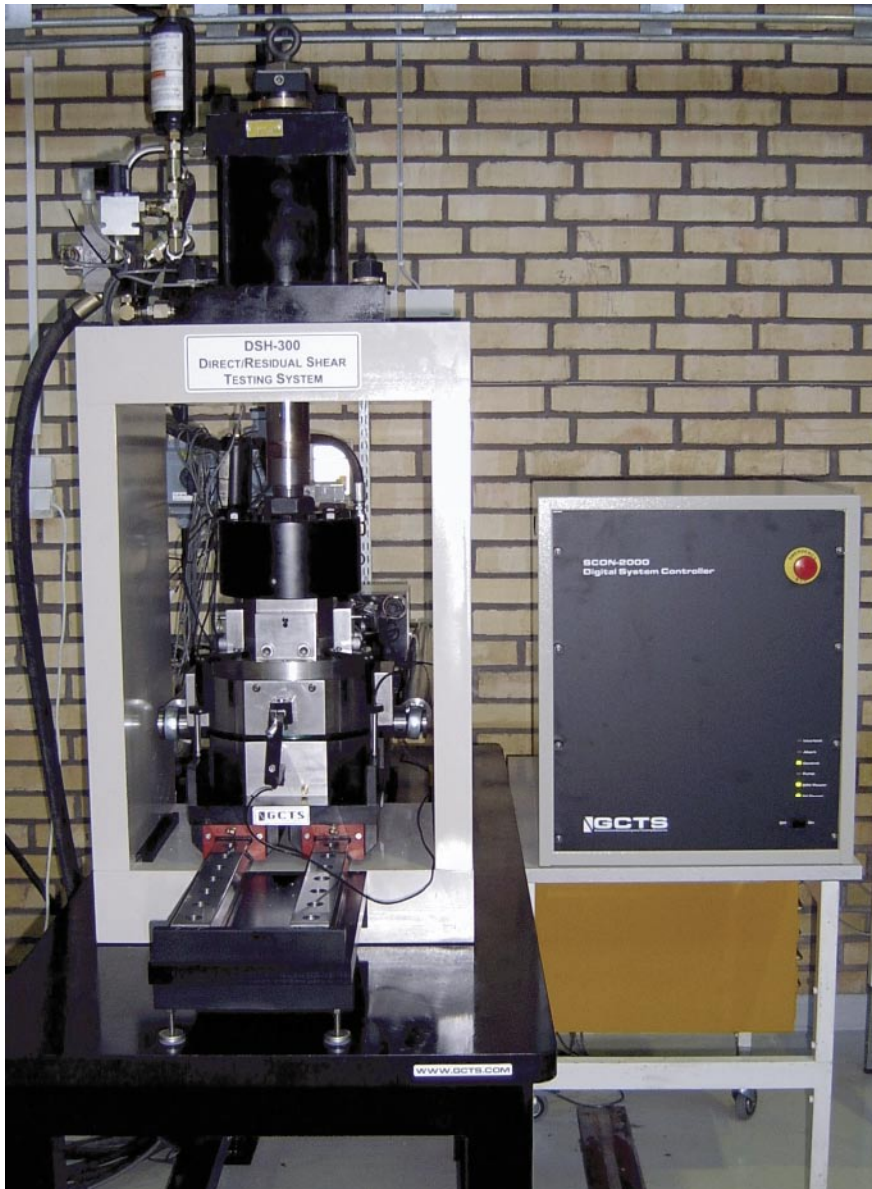
Figure 3-1. Equipment for direct shear tests, i.e. load frame and digital controller unit.

A servo hydraulic testing machine, designed for direct shear tests, has been used for the normal loading and shear tests, see Figure 3-1. The machine has two shear boxes, one upper and one lower. The upper box can be moved vertically and the lower can be moved horizontally. Two actuators, one acting vertically and one acting horizontally, are used to apply the forces in the two directions (degrees of freedoms). Two linear bearings are used for the guidance of the lower box in order to obtain a controlled linear movement. The maximum stroke is 100 mm in the vertical direction and ± 50 mm in the shear direction. The normal and shear displacements are measured by means of LVDTs. The vertical displacement between the shear boxes is measured by four LVDTs, positioned in a square pattern around the specimen, one in each corner. Each of the LVDTs has a measurement range of 5 mm and a relative error less than 1%. The average value of the four vertical LVDTs is used to represent the vertical (normal) displacement presented in the results section. The relative displacement between the shear boxes in the horizontal (shear) direction is measured by one LVDT, which has a 10 mm range and a relative error less than 1%.

The maximum vertical (normal) load that can be applied is 300 kN and the maximum load in the horizontal (shear) direction is ± 300 kN. Load cells are used to measure the forces in both directions. The accuracy of the load measurement is within 1%. The machine is connected to a digital controller with a computer interface for setting up and running tests.

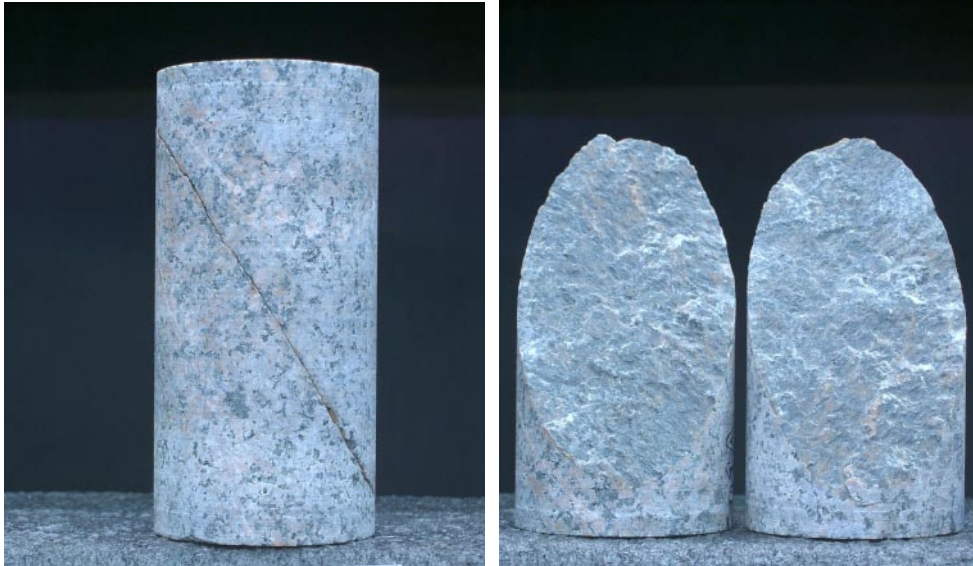
Specimen ID: KSH01A-117-1

Before mechanical test

The rock specimen in the upper half has cracked on the edge of the rear end.

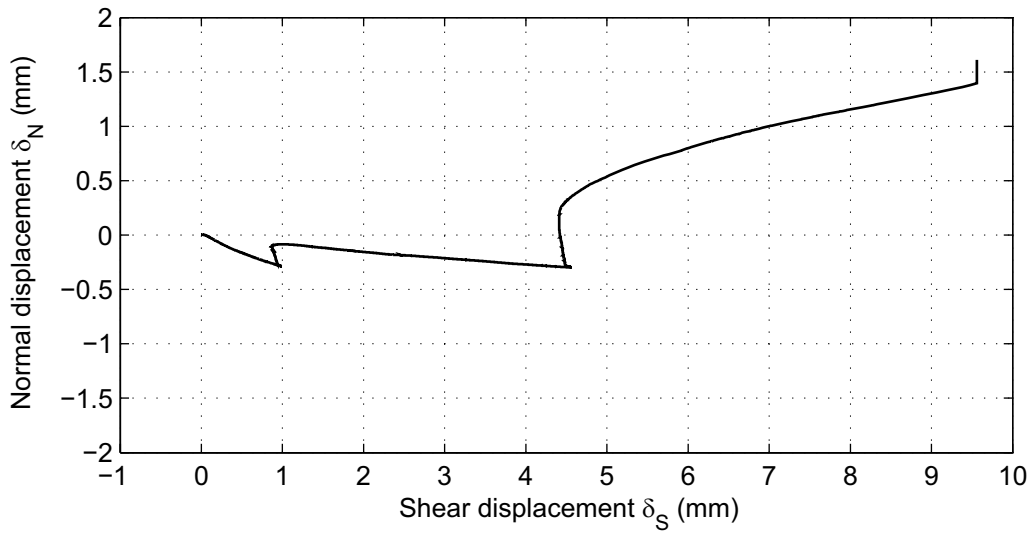
Specimen ID: KSH01A-117-01

Shear area : 37.3 cm²

The specimens and joints before casting and after testing are shown on pictures. Comments on observations appeared during the testing are reported. The results are shown in diagrams. The upper diagrams show the results from the normal loading tests. The black curve displays the measured data and the red curve displays the adjusted data, cf Section 4.5. The diagrams in the middle show the results from the shear tests and the lower diagrams show the joint dilation during the shear tests.

Two methods were used during the shear tests. The three shear cycles were supposed to be carried out successively without repositioning the shear displacement to the starting position after every cycle. The shear box was repositioned to the starting position before the third shear cycle was conducted in some tests when the shear displacement exceeded about 5 mm after the second load cycle. The green curves show the results from the restarted shear tests. Furthermore, the red triangle markers show the peak shear stresses and the red square markers show the residual stresses.

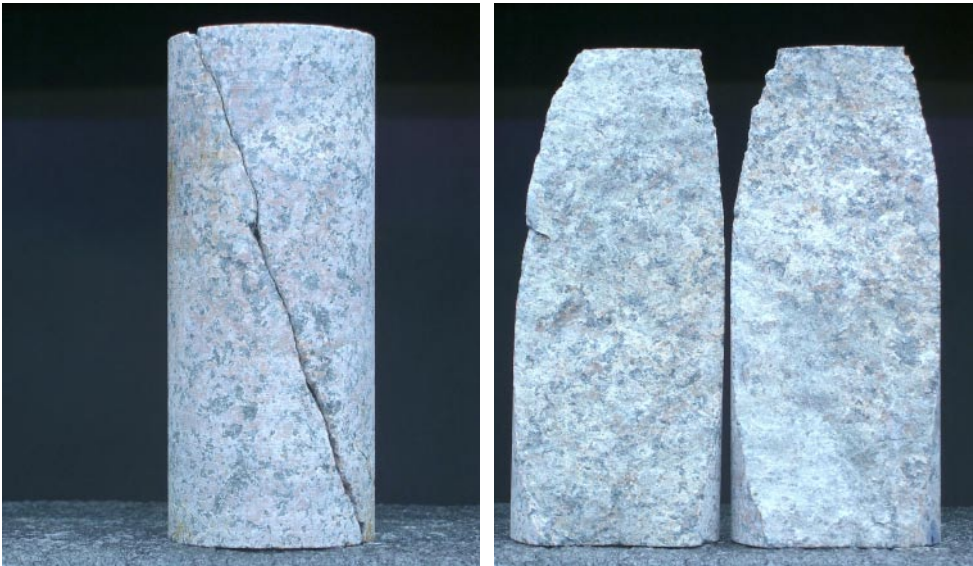
Specimen ID: KSH01A-117-3

Before mechanical test

Comments The rock specimen in the lower half has cracked in many places and has lost the attachment to the cement.

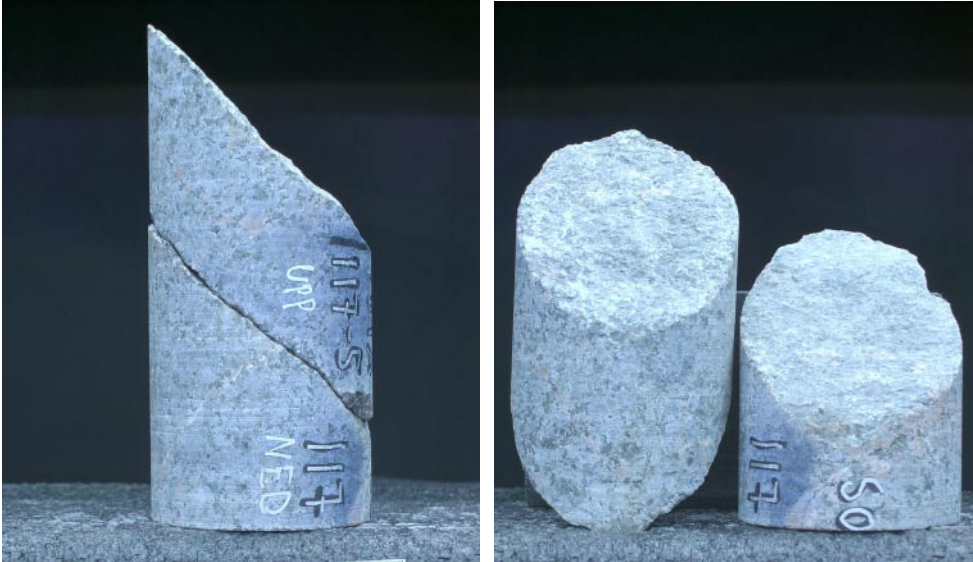
Specimen ID: KSH01A-117-5

Before mechanical test

Comments Lower specimen half has cracked in one place. The crack is thin and perpendicular to the shear direction.

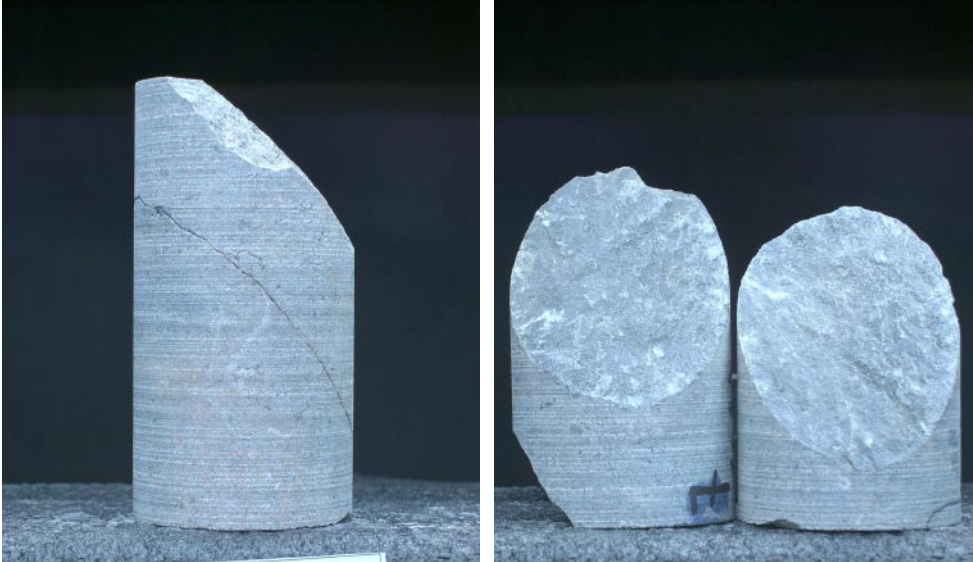
Specimen ID: KSH01A-117-8

Before mechanical test

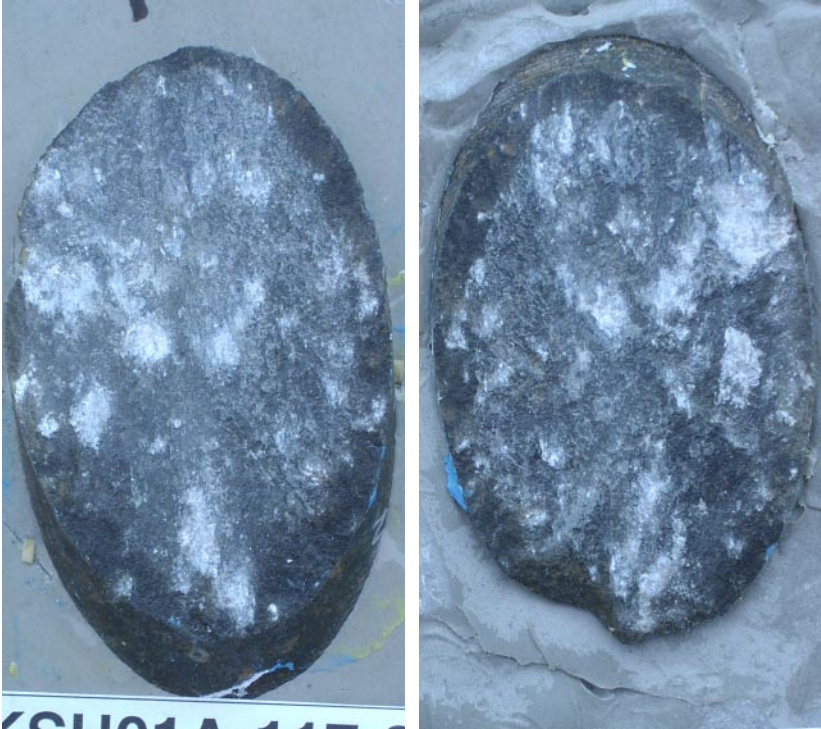
After mechanical test

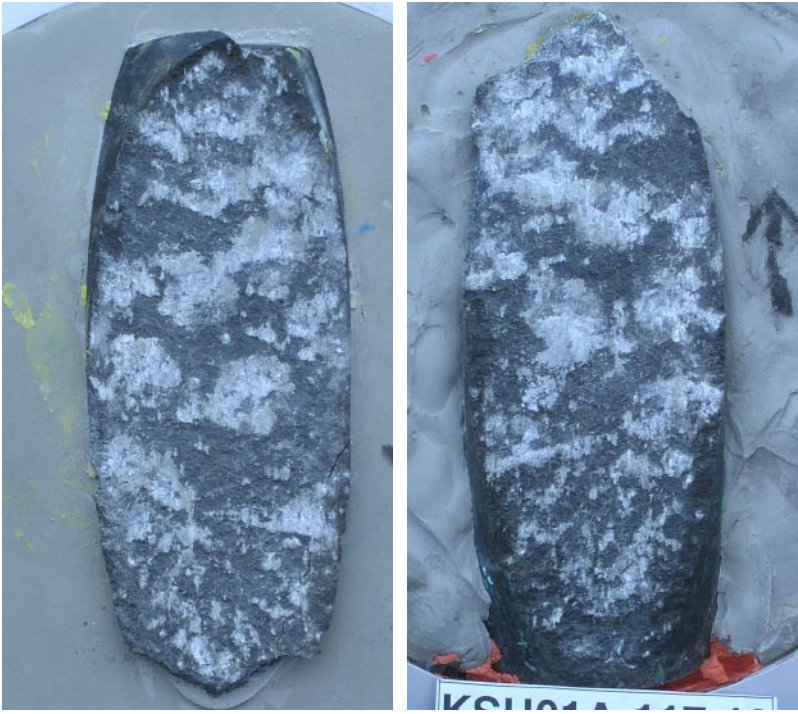
After mechanical test

Comments Lower specimen half has cracked on the edge of the end.

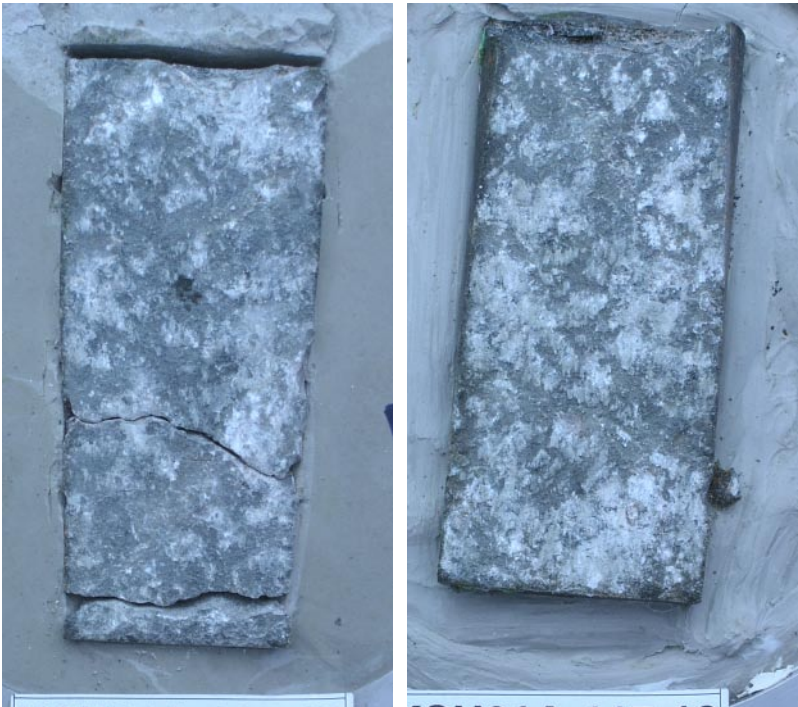
After mechanical test

Upper half: The cement has cracked behind the specimen in the shear direction and the specimen has lost its attachment to the cement.

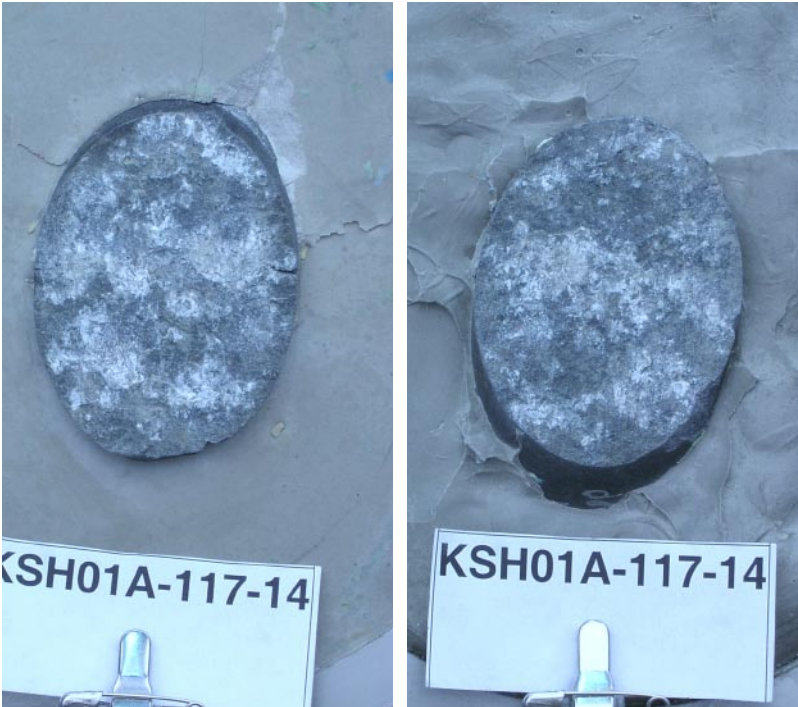
After mechanical test

Comments Lower specimen half has cracked in one place. The crack is thin and perpendicular to the shear direction.

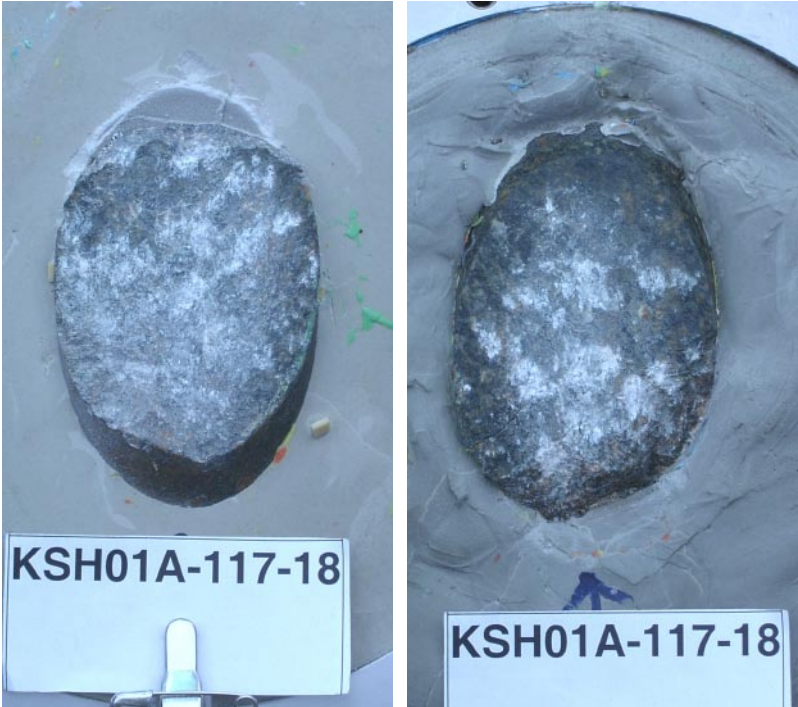
After mechanical test

Comments Upper half: The specimen has cracked. Lower half: The specimen has cracked on the edge of the end.

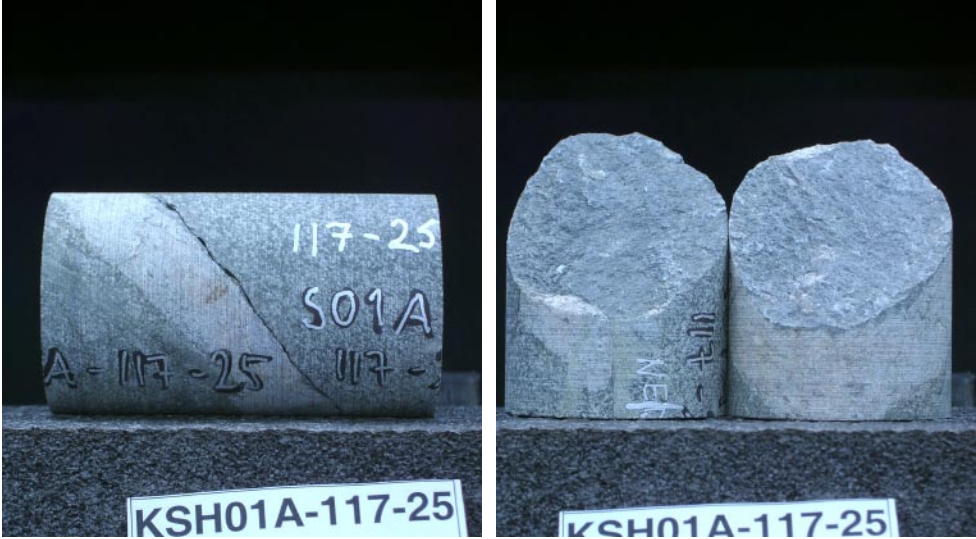
Specimen ID: KSH01A-117-25

Before mechanical test

Upper half: A protruding part of specimen has been crushed. Lower half: The specimen has cracked on the edge of the end.

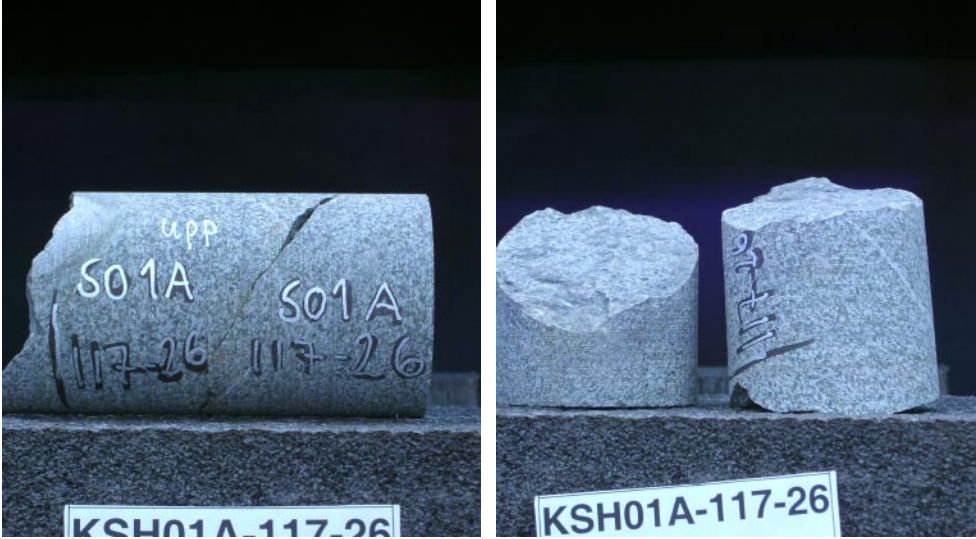
Specimen ID: KSH01A-117-26

Before mechanical test

Comments Upper half: The specimen has cracked in many places in the rear end.
