R-05-02

Äspö Pillar Stability Experiment

Final experiment design, monitoring results and observations

December 2005

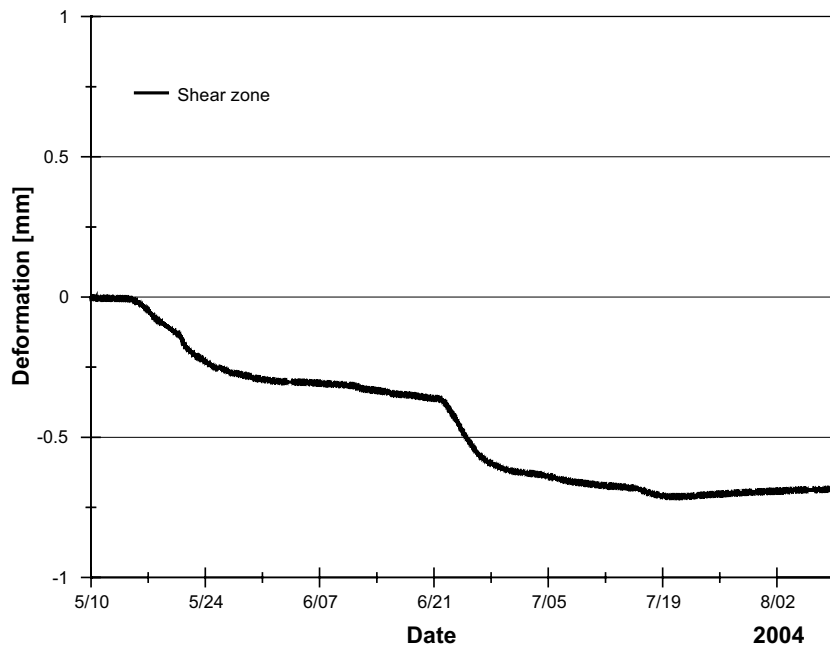
The LVDT placed along one of the larger fractures in the ductile shear zone indicated some movement along the plane of the shear zone. The deformation was quite small, approximately 0.5 mm. The plot is presented in Figure 5-31. The LVDT is extended which means that the right part of the shear zone has moved to the left.

Figure 5-31. Deformations along the shear zone at the top of the pillar.

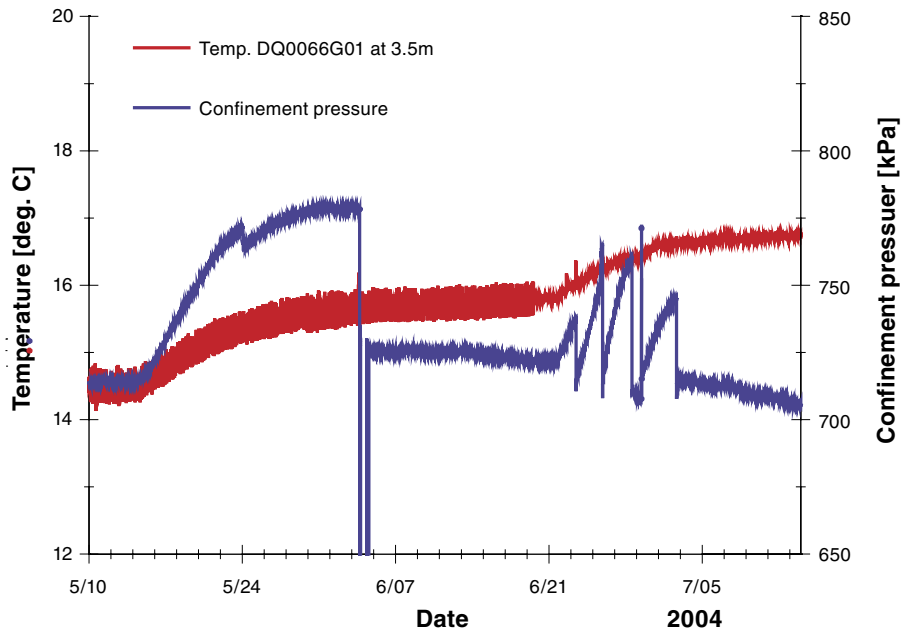
The confinement worked as planned. As expected, the pressure in the bladder increased with increasing temperature due to the volumetric expansion of the water, which also is evident when studying Figure 5-32. The pressure in the system had to be reduced on a number of occasions to keep the pressure close to the target pressure of 700 kPa. On one occasion the pressure increased at the same time as a cluster of acoustic events were recorded at a depth of 4.7 m on the confined hole's pillar side. At the end of the experiment, no physical trace of the acoustic cluster such as spalling or fracturing could be detected. It is nevertheless likely that a small displacement of the rock took place on that occasion that reduced the volume of the hole and hence increased the pressure in the hole. Since the system is stiff, very small changes in volume affect the pressure.

Figure 5-32. Confinement pressure and temperature on the hole wall in DQ0066G01 at a depth of 3.5 m. The temperature-pressure effect is quite clear, as well as the occasions when the pressure was adjusted. On June 4 the pressure did not fall, as dramatically as the graph indicates. The valve to the transducer was maintained and atmospheric pressure was logged just after the pressure decrease to 725 kPa.

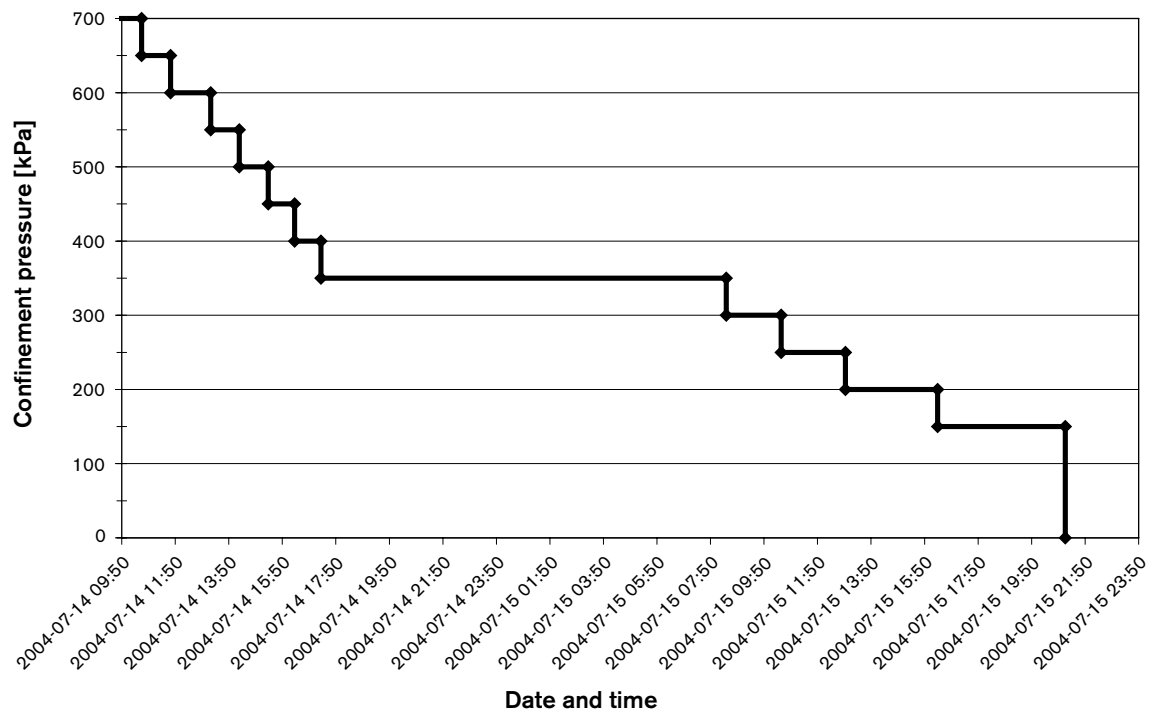
The pressure was reduced in 50 kPa decrements. After each decrement the pressure was kept constant until the acoustic emissions indicated that the spalling in the rock had ceased again. The times of the pressure decrements are presented in Figure 5-33. In the log one can see that the pressure was dropped from 150 kPa to 0 in one decrement. This was not the intention. The reason was that the pressure transducer malfunctioned and recorded a pressure of 150 kPa even when it had been removed from the confinement equipment. The transducer was checked at the surface the next day and performed as it should. The reason for the malfunction is probably that a small part in the transducer jammed on that occasion. There is therefore no reason to believe that the previously recorded pressures are corrupt.

Figure 5-33. Graph of confinement pressure versus time during confinement release in DQ0066G01.

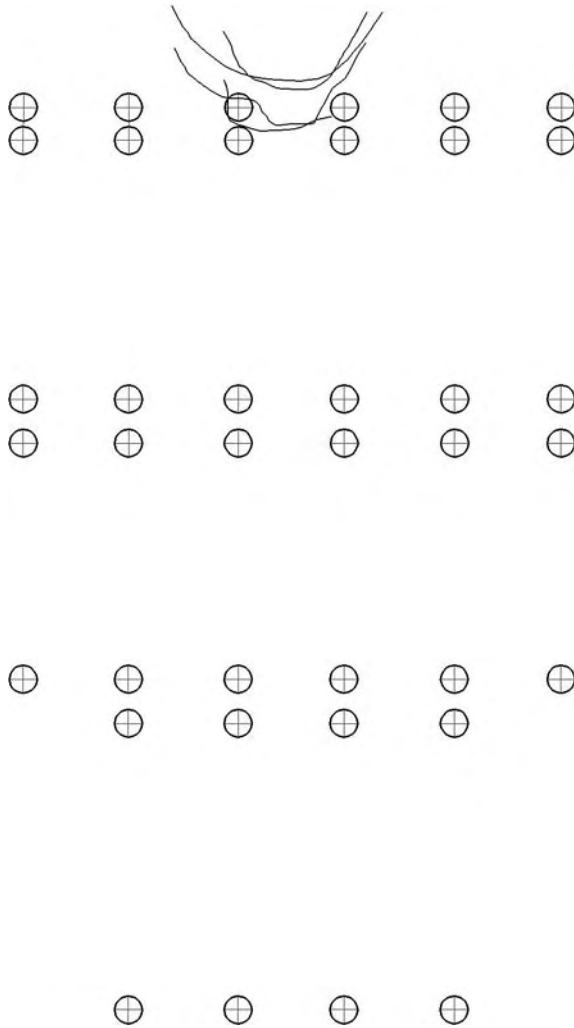
During the weekend April 30 to May 3 spalling occurred and the notch moved down between the instrument positions #3 and #4 (the locations of the instrument positions are given in Table 3-5). The spalling could be correlated with acoustic signals and with small deformations. It is clear that the extent of the spalling was affected by the force applied to the rock by the springs in the LVDT sensors. As can be seen in Figure 5-35, the fracturing occurs around the steel plates. This is also the first time that small radial expansion displacements (contraction) directed into the pillar were noticed.

Practically no displacements or any acoustic events of importance took place until May 12. In the afternoon, the AE system started to pick up events and at the same time position #3 was displaced almost 1 mm. A visit was therefore made in the hole and the new fracturing was sketched. The summary sketch in Figure 5-35 shows that a small slab was created beneath the #3 instrument plate. The slab was terminated close to instrument plate #4 where the force from the LVDT spring was probably large enough to suppress the spalling.

Figure 5-35. Summary sketch of the spalling observations between April 26 and May 14. The lines represents fractures.

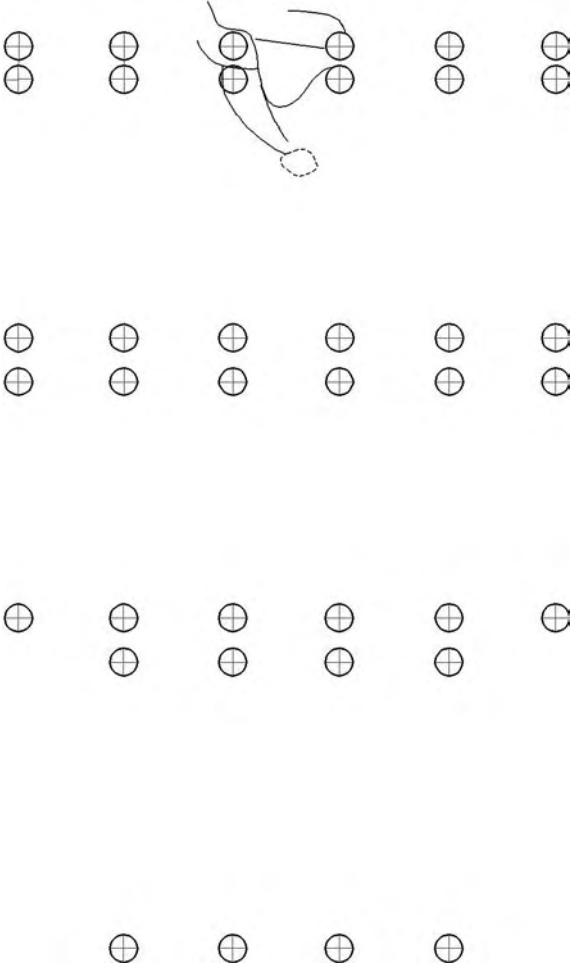
Fracturing/slabbing associated with the other recordings includes a slab that was created beneath the short-range sensor at position #3. Fractures from that slab extended down the hole approximately 15 cm, where chipping occurred in a small mylonitized (dashed line) area. Still no fractures go past any of the sensors at position #4. The increasing dilation of the previously formed slabs is clearly visible. The dilatation of the fractures was approximately 1–2 mm.

Figure 5-36. Spalling observations, May 18. Dashed line, chipping in mylonitized area.

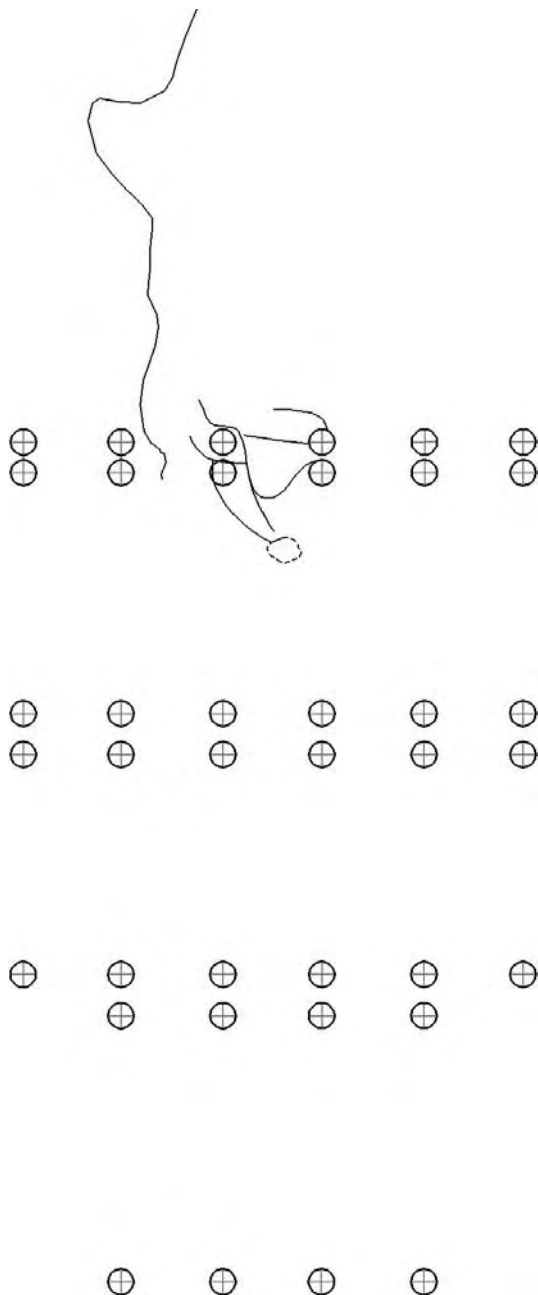
The downward spalling propagation was very small on this date compared with the earlier observation dates. The slabs already formed continued to dilate, however, on May 25 a slab fell off the borehole wall. The upper part of the slab was attached to the rock wall and the lower part was forced to dilate by the underlying slabs (the long line in the figure). The edge of this slab was dilated between 10 to 20 mm. The slab was broken in a thin sub-horizontal pegmatite vein at the upper end of the long line.

When the hole was mapped that day, the increasing dilatation was obvious. Chipping continued in the thin mylonite band and the dilatation of the fractures from the rock wall was 5 to 10 mm. Figure 5-38 presents the spalling observations and Figure 5-39 shows photographs of positions #3 and #4.

Figure 5-38. Spalling observations May 25.

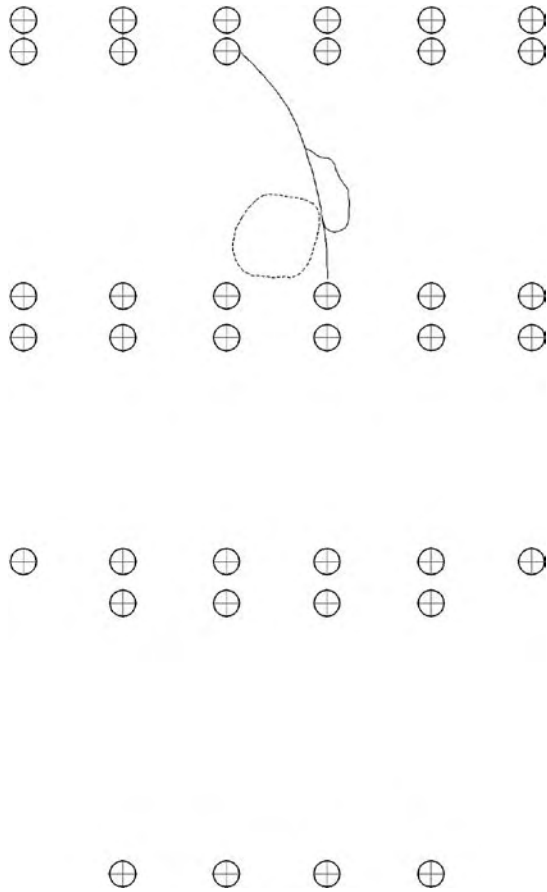
On May 28, displacements on the mm scale occurred at both the 2.5 and 3.0 m levels. A check was made in the hole but no new fractures were seen. There were some small additional chips between positions #9 and #10 (3 m level). Generally larger dilatation at almost all existing fractures was observed, Figure 5-40. A photograph of sensor position #3 is presented in Figure 5-41.

Figure 5-40. Spalling observations May 27. Dashed area – chipping. Oval area chips in mylonitized rock.

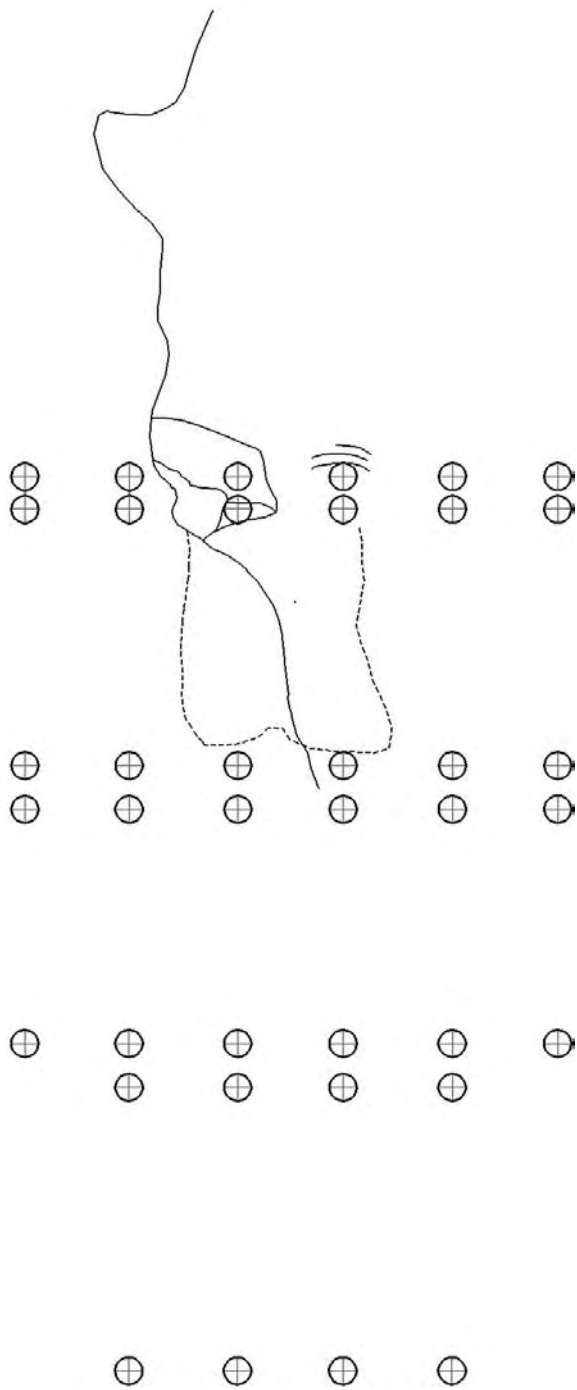
Chips had now formed around the centre instruments at the 3 m level between positions #9 and #10. Areas with small chips as well as increased dilatation in the preexisting spalling fractures were observed as well as drummy areas (inside dashed line) in Figure 5-42. A sub vertical granite vein above position #4 is drummy and small chips is formed around it. The dilatation of the long fracture above position #2 is approximately 20 mm. The photographs in Figure 5-43 shows the fracturing at position #10, which was not present at the previous hole visit. The figure also shows position #3.

Figure 5-42. Spalling observations on June 2. Small chips and drummy inside spalled line.

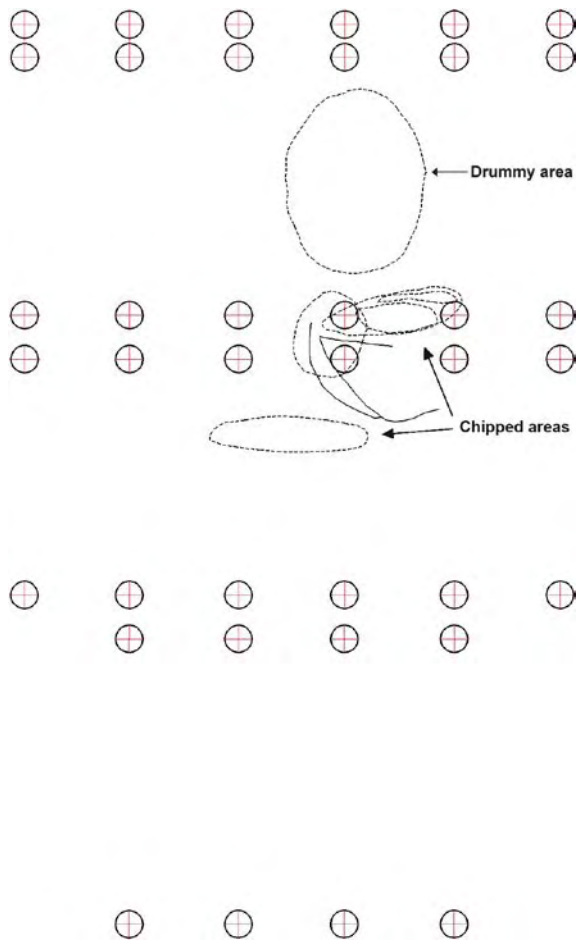
The spalling had now propagated below the instrument level at 3 m. A drummy area was formed between the instrument levels at 2.5 and 3 m (large dashed area). Chipping had occurred between the instrument positions #10 and 11 (small dashed ovals). Small chippings in a limited area were observed at the centre of the pillar just below the 3 m instrumentation level (oval dashed area). The spalling is illustrated in Figure 5-44 and photographs of the spalling at the 2.5 and 3 m levels are presented in Figure 5-45.

Figure 5-44. Spalling observations on June 8.

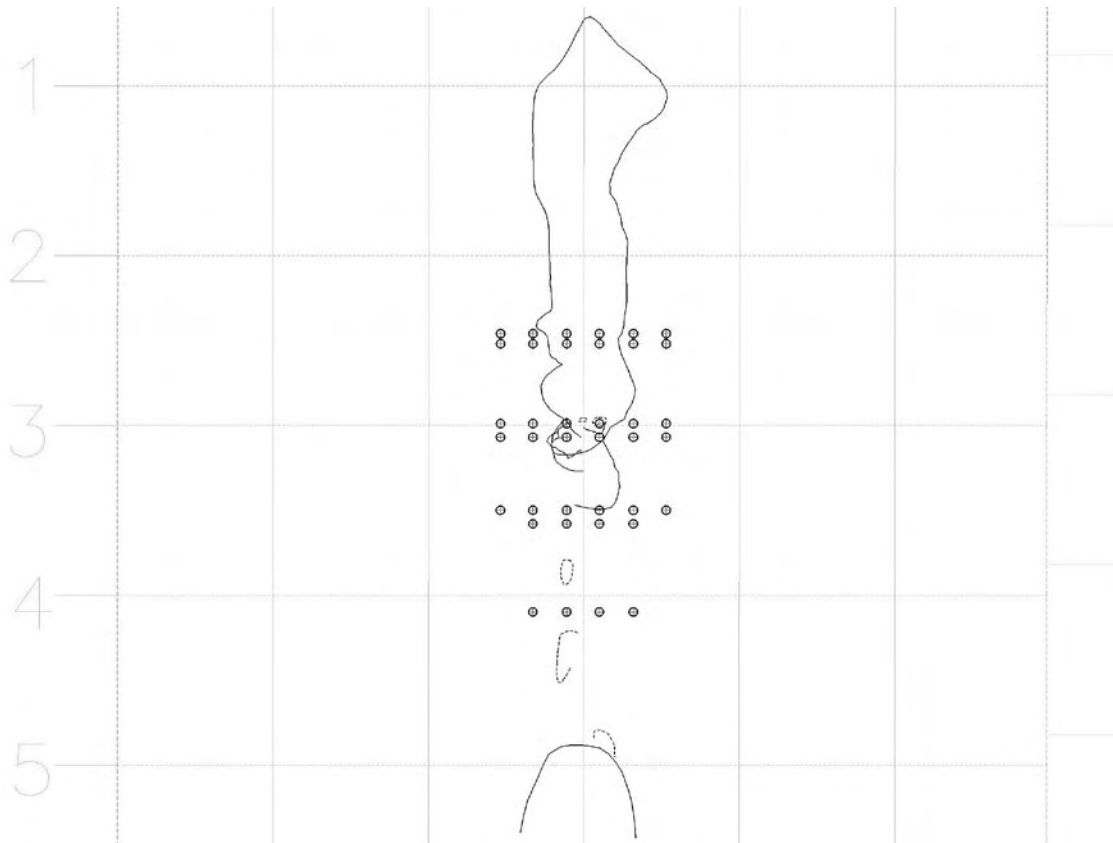
The major difference since the last spalling observation was that the spalled zone had widened in the horizontal direction at 3 m. Thin finger nail sized chips were formed between the pillar centre and the long curved dashed line, Figure 5-47. Small areas with limited spalling were observed just above 4 m and at approximately 4.5 m depth (dashed lines). At 4.5 m the spalling was associated with an inclusion of greenstone. Just above 5 m depth spalling was initiated in mylonitized rock close to an existing fracture. The dilatation of the fractures above the 3 m instrument level lies between 10 to 20 mm. The spalling is illustrated in Figure 5-46 and Figure 5-47. Photographs of the spalling at the 2.5 and 3 m levels are shown in Figure 5-48.

Figure 5-46. General extent of spalling on June 16.

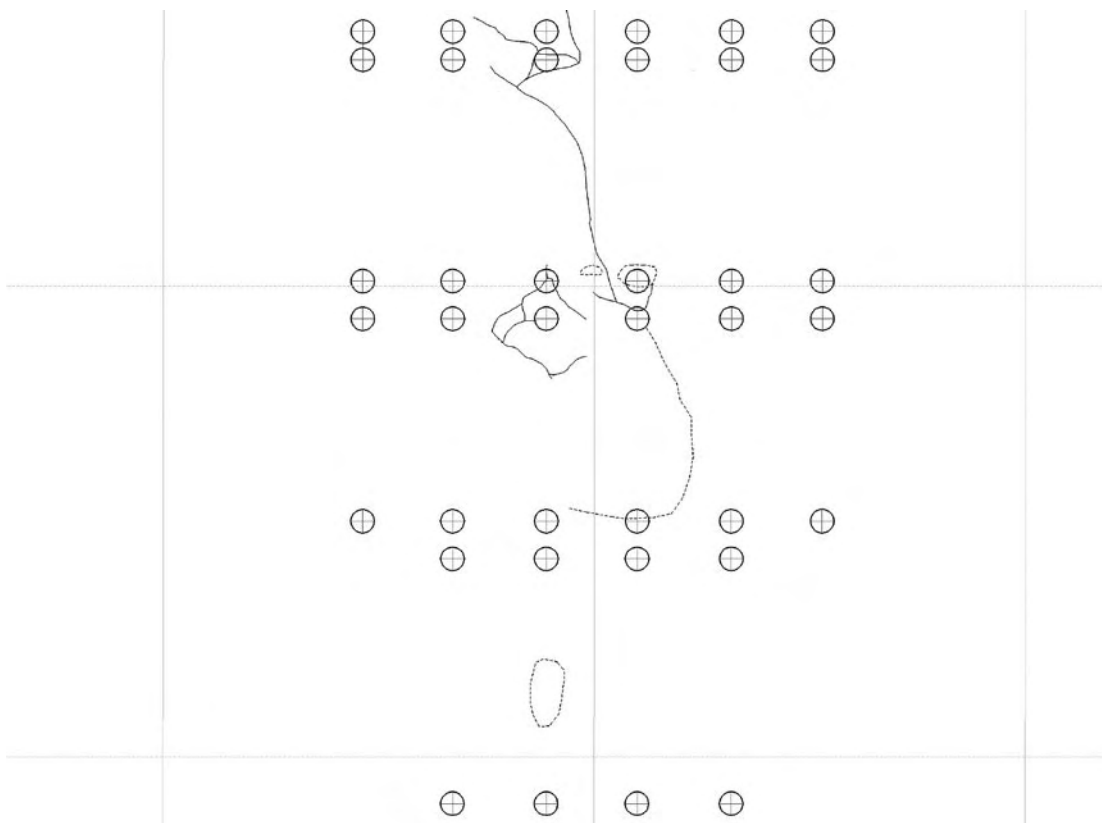
Figure 5-47. Detailed spalling observations on June 16. At 3 m depth a small rock fragment had fallen of at the very pillar centre (dashed oval).

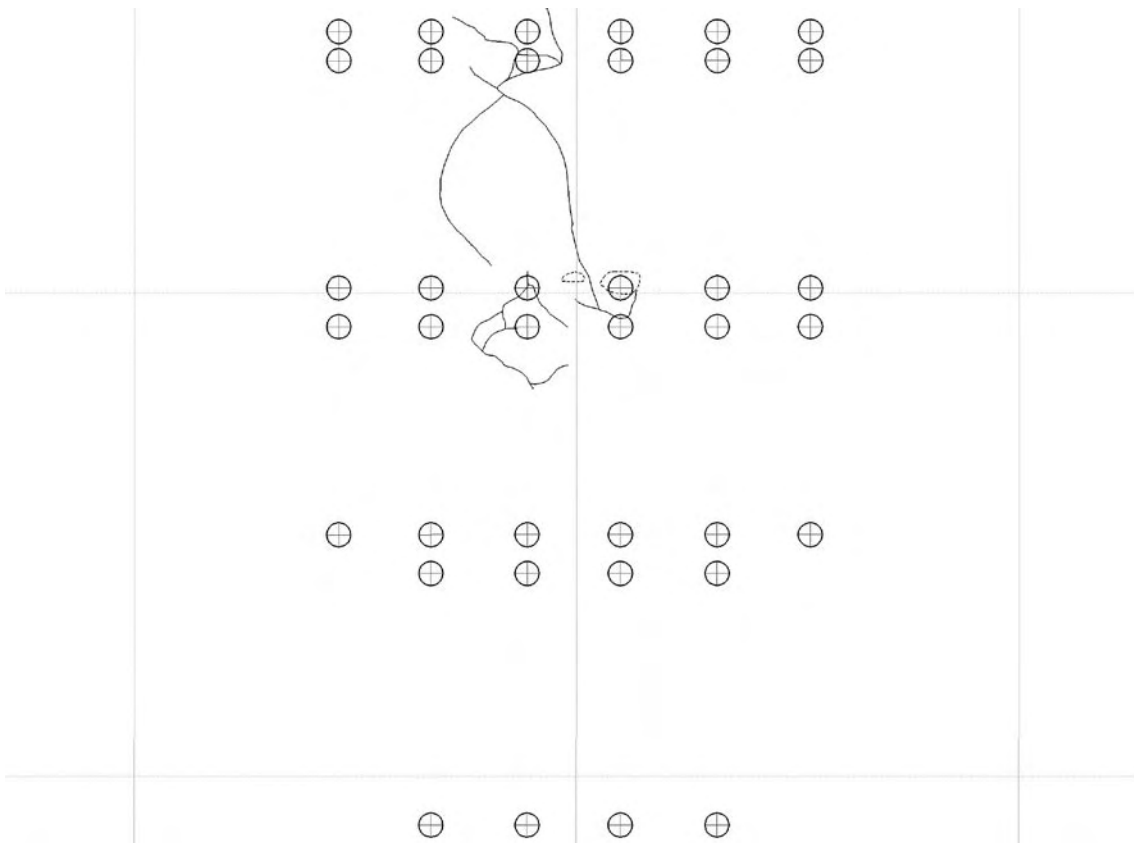
Chipping had now occurred slightly to the left of the pillar centre at between the 2.5 and 3 m instrument levels in the area created by the lines. The chips there were thin with a width of approximately 5–10 and length of 10 centimetres. The dilatation of the fractures above the 3 m instrument level lies between 10 to 20 mm. The spalling is illustrated in Figure 5-49 and photographs of the spalling at the 2.5 and 3 m levels are shown in Figure 5-50.

Figure 5-49. General extent of spalling on June 23.

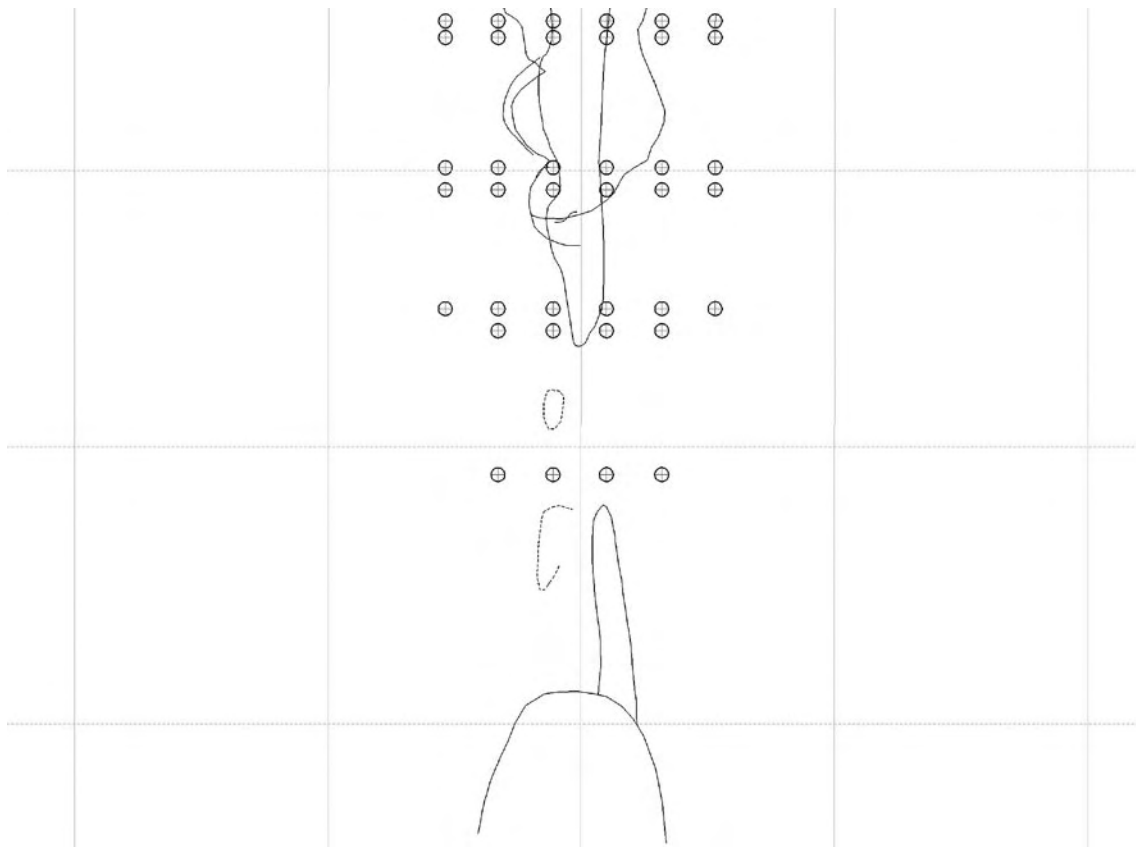
Now the spalling had propagated to the 3.5 m instrument level. The spalled zones at approximately 4 and 4.5 m had the same area but were more spalled. The oxidized and mylonitized part of the pillar at approximately depth of 5 m had continued to spall. The spalling had propagated upwards and had reached a hole depth of 4.2 m. The notches in the two spalling fronts seemed to be moving directly against each other. Quite a lot of small fractures are formed around instrument position #10 lower. The U-shaped line at the 3.5 m instrument level contains thin chips from coin size and up. The spalling is illustrated in Figure 5-51 and Figure 5-52. Photographs of the spalling at the 2.5 and 3 m levels are shown in Figure 5-53. Nothing seems to have happened in the upper part of the pillar.

Figure 5-51. General extent of spalling on June 29.

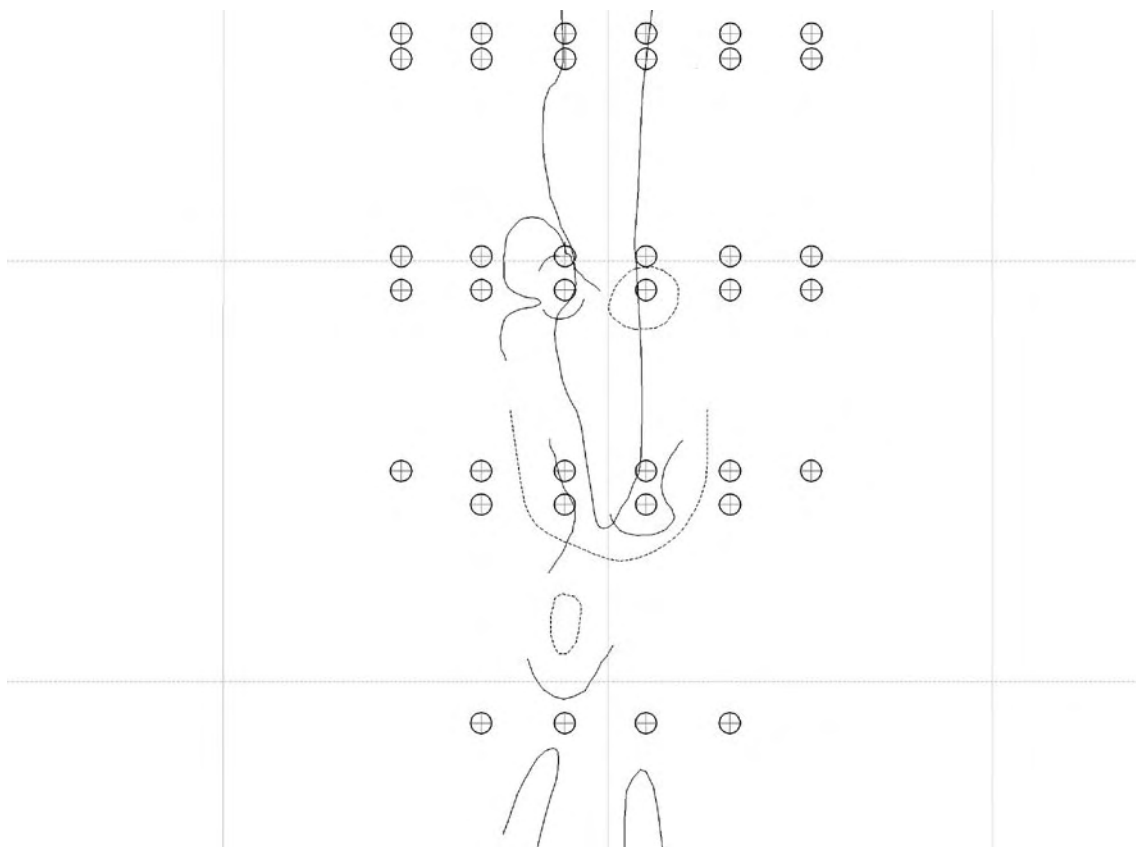
Figure 5-52. Detailed spalling observations on June 29.

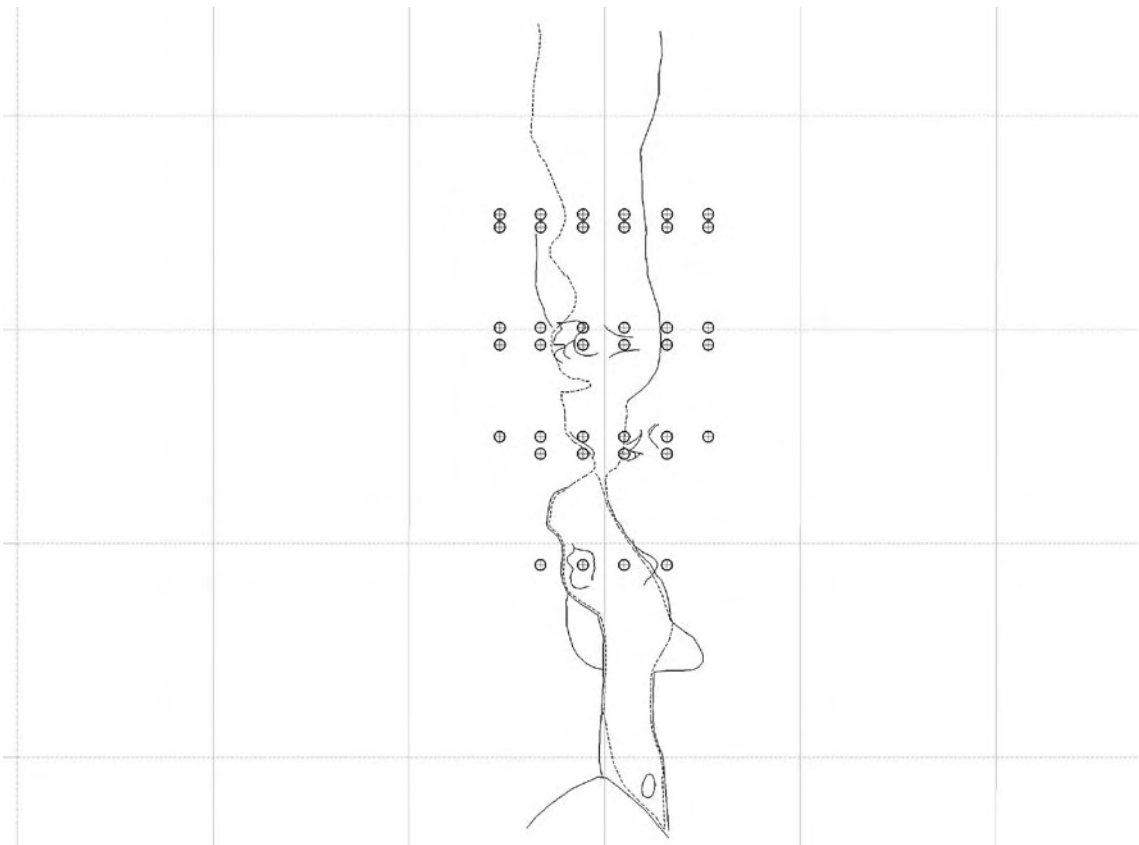
The upper and lower spalling fronts were now joined. Additional fracturing was observed at the 3, 3.5 and 4.1 m instrument levels as well as at a depth of 5 m close to a fracture trace. The spalling is illustrated in Figure 5-54 and Figure 5-55. Photographs of position #10 and #16 in Figure 5-56.

Figure 5-54. General extent of spalling on July 6.

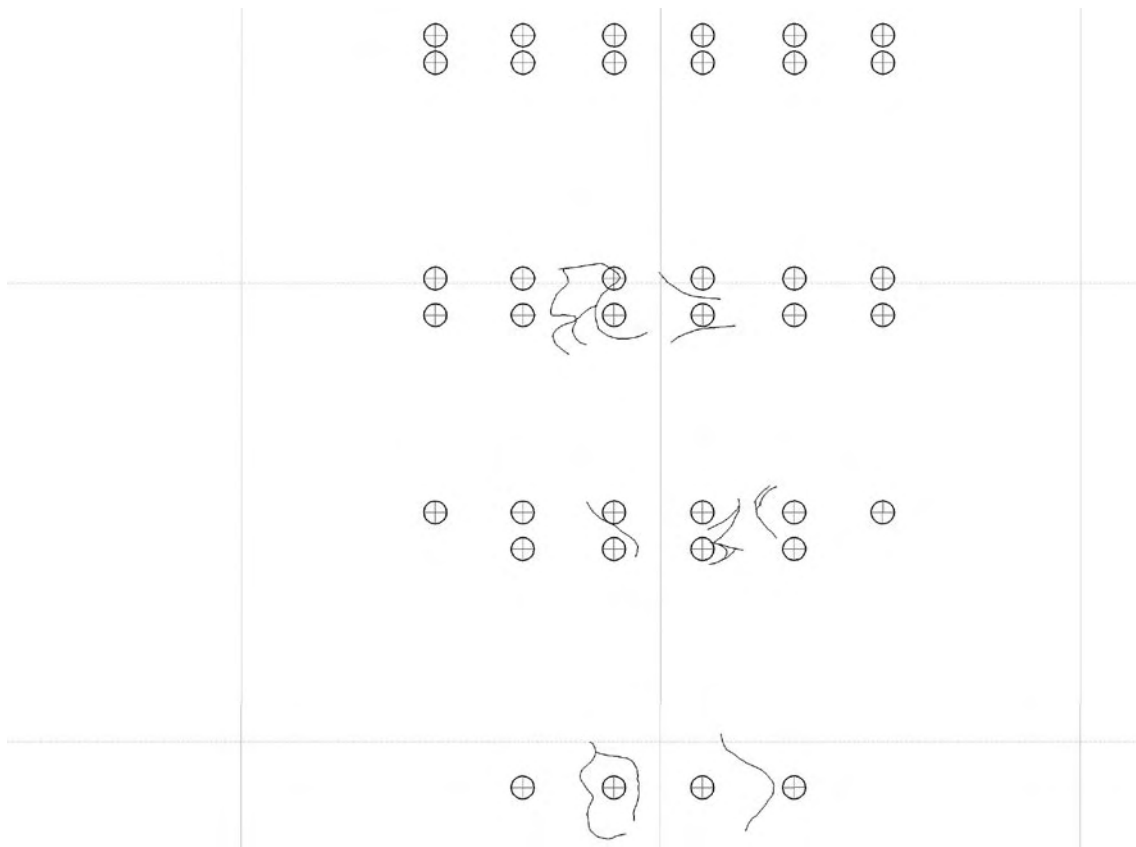
Figure 5-55. Detailed spalling observations on July 6.

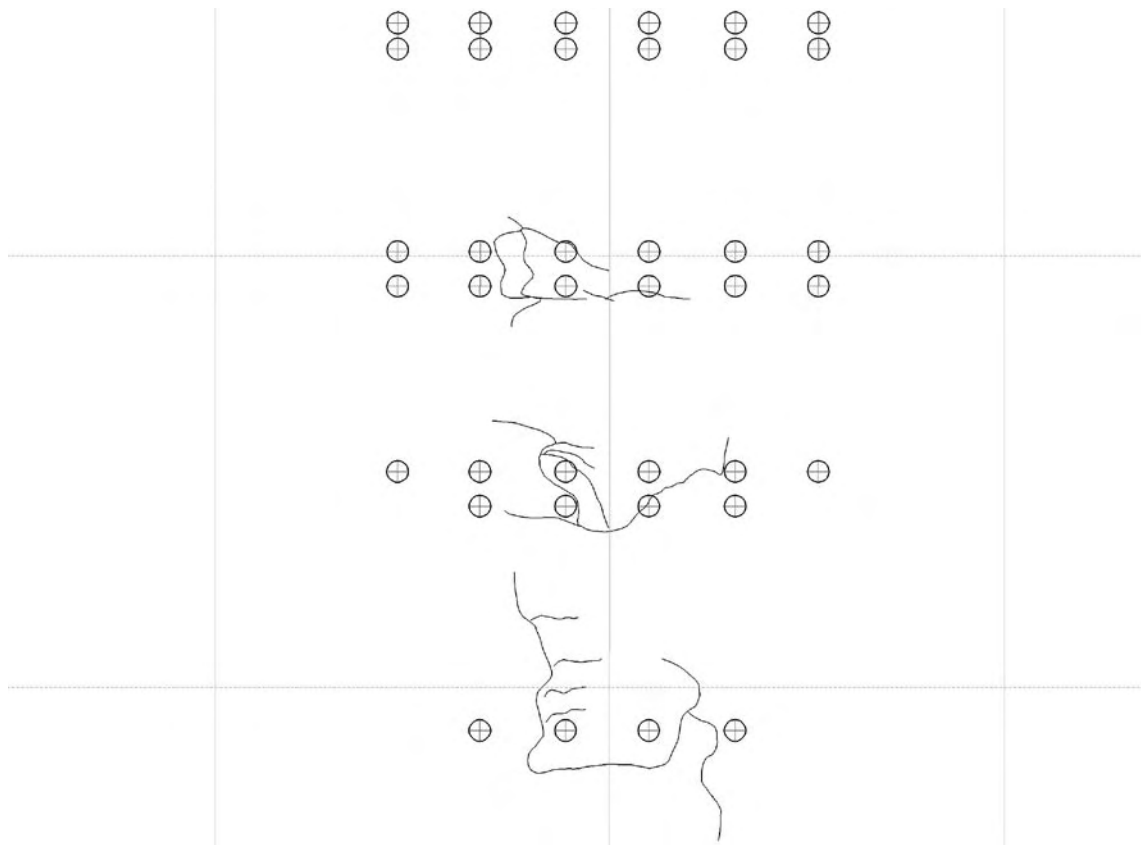
A few new fractures were observed. Dilatation was increased at most locations, but fracture propagation had probably almost ceased due to the fact that the temperature was reaching a constant level and hence very small additional thermal stresses were being added. The spalling is illustrated in Figure 5-57.

Figure 5-57. Spalling observations July 12.

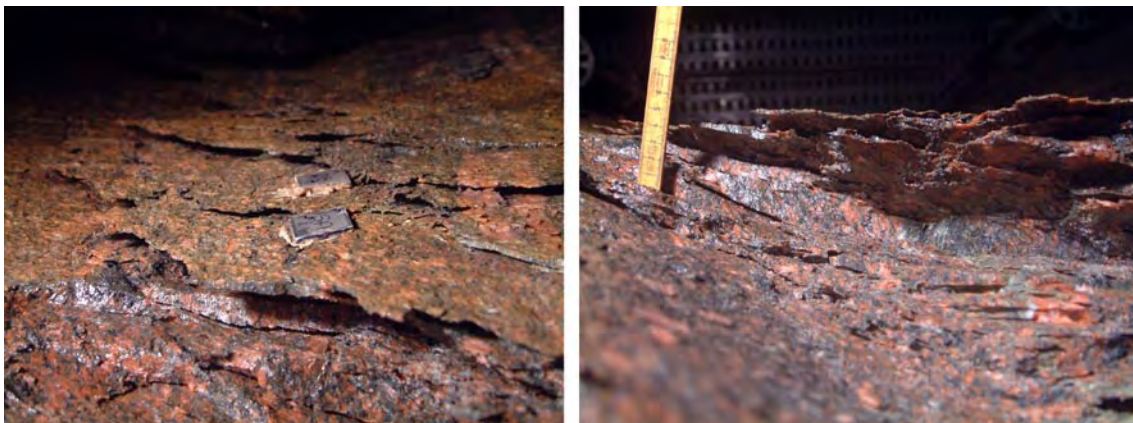
The notch surface between 3.2 to 2.7 m is quite smooth, Figure 5-64, especially above 3 m, and arching of the chips is visible. The slabs closest to the hole surface are the largest, after which the slabs decrease in size only to increase again at the notch bottom. It is mainly the slabs closer to the tip of the notch that are arched. As the 2.5 m instrument level is approached, an excellent view is obtained of the slabs beneath instrument position #3, Figure 5-65.

Figure 5-65. Photograph of the steel plates at instrument position #3 (left) and a photograph taken directly from below at the same location.

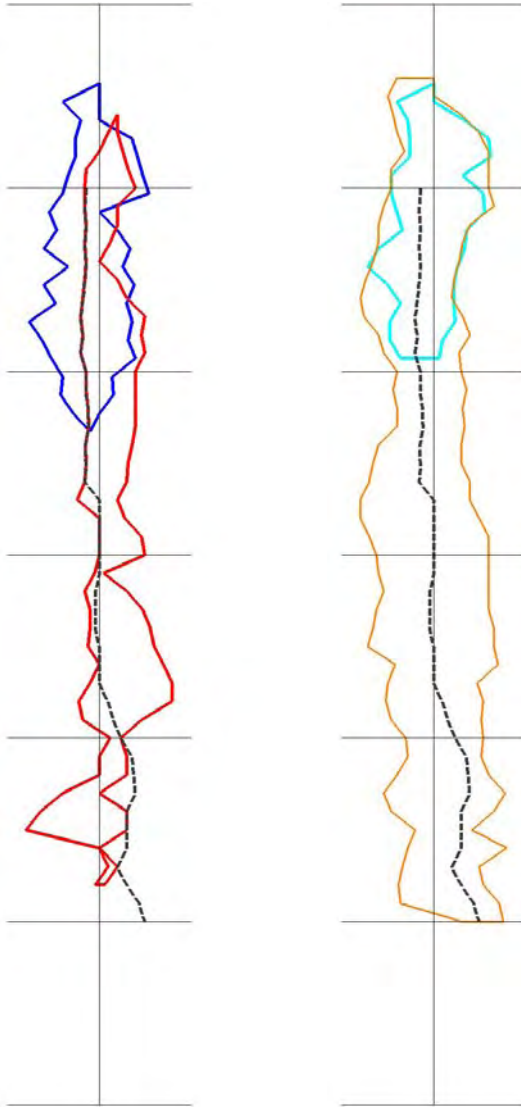
Before the heating started and after the removal of the chips/slabs, the parts of the pillar wall that were spalled and drummy were mapped. Every 10 cm, the extent of the spalling and the drummy length was measured to the left and right of the centre line of the pillar. The individual points were connected by straight lines. A screwdriver was tapped against the rock wall to map the drummy zones. Spalling was defined as the parts of the rock wall where chips/slabs had fallen off or been removed. The results of the mapping, including the location of the notch after heating, are presented in Figure 5-70. The notch is located very close to the left boundary of the drummy area after heating. This is an effect of the induced fractures coming in from the left described in the sections about the removal of the slabs. Only the very superficial slabs created on the right side could be removed. The fractures from the left therefore continue beneath the rock surface, making it drummy.

Figure 5-70. Left: mapping of the drummy areas before and after heating. Blue area before and red area after heating. Right: mapping of the spalled areas before and after heating. Turquoise area before and orange area after heating. The dashed line in both figures is the location of the deepest part of the notch after heating.

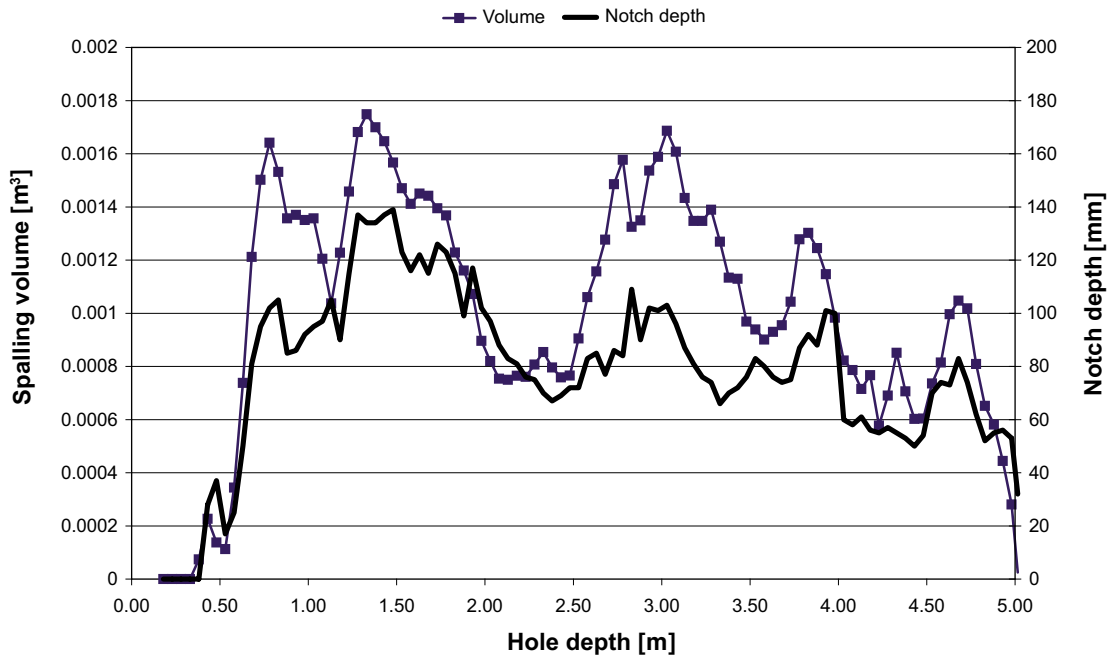
Laser scanning was performed in the hole after the slabs were removed. A 3D survey of the spalled zone was thereby obtained. This survey was used to make a more precise drawing of the extent of the notch. In Figure 5-71 this drawing is superimposed on a photograph of the pillar wall. The laser scan was also used to measure the horizontal contour of the spalled zone. Spalling depth was plotted in intervals of 5 cm. The volume of spalled and removed rock over the depth of the notch is presented in Figure 5-72. The total spalled volume is approximately 0.1 m³. In Figure 5-73 the spalled volume is presented together with the spalled area.

Figure 5-72. The volume of spalled and removed rock and the depth of the notch. The volume is presented in 50 mm increments.

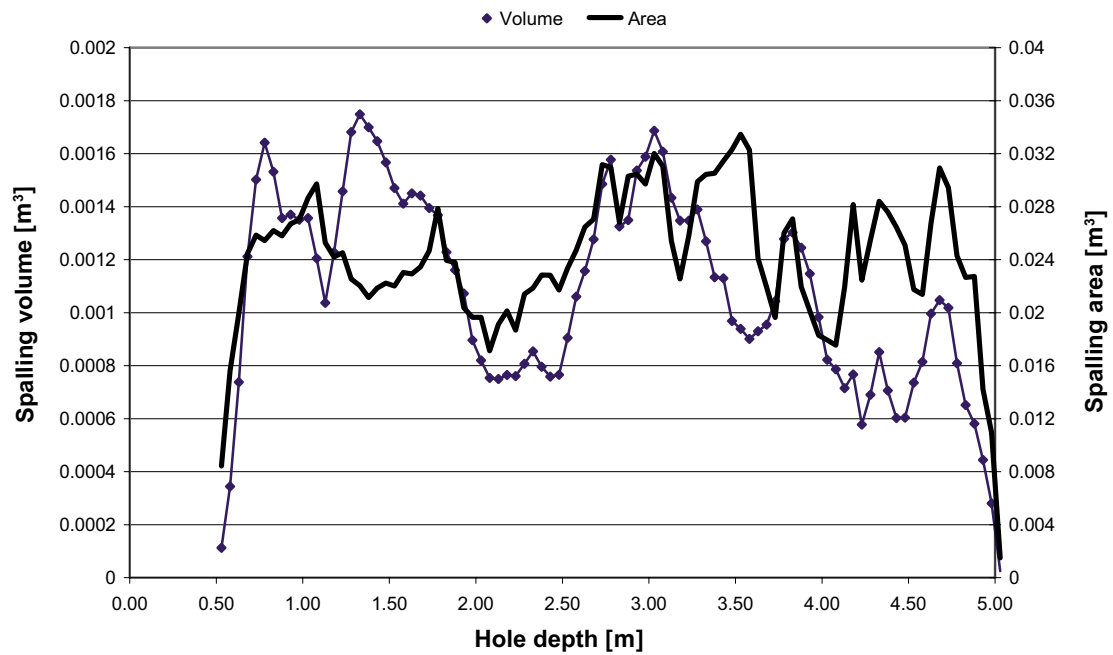
Figure 5-73. The volume and the area of the spalled and removed rock. Both presented in 50 mm increments.

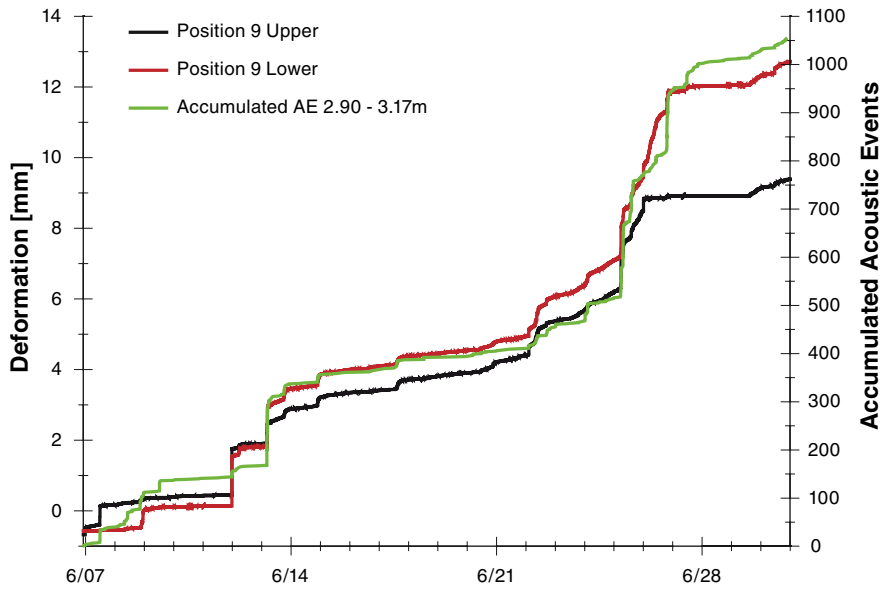
Figure 6-1. Deformations at upper and lower instrument positions #9. All the accumulated acoustic events at that instrument level (2) are also included.

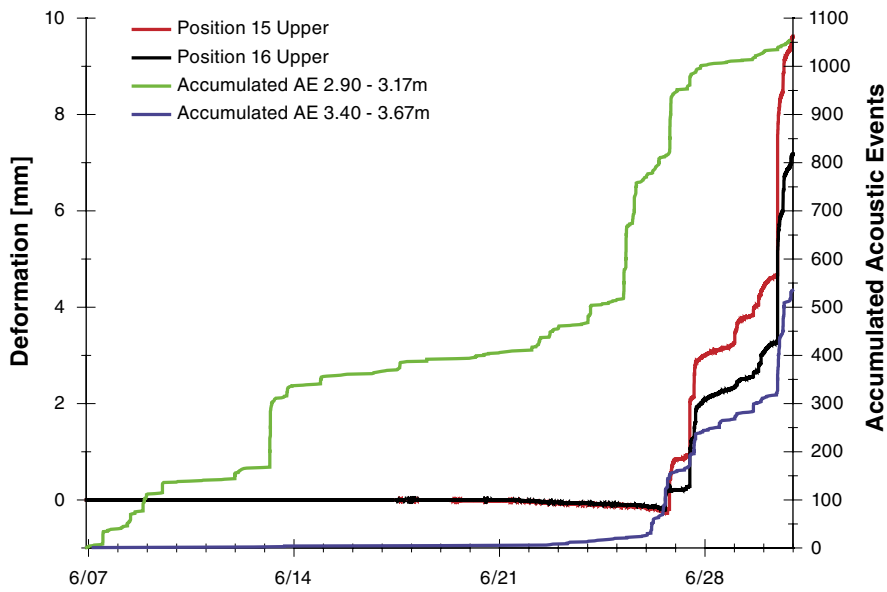
Figure 6-2. Deformations at upper instrument positions #15 and #16. All the accumulated acoustic events at that instrument level (3) are also included. The acoustic emissions from the second level are also included for comparison.

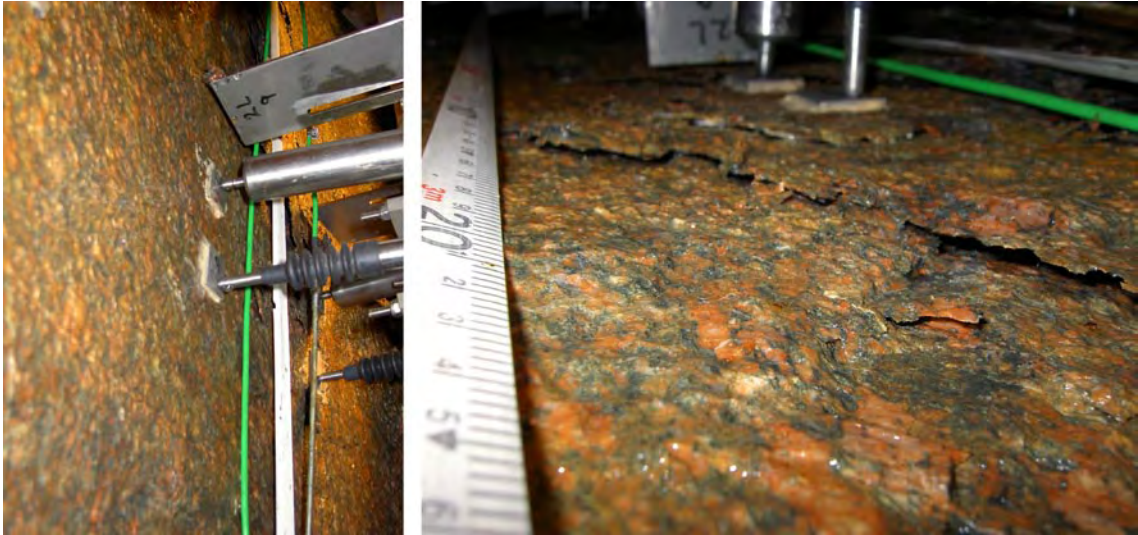
Photographs of the instrument positions were taken during visits in the hole. To exemplify the development of the notch, photographs taken at the approximate same positions at two different dates are compared in Figure 6-3 and Figure 6-4.

Figure 6-3. Photograph of instrument position #9 was taken on June 2nd (left) and on June 16th (right).

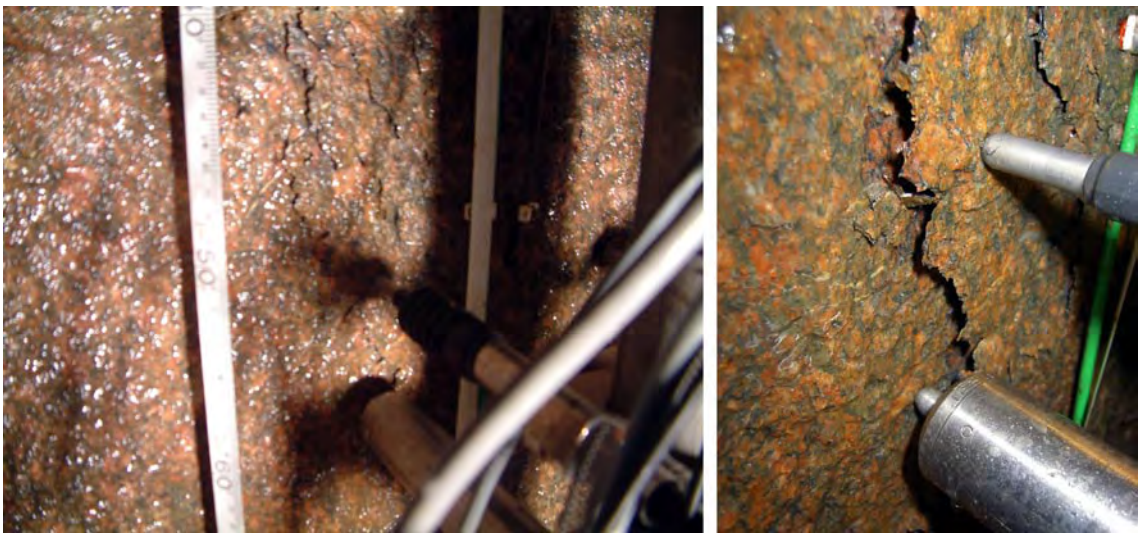
Figure 6-4. Photograph of instrument position #15 was taken on June 29th (left) and on July 12th (right).
