R-09-39

Examination of the Excavation Damaged Zone in the TASS tunnel, Äspö HRL

October 2009

Svensk Kärnbränslehantering AB

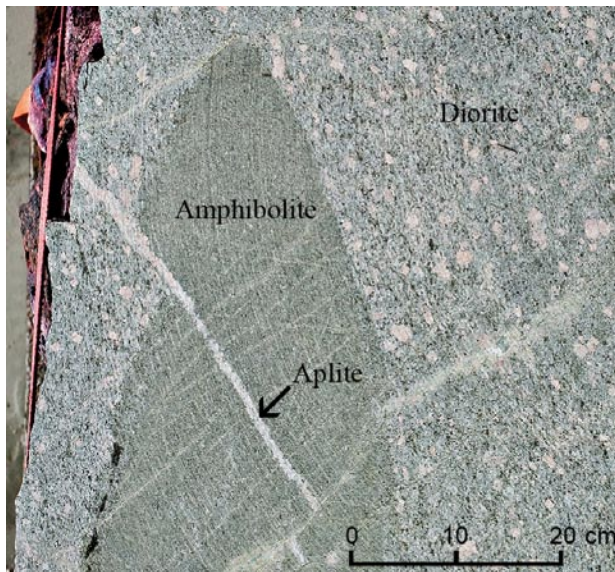
In slab 37B-08 a bigger fine-grained mafic rock fragment appears the part visible in the slab is 90 cm×30 cm. This fragment cuts the foliation of the diorite. The fragment is possible to follow from slab 37B-08 to slab 38B-04, see Figure 2-3.

A 1–2 cm thin aplite dyke cuts through the Äspö diorite and a fine-grained mafic rock from slab 38B-01 to slab 38B-08, see Figure 2-3.

Figure 2-3. Diorite with a fine-grained mafic rock fragment and a 1–2 cm wide aplite dyke in block 38.

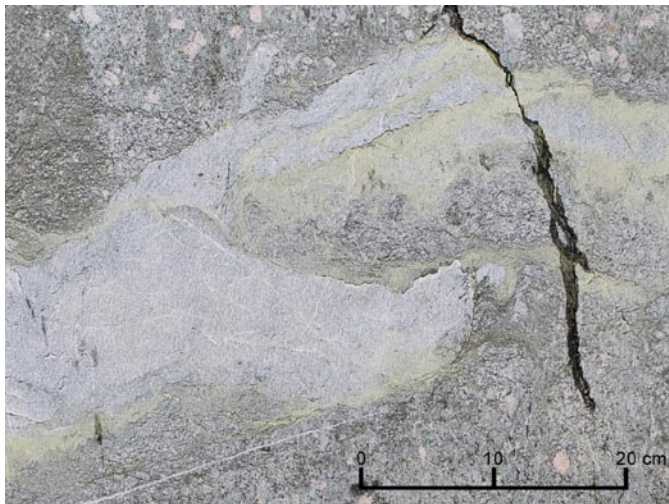
In slab 42B-07 to 43B-03 a 10–20 cm wide aplitic dyke appears. This aplite is fine grained, grey to green and massive. In the contact area (3 cm wide) with the aplite the Äspö diorite is more foliated (ductile deformation), less porphyritic and contains more mica and epidote than usual, see Figure 2-4.

Figure 2-4. Aplite dyke and Äspö diorite in block 42B. The contact area is 3 cm wide.

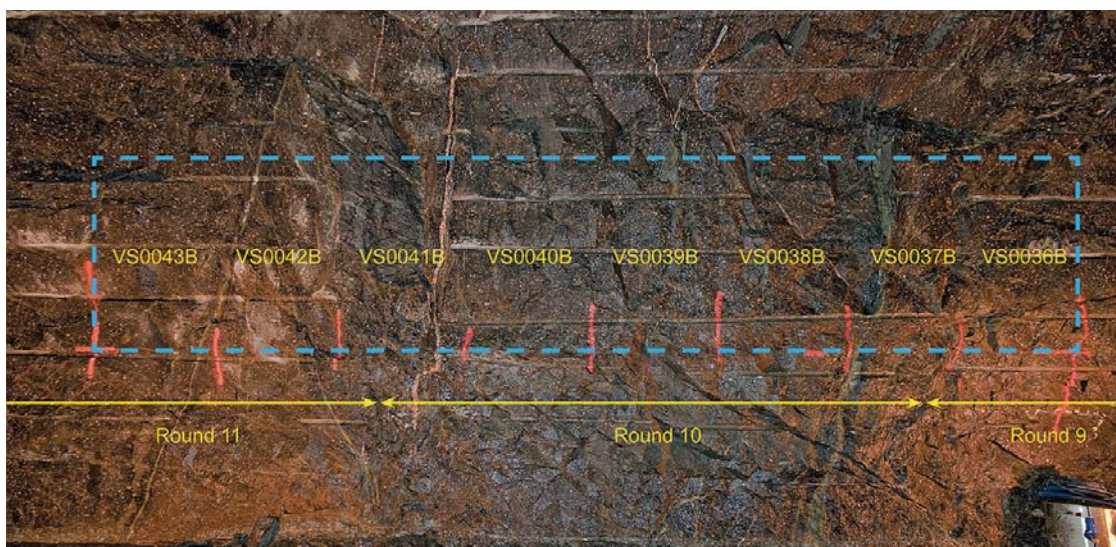
Note that it is very hard to find out exactly where rounds start and stop. The reason for this is that parts of the borehole collars and sockets have disappeared due to the blasting or scaling. Also notice that a vertical wedge has fallen out from the transition zone between round 10 and round 11.

Figure 4-1. The test area and the different rounds.

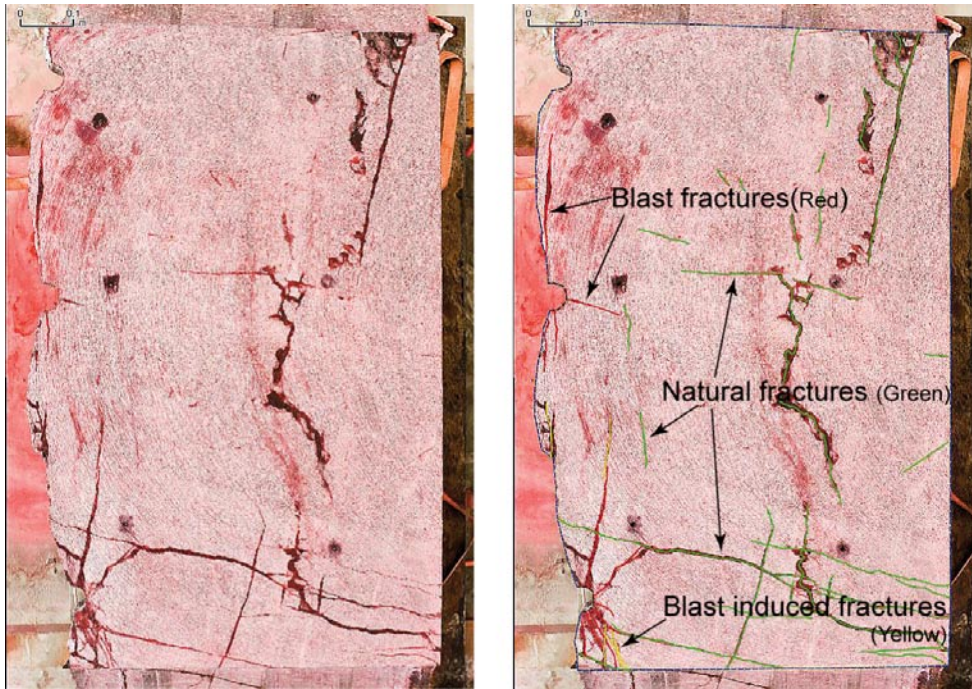
Figure 5-2. Slab 40B-01; photo without and with digitized fractures on the right.

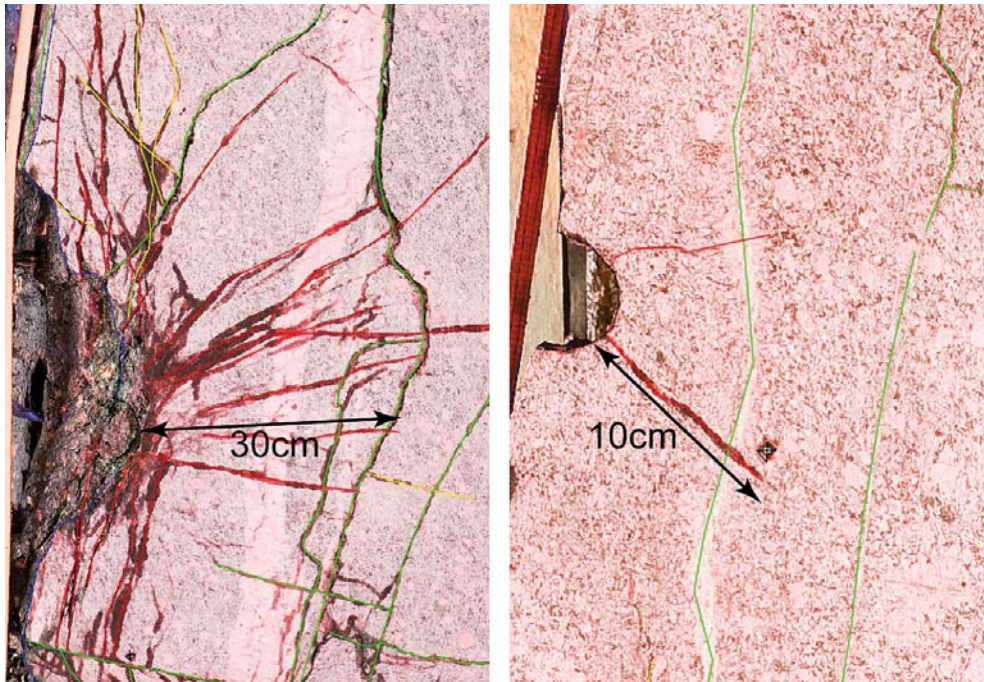
Some typical fracture patterns from blasting in this study are shown in Figure 6-5. Here the differences in fracturing between the heavier bottom charges and the lighter column charges are obvious. The photo to the left shows a typical fracture pattern from the bottom charge. The charge weight from the bottom charge corresponds to a charge weight 5 times the weight of the column charge.

The fracture length from the bottom charge is 30–45 cm. The arrow in the left photo is 30 cm long. The fracture length from the column charge shown to the right is 10 cm, as shown by the arrow. Note also the differences in the fracture patterns. The bottom charge generates many more fractures than the column charge. Some of these blasting fractures pass the natural fractures and continue further into the rock mass. This is a rather typical behaviour for blasting fractures.

Figure 6-5. Left: Fractures from bottom charge, arrow length 30 cm. Right: Fractures from column charge, arrow length 10 cm.

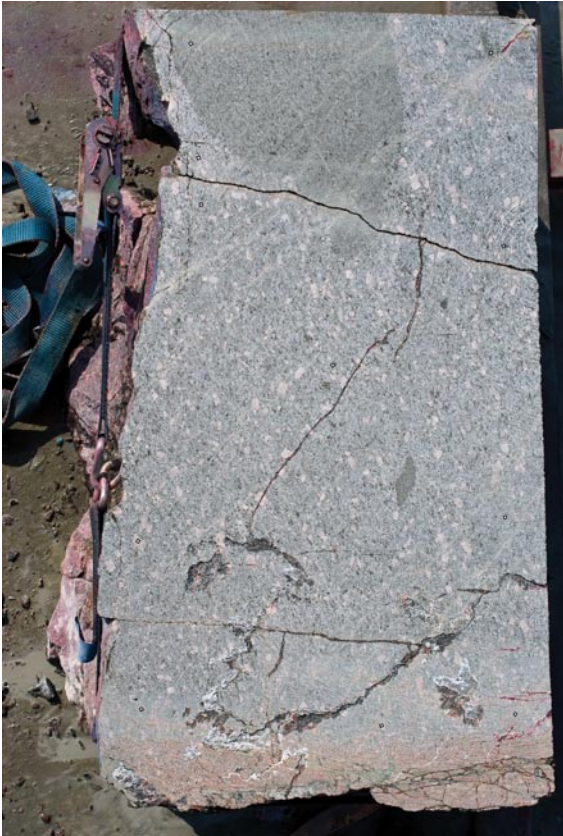
Fractures with a strike direction near perpendicular to the investigated section will generally be seen as straight or almost straight lines whereas fractures crossing the investigated section at an acute angle will be more winding, and for very sub-parallel fractures, the fracture trace will almost form a half circle, Figure 6-14.

Figure 6-14. Section 36B-06. The nearly straight fracture trace at the top belongs to a fracture intersecting the section at a near perpendicular angle. The irregular fracture trace below belongs to a fracture, which is sub-parallel to the section, intersecting the section at an acute angle.

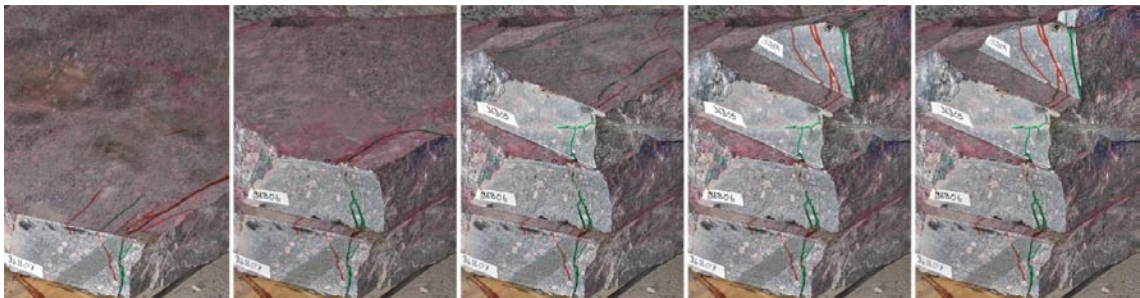
Figure 6-17. Detailed investigation, case 1.

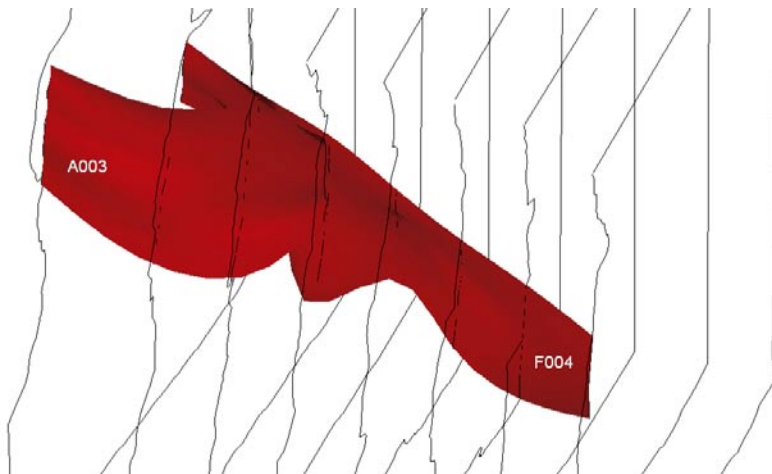
The investigated blast fracture A004 in case 1 was first modelled as quite long, spanning over 7 sections. It was also slightly wavy, bending faintly to one side and then shifting to the other and back again, see Figure 6-19.

Figure 6-19. Case 1. Modelled fractures before detailed investigation.

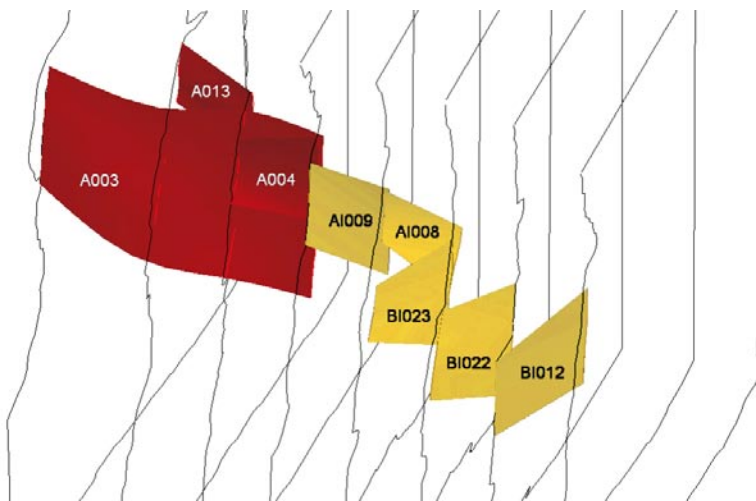
The detailed investigation showed that this was instead a set of sub-parallel fractures intersected by small crossing fractures as shown in Figure 6-18. The fractures also often connected with the edge of adjacent sections, thus forming the tunnel wall. The crossing fractures could not be detected, and hence not modelled, since they are sub-parallel to the investigated sections, the result of the remodelling is shown in Figure 6-20.

Figure 6-20. Case 1. Modelled fractures after detailed investigation.

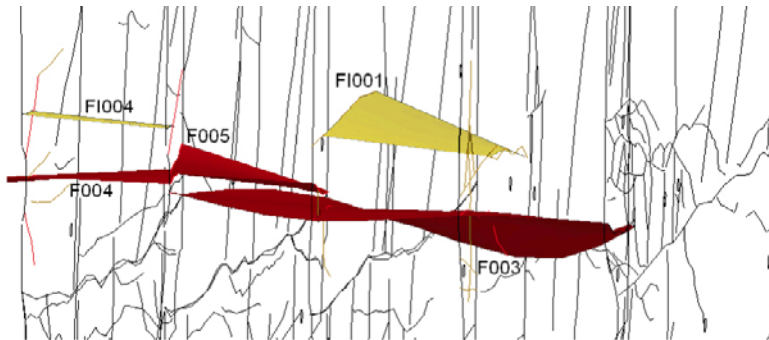
Regarding the investigated fracture F003 in case 3 the detailed investigation showed that the modelled fractures around the investigated area had a slightly different direction than the actual fractures. Some remodelling was done to correct the fractures but these are small changes that do not affect the overall fracture pattern. The original model of fracture F003, and also to some extent that of F005, show the twisted or wobbling appearance that normally was avoided when modelling. The detailed investigation showed, however, that the actual geometry of the fractures around the area was more planar. This confirms the initial assumption that blast induced fractures are more or less planar. This is also in agreement with the conceptual understanding of the blasting process, see section 6.1.

Figure 6-21. Case 3. Modelled fractures before detailed investigation.

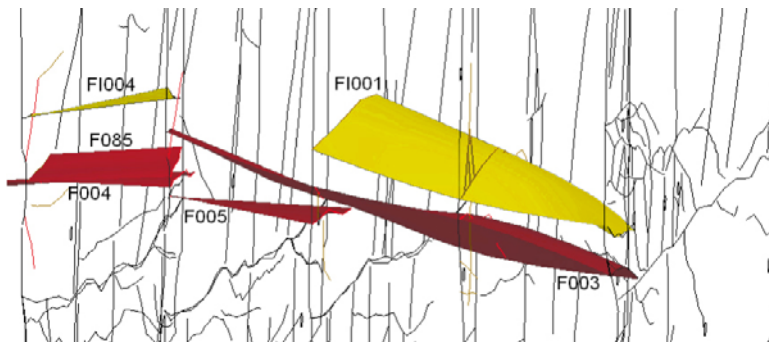
Figure 6-22. Case 3. Modelled fractures after detailed investigation.

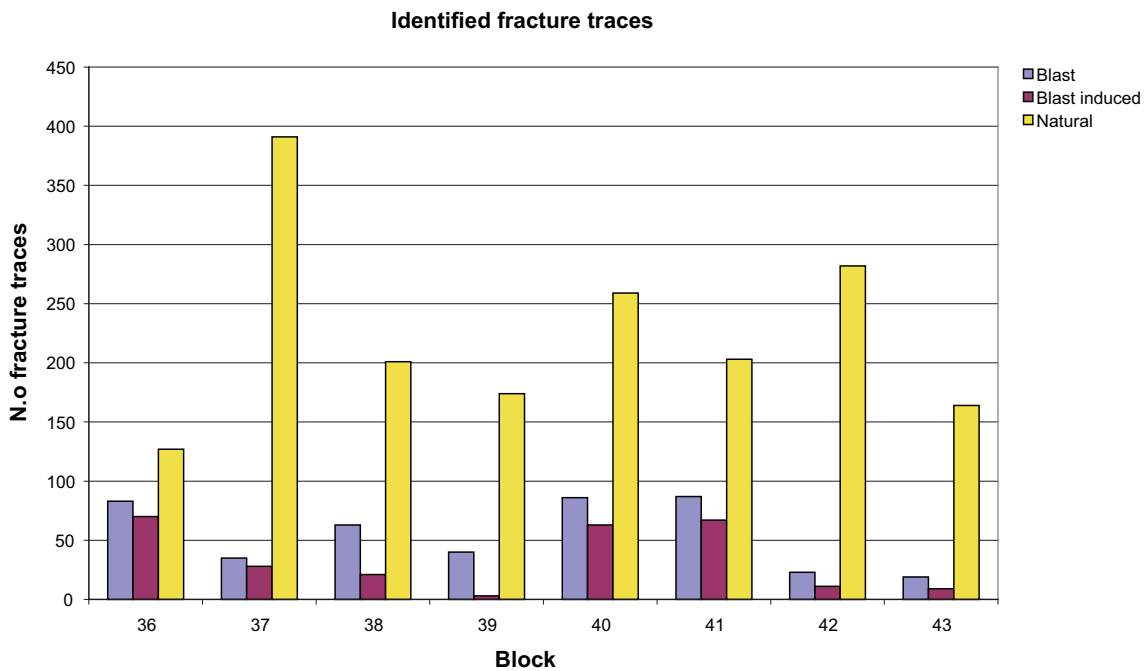
The total number of fracture traces identified in all of the slabs was 2,509 of which 1,801 were natural fractures, 436 were blasting fractures and 272 were blast induced fractures. Figure 7-5 shows the distribution of different fracture types in all of the blocks. Block 37 has the highest number of natural fractures, the other blocks seems to have about the same number of natural fractures.

Figure 7-5. Total number of identified fracture traces.

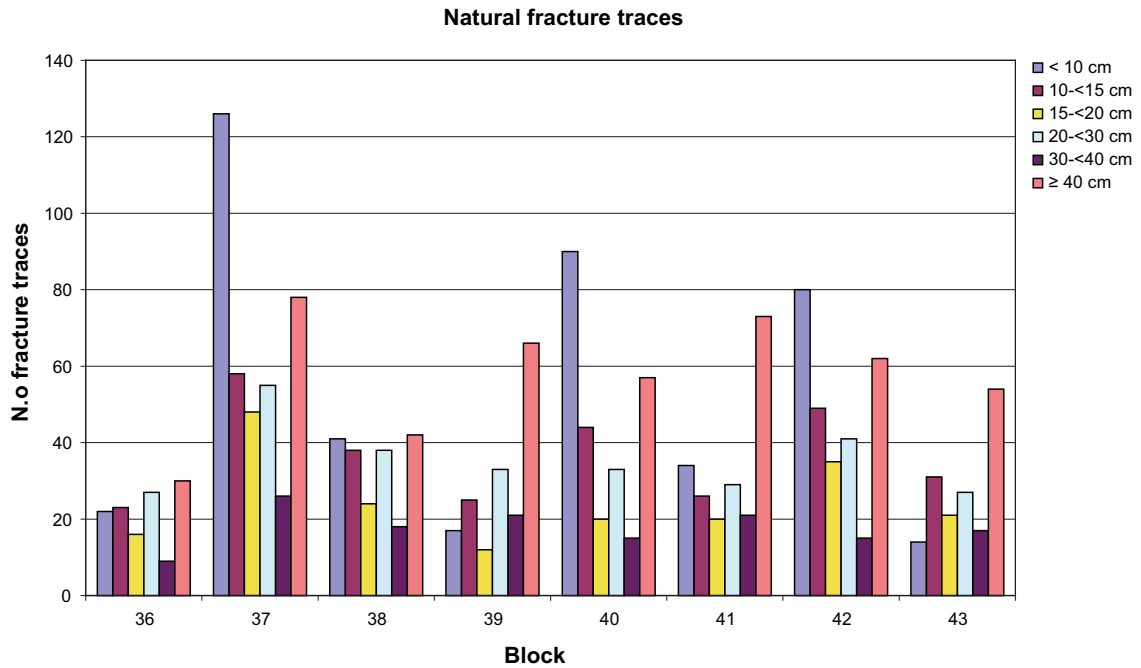
Figure 7-6 shows the fracture trace distribution of natural fracture traces in all the blocks. The distribution is divided into six groups, < 10 cm, 10–<15 cm, 15–<20 cm, 20–<30 cm, 30–<40 cm and < 40 cm. There exist a large number of short natural fracture traces in block 37. Blocks 40 and 42 also have a high number of the shortest fracture traces. Block 37 is outstanding and seems to have the highest frequencies of short, medium and long fracture traces.

Figure 7-6. Distribution of natural fracture traces.

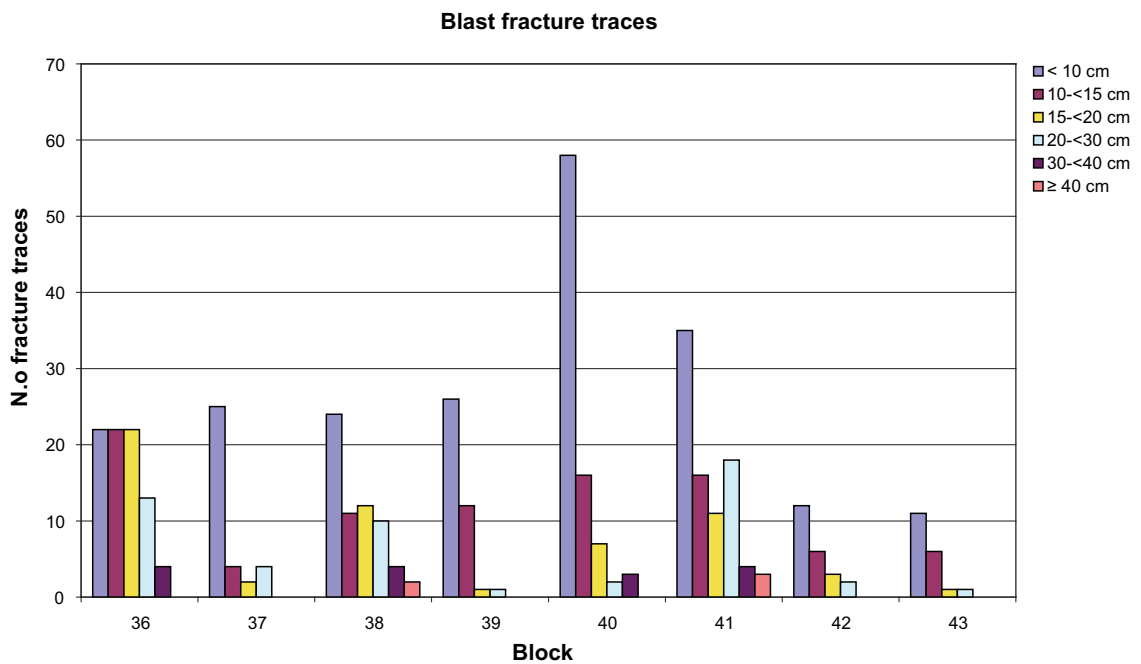
In Figure 7-7 the distribution of blast fracture traces is shown. Block 40 has the by far highest number of short blast fracture traces. One would sooner expect this to occur in blocks 36–37 and 41–42 since they are affected by the bottom charges. On the other hand blocks 36, 38 and 41 seems to have the highest proportion of medium long blast fracture traces. Block 43 has the lowest number of blast fracture traces.

Figure 7-7. Distribution of blast fracture traces.

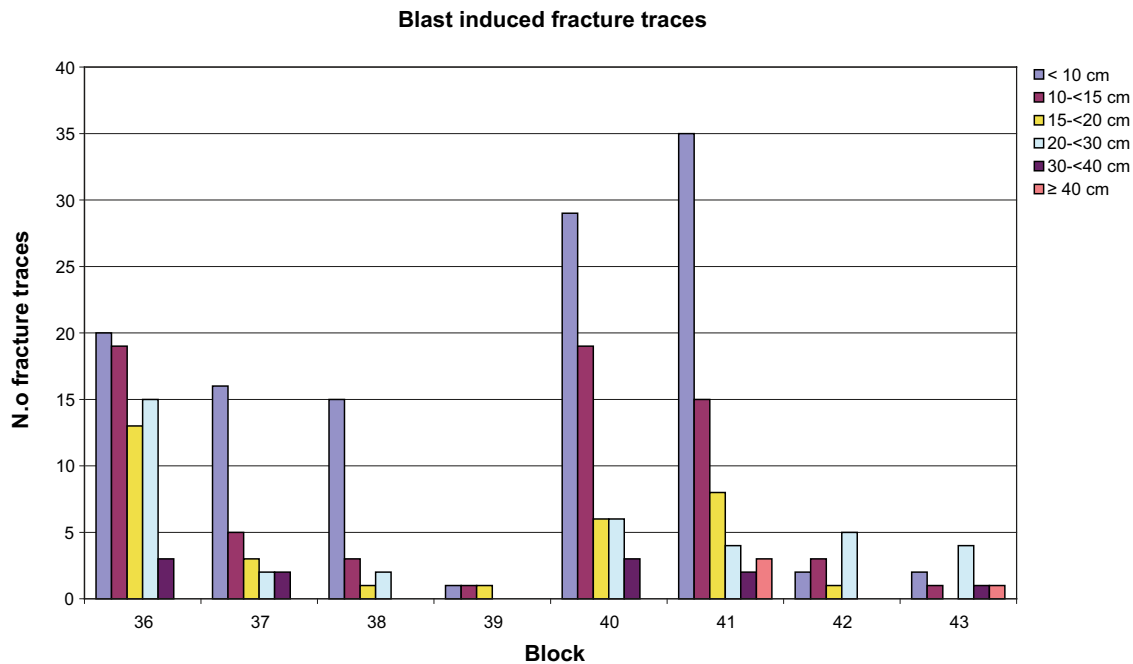
Figure 7-8 shows the distribution of blast induced fracture traces. Blocks 40 and 41 have the highest number of short fracture traces while block 39 has the smallest number of fracture traces of all the blocks. Block 36 has the highest number of medium long fracture traces.

Figure 7-8. Distribution of blast induced fracture traces.

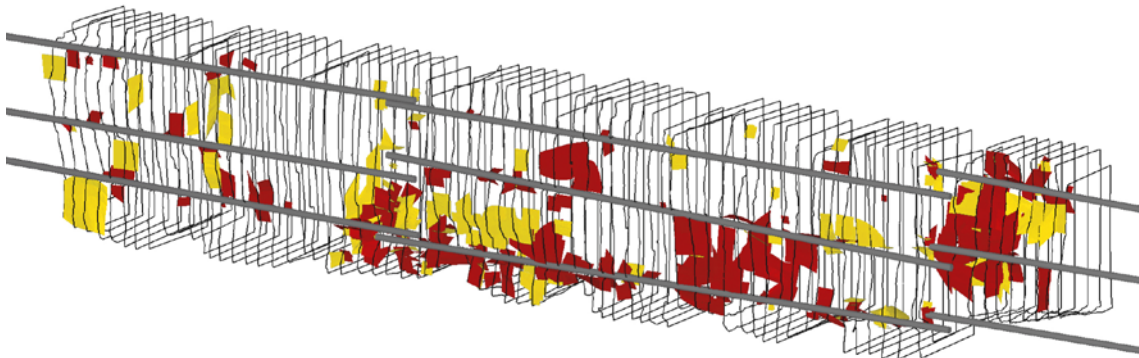
Figure 7-10. Modelled blast (red) and blast induced (yellow) fractures.

The longest blast fracture plane we have modelled goes through five sections, and is about 50 cm long. It does not shortcut any of the modelled natural fractures. However, since the extension in the edges of the modelled surface is somewhat underestimated, see section 7.2.5, it is possible that the fracture could shortcut two modelled natural fractures.

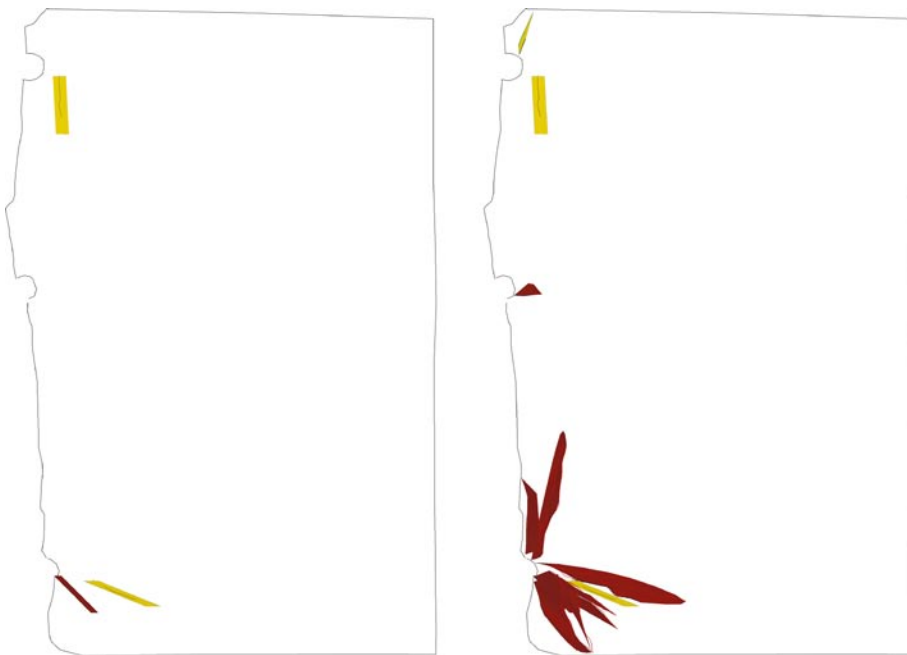
Figure 8-3. Fractures detected in only one section modelled as planes on the left and the same fractures shown together with surrounding fractures on the right.

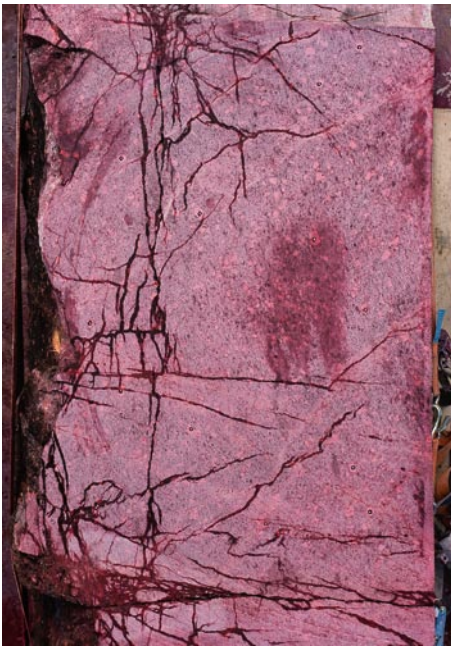
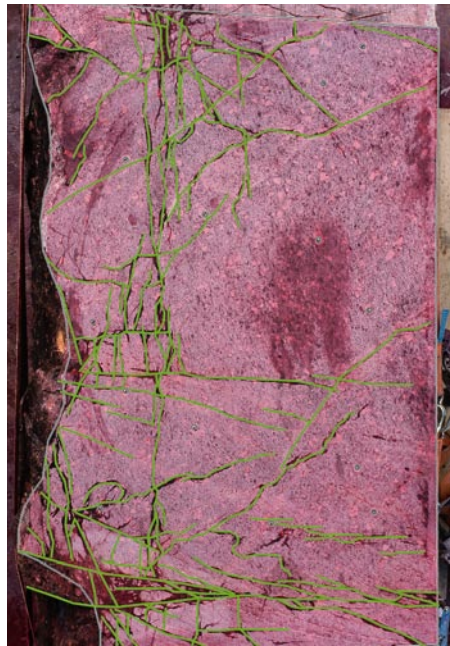
VS0037B01

One example of this is section 37B-01, shown in appendix 1 (VS0037B01), which is located ahead of the bottom charge in round number 9. The original classification of the fractures as natural was revised when modelling, see Figure 8-1.

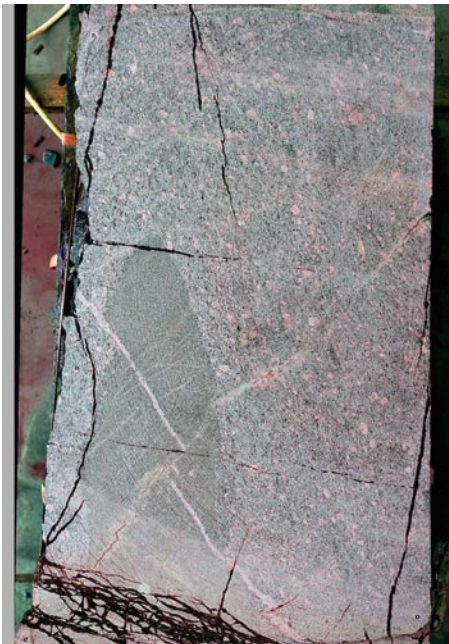
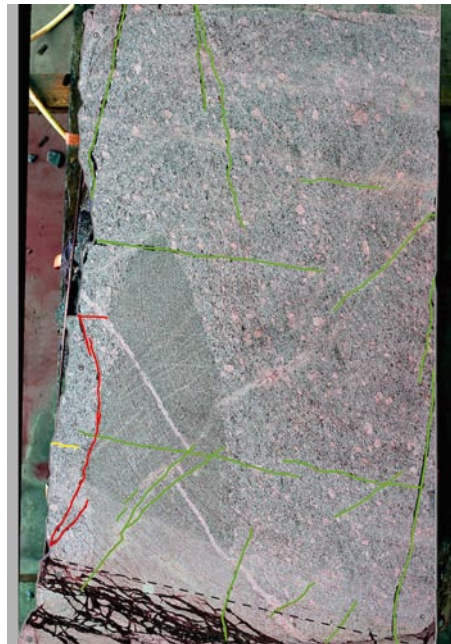
VS0038B02

Photos of block sides without and with digitized fracture traces classified as natural fractures (green), blast fractures (red) and blast induced fractures (yellow). The digitized fracture traces have their original classification; however, some were re-evaluated when modelling.
