Technical Report

TR-18-17

December 2018

Examination of copper corrosion specimens from ABM 45, package 5

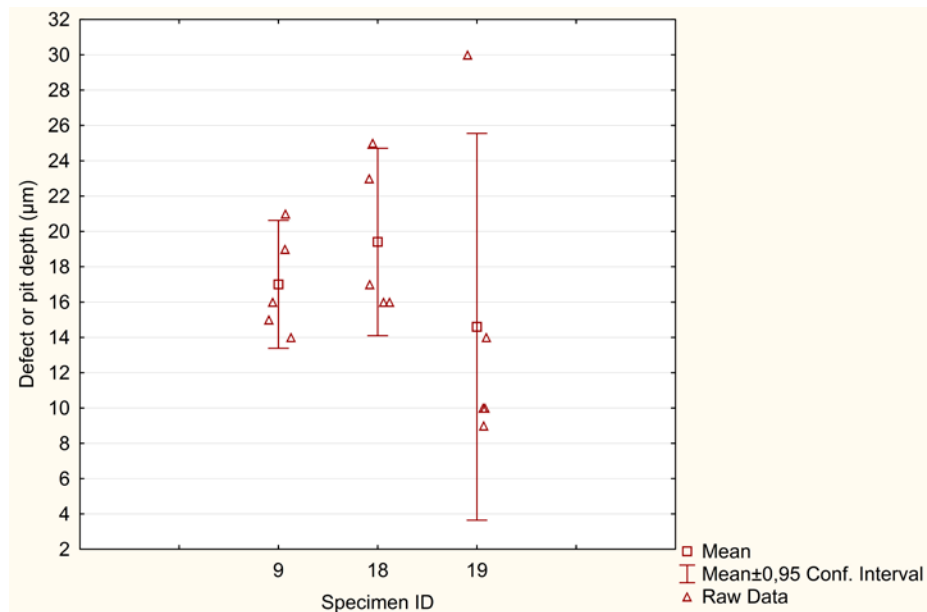
Figure 3-7. Mean plot of the deepest defects found on Specimen 9 (corroded specimen, after cleaning) and reference Specimens 18 (after cleaning) and 19 (oxide still present) (Table 3-2). The mutual overlap between the mean values and the two standard deviations (95 % confidence intervals) of the corroded specimen and the references mean that there is no significant difference between the five deepest defects on the specimens.

The deepest defect found on the corroded Specimen 9 was 21 μm , while the deepest defect found on the reference specimen was 25 μm (Table 3-2). The average of the five deepest defects found on the corroded Specimen 9 were 17 μm , while the corresponding average defect depth for the reference specimen was 19.4 μm . A comparison between the deepest defects found on the corroded specimens with the defects found on the references shows that there is a mutual overlap of the confidence intervals (95 %) and the mean values of the deepest defects found on the specimens (Figure 3-7). This means that there is no significant difference between the deepest defects found on the specimen surfaces, which suggests that these are not related to corrosion during the experimental exposure.

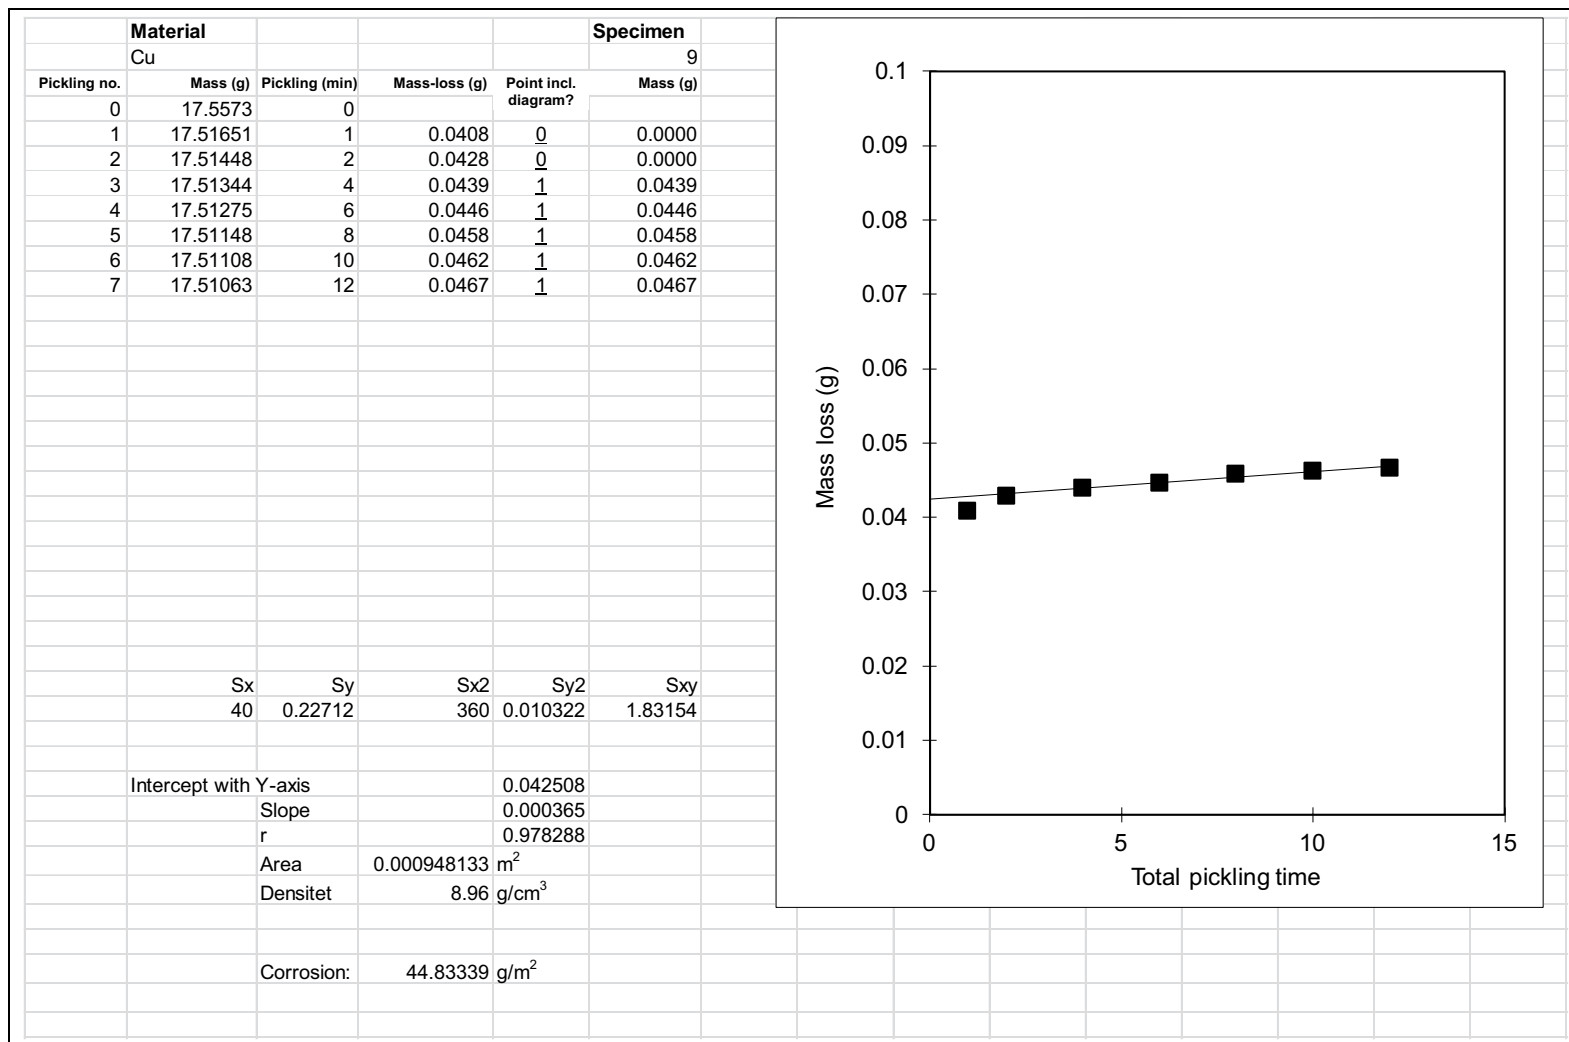
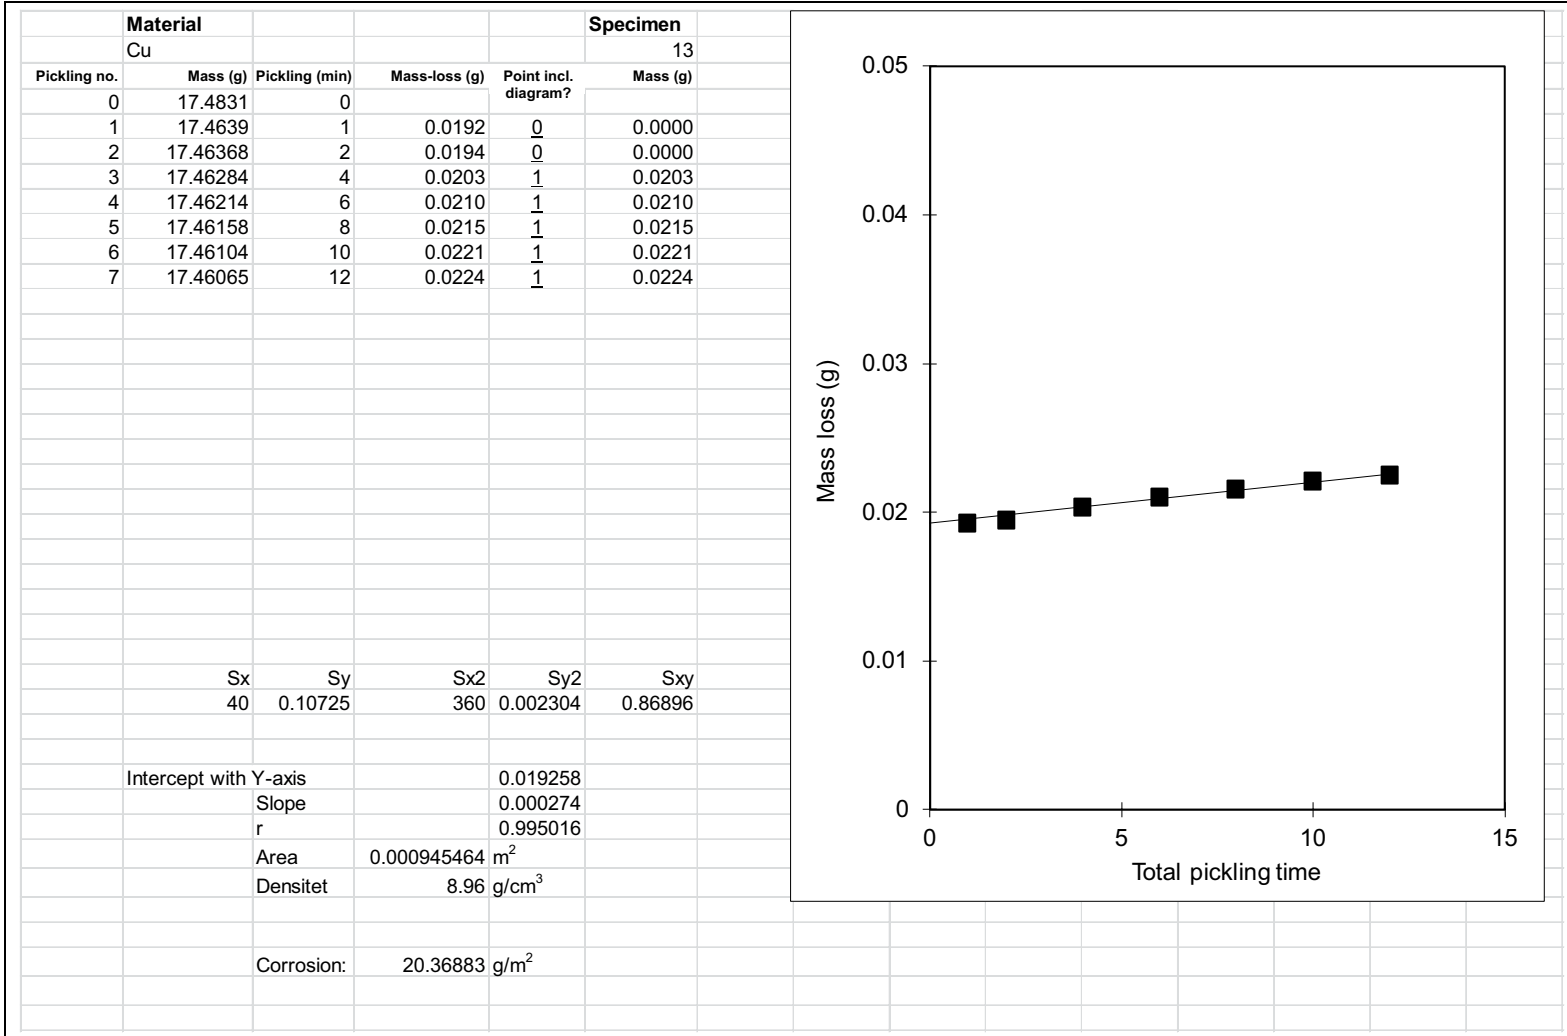
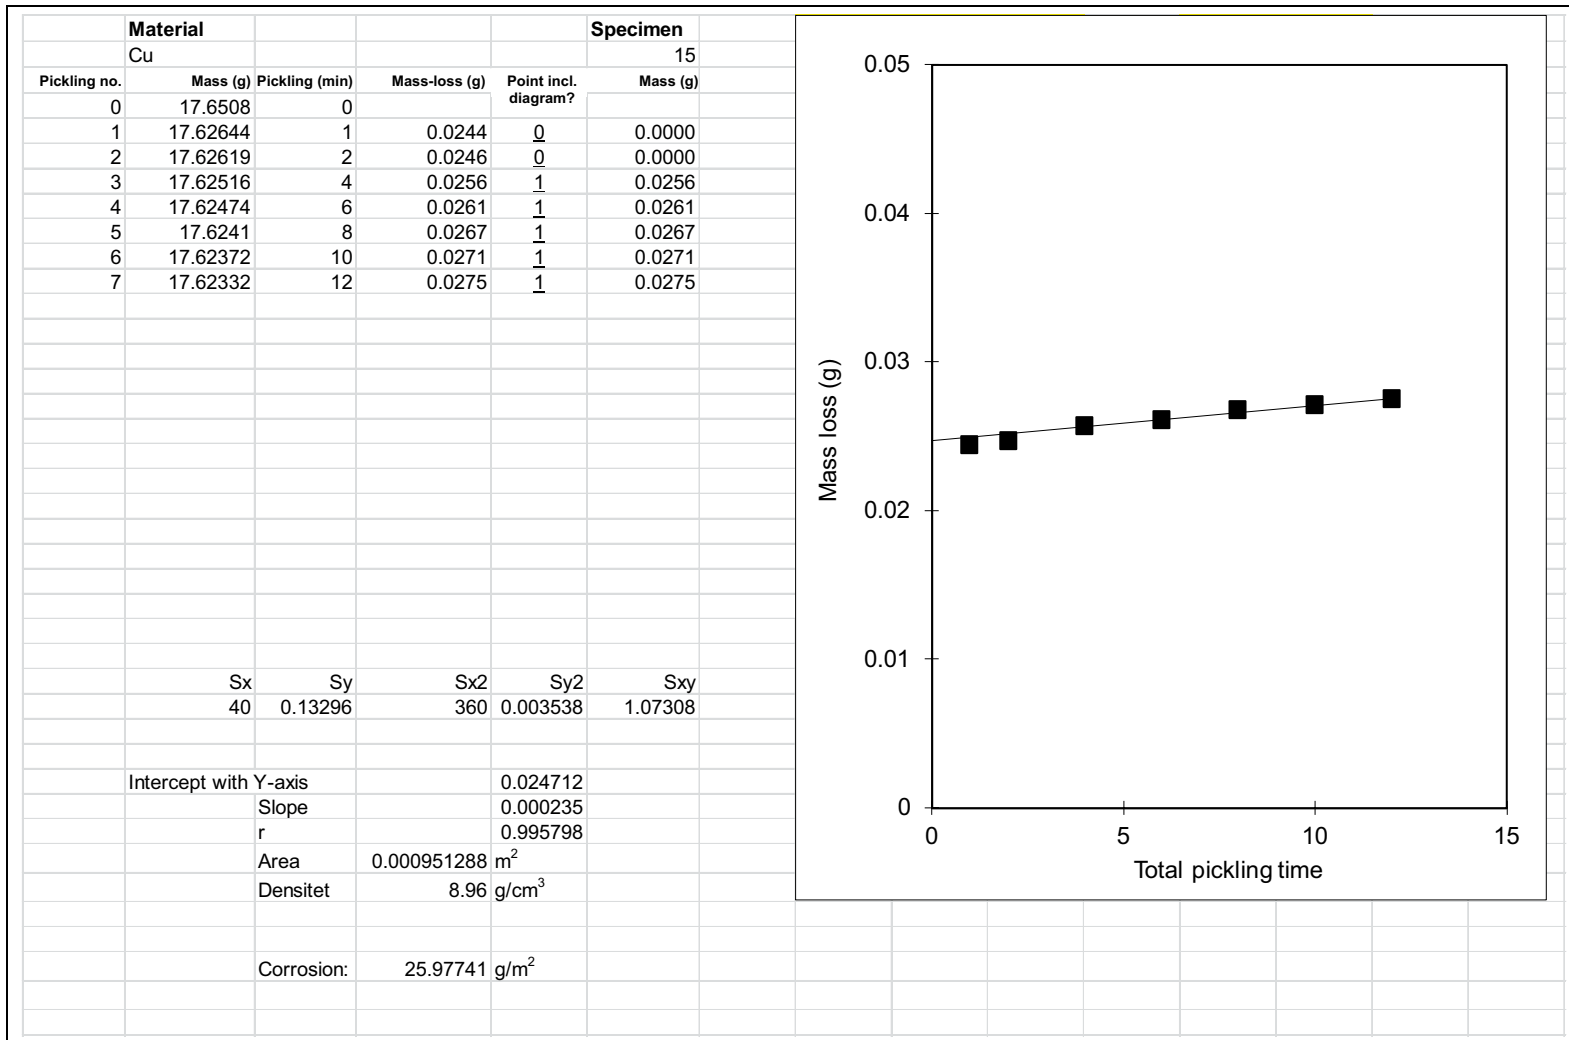
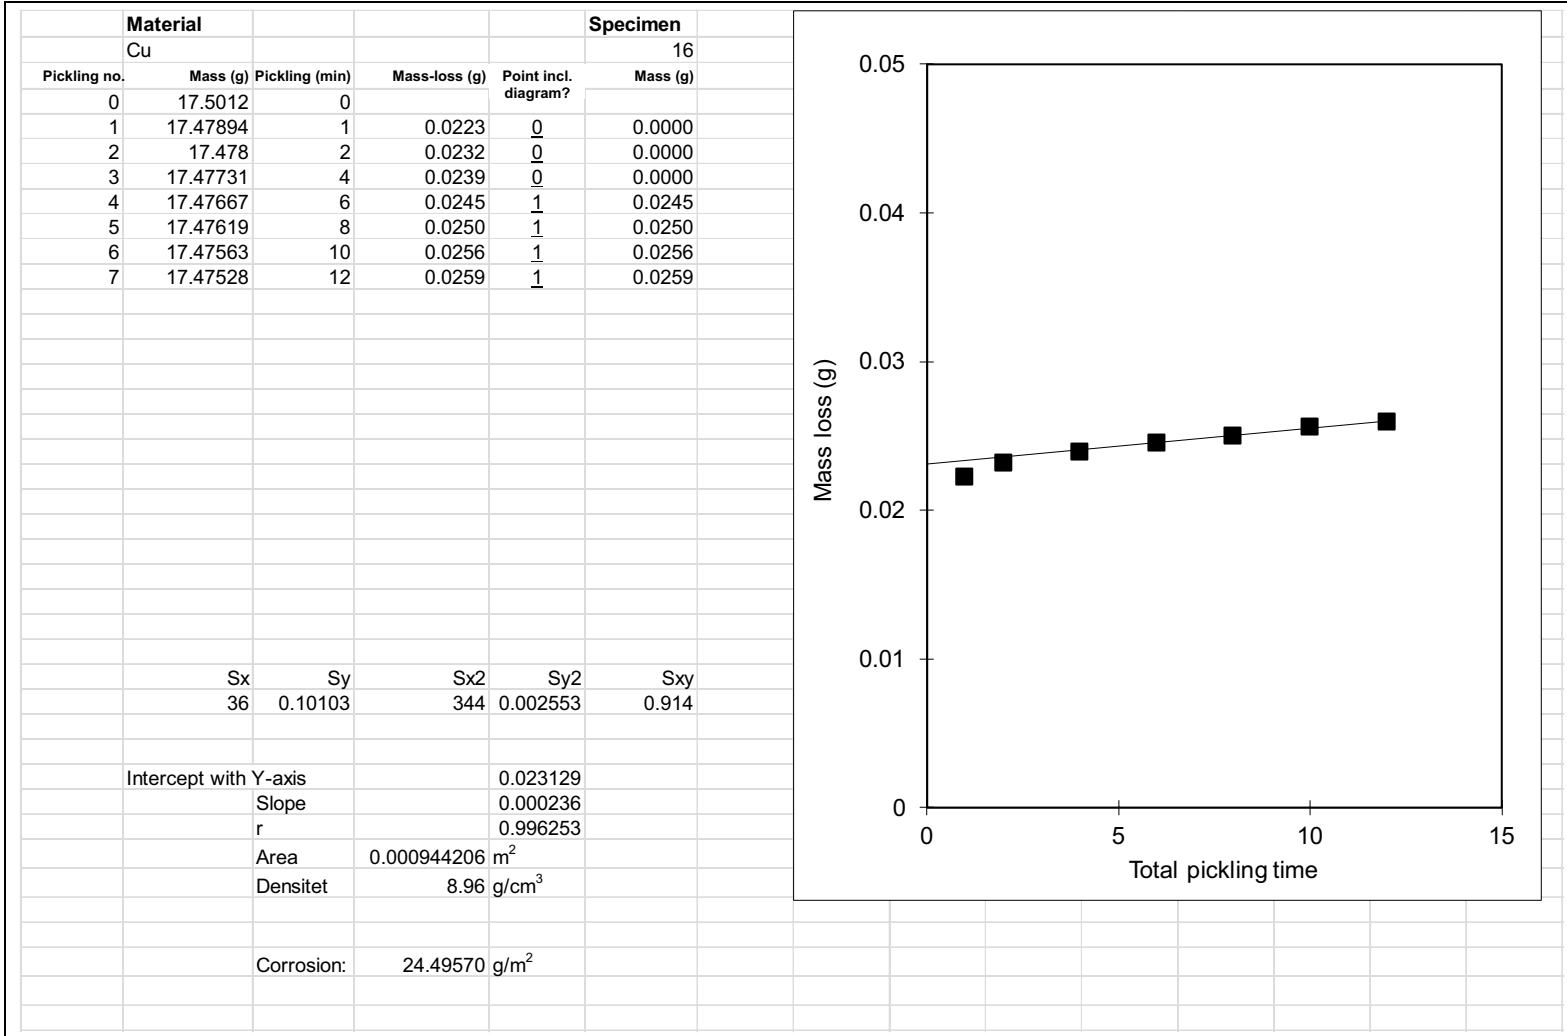
Specimen ID	Mass-loss		Average corrosion depth [μm]
	[g]	[g/m^2]	
9	0.0425	44.8334	5.00
13	0.0193	20.3688	2.27
15	0.0247	25.9774	2.90
16	0.0231	24.4957	2.73
Mean	0.0274	28.9188	3.23
Standard deviation	0.0103	10.8719	1.21
18 (reference)	0.0051	5.4151	0.60

Raw data from the gravimetric analysis of the corroded Specimens 9, 13, 15, 16, and the unexposed reference Specimen 18. The gravimetric analysis was carried out in accordance with the standard SS-EN ISO 8407:2014.
