Technical Report

TR-18-14

Corrosion morphology of copper in anoxic sulphide environments

SVENSK KÄRNBRÄNSLEHANTERING AB

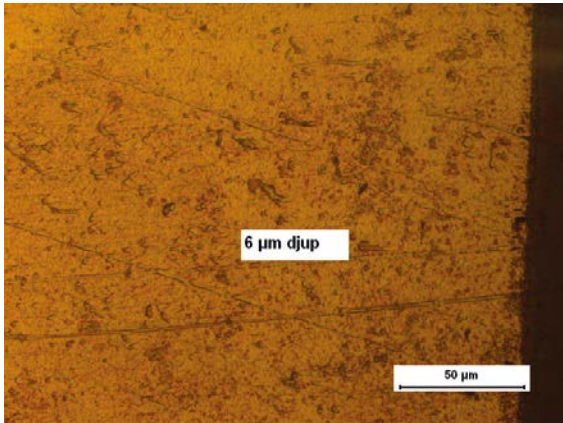
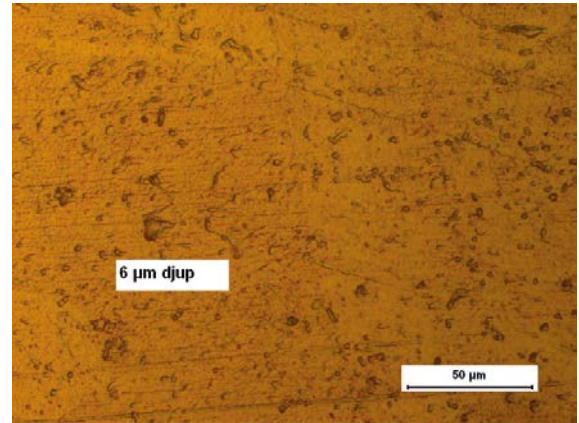
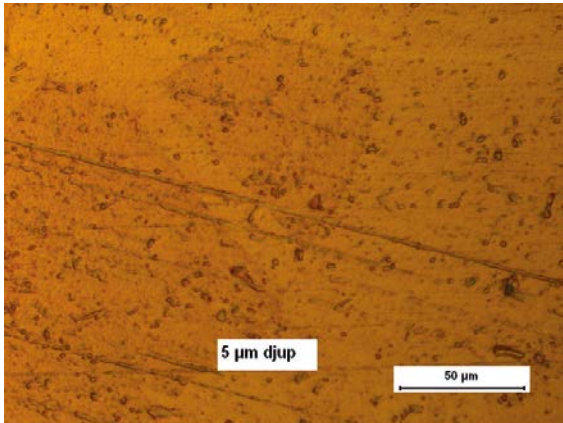
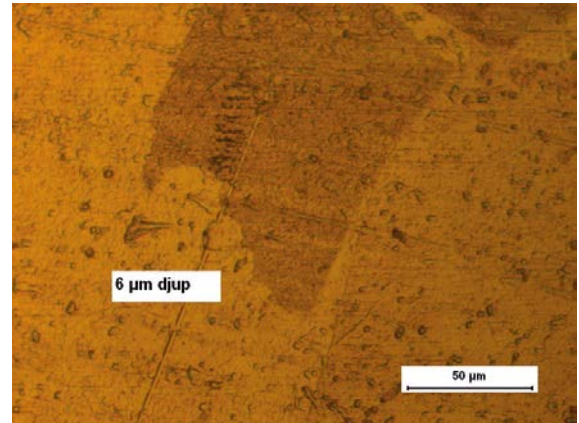
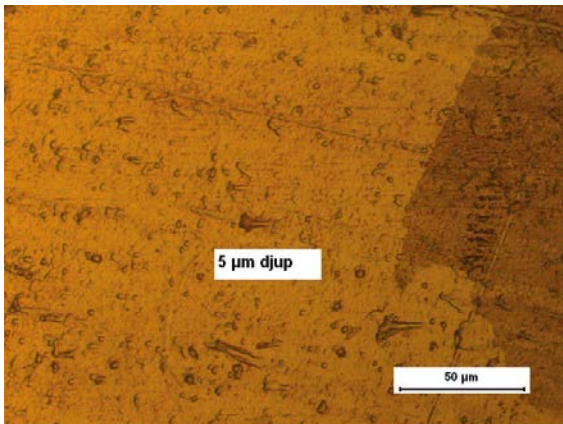
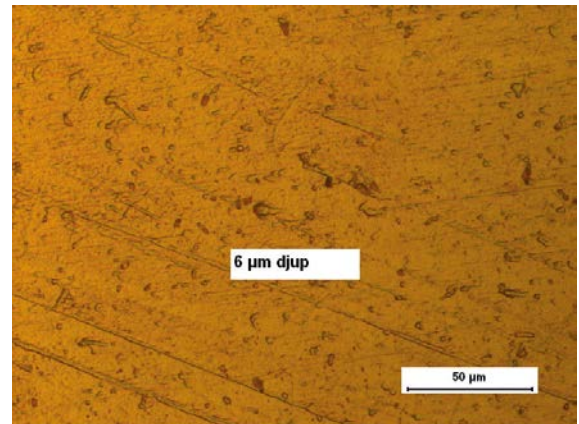
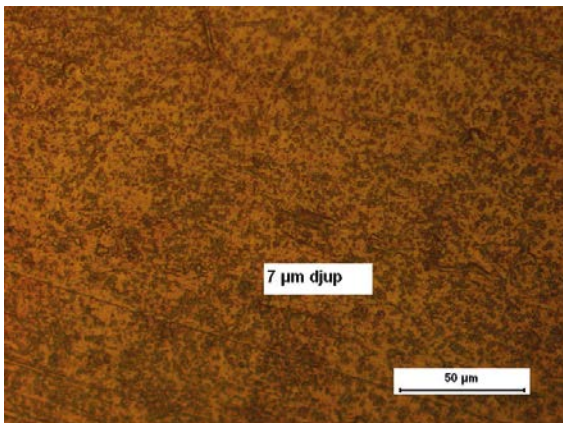
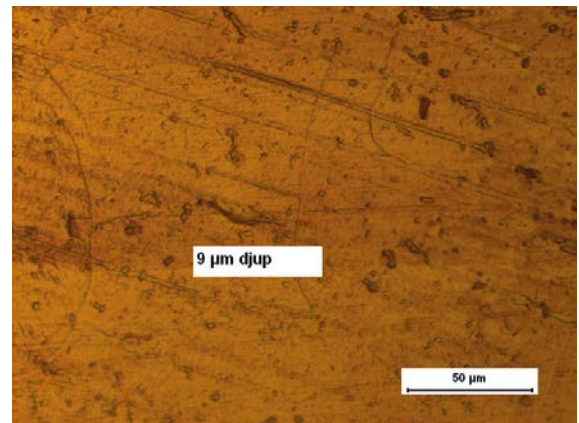
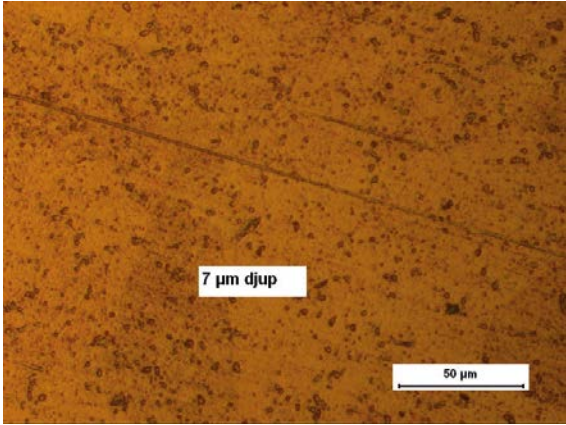
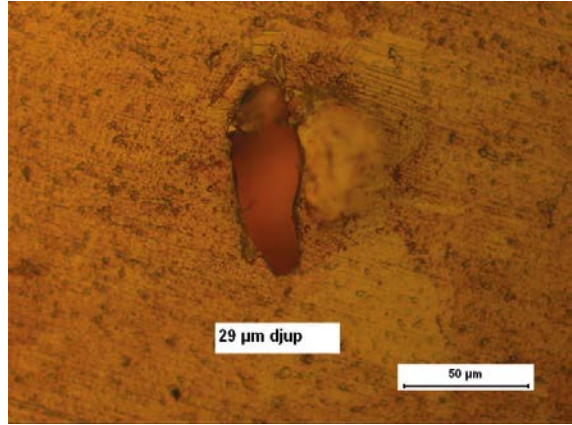
SRB exposures – Bio C coupon S8-7 side 1

The surfaces of the SRB exposure coupons were characterized for defects after pickling. The reference coupons were characterized before and after pickling. The images contained in the appendix show all the defects that have been measured on the coupons in the microscope. The criterion for measurement was defect depth greater than 6 μm . Only the two largest surface areas of each coupon were analysed, and were denoted side 1 and 2.
