**TR-18-02**

June 2019

# Full-scale test of the Dome Plug for KBS-3V deposition tunnels

## Project summary and evaluation of the final results

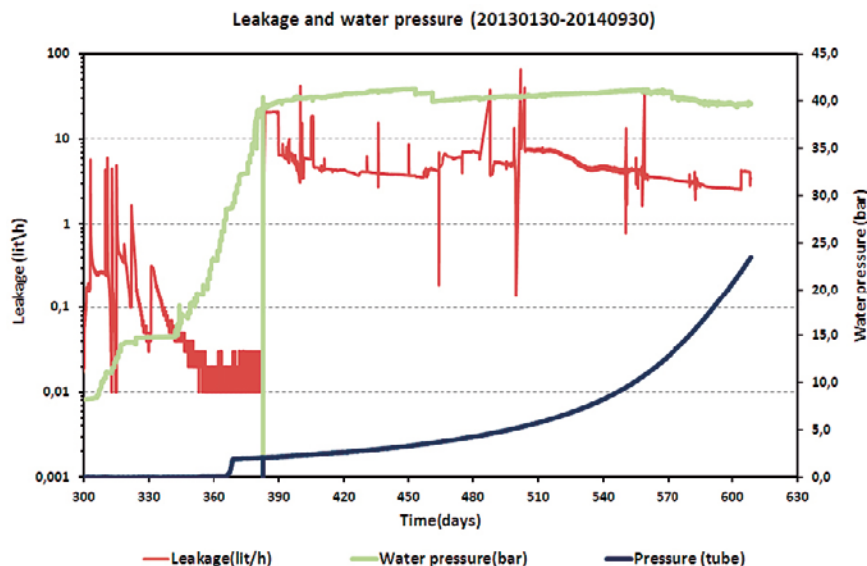
The original intent of the full-scale test was to pressurize the dome plug at 7 MPa. At the initial pressurization, the water pressure was increased by 0.25 MPa per week. However, when the water pressure reached 3.1 MPa, large leakage occurred. Two major leakage paths were identified, the pipe containing the cables from the instrumentation in the concrete dome and water bearing fractures in the rock surfacing 14 m downstream of the concrete dome. Both water escapes were deemed to be related to the experiment setup rather than the plug design. The leakage from the rock fracture and cable lead through was recorded separately from the water in the weir. The water from the cable feed through was also diverted and measured separately. The leakage and water pressure during the pressurization is illustrated in Figure 2-21.

Figure 2-21. Applied water pressure and leakage measured from the measurement weir.

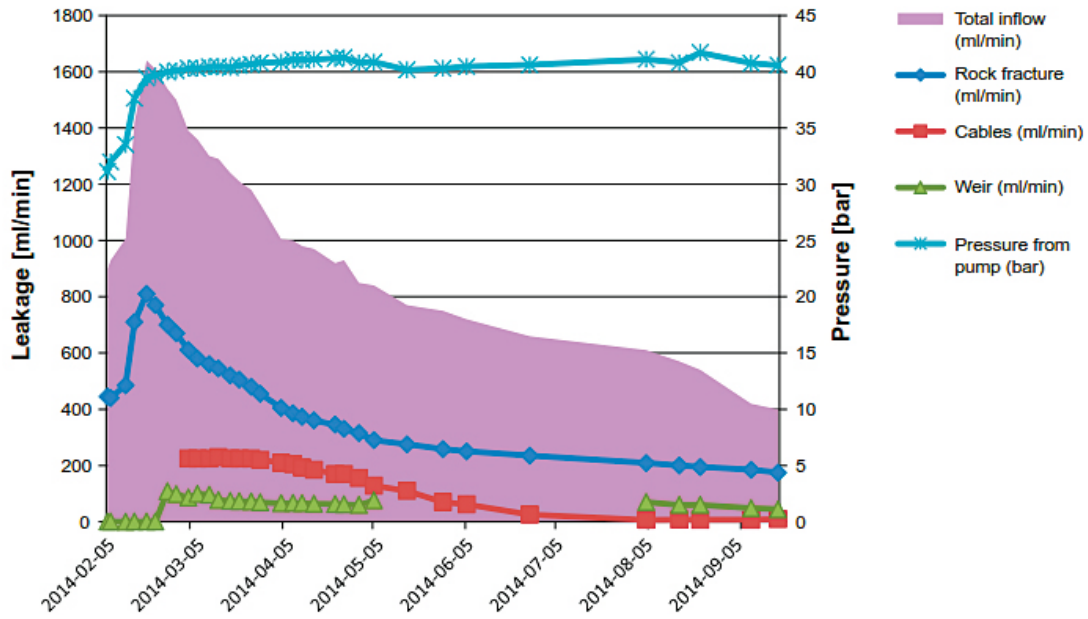
When the leakage increased, it was decided to pressurize the dome at 4 MPa instead of 7 MPa. This was deemed sufficient since 4 MPa is close to the maximum theoretical hydraulic head of the final repository, see e.g. Malm (2012). When the water pressure was held constant, the leakage steadily decreased. In Figure 2-22, the total pressure, water inflow and leakage to the different outlets is presented. September 30, 2014, the total inflow of water was 399 ml/min, the leakage was distributed to:

- Weir 11 %, 43 ml/min.
- Cable bundle 2 %, 8.5 ml/min.
- Rock fracture 42 %, 169 ml/min.
- Remaining rock mass 45 %, 178.5 ml/min.

Grahm et al. (2015) concludes that the reduced leakage to the weir and through the cable bundle probably is due to the saturation of the bentonite seal. The reduced leakage to the rock could be due to clogging of the cracks by bentonite. However, this cannot be verified since it is unknown where the leakage occurs.

Figure 2-22. Water pressure from pump, total water inflow and leakage measured in the weir, cable lead-through and the rock fracture for the pressurization to September 30, 2014. The leakage to the weir is low during the pressurization, this is because the filter was clogged.

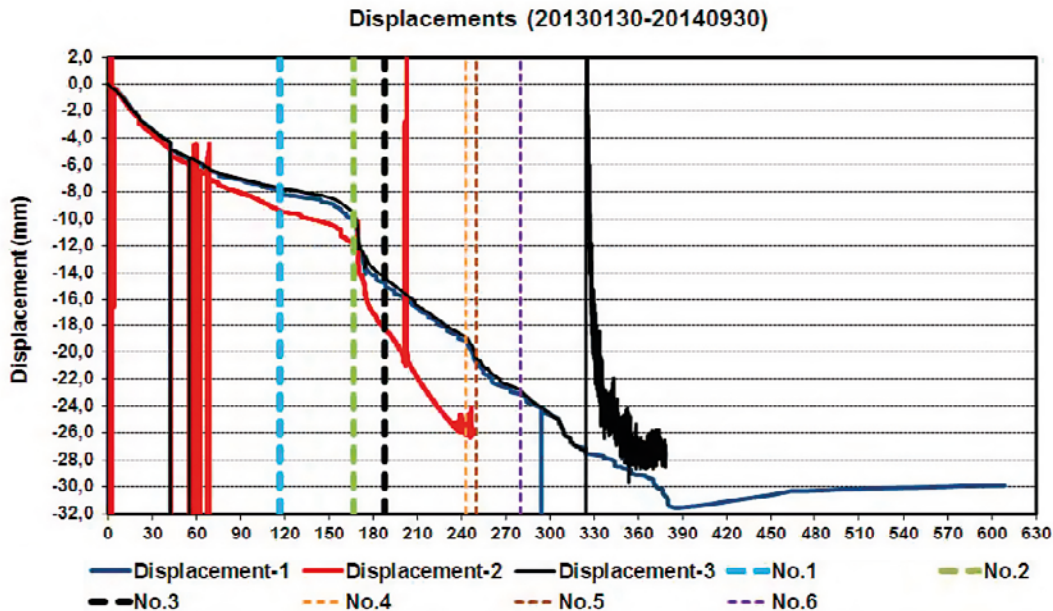
Three extensometers were installed, which measured the displacement between the concrete back wall and the downstream side of the backfill, LECA-beams and filter section, see Section 2.2.2. The displacements are presented in Figure 2-28. As can be seen in the figure, the sensors failed at a displacement about  $-30$  mm. This is probably because the extensometers were deformed to their limit. The negative sign mean that the relevant sections are compressed i.e. move in the upstream direction due to the expansion of the bentonite seal.

*Figure 2-28. Relative displacements between the concrete back wall and the downstream side of the backfill (1), downstream side of the gravel filter (2) and the downstream side of the LECA-beams (3) (Grahm et al. 2015). The vertical lines represent timepoints used in the reference.*

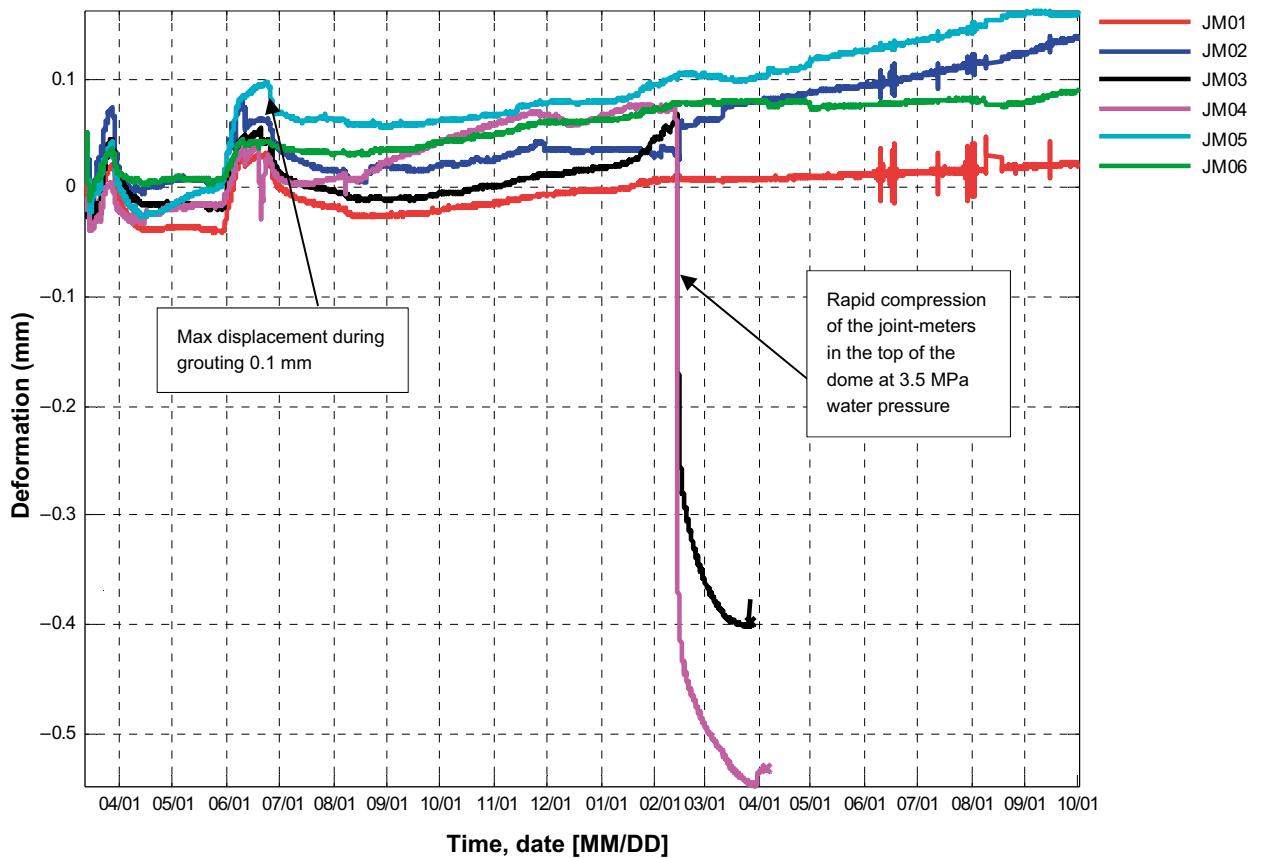
The joint meters were an important indicator if the concrete dome had released from the rock along the slot abutment. The calculated value of the gap, if the concrete was subjected to unrestrained shrinkage, was 4.1 mm. The results from the joint meters up to the time of the pressurization are presented in Figure 2-29. The largest measured gap was of 0.1 mm, which shows that the concrete dome did not release from the rock, at least not at the location of these sensors. The relative displacements are small in the joint meters and likely corresponds to the strain in the concrete. However, the displacements are larger after the contact grouting, which indicates that the grouting was successful.

During the pressurization of the plug to 4 MPa, two joint meters were rapidly compressed to their maximum. This could indicate cracking or a loss of bond in the upstream face of the slot abutment.

*Figure 2-29. Relative displacements in the interface between the rock and concrete dome.*

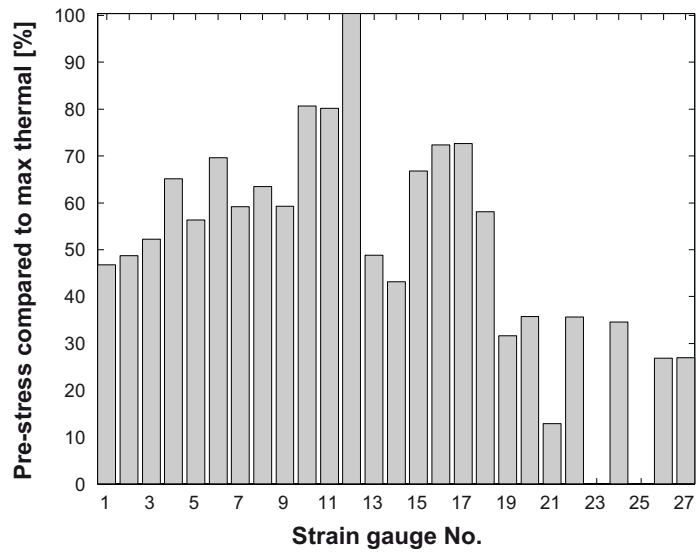
The ratio between the measured difference in strain and the theoretical prestress is presented in Figure 2-32. The mean prestress is 53 % and many strain gauges show a quite low prestress. There is a tendency that the prestress is larger in the upstream part of the concrete dome. The sensor ST12, which has a prestress of 100 % is in the centre of the plug toward the upstream face and is oriented in the vertical direction. From this, it can be concluded that the concrete dome released partially from the rock and that the upstream side of the plug released more than the downstream side.

*Figure 2-32. Achieved prestress as a ratio of the theoretical maximum (Grahm et al. 2015).*

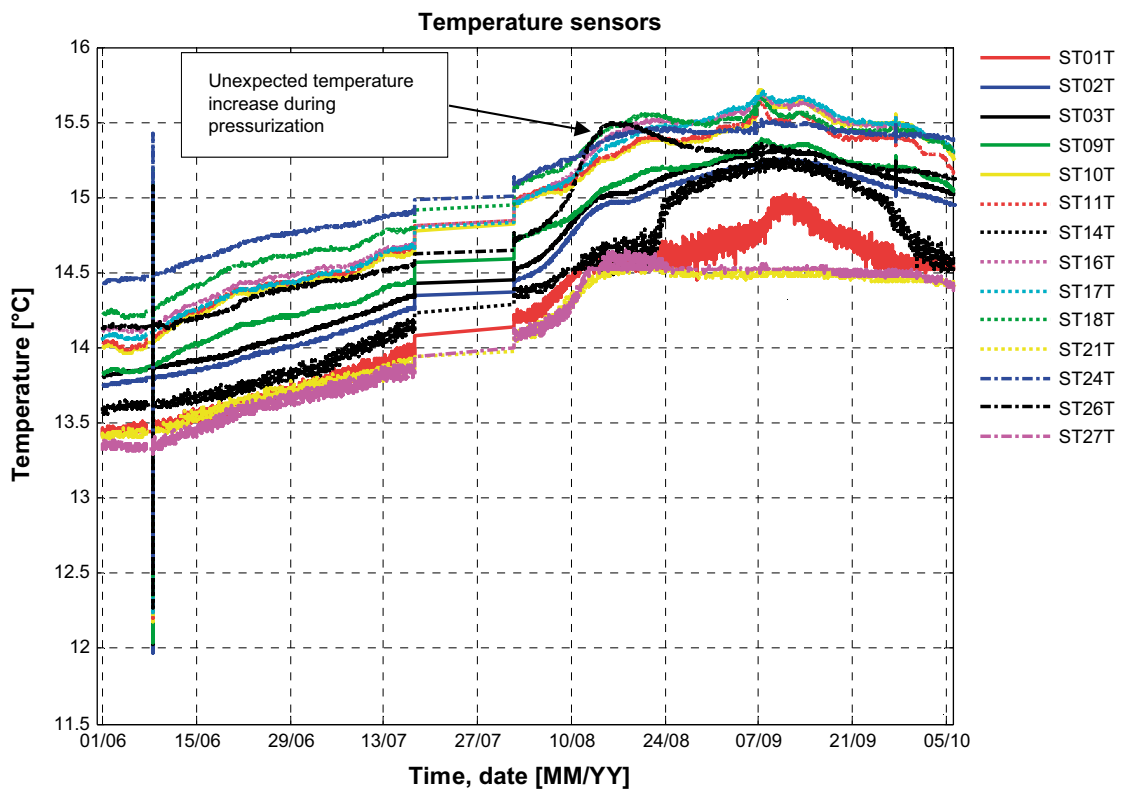
During the studied period between July 1st and August 20th, 2017, no shift in the ambient temperature was recorded and no other activities occurred that would affect the temperature in the concrete. However, while studying the zoomed in recordings of the concrete temperature in Figure 4-4, some unexpected behaviours can be seen starting from August 1st.

Figure 4-4. Measured temperature from all temperature sensors in the concrete dome during the gas leakage and strength tests (Malm et al. 2019).

The behaviour is most obvious in sensor ST27T, which gives a significantly larger temperature peak than expected. The peak also occurs earlier than expected. This sensor is placed close to the downstream side of the abutment at the right-hand side as seen in Figure 4-8. The temperature is 0.5 °C higher than expected at August 15th, the day when the pressure reached 8 MPa.

The rising temperature could occur for two reasons: leakage or confined pressure. If leakage occurred at the interface between the rock and the concrete in this region, the temperature of the flowing water would affect the surrounding structure. The temperature of the water used for pressurization was not recorded, since all temperature sensors in the backfill and bentonite seal had malfunctioned at the time of the strength test. However, it seems unlikely that the temperature would be higher than the ambient temperature since it was stored in a tank in the monitoring niche. Leakage is therefore not considered a probable cause to the rise in temperature. In a confined space, however, the temperature can rise due to an increased pressure if the pressure rises rapidly and the temperature does not have time to distribute in the surrounding structure.

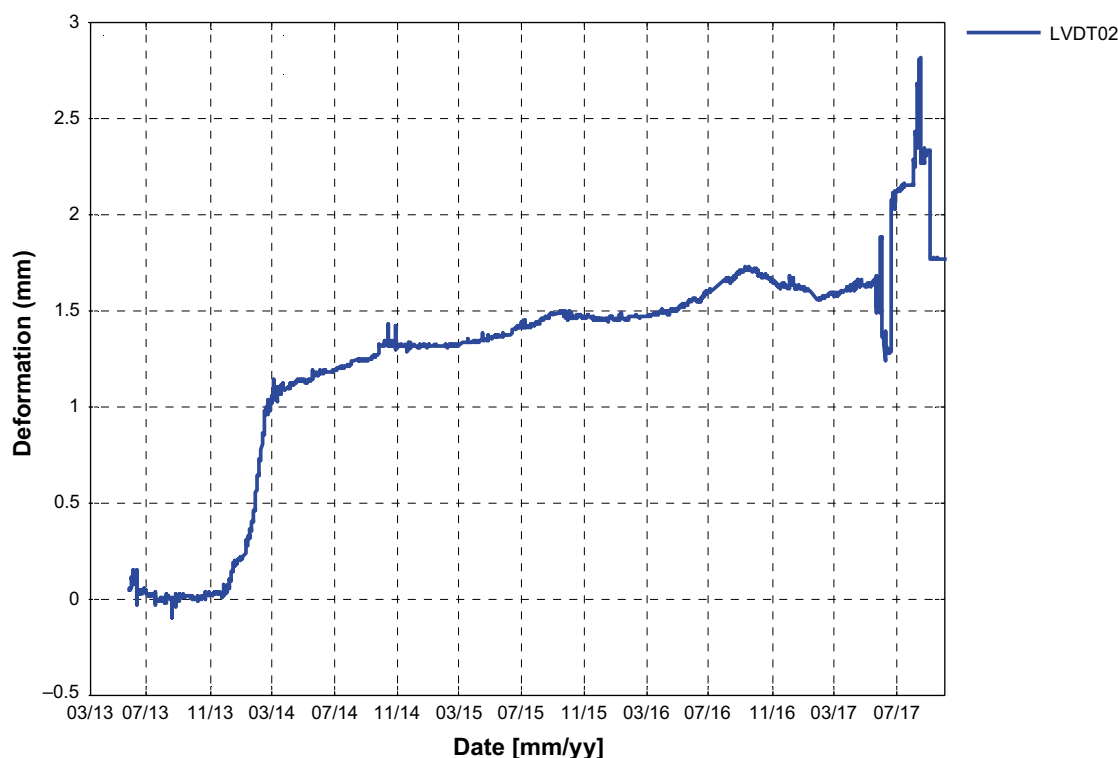
**Figure 4-5.** Measured displacements in the downstream direction in LVDT002, placed at the quarter point above the centre of the plug for the entire duration of the full-scale test (Malm et al. 2019).

When the concrete dome was unloaded for the gas leakage test, the deflection decreased about 0.3 mm (to 1.3 mm). The decreased deflection is significantly less than the initial 1 mm, which was measured during the loading in 2013/2014. The reason for this is to some extent creep. If the concrete dome would have been unloaded for a longer time, the deflection would decrease further but not return to the initial state. The irreversible effects are caused by cracking in the concrete and the increased swelling pressure of the bentonite.

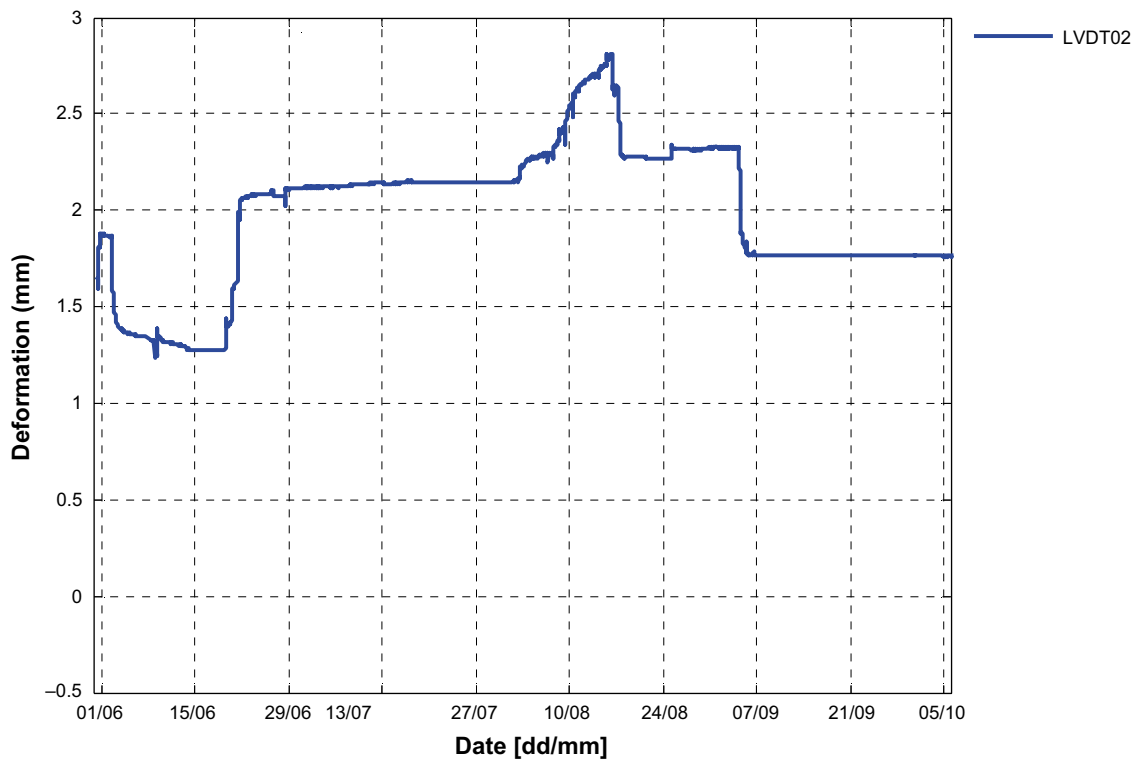
After the gas leakage test, when the pressure was resumed to 4 MPa, the deflection increased to 2.1 mm. The difference in deflection before and after the gas leakage test can be seen in Figure 4-6. It is likely caused by cracking in the concrete dome or loss of bond in the interface between the rock and concrete. As later shown in Section 4.2.2, reduced water pressure leads to increased risk for cracking, especially in the region close to the upstream end of the slot abutment.

During the strength test, the deflection increased by 0.7 mm as the water pressure increased from 4 to 8 MPa. The displacement was also larger after the strength test than before, both when the water pressure was 4 MPa and when the pressure was released. This indicates that further cracking and permanent deformations. The final deflection of the unloaded plug was 1.8 mm at location of the sensor LVDT002.

**Figure 4-6.** Measured displacements in the downstream direction in LVDT002, placed at the quarter point above the centre of the plug for the duration of the gas leakage and strength tests (Malm et al. 2019).

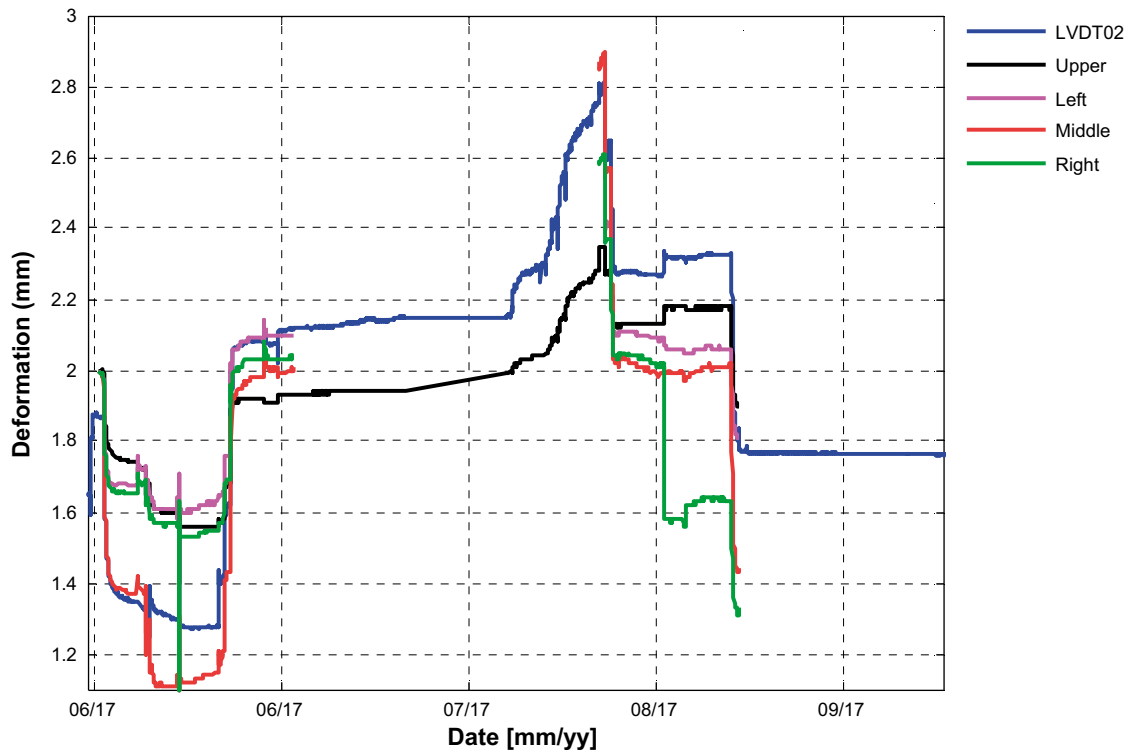
The LVDT-meters installed before the gas leakage and strength tests gave equivalent results as LVDT002, even though some of these sensors did not give a reliable signal throughout the entire test. The measurements from all LVDT sensors are presented in Figure 4-7.

Figure 4-7. Measured displacements in the downstream direction in all LVDT-sensors during the gas leakage and strength tests (Malm et al. 2019).

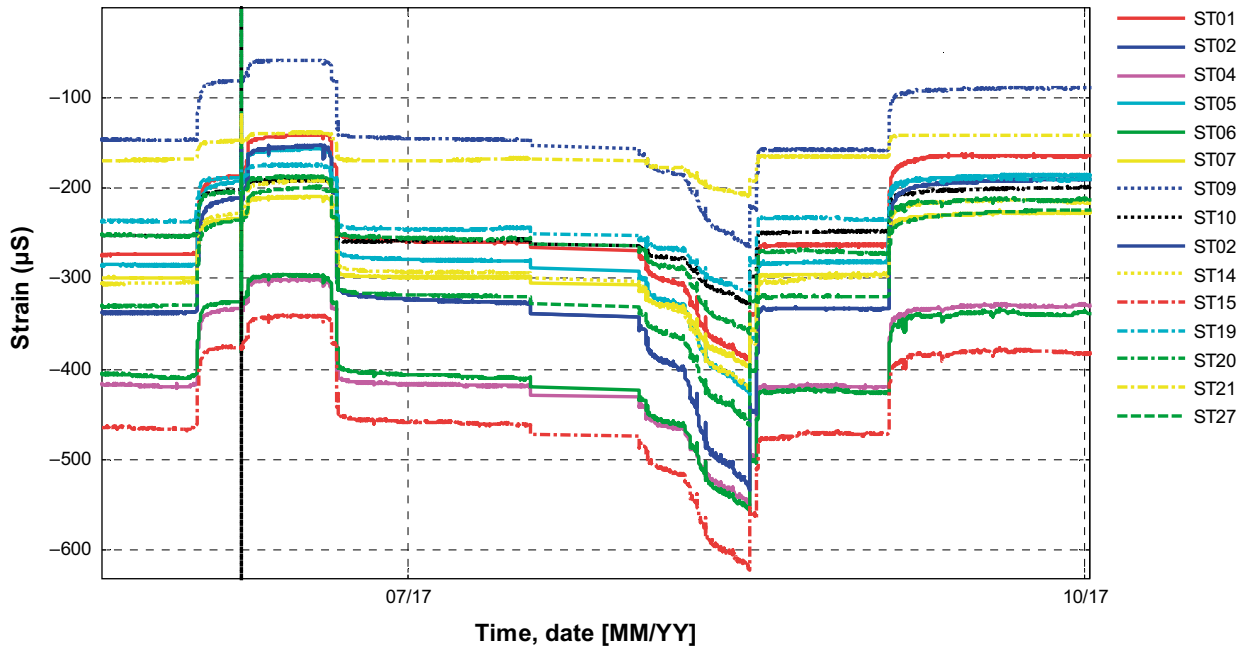
During the gas leakage and strength tests, the strain varied with the changes in water pressure. During the gas leakage test, when the pressure was released, the strain increased about 100–120  $\mu\text{S}$  (see Figure 4-9). If the elastic modulus of concrete of 33.9 GPa is assumed, according to Vogt et al. (2009), the reduced strain corresponds to a reduction of the compressive stress by 3.3 to 4.4 MPa. During the strength test when the water pressure was increased from 4 MPa to 8 MPa, the strain decreased by 100–150  $\mu\text{S}$ . This corresponds to increased compressive stress of 3.3 to 5.1 MPa.

It can be noted that the strain level remains the same before and after the tests. Which means that the concrete dome mainly behaves linear elastically, in the areas where the strain gauges are placed, based on the recordings from the strain gauges.

**Figure 4-9.** Recorded strain from the strain gauges embedded in the concrete during the gas leakage and strength tests (Malm et al. 2019).

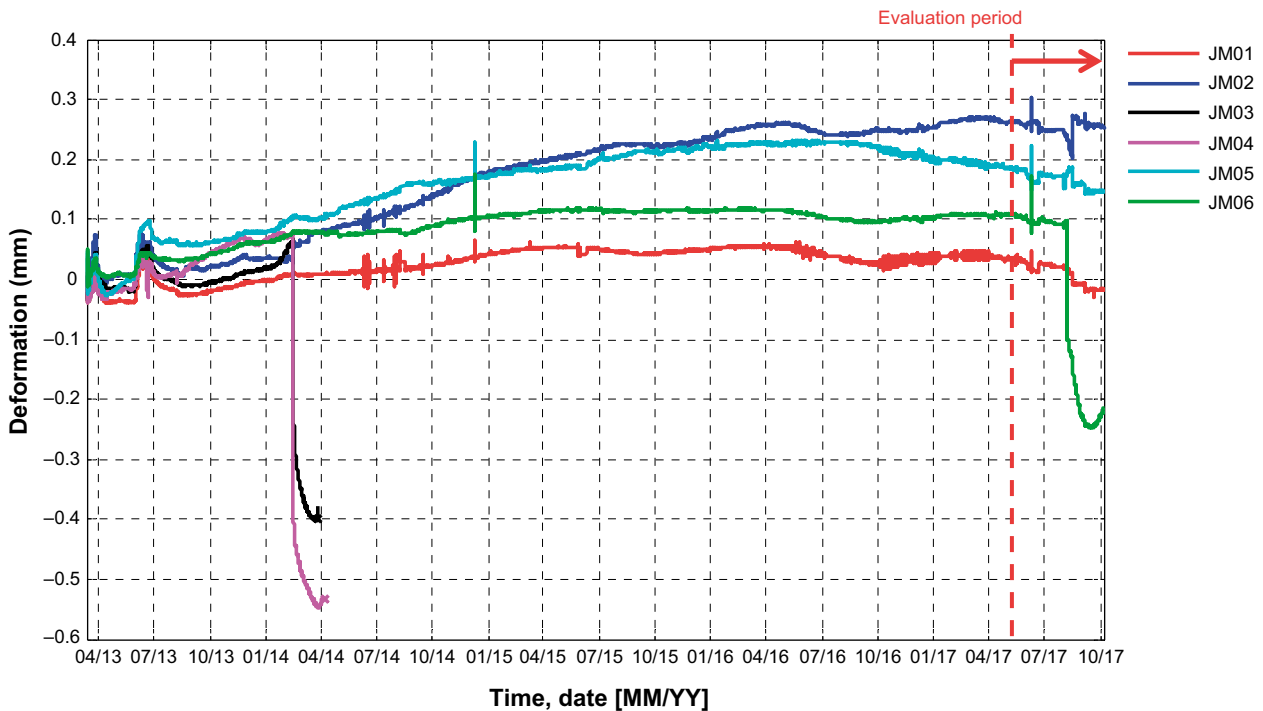
At the start of the gas pressure test, four joint-meters was still functioning. The relative displacement is presented in Figure 4-11. For three of the four of the joint-meters, the variation in displacement is small. This indicates that the bond between the rock and concrete is intact in these regions. However, the fourth joint-meter, JM06, compresses rapidly during the strength test. The compression indicates cracking or loss of bond that leads to increased compressive stress and movement in the joint. This behaviour is similar to JM03 and JM04, which failed during the initial loading, see Figure 4-12.

Figure 4-11. Relative displacement in all joint-meters during the entire full-scale test (Malm et al. 2019).

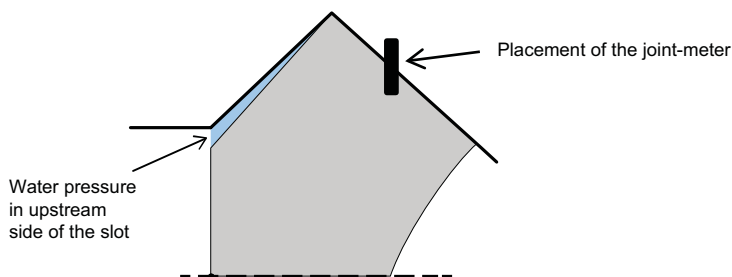
Figure 4-12. Illustration of the top of the dome with release of bond on the upstream surface of the slot abutment.

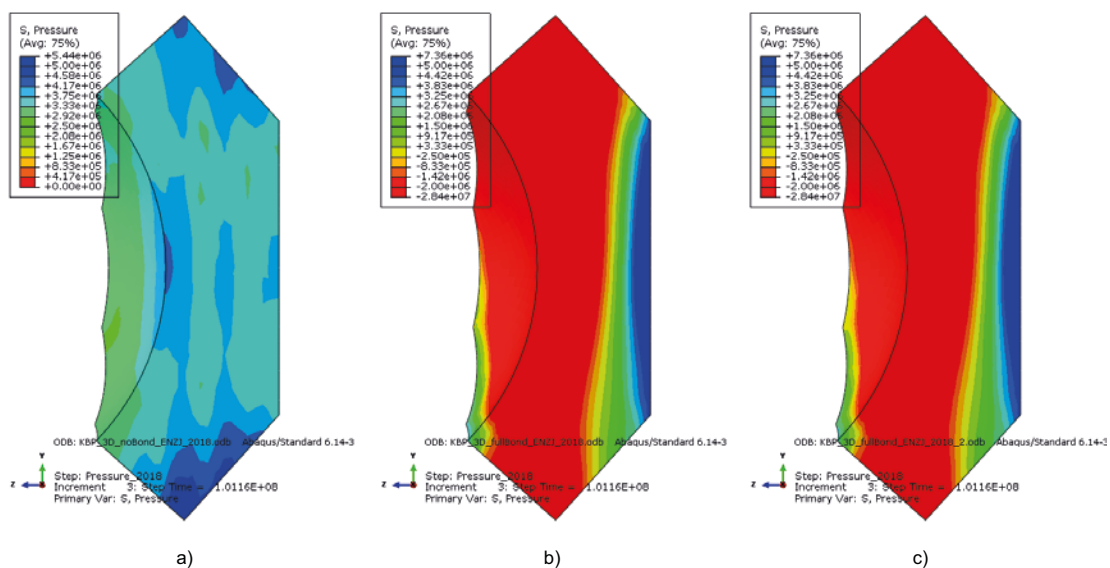
The simulations showed that there would be an increased risk for cracking or loss of bond between the rock and concrete during the gas leakage test. The cracking would occur in the top and centre of the concrete dome, primarily near the downstream side. However, no cracking except micro-cracking (see Section 6.3.2) was observed in this area after the tests were performed. The stresses in the simulation during the gas leakage test is presented in Figure 4-14.

**Figure 4-14.** Stress distribution during drainage, before gas leakage test, a) No bond before contact grouting, b) Initial full bond with release during the cooling before contact grouting, c) Initial full bond with release when the water pressure is applied (Malm et al. 2019), Unit: Pa.

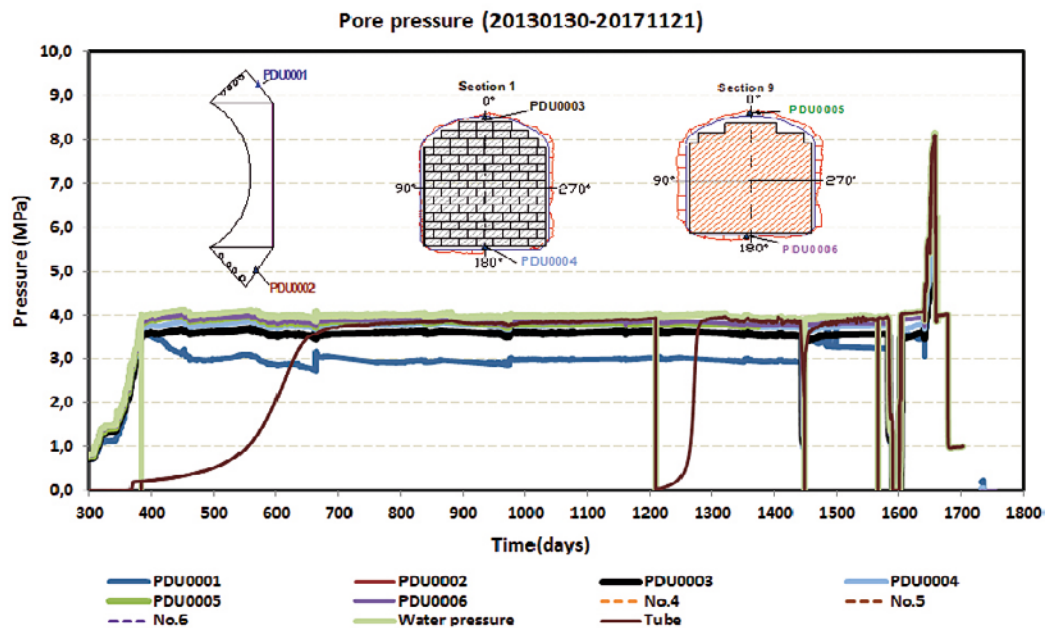
The monitored pore pressure is presented in Figure 4-24. As can be seen in the figure, the pore pressure is close to (slightly below) the water pressure in all monitoring points except the sensor mounted in the top of the slot (PDU0001). This sensor showed increasing pressure of the same magnitude as all other sensors during the initial pressure increase to 4 MPa of water pressure in 2013/2014. This shows that the bentonite seal was not water tight initially. As the water pressure in the filter was maintained constant at 4 MPa, the pore pressure in the slot successively decreased to about 3 MPa and was constant at this level until the filter was drained during the gas tightness test. This showed that the bentonite seal started to seal and to some extent started to restrict access of water to this location. However, considering that a significant water pressure was present, this shows that the concrete dome was subjected to water pressure and that the concrete dome constituted an important part of the water tightness of the plug system.

Figure 4-24. Development of the pore pressure in the plug, from Åkesson et al. (2019).

These results show that the bentonite seal was by-passed to a great extent in the full-scale test, where the water in the filter was transported in the rock due to fractures and micro-fractures. These conclusions are further supported by the measurements of the water content in the bentonite seal, presented in Section 8.3.1.

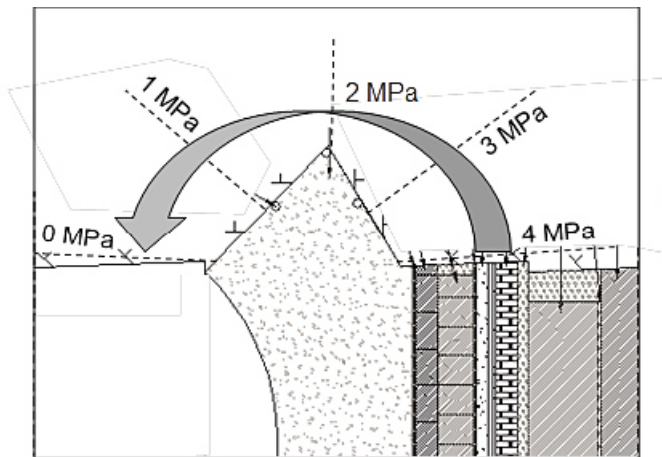
It seems likely that the water leakage had by-passed the bentonite seal and resulted in a pressure distribution in the rock as shown in Figure 4-25.

Figure 4-25. Illustration of assumed distribution of pore pressure in the rock.

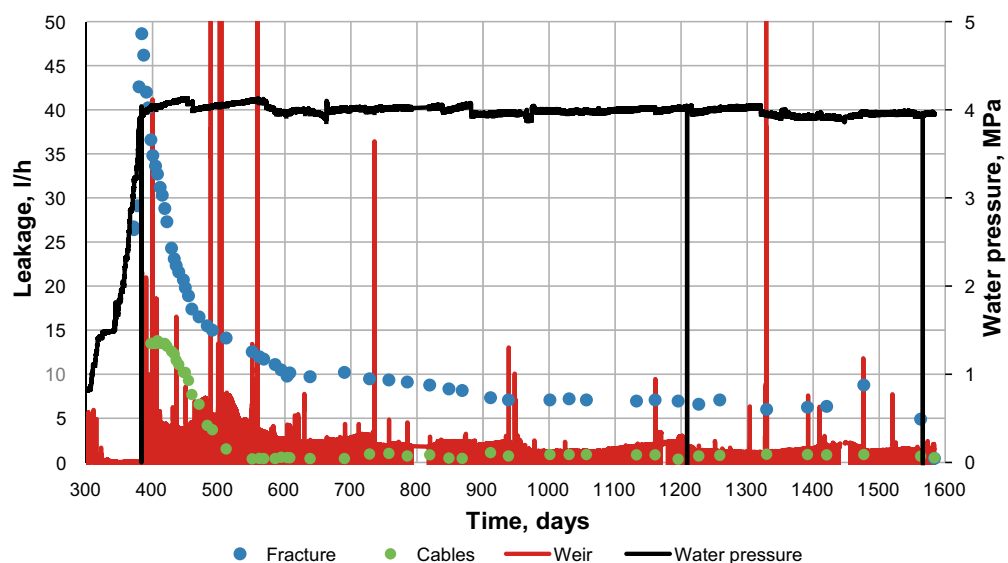
Figure 4-33. Determined leakages and water pressure plotted versus time, from Åkesson et al. (2019).

As mentioned in Grahm et al. (2015), the first two sources are experimentally related escapes of water and therefore separated from the leakage through the plug. During the initial pressurization to 4 MPa, a fracture mapped as small and dry before the test started to have significant leakage when the pressure increased up to 3.1 MPa. The water escape from this rock fracture is located about 14 m from the plug. The other source of experimentally related leakage is from the cable bundle of embedded sensors in the concrete. These sensors were not designed to be subjected to significant water pressures, since it was believed that there should be no direct water pressure in these regions. The leakage through the surrounding rock mass is considerable but can also be regarded as a part of the experiment setup.

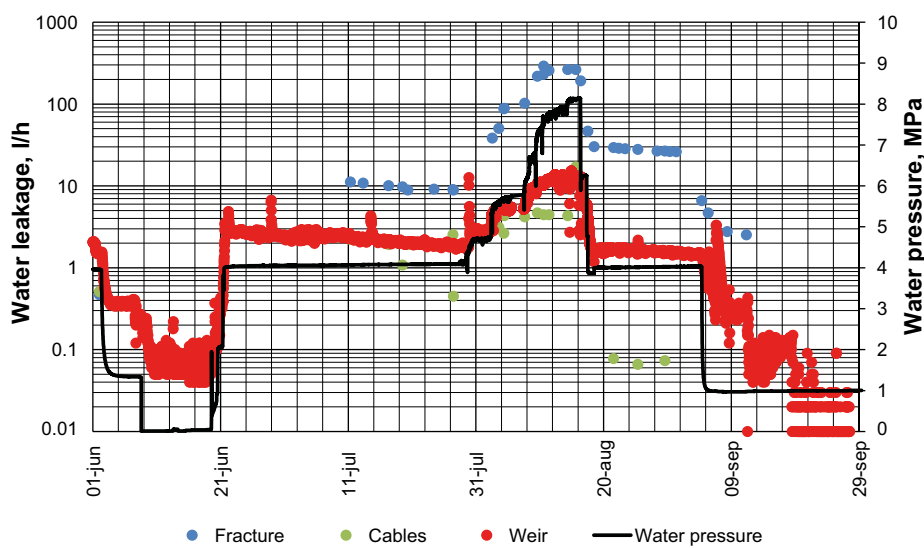
Figure 4-35. Applied water pressure and measured leakages from weir, rock fracture and from cables plotted versus time (Åkesson et al. 2019).

The measurements showed that all observed leakages decreased to zero during the gas tightness test. The measured leakage through the plug and the cables increased to the same level as before the test only a few weeks after the pressure had been increased up to 4 MPa again.

During the strength test significant increase in leakage was observed. The leakage in the rock fracture reached about 257 l/h (compared to 7–8 l/h before the test). The leakage through the cables increased to 15 l/h compared to 1 l/h when the pressure was 4 MPa. The leakage collected in the weir increased to about 13 l/h compared to 1–2 l/h prior to the pressure increase.

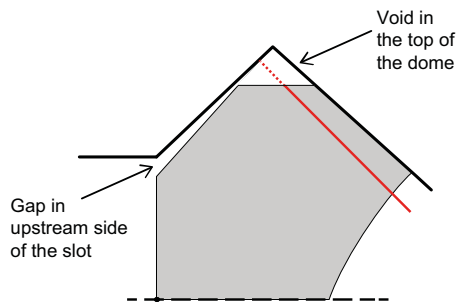
The aim of the NDT was to detect manufacturing defects in the concrete dome. Therefore, the contractor did not target the abutments of the structure or the affected area. According to Malm et al. (2019), the contractor claimed that the void would be impossible to detect even if it was targeted. The void was located deep into the plug. When NDT is used at depths of more than 2 meters, the resolution is very coarse. The results from this depth could at best indicate that an anomaly exists in an area. If the cavity was detected, only the front surface would be seen in the scan. The depth or the shape of the cavity could not be scanned, since the waves reflect and does not travel through the void. In addition, the location of the void is problematic since it borders to the edge of the concrete dome. Since the inspection waves spreads out in a slightly circular pattern, they will reflect of the abutments. This creates interference, which is common while scanning close to the edge of a slab. This is illustrated in Figure 5-4, where the top of the dome is illustrated with the void in the top and the gap on the upstream surface of the slot abutment. The wave from the NDT scan is illustrated with the red line. If the scan is performed on a case where a void exists in the top, then the wave will be reflected at the intersection between concrete and air (solid line) compared to a case without the void where it is reflected at the interface between concrete and rock (dotted line). The difference in length between the solid and the dotted line is quite small and considering the uncertainties when scanning at such great depths, this type of defect will likely not be easy to detect.

**Figure 5-4.** Illustration of the top of the dome, with the void in the top and a gap on the upstream surface of the slot. The wave from the NDT scan is illustrated with a red line.

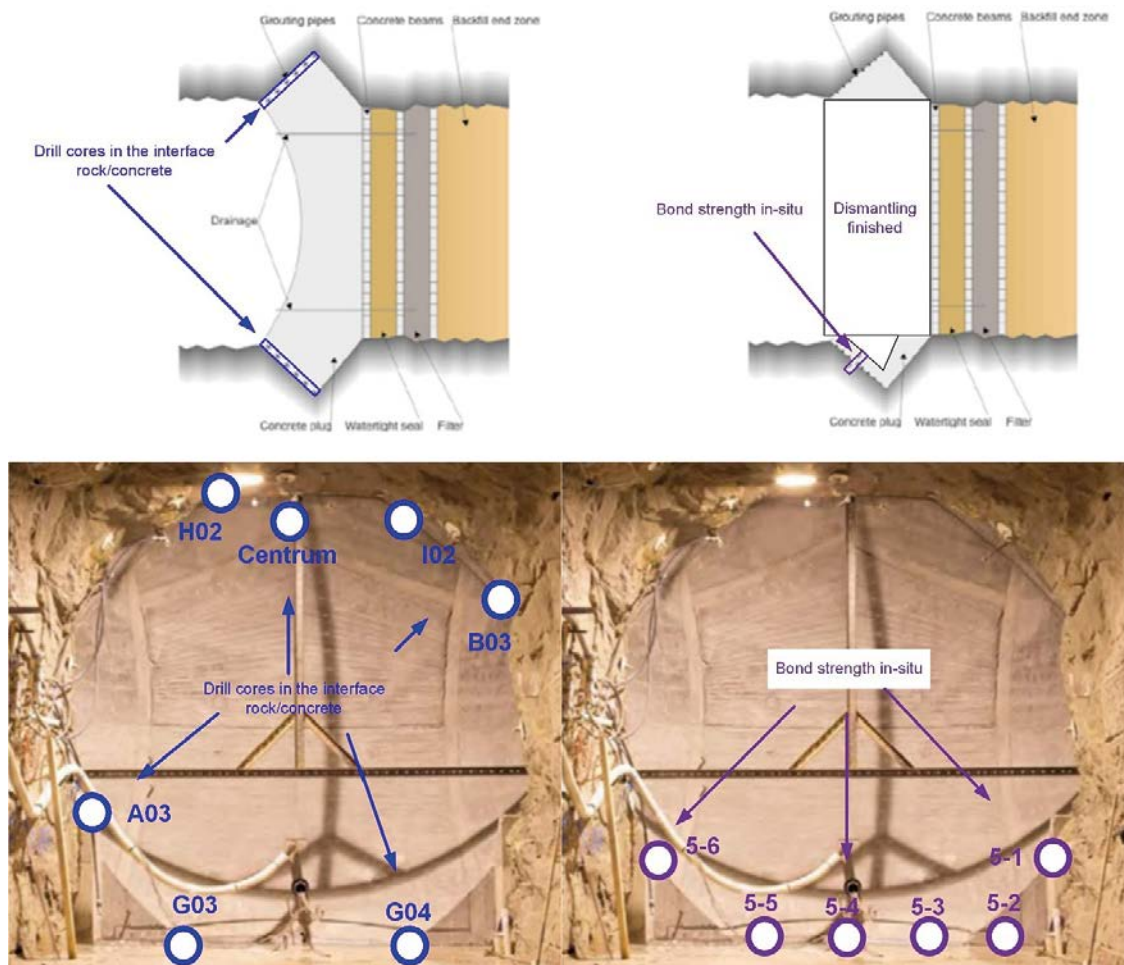
**Figure 6-2.** Drill cores with diameter 150 mm for investigation of the interface between rock and concrete (left). In-situ test of bond strength between rock and concrete on the upstream face of the slot in the rock (Vogt 2019).

Core sampling and visual observations did not show any obvious defects such as cracks, honeycombing or large voids in the concrete. However, in the top of the dome, a triangular void was detected during core drilling of the core denoted H02 as previously shown in Figure 6-2. This void showed that the casting of the dome had not completely filled the volume. In Figure 6-6 a), the placement of the drilled core is illustrated. The height of the void was about 0.4 m and it was observed during core drilling that top of the dome was partially filled with grout material as shown in Figure 6-6 b).

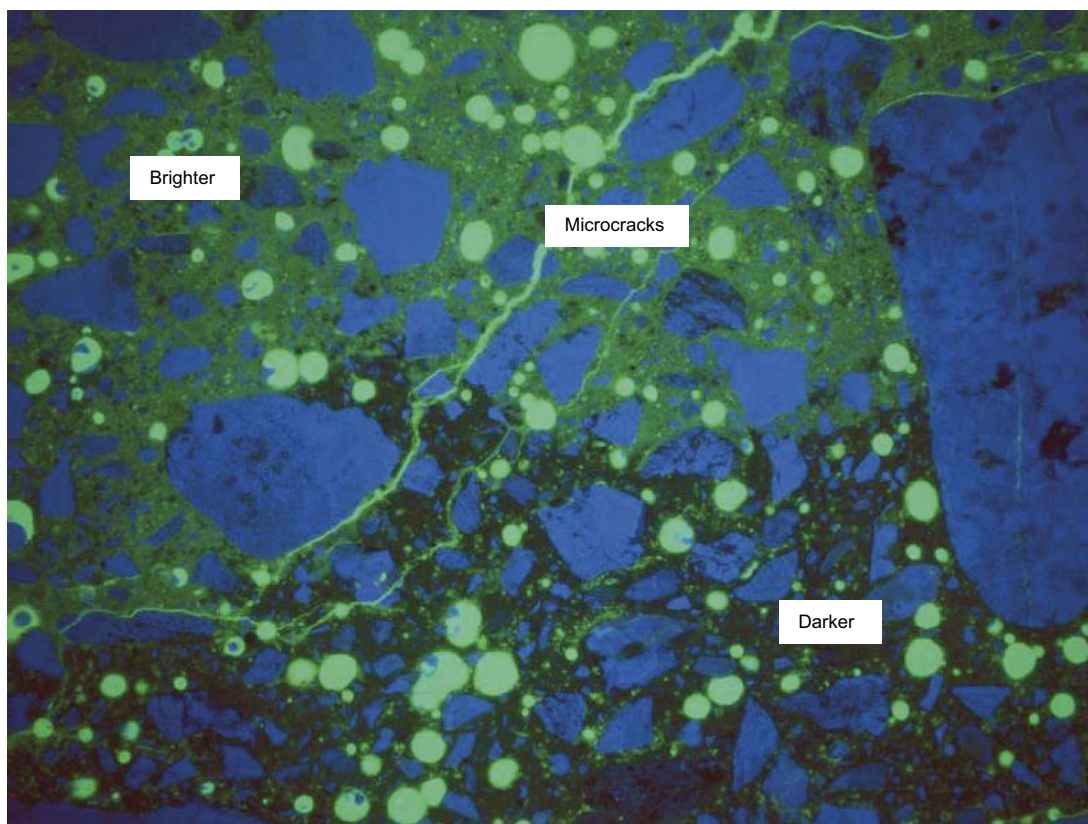
A UV photo of the concrete located close to the downstream surface of the dome is shown in Figure 6-5. In the upper part of the photo, the concrete has a brighter colour than in the bottom. The reason for this is that the concrete closer to the surface (in the top of the figure) has higher degree of porosity compared to the concrete at greater depth (in the bottom of the figure). It is also possible to see a micro-crack that goes from the surface and in the concrete, which are illustrated with a bright green colour in the figure. The micro-cracks run around the ballast grains, which indicates lower fracture energy. The observed micro-cracks have according to Vogt (2019) probably formed due to restrained shrinkage of the cement paste. Vogt (2019) also states that based on observations made in thin sections, there is no evidence of reduced durability of the concrete.

**Figure 6-5.** UV light of the sample 3.2.1-1 located 5–10 mm from the downstream surface. Width of the figure is 6.7 mm. The brighter area in top of the figure illustrates higher porosity compared to the darker area in the bottom area.

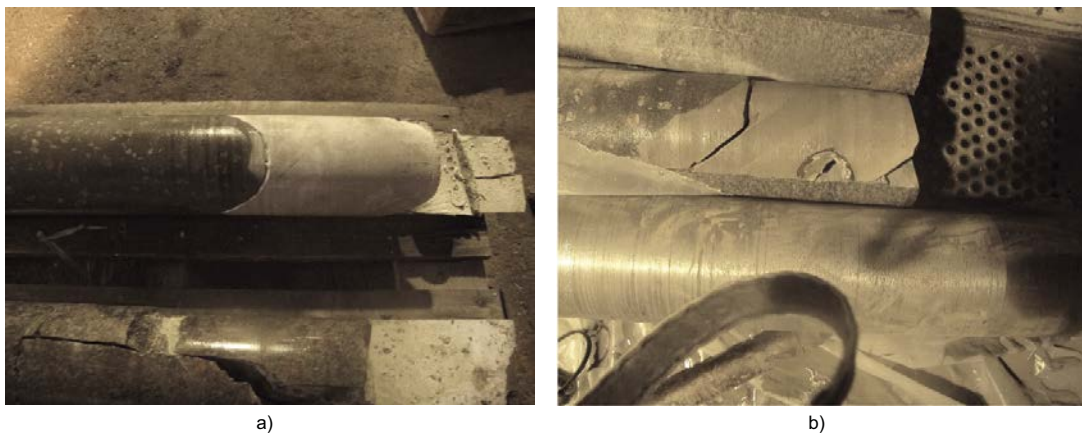
The same observations were then made for all 50/50 cores sampled near the top of the dome and in Figure 6-7 the cores from H02 and I02 are shown. The grout material can be seen as a brighter grey colour with absence of larger aggregates. One additional core was sampled in the centre (denoted Centre in Figure 6-2) of the dome and is shown in Figure 7-11a. For clarification, a picture of the void taken during dismantling of the dome is presented in Figure 7-11b. An additional drill core and a photography of the void are presented in Figure 6-8. Further discussion regarding the detected void in the top of the concrete dome is presented in Section 7.2.

**Figure 6-7.** a) Drill cores H02 and b) I02. The top part of the cores is displayed.

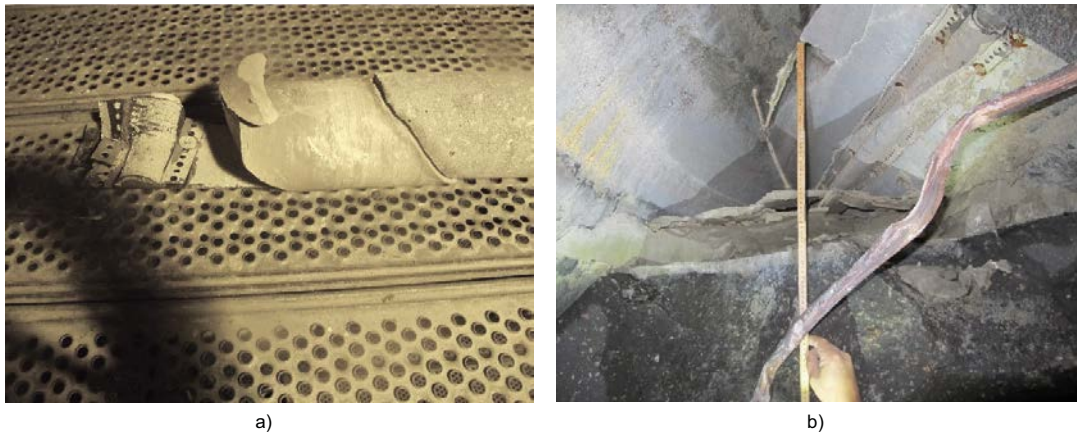
*Figure 6-8. a) Drill core “centre” and b) void on top of the concrete.*

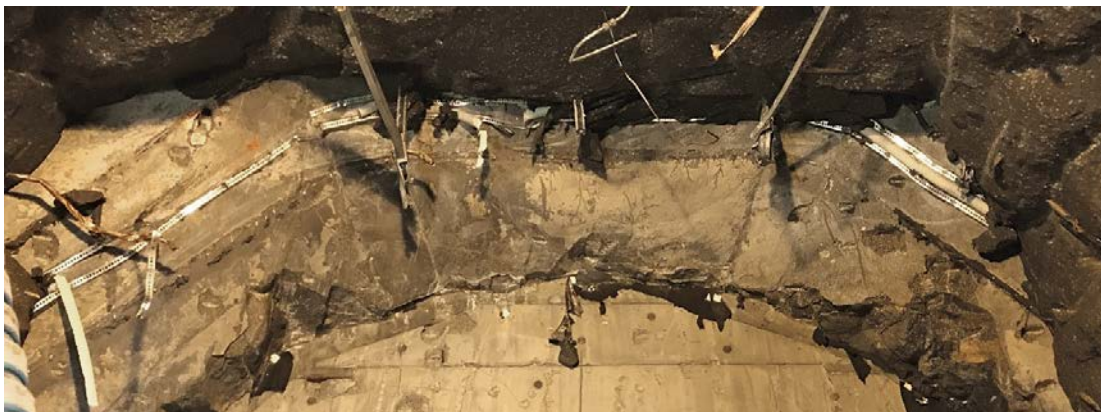
Figure 7-6, Figure 7-7, and Figure 7-8 shows the state of the concrete dome after 4, 9 and 14 days respectively. Figure 7-9 shows the upstream face of the slot abutment where a thin layer of grout from the contact grouting is visible in certain areas. If this area had any bond between concrete and rock, then pieces of concrete would have been seen on the rock surface. In addition, in Figure 7-6a, the concrete on the upstream in the top-right corner of the photo has fallen from the slot. This shows that the bond in this area was lost, most likely during the increasing water pressure as previously discussed.

*Figure 7-9. Some areas are visible with a thin layer of grout on the upstream side of the slot.*

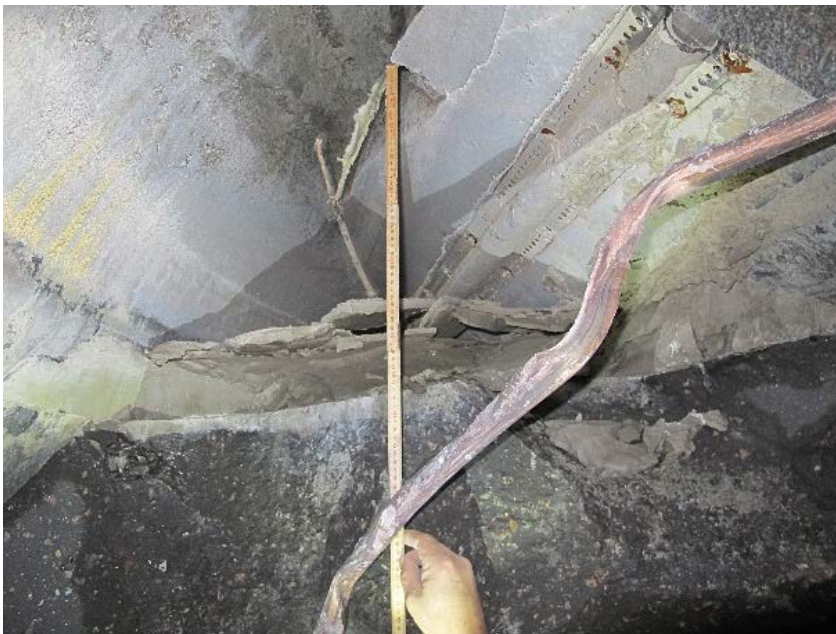
As mentioned previously, this void was partially filled with grout, where the grout thickness was estimated to be about 10 cm as seen in Figure 7-11. This corresponds to about 380 litres of excess grout that had been placed in the top of the dome. As mentioned in Grahm et al. (2015), it was noticed during grouting that significantly more grout than expected was used. According to Grahm et al. (2015) 654 litres of grout was used compared to the estimated 260 litres. The difference between the used and estimated amount of grout is 394 litres which corresponds to the amount of grout found in the top of the dome.

**Figure 7-11.** Measuring the height of the void, about 40 cm whereof 10 cm is filled with grout.

During the drilling of the core samples, a large void was detected in the top of the concrete dome. The void occurred during the pouring of the concrete dome because the formwork was not top filled. The void had an estimated volume of about 0.8 m<sup>3</sup>. During the contact grouting, a 10 cm thick layer of grout was collected in the void. The concrete dome performed as expected despite the void. Finding the void did however explain why some sensors in the top of the concrete dome failed prematurely and why there was an increased leakage in the top of the dome.

The venting tubes could be placed within the concrete body and should be removed after casting is finished to prevent possible leakage paths. Alternatively, the venting pipes could be placed in the rock, but also in this case it is important to prevent that these form leakage paths in the future. Two examples for placement of venting tubes are illustrated in Figure 9-1. It could also be possible to use grouting tubes in the positions shown in Figure 9-1 for additional grouting as a complement to the circular grouting tubes placed in the slot.

It should also be possible to cast the top of the dome with a modified concrete mix, consisting of smaller aggregates and higher amount of super-plasticizer. This would improve the flowability of the low-pH concrete and could thereby simplify top filling of the slot. This is however, difficult to perform with the pumping technique used in the DomPlu test. The concrete was pumped in the top of the formwork and thereby pumped in at a lower elevation than the slot, see Figure 9-2a. To use a modified concrete mix would require additional pumping pipes at the top of the slot. Same as with the venting pipes, it is important that these are removed after casting and that the volume is filled with concrete to avoid future leakage paths.

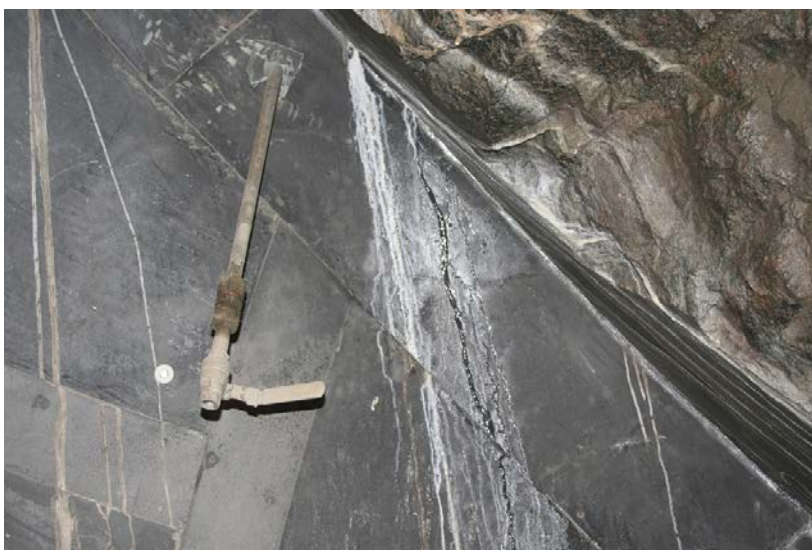
The void in the top also explains other observations made during the monitoring the behaviour during pressurization of the dome. Leakage was detected in the area in the top as shown in Figure 7-13. This leakage was detected near the drill hole I02, see Figure 6-2. This seems reasonable considering that the void in the top was water filled and had a water pressure of about 3 MPa, as previously shown in Figure 4-24.

**Figure 7-13.** Illustration of leakage at the concrete rock interface during the initial pressurization up to 4 MPa, from Grahm et al. (2015).
