**TR-18-02**

June 2019

# Full-scale test of the Dome Plug for KBS-3V deposition tunnels

## Project summary and evaluation of the final results

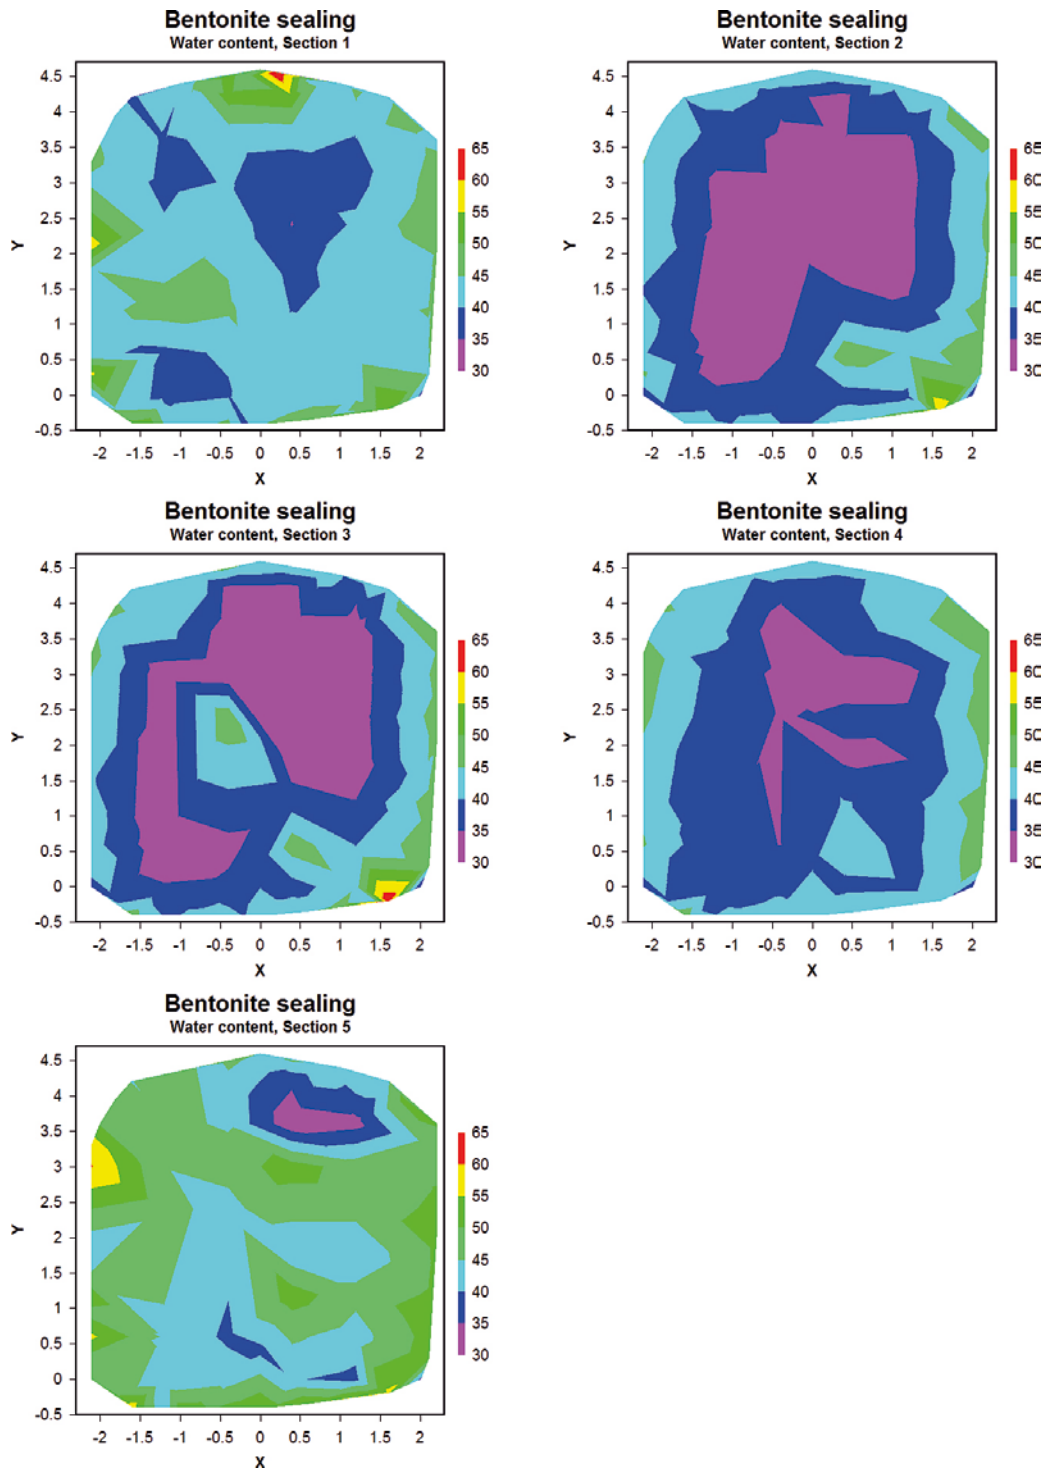
The water content was measured in all samples in the bentonite seal and the results have been summarized in contour plots for each section as seen in Figure 8-3. As seen in the figure, the water content is highest in BT5 (closest to the filter) and in BT1 (closest to the concrete dome). If no leakage occurred in the rock, then the water content is expected to have its highest in BT5 and decrease over the thickness of the bentonite seal. Considering that the section closest to the concrete dome shows almost as high water-content as the section closest to the filter, this indicates that the bentonite seal has been by-passed in the full-scale test. Furthermore, the pore pressure sensor installed in the slot showed that the water pressure on the concrete dome was about 3 MPa while the filter pressure was 4 MPa. This also indicates that the bentonite seal was by-passed.

**Figure 8-3.** Graphs showing the water content distribution in the bentonite seal in the five different sections sampled, Åkesson et al. (2019).

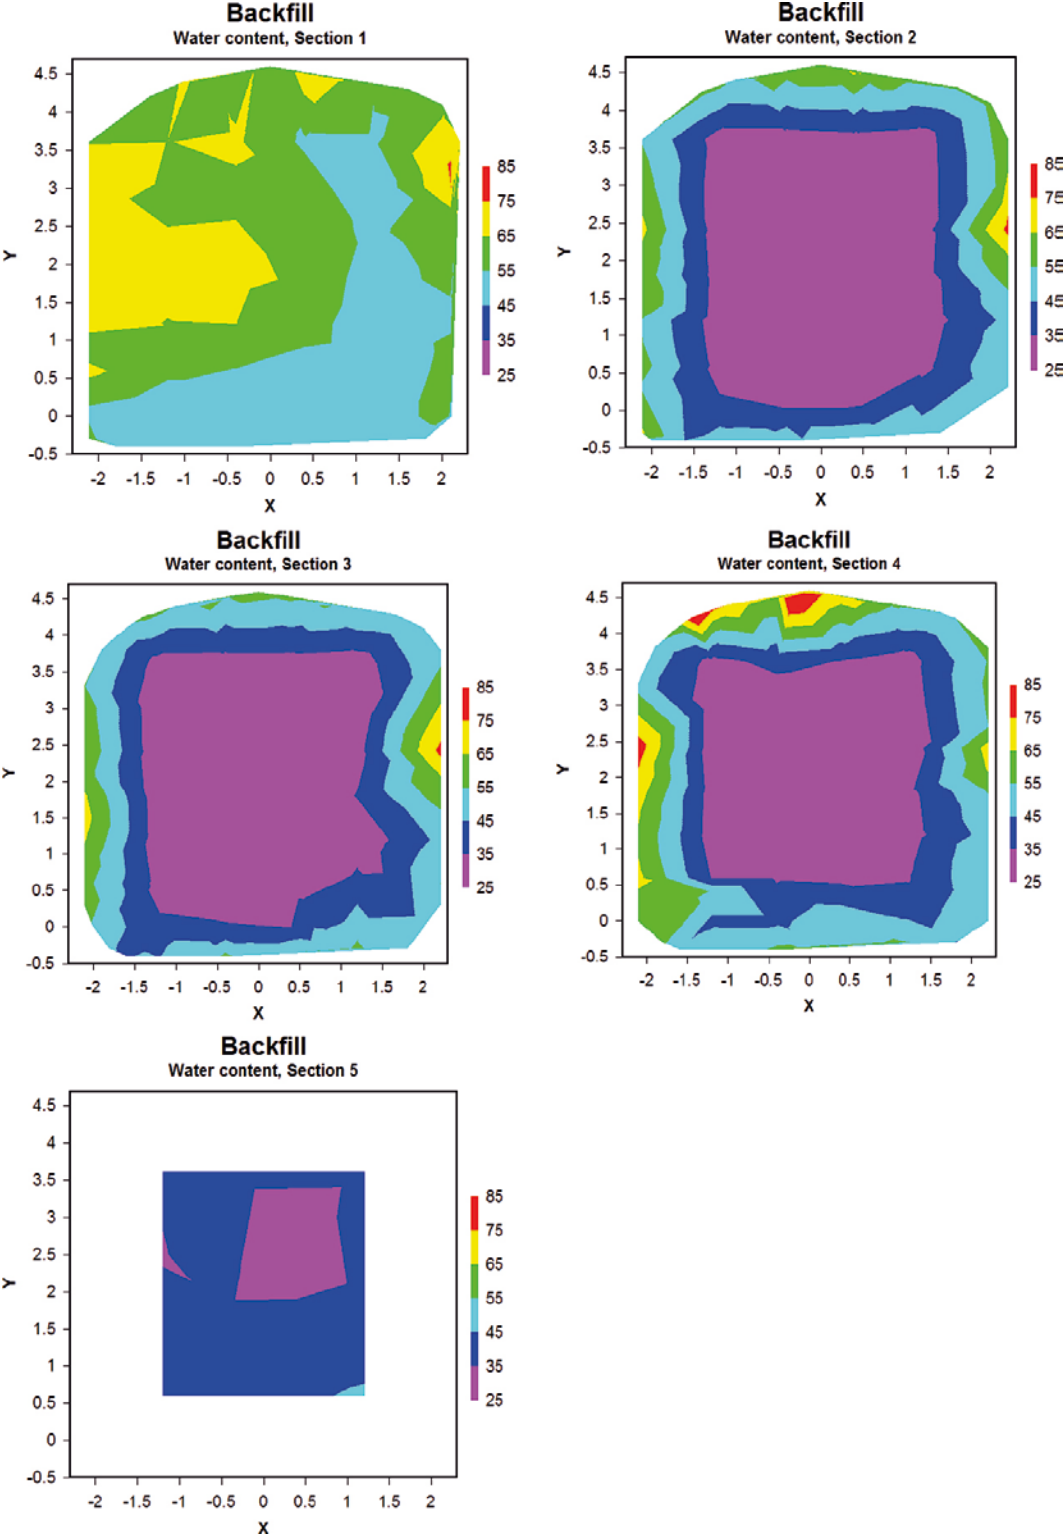
The visualization of the results has been done in a similar way for the backfill which are presented in Figure 8-4. As can be seen from the results, the highest water content is obtained in section BF1 (closest to the filter) and BF4 (closest to the concrete wall). In this case, it was expected that the section denoted BF4 should show a high water-content since water also was pumped in to the macadam pocket located next to the concrete wall.

Figure 8-4. Graphs showing the water content distribution in the backfill in the five different sections sampled, Åkesson et al. (2019).

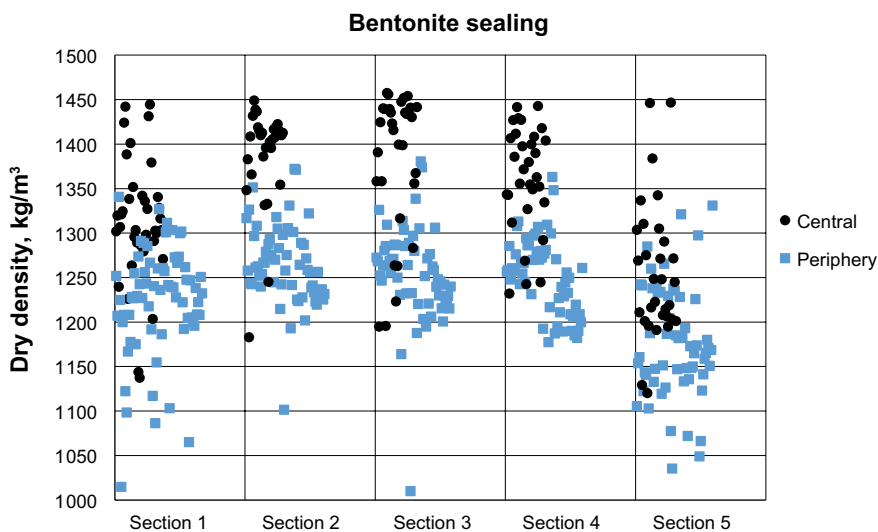
Overall, the density in the bentonite seal varied between 1 020 and 1 460 kg/m<sup>3</sup>. The lowest density was found in the periphery, where the dry density at installation was 900 kg/m<sup>3</sup>. The density in these regions had after termination of the test increased to between 1 020–1 370 kg/m<sup>3</sup>. This means that the central blocks, with an installed dry density of 1 682 kg/m<sup>3</sup> had swelled and compressed the pellet filling. The variation in density in the central parts varied between 1 120 and 1 460 kg/m<sup>3</sup>.

**Figure 8-5.** Graph showing the results from all measurements on dry density in the bentonite seal. The results are divided after measuring section on the x-axis. The samples taken from the central parts (former block stack) are marked with black dots and the samples taken in the periphery (former pellet filled slot) are marked with blue cubes, Åkesson et al. (2019).

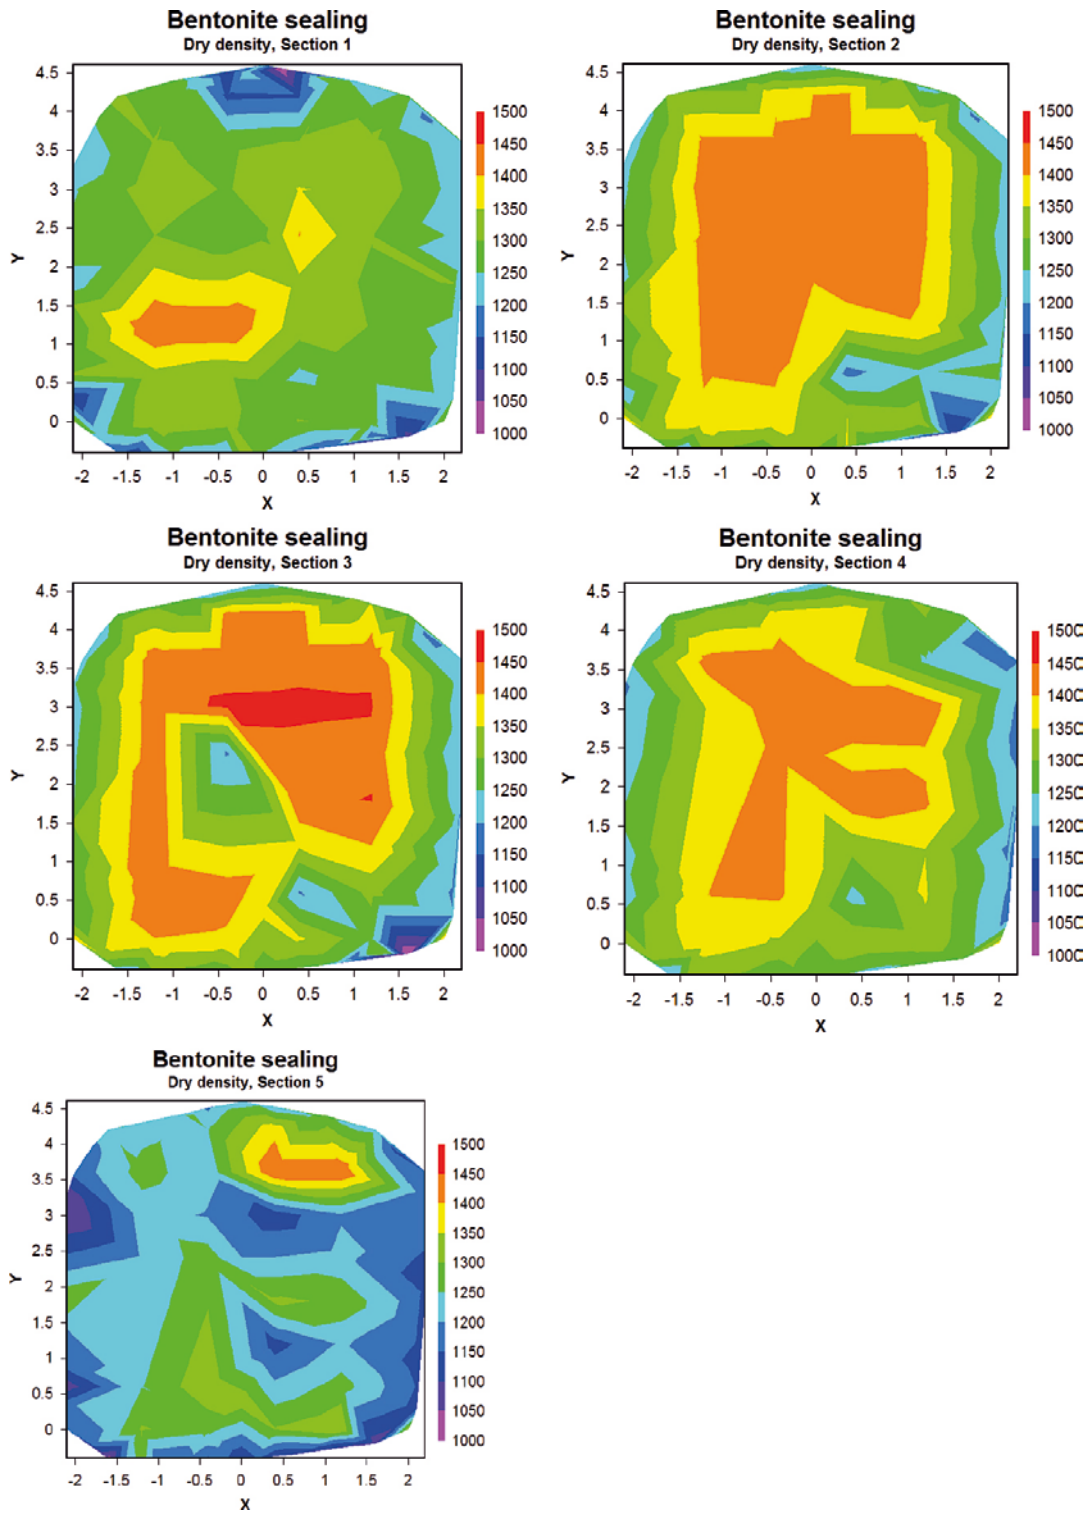
The resulting dry density is also presented as contour plots in Figure 8-6 for each section. It can be seen in the figure that the dry density is lowest in section BT5 which is located closest to the filter. This indicates that the swelling of the bentonite seal has caused movement towards the filter, i.e. the bentonite seal has compressed the filter. The density is also lower in section BT1 which is located closest to the concrete beams. According to Åkesson et al. (2019), this is likely caused by flowing water during the initial pressurization to 4 MPa, where the water entered the bentonite seal from the initial gaps between the concrete beams (and through the mesh of the geo-textiles). This may have caused early swelling of the bentonite in this section.

*Figure 8-6. Illustration of the distribution of dry density in the bentonite seal, Åkesson et al. (2019).*

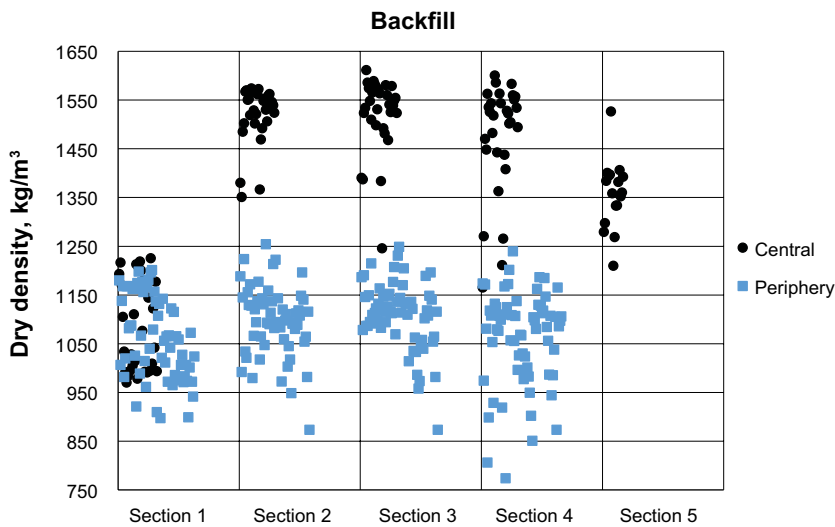
The results show large difference between the periphery (i.e. where the pellets were installed) and the central part (i.e. where the blocks were stacked) for all sections except BF1 which is located closest to the LECA beams. The density for the periphery samples is between 875 and 1 225 kg/m<sup>3</sup>. The density for the central parts was between 1 200 and 1 600 kg/m<sup>3</sup>, with exception of Section 1 but also Section 5. The reason why the inner section is lower is because pellets were installed between these blocks and the concrete wall. According to Åkesson et al. (2019) these large differences in density shows that the backfill has not homogenized.

**Figure 8-7.** Graph showing the results from all measurements on dry density in the backfill. The results are divided after measuring section on the x-axis. The samples taken from the central parts (former block stack) are marked with black dots and the samples taken in the periphery (former pellet filled slot) are marked with blue cubes, Åkesson et al. (2018).

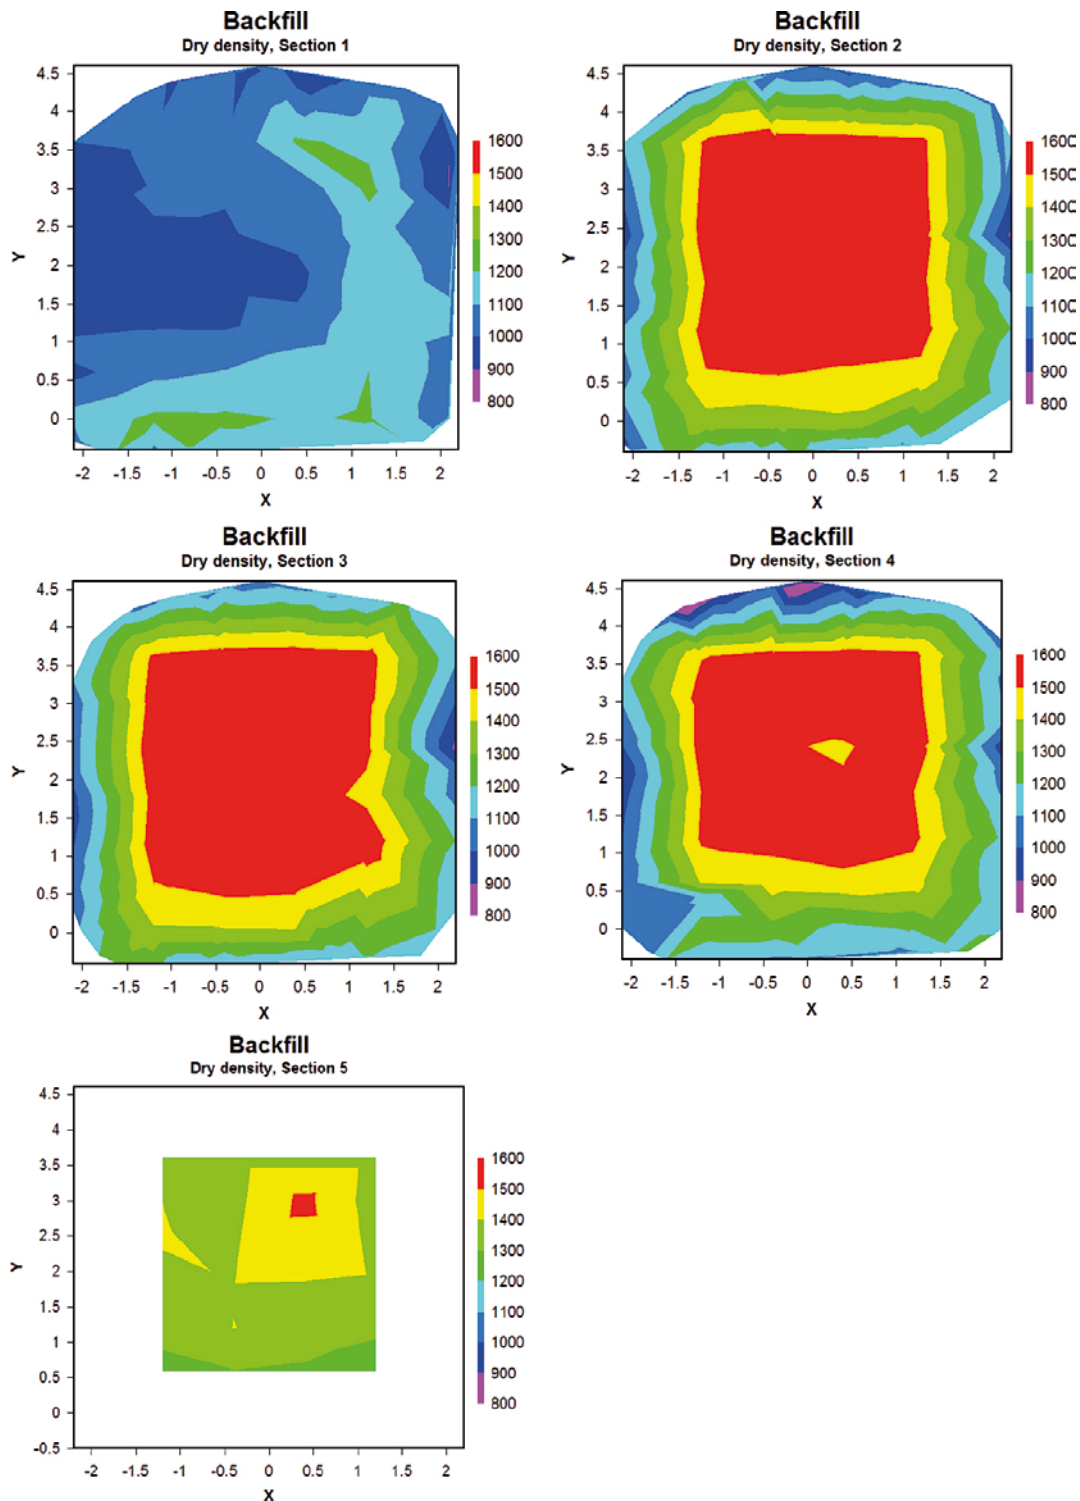
Results are also presented as contour plots for each section, see Figure 8-8. These results clearly show the high density of the central parts in Section 2 to 4. This is likely a result of that the bentonite backfill has not homogenized even after five years after construction.

Figure 8-8. Illustration of the dry density in the bentonite backfill, Åkesson et al. (2019).

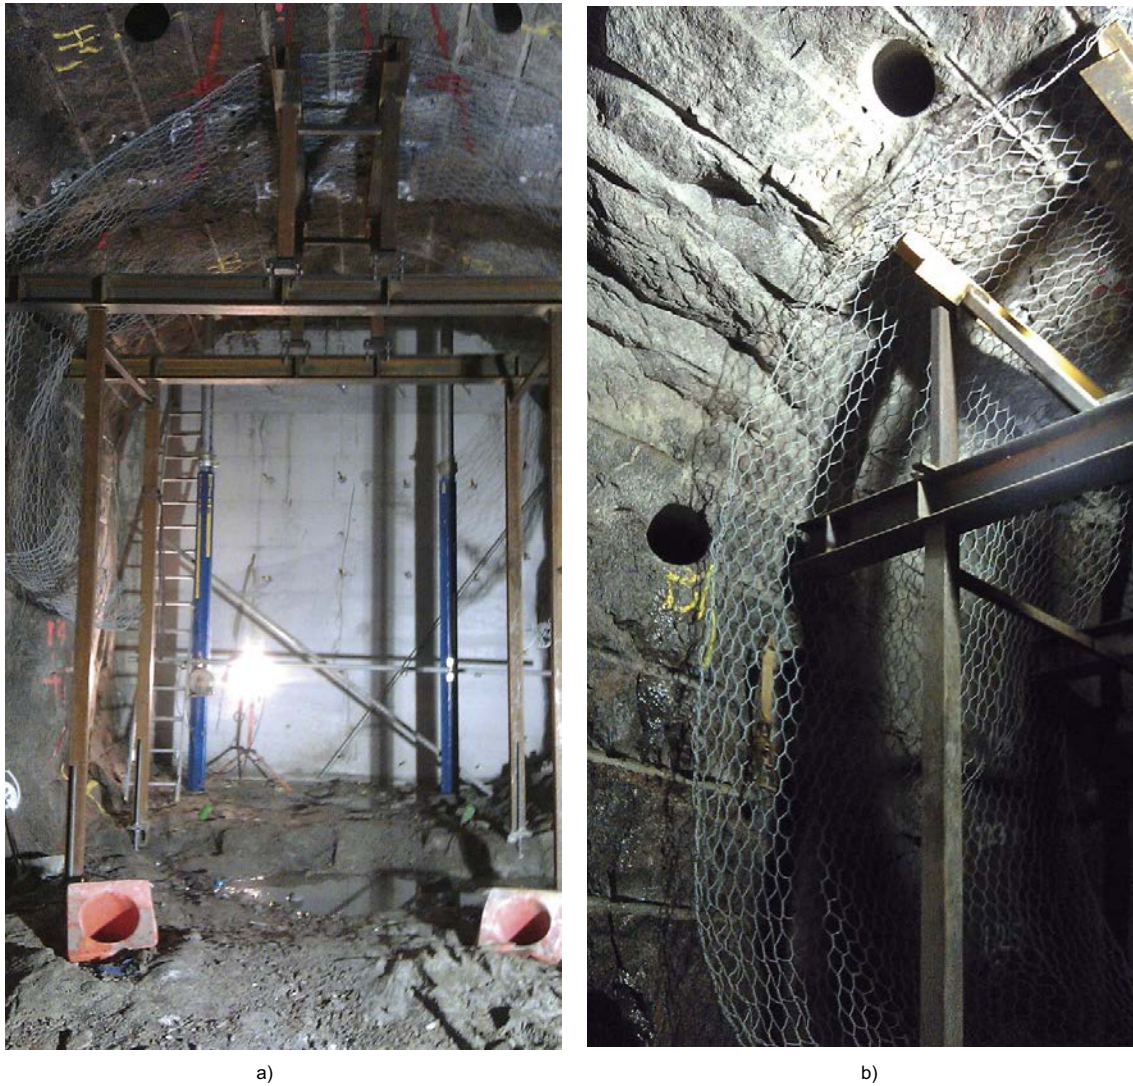
The occupational safety of workers from the risk of rock blocks falling down, is an important aspect to consider at the slot abutment. In the DomPlu test, this was achieved by building a support frame with a mesh that prevented falling blocks, see Figure 9-5. In a future repository, the slot can either be excavated directly after the excavation of the deposition tunnel or just before installation of the plug. Depending on when the slot is excavated, the need for occupational safety measures varies. Keeping a rock excavation open for a longer period of time increases the risk of large deformations, rock spalling or falling blocks.

**Figure 9-5.** a) Erected safety scaffolding including a mesh to protect workers from falling rocks. b) Detail of the scaffolding with two of the Ø 250 mm boreholes for the wire-sawing are also visible. From *Grahm et al. (2015)*.

Installation of a supporting steel structure, may interfere with transportation in the tunnel to some extent. A steel frame might therefore not be viable in a case where the tunnel area is reduced, since it could result in a size restriction of the transport past the plug location.

Installing rock bolts could be one method to stabilize the rock at the plug location. However, it needs to be further analysed if the installation of bolts can affect the performance of the plug system.
