**TR-22-01**

# Analysis of corrosion products on filter housings in the Lasgit field experiment

SVENSK KÄRNBRÄNSLEHANTERING AB

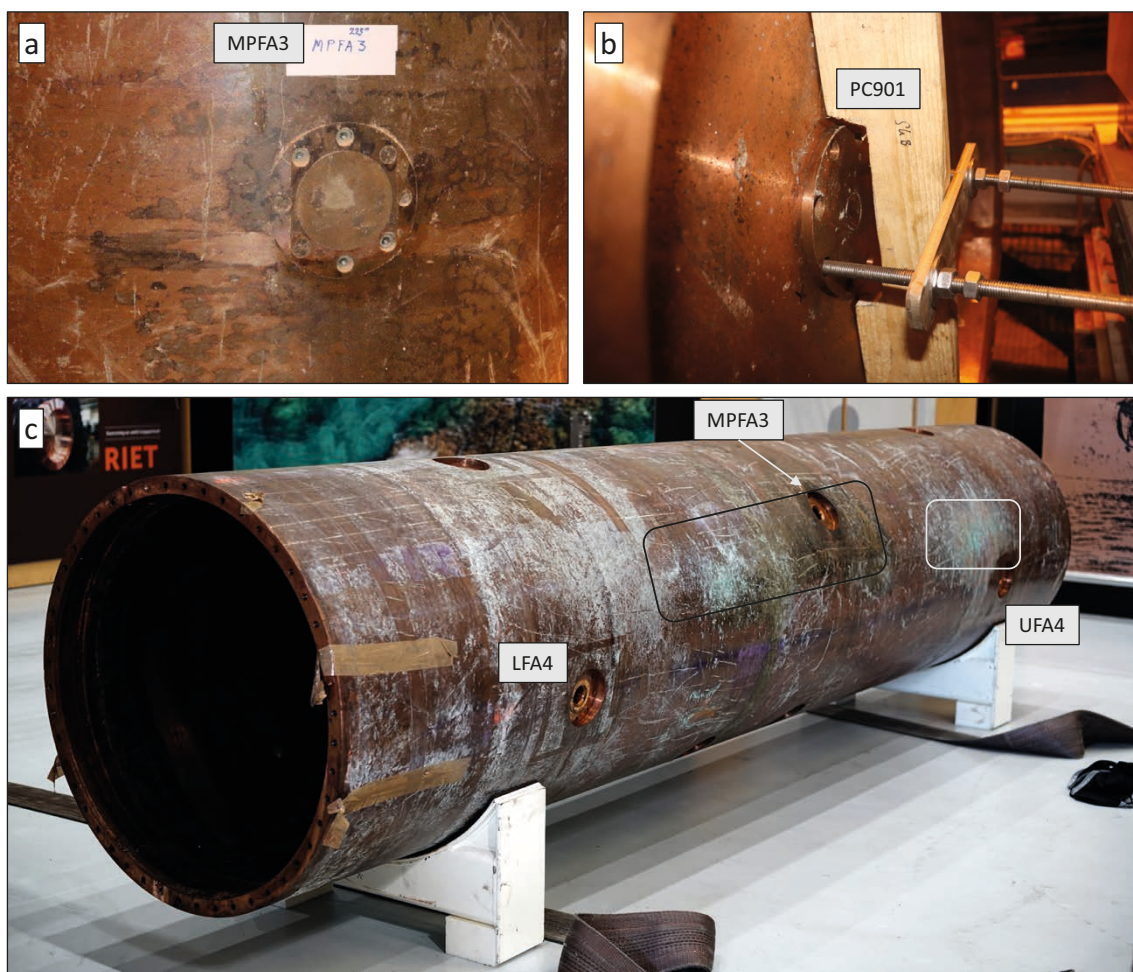
**Figure 1-3.** Images of (a) the Lasgit canister upon retrieval with filter assembly still in place, (b) removal of filter assembly (PC901), and (c) the Lasgit canister after removal of the cast iron insert and filter assemblies. A sample of corrosion products on the canister surface was extracted from the area marked with a light grey rectangle to the right in image (c). Further details are provided in the results section below.

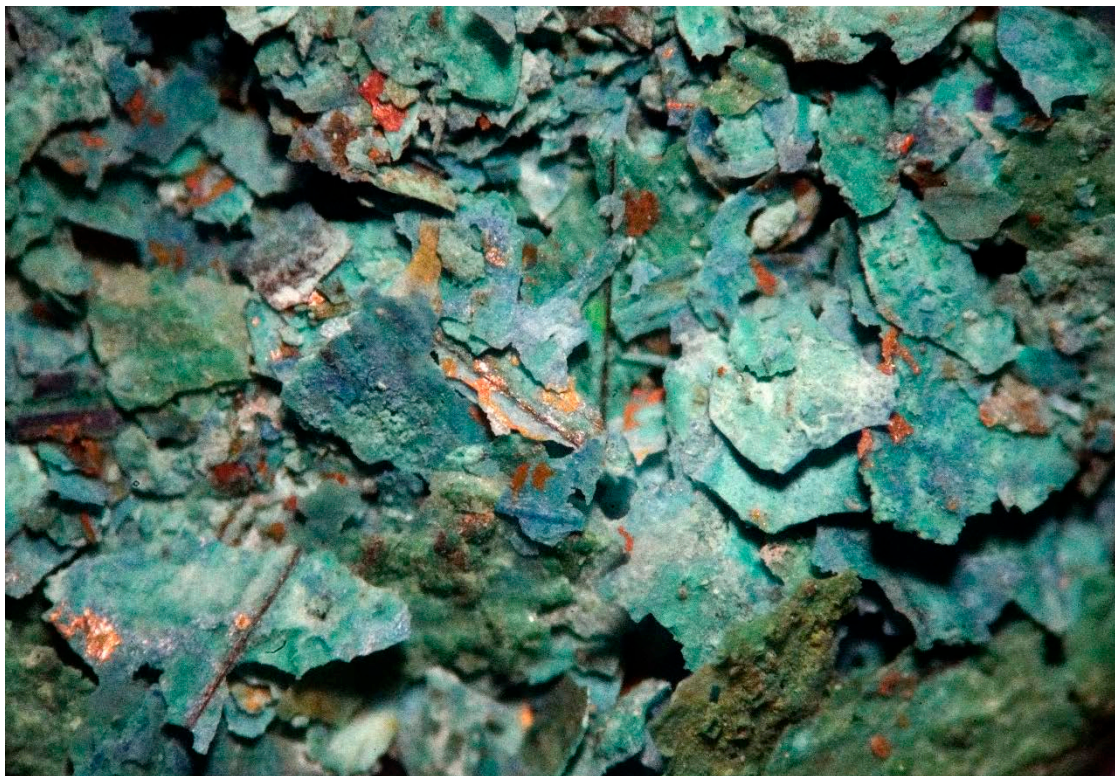
For XRD analysis of green-blue copper corrosion products, sampling from the surface of the Lasgit canister was done using a sharp plastic object. Sampling was done from the area marked with a grey rectangle in Figure 1-3. The sample was photographed in an optical microscope and presented in Figure 2-2, which showed what appeared to be a couple of different phases. The sample was milled to a powder by hand, in an agate mortar. XRD analysis of the milled copper corrosion products samples from the canister surface, were performed at the Äspö Hard Rock Laboratory, using a Panalytical XPert diffractometer with a Co X-ray tube (1.789 Å), and a PIXcel detector. A programmable divergence slit was used, and data was collected between 4 and 100° (2θ) for approximately 15 minutes. A zero background silicon substrate was used as a sample holder. The Panalytical Highscore software was used for data evaluation including the database of reference data, as well as for plotting.

**Figure 2-2.** Copper corrosion products scraped from the Lasgit canister after retrieval at the Canister Laboratory. Sampling was made from the area marked with a grey rectangle in Figure 1-3c.

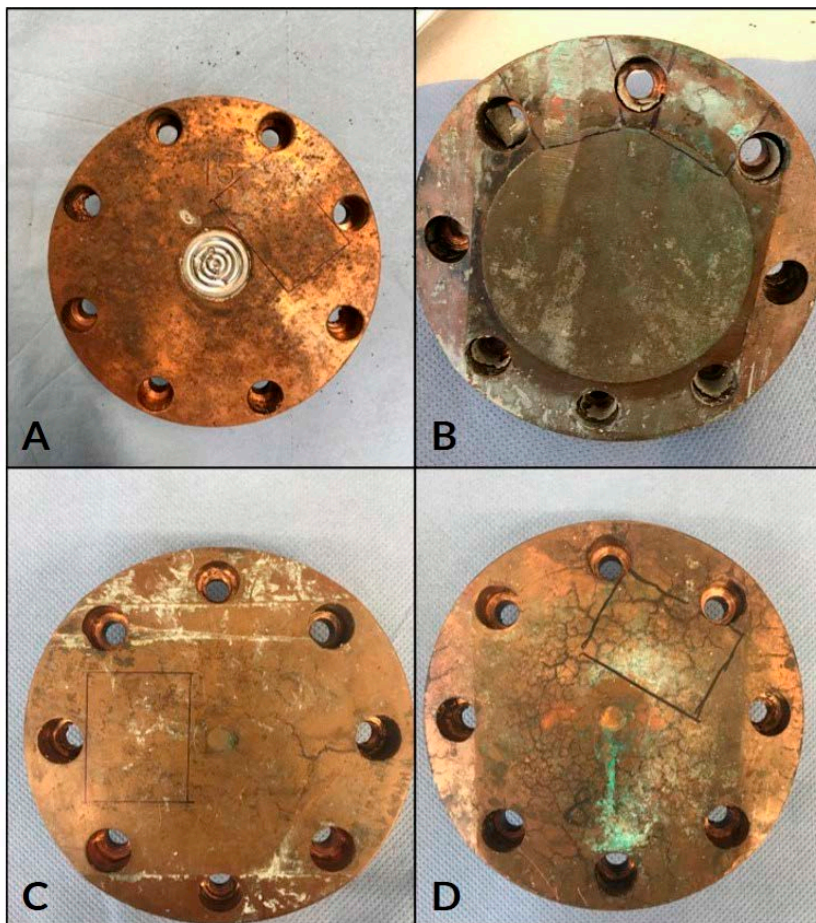
*Figure 3-1. The four filter housings that were analysed; A) PC901, B) MPFA1, C) LFA2 and D) UFA4 with sample areas marked by black rectangles.*

It was generally found that the canister surface had small dark brown or black patches, of which some had a green-blue interior (Figure 3-95). Another common feature of the canister surface was the dark reticulated pattern seen e.g. on the canister surface in Figure 3-1d, on the filter housings LFA2 and UFA4 in Figure 3-1c and 3-1d, as well as on the canister base in Figure 3-95.

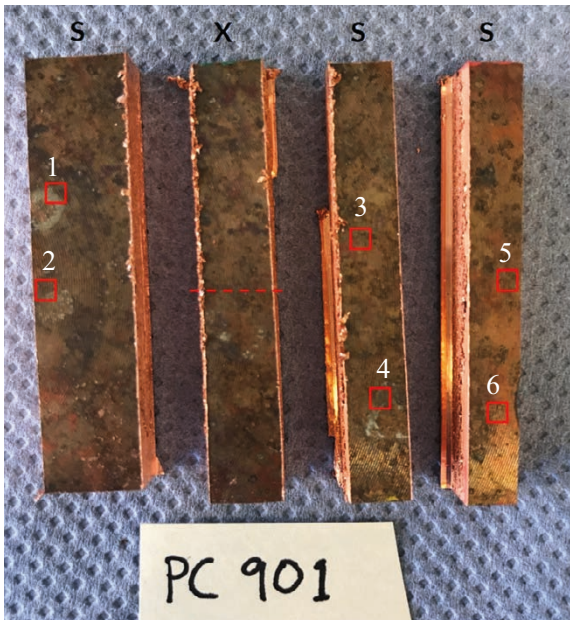
**Figure 3-3.** The four test coupons taken from filter housing PC901. 'S' denotes coupons chosen for surface analysis and 'X' for cross section analysis. Machining marks (present on the entire surface) are clearly visible on the lower part of the two rightmost samples.

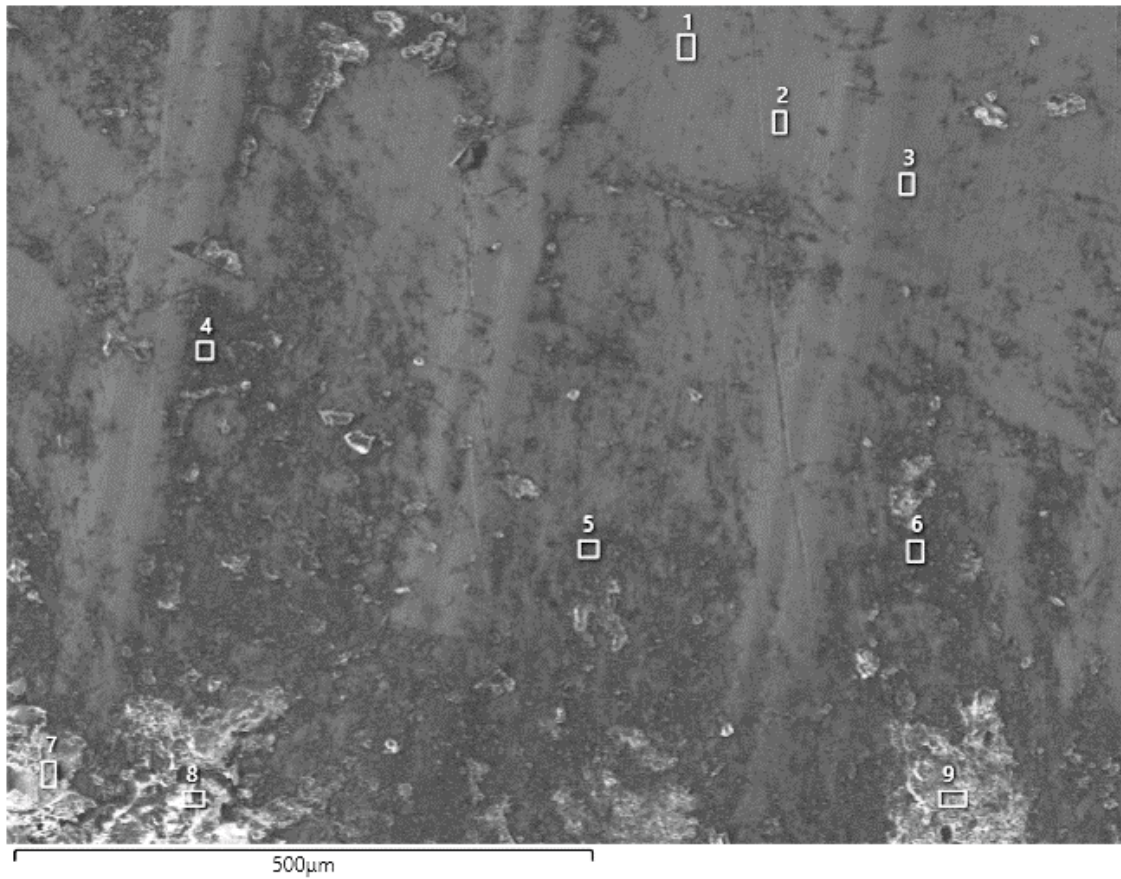
higher levels using higher magnification. The observation of 5-8 at% sulfur and 6-7 at% calcium in Figure 3-6 indicate the presence of  $\text{CaSO}_4$  from the bentonite clay. The detection of 9 at% sulfur, but only 2 at% calcium and 2 at% iron at a spot in Figure 3-7 could indicate the formation of copper sulfide. These observations are in line with the results from earlier field tests such as LOT (Johansson et al. 2020).

**Figure 3-6.** SEM image of PC901 site 3. The EDS result of PC901 site 3 is shown in the table.

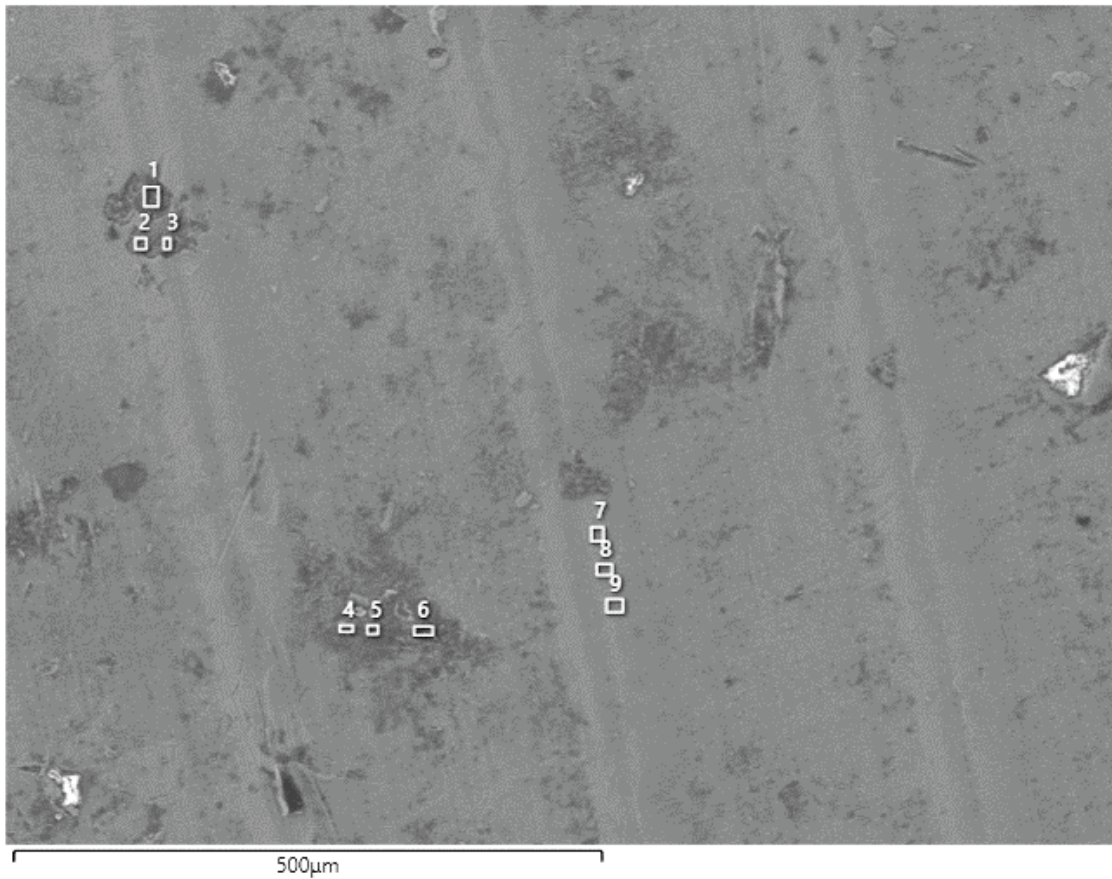
**Figure 3-7.** SEM image of PC901 site 4. The EDS result of PC901 site 4 is shown in the table.

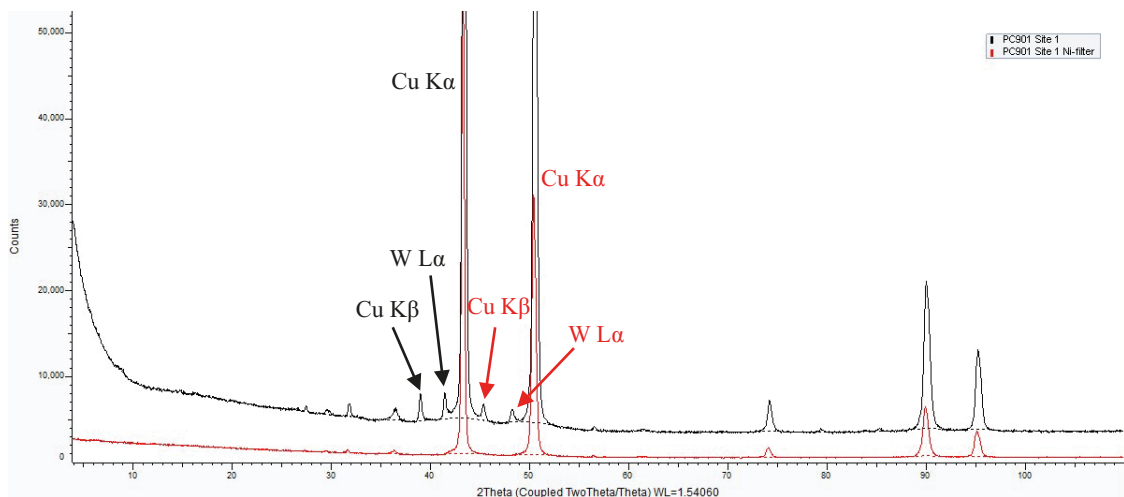
Corrosion products were analyzed by XRD on the sample coupon surfaces. Apart from metallic copper, small peaks of cuprite were observed at  $36.5\ 2\theta$ , which can be seen in Figure 3-16. MgO was detected at angle  $62\ 2\theta$  for bentonite which was added to see the contribution of bentonite on the copper samples. No clear peaks of MgO was observed for PC901 or any of the other filter housing samples. Several “satellite peaks” can be seen around the main copper peaks, similar to the findings in previous studies from field tests (Johansson et al. 2020). The unidentified “satellite peaks” were located at  $39, 41.5, 45.5$  and  $48.5\ 2\theta$  and were observed on all samples. A Ni-filter was used to remove Cu  $K\beta$  X-rays along with other high energy background radiation, see red graph in Figure 3-17. After removing  $K\beta$  X-rays and other background radiation only cuprite and metallic copper peaks could be seen. However, the Cu  $K\beta$  X-rays were only seen at  $39$  and  $45.5\ 2\theta$  leaving the peaks at  $41.5$  and  $48.5\ 2\theta$  unidentified. Aged X-ray tubes with tungsten filaments deposit W on the inside glass envelope. This produces W  $L\alpha$  peaks and it could be found that it coincides with the peaks at  $41.5$  and  $48.5$  which is also filtered out by the Ni-filter.

Figure 3-17. XRD diffractogram of PC901 site 1 (black) and the same diffractogram where a Ni-filter was used to filter away Cu  $K\beta$  and W  $L\alpha$  peaks (red).

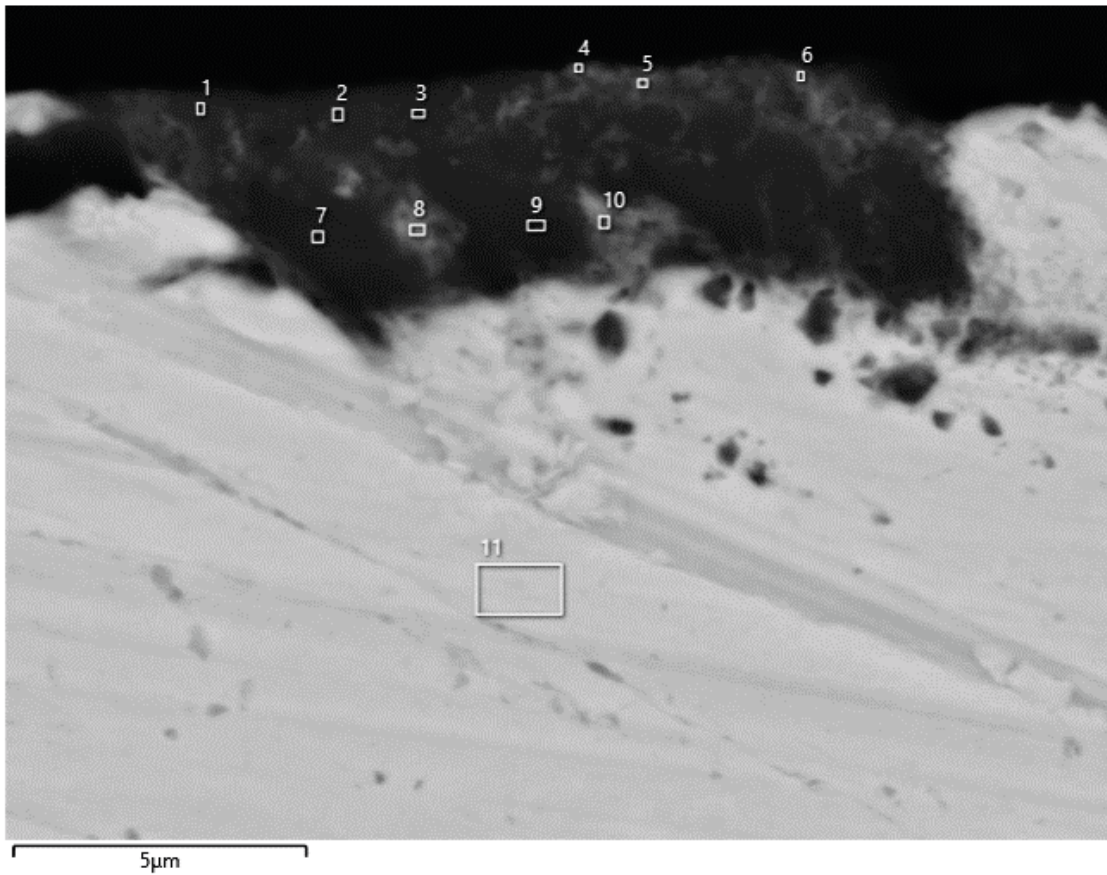
**Figure 3-20.** SEM image of the cross section of PC901, depicting a surface defect with a SiC particle from the polishing. The EDS result of the cross section of PC901 is shown in the table.

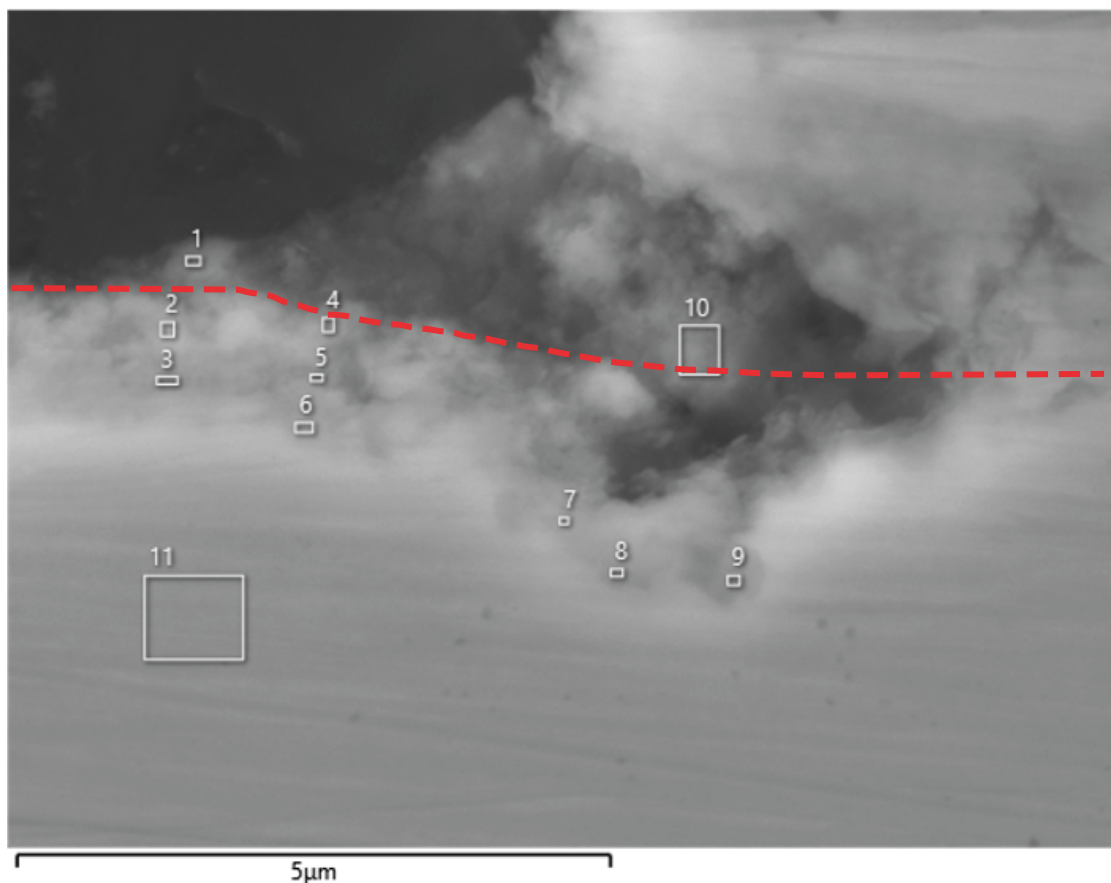
**Figure 3-22.** SEM image of the cross section of PC901, diamond polished. A dashed red line indicates approximately where two surface-to-surface mounted samples meet. Closest to the dashed line is the exposed surface of the sample with corresponding oxide layer and clay particles. The EDS result of the cross section of PC901, diamond polished, is shown in the table.

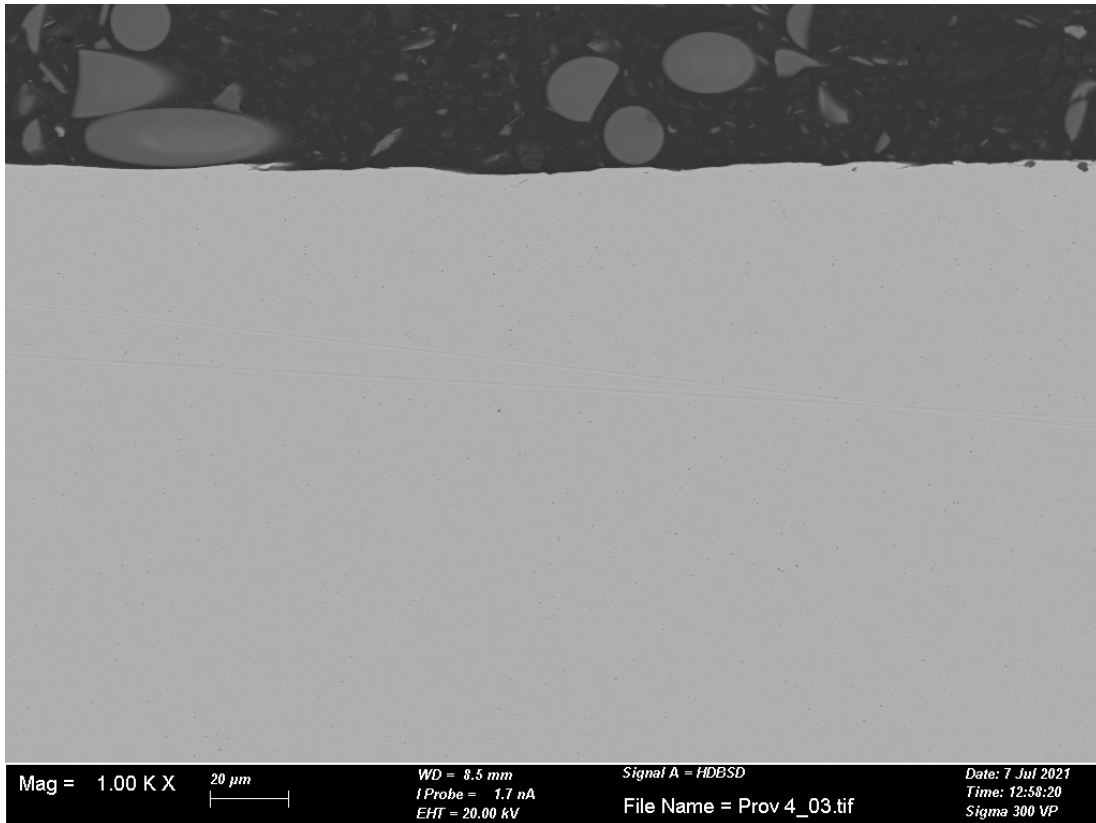
*Figure 3-27. SEM image overview of cross section at  $\times 1\,000$  magnification, PC901.*

SEM micrographs taken at magnification  $\times 1\,000$  or lower, show a relatively smooth surface profile with shallow pits or other, possibly corrosion-induced, defects and a generally thin oxide film (e.g. Figures 3-27, 3-51, 3-70, 3-94). However, locally there are a few observations of up to  $10\ \mu\text{m}$  thick oxide (e.g. Figures 3-44–3-46) and  $5\ \mu\text{m}$  pits or defects (e.g. Figure 3-25). It is not possible to quantify with accuracy how much of this oxide that was present from prior to exposure, and how much that had formed due to corrosion during the exposure, or possibly after retrieval. No efforts were carried out to determining the specific influence of the rather unique starting conditions for the Lasgit experiment, with weakly oxidizing and saturated conditions, as it should be noted that such conditions are unlikely in the planned final repository. Two SEM micrographs taken normal to the P901 filter house surface, namely Figure 3-12 and 3-14, show EDS measurements of the entire micrograph, indicating a surface relatively free from bentonite. Here, there is roughly a 1:2 oxygen–copper relationship, suggesting a cuprite film with a thickness in the order of the penetration depth of the EDS i.e. micron scale. This would indicate that it is possible, or even probable, that a cuprite film of this thickness is present throughout the copper, albeit in many cases covered by bentonite. At some smaller spots for the other filter housings, similar cuprite films could be inferred by the same argument, see spots 4–6 in Figure 3-36, spots 7–9 in Figure 3-54, and spots 7–9 in Figure 3-74. This correlates with the SEM cross sections, which display oxide layers in the range of a few, up to ten micrometres. It may be roughly estimated that, based on the shiny appearance of the filter housings in photos taken prior to the installation and exposure, the thickness of the initially present oxide may on average have been of the order of tens up to a few hundred nanometer (Leygraf et al. 2019).

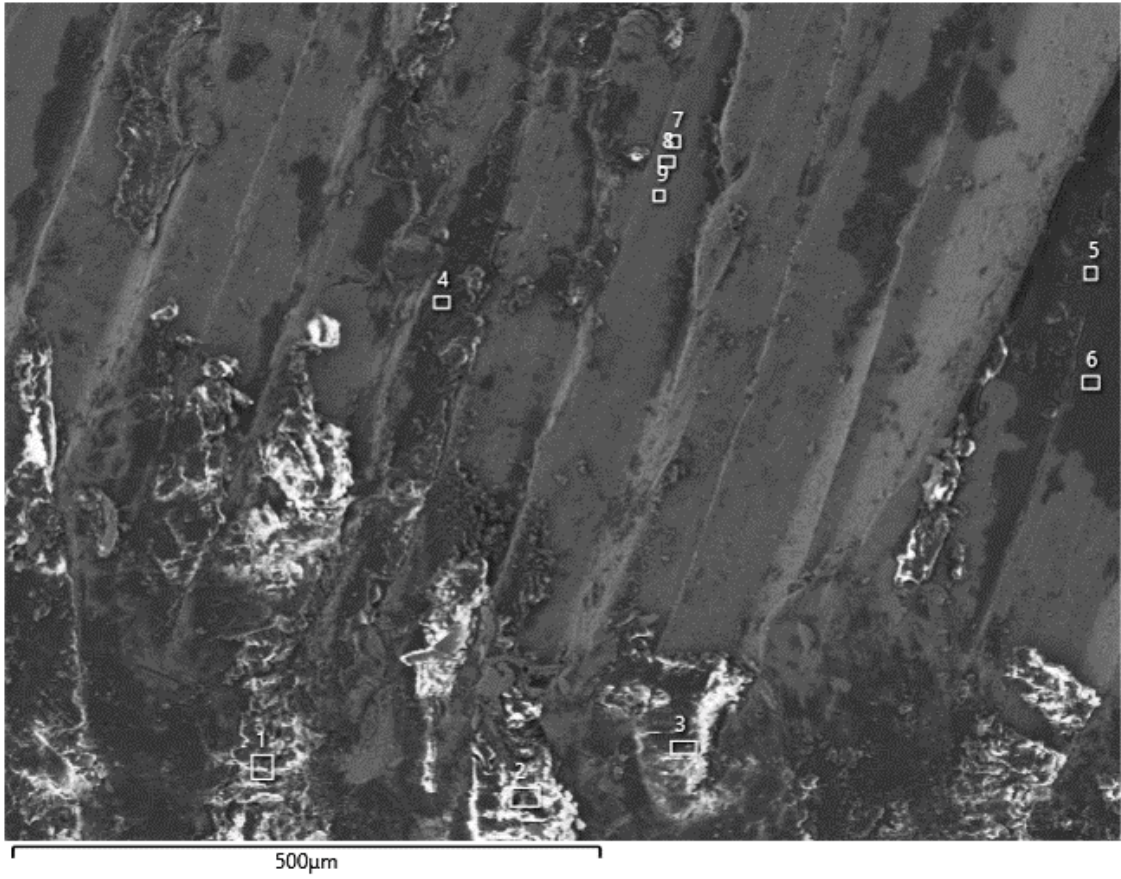
SEM/EDS analysis was carried out on the surface sample sites. Images show clear machining marks from manufacturing of the filter housings. Elemental analysis on the surface show mainly copper and oxygen with clustered bentonite or bentonite located inside the machining grooves. Small amounts of chlorine, iron, and sulfur were also observed for MPFA1 which can be seen in Figures 3-31–3-41 and corresponding tables. Light grey areas appear visibly as a bare copper surface with a thin oxide layer and darker areas to be bentonite and corrosion products. The level of sulfur was generally lower than 1 at% when analyzed over larger areas (as in Figures 3-37–3-41), and even observations using higher magnification showed at most a few at% sulfur (Figures 3-31–3-36).

*Figure 3-31. SEM image of MPFAI site 1. The EDS result of MPFAI site 1 is shown in the table.*

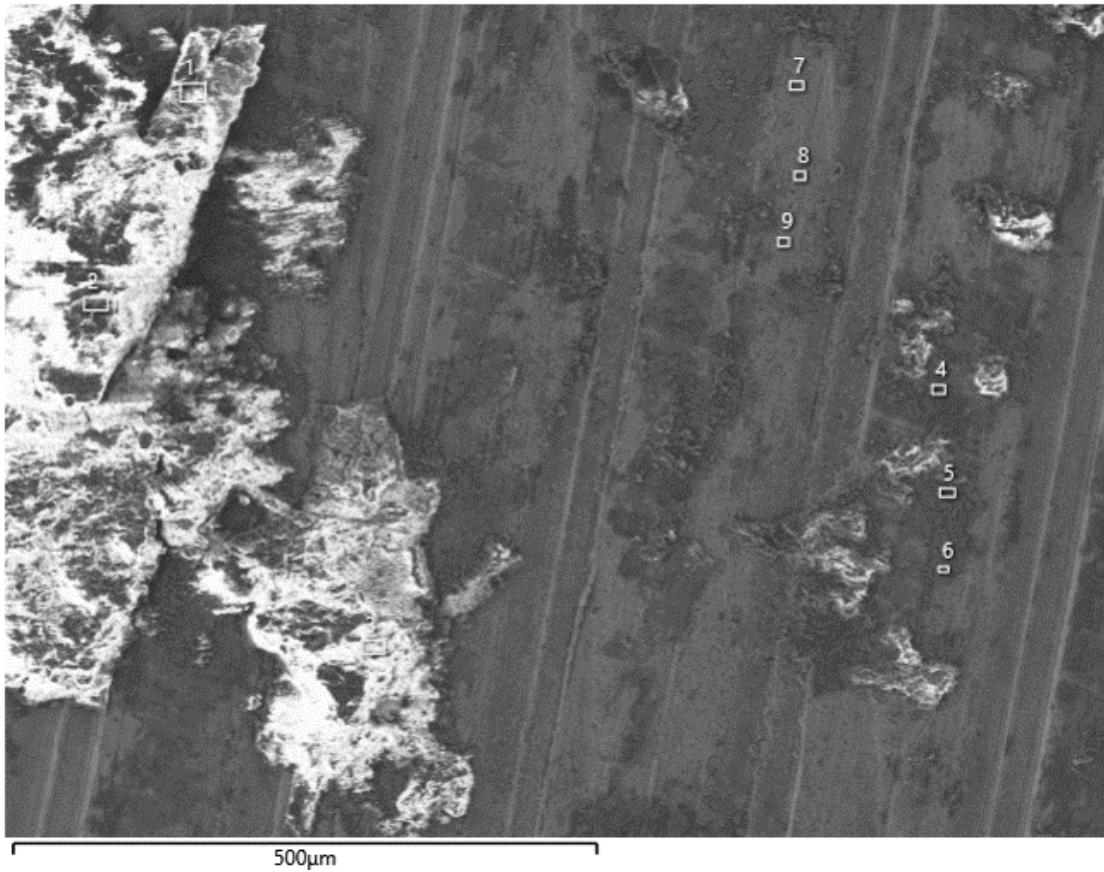
Figure 3-32. SEM image of MPFAI site 2. The EDS result of MPFAI site 2 is shown in the table.

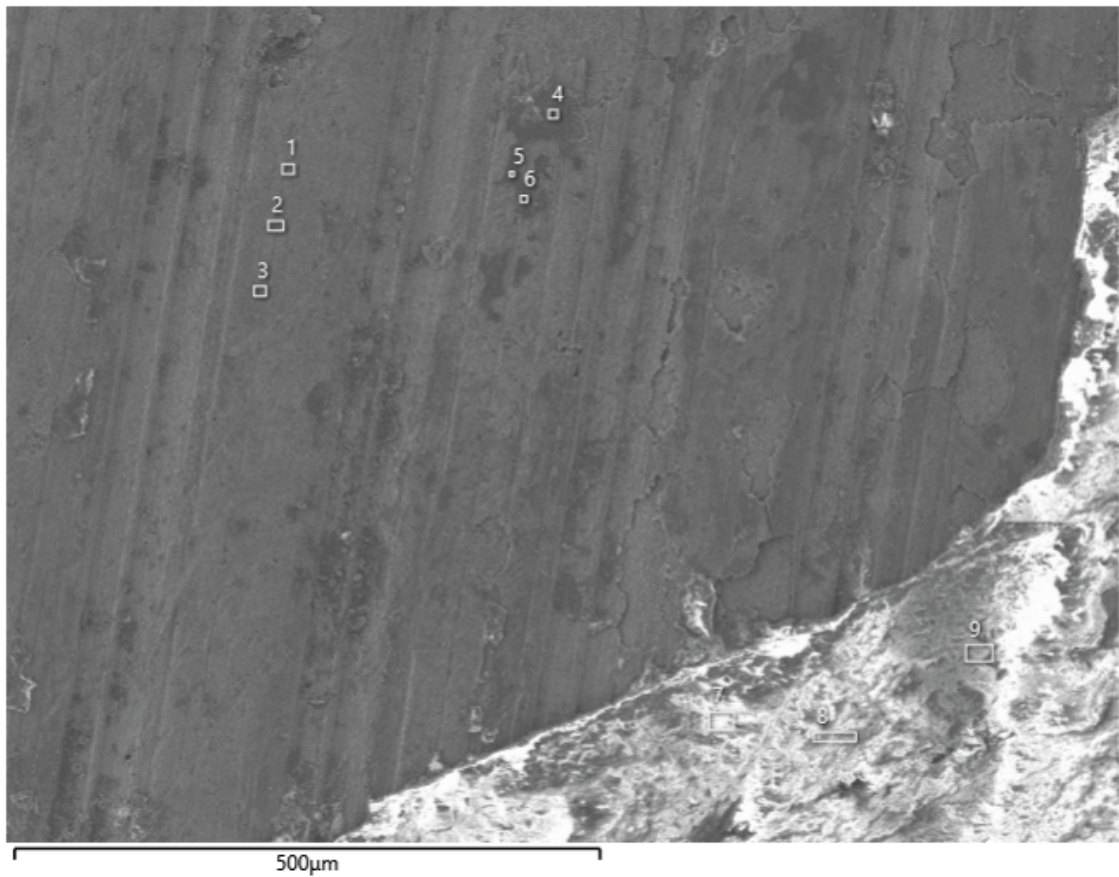
**Figure 3-33.** SEM image of MPFAI site 3. The EDS result of MPFAI site 3 is shown in the table.

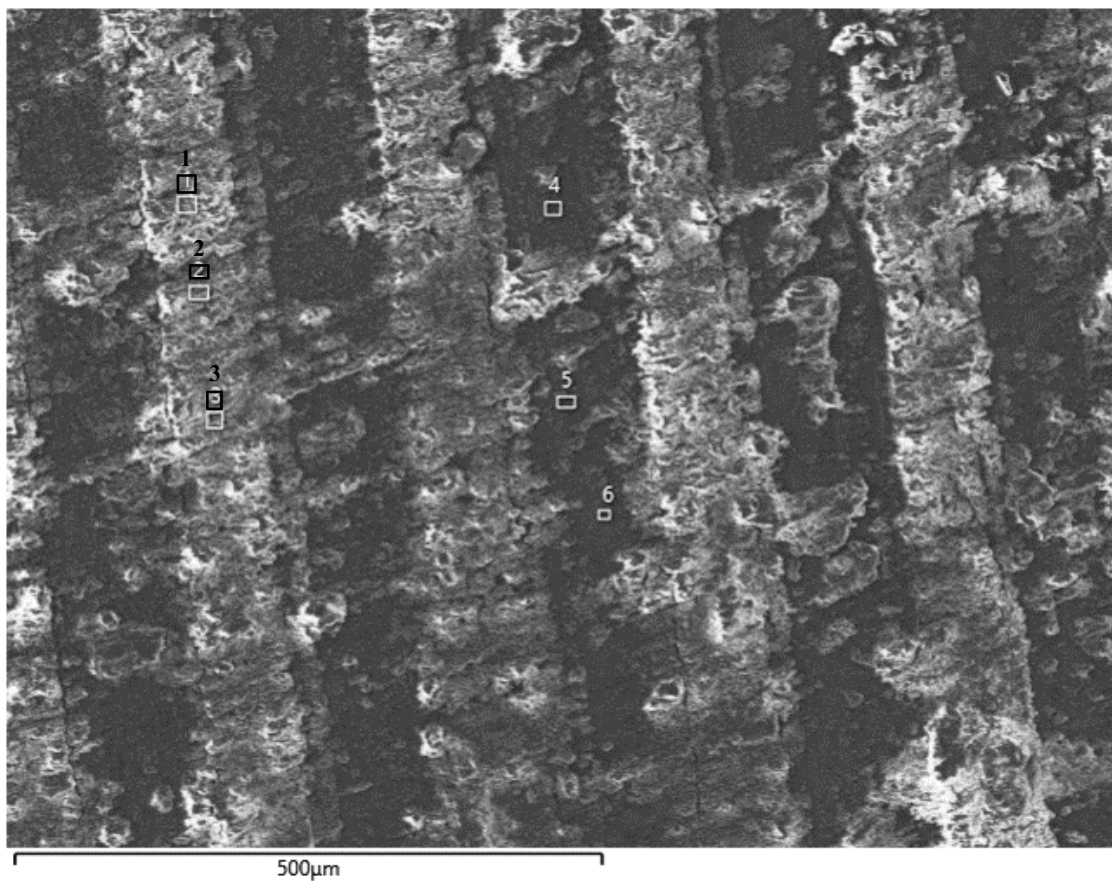
*Figure 3-34. SEM image of MPFAI site 4. The EDS result of MPFAI site 4 is shown in the table.*

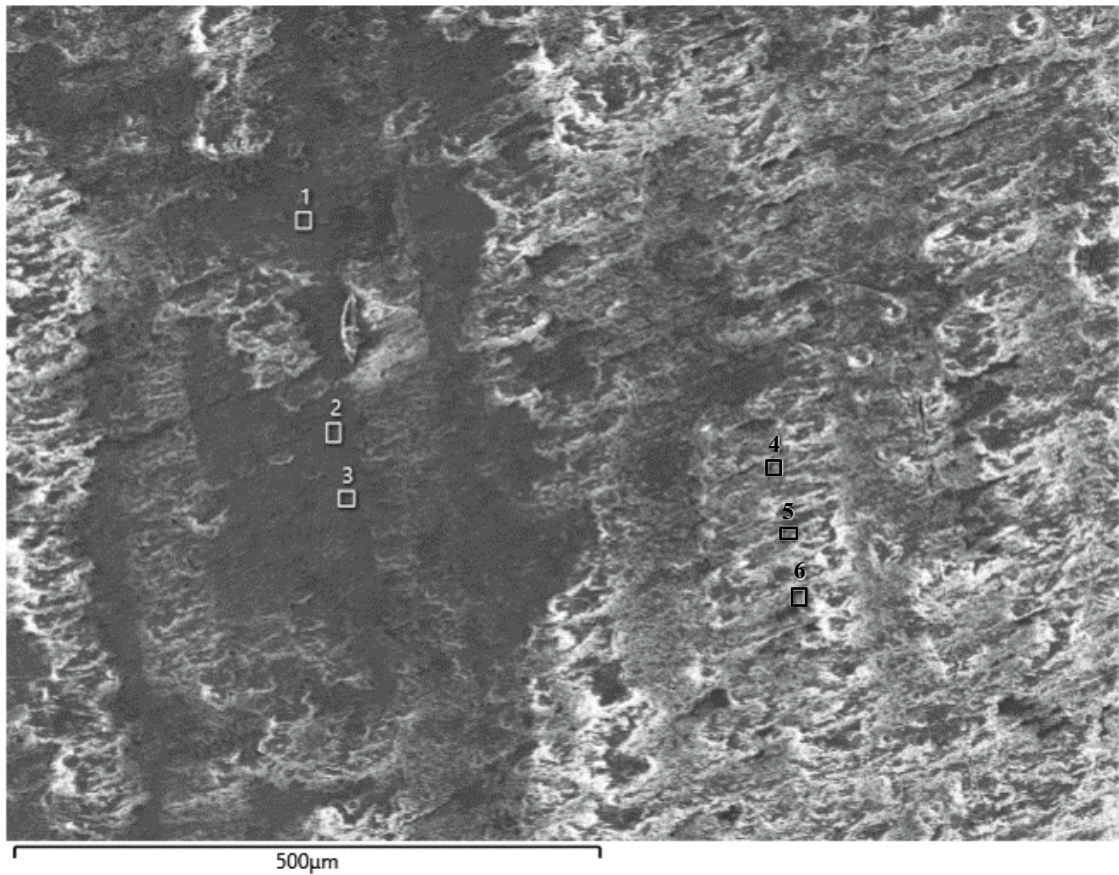
**Figure 3-35.** SEM image of MPFA1 site 5. The EDS result of MPFA1 site 5 is shown in the table.

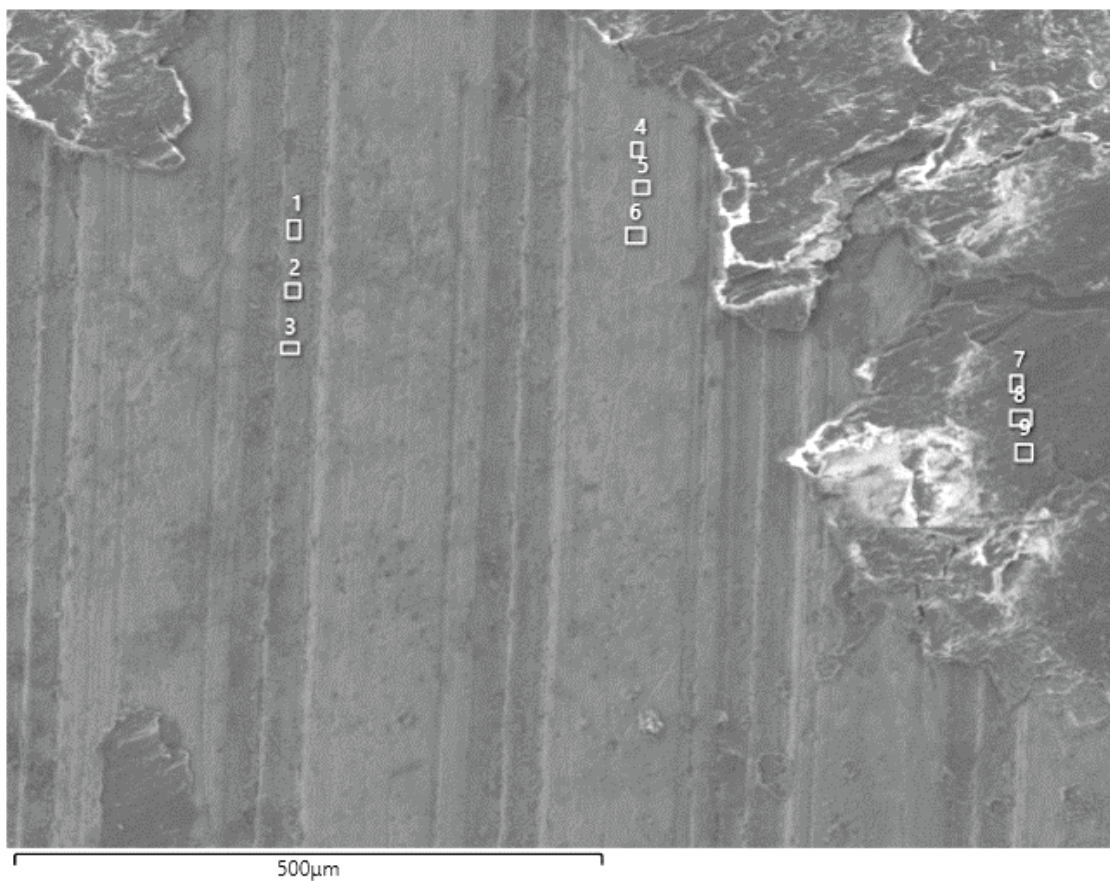
**Figure 3-36.** SEM image of MPFAI site 6. The EDS result of MPFAI site 6 is shown in the table.

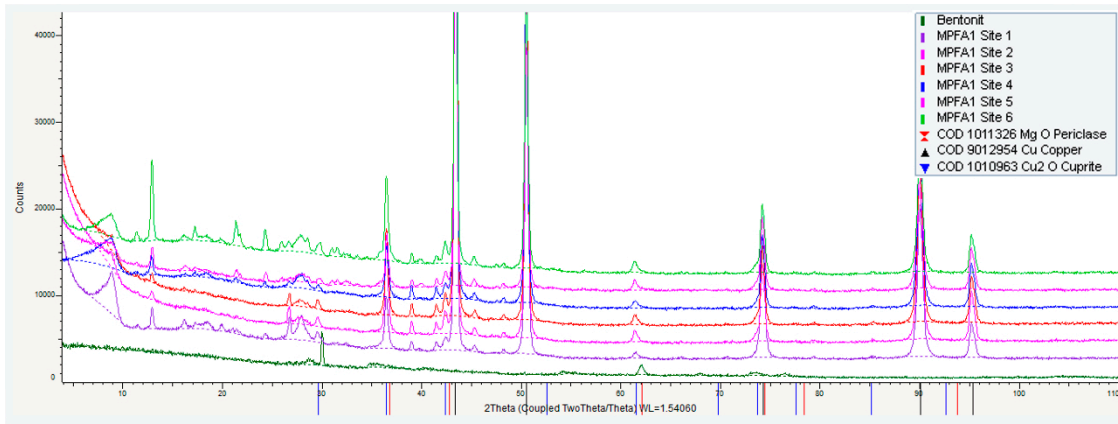
Corrosion products were analyzed in the XRD on the sample coupon surfaces. Peaks of cuprite at 36.5 and 61.5  $2\theta$  could be found for MPFA1, more visible here than for PC901, along with metallic copper, which can be seen in Figure 3-42.

Figure 3-42. XRD diffractograms obtained from the surface of MPFA1.

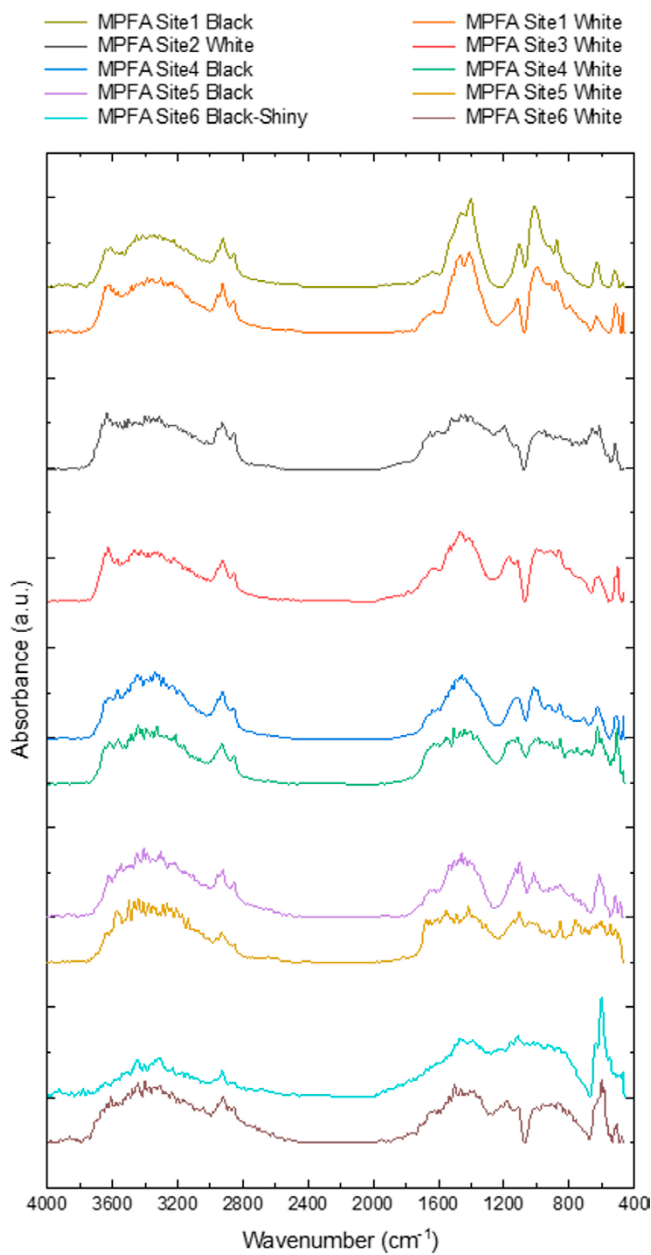
IRRAS measurements were made on the MPFA1 coupon sites and their corresponding IR-spectra can be seen in Figure 3-43. Only site 6 shows a clear cuprite peak around 630  $\text{cm}^{-1}$ . Double peaks around 1300–1600  $\text{cm}^{-1}$  are again visible and indicates malachite. Peak at 1000  $\text{cm}^{-1}$ , 3600  $\text{cm}^{-1}$  and double peaks at 500–600  $\text{cm}^{-1}$  indicate bentonite.

Figure 3-43. Infrared spectra from FTIR/IRRAS measurement on surface of sample MPFA1.

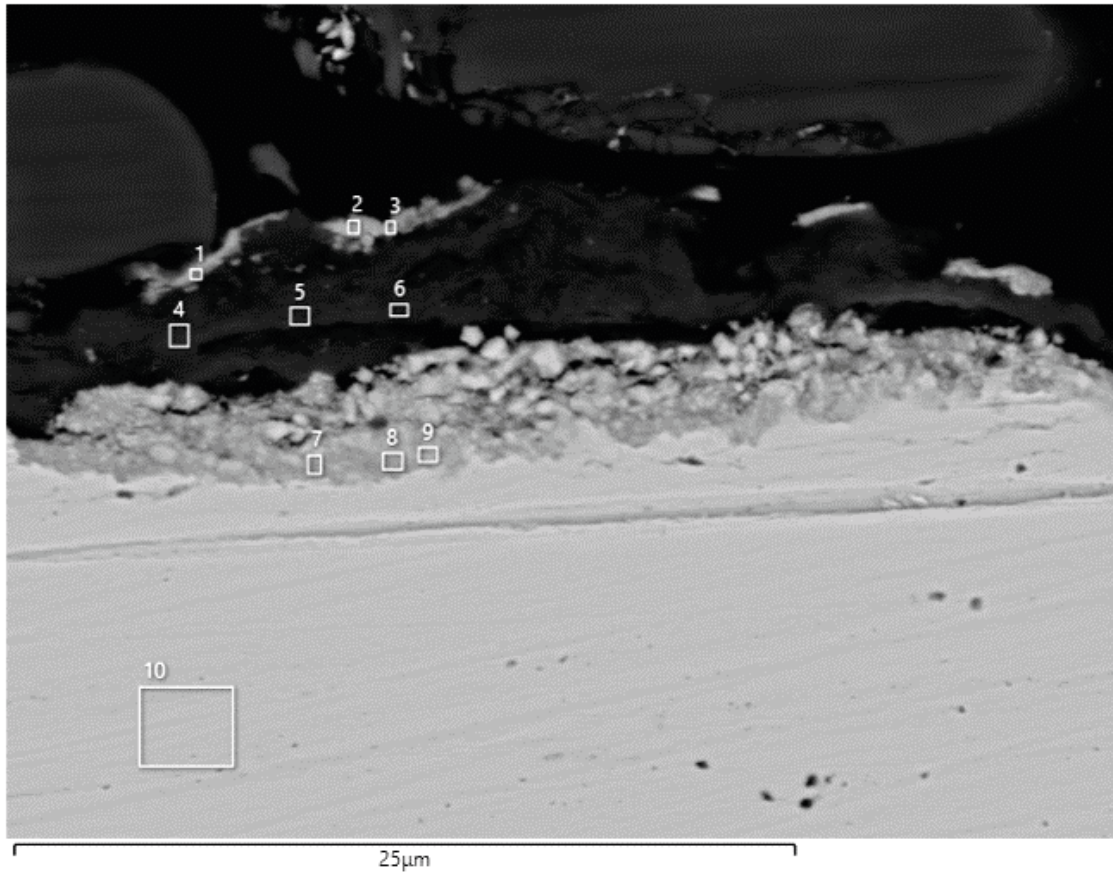
The cross section samples were cut in half, cast into epoxy resin while mounted surface to surface, polished, and analysed with SEM/EDS. Images and EDS analysis after dry grinding of the cross section of MPFA1 can be seen in Figures 3-44–3-46. Subsequently the cross section was diamond polished and analysed, which can be seen in Figures 3-47–3-51. The cross section images show a slightly rough surface appearance, with a porous oxide layer visible for some samples, although no clear explanation for this have been found. No clear signs of localised corrosion were observed. The SEM images seem to show a slightly thicker oxide layer in general than for PC901. However, no quantitative comparison has been attempted. The EDS result show bentonite and small amounts of chlorine while sulfur is not distinctly detected.

**Figure 3-44.** SEM image of the cross section of MPFA1. The EDS result of the cross section of MPFA1 is shown in the table.

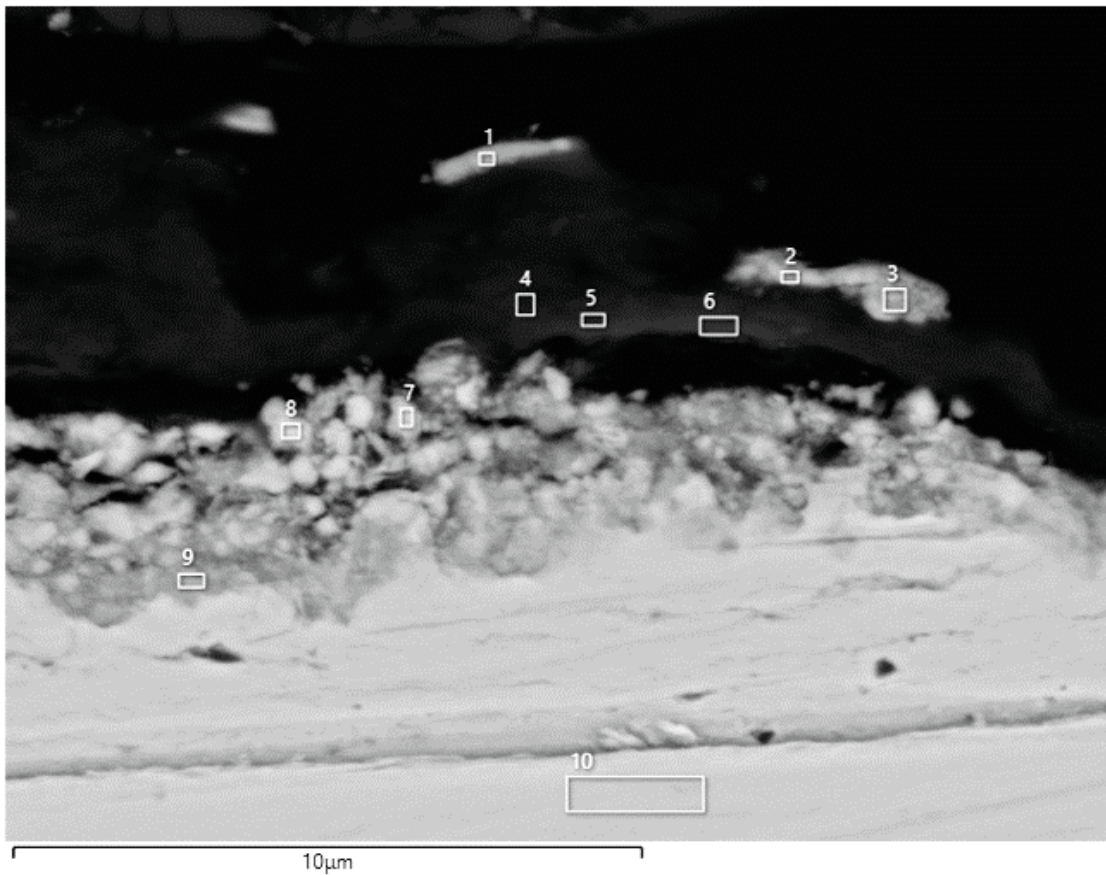
**Figure 3-45.** SEM image of the cross section of MPFA1. The EDS result of the cross section of MPFA1 in the table.

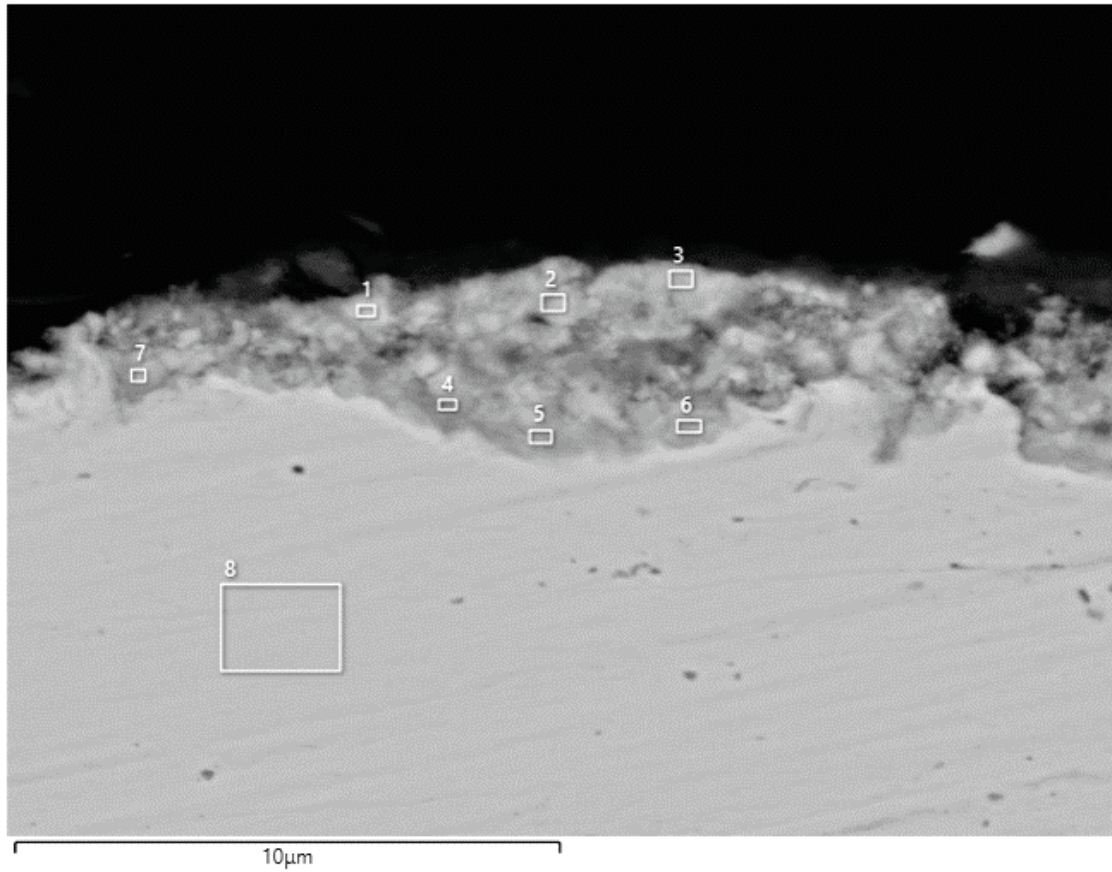
**Figure 3-46.** SEM image of the cross section of MPFA1. The EDS result of the cross section of MPFA1 is shown in the table.

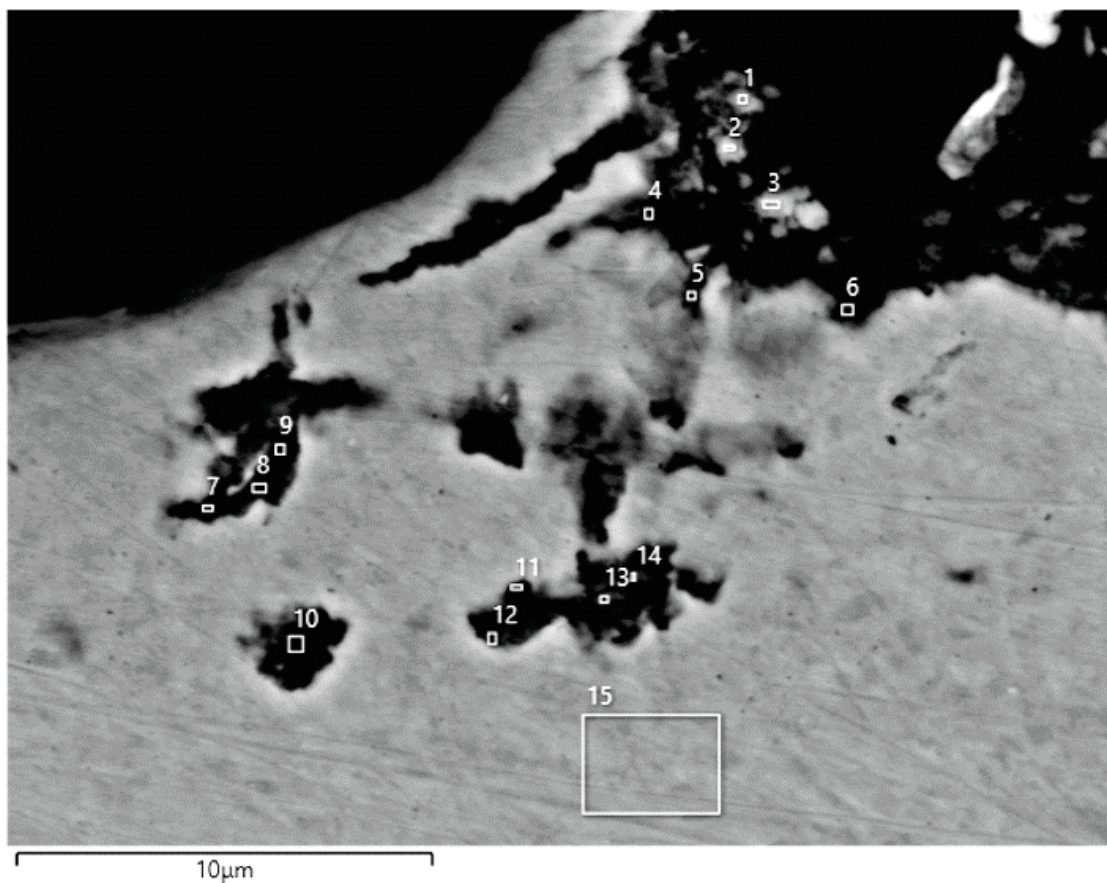
**Figure 3-47.** SEM image of the cross section of MPFA1, diamond polished. The EDS result of the cross section of MPFA1, diamond polished, in the table.
