**TR-22-01**

# Analysis of corrosion products on filter housings in the Lasgit field experiment

SVENSK KÄRNBRÄNSLEHANTERING AB

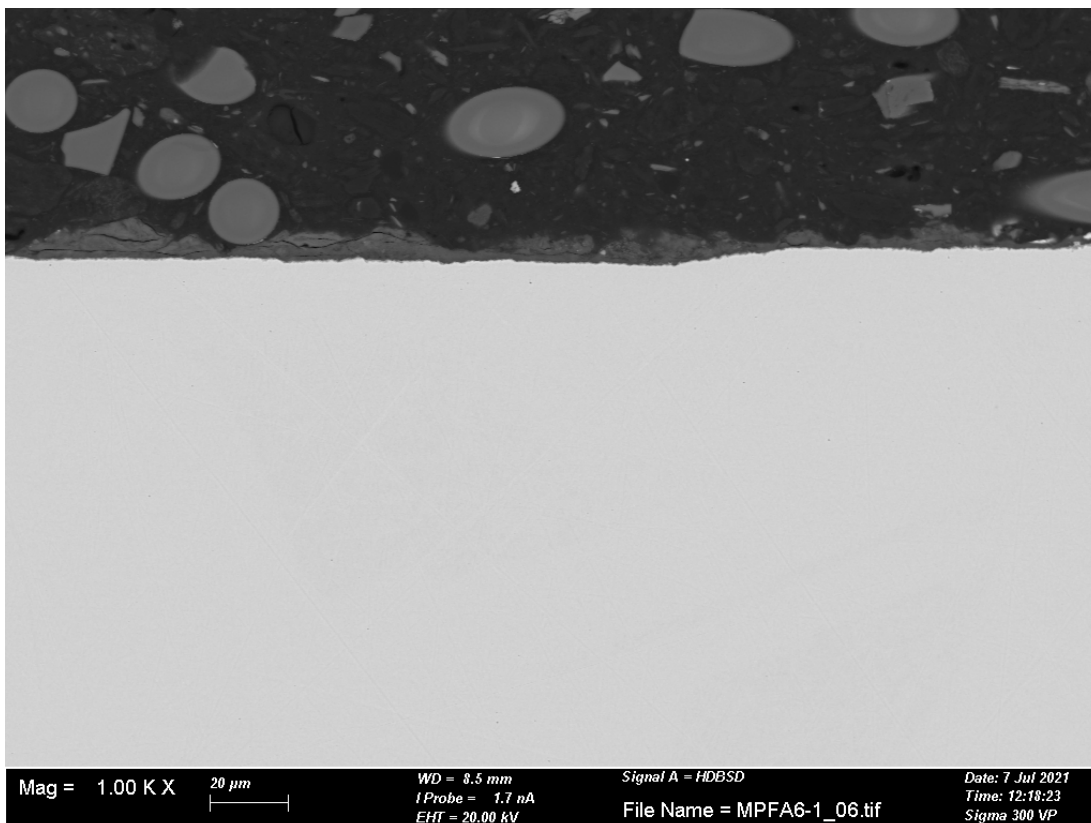
*Figure 3-51. SEM image overview of cross section at ×1 000 magnification, MPFA1.*

SEM micrographs taken at magnification  $\times 1\,000$  or lower, show a relatively smooth surface profile with shallow pits or other, possibly corrosion-induced, defects and a generally thin oxide film (e.g. Figures 3-27, 3-51, 3-70, 3-94). However, locally there are a few observations of up to  $10\ \mu\text{m}$  thick oxide (e.g. Figures 3-44–3-46) and  $5\ \mu\text{m}$  pits or defects (e.g. Figure 3-25). It is not possible to quantify with accuracy how much of this oxide that was present from prior to exposure, and how much that had formed due to corrosion during the exposure, or possibly after retrieval. No efforts were carried out to determining the specific influence of the rather unique starting conditions for the Lasgit experiment, with weakly oxidizing and saturated conditions, as it should be noted that such conditions are unlikely in the planned final repository. Two SEM micrographs taken normal to the P901 filter house surface, namely Figure 3-12 and 3-14, show EDS measurements of the entire micrograph, indicating a surface relatively free from bentonite. Here, there is roughly a 1:2 oxygen–copper relationship, suggesting a cuprite film with a thickness in the order of the penetration depth of the EDS i.e. micron scale. This would indicate that it is possible, or even probable, that a cuprite film of this thickness is present throughout the copper, albeit in many cases covered by bentonite. At some smaller spots for the other filter housings, similar cuprite films could be inferred by the same argument, see spots 4–6 in Figure 3-36, spots 7–9 in Figure 3-54, and spots 7–9 in Figure 3-74. This correlates with the SEM cross sections, which display oxide layers in the range of a few, up to ten micrometres. It may be roughly estimated that, based on the shiny appearance of the filter housings in photos taken prior to the installation and exposure, the thickness of the initially present oxide may on average have been of the order of tens up to a few hundred nanometer (Leygraf et al. 2019).

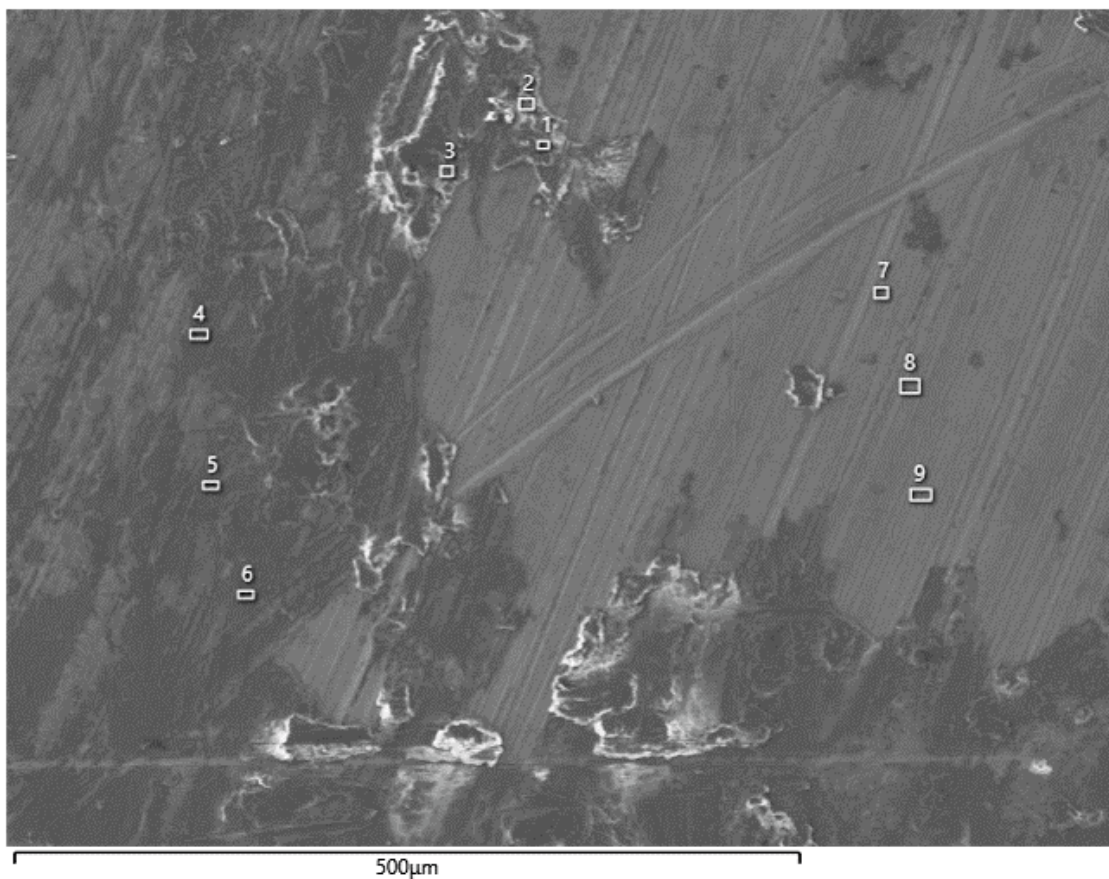
SEM/EDS analysis was carried out on the surface of the samples. Images showed clear machining marks from the manufacturing of the filter housings, similar to the previous filter housings. Elemental analysis on the surface showed mainly copper and oxygen with bentonite clustered and spread on most surfaces. Small amounts of iron and chlorine were detected for LFA2, and the level of sulfur was generally  $< 1$  at%, see Figures 3-54–3-61 and corresponding tables. Similar to previous filter housings, light grey areas appear to be bare copper surface with a thin oxide layer and darker areas to be bentonite and corrosion products.

*Figure 3-54. SEM image of LFA2 site 1. The EDS result of LFA2 site 1 is shown in the table.*

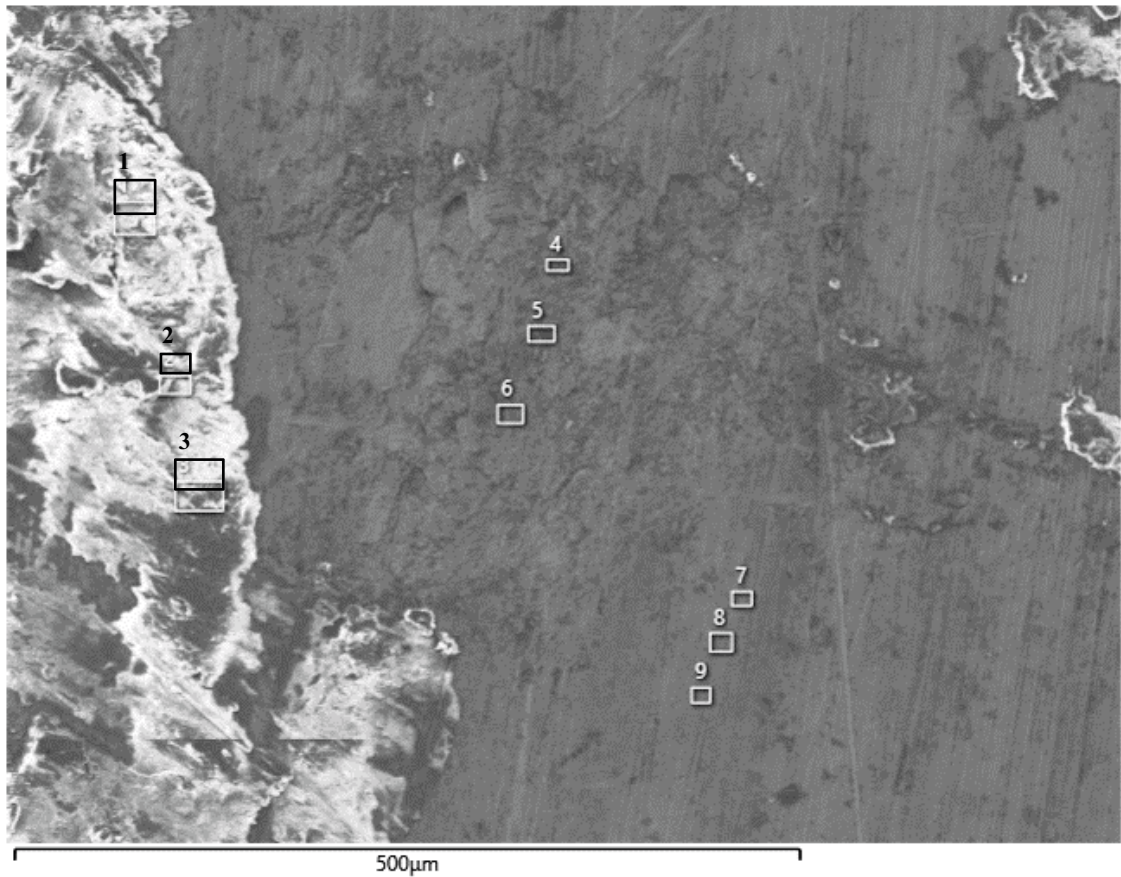
*Figure 3-55. SEM image of LFA2 site 2. The EDS result of LFA2 site 2 is shown in the table.*

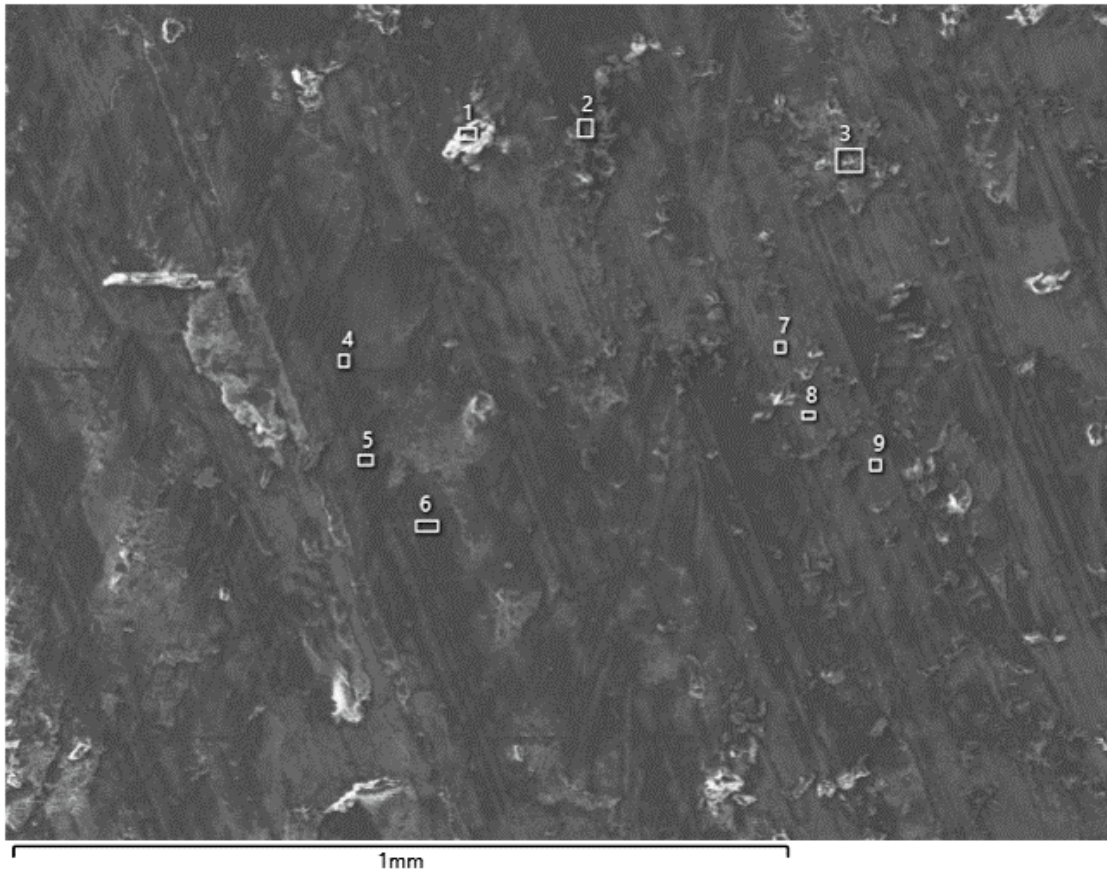
Figure 3-56. SEM image of LFA2 site 3. The EDS result of LFA2 site 3 is shown in the table.

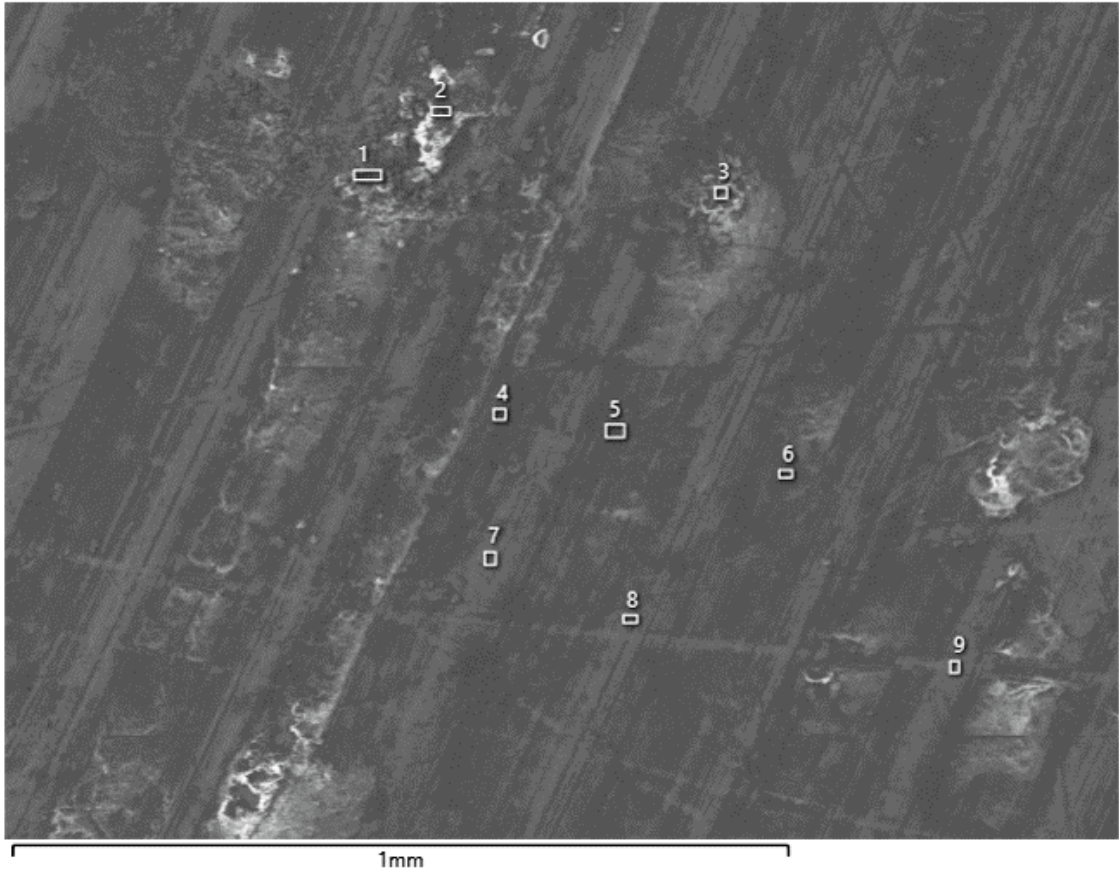
**Figure 3-57.** SEM image of LFA2 site 4. The EDS result of LFA2 site 4 is shown in the table.

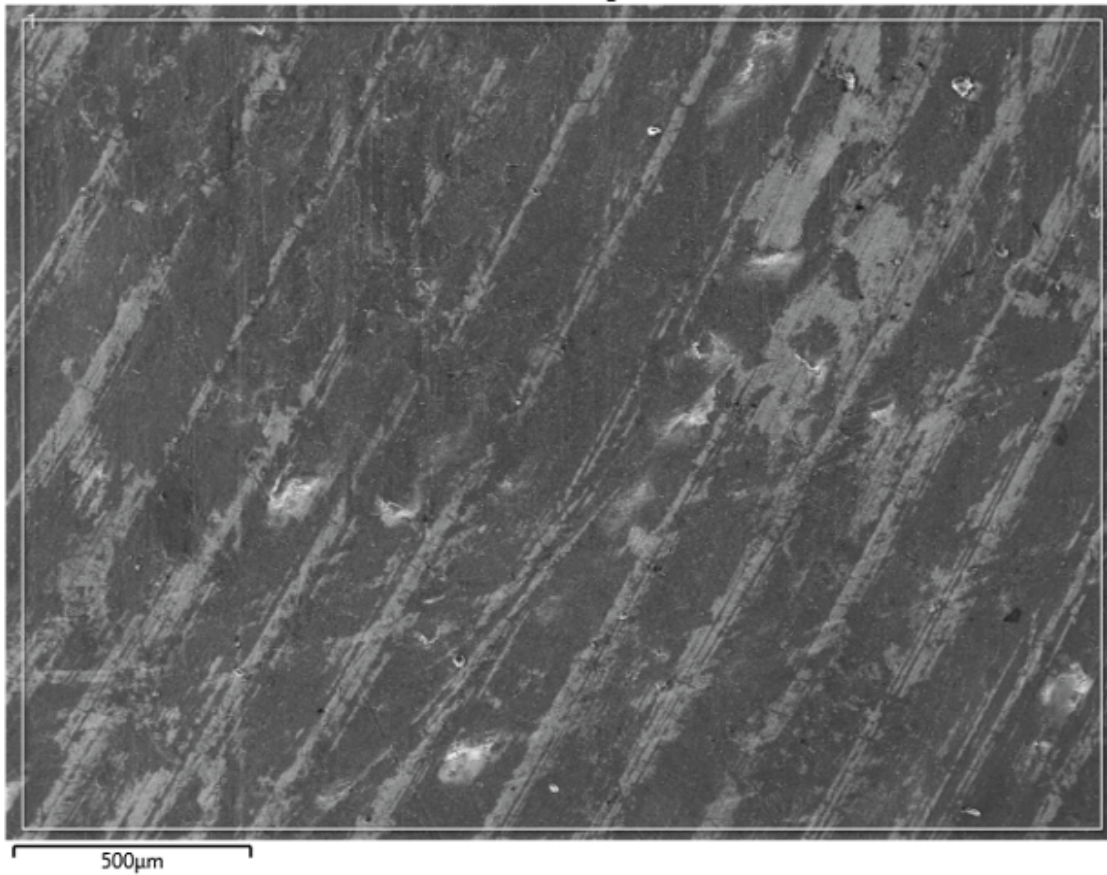
**Figure 3-58.** SEM image of LFA2 site 1. The EDS result of LFA2 site 1 is shown in the table. EDS over larger area.

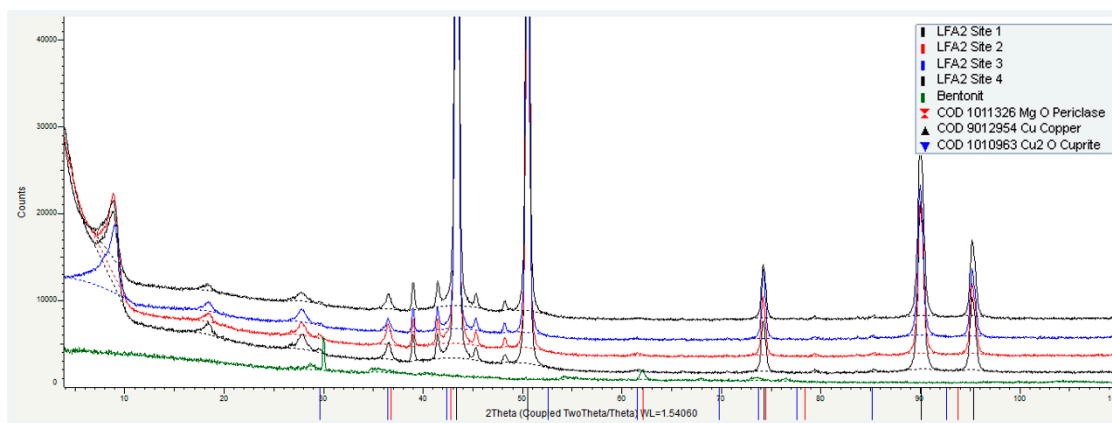
Corrosion products were analyzed in the XRD on the sample coupon surfaces. Small peaks of cuprite could be found at an angle of  $36.5\ 2\theta$  which can be seen in Figure 3-62.

Figure 3-62. XRD diffractograms obtained from the surface of LFA2.

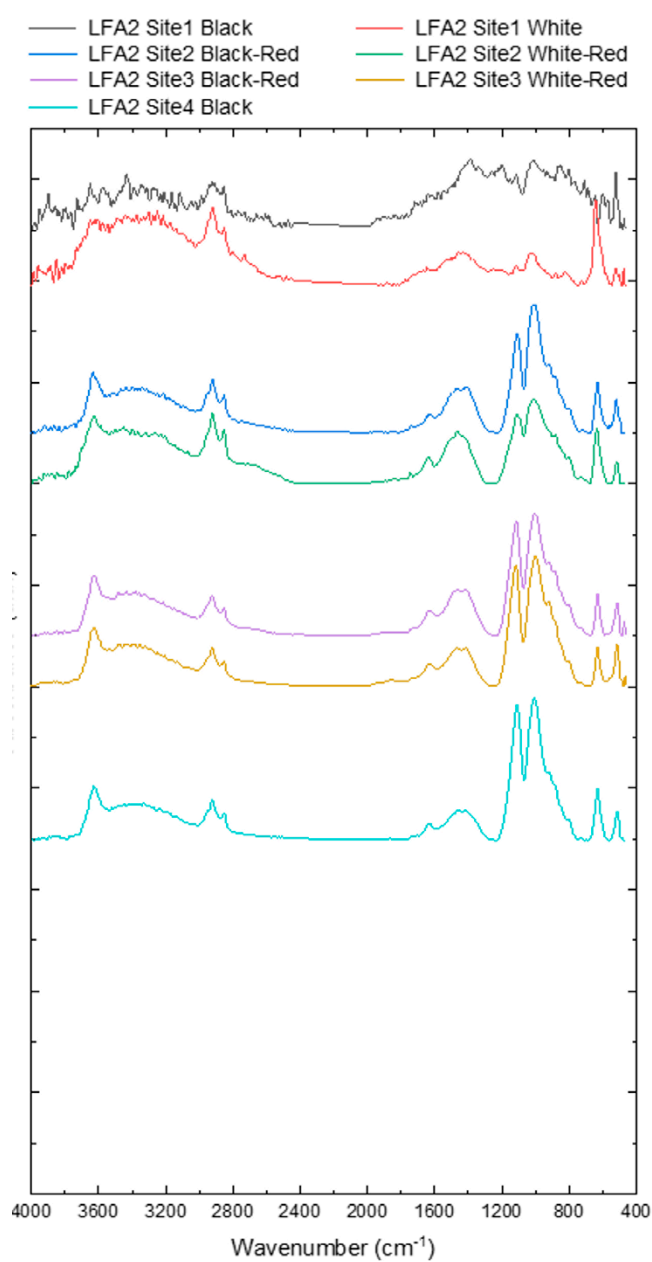
IRRAS measurements were made on the LFA2 coupon sites and their corresponding IR-spectra can be seen in Figure 3-63. The cuprite peak around  $630\ \text{cm}^{-1}$  is less visible for LFA2 than for PC901. Malachite double peaks around  $1300\text{--}1600\ \text{cm}^{-1}$  are less visible for LFA2 than the other filter housings. The peaks at  $1000\ \text{cm}^{-1}$ ,  $3600\ \text{cm}^{-1}$ , and double peaks at  $500\text{--}600\ \text{cm}^{-1}$  indicate bentonite. Several sites for LFA2 show a distinct peak at  $1100\ \text{cm}^{-1}$  indicating the presence of sulfate mineral (e.g.  $\text{CaSO}_4$ ).

Figure 3-63. Infrared spectra from FTIR/IRRAS measurement on surface of sample LFA2.

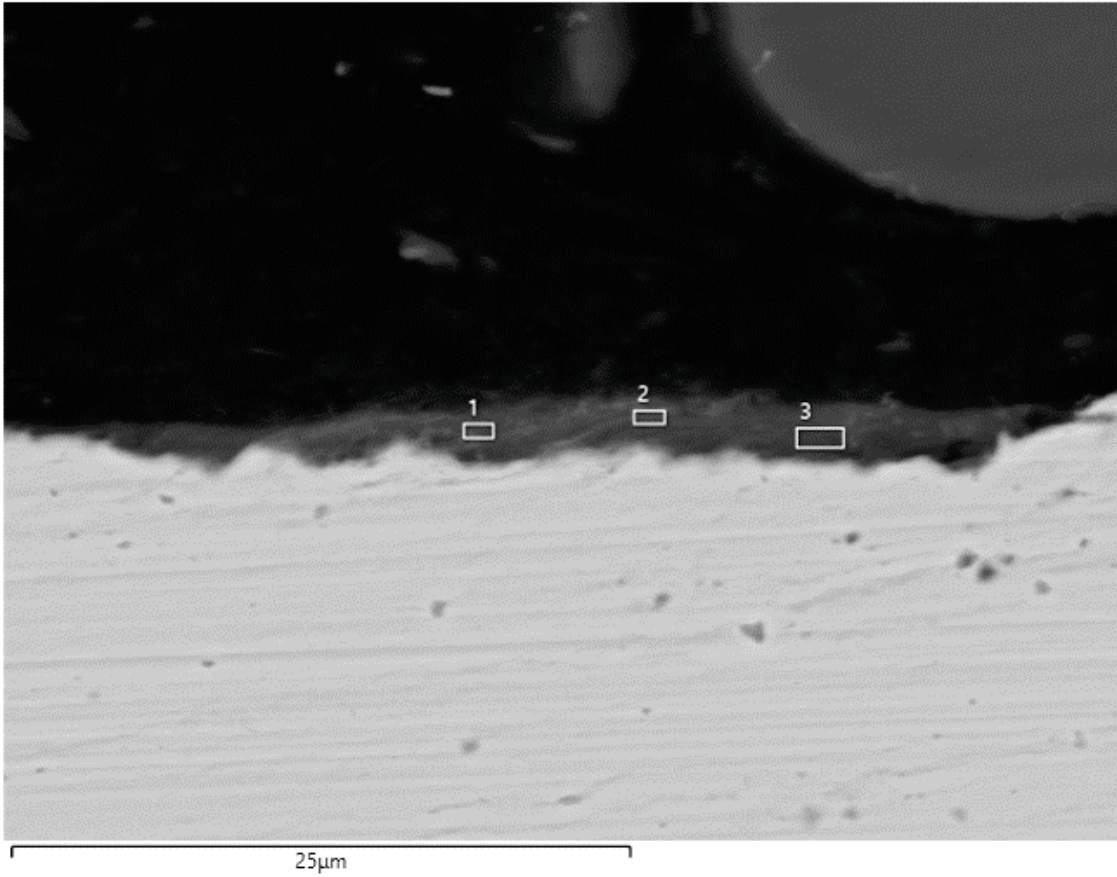
The cross section samples cut in half, cast into epoxy resin while mounted surface to surface, polished and analysed with SEM/EDS. Figures 3-64–3-65 and corresponding tables were analysed after dry grinding. Figures 3-66–3-70 were analysed after diamond polishing. The cross section images showed that the surfaces in general had a machined appearance with no clear signs of localised corrosion. The SEM images show a thin oxide layer between 1 and 5  $\mu\text{m}$ , which can be noted in some cases to be rather porous (Figure 3-66). In the right-hand side Figures 3-69–3-70, a porous films can be seen, similar to the porous oxide observed in Figure 3-44. The EDS result show signs of sulfur being present in the cross section of one sample with a tendency to slightly enhanced levels farther out on the oxide layer (Figure 3-66). Since this trend is also seen for calcium the most likely source is precipitation of  $\text{CaSO}_4$  from the bentonite clay. The detection of ca 20 at% silicon and 9 at% aluminium suggests that the adherent layer in Figure 3-65 is bentonite clay.

**Figure 3-65.** SEM image of the cross section of LFA2. The EDS result of the cross section of LFA2 is shown in the table.

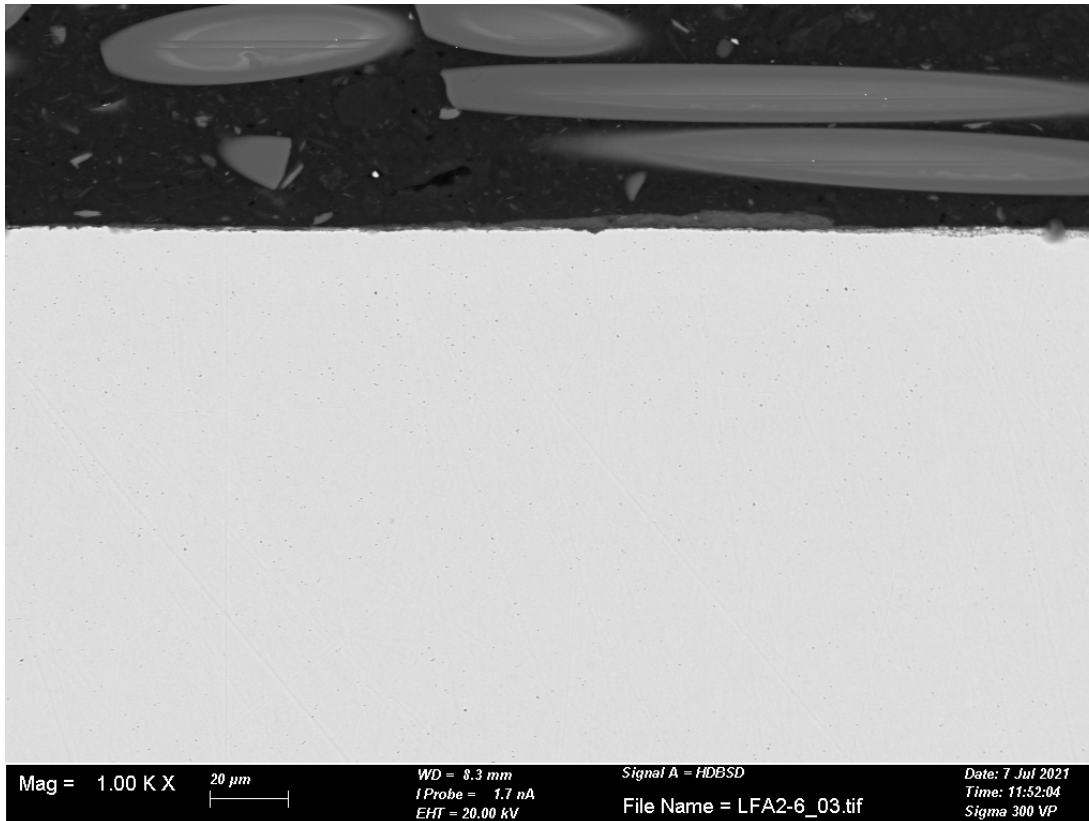
*Figure 3-70. SEM image overview of cross section at ×1 000 magnification, LFA2.*

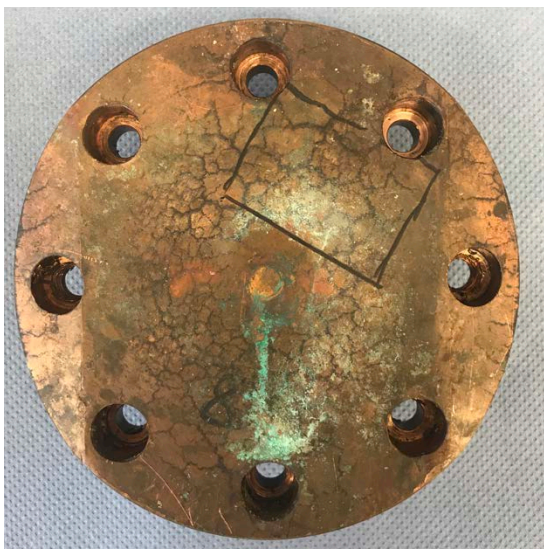
In Figure 3-71, an overview of filter housing is presented UFA4, with the designated areas for sample coupons marked with a black rectangle. Sample preparation was carried out the same way as PC901 and LFA2. An overview of the four sample coupons for filter housing UFA4 can be seen in Figure 3-72 along with their designated surface analysis sites, marked with red rectangles. A black reticulated pattern was observed on the surface of filter housing UFA4. Analysis sites 1, 3 and 4 were chosen to include the black reticulated pattern in an attempt to determine its composition.

*Figure 3-71. Overview of filter housing UFA4 and the area of which sample coupons for analysis was taken, marked with a black rectangle.*

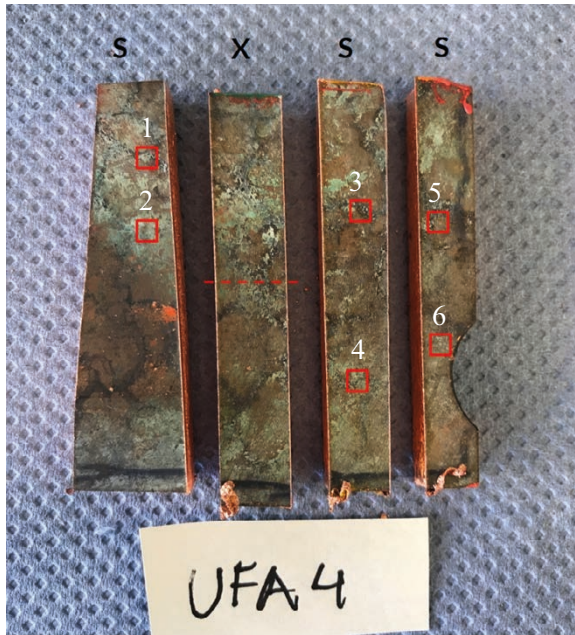
**Figure 3-72.** The four test coupons taken from filter housing UFA4. 'S' denotes coupons chosen for surface analysis and 'X' for cross section analysis.

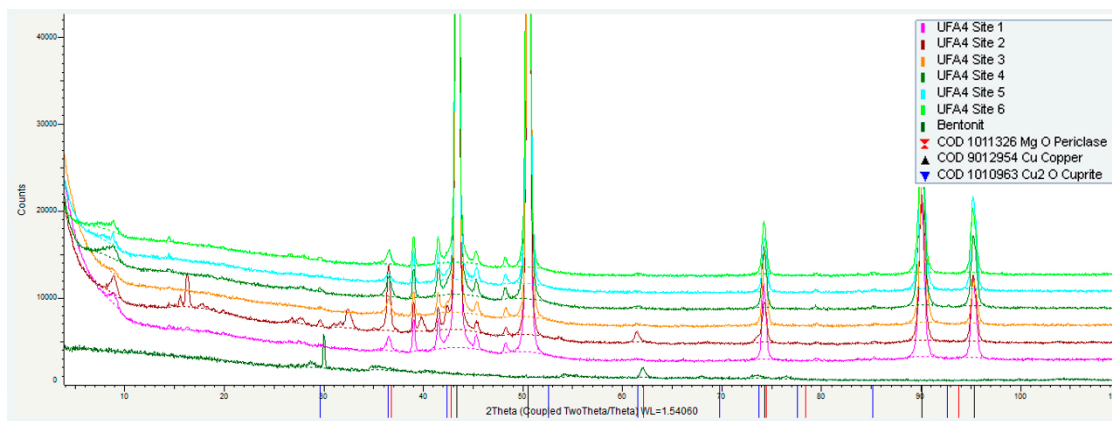
Corrosion products were analysed in the XRD on the sample coupon surfaces. Small peaks of cuprite could be found at an angle of  $36.5\ 2\theta$  along with peaks originating from metallic copper, which can be seen in Figure 3-85.

Figure 3-85. XRD diffractograms obtained from the surface of UFA4.

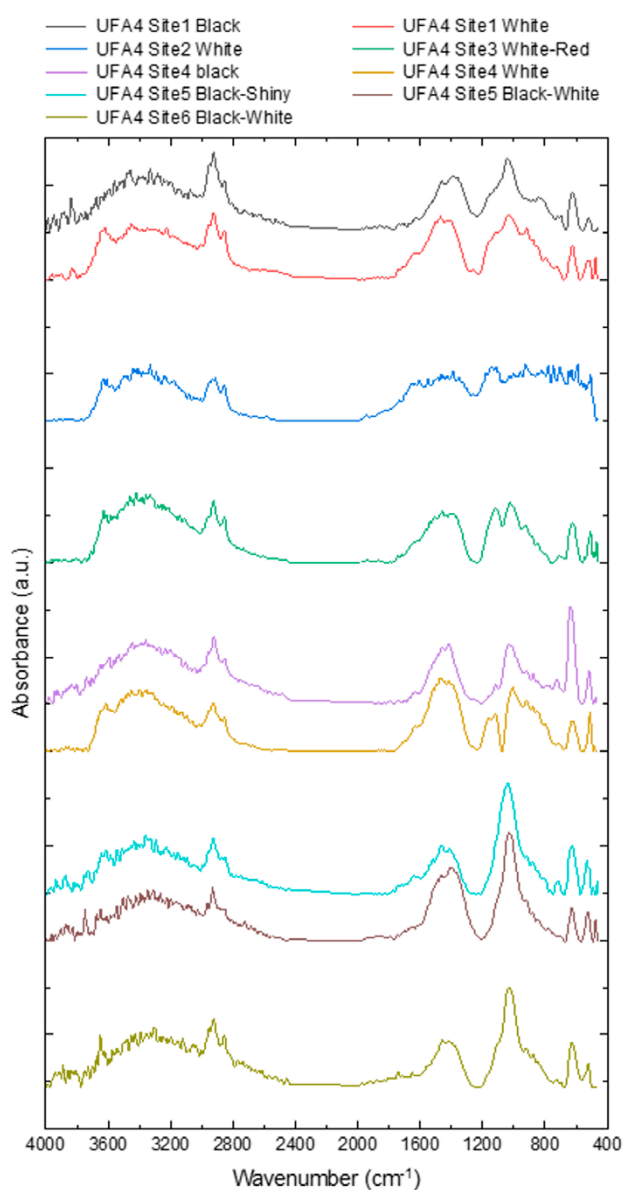
IRRAS measurements were made on the UFA4 coupon sites and their corresponding IR-spectra can be seen in Figure 3-86. A Peak around  $630\ \text{cm}^{-1}$  can be seen for a few sites indicating the presence of cuprite. Double peaks around  $1\ 300\text{--}1\ 600\ \text{cm}^{-1}$  indicates malachite. Peak at  $1\ 000\ \text{cm}^{-1}$ ,  $3\ 600\ \text{cm}^{-1}$ , and double peaks at  $500\text{--}600\ \text{cm}^{-1}$  indicate bentonite. Site 3 show a peak at  $1\ 100\ \text{cm}^{-1}$  which could indicate adsorbed sulphate or precipitated sulphate minerals.

Figure 3-86. Infrared spectra from FTIR/IRRAS measurement on surface of sample UFA4.

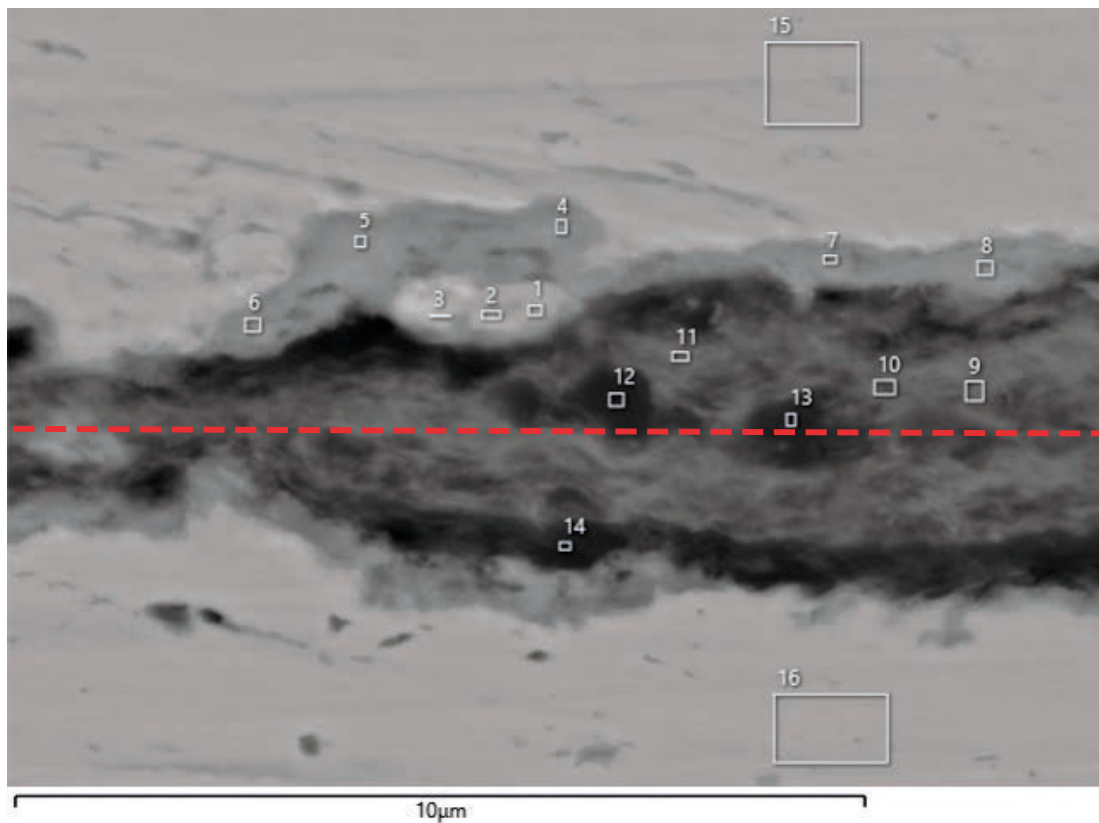
The cross section samples were cut in half, cast into epoxy resin while mounted surface-to-surface, polished and analysed with SEM/EDS. Figures 3-87–3-89 were analysed after dry grinding. Figure 3-90–3-94 were analysed after diamond polishing. The cross section images show that the surfaces generally displayed a slightly rough appearance. The SEM images show a slightly thicker oxide layer than PC901 and LFA2. The EDS result show signs of sulfur being present in the cross section of the sample with a tendency of enhanced levels farther out in the oxide layer (Figure 3-90). As there only seem to be minimal amounts of bentonite present in this micrograph, and since the levels of calcium and iron are very low, the most likely origin of the enhanced levels of sulfur is the sulfidation of the underlying copper oxide film and the resulting formation of copper sulfide. Molybdenum was detected in Figure 3-91 scan 11. Due to overlapping peaks in the EDS spectra molybdenum could be a misidentification of sulfur.

**Figure 87.** SEM image of the cross section of UFA4. The image shows the two surfaces of the cross section sample mounted surface to surface. This method was chosen to protect the oxide layer during polishing of the sample. A red dashed line indicates the rough location of the half way point. The EDS result of the cross section of UFA4 is shown in the table.

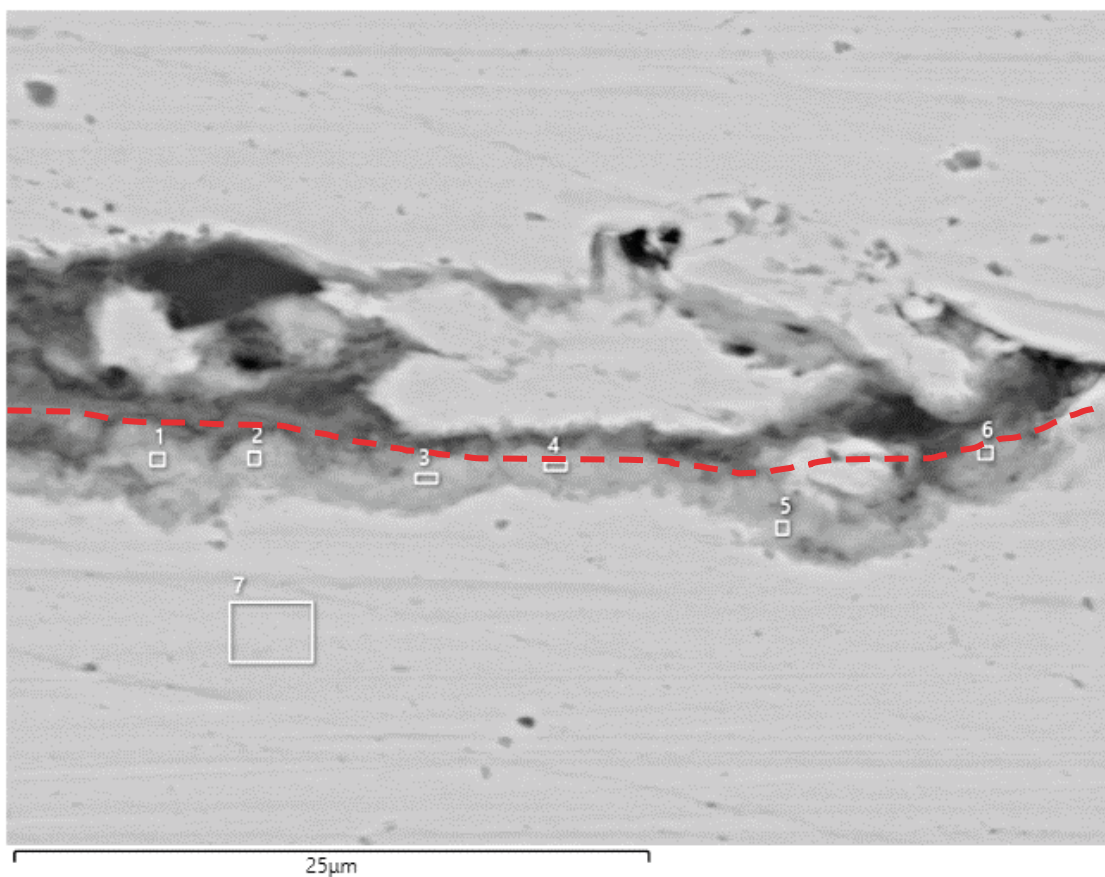
**Figure 3-88.** SEM image of the cross section of UFA4. The image shows the two surfaces of the cross section sample mounted surface to surface. In this image a copper particle seems to be present between the two surfaces. A red dashed line indicates the rough location of the separation of the two surfaces. The EDS result of the cross section of UFA4 is shown in the table.

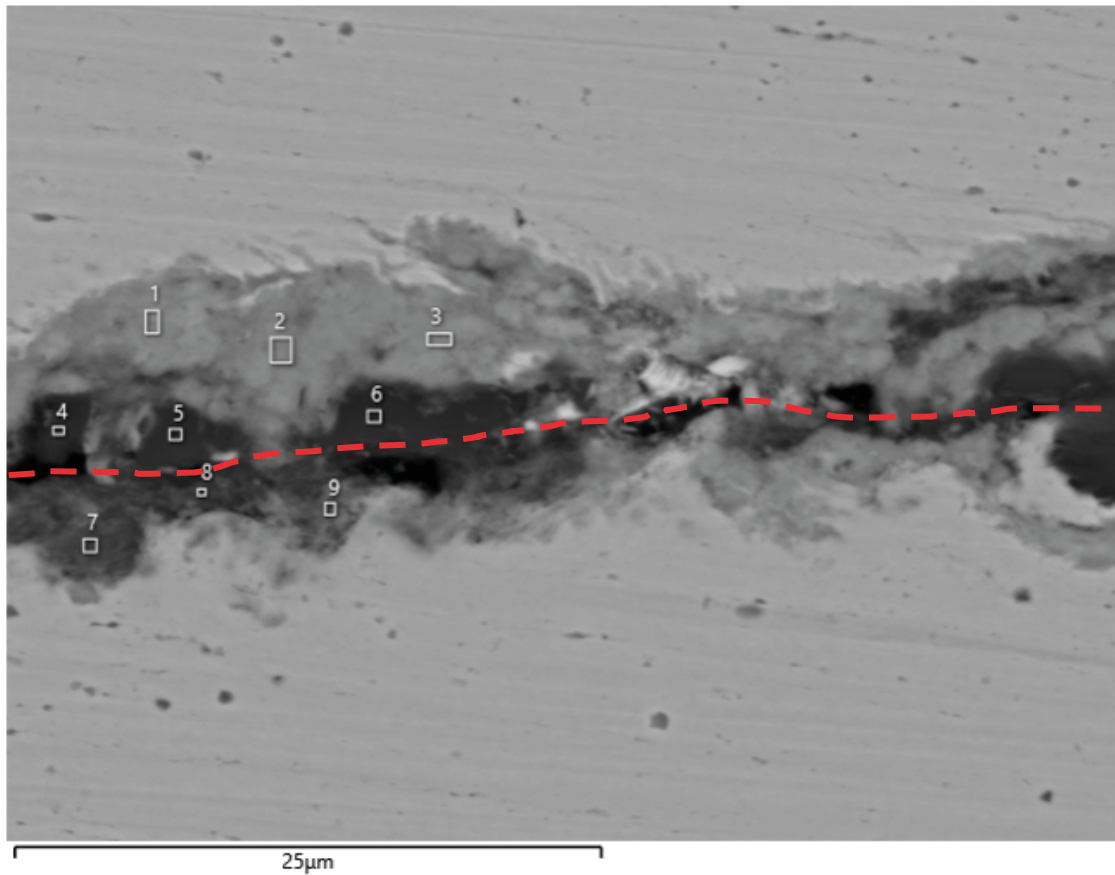
**Figure 3-89.** SEM image of the cross section of UFA4. The image shows the two surfaces of the cross section sample mounted surface to surface. A red dashed line indicates the rough location of the separation of the two surfaces. The EDS image of the cross section of UFA4 is shown in the table.

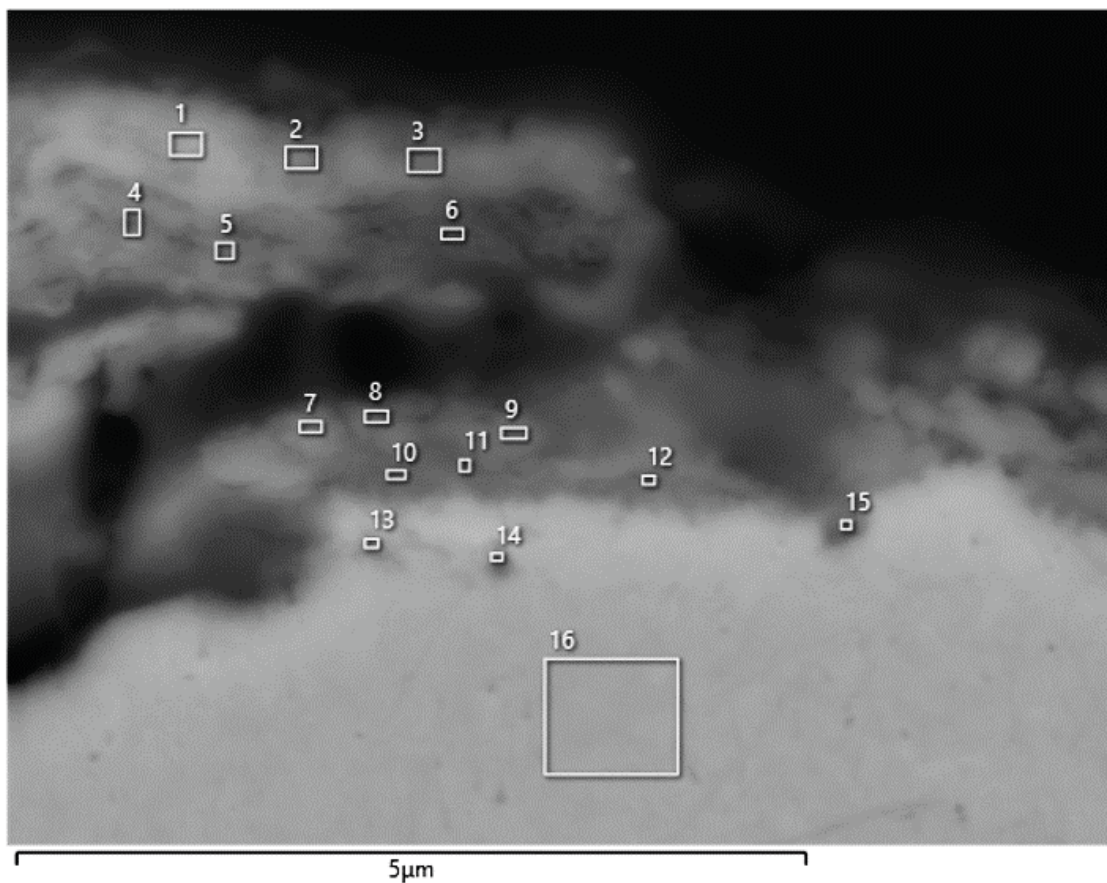
**Figure 3-90.** SEM image of the cross section of UFA4, diamond polished. The EDS result of the cross section of UFA4, diamond polished, is shown in the table.

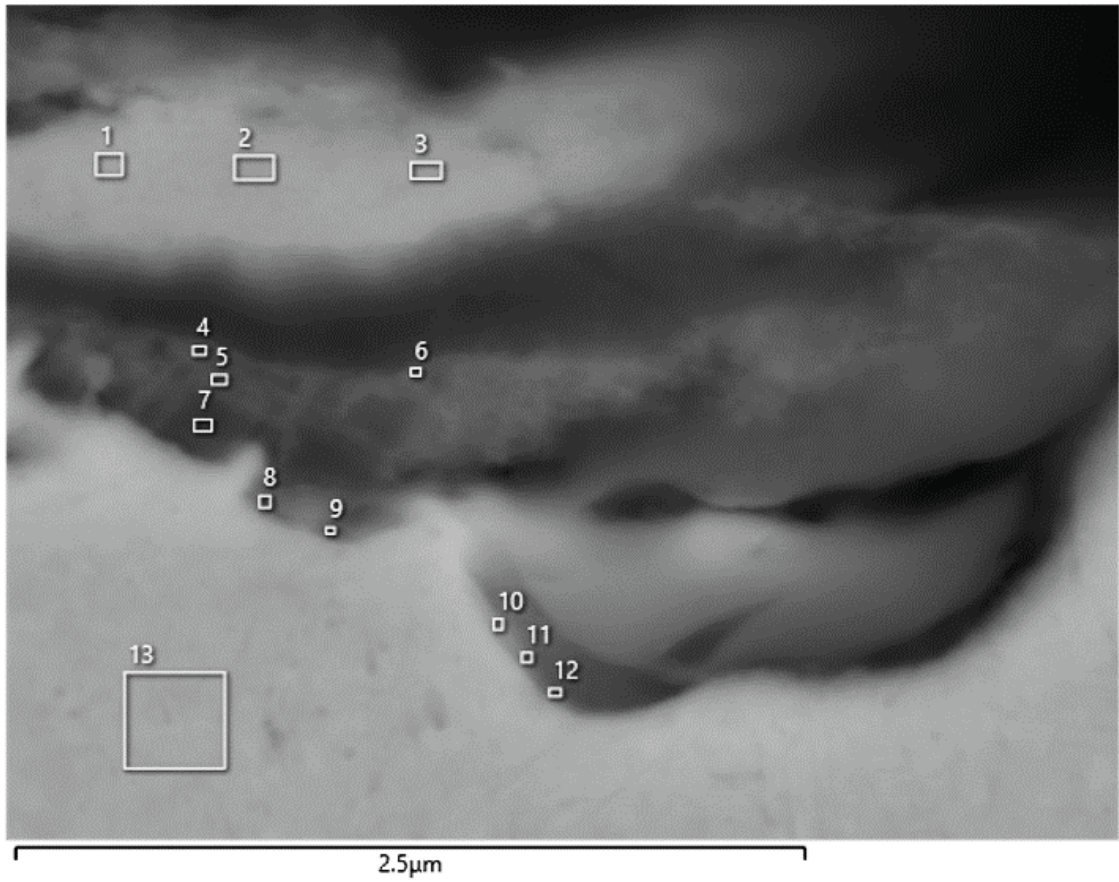
**Figure 3-91.** SEM image of the cross section of UFA4, diamond polished. The EDS result of the cross section of UFA4, diamond polished, is shown in the table.

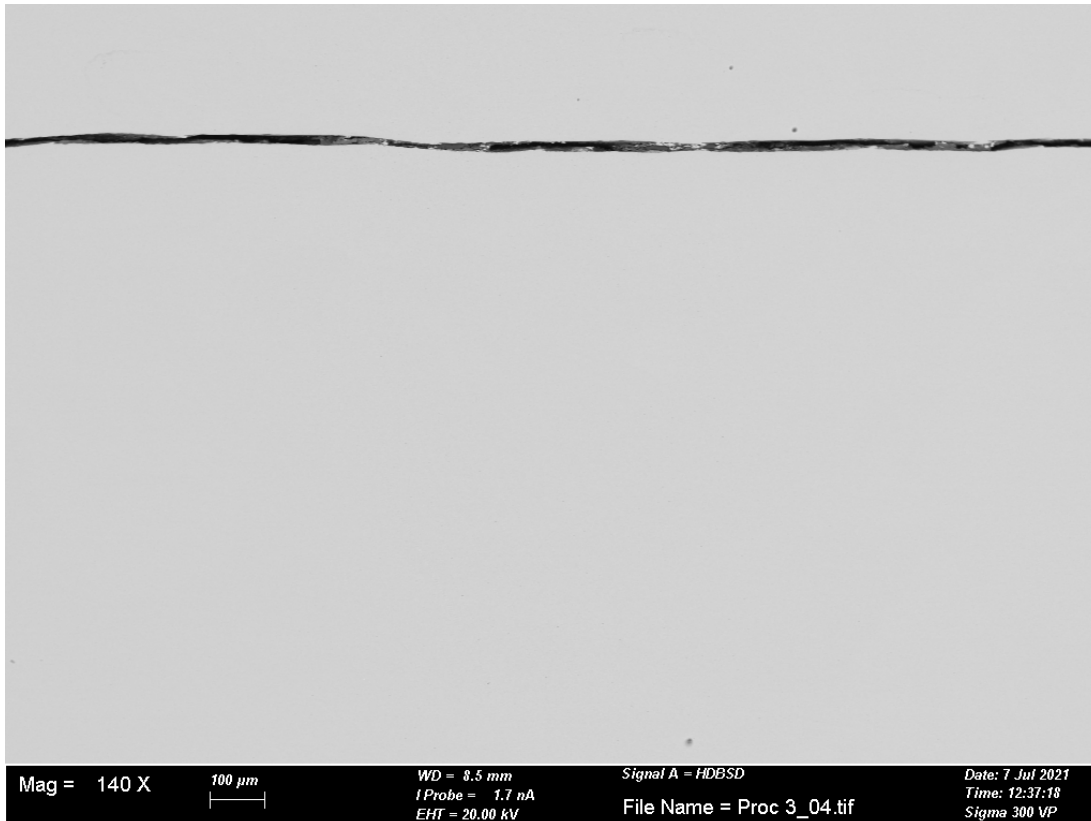
**Figure 3-92.** SEM image overview of cross section mounted in epoxy resin surface to surface at  $\times 140$  magnification, UFA4.

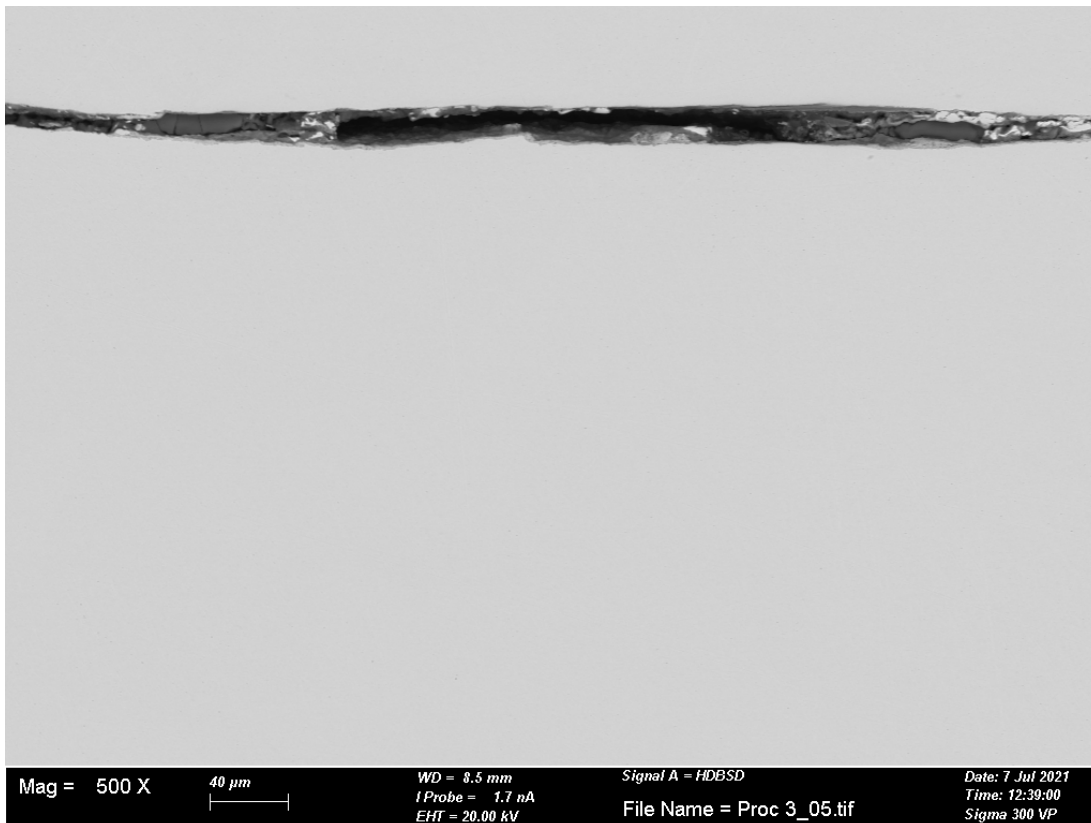
**Figure 3-93.** SEM image overview of cross section mounted in epoxy resin surface to surface at  $\times 500$  magnification, UFA4.

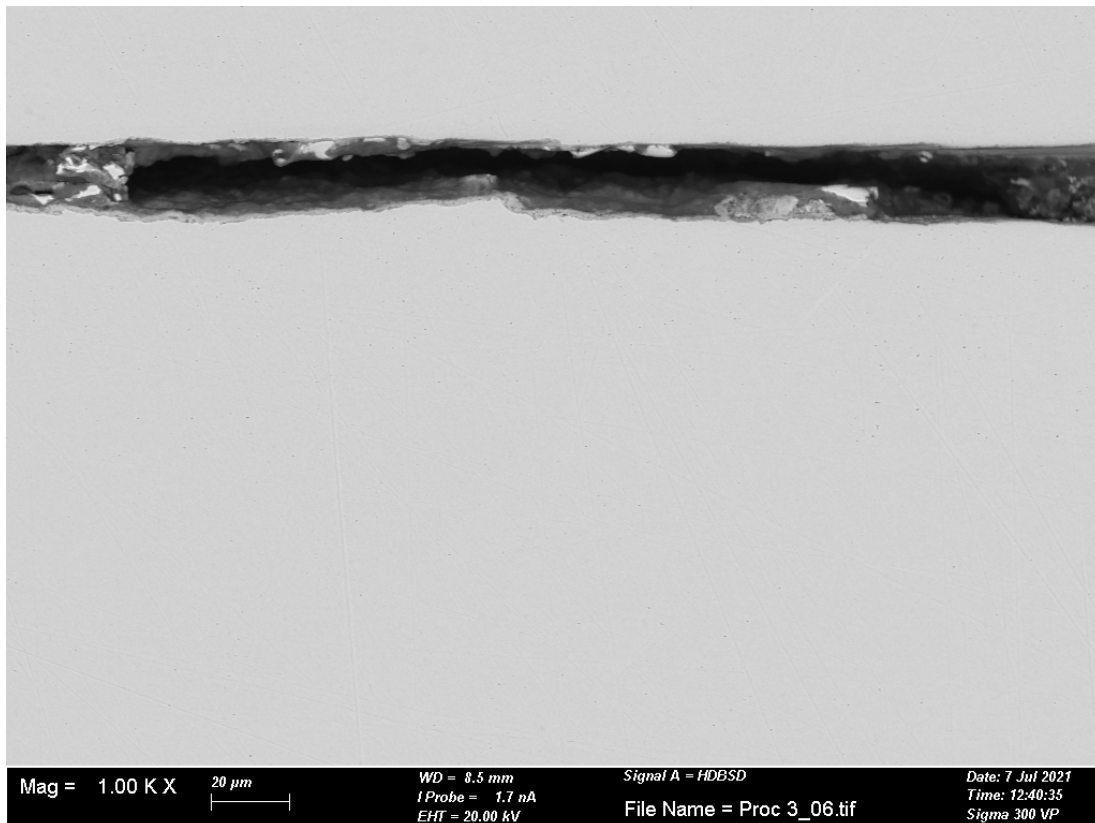
**Figure 3-94.** SEM image overview of cross section mounted in epoxy resin surface to surface at  $\times 1000$  magnification, UFA4.

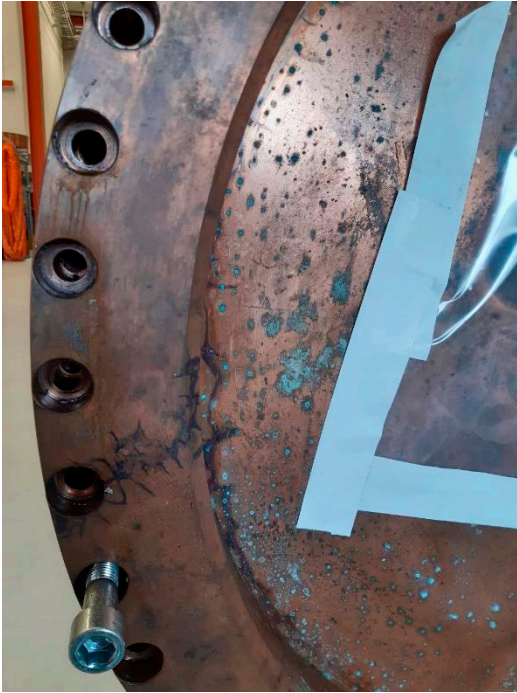
It was generally found that the canister surface had small dark brown or black patches, of which some had a green-blue interior (Figure 3-95). Another common feature of the canister surface was the dark reticulated pattern seen e.g. on the canister surface in Figure 3-1d, on the filter housings LFA2 and UFA4 in Figure 3-1c and 3-1d, as well as on the canister base in Figure 3-95.

*Figure 3-95. Canister base after retrieval.*

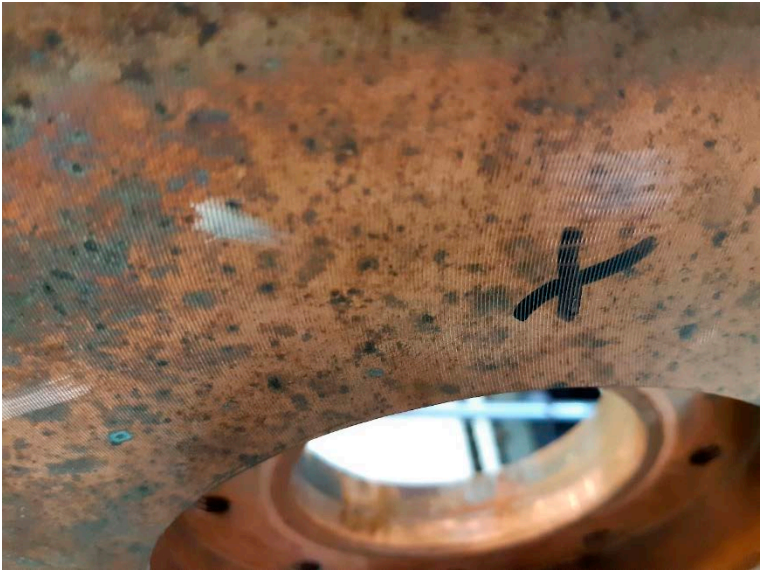
Close-up photos were taken of the different type areas and the deposits were removed in order to see how it had affected the underlying copper surface. Typical dark patches are shown in Figure 3-96, which is a detail from the canister base near the position of the filter housing PC901. As can be seen in Figure 3-1a, the same type of dark patches were found on the filter housing. In the photo depicted in Figure 3-96, the dark deposits have been scraped off at three positions, clearly revealing the band pattern from the machining of the canister components and showing that at these positions any influence of corrosion was, at most, less than the depth of the original deformation of the surface caused during manufacturing.

*Figure 3-96. Close-up of area of the canister base, with dark patches near the position of PC901.*

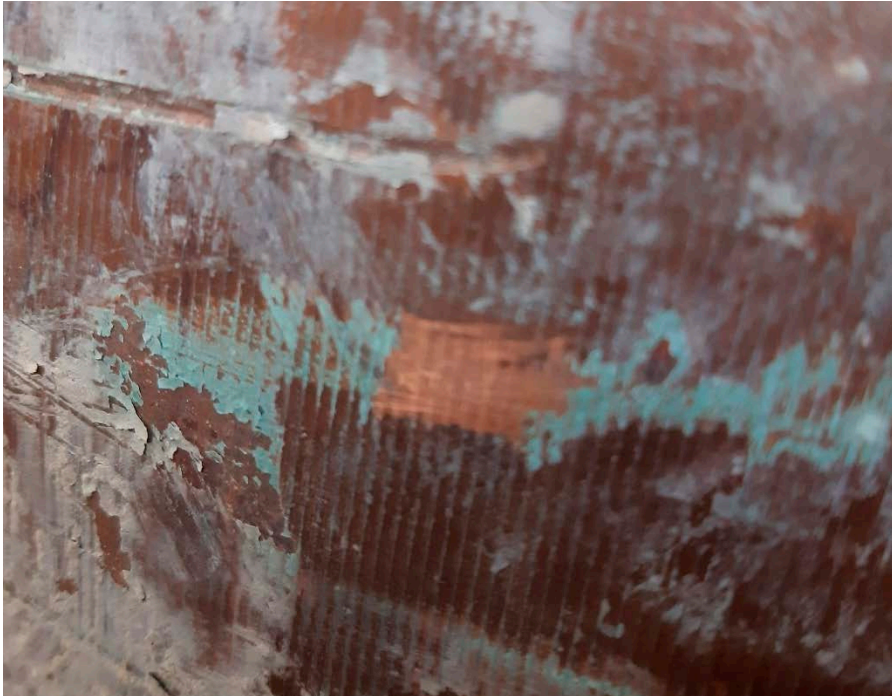
An example of an area with typical green-blue corrosion products is shown in Figure 3-97. Some of the deposit was scraped off using a scalpel. The deposit was found to be very loosely attached to the surface, easily flaking off when scraping the area, and the underlying copper surface displayed the band pattern resulting from machining of canister components.

*Figure 3-97. Close-up of area with green-blue deposits, of which some has been removed using a scalpel.*
