**TR-22-01**

# Analysis of corrosion products on filter housings in the Lasgit field experiment

SVENSK KÄRNBRÄNSLEHANTERING AB

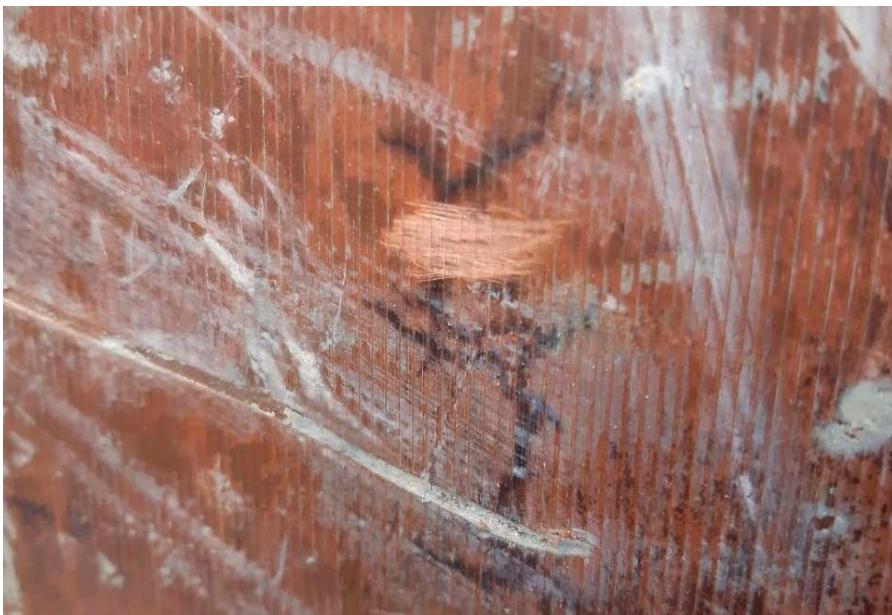
An example of an area displaying the dark reticulated pattern is shown in Figure 3-98. As can be seen in the middle of the photo, part of the deposit forming the pattern was scraped off using a scalpel and just as for the other types of corrosion products and deposits found, no visible corrosion of the underlying copper surface was observed.

*Figure 3-98. Close-up of area with the typical dark reticulated pattern. Some of the deposit has been removed using a scalpel.*

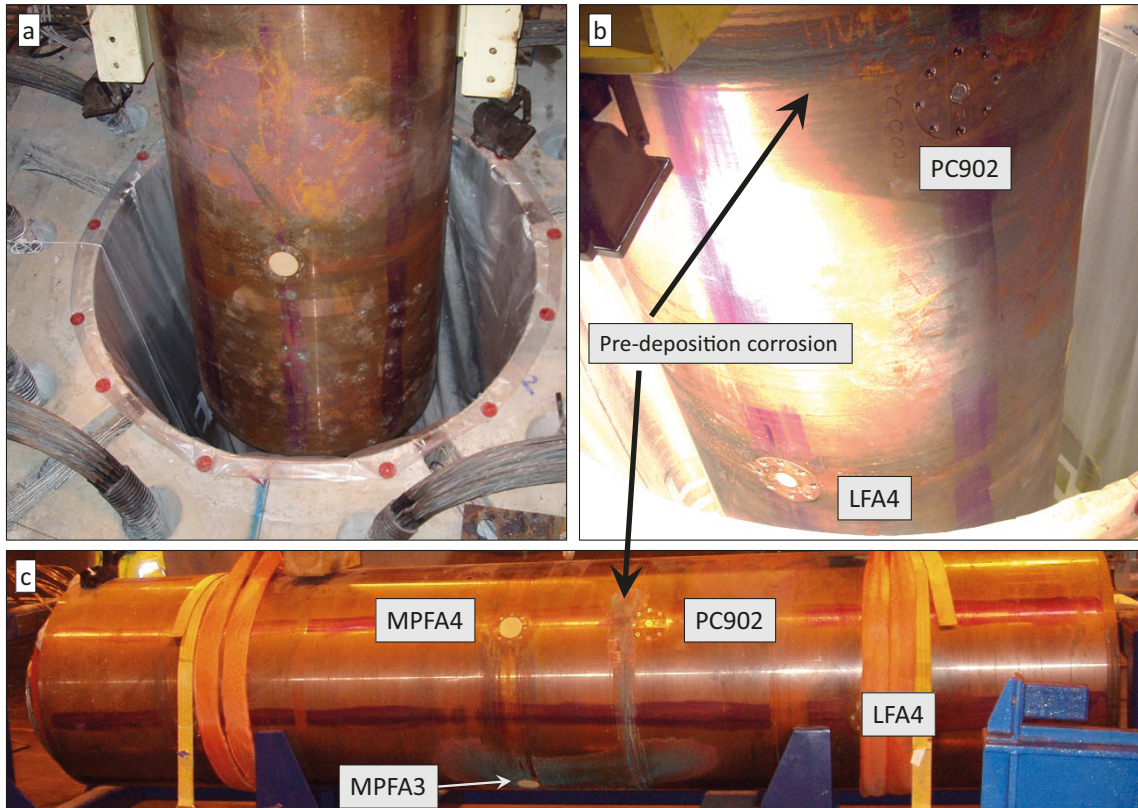
The state of the Lasgit canister upon deposition is shown in three photographs in Figure 3-99. Figure 3-99a shows the lower part of the canister upon deposition, displaying one filter assembly and the axial purple markings spaced by 45° for filter assembly placement. In Figure 3-99b, filter assembly FLA4 is visible in the bottom left part of the image and the total stress sensor PC902 is visible in the top right part of the image. Additionally, in Figure 3-99b, a green-blue line of corrosion products can vaguely be seen above the total stress sensor, indicated by a black arrow. This line of corrosion products is also visible in the bottom part of Figure 3-99c, showing the Lasgit canister in the Äspö HRL tunnel before deposition. An additional, larger green-blue area is clearly visible in Figure 3-99c, partly covering filter assembly MPFA3. It is thus clear that some green-blue copper corrosion products were already present on the canister upon deposition. The same region where the green-blue corrosion products are observed in Figure 3-99c is also marked with a black rectangle in Figure 1-3c, here, the corrosion products are no longer clearly visible. Additionally, the large region of green-blue corrosion products partly covering filter assembly MPFA3 in Figure 3-99c is not visible on the same filter housing upon retrieval of the canister on January 25, as clearly shown in Figure 1-3a. By this comparison, the corrosion products from before deposition of the Lasgit canister are much less visible on the canister after retrieval.

**Figure 3-99.** The pictures show the Lasgit canister before deposition, (a) showing the bottom part of the canister; (b) showing the bottom part as well as the total stress sensor PC902, (c) showing a side view of the entire canister highlighting the presence of green-blue corrosion products on the canister at deposition.

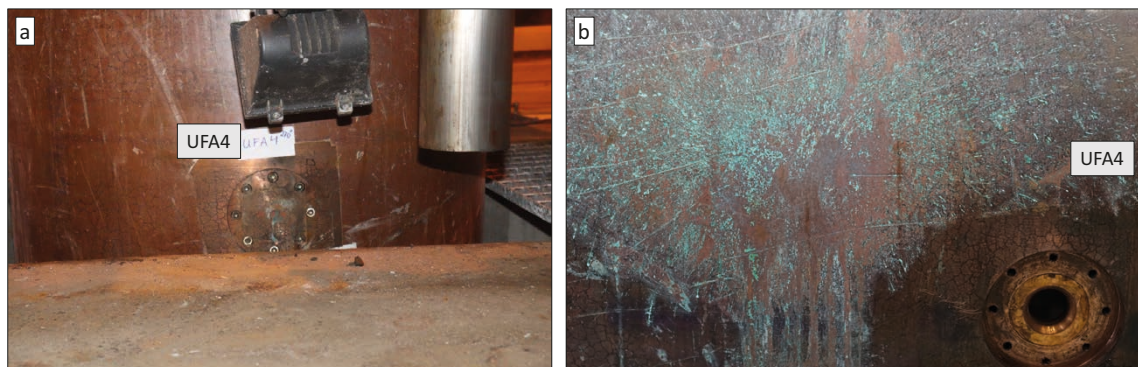
The left-hand side of Figure 3-100a shows the same area as in Figure 3-100b, however when the Lasgit canister is being retrieved from the deposition hole. It should again be noted that the two images (showing partly the same area) are taken roughly one month apart, with Figure 3-100a taken first upon retrieval. It can thus be concluded that the green-blue corrosion products observed in Figure 3-100b, and characterised with XRD, formed after canister retrieval but before examination at the Canister Laboratory. It can, however, not be excluded that similar-looking corrosion products noted on other parts of the Lasgit canister may have formed during the course of the Lasgit experiment.

**Figure 3-100.** The same area of the Lasgit canister photographed directly upon retrieval from the deposition hole at the Äspö HRL (a), and after arrival to the Canister laboratory in Oskarshamn (b). Note that the image to the left was taken roughly one month prior to the image to the right.

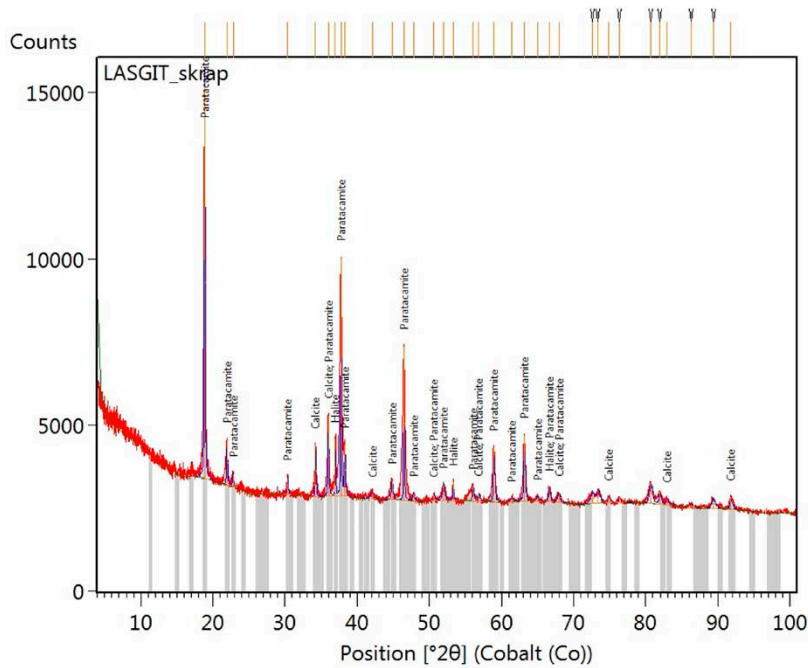
A scrape sample was taken from the large area of green-blue deposits marked with a grey rectangle in Figure 1-3c. A close-up of the sample is shown in Figure 2-2. The sample was examined using XRD and XRF. In the evaluation of the XRD data (Figure 3-101) the dominant phase was identified as paratacamite (possibly clinoatacamite; a chemically very similar mineral). Both can be expressed as  $\text{Cu}_2(\text{OH})_3\text{Cl}$ . The minor phases were calcite and halite, and in the low angle region some smectite reflections were probably present, however the intensity is in the range of the background noise. The XRD reference data used for identification were halite (COD 96-900-8679), calcite (ICSD 98-016-9917), paratacamite (COD 96-900-7605), clinoatacamite (ICSD 98-026-0350) and atacamite (ICSD 98-015-3706). Formation of paratacamite as a copper corrosion product in chloride rich waters is not unexpected (Huttunen-Saarivirta et al. 2017, Johansson et al. 2020, Karnland et al. 2009). It is therefore concluded that the observed paratacamite formed from oxidic corrosion after retrieval and during the one month storage in the deposition tunnel, which had a temperature of 10–16 °C and a humidity of 52–82 %RH (see Appendix B). The source of chloride could either have been groundwater during the exposure in the deposition hole, or groundwater dripping onto the canister during storage in the Äspö tunnel after retrieval. The latter is considered more probable, as these corrosion products appear patch-wise on the canister.

**Figure 3-101.** XRD pattern of the scraping sample from the Lasgit canister surface. The reflections are marked with corresponding phases.

Analysis with XRF confirmed the chemical interpretation of the XRD data. The sample was dominated by Cu (64 wt% CuO), Cl (20 wt%) and Ca (9 wt% CaO). Minor levels of Mg, Si and Al indicate that there are some low levels of smectite present in the sample, as expected due to the bentonite contact with the canister. The Si/Al ratio of the scraping sample was 2.95, which is very close to the 2.97 of a MX80 sample, a similar but not identical bentonite to one used in the experiment (Table 3-2). The Al and Si content of the scraping sample indicated that it contains approximately 4 wt% montmorillonite.
