Äspö HRL

Experiences of blasting of the TASQ tunnel

November 2004

Svensk Kärnbränslehantering AB

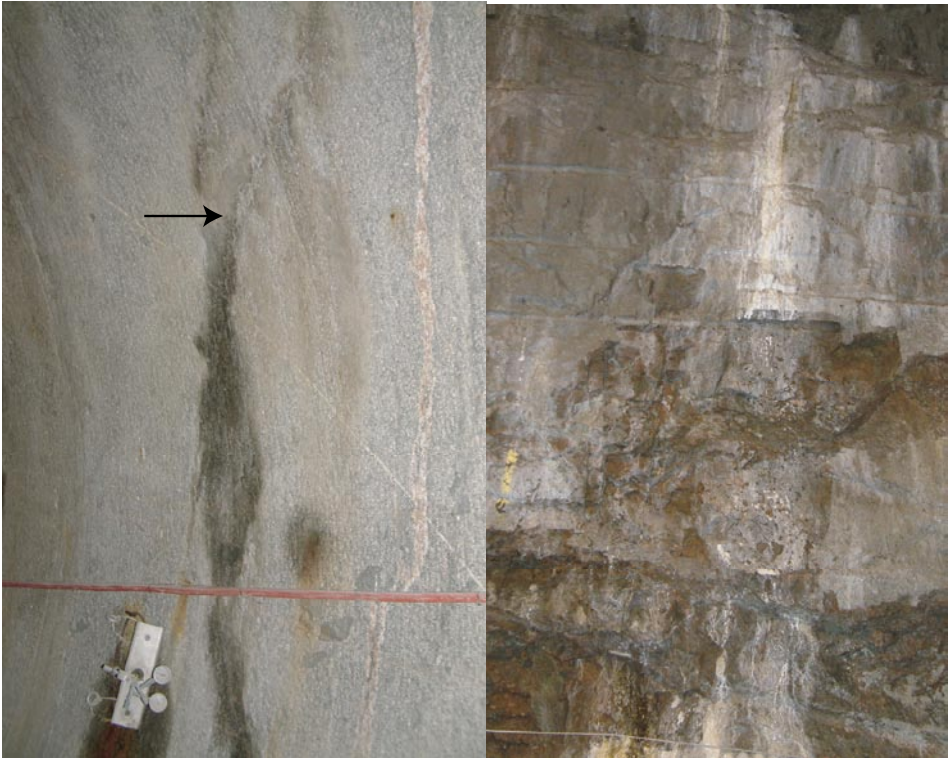
Water leakage from the fracture set oriented in NW-SE/sub vertical was most pronounced in sections 0/060 and 0/064 of the tunnel. This area was subject grouting /Emmelin et al. 2004/. Generally the leakage causes damp surfaces or, at most, seepage. Occasionally, however leakage has been classified as flowing, in these cases exclusively generated in the above mentioned tunnel-perpendicular set. Two fractures of this set are intersected by deposition hole DQ0066G01. Calculations of total inflow in this deposition hole indicated 30 litres/minute.

Figure 2-3. The waterbearing fracture set 2, trending NW. Observation in the TBM tunnel just outside the TASQ tunnel (left). Notice how the fracture spays into two in the upper part of the photo. The right photo is from the TASQ tunnel. The fracture set is perpendicular to the tunnel, and (at the arrow) less visible. This section was grouted, the light strips are calcite precipitation from the cement.

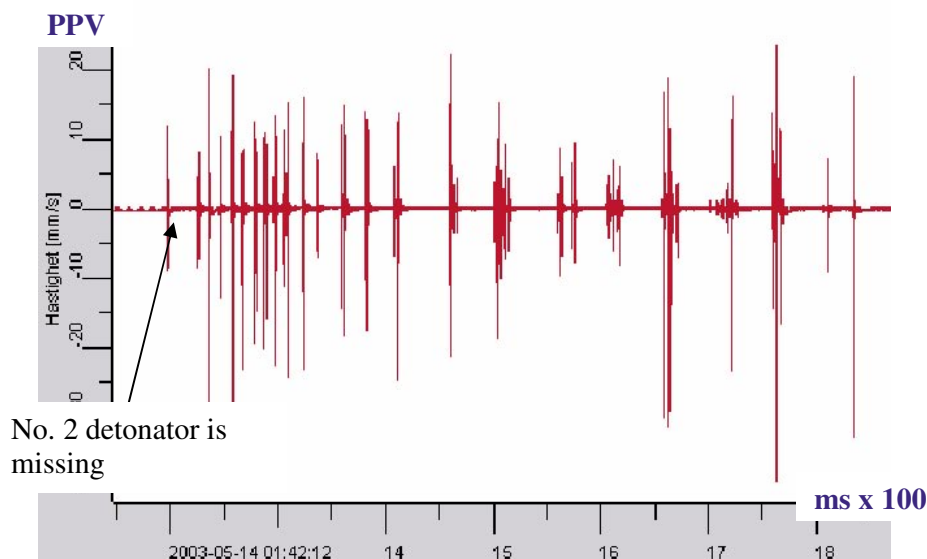
A deeper analysis of the vibration records in Figure 6-2 shows that the second hole in the cut is missing. Normally one missing charge in a cut with 4 large holes should not reduce the possibility of establishing a good opening for the rest of the round.

Figure 6-2. The time history for blast round no 15. Each wave package in the left part of the time window corresponds to a detonating hole.

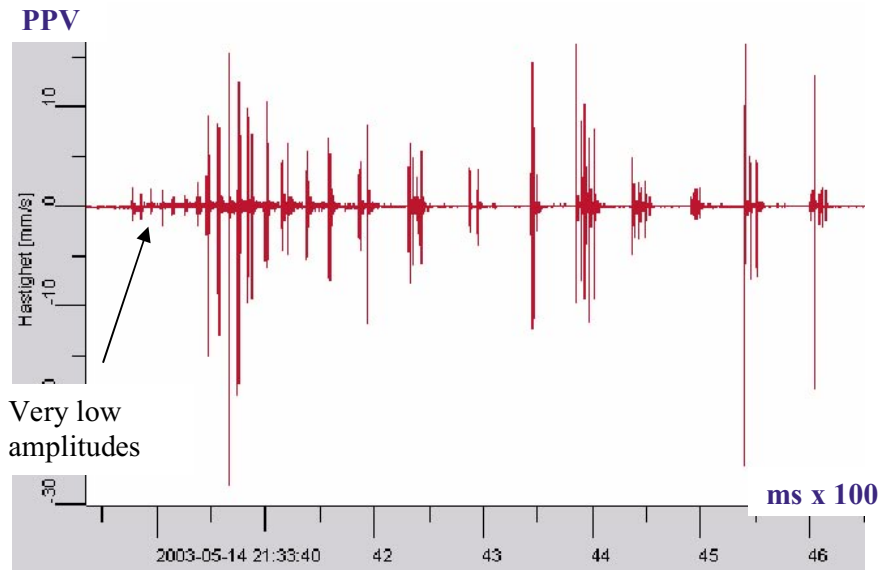
As showed in Figure 6-3 very low amplitudes were registered in the vibration monitoring record for the first 7 holes in the round.

Figure 6-3. The time history for blast round no 16. Each wave package in the left part of the time window corresponds to a detonating hole.

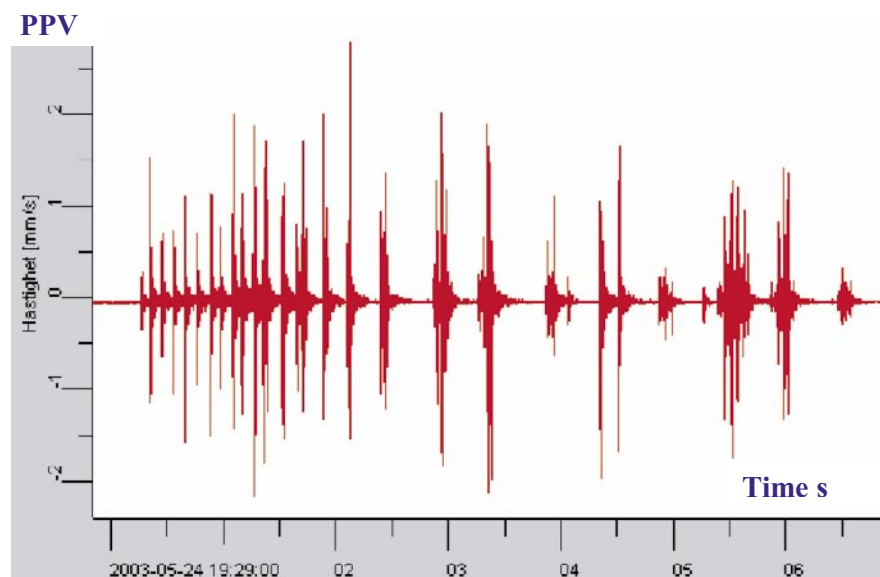
The cut holes had broken out of the face. Some holes below and to the right of the cut and some holes above the cut had broken out further in but not all the way out to the free face. No disturbances were found in the initiation sequence of the cut, see Figure 6-4. All holes in the first critical part of the initiation showed full functionality.

Figure 6-4. The time history for blast round no 21. Each wave package in the left part of the time window corresponds to a detonating hole.

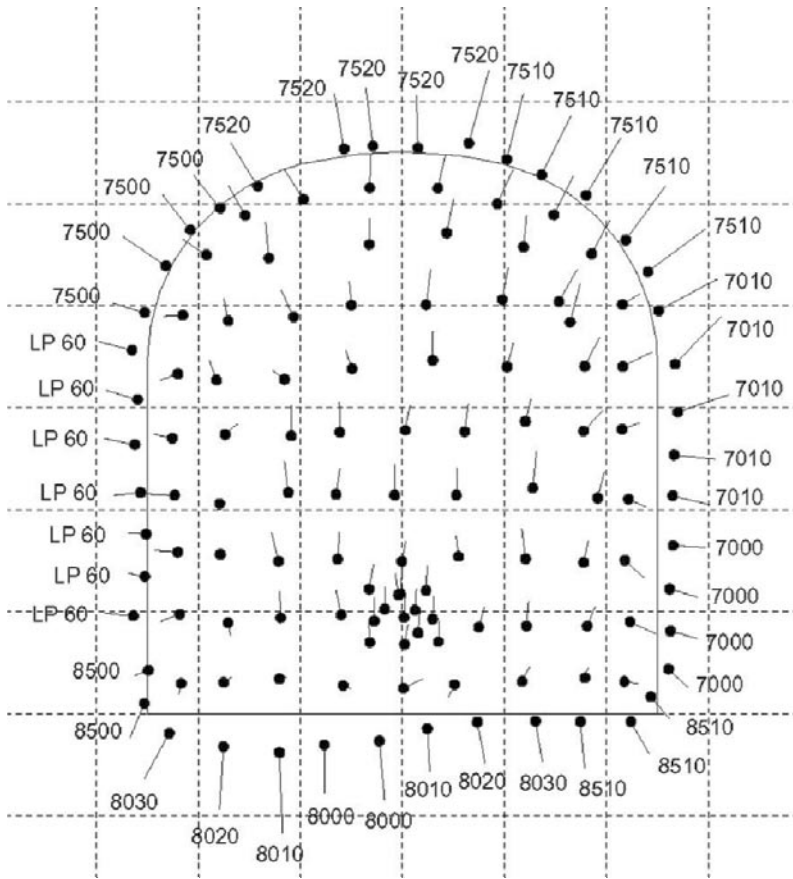
Figure 6-13. Hole trajectories and initiation of the contour holes in Test section 2; round 33.

Due to lack of Nonel-caps more electronic detonators had to be used. Other interval numbers than the planned were also used as Figure 6-13 shows. The interval time for the electronic caps here starts at 7,000 ms compared to planned 5,000 ms but the time steps between the contour holes were not changed. Electronic caps were also used for the bottom holes (in the lifters). The Nonel LP caps were used as planned in on the left hand wall but caps number 45 (4,500 ms) were replaced by caps number 60 (6,000 ms).

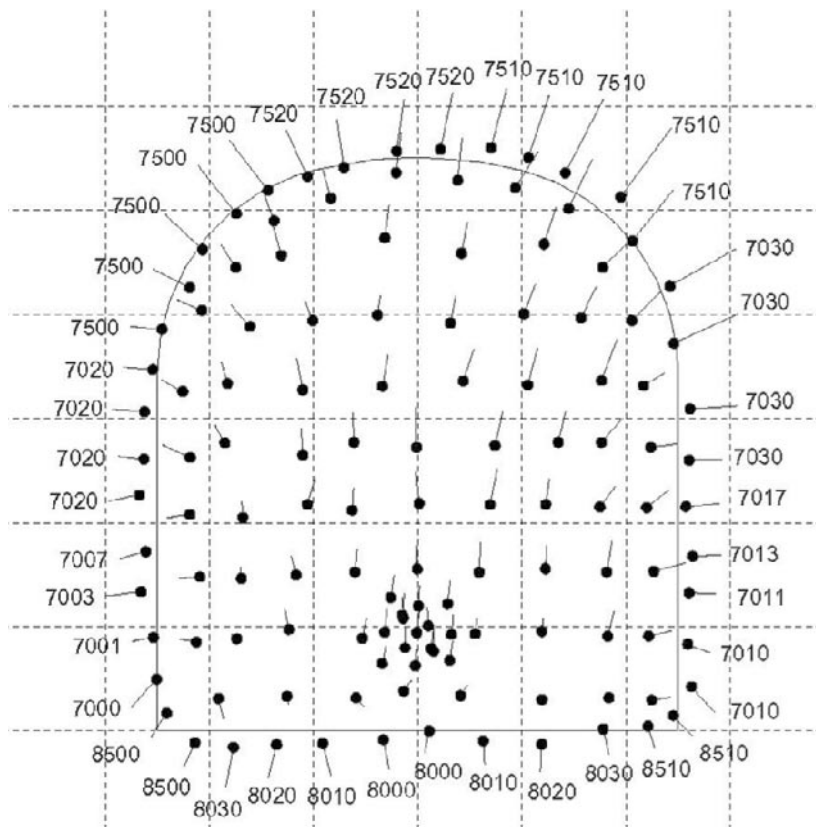
Figure 6-14. Hole trajectories and initiation of the contour holes in Test section 3; round 34.

The initiation plan of this round was also changed due to lack of Nonel-caps. Instead of starting the contour intervals at 4,500 ms as planned, the starter hole was given the initiation time 7,000 ms, see Figure 6-14. The time steps between the contour holes were not changed. Electronic caps were used for the bottom holes.

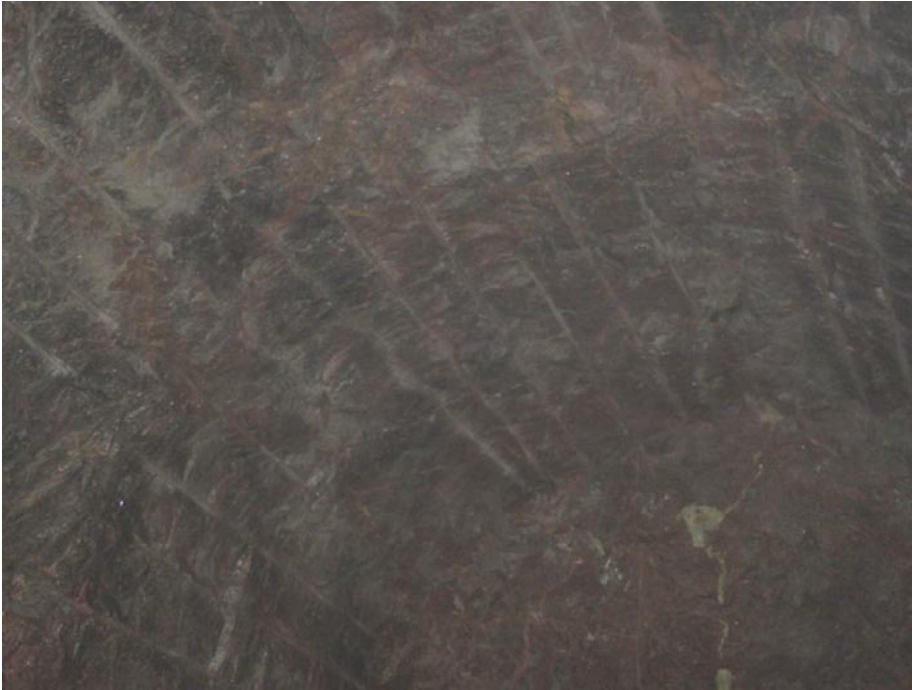
The result of the blast was very good with the highest number of half casts of all the three rounds; see Figure 6-21 which shows the result in the roof.

Figure 6-21. Half casts in the roof of round 3.

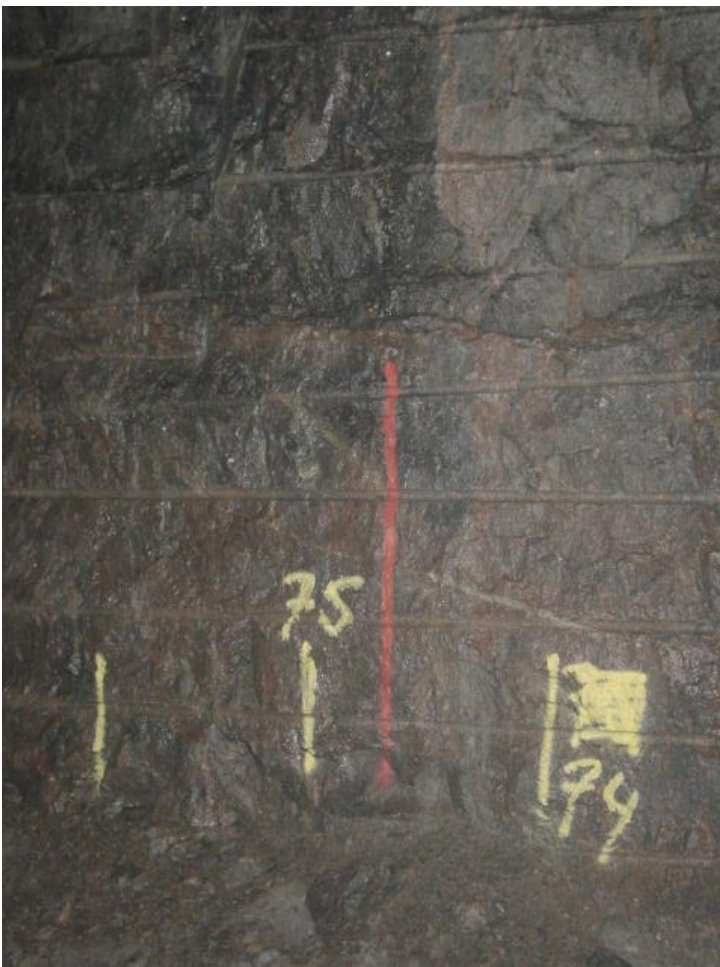
Figure 6-22. Right hand wall from test round 2.

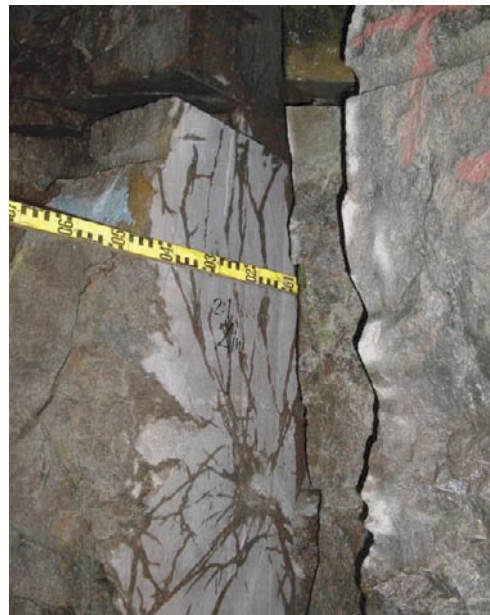
Figure 7-7. Left slot wall, upper part.

Generally there was too much of water on these surfaces for a proper analysis. However, on the left wall the influence of a confined hole is visible. There are many long cracks from this hole compared to the upper half-pipe with almost no cracks. Another reason for the long cracks is that the hole probable was partly filled with water when blasted. The drill rig in the TASQ-tunnel used water to flush away the cuttings. This hole, together with many other measured boreholes, was not horizontal. They were dipping 1–3 degrees forward and were most likely partly filled with water when they were charged. There are some shorter cracks from the other half-pipes; the longest is around 20 cm. There are also some blast induced cracks and natural cracks. More details may be found in Appendix 3 and in Section 7.3.5.

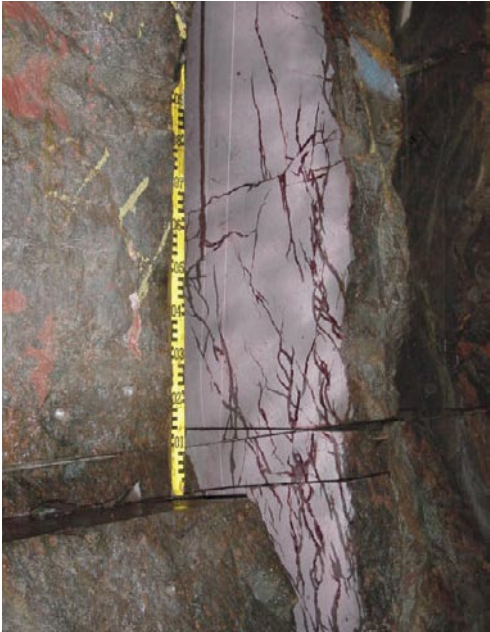
Figure 7-9. Cracks in lower part of right slot wall.

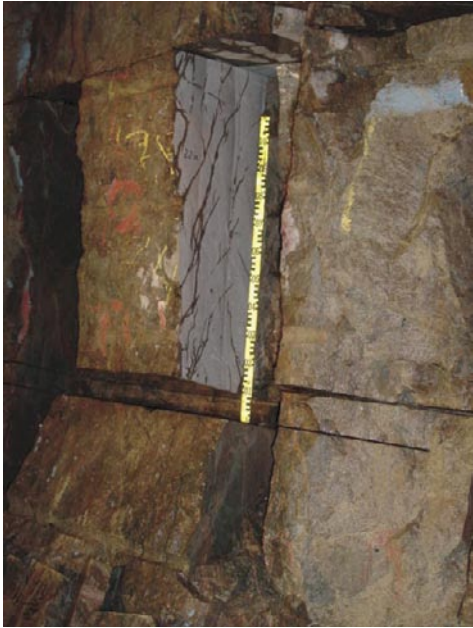
In the upper part of Figure 7-8 cracks from a bottom charge are shown. This is a very typical crack pattern from a confined charge with symmetrical cracks all around the hole. There are also a number of cracks from the half-pipes; the longest is around 20 cm. On the left wall, the cracks from the half-pipes have about the same length. But there are also longer cracks; the longest around 40 cm which seems to originate from the half-pipes. These cracks might also be classified as blast induced cracks. Most of the half-pipes in this section pointed downward which could indicate that the holes were partly filled with water when blasted. There are also many natural cracks in this section. Most of them have a more vertical plunge. One of these cracks was an open crack. More details may be found in Appendix 3 and in Section 7.3.5.

Figure 7-10. Cracks from left slot wall.

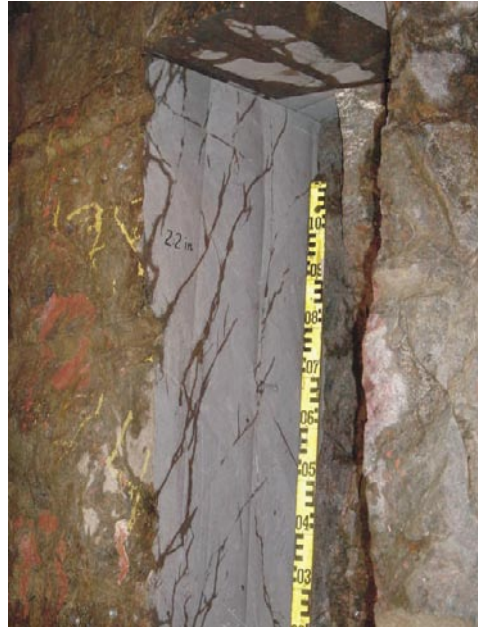
Figure 7-11. Cracks from upper part of left slot wall.

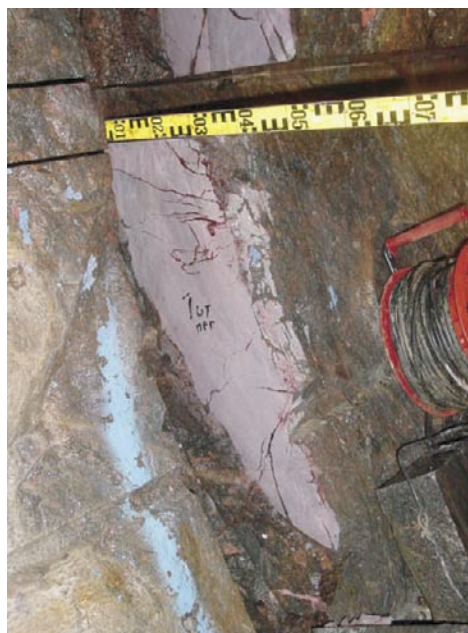
Figure 7-13. Cracks from the bench, right slot wall.

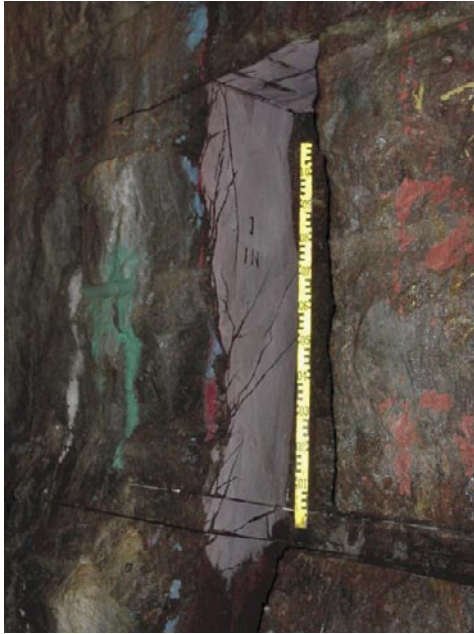
Figure 7-14. Cracks from left slot wall.

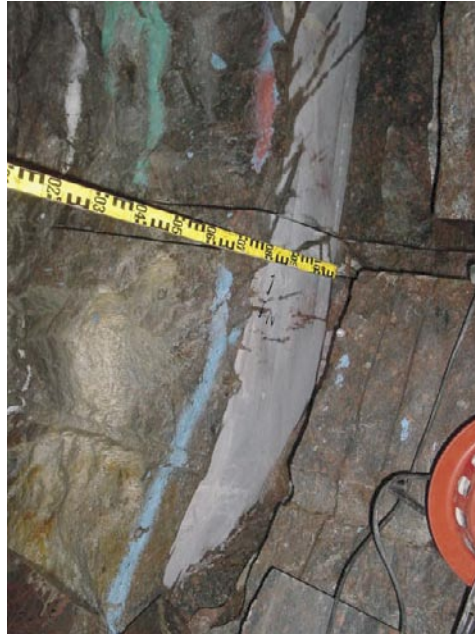
Figure 7-15. Cracks from the bench, left slot wall.

It is also obvious that there are fewer cracks from the bench than from the tunnel, see Figure 7-15. The reason for that could be:

- Another stress situation around the tunnel during the bench blast (blast induced cracks were reduced).
- The bench holes observed in the lower part of the wall seem to be more horizontal (smaller risk of being filled with water).

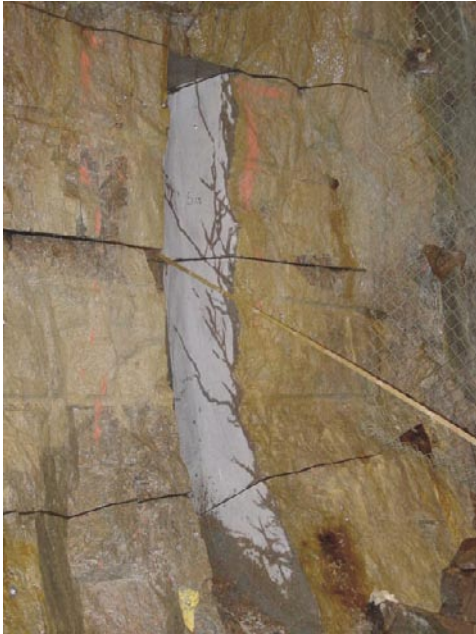
The first plan was to make a slot in the right hand wall were there were more half pipes but unfortunately that could not be done. A slot was therefore made in the left hand side of the tunnel in the middle of round 34. There was a lot of water dripping from the roof in this section. Some of the half-pipes had a negative slope and these holes could therefore have been waterfilled when blasted. Figure 7-16, 7-17, 7-18 and 7-19 shows the crack pattern in this section. Three half pipes were crossed and the longest cracks were 50–60 cm long. One explanation might be that some of these cracks have been induced during the blasting as they do not originate from the bore holes.

Figure 7-16. Cracks from the right slot wall.

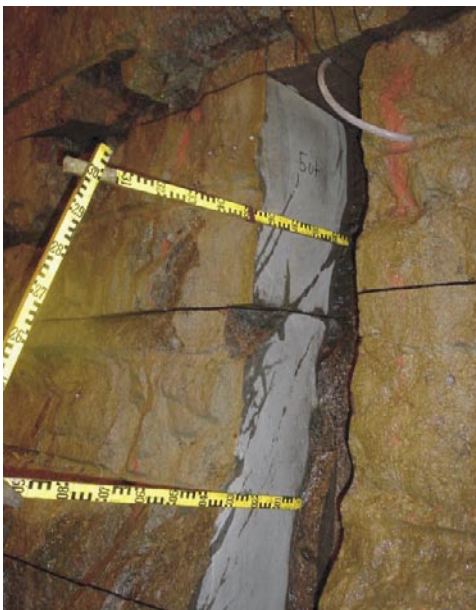
Figure 7-18. Cracks from the left slot wall.

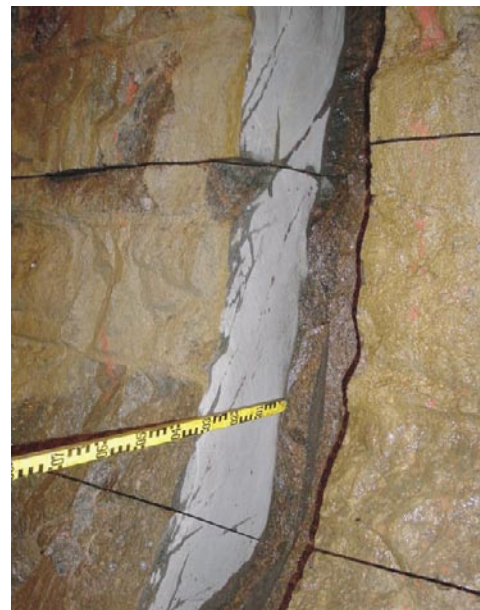
Figure 7-19. Cracks from the left slot wall.

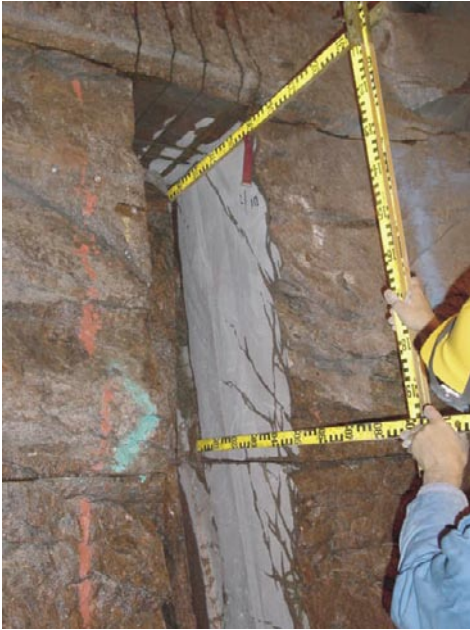
In the transition zone all of the holes were initiated by Nonel. There are two half-pipes one from the tunnel and the other from the bench, see Figure 7-20 and Figure 7-21. There are no visible cracks from the half-pipes in the tunnel part. From the half-pipe in the bench part are two visible cracks with a crack length less than 10 cm. Blast induced cracks as well as natural cracks are common in this section, see Figure 7-22 and Figure 7-23. The number and lengths of cracks in this transition section doesn't differ from the situation in the other test sections.

Figure 7-20. Cracks from right wall.

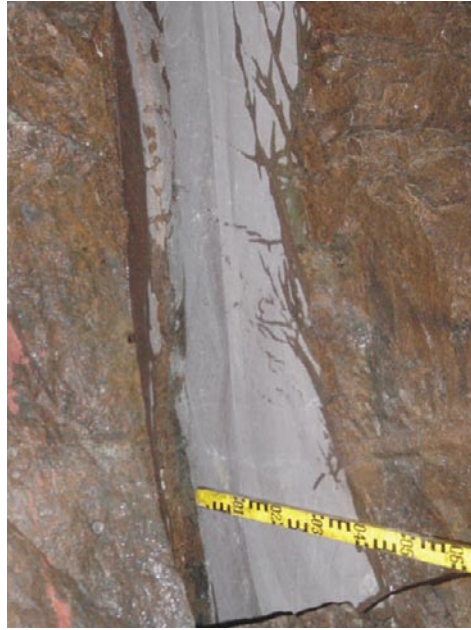
Figure 7-21. Cracks from the tunnel and bench.

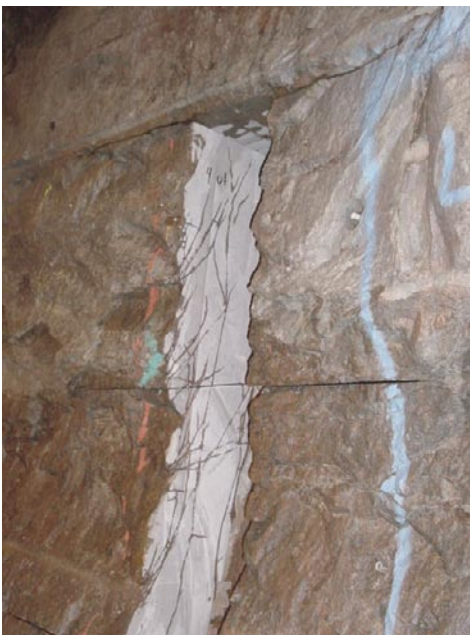
Figure 7-22. Cracks in the left wall.

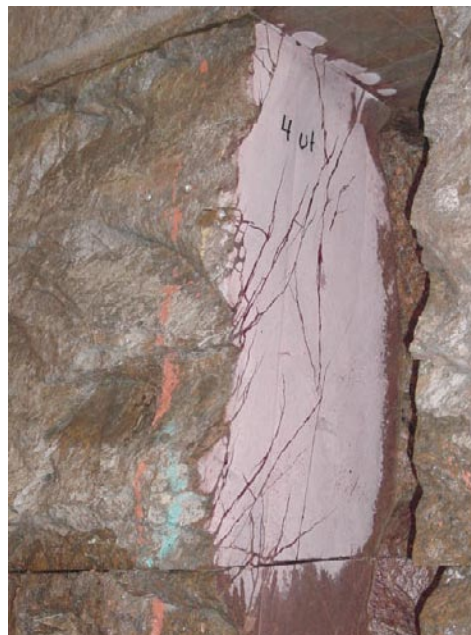
Figure 7-23. A zoom in of the upper part.

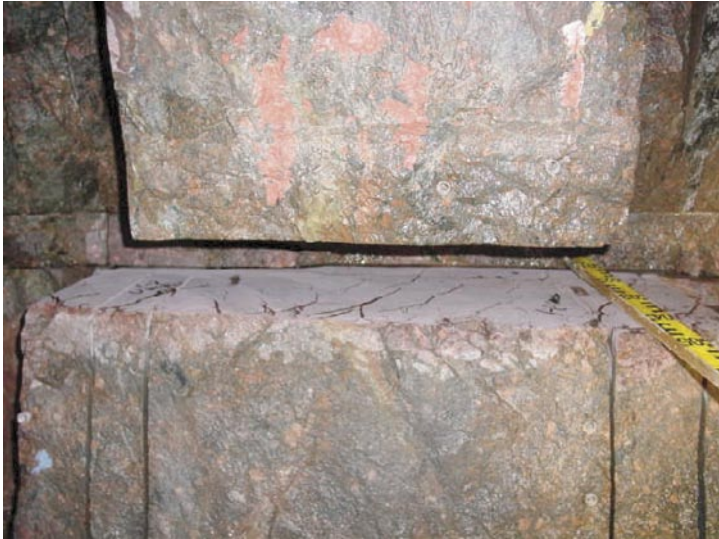
There were a number of parallel cracks going from the surface and into the wall, see Figure 7-24. The distances between these cracks are approximately 10 cm. Some of these cracks are found also on the tunnel wall. One of the cracks shows up as a filled thin zone on the wall.

Figure 7-24. *The horizontal slot.*

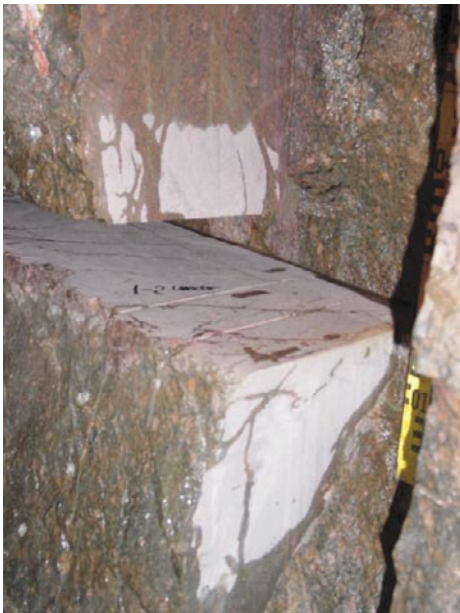
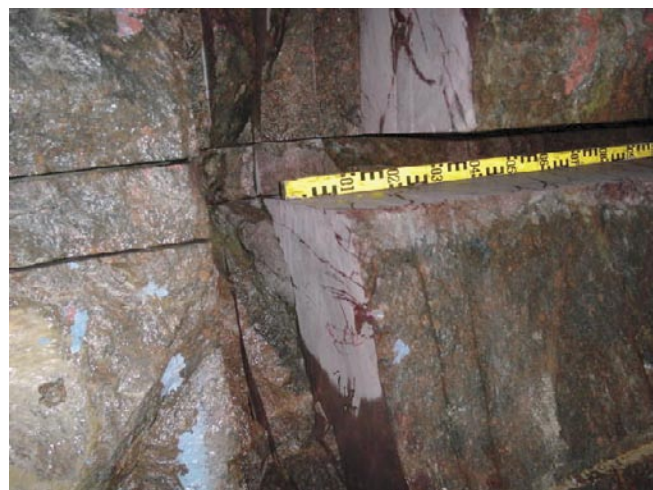
Figure 7-25. *Vertical right cut.*

Figure 7-26. *Vertical left cut.*

There are also some blast induced cracks in the vertical cuts in Figure 7-25 and Figure 7-26 like the cracks in the previous vertical cuts. The crack pattern from the upper surface is different, see Figures 7-27 and 7-28. There are many cracks near the tunnel surface, a long parallel to the surface and a shorter one pointing into the slot. These cracks should also have been found on the lower surface but this area probably was sliced away by the cutting of the slot. The system of parallel cracks going into the wall that was found on the lower surface could not be found on the upper surface. There are only a few cracks going further into the slot and these cracks are not parallel to each other.

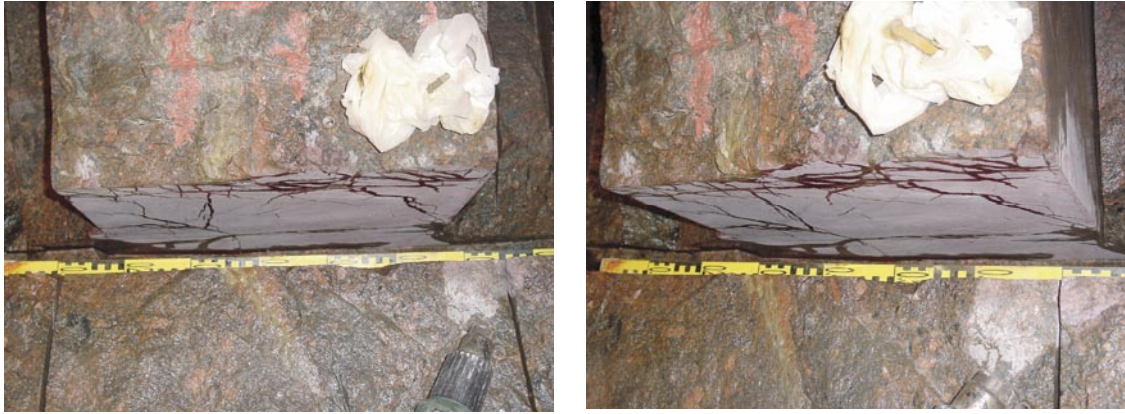
The crack pattern in this horizontal slot shows no indication of a continuous damage zone parallel to the tunnel wall.

Figure 7-27 and Figure 7-28. The upper surface of the horizontal slot.

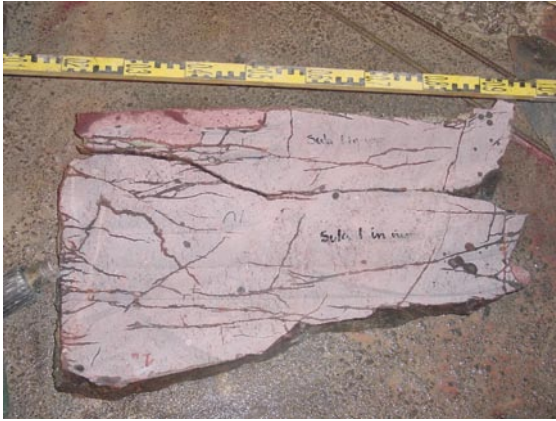
Slice no 1 fell apart into two parts. To the left of the upper part some concrete could be seen. There are two vertical cracks with a length of 8 cm and 12 cm and some horizontal cracks. In the lower part there are more cracks both horizontal and vertical. All of the cracks seem to be induced or natural cracks. From the second slice (Figure 7-31) there are fewer cracks. Notice that this slice is facing the other way. There are no visible cracks from the half-pipe (to the left of the upper slice). The right hand side of this part shows a layer of concrete. In the lower part there are some horizontal natural or induced cracks, some of them seem to have been open.

Figure 7-30. Slice no 1 (first slice from left to right in Test zone 1).

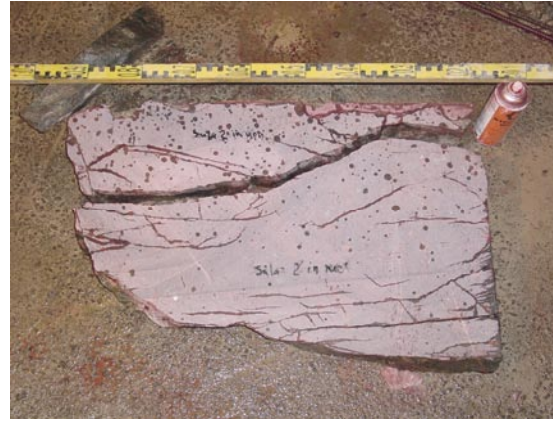
Figure 7-31. Slice no 2 from Test zone 1.

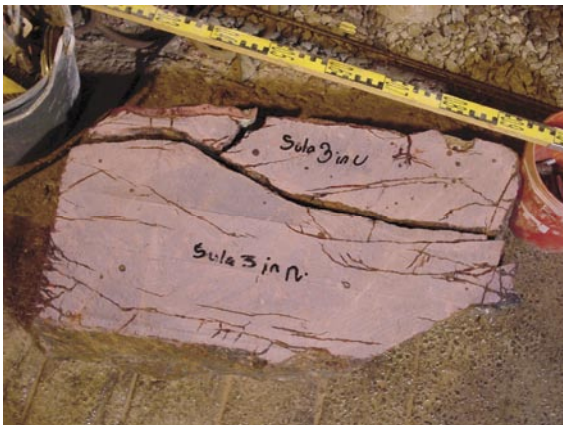
Figure 7-32. Slice no 3 from Test zone 1.

The crack pattern on slice no 3 in Figure 7-32 looks similar those on the other slices. There are no visible cracks from the half-pipe (to the right of the upper part). There is only one crack going from the surface into the upper part and the length of this crack is 5 cm. In the lower part there are some horizontal natural or induced cracks. From slot no 0 some parallel, nearly horizontal cracks could be seen, see Figure 7-33. There is also one vertical crack but this seems to be a natural crack as it is also visible on the upper surface. There are no cracks emanating from the half-pipe.

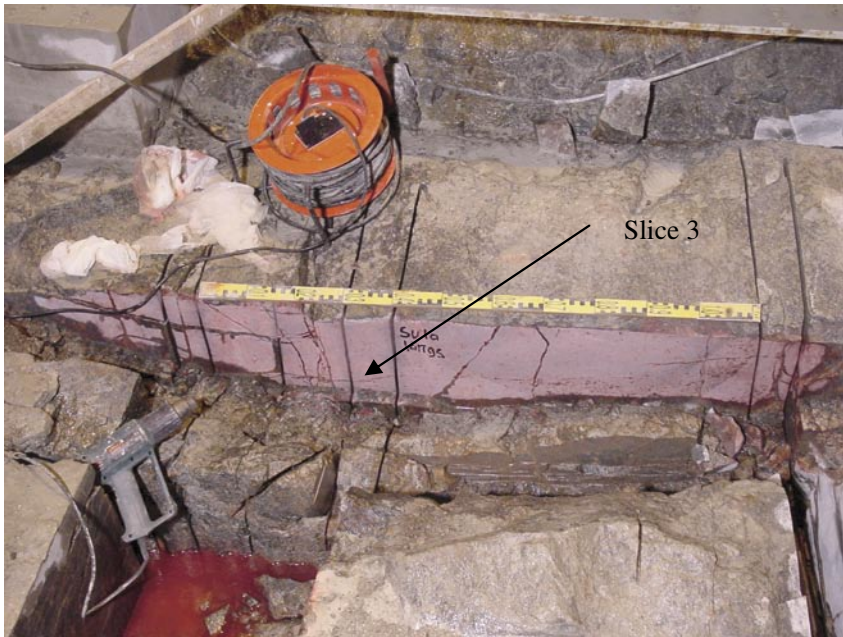
A saw cut was also made along the tunnel and the result could be seen in Figure 7-34. There are a few vertical cracks with a length of some 20 cm and also an inclined natural crack. There is no evidence of any continuous damage zone.

Figure 7-34. A saw cut along the tunnel direction.
