Deep repository – engineered barrier systems

Half scale tests to examine water uptake by bentonite pellets in a block-pellet backfill system

December 2008

Svensk Kärnbränslehantering AB

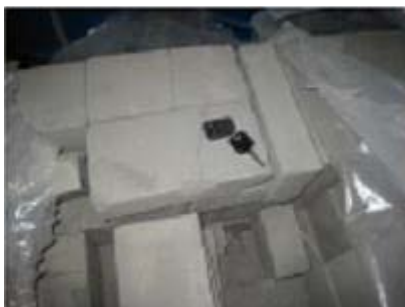
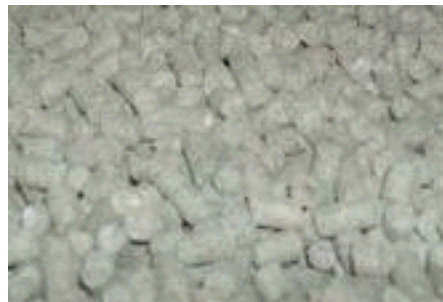
Friedlandand Clay Blocks

Cebogel Pellets

Figure 3-1. Clay Materials Used in ½-Scale Tests.

Friedland-clay is a smectitic clay from northeastern Germany that has a limited swelling capacity and is being considered as a potentially suitable backfilling material in a repository, provided it is precompacted to an adequate density. The raw material used for manufacture of these blocks is of much lower smectite content than the “bentonite” materials (reportedly approximately 45–50% of which 50% is montmorillonite and the remainder mixed layer clays of lower swelling capacity) and is generally referred to as a smectitic clay rather than bentonite. The mineralogy of the material has been studied by several researchers including, /Henning 1971, Pusch 1998, 2001, Carlson 2004, Karnland et al. 2006/. A summary of these data is provided in the report by /Dixon et al. 2008a/. The blocks shown in Figure 3-1 were manufactured in Sweden by Höganäs Bjuf using uniaxial compression.

packing efficiencies achieved in each test, but was measured for each test pair installed. The diameter of each pellet is 6.5 mm and their length is between 5 and 20 mm and can be seen in Figure 3-1. The producer reports that the bulk density achievable through pouring of pellets is approximately 1,100 kg/m³ and the dry density of the individual pellets is 1,810 kg/m³ with an as-produced gravimetric water content of 16%. The actual dry density of the poured pellet mass was calculated to be between 950 and 1,080 kg/m³ for the tests done in this study with an average of 1,000 kg/m³ at the start of testing and the gravimetric water content was measured to average 18.9%. The specifics for each test are presented in Chapter 6 of this report.

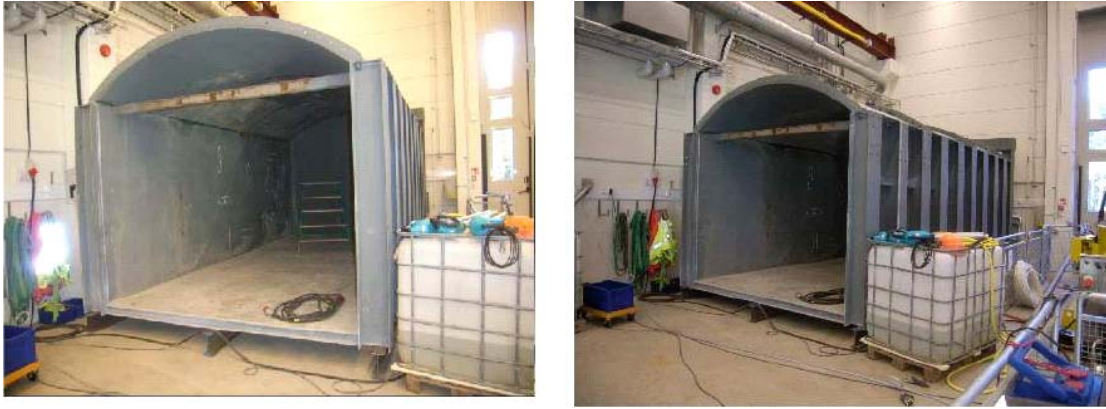
Figure 4-2. As-built 1/2-Scale test chamber.

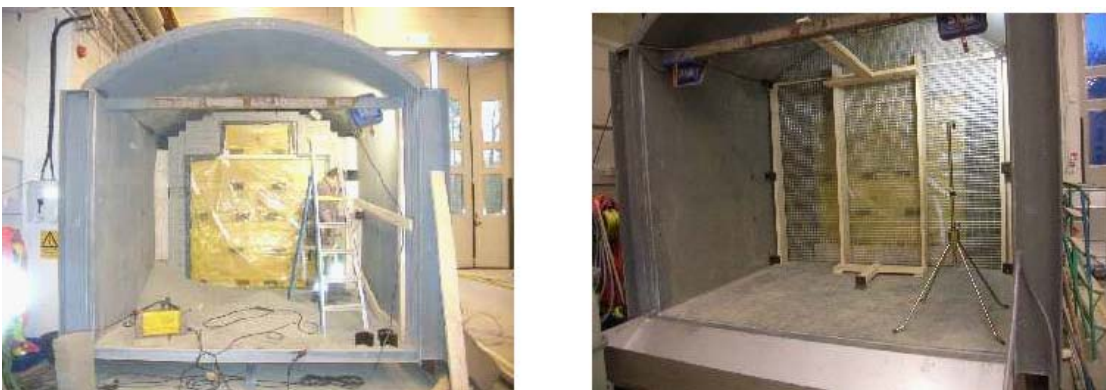
Figure 4-3. Chamber and restraint system.

Based on the dimensions provided in Figure 4-1, the cross-sectional area of the test chamber is nominally 7.1 m². The chamber length is 6 m but only 4 m was utilized for each assembly, as shown in Figure 4-3. The use of only 4 m of its length (volume of 28.8 m³) was based on several factors. As there was a limited supply of block materials and if 4 or more test assemblies were to be constructed there would be an insufficient supply of clay blocks. Another reason for utilizing only 4 m of the chamber’s length was decision, based on the results of previous, smaller-scale simulations /Dixon et al. 2008a/, to provide mechanical restraint to the downstream face, as shown in Figure 4-3. Additionally, the length of time needed before water exits the test should be at least in part determined by the distance it has to travel before it exits the chamber. Based on a review of the smaller scale tests done at Äspö during 2006/07 /Dixon et al. 2008a/, it was decided that extending the flow path length to more than 2.2 m (or 4-m for Test assemblies 5 and 6), from the 0.6-m-length of previous tests was unnecessary and that a system of 4-m total length would provide a suitable up-scaling to allow for evaluation of the role of path-length. The results of the smaller tests done at Äspö /Dixon et al. 2008a/ indicated that only a small proportion of the pellet fill would initially interact with the inflowing water. Previous tests also indicated that for most situations, the majority of backfill block – filled region was little influenced by the inflowing water at the earliest states of hydration. The type of backfill blocks (Friedland clay), utilized in the previous smaller-scale tests were only available in limited quantities and so there was a desire to use the materials available in the most judicious manner possible.

The first test assembly of the ½-Scale test series was built to the geometry shown in Figure 4-3. The total length of the installed test was 3.95 m and the total chamber volume utilized in this assembly was 28.2 m³. On the floor of the test chamber 1,221 kg of Cebogel pellets were installed, providing a thickness of 40 mm (rear of chamber) to 100 mm (front of test assembly). The chamber was tilted slightly so that the downstream face was 60 mm lower than the rear, simulating the expected conditions in an emplacement tunnel. The underlying pellet materials therefore occupied 0.77 m³. A gap averaging 155 mm (± 10) width was left between the blocks and the chamber wall and into this volume the Cebogel pellets were installed.

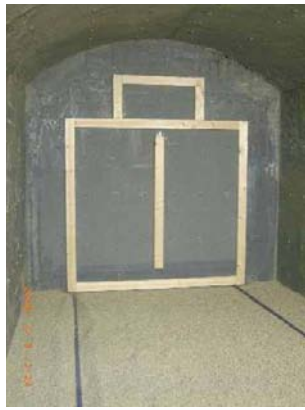
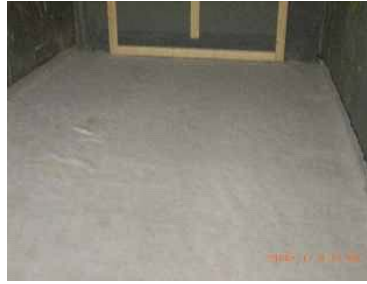
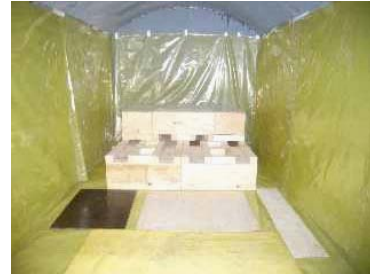
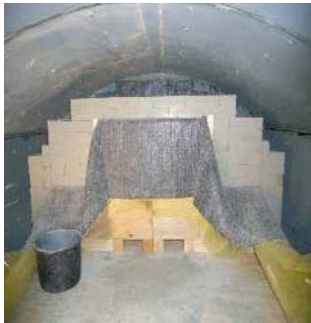
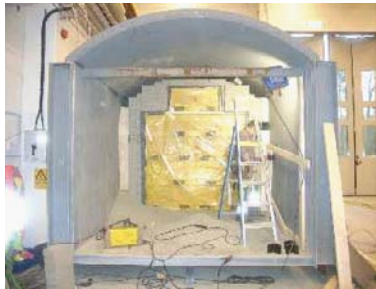
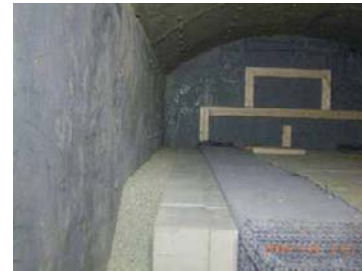
(a) Bentonite-Pellet Base

(b) Geotextile

(c) Plastic liner & filler blocks

(d) Wooden Blocks with Plastic and Geotextile

(e) Completed Installation

(f) Pellet fill along wall

Figure 4-4. Generic assembly process used in 1/2-Scale Tests.

The construction layout developed for the 1/2-Scale tests included, for the first installation of clay pellets to a thickness of 0.1 m on floor of the rearmost 4 m of the test chamber (Figure 4-4). On this base a large number of backfill-block sized boxes were installed, they were surrounded with heavy-gage plastic sheeting to prevent water penetration into the central volume. The plastic-encapsulated volume was then covered with a bentonite geotextile in order to simulate the type of contact that might be provided by dense clay backfill blocks (Figure 4-4). Beyond the geotextile layer a further layer of backfill blocks of the same type as were previously used in the smaller-scale backfill and pellet tests were installed (Figure 4-4). The limited thickness of backfill blocks were deemed to be sufficient based on the experiences of the previous smaller-scale tests where water penetration into the block-filled volume was typically very limited or only for the period at the start of testing. This construction thereby provided a reasonable simulation of a large mass of backfill blocks in a tunnel environment while minimizing the number blocks actually used.

In this assembly a total of 1,740 clay blocks were installed around the wooden box core. A sketch and a photograph showing the details of the clay block assembly pattern are provided in Figure 4-12. Details related to water movement into and through Assembly 2 (Tests 3 and 4) are provided in Chapter 6 of this document. The blocks in the lower portion of the assembly were installed in the same manner as in Assembly 1 (two layers of blocks totalling 225 mm thickness between the geotextile liner and the gap where pellets were subsequently installed). The general sequencing of the construction of Assembly 2 was much the same as for Assembly 1 and can be seen in Figure 4-4.

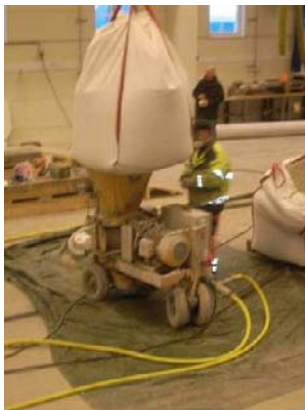
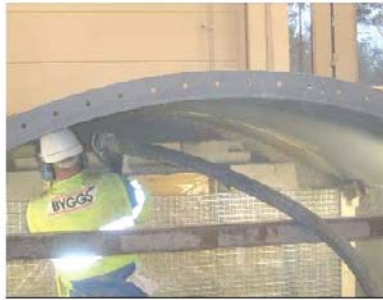
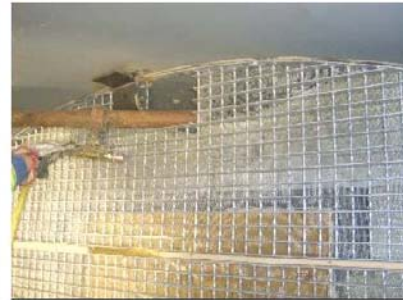
Supplying pellets to shotcrete machine

Blowing pellets into crown

Final filling of crown region

Figure 4-5. Pellet installation into roof region of Assemblies 1 through 3.

A gap of 155 mm was intentionally left between the walls of the test chamber and the clay blocks to simulate the space that would not be able to be filled with block materials in an actual repository. Into this gap bentonite pellets were installed by pouring as the test was built from the floor up (Figure 4-5). The pellets also provided physical support to the clay blocks ensuring that they stayed as they were initially installed.

Three of the assemblies (Tests 1–6), done as part of the ½-Scale test series involved installation of the pellet fill in two distinct phases. These six tests had the central block assembly installed in stages building upwards from the floor and the pellet fill along the sidewalls was installed stepwise as the blocks were installed (Figure 4-5). This approach provided the maximum lateral support to the block assemblies, precluding any physical instability developing that might threaten the assembly's integrity. This method also resulted in a relatively high as-placed pellet density to be achieved in the sidewall regions. The uppermost sections of blocks could not be installed in parallel with the pellets and as a result the pellet filling of this region occurred after block installation was completed. Air-dry clay pellets were blown into this region using a machine used to install cementitious materials (shotcrete/gunnite) shown in Figure 4-5.

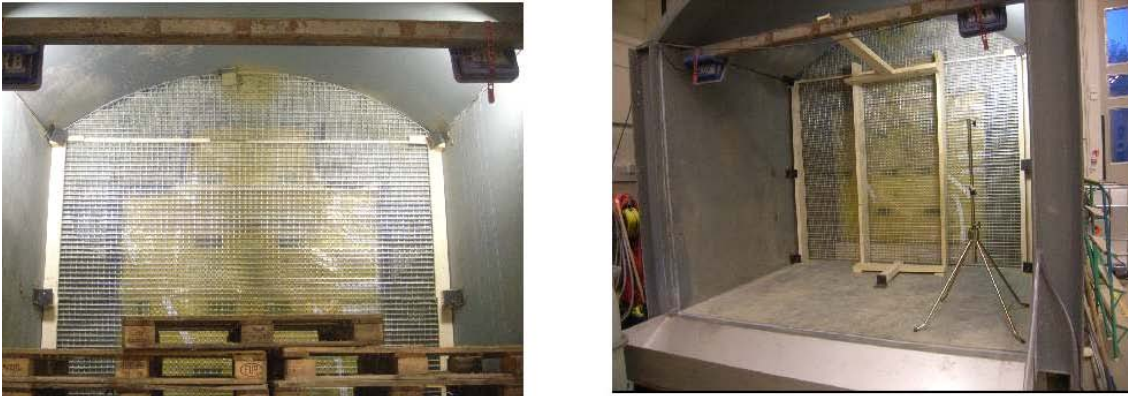
Figure 4-6. Mesh and Restraint at Downstream Face in Tests 1 Through 6.

The downstream face of the test assembly required vertical support to avoid potential slumping or collapse should the system destabilize in the course of testing. Restraint was provided in Tests 1–6 and 11–12 by a stiff steel grating and screen system (Figure 4-6). This structure served the same function as the restraint grid used in the smaller tests /Dixon et al. 2008a/.

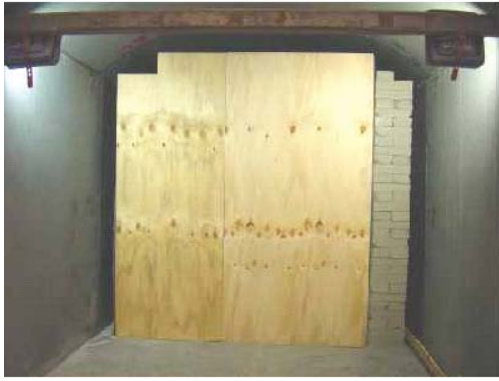
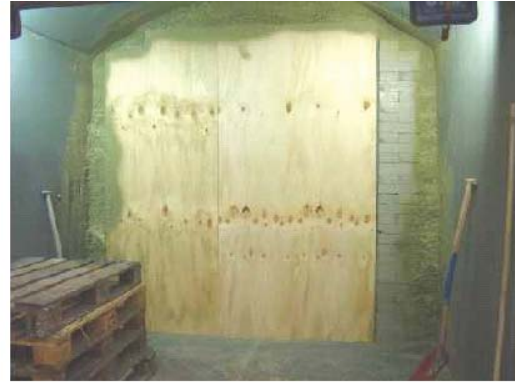
Setup showing blocks on right side and geotextile-only on left side

Setup following clay pellet installation

Figure 4-7. General layout of Assemblies 4, 5 and 6 (Tests 7 through 12) where pellets were installed in one operation.

The setup process described above was used for Assemblies 1 through 3 (Tests 1 through 6) and Assembly 6 (Tests 11–12). The setup of Assemblies 4 through 6 (Tests 7 through 12) differed considerably from previous ones in that the entire pellet fill was installed at the end of block assembly (Figure 4-7 and Figure 4-8) and there were no pellets installed on the chamber floor for Assemblies 4 and 5. The first six tests confirmed that water does not travel readily along the floor of the chamber, similar to what was observed in smaller-scale simulations /Dixon et al. 2008a/. This meant that the granular bed installed below those tests served no function in terms of controlling flow and so was not installed for Assemblies 4 and 5. The final assembly of this study (Tests 11–12) also had pellets installed so as to provide full comparability to Assembly 1 (identical inflow rates were supplied at 2.2 m rather than 4 m from the downstream face). Additionally, the last 6 tests did not have large volumes of blocks installed as they too were also found to play little role in movement of water. Tests 7, 9 and 11 (left side of assemblies) did not have a block component at all, only the pellet fill with the bentonite geotextile mat providing the hydraulic boundary between the centre of the chamber and the pellets. Tests 8, 10 and 12 had a 300 mm thickness of blocks installed between the pellets and the internal spacer of the assembly.

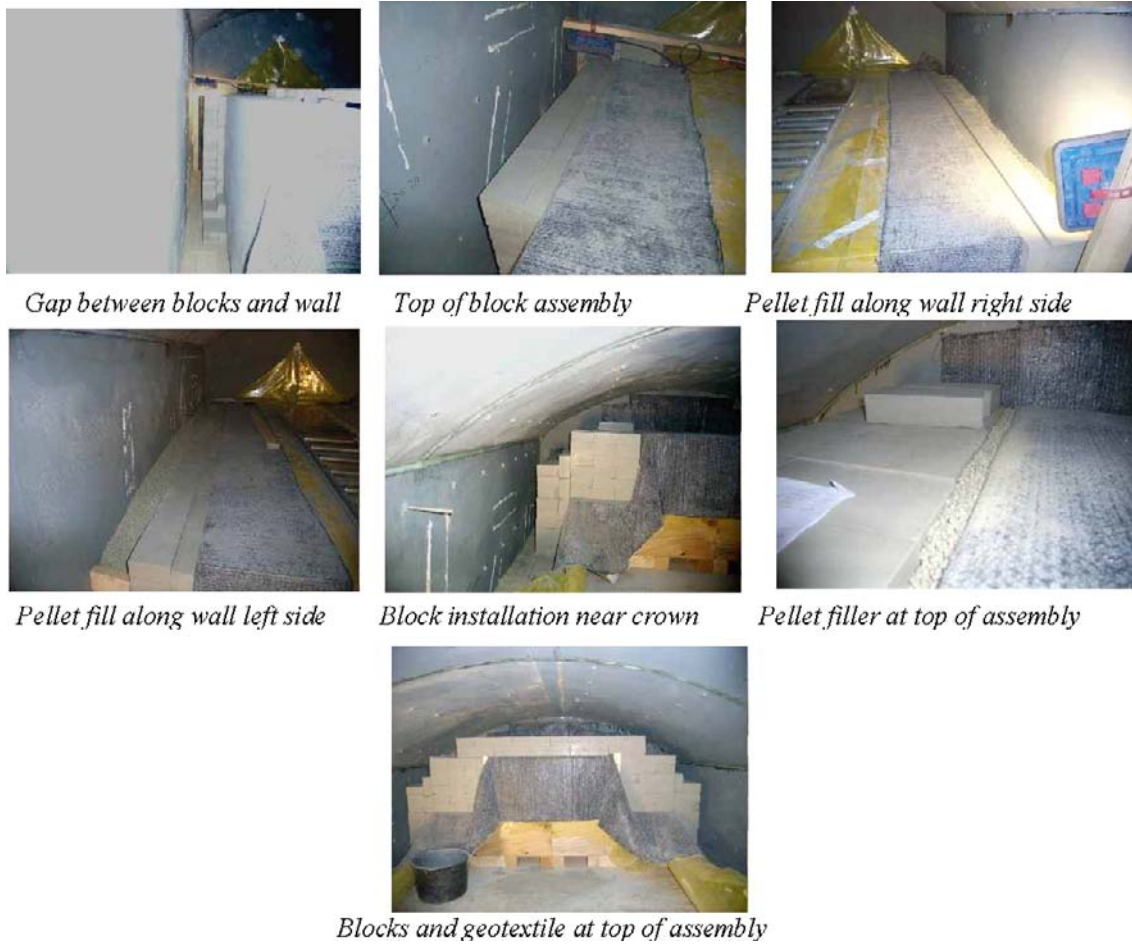
Figure 4-10. Construction steps for Assembly 1 (Tests 1, 2).

Figure 4-10 shows the sequencing of the construction of Assembly 1. A detailed sketch and a photograph showing the details of the clay block assembly pattern in the uppermost portions are provided in Figure 4-11. It should be noted that the slight lateral offset of the side blocks is the result of the overlapping of the bentonite geotextile next to the boxes. This resulted in approximately a 10 mm thicker geotextile layer in the uppermost region. The method used to install the wooden boxes also resulted in a small gap (30mm) being left between the uppermost wooden boxes and the block assembly on each side, as shown in Figure 4-10. In order to deal with this, the volume was filled with pellet materials. Neither of these slight as-built variations from the initial design plan affected the behaviour of the system.

The general layout of Tests 1 and 2 was provided in Figure 4-10. Test 1 was located on the left side of Assembly 1 and Test 2 occupied the right-hand side. These tests were provided with water at constant inflow rates of 0.25 and 0.5 l/min (15 and 30 l/hr) respectively, via small point sources of water located in the steel wall. The inflow points were located at 1.8 m from the rear of the chamber and 1.5 above the floor on each side. The water entering the pellet fill was allowed to move freely, with no restrictions beyond those induced by the test construction (no exit to rear of chamber).

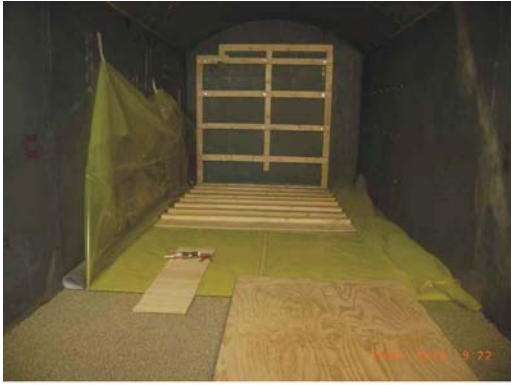
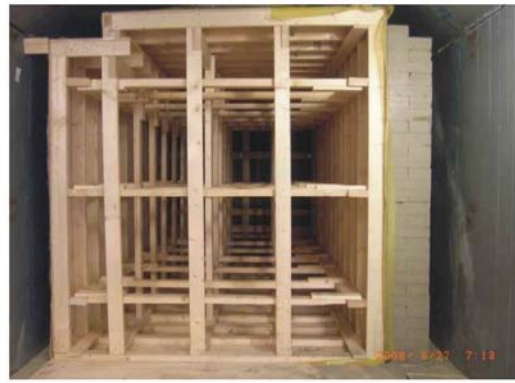
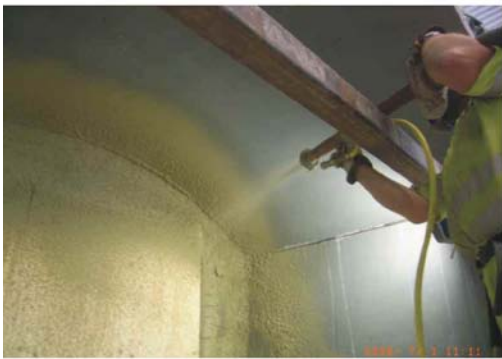
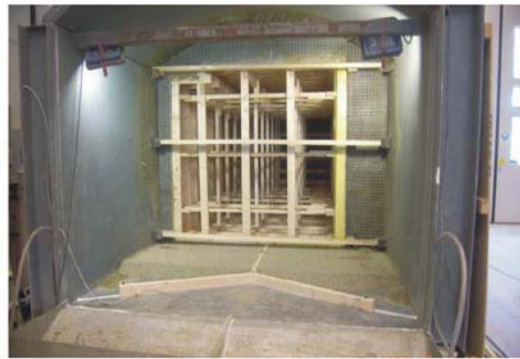
Pellets Installed on Floor

Framework and Blocks

*Blowing Wet Pellets
at Downstream Face*

Completed Assembly

Figure 4-15. Assemblies 5 and 6 (Tests 9–12) and appearance at the start of operation (Assembly 6 shown).

In these assemblies there were pellets installed on the floor of the chamber beneath the blocks and the central portion of the chamber was empty excepting for a wooden braced internal plywood formwork (Figure 4-15). In order to simulate the type of surface that exiting water would encounter in a backfilled tunnel, crushed bentonite (Minelco) was also installed as a 100 mm-thick layer on the floor at the downstream face in Assembly 5 (Figure 4-15). This simulated what might be encountered in a tunnel where flooring materials were installed prior to backfilling but backfilling operations had not progressed further. This material also retarded water movement into the base of the blocks or under the formwork. In Assembly 6 the Minelco granular materials was replaced by Cebogel pellets that were installed as a complete flooring material beneath the blocks.

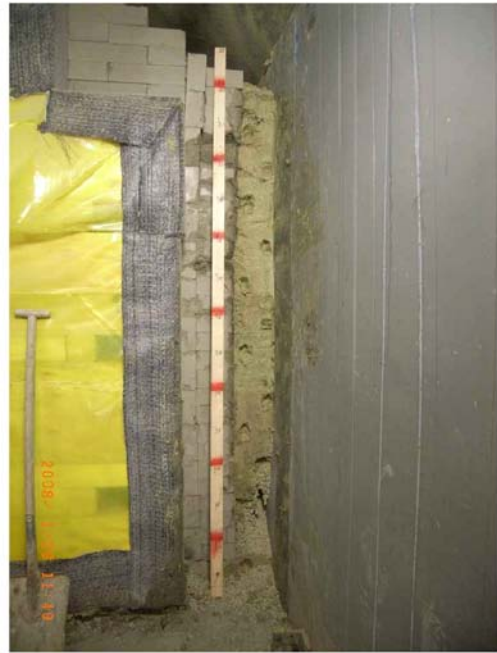
Note measuring stick with pre-marked 150-mm sampling intervals. Sampled locations can be seen on photograph

Figure 5-1. Sampling to determine distribution of water in pellet fill.

On completion of initial examination of the end-of-test state of each test set-up, the pellet filled volume was sampled to water content determination. This sampling was done using a pre-defined sampling pattern that would allow for capturing of the basic water distribution in this volume. The sampling pattern developed for tests occupying the left-hand side of the chamber (odd numbered tests), is shown in Figure 5-1.

For tests occupying the right-hand side of the chamber (even numbered tests), the sampling plan was the same. The generic sampling plan called for sampling that would collect 36 individual samples at each of 0, 0.6, 1.2, 1.8, 2.4, 3.0, 3.6 and 4.0-m distances from the front face. These samples were recovered from approximately 20 mm distance from the chamber wall, or block/geotextile contacts so as to provide a uniform sampling protocol. In practice, full sets of samples were often not collected since water distribution tended to be quite localized. In tests where large volumes did not contain any additional water at the time of test completion samples were not recovered from these dry regions. They were noted as being dry and the samples recovered from the wet regions were numbered based on the template so that their location could be readily identified. Beyond the basic sampling pattern used, if there were particular locations not immediately on a preset sampling location then additional samples were taken and their location noted.

Measurements of water distribution in Test 5 shows a water distribution not dissimilar to the other tests and which are consistent with the visual observations (Figure A-10). The region closest to the inlet port (sampling location 18 in Figure 5-1) were the wettest and a relatively narrow band of wetting extending at about the same elevation as the inlet port towards the downstream face of the assembly. The water also spread to the rear from the inlet with an apparent tendency to move upwards in the pellet mass rather than towards the floor. At the rear- and upper-most region of this test there is an apparent localized wetting at the crown, perhaps the result of tiny piping features or water moving along narrow channels along the chamber wall – pellet interface.

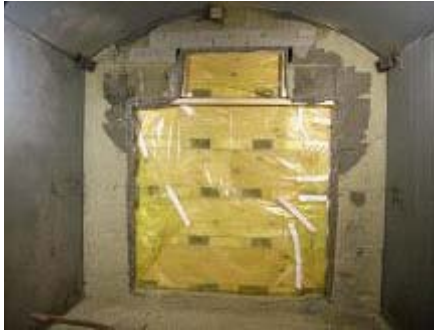
(a) Wet downstream face

Figure 6-1. Face of Test 1 and Test 2 at end of testing.

Figure 6-1 shows the limited region where water uptake occurred and Figure 6-3 shows the pathways taken. As with Test 1, the lower regions (close to front face and at elevation of water inlet port), showed more extensive water influx with some limited early erosive activity during the period before the pellets had hydrated sufficiently to seal off water influx towards the core of the test (Figure 6-2). A detailed description of the evolution of this test, wetting patterns observed during dismantling and other events of interest are provided in Appendix A. Resistance to water inflow was essentially identical to that observed in Test 1 and is discussed in Section 6-2. Outflow rate and erosion from this test are discussed in Sections 6.2 and 6.3 respectively.

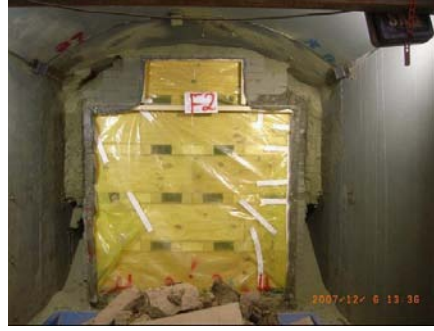
(b) Dry material at crown and base of assembly, just in from front face

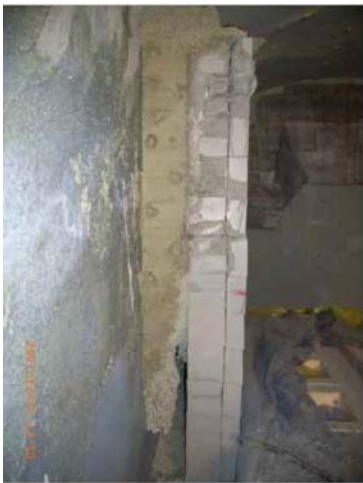
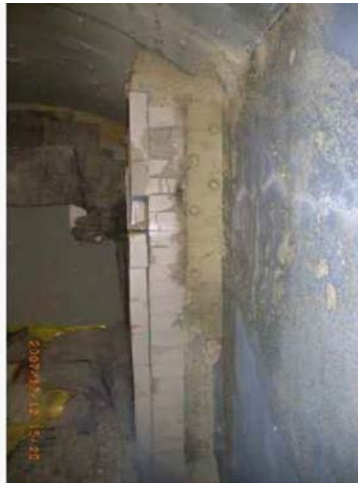
Test 1

Test 2

(Note loose, dry pellet materials near floor and at crown of chamber)

Figure 6-2. Water inflow along block joints at depth of water inflow in Tests 1 and 2. (wetting shows as dark areas on block edges).

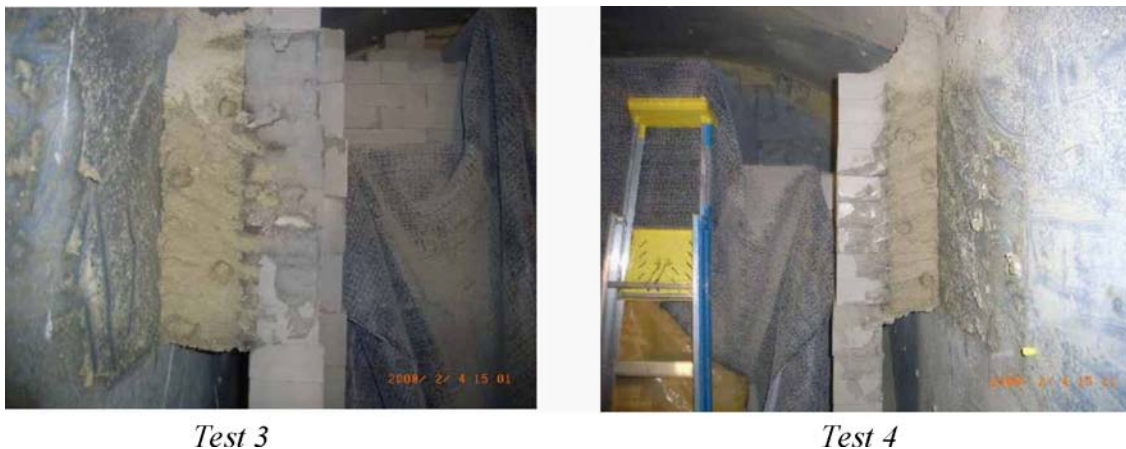
Figure 6-4. Wetting near Inflow location in Tests 3 and 4. (Note very limited extent of wetting and dark areas where limited water movement inwards along block joints occurred).

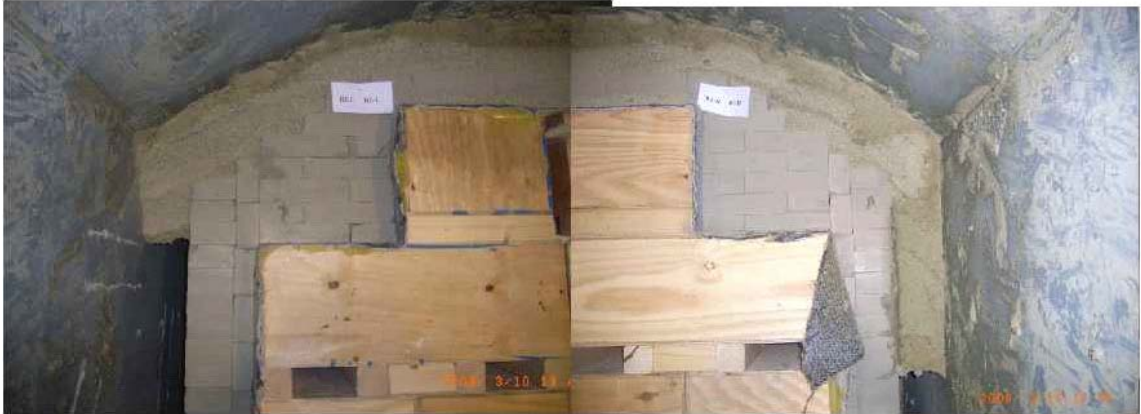
Figure 6-6. Wetting along crown of Assembly 3 (Tests 5, 6). (Note dry (empty regions along walls) and wetting (darker regions) along crown.

Figure 6-6 shows that there was only limited water inflow into the block-filled region via the block joints and that is likely occurred for only a short time at the start of testing (partially dried wetting locations). There was a higher degree of water movement towards the rear of the chamber than was evident in previous tests with water tending to pool as a perched water table in the rear of the cell. Unlike previous tests, there is clear evidence of a developing hydraulic connection between the two sides of the chamber. There was no apparent fluid flow occurring between the two sides at the end of the test but wetting was clearly occurring along the crown of the chamber, likely from Test 6 (right side) towards the left (Test 5). This is discussed further in the discussion of Test 6 and in Appendix A.

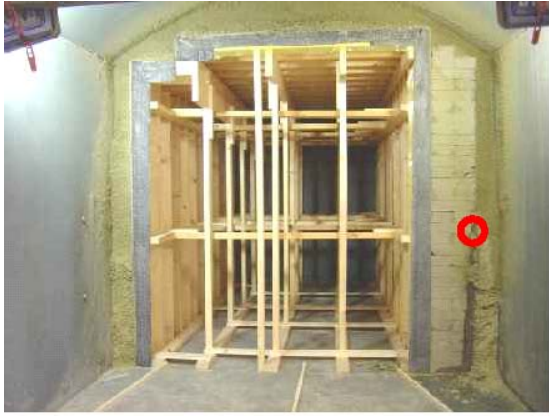
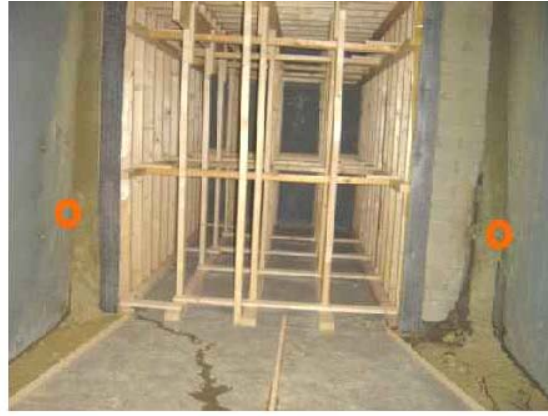
Initial outflow from Test 8 (right)

End-of-test outflow locations

Figure 6-8. Front Face of Tests 7 and 8 at the start of outflow and end of testing.

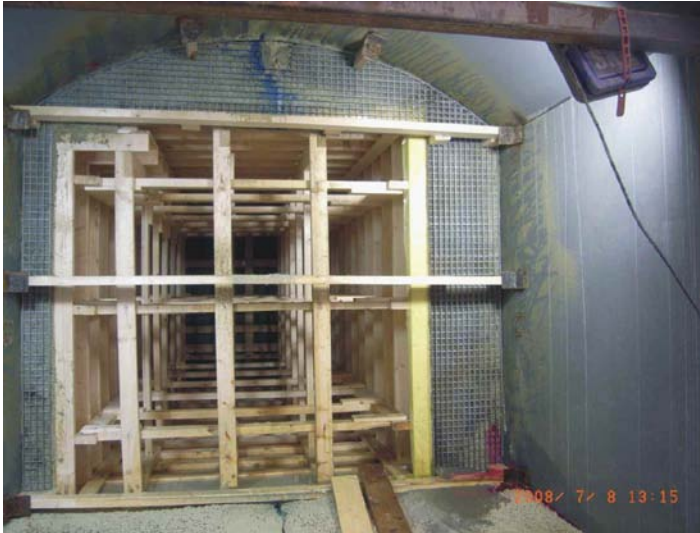
Figure 6-14. *Assembly 6 (Tests 11 and 12) at the end of testing Test 12. (Note blue tracer exiting a crown of chamber).*

Test 11 was provided with water at a rate of 0.25 l/min at the rear of the chamber, from a point 1.8 m above the floor and 60 mm in from the chamber's sidewall (4 m distance from front face), for a period of 7 days (168 h). This test had water outflow noted after approximately 20 hours of operation, exiting from a small region of the assembly in the upper region, slightly to the left of the centreline (Figure 6-14). This is the only test that showed actual outflow from the upper regions of the assembly.

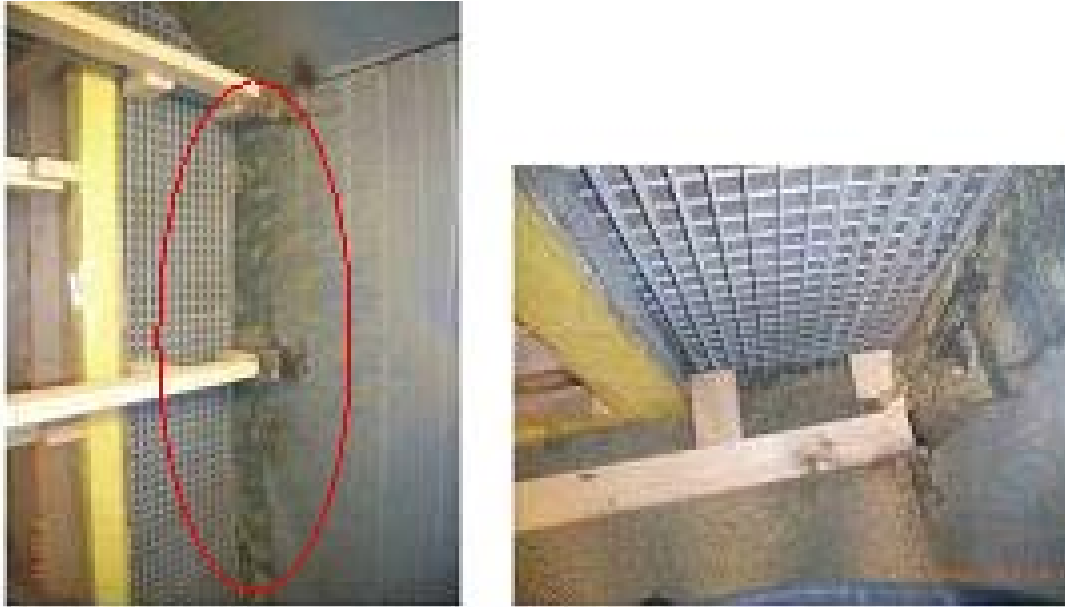
Figure 6-16. Face of Test 12 showing damp surface exiting pellet fill.

This test had water outflow noted after approximately 24 hours of operation. Initially outflow was along the chamber – pellet contact as a damp film as can be seen in Figure 6-16 (circled in red). At 40 h, liquid water outflow was noted along the pellet – block contact at approximately 0.1 m elevation (red circled). This outflow location remained at this elevation for the remainder of the test, shifting towards the pellet-chamber wall contact by 67 h after which it did not move further. Details regarding the properties of this test and water content distribution measured during dismantling are provided in Appendix A.

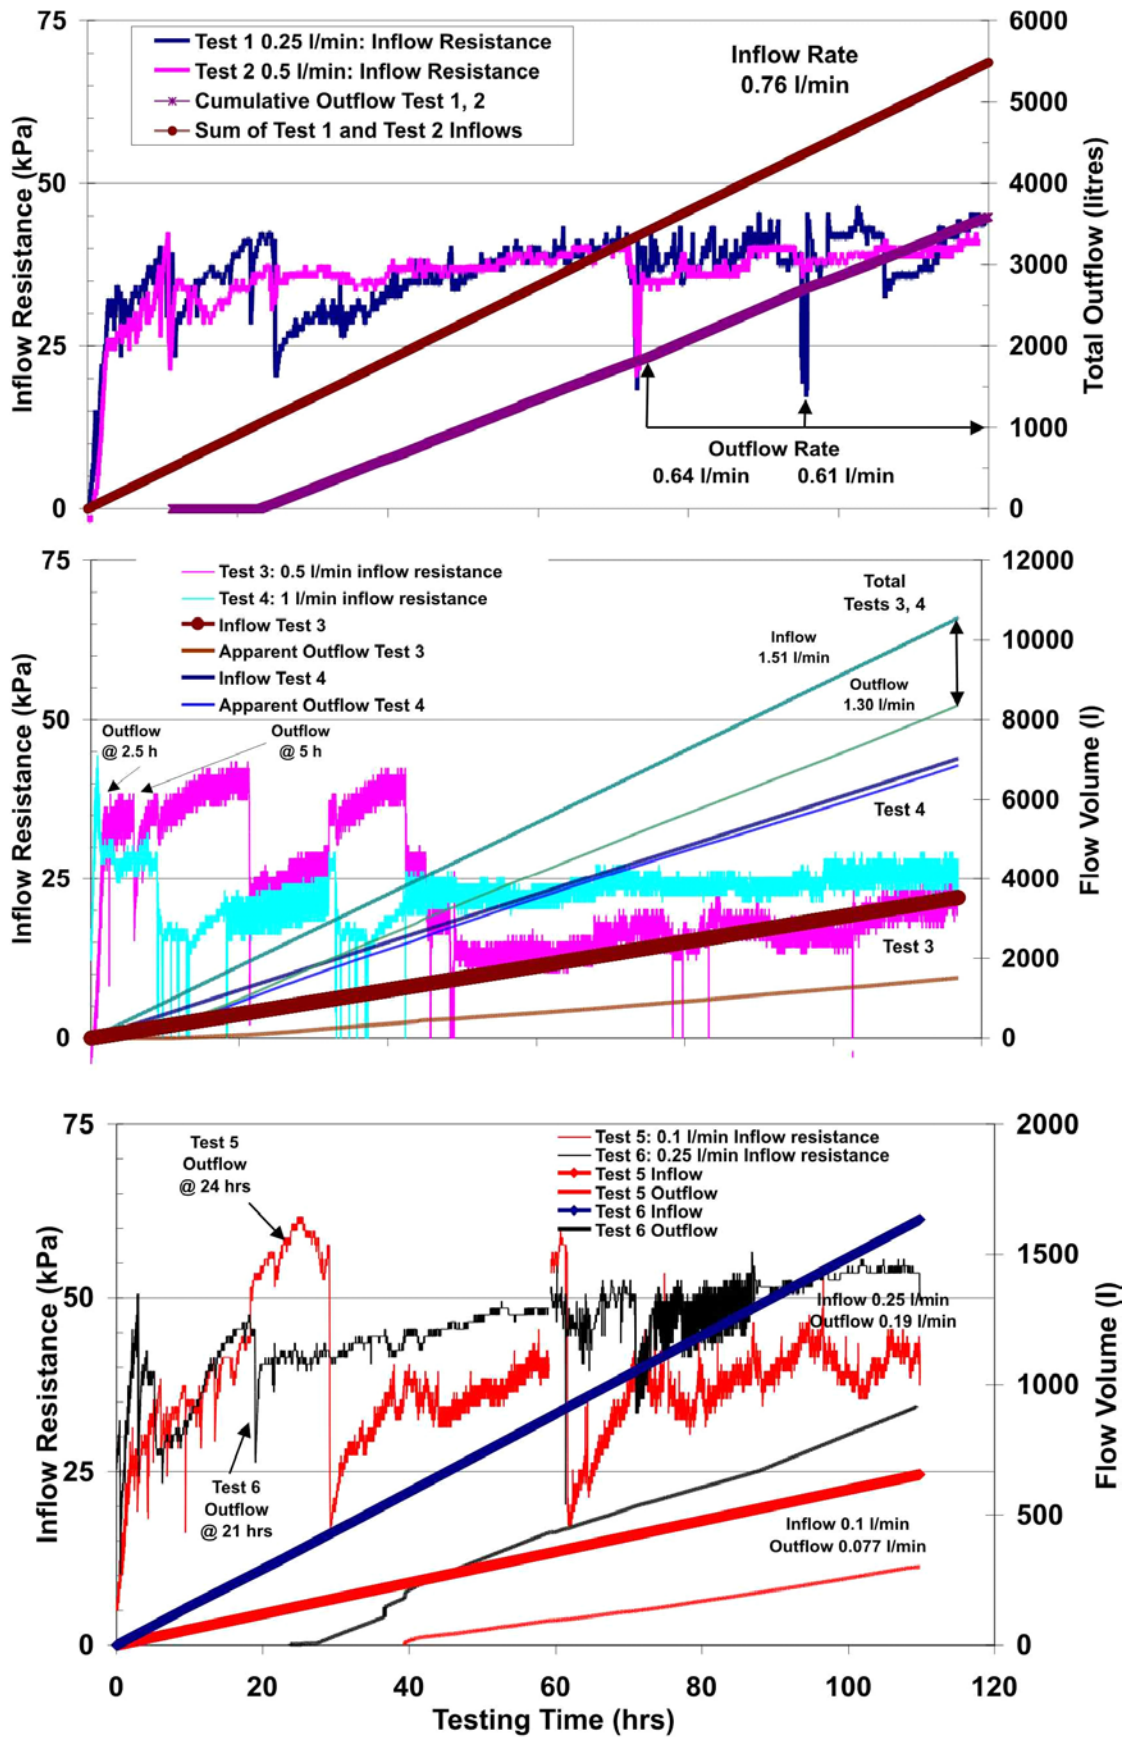
Figure 6-17. Resistance to water inflow and inflow/outflow for Tests 1 through 6.

Figure 6-17 presents the inflow resistance data for the first 6 tests done in the half-scale chamber and Figure 6-18 provides data from the last 6 tests. The inflow resistance data shows the same generic patterns observed in previous smaller-scale tests. There was a fairly rapid development of resistance to inflow until the system is able to develop a preferential flow path to the front face of the chamber. The tests all showed occasions where these channelling events occurred and inflow resistance changed rapidly. The magnitude of resistance to inflow for all these tests was relatively low, never exceeding 100 kPa and typically in the order of 25 to 50 kPa. In two cases (Tests 3 and 7) the longer-term inflow resistance decreased to less than 20 kPa, indicative of an open, stable flow path.

Figures 6-17 and 6-18 also present the inflow/outflow balances for those tests where it was possible to measure outflow. As was noted previously, Tests 1 through 4 did not have water collection systems installed that were capable of separating the flow from the two sides of the assemblies. As a result Assembly 1 (Tests 1-2) and Assembly 2 (Tests 3-4) can be considered as a simulation of full tunnel sections where there are water inlet points on either side of the tunnel. Water entering the tunnel moves independently from these two inlet points, staying on the side of the tunnel they initiated on and exit the face of the backfilled volume in two separate locations. The total quantity/rate of water exiting the tunnel section is measured to be 84% and 87% for Assemblies 1 and 2 respectively.

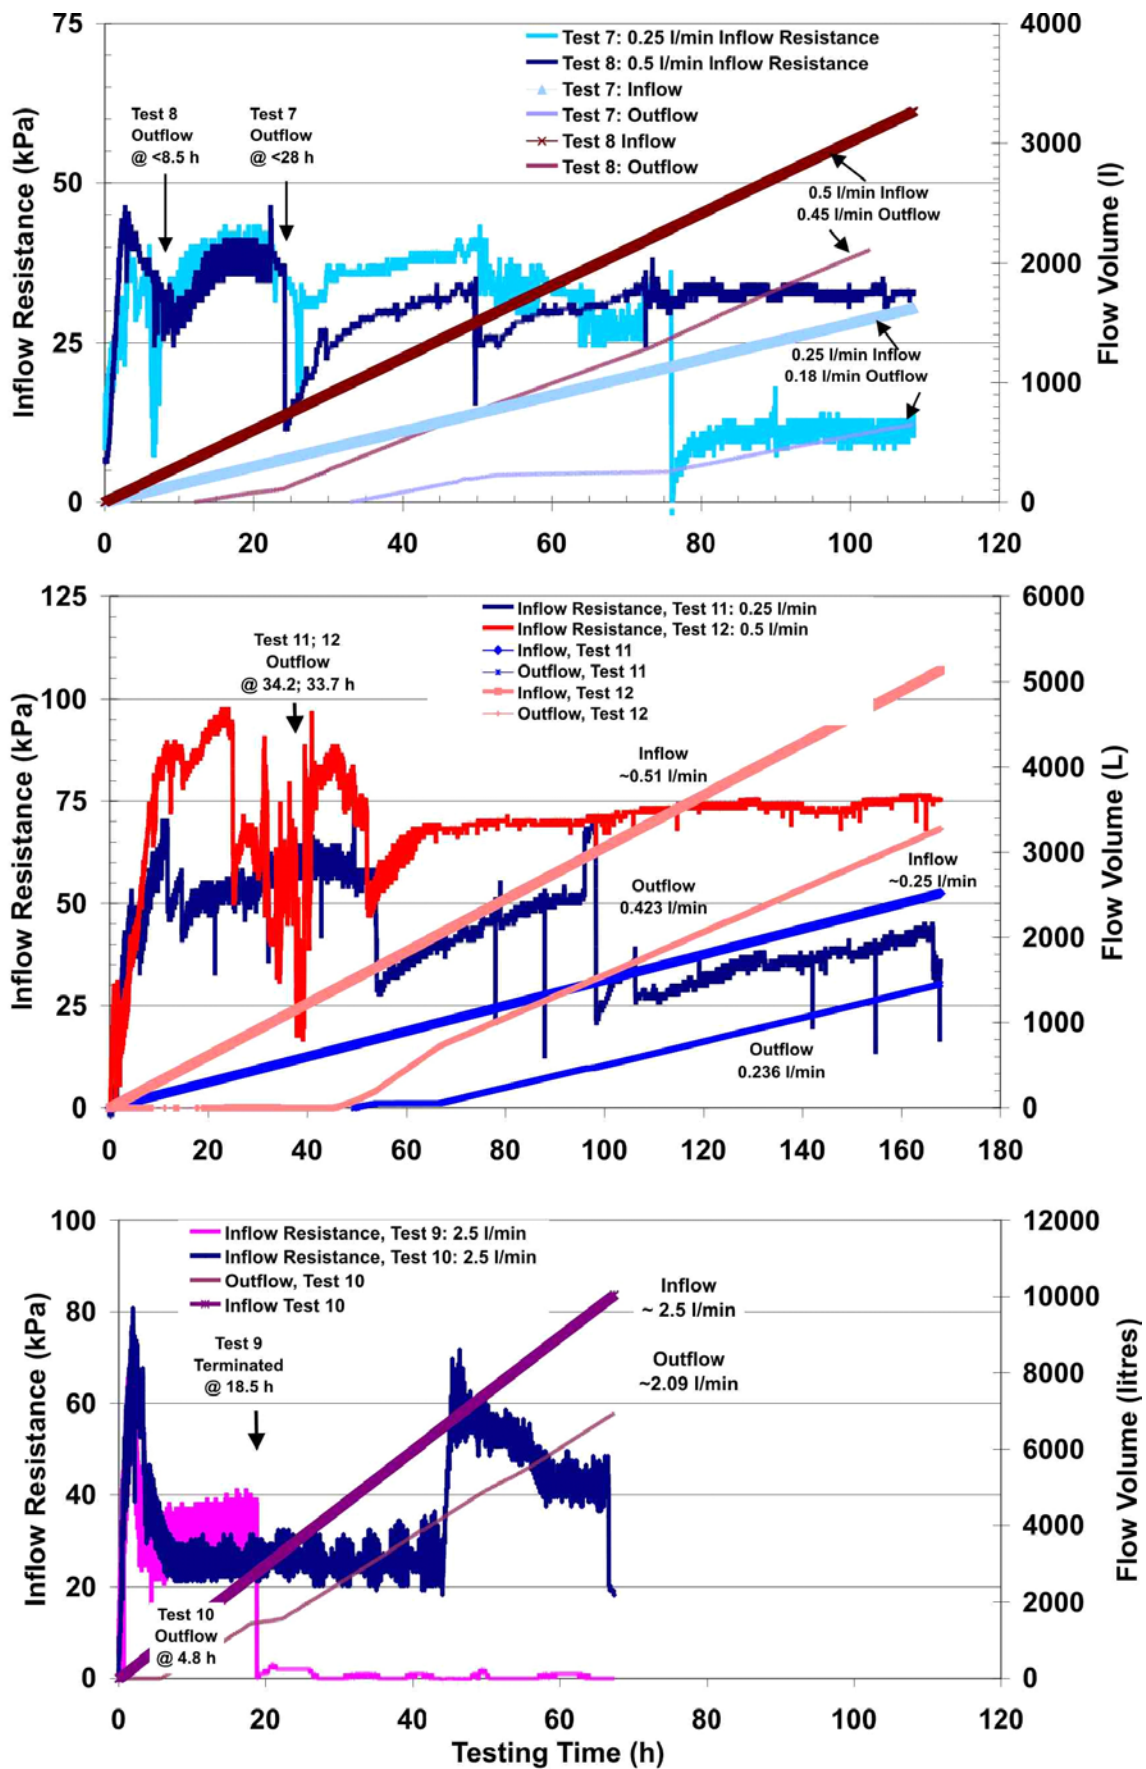
Figure 6-18. Resistance to water inflow and inflow/outflow for Tests 7 through 12 (Tests 9-12 had water supplied at rear of chamber rather than at midpoint).

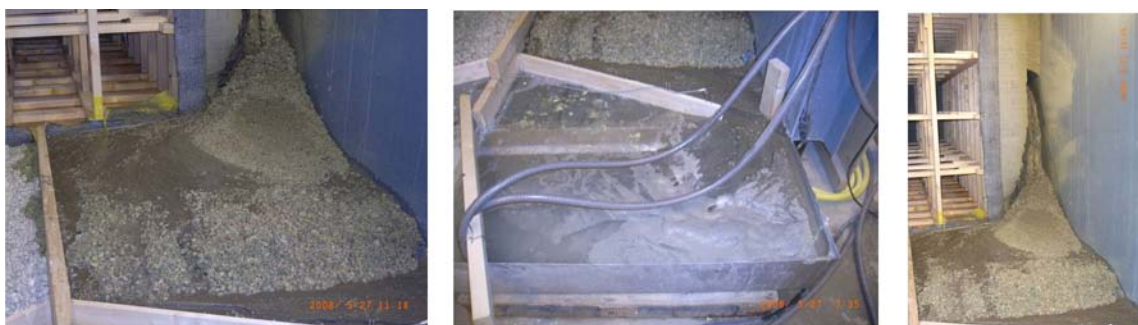
Figure 6-19. Sediment accumulation in collection trays in Test 10.

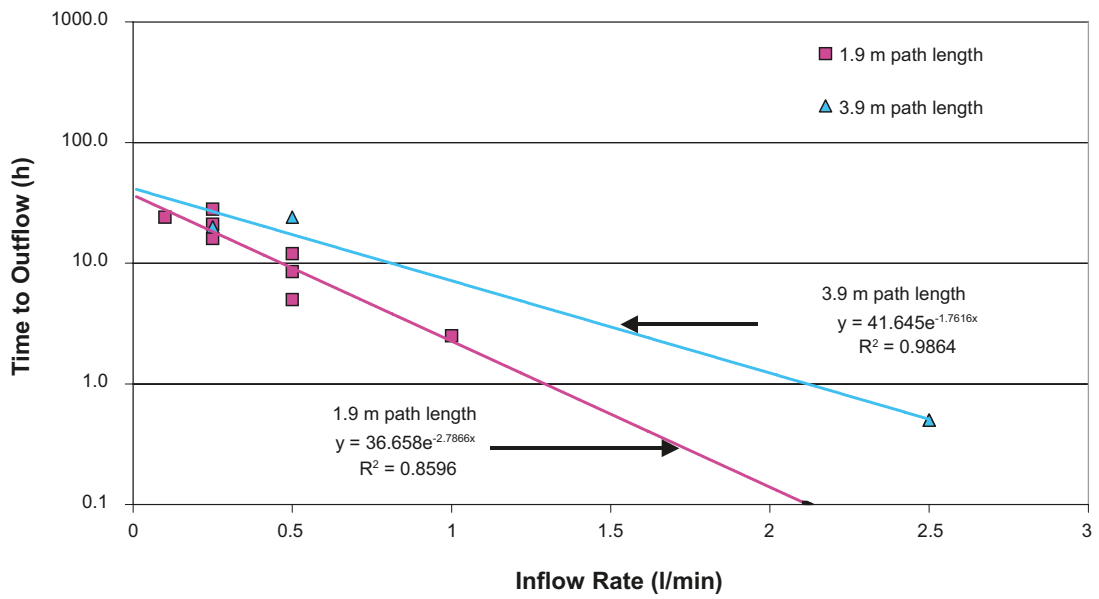
(a) Time to outflow from half-scale tests, linear plot.

(b) Time to outflow from Half-scale tests, log-linear plot.

Figure 6-20. Relationship between time and outflow rate in Half-Scale tests.

The tests showed a longer time between start of inflow and initiation of outflow when the path length was increased (see Figure 6-20). This is not an unexpected result but in an ideal system it might be expected that a doubling of flow path length result in a doubling of the time to outflow, this was not the case in these tests. Similarly, a simple linear relationship between inflow rate and time to water discharge could be anticipated, but again while an increase in inflow rate resulted in a decrease in the time to outflow this relationship was not directly proportional. Factors such as density of the pellet fill, minor variations in the packing pattern of the pellets and inflow location all come into play in determining the time to outflow. Deviations from simple linear relationships in the flow rate – time to outflow and flow path length – time to outflow were particularly evident in the systems where the inflow rate was less than 0.5 l/min. It would seem that at lower inflow rates the effects of secondary factors such as texture and density play a greater role in determining outflow behaviour.

The results of similar, but smaller scale and shorter flow path tests done at Äspö /Dixon et al. 2008/ are consistent with those presented in Figure 6-20. These data will be discussed in greater detail in Chapter 7 of this report.

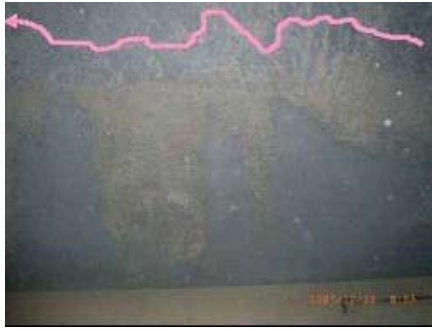
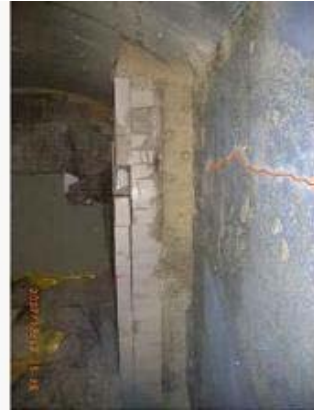
Test 1

Test 2

Figure 6-21. Evidence of flow channels in Tests 1 and 2. (Pathway location traced with arrow showing direction of flow).

Once flow channels were established, the erosion rate dropped off to very low levels. These channels were discernible on some occasions during dismantling of the tests; they tended to be slightly tortuous features, which had a specific, very thin sediment deposit on the chamber walls (very fine materials that provided a traceable feature). Figure 6-21 and Figure 6-22 show the type of flow path observed during dismantling of Tests 1–2 and Tests 11–12 respectively.

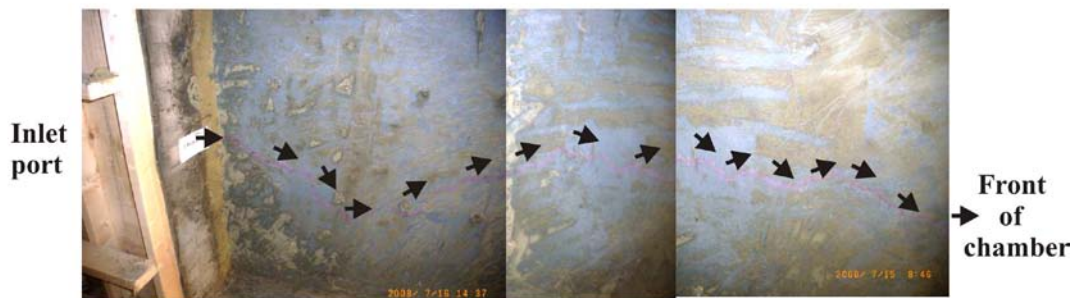
(a) Test 11 showing flow path along back wall and roof of chamber

(b) Test 12 showing flow path along wall of chamber

Figure 6-22. Tracer-highlighted flow paths on roof (Test 11) and side wall (Test 12). (actual dye tracks shown in photographs).

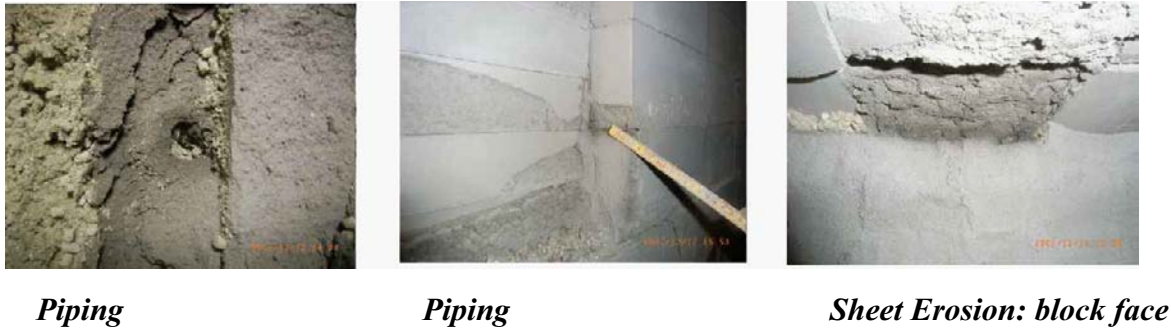
Figure 6-23a. Short-term erosional features observed in block-filled regions.

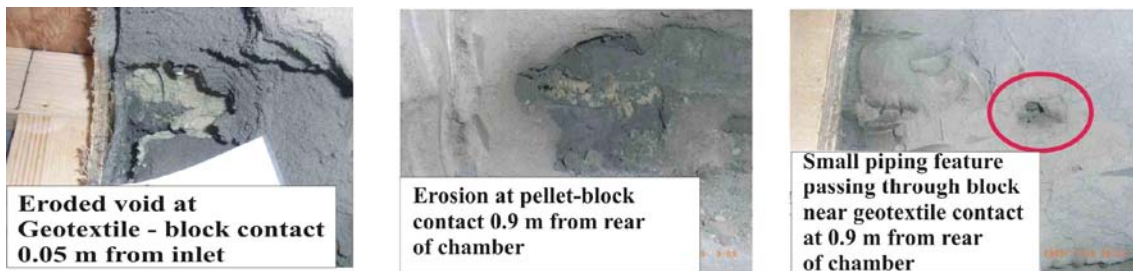
Figure 6-23b. Piping features initially present along pellet-block interface in Test 12.
