Deep repository – engineered barrier systems

Half scale tests to examine water uptake by bentonite pellets in a block-pellet backfill system

December 2008

Svensk Kärnbränslehantering AB

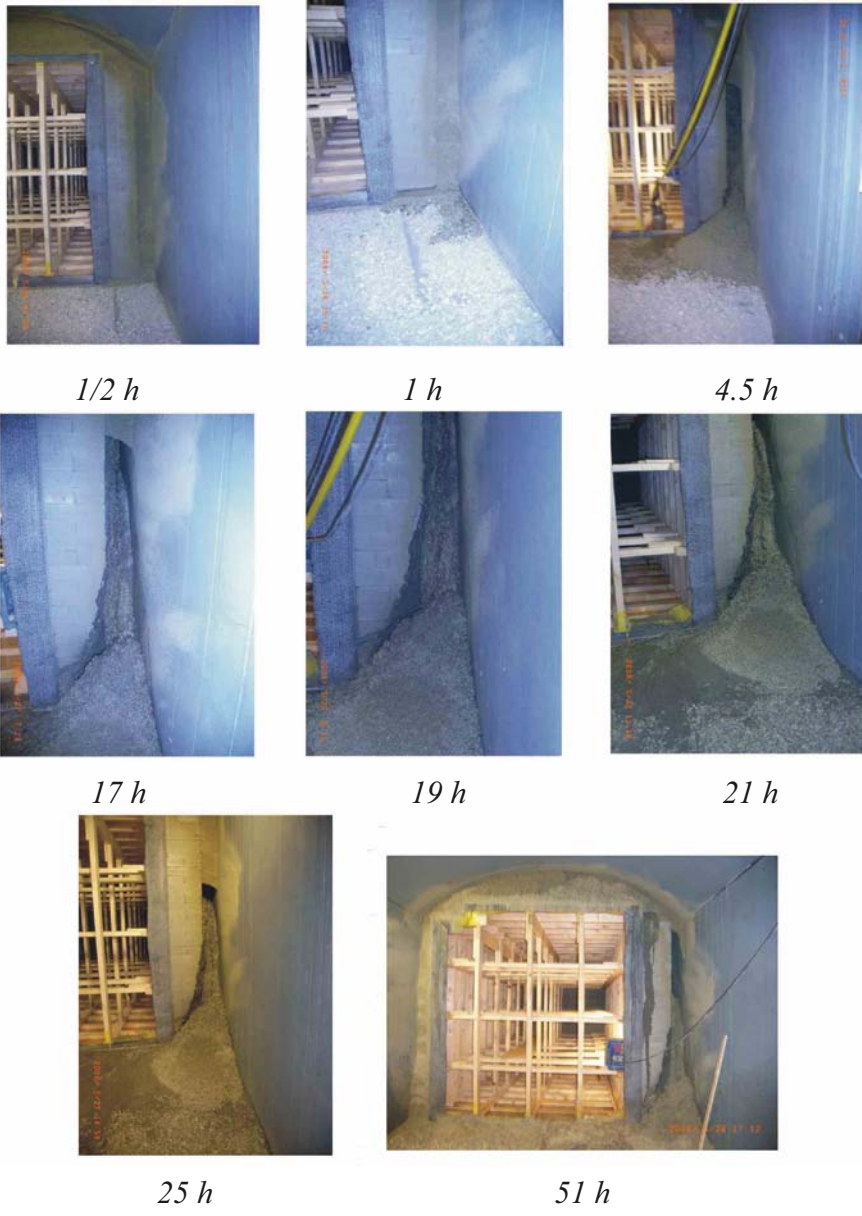
Figure 6-24. Ongoing erosion at inflow rate of 2.5 l/min.

Test 10, operated at 2.5 l/min inflow for a period of 3 days, showed very high and ongoing erosion throughout its operation. Such an inflow rate was predicted to be unacceptable prior to its testing but the test was done anyway to provide information on what would happen under very high inflow conditions. As can be seen in Figure 6-24 water first exited between the chamber wall and the clay blocks, gradually eroded downwards as materials were removed and deposited as a sediment fan on the surface of the pellets initially present on the floor in front of the backfilled volume. Both clay pellets and block materials were removed in the course of the flow (dark and light eroded materials seen in Figure 6-19). Erosion is likely to depend on a) the amount of water flowing through a channel and b) the velocity of the flow (turbulent versus laminar flow). As a result a large, continuous channel was carved through the pellet-filled region. The outflow pipe and continued removal of large quantities of both bentonite and Friedland clay is indicative of a system where considerable ongoing erosion is occurring (Figure 6-24). This is an extremely undesirable situation as it means that large quantities of backfill materials are being physically relocated from already backfilled regions to the open tunnel. The result will be the development of a region of much reduced density (or a cavity). Such a situation would likely prove difficult to deal with in a repository situation and thereby a situation where 2.5 l/min is supplied to a localized area will be unsuitable with respect to backfill stability and would likely require some form of remediation.

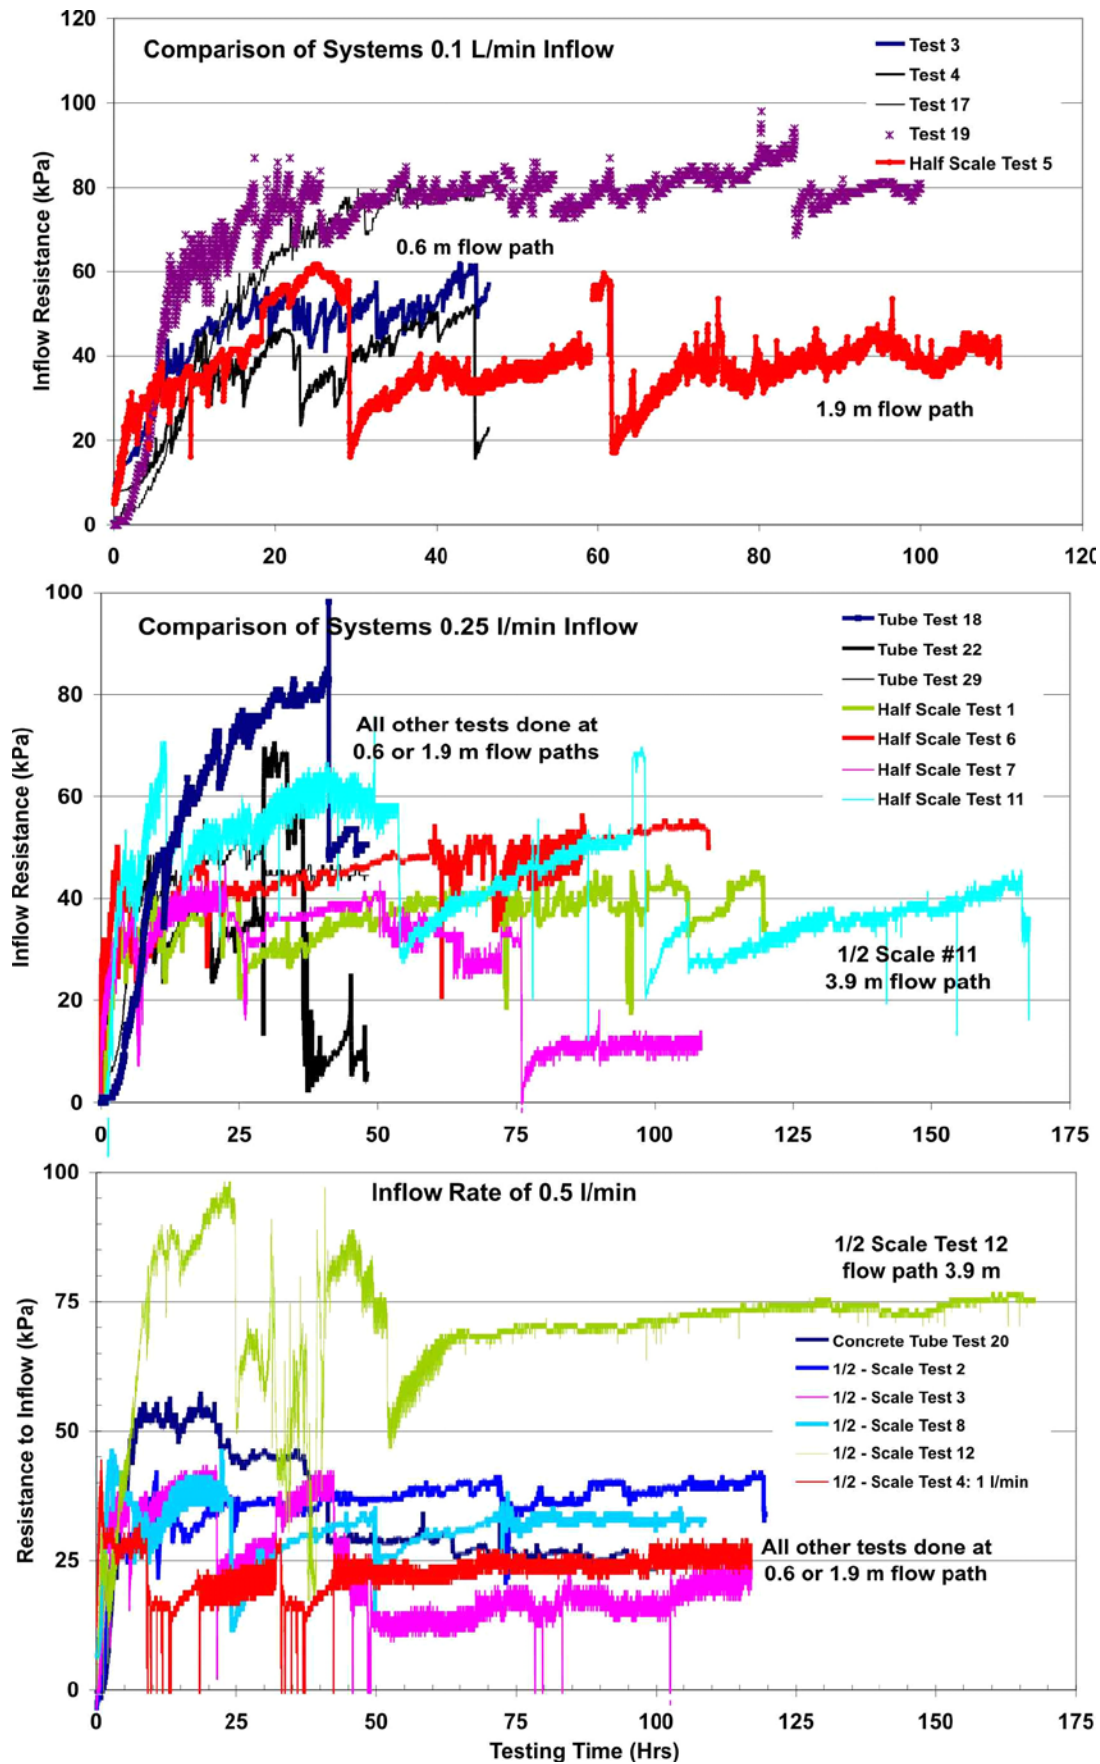
Figure 7-1. Comparison of inflow resistance in Concrete Tube and 1/2-Scale tests.

The data from the combined Tube- and ½-Scale Tests are presented in Figure 7-1. This data shows that there is no discernible change in the resistance to water flow as the result of slight changes in backfilling technique, increasing path length (1.9 or 3.9 m versus 0.6 m) or test dimension. Only in one test (at 0.5 l/min inflow for a path length of 3.9 m), did the ½-Scale Test show a resistance that was consistently higher than other tests (75 kPa versus 20–40 kPa), which while substantial is not really significant in terms of the ability of the system to resist throughflow.

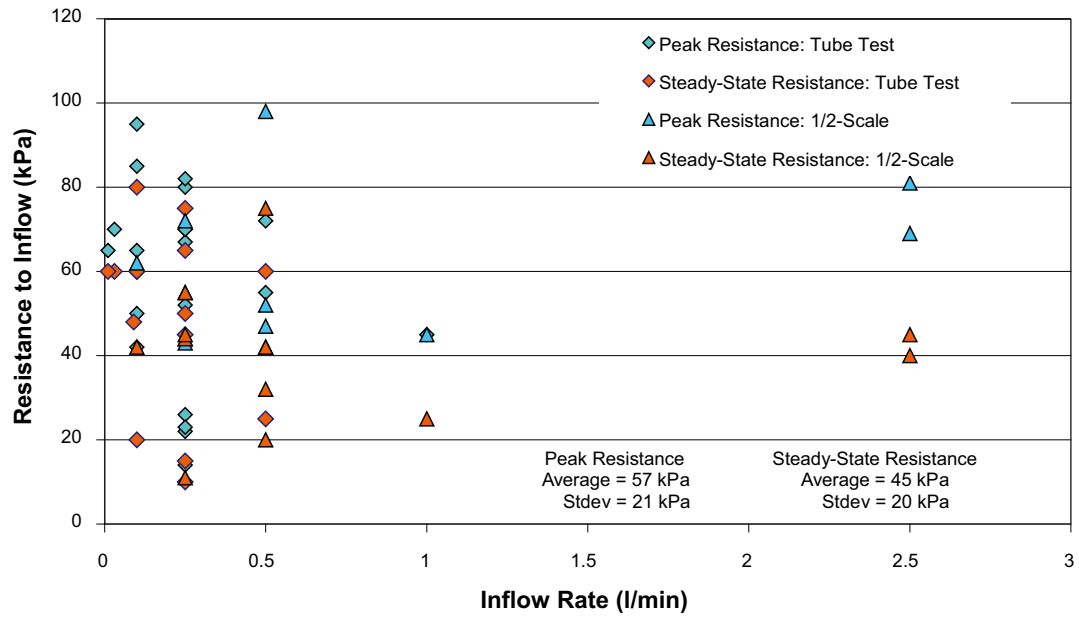
Figure 7-2. Resistance to water inflow: comparison of 1/2-Scale and Pipe-Tests.

These tests show that once the flow channels were established and water was bypassing the bulk of the backfilled volume, there was typically a decrease in flow resistance by a few 10's of kPa as can also be seen in Figure 7-2.

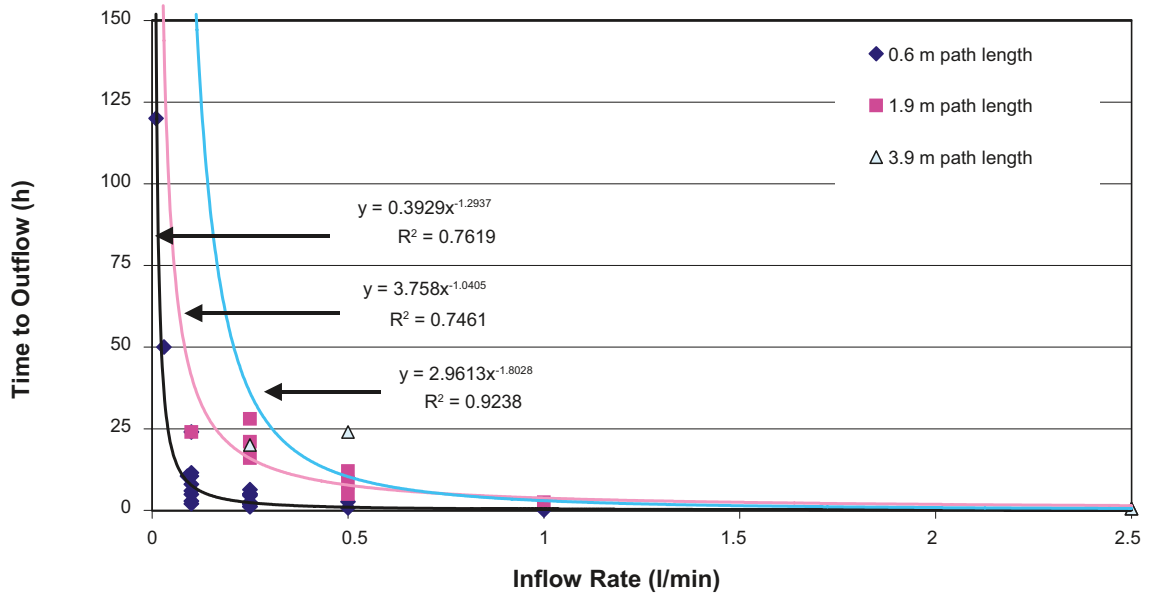
Figure 7-3. Time required for water to exit backfilled volume at various inflow rates.

(a) Inflow rate versus time to start of outflow (linear scale) for all tests.

(b) Inflow rate versus time to start of outflow (log-linear scale) where inflow > 0.1 l/min.

When the data presented in Figure 6-30 is compared to that generated by the larger number of tests previously completed at smaller-scale and for a shorter flow path the results shown in Figure 7-3 are obtained. In Figure 7-3(a) all of the data available are plotted and at inflow rates of less than 0.1 l/min the time to outflow increased exponentially with decreasing inflow rate. This is indicative of a system where very slow infiltration rate results in a greater proportion of absorption of water by the surrounding pellet materials. This results in a much-extended period before water makes its way to the front face of the assembly. However, if water is being supplied to the chamber at a single location, outflow will eventually occur prior to the system obtaining full water saturation and outflow will occur via small piping type feature(s).

If the time for outflow development is examined for only those systems where inflow is via a discrete location at a rate of 0.1 l/min or higher, the relationship shown in Figure 7-3(b) is obtained. The time to start of outflow is clearly dependent on the both the distance from the inflow point and also the inflow rate although the limited body of data for longer flow paths makes the relationship somewhat difficult to quantify. These data are consistent with the conceptual model provided in Section 6.2.1.

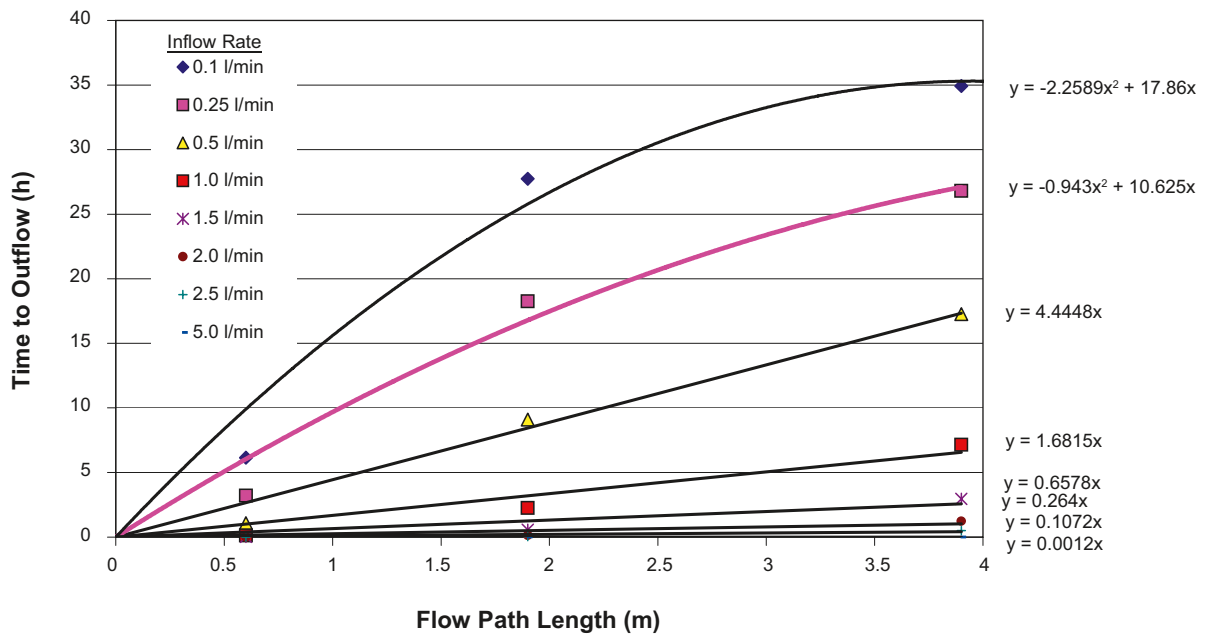
Figure 7-4. Length of flow path and estimated time required for water outflow at inflow rates of 0.1 to 5.0 l/min.

Using the data generated in the ½-Scale Tests and the smaller-scale tests done previously, it is possible to generate an estimate of the time that will pass between backfilling past a discrete inflow point and water subsequently exiting the face of the backfill at some distance away. This is shown in Figure 7-4 and for most cases a linear extrapolation of the data seems appropriate. However, at low inflow rates (0.1 and 0.25 l/min), this relationship is better described using a second order polynomial fit. It should be noted that these numerical extrapolations, especially the polynomial fits, are only valid for flow paths to a maximum length of approximately 4 m and more data is needed before extending the presented relationships to longer flow paths.

The data provided in Figure 7-4 can be plotted in another manner that is perhaps more directly applicable to the tunnel backfilling process and design requirements for backfilling rate. If it is assumed that the data plotted in Figure 7-4 is representative of a steady-state water penetration process then the penetration rate of the piping features per day can be estimated for the range of water inflow rates examined in this study. From this it is possible to determine at what rate backfilling must continue in order to stay ahead of the water conductive features developed. It should be noted that such calculations are not necessarily conservative, as time progresses, length of tunnel backfilled and degree of water saturation in the backfilled tunnel increases, a higher proportion of the inflowing water will be trying to move downstream. In the tests conducted in this study this would represent a potential 20% increase in the rate of water supply to the piping feature (outflow in this study was ~ 80% of inflow).

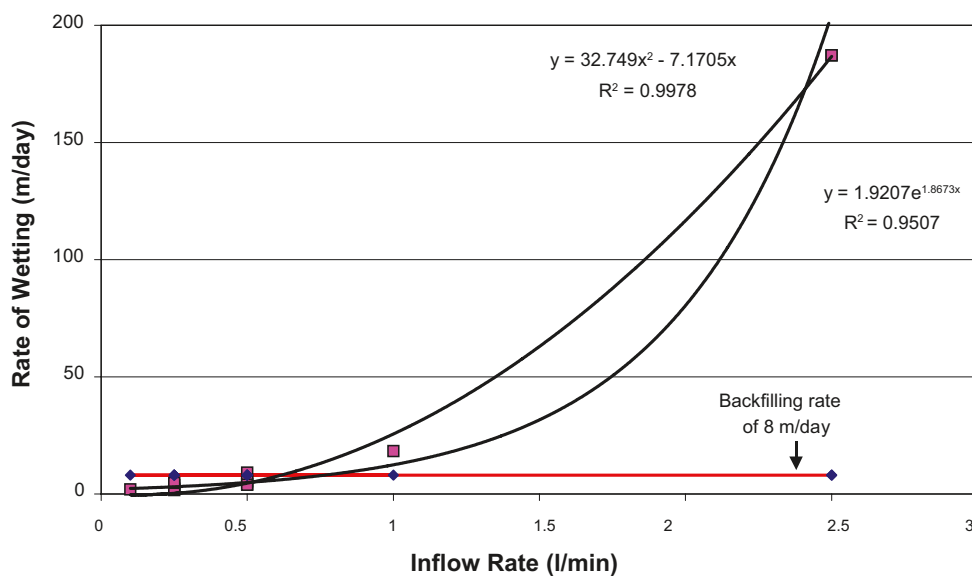
Figure 7-5. Rate of water penetration through pellet backfill (m/day) at various inflow rates.

Figure 7-5 presents the results of estimation of the rate of water penetration via perimeter piping features in a recently backfilled section of tunnel. It indicates that if a backfilling rate of 6–8 m/day is desired that a single water conductive channel cannot carry more than approximately 0.5 l/min in order for the backfilling process to continue without potentially adverse interaction with inflowing water. At this backfilling rate, the piping feature will not be able to penetrate sufficiently rapidly to reach the working front of the backfill. It should be noted that this type of inflow rate calculation is of limited value as water influx is continuous and backfilling is a stepwise process. It also does not take into account interactions or interconnection of rock hydraulic features. It is more appropriate to develop means whereby most of the water entering the open excavation or entering via already backfilled volumes is dealt with via collection prior to installation of new volumes of backfill. Ideally this would include pre-backfilling treatment to at least temporarily reduce influx into the open excavations through means such as grouting or localized shotcreting.

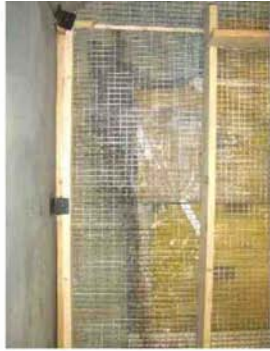
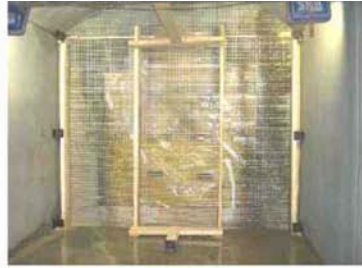
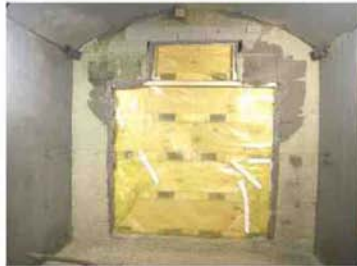
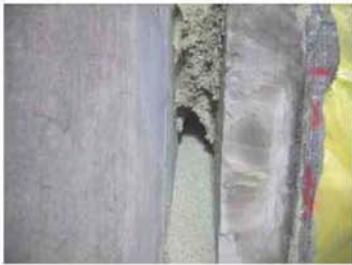
Figure A-1. Downstream face of Test 1 and Test 2.

Test 1

Test 2

Just prior to disassembly: note water on floor of test chamber

**Assembly immediately after restraint removed
Dark regions are wet clay blocks, note dry regions
near crown and bentonite on surface of lower blocks**

**Assembly immediately after restraint and first block layer removed
Wetting limited to block joints and very distinct areas of pellets
Remaining pellets still dry and loose**

Figures A-1 and A-2 shown the patterns of water movement out of Test 2 and the wetting patterns observed during dismantling. Figure A-5 shows the wetting pattern in the uppermost block filled region of Test 2. This shows the same pattern as was evident in Test 1, a relatively random pattern of limited water inflow into the blocks with no ongoing flow was found. As with Test 1, the lower regions (close to distance from front face and elevation of water inlet port), showed more extensive water influx into both the pellet fill and the blocks with some limited early erosive activity during the period before the pellets had hydrated sufficiently to seal off water influx towards the core of the test. Hydration of the pellet filled regions was also notably incomplete, only a limited portion of the pellet fill had actually hydrated after 5 days of water inflow and this tended to be in the regions about 1 m above the floor and extending upwards towards the crown of the chamber. Water seems to have initially moved generally downwards (with gravity) and in some regions briefly penetrated along the block joints. Relatively quickly the pellets hydrated and sealed off essentially the entire test. This forced water to move along the path of lest resistance, generally along the pellet-outside wall contact moving either towards the front face of the assembly or upwards towards the crown regions, showing little tendency to move into the block filled core of the test.

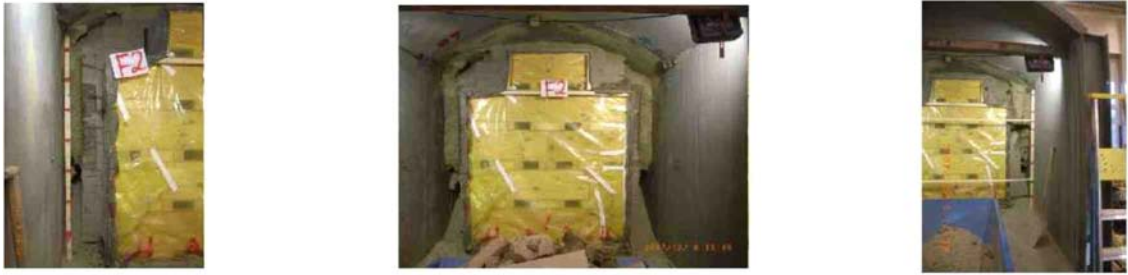
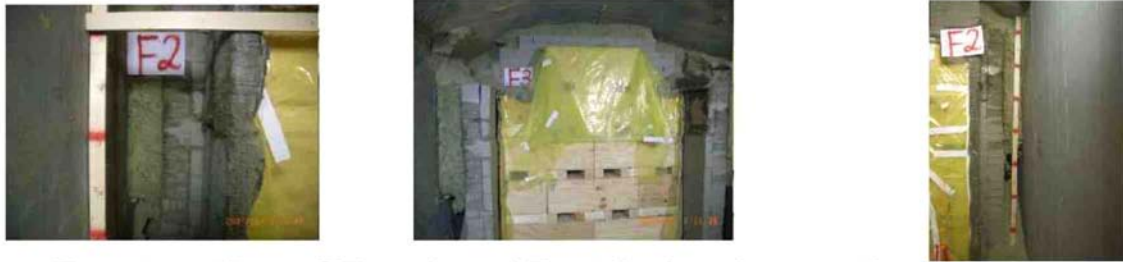
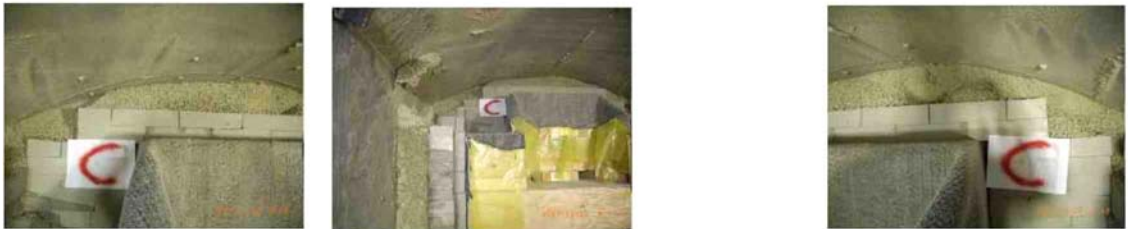
Figure A-2. Wetting patterns for Test 1 and Test 2.

Front face of Test 1 and Test 2 once surface layer removed

Front portion of Test 1 and Test 2 showing vertical wetting

Central portion of Test 1 and Test 2 showing dry crown region

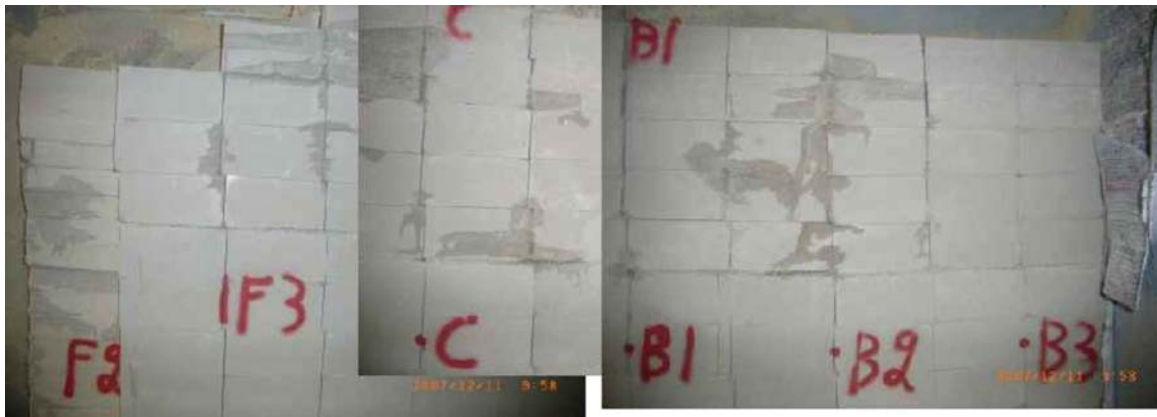
Figure A-3. Movement of water along block joints near top of Test 1. (view from front (F) to back (B)).

Water first exited this test between 8 and 24 hours after start of inflow. The exact time was not recorded as it occurred during the night when there was no visual monitoring occurring. Based on the degree of water outflow observed at 24 hours it was estimated that the outflow likely began at about 16 hours. Water initially exited the test at the block pellet interface at a slightly lower elevation than the water inlet (approximately 1 m). In the early outflow period the location of the outflow location gradually moving upwards and towards the chamber wall. This is attributed to the successive vertical hydration of the pellets, inducing a greater and greater resistance to water movement through them. Within 48 hours the flow path appears to have stabilized to a single location along the wall – pellet contact at an elevation of approximately 2 m from the floor of the chamber, showing little erosive action (clear outflow). This test was carefully photographed in order to capture a visual record of the flow behaviour and location. Figure A-1 and Figure A-2 provide photo records of the water movement out of Test 1 and the wetting pattern evident during dismantling. Figure A-3 presents a view of the inside face of the blocks in the upper part of Test 1 (geotextile-block contact), illustrating the limited water inflow into the upper block-filled region.

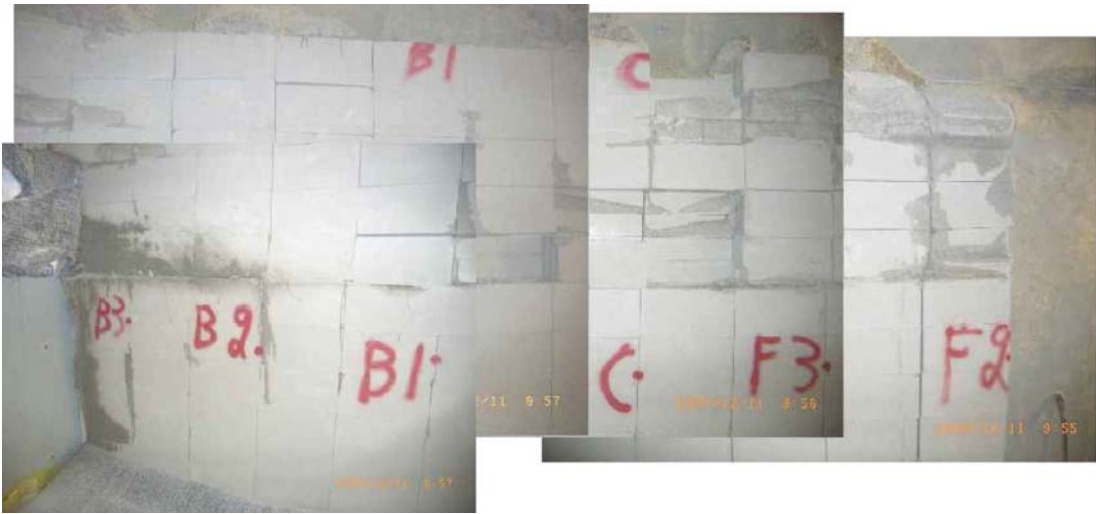
Figure A-5. Movement of water along block joints near top of Test 2. (Photomosaic view from rear (left) to front (right) along the block-geotextile boundary).

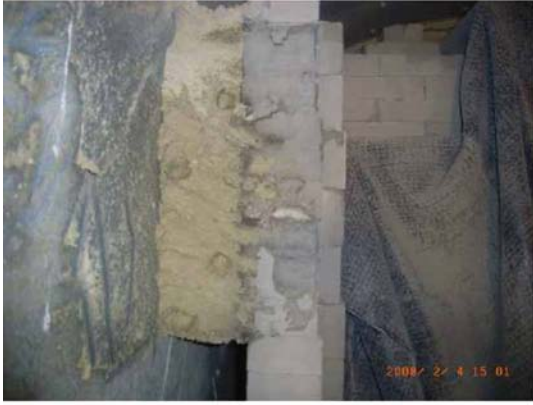
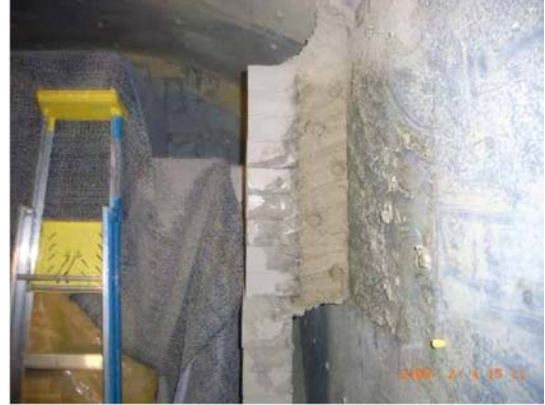
Figure A-7. *Wetting near inflow location in Tests 3 and 4.*

Test 3

Test 4

(Note dry regions below and above inflow elevation)

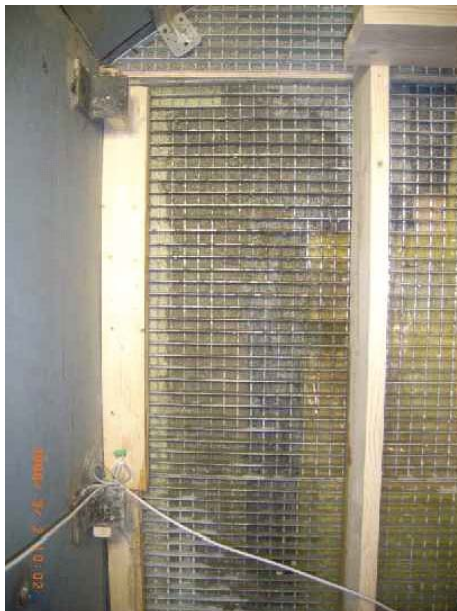
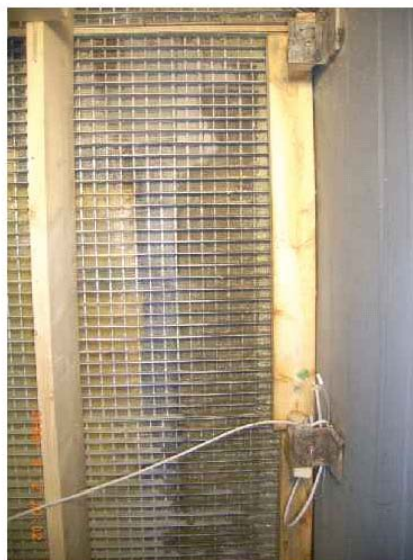
Figure A-9. Front Face of Assembly 3 (Tests 5, 6) showing wet regions.

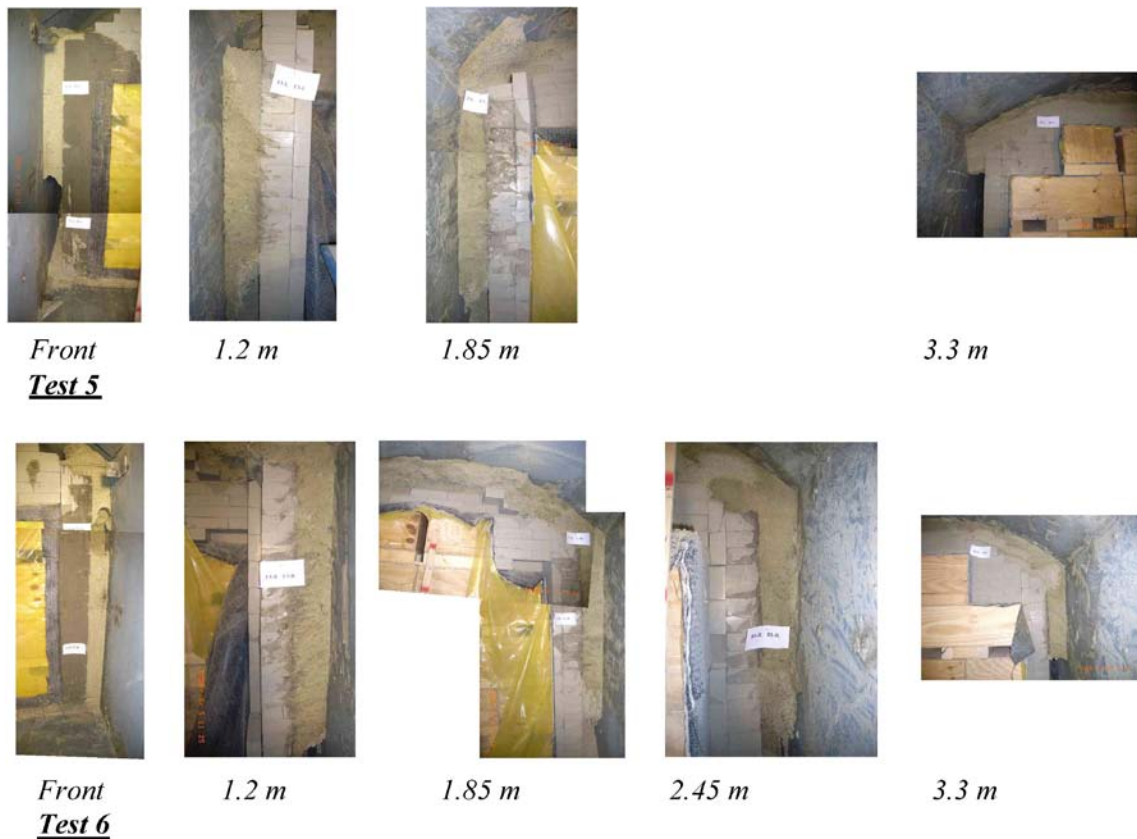
Figure A-10. Excavation profiles for Test 5 and Test 6. (note: incomplete wetting of pellets and movement of water into upper rear part of tests).

Test 6 operated at an inflow rate of 0.25 l/min at 1.8 m distance from the rear of the chamber, 1.5 m above the floor, for a total of 5 days. Outflow occurred after 21 hours of operation. The downstream face of the test showed the same pattern of water outflow (along steel wall at approximately the inflow port elevation) as was observed for most other tests (Figure A-9). The distribution of water within the pellet fill at various depths in Test 6 is presented in Figure A-10.

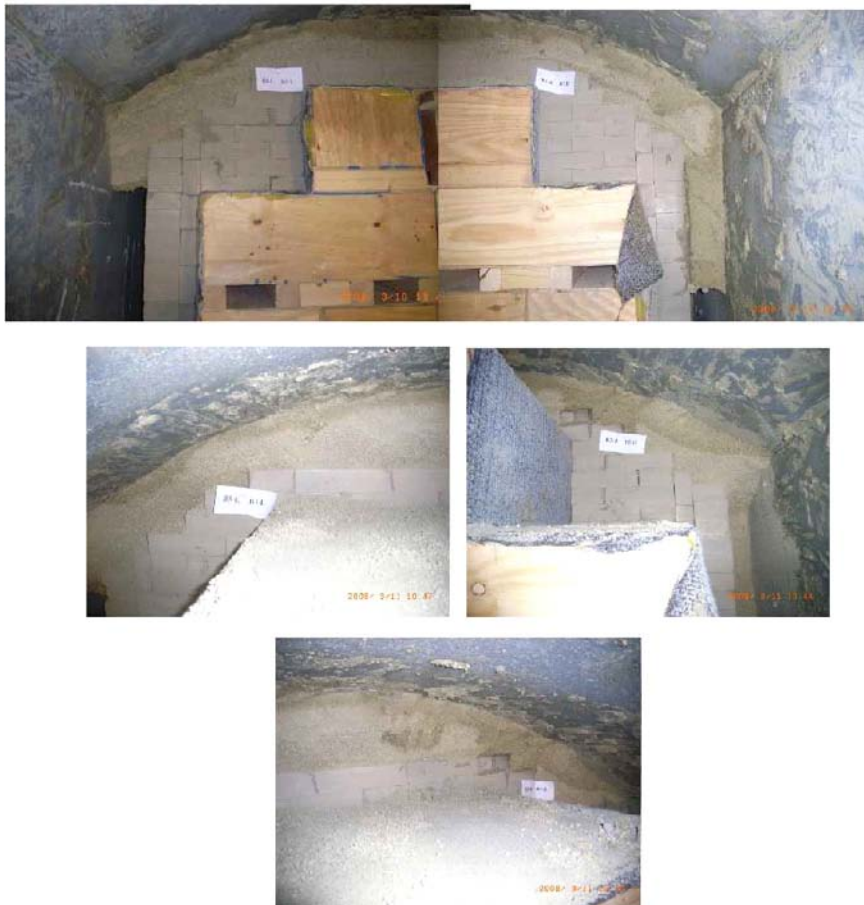
Figure A-11. Wetting along crown of Assembly 3 (Tests 5, 6).

In general the water distribution pattern is similar to that observed in previous tests with one exception. There is a clear wetting process that has occurred in the pellet filling towards the rear of the chamber, particularly along the chamber roof and the pellet filling. There is a continuous layer of moistened pellets along the roof in the rearmost 1 to 2 m of the test. Additionally in Figure A-10 at 2.85 m depth, there is a wetting front extending upwards into the pellets in the lower crown region. The shape of this wetting feature indicates flow from the right-hand side (Test 6) towards the left (Test 5). Figure A-11 shows this even more clearly with a much greater volume of dampened pellets on the right side of the crown region than is visible on the left, again supporting the conclusion that flow was moving from right to left. This type of feature indicates that within 5 days water not exiting the assembly via the flow channels developed early in the test has begun to wet towards the crown of the assembly and also to move towards areas of lower degree of wetting (lower inflow rate). This indicates that it is quite possible that initially unconnected inflow locations may eventually merge into a single flow path and that water is moving a considerable distance from its inflow point, despite most of the inflow volume being channelled towards the downstream face of the backfill. At the end of operation Test 6 has 76% of its inflow exiting the front face of the assembly. Although a large volume this meant that Test 6 was supplying as much as 3.6 l/h to the still-dry portions of the assembly. Over the course of 5 days this represents 432 l of water retained within the assembly.

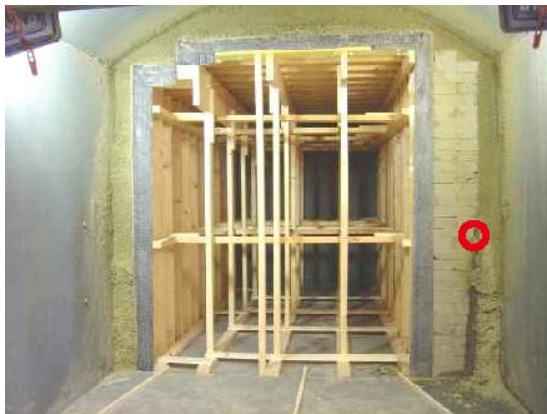
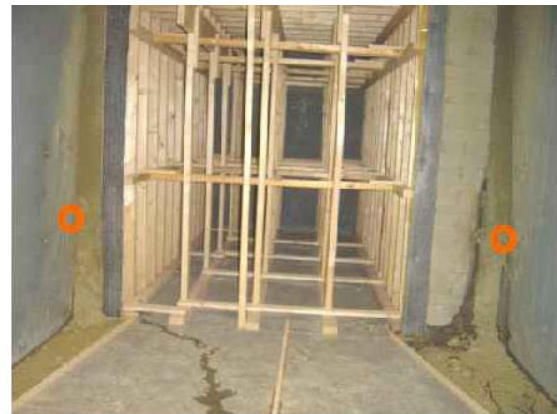
Figure A-12. Front face of Tests 7 and 8 at the start of outflow and end of testing.

Initial outflow from Test 8 (right)

End-of-test outflow locations

Figure A-12 shows the front face of Assembly at the start of outflow from Test 8 and at the end of testing, just prior to disassembly. It can be seen that there was very little change in the front face following almost 5 days of water influx (0.25 l/min left side, 0.5 l/min right side). These tests did not run for their full planned time as a mechanical failure in the pumping system resulted in loss of water supply approximately 12 hours before the tests were scheduled to end. Given the stability of the flow rates, flow resistances and lack of deformation in the front face of these tests, loss of 12 hours of testing time was not deemed to have affected the results obtained. Figure A-12 clearly shows the high mechanical stability of the system after 5 days of water supply to the pellets. Outflow from Test 7 was always at pellet-chamber wall contact. Test 8 initially began to show water outflow at pellet-block contact, visually evident by dark, wet region in Figure A-12. The outflow location subsequently moved to the chamber wall within 12 hrs of flow starting. Figure A-12 also shows how little material was removed by the exiting water.

Test 8 was supplied water at 0.5 l/min at 1.8 m distance from the rear of the chamber and an elevation of 1.5 m from the floor. Outflow began at approximately 8.5 h into its operation, determined using the conductivity sensor. This sensor was used to detect water movement into the outflow collection system. Outflow from Test 8 began at a single point, approximately 1.5 m from the floor of the chamber at the pellet-block contact and shifted to the pellet-chamber wall contact within a day. There was limited but discernible erosive activity during those 4 days, with the loss of a small quantity of pellet materials (determined by its lighter colour). Much of the material that accumulated at the toe of the assembly was the result of water moving down the vertical face of the assembly and bentonite pellets swelling at the downstream face (see Figure A-12 and Figure A-15).

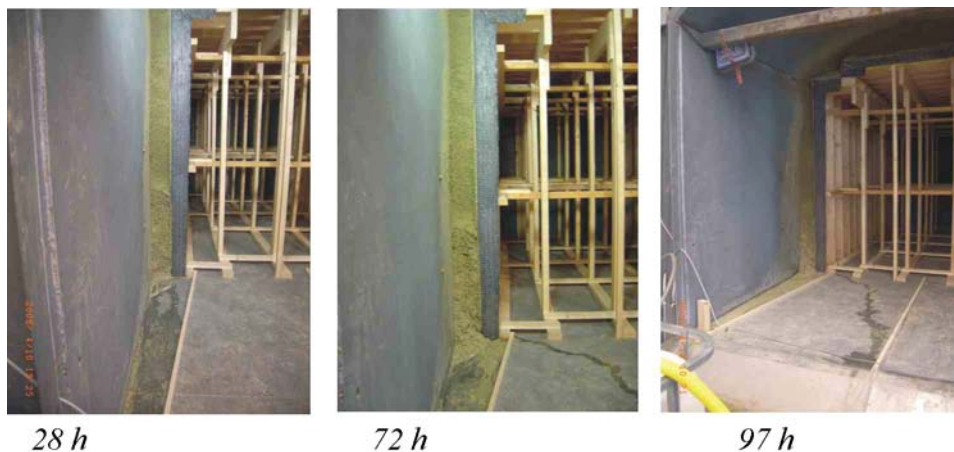
Figure A-13. Water outflow from Test 7 at various times.

Figure A-13 shows the front face of Test 7 in the course of water inflow and the outflow elevation can be seen as the coarser textured lower portion. This texturing was caused by the water exiting the test and flowing down the face of the pellet fill, causing swelling of this region. Figure A-14 shows the appearance of the pellet-filled region in the course of dismantling this test. The downstream face was quite uniformly wet to an elevation of approximately 2 m as can be seen in Figure A-14a. Wetting was somewhat less uniform but still extensive for the entire length of the assembly with a tendency towards reduced height of wetting towards the rear of the test (Figure A-14b).

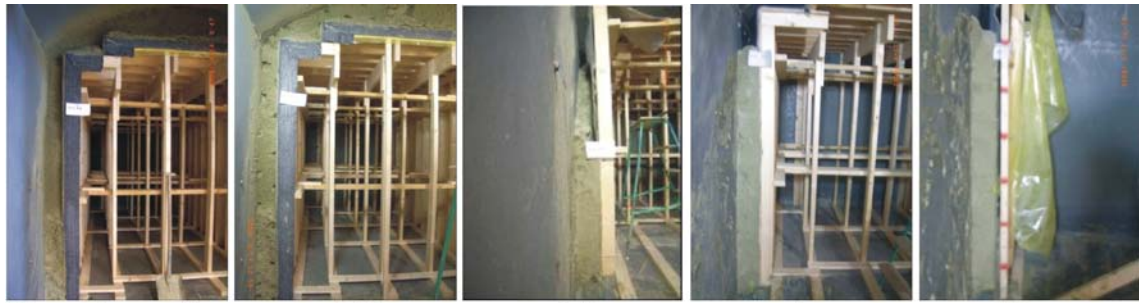
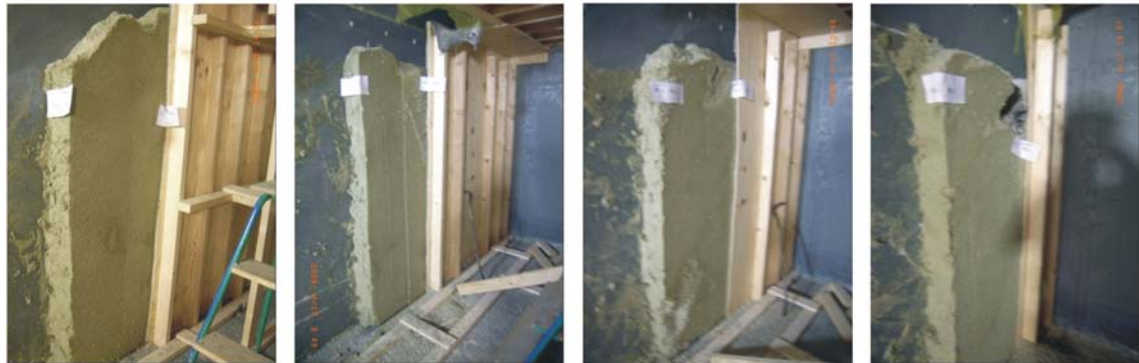
Figure A-14. Test 7: Wetting of pellet-filled region.

Downstream face ~0.15 m ~0.5 m ~1 m ~1.5 m
 (a) Wetting patterns observed at various distances from front face of Test 7

~0.5 – 1.5 m ~1.5 – 2.5 m ~2.5 – 3.5 m ~3.5 – 4 m
 (b) Wetting of pellet fill along walls of chamber following removal of dry pellets

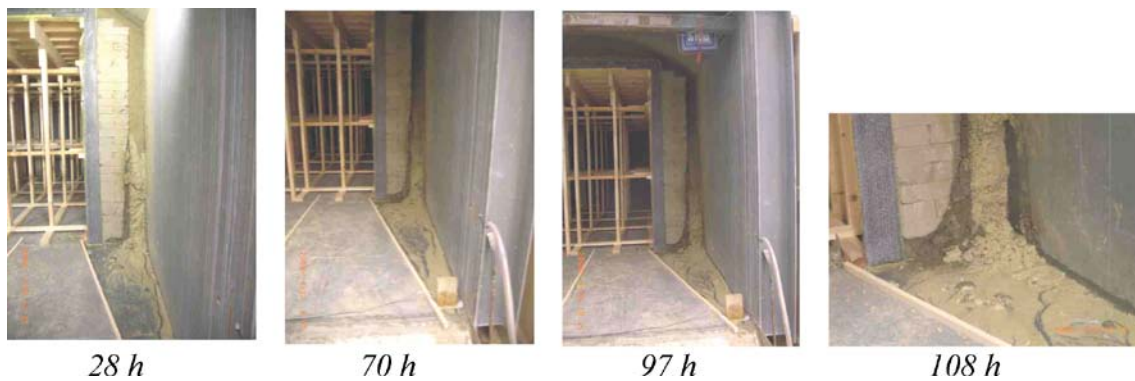
Figure A-15. Water outflow during operation of Test 8.

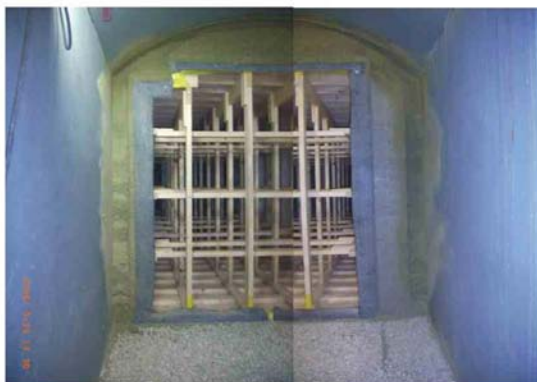
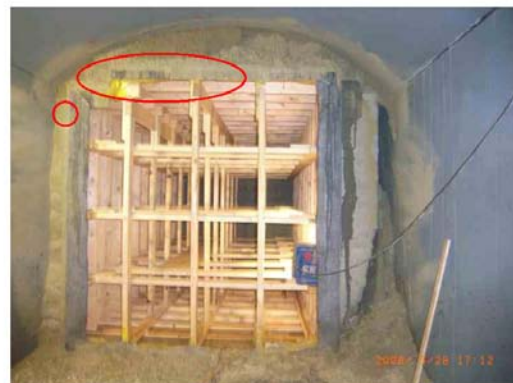
Figure A-18. Downstream face of Assembly 5 (Tests 9, 10).

Start of Test

Prior to Test Termination

Figure A-18 shows the front face of Assembly 5 at the start of testing and on completion, just prior to disassembly. It can be seen that there was extensive erosion of material from the pellet-filled volume of Test 10 and subsequent deposition of that material as an outflow fan at the face and also in the collection system located beyond that location. Test 9 shows little evidence of outflow, due to the discontinuation of water supply to the left side of the Assembly after only 17 hours of operation. The crown region on the left side (Test 9) did however show considerable evidence of wetting after 2 days of water supply to Test 10 (right side, circled in Figure A-18), as a result of water migration within the assembly.

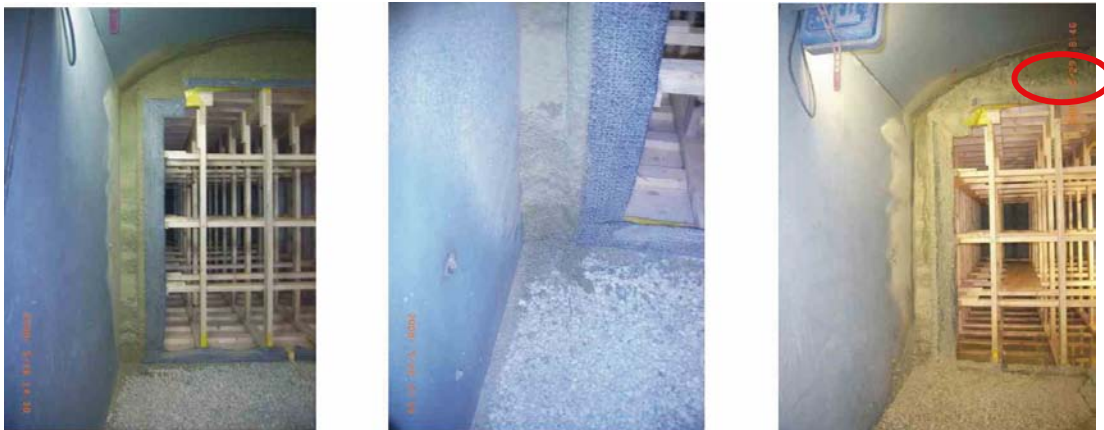
Figure A-19. Appearance and water distribution in Test 9.

(a) Test 9 at beginning of water inflow and at time of dismantling (note water standing on floor of wooden framed volume)

Test 9 had water supplied at a rate of 2.5 l/min via an inlet port located at the rear of the chamber 0.3 m above the floor and 60 mm in from the sidewall. This test did not run for the planned duration due to development of an internal leakage path that exited on the floor of the assembly within the wooden framework. The result was water exiting the test without being forced to flow through the assembly to the downstream face. As a result, there was a risk to Test 10 since water standing on the floor could potentially enter the block-pellet assembly on the right-hand side of the system. This leak was detected 15 hours into the test's operation and could not be corrected. As a result, water supply was discontinued after only 17.5 hours of operation. Although this part of Assembly 5 was not operated beyond the first few hours, water was noted to be exiting the test in the lower pellet-filled region close to the floor of the chamber after approximately ½ hour of operation. This test was also sampled for water content distribution and photographed in the course of dismantling the assembly. Unlike previous tests there is a clear hydraulic interaction between the two sides of Assembly 5. In the final two days of operation of Test 10, there was a clear wetting upwards in the assembly, with water moving along the pellet-chamber crown interface and then moving both forward in the assembly and down along the side of Test 9 as can be seen in the red-circled areas in Figure A-19.

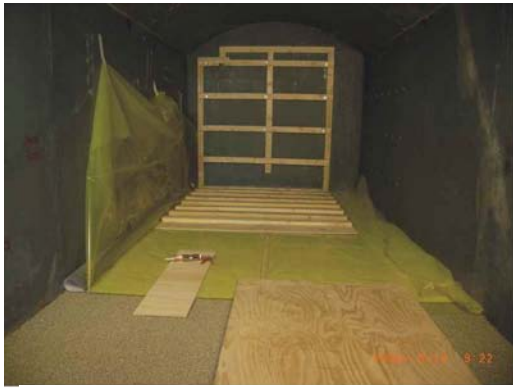
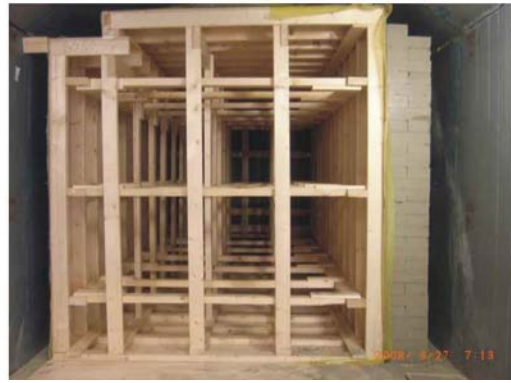
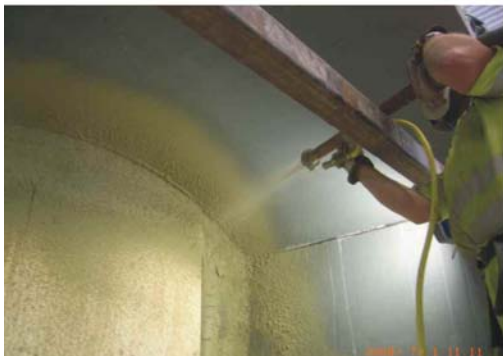
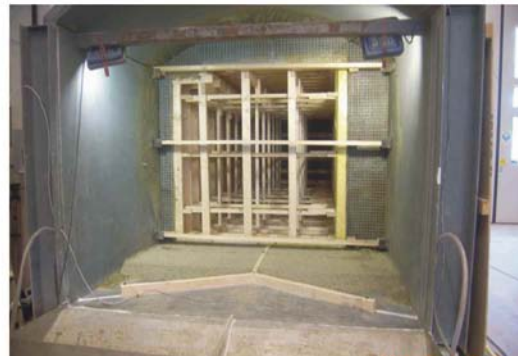
Figure A-23. Assembly 6 (Tests 11 and 12) and appearance at the start of operation. (Note pellet flooring installed below and in front of assembly).

Pellets Installed on Floor

Framework and Blocks

Blowing in Pellets

Completed Assembly

Tests 11 and 12 were installed in a manner similar to that used in Tests 7 through 10 with a wetter pellet material used on the downstream face to facilitate filling of the volume using blown pellets. In this assembly there were several differences from previous simulations, firstly the entire chamber had a 50 mm thick layer of pellets installed on it. On top of this layer the remainder of the assembly was constructed, with no blocks installed on the left side (Test 11) and a 0.3 m thick block assembly installed on the right side (Test 12). The pellets simulated the conditions that might be expected to exist in an actual repository tunnel where pellets are used to level the floor and on which the clay blocks would be placed. Water was supplied at 1.8 and 0.3 m elevation from the rear of the chamber at inflow rates of 0.25 and 0.5 l/min respectively for a period of seven days, at the end of which time it was dismantled and sampled as per previous tests. Figure A-24 shows the construction and the front face of this assembly prior to the start of wetting. Figure A-25 shows the assembly at the time of test completion, with outflow locations clearly shown using coloured dyes (blue for Test 11 and pink for Test 12).
