**P-06-29**

## **Forsmark site investigation**

### **Borehole KFM09A**

#### **Normal loading and shear tests on joints**

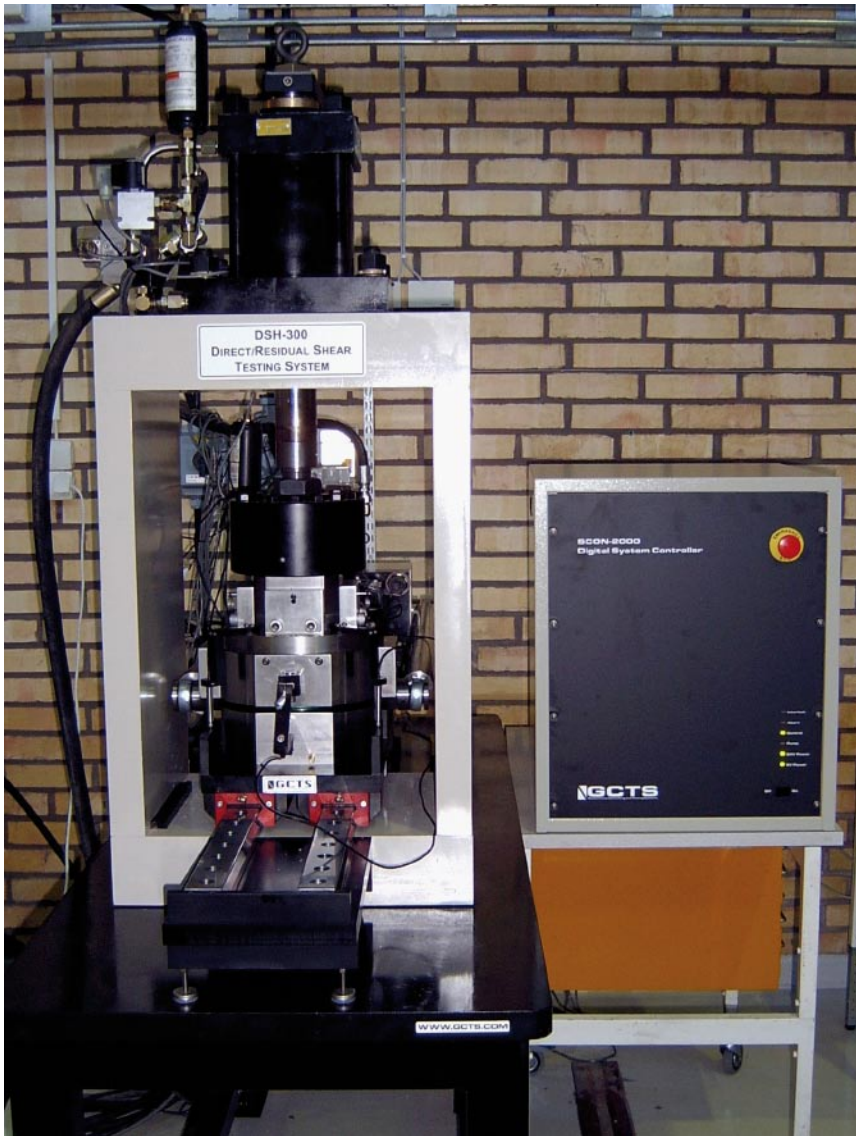
*Figure 3-1. Equipment for direct shear tests and digital controller unit.*

A servo hydraulic testing machine, designed for direct shear tests, has been used for the normal loading and shear tests, see Figure 3-1. The machine is supplied with two shear boxes, one upper and one lower. The upper box can be moved vertically and the lower box horizontally. Two actuators, one acting vertically and one acting horizontally, are used to apply the forces in the two directions (degrees of freedoms). Two linear bearings are guiding the lower box in order to obtain a controlled linear movement. The maximum stroke is 100 mm in the vertical direction and  $\pm 50$  mm in the shear direction.

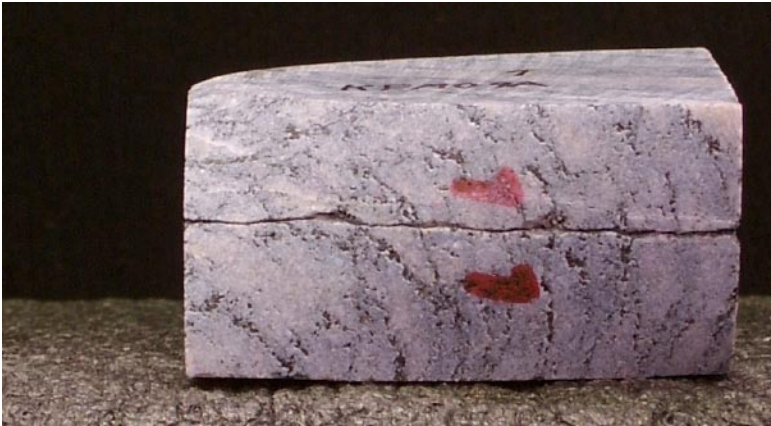
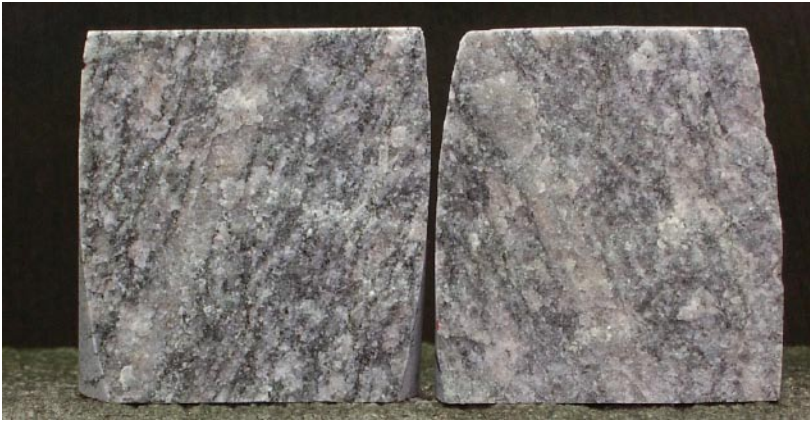
Specimen ID: KFM09A-117-1

**Comments** Upper half: At the front end of the specimens, one crack across the joint surface was observed.  
Lower half: At the rear end of the specimen, small pieces have spalled off.

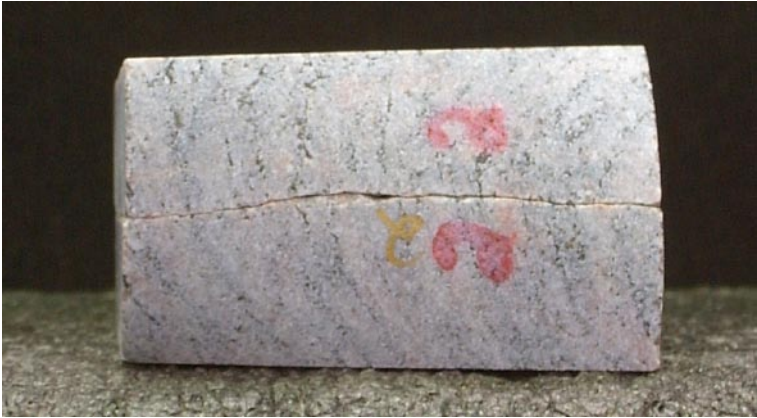
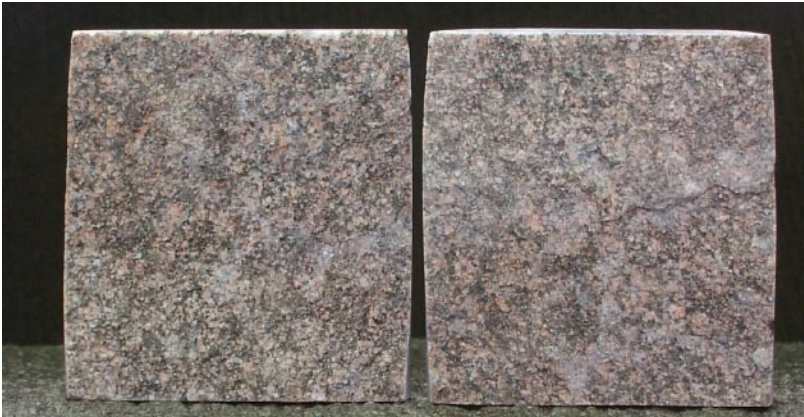
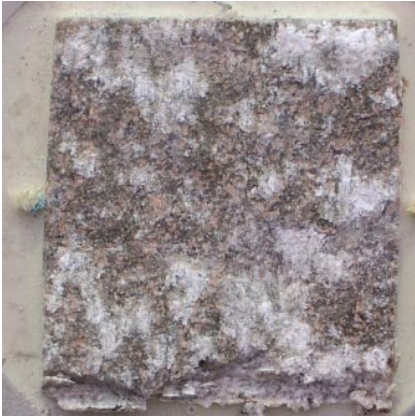
Specimen ID: KFM09A-117-2

Upper half: At the front end of the specimen, one crack across the joint surface was observed. At the rear end of the specimen, small pieces have spalled off.  
Lower half: At the rear end of the specimen, small pieces have spalled off.

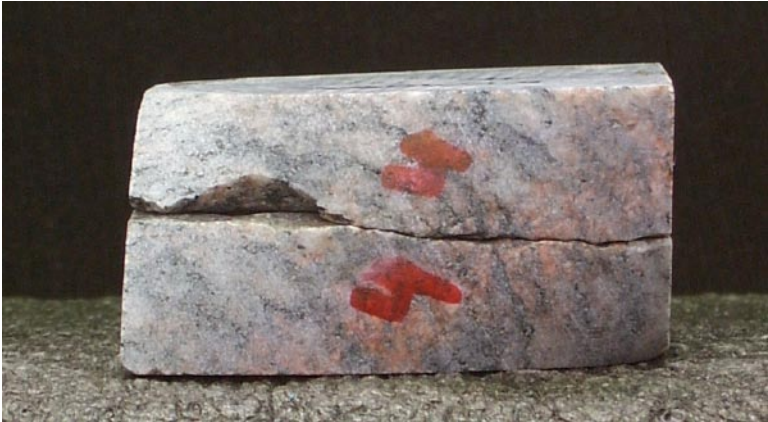
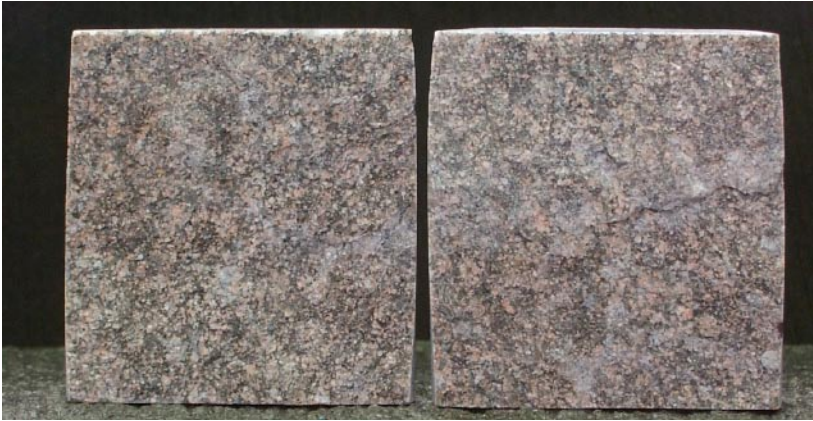
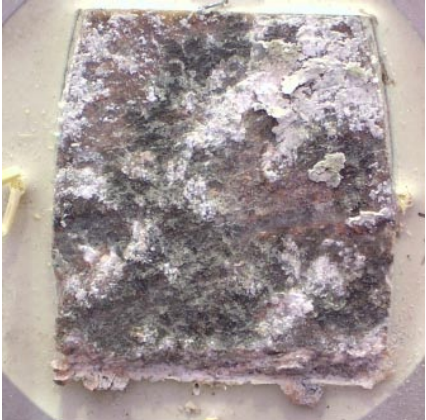
Specimen ID: KFM09A-117-4

Upper half: At the rear end of the specimen, small pieces have spalled off.  
Lower half: At the middle of the specimen, one crack across the joint surface was observed. At the rear end of the specimen, small pieces have spalled off.

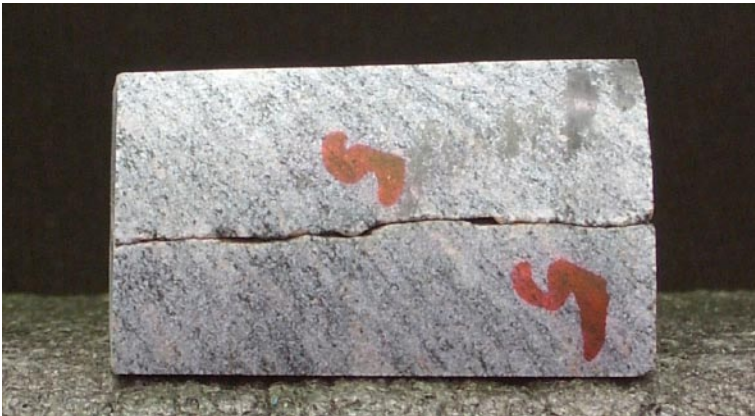
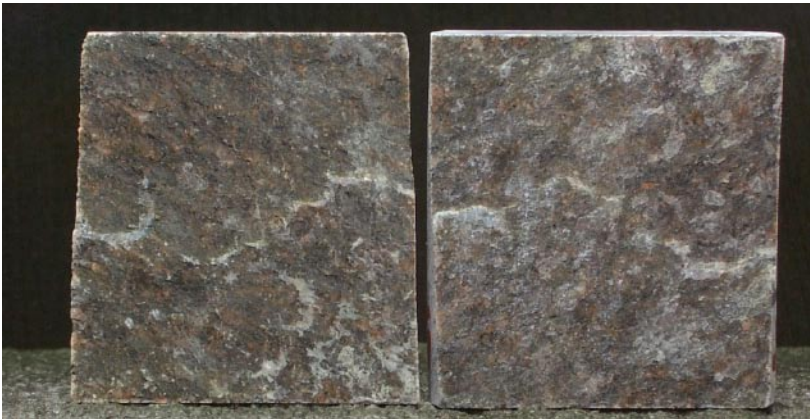
Specimen ID: KFM09A-117-5

Upper half: At the rear end of the specimen, small pieces have spalled off.  
Lower half: At the rear end of the specimen, small pieces have spalled off. One small crack was observed at middle of the specimen.

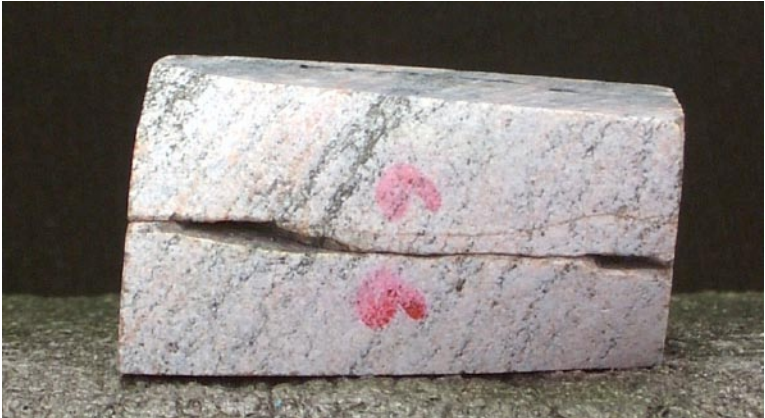
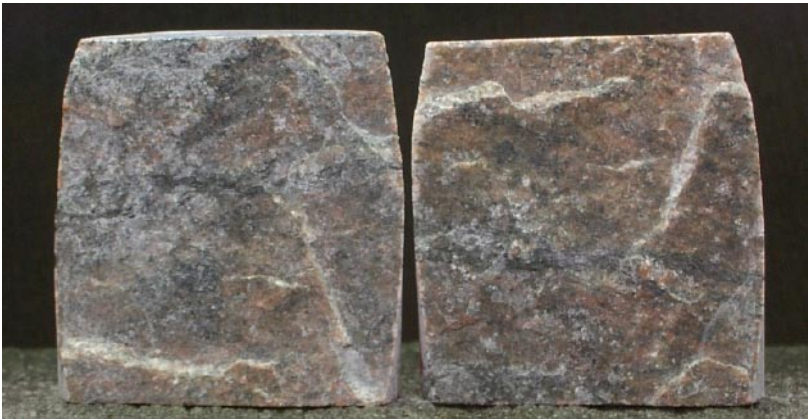
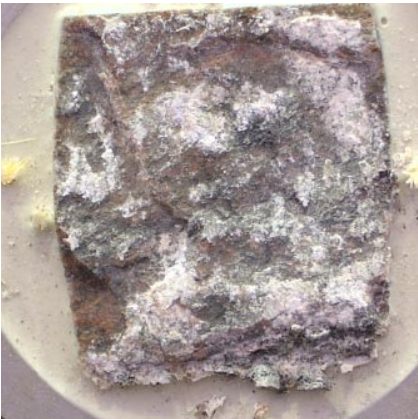
Specimen ID: KFM09A-117-6

Upper half: At the rear end of the specimen, small pieces have spalled off.  
Lower half: At the rear end of the specimen, small pieces have spalled off.

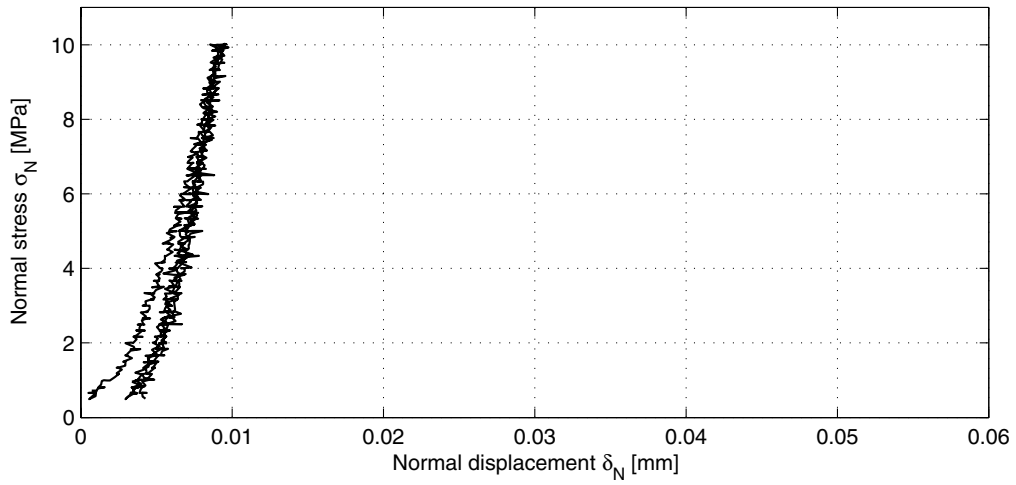
Specimen ID: KFM09A-117-06

Joint area : 26.2 cm<sup>2</sup>

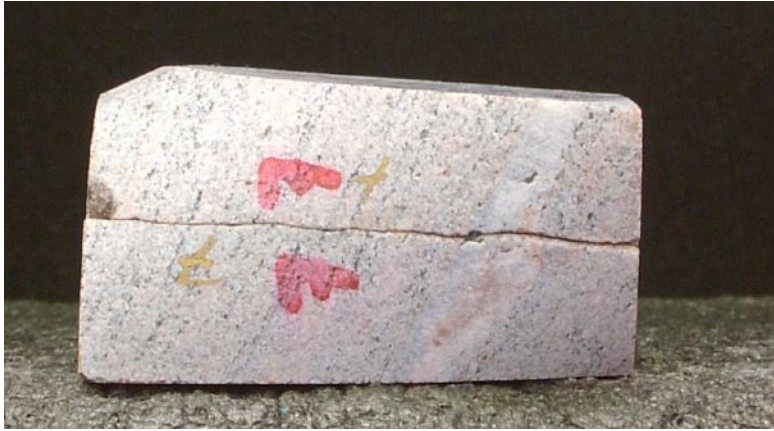
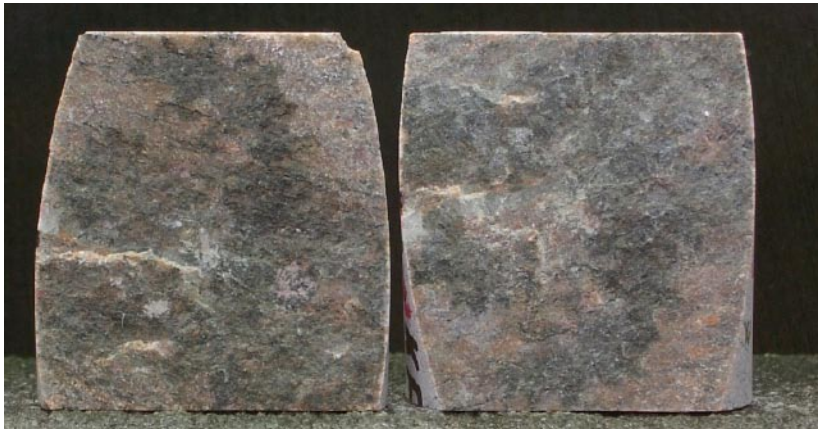
Specimen ID: KFM09A-117-7

Upper half: At the rear end of the specimen, small pieces have spalled off.

Lower half: At the rear end of the specimen, small pieces have spalled off. Two cracks were observed across the joint surface; one at the middle and one at the front end of the specimen.

Some small amount of epoxy was observed in the joint and across the joint at the side of the specimen. The epoxy in the joint clearly affects the peak shear strength at the first shear load cycle. However, due to the limited distribution and thickness of the epoxy layer, the influence on the results after it has been broken is probably negligible.
