P-06-75

Oskarshamn site investigation

Borehole KLX12A

Normal loading and shear tests on joints

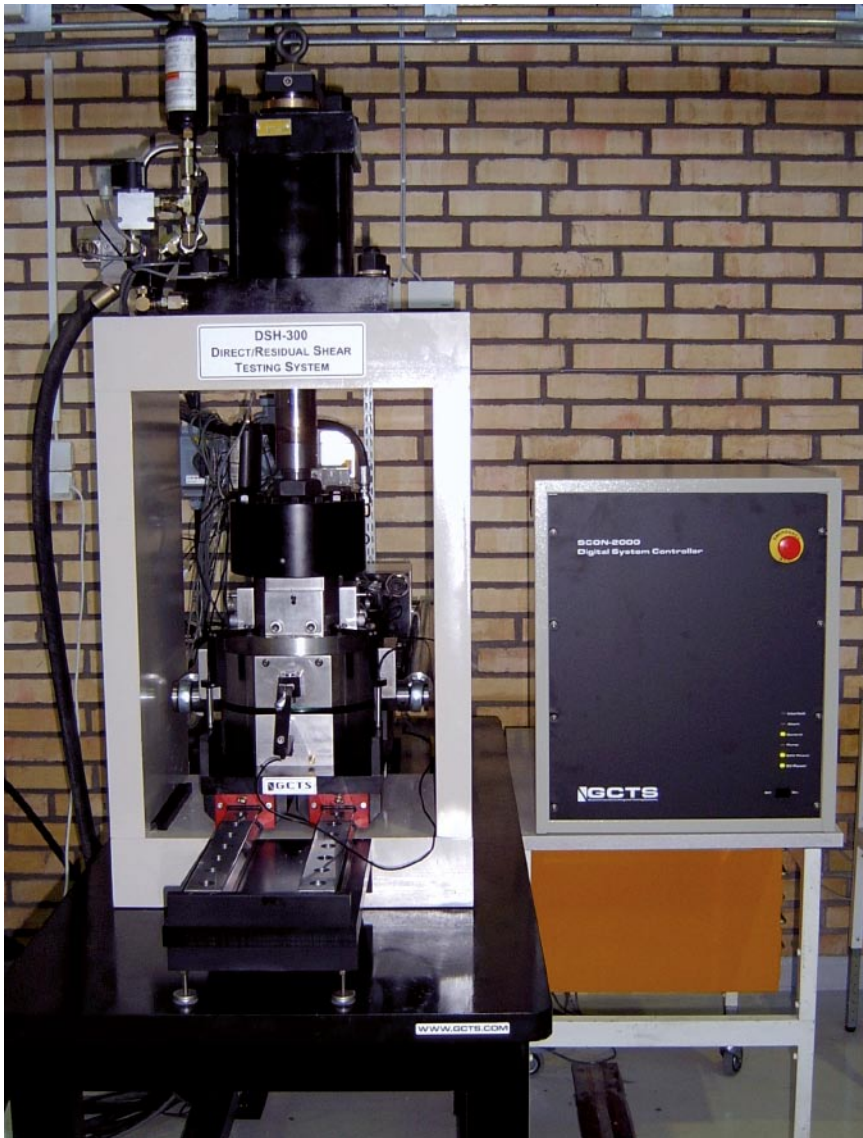
Figure 3-1. Equipment for direct shear tests and digital controller unit.

A servo hydraulic testing machine, designed for direct shear tests, has been used for the normal loading and shear tests, see Figure 3-1. The machine is supplied with two shear boxes, one upper and one lower. The upper box can be moved vertically and the lower box horizontally. Two actuators, one acting vertically and one acting horizontally, are used to apply the forces in the two directions (degrees of freedoms). Two linear bearings are guiding the lower box in order to obtain a controlled linear movement. The maximum stroke is 100 mm in the vertical direction and ± 50 mm in the shear direction.

In the normal loading test the normal displacement over the joint is measured by the use of two crack opening displacement gauges (COD) attached at two opposite sides of the rock specimen. Each of the CODs has a measurement range of 4 mm and a relative error less than 1%. The average value of these two CODs is used to represent the normal deformation over the rock joint presented in the results section.

In the shear test the normal and shear displacements are measured by means of LVDTs. The vertical displacement between the shear boxes is measured by four LVDTs, positioned in a square pattern around the specimen, one in each corner. Each of the LVDTs has a measurement range of 5 mm and a relative error less than 1%. The average value of these four LVDTs is used to represent the vertical (normal) displacement presented in the results section. The relative displacement between the shear boxes in the horizontal (shear) direction is measured by one LVDT, which has a 10 mm range and a relative error less than 1%.

The maximum vertical (normal) load that can be applied is 300 kN and the maximum load in the horizontal (shear) direction is ± 300 kN. Load cells are used to measure the forces in both directions. The accuracy of the load measurement is within 1%. The machine is connected to a digital controller with a computer interface for setting up and running tests.

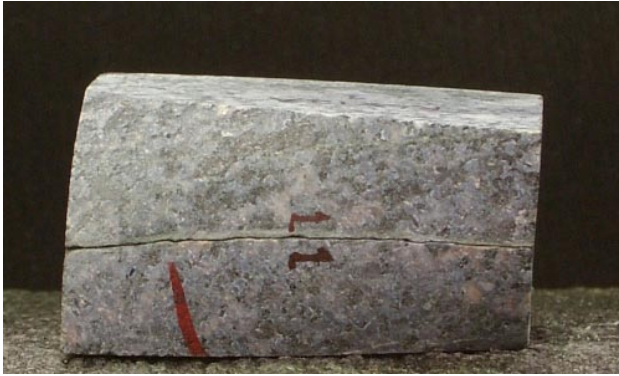
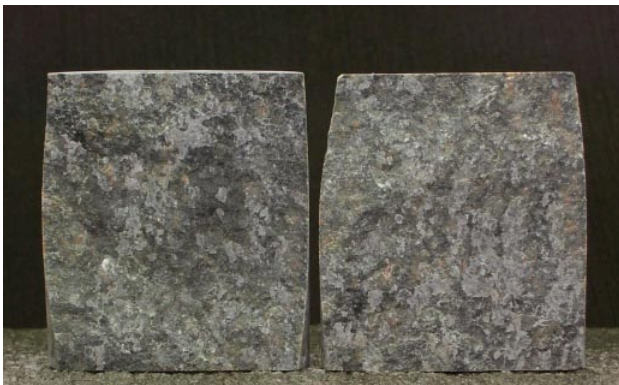
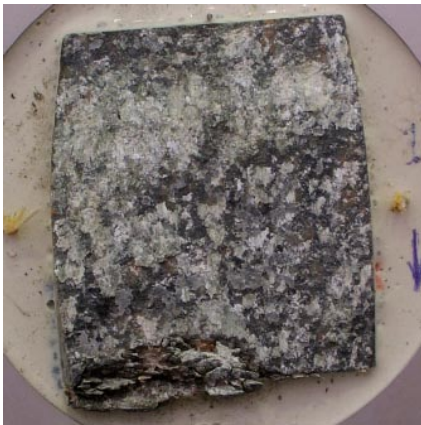
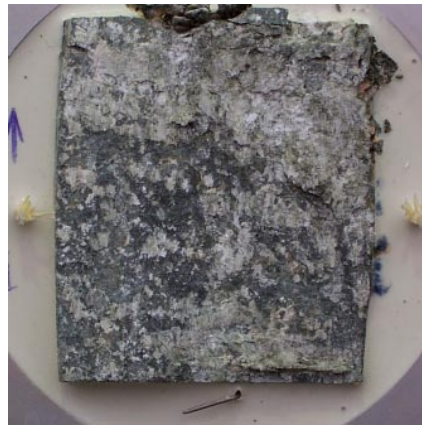
Specimen ID: KLX12A-117-1

Upper half: At the rear end of the specimen, small pieces have spalled off.
Lower half: At the rear end of the specimen, small pieces have spalled off.

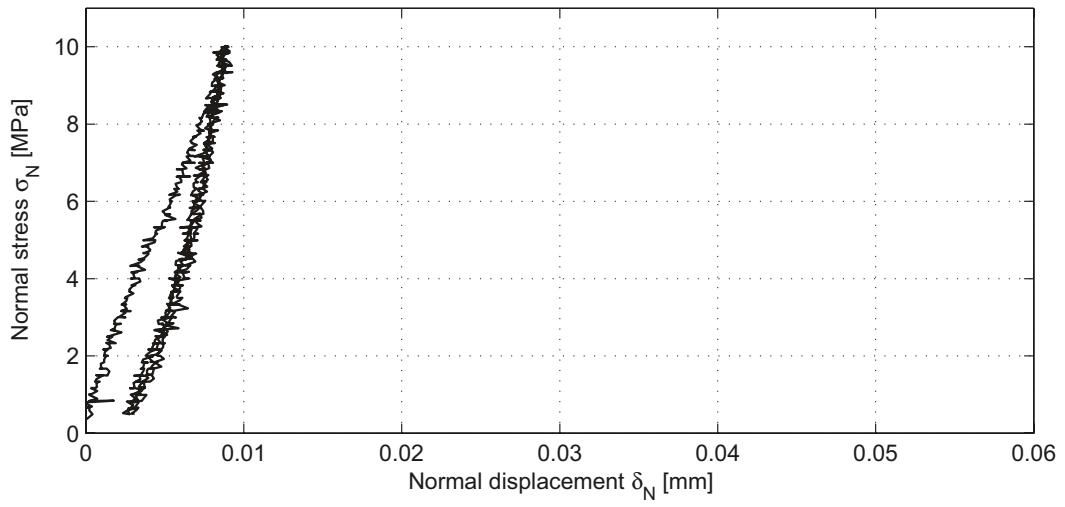
Specimen ID: KLX12A-117-1

The specimens and joints before casting and after testing are shown on photos. Comments on observations appeared during the testing are reported. The results from the normal loading tests are shown in the upper diagrams and the results from shear tests in the middle and the lower diagrams. The results from the shear tests for the three normal stress levels are displayed in black (0.5 MPa), green (5 MPa) and blue (20 MPa), respectively. Furthermore, the red triangle markers show the peak shear stresses and the red square markers indicate the residual stresses. Moreover, the dilatancy in the joints is derived from the shearing part of the three shear cycles.

Joint area : 27.3 cm²

Identification	Area [cm ²]	Peak 05 [MPa]	Resid 05 [MPa]	Peak 5 [MPa]	Resid 5 [MPa]	Peak 20 [MPa]	Resid 20 [MPa]	Comments
KLX12A-117-1	27.3	0.97	0.82	5.22	4.93	16.95	15.40	
KLX12A-117-3	23.6	2.42	1.32	6.99	4.06	18.12	14.30	
KLX12A-117-4	25.6	3.21	0.95	5.88	4.99	17.58	16.89	
KLX12A-117-5	27.5	1.14	0.91	5.03	4.56	15.88	13.63	
KLX12A-117-6	26.8	1.42	0.93	5.00	4.23	14.91	14.59

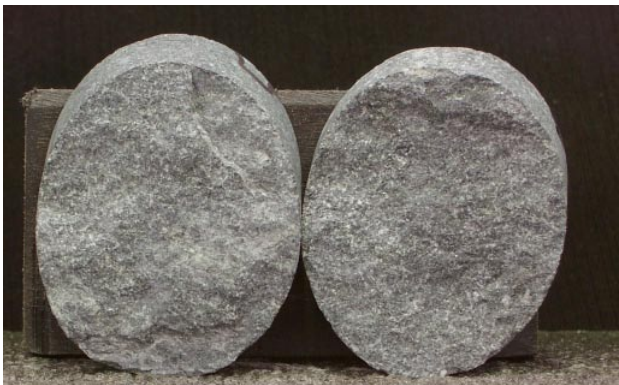
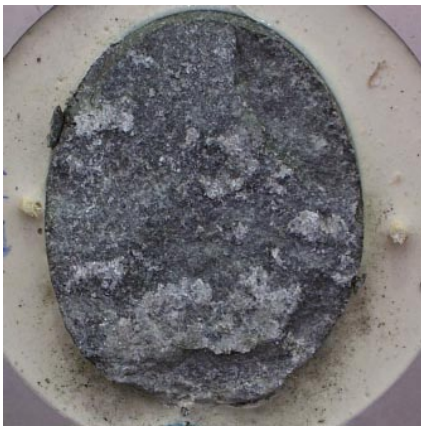
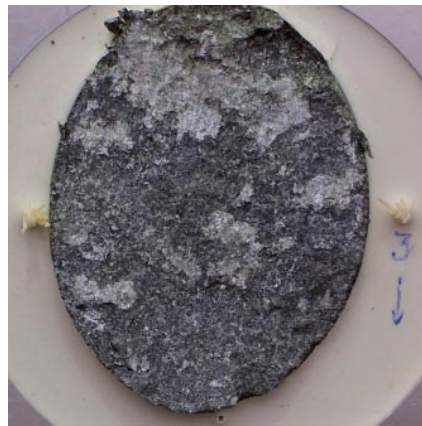
Specimen ID: KLX12A-117-3

Upper half: At the rear end of the specimen, small pieces have spalled off.

Lower half: At the rear end of the specimen, small pieces have spalled off.

The fracture has some larger irregularities that may have some influence on the test results.

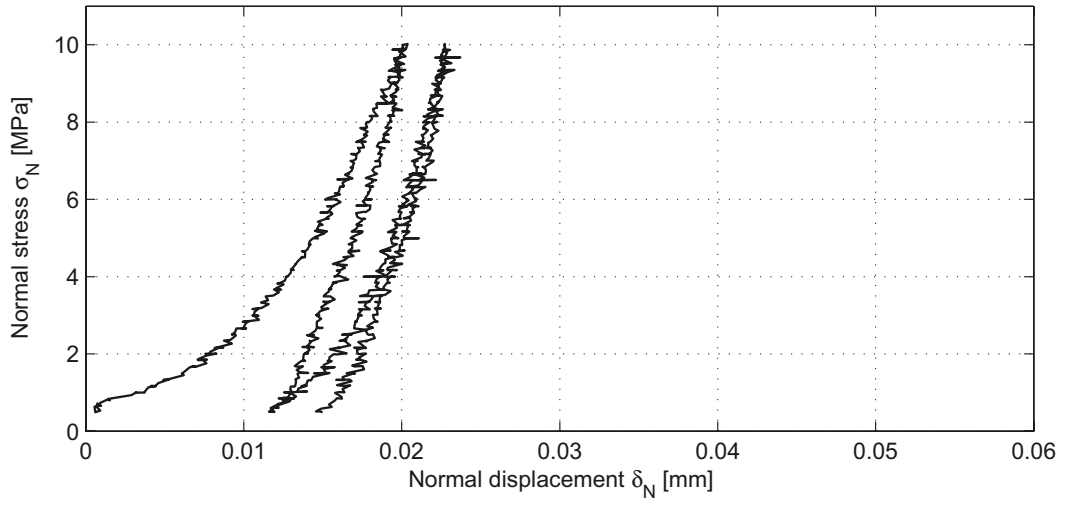
Specimen ID: KLX12A-117-3

Joint area : 23.6 cm²

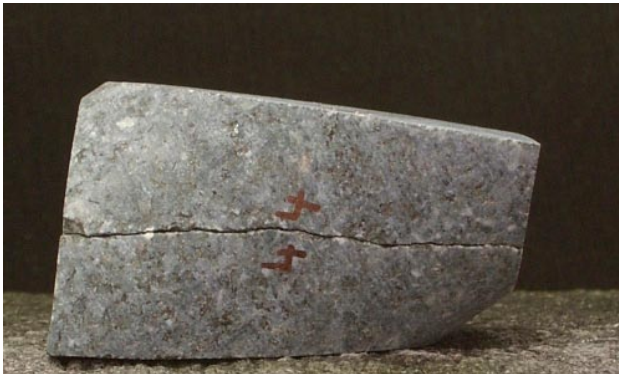
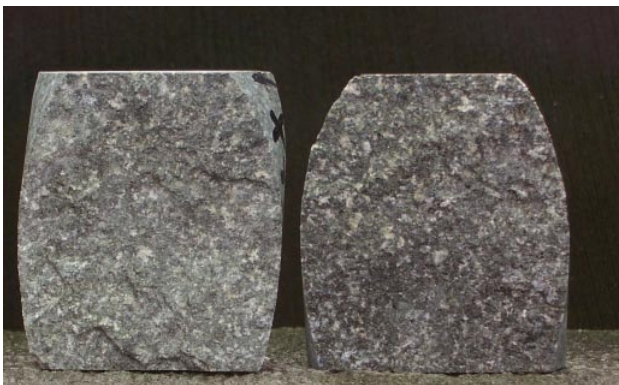
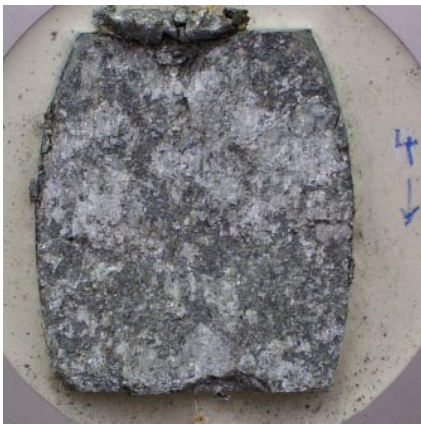
Specimen ID: KLX12A-117-4

Upper half: At the rear end of the specimen, small pieces have spalled off.

Lower half: At the rear end of the specimen, small pieces have spalled off.

The fracture has some larger irregularities that may have some influence on the test results.

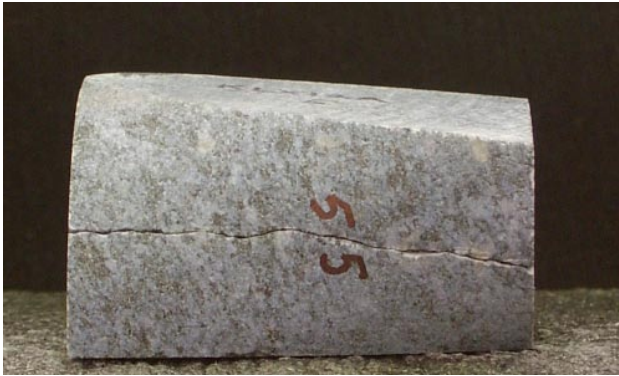
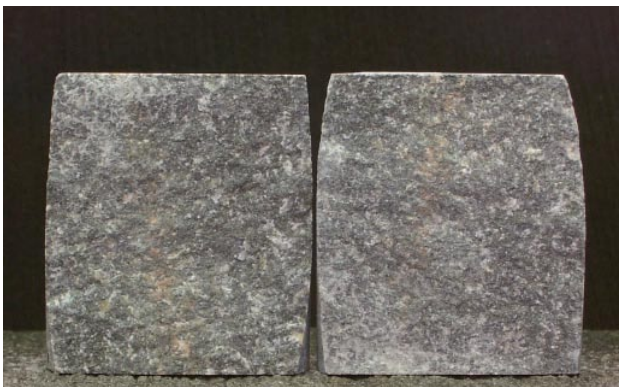
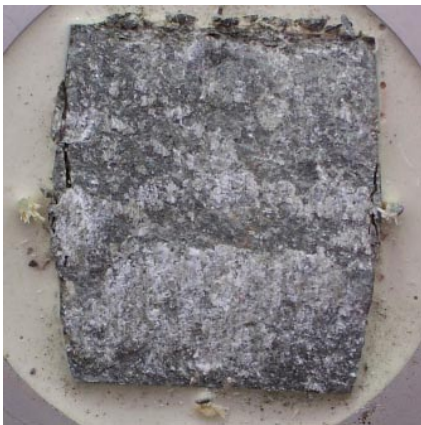
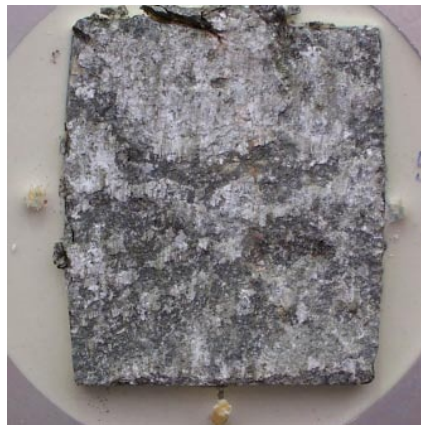
Specimen ID: KLX12A-117-5

Upper half: At the rear end of the specimen, small pieces have spalled off.
Lower half: At the rear end of the specimen, small pieces have spalled off.

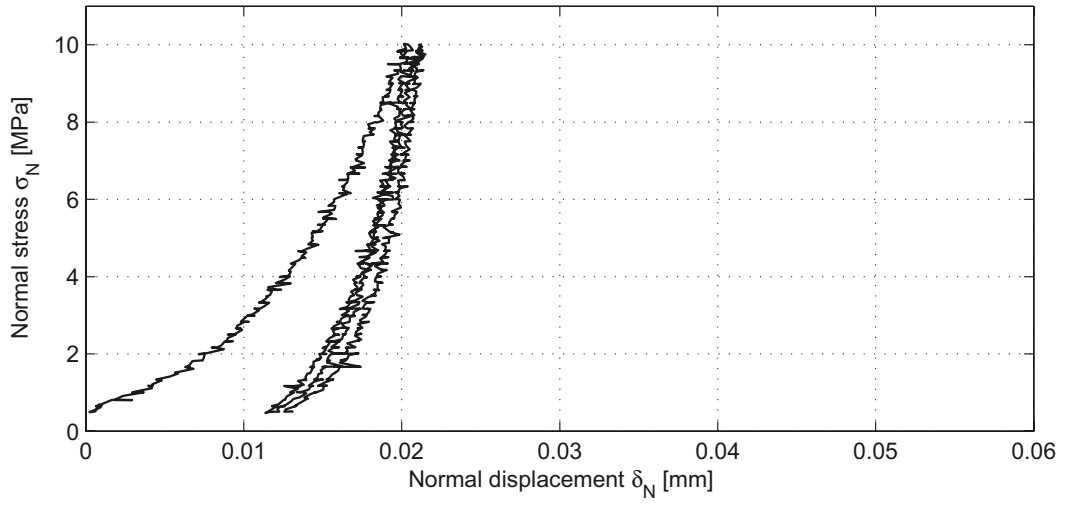
Specimen ID: KLX12A-117-5

Joint area : 27.5 cm²

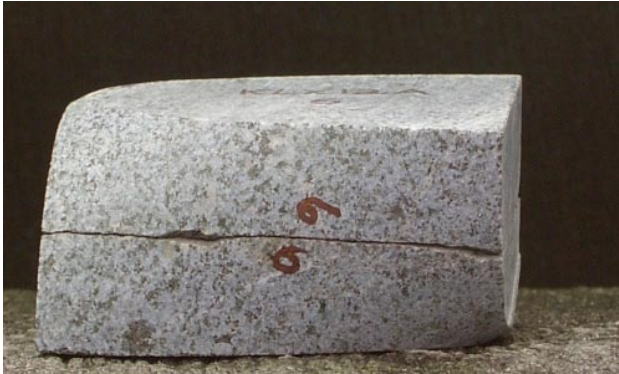
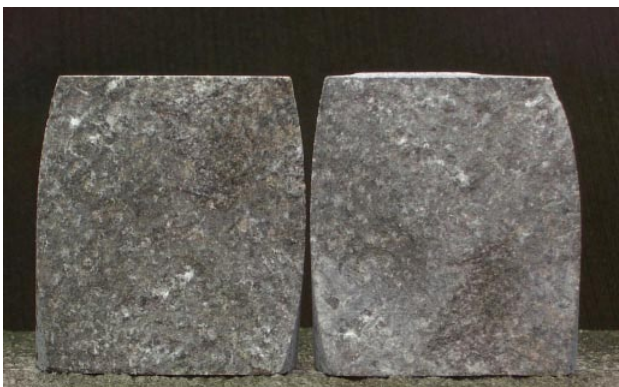
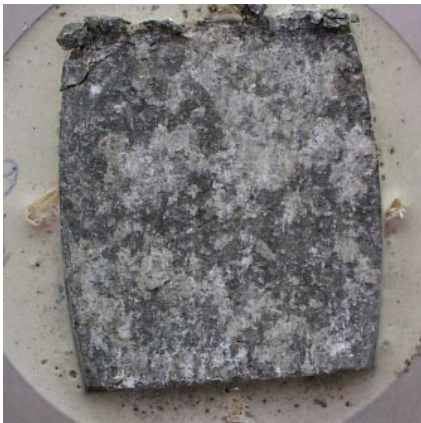
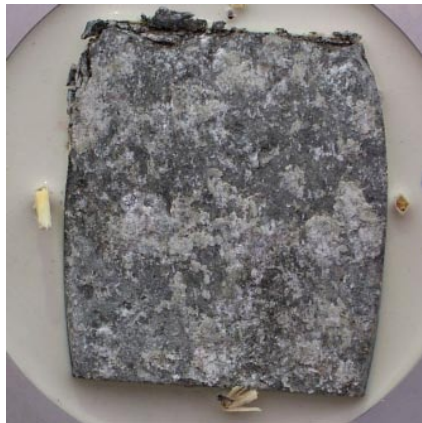
Specimen ID: KLX12A-117-6

Upper half: At the rear end of the specimen, small pieces have spalled off.

Lower half: At the rear end of the specimen, small pieces have spalled off.
