**International
Progress Report**

IPR-10-18

Äspö Hard Rock Laboratory

Sensors Data Report No 23

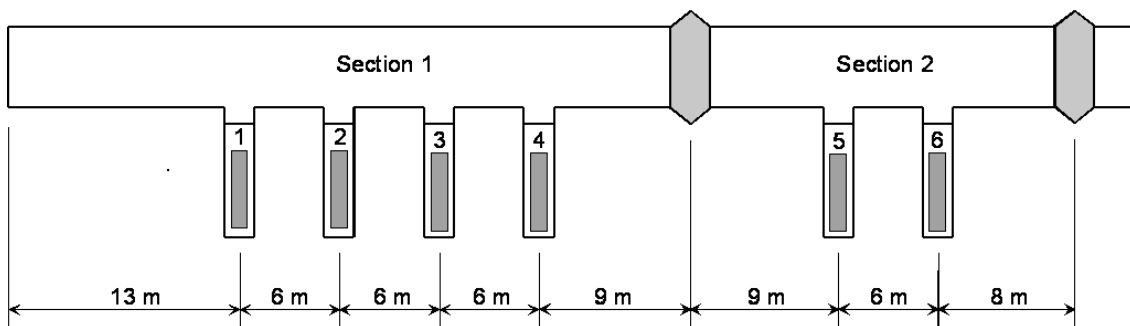
Figure 1-1. Schematic view of the Prototype Repository.

Section 1 consists of four full-scale deposition holes, copper canisters equipped with electrical heaters, bentonite blocks and a deposition tunnel backfilled with a mixture of bentonite and crushed rock and ends with a concrete plug as shown in Figure 1-1.

Section 2 consists of two full-scale deposition holes with a backfilled tunnel section and ends also with a concrete plug.

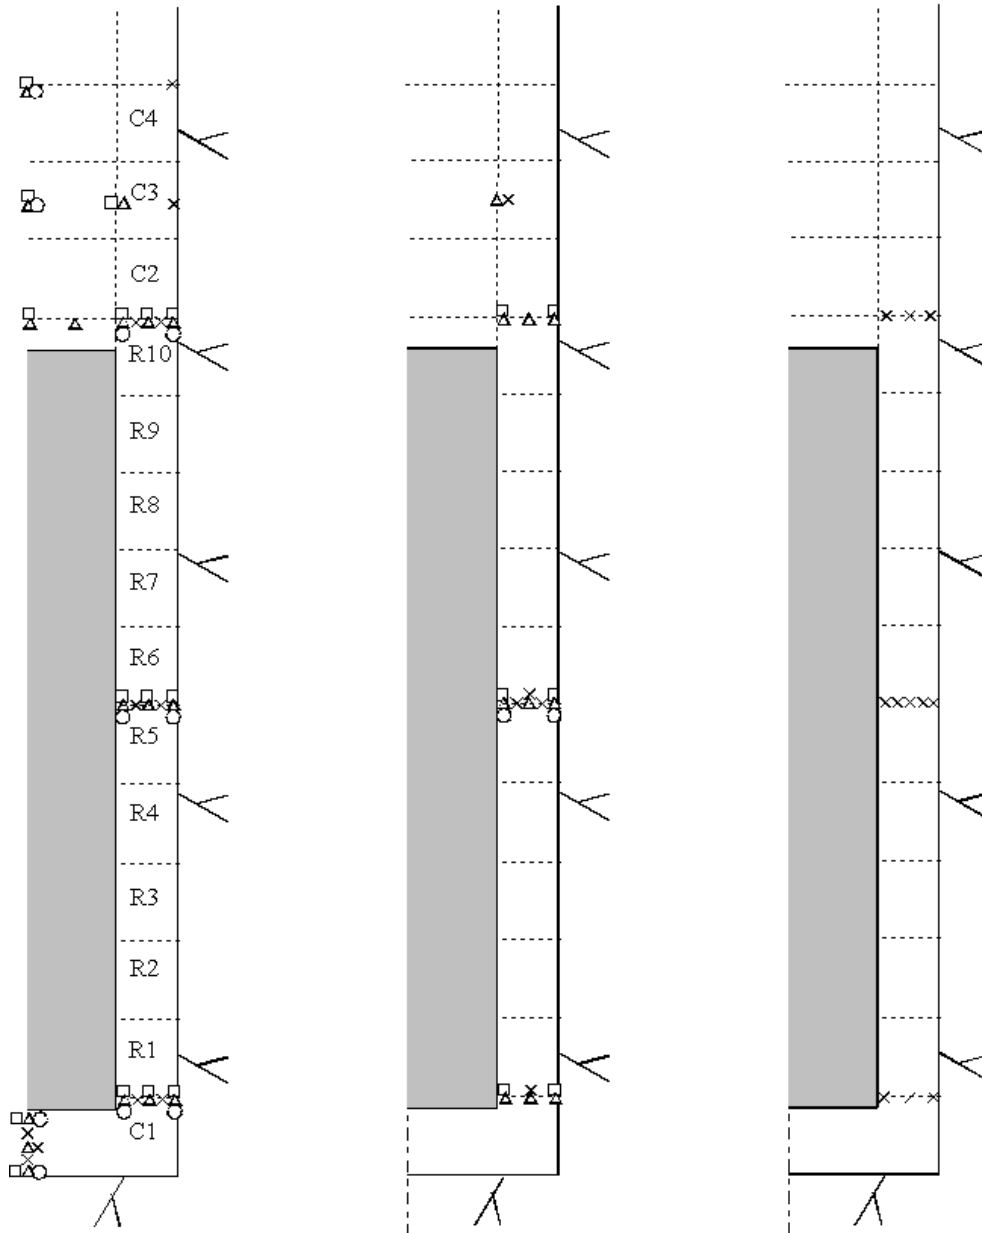
Figure 4-1. Schematic view over the instruments in four vertical sections and the block designation.

The instruments are located in three main levels in the blocks, 50 mm, 160 mm and 250 mm, from the upper surface. The thermocouples are mostly placed in the 50 mm level and the other gauges in the 160 mm level except for the Geokon type 1 pressure sensors and the Rotronic humidity sensors, which are placed in the 250 mm level depending on the size of the sensor house.

The bentonite blocks are called cylinders and rings. The cylinders are numbered C1-C4 and the rings R1-R10 respectively, see Figure 4-1.

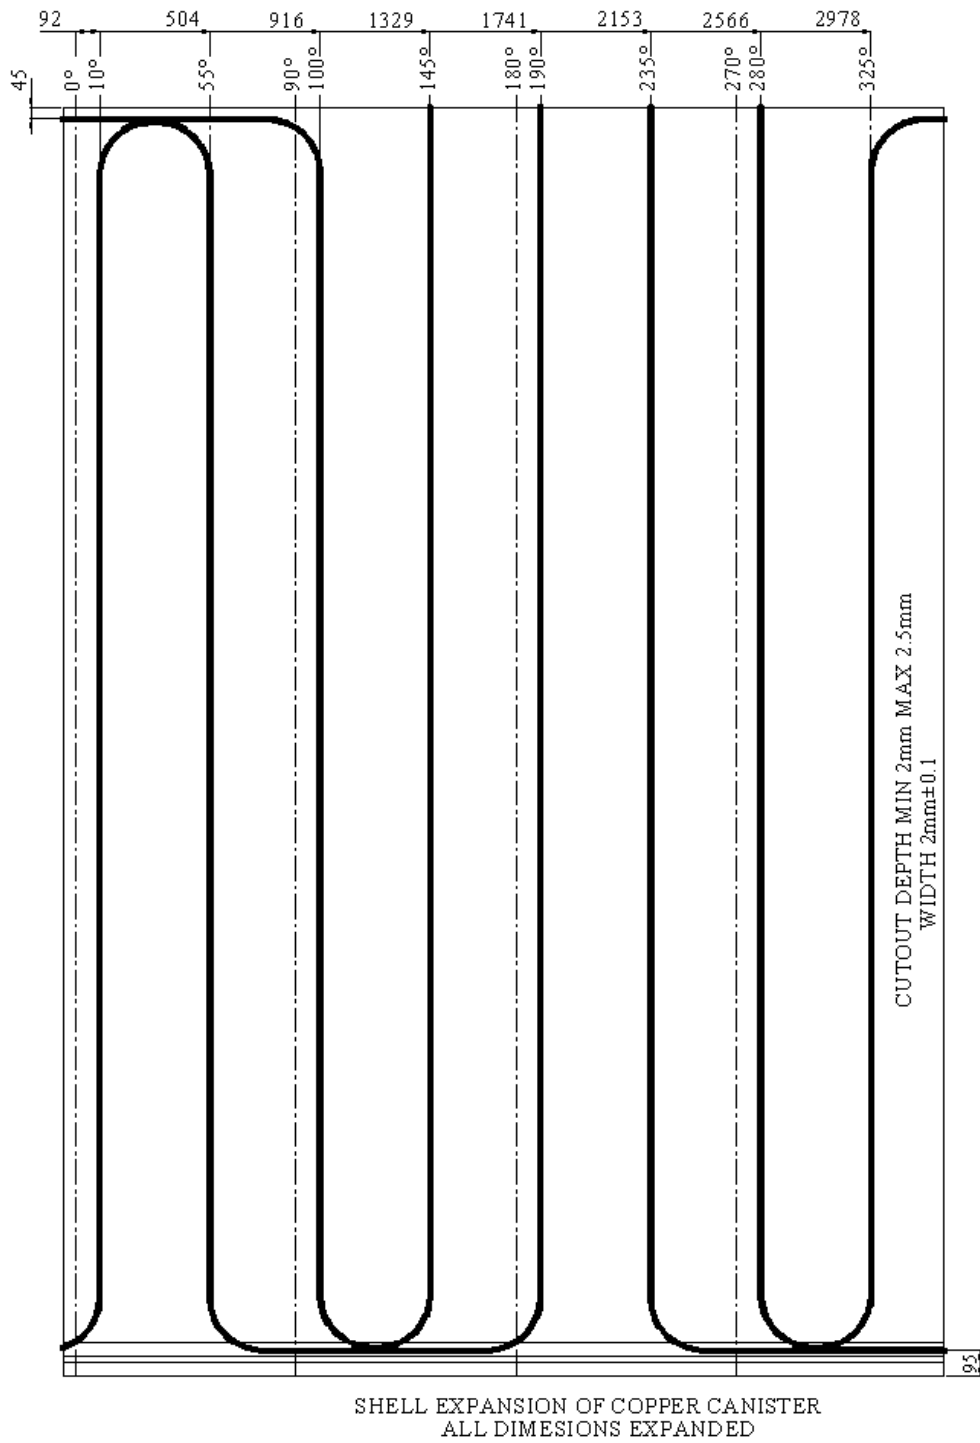
Figure 4-2. Laying of the optical fiber cables with protection tube of Inconel 625(outer diameter 2 mm) for measurement of the canister surface temperature (surface unfolded).

With this laying the cables will enter and exit the surface at almost the same position. Curvatures are shaped as a quarter circle with a radius of 20 cm. The cables are placed in a milled out channels on the surface. The channels have a width and a depth of just above 2 mm

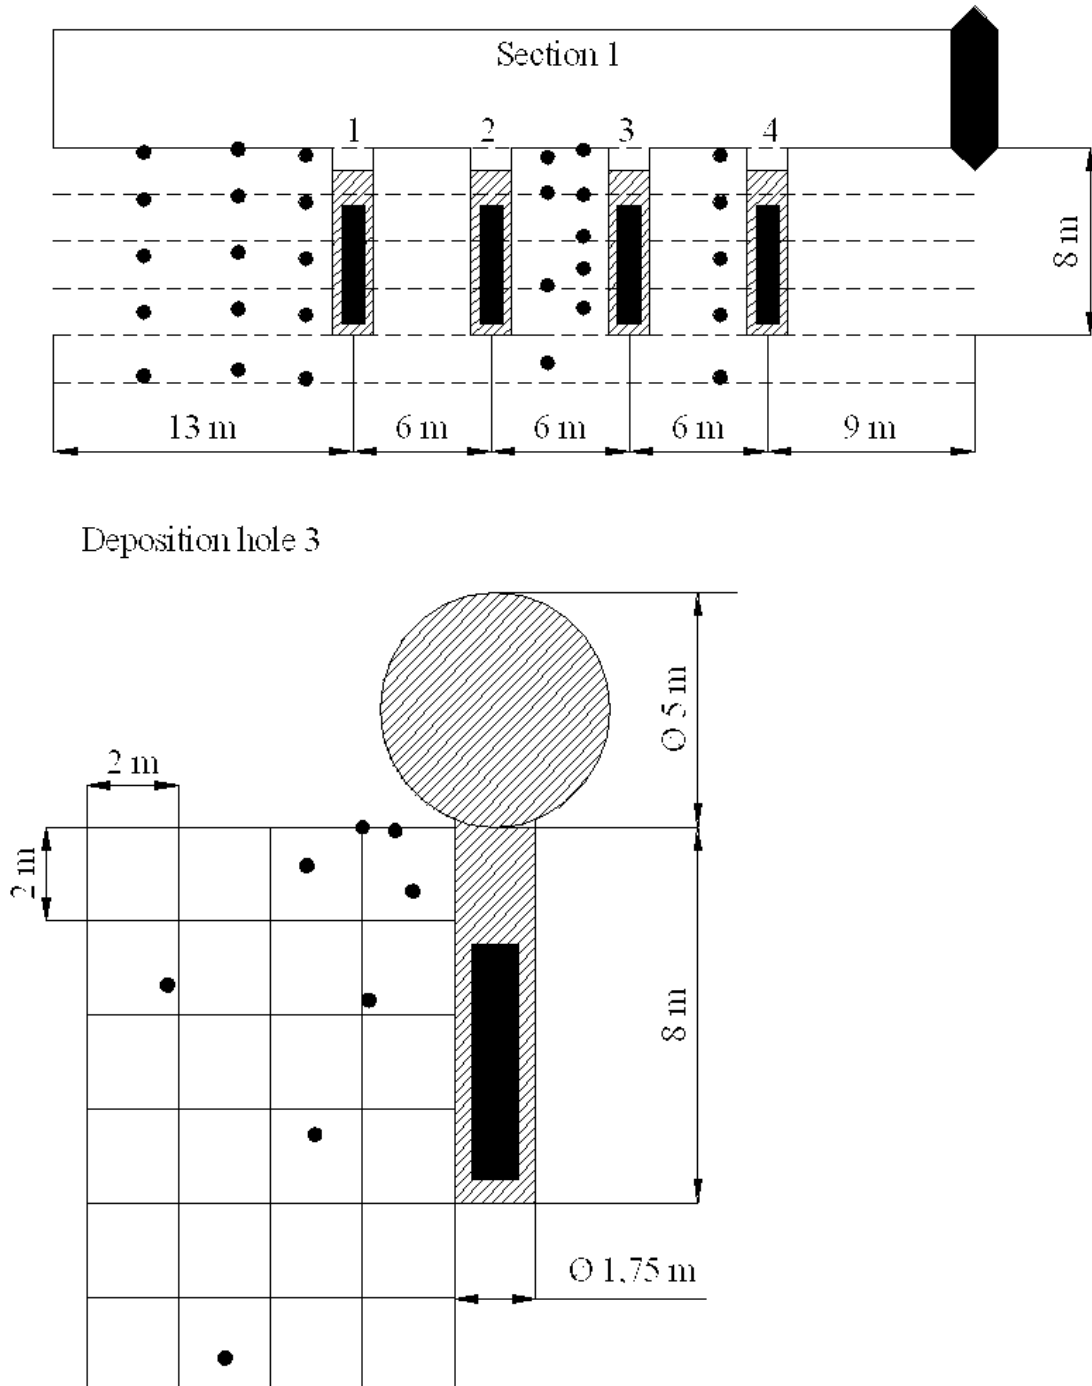
Figure 4-3. Overview of the temperature sensors in the rock. Length section (upper) and cross section (towards the end of the tunnel).

The positions of the temperature sensors in the rock are termed in the same way as the sensors in the buffer in the deposition holes. Figure 4-3 shows an overview of the temperature sensors placed in the rock. The sensors are assigned to the closest deposition hole. The positions are described in Table 4-10.

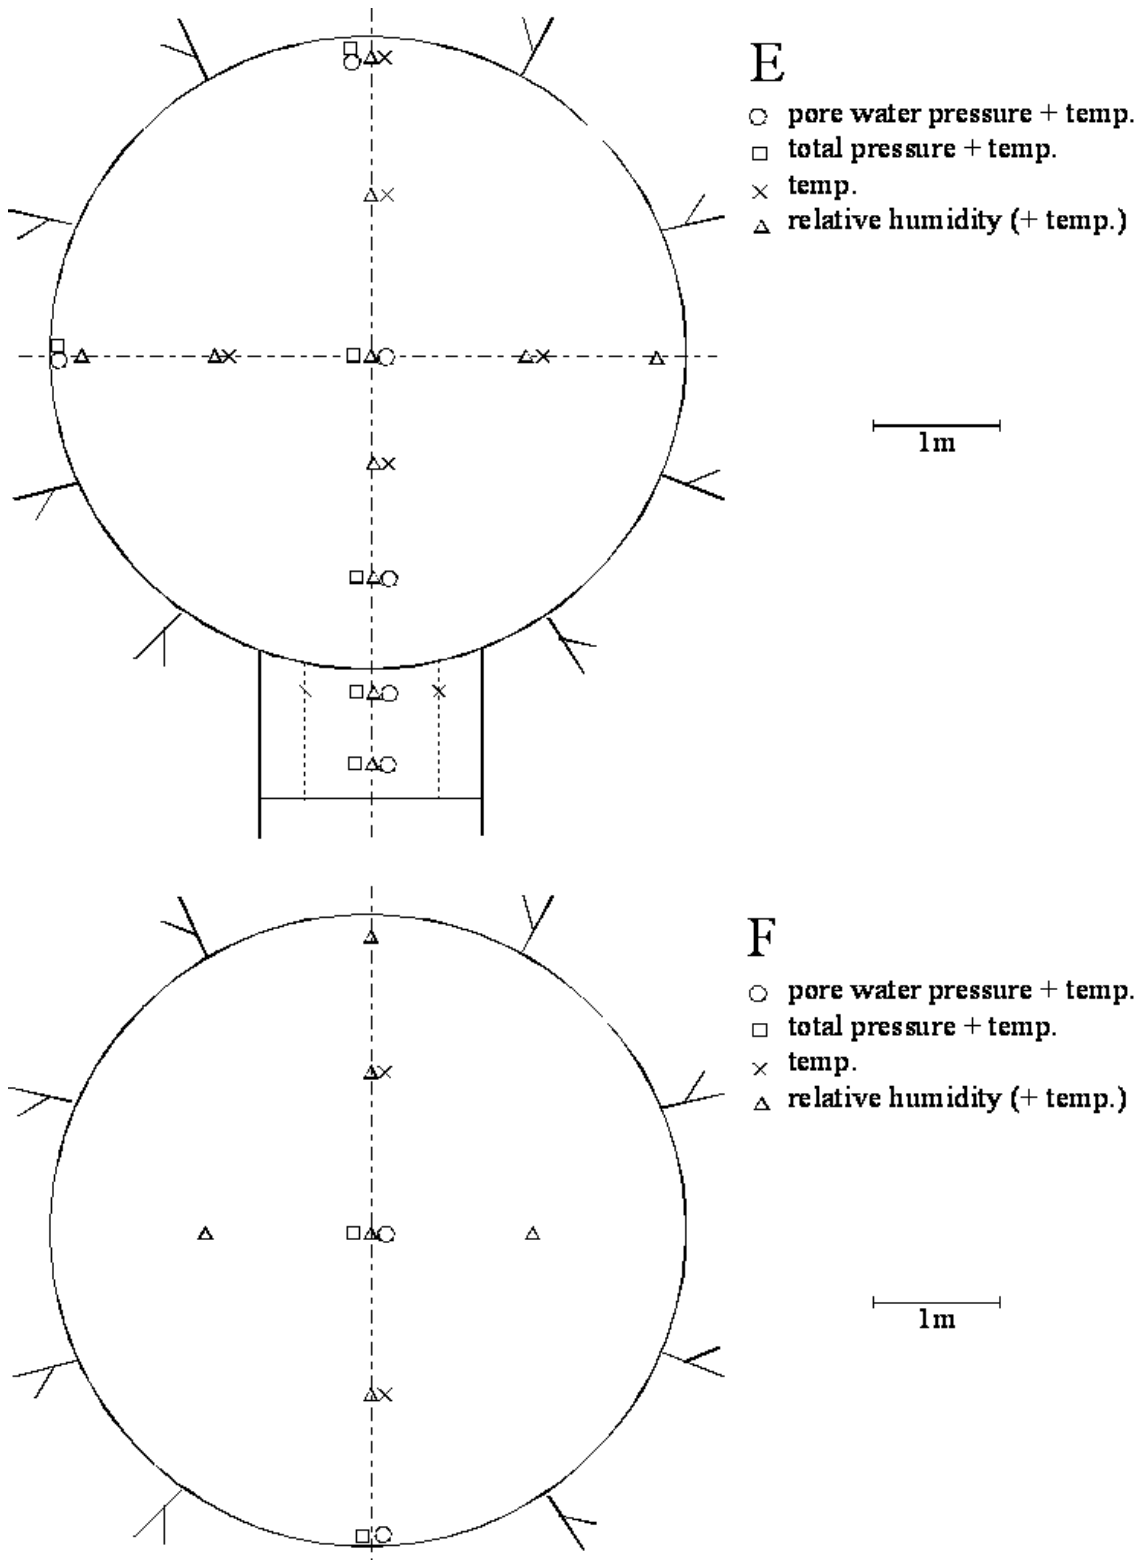
Figure 4-5. Schematic view over the sensors positions in the different sections.

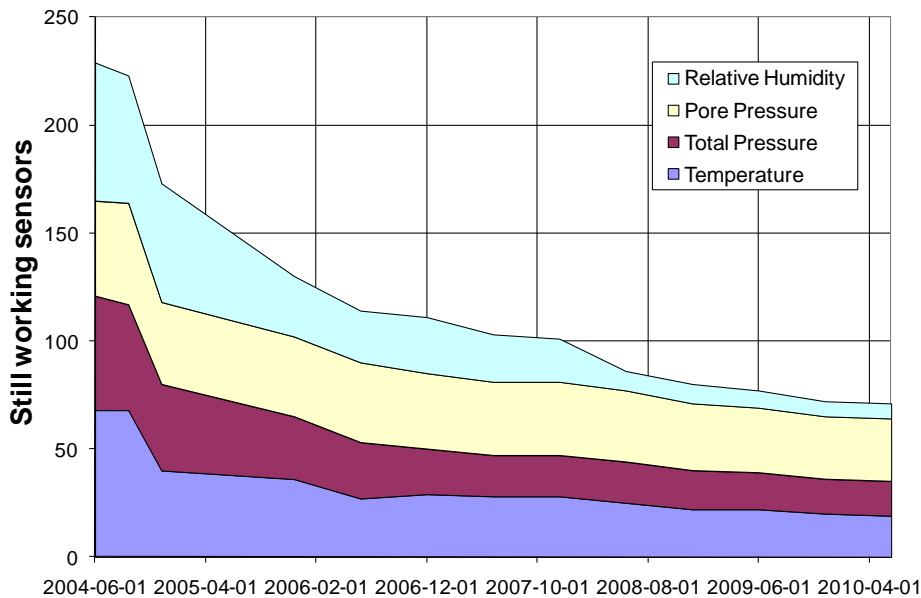
Figure 5-1. The number of still working sensors placed in the buffer and backfill in Section 1 as function of time. The coloured fields are representing the four types of installed sensors.

At present about 255 (excluding water pressure sensors in the rock and the displacement sensors for the canister) out of totally 363 installed sensors are out of order. In Figure 5-1 the numbers of still working sensors in the buffer and the backfill of Section 1 are plotted as function of time from June 2004. The figure shows that the majority of the broken sensors are RH-sensors and thermocouples (in deposition hole 3). The figure also shows that the numbers of broken sensors increased after the closing of the drainage of the tunnel.

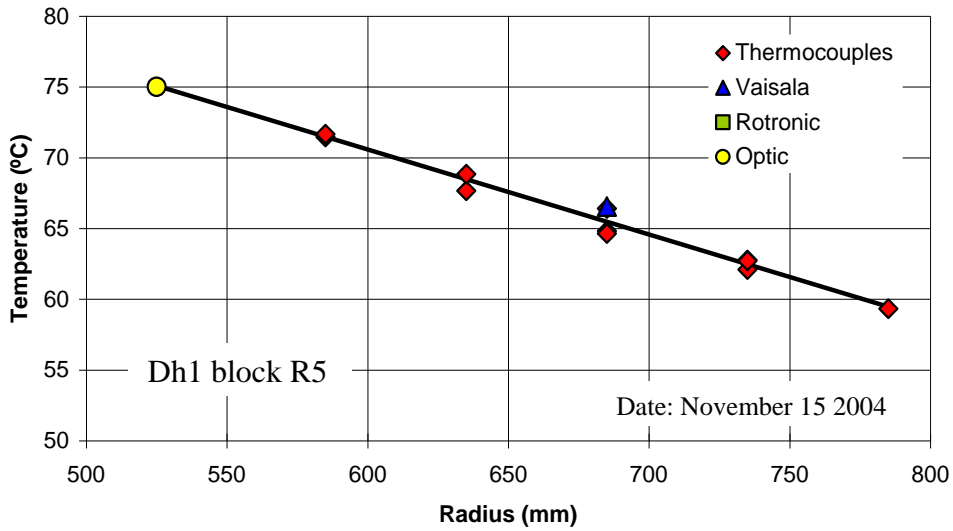
Figure 5-2. The temperature in block R5 in Dh 1 as function of radius from the centre of the deposition hole on November 15, 2004.

In Figure 5-2 the temperature in the buffer is plotted as function of the radius from the centre of the deposition hole. The measurements are made with different type of sensors in block R5 (at mid height of the canister). A straight line is fitted to the measured values. The temperature gradient is determined from the fitted line in the figure. This gradient together with the temperature on the canister surface and the temperature in the buffer close to the outer radius of the ring shaped block ($r = 785$ mm) are plotted as function of time in Figure 5-4. The shaded part of the plot represents the time when the power to the canister was switched off at the beginning of December 2004. The plot shows that the temperature after this is somewhat lower than before, probably due to the fact that no power is applied to canister 2 after December 2 2004. However the temperature gradient over the buffer is similar before and after the switch on/off the power of the canisters. The determination of the gradient was made up to the beginning of December 2005. After that the number of still working sensors are too few, to be able to determine the temperature gradient.

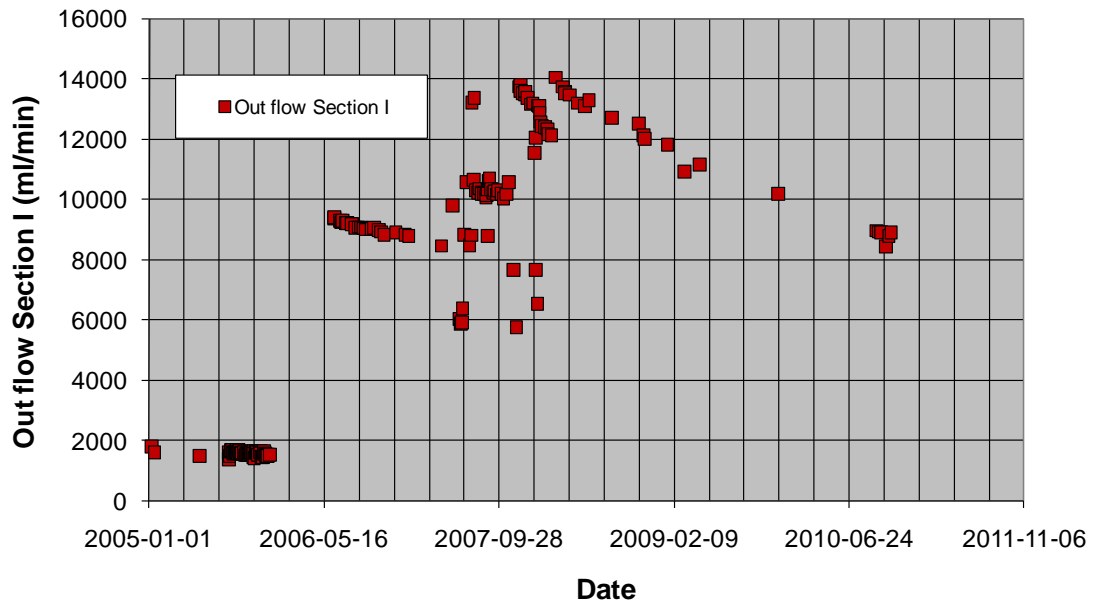
Figure 5-9. The measured outflow from the inner section of the Prototype tunnel.

The outflow from the inner section of the Prototype tunnel as function of time is shown in Figure 5-9. The figure is showing that the outflow from Section I increased from about 1.8 l/min to about 9 l/min when the installed packer was broken. The large scatter and the increase in the outflow starting at the beginning of summer 2007 are probably caused by the work with the new tunnel placed close to the Prototype tunnel.

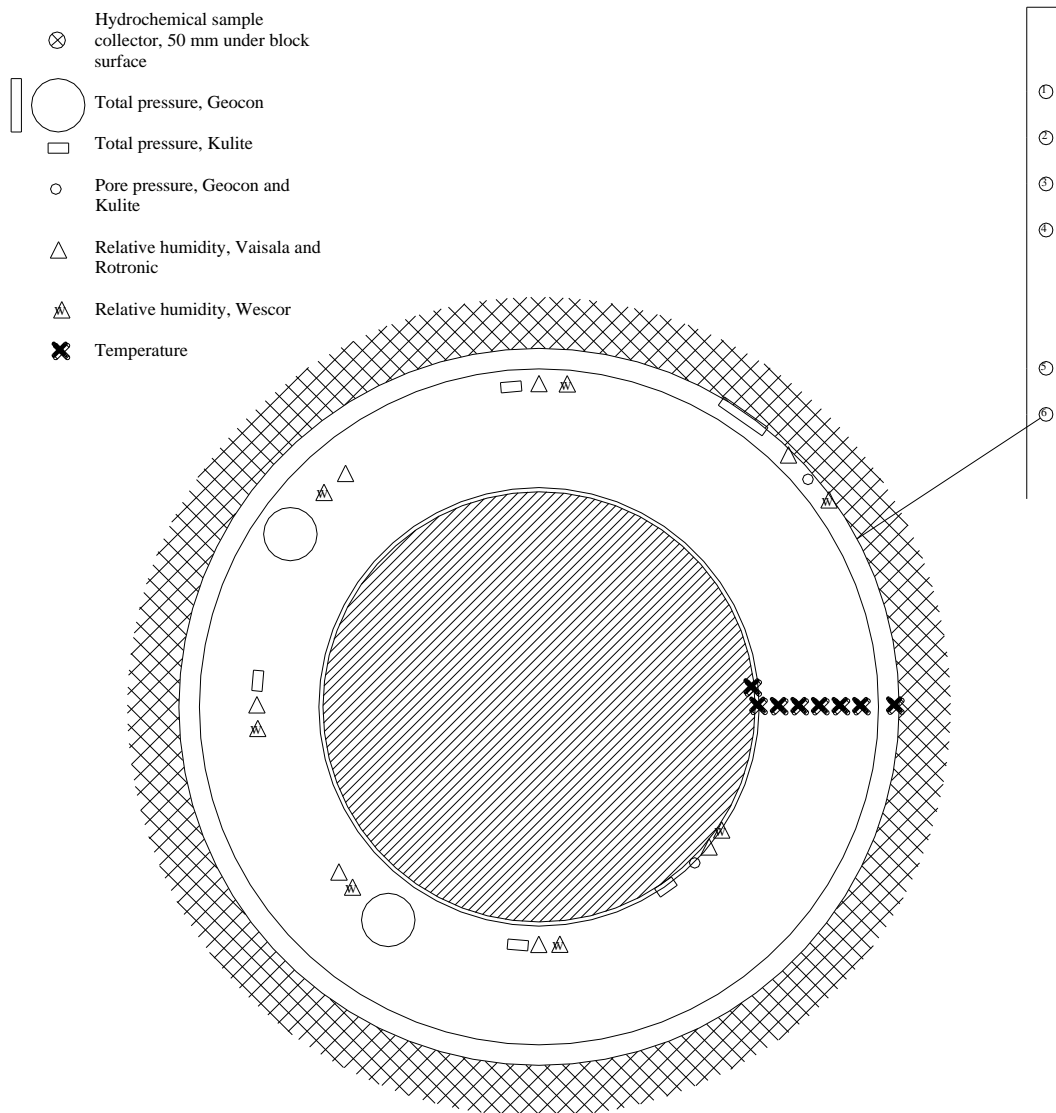
Figure 6-1. Schematic view over the instruments positions in deposition hole 6. The instruments are placed in eight vertical sections, where four sections are represented in each instrumented block.

Thermocouples in the rock are placed on 3 levels in each deposition hole (bottom, 3 m and 6 m level). Thermocouples are placed in the bottom of the deposition holes in a vertical hole at the centre of the deposition hole. On level 3 m and 6 m the thermocouples are placed in two vertical directions perpendicular to each other.

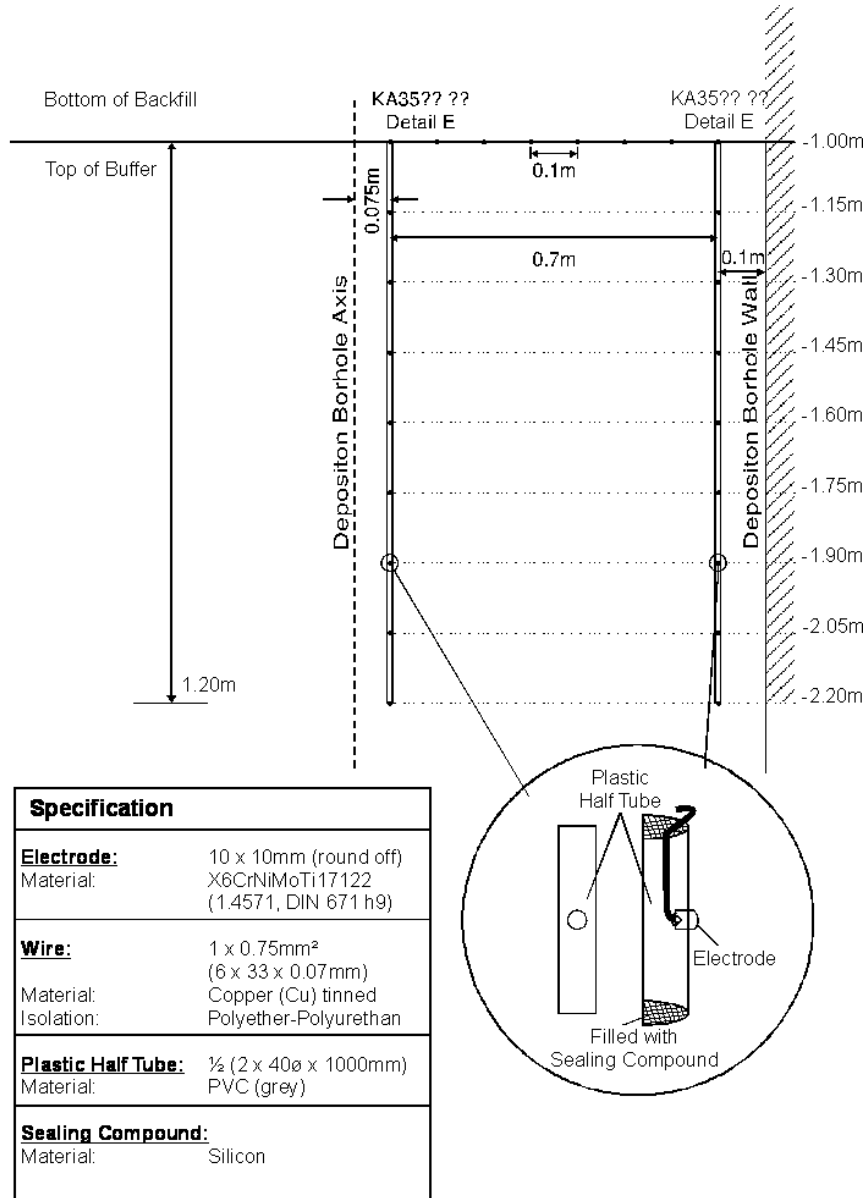
The array is made up of the electrodes located in the buffer at the top of deposition hole #5 (see figure) and of the electrodes in the upper part of borehole KA 3550 G04 in the rock (see figure in section 4.1).

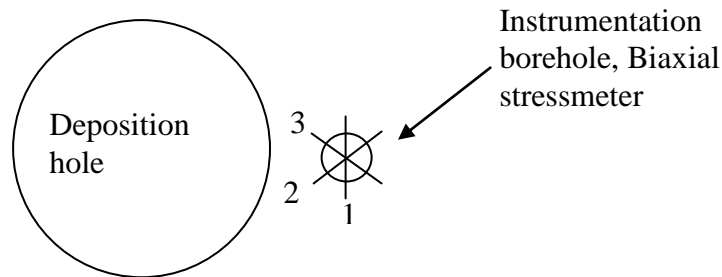
Figure 2-7. Plan view of positioning of instrumentation in boreholes around deposition holes.

Installation of the stressmeter gauge is accomplished by inserting the gauge into a grout-filled borehole using a setting tool and self-aligning setting rod. The stress cell is orientated so that the first vibrating wire is orientated tangentially to the canister hole. The second wire is orientated 60° from tangential direction and the third wire is orientated 120° from tangential direction.

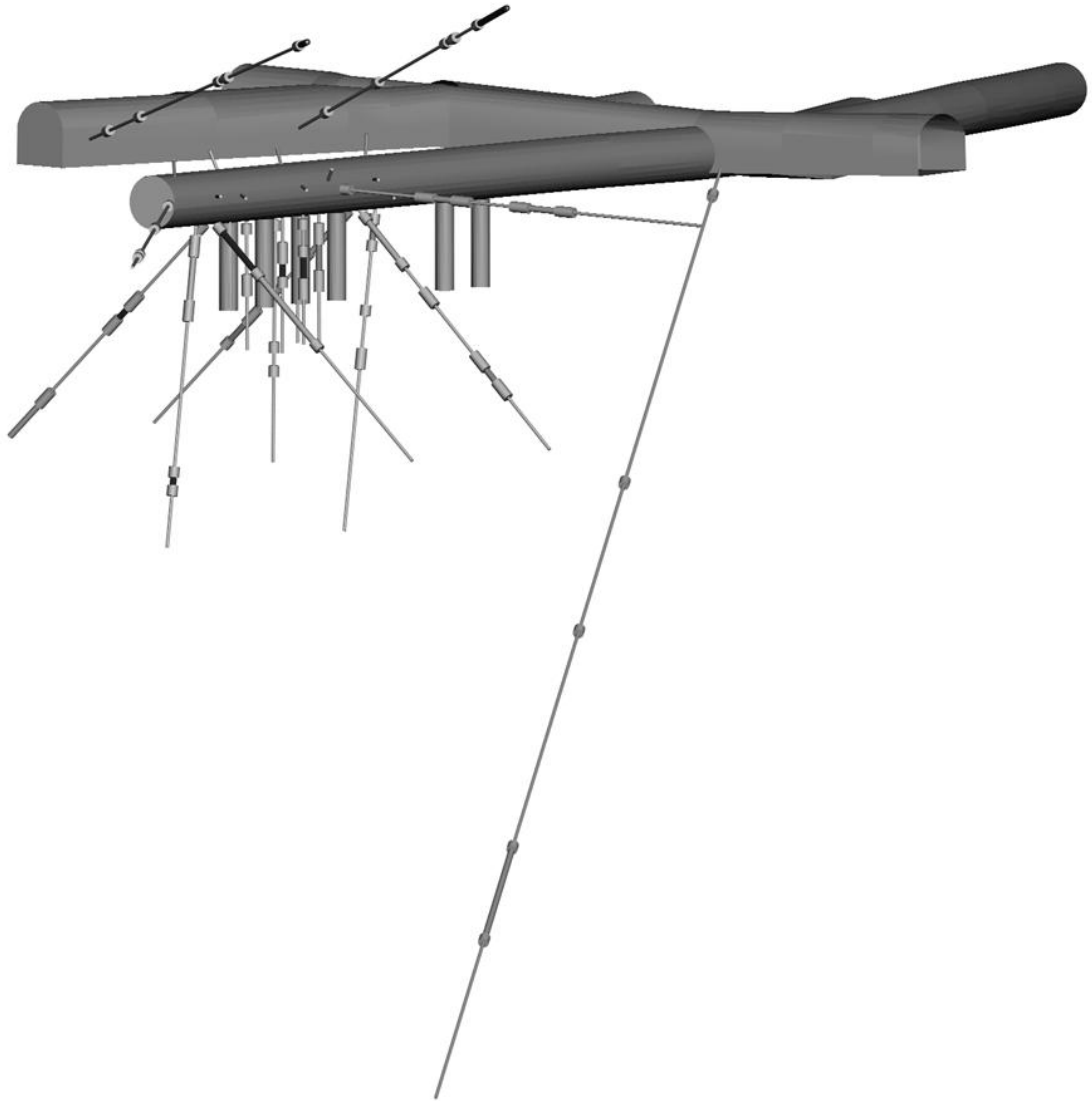
Figure 1. View of the drilled core holes in the Prototype Repository Section I. The length from the I-tunnel to the end of the TBM-tunnel is 90 m. The diameter of the TBM tunnel is 5m and the diameter of the deposition holes is 1.75 m. The depth of the deposition holes is 8.37 m in the centre and 8.15 m along the deposition hole wall. The diameter of the core holes is 76 mm except for the short core holes in the roof of the TBM tunnel that have a diameter of 56 mm. The monitoring boreholes used in the presentation in this report are located in the inner part of the tunnel surrounding the area with the four innermost canister holes. Also included are two holes drilled from the G-tunnel and the long hole KA3510A drilled from the main tunnel.

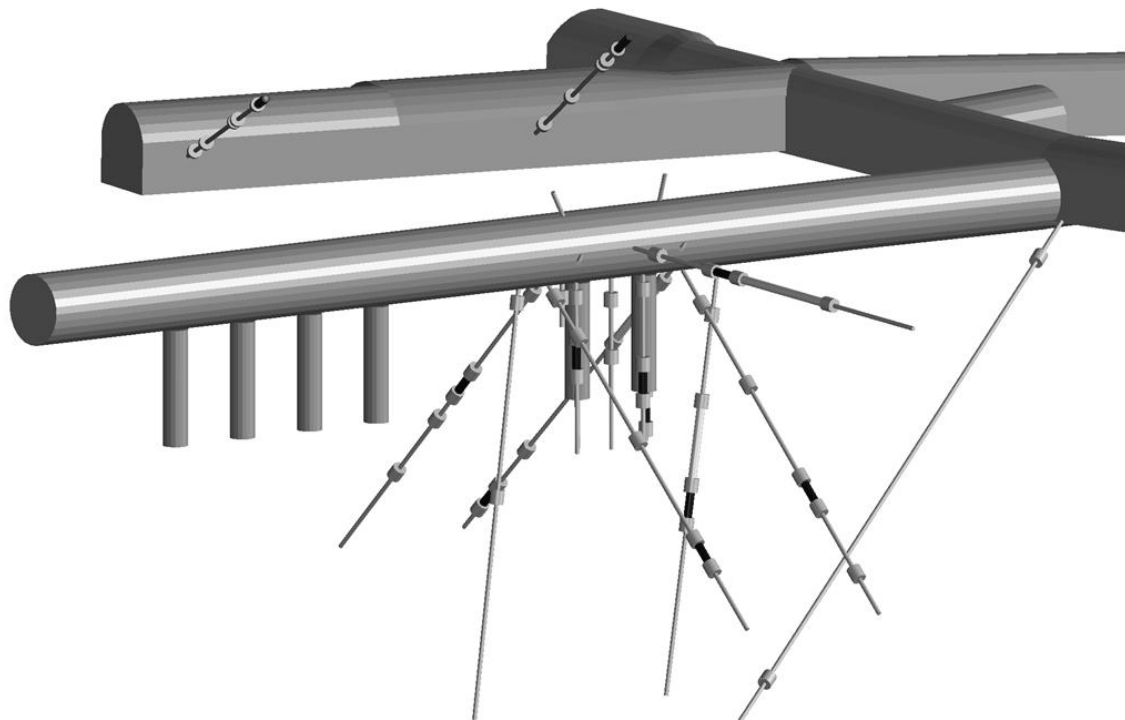
Figure 3. View of the drilled core holes in the Prototype Repository Section II. The length from the I-tunnel to the end of the TBM-tunnel is 90 m. The diameter of the TBM tunnel is 5m and the diameter of the deposition holes is 1.75 m. The depth of the deposition holes is holes is 8.37 m in the centre and 8.15 m along the deposition hole wall. The diameter of the core holes is 76 mm except for the short core holes in the roof of the TBM tunnel that have a diameter of 56 mm. The monitoring boreholes used in the presentation in this report are located in the inner part of the tunnel surrounding the area with the four innermost canister holes. Also included are two holes drilled from the G-tunnel and the long hole KA3510A drilled from the main tunnel.
