Technical Report

TR-19-15

Supplementary information on canister integrity issues

SVENSK KÄRNBRÄNSLEHANTERING AB

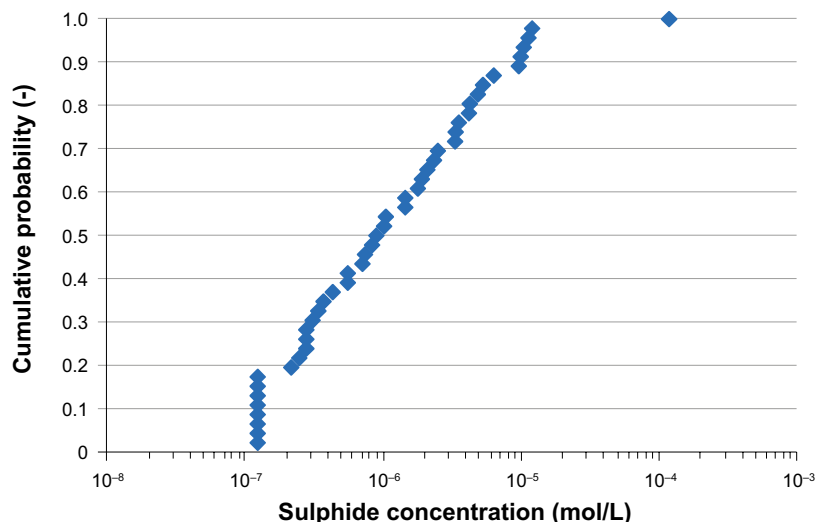
Figure 2-4. Groundwater sulphide concentrations used in the safety assessment SR-Site. Data below the detection limit of the analyses, which is between 9×10^{-7} and 6×10^{-8} mol/L, are set to the lowest value in the distribution, 1.2×10^{-7} mol/L. The maximum value is 1.2×10^{-4} mol/L, whereas all other values are at least one order of magnitude lower.

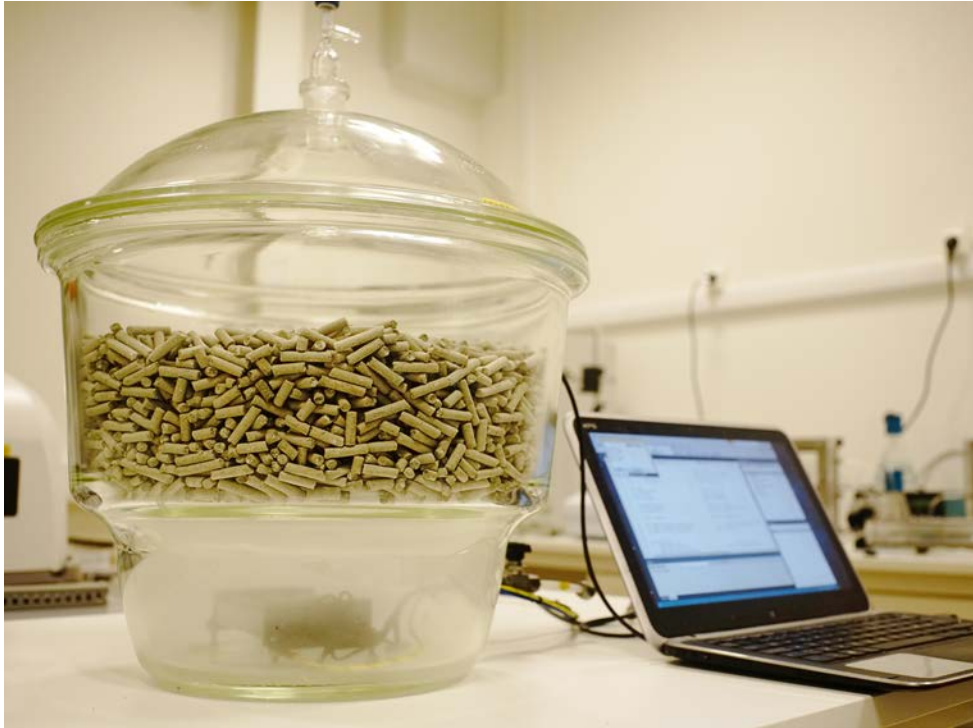
Figure 2-10. Test containing bentonite pellets in a desiccator, heated from below, regulated with a temperature probe in the pellets, and also containing a flask with a solution of divalent copper ions to capture any hydrogen sulphide formed.

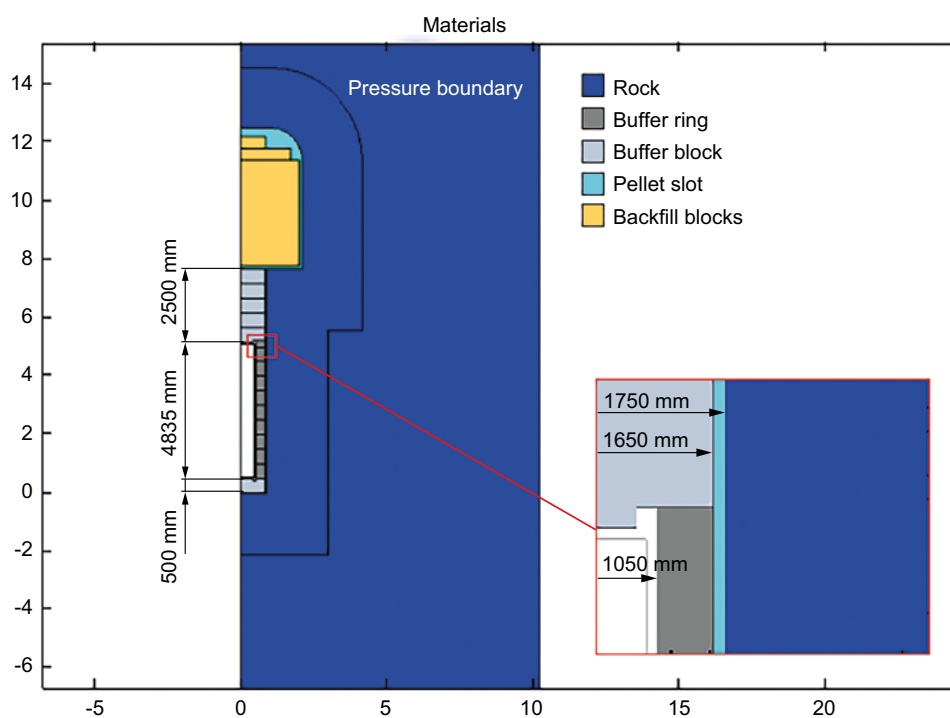
Figure 2-13. Geometry and the different materials used in the model. The x- and y-axes have units of metres. (Eriksson and Hedin 2019)

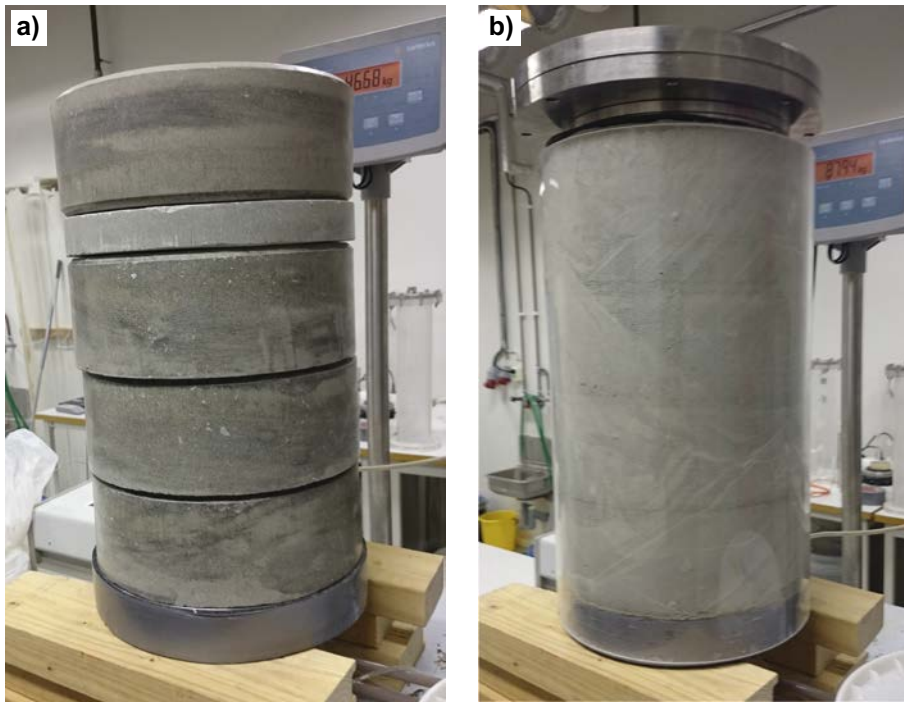
Figure 3-2. The configuration of the most recent test, Test 9: a) Four bentonite rings and a massive block stacked on top of each other, b) The full set-up before starting the experiment. (Birgersson and Goudarzi 2017).

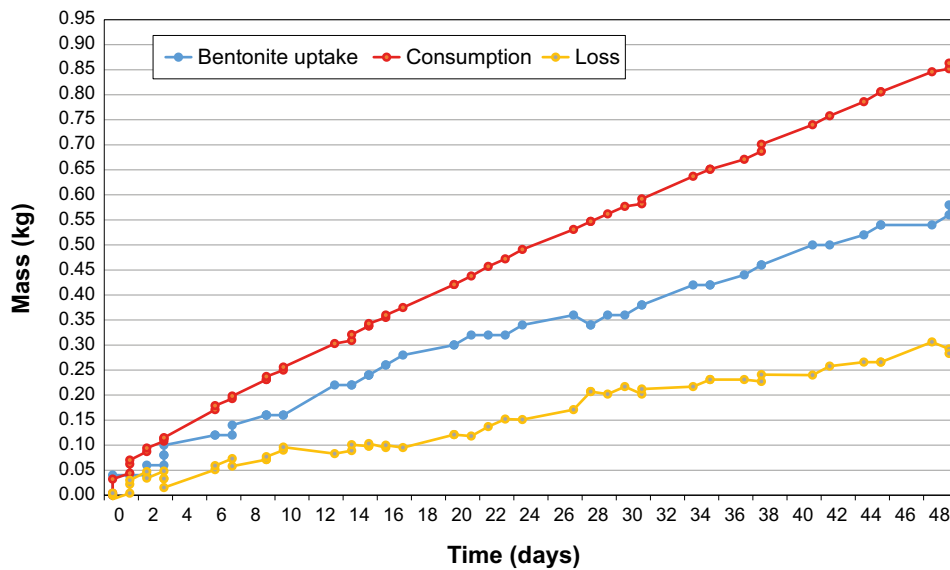
Figure 3-3. Total water consumption, water uptake in the bentonite, and loss of water to the environment, measured in Test 9 (Birgersson and Goudarzi 2017).

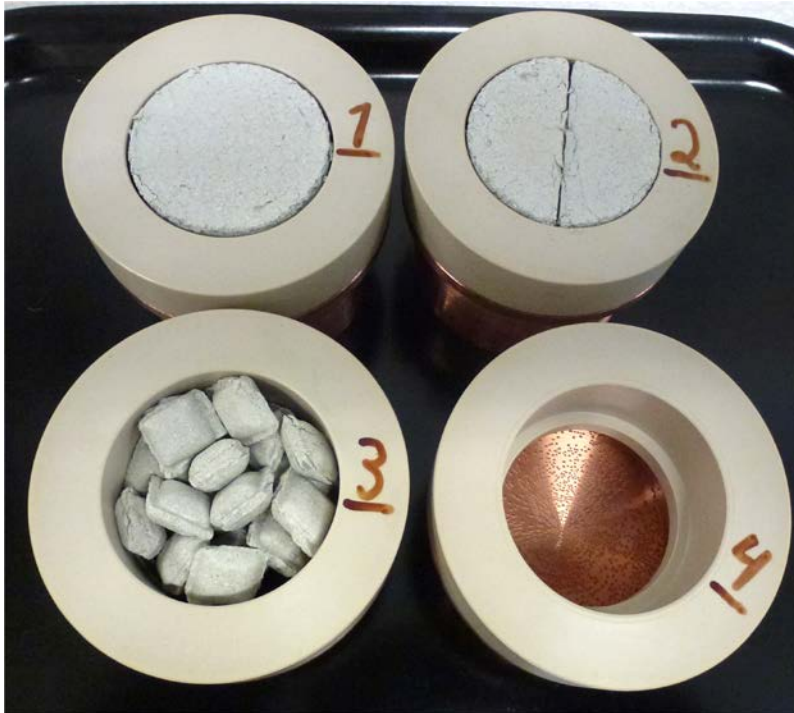
Figure 3-7. Photo showing the four different test types included in all test series: 1. Block, 2. Fractured Block, 3. Pellets and 4. Reference. (Åkesson et al. 2019)

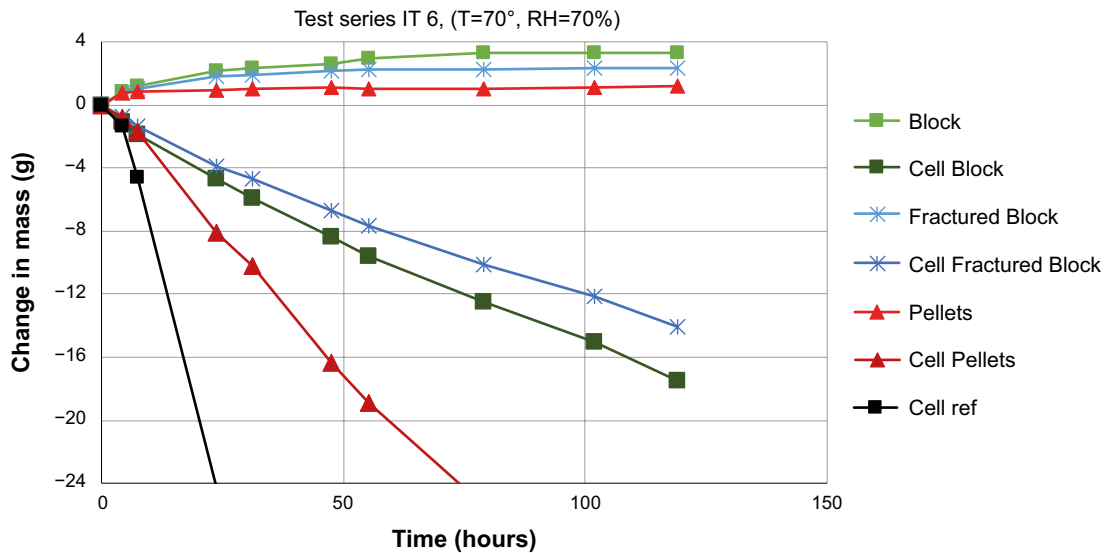
Figure 3-8. Data determined during the test period for isothermal test series 6. The “cell” lines show the change of weight of the total test cell, including water, while block, fractured block and pellet show the mass change in the bentonite only. (Åkesson et al. 2019)

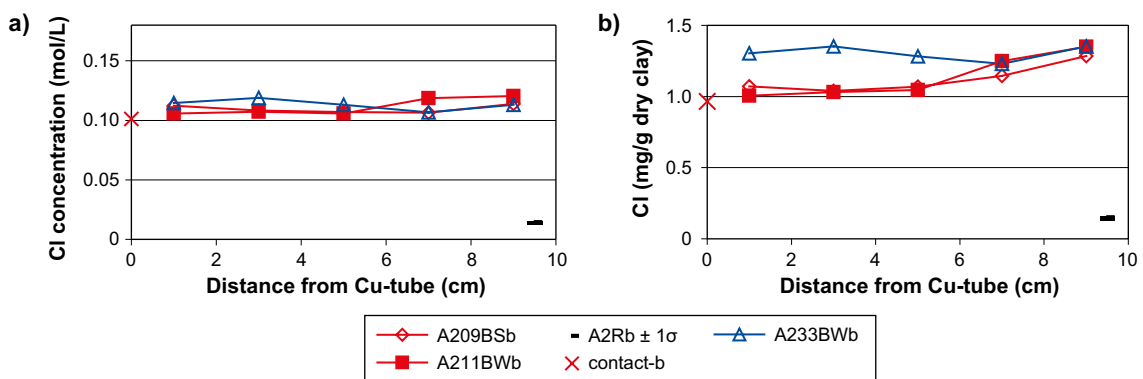
Figure 3-11. The radial distribution of Cl in water extracts of bulk samples from blocks 09, 11 and 33 of the LOT A2 parcel taken at 90, 110 and 330 cm from the bottom of the deposition hole. Blocks 9 and 11 were exposed to the highest temperatures in the test, while block 33 was located in a cold section. The concentration of the reference samples (A2Rb) is shown at position 9.5 cm as the mean ± 1 standard deviation of five samples (Karnland et al. 2009). The concentrations are given as a) mol/L, b) mg/g dry bentonite.

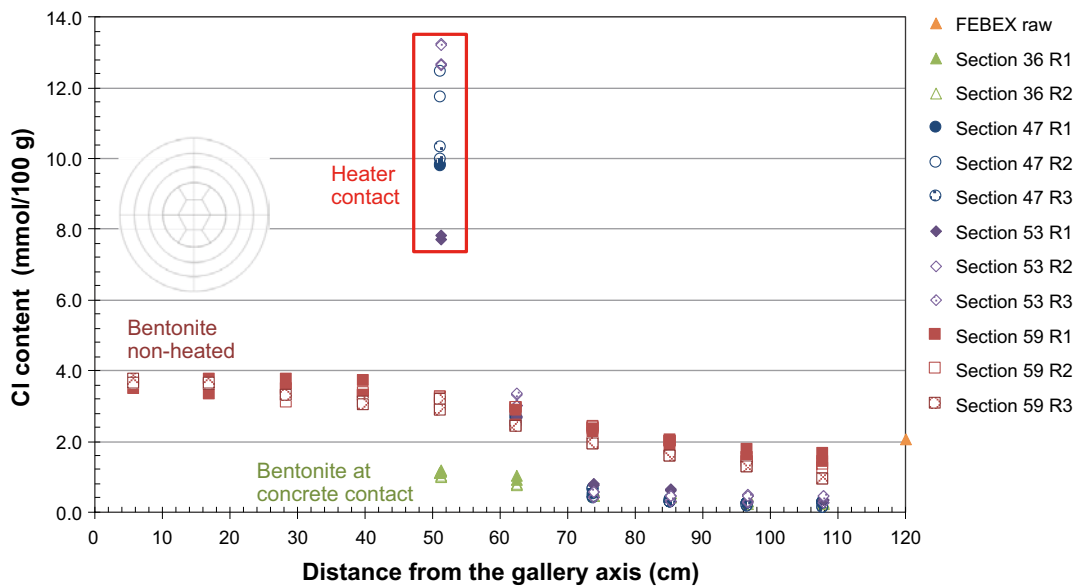
Figure 3-13. Chloride content (1:4 aqueous leaching) from samples at different sections in three radii after dismantling of Heater #2 in 2015. The initial chloride concentration in the FEBEX bentonite is shown as a yellow triangle far to the right in the Figure (Fernandez et al. 2018).

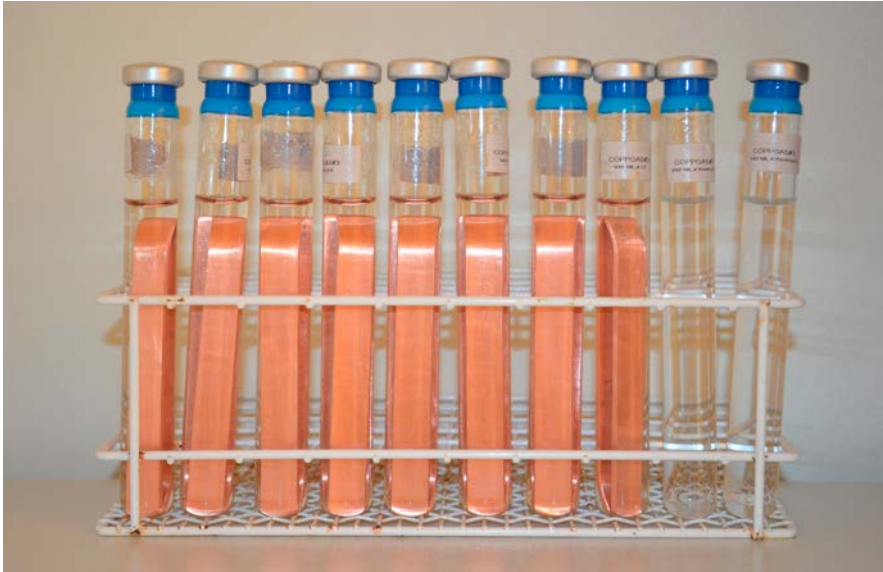
Figure 4-2. Pairs of copper pieces immersed in pure water; contained in butyl rubber sealed borosilicate glass tubes. The 6 cm³ gas phase at the top is sampled and analysed at regular intervals. Two tubes contain only water and gas. The image was taken after 27 months of exposure to pure, oxygen free water at 70 °C. (Johansson et al. 2015)

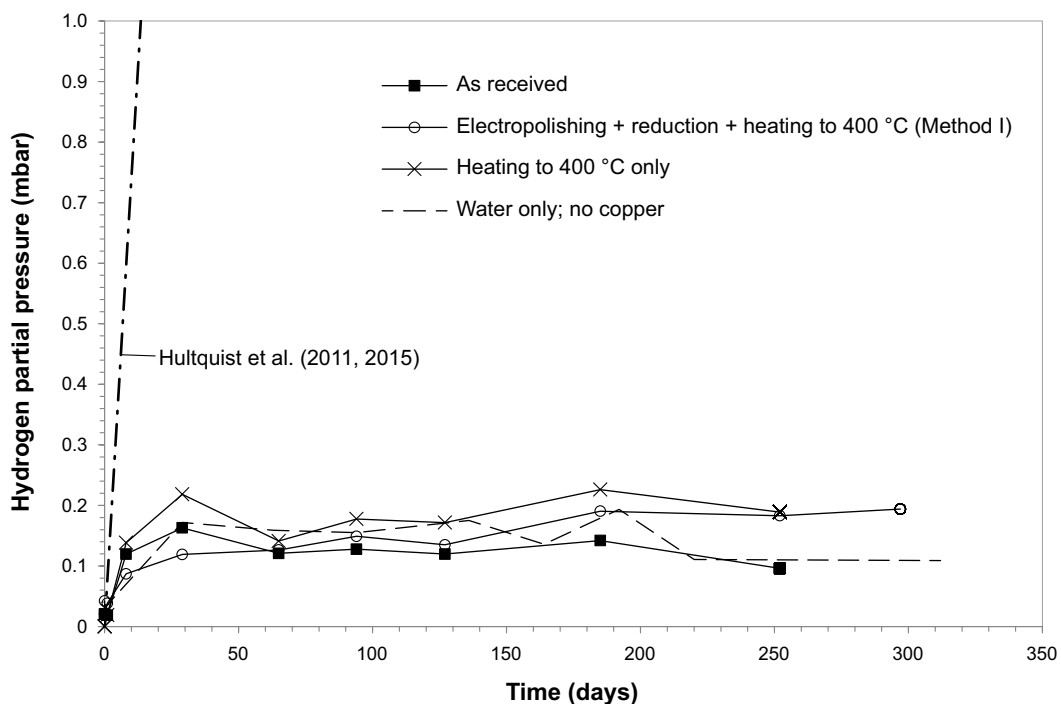
Figure 4-3. Hydrogen evolution from samples of 99.95 % Cu-OF (oxygen free copper) with different surface treatments. The expected hydrogen evolution rate according to Hultquist et al. (2011, 2015) is also shown. (Hedin et al. 2018)

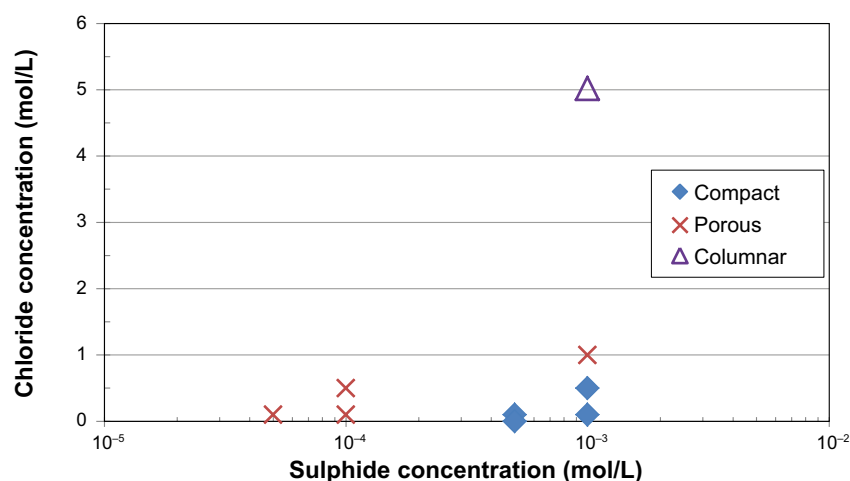
Figure 5-5. Morphology of copper sulphide films as interpreted from cross sections studied with SEM, as a function of bulk sulphide and chloride concentrations in solution. Data from Chen J et al. (2014) and King et al. (2017).

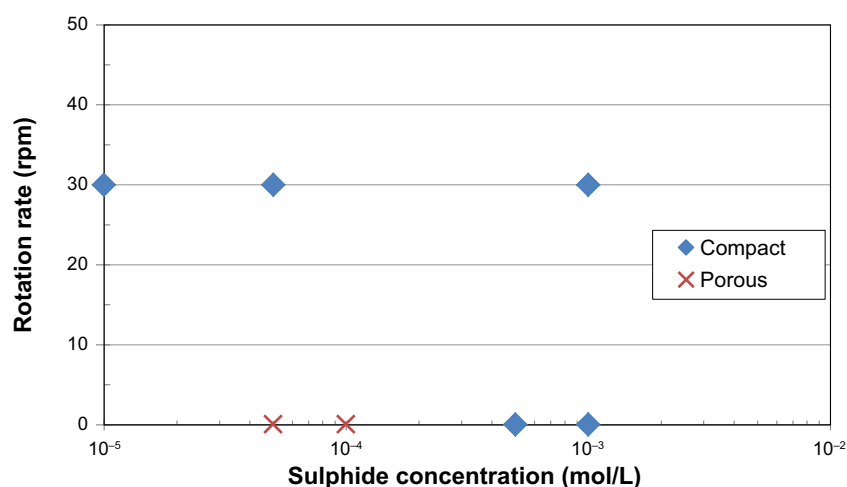
Figure 5-6. Morphology of copper sulphide films as interpreted from cross sections studied with SEM, as a function of bulk sulphide concentration and electrode rotation rate, at a constant chloride concentration of 0.1 mol/L. Data from Chen J et al. (2014) and King et al. (2017).

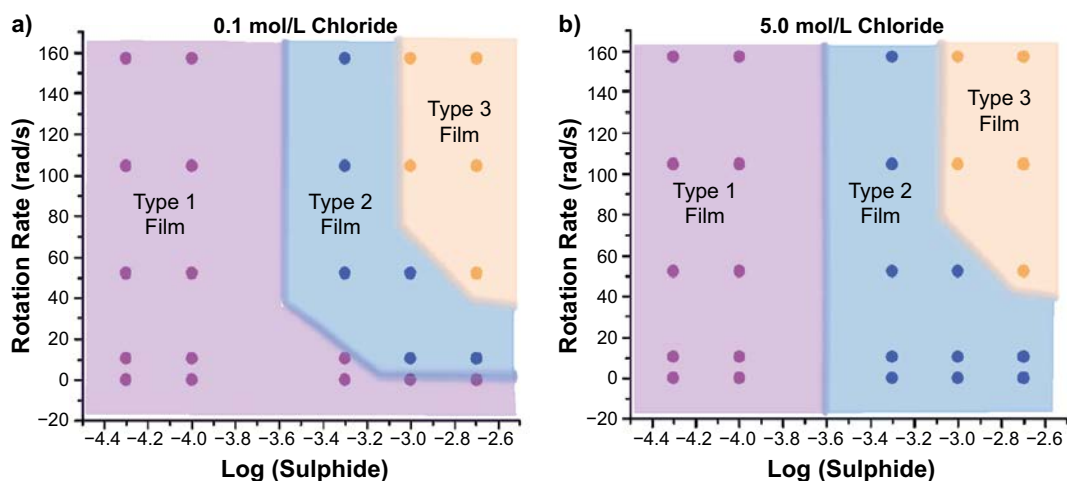
Figure 5-9. Summary of the conditions under which porous (Type I and II) and compact, possibly passive (Type III) films are formed, as a function of sulphide concentration and electrode rotation rate (a measure of the flux of sulphide to the electrode), for a) 0.1 mol/L chloride, b) 5.0 mol/L chloride (Martino et al. 2017).

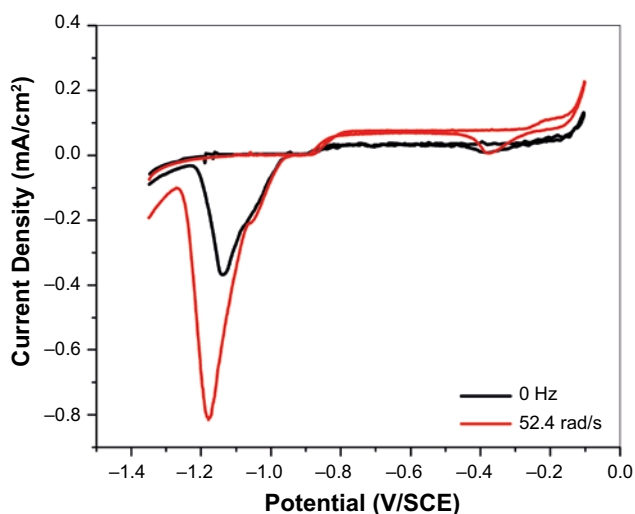
Figure 5-10. Cyclic voltammograms under stagnant conditions and with increased sulphide flux (rotating electrode, 52.4 rad/s), in 10^{-4} mol/L HS^- and 0.1 mol/L Cl^- (Martino et al. 2017).

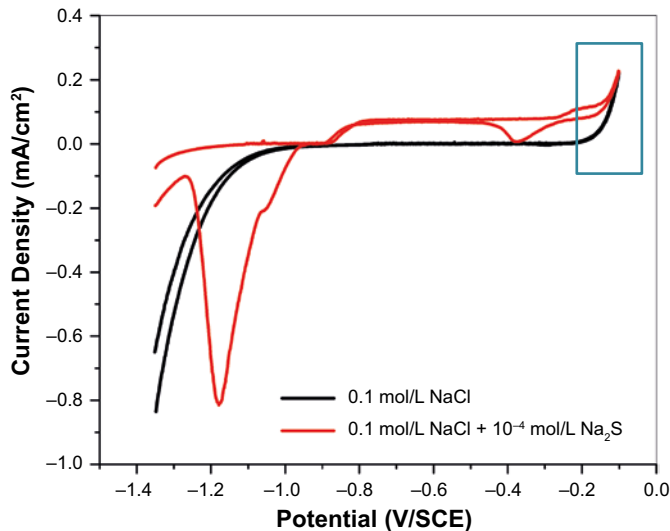
Figure 5-11. Cyclic voltammograms in 0.1 mol/L chloride concentration, with and without added sulphide, using a rotating electrode (52.4 rad/s).

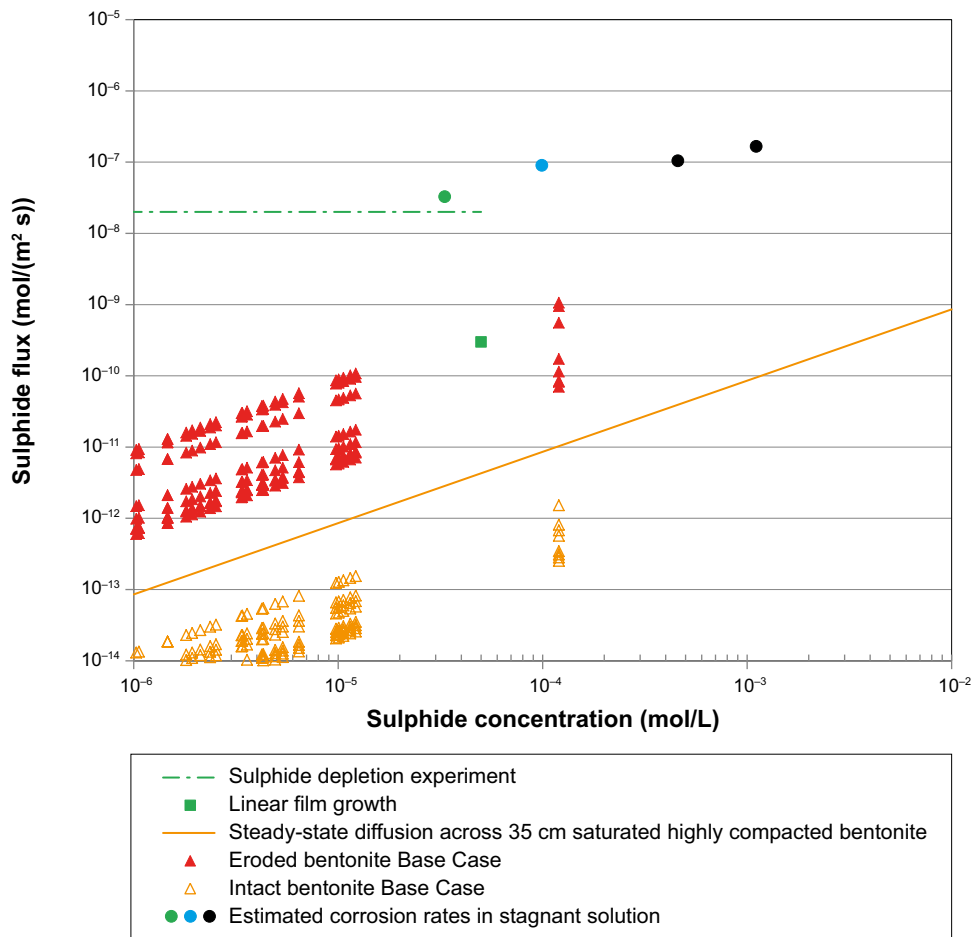
Figure 5-16. Comparison of the flux of sulphide to the canister in the repository (orange and red) with the estimated threshold flux for sulphide-transport control (green) of the overall corrosion reaction. Repository fluxes for intact and eroded bentonite are taken from the Base Case analyses performed for SR-Site. Only the 8 deposition positions with the highest fluxes out of the 6000 are shown. The sulphide flux corresponding to the estimated corrosion rates for experiments in stagnant bulk solution are also shown (circles: green – transport control, blue – mixed control, black – kinetic control).

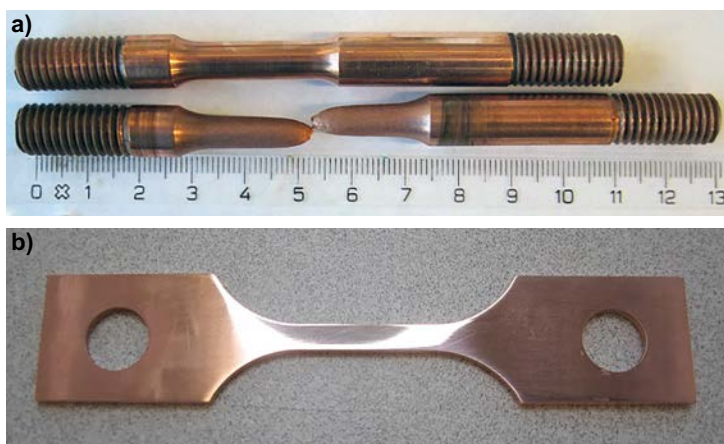
Figure 6-1. Examples of tensile specimens used for slow strain rate testing (SSRT), a) round specimens, before and after drawn to rupture, b) a flat rectangular specimen (Taxén et al. 2018).

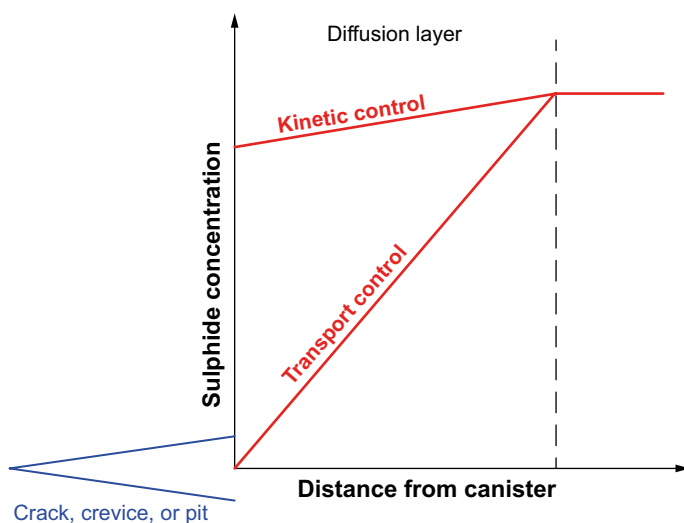
Figure 6-7. Schematic of the difference in surface concentration of sulphide and the resulting driving force for transport into a crack, crevice, or pit depending upon the rate-controlling process for canister corrosion.
