Report  
**P-20-33**  
June 2021

# Prototype Repository – Sensor data report

Period 2001-09-17 to 2020-01-01  
Report No 31

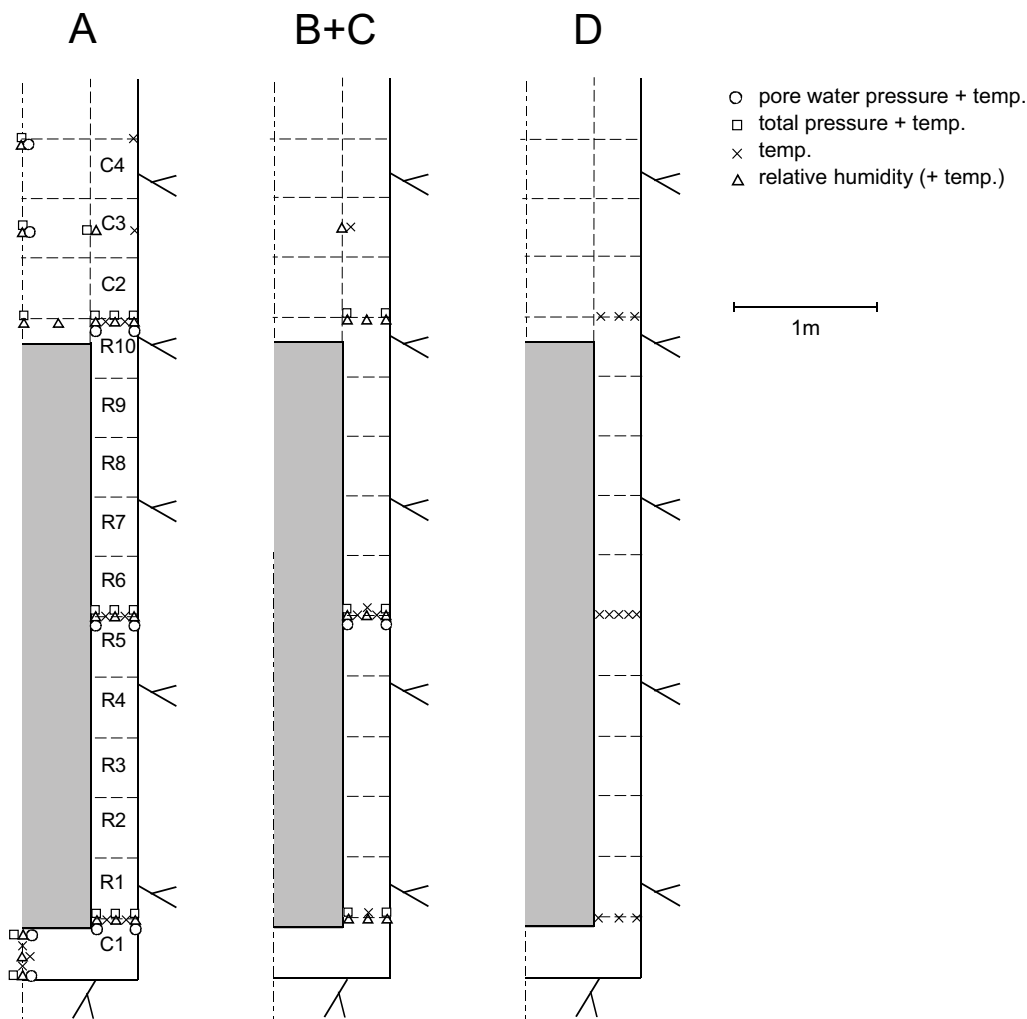
**Figure 4-1.** Schematic view over the instruments in four vertical sections and the block designation.

Figure 4-1 shows an overview of the instruments in the buffer. The bentonite blocks are called cylinders and rings. The cylinders are numbered C1–C4 and the rings R1–R10 respectively.

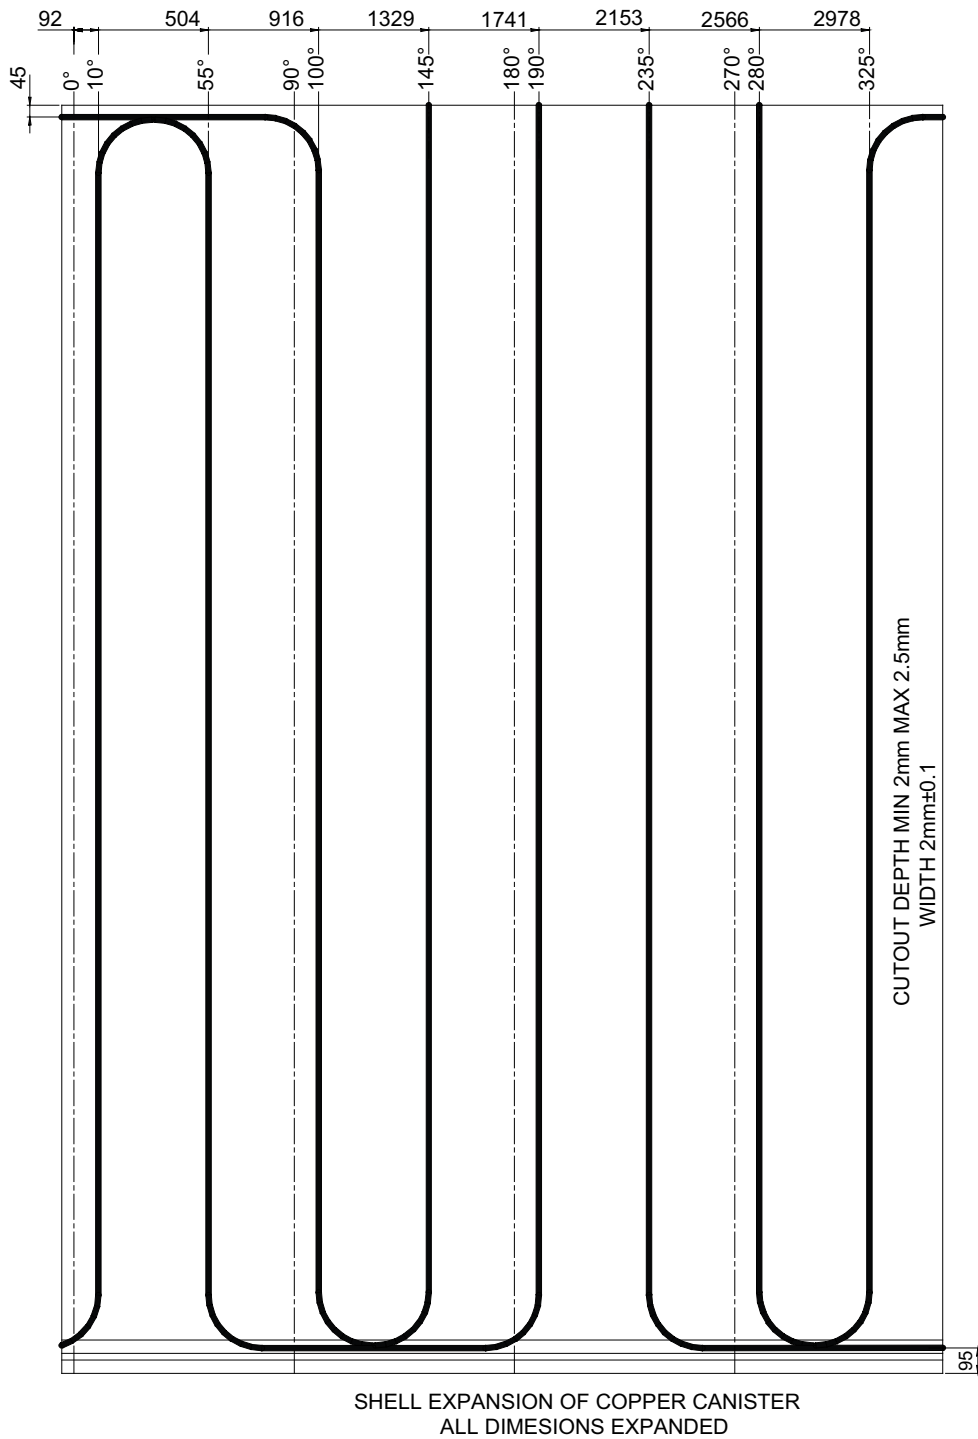
**Figure 4-2.** Laying of the optical fiber cables with protection tube of Inconel 625 (outer diameter 2 mm) for measurement of the canister surface temperature (surface unfolded).

With this laying the cables will enter and exit the surface at almost the same position. Curvatures are shaped as a quarter circle with a radius of 20 cm. The cables are placed in a milled out channels on the surface. The channels have a width and a depth of just above 2 mm.

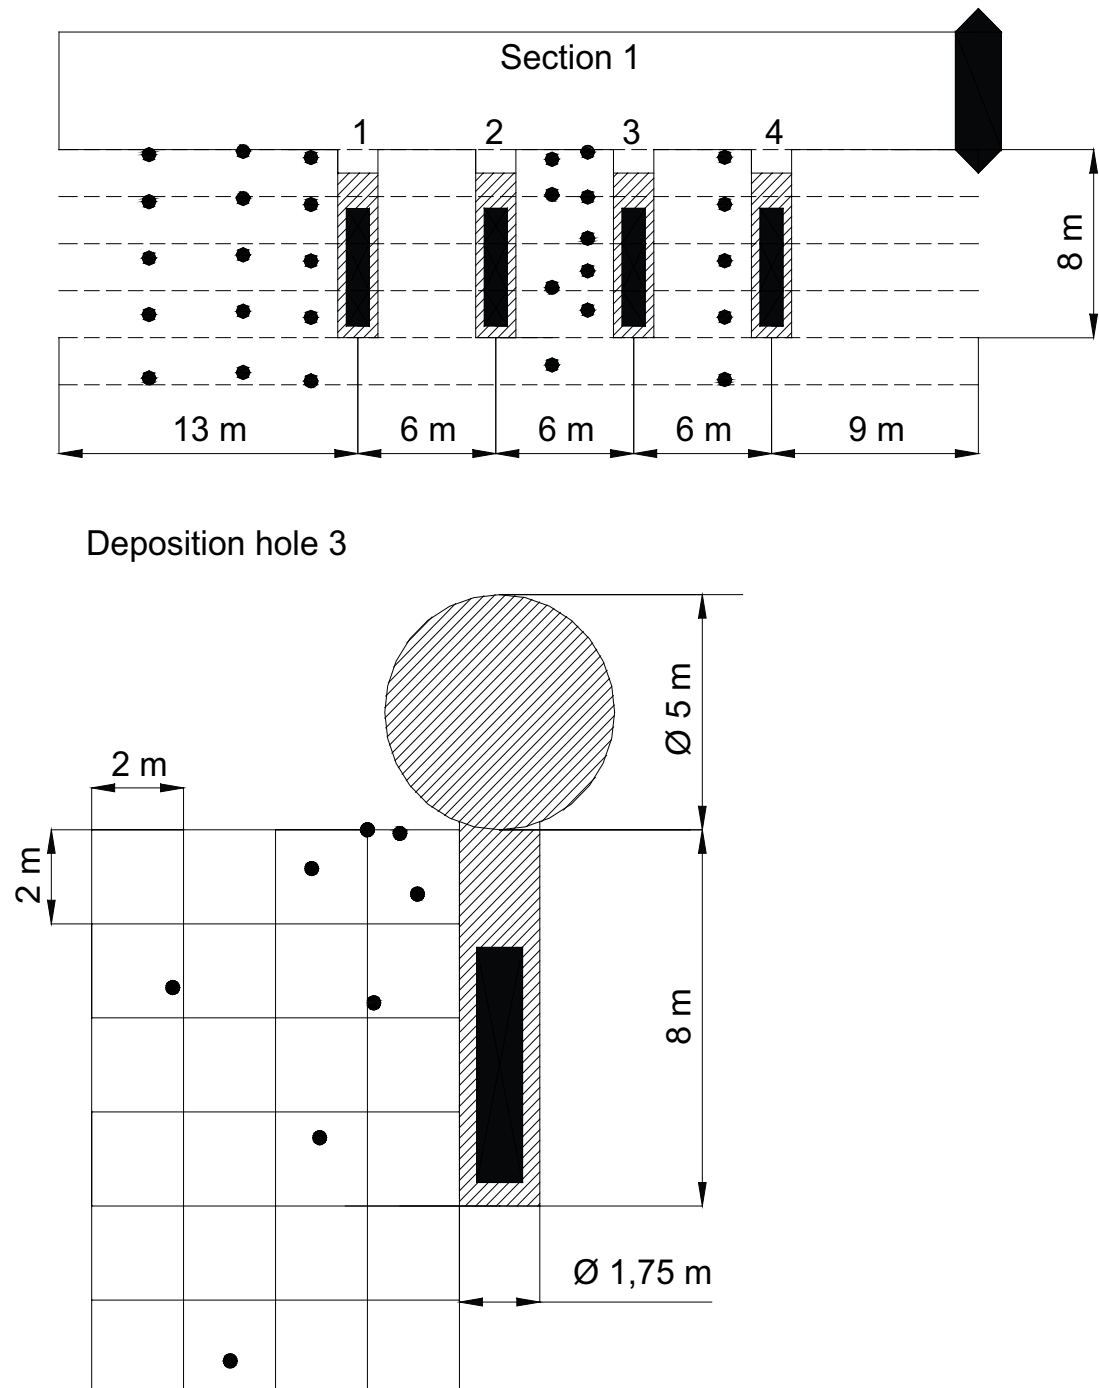
**Figure 4-3.** Overview of the temperature sensors in the rock. Length section (upper) and cross section (towards the end of the tunnel).

The positions of the temperature sensors in the rock are termed in the same way as the sensors in the buffer in the deposition holes. Figure 4-3 shows an overview of the temperature sensors placed in the rock. The sensors are assigned to the closest deposition hole. The positions are described in Table 4-9.

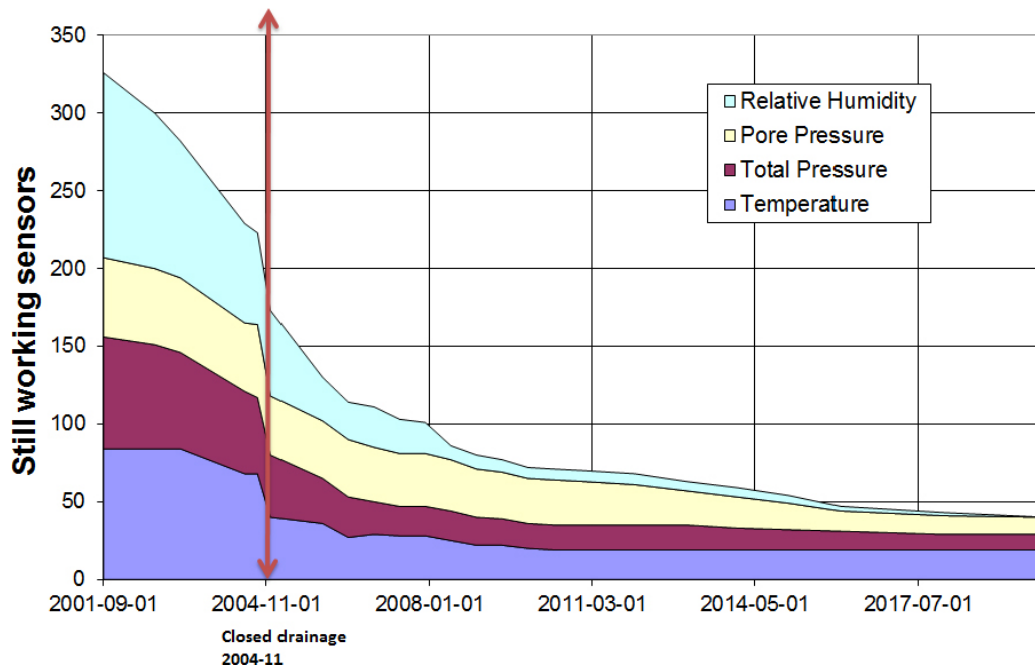
**Figure 5-1.** The number of still working sensors placed in the buffer and backfill in Section 1 as function of date. The coloured fields are representing the four types of installed sensors.

In Figure 5-1 the numbers of still working sensors in the buffer and the backfill of Section 1 are plotted as function of time from September 2001. The figure shows that the majority of the broken sensors are RH-sensors and thermocouples (in deposition hole). The figure also shows that the numbers of broken sensors increased after the closing of the drainage of the tunnel.

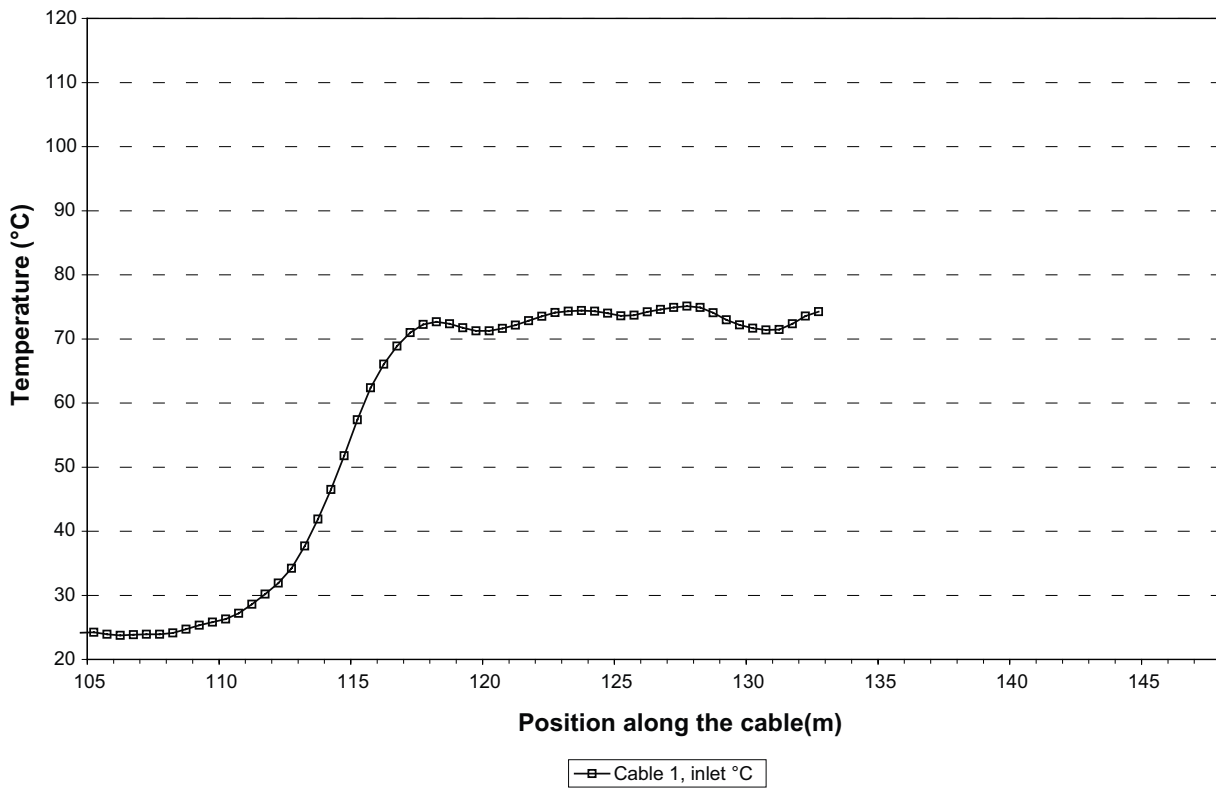
Prototypel Hole 1 \ Canister (041201)  
 Temperature profile on the canister surface - Optical fiber cables

The first diagram shows the maximum temperature, measured with the optical cables placed on the surface of the canister, plotted as function of time. The maximum measured temperature on the canister surface is about 75 °C. With no damages on the optical cables this plot should have four curves. Only one curve with relevant values is presented here up to December 24 which indicates that the optical cables are damaged. The second diagram shows the distribution of the temperature along the optical cables at December 1 2004. The length of the cables on the canister surface is about 20 m. The variation of a few degrees is caused by the difference in temperature in the centre and ends of the canister. At December 15 2004 the optical system for measuring the temperature on this canister stopped functioning.

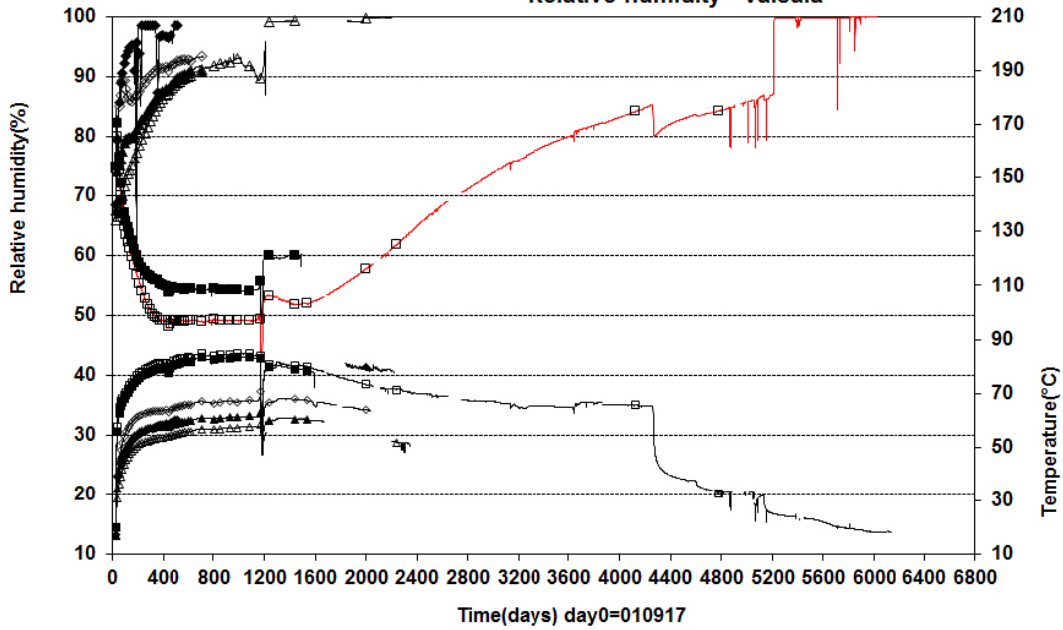
Prototype\Hole 3\Ring 10 (20010917-20200101)  
Relative humidity - Vaisala

| □ WBU30022(5.416\180°\0.050) | ■ WBU30023(5.396\352°\0.262) | ◇ WBU30024(5.396\350°\0.585) |

A significant drying of the bentonite close to the top of the canister was observed by the two sensors WBU30022 and WBU30023. After the closing of the drainage both sensors indicated an instant and significant increasing in relative humidity. Sensor (WBU30022) is earlier measured an increasing in humidity, implying a wetting of the buffer close to the canister lid.

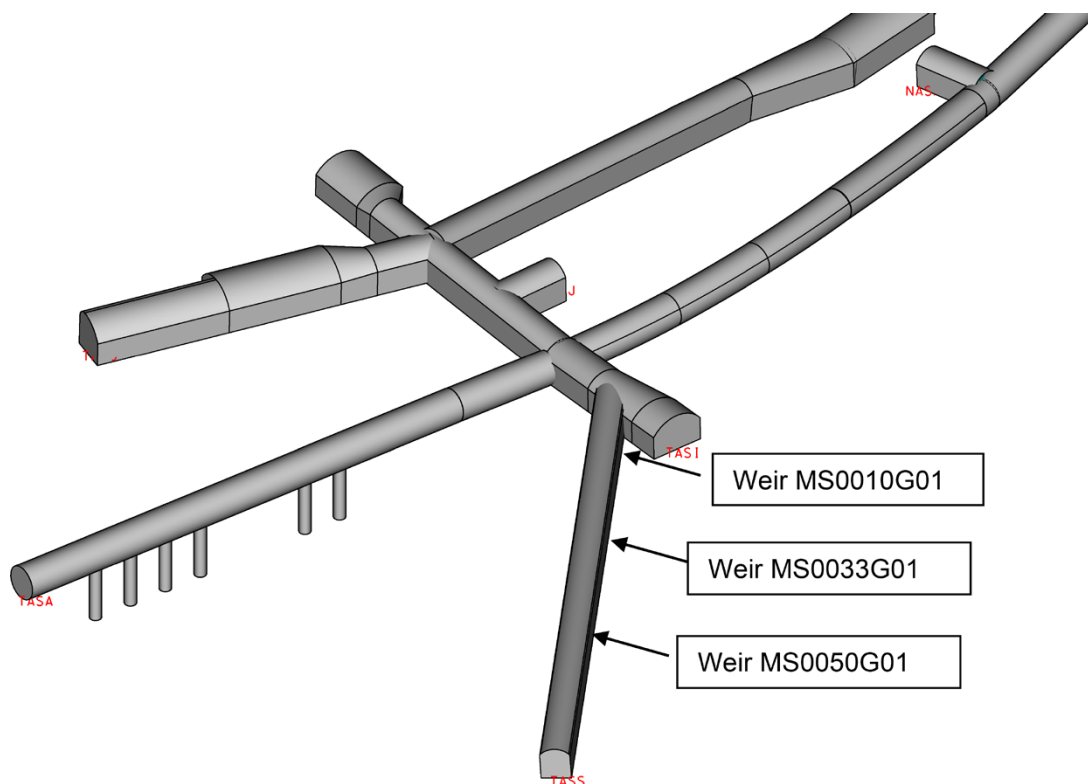
**Figure A5-3.** The tunnel-system including the TASS-tunnel with indication of the weir locations in TASS.

Three weirs are located within the TASS-tunnel and their locations are shown in Figure A5-3 below, measuring the flow into sections 10–33 m, 33–50 m and 50–80.7 m respectively.
