Report  
**P-21-28**  
April 2022

# Prototype Repository – Sensor data report

Period 2001-09-17 to 2021-01-01  
Report No 32

Reza Goudarzi, Clay Technology AB

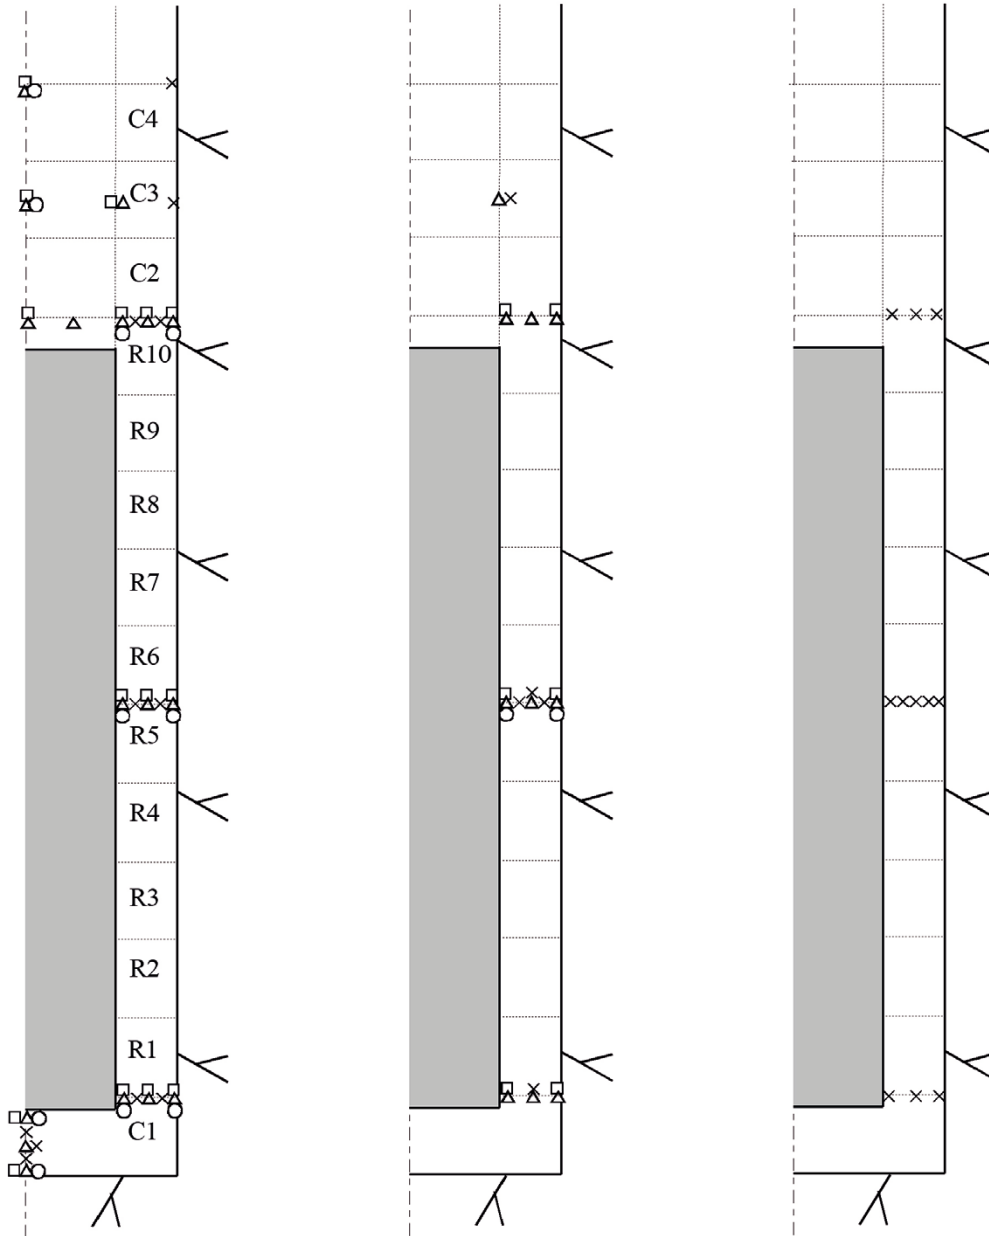
Figure 4-1. Schematic view over the instruments in four vertical sections and the block designation.

The instruments are located in three main levels in the blocks, 50 mm, 160 mm and 250 mm, from the upper surface. The thermocouples are mostly placed in the 50 mm level and the other gauges in the 160 mm level except for the Geocon type 1 pressure sensors and the Rotronic humidity sensors, which are placed in the 250 mm level depending on the size of the sensor house.

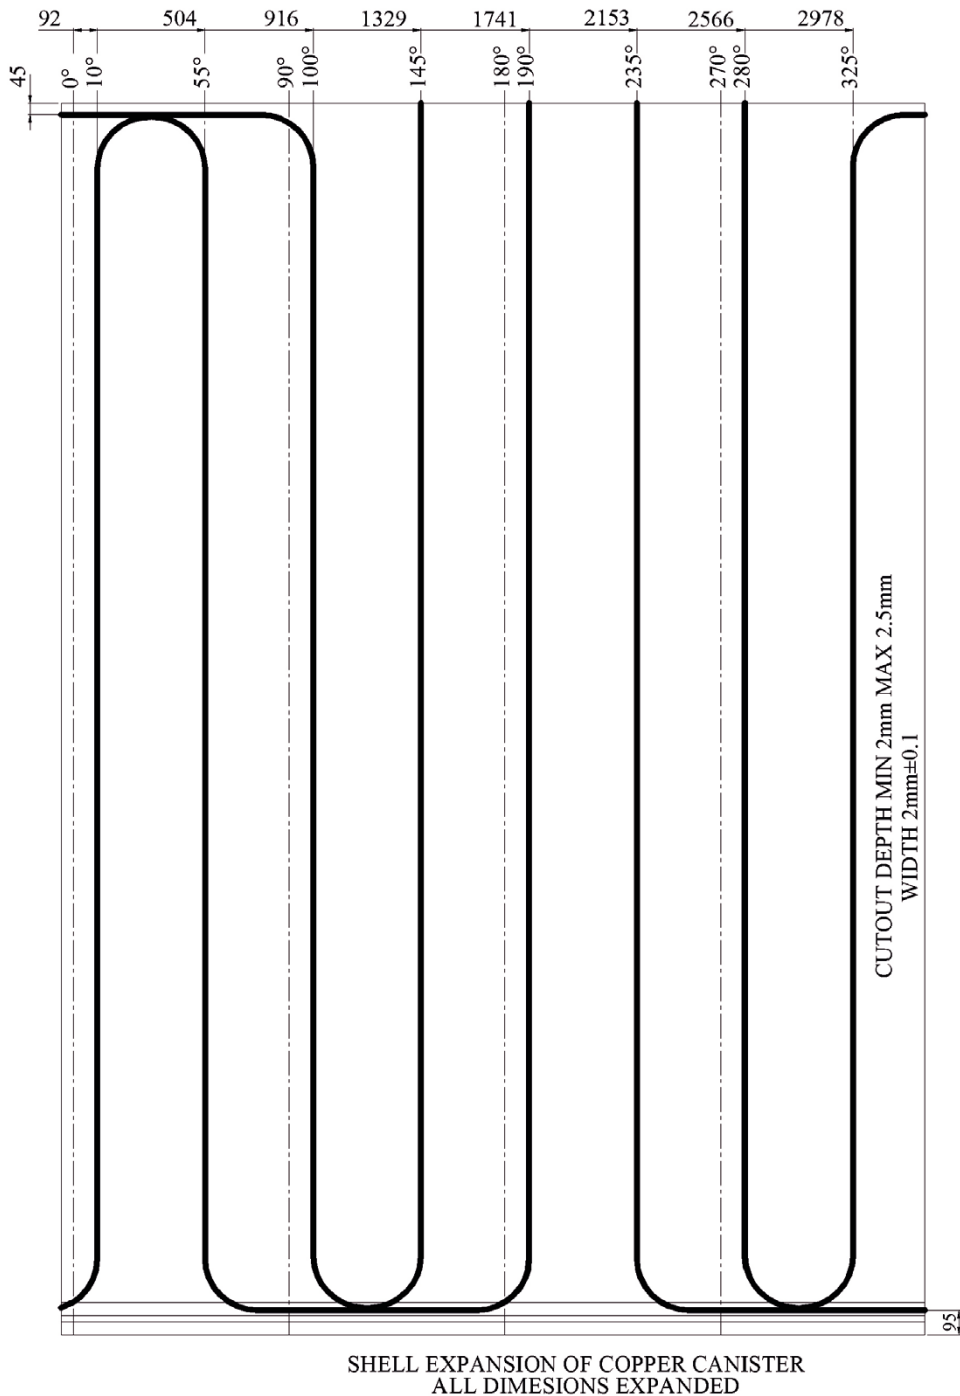
**Figure 4-2.** Laying of the optical fiber cables with protection tube of Inconel 625 (outer diameter 2 mm) for measurement of the canister surface temperature (surface unfolded).

With this laying the cables will enter and exit the surface at almost the same position. Curvatures are shaped as a quarter circle with a radius of 20 cm. The cables are placed in a milled out channel on the surface. The channels have a width and a depth of just above 2 mm.

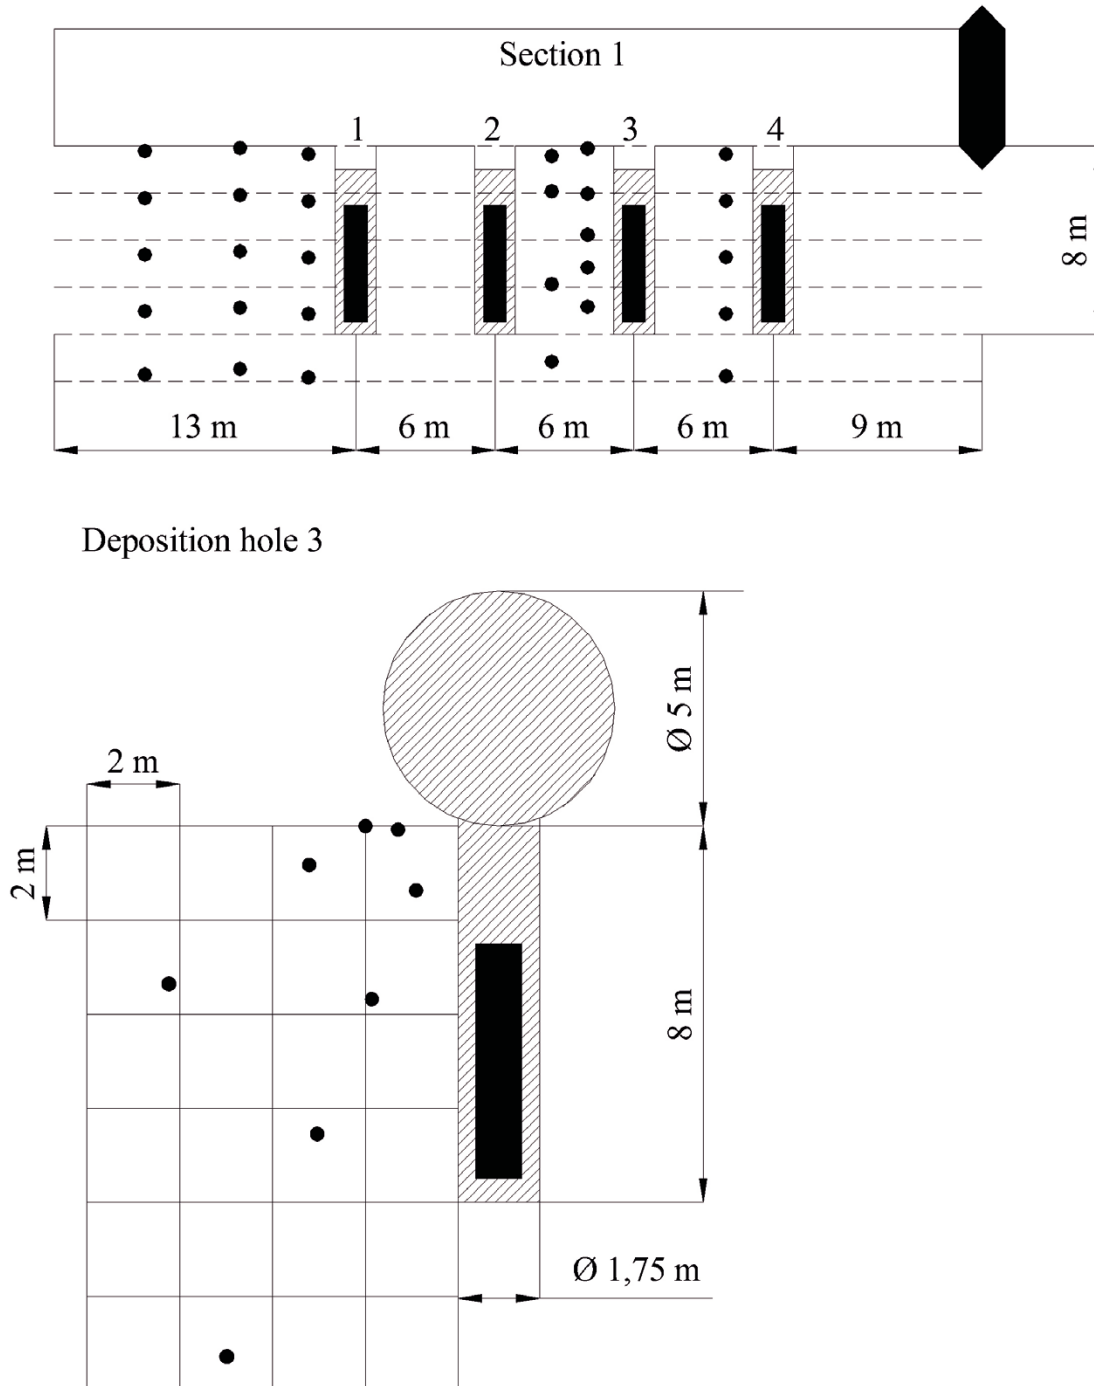
**Figure 4-3.** Overview of the temperature sensors in the rock. Length section (upper) and cross section (towards the end of the tunnel).

The positions of the temperature sensors in the rock are termed in the same way as the sensors in the buffer in the deposition holes. Figure 4-3 shows an overview of the temperature sensors placed in the rock. The sensors are assigned to the closest deposition hole. The positions are described in Table 4-9.

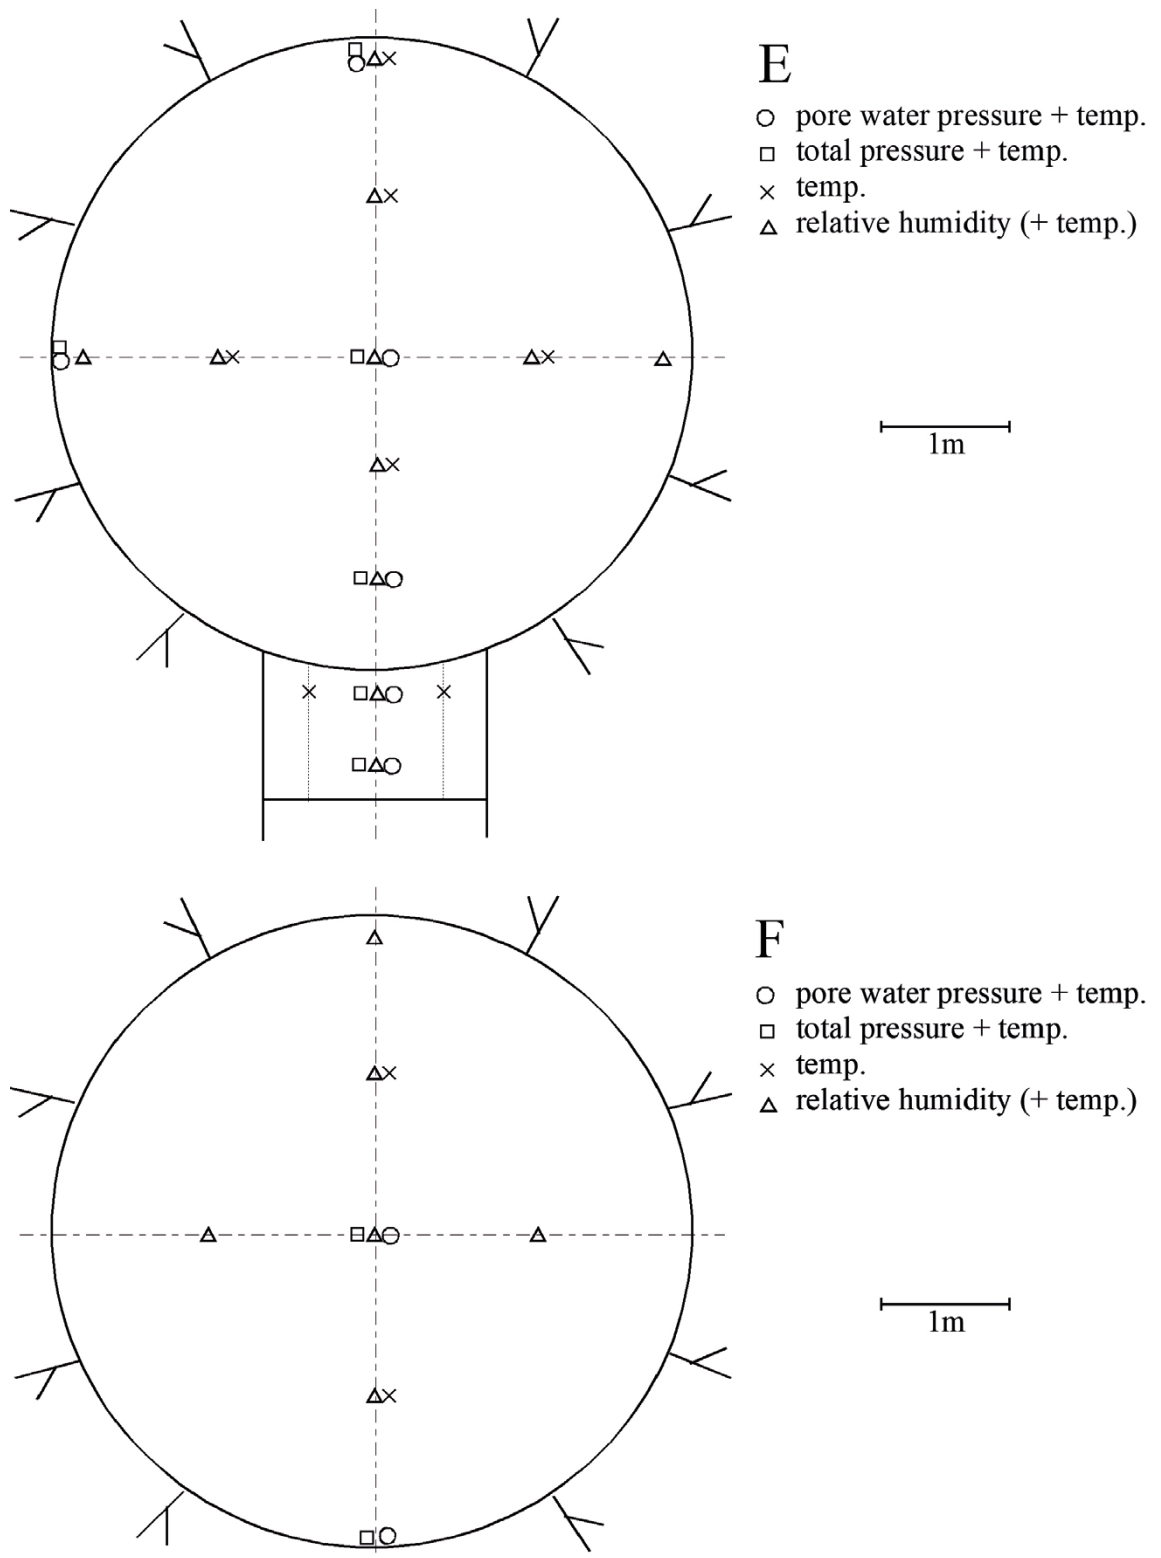
**Figure 4-5.** Schematic view over the sensors positions in the different sections.

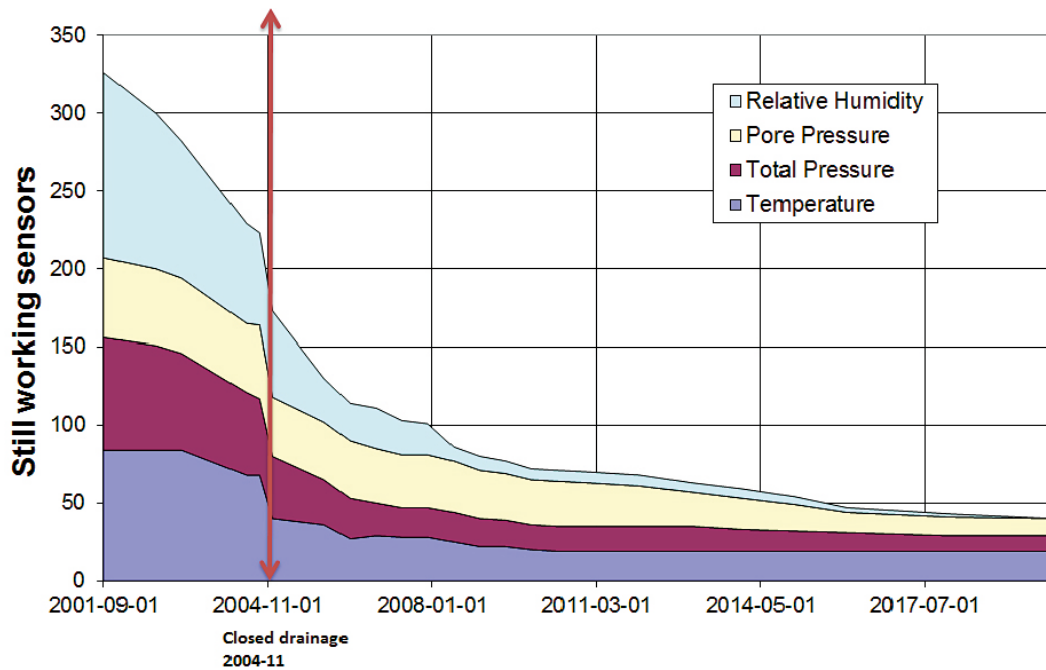
**Figure 5-1.** The number of still working sensors placed in the buffer and backfill in Section 1 as function of date. The coloured fields are representing the four types of installed sensors.

In Figure 5-1 the numbers of still working sensors in the buffer and the backfill of Section 1 are plotted as function of time from September 2001. The figure shows that the majority of the broken sensors are RH-sensors and thermocouples (in deposition hole). The figure also shows that the numbers of broken sensors increased after the closing of the drainage of the tunnel.

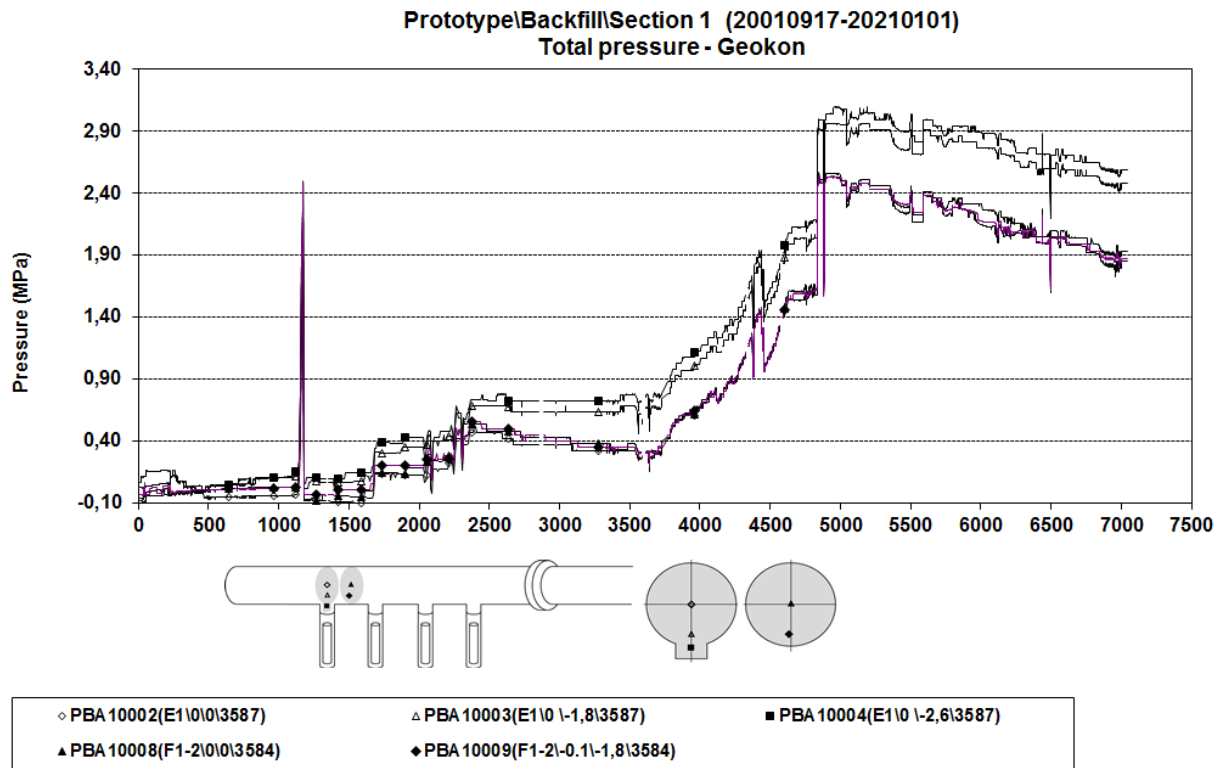
Prototype\Backfill\Section 1 (20010917-20210101)  
Total pressure - Geokon

All these sensors yielded high increase in total pressure in connection with closing of the tunnel drainage. The maximum measured pressure was about 2.5 MPa. After the opening of the drainage the total pressure was stabilized on the same level as before the closing of the drainage (maximum pressure about 0.2 MPa). At around the 20th of April 2006, a packer placed in a borehole in Section I of the tunnel started to leak resulting in an increase of water drained out from the inner section from about 1.5 l/min to about 9 l/min. The damaged packer also caused an increase in the measured total pressure of about 300 kPa (around day 1 660). At the beginning of April 2007 some of the sensors indicated an increase in the measured pressure. The change in the measure pressures was probably related to the work with the excavation of a new tunnel near by the Prototype-tunnel which was initialized at that time. The measured total pressures at the end of this measuring period vary between 1 600– 2 600 kPa at the end of this measuring period. The rapidly increase of pressure around day 4 600 caused probably by a damaged packer. Three sensors are out of order.

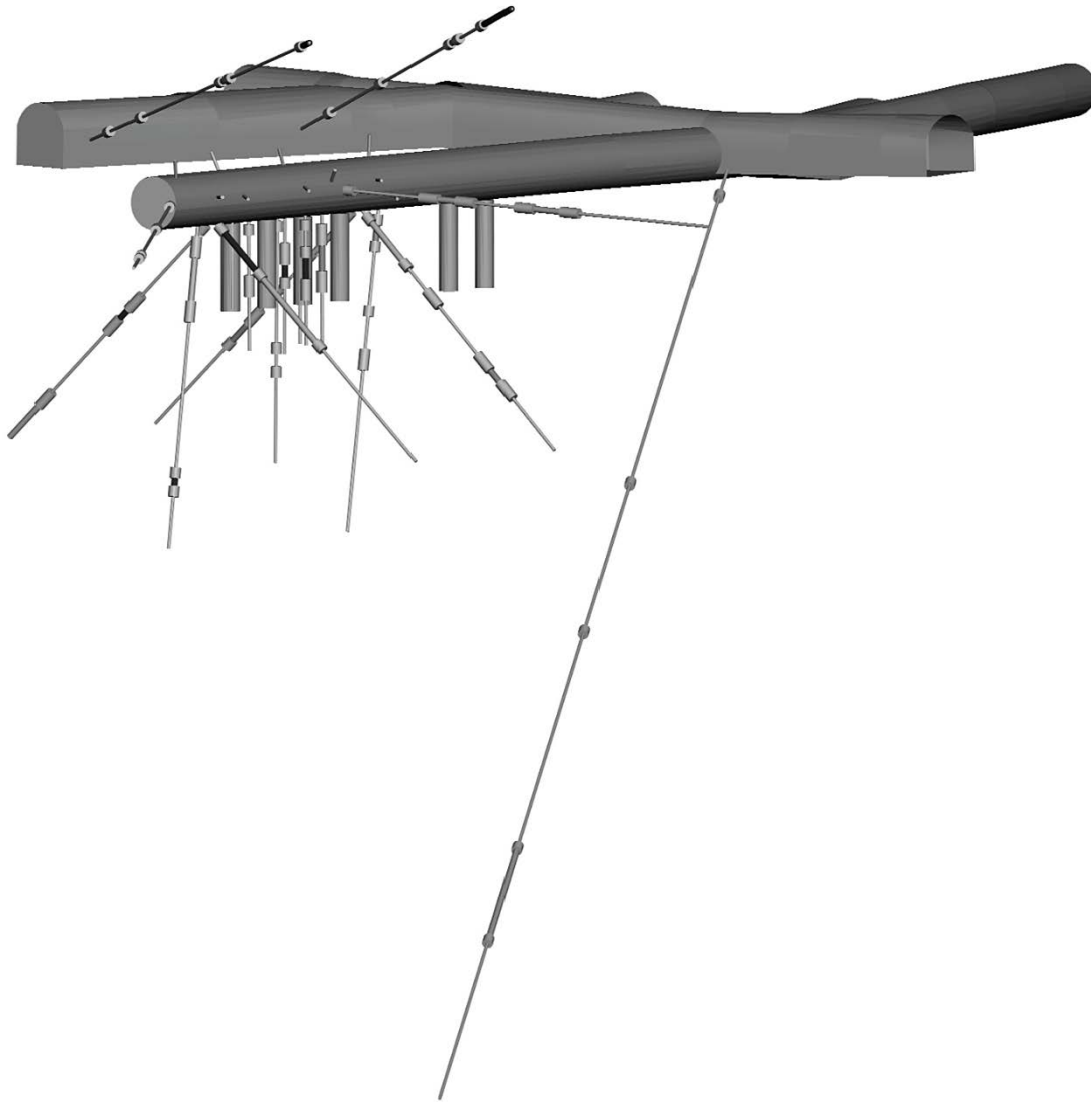
**Figure A5-1.** View of the drilled core holes in the Prototype Repository Section I. The length from the I-tunnel to the end of the TBM-tunnel is 90 m. The diameter of the TBM tunnel is 5 m and the diameter of the deposition holes is 1.75 m. The depth of the deposition holes is 8.37 m in the centre and 8.15 m along the deposition hole wall. The diameter of the core holes is 76 mm except for the short core holes in the roof of the TBM tunnel that have a diameter of 56 mm. The monitoring boreholes used in the presentation in this report are located in the inner part of the tunnel surrounding the area with the four innermost canister holes. Also included are two holes drilled from the G-tunnel and the long hole KA3510A drilled from the main tunnel.

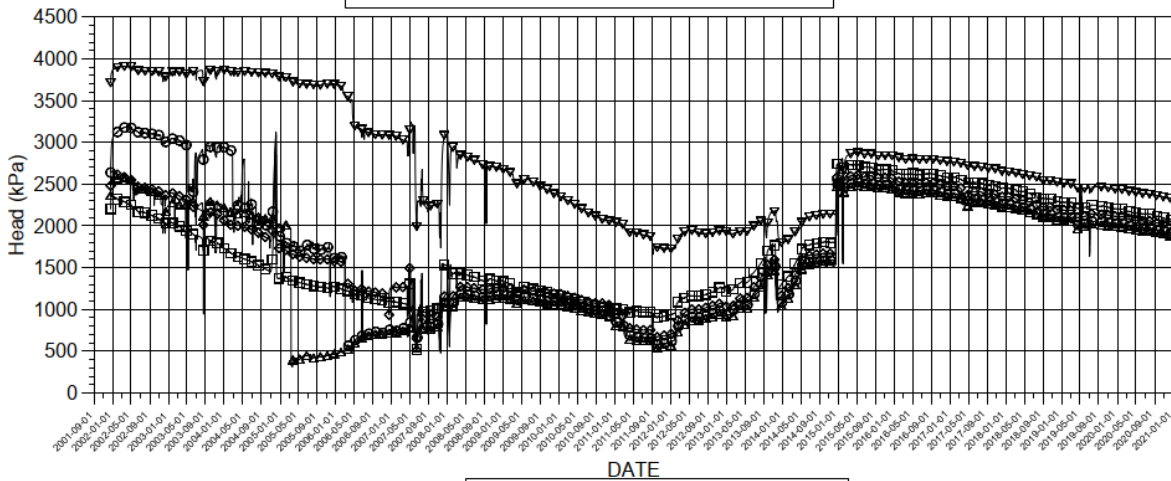
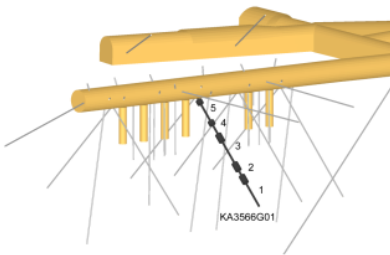
### KA3566G01 PRESSURE HEAD

- Start backfilling of section I 2001-09-03
- Stop backfilling of section I 2001-11-20
- Casting of inner plug finalized 2001-12-19
- Start backfilling of section II 2003-04-29
- Stop backfilling of section II 2003-06-27
- Casting of outer plug finalized 2003-09-11
- Packer failure of KA3573A.3 2006-04-18
- Start drilling of Fine Sealing Project 2007-03-12
- Start grouting of Fine Sealing Project 2007-11-19
- Excavation start of TASS tunnel 2007-12-11
- Excavation stop of TASS tunnel 2008-12-18
- Demolition work start Section II December 2010
- Demolition work Section II finalized 2011-12-15
- Replacement of packers Section II December 2014

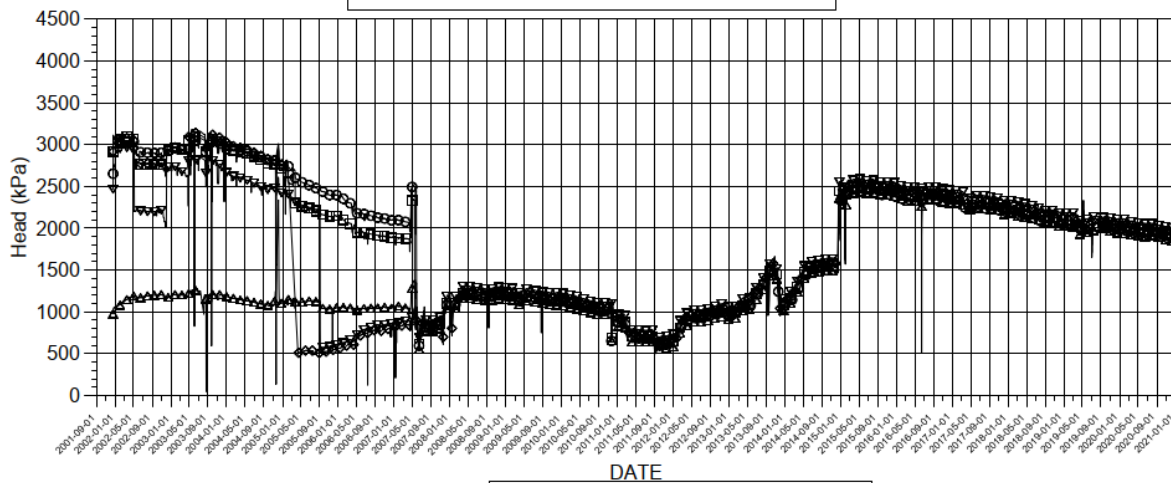
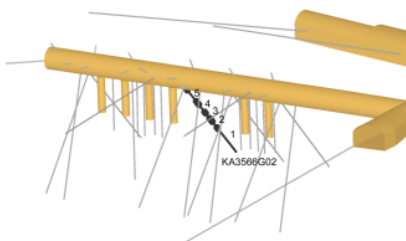
### KA3566G02 PRESSURE HEAD

- Start backfilling of section I 2001-09-03
- Stop backfilling of section I 2001-11-20
- Casting of inner plug finalized 2001-12-19
- Start backfilling of section II 2003-04-29
- Stop backfilling of section II 2003-06-27
- Casting of outer plug finalized 2003-09-11
- Packer failure of KA3573A.3 2006-04-18
- Start drilling of Fine Sealing Project 2007-03-12
- Start grouting of Fine Sealing Project 2007-11-19
- Excavation start of TASS tunnel 2007-12-11
- Excavation stop of TASS tunnel 2008-12-18
- Demolition work start Section II December 2010
- Demolition work Section II finalized 2011-12-15
- Replacement of packers Section II December 2014

- ▽ G02:1 19 m - 30 m
- ◇ G02:2 16 m - 18 m
- G02:3 12 m - 14 m
- G02:4 8 m - 11 m
- △ G02:5 1.5 m - 6 m
